# Cane Creek Tributary Stream Restoration Site Monitoring Report MY04

Basin 03010104  
EEP Project ID # 92325  
Contract # D06002

February 2013

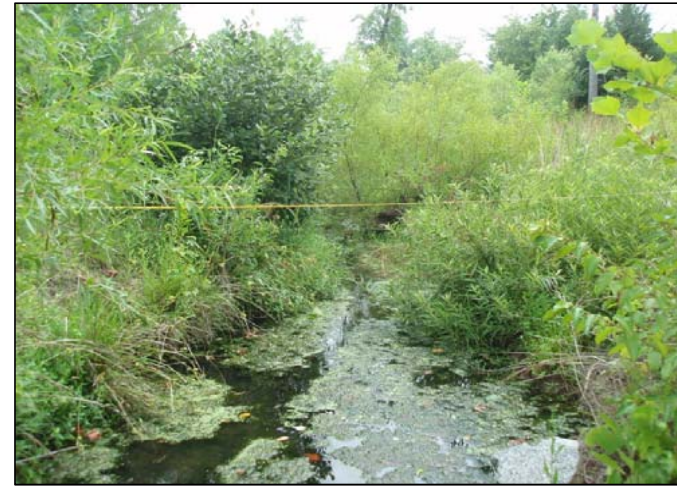
Station	Elevation
0.0	501.64
0.7	501.33
3.3	501.15
5.5	500.96
8.8	500.43
12.2	499.98
15.2	499.65
18.8	499.57
20.5	499.38
21.0	499.17
21.3	498.35
22.1	497.69
22.8	497.08
23.5	496.58
24.7	496.07
26.7	495.67
28.4	496.03
30.0	496.06
30.8	496.32
31.4	496.93
31.7	497.64
32.9	497.96
34.1	498.54
34.5	499.41
35.5	499.58
38.3	499.67
41.9	500.24
45.5	500.99
49.4	501.28
54.1	501.66
57.7	501.67
60.2	501.62
60.3	501.89

SUMMARY DATA	
<b>Bankfull Elevation:</b>	499.4
<b>Bankfull Cross-Sectional Area:</b>	35.2
<b>Bankfull Width:</b>	14.0
<b>Flood Prone Area Elevation:</b>	-
<b>Flood Prone Width:</b>	-
<b>Max Depth at Bankfull:</b>	3.7
<b>Mean Depth at Bankfull:</b>	2.5
<b>W / D Ratio:</b>	-
<b>Entrenchment Ratio:</b>	-
<b>Bank Height Ratio:</b>	-

Stream Type C/B4

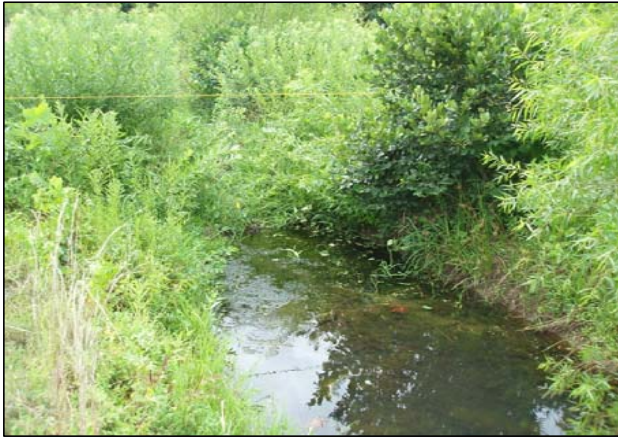
<b>River Basin:</b>	Roanoke
<b>Watershed:</b>	Cane Creek, MY-04
<b>XS ID</b>	XS-2, Riffle, T1-4
<b>Drainage Area (sq mi):</b>	0.62
<b>Date:</b>	7/16/2012
<b>Field Crew:</b>	A. French, F. Davis

Station	Elevation
0.0	501.44
0.4	501.24
2.5	501.32
5.3	501.26
10.3	501.22
14.4	500.78
17.2	499.89
19.1	499.34
21.2	498.70
23.1	498.27
25.6	497.73
28.4	497.48
31.1	497.26
33.3	497.00
34.4	496.76
34.9	496.27
35.5	495.58
36.4	495.41
37.1	495.56
38.1	495.61
39.0	495.57
40.1	495.48
40.9	495.58
41.5	495.97
42.4	496.40
43.5	496.39
44.4	496.97
45.9	497.17
47.7	497.38
50.8	497.48
52.8	497.67
55.1	498.32
57.2	498.85
59.5	499.23
60.5	499.73
61.6	500.01
63.3	500.31
67.5	500.61
69.5	500.73
70.0	500.95

SUMMARY DATA	
<b>Bankfull Elevation:</b>	497.4
<b>Bankfull Cross-Sectional Area:</b>	17.0
<b>Bankfull Width:</b>	18.2
<b>Flood Prone Area Elevation:</b>	499.3
<b>Flood Prone Width:</b>	40.0
<b>Max Depth at Bankfull:</b>	2.0
<b>Mean Depth at Bankfull:</b>	0.9
<b>W / D Ratio:</b>	19.5
<b>Entrenchment Ratio:</b>	2.2
<b>Bank Height Ratio:</b>	1.0

<b>Stream Type</b>	C/B4
--------------------	------

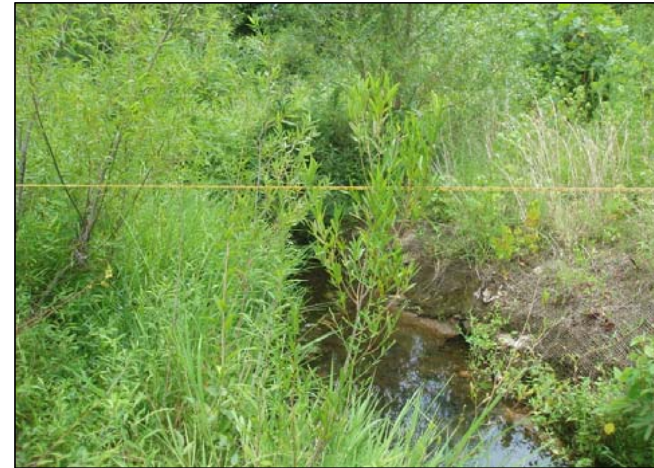
<b>River Basin:</b>	Roanoke
<b>Watershed:</b>	Cane Creek, MY-04
<b>XS ID</b>	XS-3, Pool, T1-4
<b>Drainage Area (sq mi):</b>	0.62
<b>Date:</b>	7/16/2012
<b>Field Crew:</b>	A. French, F. Davis

Station	Elevation
0.0	499.31
1.4	499.05
5.0	498.73
6.6	498.43
8.8	497.70
11.6	496.49
14.0	496.02
17.2	495.66
19.8	495.25
21.8	494.89
23.2	494.52
25.1	494.27
25.6	494.01
25.9	493.58
26.5	492.93
27.2	492.60
28.0	492.49
29.1	492.05
29.8	491.98
30.5	492.66
31.4	493.58
31.8	494.07
33.1	494.75
33.7	494.91
34.5	495.59
36.5	495.93
39.4	495.93
41.7	496.24
43.4	496.72
45.7	497.48
48.0	498.09
50.7	498.32
53.4	498.38
55.1	498.38
55.6	498.56

SUMMARY DATA	
<b>Bankfull Elevation:</b>	495.2
<b>Bankfull Cross-Sectional Area:</b>	19.6
<b>Bankfull Width:</b>	14.0
<b>Flood Prone Area Elevation:</b>	-
<b>Flood Prone Width:</b>	-
<b>Max Depth at Bankfull:</b>	3.2
<b>Mean Depth at Bankfull:</b>	1.4
<b>W / D Ratio:</b>	-
<b>Entrenchment Ratio:</b>	-
<b>Bank Height Ratio:</b>	-

<b>Stream Type</b>	C/B4
--------------------	------

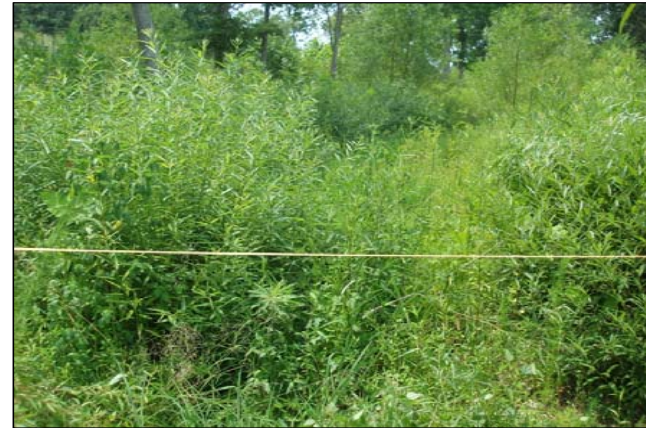
<b>River Basin:</b>	Roanoke
<b>Watershed:</b>	Cane Creek, MY-04
<b>XS ID</b>	XS-4, Riffle, T1-5
<b>Drainage Area (sq mi):</b>	0.70
<b>Date:</b>	7/16/2012
<b>Field Crew:</b>	A. French, F. Davis

Station	Elevation
0.0	493.61
0.0	493.27
2.9	493.14
4.7	492.95
5.8	492.48
8.6	491.80
11.3	490.79
13.8	490.25
17.4	489.77
20.5	489.65
23.5	488.89
26.3	488.68
28.6	488.40
30.0	488.08
31.5	487.53
33.0	487.44
33.7	487.89
34.5	488.19
35.9	488.51
37.3	488.74
37.8	489.63
39.8	489.69
41.5	489.92
44.1	490.45
45.9	491.05
48.7	491.62
51.0	491.68
53.5	491.82
54.0	491.99

SUMMARY DATA	
<b>Bankfull Elevation:</b>	489.6
<b>Bankfull Cross-Sectional Area:</b>	19.3
<b>Bankfull Width:</b>	17.1
<b>Flood Prone Area Elevation:</b>	491.7
<b>Flood Prone Width:</b>	42.0
<b>Max Depth at Bankfull:</b>	2.2
<b>Mean Depth at Bankfull:</b>	1.1
<b>W / D Ratio:</b>	15.2
<b>Entrenchment Ratio:</b>	2.5
<b>Bank Height Ratio:</b>	1.0

Stream Type C/B4

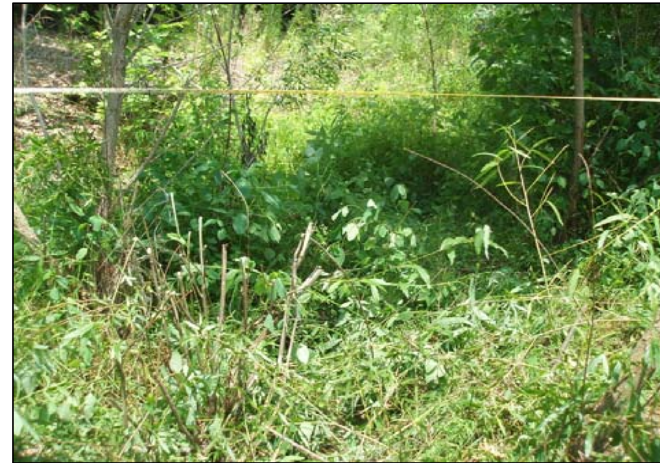
<b>River Basin:</b>	Roanoke
<b>Watershed:</b>	Cane Creek, MY-04
<b>XS ID</b>	XS-5, Riffle, T2-2
<b>Drainage Area (sq mi):</b>	0.11
<b>Date:</b>	7/16/2012
<b>Field Crew:</b>	A. French, F. Davis

Station	Elevation
0.0	520.97
0.9	520.59
3.1	519.98
4.7	519.63
6.4	519.15
8.6	518.46
10.7	517.77
12.6	516.96
14.7	516.27
16.7	515.98
18.4	515.85
20.2	515.45
21.9	514.75
22.4	514.54
23.3	514.41
24.2	514.55
25.0	515.13
25.9	515.41
27.5	515.85
29.0	516.03
31.0	516.13
33.0	516.51
35.3	517.10
37.6	517.67
39.7	518.31
41.7	518.76
42.0	518.85
45.1	519.45
46.9	519.94
47.1	520.20

SUMMARY DATA	
<b>Bankfull Elevation:</b>	515.7
<b>Bankfull Cross-Sectional Area:</b>	5.1
<b>Bankfull Width:</b>	7.8
<b>Flood Prone Area Elevation:</b>	517.0
<b>Flood Prone Width:</b>	23.0
<b>Max Depth at Bankfull:</b>	1.3
<b>Mean Depth at Bankfull:</b>	0.7
<b>W / D Ratio:</b>	11.9
<b>Entrenchment Ratio:</b>	2.9
<b>Bank Height Ratio:</b>	1.0

<b>Stream Type</b>	C/E4
--------------------	------

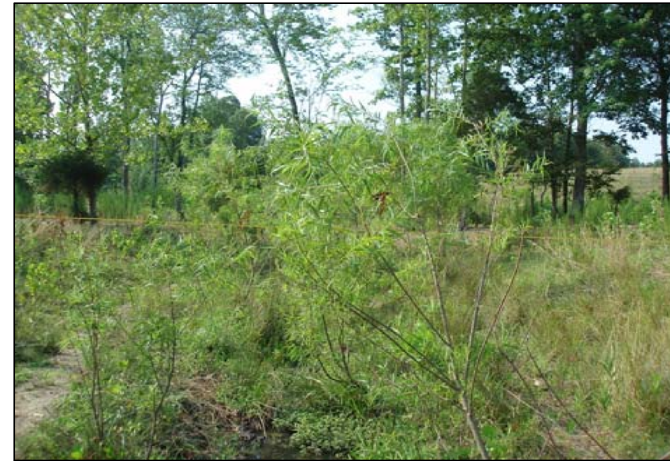
<b>River Basin:</b>	Roanoke
<b>Watershed:</b>	Cane Creek, MY-04
<b>XS ID</b>	XS-8, Riffle, T3-2
<b>Drainage Area (sq mi):</b>	0.08
<b>Date:</b>	7/16/2012
<b>Field Crew:</b>	A. French, F. Davis

Station	Elevation
0.0	513.24
0.6	512.90
3.6	512.63
6.1	512.11
7.3	511.65
9.7	510.76
12.2	509.92
14.8	508.95
16.7	508.43
19.7	508.27
22.3	508.05
23.5	507.81
24.7	507.66
25.6	507.45
26.2	507.23
26.9	507.28
27.6	507.27
29.3	507.66
30.0	508.02
32.0	508.27
34.5	508.39
38.4	509.02
41.6	509.61
45.3	510.42
49.0	511.20
53.2	512.13
56.0	512.50
56.4	512.71
56.3	512.80

SUMMARY DATA	
<b>Bankfull Elevation:</b>	508.0
<b>Bankfull Cross-Sectional Area:</b>	3.5
<b>Bankfull Width:</b>	7.8
<b>Flood Prone Area Elevation:</b>	508.8
<b>Flood Prone Width:</b>	23.5
<b>Max Depth at Bankfull:</b>	0.8
<b>Mean Depth at Bankfull:</b>	0.4
<b>W / D Ratio:</b>	17.4
<b>Entrenchment Ratio:</b>	3.0
<b>Bank Height Ratio:</b>	1.0

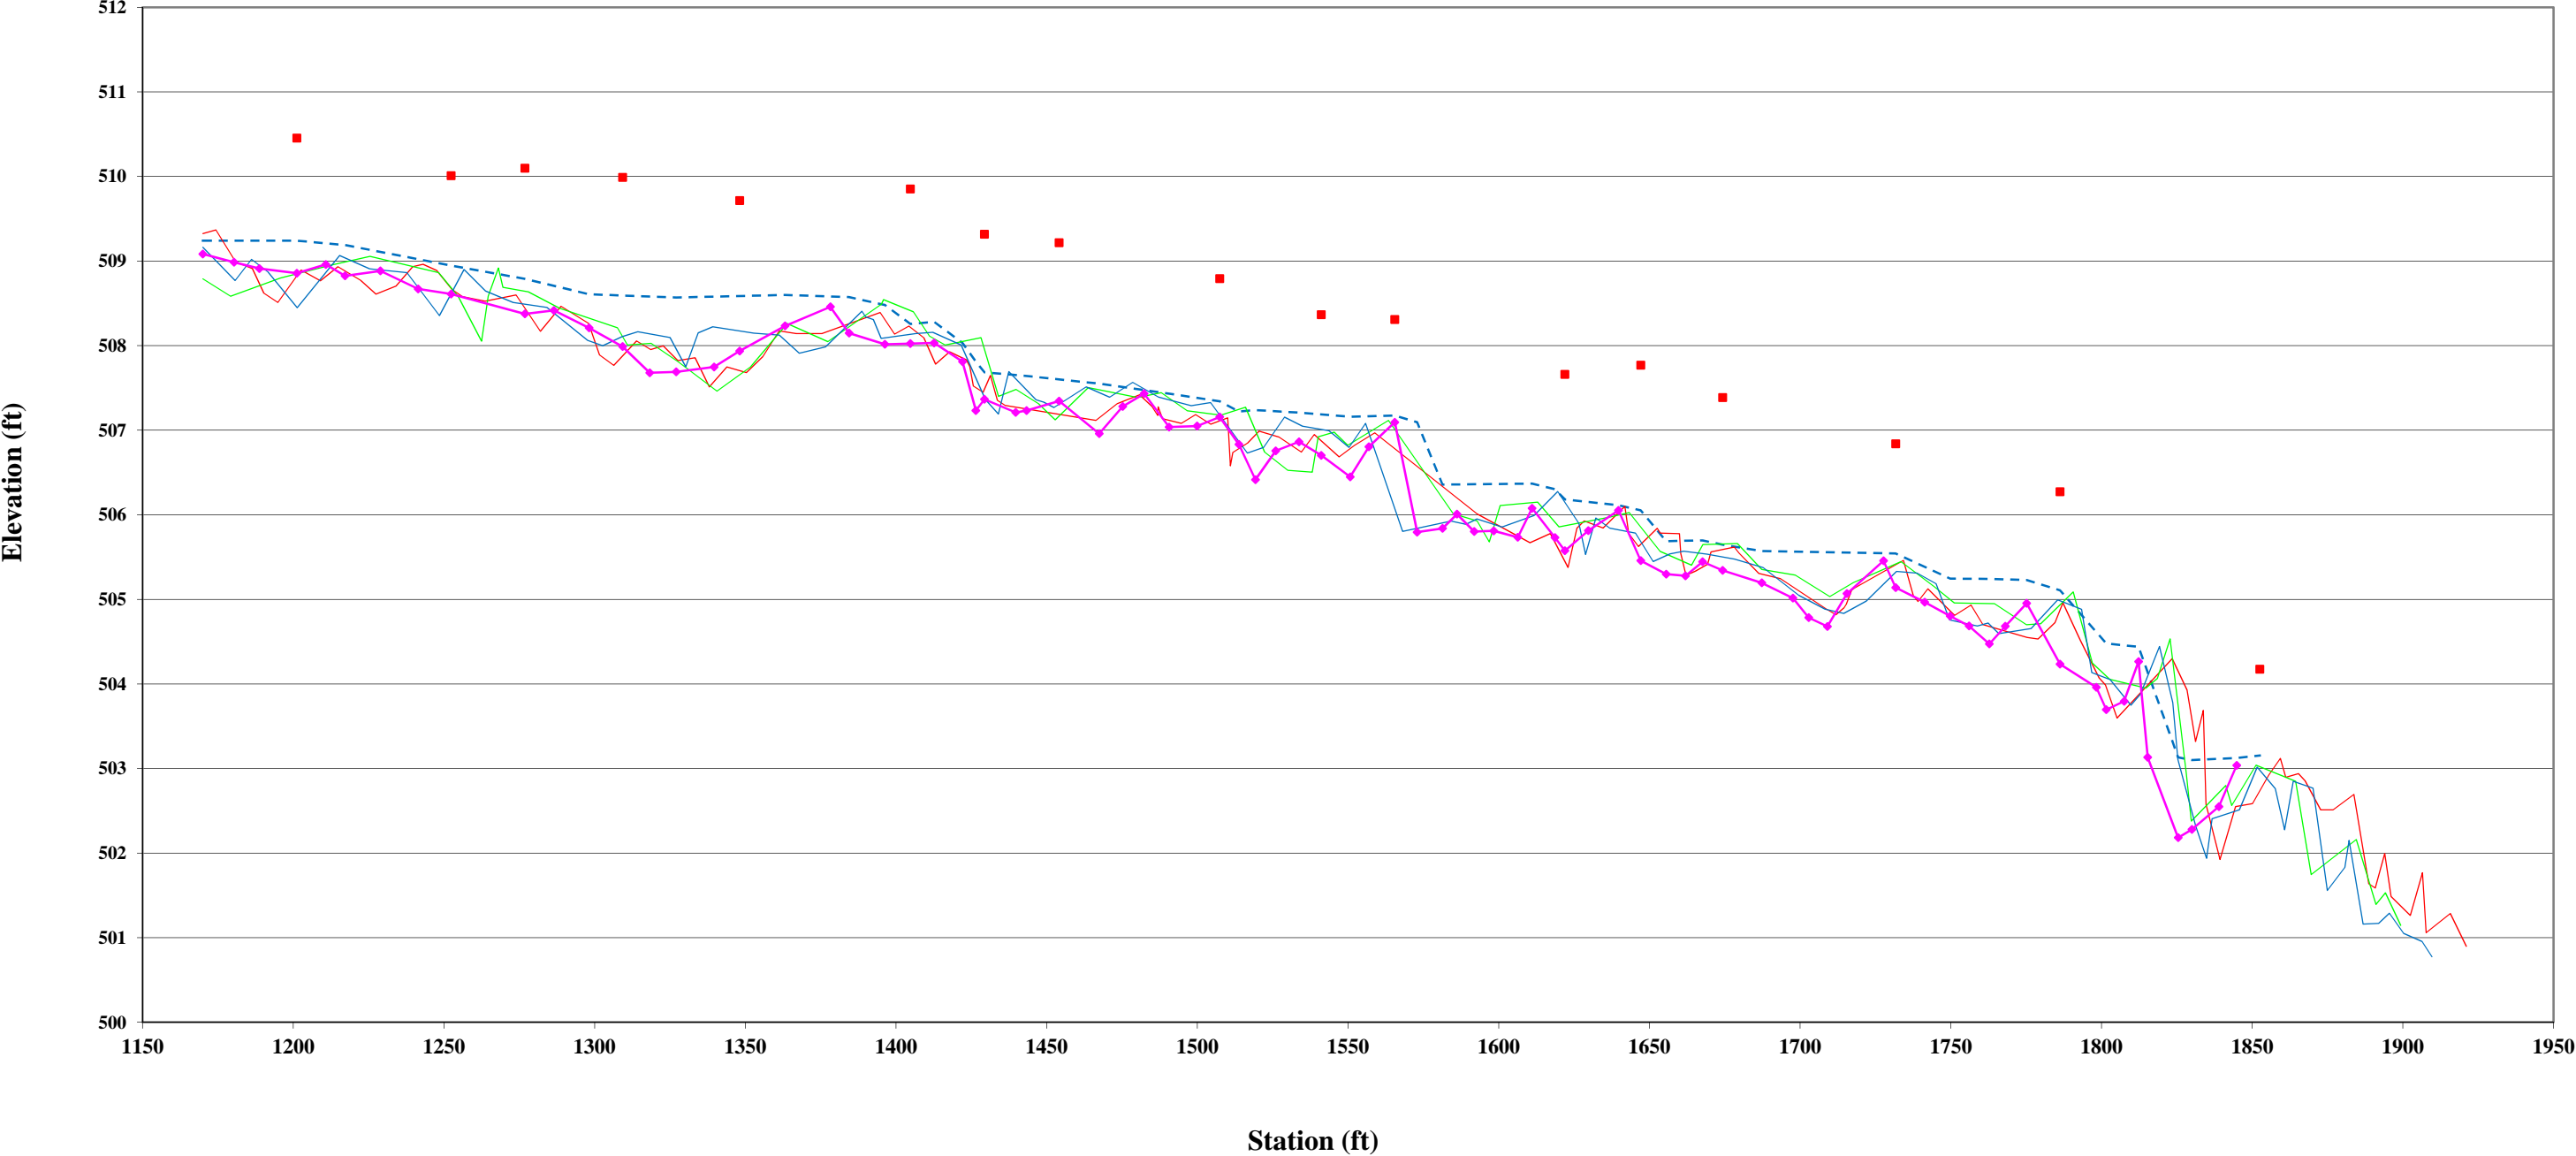
**Cane Creek Tributary Site  
 Longitudinal Profile 1  
 Tributary 1, MY-04  
 Stations 11+70 - 19+10**

■ Bankfull   
 - - - Water Surface   
 — MY-01\*   
 — MY-02   
 — MY-03   
 —◆— MY-04

\*Profile added during MY-01
