AS-BUILT MITIGATION PLAN
CANE CREEK RESTORATION SITE
RUTHERFORD COUNTY, NORTH CAROLINA

(CONTRACT #16-D06027-E)
FULL DELIVERY PROJECT
BROAD RIVER BASIN
CATALOGING UNIT 03050105

**CANE CREEK STREAM AND WETLAND RESTORATION SITE
AS-BUILT MITIGATION PLAN
RUTHERFORD COUNTY**

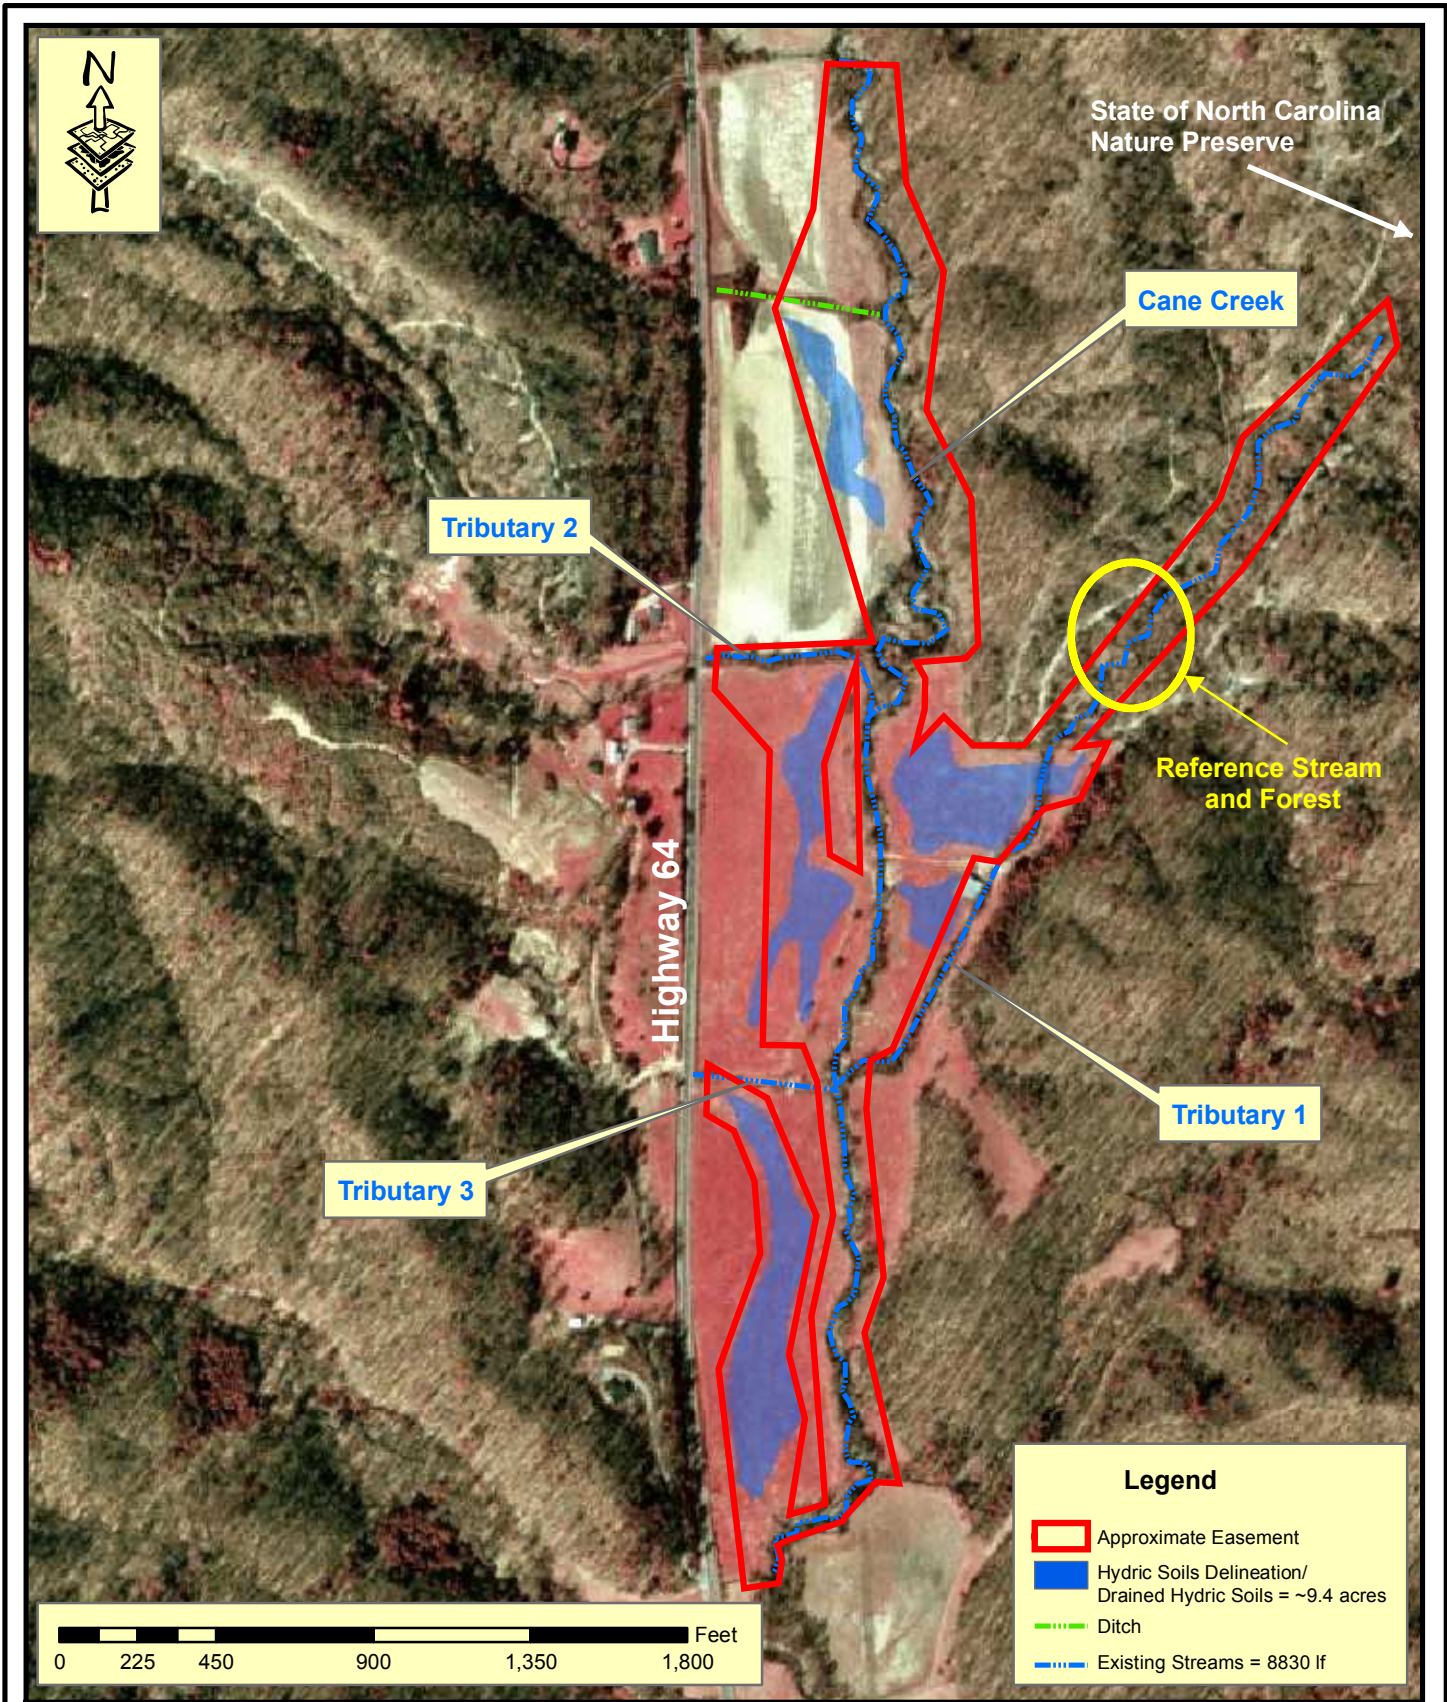
**PRECONSTRUCTION CONDITIONS
CANE CREEK RESTORATION SITE
Rutherford County, North Carolina**

Prior to implementation the Site was characterized by agricultural land utilized primarily for row crop and hay production (Figure 3, Appendix A). Riparian vegetation adjacent to Site streams was sparse and disturbed due to plowing and regular maintenance, and row crop areas were subject to broadcast application of various agricultural chemicals. In addition, stream channels had been straightened and dredged. These factors resulted in degraded water quality, unstable channel characteristics (stream entrenchment, erosion, and bank collapse), and decreased wetland function.

Prior to construction, the majority of the Site was utilized for row crop and hay production (Figure 3, Appendix A). In order to maximize useable field acreage streams were channelized and riparian vegetation was removed. Site streams were subject to contamination from the broadcast application of agricultural chemicals. The agricultural practices of the Site were contributory factors to degraded water quality, unstable channel characteristics (stream entrenchment, erosion, and bank collapse), and decreased wetland function.

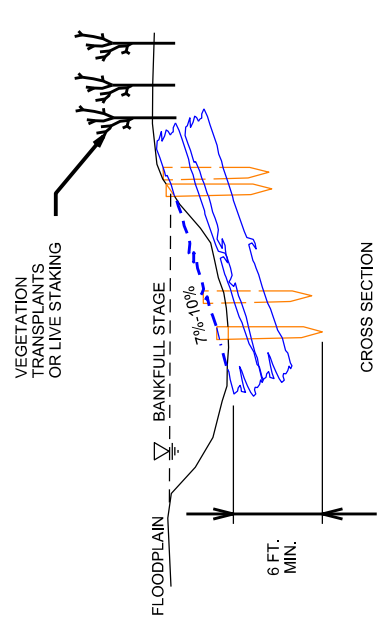
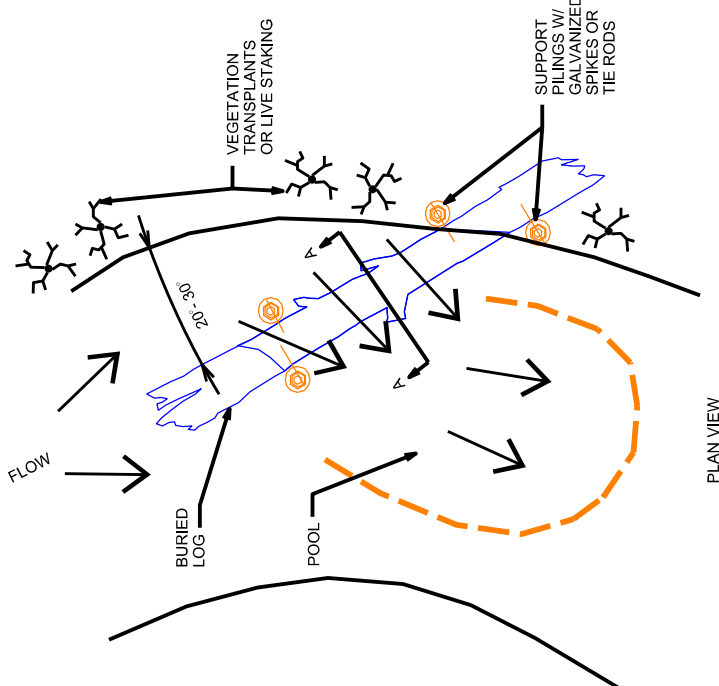
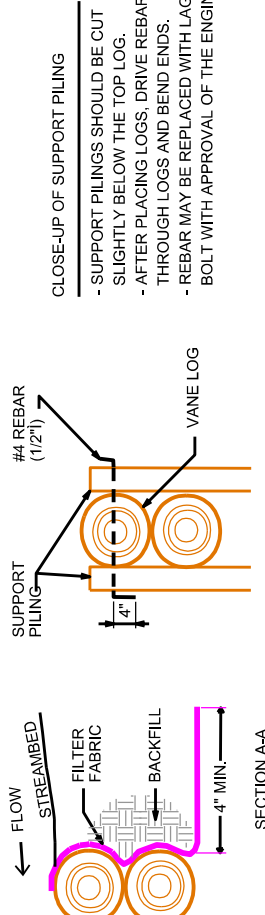
TYPICAL LOG VANE

- NOTES:
1. EXPOSED VANE OCCUPIES 1/3 OF THE BANKFULL WIDTH OF THE CHANNEL.
 2. SUPPORT PILINGS SHALL BE PENCIL SHARPENED, UNTREATED, PEELED, A MINIMUM OF 4 INCHES IN TOP DIAMETER, AND 8 FEET LONG.
 3. LOGS SHALL CONSIST OF NATIVE HARDWOOD SPECIES, RELATIVELY STRAIGHT WITH A MINIMUM DIAMETER OF 15 INCHES AND APPROXIMATELY 35 FEET IN LENGTH.
 4. USE FILTER FABRIC TO SEAL GAPS BETWEEN LOGS.

- CLOSE-UP OF SUPPORT PILING
- SUPPORT PILING SHOULD BE CUT SLIGHTLY BELOW THE TOP LOG.
 - AFTER PLACING LOGS, DRIVE REBAR THROUGH LOGS AND BEND ENDS.
 - REBAR MAY BE REPLACED WITH LAG BOLT WITH APPROVAL OF THE ENGINEER.

In-stream structures were used within the Site for bank stabilization, grade control, and habitat improvement. This included the installation of two J-hook vanes, six log vanes, two rock cross-vanes, three step-pool structures, and ten A-vanes (Figures 4A-4B, Appendix A).

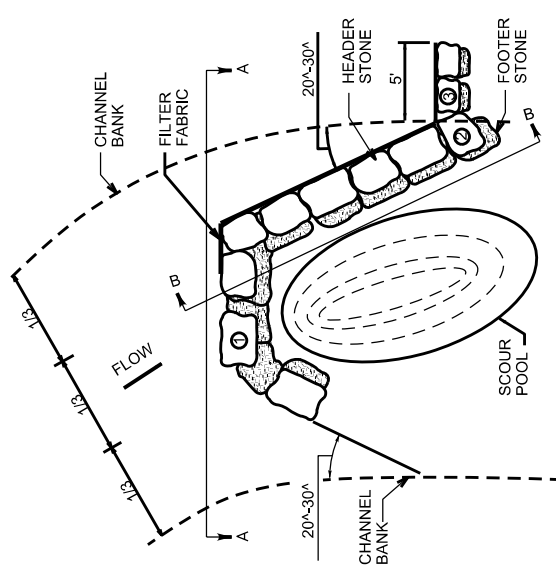
TYPICAL J-HOOK VANE

NOTE:
 HEADER AND FOOTER STONES ARE LARGE, ANGULAR BOULDERS MEASURING A MINIMUM OF 24" ALONG THE SHORTEST DIMENSION.

REACH	ARM LENGTH (FT.)	CHANNEL DEPTH (FT.)
TRIBUTARY 1	10.0	1.5
TRIBUTARIES 2 AND 3	7.0	0.8

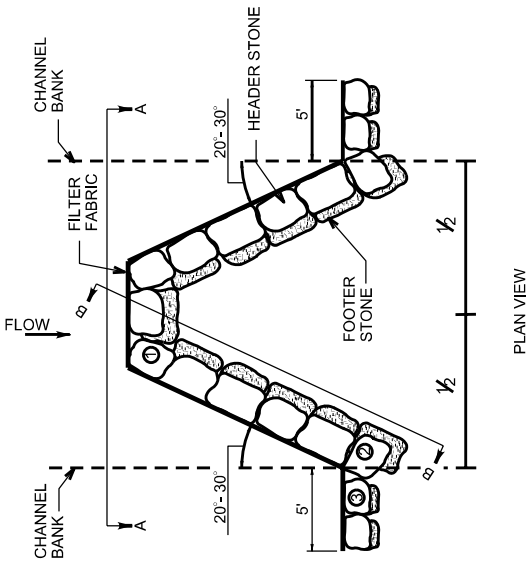
TYPICAL CROSS-VANE

NOTE:
 HEADER AND FOOTER STONES ARE LARGE, ANGULAR BOULDERS MEASURING A MINIMUM OF 24" ALONG THE SHORTEST DIMENSION.

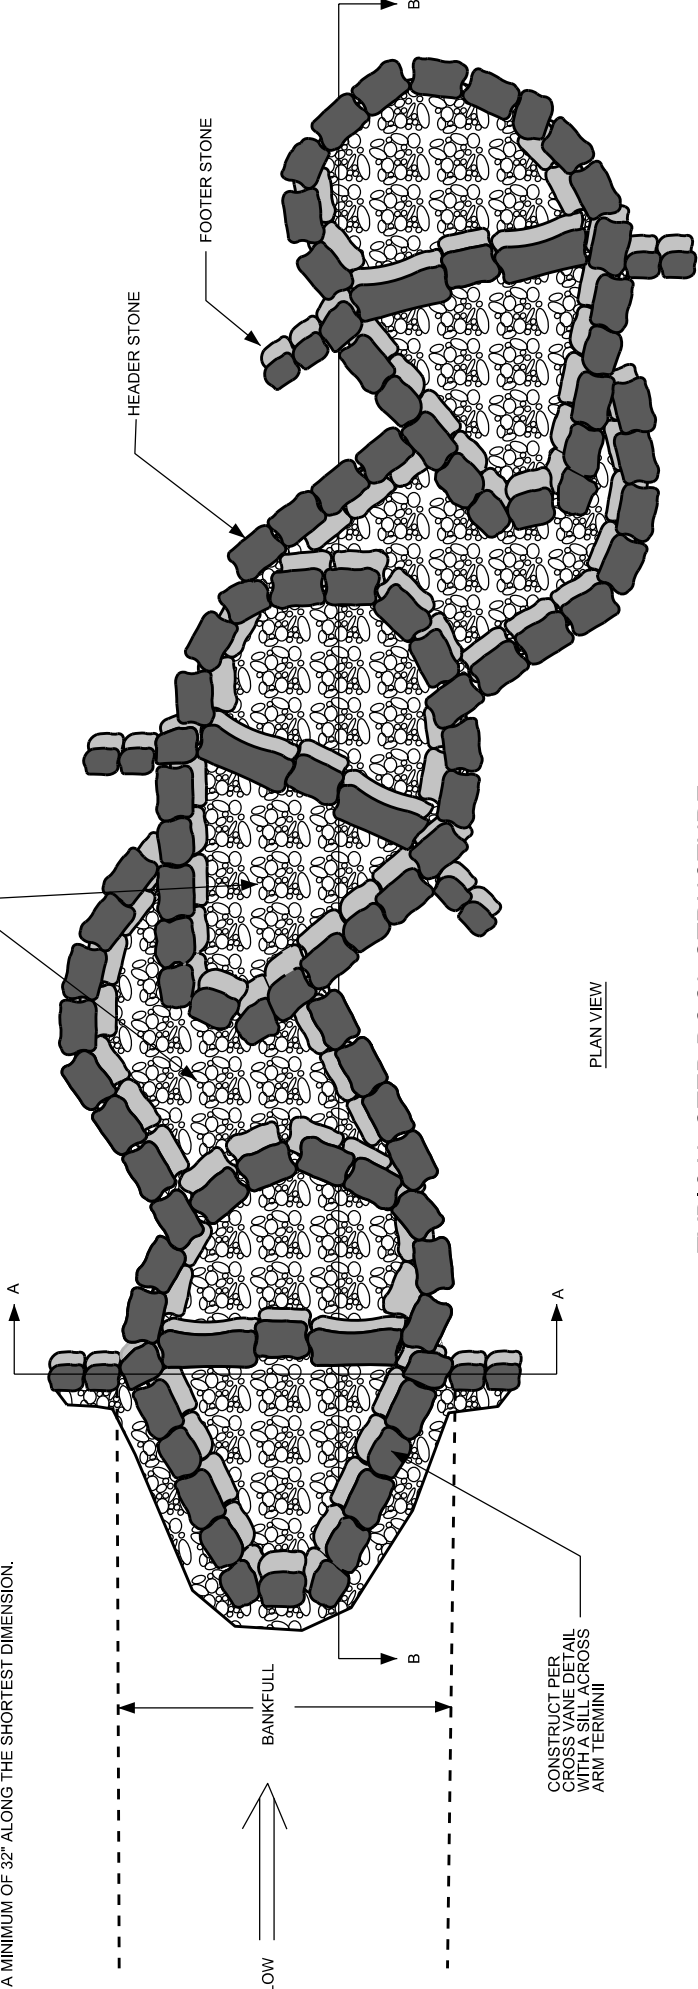
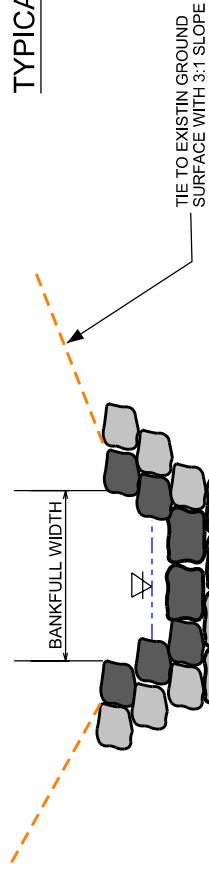
TYPICAL STEP POOL STRUCTURE

FILL SQUIL HOLE TO MINIMUM DEPTH
6 INCHES CLASS 1 STONE
ON TOP OF FILTER FABRIC

CONSTRUCT PER
CROSS VANE DETAIL
WITH A HILL ACROSS
ARM TERMINI

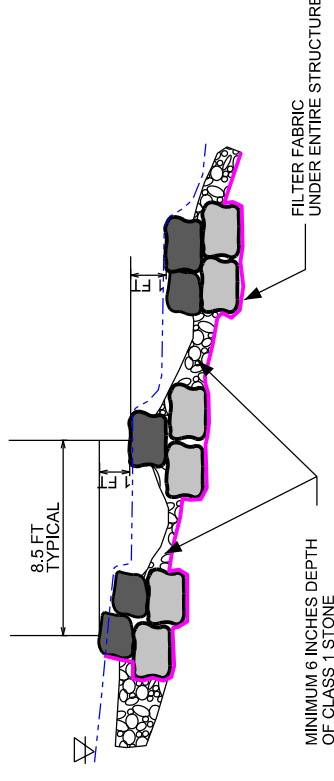
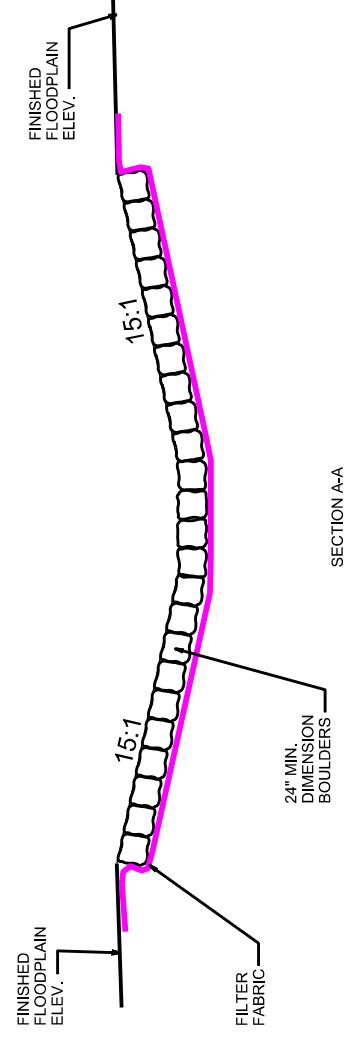
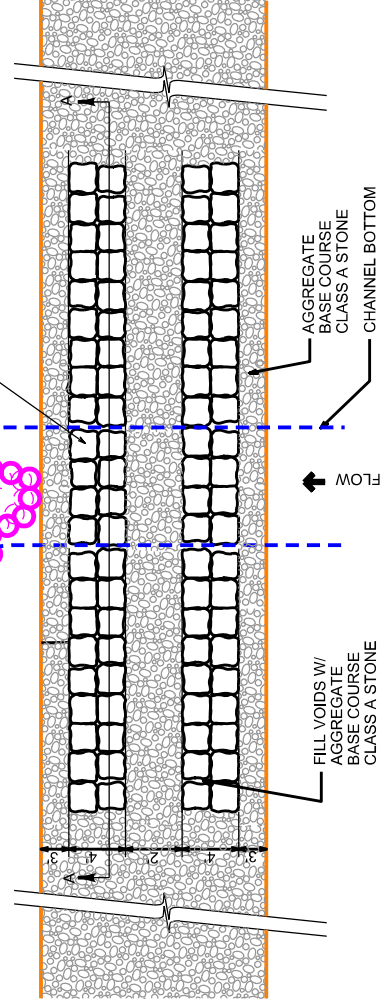
PERMANENT CHANNEL FORD DETAIL

1. KEEP FORD CROSS FALL WITHIN 1-2% OF STREAM GRADIENT.
2. FILL VOIDS BETWEEN 24" MINIMUM DIMENSION BOULDERS W/ AGGREGATE BASE COURSE CLASS A TO CREATE DRIVEABLE SURFACE.

Landowner constraints necessitated the installation of three channel fords to allow access to portions of the property isolated by the conservation easement and stream restoration activities. The location of the channel fords are depicted on Figure 4A (Appendix A). The fords were constructed of hydraulically stable rip-rap or suitable rock and are large enough to handle the weight of anticipated vehicular traffic.

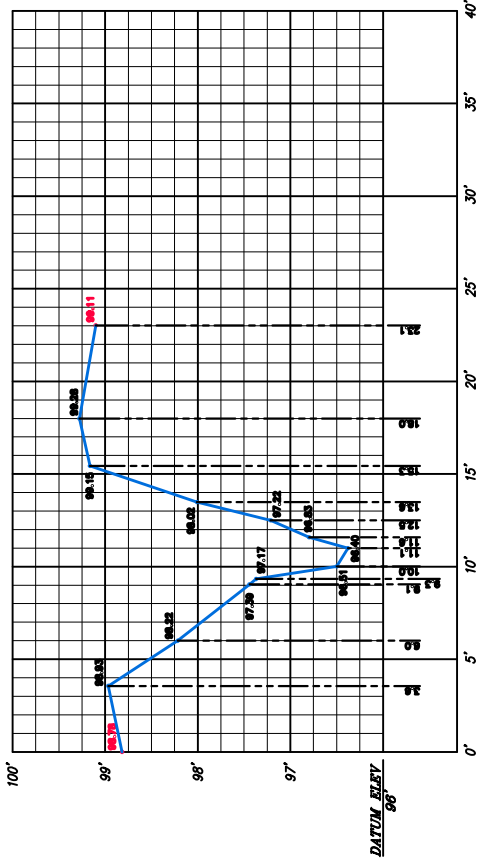
TRIB. 1 - CROSS-SECTION 1
(EAST BANK TO WEST BANK)
SCALE: 1"=5' HORZ./1"=1' VERT.

Baseline/as-built measurements were performed in April 2008. As-built channels emulated the proposed channel morphology; cross-section and longitudinal profile plots can be found in Appendix C.

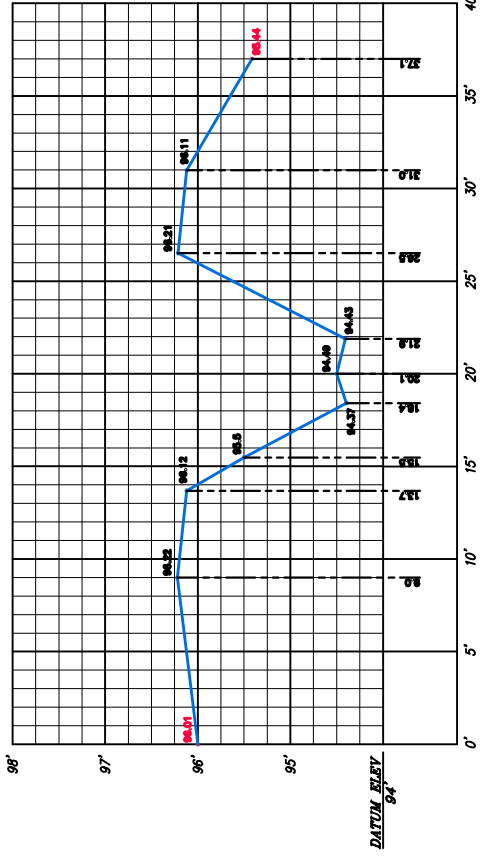
TRIB. 1 - CROSS-SECTION 3
(EAST BANK TO WEST BANK)
SCALE: 1"=5' HORZ./1"=1' VERT.

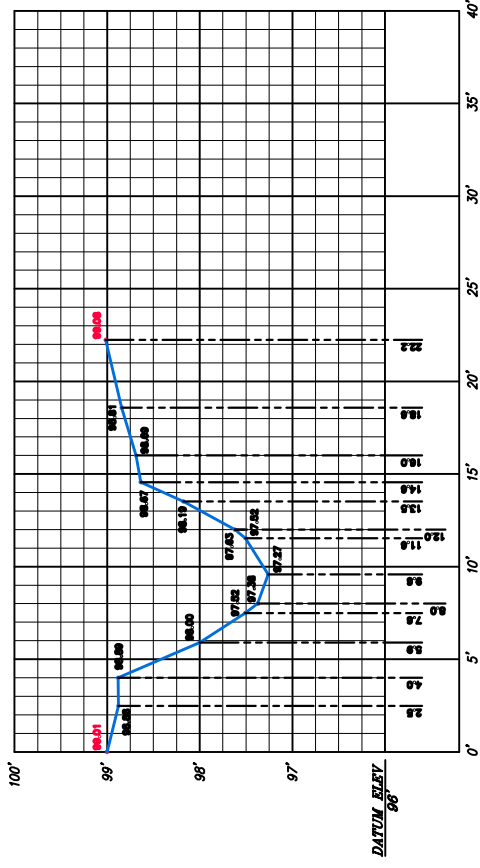
TRIB. 1 - CROSS-SECTION 2
(EAST BANK TO WEST BANK)
SCALE: 1"=5' HORZ./1"=1' VERT.

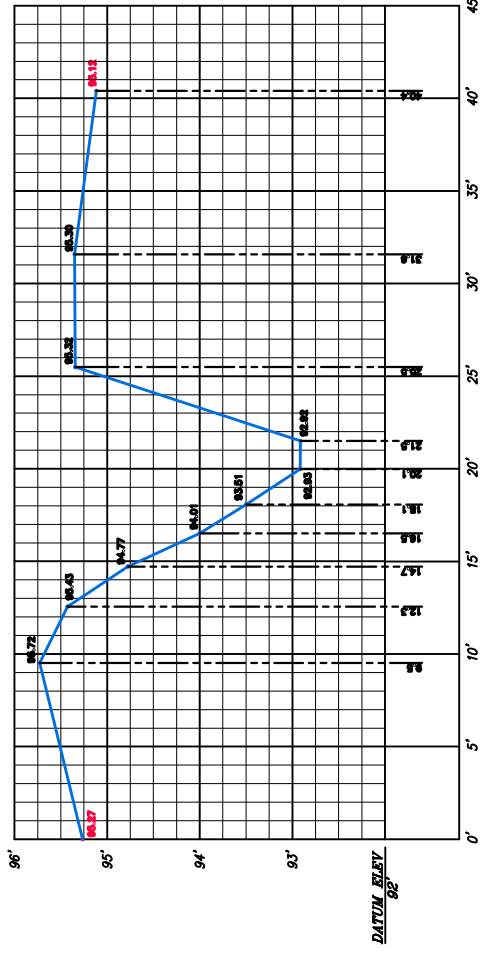
TRIB. 1 - CROSS-SECTION 4
(EAST BANK TO WEST BANK)
SCALE: 1"=5' HORZ./1"=1' VERT.

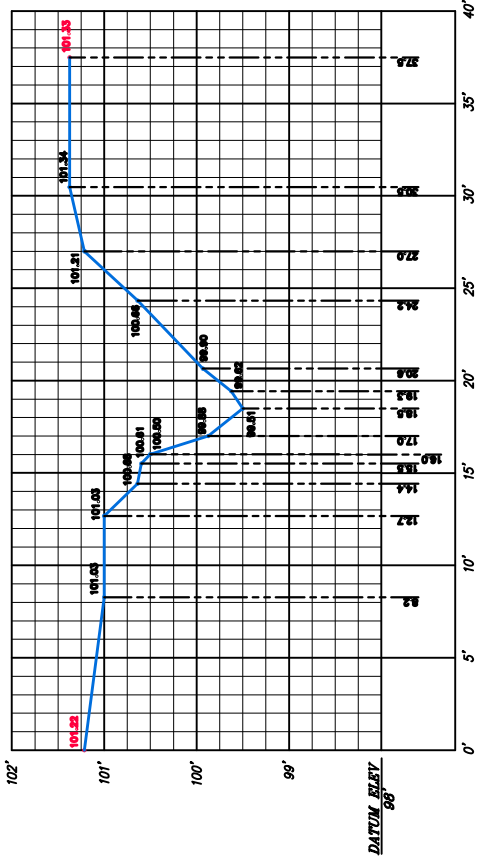
TRIB. 2 - CROSS-SECTION 1
 (EAST BANK TO WEST BANK)
 SCALE: 1"=5' HORIZ./1"=1' VERT.

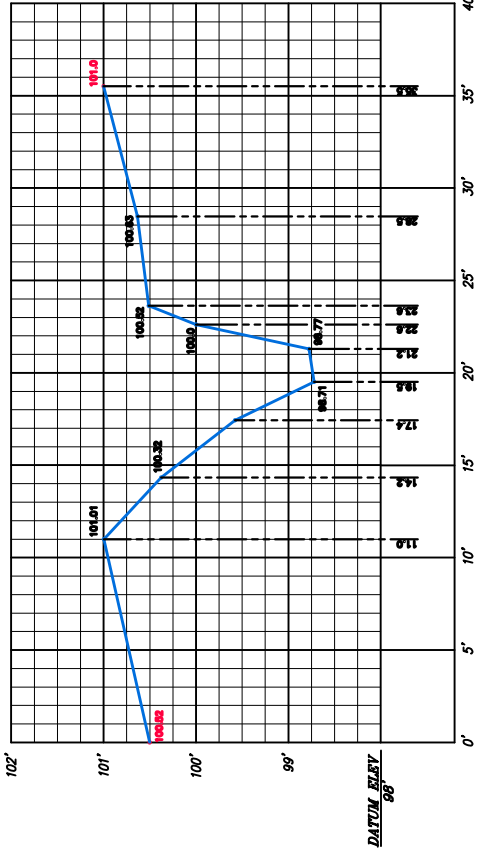
TRIB. 2 - CROSS-SECTION 3
 (EAST BANK TO WEST BANK)
 SCALE: 1"=5' HORIZ./1"=1' VERT.

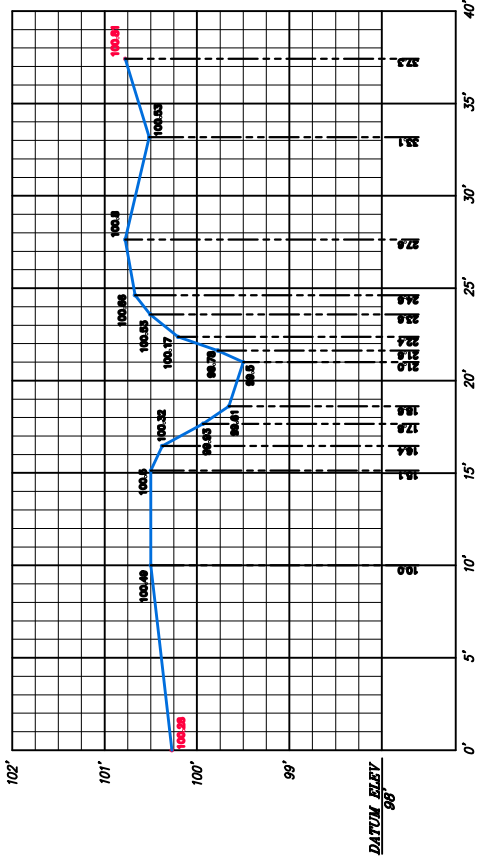
TRIB. 2 - CROSS-SECTION 2
 (EAST BANK TO WEST BANK)
 SCALE: 1"=5' HORIZ./1"=1' VERT.

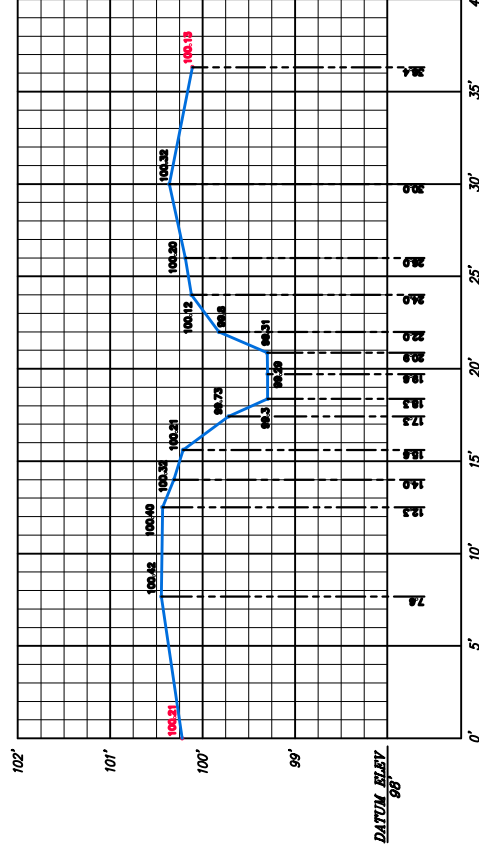
TRIB. 2 - CROSS-SECTION 4
 (EAST BANK TO WEST BANK)
 SCALE: 1"=5' HORIZ./1"=1' VERT.

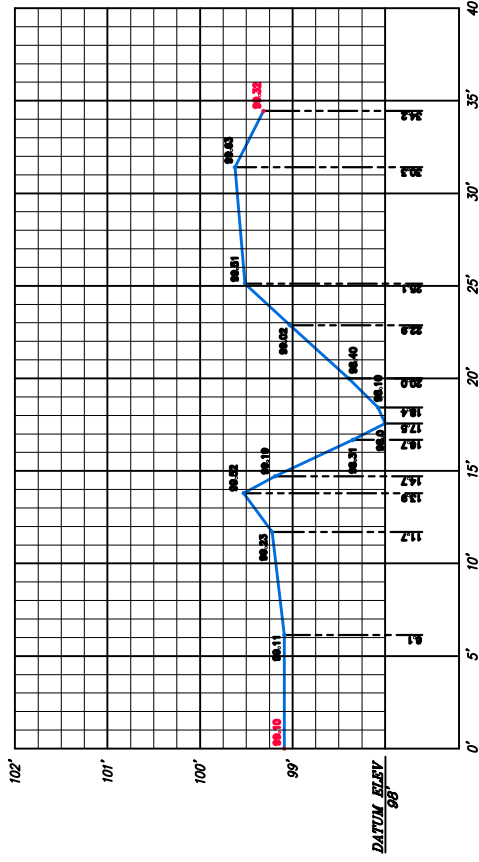
TRIB. 2 - CROSS-SECTION 5
(EAST BANK TO WEST BANK)
SCALE: 1"=5' HORIZ./1"=1' VERT.

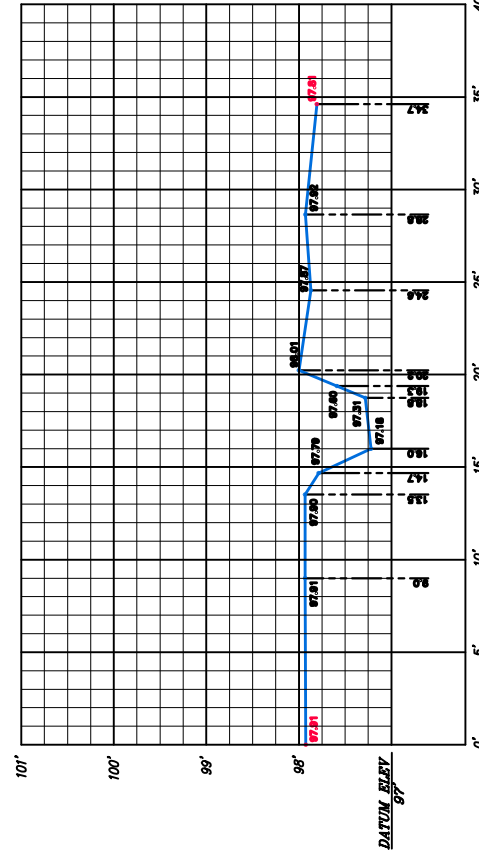
TRIB. 2 - CROSS-SECTION 7
(EAST BANK TO WEST BANK)
SCALE: 1"=5' HORIZ./1"=1' VERT.

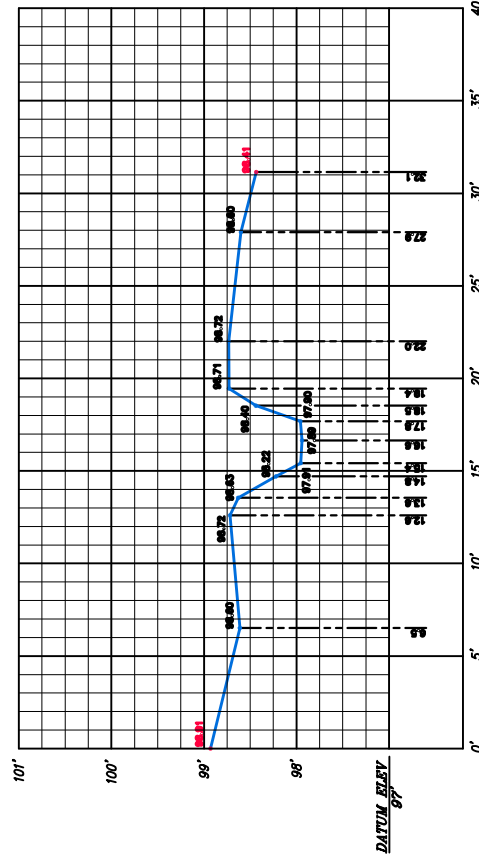
TRIB. 2 - CROSS-SECTION 6
(EAST BANK TO WEST BANK)
SCALE: 1"=5' HORIZ./1"=1' VERT.

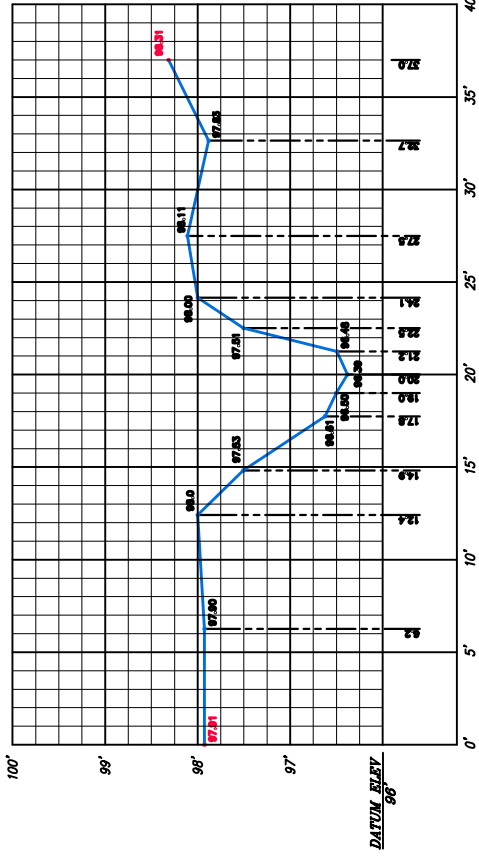
TRIB. 2 - CROSS-SECTION 8
(EAST BANK TO WEST BANK)
SCALE: 1"=5' HORIZ./1"=1' VERT.

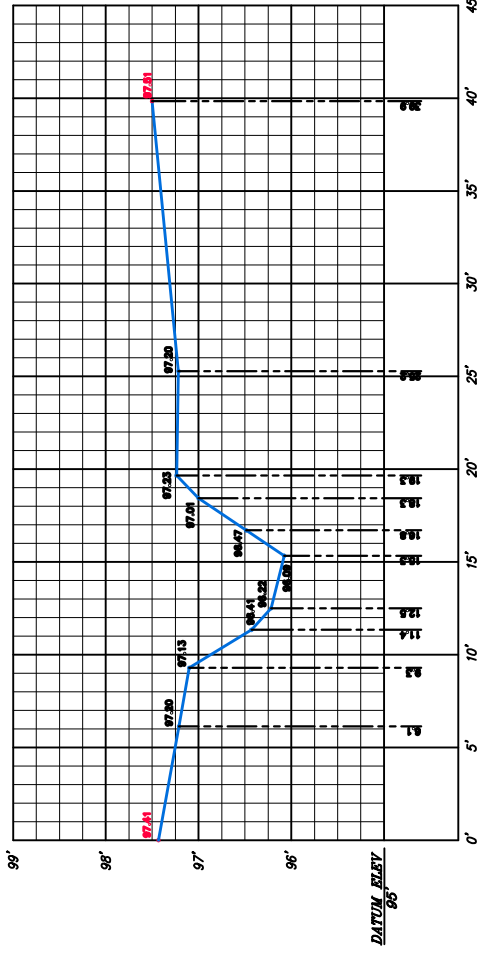
TRIB. 3 - CROSS-SECTION 5
(EAST BANK TO WEST BANK)
SCALE: 1"=5' HORZ./1"=1' VERT.

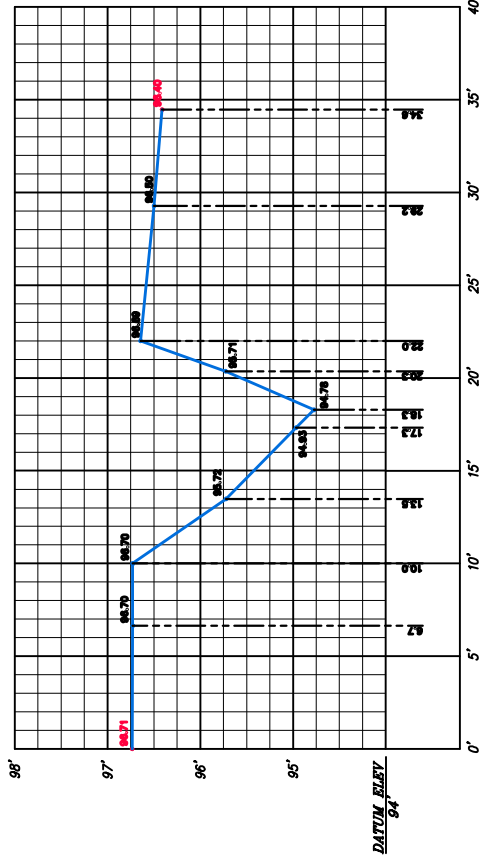
TRIB. 3 - CROSS-SECTION 7
(EAST BANK TO WEST BANK)
SCALE: 1"=5' HORZ./1"=1' VERT.

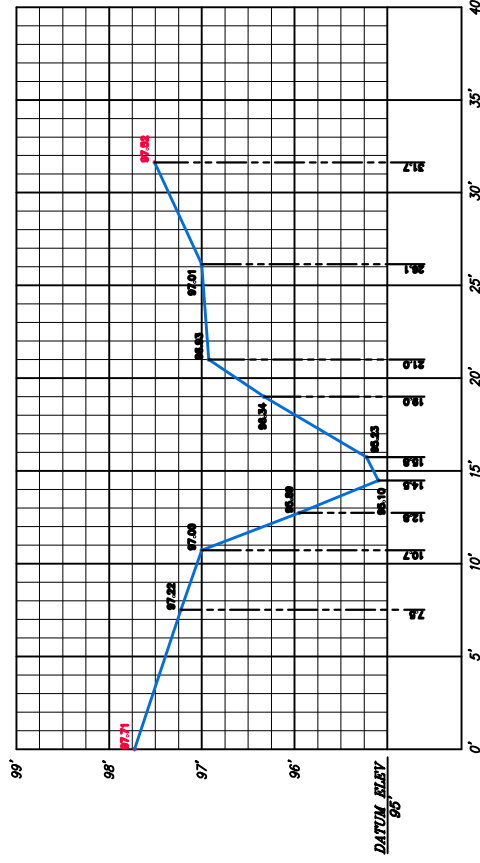
TRIB. 3 - CROSS-SECTION 6
(EAST BANK TO WEST BANK)
SCALE: 1"=5' HORZ./1"=1' VERT.

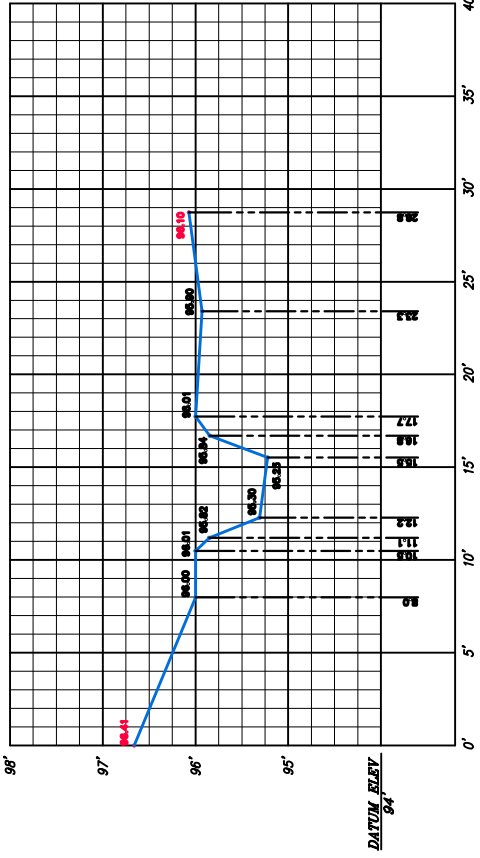
TRIB. 3 - CROSS-SECTION 8
(EAST BANK TO WEST BANK)
SCALE: 1"=5' HORZ./1"=1' VERT.

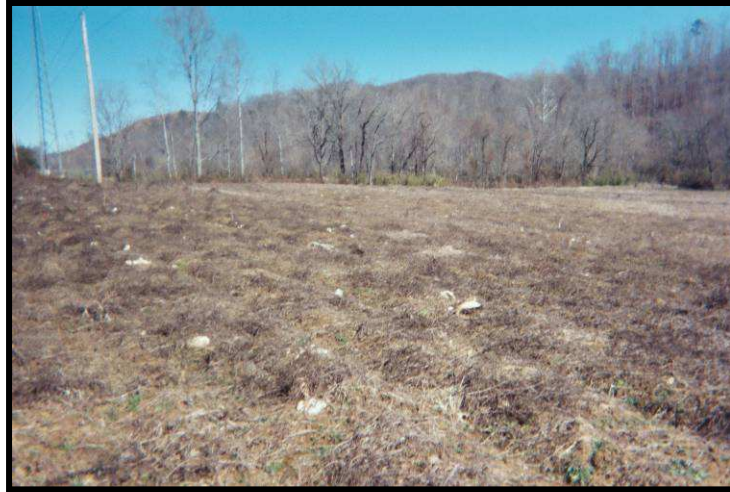
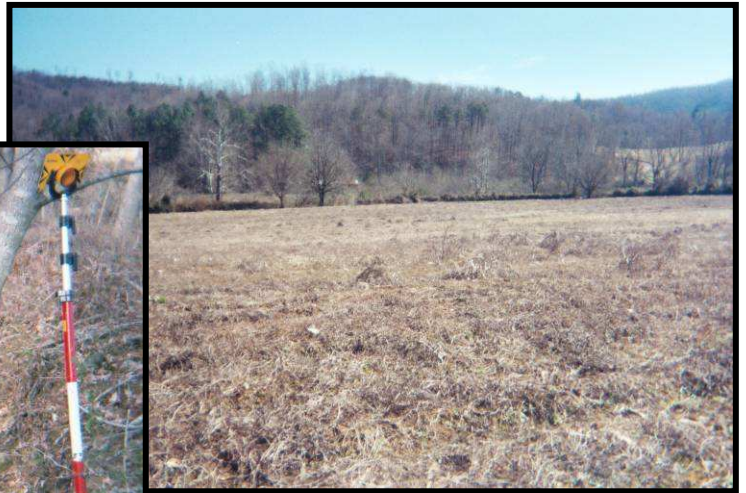
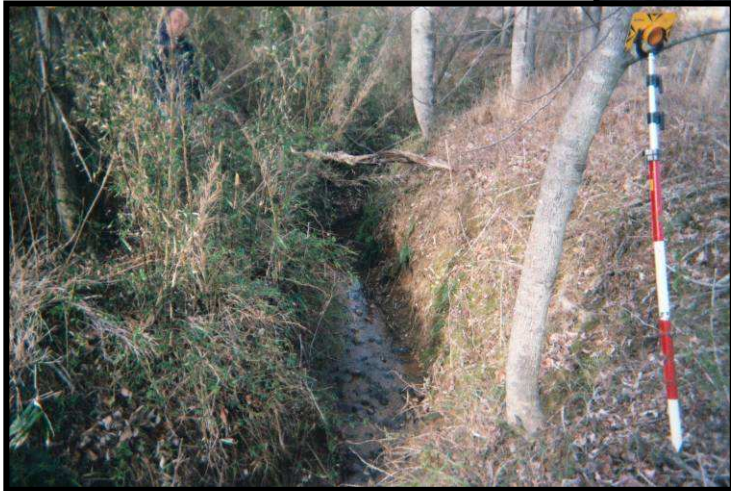
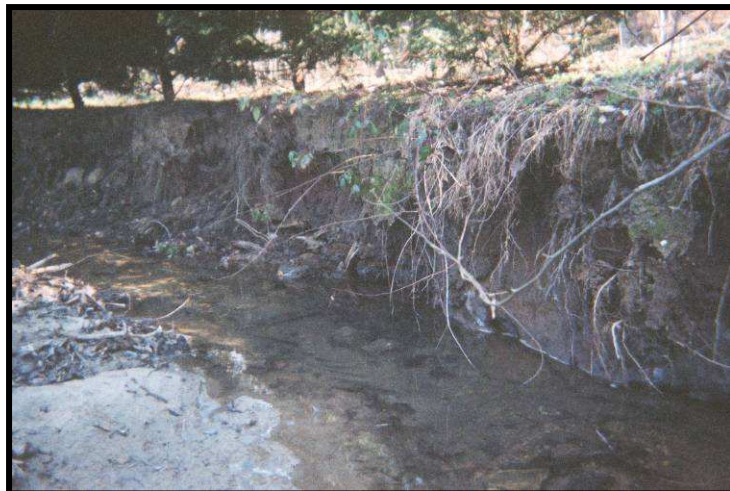
**Cane Creek Preconstruction Conditions
Taken March 2007**

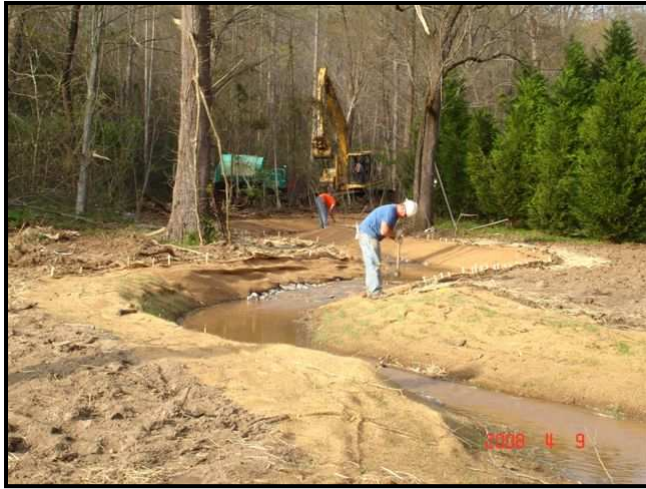
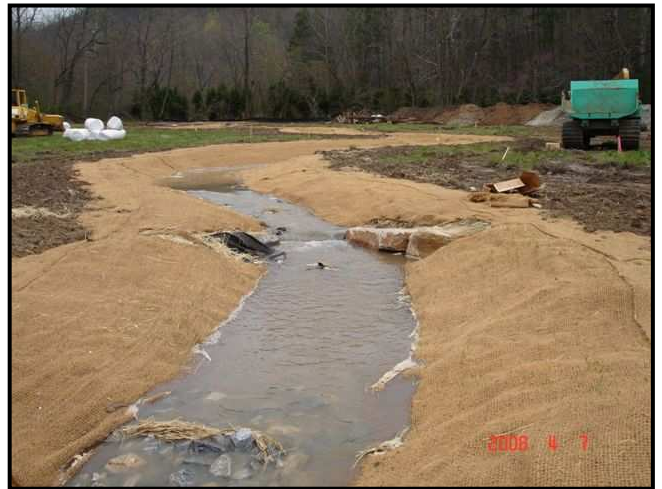
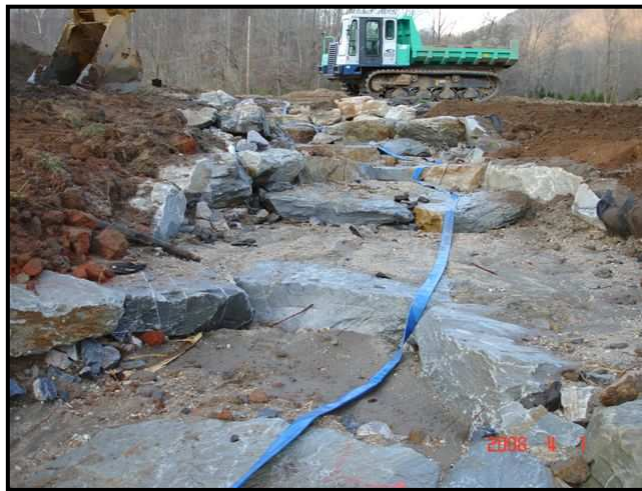
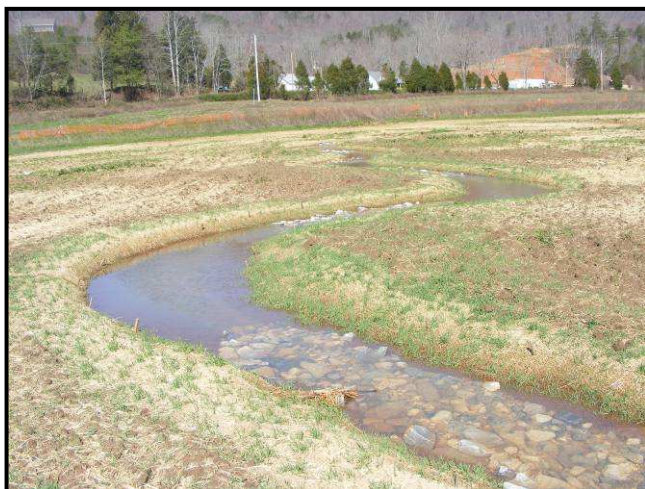
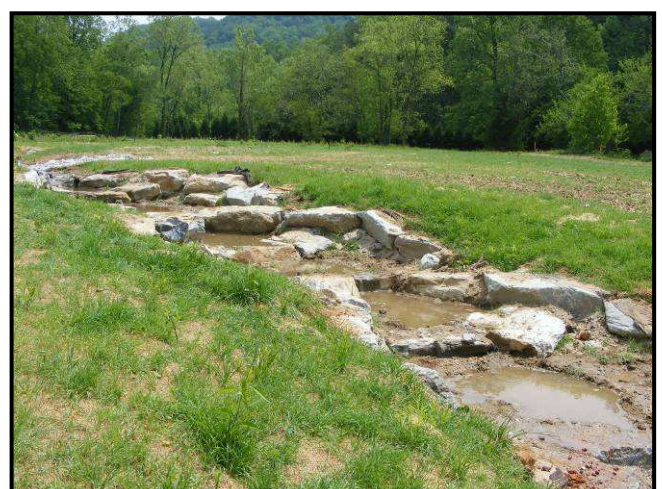
**Cane Creek During Construction
Taken April 2008**

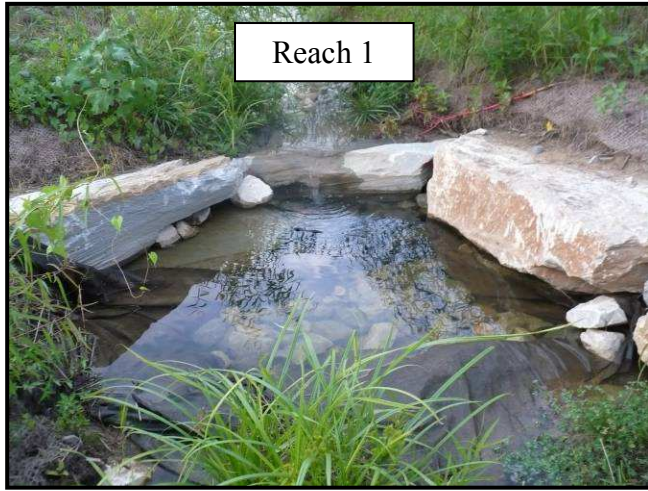
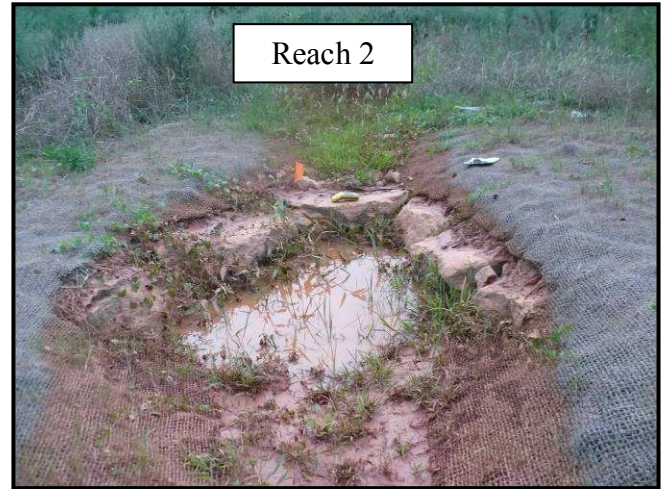
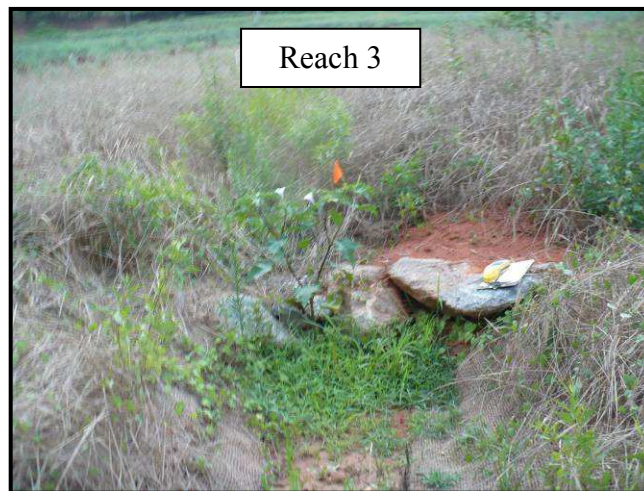
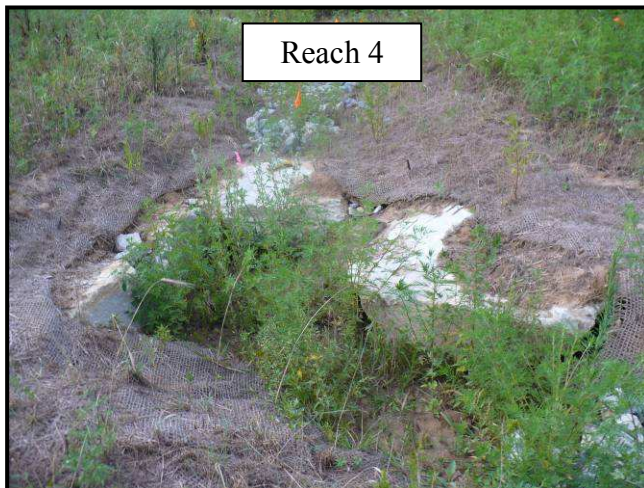
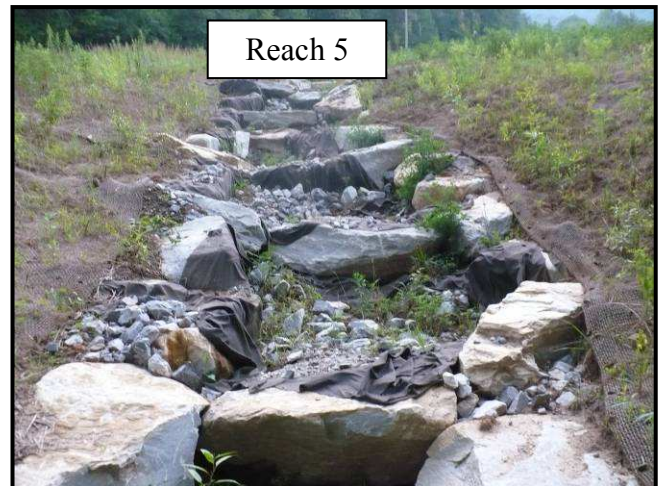
Cane Creek
Baseline Stream Structure Photographs taken July 2008

Visual assessment of in-stream structures will be conducted to determine if failure has occurred. Failure of a structure may be indicated by collapse of the structure, undermining of the structure, abandonment of the channel around the structure, and/or stream flow beneath the structure.

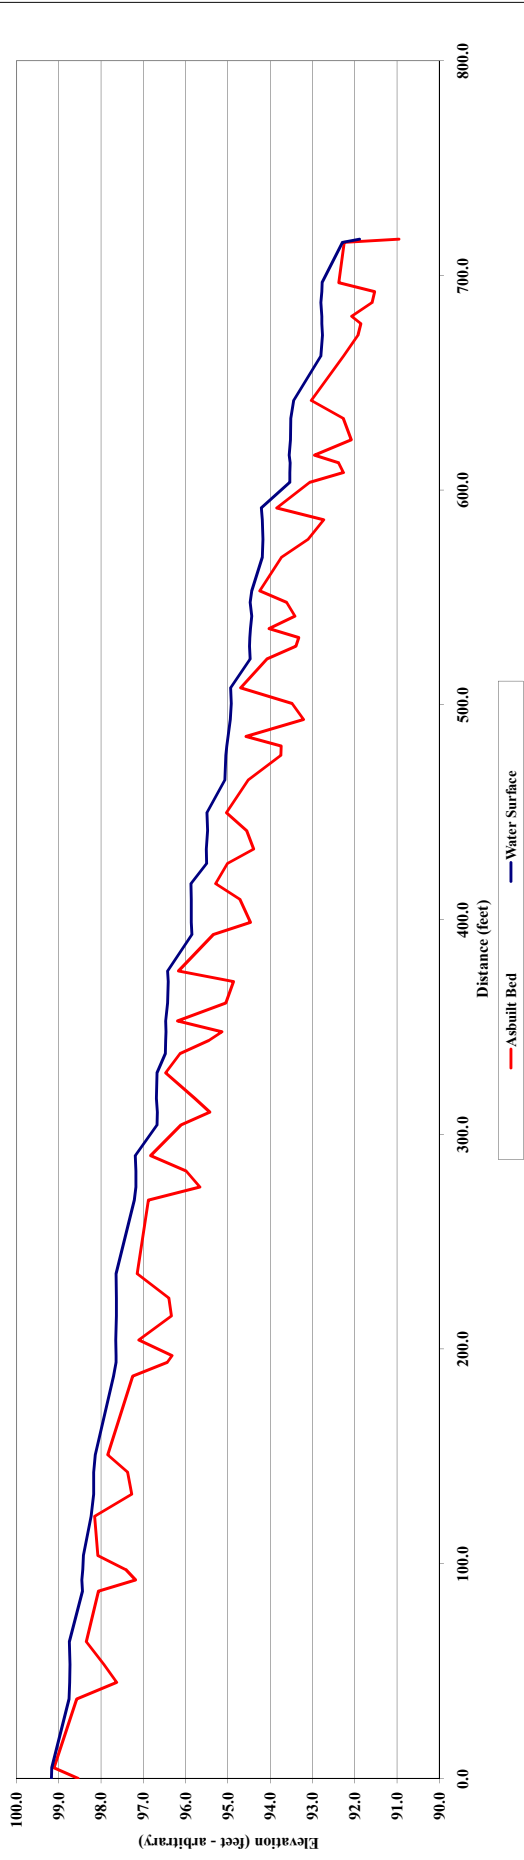
Cane Creek AsBuilt Profile - Reach 1

Project Name: Cane Creek AsBuilt												
Reach: 1												
Feature: Profile												
Date: 5/6/08												
Crew: Adams, Jeffers												
Station	As-built			2008 Survey			2009 Survey			2010 Survey		
	Bed Elevation	Water Elevation	Station	Bed Elevation	Water Elevation	Station	Bed Elevation	Water Elevation	Station	Bed Elevation	Water Elevation

AsBuilt	2008	2009	2010
Avg. Water Surface Slope			
Avg. Effile Slope			
Avg. Pool Slope			
Avg. Run Slope			
Avg. Cflie Slope

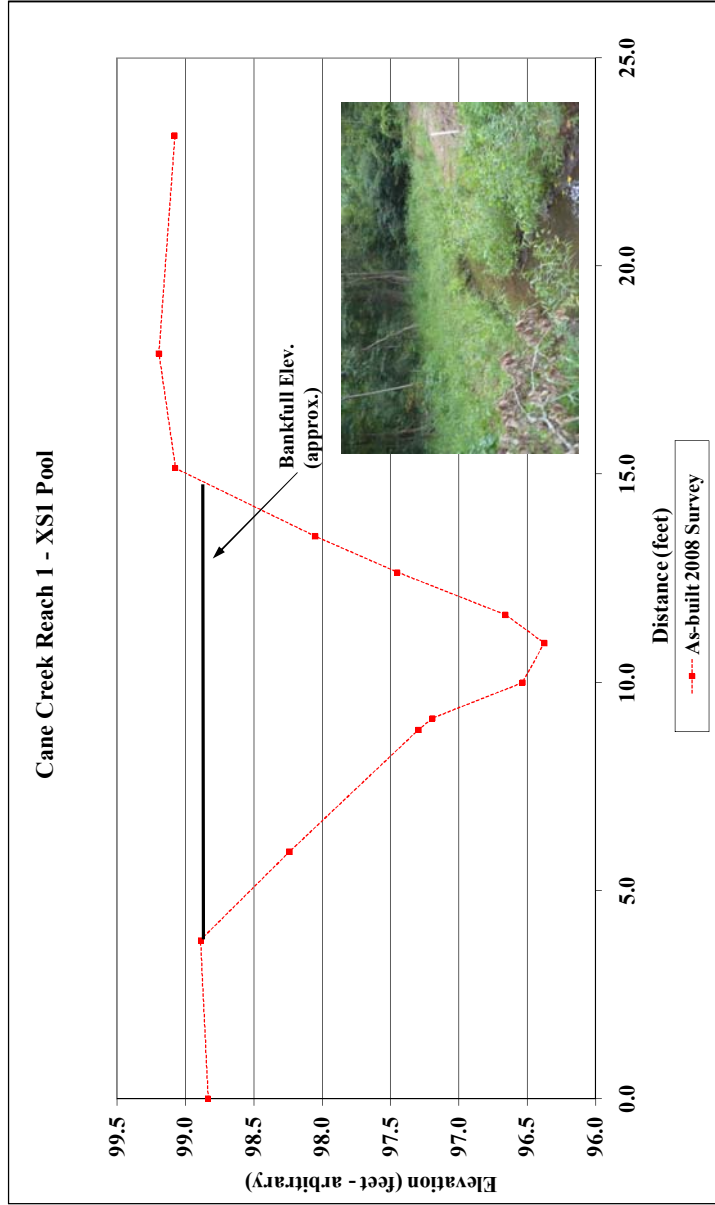
Project Name Cane Creek
 Cross Section R1-XS1
 Feature Pool
 Date 5/6/08
 Crew Adams, Jeffers

As-built	2008	2009	2010
Area	13.5			
Width	11.0			
Mean Depth	1.2			
Max Depth	2.5			
W/D Ratio	NA

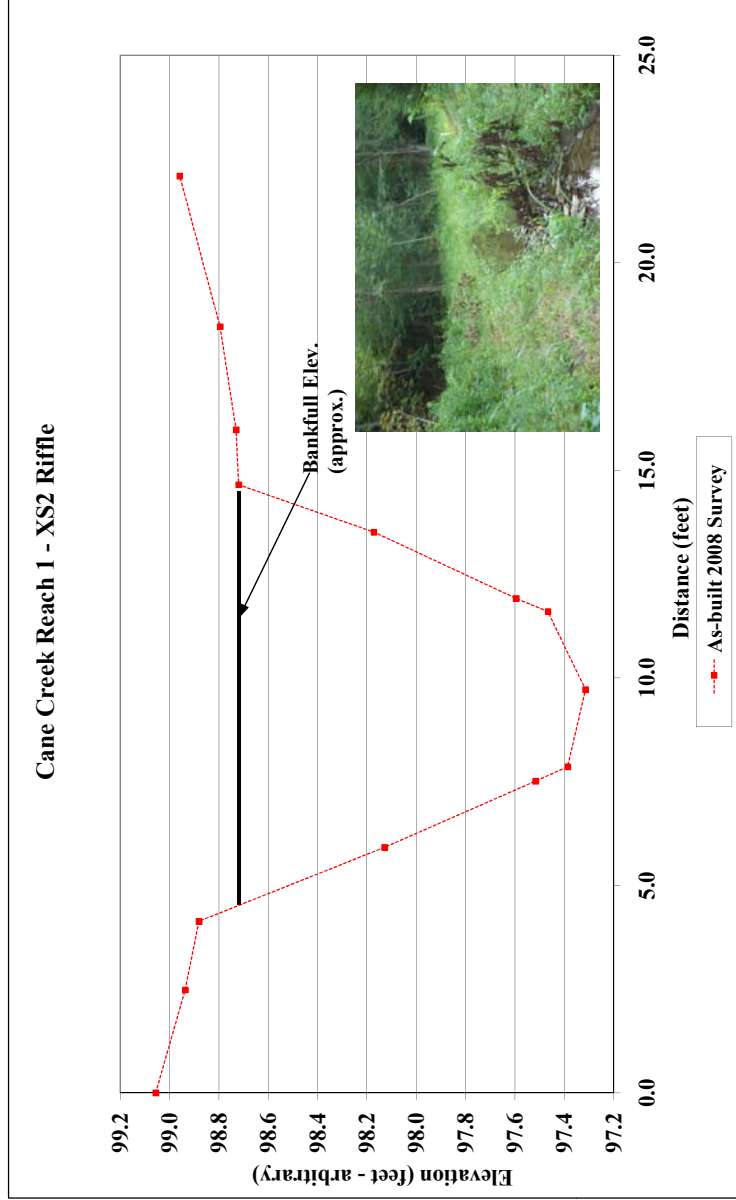
Project Name Cane Creek			
Cross Section R1-XS2			
Feature Riffle			
Date 5/6/08			
Crew Adams, Jeffers			
As-built	2008	2009	2010
2008 Survey	2008 Survey	2009 Survey	2010 Survey
Station	Station	Station	Station
Elevation	Elevation	Elevation	Elevation
0.0 99.1			
2.5 98.9			
4.1 98.9			
5.9 98.1			
7.5 97.5			
7.9 97.4			
9.7 97.3			
11.6 97.5			
11.9 97.6			
13.5 98.2			
14.7 98.7			
16.0 98.7			
18.5 98.8			
22.1 99.0

Area	As-built	2008	2009	2010
Width	9.4			
Mean Depth	10.1			
Max Depth	0.9			
W/D Ratio	1.4			
	11.0
