AS-BUILT MITIGATION PLAN
CANE CREEK RESTORATION SITE
RUTHERFORD COUNTY, NORTH CAROLINA

(CONTRACT #16-D06027-E)
FULL DELIVERY PROJECT
BROAD RIVER BASIN
CATALOGING UNIT 03050105

**CANE CREEK STREAM AND WETLAND RESTORATION SITE
AS-BUILT MITIGATION PLAN
RUTHERFORD COUNTY**

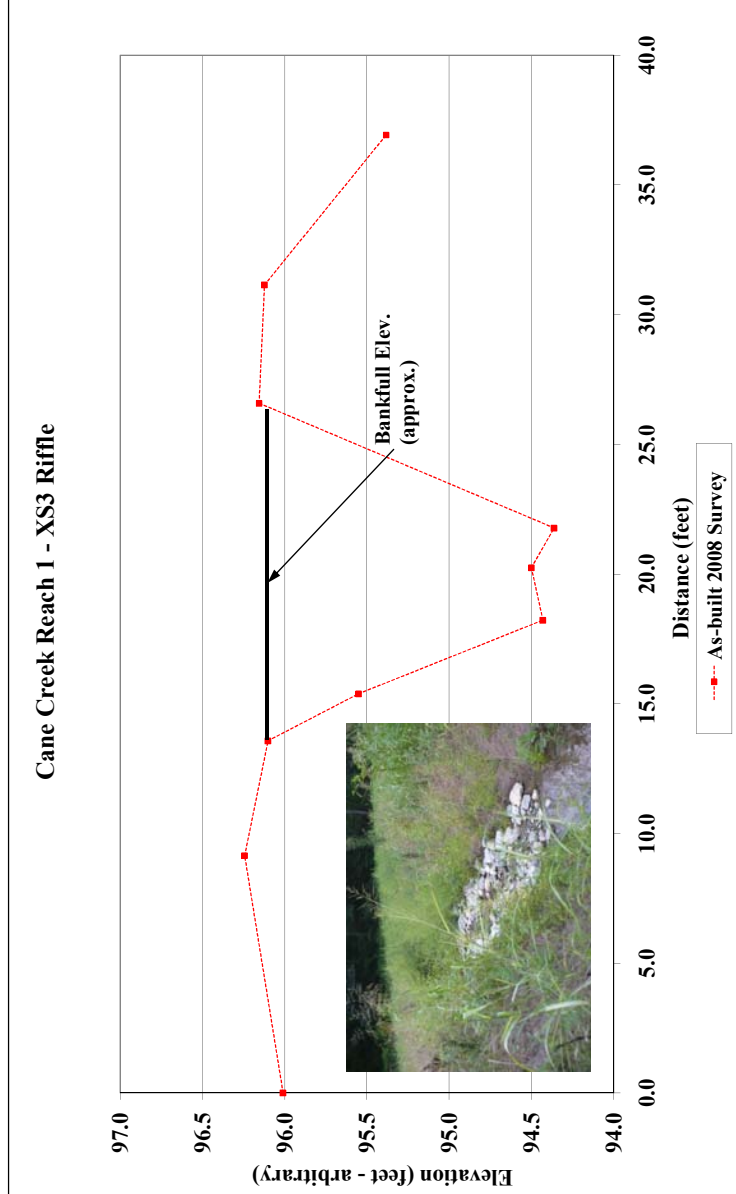
Project Name Cane Creek				
Cross Section R1-XS3				
Feature Riffle				
Date 5/6/08				
Crew Adams, Jeffers				
As-built	2008	2009	2010	
Station	2008 Survey	2009 Survey	2010 Survey	
0.0	Elevation	Station	Elevation	Station
9.1	96.2			
13.6	96.1			
15.4	95.5			
18.2	94.4			
20.2	94.5			
21.8	94.4			
26.6	96.2			
31.1	96.1			
36.9	95.4

Area	As-built	2008	2009	2010
Width	13.6			
Mean Depth	12.9			
Max Depth	1.1			
W/D Ratio	1.7			
	12.2

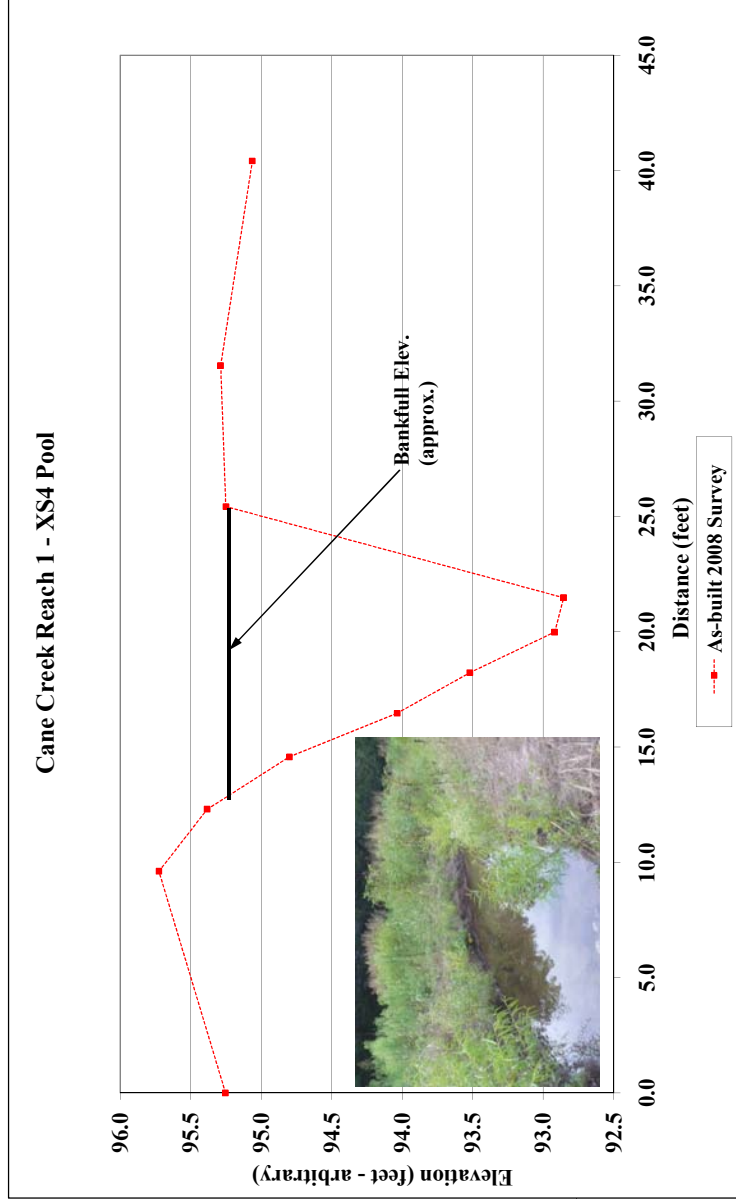
Project Name Cane Creek Cross Section R1-XS4 Feature Pool Date 5/6/08 Crew Adams, Jeffers				
	2008	2009	2010	
As-built	2008 Survey	2009 Survey	2010 Survey	
Station	Station	Station	Station	
0.0	95.3		Elevation	
9.6	95.7		Elevation	
12.3	95.4		Elevation	
14.6	94.8		Elevation	
16.5	94.0		Elevation	
18.2	93.5		Elevation	
20.0	92.9		Elevation	
21.5	92.9		Elevation	
25.4	95.3		Elevation	
31.5	95.3		Elevation	
40.4	95.1		Elevation

Area	As-built	2008	2009	2010
Width	16.4			
Mean Depth	12.6			
Max Depth	1.3			
W/D Ratio	2.4			
	NA

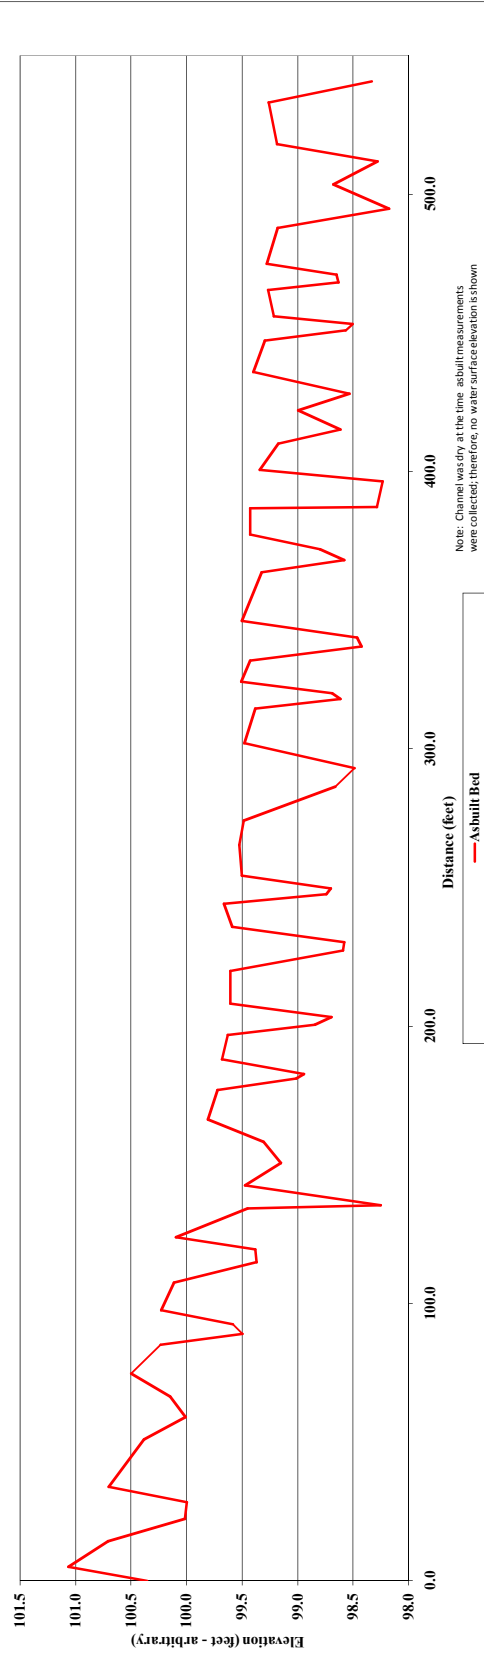
Cane Creek Profile - Reach 2

Project Name Cane Creek AsBuilt									
Reach 2 Profile									
Feature 50608									
Date Adams, Jeffers									
Crew									
As-built		2008 Survey		2009 Survey		2010 Survey		2010	
Station	Bed Elevation	Water Elevation	Station	Bed Elevation	Water Elevation	Station	Bed Elevation	Water Elevation	Water Elevation
0.0	100.4								
5.1	101.1								
14.2	100.7								
22.3	100.0								
27.3	100.0								
33.9	100.7								
50.9	100.4								
58.9	100.0								
66.5	100.1								
74.6	100.5								
85.0	100.2								
89.0	99.5								
92.4	99.6								
95.4	100.1								
107.3	100.1								
114.9	99.4								
119.5	99.4								
123.9	100.1								
134.1	99.5								
135.3	98.2								
142.6	99.5								
150.6	99.1

Avg. Water Surface Slope	2008	2009	2010
Avg. Riffle Slope			
Avg. Pool Slope			
Avg. Run Slope			
Avg. Gidle Slope			
As-built	0.0056

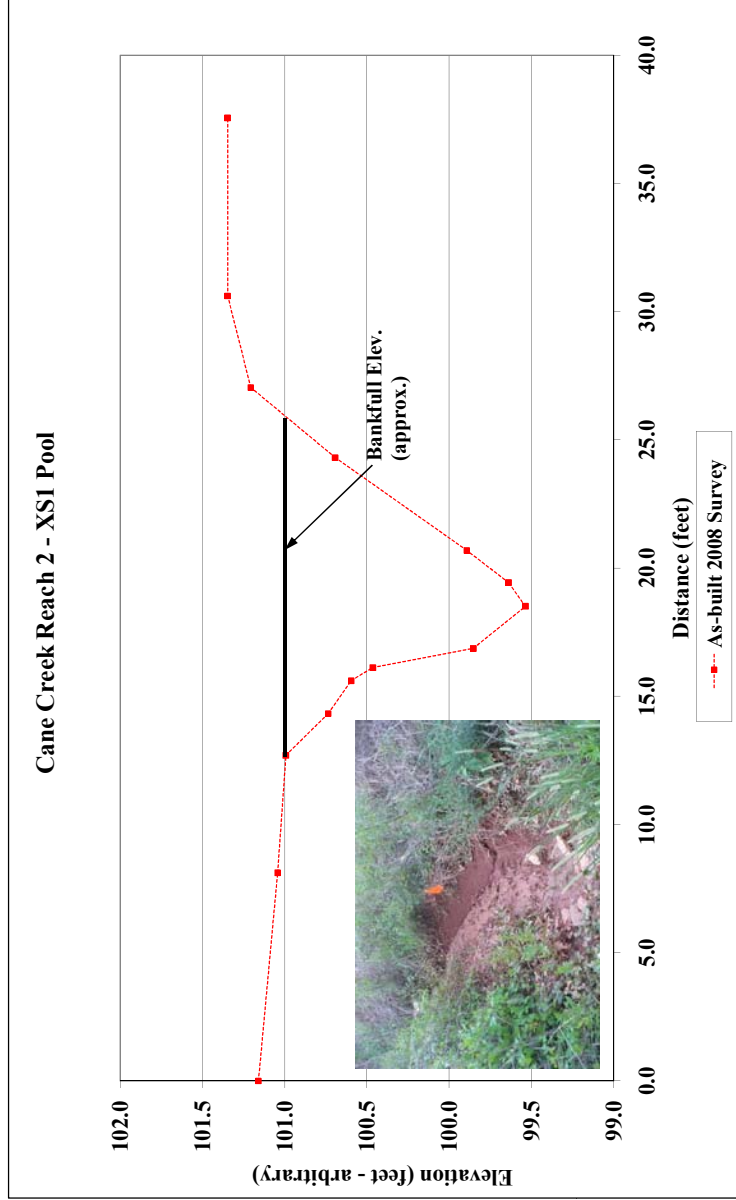
Project Name Cane Creek				
Cross Section R2-XS1				
Feature Pool				
Date 5/6/08				
Crew Adams, Jeffers				
As-built	2008	2009	2010	
Station	2008 Survey	2009 Survey	2010 Survey	
0.0	Elevation	Elevation	Elevation	
8.1	101.2			
12.7	101.0			
14.3	100.7			
15.6	100.6			
16.1	100.5			
16.9	99.9			
18.5	99.5			
19.4	99.6			
20.7	99.9			
24.3	100.7			
27.0	101.2			
30.6	101.3			
37.6	101.3

Area	As-built	2008	2009	2010
Width	9.3			
Mean Depth	13.4			
Max Depth	0.7			
W/D Ratio	1.5			
	N/A

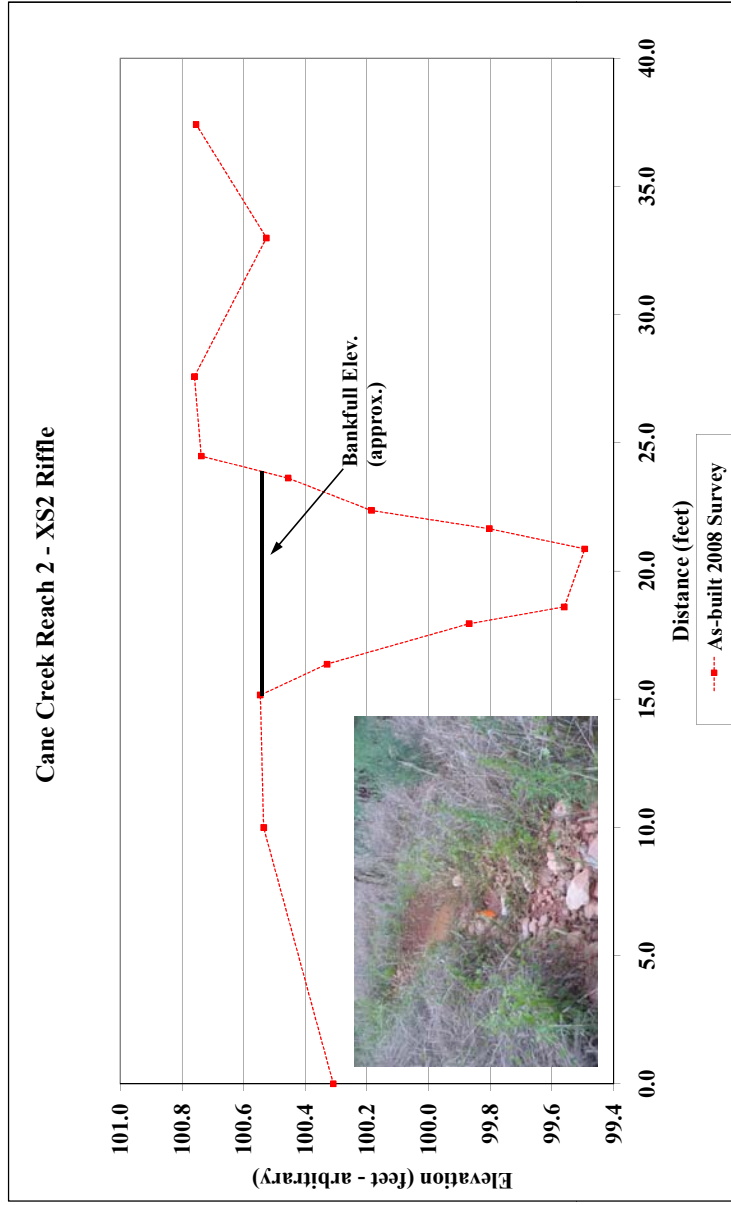
Project Name Cane Creek			
Cross Section R2-XS2			
Feature Riffle			
Date 5/6/08			
Crew Adams, Jeffers			
As-built	2008	2009	2010
Station	2008 Survey Station	2009 Survey Station	2010 Survey Station
0.0	100.3		
10.0	100.5		
15.2	100.5		
16.4	100.3		
17.9	99.9		
18.6	99.6		
20.9	99.5		
21.7	99.8		
22.4	100.2		
23.6	100.5		
24.5	100.7		
27.6	100.8		
33.0	100.5		
37.4	100.8

Area	As-built	2008	2009	2010
Width	5.1			
Mean Depth	9.2			
Max Depth	0.6			
W/D Ratio	1.1			
	16.5

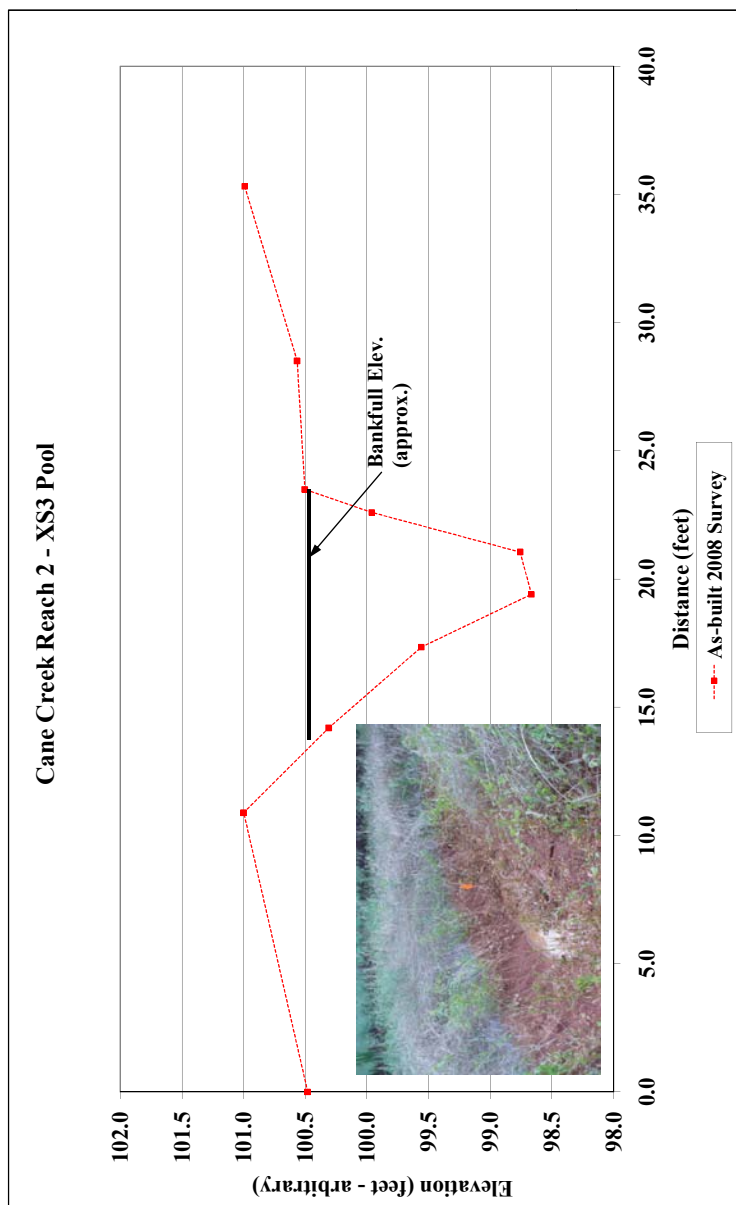
Project Name Cane Creek			
Cross Section R2-XS3			
Feature Pool			
Date 5/6/08			
Crew Adams, Jeffers			
As-built	2008	2009	2010
Survey Station	2008 Survey Station	2009 Survey Station	2010 Survey Station
Elevation	Elevation	Elevation	Elevation
0.0 100.5			
10.9 101.0			
14.2 100.3			
17.3 99.6			
19.4 98.7			
21.1 98.8			
22.6 100.0			
23.5 100.5			
28.5 100.6			
35.3 101.0

Area	As-built	2008	2009	2010
Width	9.7			
Mean Depth	10.2			
Max Depth	1.0			
W/D Ratio	1.8			
	N/A

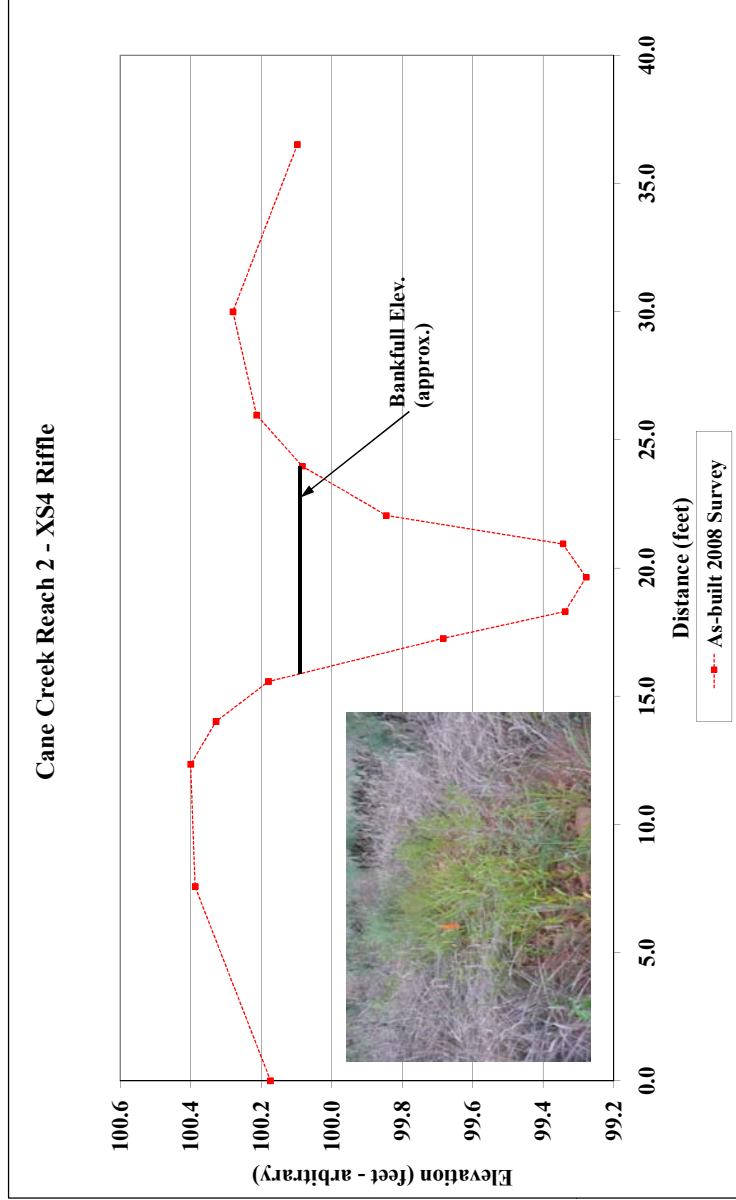
Project Name Cane Creek			
Cross Section R2-XS4			
Feature Riffle			
Date 5/6/08			
Crew Adams, Jeffers			
As-built	2008	2009	2010
Survey Station	2008 Survey Station	2009 Survey Station	2010 Survey Station
0.0	100.2		
7.6	100.4		
12.3	100.4		
14.0	100.3		
15.6	100.2		
17.3	99.7		
18.3	99.3		
19.6	99.3		
20.9	99.3		
22.0	99.8		
24.0	100.1		
26.0	100.2		
30.0	100.3		
36.5	100.1

Area	As-built	2008	2009	2010
Width	3.7			
Mean Depth	8.1			
Max Depth	0.5			
W/D Ratio	0.8			
	17.8

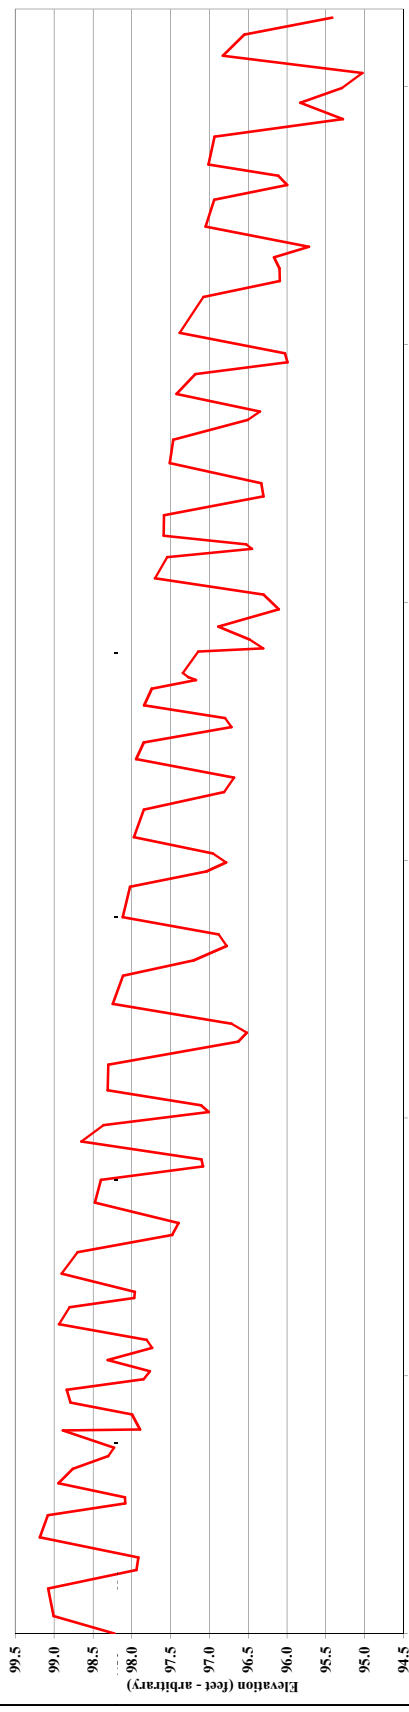
Cane Creek Profile - Reach 3

Project Name		Cane Creek Asphalt				
Reach		3				
Profile						
Feature		50608				
Date		Adams, Jeffers				
Crew						
Station	2008 Survey Bed Elevation	2008 Survey Water Elevation	2009 Survey Bed Elevation	2009 Survey Water Elevation	2010 Survey Bed Elevation	2010 Survey Water Elevation
0.0	98.2					
6.9	99.0					
17.5	99.1					
24.7	97.9					
27.6	97.9					
37.4	99.2					
45.9	99.1					
50.5	98.1					
52.9	98.1					
58.4	98.9					
69.0	98.3					
72.2	98.2					
78.2	98.2					
79.3	97.9					
85.1	98.0					
89.6	98.8					
94.6	98.8					
98.7	97.8

Avg. Water Surface Slope	0.0035
Avg. Riffle Slope	
Avg. Pool Slope	
Avg. Run Slope	
Avg. Glide Slope

Note: Channel was dry at the time asphalt measurements were collected; therefore, no water surface elevation is shown

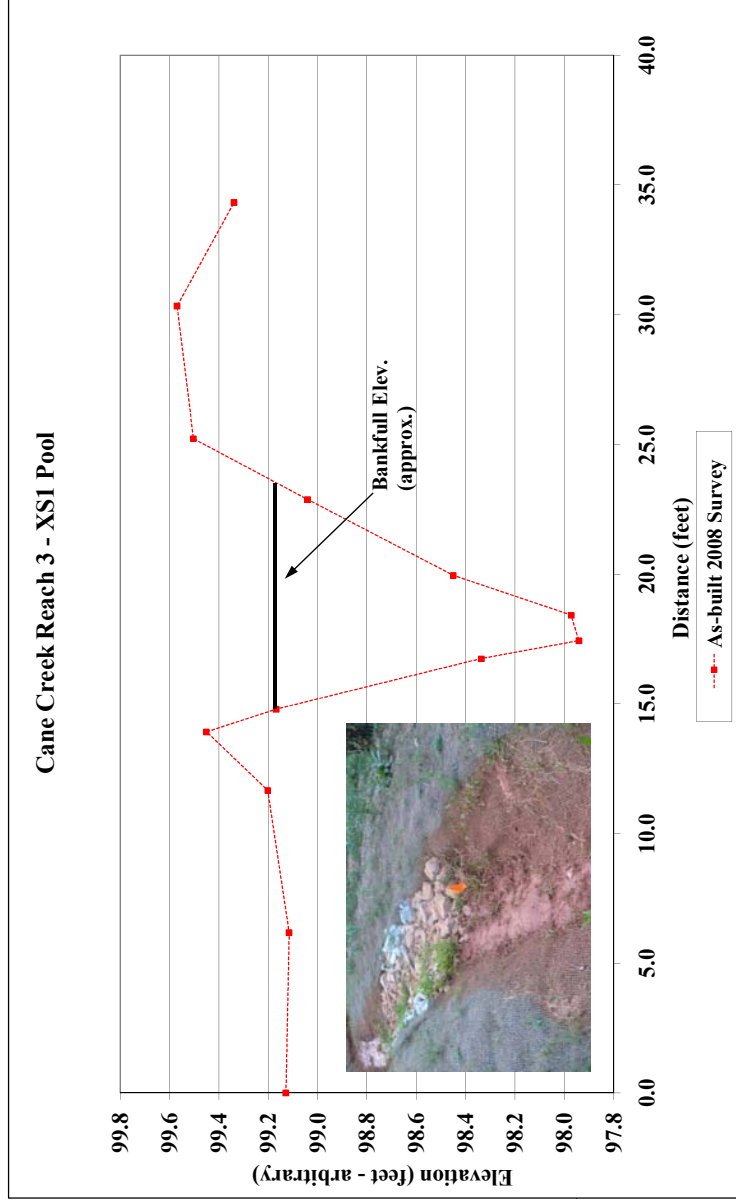
Project Name Cane Creek			
Cross Section R3-XS1			
Feature Pool			
Date 5/6/08			
Crew Adams, Jeffers			
As-built	2008	2009	2010
Station	2008 Survey	2009 Survey	2010 Survey
	Elevation	Elevation	Elevation
0.0	99.1		
6.2	99.1		
11.7	99.2		
13.9	99.5		
14.8	99.2		
16.7	98.3		
17.4	97.9		
18.4	98.0		
19.9	98.4		
22.9	99.0		
25.2	99.5		
30.3	99.6		
34.3	99.3

Area	As-built	2008	2009	2010
Width	5.4			
Mean Depth	8.7			
Max Depth	0.6			
W/D Ratio	1.2			
	N/A

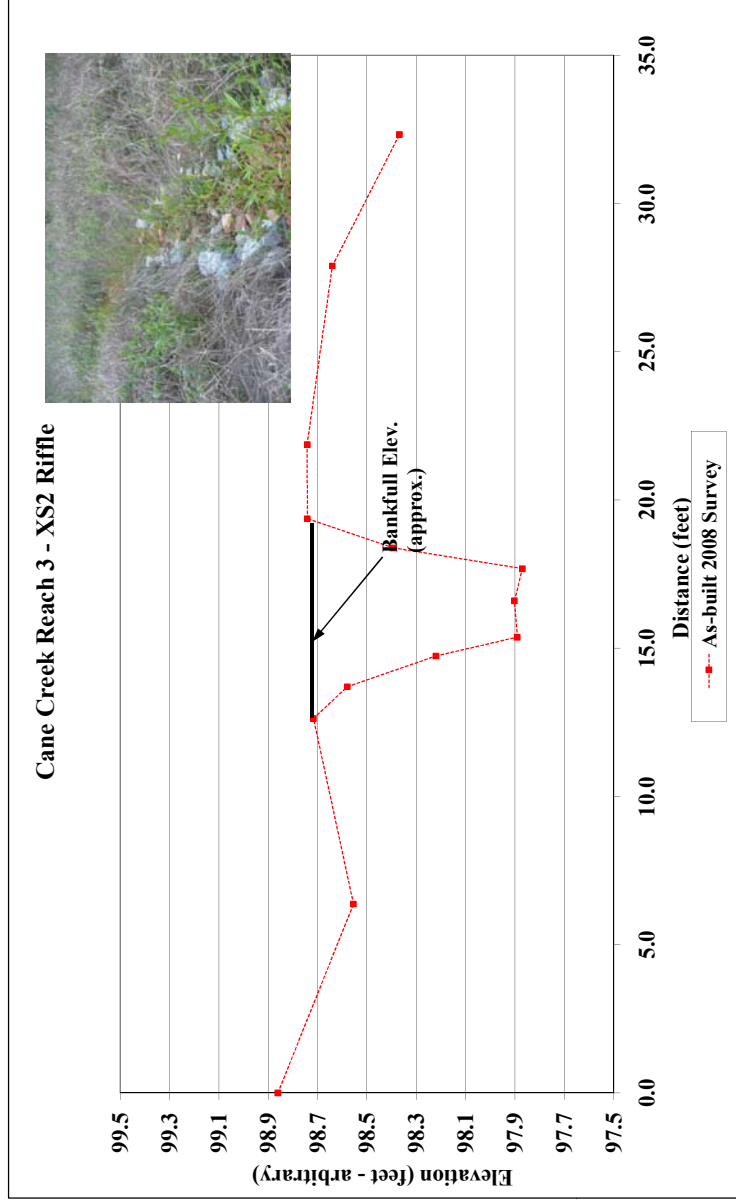
Project Name Cane Creek				
Cross Section R3-XS2				
Feature Riffle				
Date 5/6/08				
Crew Adams, Jeffers				
As-built	2008	2009	2010	
Station	2008 Survey Station	2009 Survey Station	2010 Survey Station	
Elevation	Elevation	Elevation	Elevation	
0.0	98.9			
6.4	98.6			
12.6	98.7			
13.7	98.6			
14.7	98.2			
15.4	97.9			
16.6	97.9			
17.7	97.9			
18.4	98.4			
19.4	98.7			
21.9	98.7			
27.9	98.6			
32.3	98.4

As-built	2008	2009	2010
Area	3.3		
Width	6.6		
Mean Depth	0.5		
Max Depth	0.8		
W/D Ratio	13.5

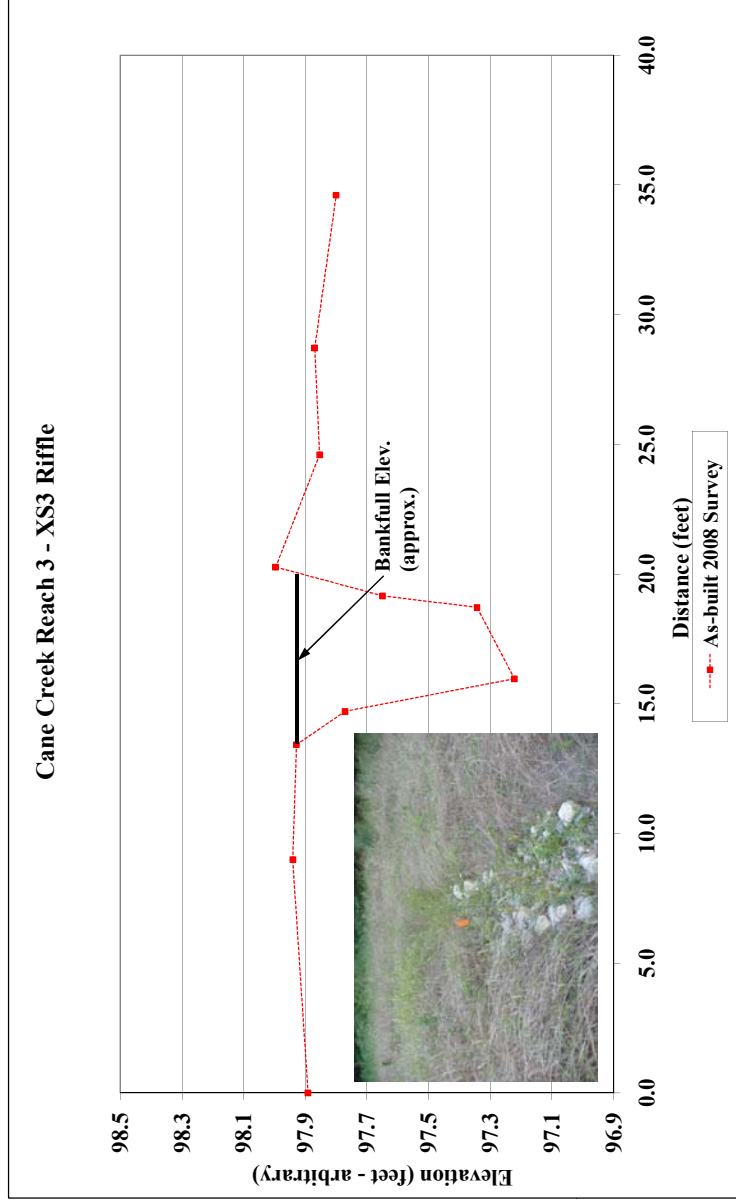
Project Name Cane Creek			
Cross Section R3-XS3			
Feature Riffle			
Date 5/6/08			
Crew Adams, Jeffers			
As-built	2008	2009	2010
Station	2008 Survey Station	2009 Survey Station	2010 Survey Station
Elevation	Elevation	Elevation	Elevation
0.0	97.9		
9.0	97.9		
13.4	97.9		
14.7	97.8		
16.0	97.2		
18.7	97.3		
19.2	97.6		
20.3	98.0		
24.6	97.9		
28.7	97.9		
34.6	97.8

Area	As-built	2008	2009	2010
Width	2.7			
Mean Depth	6.6			
Max Depth	0.4			
W/D Ratio	0.7			
	16.0

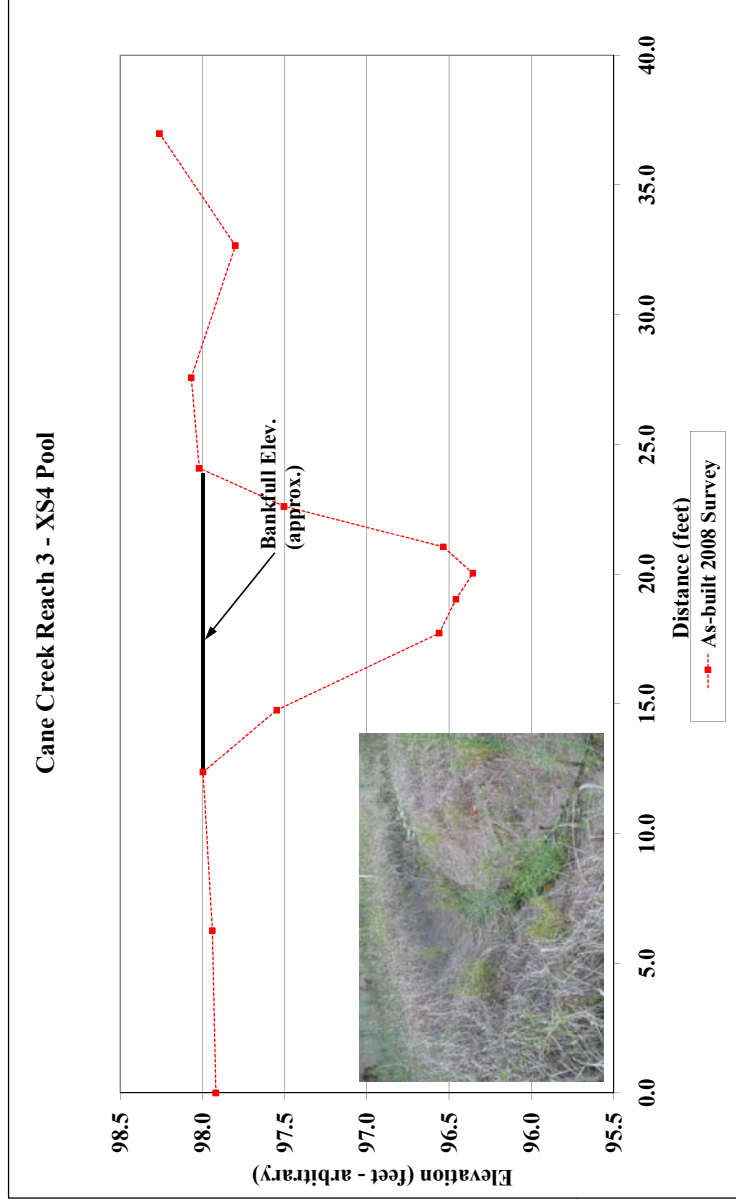
Project Name Cane Creek				
Cross Section R3-XS4				
Feature Pool				
Date 5/6/08				
Crew Adams, Jeffers				
As-built	2008	2009	2010	
2008 Survey	2008 Survey	2009 Survey	2010 Survey	
Station	Station	Station	Station	Elevation
0.0	97.9			
6.3	97.9			
12.4	98.0			
14.8	97.5			
17.7	96.6			
19.0	96.5			
20.0	96.4			
21.1	96.5			
22.6	97.5			
24.1	98.0			
27.6	98.1			
32.7	97.8			
37.0	98.3

Area	As-built	2008	2009	2010
Width	10.3			
Mean Depth	11.6			
Max Depth	0.9			
W/D Ratio	1.6			
	N/A

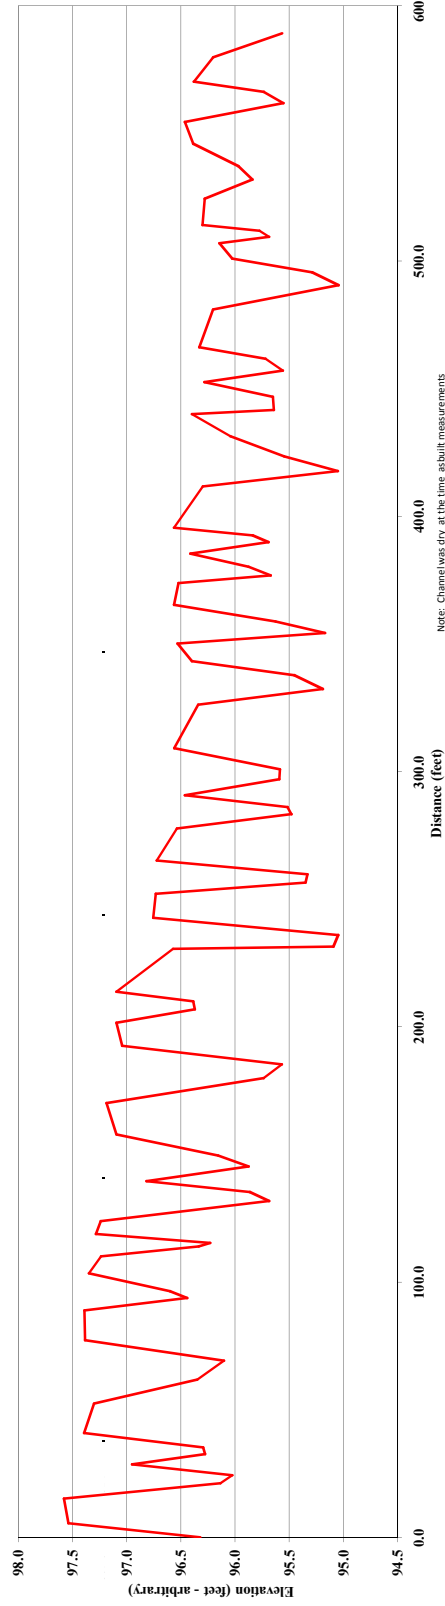
Cane Creek Profile - Reach 4

Project Name				Cane Creek As-built				
Reach				4				
Feature				Profile				
Date				06/08				
Drawn				Adrienne Jeffers				
Station	2008 Survey Bed Elevation	2008 Survey Water Elevation	Station	2009 Survey Bed Elevation	2009 Survey Water Elevation	Station	2010 Survey Bed Elevation	2010 Survey Water Elevation
0.0	96.3							
1.5	97.5							
3.0	97.4							
4.5	97.2							
6.0	96.1							
7.5	96.0							
9.0	97.0							
10.5	96.3							
12.0	96.3							
13.5	97.4							
15.0	97.1							
16.5	97.2							
18.0	96.3							
19.5	96.1							
21.0	97.4							
22.5	97.4							
24.0	96.4							
25.5	96.6							
27.0	100.4							
28.5	100.4							
30.0	97.3							
31.5	114.0							
33.0	96.3							
34.5	96.2							
36.0	118.9							
37.5	97.3

A-s-built	2008	2009	2010
Avg. Water Surface Slope			
Avg. Right Slope			
Avg. Left Slope			
Avg. Grade Slope			
A-s-built	0.0020

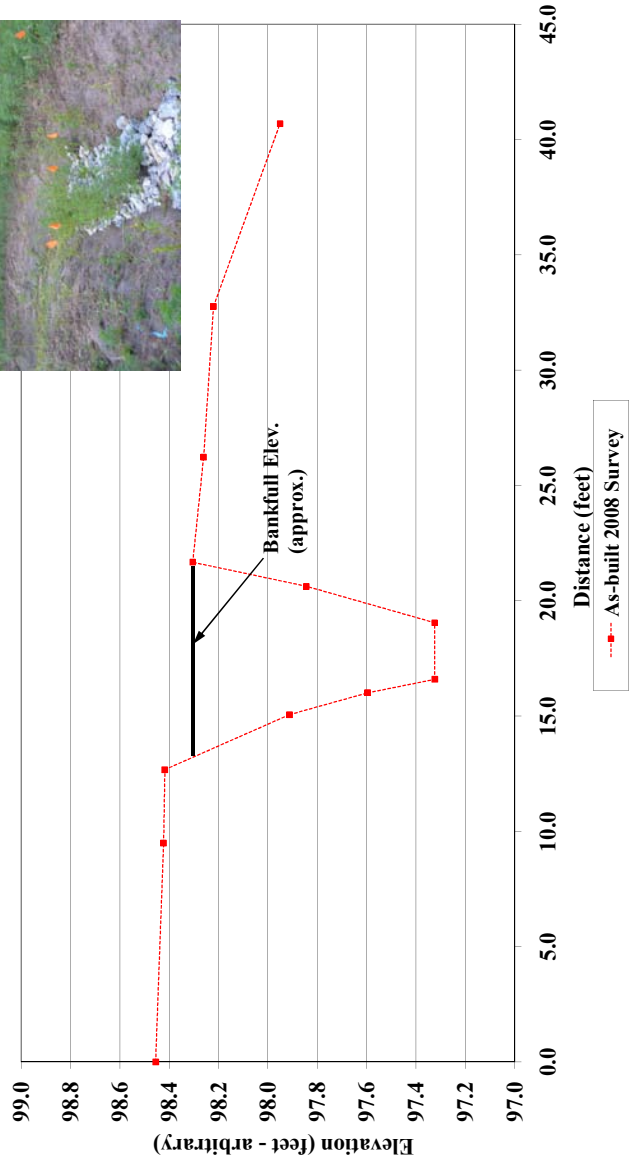
Cane Creek Reach 4 - XS1 Riffle

Project Name Cane Creek			
Cross Section R4-XS1			
Feature Riffle			
Date 5/6/08			
Crew Adams, Jeffers			
As-built	2008	2009	2010
2008 Survey	2008 Survey	2009 Survey	2010 Survey
Station	Station	Station	Station
Elevation	Elevation	Elevation	Elevation
0.0 98.5			
9.5 98.4			
12.7 98.4			
15.1 97.9			
16.0 97.6			
16.6 97.3			
19.0 97.3			
20.6 97.8			
21.7 98.3			
26.2 98.3			
32.8 98.2			
40.7 98.0

Area	As-built	2008	2009	2010
Width	5.2			
Mean Depth	8.5			
Max Depth	0.6			
W/D Ratio	1.0			
	13.8

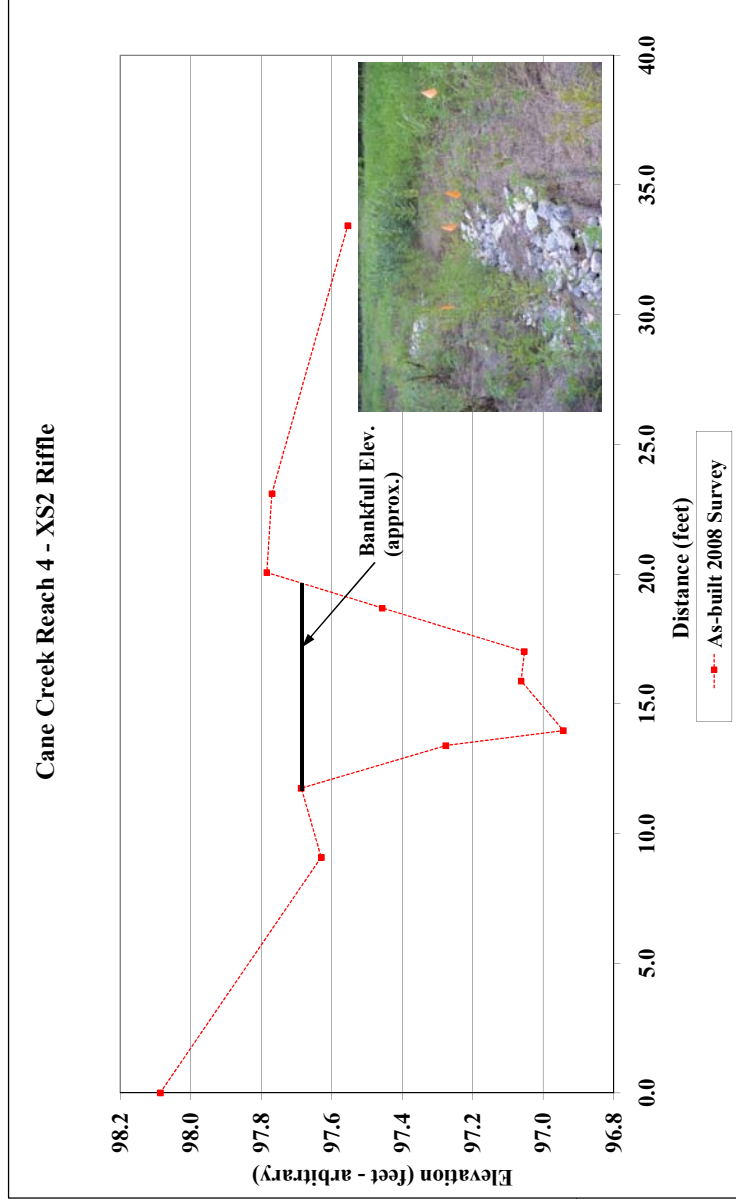
Project Name Cane Creek			
Cross Section R4-XS2			
Feature Riffle			
Date 5/6/08			
Crew Adams, Jeffers			
As-built	2008	2009	2010
Station	2008 Survey	2009 Survey	2010 Survey
	Station	Station	Station
	Elevation	Elevation	Elevation
0.0	98.1		
9.1	97.6		
11.7	97.7		
13.4	97.3		
14.0	96.9		
15.9	97.1		
17.0	97.1		
18.7	97.5		
20.1	97.8		
23.1	97.8		
33.4	97.6

Area	As-built	2008	2009	2010
Width	3.5			
Mean Depth	7.9			
Max Depth	0.4			
W/D Ratio	0.7			
	17.7

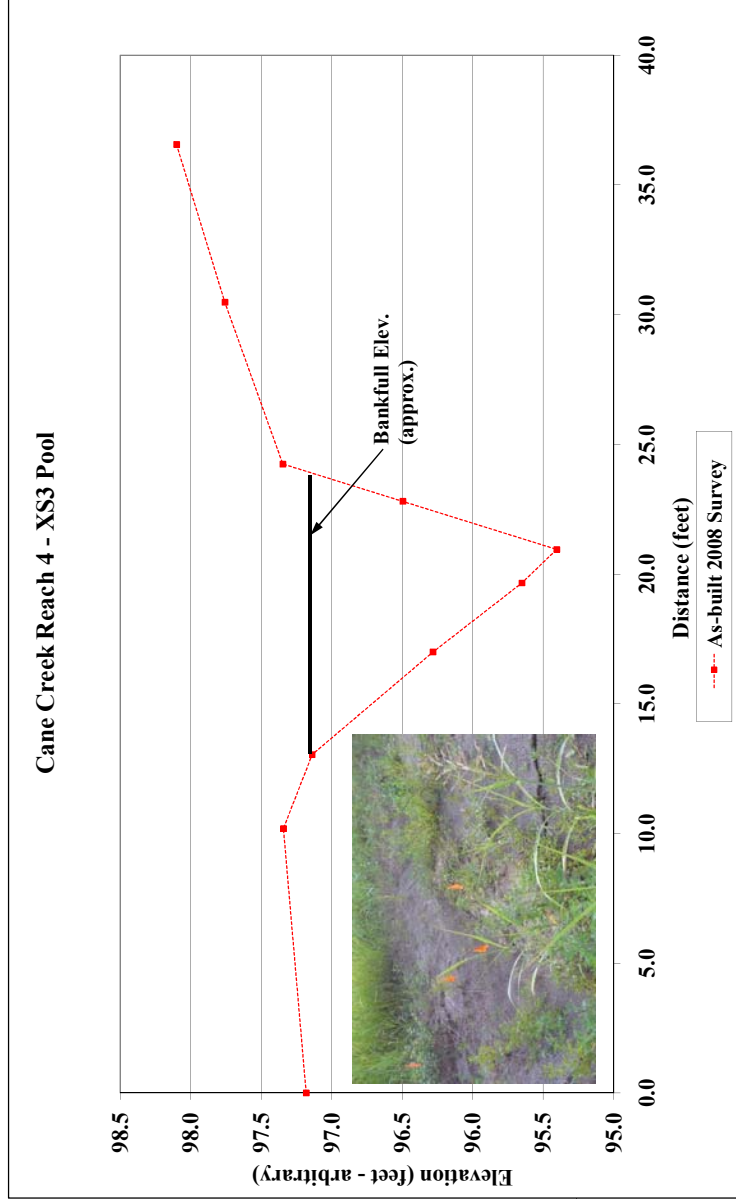
Project Name Cane Creek				
Cross Section R4-XS3				
Feature Pool				
Date 5/6/08				
Crew Adams, Jeffers				
As-built	2008	2009	2010	
Survey Station	2008 Survey Station	2009 Survey Station	2010 Survey Station	
0.0	97.2			
10.2	97.3			
13.0	97.1			
17.0	96.3			
19.7	95.7			
21.0	95.4			
22.8	96.5			
24.2	97.3			
30.5	97.8			
36.6	98.1

Area	As-built	2008	2009	2010
9.5				
Width	10.9			
Mean Depth	0.9			
Max Depth	1.7			
W/D Ratio	N/A

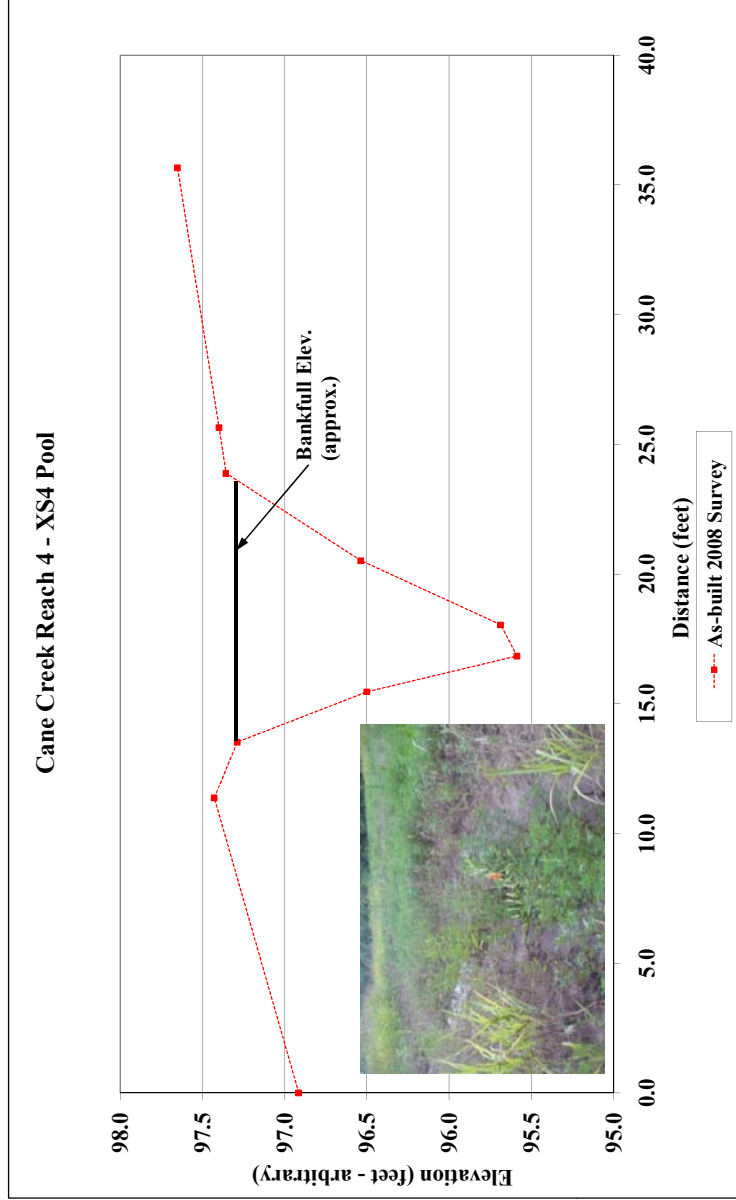
Project Name Cane Creek			
Cross Section R4-XS4			
Feature Pool			
Date 5/6/08			
Crew Adams, Jeffers			
As-built	2008	2009	2010
2008 Survey	2008 Survey	2009 Survey	2010 Survey
Station	Station	Station	Station
Elevation	Elevation	Elevation	Elevation
0.0 96.9			
11.4 97.4			
13.5 97.3			
15.5 96.5			
16.8 95.6			
18.0 95.7			
20.5 96.5			
23.9 97.4			
25.7 97.4			
35.7 97.7

Area	As-built	2008	2009	2010
Width	8.5			
Mean Depth	10.1			
Max Depth	0.8			
W/D Ratio	1.7			
	NA

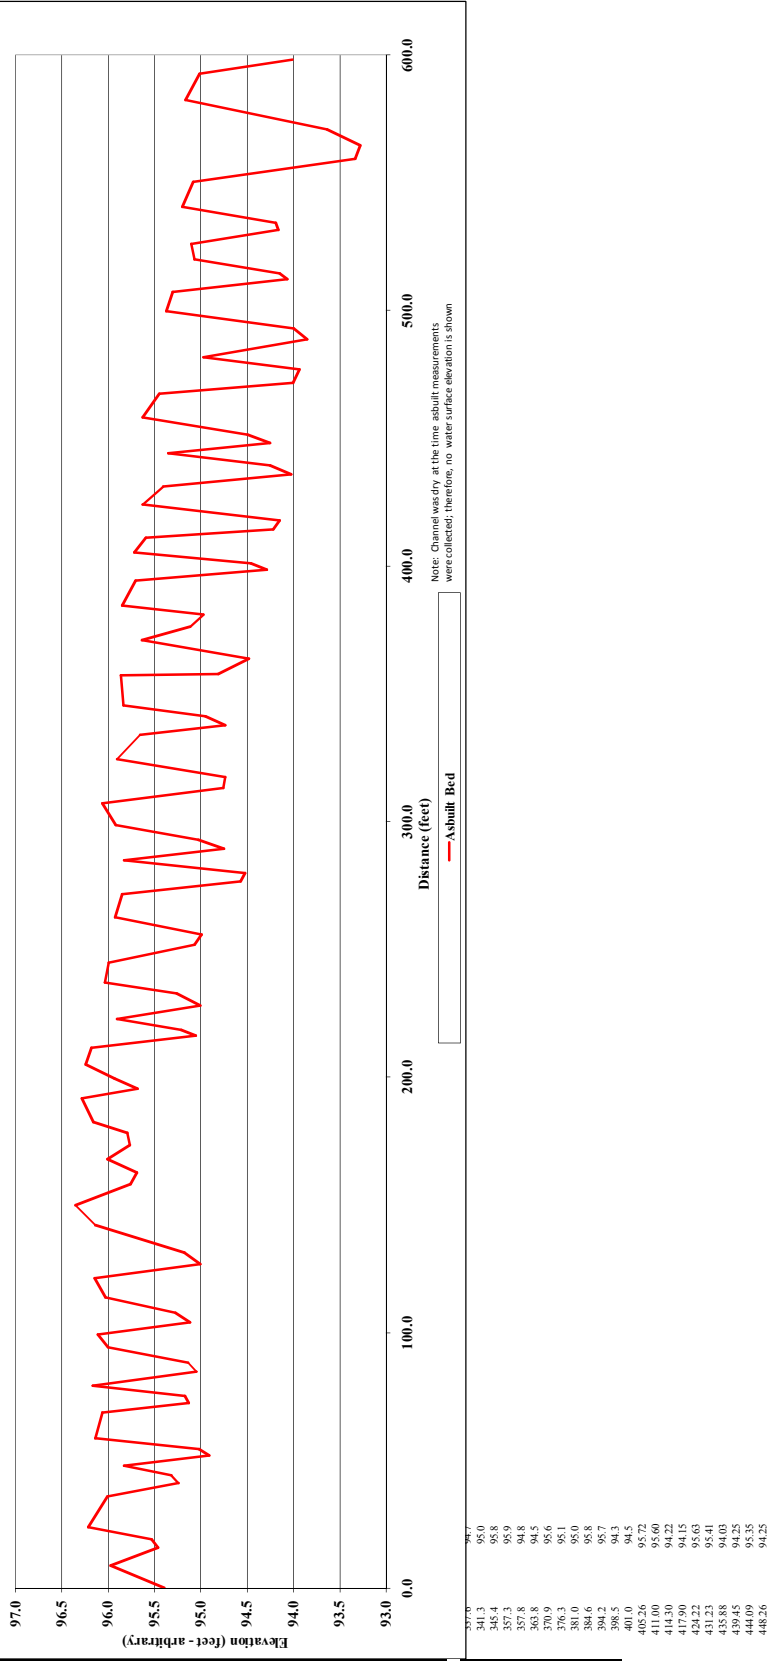
Cane Creek Profile--Reach 5

Project Name		Cane Creek									
Reach		5									
Profile											
Feature											
Crew		Adams, Jeffers									
Station	As-built 2008 Survey Bed Elevation	2008 Survey Bed Elevation	Water Elevation	Station	2009 Survey Bed Elevation	2009 Survey Bed Elevation	Water Elevation	Station	2010 Survey Bed Elevation	2010 Survey Bed Elevation	Water Elevation
89.0	96.0	96.0									
89.5	95.5	95.5									
19.0	95.5	95.5									
23.7	96.2	96.2									
35.8	96.0	96.0									
41.1	95.2	95.2									
47.9	95.8	95.8									
52.0	94.9	94.9									
54.4	95.0	95.0									
58.8	96.1	96.1									
58.7	96.1	96.1									
67.1	95.2	95.2									
75.1	95.2	95.2									
79.2	96.2	96.2									
84.7	95.0	95.0									
88.3	95.1	95.1									
94.1	96.0	96.0									
97.1	95.1	95.1									
103.9	95.1	95.1									
107.7	95.3	95.3									
113.7	96.0	96.0

Avg. Water Surface Slope	Asphalt	2008	2009	2010
Avg. Riffle Slope	0.0014			
Avg. Pool Slope				
Avg. Run Slope				
Avg. Gully Slope

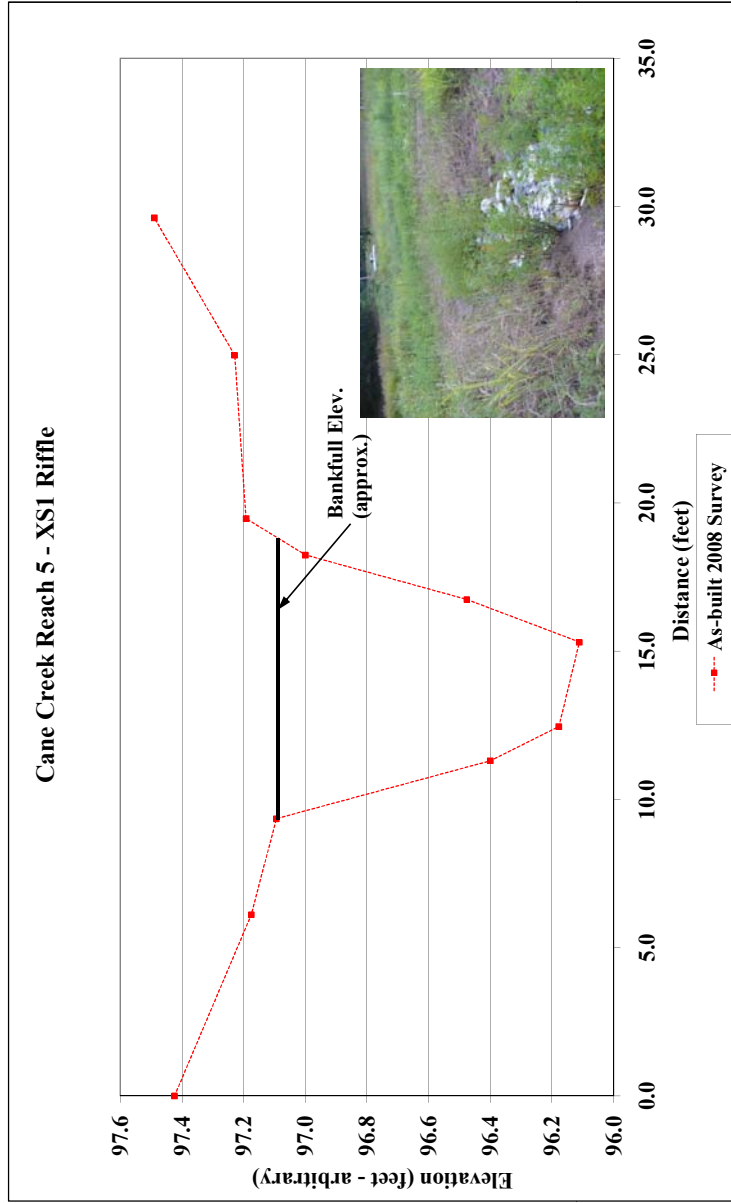
Project Name Cane Creek			
Cross Section R5-XS1			
Feature Riffle			
Date 5/6/08			
Crew Adams, Jeffers			
As-built	2008	2009	2010
2008 Survey	2008 Survey	2009 Survey	2010 Survey
Station	Station	Station	Station
Elevation	Elevation	Elevation	Elevation
0.0 97.4			
6.1 97.2			
9.3 97.1			
11.3 96.4			
12.5 96.2			
15.3 96.1			
16.7 96.5			
18.2 97.0			
19.5 97.2			
25.0 97.2			
29.6 97.5

Area	As-built	2008	2009	2010
Width	6.0			
Mean Depth	9.4			
Max Depth	0.6			
W/D Ratio	1.0			
	14.9

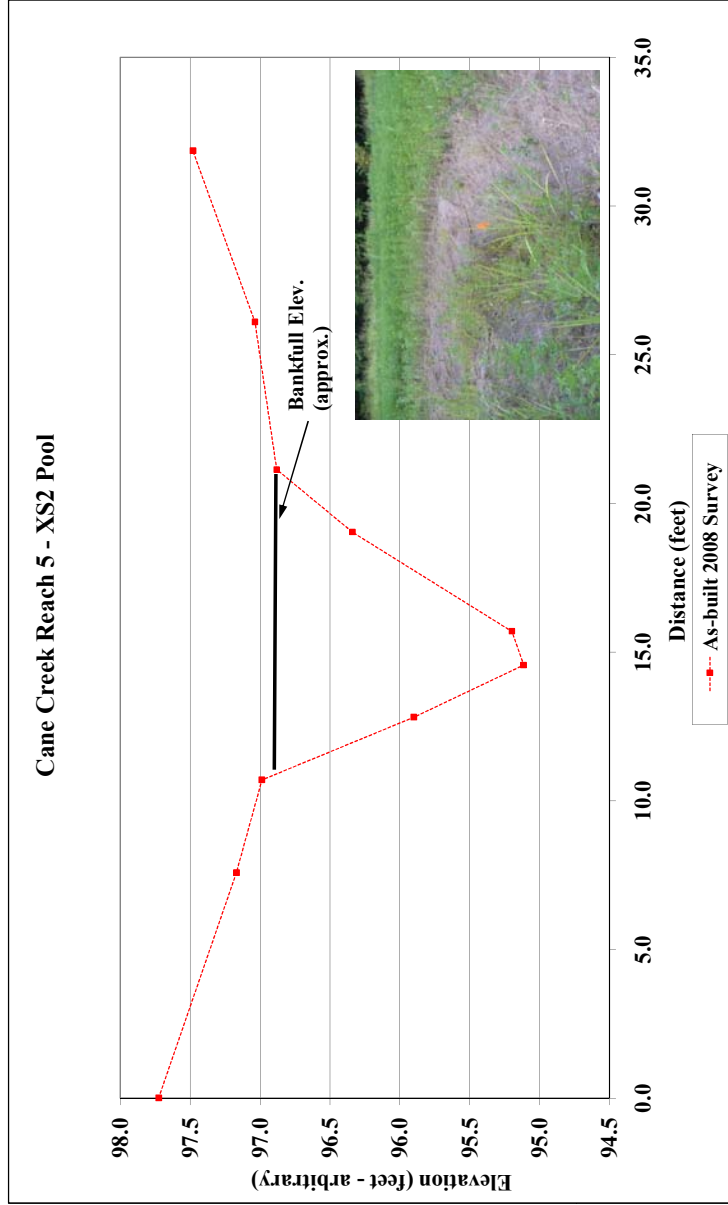
Project Name Cane Creek			
Cross Section R5-XS2			
Feature Pool			
Date 5/6/08			
Crew Adams, Jeffers			
As-built	2008	2009	2010
2008 Survey	2008 Survey	2009 Survey	2010 Survey
Station	Station	Station	Station
Elevation	Elevation	Elevation	Elevation
0.0 97.7			
7.6 97.2			
10.7 97.0			
12.8 95.9			
14.6 95.1			
15.7 95.2			
19.0 96.3			
21.1 96.9			
26.1 97.0			
31.9 97.5

Area	As-built	2008	2009	2010
Width	8.5			
Mean Depth	9.6			
Max Depth	0.9			
W/D Ratio	1.7			
	NA

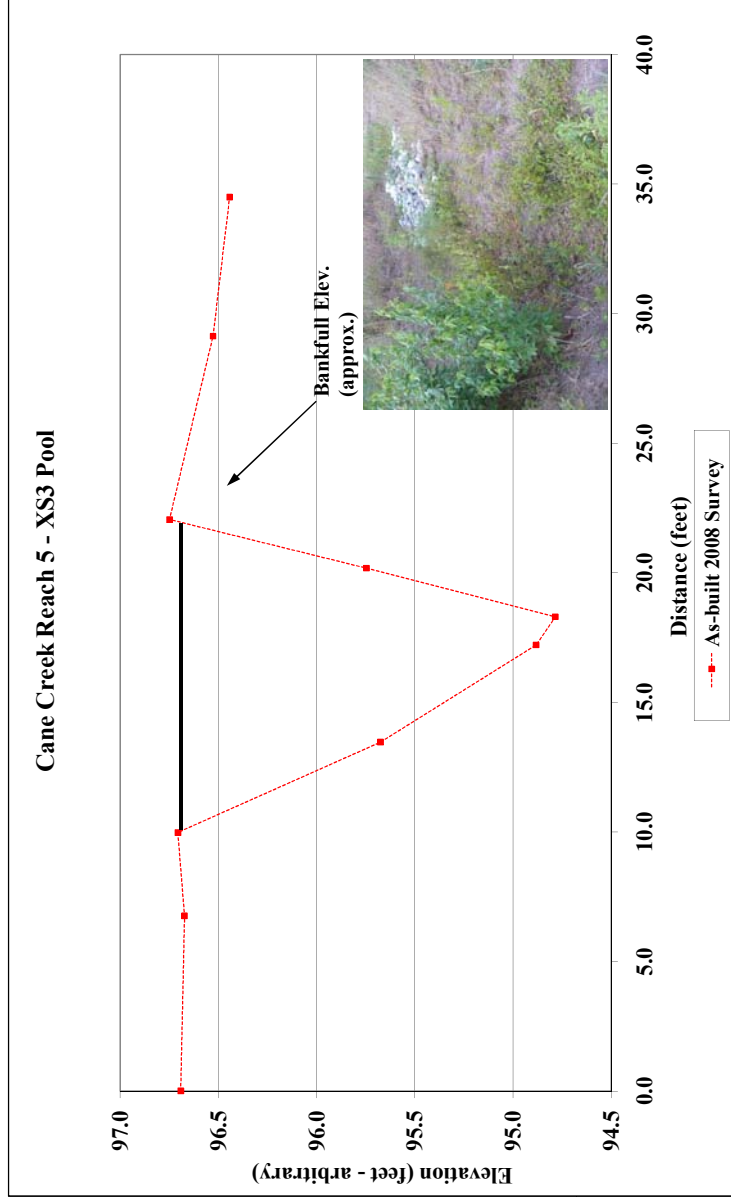
Project Name Cane Creek			
Cross Section R5-XS3			
Feature Pool			
Date 5/6/08			
Crew Adams, Jeffers			
As-built	2008	2009	2010
2008 Survey	2008 Survey	2009 Survey	2010 Survey
Station	Station	Station	Station
Elevation	Elevation	Elevation	Elevation
0.0 96.7			
6.8 96.7			
10.0 96.7			
13.5 95.7			
17.2 94.9			
18.3 94.8			
20.2 95.7			
22.1 96.7			
29.1 96.5			
34.5 96.4

Area	As-built	2008	2009	2010
Width	12.3			
Mean Depth	11.8			
Max Depth	1.0			
W/D Ratio	1.9			
	N/A

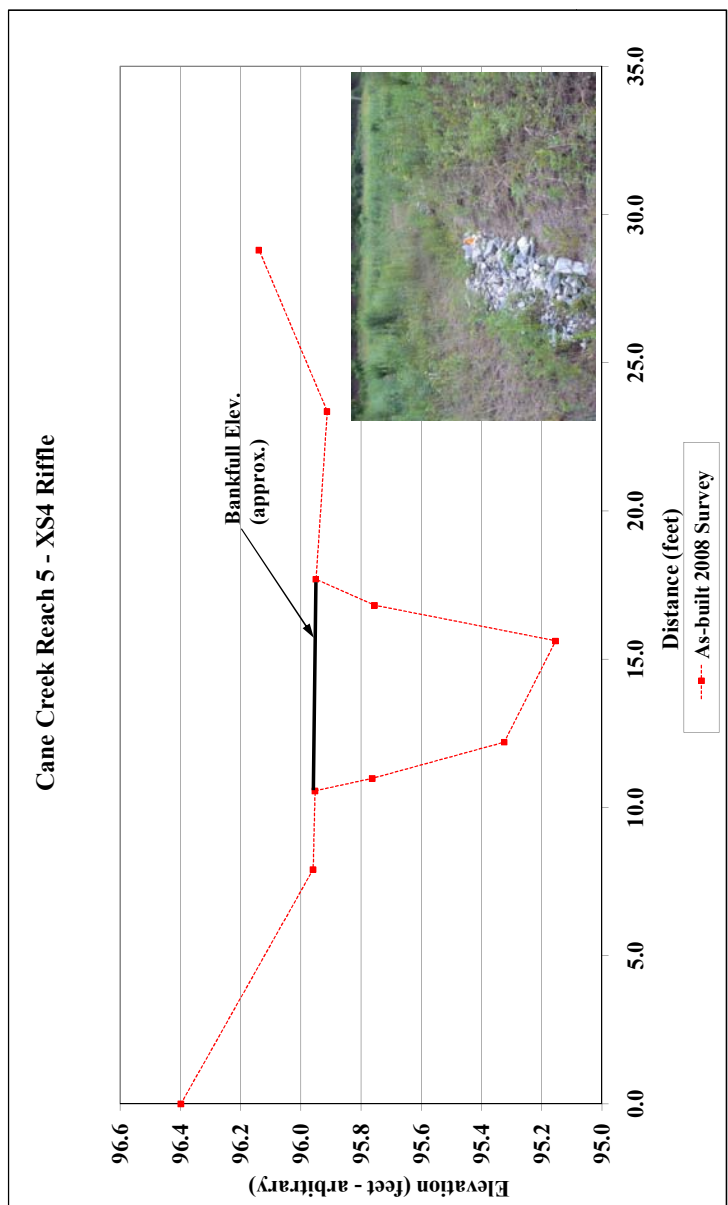
Project Name Cane Creek			
Cross Section R5-XS4			
Feature Riffle			
Date 5/6/08			
Crew Adams, Jeffers			
As-built	2008	2009	2010
2008 Survey	2008 Survey	2009 Survey	2010 Survey
Station	Station	Station	Station
Elevation	Elevation	Elevation	Elevation
0.0 96.4			
7.9 96.0			
10.6 96.0			
11.0 95.8			
12.2 95.3			
15.6 95.2			
16.8 95.8			
17.7 96.0			
23.4 95.9			
28.8 96.1

Area	As-built	2008	2009	2010
Width	3.6			
Mean Depth	7.1			
Max Depth	0.5			
W/D Ratio	0.8			
	13.9
