MONITORING YEAR 1 ANNUAL REPORT FINAL

CATFISH POND MITIGATION SITE

Durham County, NC

DMS Project No. 100039

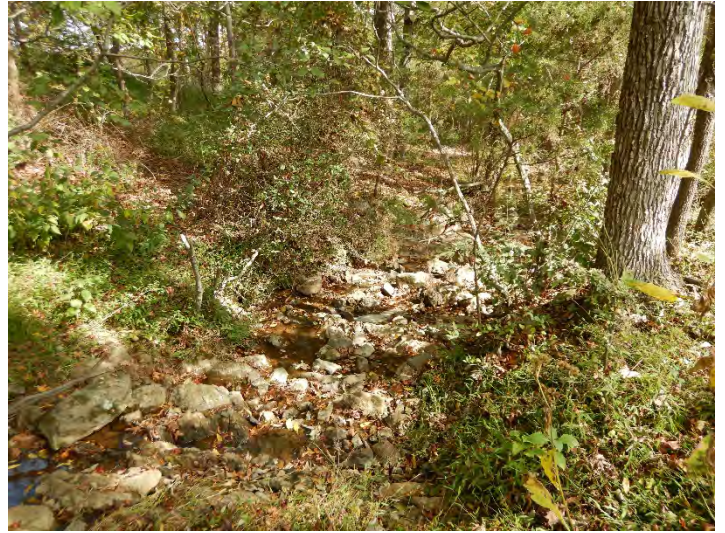
PHOTO POINT 16 UT1 R4 – upstream (10/22/2020)

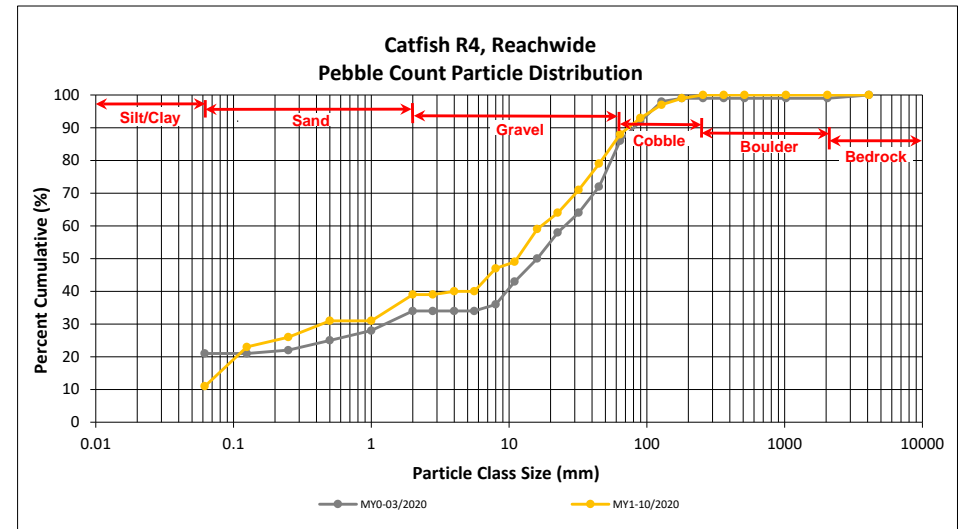
Reachwide Pebble Count Plots

Particle Class		Diameter (mm)		Particle Count			Reach Summary	
		min	max	Riffle	Pool	Total	Class Percentage	Percent Cumulative
SILT/CLAY	Silt/Clay	0.000	0.062	2	9	11	11	11
	Very fine	0.062	0.125	1	11	12	12	23
SAND	Fine	0.125	0.250	1	2	3	3	26
	Medium	0.25	0.50	1	4	5	5	31
	Coarse	0.5	1.0					31
	Very Coarse	1.0	2.0	3	5	8	8	39
	Very Fine	2.0	2.8					39
GRAVEL	Very Fine	2.8	4.0		1	1	1	40
	Fine	4.0	5.6					40
	Fine	5.6	8.0	2	5	7	7	47
	Medium	8.0	11.0		2	2	2	49
	Medium	11.0	16.0	4	6	10	10	59
	Coarse	16.0	22.6	3	2	5	5	64
	Coarse	22.6	32	6	1	7	7	71
	Very Coarse	32	45	8		8	8	79
	Very Coarse	45	64	9		9	9	88
	COBBLE	Small	64	90	5		5	5
Small		90	128	3	1	4	4	97
Large		128	180	2		2	2	99
Large		180	256		1	1	1	100
BOULDER	Small	256	362					100
	Small	362	512					100
	Medium	512	1024					100
	Large/Very Large	1024	2048					100
BEDROCK	Bedrock	2048	>2048					100
Total				50	50	100	100	100

Reachwide Channel materials (mm)	
D ₁₆ =	0.08
D ₃₅ =	1.41
D ₅₀ =	11.4
D ₈₄ =	54.7
D ₉₅ =	107.3
D ₁₀₀ =	256.0

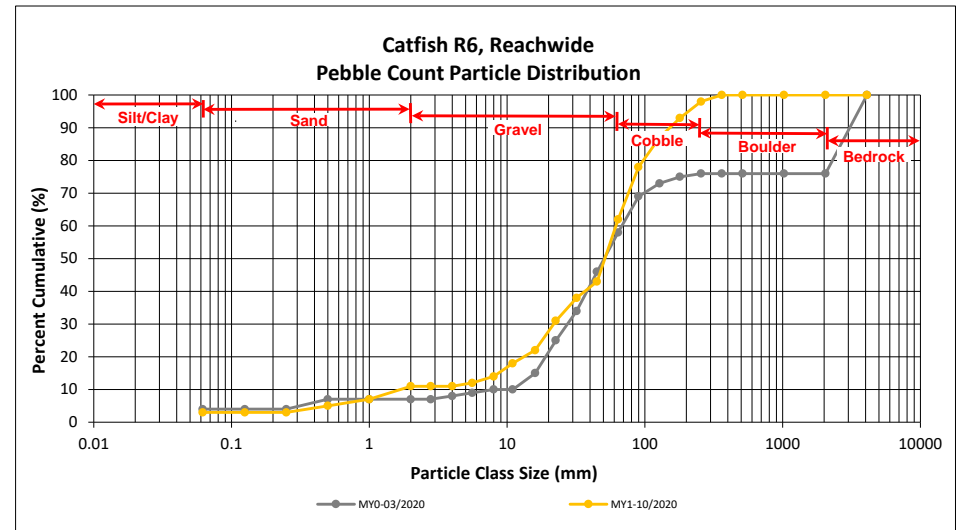
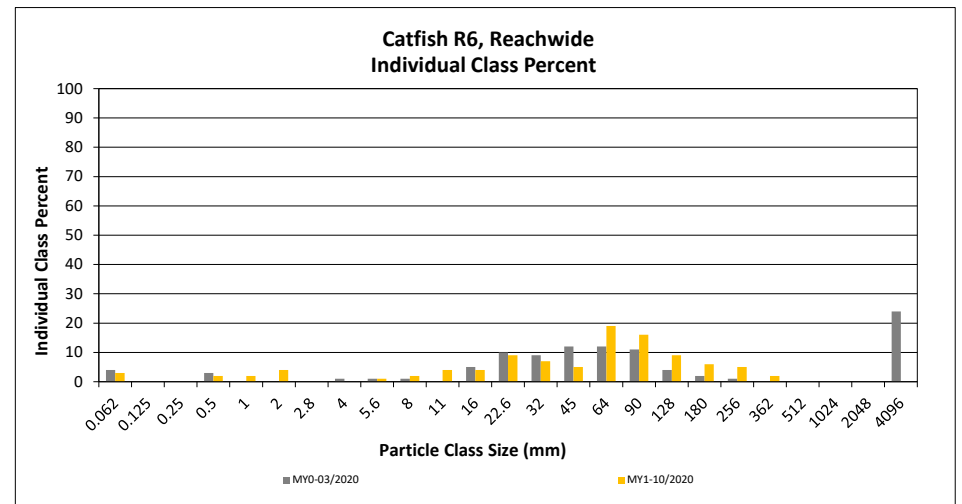
Reachwide Pebble Count Plots

Particle Class		Diameter (mm)		Particle Count			Reach Summary	
		min	max	Riffle	Pool	Total	Class Percentage	Percent Cumulative
SILT/CLAY	Silt/Clay	0.000	0.062	1	2	3	3	3
	Very fine	0.062	0.125					3
SAND	Fine	0.125	0.250					3
	Medium	0.25	0.50	1	1	2	2	5
	Coarse	0.5	1.0		2	2	2	7
	Very Coarse	1.0	2.0	2	2	4	4	11
	Very Fine	2.0	2.8					11
GRAVEL	Very Fine	2.8	4.0					11
	Fine	4.0	5.6		1	1	1	12
	Fine	5.6	8.0		2	2	2	14
	Medium	8.0	11.0	1	3	4	4	18
	Medium	11.0	16.0	3	1	4	4	22
	Coarse	16.0	22.6	8	1	9	9	31
	Coarse	22.6	32	5	2	7	7	38
	Very Coarse	32	45	4	1	5	5	43
	Very Coarse	45	64	15	4	19	19	62
	Small	64	90	11	5	16	16	78
COBBLE	Small	90	128	8	1	9	9	87
	Large	128	180	6		6	6	93
	Large	180	256	3	2	5	5	98
	Small	256	362	2		2	2	100
BOULDER	Small	362	512					100
	Medium	512	1024					100
	Large/Very Large	1024	2048					100
	Bedrock	2048	>2048					100
Total				70	30	100	100	100

Reachwide Channel materials (mm)	
D ₁₆ =	9.38
D ₃₅ =	27.57
D ₅₀ =	51.2
D ₈₄ =	113.8
D ₉₅ =	207.2
D ₁₀₀ =	362.0

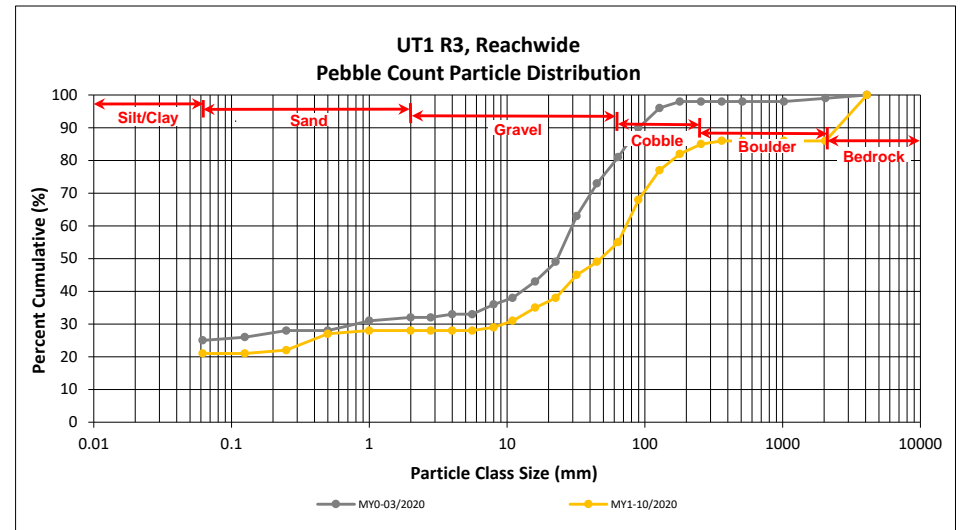
Reachwide Pebble Count Plots

Particle Class		Diameter (mm)		Particle Count			Reach Summary	
		min	max	Riffle	Pool	Total	Class Percentage	Percent Cumulative
SILT/CLAY	Silt/Clay	0.000	0.062	3	18	21	21	21
	Very fine	0.062	0.125					21
SAND	Fine	0.125	0.250	1		1	1	22
	Medium	0.25	0.50	1	4	5	5	27
	Coarse	0.5	1.0		1	1	1	28
	Very Coarse	1.0	2.0					28
GRAVEL	Very Fine	2.0	2.8					28
	Very Fine	2.8	4.0					28
	Fine	4.0	5.6					28
	Fine	5.6	8.0	1	1	2	2	29
	Medium	8.0	11.0	2		2	2	31
	Medium	11.0	16.0	1	3	4	4	35
	Coarse	16.0	22.6	2	1	3	3	38
	Coarse	22.6	32	5	2	7	7	45
COBBLE	Very Coarse	32	45	3	1	4	4	49
	Very Coarse	45	64	4	2	6	6	55
	Small	64	90	11	2	13	13	68
	Small	90	128	6	3	9	9	77
BOULDER	Large	128	180	3	2	5	5	82
	Large	180	256	3		3	3	85
	Small	256	362	1		1	1	86
BOULDER	Small	362	512					86
	Medium	512	1024					86
	Large/Very Large	1024	2048					86
BEDROCK	Bedrock	2048	>2048	4	10	14	14	100
Total				50	50	100	100	100

Reachwide Channel materials (mm)	
D ₁₆ =	Silt/Clay
D ₃₅ =	16.00
D ₅₀ =	47.7
D ₈₄ =	227.6
D ₉₅ =	3197.8
D ₁₀₀ =	>2048

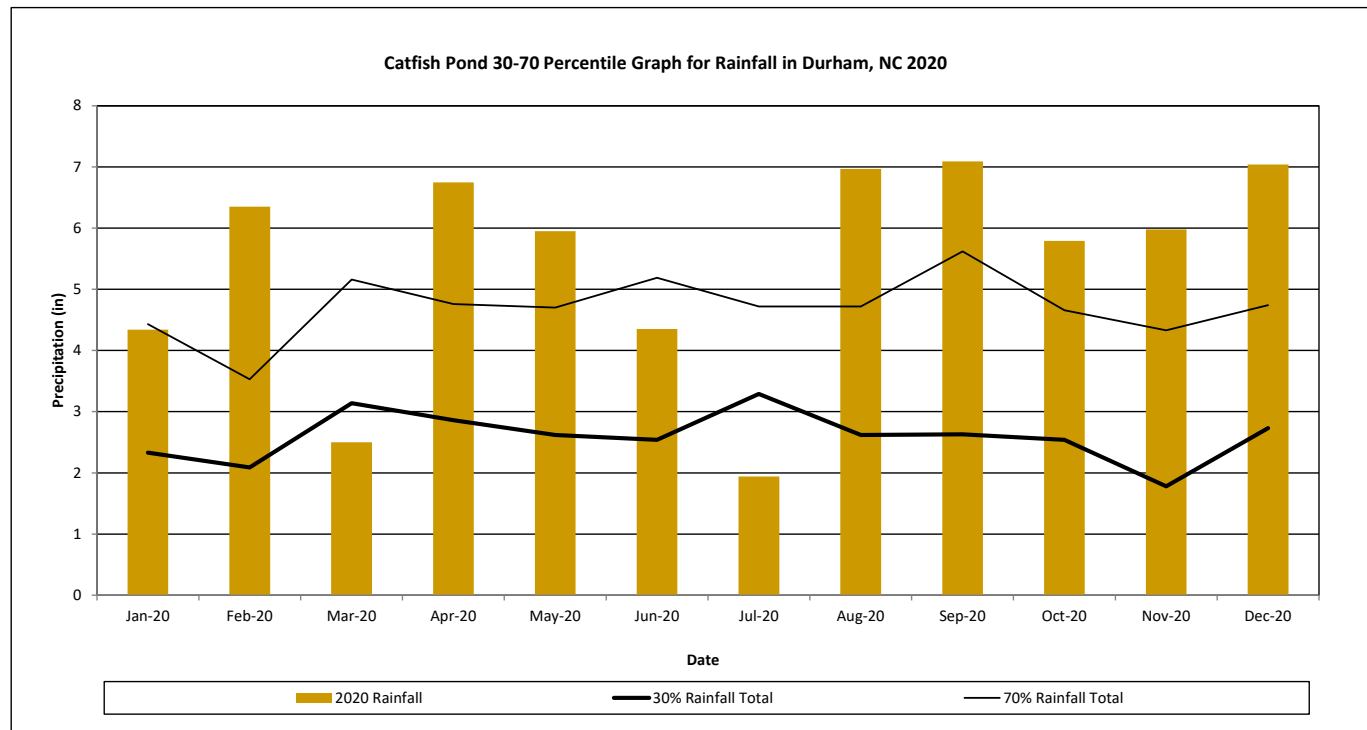
Monthly Rainfall Data

¹ 2020 monthly rainfall from USDA Station Durham 10.7 NNE.

² 30th and 70th percentile rainfall data collected from weather station Roxboro 7 ESE, NC (USDA, 2020).

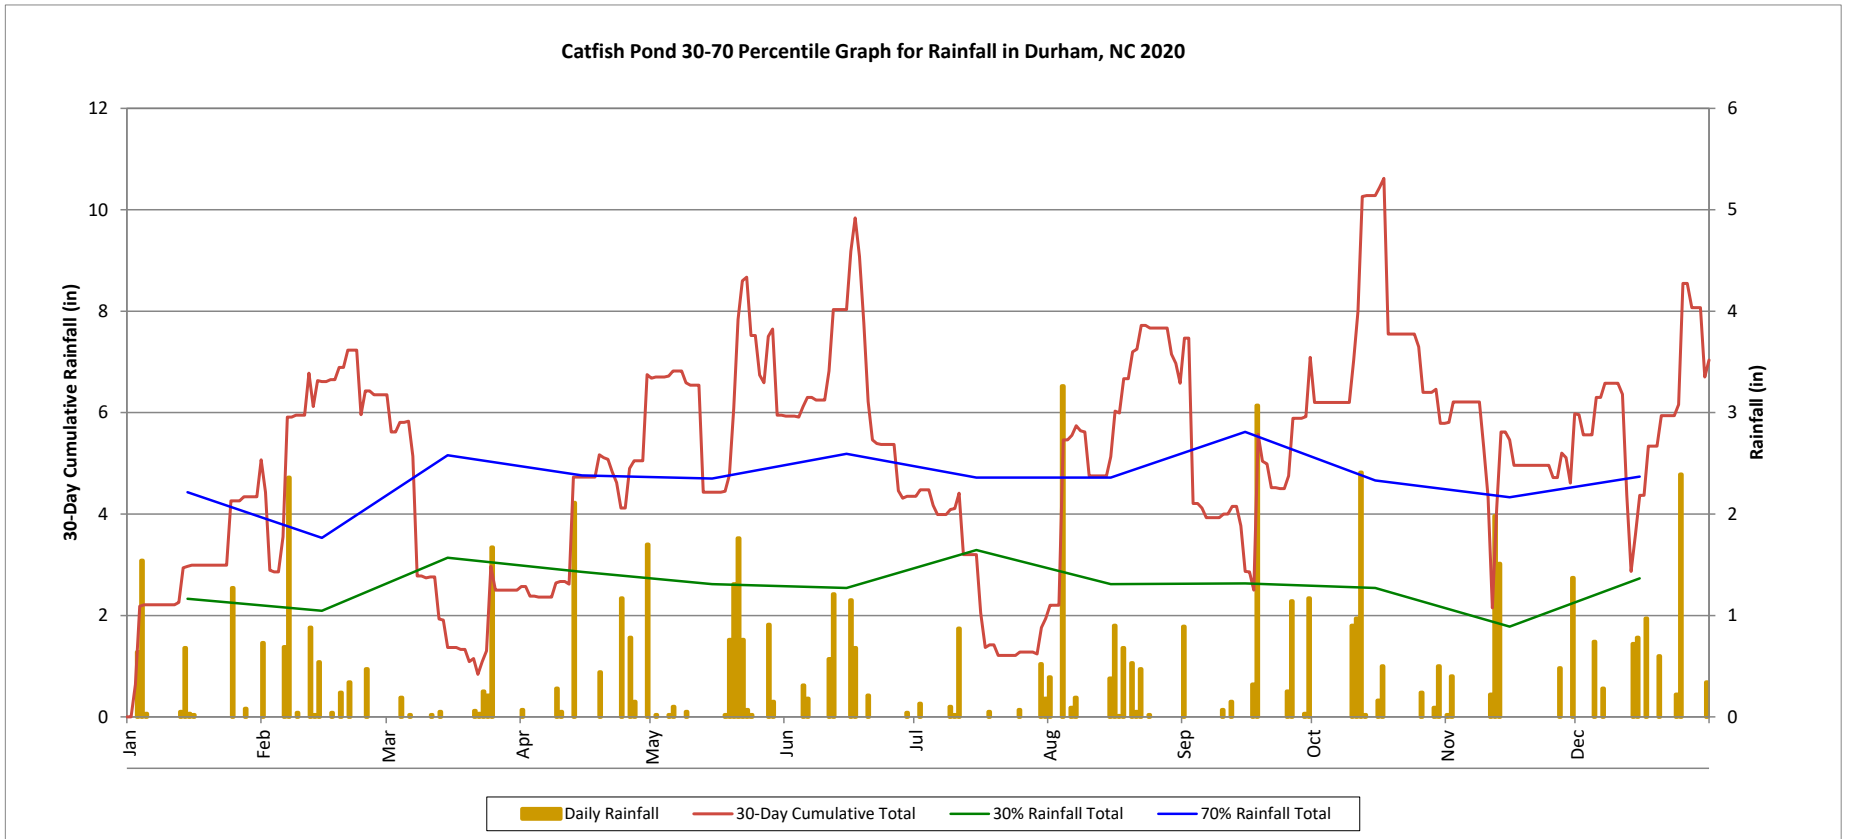
30-Day Cumulative Total Rainfall Data

¹ 2020 monthly rainfall from USDA Station Durham 10.7 NNE.

² 30th and 70th percentile rainfall data collected from weather station Roxboro 7 ESE, NC (USDA, 2020).
