# **Monitoring Report MY05**

**Cedar Branch Restoration Site  
Monitoring Year 05  
DMS Contract 6598  
DMS Project Number 97009  
RFP#16-006313 (Issue Date: January 21, 2015)**

**DWR #: 20150904  
USACE Action ID: 2003-21395  
Randolph County, North Carolina**

Subject: Cedar Branch Stream Restoration Site  
MY-05 Monitoring Report Comments  
Yadkin River Basin CU 03040103  
Randolph County, North Carolina  
NCDMS Project # 97009  
Contract # 006598

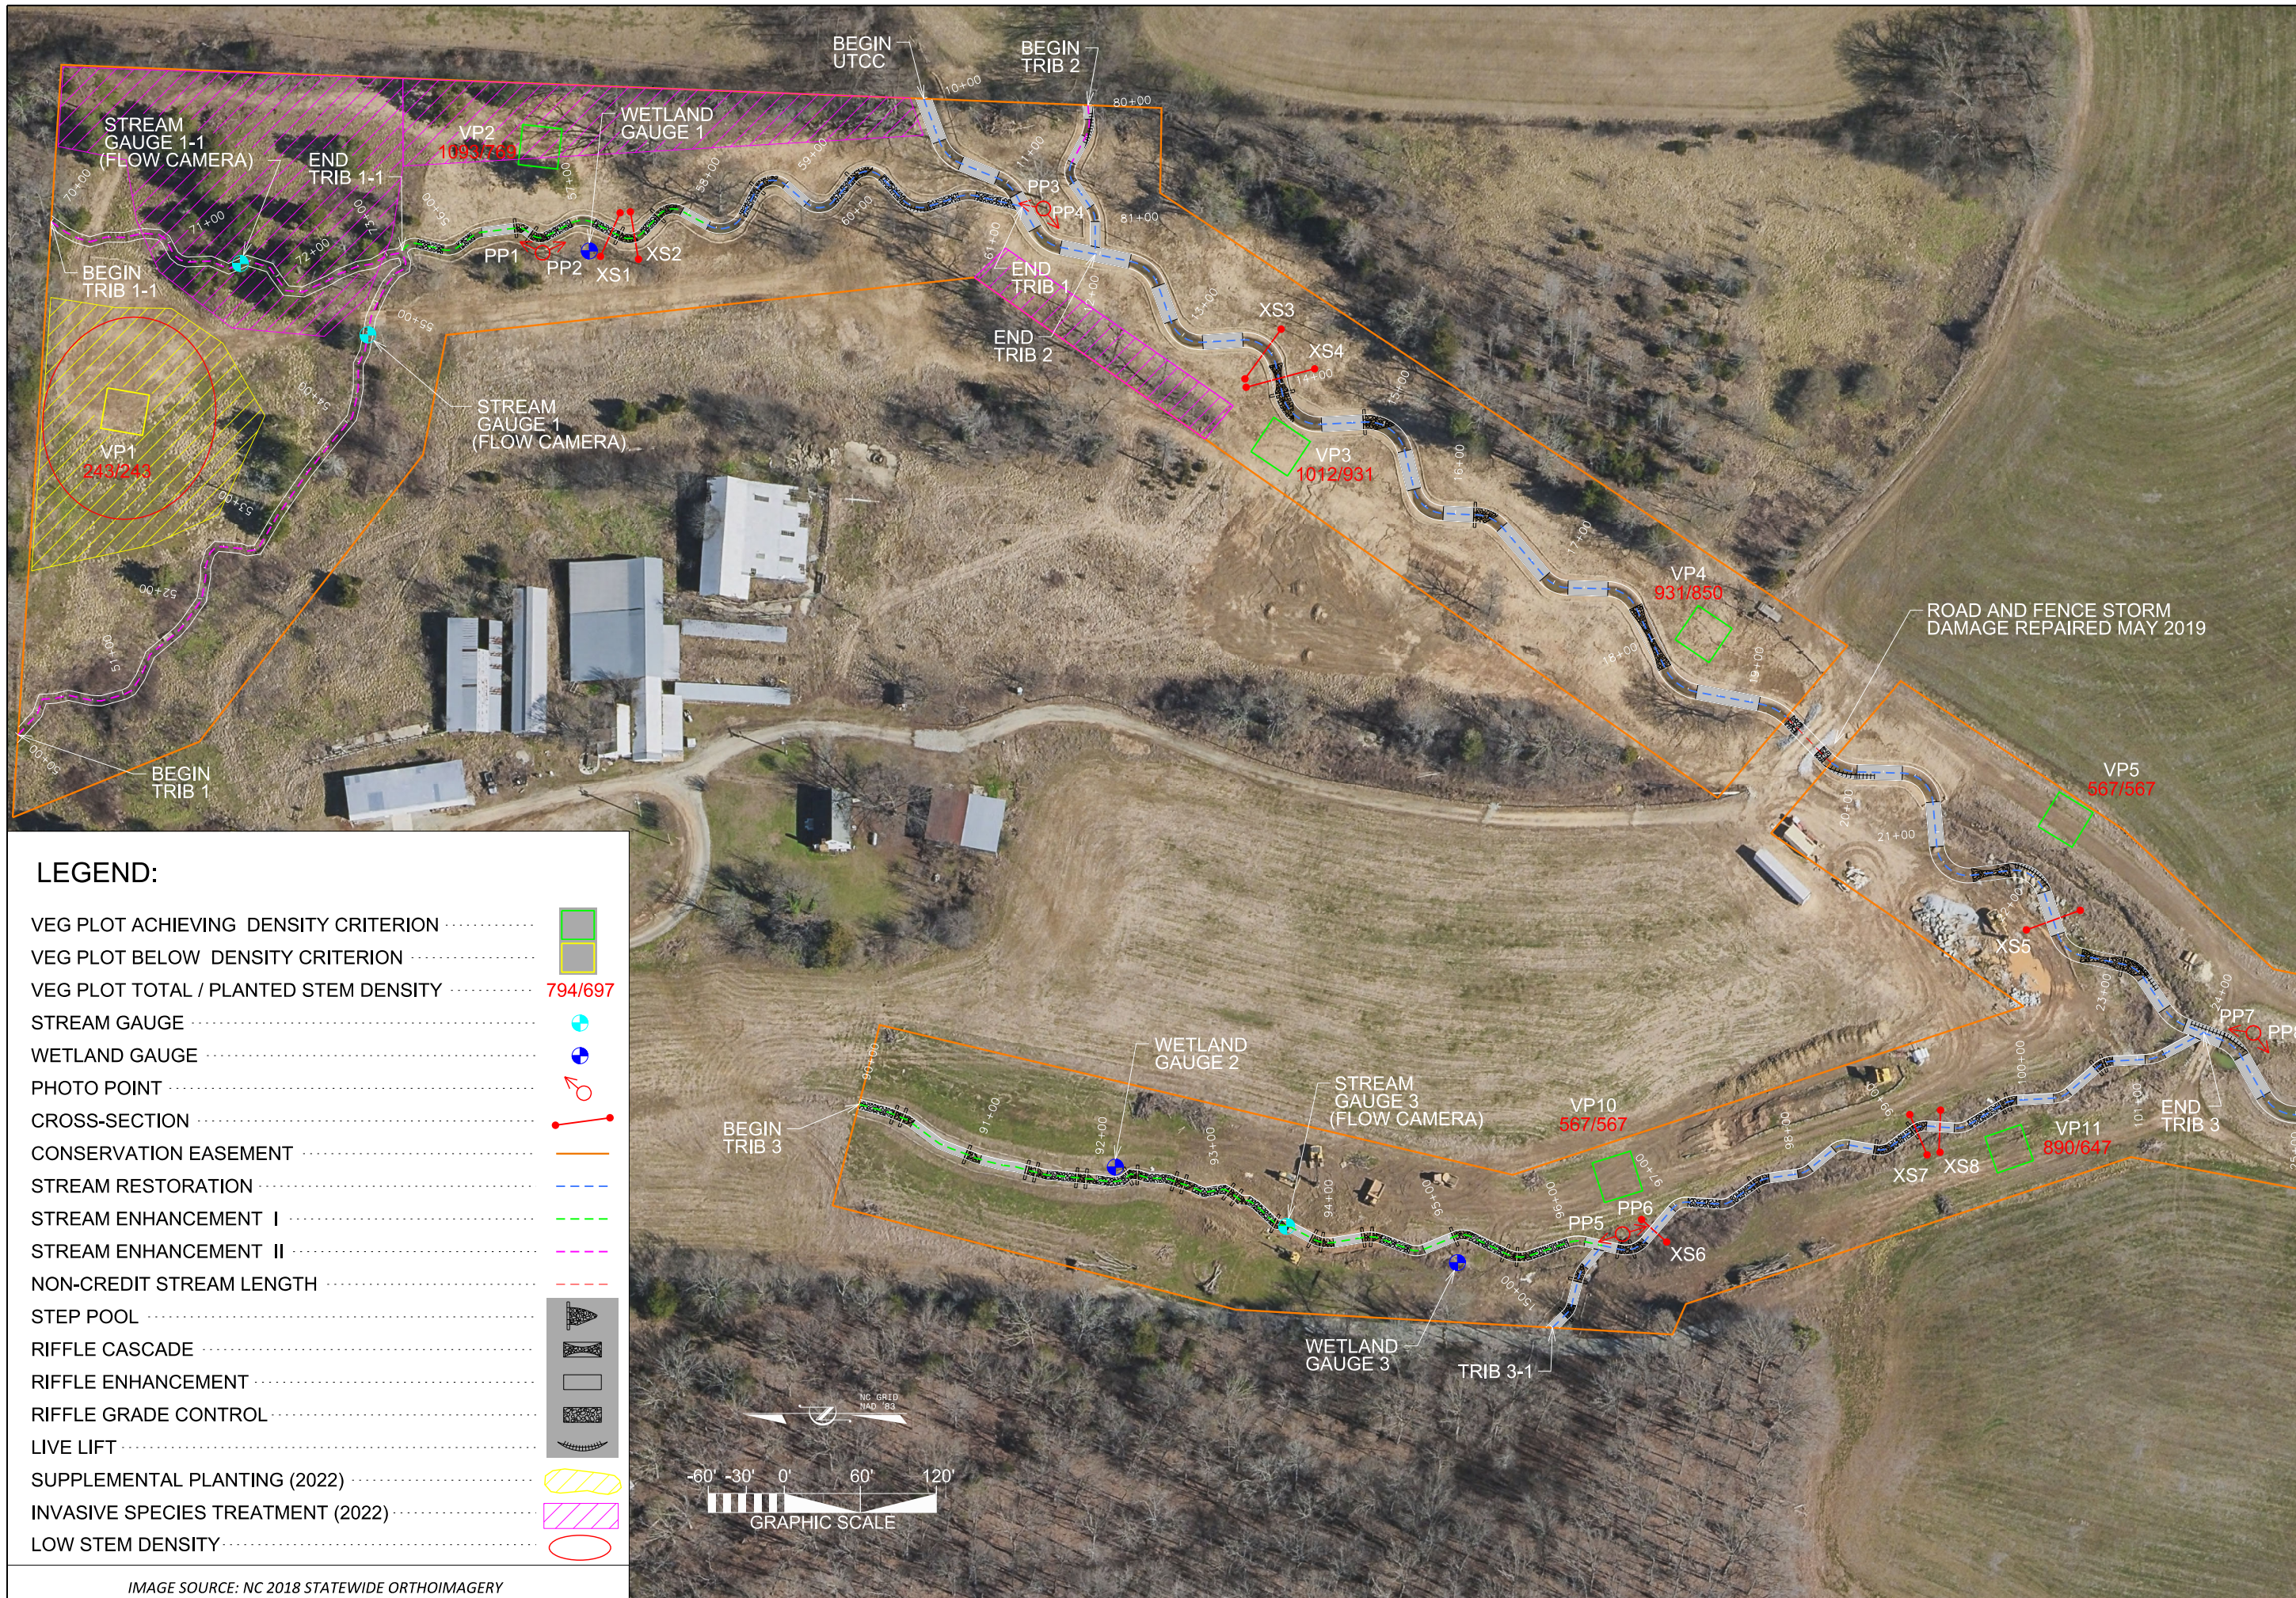
REVISIONS
 <b>KCI</b> ASSOCIATES OF NC ENGINEERS • PLANNERS • SCIENTISTS 4505 FALLS OF NEUSE ROAD, SUITE 400 RALEIGH, NORTH CAROLINA 27609	
<b>CEDAR BRANCH          STREAM RESTORATION SITE          MONITORING YEAR 5</b> RANDOLPH COUNTY, NORTH CAROLINA	
DATE: DEC 2022 SCALE: GRAPHIC	
<b>CURRENT          CONDITION          PLAN VIEW</b>	
SHEET 1 OF 2

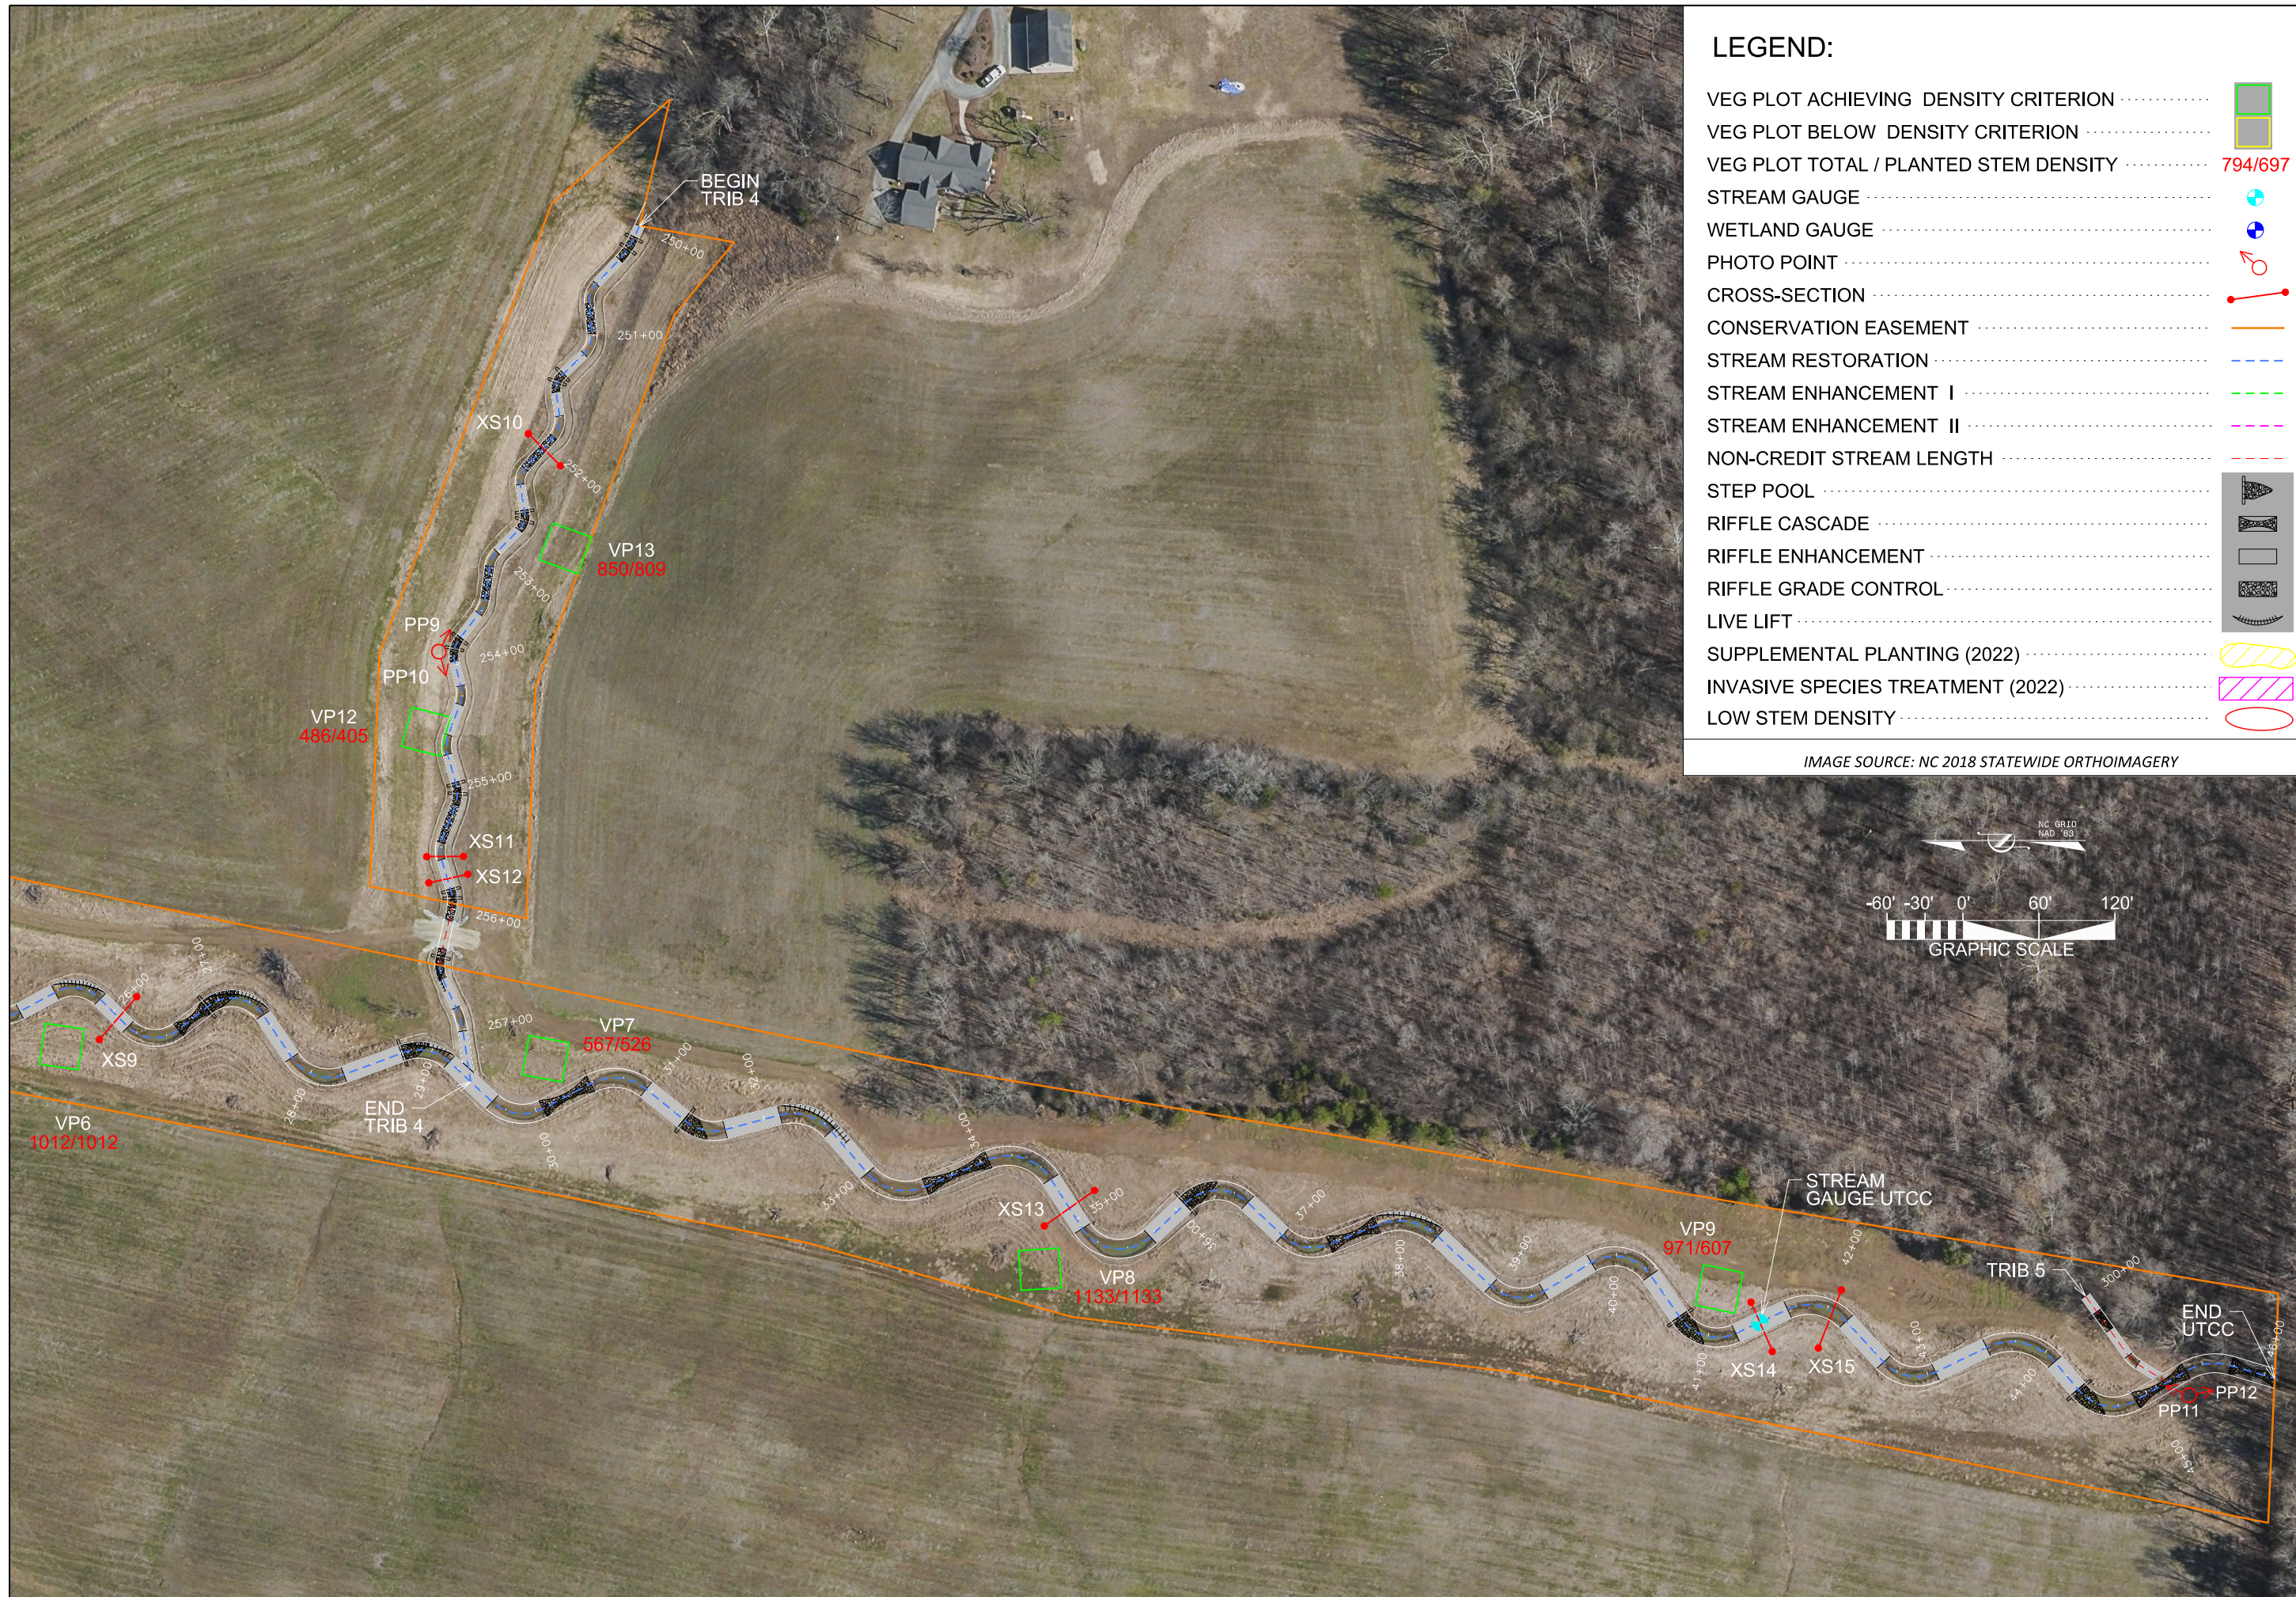
REVISIONS
 <b>KCI</b> <small>ASSOCIATES OF NC</small> <b>ENGINEERS • PLANNERS • SCIENTISTS</b> <small>4605 FALLS OF NEUSE ROAD, SUITE 400          RALEIGH, NORTH CAROLINA 27609</small>	 <b>NC</b> <small>NC DEQ - DIVISION OF          MITIGATION SERVICES</small>
<b>CEDAR BRANCH          STREAM RESTORATION SITE          MONITORING YEAR 5</b> RANDOLPH COUNTY, NORTH CAROLINA	
DATE: DEC 2022 SCALE: GRAPHIC	
<b>CURRENT          CONDITION          PLAN VIEW</b>	
SHEET 2 OF 2

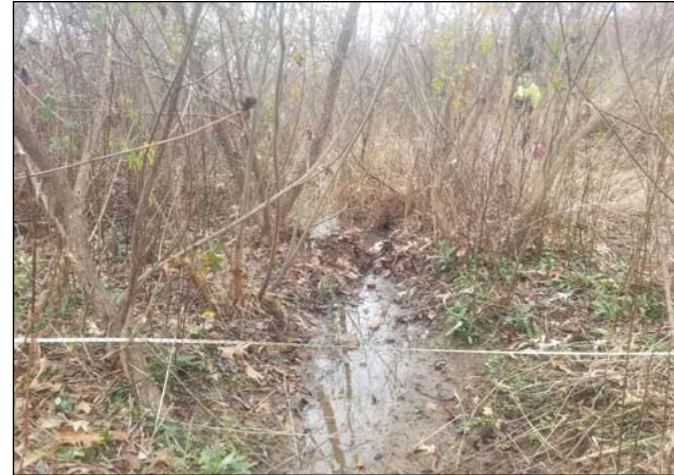
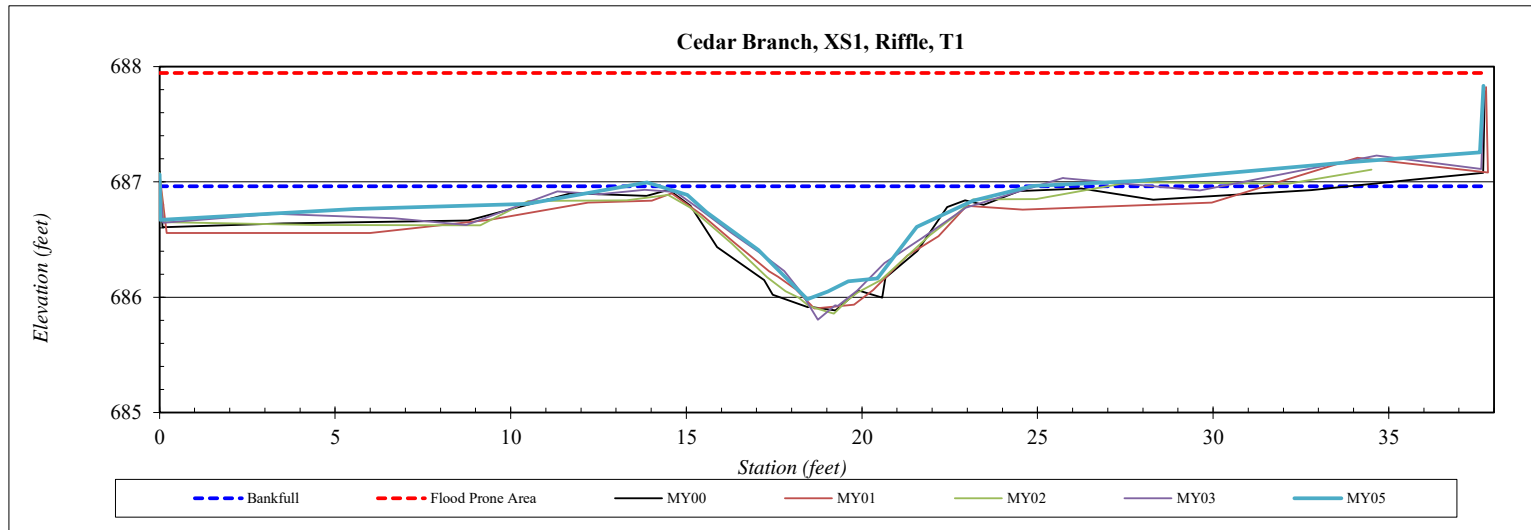
<b>River Basin:</b>	Yadkin River
<b>Site:</b>	Cedar Branch
<b>XS ID</b>	XS1
<b>Drainage Area (sq mi):</b>	0.05
<b>Date:</b>	12/13/2022
<b>Field Crew:</b>	TS, KB

Station	Elevation
0.0	687.07
0.0	686.67
5.6	686.77
10.5	686.81
13.9	687.00
15.0	686.89
15.6	686.74
17.0	686.41
18.0	686.11
18.4	685.98
19.0	686.05
19.6	686.14
20.4	686.16
21.6	686.61
23.2	686.84
24.9	686.96
27.9	687.01
33.9	687.17
37.6	687.26
37.7	687.83

SUMMARY DATA	
<b>Current Bankfull Elevation:</b>	686.96
<b>Bankfull Cross-Sectional Area:</b>	4.6
<b>Total Cross-Sectional Area:</b>	3.5
<b>Bankfull Width:</b>	10.6
<b>Flood Prone Area Elevation:</b>	687.9
<b>Flood Prone Width:</b>	37.7
<b>Max Depth at Bankfull:</b>	1.0
<b>Mean Depth at Bankfull:</b>	0.4
<b>W / D Ratio:</b>	24.4
<b>Entrenchment Ratio:</b>	3.5
<b>Bank Height Ratio:</b>	0.9

The fifth year cross-section survey was completed on December 14, 2022. This survey found the stream functioning as designed, with some small variation as is typical for stream restoration projects. There has been a small amount of aggradation in the cross-sections near the top of T1 (XS 1 and 2) and the cross-section near the top of T4 (XS10). This small build-up of sediment is part of the natural movement of sediment through the system and is not a reflection of instability.

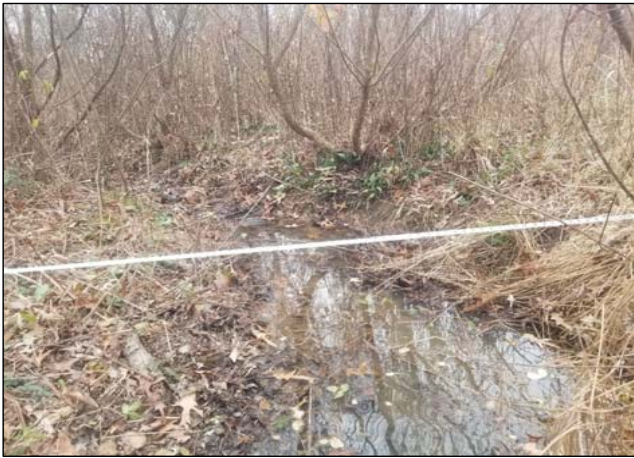
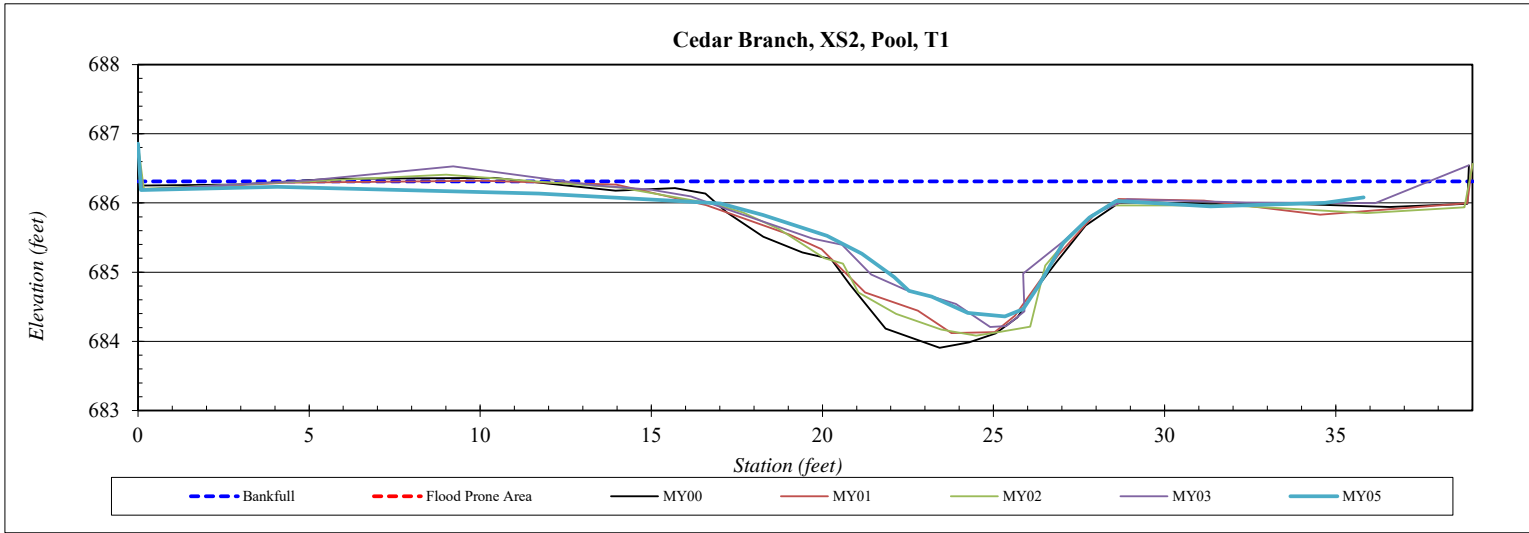
<b>River Basin:</b>	Yadkin River
<b>Site:</b>	Cedar Branch
<b>XS ID</b>	XS2
<b>Drainage Area (sq mi):</b>	0.05
<b>Date:</b>	12/13/2022
<b>Field Crew:</b>	TS, KB

Station	Elevation
0.0	686.86
0.1	686.19
4.1	686.23
11.7	686.14
15.6	686.03
17.0	685.99
18.3	685.82
20.1	685.52
21.2	685.27
22.1	684.93
22.5	684.73
23.2	684.65
24.2	684.41
25.3	684.36
25.9	684.47
26.3	684.78
27.0	685.43
27.8	685.79
28.6	686.03
31.3	685.95
34.7	686.00
35.8	686.08

SUMMARY DATA	
<b>Current Bankfull Elevation:</b>	686.32
<b>Bankfull Cross-Sectional Area:</b>	13.4
<b>Total Cross-Sectional Area:</b>	9.4
<b>Bankfull Width:</b>	13.0
<b>Flood Prone Area Elevation:</b>	---
<b>Flood Prone Width:</b>	---
<b>Max Depth at Bankfull:</b>	2.0
<b>Mean Depth at Bankfull:</b>	1.0
<b>W / D Ratio:</b>	---
<b>Entrenchment Ratio:</b>	---
<b>Bank Height Ratio:</b>	---

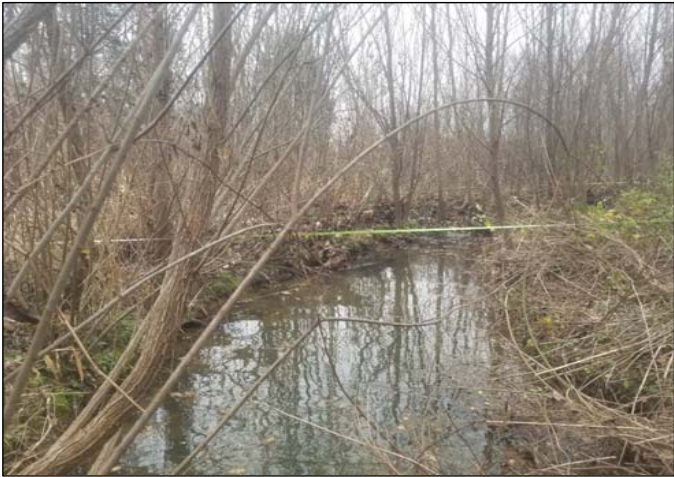
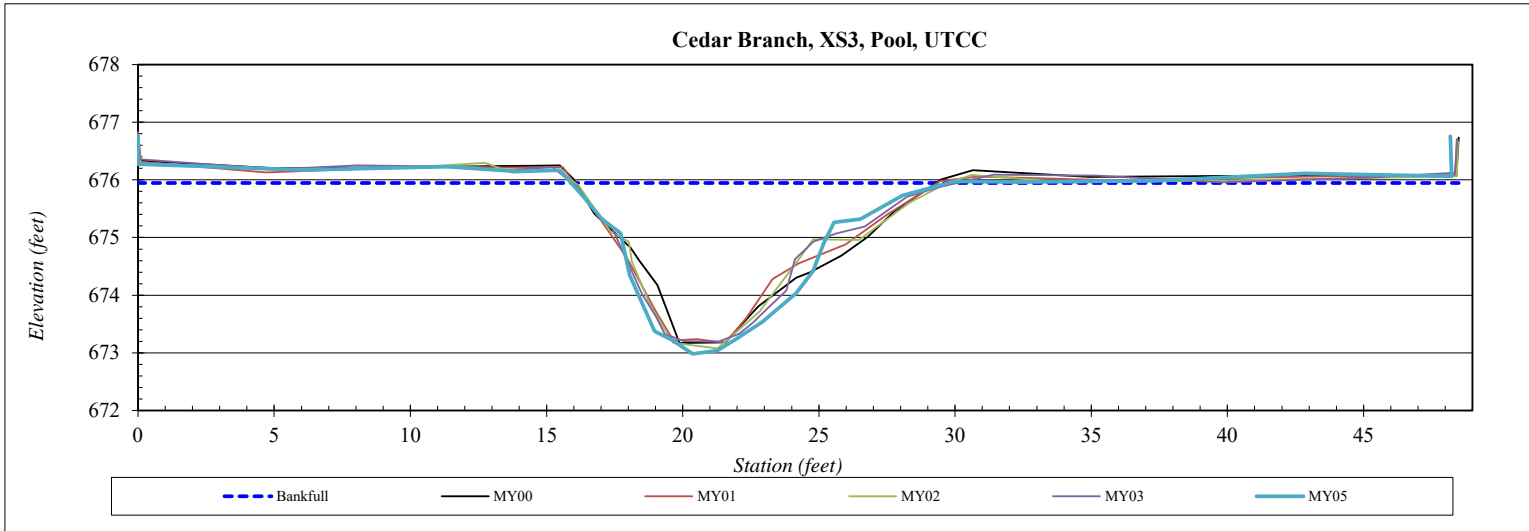
<b>River Basin:</b>	Yadkin River
<b>Site:</b>	Cedar Branch
<b>XS ID</b>	XS3
<b>Drainage Area (sq mi):</b>	0.21
<b>Date:</b>	12/13/2022
<b>Field Crew:</b>	TS, KB

Station	Elevation
0.0	676.77
0.0	676.27
6.1	676.18
11.4	676.23
14.0	676.15
15.5	676.17
16.4	675.71
17.0	675.33
17.7	675.08
18.0	674.35
19.0	673.38
19.6	673.22
20.4	672.99
21.3	673.04
22.0	673.25
22.9	673.54
24.2	674.03
24.8	674.41
25.2	674.90
25.6	675.26
26.5	675.32
28.1	675.73
30.0	675.98
32.4	675.97
37.3	675.98
42.9	676.11
48.2	676.06
48.2	676.76

SUMMARY DATA	
<b>Current Bankfull Elevation:</b>	675.95
<b>Bankfull Cross-Sectional Area:</b>	20.2
<b>Total Cross-Sectional Area:</b>	21.3
<b>Bankfull Width:</b>	13.9
<b>Flood Prone Area Elevation:</b>	---
<b>Flood Prone Width:</b>	---
<b>Max Depth at Bankfull:</b>	3.0
<b>Mean Depth at Bankfull:</b>	1.5
<b>W / D Ratio:</b>	---
<b>Entrenchment Ratio:</b>	---
<b>Bank Height Ratio:</b>	---

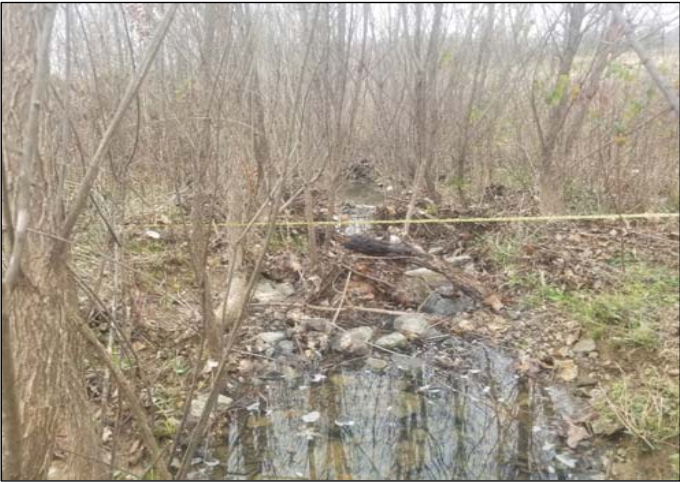
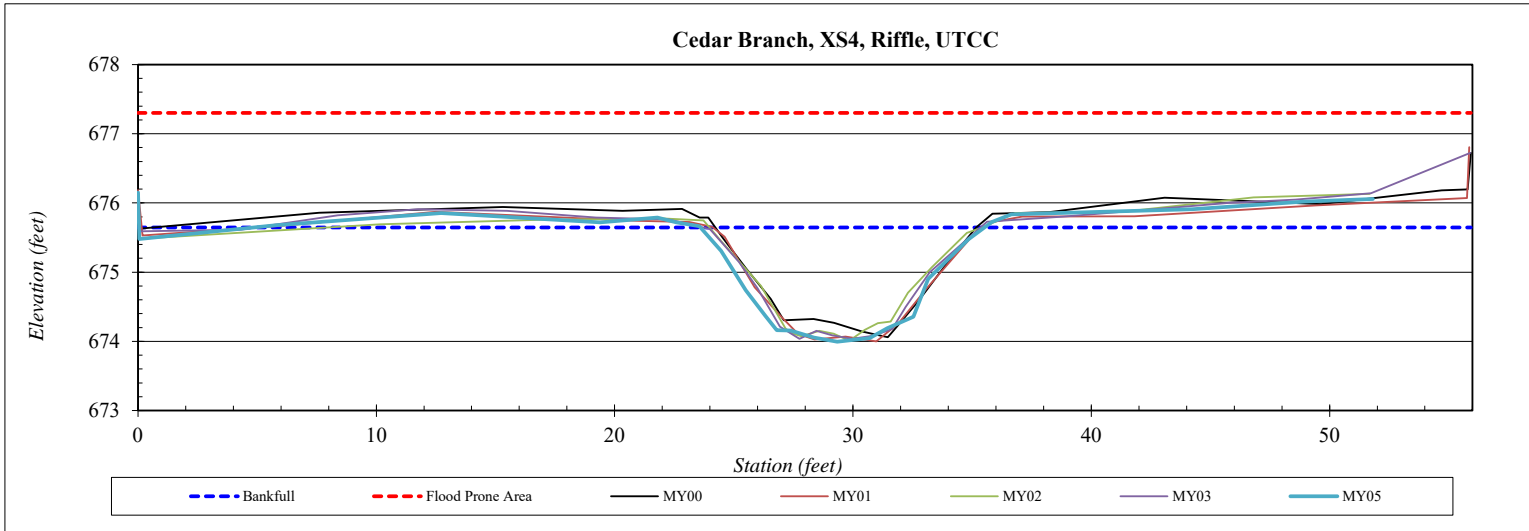
<b>River Basin:</b>	Yadkin River
<b>Site:</b>	Cedar Branch
<b>XS ID</b>	XS4
<b>Drainage Area (sq mi):</b>	0.21
<b>Date:</b>	12/13/2022
<b>Field Crew:</b>	TS, KB

Station	Elevation
0.0	676.15
0.0	675.48
5.8	675.68
12.7	675.85
19.4	675.72
21.8	675.79
22.6	675.72
23.6	675.66
24.5	675.31
25.5	674.74
26.3	674.36
26.8	674.16
27.4	674.16
28.4	674.05
29.3	674.00
30.1	674.02
30.7	674.05
31.4	674.19
32.5	674.36
33.2	674.90
34.8	675.48
35.8	675.72
36.7	675.84
38.5	675.86
44.2	675.91
49.0	676.02
51.8	676.06

SUMMARY DATA	
<b>Current Bankfull Elevation:</b>	675.65
<b>Bankfull Cross-Sectional Area:</b>	12.6
<b>Total Cross-Sectional Area:</b>	14.5
<b>Bankfull Width:</b>	11.9
<b>Flood Prone Area Elevation:</b>	677.3
<b>Flood Prone Width:</b>	51.8
<b>Max Depth at Bankfull:</b>	1.7
<b>Mean Depth at Bankfull:</b>	1.1
<b>W / D Ratio:</b>	11.3
<b>Entrenchment Ratio:</b>	4.3
<b>Bank Height Ratio:</b>	1.0

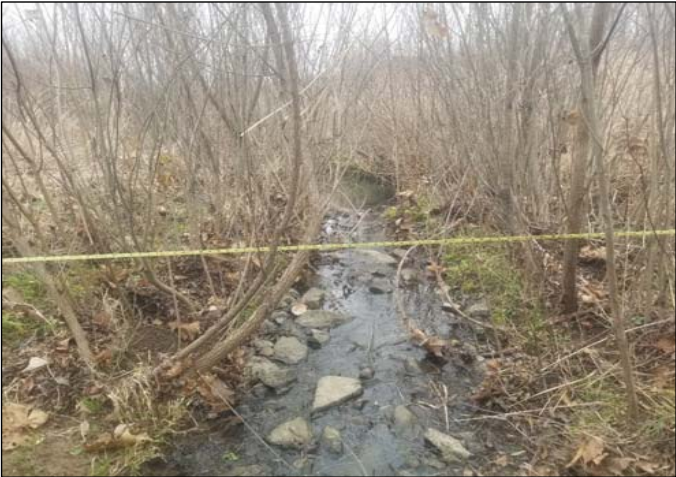
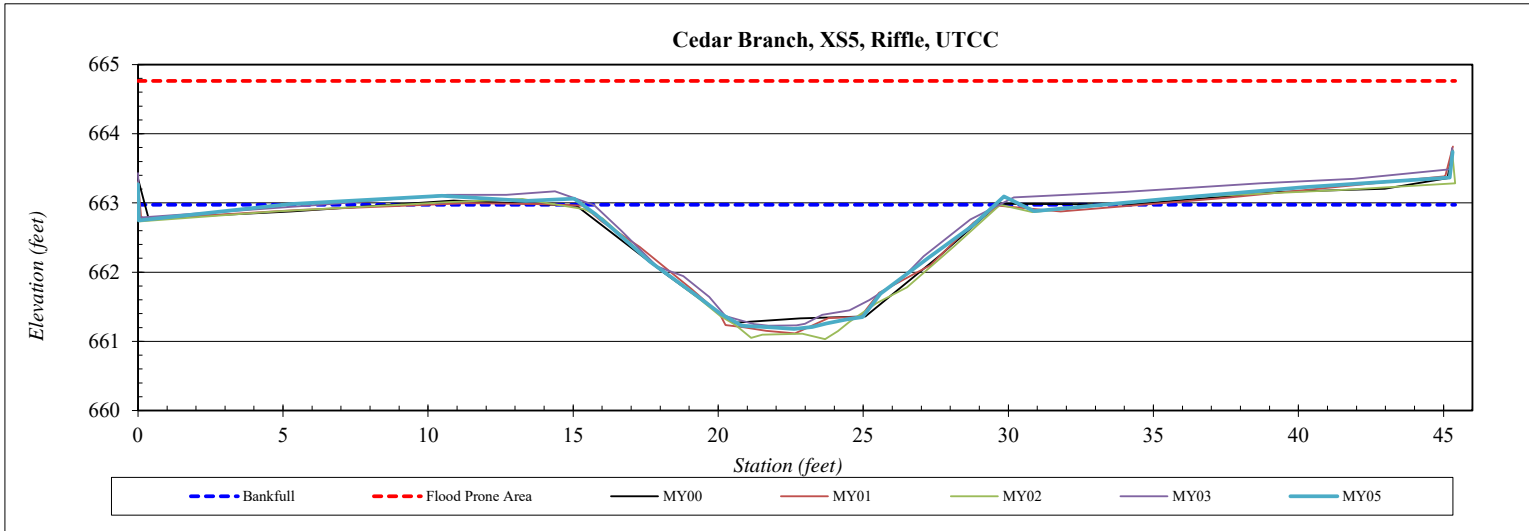
<b>River Basin:</b>	Yadkin River
<b>Site:</b>	Cedar Branch
<b>XS ID</b>	XS5
<b>Drainage Area (sq mi):</b>	0.21
<b>Date:</b>	12/13/2022
<b>Field Crew:</b>	TS, KB

Station	Elevation
0.0	663.27
0.0	662.75
5.2	662.98
10.5	663.11
13.4	663.03
15.0	663.06
15.8	662.84
16.3	662.66
17.6	662.15
19.2	661.67
20.1	661.40
20.8	661.23
22.0	661.20
22.6	661.18
23.2	661.21
23.7	661.26
24.4	661.32
25.0	661.35
25.6	661.69
27.3	662.21
28.8	662.67
29.8	663.10
30.9	662.88
35.4	663.06
40.2	663.23
45.2	663.37
45.3	663.74

SUMMARY DATA	
<b>Current Bankfull Elevation:</b>	662.97
<b>Bankfull Cross-Sectional Area:</b>	15.8
<b>Total Cross-Sectional Area:</b>	15.6
<b>Bankfull Width:</b>	14.2
<b>Flood Prone Area Elevation:</b>	664.8
<b>Flood Prone Width:</b>	45.3
<b>Max Depth at Bankfull:</b>	1.8
<b>Mean Depth at Bankfull:</b>	1.1
<b>W / D Ratio:</b>	12.8
<b>Entrenchment Ratio:</b>	3.2
<b>Bank Height Ratio:</b>	1.0

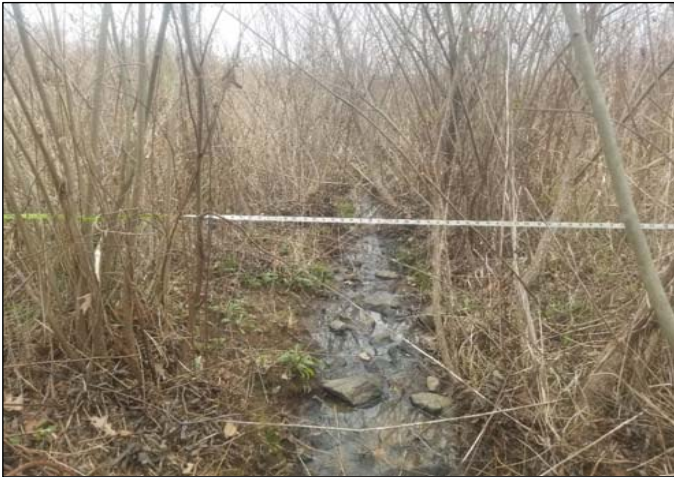
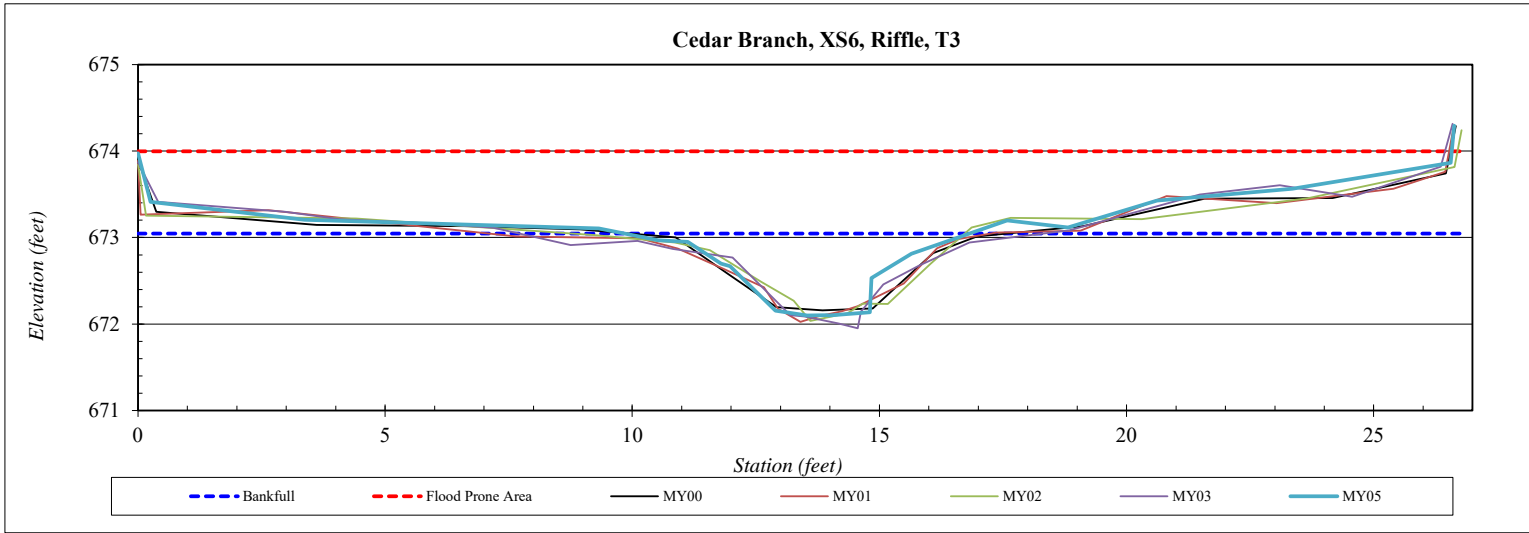
<b>River Basin:</b>	Yadkin River
<b>Site:</b>	Cedar Branch
<b>XS ID</b>	XS6
<b>Drainage Area (sq mi):</b>	0.04
<b>Date:</b>	12/13/2022
<b>Field Crew:</b>	TS, KB

Station	Elevation
0.0	673.98
0.3	673.41
3.4	673.20
6.9	673.15
9.3	673.11
10.5	672.97
11.1	672.95
11.8	672.70
12.0	672.67
12.9	672.16
13.5	672.10
13.9	672.10
14.0	672.10
14.8	672.14
14.8	672.53
15.6	672.81
17.6	673.20
18.8	673.12
20.6	673.43
23.4	673.56
26.6	673.86
26.6	674.30

SUMMARY DATA	
<b>Current Bankfull Elevation:</b>	673.05
<b>Bankfull Cross-Sectional Area:</b>	3.1
<b>Total Cross-Sectional Area:</b>	2.8
<b>Bankfull Width:</b>	7.0
<b>Flood Prone Area Elevation:</b>	674.0
<b>Flood Prone Width:</b>	26.6
<b>Max Depth at Bankfull:</b>	0.9
<b>Mean Depth at Bankfull:</b>	0.4
<b>W / D Ratio:</b>	15.7
<b>Entrenchment Ratio:</b>	3.8
<b>Bank Height Ratio:</b>	0.9

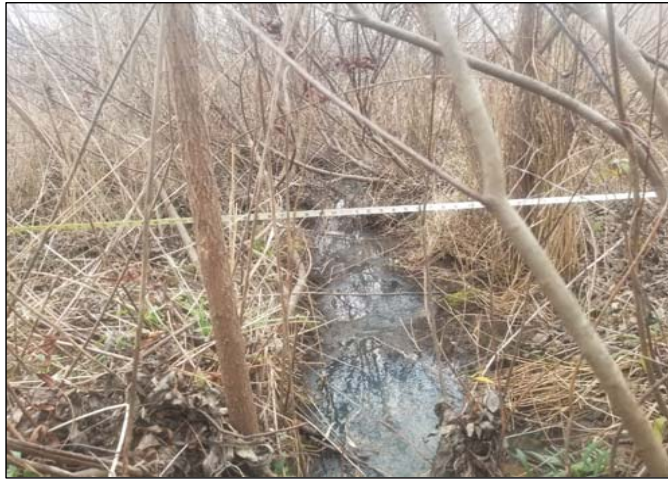
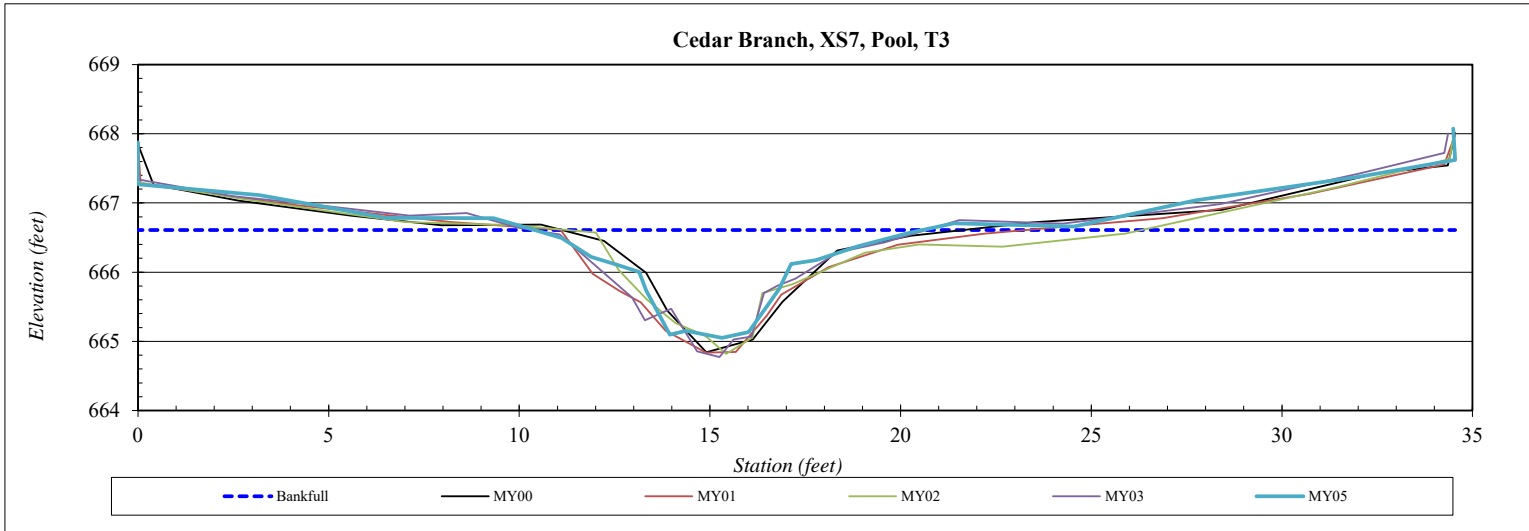
<b>River Basin:</b>	Yadkin River
<b>Site:</b>	Cedar Branch
<b>XS ID</b>	XS7
<b>Drainage Area (sq mi):</b>	0.04
<b>Date:</b>	12/13/2022
<b>Field Crew:</b>	TS, KB

Station	Elevation
0.0	667.87
0.0	667.27
3.2	667.11
6.5	666.79
9.3	666.78
10.3	666.63
11.1	666.49
11.9	666.22
12.5	666.11
13.1	666.00
13.3	665.74
13.9	665.10
14.4	665.15
15.3	665.05
16.0	665.13
16.8	665.75
17.1	666.12
17.8	666.17
18.9	666.37
20.3	666.57
21.4	666.70
24.5	666.66
27.7	667.04
32.0	667.38
34.5	667.62
34.5	668.08

SUMMARY DATA	
<b>Current Bankfull Elevation:</b>	666.61
<b>Bankfull Cross-Sectional Area:</b>	6.9
<b>Total Cross-Sectional Area:</b>	6.8
<b>Bankfull Width:</b>	10.2
<b>Flood Prone Area Elevation:</b>	---
<b>Flood Prone Width:</b>	---
<b>Max Depth at Bankfull:</b>	1.6
<b>Mean Depth at Bankfull:</b>	0.7
<b>W / D Ratio:</b>	---
<b>Entrenchment Ratio:</b>	---
<b>Bank Height Ratio:</b>	---

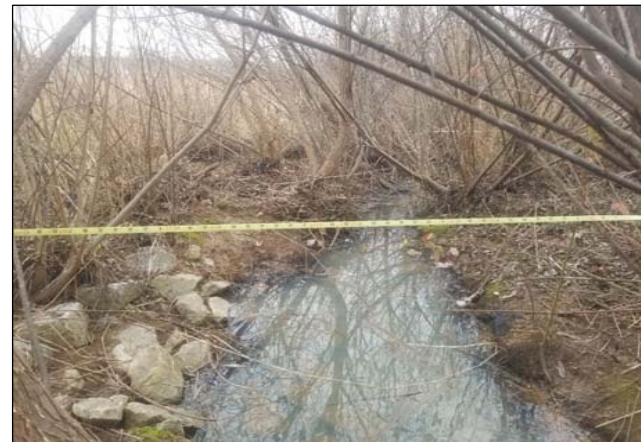
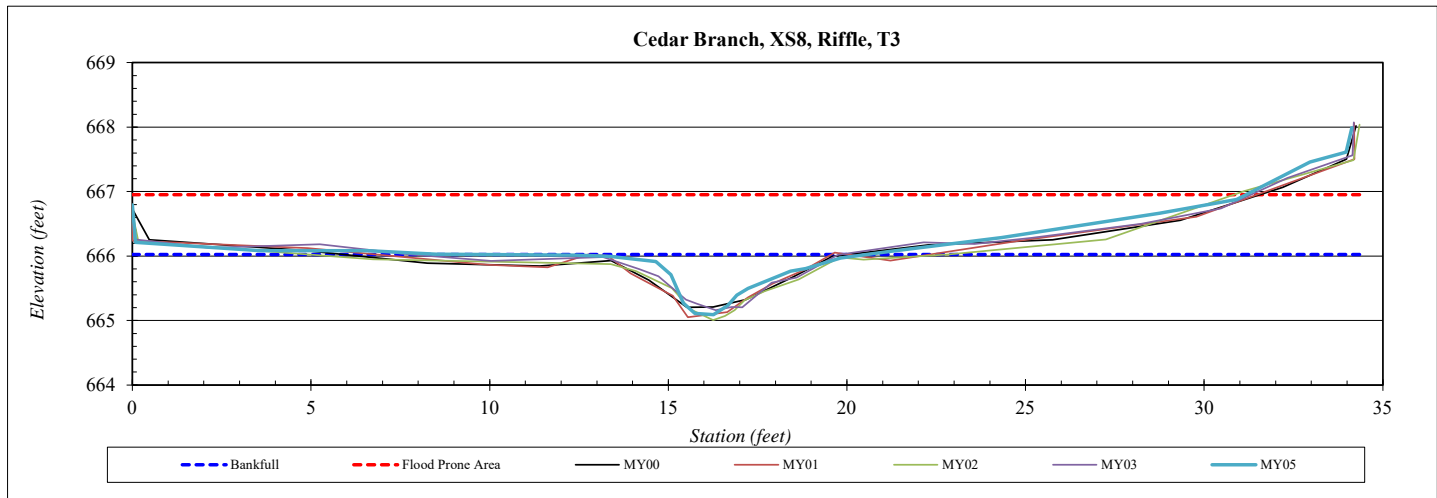
<b>River Basin:</b>	Yadkin River
<b>Site:</b>	Cedar Branch
<b>XS ID</b>	XS8
<b>Drainage Area (sq mi):</b>	0.04
<b>Date:</b>	12/13/2022
<b>Field Crew:</b>	TS, KB

Station	Elevation
0.0	666.80
0.1	666.21
3.6	666.09
6.6	666.09
8.5	666.03
12.4	666.01
13.4	666.00
14.6	665.91
15.1	665.71
15.4	665.27
15.7	665.11
16.3	665.09
16.7	665.24
16.9	665.39
17.2	665.50
18.4	665.77
18.8	665.81
19.8	665.97
21.2	666.07
24.3	666.29
28.8	666.67
30.9	666.88
33.0	667.46
34.0	667.61
34.1	667.99

SUMMARY DATA	
<b>Current Bankfull Elevation:</b>	666.02
<b>Bankfull Cross-Sectional Area:</b>	2.5
<b>Total Cross-Sectional Area:</b>	2.0
<b>Bankfull Width:</b>	7.2
<b>Flood Prone Area Elevation:</b>	667.0
<b>Flood Prone Width:</b>	31.2
<b>Max Depth at Bankfull:</b>	0.9
<b>Mean Depth at Bankfull:</b>	0.4
<b>W / D Ratio:</b>	20.3
<b>Entrenchment Ratio:</b>	4.3
<b>Bank Height Ratio:</b>	0.9

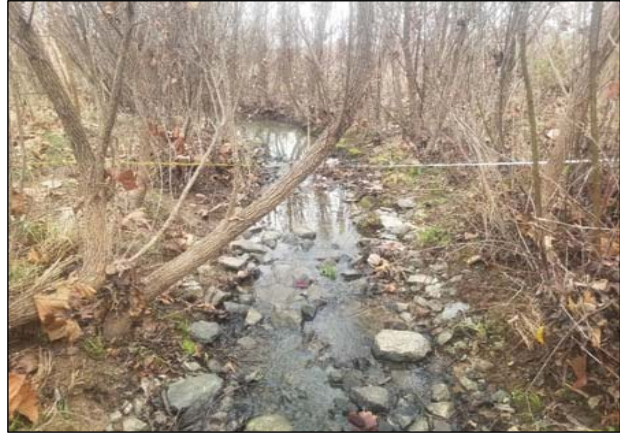
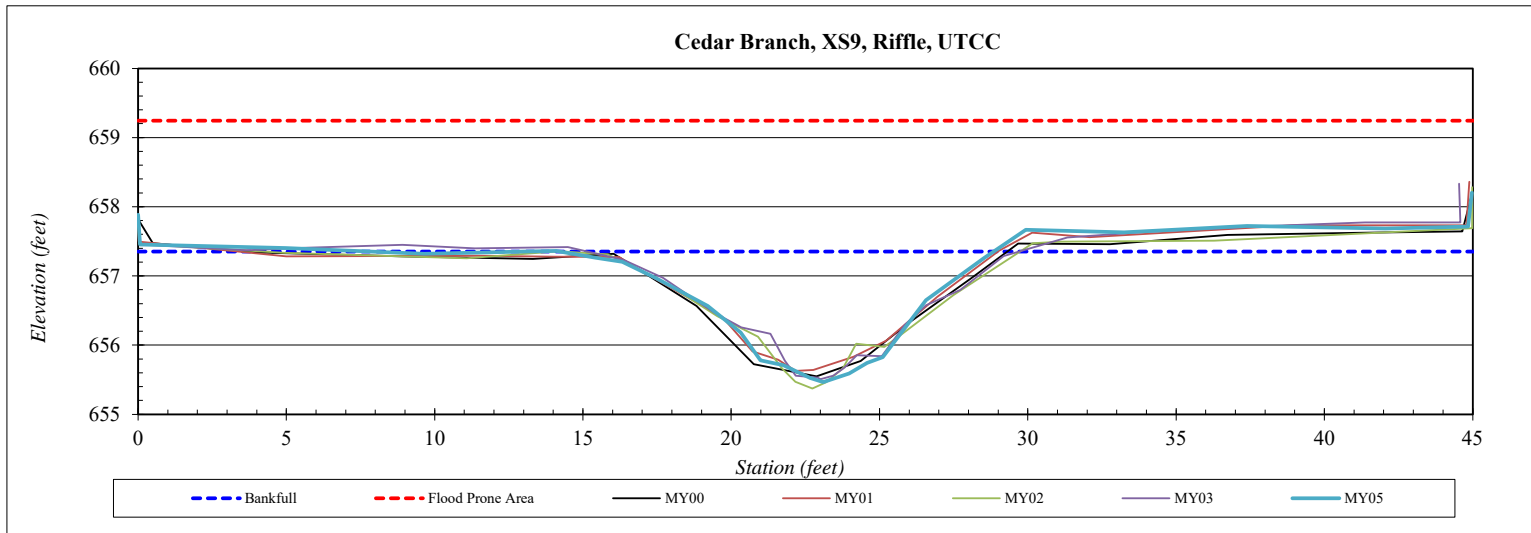
<b>River Basin:</b>	Yadkin River
<b>Site:</b>	Cedar Branch
<b>XS ID</b>	XS9
<b>Drainage Area (sq mi):</b>	0.28
<b>Date:</b>	12/14/2022
<b>Field Crew:</b>	TS, KB

Station	Elevation
0.0	657.89
0.1	657.45
5.0	657.41
9.7	657.32
13.0	657.35
14.1	657.36
15.4	657.27
16.3	657.20
17.5	656.97
19.2	656.57
20.3	656.18
21.0	655.78
21.8	655.71
22.7	655.53
23.1	655.47
24.0	655.59
24.6	655.74
25.1	655.82
26.6	656.65
28.5	657.26
29.9	657.67
33.2	657.63
37.4	657.72
42.1	657.68
44.8	657.72
45.0	658.21

SUMMARY DATA	
<b>Current Bankfull Elevation:</b>	657.36
<b>Bankfull Cross-Sectional Area:</b>	13.0
<b>Total Cross-Sectional Area:</b>	12.5
<b>Bankfull Width:</b>	14.7
<b>Flood Prone Area Elevation:</b>	659.2
<b>Flood Prone Width:</b>	45.0
<b>Max Depth at Bankfull:</b>	1.9
<b>Mean Depth at Bankfull:</b>	0.9
<b>W / D Ratio:</b>	16.5
<b>Entrenchment Ratio:</b>	3.1
<b>Bank Height Ratio:</b>	1.0

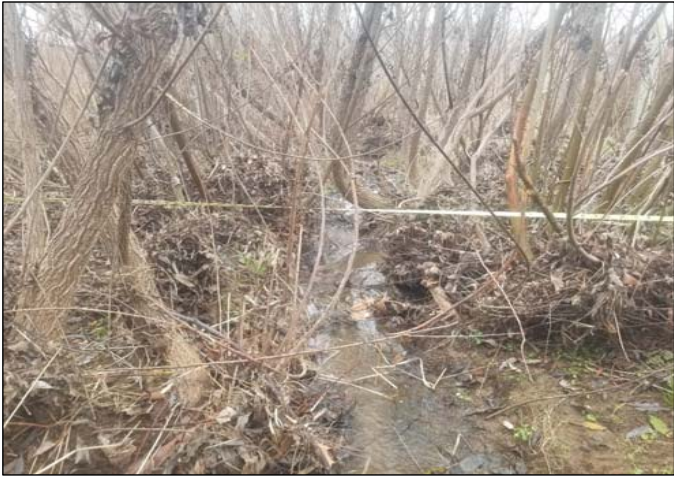
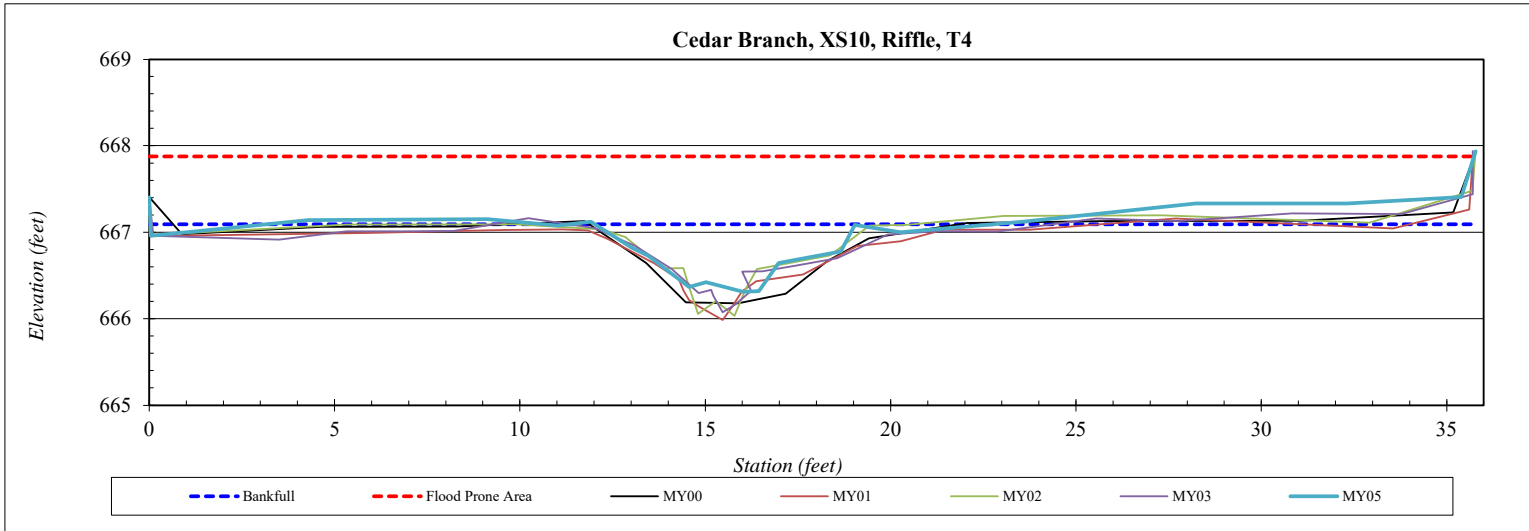
<b>River Basin:</b>	Yadkin River
<b>Site:</b>	Cedar Branch
<b>XS ID</b>	XS10
<b>Drainage Area (sq mi):</b>	0.05
<b>Date:</b>	12/14/2022
<b>Field Crew:</b>	TS, KB

Station	Elevation
0.0	667.40
0.0	666.96
4.3	667.14
9.1	667.15
11.0	667.08
11.9	667.12
13.0	666.83
13.5	666.73
14.6	666.37
15.0	666.42
16.0	666.31
16.4	666.32
17.0	666.64
18.7	666.78
19.0	667.08
20.3	667.00
23.6	667.12
28.2	667.33
32.3	667.33
35.4	667.41
35.8	667.94

SUMMARY DATA	
<b>Current Bankfull Elevation:</b>	667.09
<b>Bankfull Cross-Sectional Area:</b>	3.3
<b>Total Cross-Sectional Area:</b>	2.2
<b>Bankfull Width:</b>	7.0
<b>Flood Prone Area Elevation:</b>	667.9
<b>Flood Prone Width:</b>	35.7
<b>Max Depth at Bankfull:</b>	0.8
<b>Mean Depth at Bankfull:</b>	0.5
<b>W / D Ratio:</b>	15.0
<b>Entrenchment Ratio:</b>	5.1
<b>Bank Height Ratio:</b>	1.0

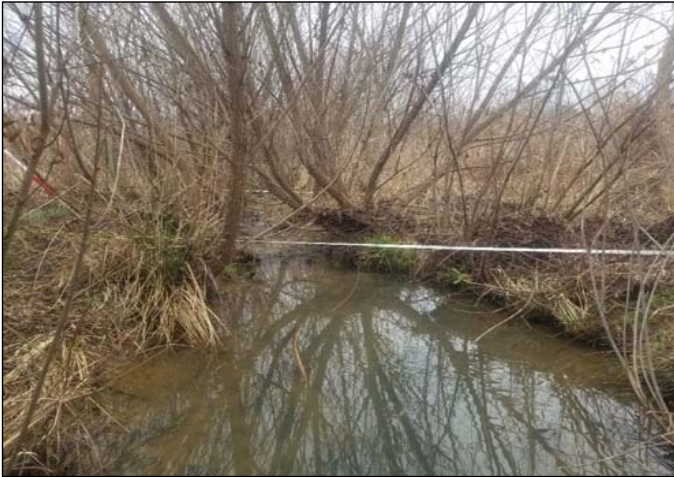
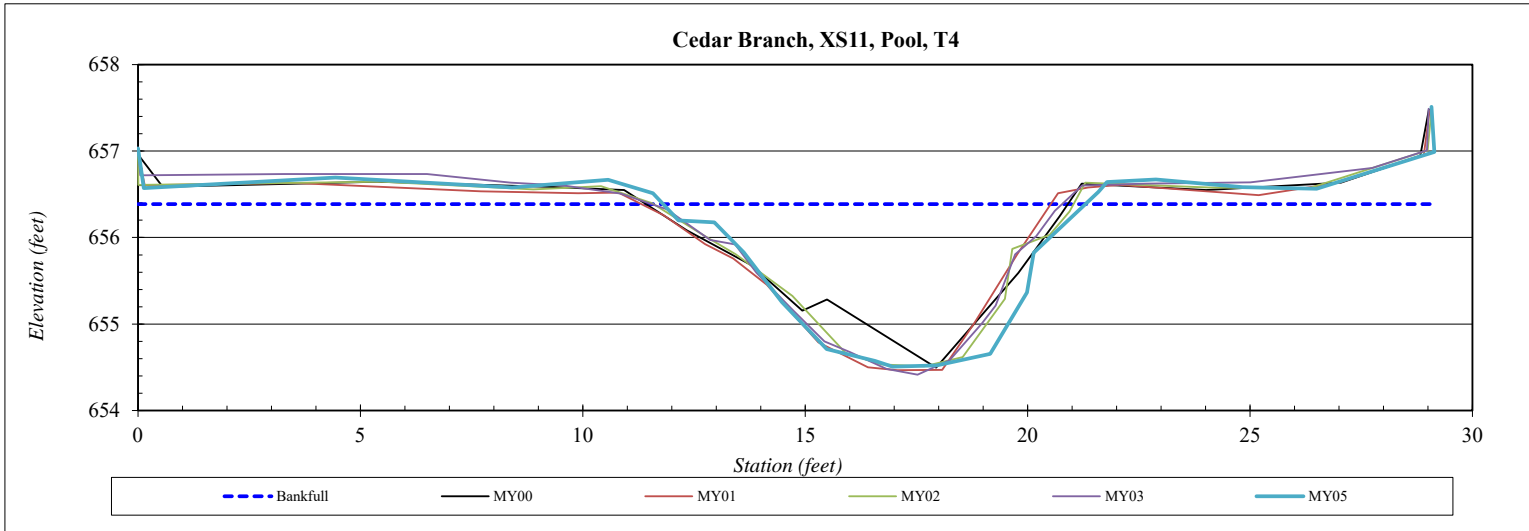
<b>River Basin:</b>	Yadkin River
<b>Site:</b>	Cedar Branch
<b>XS ID</b>	XS11
<b>Drainage Area (sq mi):</b>	0.05
<b>Date:</b>	12/14/2022
<b>Field Crew:</b>	TS, KB

Station	Elevation
0.0	657.03
0.1	656.57
4.4	656.69
8.4	656.58
10.6	656.67
11.6	656.51
12.2	656.20
13.0	656.18
13.6	655.83
14.5	655.26
15.5	654.71
16.6	654.57
17.0	654.51
18.0	654.52
19.2	654.65
20.0	655.37
20.1	655.83
21.6	656.53
21.8	656.64
22.9	656.67
24.8	656.58
26.5	656.57
29.1	656.99
29.1	657.51

SUMMARY DATA	
<b>Current Bankfull Elevation:</b>	656.39
<b>Bankfull Cross-Sectional Area:</b>	10.8
<b>Total Cross-Sectional Area:</b>	12.4
<b>Bankfull Width:</b>	9.5
<b>Flood Prone Area Elevation:</b>	---
<b>Flood Prone Width:</b>	---
<b>Max Depth at Bankfull:</b>	1.9
<b>Mean Depth at Bankfull:</b>	1.1
<b>W / D Ratio:</b>	---
<b>Entrenchment Ratio:</b>	---
<b>Bank Height Ratio:</b>	---
