# **Monitoring Report MY05**

**Cedar Branch Restoration Site  
Monitoring Year 05  
DMS Contract 6598  
DMS Project Number 97009  
RFP#16-006313 (Issue Date: January 21, 2015)**

**DWR #: 20150904  
USACE Action ID: 2003-21395  
Randolph County, North Carolina**

Subject: Cedar Branch Stream Restoration Site  
MY-05 Monitoring Report Comments  
Yadkin River Basin CU 03040103  
Randolph County, North Carolina  
NCDMS Project # 97009  
Contract # 006598

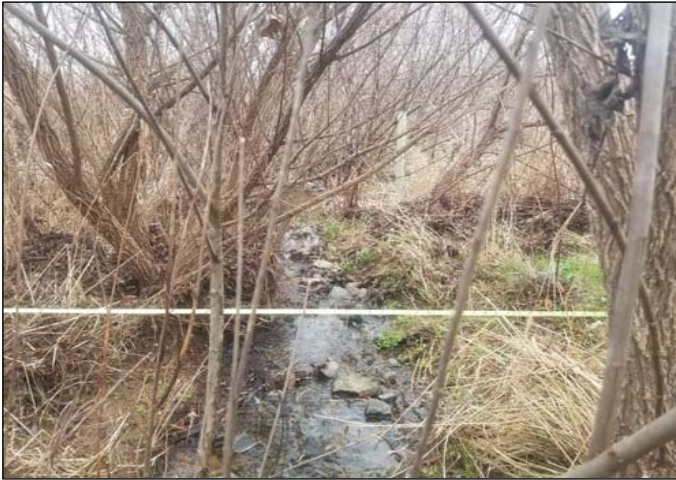
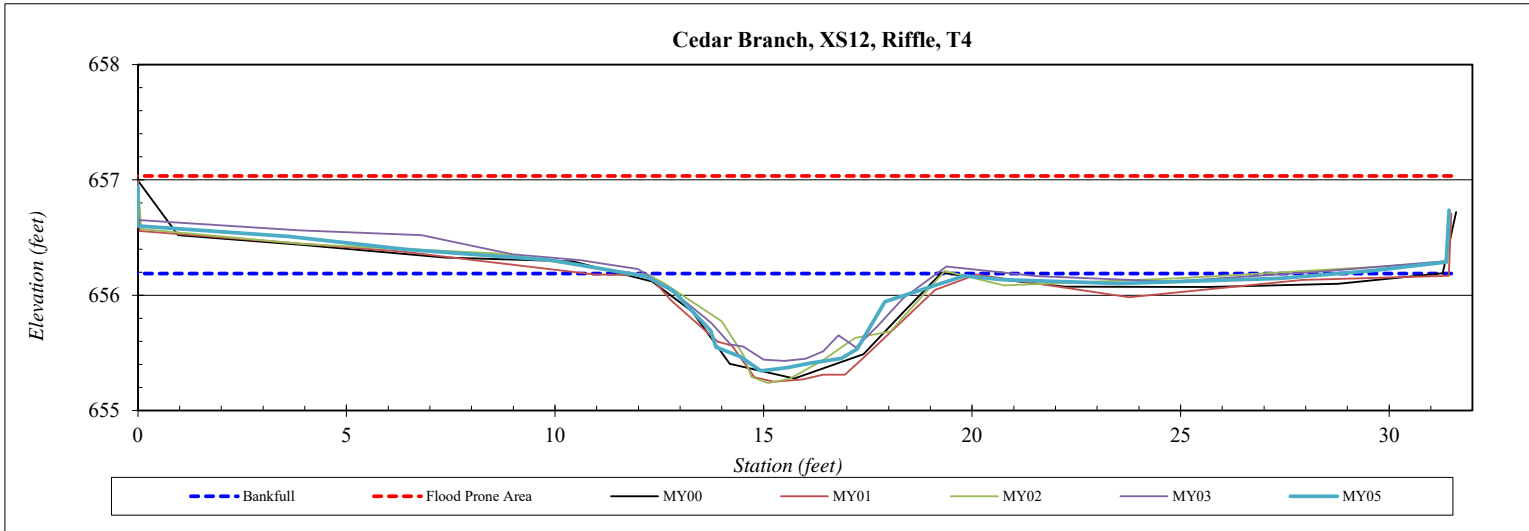
<b>River Basin:</b>	Yadkin River
<b>Site:</b>	Cedar Branch
<b>XS ID</b>	XS12
<b>Drainage Area (sq mi):</b>	0.05
<b>Date:</b>	12/14/2022
<b>Field Crew:</b>	TS, KB

Station	Elevation
0.0	656.94
0.0	656.60
3.6	656.51
6.5	656.40
9.9	656.30
12.2	656.16
12.8	656.04
13.7	655.69
13.9	655.55
14.4	655.47
14.9	655.35
15.6	655.37
16.1	655.41
16.9	655.45
17.2	655.53
17.9	655.94
19.8	656.17
20.7	656.14
23.5	656.10
27.4	656.15
29.6	656.21
31.4	656.29
31.4	656.74

SUMMARY DATA	
<b>Current Bankfull Elevation:</b>	656.19
<b>Bankfull Cross-Sectional Area:</b>	3.5
<b>Total Cross-Sectional Area:</b>	3.0
<b>Bankfull Width:</b>	7.0
<b>Flood Prone Area Elevation:</b>	657.0
<b>Flood Prone Width:</b>	31.4
<b>Max Depth at Bankfull:</b>	0.8
<b>Mean Depth at Bankfull:</b>	0.5
<b>W / D Ratio:</b>	14.0
<b>Entrenchment Ratio:</b>	4.5
<b>Bank Height Ratio:</b>	1.0

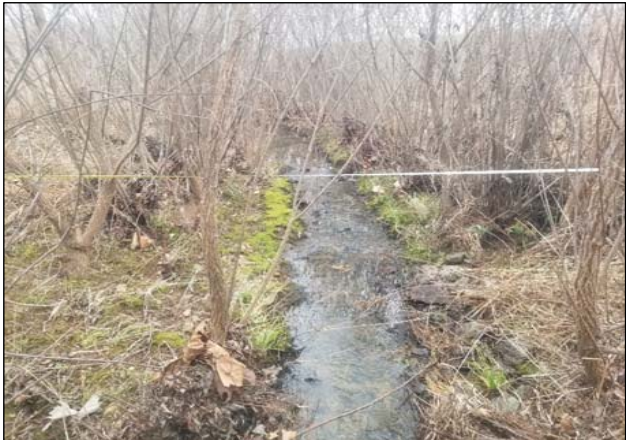
<b>River Basin:</b>	Yadkin River
<b>Site:</b>	Cedar Branch
<b>XS ID</b>	XS13
<b>Drainage Area (sq mi):</b>	0.41
<b>Date:</b>	12/14/2022
<b>Field Crew:</b>	TS, KB

Station	Elevation
0.0	646.09
-0.1	645.72
4.6	645.66
8.3	645.62
11.9	645.62
12.9	645.39
13.4	645.35
14.1	645.35
14.5	645.64
15.9	645.60
16.6	645.46
17.8	645.15
18.6	645.16
20.5	644.63
21.7	644.50
22.2	644.27
22.9	644.11
23.4	644.03
24.1	644.05
24.6	644.04
25.1	644.28
25.9	644.19
26.3	644.82
28.1	645.20
29.6	645.48
30.4	645.82
33.5	645.87
40.4	645.99
45.4	646.21
48.4	646.18
48.5	646.72

SUMMARY DATA	
<b>Current Bankfull Elevation:</b>	645.47
<b>Bankfull Cross-Sectional Area:</b>	9.6
<b>Total Cross-Sectional Area:</b>	6.8
<b>Bankfull Width:</b>	13.0
<b>Flood Prone Area Elevation:</b>	646.9
<b>Flood Prone Width:</b>	48.5
<b>Max Depth at Bankfull:</b>	1.4
<b>Mean Depth at Bankfull:</b>	0.7
<b>W / D Ratio:</b>	17.7
<b>Entrenchment Ratio:</b>	3.7
<b>Bank Height Ratio:</b>	1.1

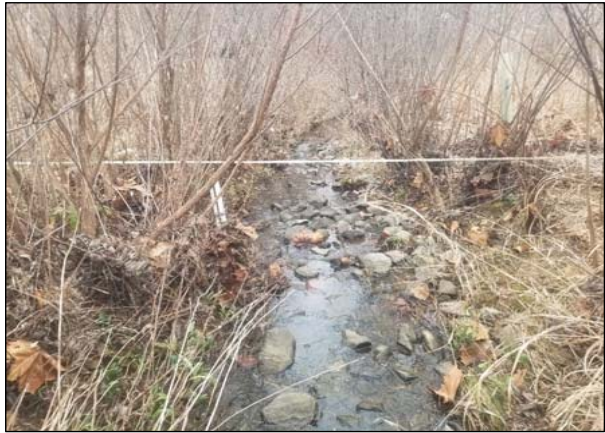
<b>River Basin:</b>	Yadkin River
<b>Site:</b>	Cedar Branch
<b>XS ID</b>	XS14
<b>Drainage Area (sq mi):</b>	0.41
<b>Date:</b>	12/14/2022
<b>Field Crew:</b>	TS, KB

Station	Elevation
0.0	638.84
0.2	638.52
4.5	638.50
8.2	638.36
11.8	638.36
12.7	638.37
13.6	638.21
15.3	637.90
16.7	637.67
17.9	637.24
18.1	636.99
19.1	636.56
19.9	636.56
20.3	636.44
21.6	636.44
22.1	636.46
22.8	636.66
23.1	636.84
23.6	636.83
23.9	636.95
24.9	637.42
25.2	637.56
27.2	638.07
29.1	638.42
30.4	638.41
34.8	638.50
39.9	638.49
43.4	638.56
43.7	639.05

SUMMARY DATA	
<b>Current Bankfull Elevation:</b>	638.02
<b>Bankfull Cross-Sectional Area:</b>	12.8
<b>Total Cross-Sectional Area:</b>	11.7
<b>Bankfull Width:</b>	14.0
<b>Flood Prone Area Elevation:</b>	639.7
<b>Flood Prone Width:</b>	43.7
<b>Max Depth at Bankfull:</b>	1.7
<b>Mean Depth at Bankfull:</b>	0.9
<b>W / D Ratio:</b>	15.3
<b>Entrenchment Ratio:</b>	3.1
<b>Bank Height Ratio:</b>	1.2

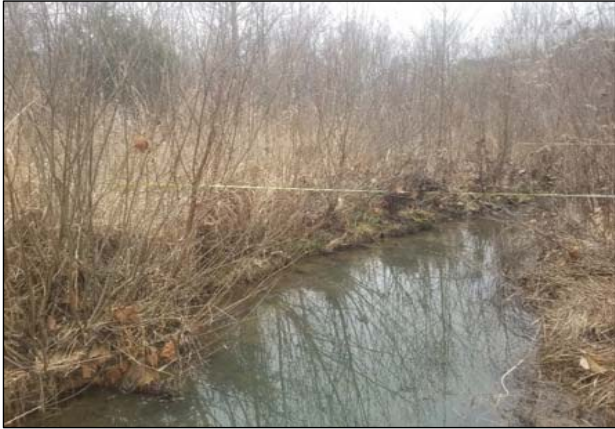
<b>River Basin:</b>	Yadkin River
<b>Site:</b>	Cedar Branch
<b>XS ID</b>	XS15
<b>Drainage Area (sq mi):</b>	0.41
<b>Date:</b>	12/14/2022
<b>Field Crew:</b>	TS, KB

Station	Elevation
0.0	638.15
-0.1	637.87
6.1	637.52
9.5	637.84
11.6	637.68
12.5	637.77
13.1	637.69
14.4	636.98
15.7	635.96
16.8	635.35
18.1	634.58
19.1	634.72
20.3	634.58
22.5	634.73
23.6	635.03
24.7	635.43
25.6	636.04
28.7	636.68
31.3	637.10
33.6	637.67
34.6	637.68
37.3	637.80
42.5	637.69
49.0	637.75
49.2	638.31

SUMMARY DATA	
<b>Current Bankfull Elevation:</b>	637.55
<b>Bankfull Cross-Sectional Area:</b>	35.8
<b>Total Cross-Sectional Area:</b>	33.3
<b>Bankfull Width:</b>	20.5
<b>Flood Prone Area Elevation:</b>	---
<b>Flood Prone Width:</b>	---
<b>Max Depth at Bankfull:</b>	3.1
<b>Mean Depth at Bankfull:</b>	1.7
<b>W / D Ratio:</b>	---
<b>Entrenchment Ratio:</b>	---
<b>Bank Height Ratio:</b>	---

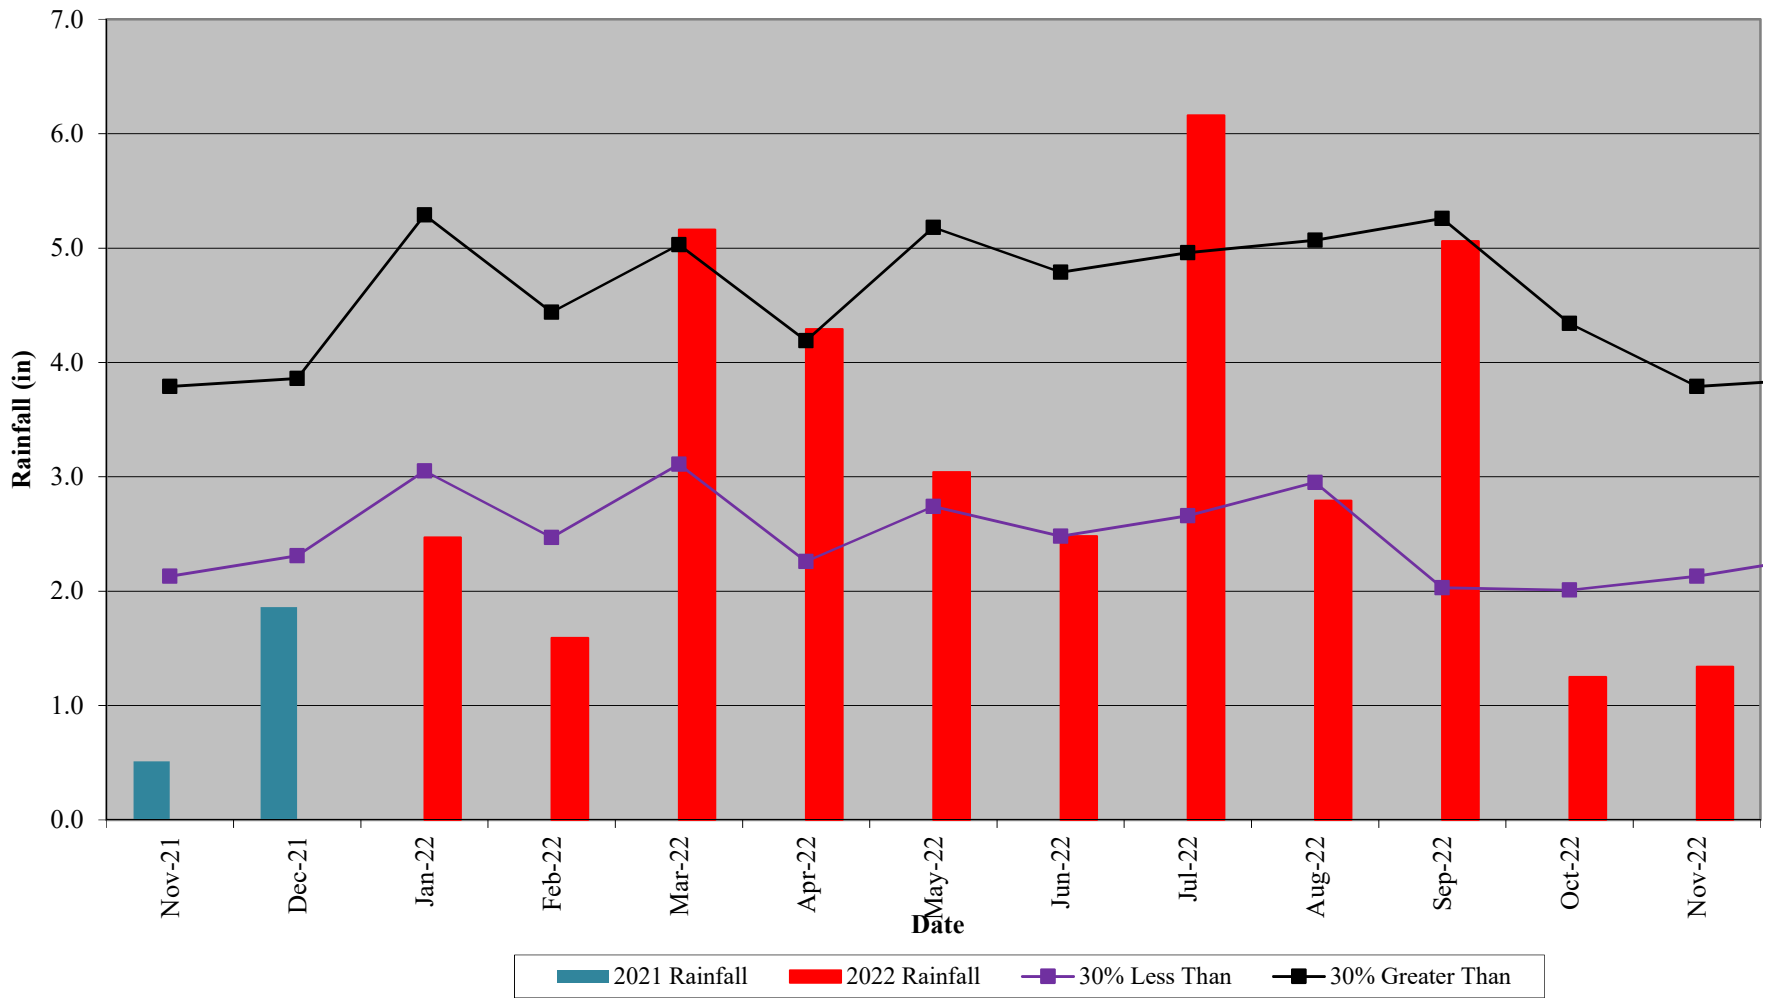
**Cedar Branch Restoration Site  
30-70 Percentile Graph  
WETS Station Name: Asheboro, NC**

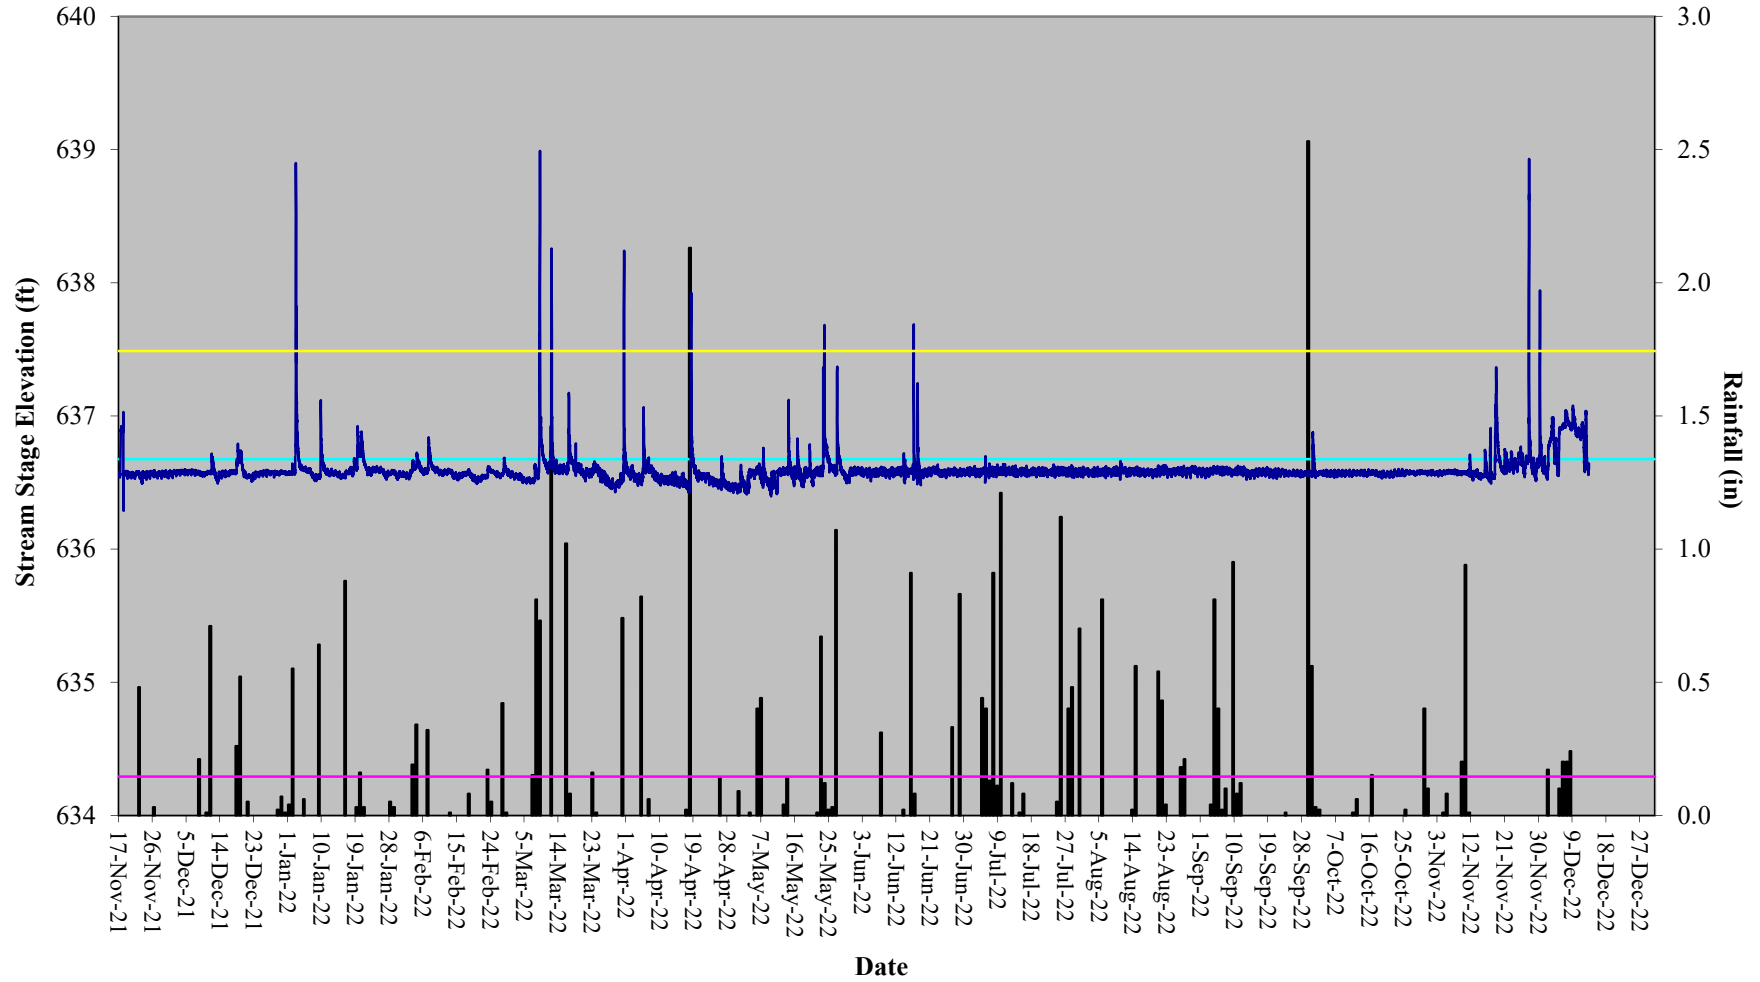
# Cedar Branch Restoration Site Hydrograph Stream Gauge UTCC

<b>Table 10. Verification of Bankfull Events Cedar Branch Restoration Site, DMS Project #97009</b>							
<b>Gage ID</b>	<b>MY1 2018</b>	<b>MY2 2019</b>	<b>MY3 2020</b>	<b>MY4 2021</b>	<b>MY5 2022</b>	<b>MY6 2023</b>	<b>MY7 2024</b>
UTCC	5	15	17	9	8

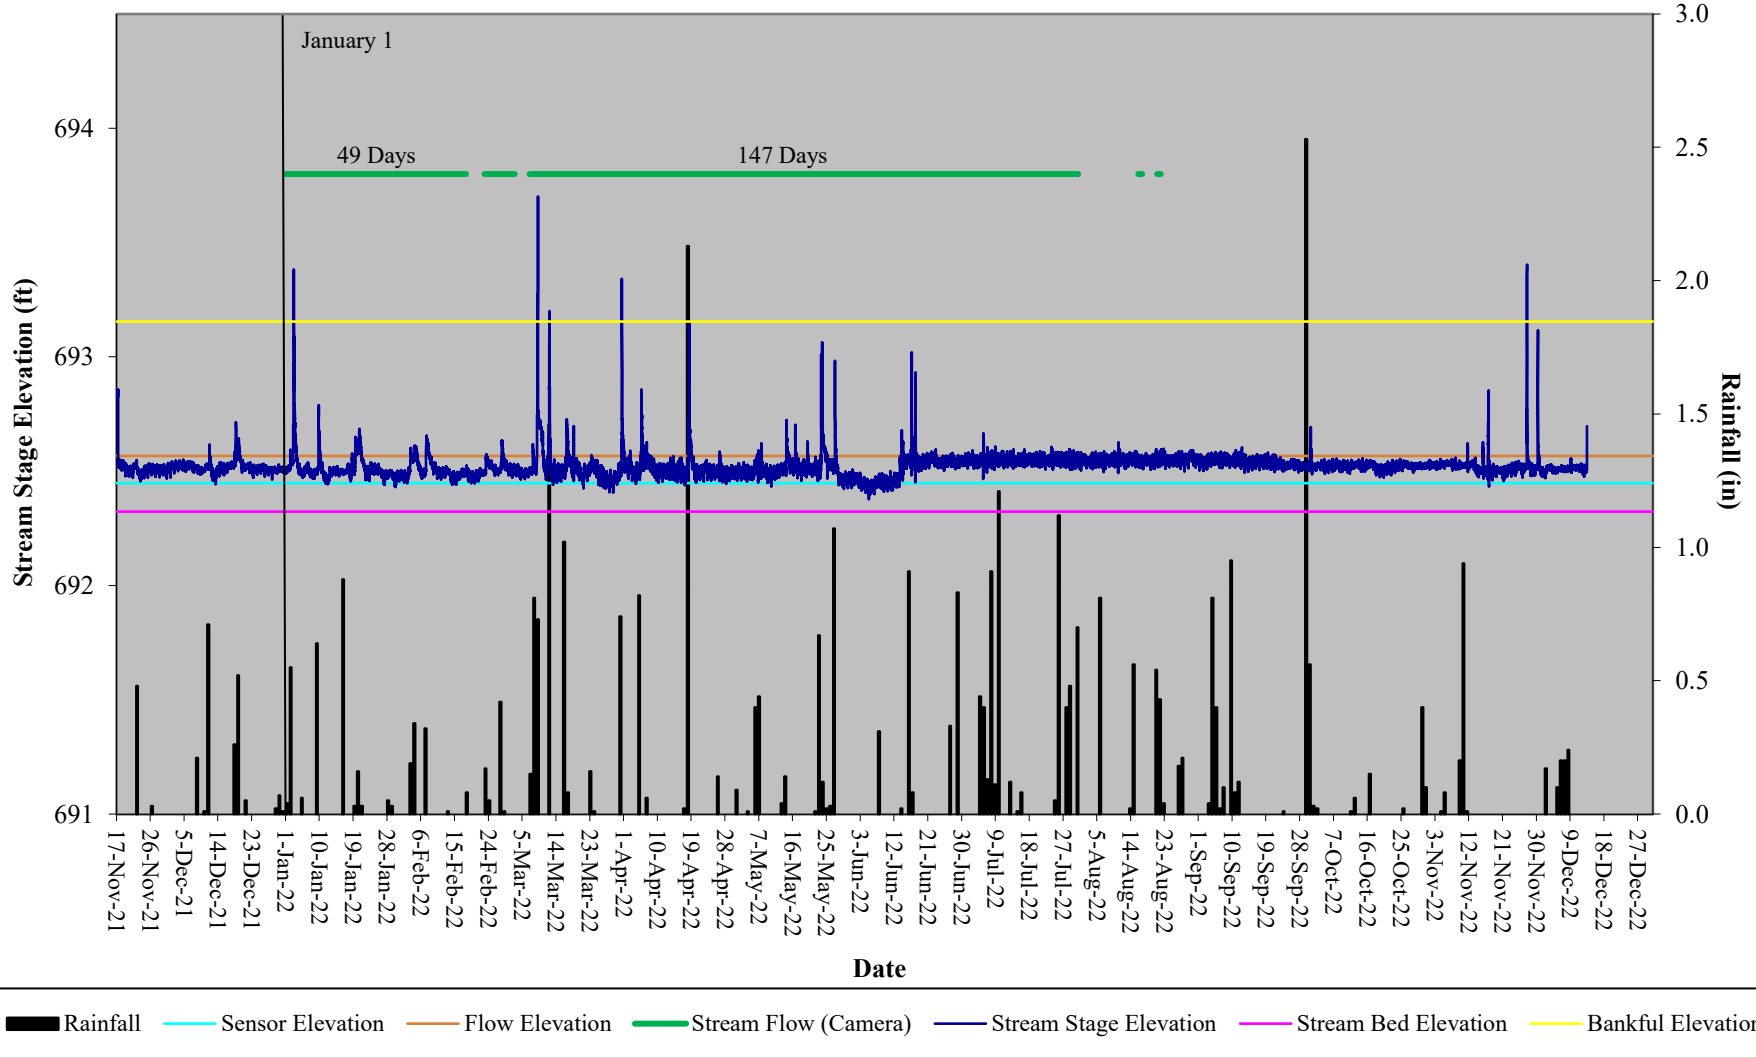
### Cedar Branch Restoration Site Hydrograph T1 Stream Flow Gauge

<b>Table 11. Verification of Stream Flow Cedar Branch Restoration Site, DMS Project #97009</b>				
	<b>Gauge</b>		<b>Camera</b>	
<b>Reach</b>	<b>Dates Achieving</b>	<b>Maximum Consecutive Days</b>	<b>Dates Achieving</b>	<b>Maximum Consecutive Days</b>
T1	N/A	3	Janaury1 – February 18; March 7 – July 31	147
T1-1	N/A	17	January 10 – May 4	115
T3	April 22 – June 9	49	February 10 – August 2	173

<b>Table 12. Stream Flow Criteria Attainment Cedar Branch Restoration Site, DMS Project #97009</b>							
	<b>Greater than 30 Days of Flow/Max Consecutive Days</b>						
<b>Reach</b>	<b>MY-01 2018</b>	<b>MY-02 2019</b>	<b>MY-03 2020</b>	<b>MY-04 2021</b>	<b>MY-05 2022</b>	<b>MY-06 2023</b>	<b>MY-07 2024</b>
T1 (Gauge)	Yes/60	Yes/46	Yes/142	Yes/242	No/3		
T1 (Camera)	Yes/102	Yes/260	Yes/189	Yes/178	Yes/147		
T1-1 (Gauge)	No/16	Yes/66	Yes/65	Yes/87	No/17		
T1-1 (Camera)	No/7*	Yes/105	Yes/63	No/7*	Yes/115		
T3 (Gauge)	Yes/83	Yes/187	Yes/65	Yes/86	Yes/49		
T3 (Camera)	Yes/93	Yes/252	Yes/174	Yes/61	Yes/173

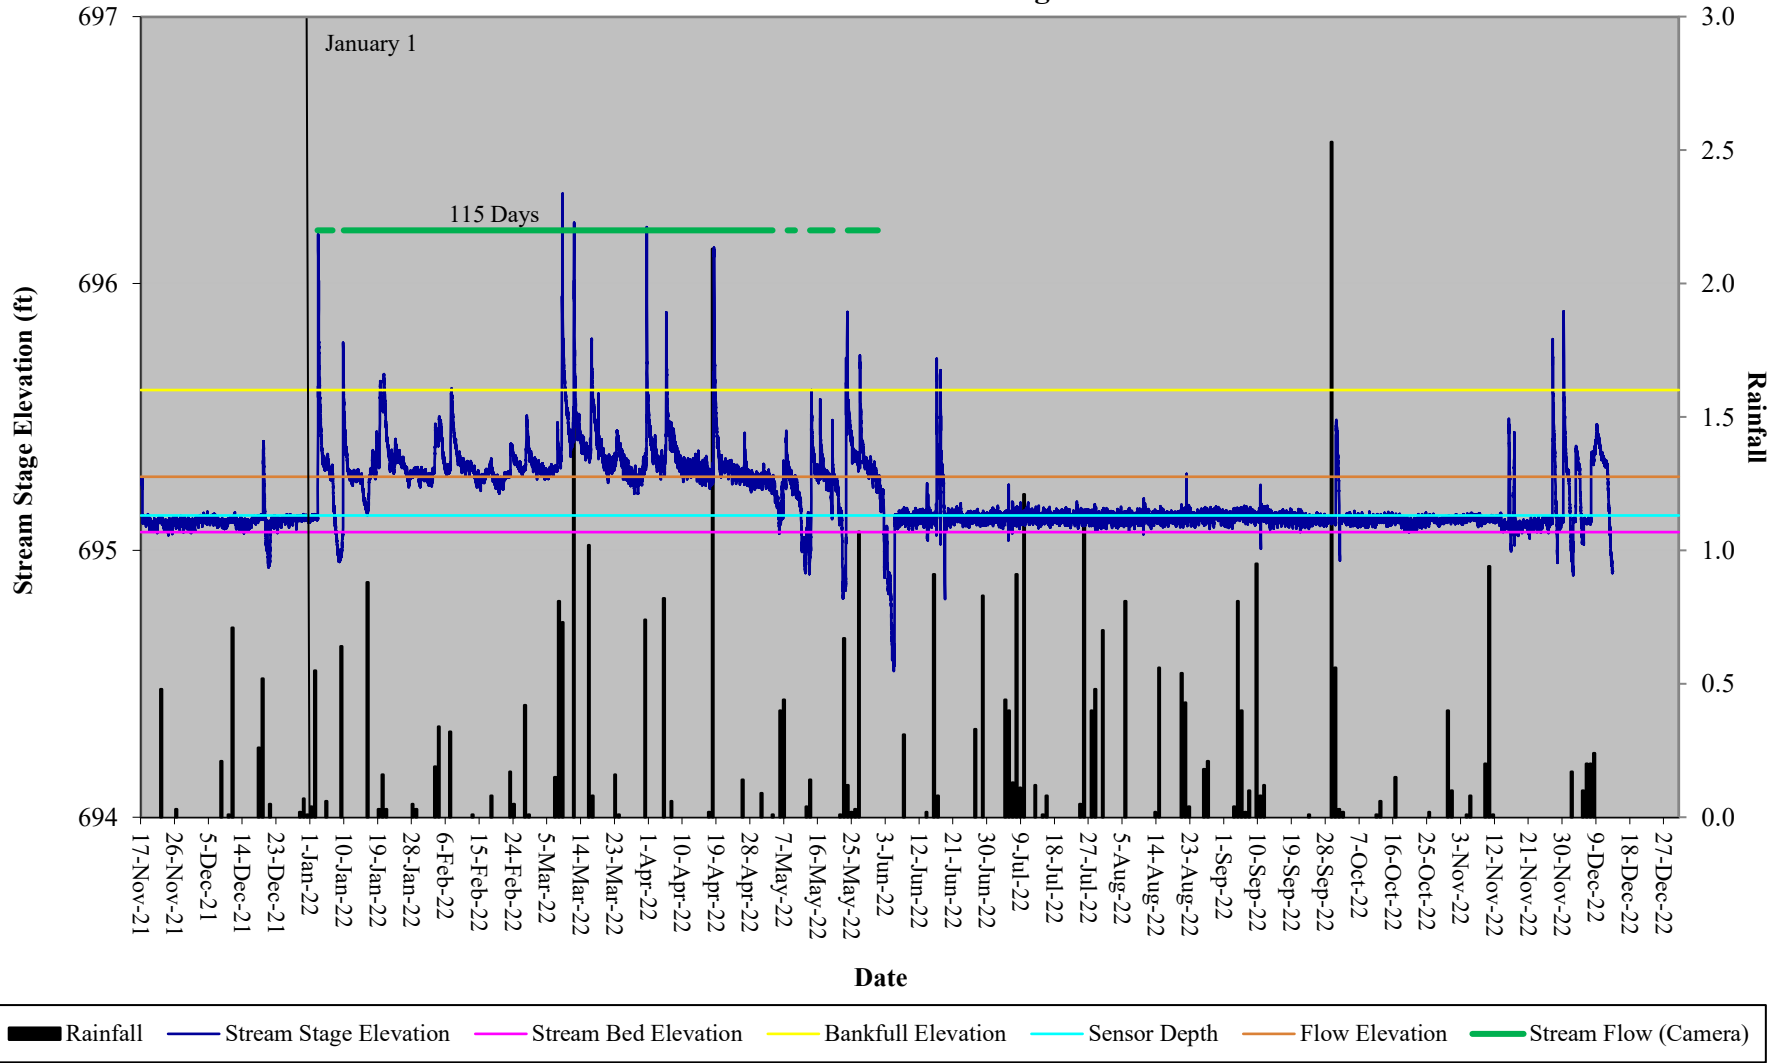
### Cedar Branch Restoration Site Hydrograph T1-1 Stream Flow Gauge

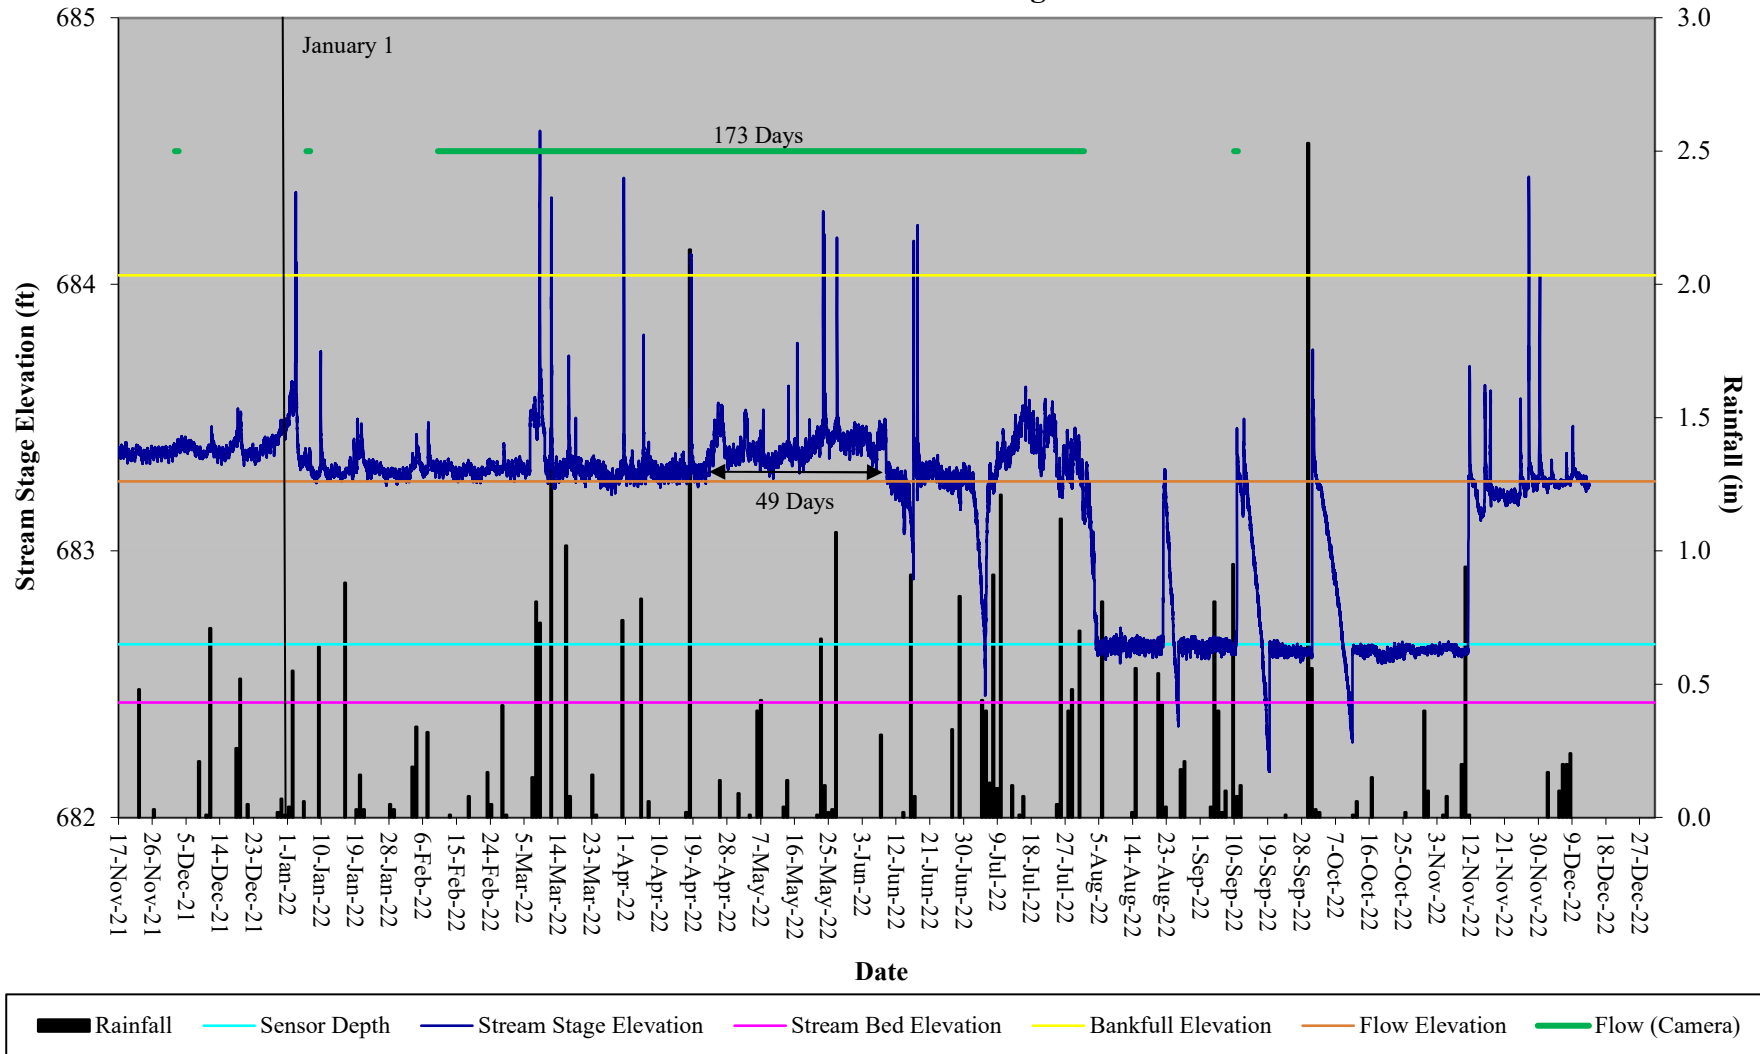
### Cedar Branch Restoration Site Hydrograph T3 Stream Flow Gauge

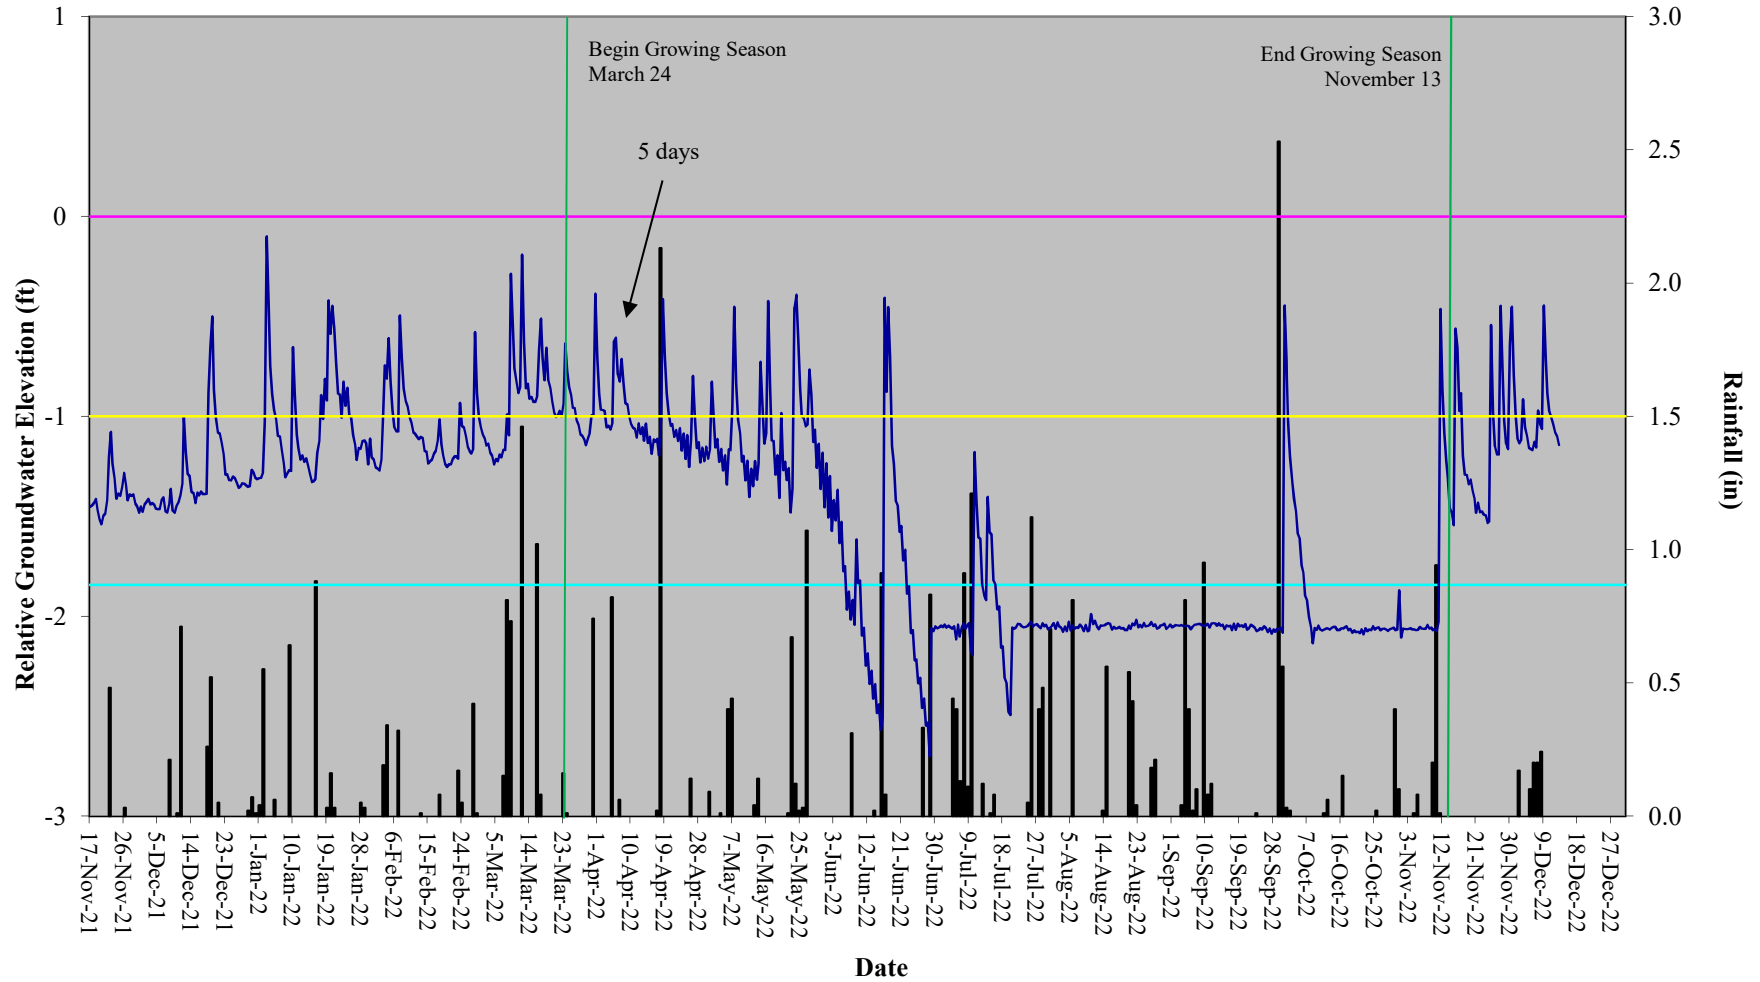
## Cedar Branch Restoration Site Hydrograph Wetland Gauge 1

<b>Max Consecutive Days During Growing Season (Percentage)</b>						
<b>Gauge #</b>	<b>Location</b>	<b>MY-01 2018</b>	<b>MY-02 2019</b>	<b>MY-03 2020</b>	<b>MY-04 2021</b>	<b>MY-05 2022</b>	<b>MY-06 2023</b>	<b>MY-07 2024</b>
Gauge 1	T1	64 (27.4%)	63 (26.7%)	55 (23.3%)	57 (24.1%)	3 (1.9%)		
Gauge 2	T3	104 (44.4%)	148 (63.2%)	119 (50.9%)	65 (27.6%)	103 (44.0%)		
Gauge 3	T3	21 (9.0%)	26 (10.9%)	13 (5.3%)	21 (9.0%)	18 (7.7%)

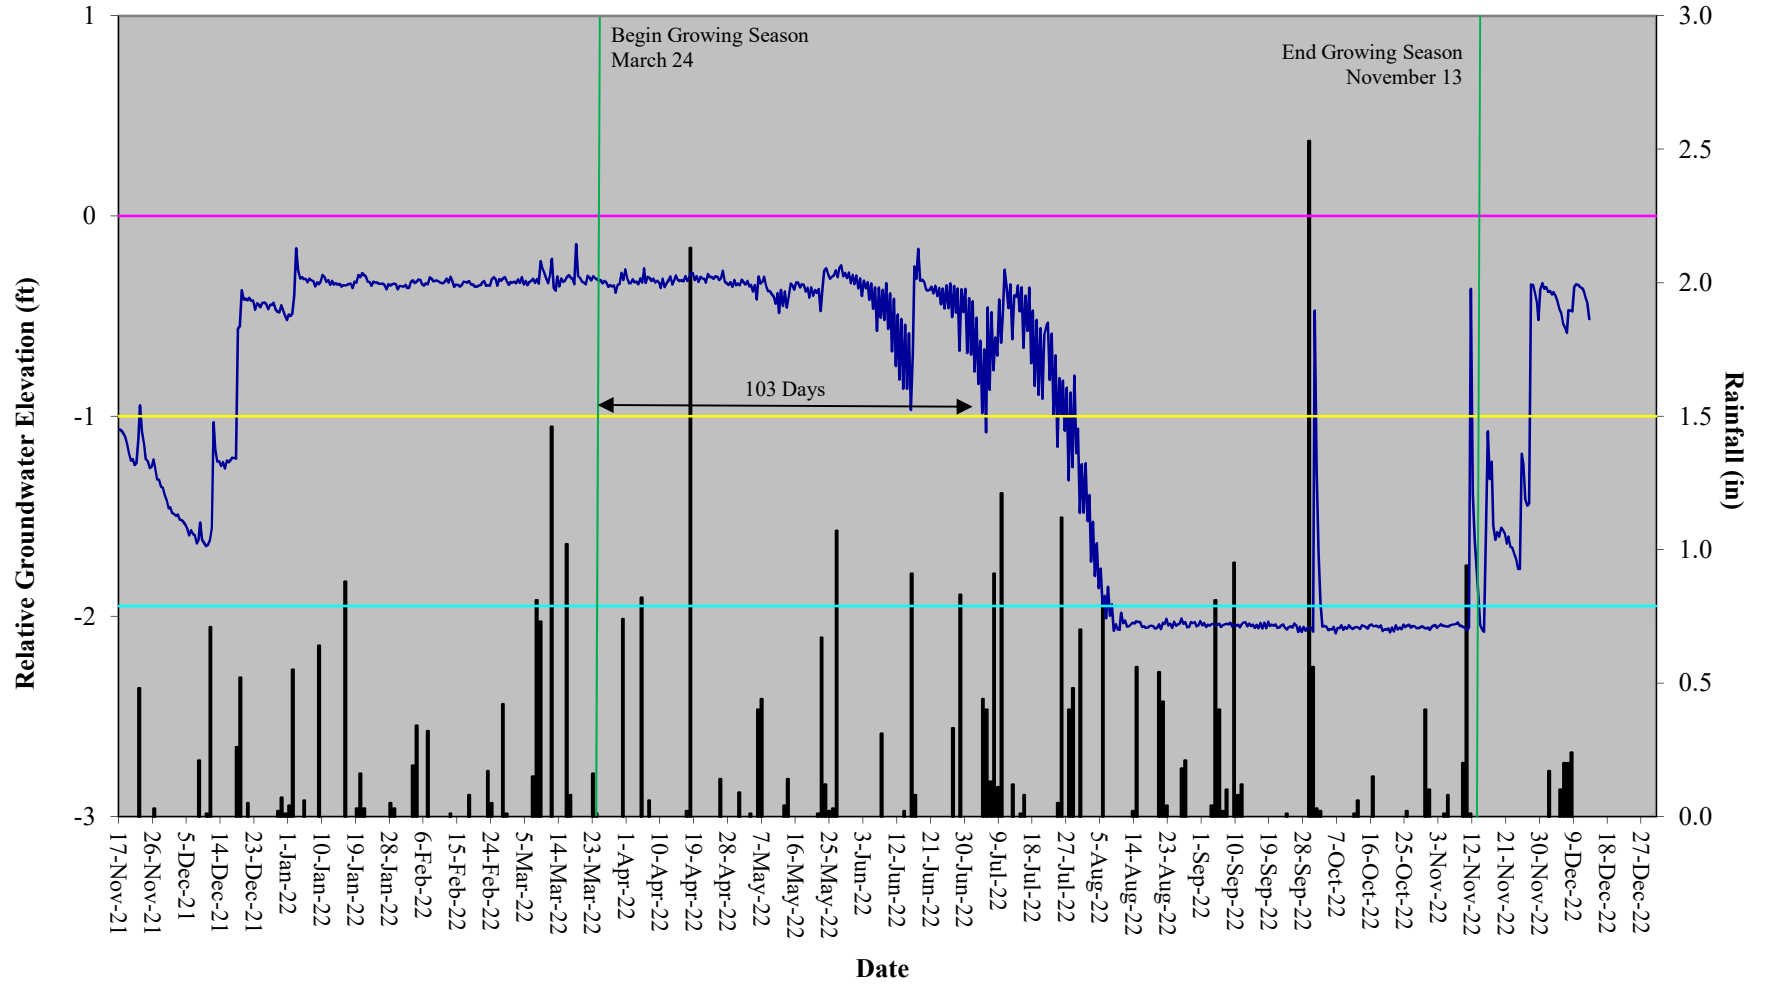
## Cedar Branch Restoration Site Hydrograph Wetland Gauge 2

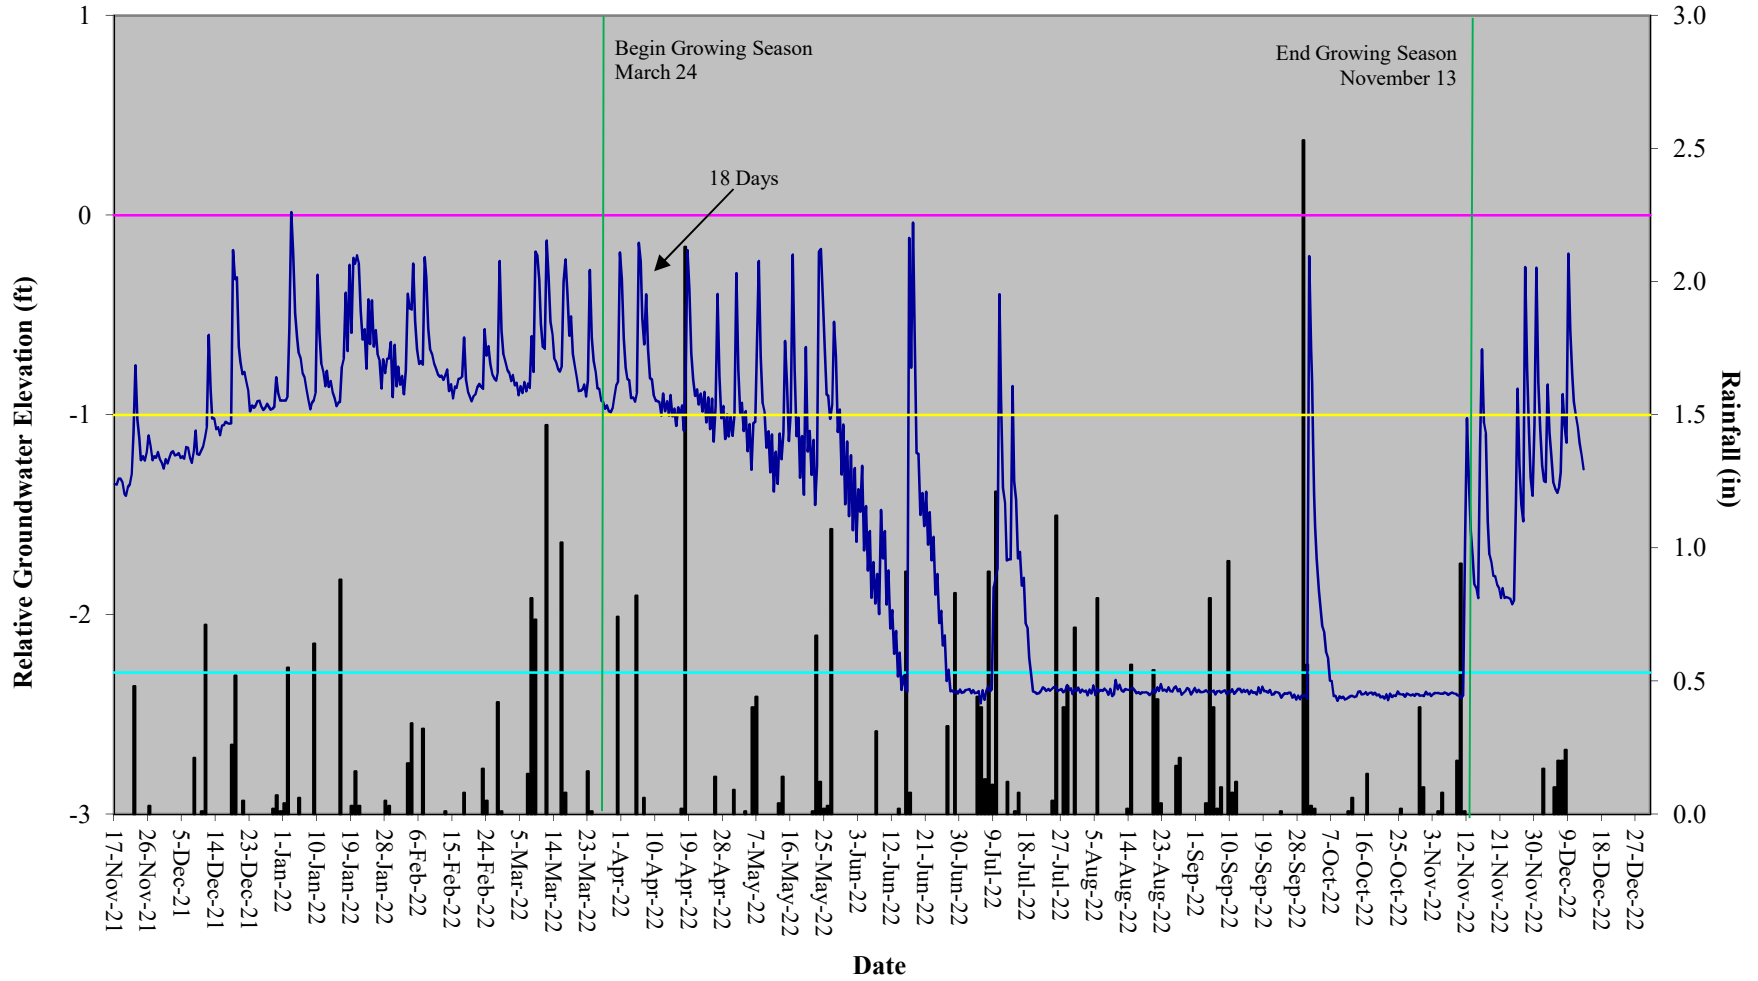
### Cedar Branch Restoration Site Hydrograph Wetland Gauge 3
