City Pond Site Stream Restoration Plan Anson County, NC

NC ECOSYSTEM
ENHANCEMENT PROGRAM

Report Prepared By Buck Engineering PC

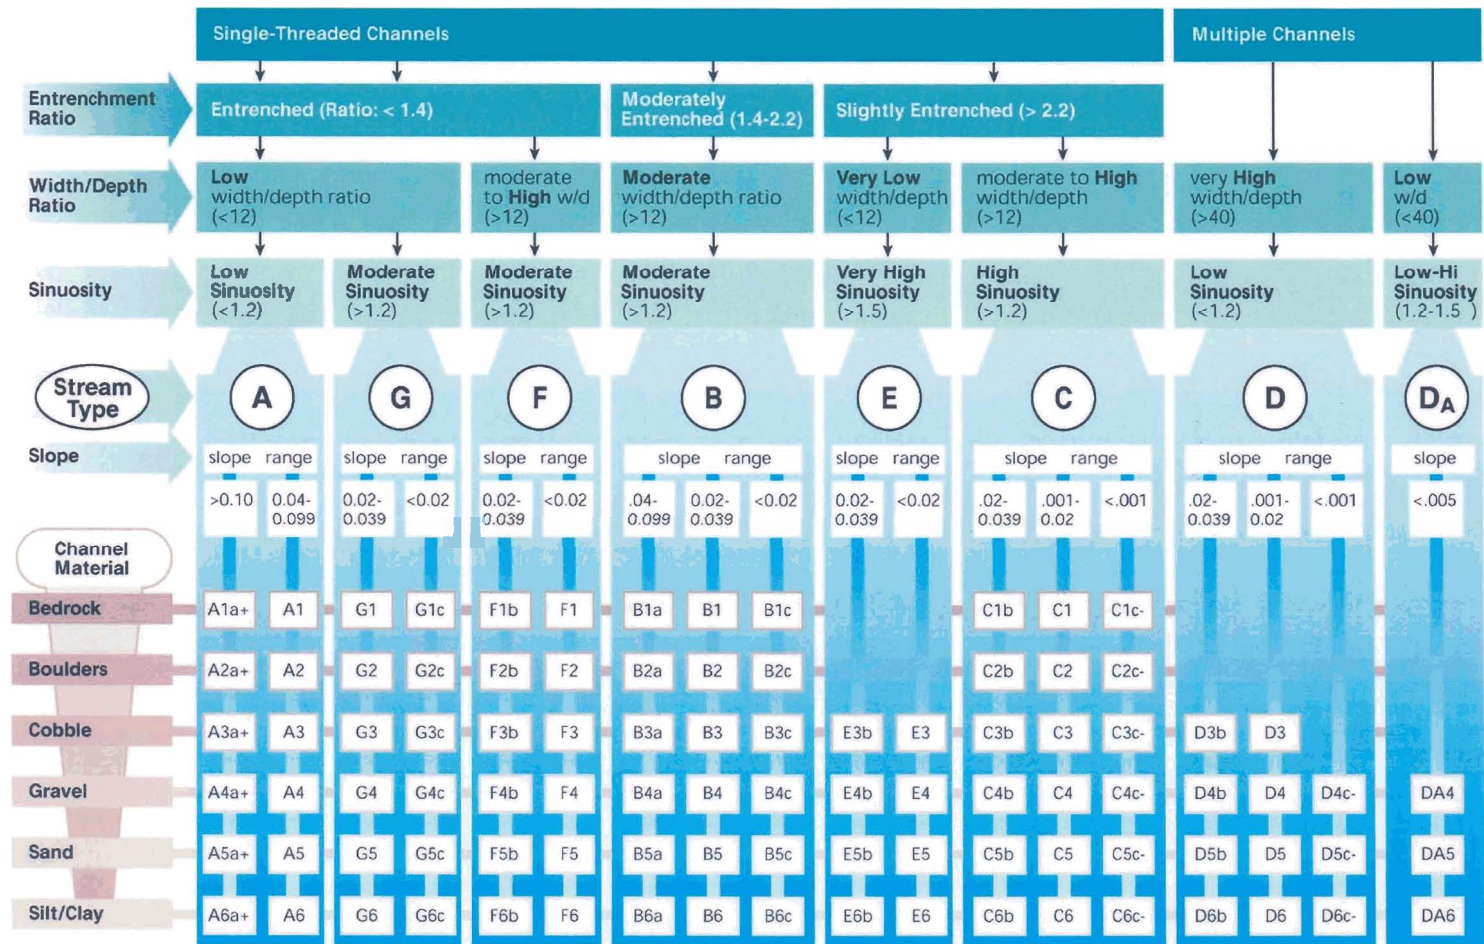
Figure 2.1
 Rosgen Stream Classification
 City Pond Site Restoration Plan

Fig. 7.12 -- Rosgen's stream classification system (Level II).
 In Stream Corridor Restoration: Principles, Processes, and Practices, 10/98.
 Intergency Stream Restoration Working Group (FISRWG)(15 Federal agencies of the US).

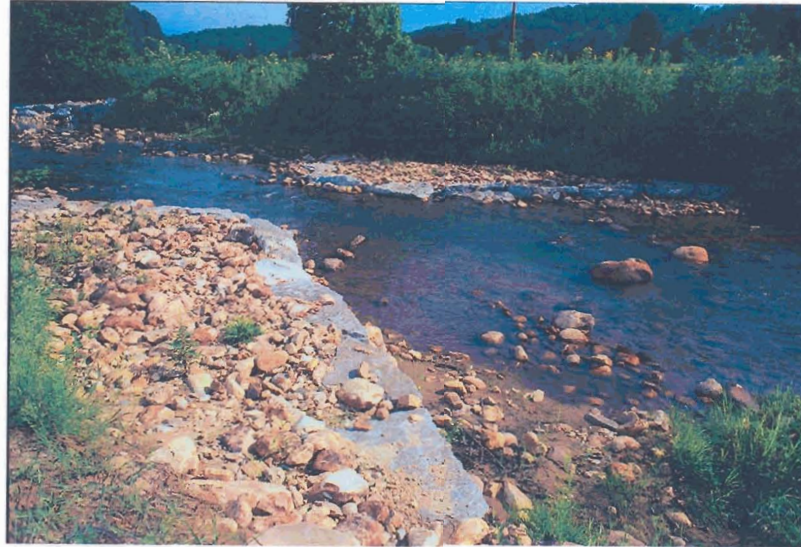
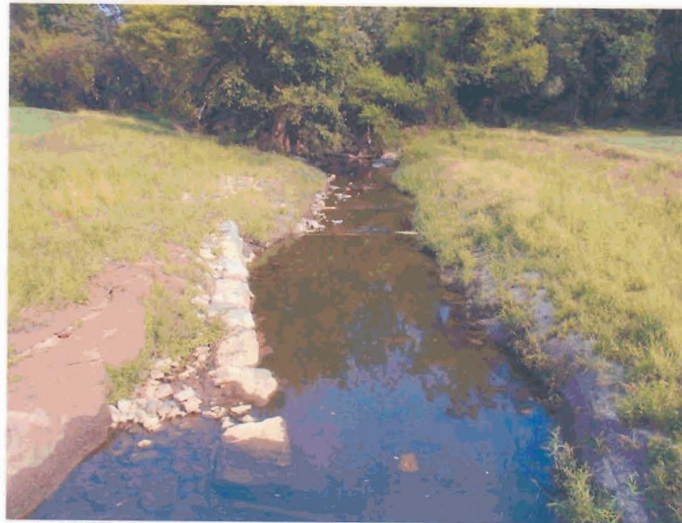
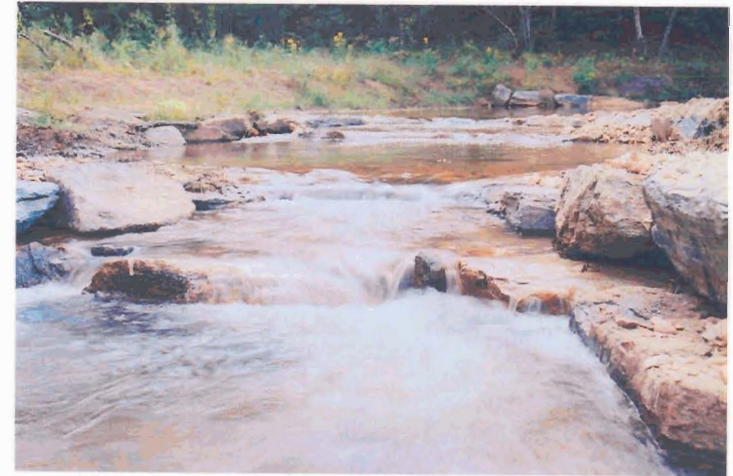
Figure 2.7
Examples of Instream Structures
City Pond Site Restoration Plan

J-Hook

Double Wing Deflector

Rock Vane

Double Drop Rock Cross Vane

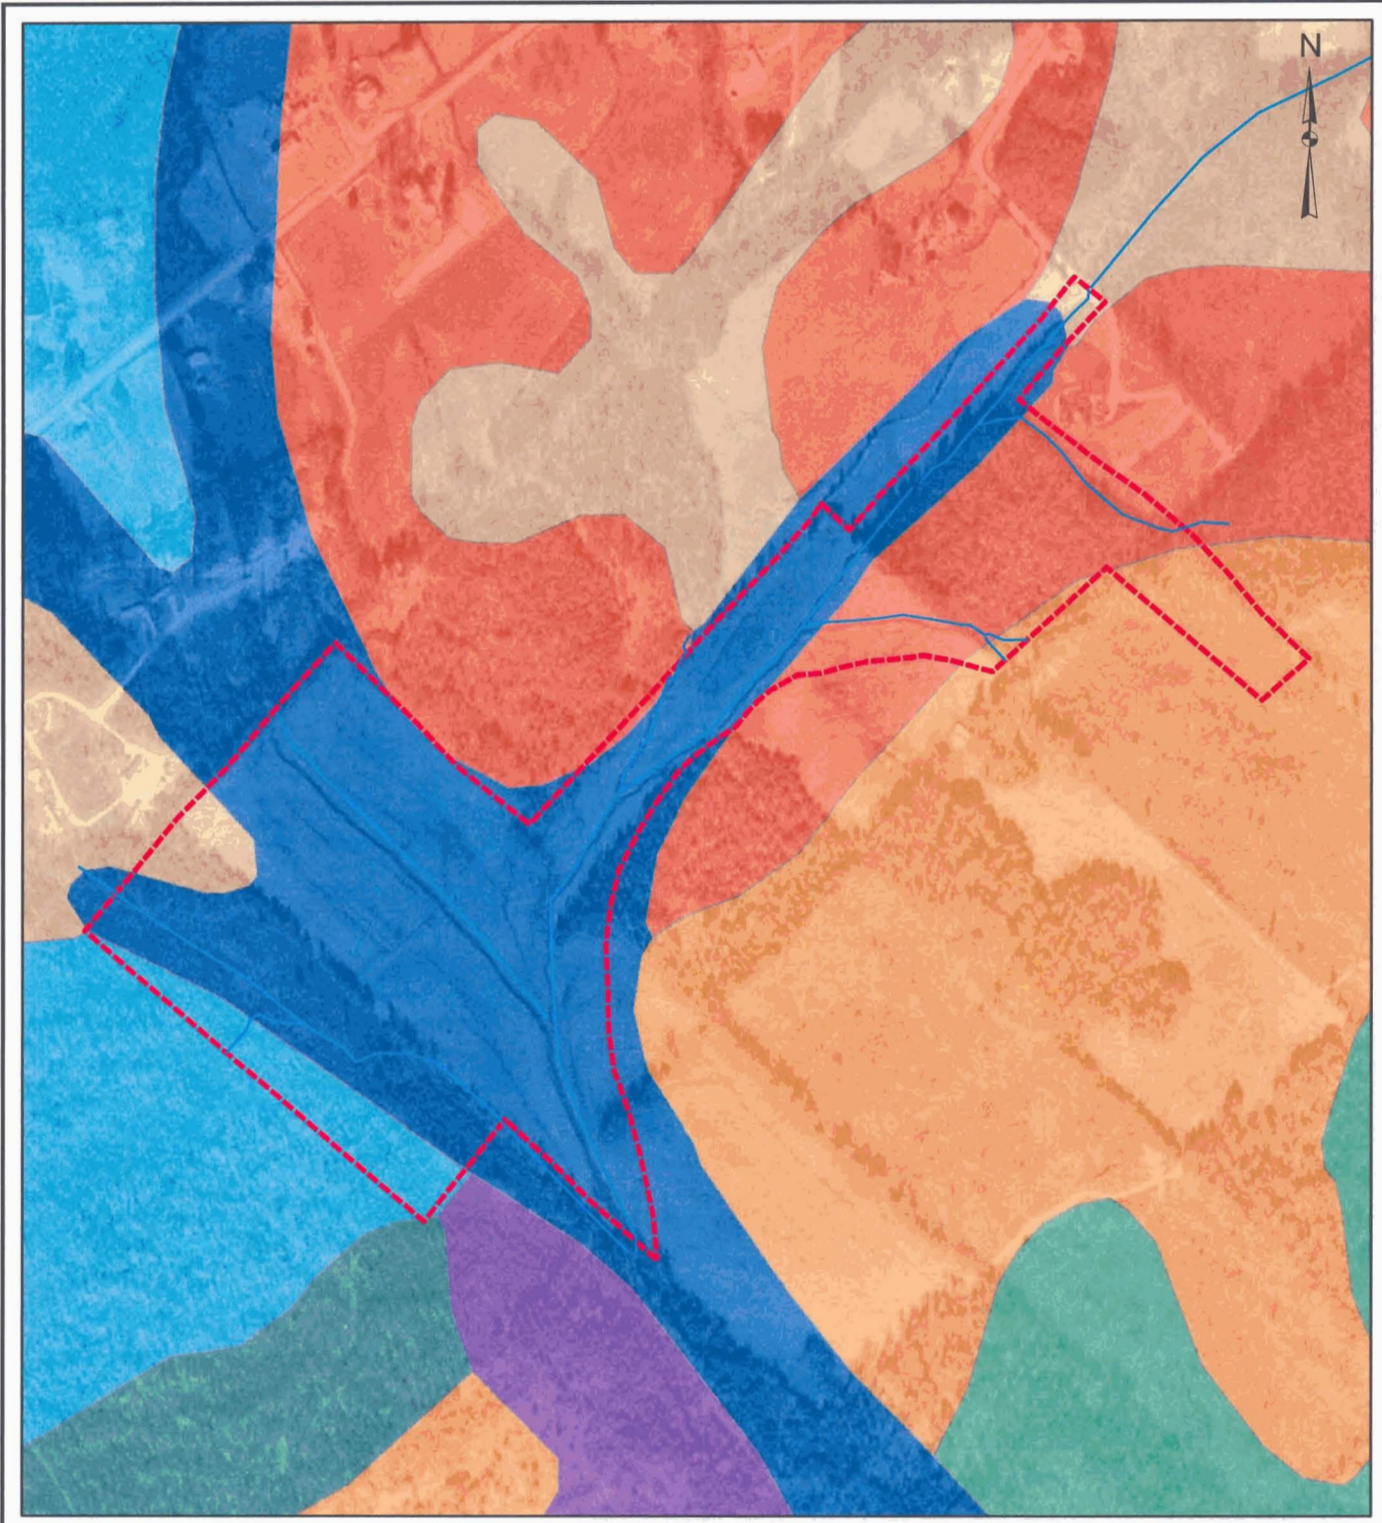
Figure 3.1. Soil Types

| Mayodan Gravelly Sandy Loam (MgB) | Stream |
| Mayodan Gravelly Sandy Loam (MgC) | Property Boundary |

Soils within the lower floodplain areas are mapped primarily as the Chewacla series (Figure 3.1) and contain several areas of hydric inclusions. Preliminary soil borings indicate that the hydric inclusions match most closely with the soil description of the Chastain series. The Chastain series can comprise up to 15% or more of the areas mapped as Chewacla. According to the Anson County Soil Survey, Chastain soils occur in concave areas such as the topographic depressions identified on the project site. On-site observations indicate that the general composition of these depressional areas closely matches the description for the Chastain series presented in the soil survey.

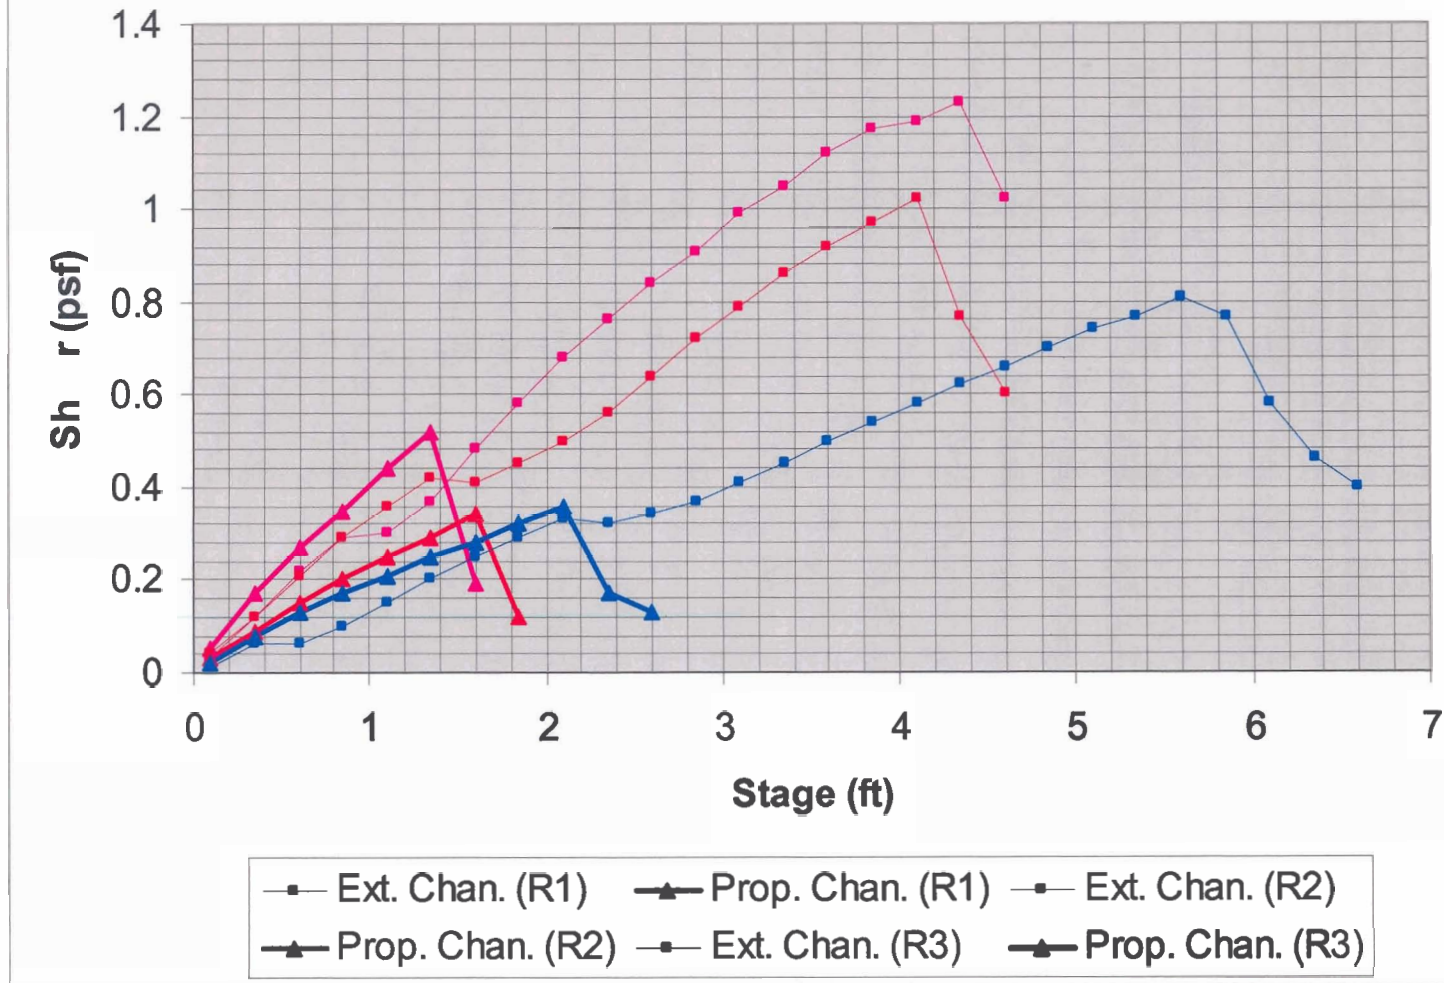
Stage vs. Shear for R1, R2, and R3 (Existing and Proposed Channel)
City Pond Site Restoration Plan

Sediment transport capacity, measured as unit stream power (W/m^2), was compared for the existing stream channel and the design conditions for R1, R2, and R3. Table 6.4 shows bankfull boundary shear stress and stream power values for existing and design conditions. Stream power values for the existing and design conditions all compare well to values for similar streams and valley types described in Nanson and Croke (1992). According to their classification system, all mainstem channels are classified as B3a valley types (gravel, sand, and silt bed streams in wide alluvial valleys). The range of stream powers for this valley type in the Nanson and Croke study is 10 to 60 W/m^2 . Figure 6.1 shows shear stress as a function of stage for the existing and proposed channel conditions. Figure 6.2 shows average channel velocity as a function of stage for the two channel conditions. Both shear stress and velocity are significantly higher at higher stages for the existing conditions channel due to the higher bank height ratios. Flows higher than bankfull are trapped in the existing incised channel resulting in excess shear stress and velocities. The design channel will allow flows greater than bankfull to spread out on the floodplain thus dissipating this excess energy. The break point on the graphs for both the existing and proposed channel conditions occurs at the top of bank stage.

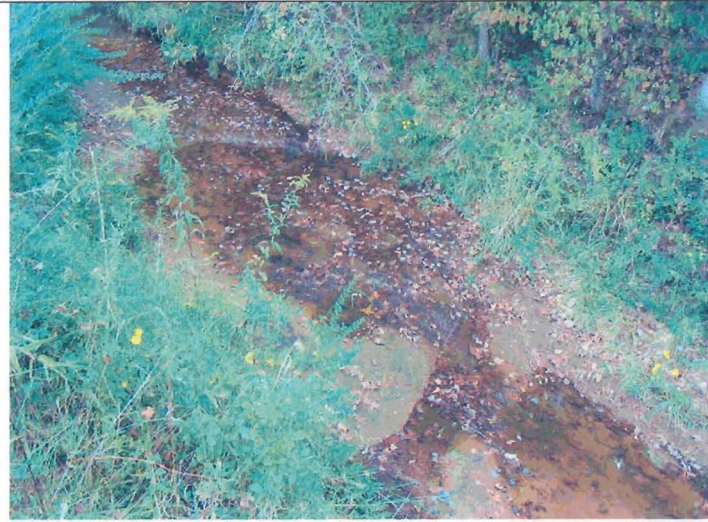
City Pond – Reach R1, weathered bedrock
