Annual Monitoring Report

Cochran Branch Stream and Wetland Restoration Site

NCDMS Project No.: 95720

Macon County, NC

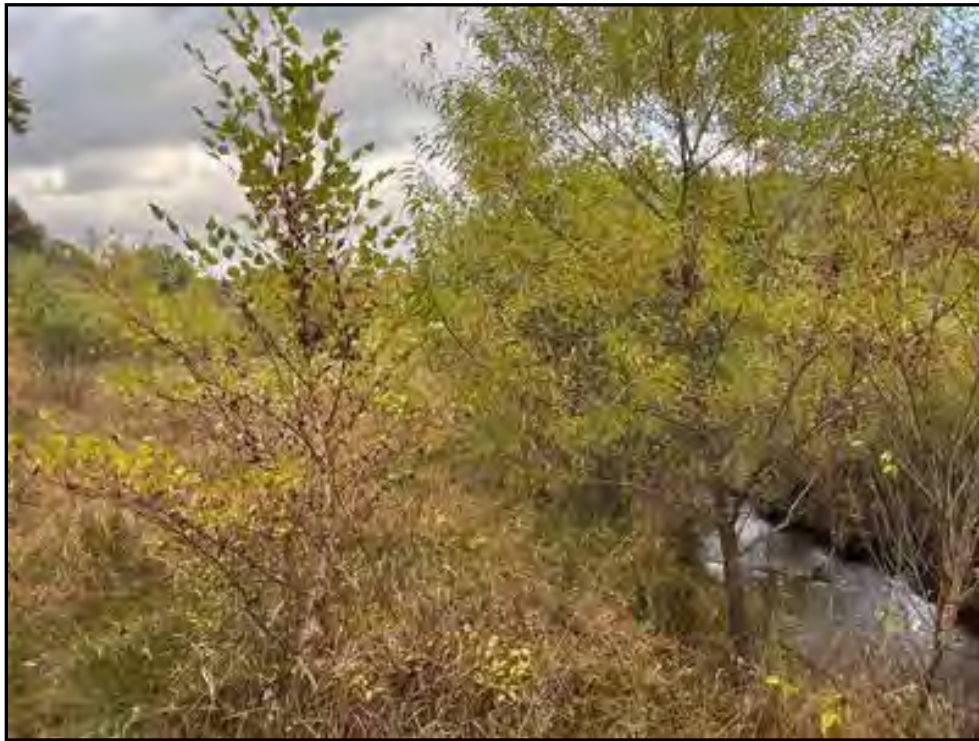
Cochran Branch Reach 1a – Permanent Photo Station 1
Station 101+33 – Downstream
October 21, 2021

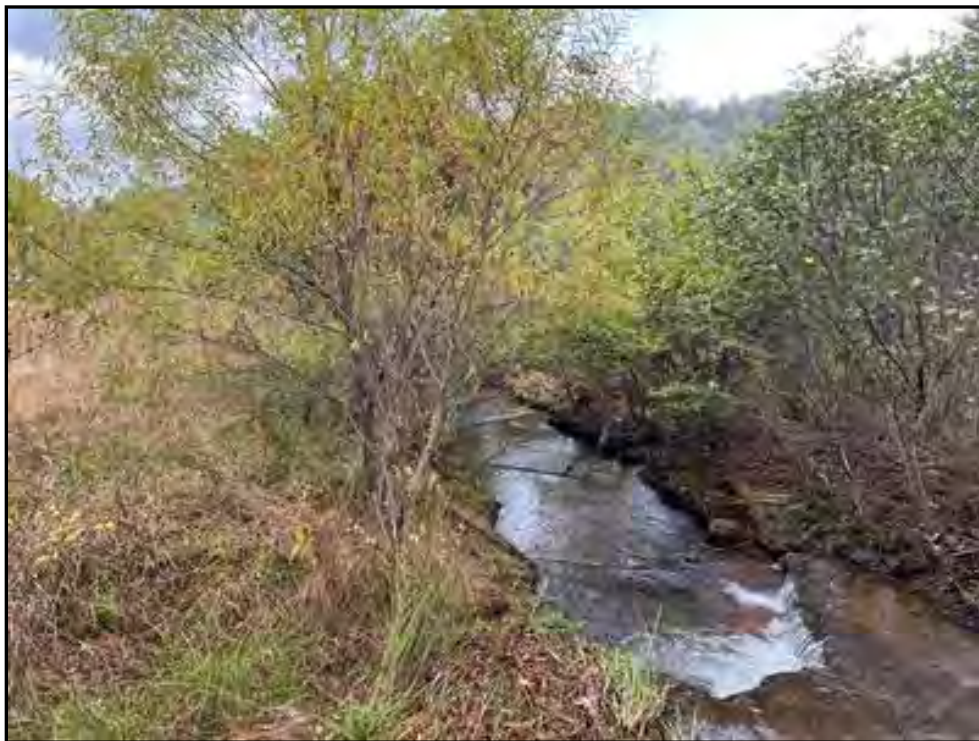
Cochran Branch Reach 1a – Permanent Photo Station 1
Station 101+33 – Upstream
October 21, 2021

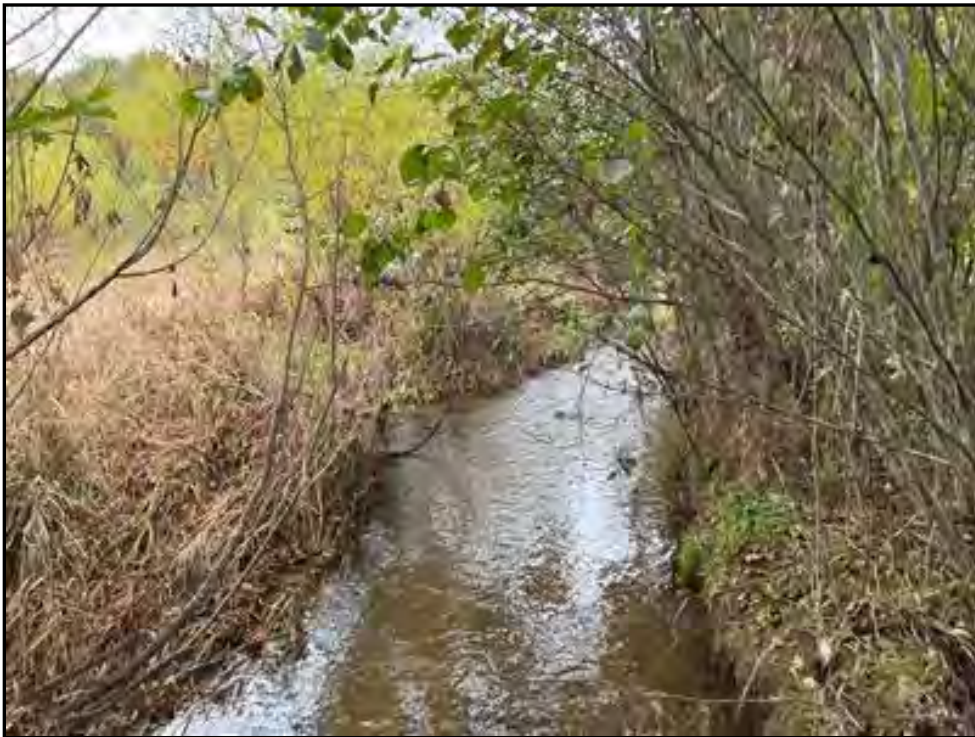
Cochran Branch – Permanent Photo Station 3
Station 108+87 – Upstream
October 21, 2021

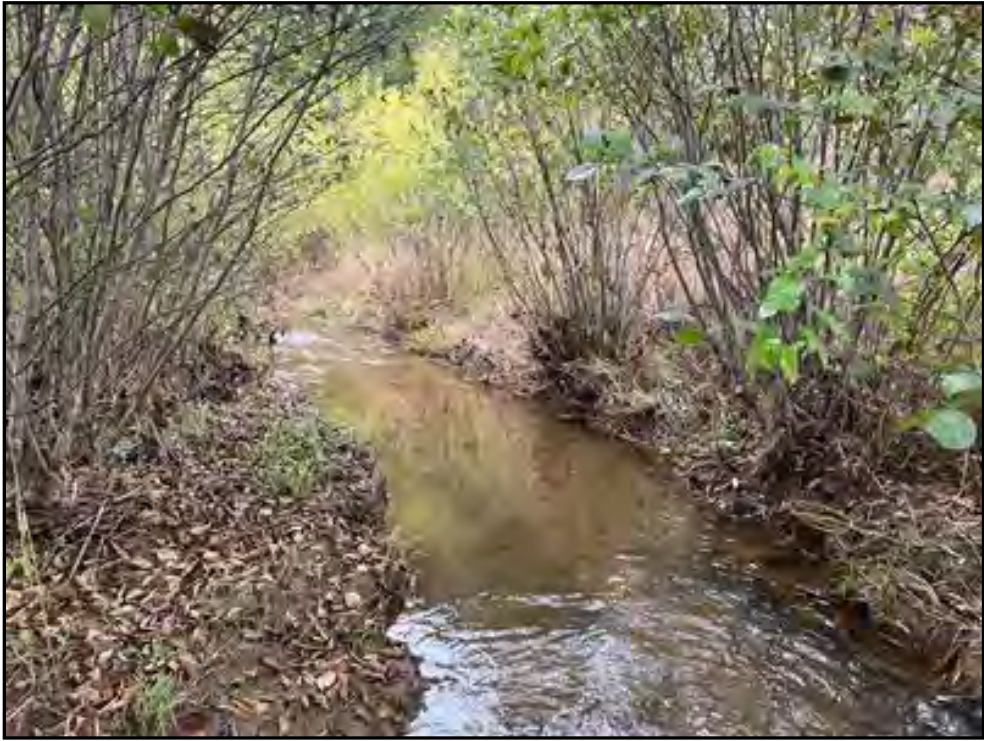
Parrish Branch – Permanent Photo Station 3
Station 108+87 – Downstream
October 21, 2021

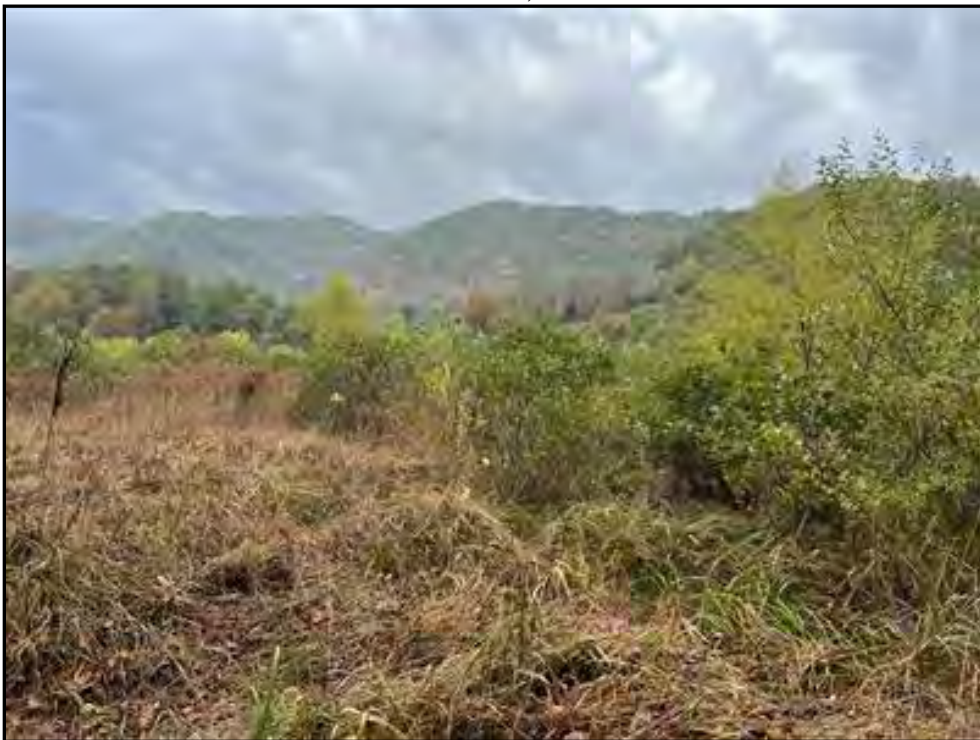
Cochran Branch – Permanent Photo Station 6
Station 114+62 – Upstream 186°
October 21, 2021

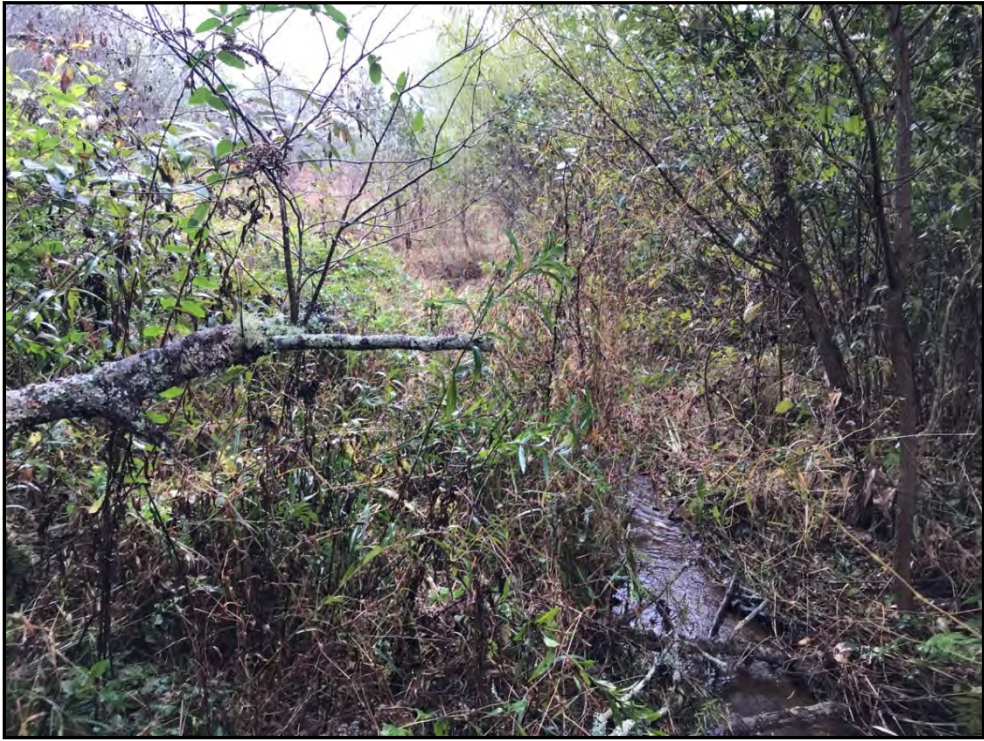
Parrish Branch – Permanent Photo Station 7
Station 200+25 – Downstream
October 21, 2021

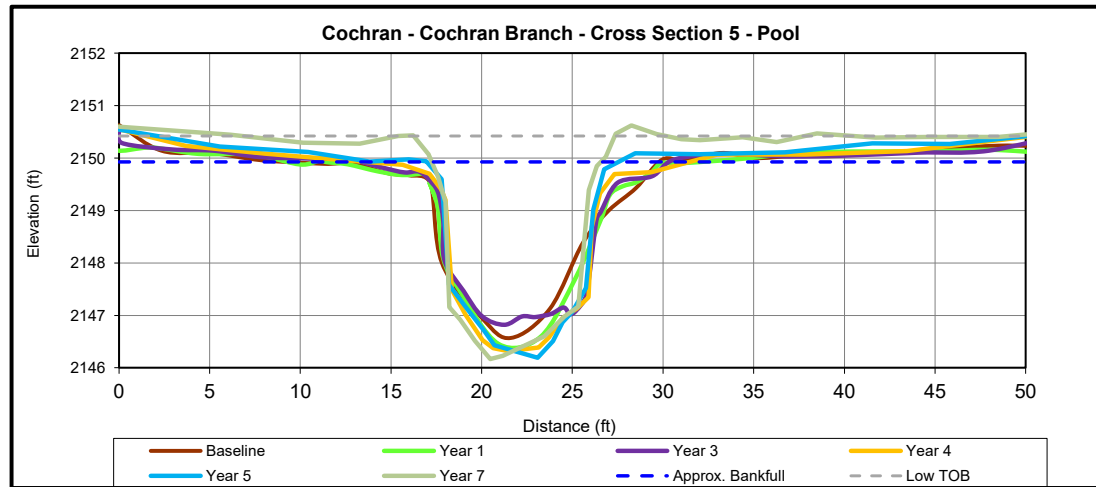
Dimension	Cross Section 5 (Pool)							
	Base	MY1	MY2	MY3	MY4	MY5	MY6	MY7
Bankfull Elevation (ft) - Based on AB-XSA ¹	2149.9	2149.9	-	2149.9	2149.8	N/A	N/A	N/A
Bankfull Width (ft) ¹	17.0	17.3	-	16.8	14.0	N/A	N/A	N/A
Floodprone Width (ft) ¹	>236.5	>236.5	-	>52.9	>52.8	N/A	N/A	N/A
Bankfull Mean Depth (ft)	1.5	1.5	-	1.5	1.8	-	N/A	-
Bankfull Max Depth (ft) ²	3.3	3.4	-	3.1	3.5	3.6	N/A	4.3
Bankfull Cross Sectional Area (ft ²) ²	25.4	26.4	-	25.2	25.4	24.5	N/A	30.5
Bankfull Width/Depth Ratio	11.4	11.4	-	11.2	7.7	-	N/A	-
Bankfull Entrenchment Ratio ¹	>13.9	>13.7	-	N/A	N/A	N/A	N/A	N/A
Bankfull Bank Height Ratio ¹	1.0	1.0	-	N/A	N/A	N/A	N/A	N/A

Note: Starting in MY5, the parameters denoted with 1 were calculated using the as-built cross sectional area as the basis for adjusting the bankfull elevation and the parameters denoted with 2 were calculated using the current years low top of bank as the bankfull elevation. These changes reflect the 2018 guidance that arose from the mitigation technical workgroup consisting of DMS, the IRT, and industry mitigation providers.

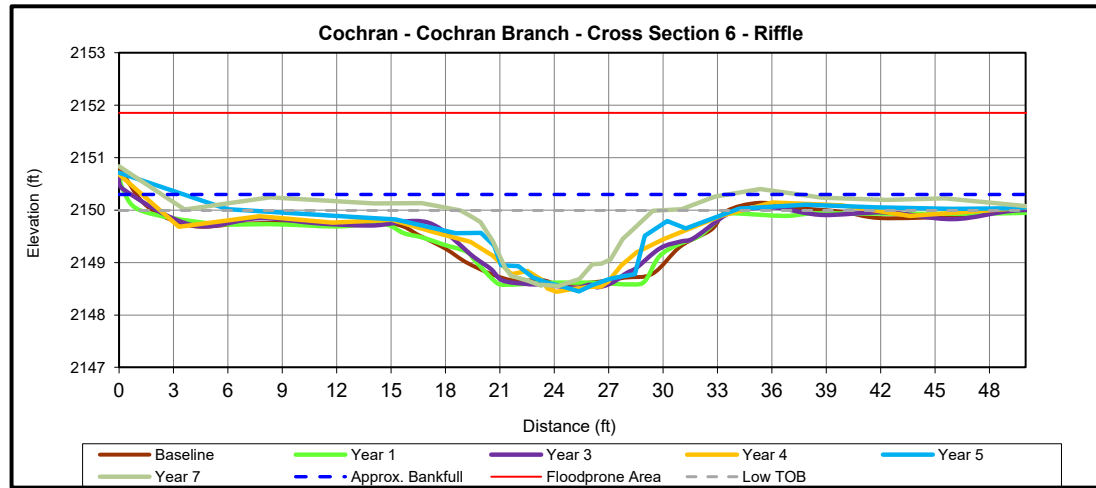
Cross Section 6 (Riffle)								
Dimension	Base	MY1	MY2	MY3	MY4	MY5	MY6	MY7
Bankfull Elevation (ft) - Based on AB-XSA ¹	2149.7	2149.7	-	2149.7	2149.9	2150.0	N/A	2150.3
Bankfull Width (ft) ¹	17.8	17.9	-	15.6	20.6	25.3	N/A	10.6
Floodprone Width (ft) ¹	>197.0	>197.0	-	>54.5	>54.5	>54.5	N/A	>54.3
Bankfull Mean Depth (ft)	0.8	0.8	-	0.8	0.7	-	N/A	-
Bankfull Max Depth (ft) ²	1.1	1.2	-	1.2	1.5	0.7	N/A	1.4
Bankfull Cross Sectional Area (ft ²) ²	13.6	13.6	-	12.1	13.6	7.0	N/A	9.3
Bankfull Width/Depth Ratio	23.4	23.4	-	20.2	31.1	-	N/A	-
Bankfull Entrenchment Ratio ¹	>11.0	>11.0	-	>3.5	>2.7	>2.2	N/A	>5.1
Bankfull Bank Height Ratio ¹	1.0	1.0	-	1.0	<1.0	<1	N/A	<1

Note: Starting in MY5, the parameters denoted with 1 were calculated using the as-built cross sectional area as the basis for adjusting the bankfull elevation and the parameters denoted with 2 were calculated using the current years low top of bank as the bankfull elevation. These changes reflect the 2018 guidance that arose from the mitigation technical workgroup consisting of DMS, the IRT, and industry mitigation providers.

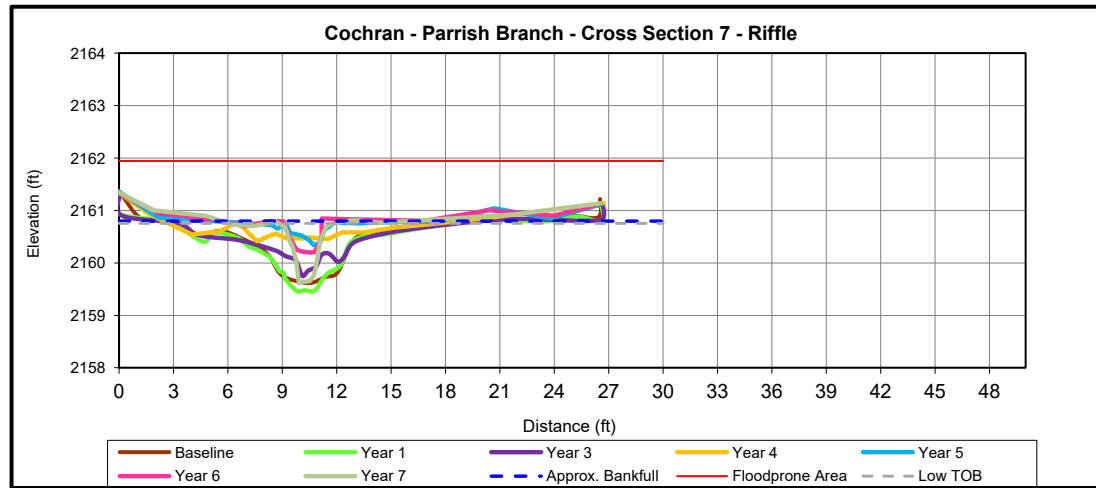
Dimension	Cross Section 7 (Riffle)							
	Base	MY1	MY2	MY3	MY4	MY5	MY6	MY7
Bankfull Elevation (ft) - Based on AB-XSA ¹	2160.2	2160.2	-	2160.2	2160.7	2160.9	2161.2	2160.8
Bankfull Width (ft) ¹	4.4	4.5	-	3.7	10.5	15.6	2.1	2.8
Floodprone Width (ft) ¹	>14.2	>14.2	-	11.9	24.0	>26.5	>26.4	>26.5
Bankfull Mean Depth (ft)	0.4	0.4	-	0.2	0.2	-	-	-
Bankfull Max Depth (ft) ²	0.6	0.7	-	0.4	0.3	0.4	0.6	1.1
Bankfull Cross Sectional Area (ft ²) ²	1.8	2.0	-	0.6	1.8	0.5	1.0	1.6
Bankfull Width/Depth Ratio	10.9	10.4	-	23.6	62.5	-	-	-
Bankfull Entrenchment Ratio ¹	>3.2	>3.1	-	3.2	2.3	>1.7	>12.6	>9.3
Bankfull Bank Height Ratio ¹	1.0	1.0	-	1.0	<1.0	<1	0.6	<1

Note: Starting in MY5, the parameters denoted with 1 were calculated using the as-built cross sectional area as the basis for adjusting the bankfull elevation and the parameters denoted with 2 were calculated using the current years low top of bank as the bankfull elevation. These changes reflect the 2018 guidance that arose from the mitigation technical workgroup consisting of DMS, the IRT, and industry mitigation providers.

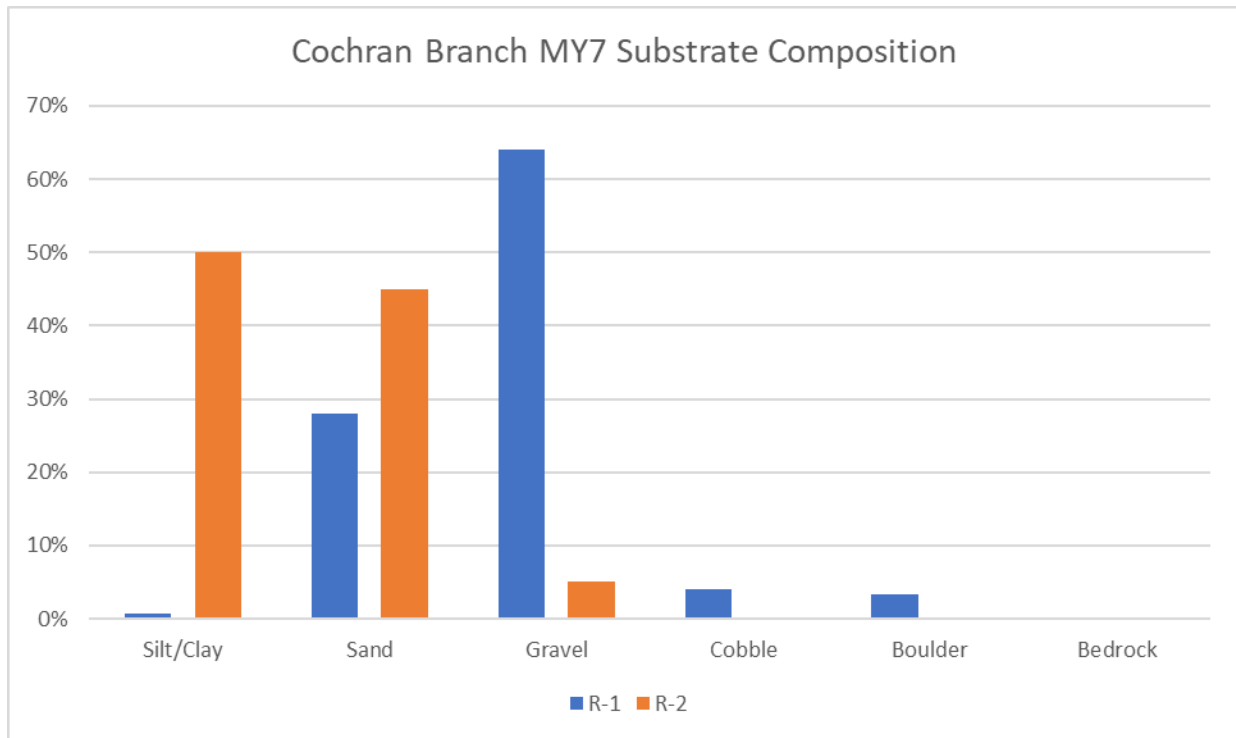
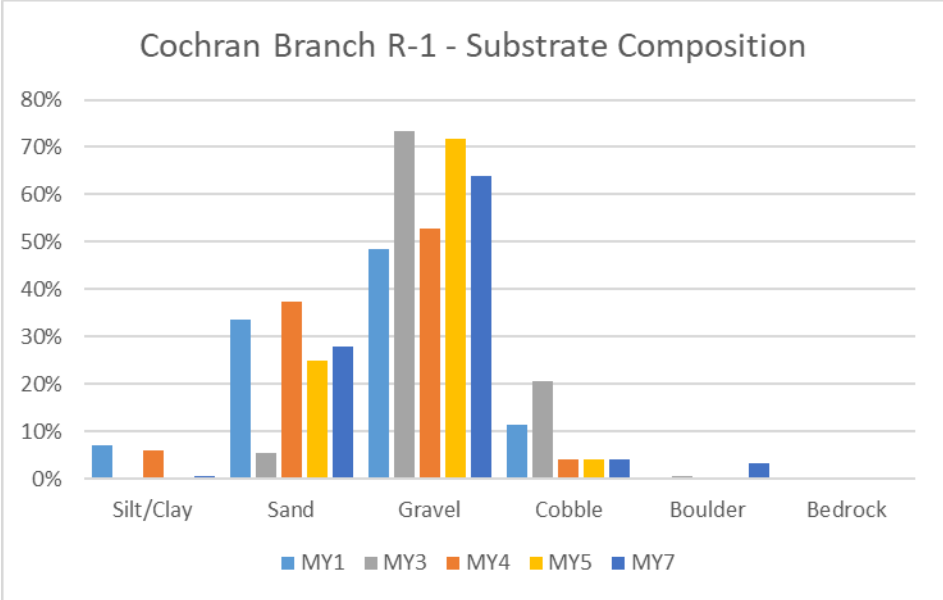
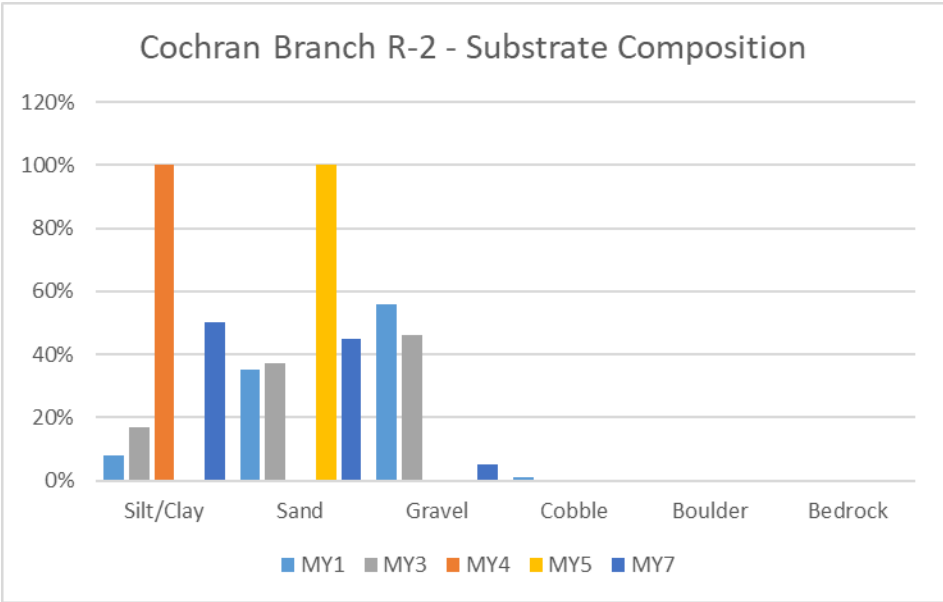
MY7 Stream Reach Substrate Composition

Table 12. Pebble Count Data Summary

Stream Reach	MY1 - 2015		MY3 - 2017		MY4 - 2018		MY5 - 2019		MY7 - 2021	
	Pebble Count		Pebble Count		Pebble Count		Pebble Count		Pebble Count	
	D ₅₀ (mm)	D ₈₄ (mm)	D ₅₀ (mm)	D ₈₄ (mm)	D ₅₀ (mm)	D ₈₄ (mm)	D ₅₀ (mm)	D ₈₄ (mm)	D ₅₀ (mm)	D ₈₄ (mm)
R-1	13.5	4.1	26.0	2.4	4.9	0.1	7.7	28.3	7.7	28.3
R-2	46.3	22.5	64.7	10.0	15.7	0.1	0.3	1.8	0.3	0.5

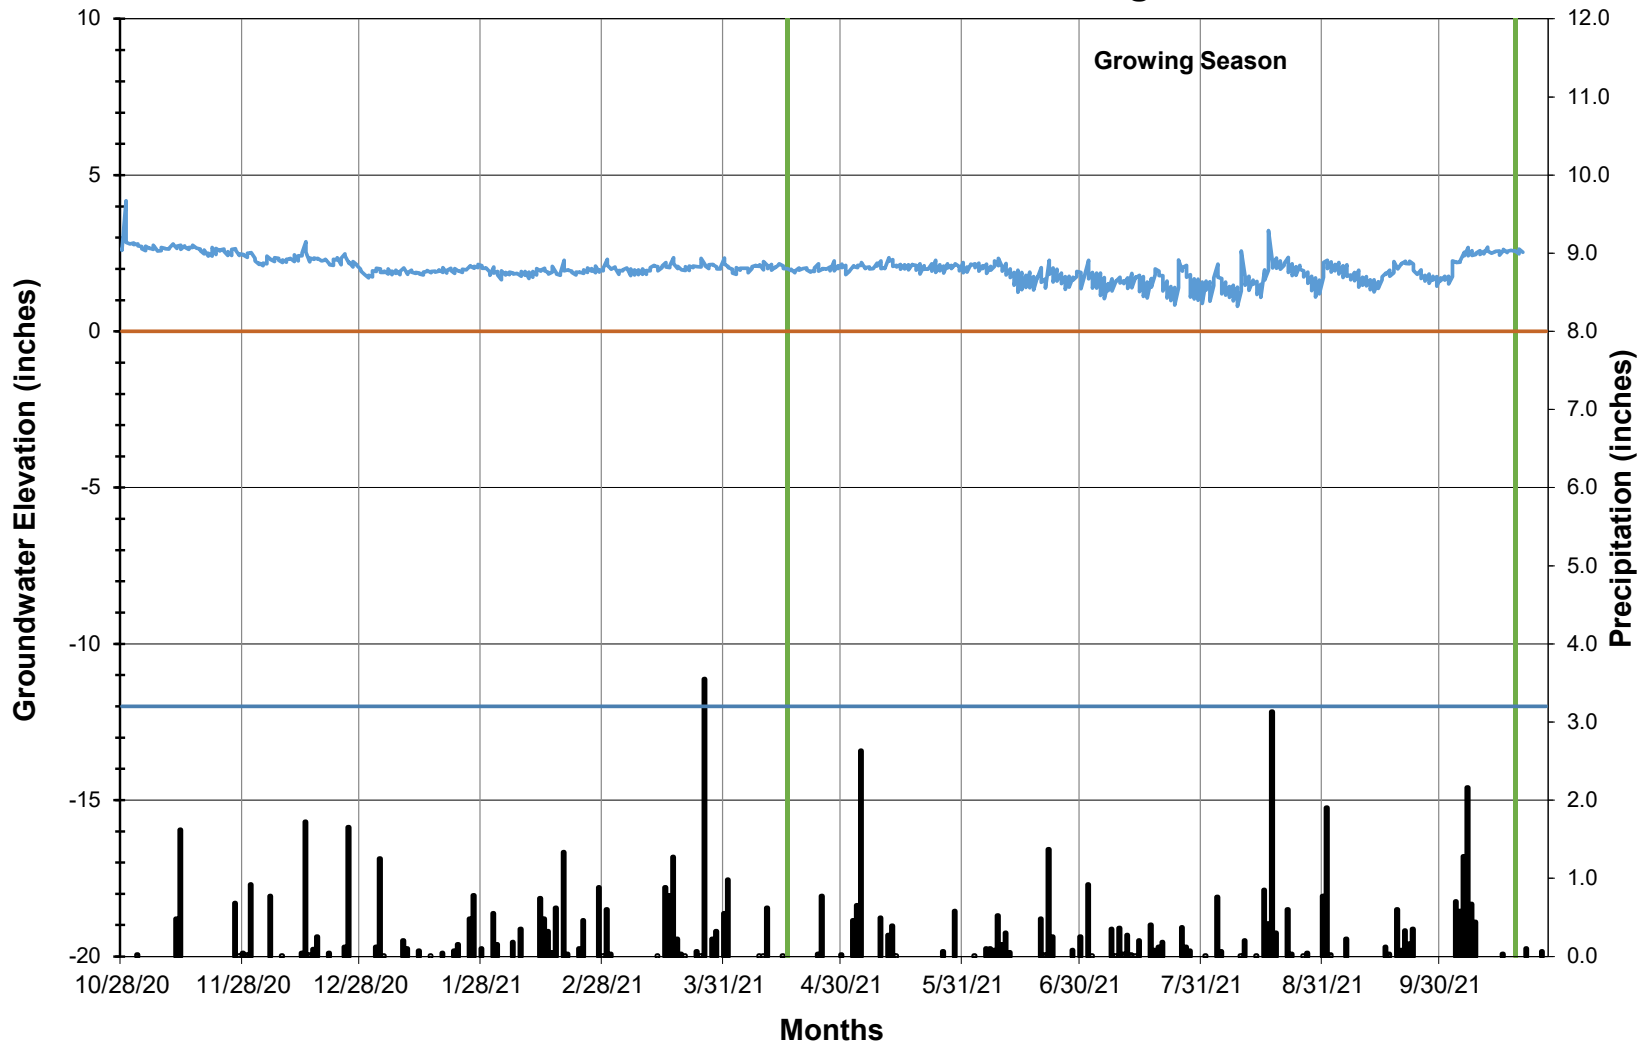
2021 Cochran Branch Groundwater Gauge AW4

Franklin Daily Rainfall CB AW4

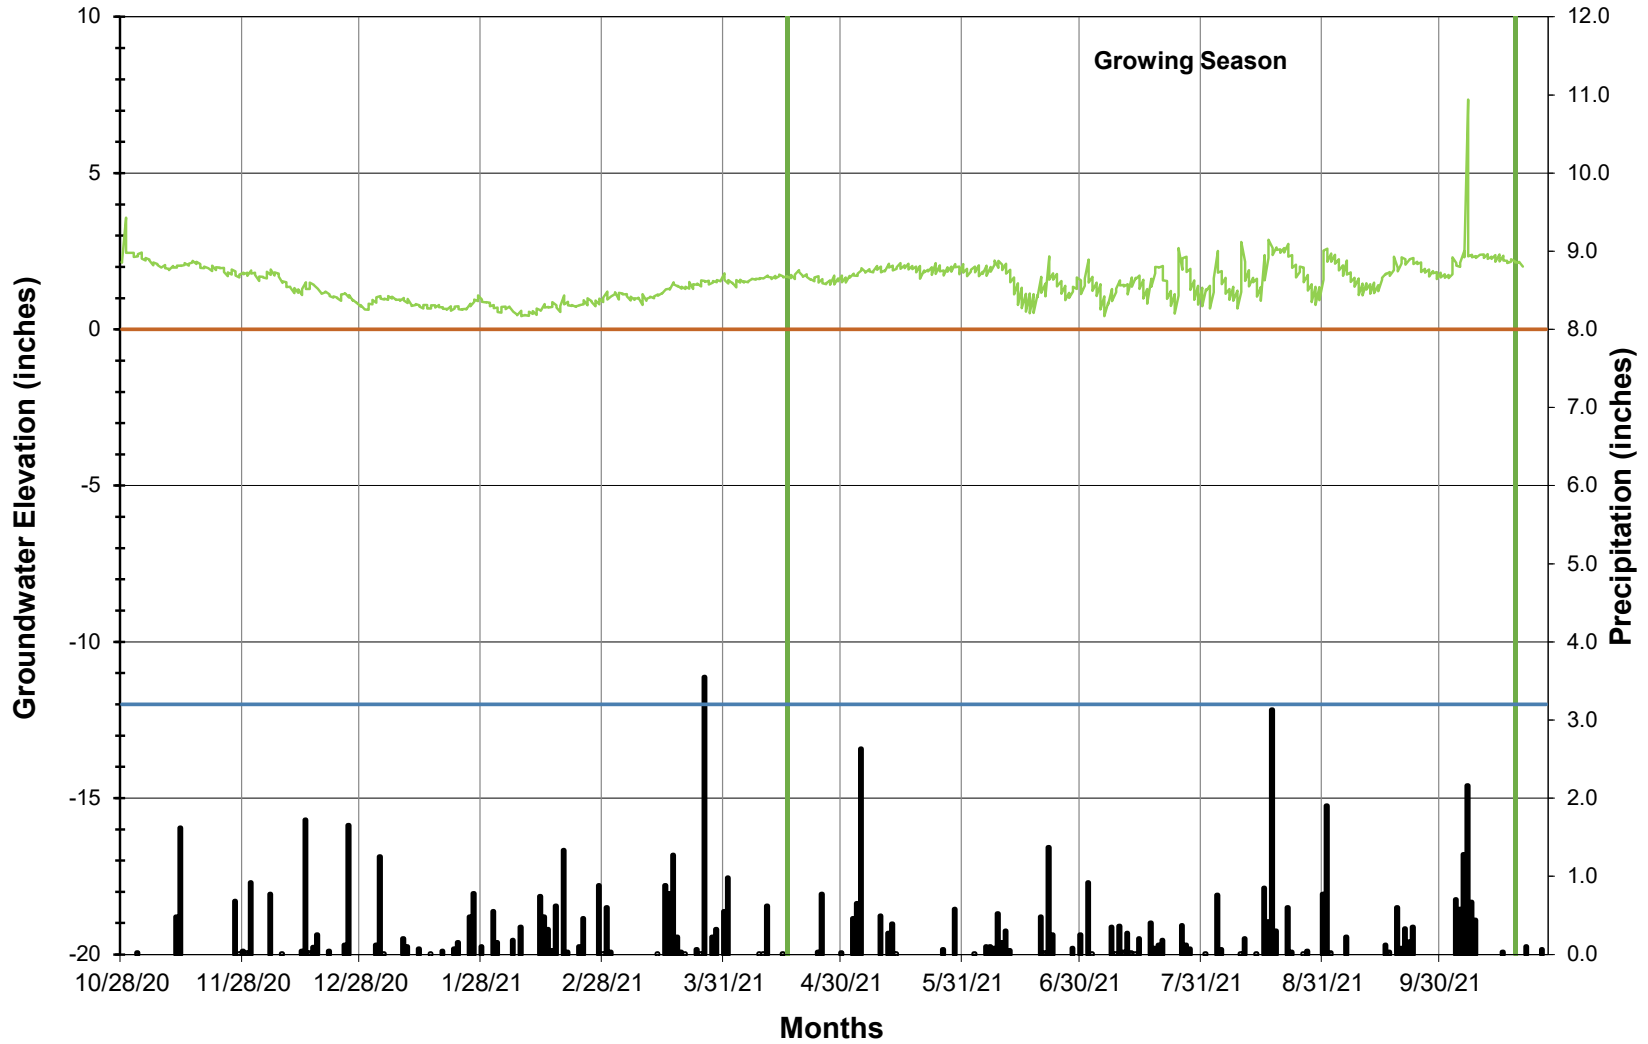
2021 Cochran Branch Groundwater Gauge AW7

Franklin Daily Rainfall CB AW7

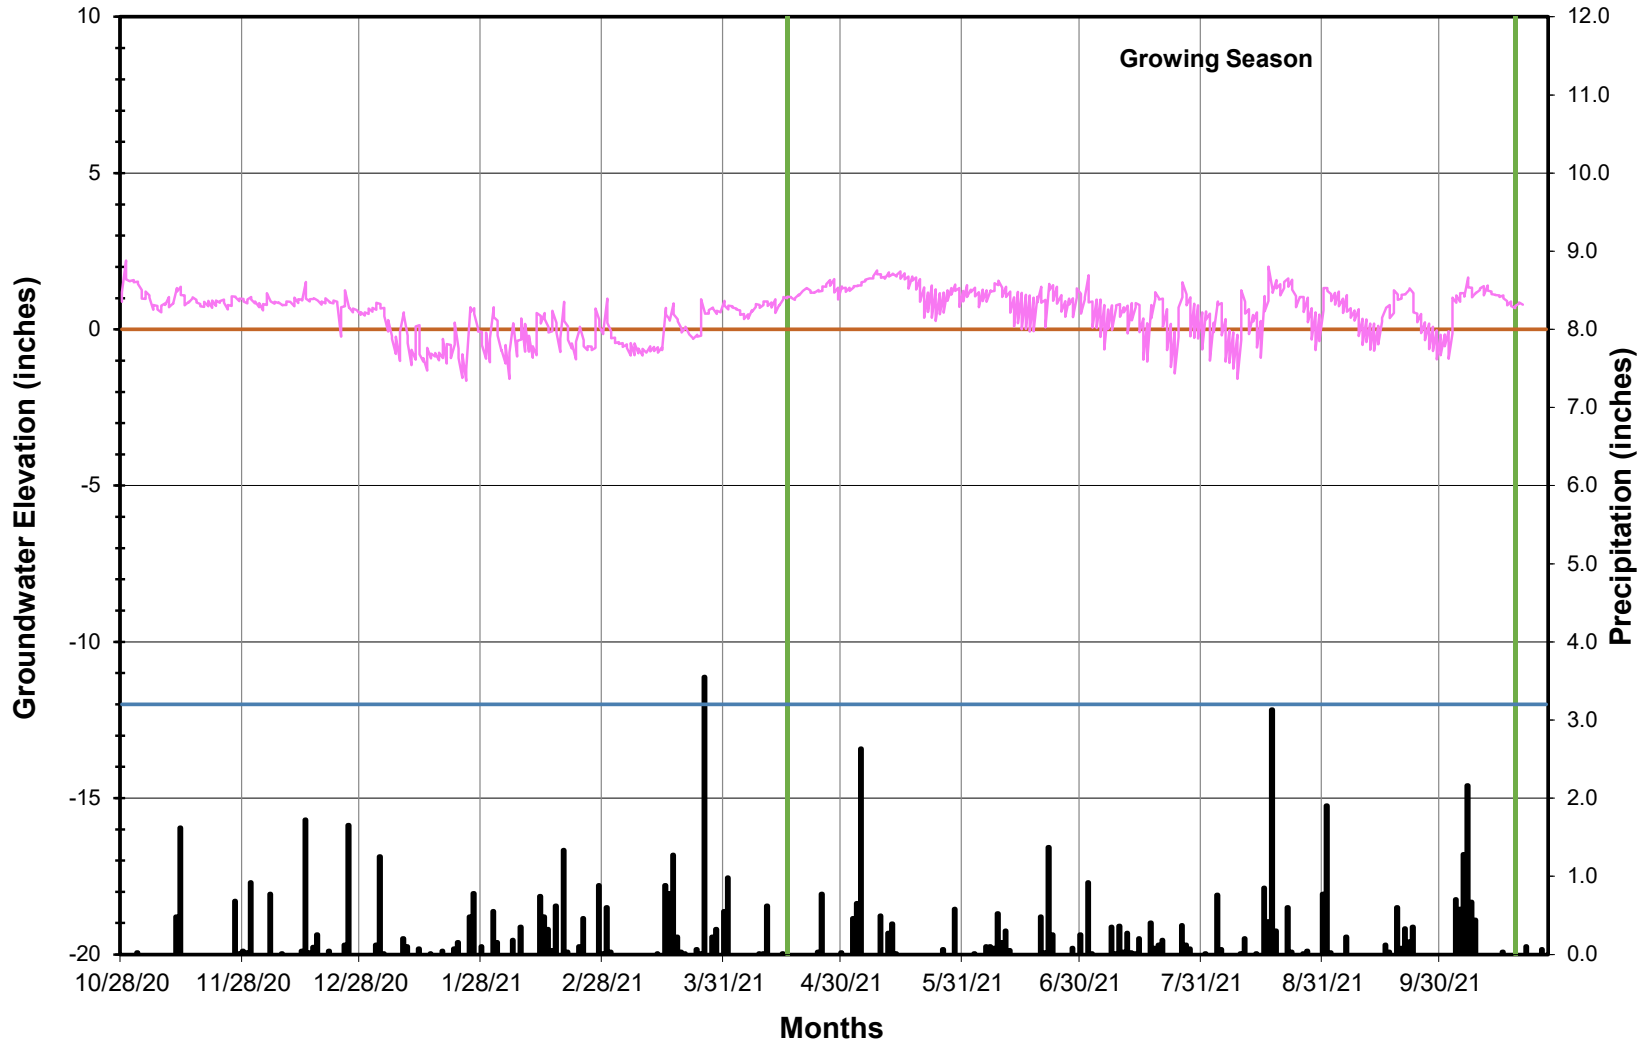
2021 Cochran Branch Groundwater Gauge AW8

Franklin Daily Rainfall CB AW8

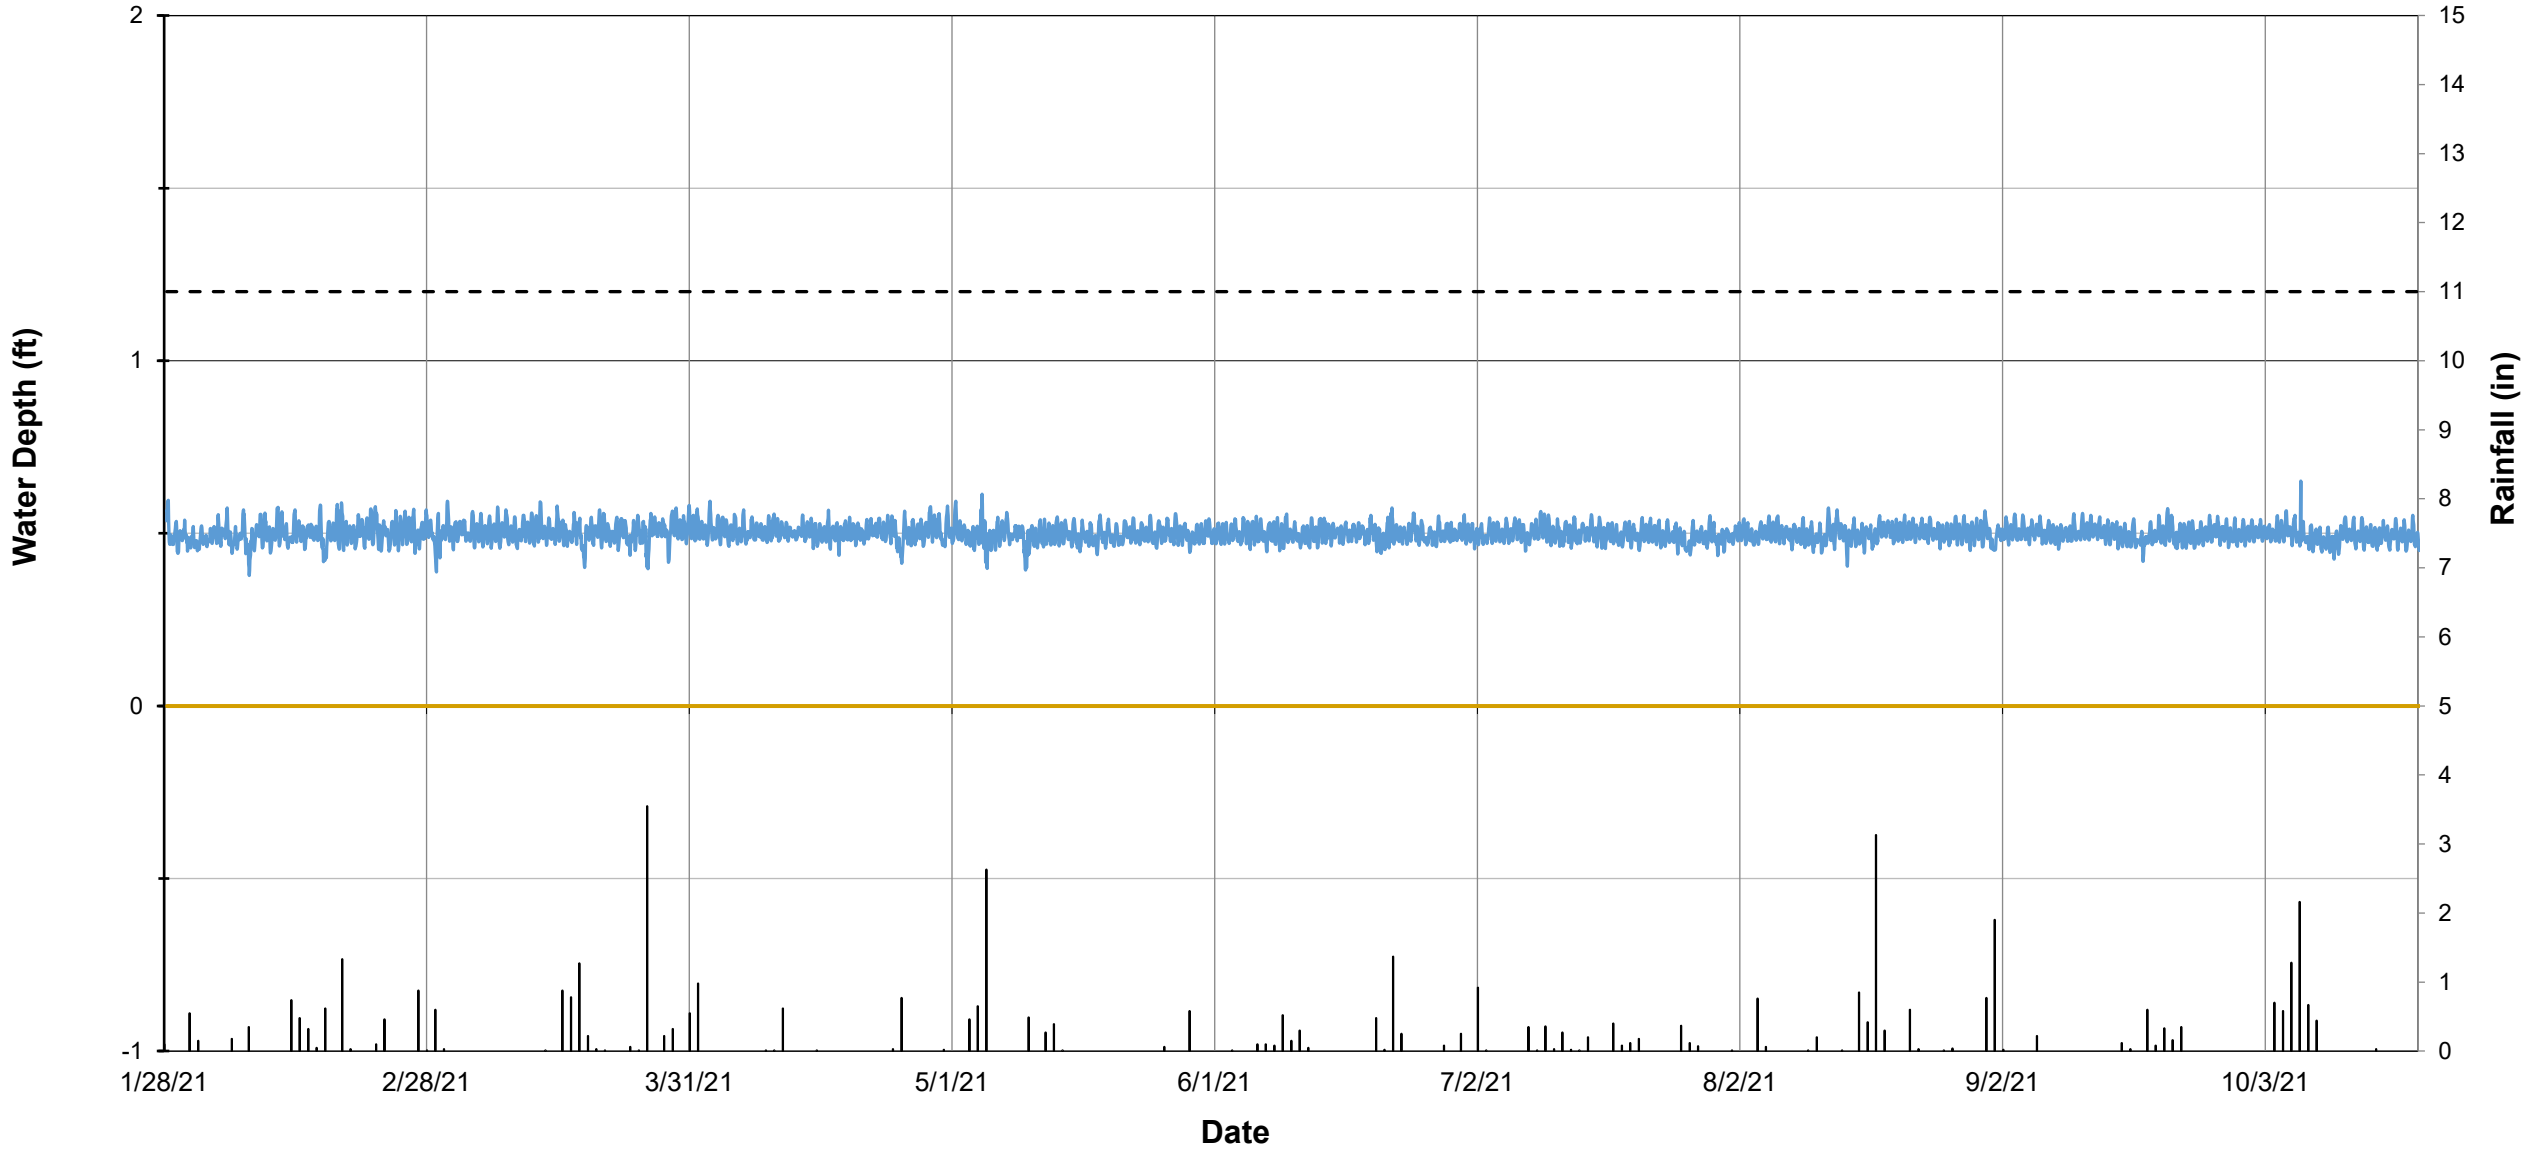
MY7 2021 Parrish Branch Stage Recorder

Legend: Rain (black bar), Parrish (blue line), Bed (yellow line), TOB (dashed black line)
