Baseline Monitoring Document and As-Built Baseline Report

Cochran Stream and Wetland Restoration Site

NCDMS Contract No. 004947

NCDMS Project No. 95720

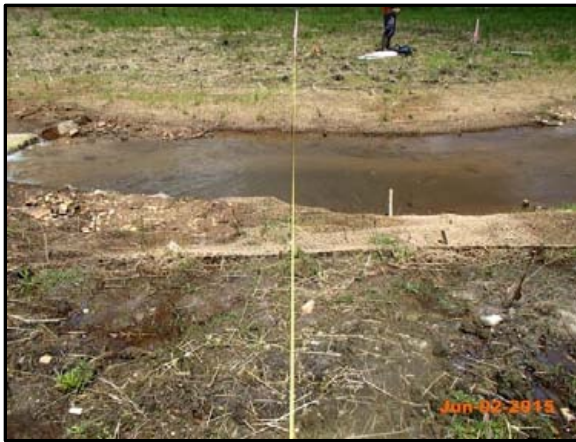
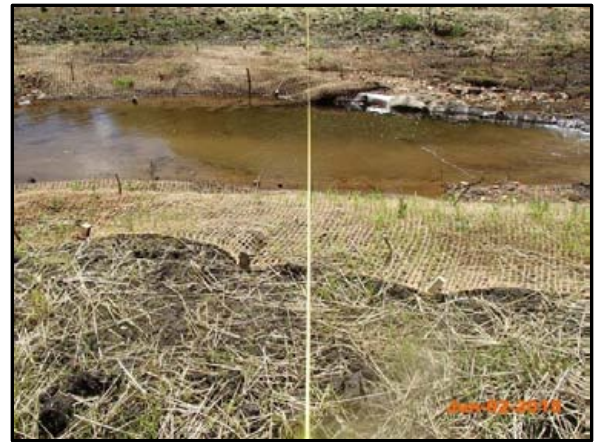
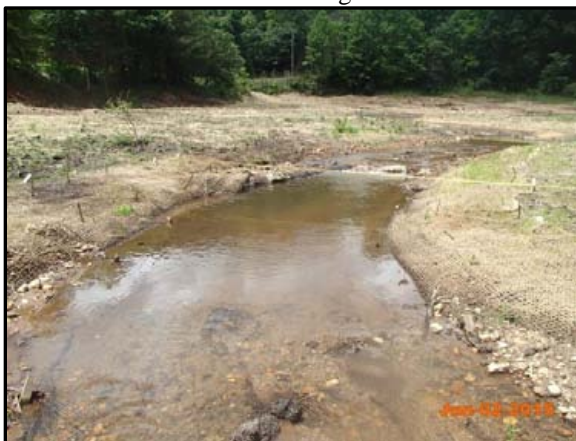
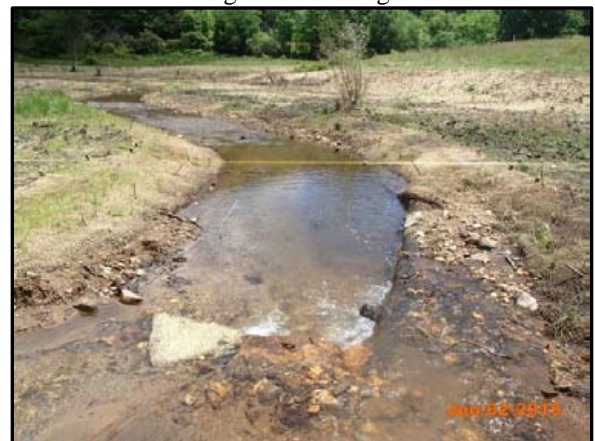
**Cochran Branch
Cross Section 1 - Pool
Station 104+73**

Left Descending Bank

Right Descending Bank

Upstream

Downstream

Permanent photo stations were established at each cross-section to digitally document annual conditions of the left and right banks. Each vegetation monitoring plot includes a photo station taken diagonally from the origin towards the opposite plot corner. Additionally, 16 permanent photo stations were established throughout the project area to provide representative digital documentation of stream features and vegetation conditions. Permanent photo stations were marked with labeled wooden stakes and red flagging tape.

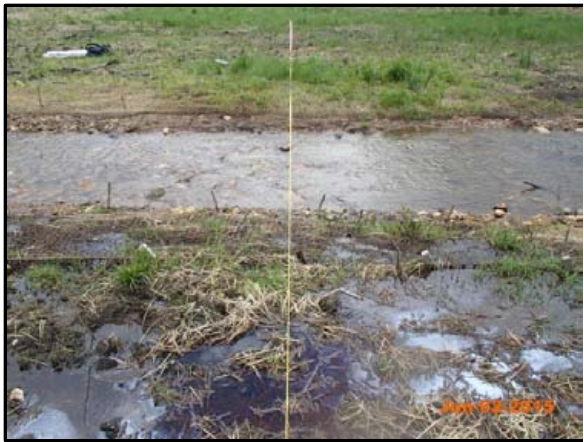
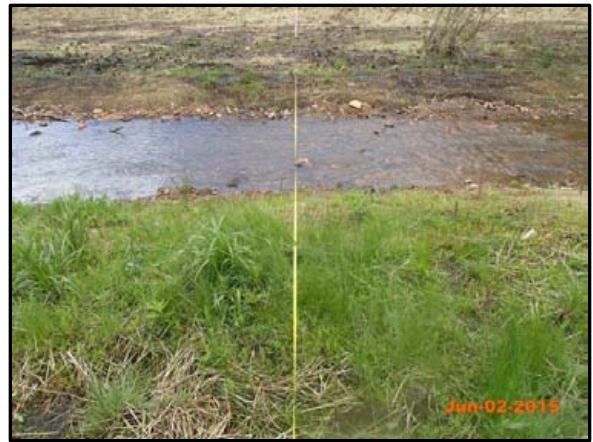
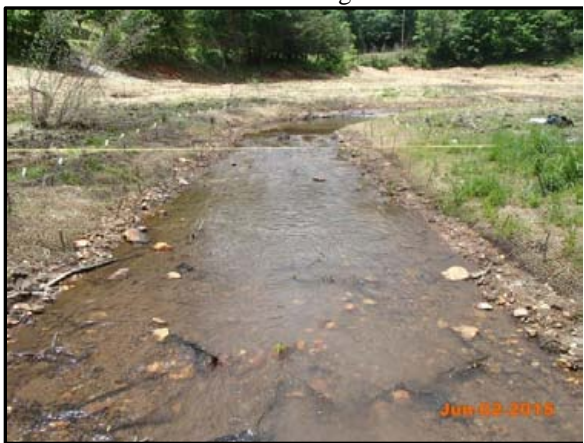
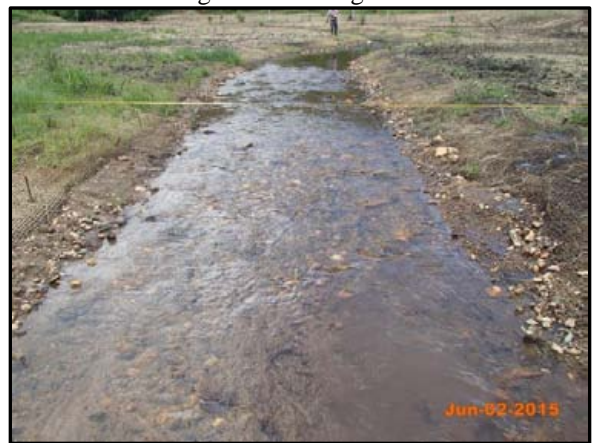
Cochran Branch
 Cross Section 2 - Riffle
 Station 105+08

Left Descending Bank

Right Descending Bank

Upstream

Downstream

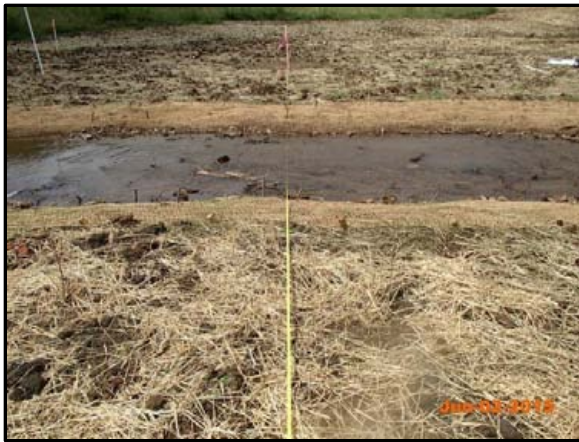
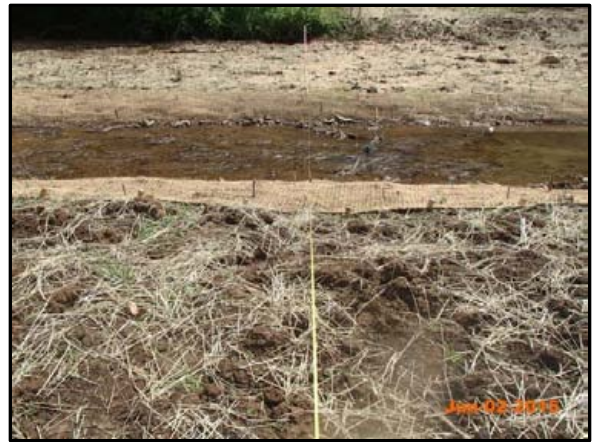
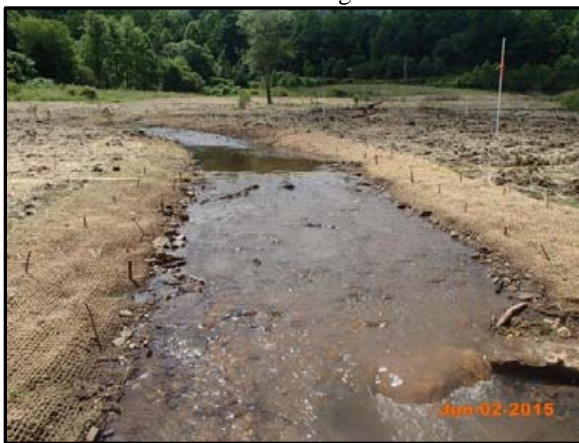
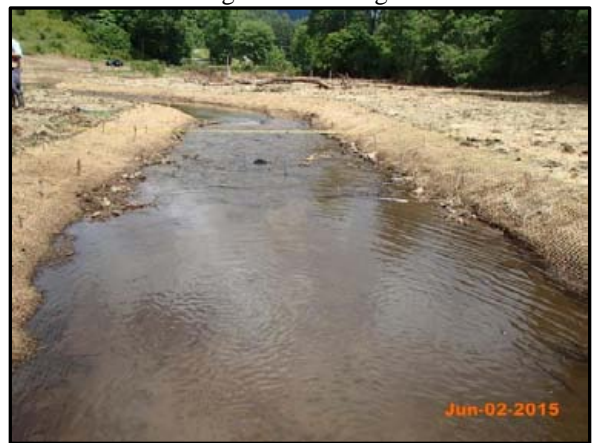
Cochran Branch
 Cross Section 3 - Riffle
 Station 110+60

Left Descending Bank

Right Descending Bank

Upstream

Downstream

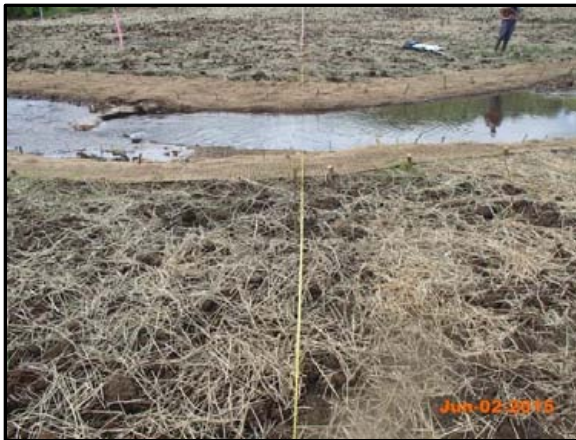
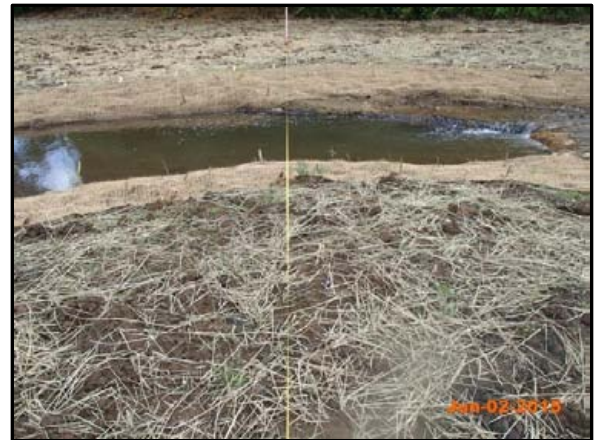
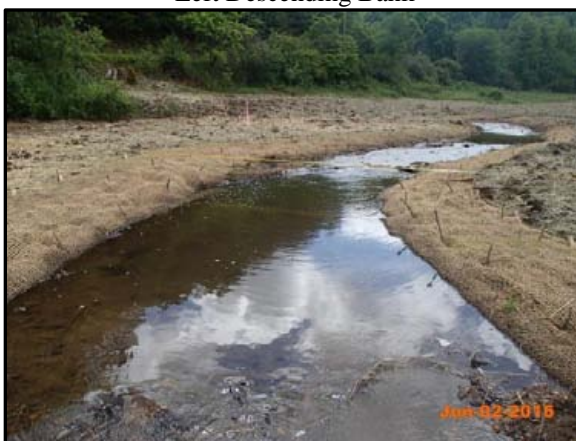
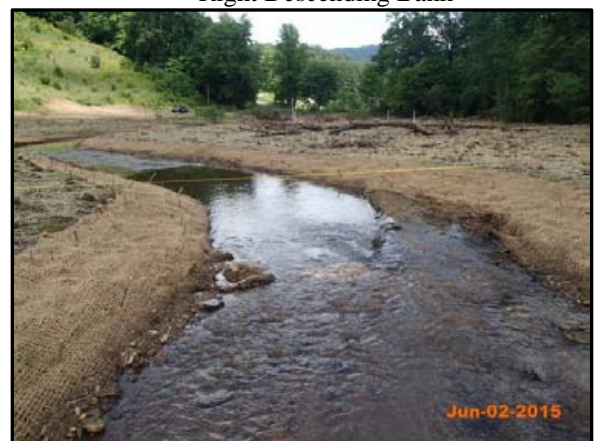
**Cochran Branch
Cross Section 4 - Pool
Station 110+90**

Left Descending Bank

Right Descending Bank

Upstream

Downstream

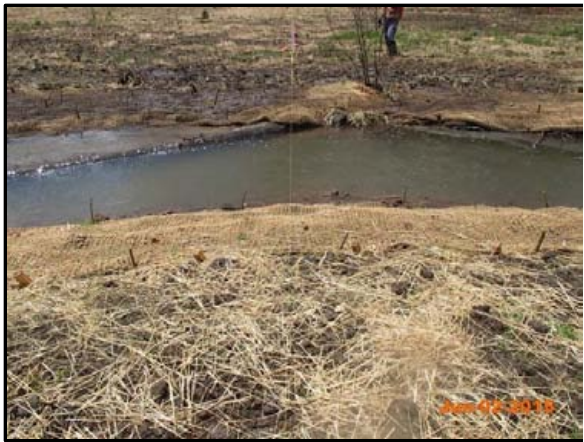
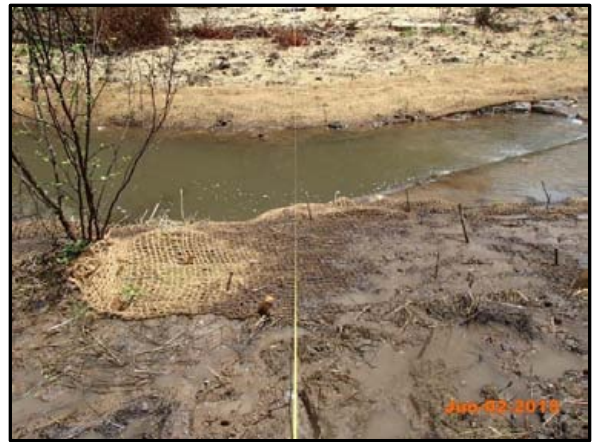
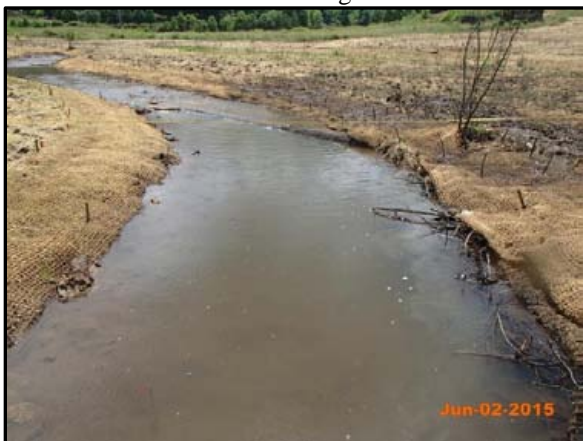
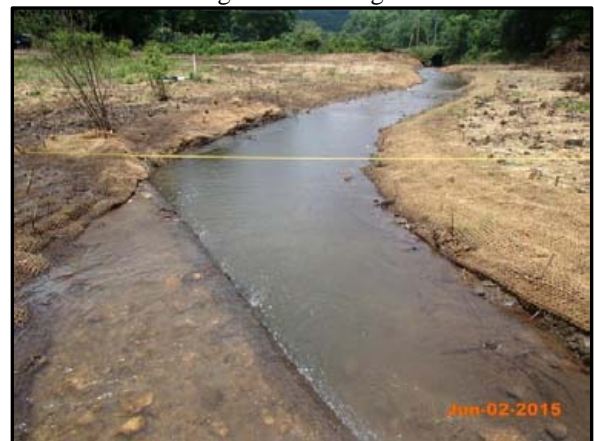
Cochran Branch
 Cross Section 5 - Pool
 Station 113+08

Left Descending Bank

Right Descending Bank

Upstream

Downstream

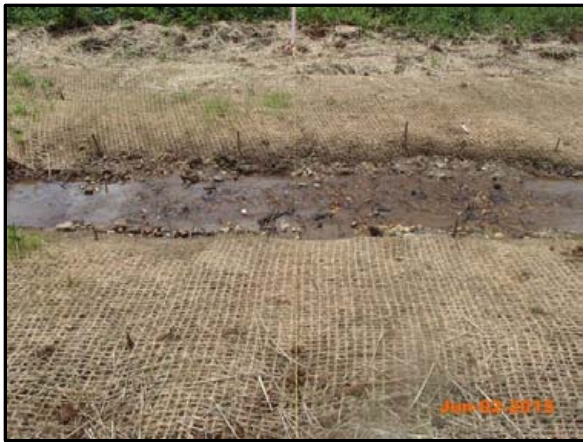
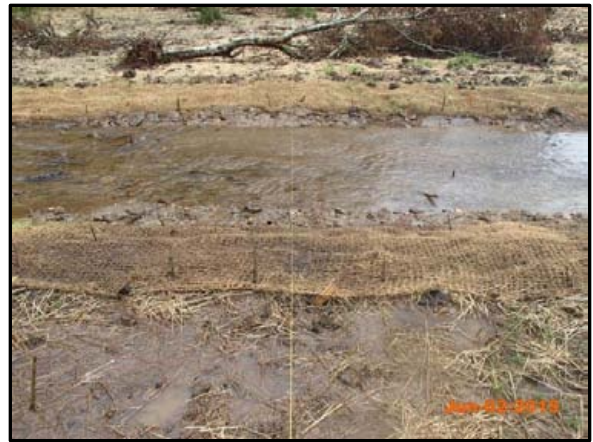
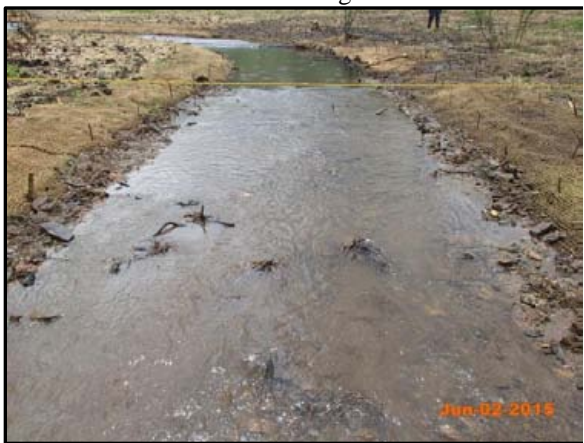
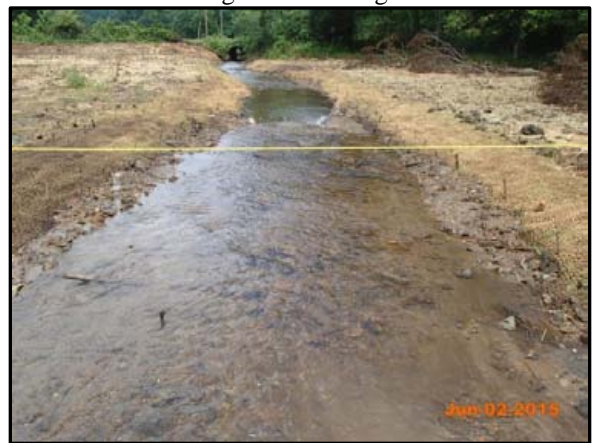
Cochran Branch
 Cross Section 6 - Riffle
 Station 113+44

Left Descending Bank

Right Descending Bank

Upstream

Downstream

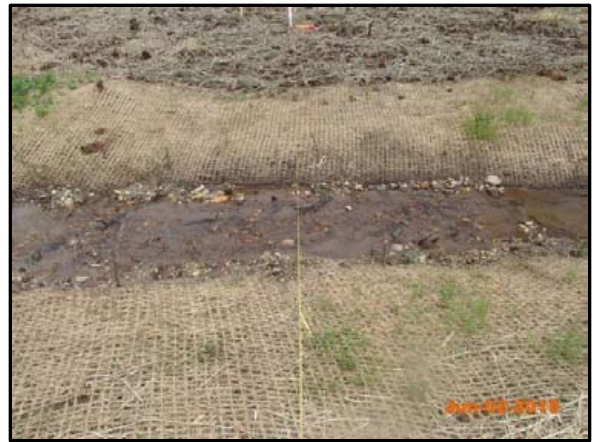
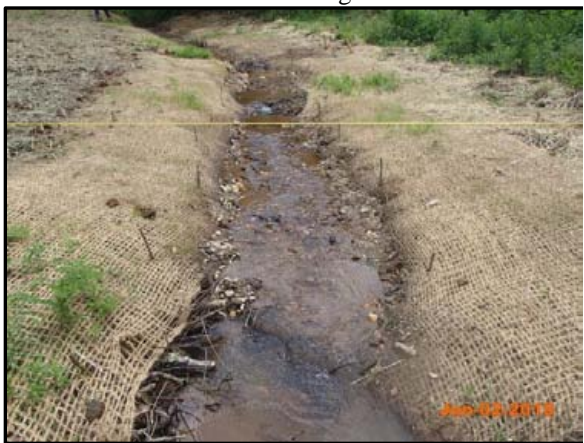
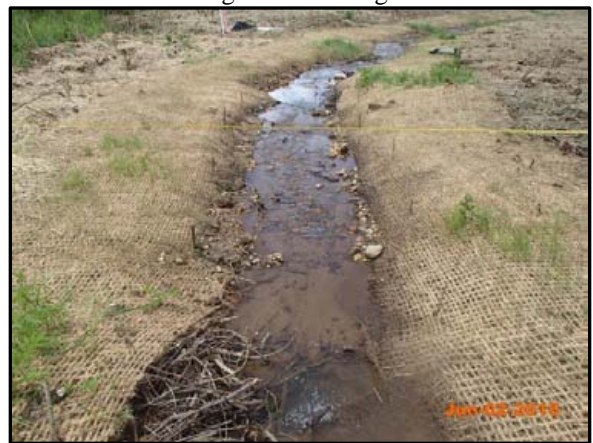
Parrish Branch
 Cross Section 7 - Riffle
 Station 200+88

Right Descending Bank

Upstream

Downstream

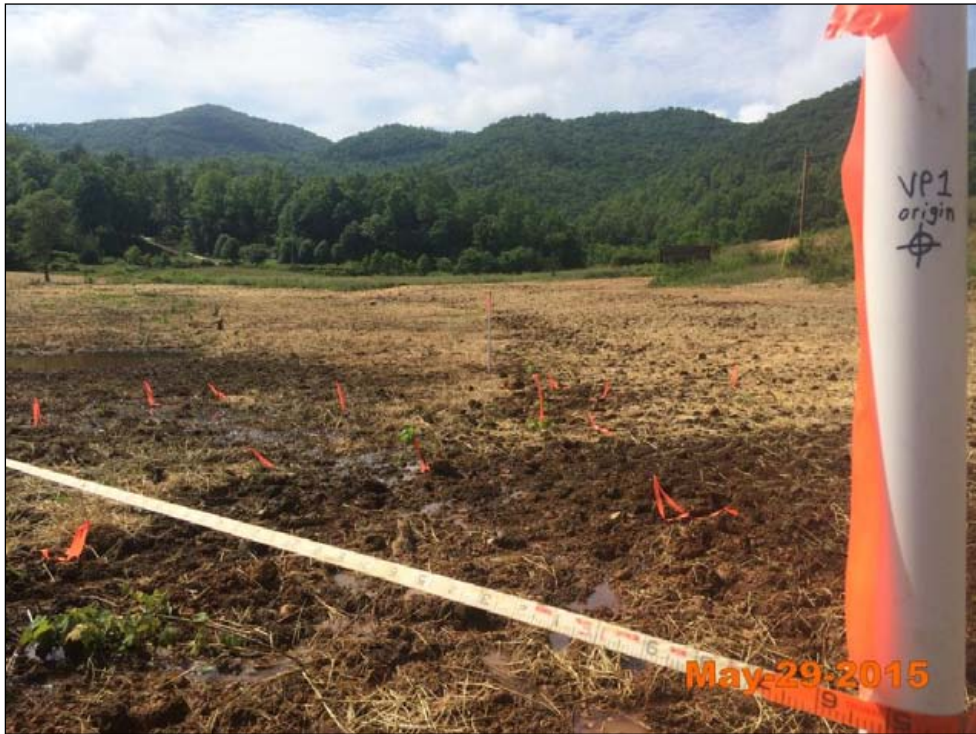
Vegetation Monitoring Plot 1

Eight vegetation monitoring plots, approximately 0.025 acres individually, were established based on guidance given in the *CVS-EEP Protocol for Recording Vegetation Version 4.2* (Lee et al. 2008). Data was collected using the Level I protocol during initial baseline monitoring to document baseline conditions immediately after construction and planting. Subsequent annual vegetation will use the Level II protocol. Annual monitoring will determine planted vegetative success and the overall trajectory of woody plant restoration and regeneration at the site. Vegetation monitoring plot corners were marked with t-posts and PVC conduit.

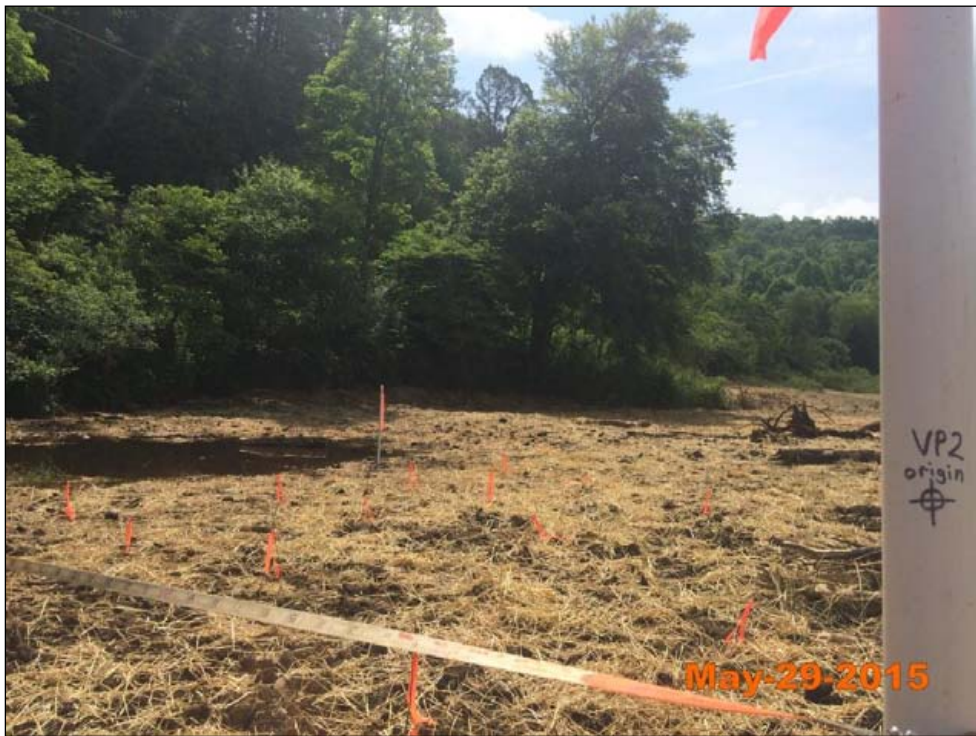
Vegetation Monitoring Plot 2

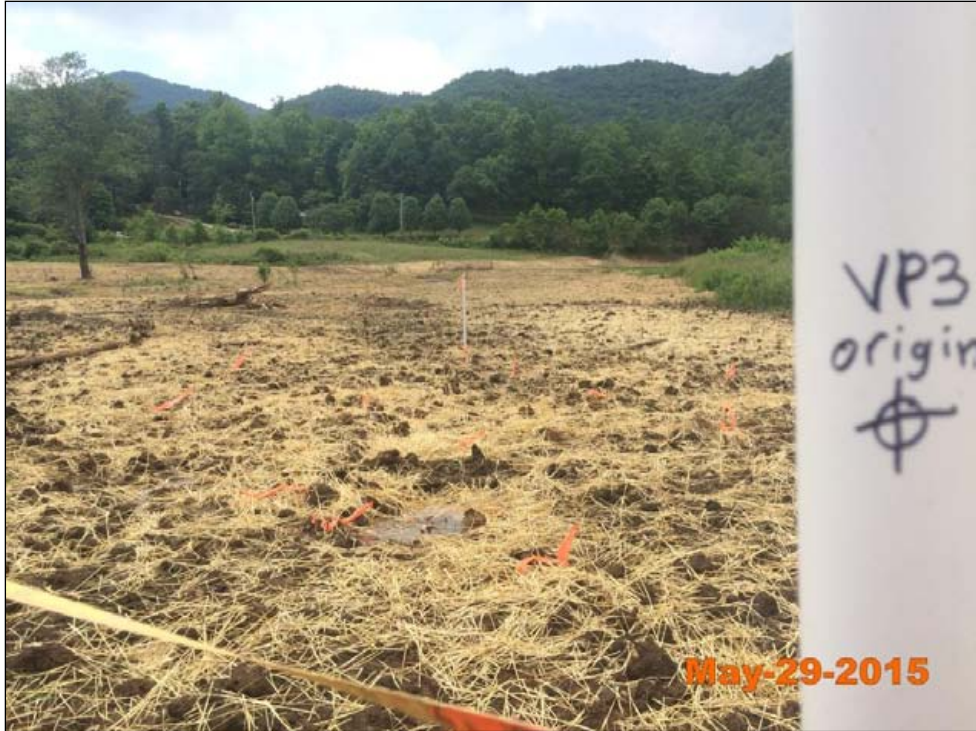
Vegetation Monitoring Plot 3

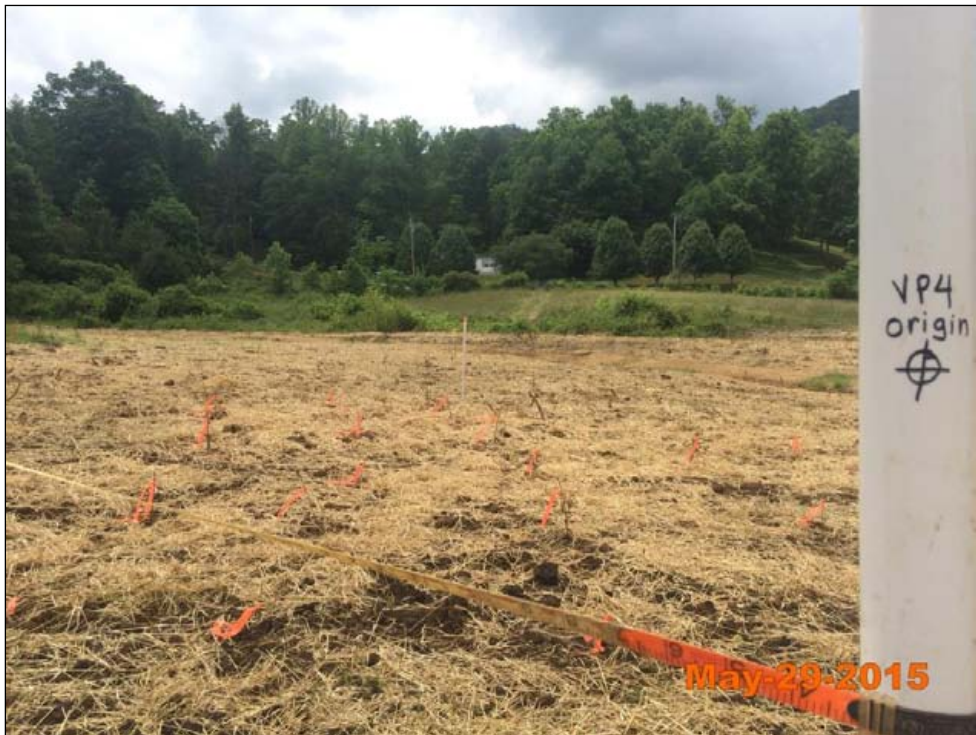
Vegetation Monitoring Plot 4

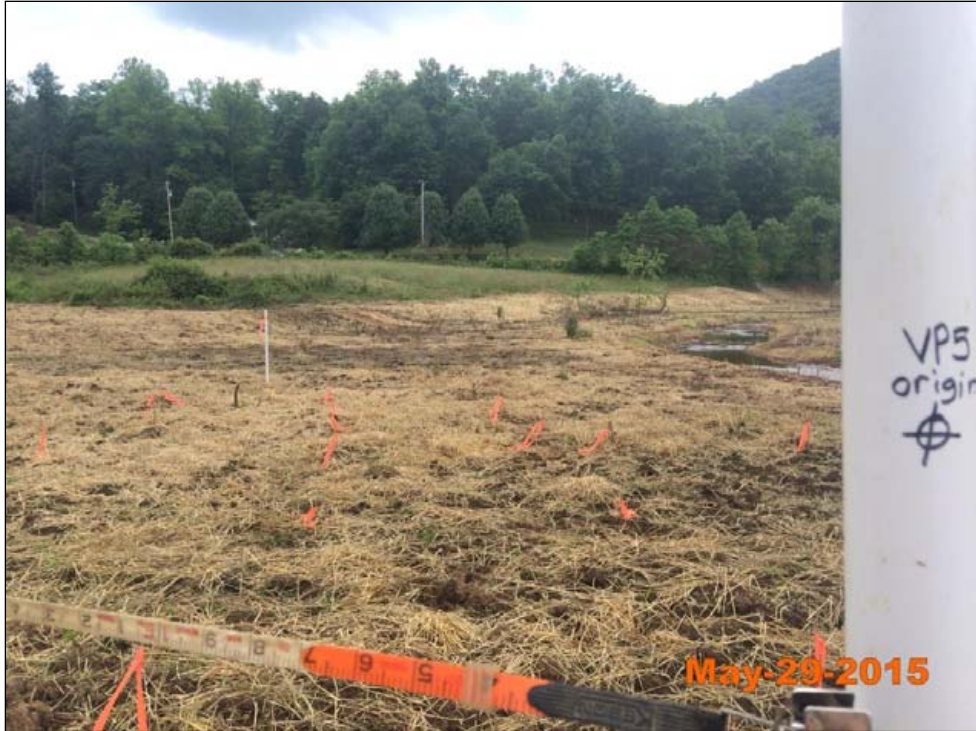
Vegetation Monitoring Plot 5

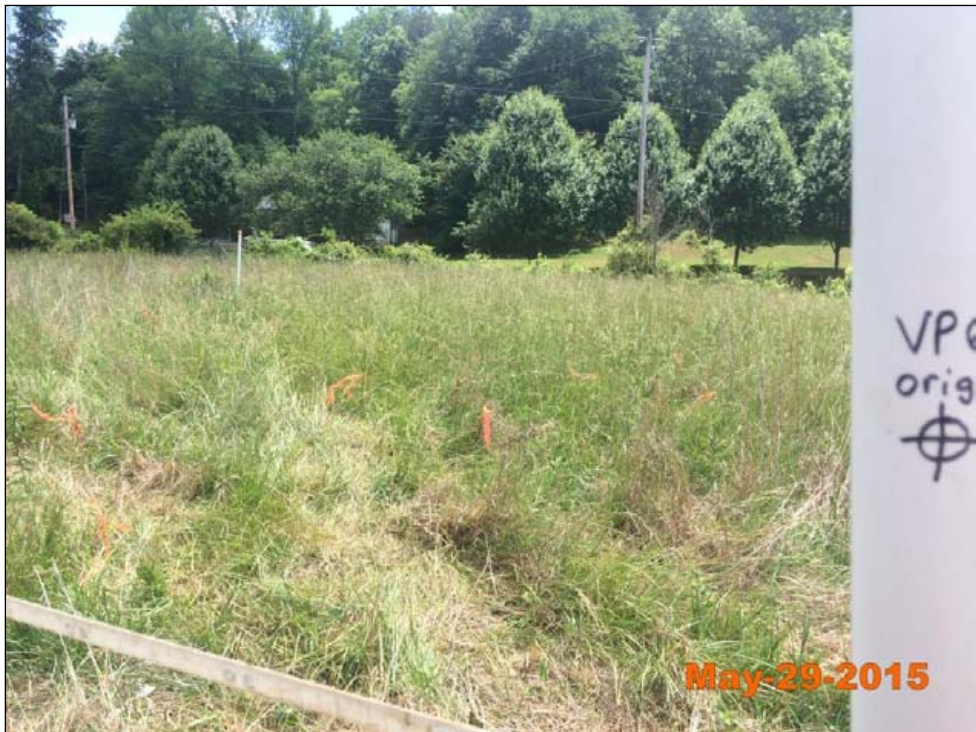
Vegetation Monitoring Plot 6

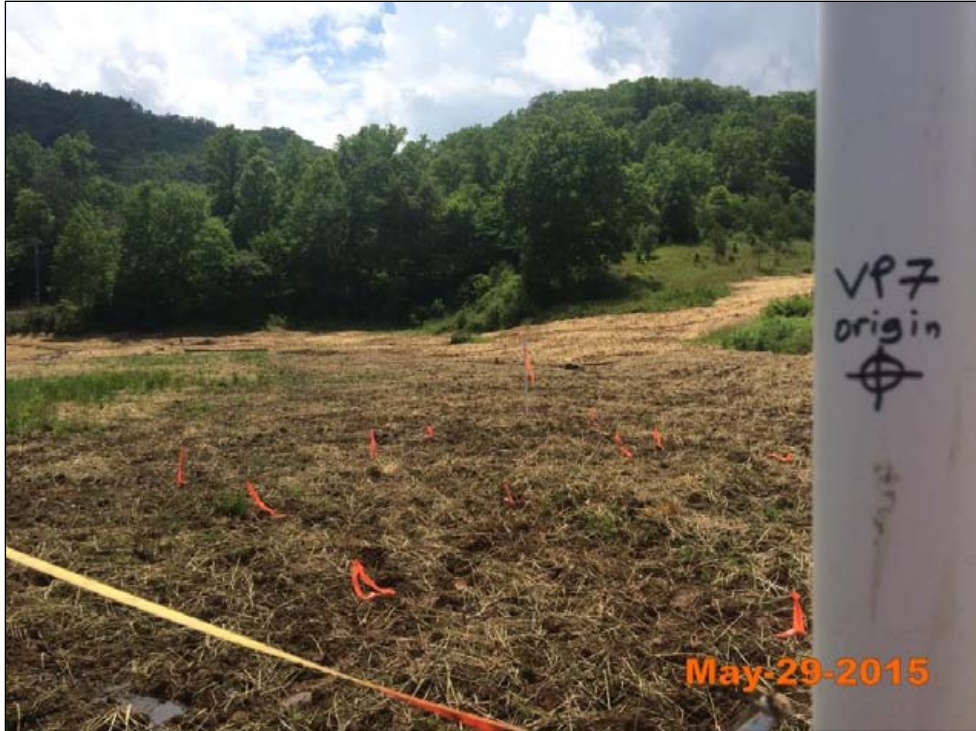
Vegetation Monitoring Plot 7

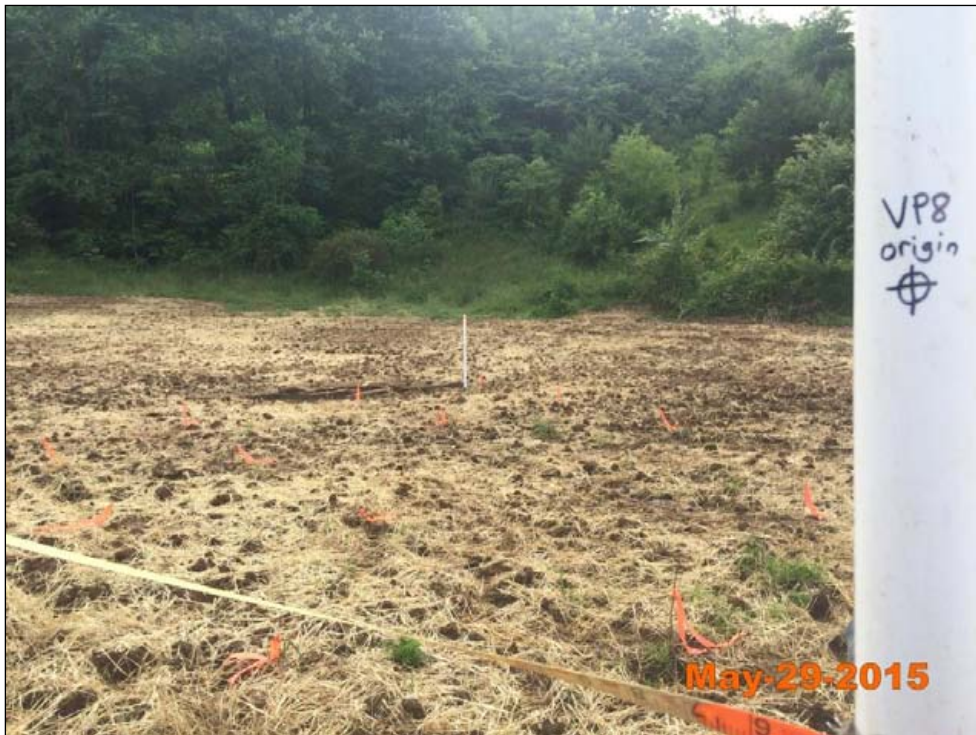
Vegetation Monitoring Plot 8
