# Collins Creek Stream Restoration Site

## Mitigation Plan

### Contract # D05011

October 2008

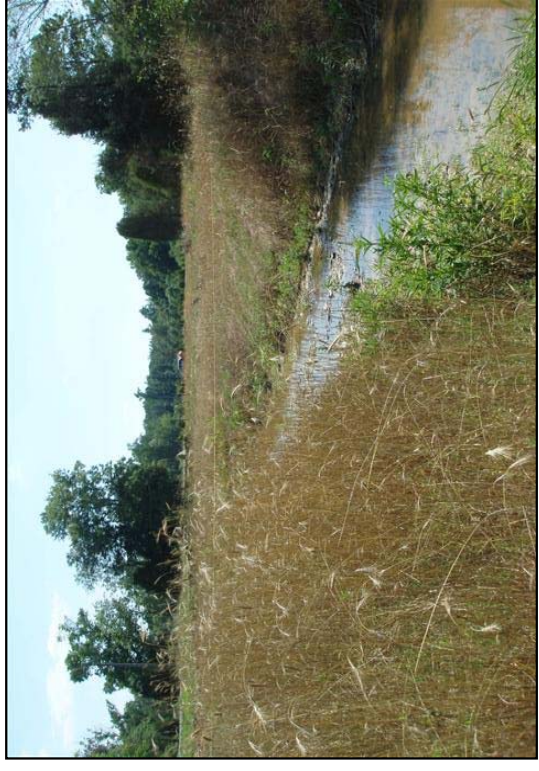
<b>River Basin:</b>	Cape Fear
<b>Watershed:</b>	Collins Creek, UTCC-1
<b>XS ID</b>	XS-1, Riffle
<b>Drainage Area (sq mi):</b>	2.51
<b>Date:</b>	7/2/2008
<b>Field Crew:</b>	B. Roberts and K. Vaughan

Stream Type C4

SUMMARY DATA	
Bankfull Elevation:	506.3
Bankfull Cross-Sectional Area:	42.4
Bankfull Width:	21.2
Flood Prone Area Elevation:	509.3
Flood Prone Width:	>65
Max Depth at Bankfull:	3.1
Mean Depth at Bankfull:	2.0
W / D Ratio:	10.6
Entrenchment Ratio:	>3
Bank Height Ratio:	1.0

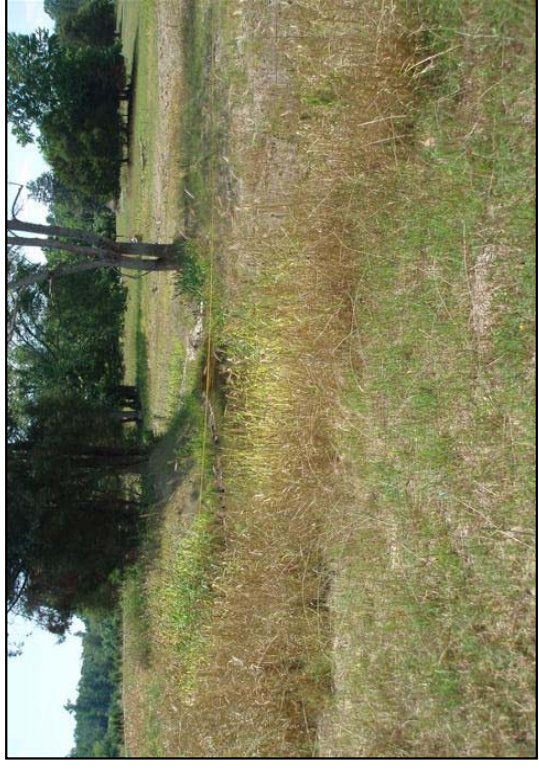
<b>River Basin:</b>	Cape Fear
<b>Watershed:</b>	Collins Creek, UTCC-1
<b>XS ID</b>	XS-2_Pool
<b>Drainage Area (sq mi):</b>	2.51
<b>Date:</b>	7/2/2008
<b>Field Crew:</b>	B. Roberts and K. Vaughan

Stream Type C4

SUMMARY DATA	
<b>Bankfull Elevation:</b>	505.5
<b>Bankfull Cross-Sectional Area:</b>	86.7
<b>Bankfull Width:</b>	35.9
<b>Flood Prone Area Elevation:</b>	-
<b>Flood Prone Width:</b>	-
<b>Max Depth at Bankfull:</b>	4.3
<b>Mean Depth at Bankfull:</b>	2.4
<b>W / D Ratio:</b>	-
<b>Entrenchment Ratio:</b>	-
<b>Bank Height Ratio:</b>	-

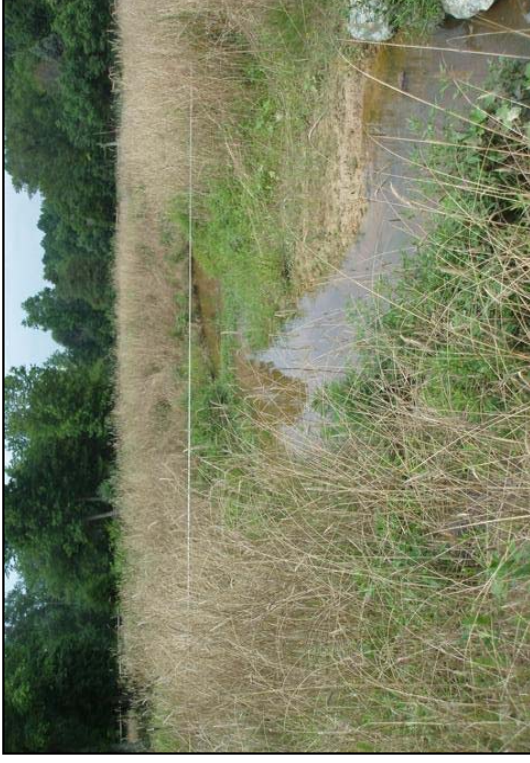
<b>River Basin:</b>	Cape Fear
<b>Watershed:</b>	Collins Creek, UTCC-3
<b>XS ID</b>	XS-3_Pool
<b>Drainage Area (sq mi):</b>	2.62
<b>Date:</b>	7/11/2008
<b>Field Crew:</b>	B. Roberts and K. Vaughan

Stream Type C4

SUMMARY DATA	
Bankfull Elevation:	503.6
Bankfull Cross-Sectional Area:	49.1
Bankfull Width:	25.3
Flood Prone Area Elevation:	-
Flood Prone Width:	-
Max Depth at Bankfull:	3.6
Mean Depth at Bankfull:	1.9
W / D Ratio:	-
Entrenchment Ratio:	-
Bank Height Ratio:	-

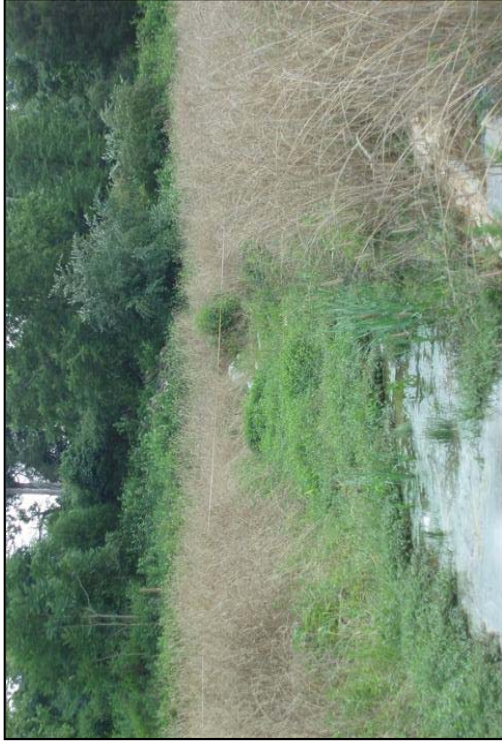
<b>River Basin:</b>	Cape Fear
<b>Watershed:</b>	Collins Creek, UTCC-3
<b>XS ID</b>	XS-4, Riffle
<b>Drainage Area (sq mi):</b>	2.62
<b>Date:</b>	7/11/2008
<b>Field Crew:</b>	B. Roberts and K. Vaughan

Stream Type: C4

SUMMARY DATA	
<b>Bankfull Elevation:</b>	503.6
<b>Bankfull Cross-Sectional Area:</b>	48.0
<b>Bankfull Width:</b>	25.5
<b>Flood Prone Area Elevation:</b>	506.3
<b>Flood Prone Width:</b>	>76
<b>Max Depth at Bankfull:</b>	2.8
<b>Mean Depth at Bankfull:</b>	1.9
<b>W / D Ratio:</b>	13.5
<b>Entrenchment Ratio:</b>	>3
<b>Bank Height Ratio:</b>	1.0

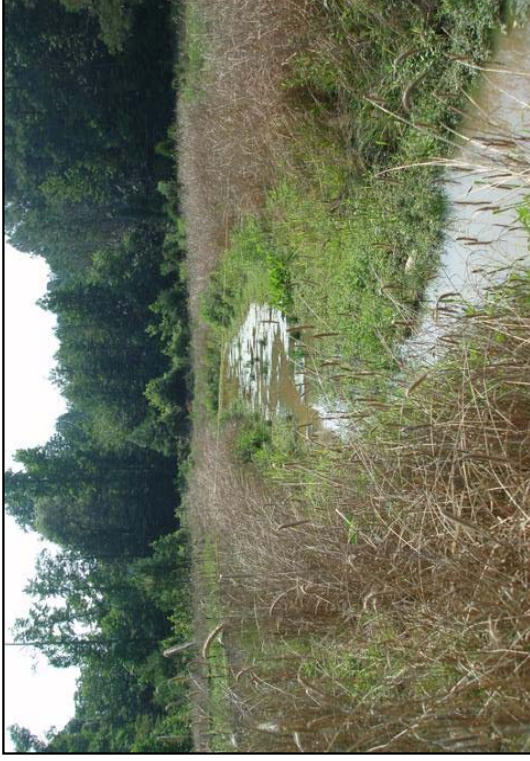
<b>River Basin:</b>	Cape Fear
<b>Watershed:</b>	Collins Creek, UTCC-3
<b>XS ID</b>	XS-5, Riffle
<b>Drainage Area (sq mi):</b>	2.62
<b>Date:</b>	7/11/2008
<b>Field Crew:</b>	B. Roberts and K. Vaughan

Stream Type C4

SUMMARY DATA	
Bankfull Elevation:	503.2
Bankfull Cross-Sectional Area:	55.5
Bankfull Width:	27.0
Flood Prone Area Elevation:	506.5
Flood Prone Width:	>74
Max Depth at Bankfull:	3.3
Mean Depth at Bankfull:	2.1
W / D Ratio:	13.1
Entrenchment Ratio:	>3
Bank Height Ratio:	1.0

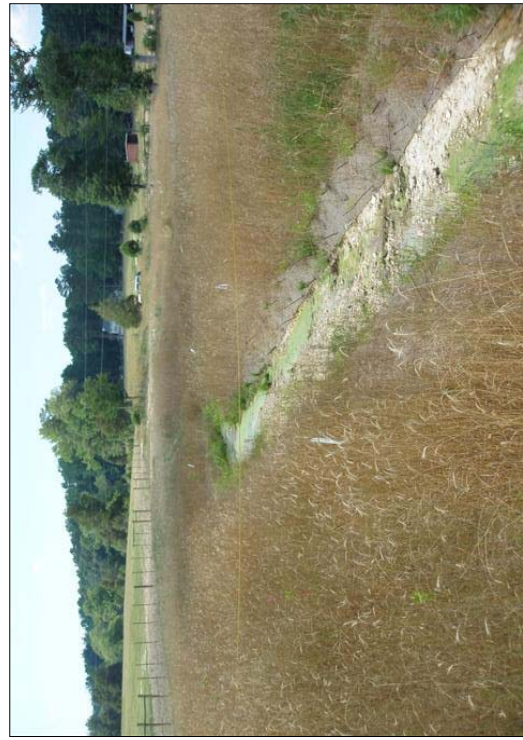
<b>River Basin:</b>	Cape Fear
<b>Watershed:</b>	Collins Creek, T1-2
<b>XS ID</b>	XS-7, Riffle
<b>Drainage Area (sq mi):</b>	0.18
<b>Date:</b>	7/11/2008
<b>Field Crew:</b>	B. Roberts and K. Vaughan

Stream Type C4

SUMMARY DATA	
<b>Bankfull Elevation:</b>	520.2
<b>Bankfull Cross-Sectional Area:</b>	11.5
<b>Bankfull Width:</b>	11.7
<b>Flood Prone Area Elevation:</b>	521.7
<b>Flood Prone Width:</b>	42
<b>Max Depth at Bankfull:</b>	1.5
<b>Mean Depth at Bankfull:</b>	1.0
<b>W / D Ratio:</b>	11.9
<b>Entrenchment Ratio:</b>	3.6
<b>Bank Height Ratio:</b>	1.0

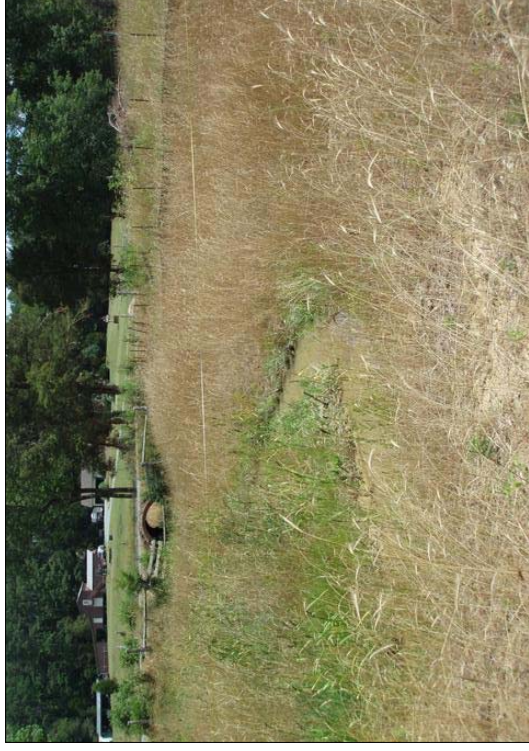
<b>River Basin:</b>	Cape Fear
<b>Watershed:</b>	Collins Creek, T1-2
<b>XS ID</b>	XS-8_Pool
<b>Drainage Area (sq mi):</b>	0.18
<b>Date:</b>	6/30/2008
<b>Field Crew:</b>	B. Roberts and K. Vaughan

Stream Type C4

SUMMARY DATA	
Bankfull Elevation:	518.2
Bankfull Cross-Sectional Area:	10.9
Bankfull Width:	13.1
Flood Prone Area Elevation:	-
Flood Prone Width:	-
Max Depth at Bankfull:	1.8
Mean Depth at Bankfull:	0.8
W / D Ratio:	-
Entrenchment Ratio:	-
Bank Height Ratio:	-

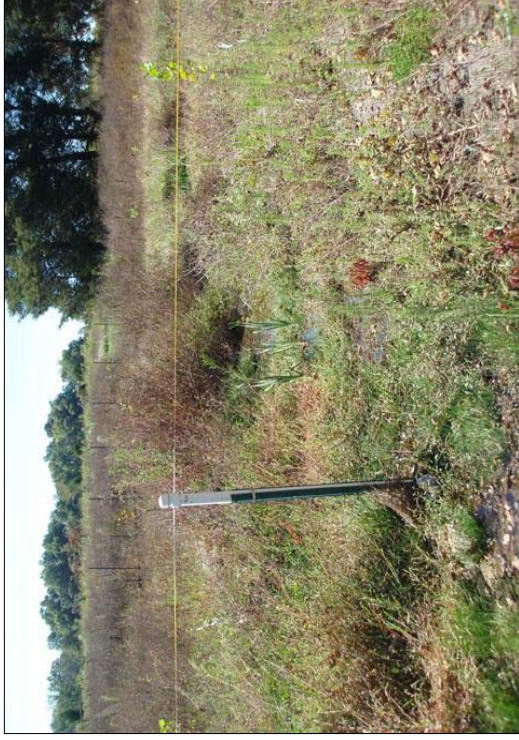
<b>River Basin:</b>	Cape Fear
<b>Watershed:</b>	Collins Creek, T1-3
<b>XS ID</b>	XS-9_Riffle
<b>Drainage Area (sq mi):</b>	0.49
<b>Date:</b>	7/1/2008
<b>Field Crew:</b>	B. Roberts and K. Vaughan

Stream Type C4

SUMMARY DATA	
Bankfull Elevation:	513.7
Bankfull Cross-Sectional Area:	20.0
Bankfull Width:	20.8
Flood Prone Area Elevation:	515.6
Flood Prone Width:	>65
Max Depth at Bankfull:	1.9
Mean Depth at Bankfull:	1.0
W / D Ratio:	21.6
Entrenchment Ratio:	>3
Bank Height Ratio:	1.0

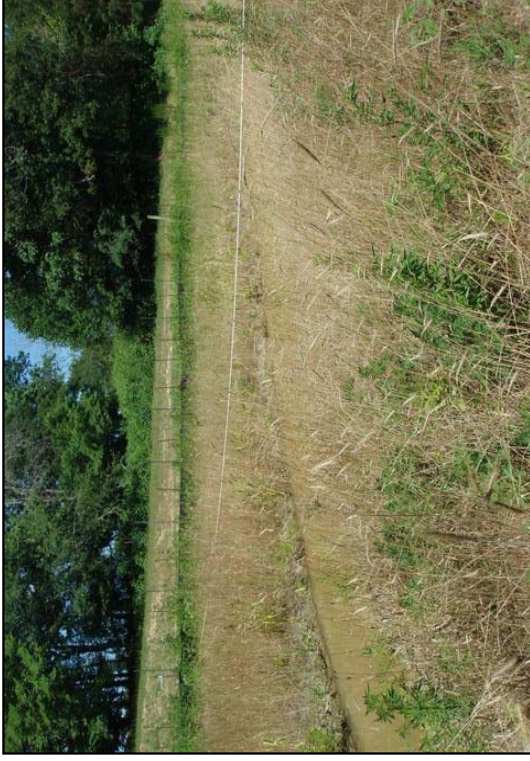
<b>River Basin:</b>	Cape Fear
<b>Watershed:</b>	Collins Creek, T1-3
<b>XS ID</b>	XS-10, Pool
<b>Drainage Area (sq mi):</b>	0.49
<b>Date:</b>	7/1/2008
<b>Field Crew:</b>	B. Roberts and K. Vaughan

Stream Type C4

SUMMARY DATA	
Bankfull Elevation:	511.8
Bankfull Cross-Sectional Area:	31.4
Bankfull Width:	22.3
Flood Prone Area Elevation:	-
Flood Prone Width:	-
Max Depth at Bankfull:	2.9
Mean Depth at Bankfull:	1.4
W / D Ratio:	-
Entrenchment Ratio:	-
Bank Height Ratio:	-

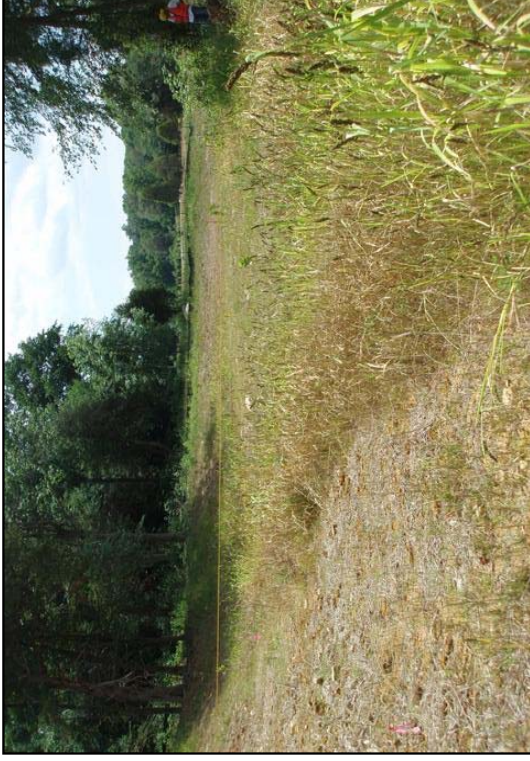
<b>River Basin:</b>	Cape Fear
<b>Watershed:</b>	Collins Creek, T1-3
<b>XS ID</b>	XS-11, Riffle
<b>Drainage Area (sq mi):</b>	0.49
<b>Date:</b>	7/11/2008
<b>Field Crew:</b>	B. Roberts and K. Vaughan

Stream Type C4

SUMMARY DATA	
Bankfull Elevation:	506.1
Bankfull Cross-Sectional Area:	14.3
Bankfull Width:	14.8
Flood Prone Area Elevation:	507.5
Flood Prone Width:	49
Max Depth at Bankfull:	1.4
Mean Depth at Bankfull:	1.0
W / D Ratio:	15.3
Entrenchment Ratio:	3.3
Bank Height Ratio:	1.0

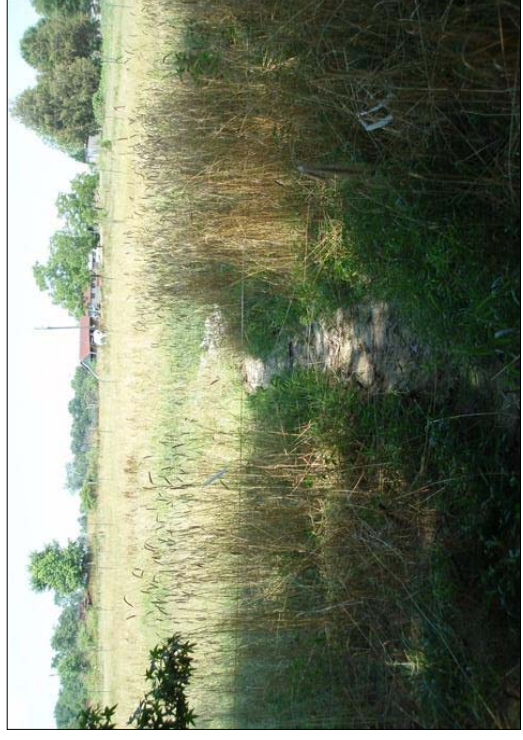
<b>River Basin:</b>	Cape Fear
<b>Watershed:</b>	Collins Creek, T1A-1
<b>XS ID</b>	XS-12, Riffle
<b>Drainage Area (sq mi):</b>	0.04
<b>Date:</b>	6/26/2008
<b>Field Crew:</b>	B. Roberts and K. Vaughan

Stream Type C4

SUMMARY DATA	
Bankfull Elevation:	535.4
Bankfull Cross-Sectional Area:	2.5
Bankfull Width:	7.9
Flood Prone Area Elevation:	536.0
Flood Prone Width:	>40
Max Depth at Bankfull:	0.6
Mean Depth at Bankfull:	0.3
W / D Ratio:	25.0
Entrenchment Ratio:	>5
Bank Height Ratio:	1.0

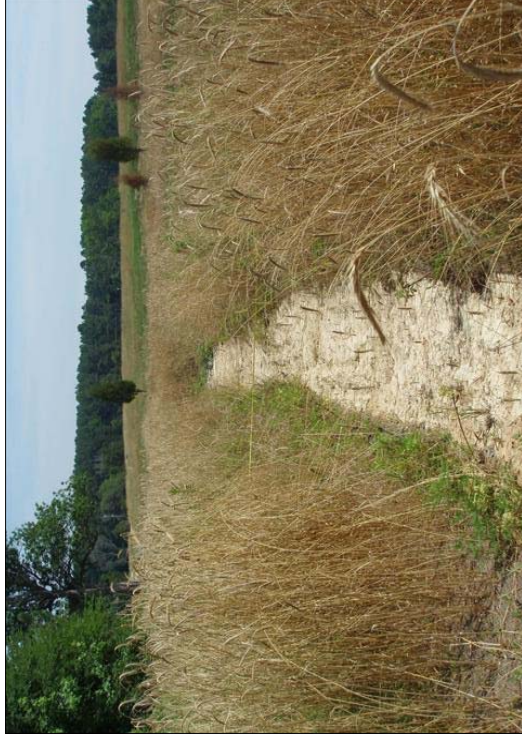
<b>River Basin:</b>	Cape Fear
<b>Watershed:</b>	Collins Creek, T1A-2
<b>XS ID</b>	XS-13, Riffle
<b>Drainage Area (sq mi):</b>	0.05
<b>Date:</b>	6/26/2008
<b>Field Crew:</b>	B. Roberts and K. Vaughan

Stream Type C4

SUMMARY DATA	
<b>Bankfull Elevation:</b>	527.7
<b>Bankfull Cross-Sectional Area:</b>	5.2
<b>Bankfull Width:</b>	9.7
<b>Flood Prone Area Elevation:</b>	528.7
<b>Flood Prone Width:</b>	>40
<b>Max Depth at Bankfull:</b>	1.0
<b>Mean Depth at Bankfull:</b>	0.5
<b>W / D Ratio:</b>	18.1
<b>Entrenchment Ratio:</b>	>4
<b>Bank Height Ratio:</b>	1.0

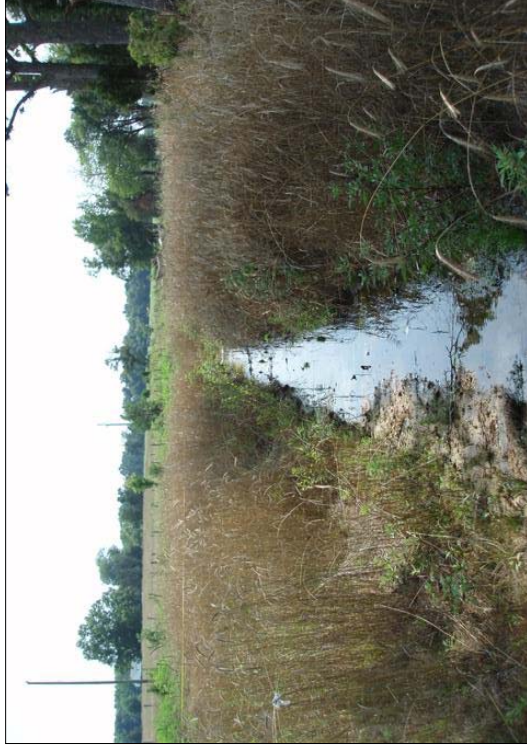
<b>River Basin:</b>	Cape Fear
<b>Watershed:</b>	Collins Creek, T1B
<b>XS ID</b>	XS-14, Riffle
<b>Drainage Area (sq mi):</b>	0.24
<b>Date:</b>	6/30/2008
<b>Field Crew:</b>	B. Roberts and K. Vaughan

Stream Type C4

SUMMARY DATA	
Bankfull Elevation:	522.6
Bankfull Cross-Sectional Area:	8.4
Bankfull Width:	11.1
Flood Prone Area Elevation:	524.0
Flood Prone Width:	43
Max Depth at Bankfull:	1.4
Mean Depth at Bankfull:	0.8
W / D Ratio:	14.7
Entrenchment Ratio:	3.8
Bank Height Ratio:	1.0

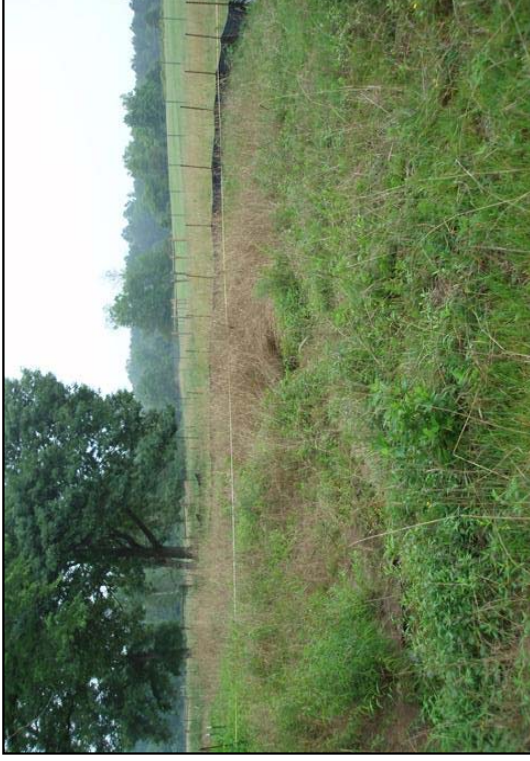
<b>River Basin:</b>	Cape Fear
<b>Watershed:</b>	Collins Creek, T2
<b>XS ID</b>	XS-15_Pool
<b>Drainage Area (sq mi):</b>	0.07
<b>Date:</b>	7/11/2008
<b>Field Crew:</b>	B. Roberts and K. Vaughan

Stream Type B4c

SUMMARY DATA	
Bankfull Elevation:	515.0
Bankfull Cross-Sectional Area:	9.8
Bankfull Width:	10.4
Flood Prone Area Elevation:	-
Flood Prone Width:	-
Max Depth at Bankfull:	1.9
Mean Depth at Bankfull:	0.9
W / D Ratio:	-
Entrenchment Ratio:	-
Bank Height Ratio:	-

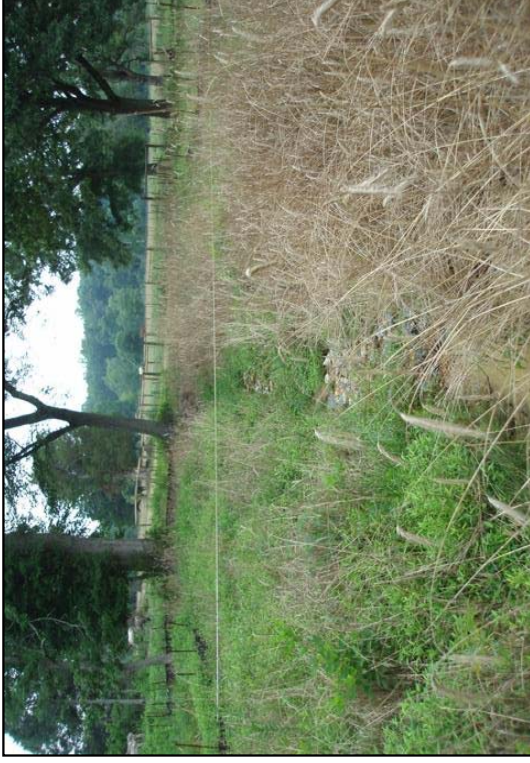
<b>River Basin:</b>	Cape Fear
<b>Watershed:</b>	Collins Creek, T2
<b>XS ID</b>	XS-16, Riffle
<b>Drainage Area (sq mi):</b>	0.07
<b>Date:</b>	7/11/2008
<b>Field Crew:</b>	B. Roberts and K. Vaughan

Stream Type B4c

SUMMARY DATA	
<b>Bankfull Elevation:</b>	514.3
<b>Bankfull Cross-Sectional Area:</b>	5.2
<b>Bankfull Width:</b>	7.4
<b>Flood Prone Area Elevation:</b>	515.5
<b>Flood Prone Width:</b>	14
<b>Max Depth at Bankfull:</b>	1.2
<b>Mean Depth at Bankfull:</b>	0.7
<b>W / D Ratio:</b>	10.5
<b>Entrenchment Ratio:</b>	1.8
<b>Bank Height Ratio:</b>	1.0

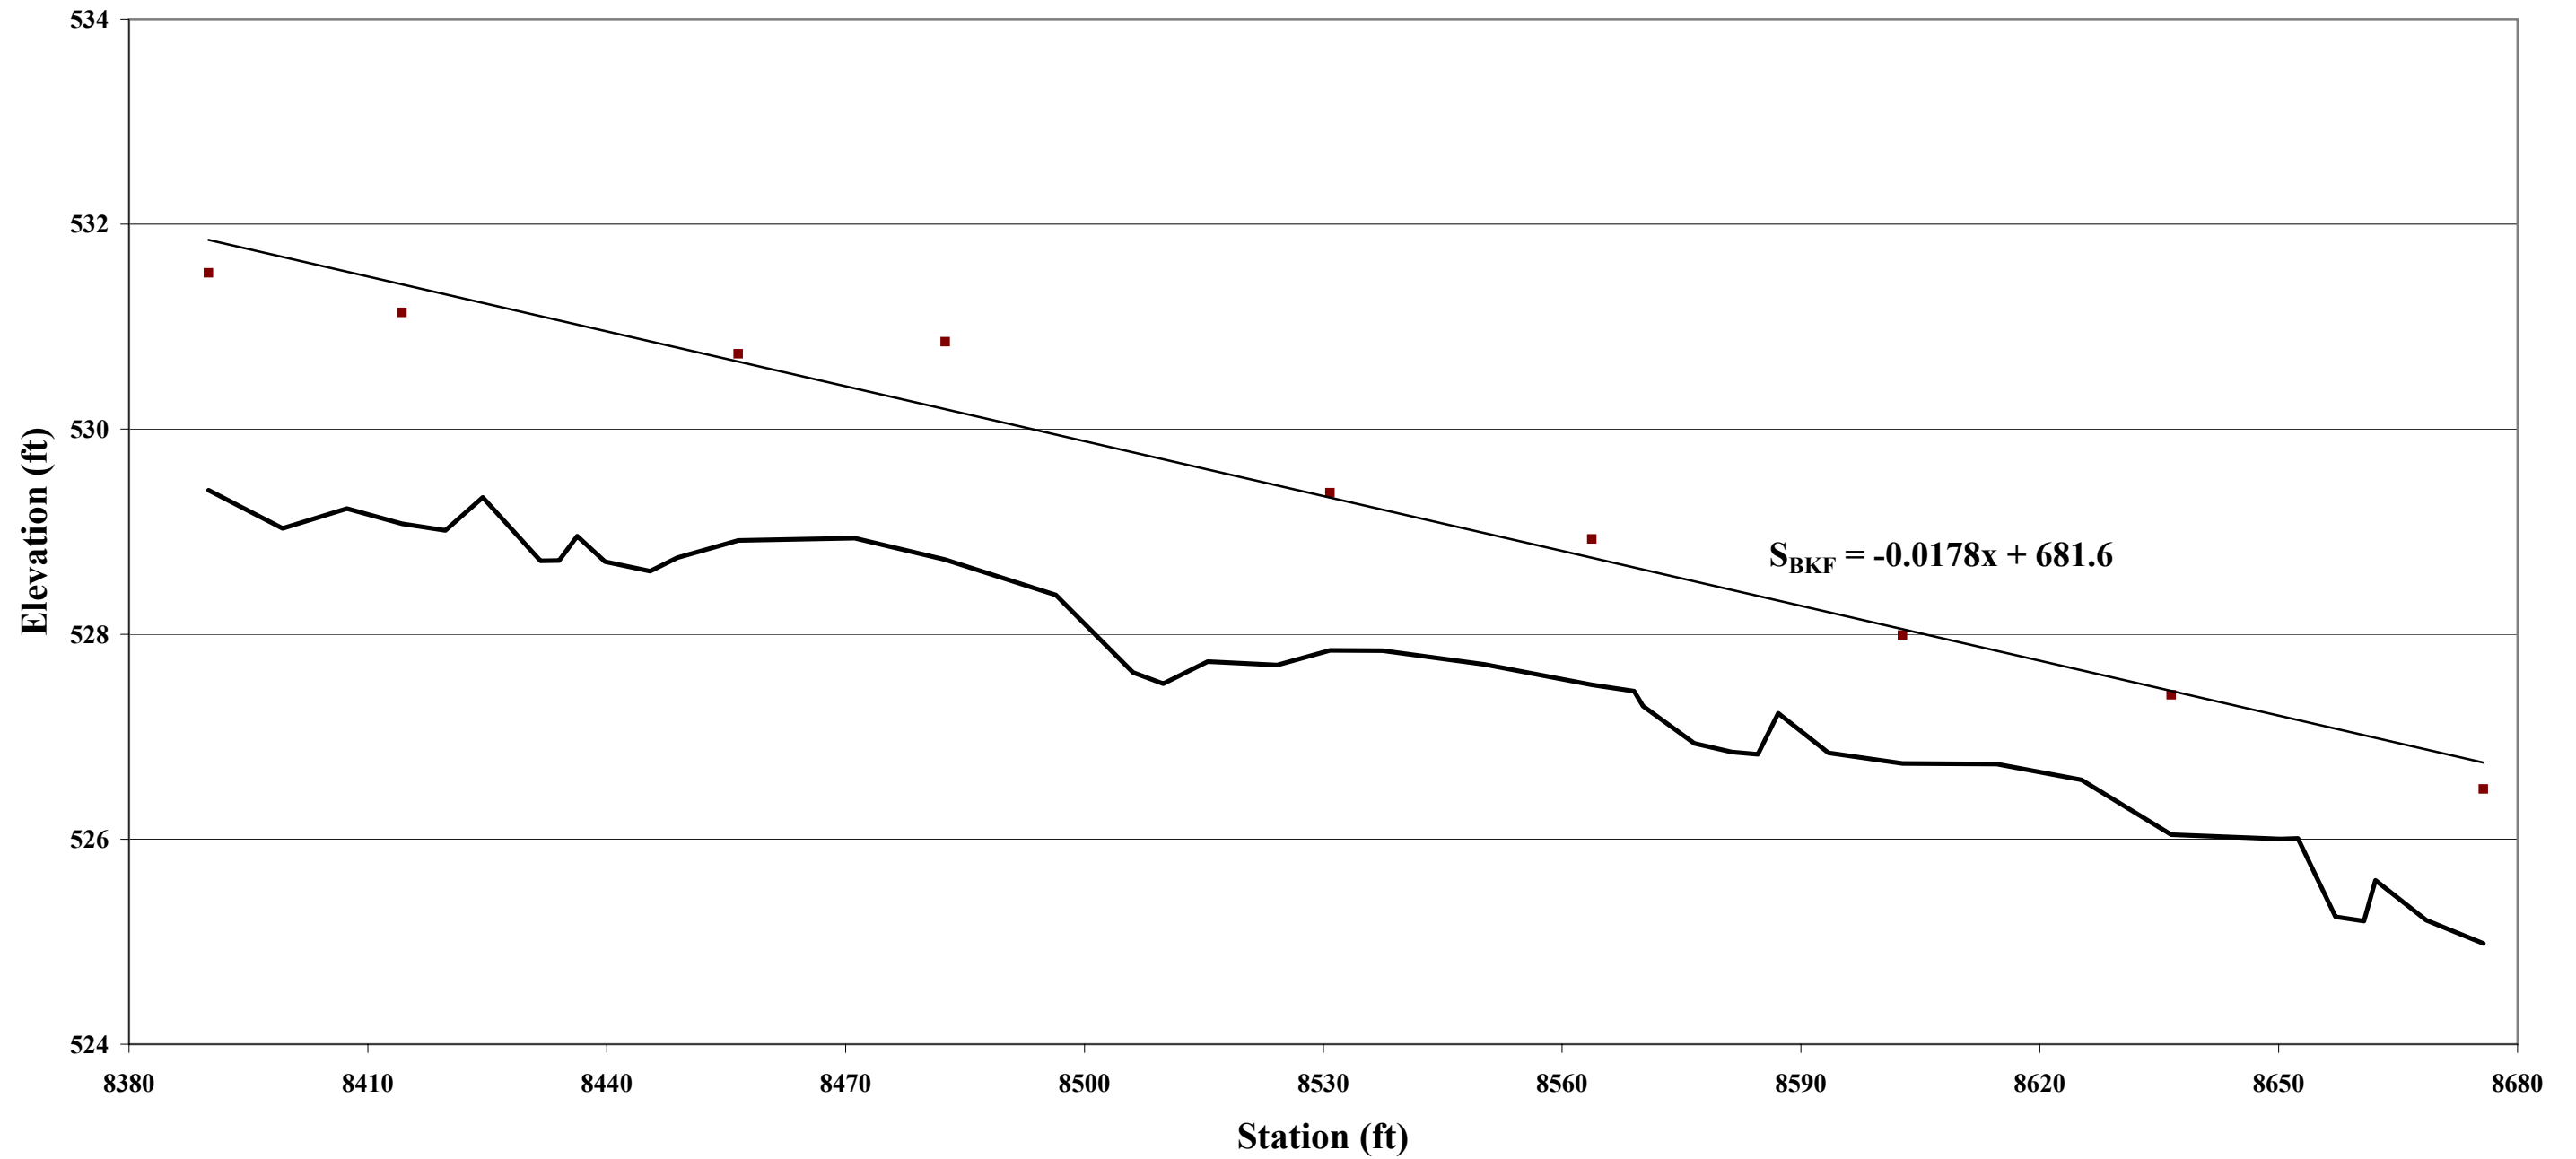
**Longitudinal Profile  
Tributary 1A, As-Built  
Stations 83+80 - 86+80**

\*No WS due to no flow in channel during survey.

Because some of the stabilizing structures and the designed profile were altered due to bedrock, it was vulnerable to destabilization from large storm events. After the repairs were completed T1A has remained stable. The condition of the reach will continue to be monitored. If there are any signs of instability, corrective actions will be taken.
