Cox Site Wetland and Stream Restoration Project As-Built Report

Johnston County, North Carolina

Design Report Prepared by Buck Engineering PC

March 2006

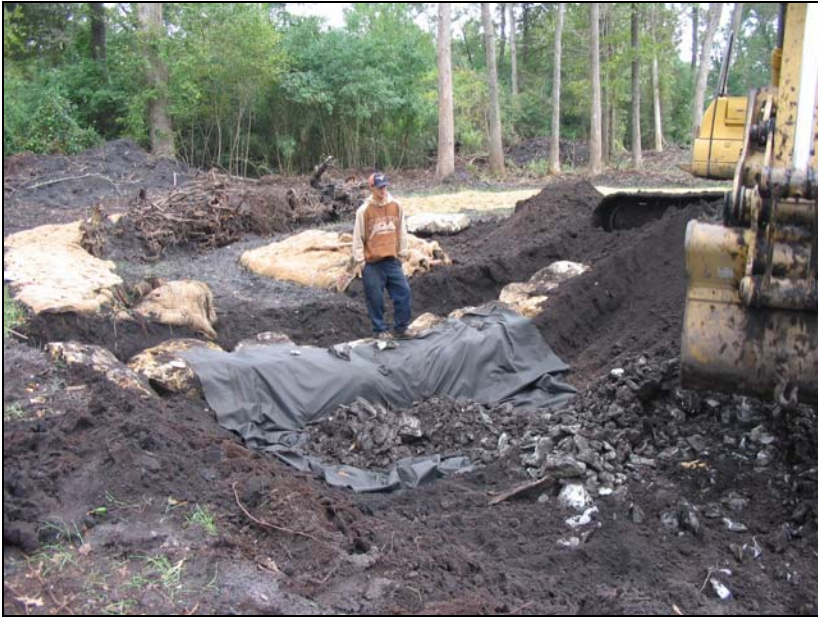
Downstream Invert on a Constructed Riffle

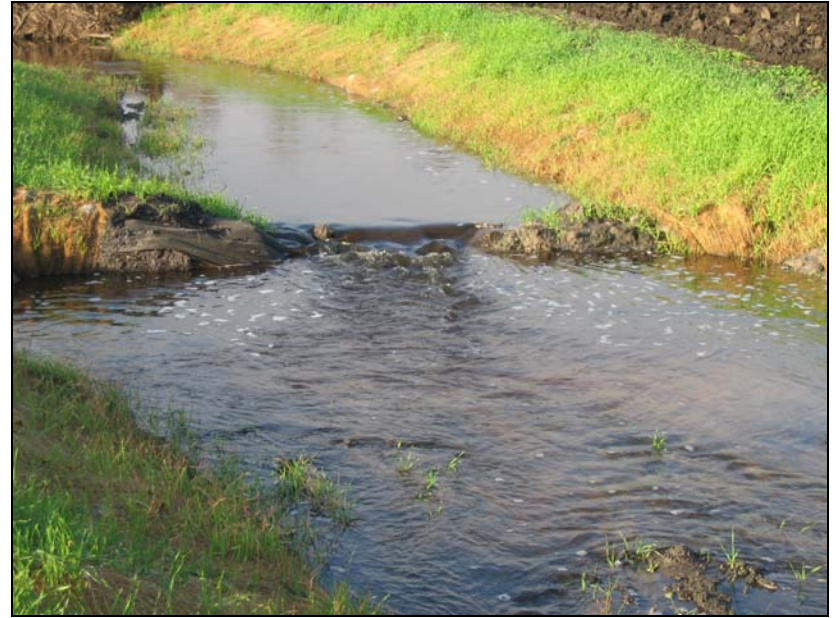
Log Weir

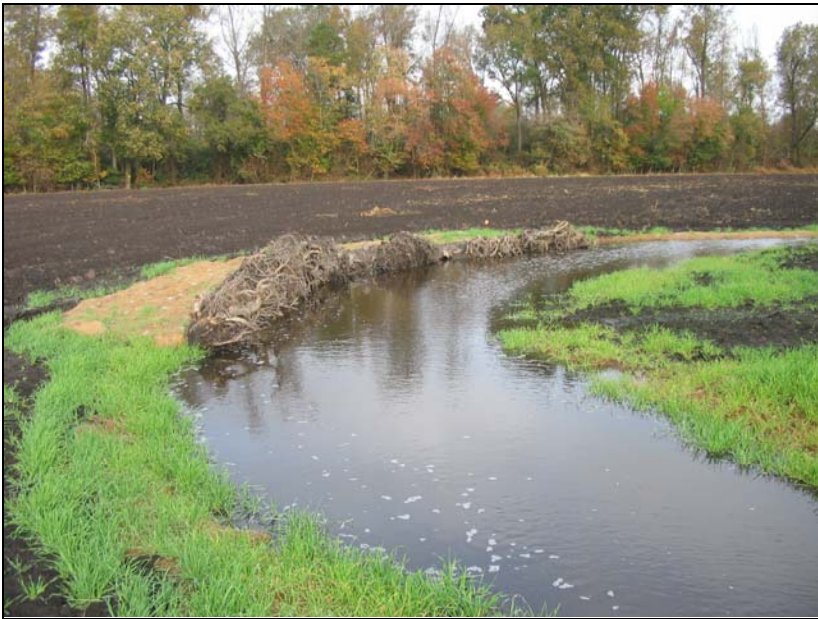
Rootwads

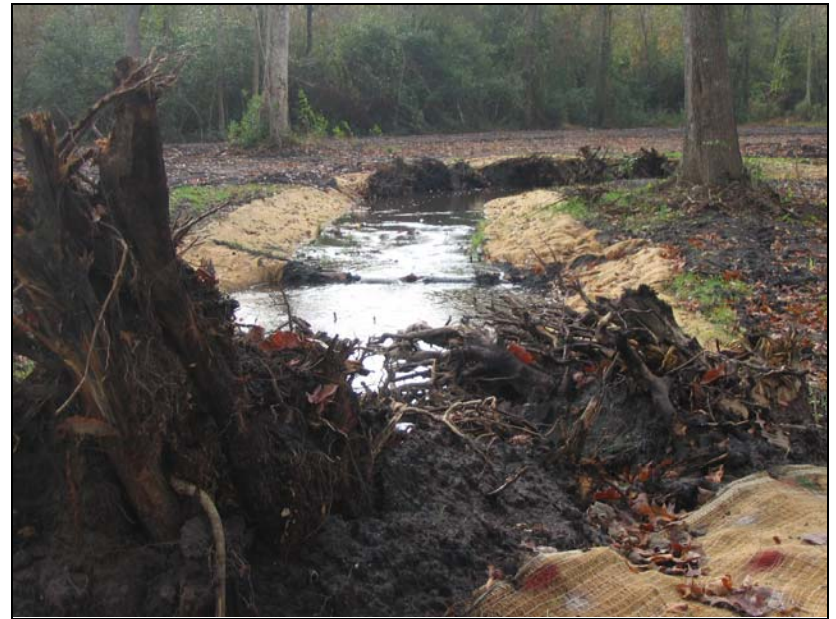
Rootwads & Constructed Riffle

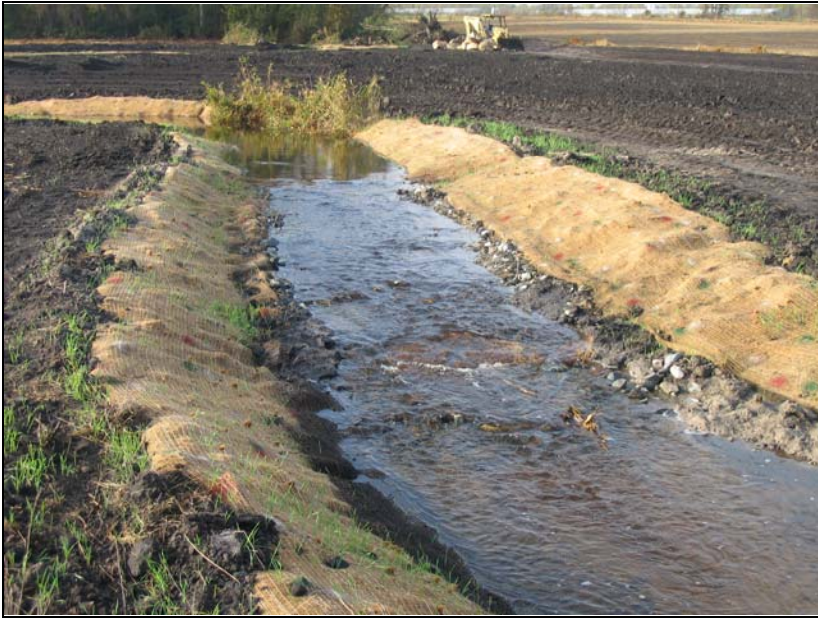
Constructed Riffle

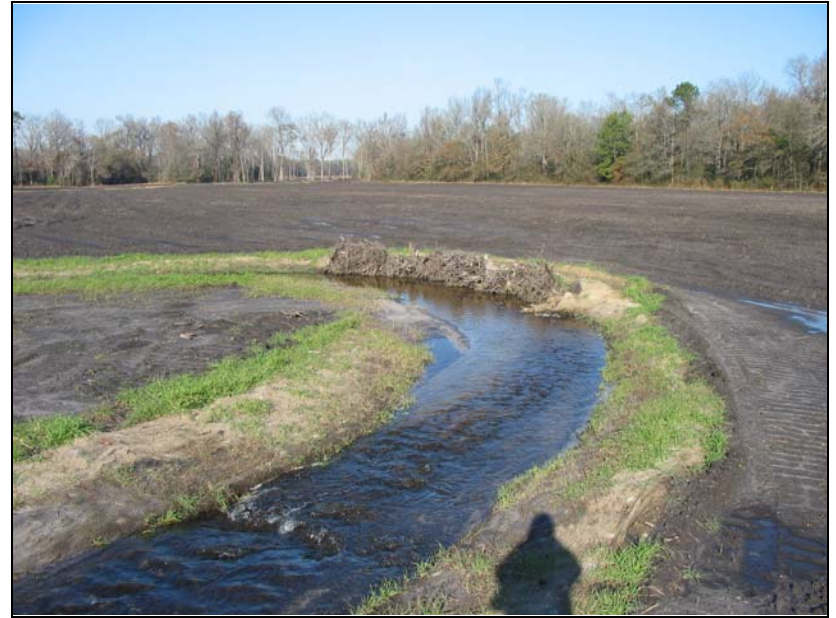
Rootwads

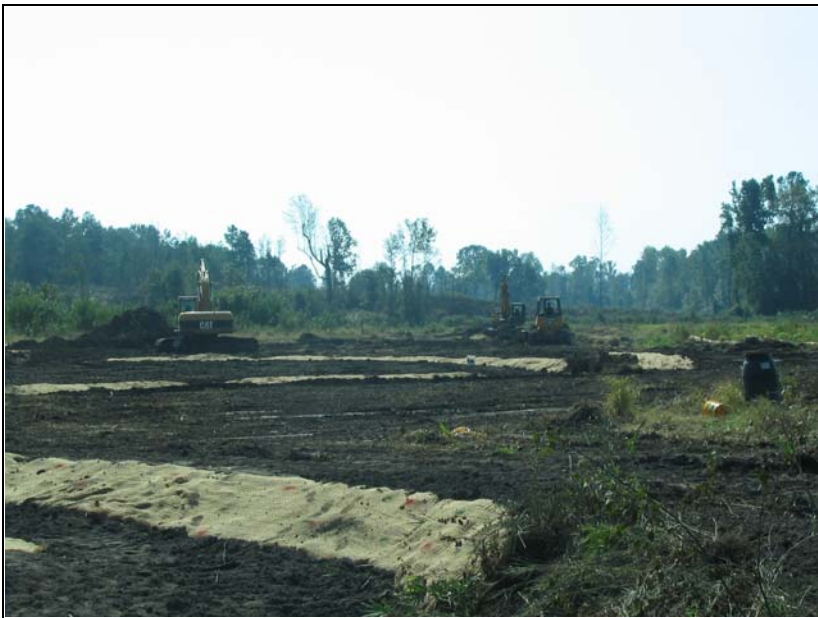
Channel Construction

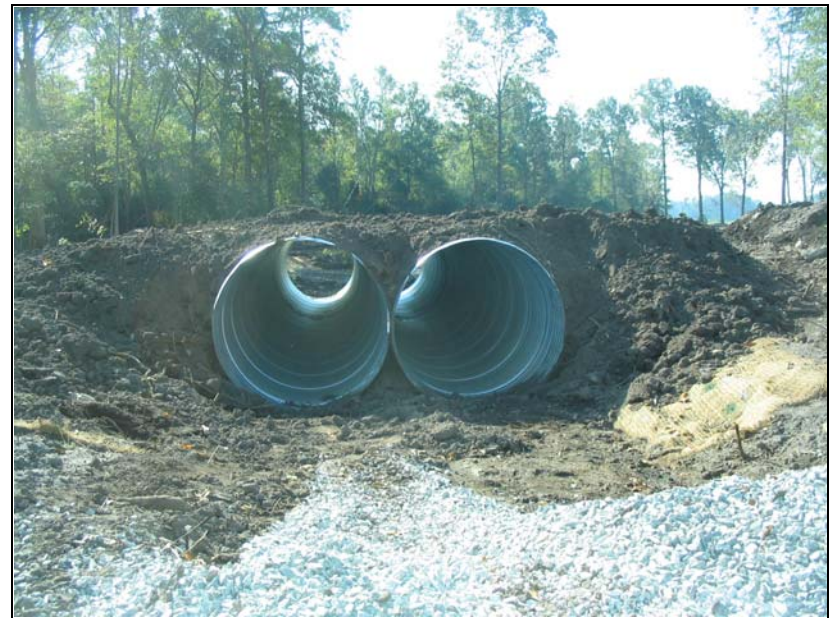
Culvert Installation in Progress

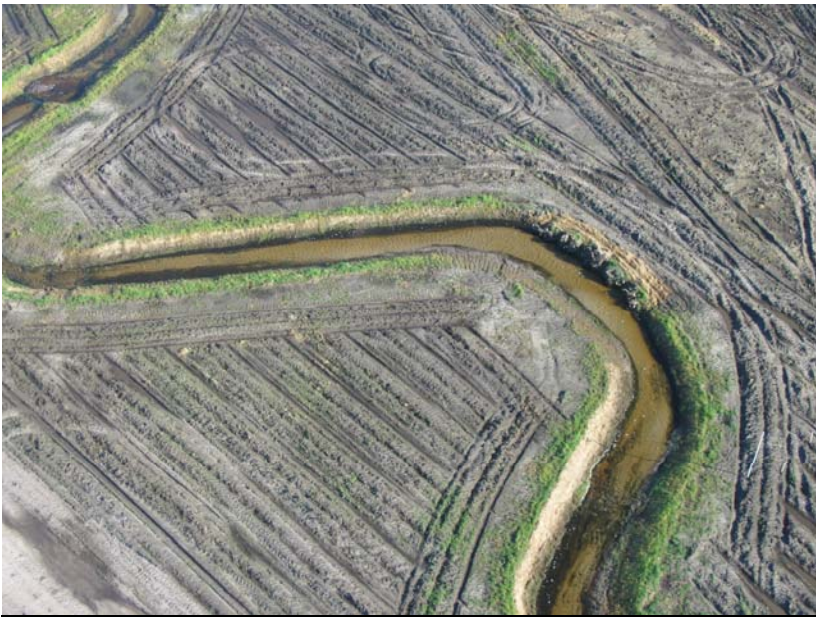
Bedload Movement

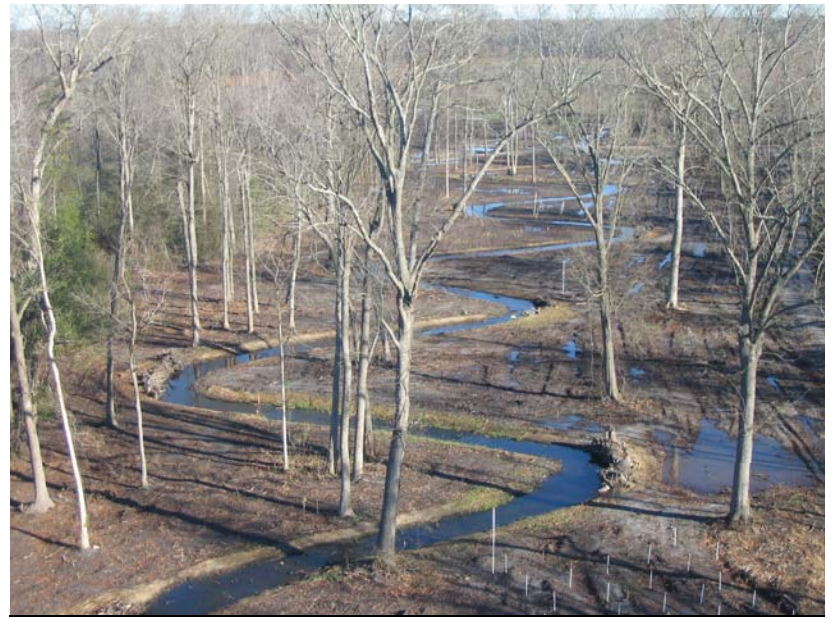
New Stream Channel Routed Through Trees

Conditions on the downstream end of the site were extremely wet, making site access and construction activities difficult. As a result, the channel alignment was adjusted in the field to allow equipment to build from relatively dry ground. The new alignment was designed using the same design parameters as were used for the original stream layout.

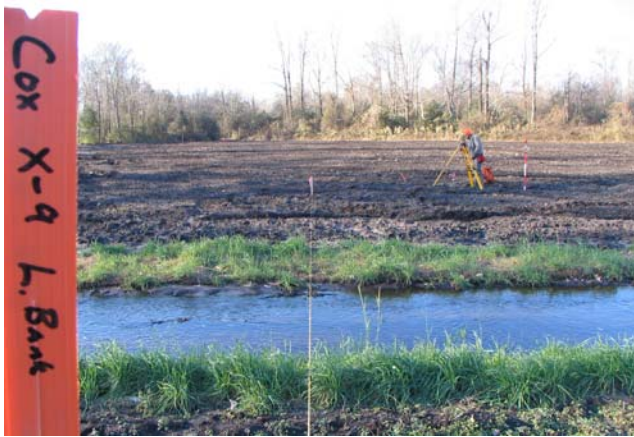
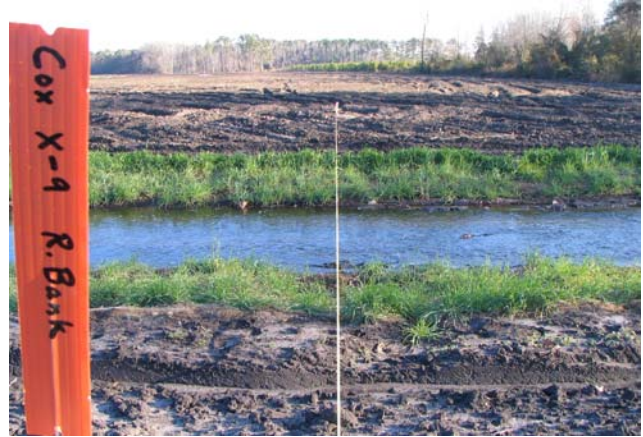
Permanent Cross-section #9
 (As-Built Data - collected Dec. 2005)

Looking at the Left Bank

Looking at the Right Bank

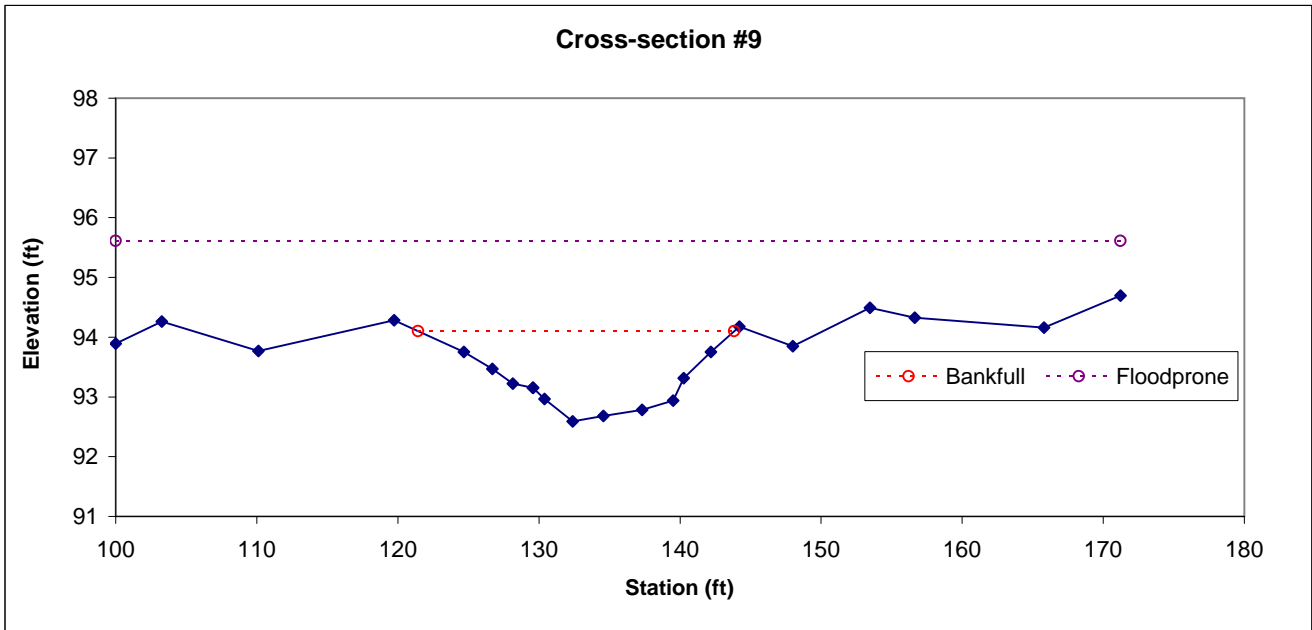
Feature	Stream Type	BKF Area	BKF Width	BKF Depth	Max BKF Depth	W/D	BH Ratio	ER	BKF Elev	TOB Elev
Riffle	C	19	22.42	0.85	1.51	26.41	1.1	3.2	94.1	94.18

For monitoring wetland and stream success criteria, 10 wells (5 automated and 5 manual), 16 permanent cross-sections, 1 rain gauge, and 1 crest gauge were installed. The permanent cross-sections will be used to monitor channel dimension and bank erosion over time. The rain gauge and crest gauge will be used to document the occurrence of bankfull events. In addition, a complete longitudinal survey was completed for the restored stream channels to provide a base-line for evaluating changes in bed conditions over time. The longitudinal profiles included the elevations of all grade control structures. The permanent cross-section and longitudinal data are provided in Appendix 2. The location of the permanent cross-sections, rain gauge, and the stream gauges are shown on the as-built plan sheets in Appendix 3.

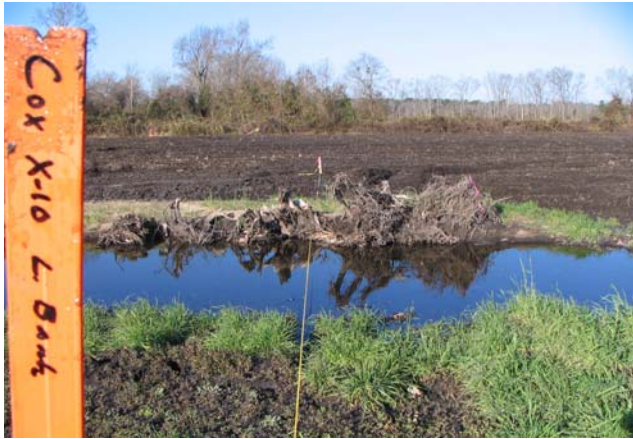
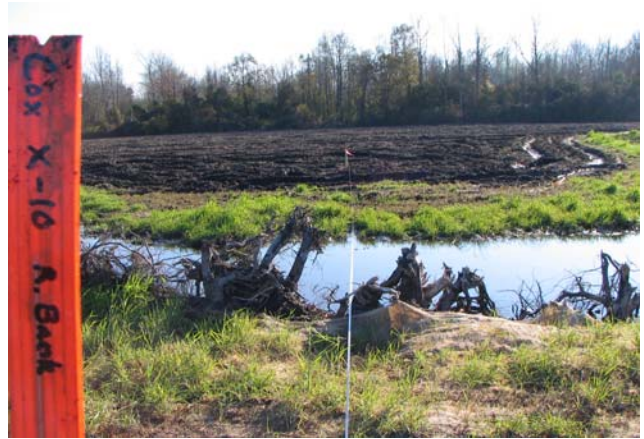
Permanent Cross-section #10
 (As-Built Data - collected Dec. 2005)

Looking at the Left Bank

Looking at the Right Bank

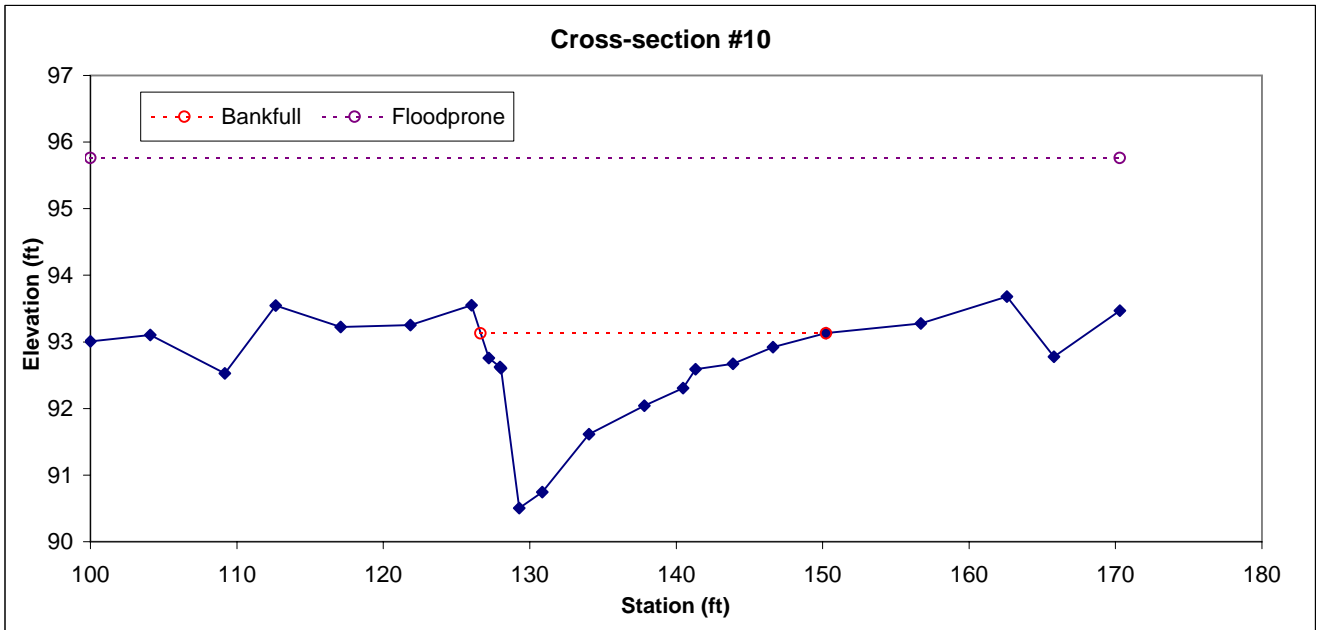
Feature	Stream Type	BKF Area	BKF Width	BKF Depth	Max BKF Depth	W/D	BH Ratio	ER	BKF Elev	TOB Elev
Pool	---	23.3	23.59	0.99	2.63	23.9	1	3	93.13	93.13

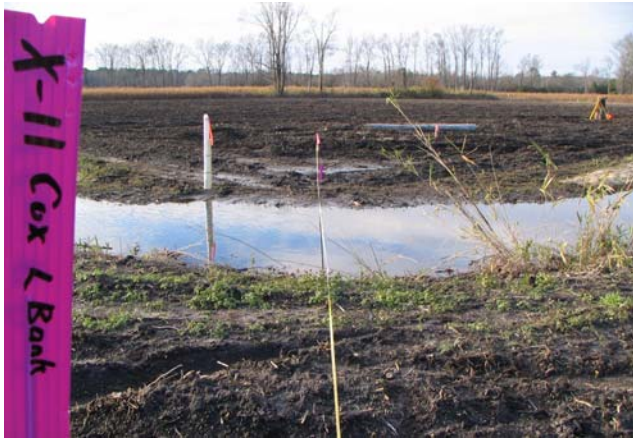
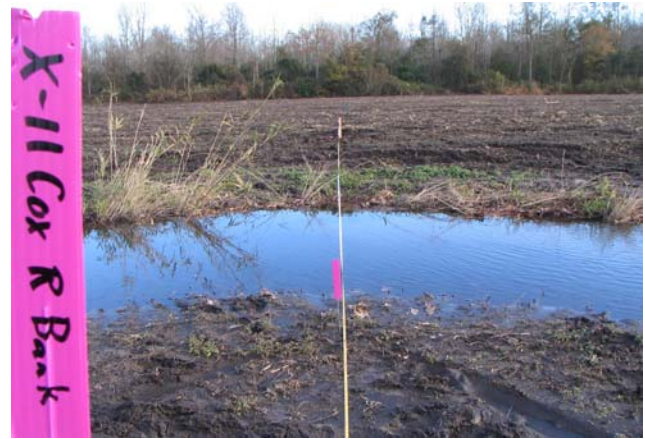
Permanent Cross-section #11
 (As-Built Data - collected Dec. 2005)

Looking at the Left Bank

Looking at the Right Bank

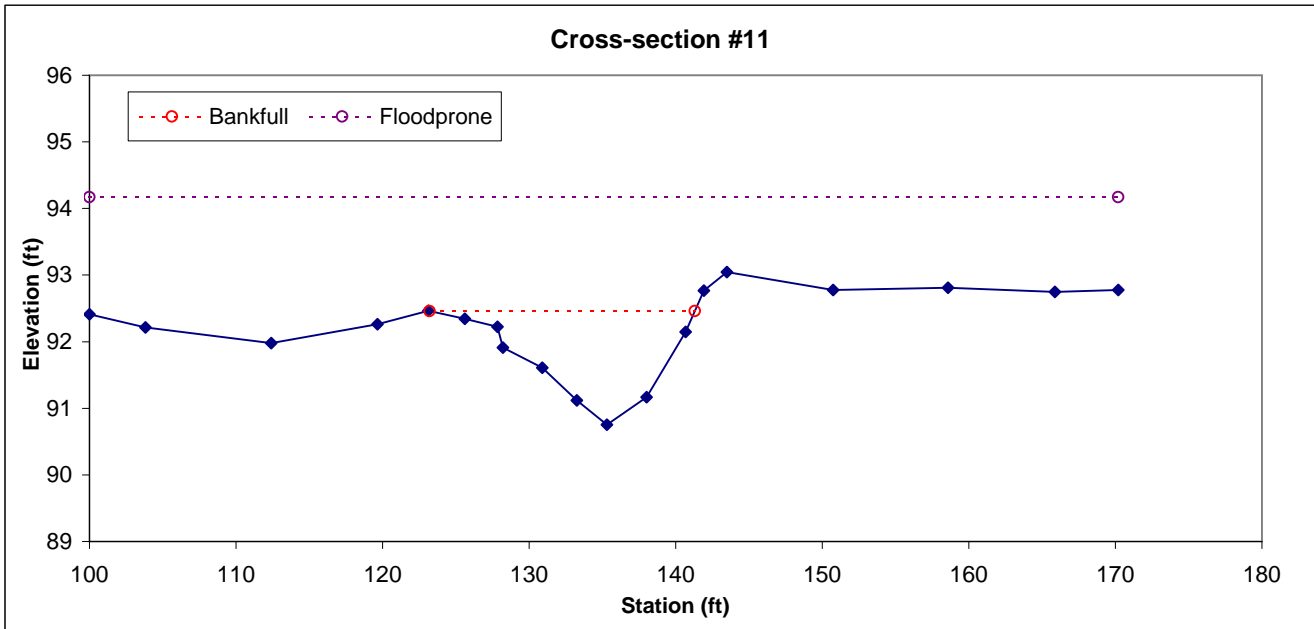
Feature	Stream Type	BKF Area	BKF Width	BKF Depth	Max BKF Depth	W/D	BH Ratio	ER	BKF Elev	TOB Elev
Pool	---	14.6	18.12	0.8	1.71	22.54	1	3.9	92.46	92.46

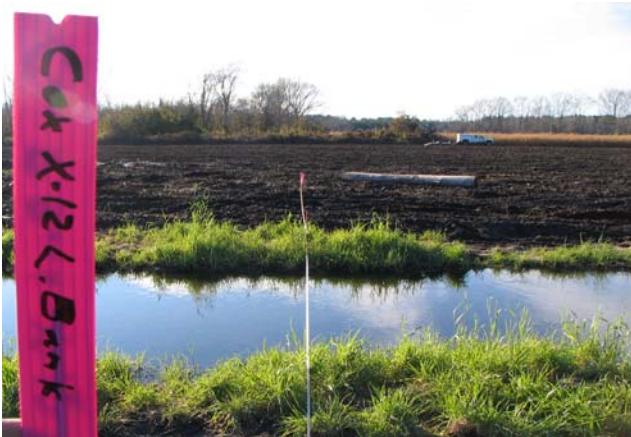
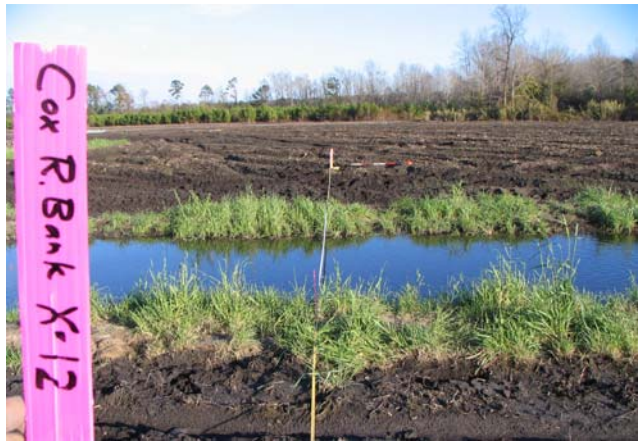
Permanent Cross-section #12
 (As-Built Data - collected Dec. 2005)

Looking at the Left Bank

Looking at the Right Bank

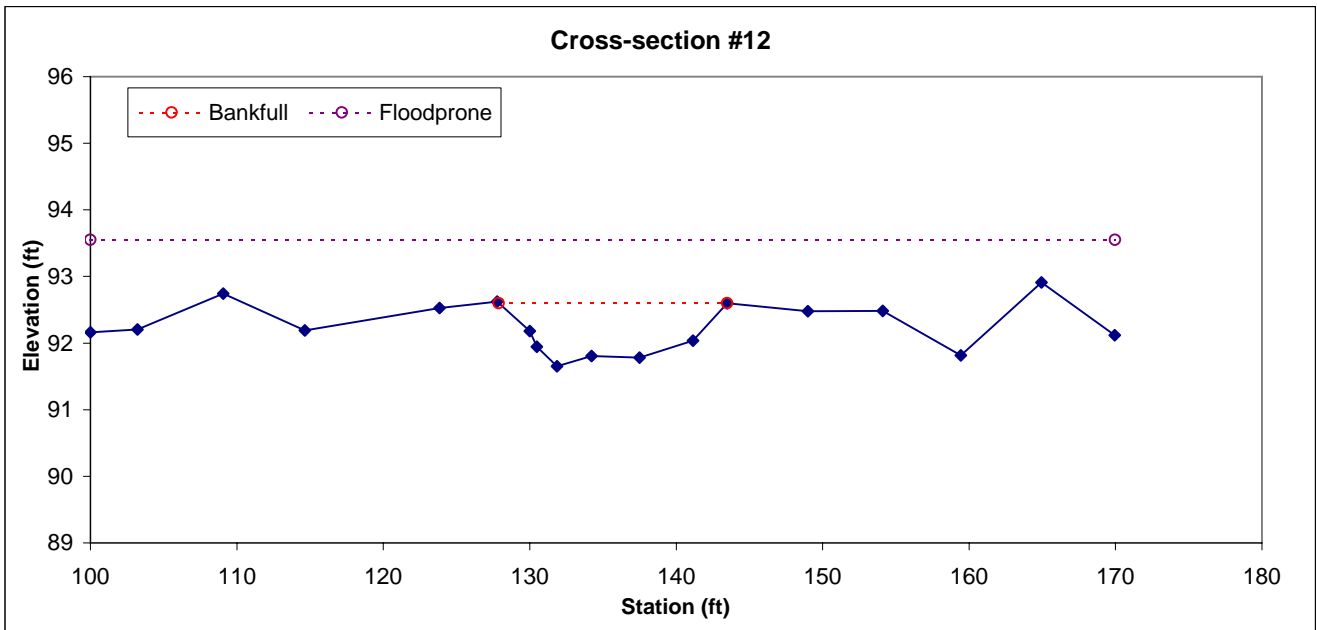
Feature	Stream Type	BKF Area	BKF Width	BKF Depth	Max BKF Depth	W/D	BH Ratio	ER	BKF Elev	TOB Elev
Riffle	C	9.7	15.6	0.62	0.95	25.18	1	4.5	92.6	92.6

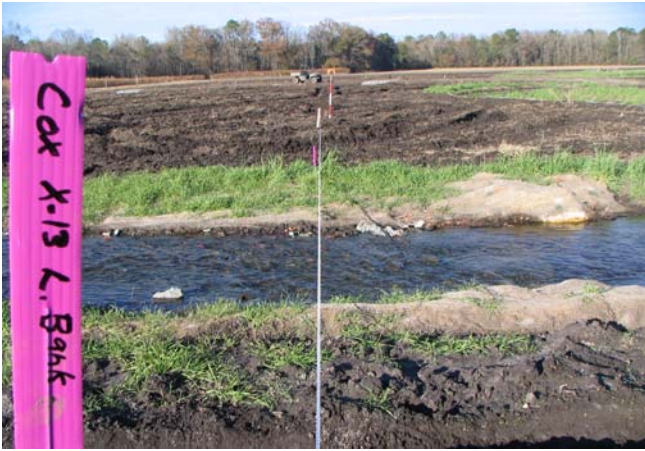
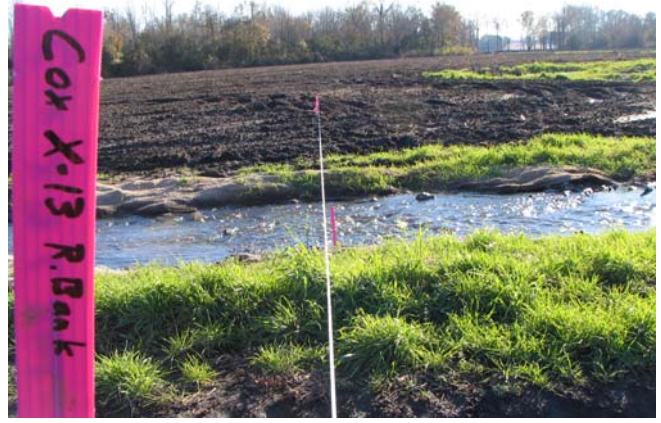
Permanent Cross-section #13
(As-Built Data - collected Dec. 2005)

Looking at the Left Bank

Looking at the Right Bank

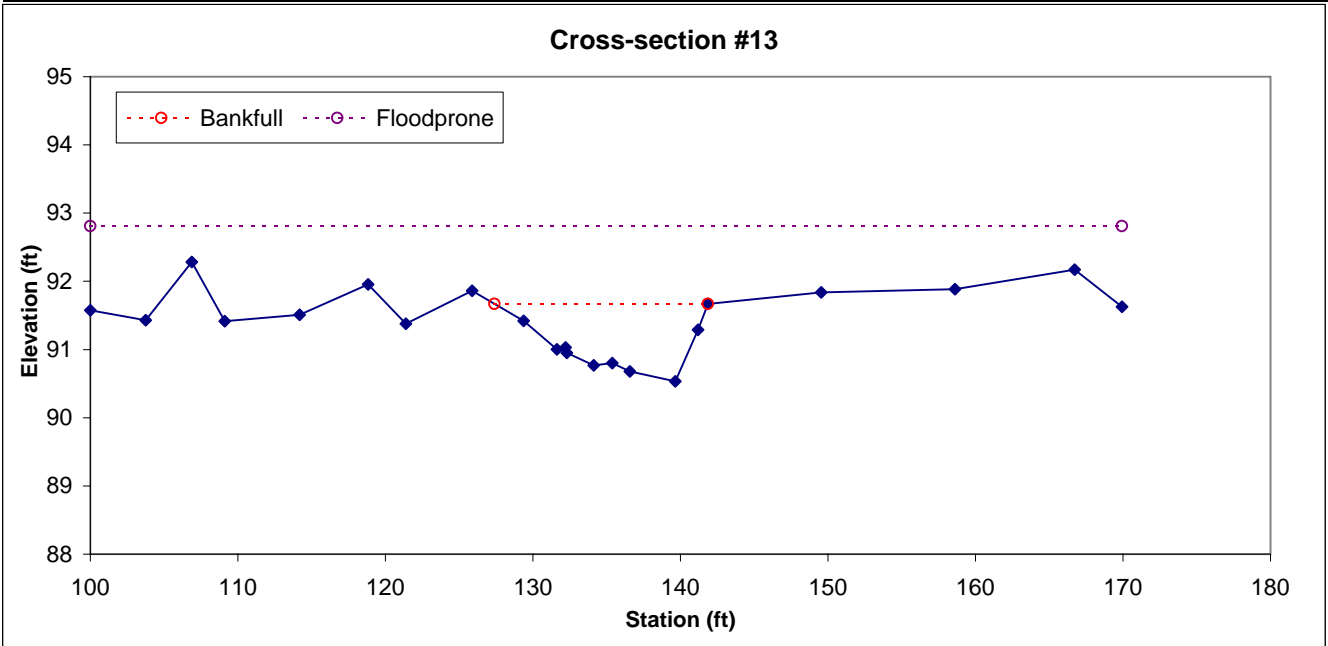
Feature	Stream Type	BKF Area	BKF Width	BKF Depth	Max BKF Depth	W/D	BH Ratio	ER	BKF Elev	TOB Elev
Riffle	C	10	14.47	0.69	1.14	20.97	1	4.8	91.67	91.67

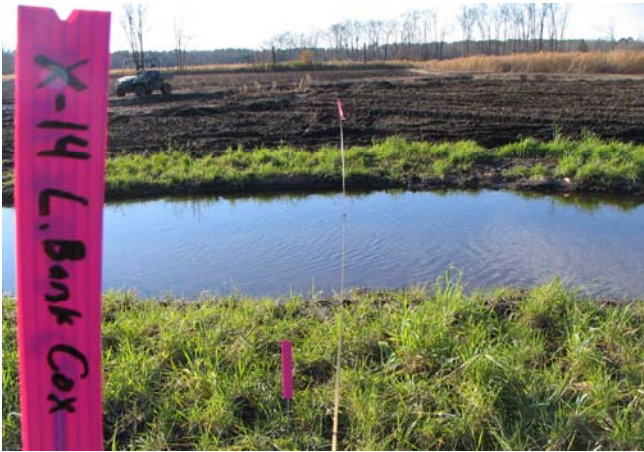
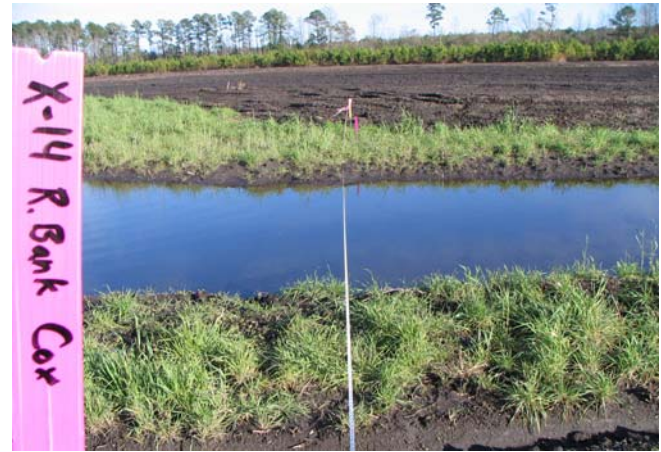
Permanent Cross-section #14
 (As-Built Data - collected Dec. 2005)

Looking at the Left Bank

Looking at the Right Bank

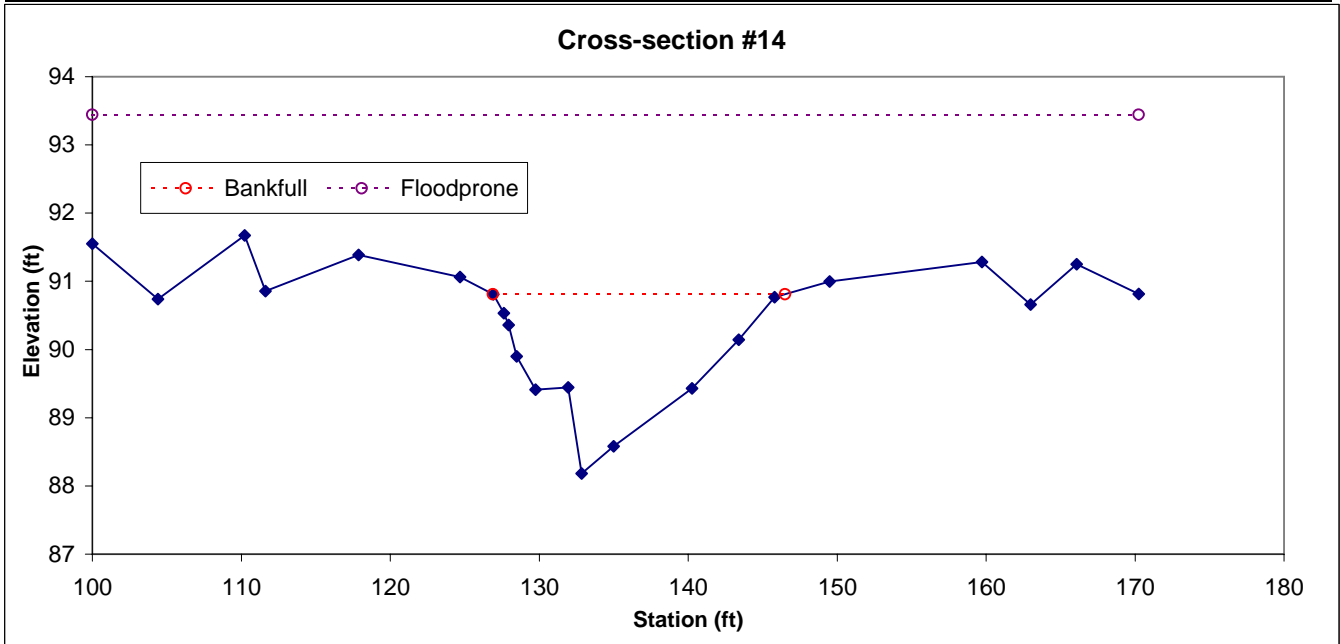
Feature	Stream Type	BKF Area	BKF Width	BKF Depth	Max BKF Depth	W/D	BH Ratio	ER	BKF Elev	TOB Elev
Pool	---	25.7	19.61	1.31	2.63	14.99	1	3.6	90.81	90.81

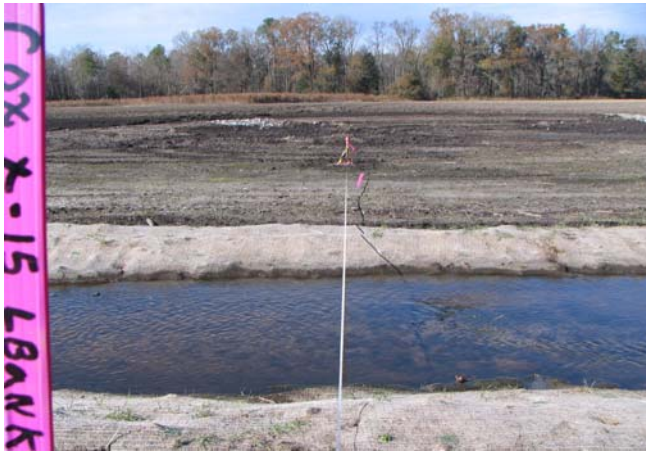
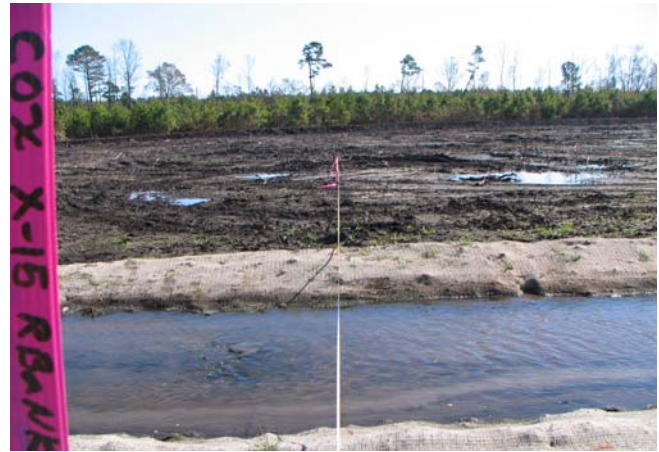
Permanent Cross-section #15

(As-Built Data - collected Dec. 2005)

Looking at the Left Bank

Looking at the Right Bank

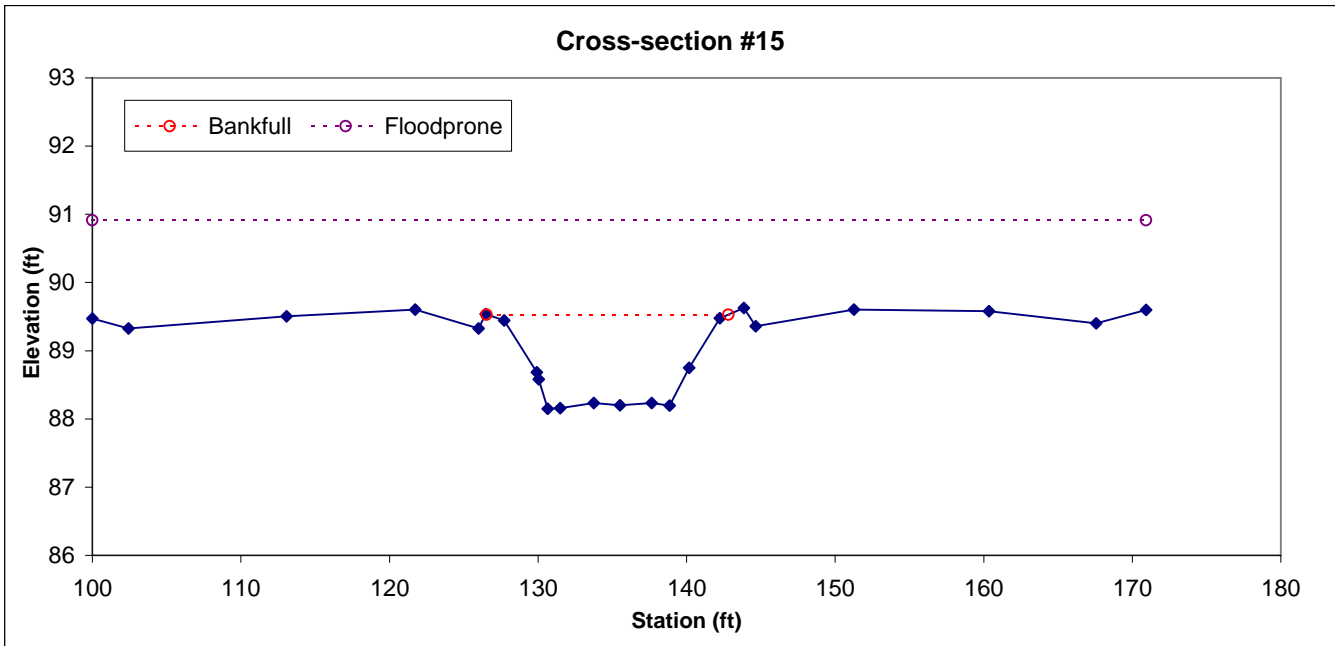
Feature	Stream Type	BKF Area	BKF Width	BKF Depth	Max BKF Depth	W/D	BH Ratio	ER	BKF Elev	TOB Elev
Riffle	C	15.1	16.28	0.92	1.38	17.61	1	4.4	89.53	89.54

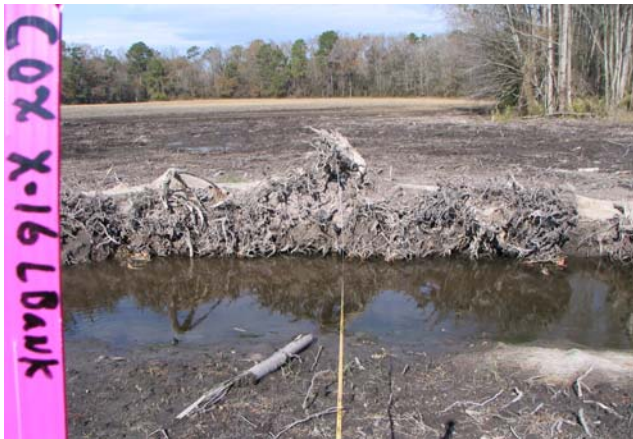
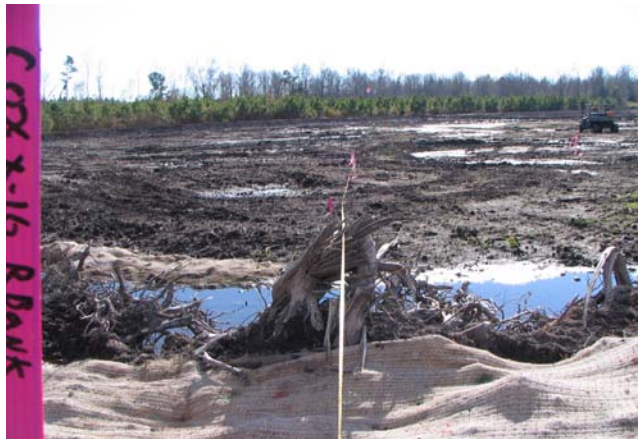
Permanent Cross-section #16

(As-Built Data - collected Dec. 2005)

Looking at the Left Bank

Looking at the Right Bank

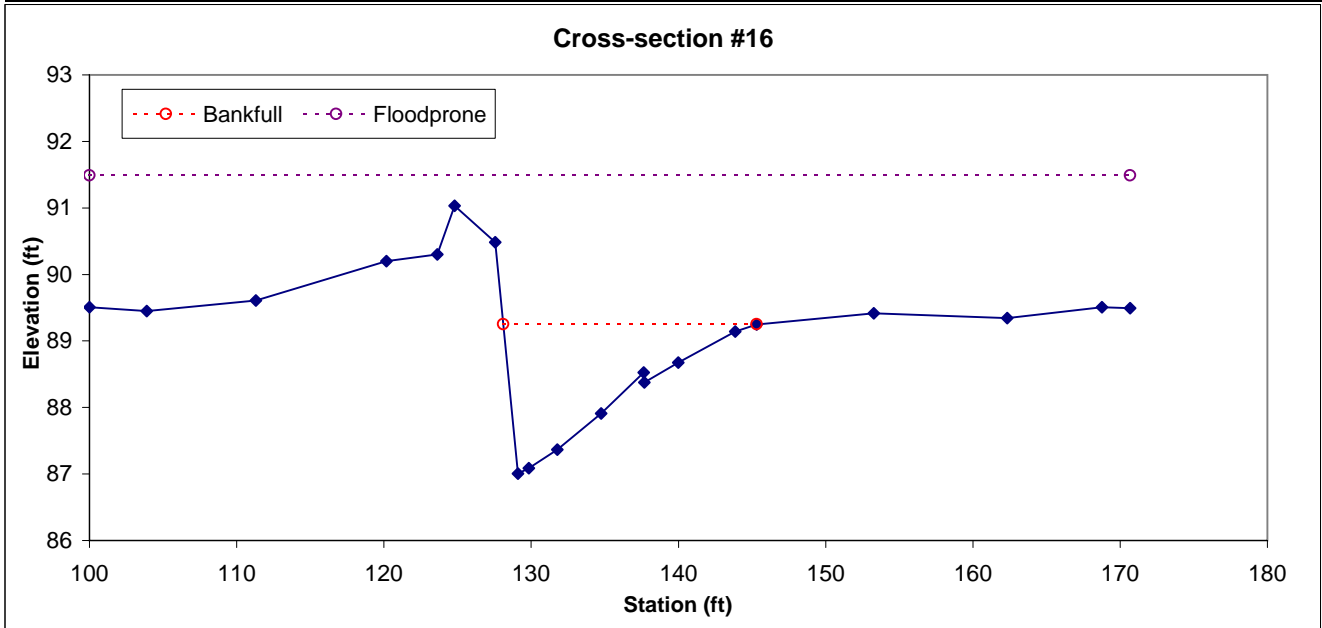
Feature	Stream Type	BKF Area	BKF Width	BKF Depth	Max BKF Depth	W/D	BH Ratio	ER	BKF Elev	TOB Elev
Pool	---	17.5	17.21	1.02	2.24	16.92	1	4.1	89.25	89.25
