MONITORING YEAR 6 ANNUAL REPORT

CROOKED CREEK #2 RESTORATION PROJECT

Union County, NC

DMS Project Number 94687

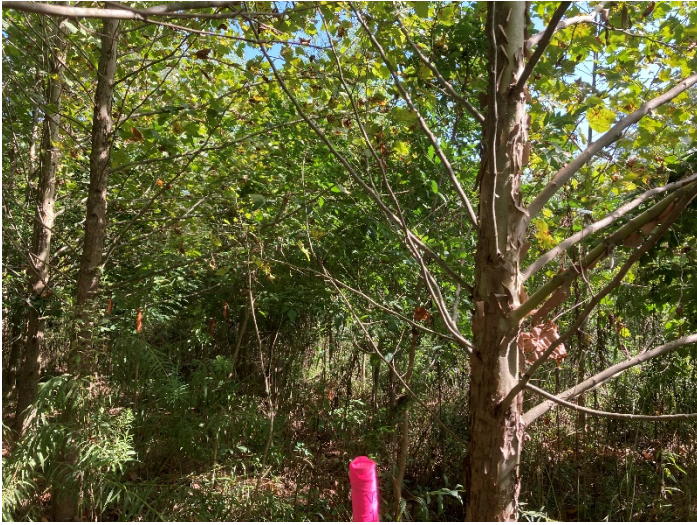
Vegetation Plot 1 – (9/1/2021)

Please refer to Appendix 2 for vegetation plot photographs and the overall vegetation condition assessment table. The vegetation data tables are located in Appendix 3. Please refer to Appendix 6 for the Invasive Species Treatment Logs.

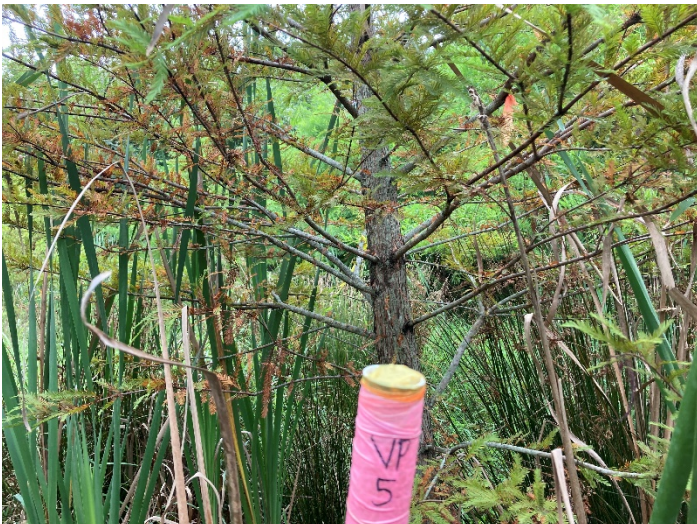
Vegetation Plot 5 – (9/1/2021)

Generally, the vegetation within the Site is healthy with a few areas of invasive plant species present. Invasive species noted on the site include cattail (*Typha latifolia*), Japanese honeysuckle (*Lonicera japonica*), Chinese privet (*Ligustrum sinense*), and balloon vine (*Cardiospermum halicacabum*). The native invasive species, cattail (*Typha latifolia*) continues to surround vegetation plot 5, but it is not adversely affecting tree growth in the plot. The colony is established but has not expanded beyond the area adjacent to vegetation plot 5.

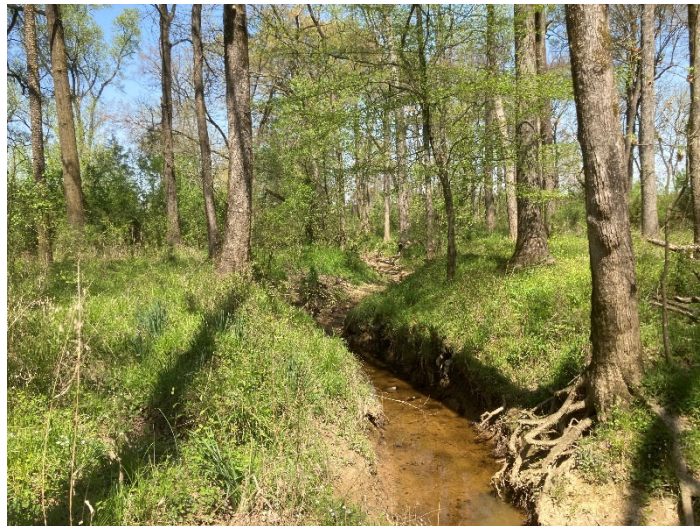
Photo Point 31 – UT2 looking upstream UT2 (4/5/2021)

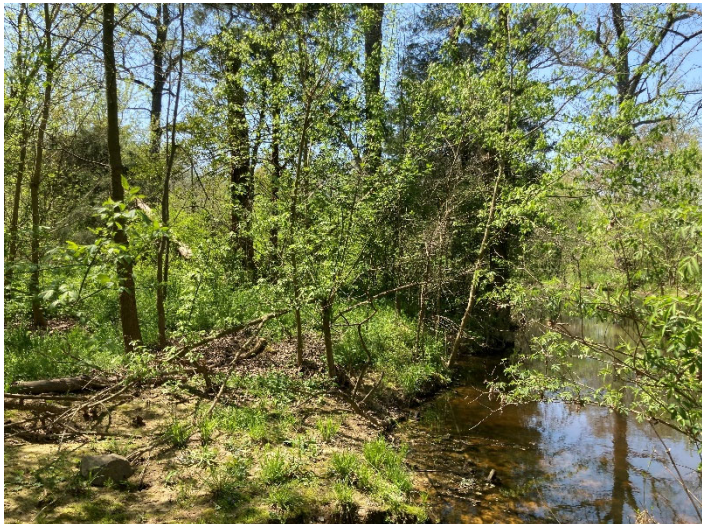
Photo Point 30 –Wetland CC outlet facing West (4/5/2021)

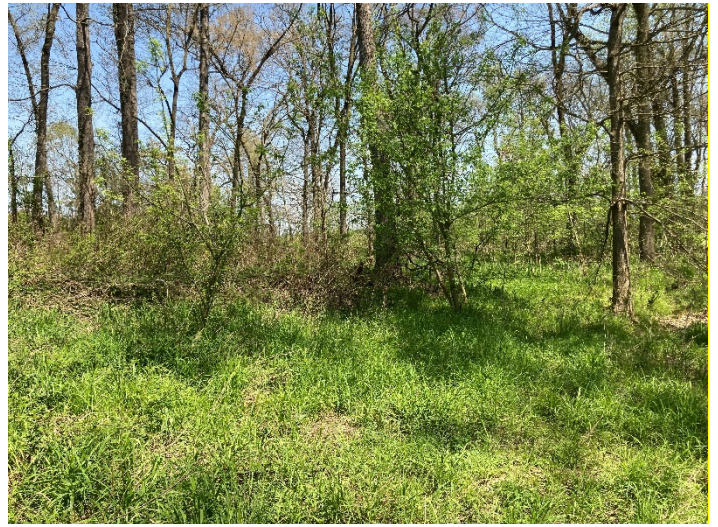
Photo Point 30 –Wetland CC outlet facing East (4/5/2021)

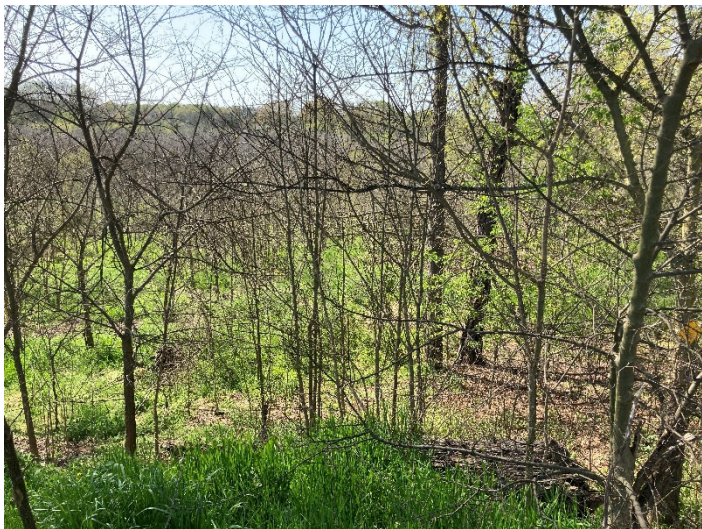
Photo Point 32 –Wetland AA facing West (4/5/2021)

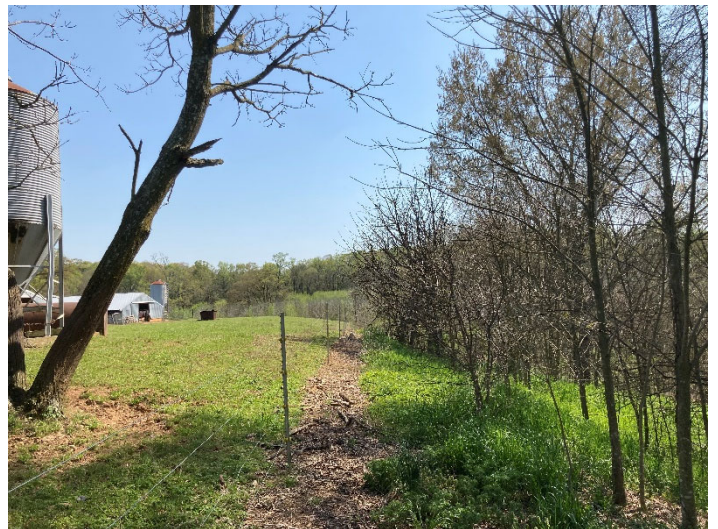
Photo Point 32 – Wetland Zone A facing South (4/5/2021)

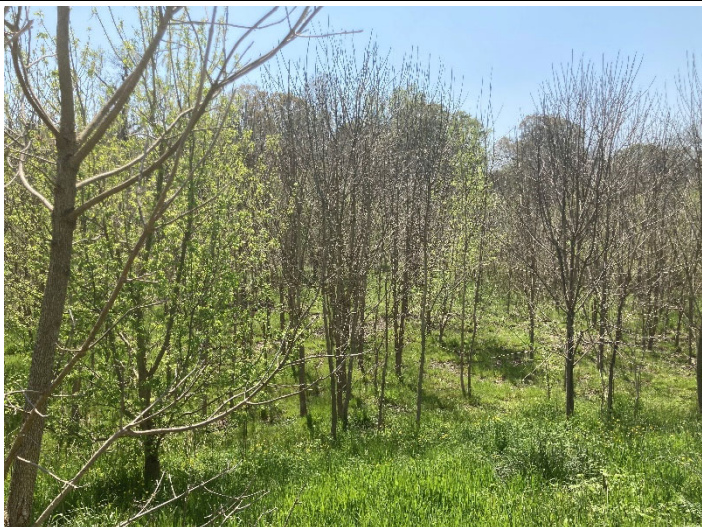
Photo Point 33 – Wetland Zone A & B facing West (4/5/2021)

Currently, there are no areas of concern within the wetland areas. Repair work completed on the headcut near Wetland Creation Zone B, previously reported in MY3, has not retreated further. There is some evidence that water has continued to move through this area where vegetation has not fully established. However, the headcut is not threatening the stability of the Site or the riparian buffer. The headcut area will continue to be monitored in MY7. Refer to Appendix 2 for wetland photographs.

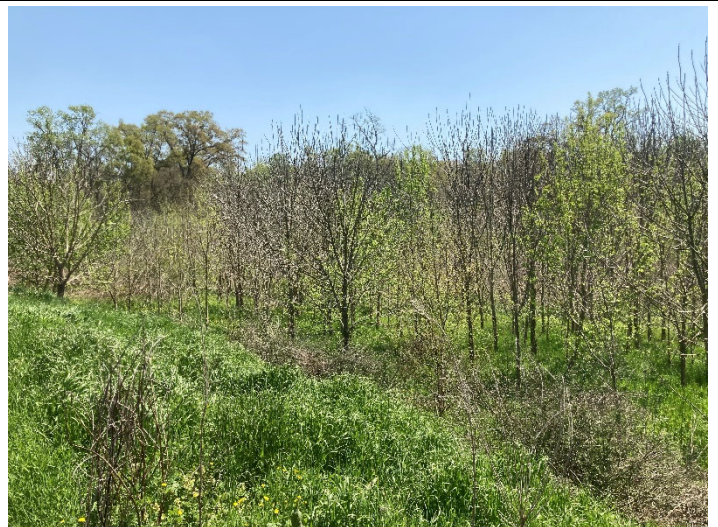
Photo Point 33 - Wetland B facing South (4/5/2021)

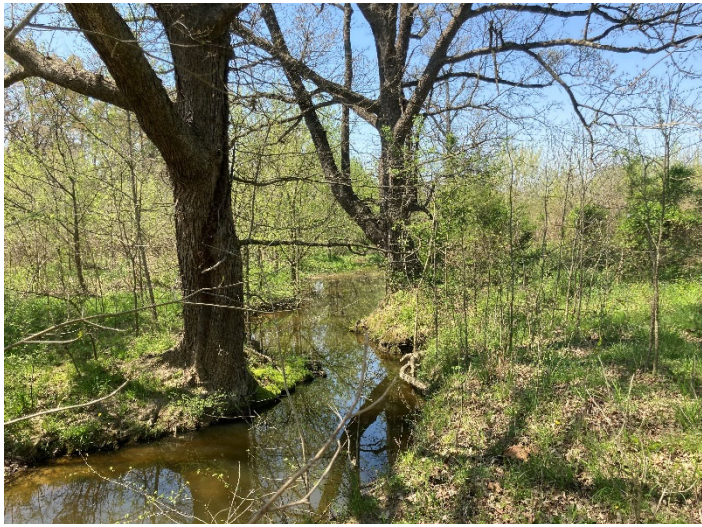
Photo Point 34 –Wetland CC facing Northwest (4/5/2021)

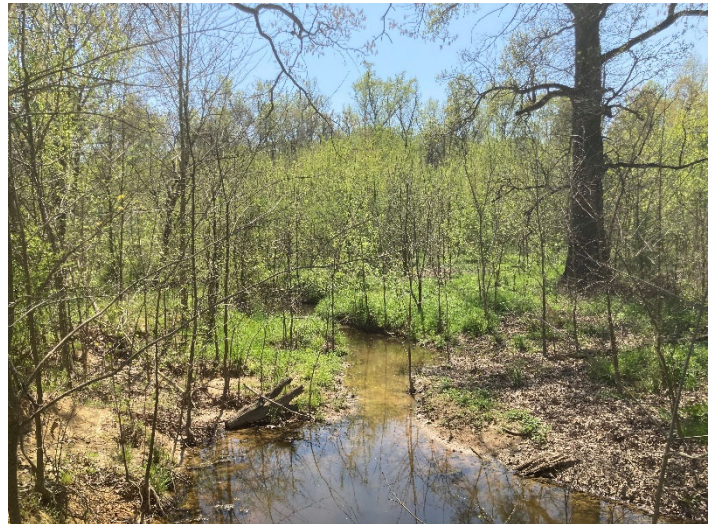
Photo Point 34 –Wetland CC facing South (4/5/2021)

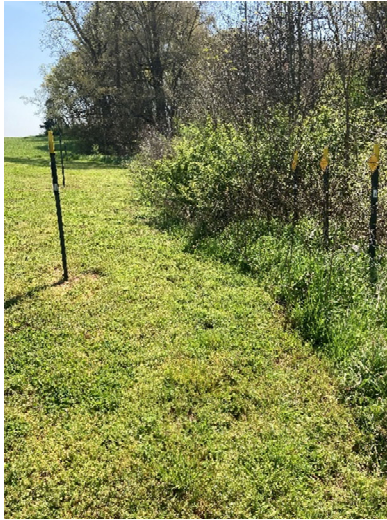
Mowing easement encroachment spring (4/05/2021)

Additionally, mowing within the easement during MY5 continued into MY6. There was evidence of mowing along the easement line in the left floodplain of Crooked Creek during the April 2021 site visit. DMS installed additional easement signs and a clear marker line connecting the easement signs with white tape to deter further mowing. No additional easement encroachments have been observed since. Wildlands will continue to monitor these areas for any evidence of future encroachment or further advancement of the previously noted areas of concern. Refer to Appendix 2 for the vegetation condition assessment table and the CCPV maps for MY6 vegetation areas of concern, and Appendix 6 for the invasive species treatment log.

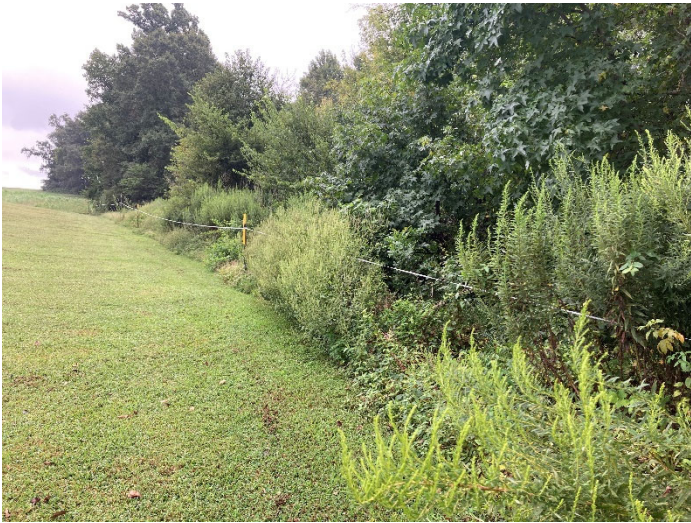
Mowing easement encroachment addressed (9/01/2021)

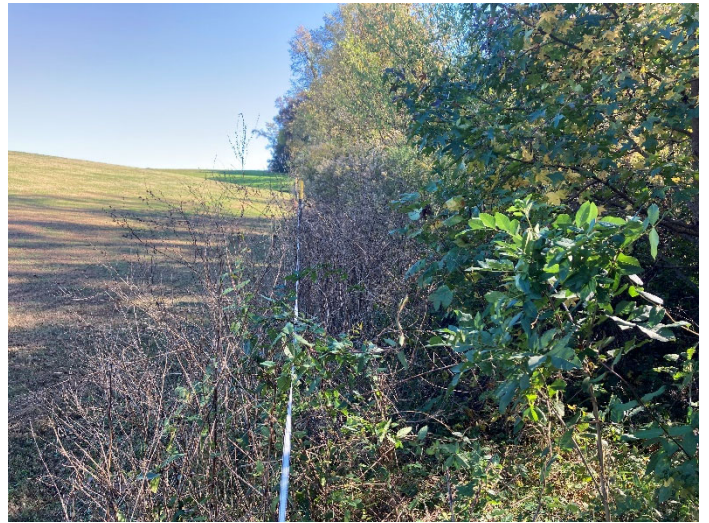
Mowing easement encroachment addressed (11/01/2021)

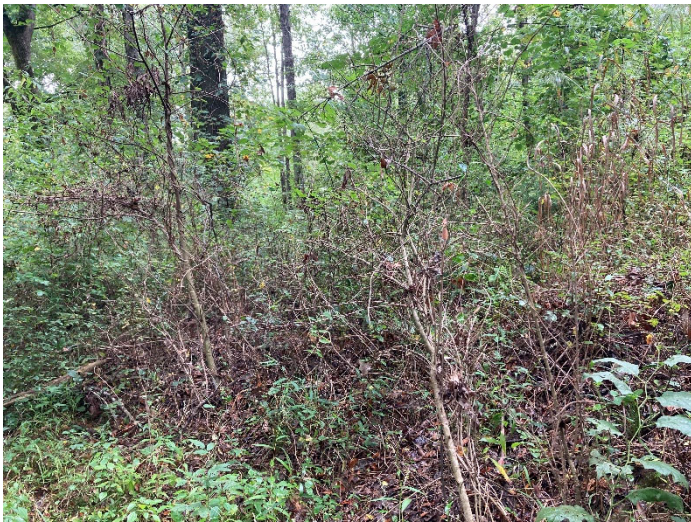
Treated honeysuckle (9/01/2021)

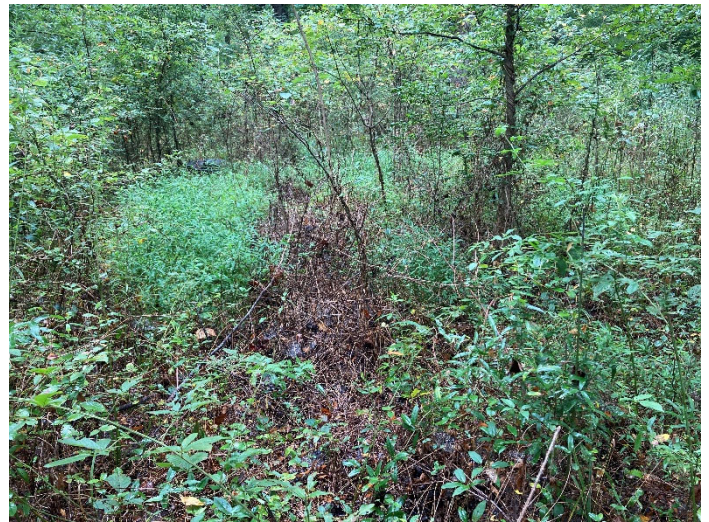
Treated privet (9/01/2021)

13 October 2020: Jason York and Drew Powers applied 10 gallons of 3% Rodeo (glyphosate) as a foliar spray on privet (*Ligustrum spp.*) along the northern bank of Crooked Creek. Approximately 60 feet from the banks were treated. Other invasive plants treated included Sacred Bamboo (*Nandina domestica*), Burning Bush (*Euonymus alata*), Japanese Honeysuckle (*Lonicera japonica*), and Callery Pear (*Pyrus calleryana*). Privet and Callery Pear were also treated with 20% Garlon 4 in Bark Oil Blue as a basal bark application near the northern most easement boundary. No stems were treated that were tall enough to fall on the adjacent fence line. Attached is a map showing the approximate area that was treated.

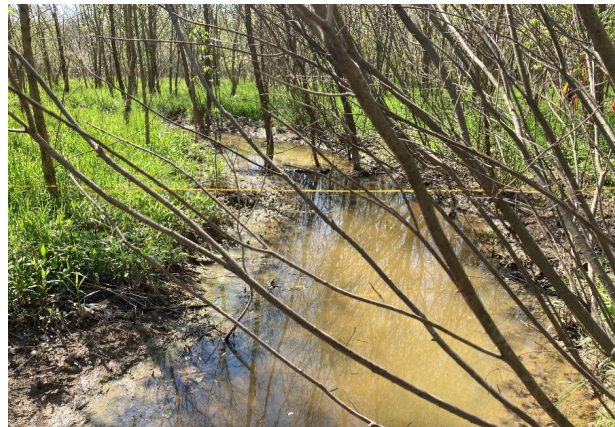
Cross Section 1-UT1

8.5	x-section area (ft.sq.)
12.2	width (ft)
0.7	mean depth (ft)
1.4	max depth (ft)
12.7	wetted perimeter (ft)
0.7	hydraulic radius (ft)
17.6	width-depth ratio

Survey Date: 04/2021
Field Crew: Wildlands Engineering

View Downstream

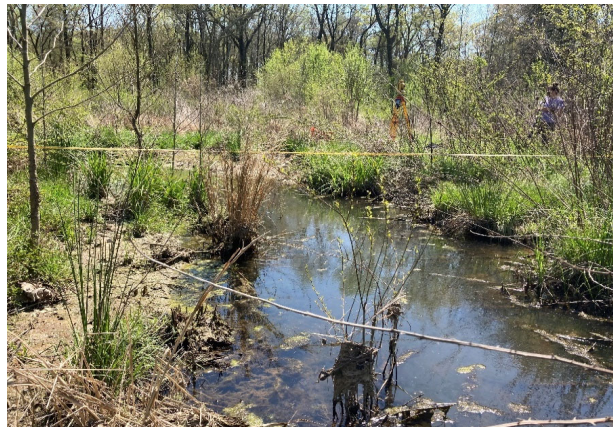
Cross Section 3-UT1

14.6	x-section area (ft.sq.)
12.8	width (ft)
1.1	mean depth (ft)
2.2	max depth (ft)
14.4	wetted perimeter (ft)
1.0	hydraulic radius (ft)
11.2	width-depth ratio

Survey Date: 04/2021
Field Crew: Wildlands Engineering

View Downstream

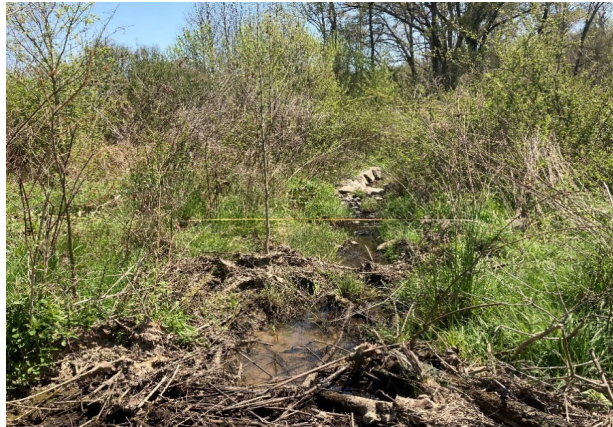
Cross Section 4-UT1

7.6	x-section area (ft.sq.)
11.8	width (ft)
0.6	mean depth (ft)
1.4	max depth (ft)
12.7	wetted perimeter (ft)
0.6	hydraulic radius (ft)
18.3	width-depth ratio
83.0	W flood prone area (ft)
7.1	entrenchment ratio
1.0	low bank height ratio

Survey Date: 04/2021

View Downstream

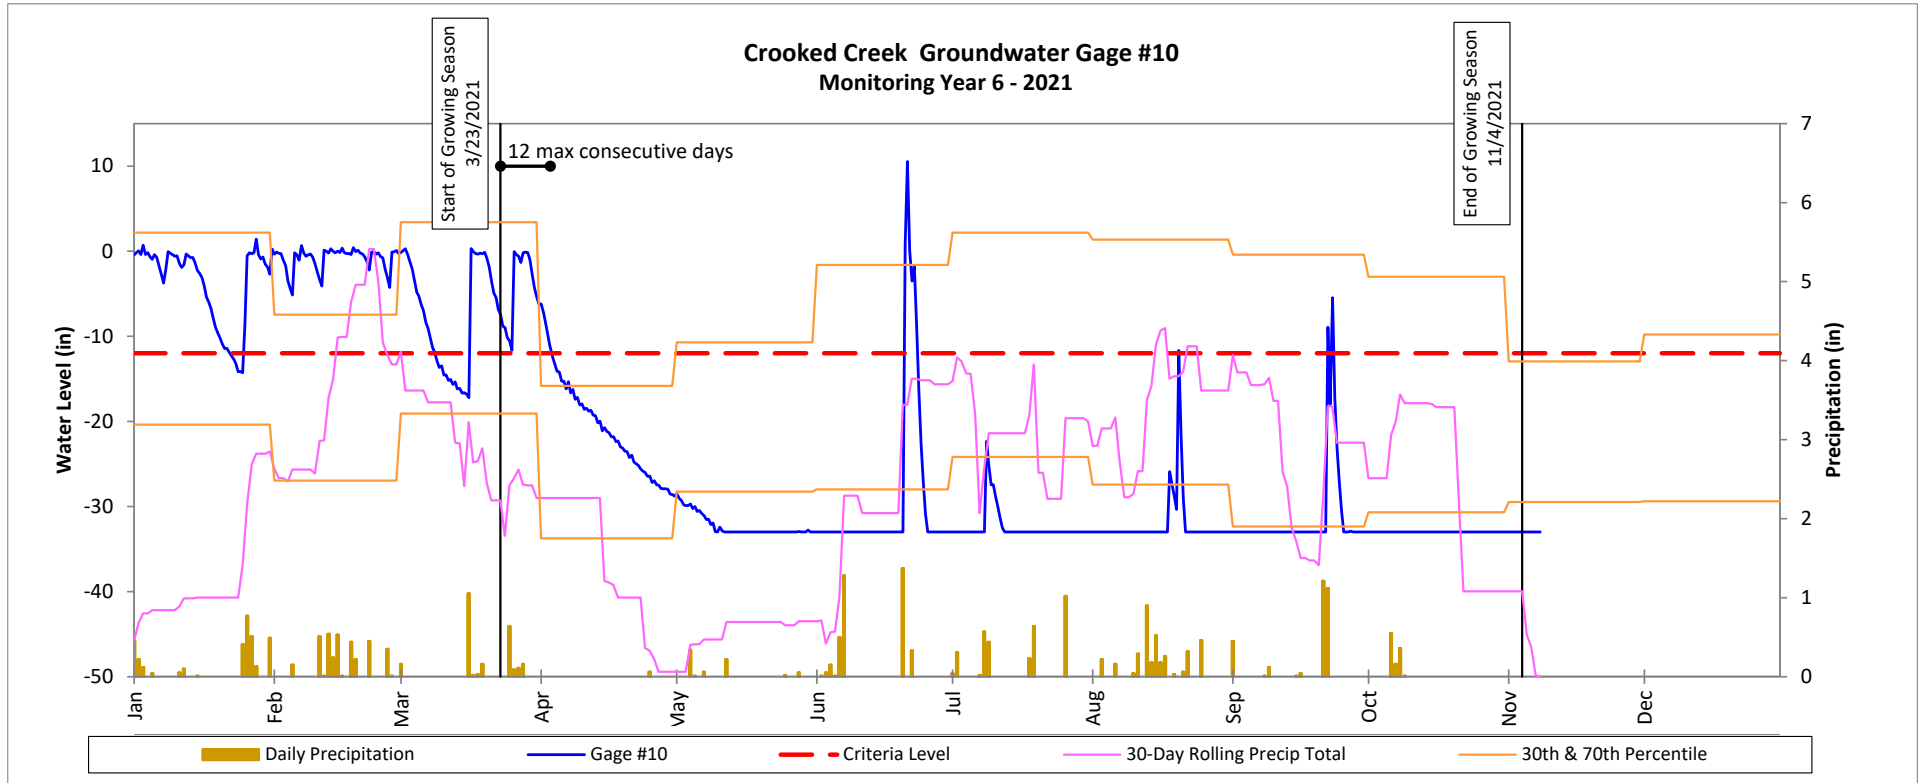
Groundwater Gage Plots

Wetland Restoration

A total of 11 groundwater gages (GWG) have been installed throughout the wetland areas to provide groundwater level data and one soil temperature probe was installed near GWG2. The target success criteria for wetland hydrology success consists of a groundwater surface within 12 inches of the ground surface for 17 consecutive days (7.5 %) of the defined 226 day growing season for Union County (March 23 through November 4) under typical precipitation conditions.

Within the group of groundwater gages not meeting success criteria in MY6 (GWGs 1, 2, 4, 5, 9, 10, and 11), GWG2, and GWG5 met in both MY4 and MY5, missing the success criteria by 3 days in MY6. GWG1, GWG9, and GWG10 are all located on the wetland edges and have not consistently met throughout the monitoring period, including MY6. These three only met in MY4, which is most likely due to the substantial rainfall that occurred in the later winter and early spring, enabling the wetlands to retain high groundwater surface levels. GWG4 has yet to meet criteria and GWG11 has not met since it was installed in March 2020. However, as detailed in the MY5 report, there is evidence from both the vegetation and the developing soils in the areas surrounding both gages that the floodplain may be saturated during a period of the year.

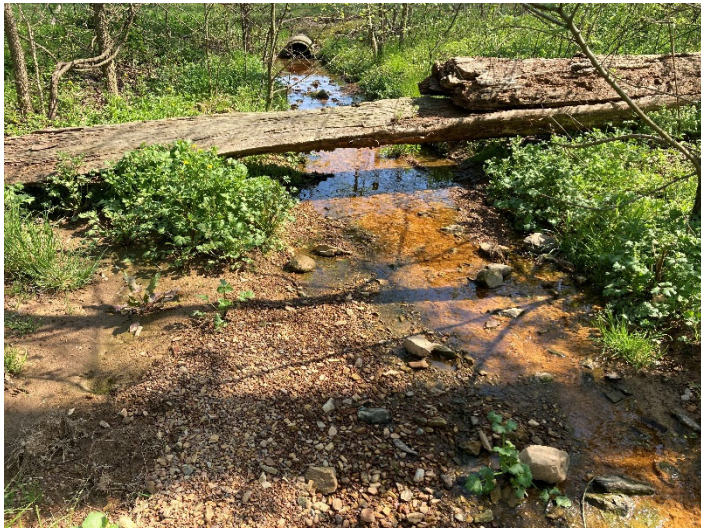
UT2 water in channel – UT2 (4/05/2021)

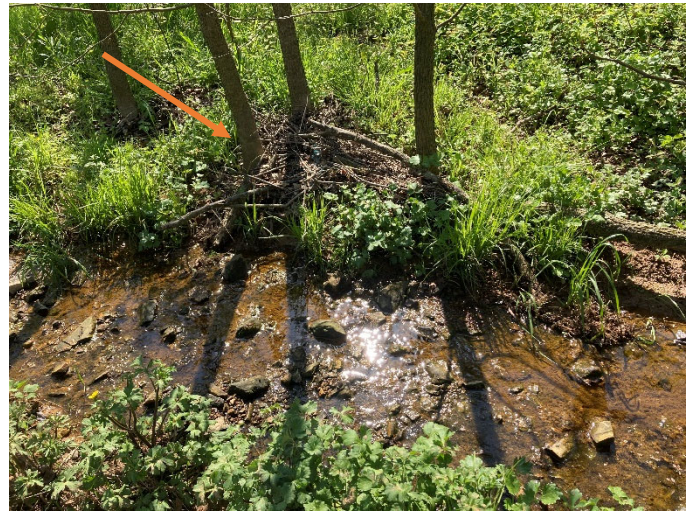
Wrack Lines – UT2 (4/05/2021)

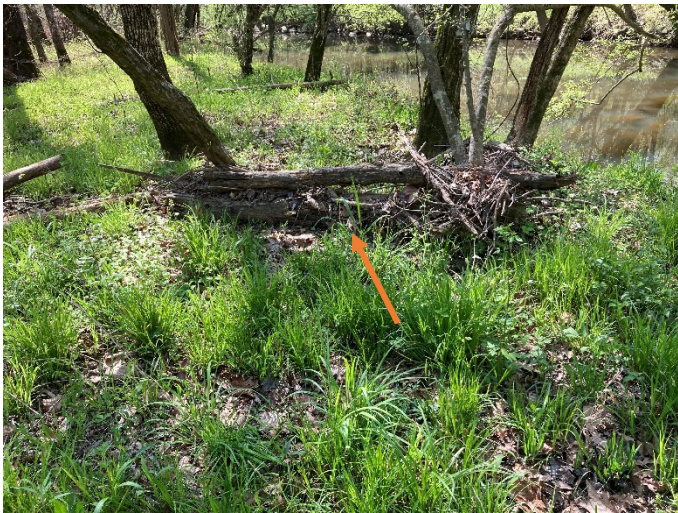
Wrack Lines – Crooked Creek (4/05/2021)

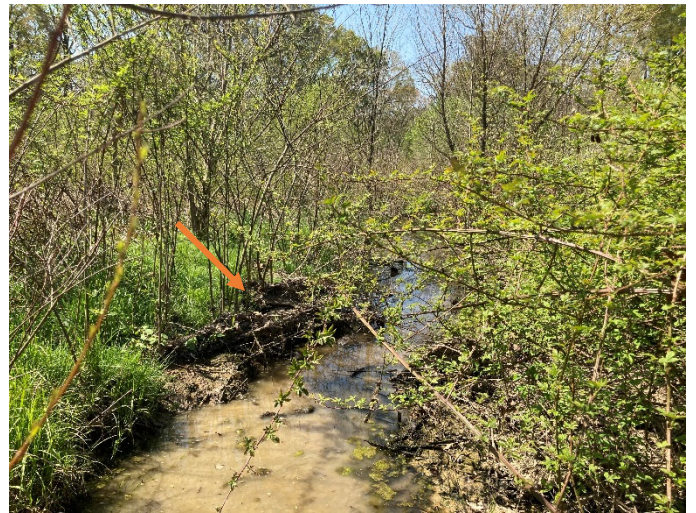
Wrack Lines – UT1 (4/05/2021)
