STREAM RESTORATION PLAN

**City of Fayetteville Property
Cross Creek and Little Cross Creek
Cumberland County, North Carolina**

October 2002

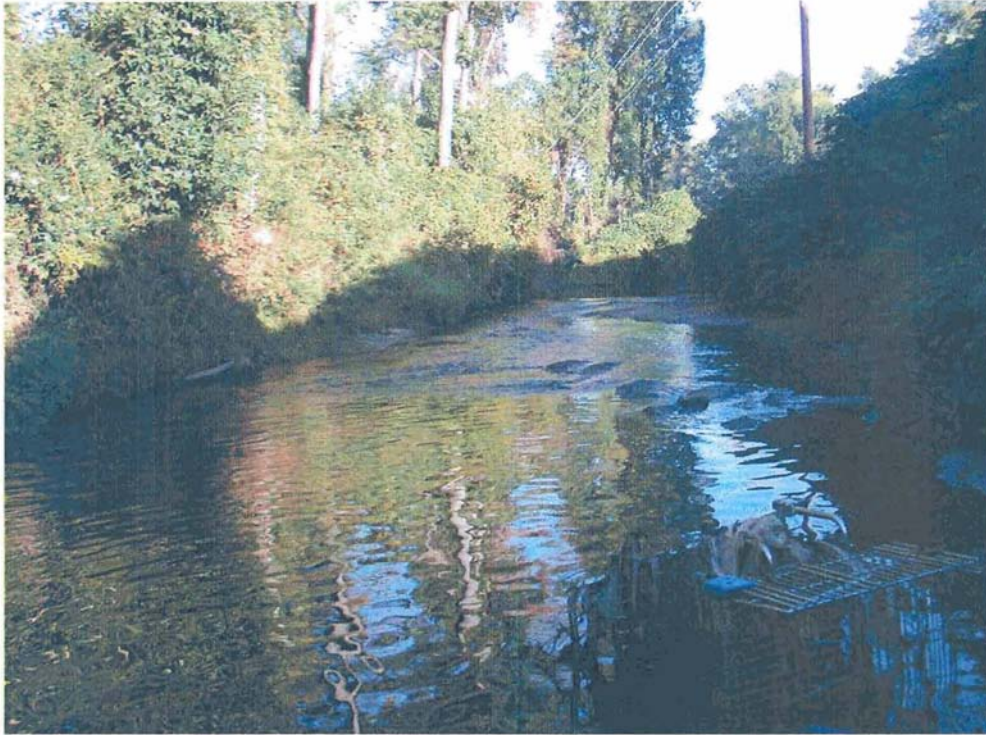
Picture 1. Looking upstream at Riffle Cross-section #1. Trash in foreground.

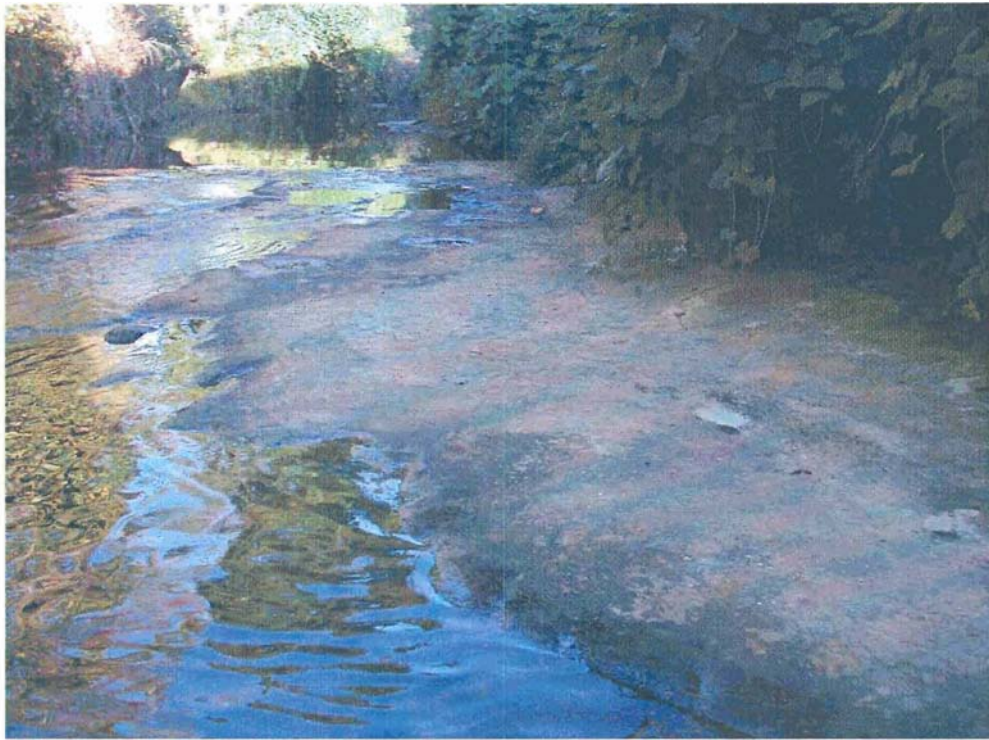
Picture 2. Tape stretched across Cross-section #1. Sandstone on the right.

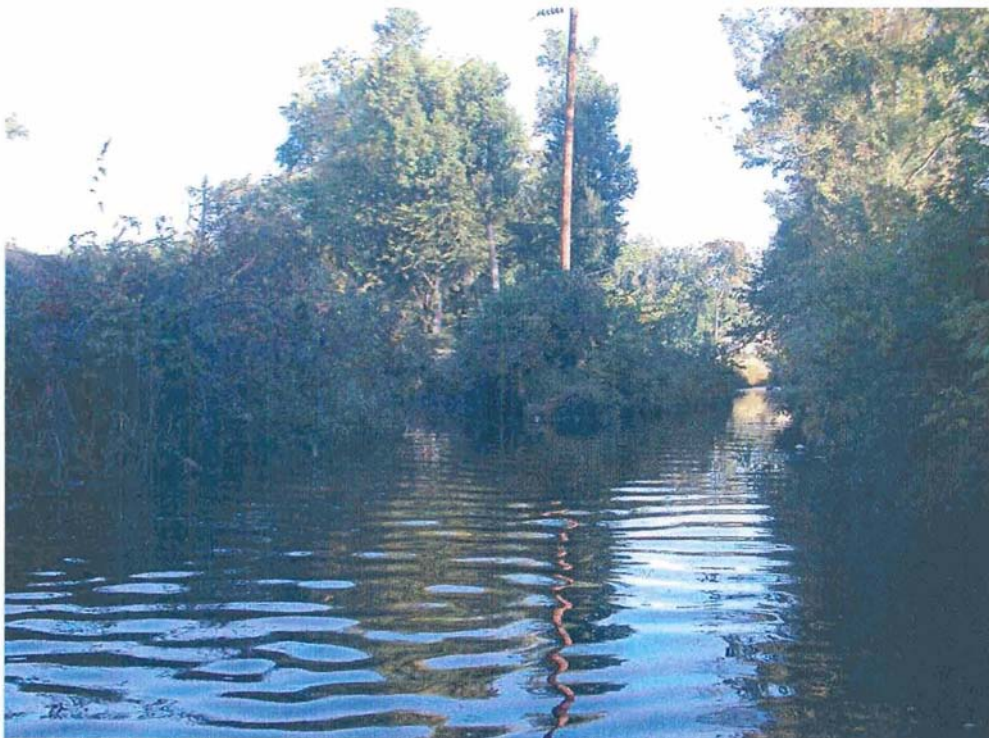
Picture 3. Sandstone at Riffle Cross-section #1. Kudzu along right bank.

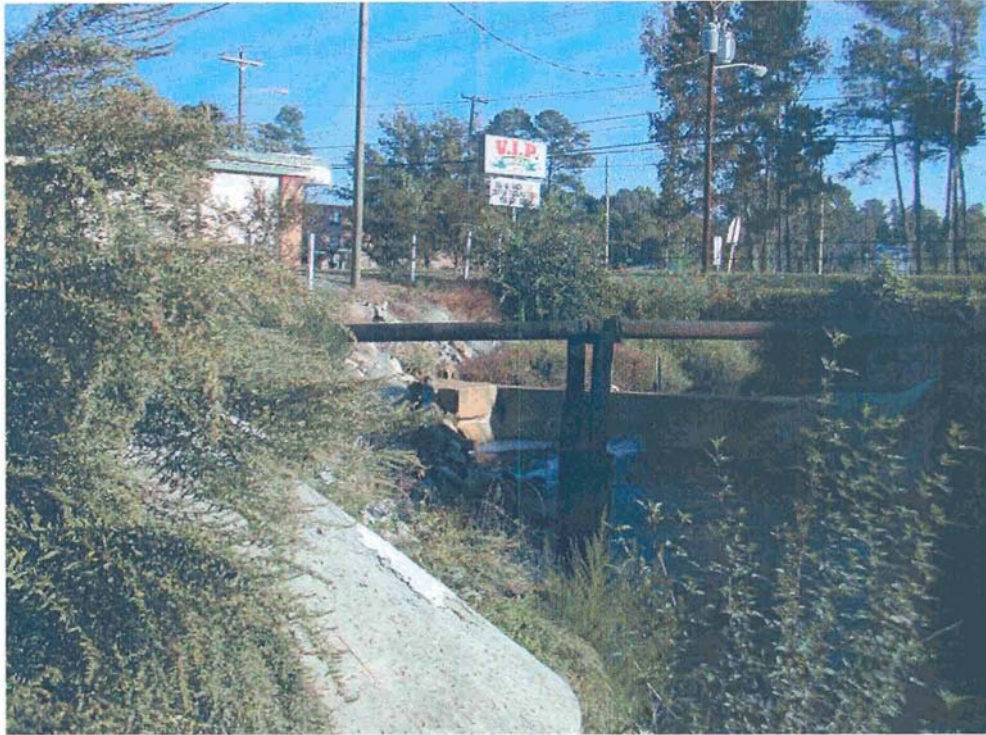
Picture 6. Looking downstream at Riffle Cross-section #2. Tape stretched across stream.

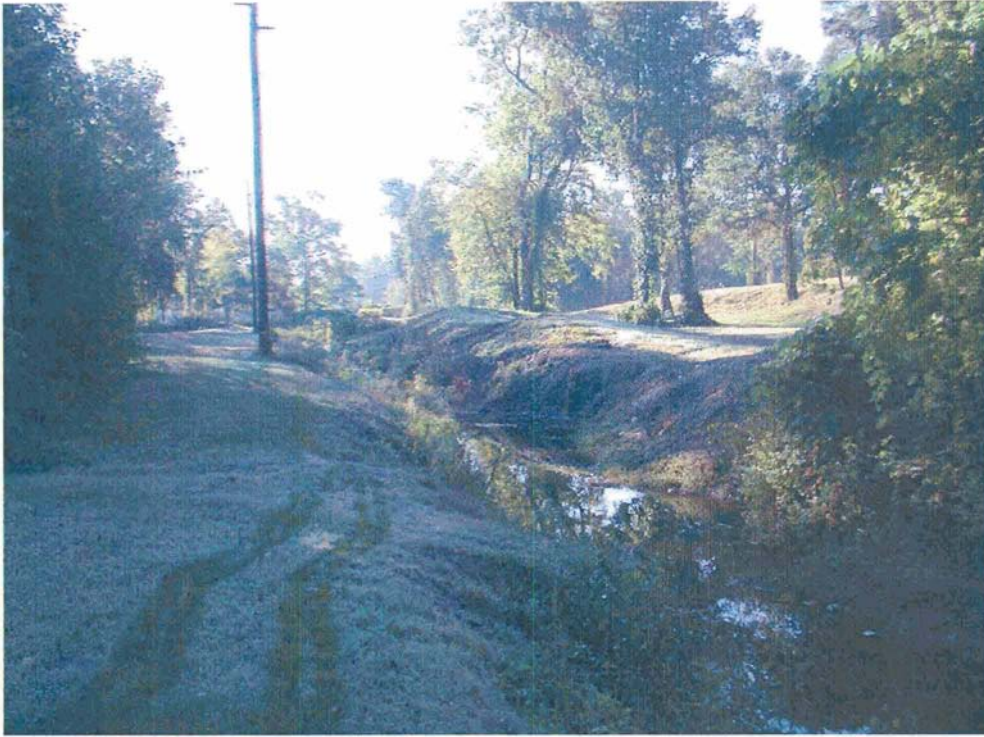
Picture 8. Culvert at beginning of Reach 3, Little Cross Creek.

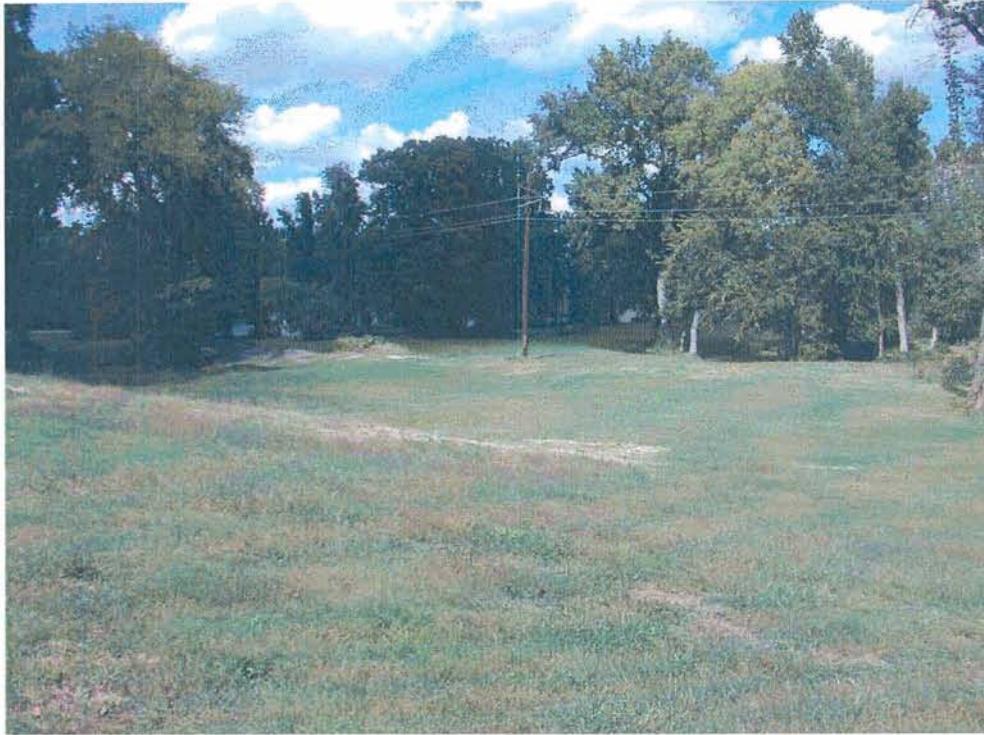
Picture 10. Looking upstream at Riffle Cross-section #3 on Little Cross Creek.

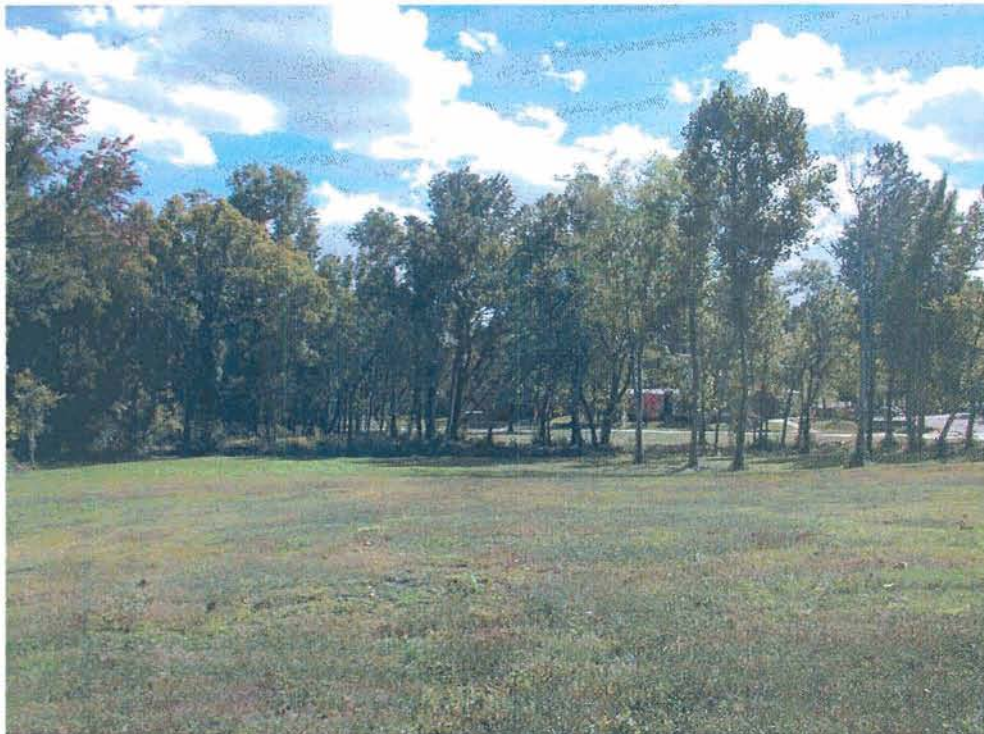
Picture 11. Hill slope along Washington Drive on west side of floodplain.

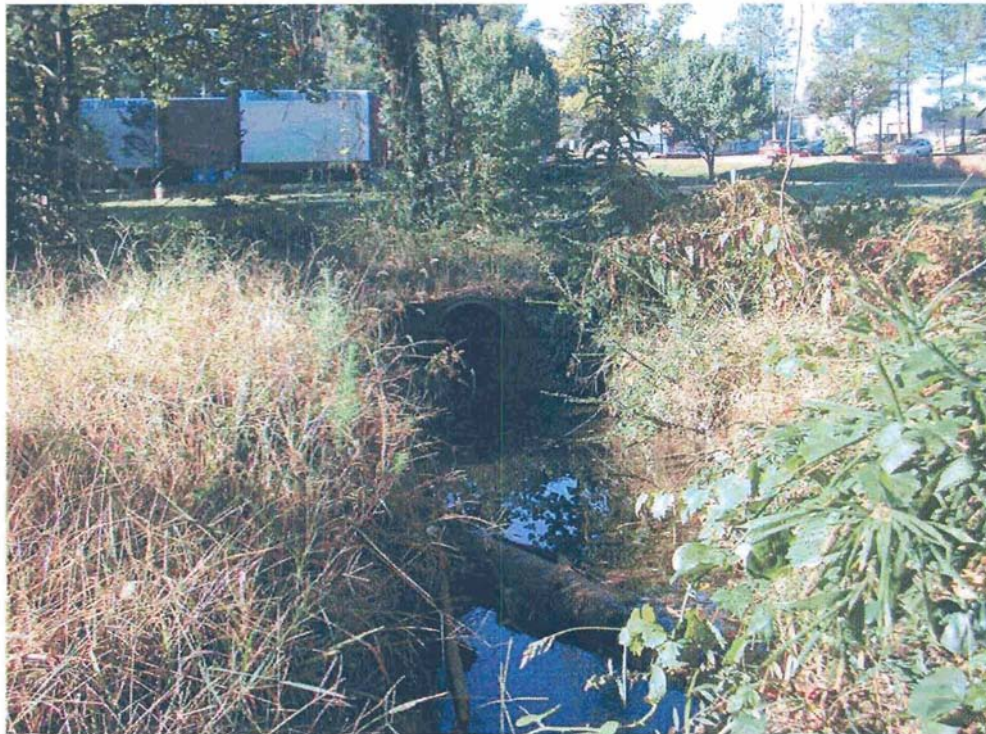
Picture 13. Large drainage ditch at south end of property. 48" pipe has failed.

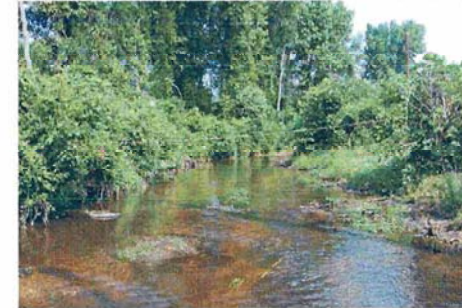
Photo of Riffle CS#6 looking in the upstream direction.

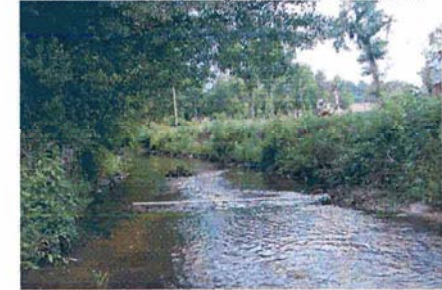
Photo of Riffle CS#5 looking in the downstream direction.

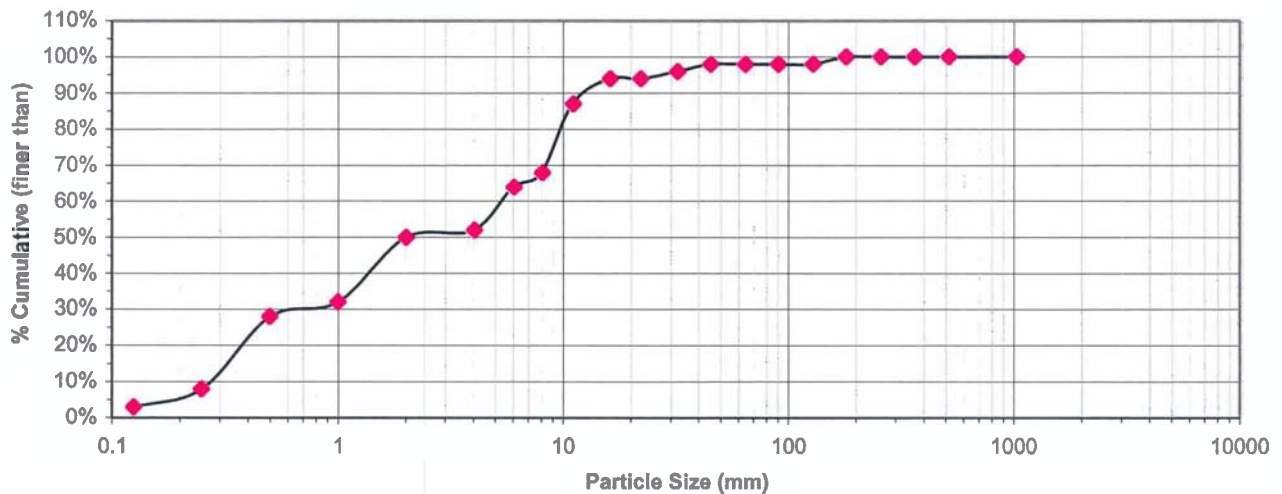
PEBBLE COUNT									
Site: Cross Creek							5/29/2002		
Party: Ben Goetz, Jan Patterson, Jane Almon							Cross Creek		
Particle Count									
Inches	Particle Silt/Clay	Millimeter < 0.062	S/C	Riffle	Run/Pool	Total No.	Item %	% Cumulative	
				0	0	0	0%	0%	
.04 - .08	Very Fine	.062 - .125	S	0	3	3	3%	3%	
	Fine	.125 - .25	A	4	1	5	5%	8%	
	Medium	.25 - .50	N	14	6	20	20%	28%	
	Coarse	.50 - 1.0	D	2	2	4	4%	32%	
	Very Coarse	1.0 - 2.0	S	0	18	18	18%	50%	
.08 - .16	Very Fine	2.0 - 4.0		0	2	2	2%	52%	
.16 - .22	Fine	4.0 - 5.7	G	10	2	12	12%	64%	
.22 - .31	Fine	5.7 - 8.0	R	1	3	4	4%	68%	
.31 - .44	Medium	8.0 - 11.3	A	11	8	19	19%	87%	
.44 - .63	Medium	11.3 - 16.0	V	3	4	7	7%	94%	
.63 - .89	Coarse	16.0 - 22.6	E	0	0	0	0%	94%	
.89 - 1.26	Coarse	22.6 - 32.0	L	2	0	2	2%	96%

Particle Size Distribution
 Cross Creek - Cumberland County, NC

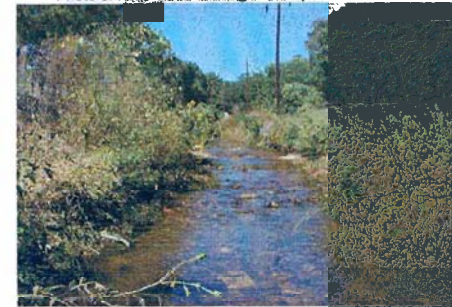
Photo of Riffle CS#3 looking in the upstream direction

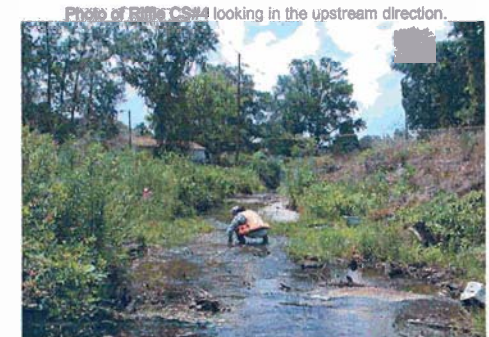
Field Crew: Ben Goetz, Jan Patterson, Jane Almon
River Basin: Cape Fear
Watershed: Little Cross Creek upstream of convergence
Stream Reach: Little Cross Creek- Reach 3
Drainage Area: 10.0 sq mi (6,503 acres)
Date: 5/29/2002
Station: ~100' upstream of convergence
Feature: Riffle CS#4

SUMMARY DATA (BANKFULL)			
A(BKF)	43.6	W(FPA)	37
W(BKF)	23.0	Slope	0.0037
Max d	2.5	Sinuosity	1.1
Mean d	1.9	Area= A	
W/D	12.1	Width= W	
Entrenchment	1.6	Depth= D	
Stream Type	G5	Bankfull= BKF	
Area from Rural Regional Curve			270

Bank Erosion Hazard Index (BEHI)			
Criteria	Value	Index	Bank Erosion
Bank H/Bkf Ht	2.4	8.5	Very Low
Root Depth/Bank Ht	0.8	3.6	Low
Root Density (%)	45	5.2	Low
Bank Angle (Degrees)	26	2.2	Low
Surface Protection (%)	80	1.9	Very Low
Bank Materials	Sand	5	
TOTAL		26.4	Moderate

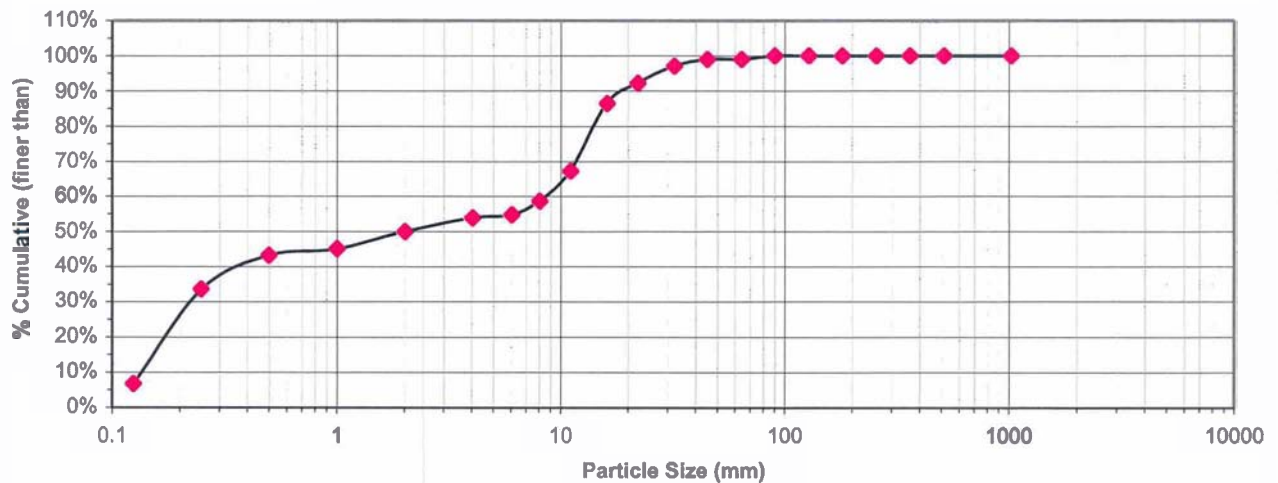
PEBBLE COUNT									
Site: Little Cross Creek							5/29/2002		
Party: Ben Goetz, Jan Patterson, Jane Almon							Little Cross Creek		
Particle Count									
Inches	Particle	Millimeter		Riffle			Total No.	Item %	% Cumulative
	Silt/Clay	< 0.062	S/C	2			2	2%	2%
.04 - .08	Very Fine	.062 - .125	S	5			5	5%	7%
	Fine	.125 - .25	A	28			28	27%	34%
	Medium	.25 - .50	N	10			10	10%	43%
	Coarse	.50 - 1.0	D	2			2	2%	45%
	Very Coarse	1.0 - 2.0	S	5			5	5%	50%
.08 - .16	Very Fine	2.0 - 4.0		4			4	4%	54%
.16 - .22	Fine	4.0 - 5.7	G	1			1	1%	55%
.22 - .31	Fine	5.7 - 8.0	R	4			4	4%	59%
.31 - .44	Medium	8.0 - 11.3	A	9			9	9%	67%
.44 - .63	Medium	11.3 - 16.0	V	20			20	19%	87%
.63 - .89	Coarse	16.0 - 22.6	E	6			6	6%	92%
.89 - 1.26	Coarse	22.6 - 32.0	L	5			5	5%	97%

Particle Size Distribution
 Little Cross Creek - Cumberland County, NC

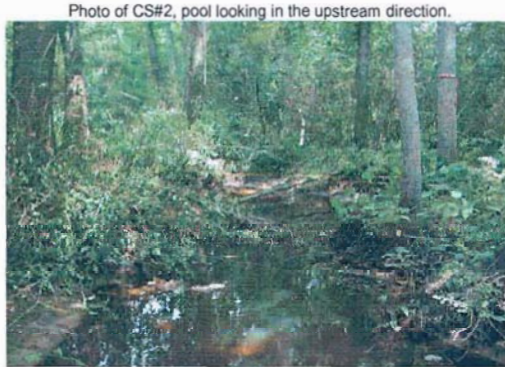
Field Crew: Ben Goetz, Jan Patterson, Jane Almon
River Basin: Cape Fear
Watershed: Country Club Branch
Reach: Hickory Hill/Elk Lodge
DA: 2.7 sq mi (1,740 ac)
Date: 6/27/2002
Station: 0+92
Feature: CS #2, Pool

SUMMARY DATA (BANKFULL)	
A(BKF)	25.0
W(BKF)	15.0
Max d	4.2
Mean d	1.7

Bank Erosion Hazard Index (BEHI)			
Criteria	Value	Index	Bank Erosion Potential
Bank Ht/Bkf Ht	1	1	very low
Root Depth/Bank Ht	1	1	very low
Root Density (%)	90	1.5	very low
Bank Angle (Degrees)	90	7.9	high
Surface Protection (%)	90	1.5	very low
Bank Materials	silt	0	
Total		12.9	low

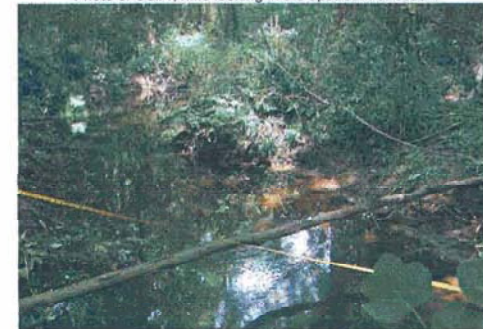
Photo of CS#1, riffle looking in the upstream direction.

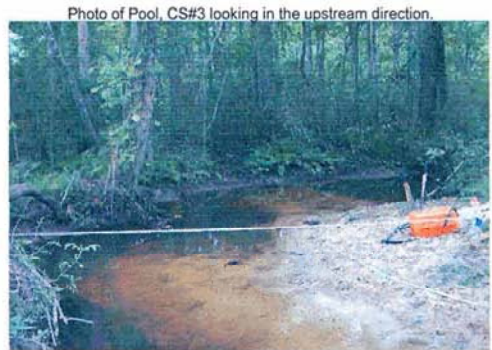
Field Crew: Ben Goetz, Jan Patterson, Jane Almon
River Basin: Cape Fear
Watershed: Country Club Branch
Reach: Hickory Hill/Elk Lodge
DA: 2.7 sq mi (1,740 ac)
Date: 6/27/2002
Station: 1+20
Feature: CS #3, Pool

BANKFULL Hydraulic Geometry		
Width (Feet)	Depth (Feet)	Area (Sq. Ft.)
0.0	0.0	0.0
12.0	0.2	1.3
6.5	0.3	1.5
5.5	0.6	2.3
3.0	0.6	1.7
3.0	0.4	1.5
3.0	0.6	1.5
1.0	0.8	0.7
3.0	1.2	2.9
1.0	1.4	1.3
1.5	1.7	2.3
1.0	1.9	1.8
1.0	2.6	2.3
0.8	2.8	2.2
0.7	2.7	1.9
0.3	3.1	0.9
0.7	0.7	1.3
1.5	0.3	0.8
0.5	0.2	0.1
1.0	0.1	0.1
2.0	0.0	0.1
TOTALS	49.0	28.4

Bank Erosion Hazard Index (BEHI)			
Criteria	Value	Index	Bank Erosion Potential
Bank Ht/Bkf Ht	1	1	very low
Root Depth/Bank Ht	1	1	very low
Root Density (%)	90	1.5	very low
Bank Angle (Degrees)	80	5.9	moderate
Surface Protection (%)	75	3.6	low
Bank Materials	silt	0	
Total		13	low

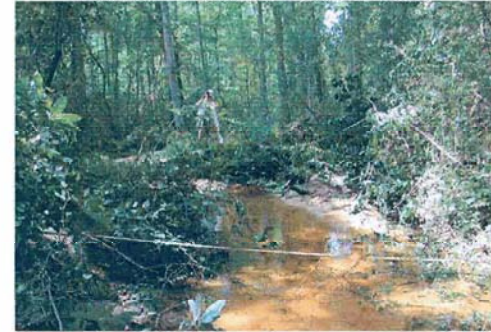
Photo of CS#4, riffle looking in the upstream direction.

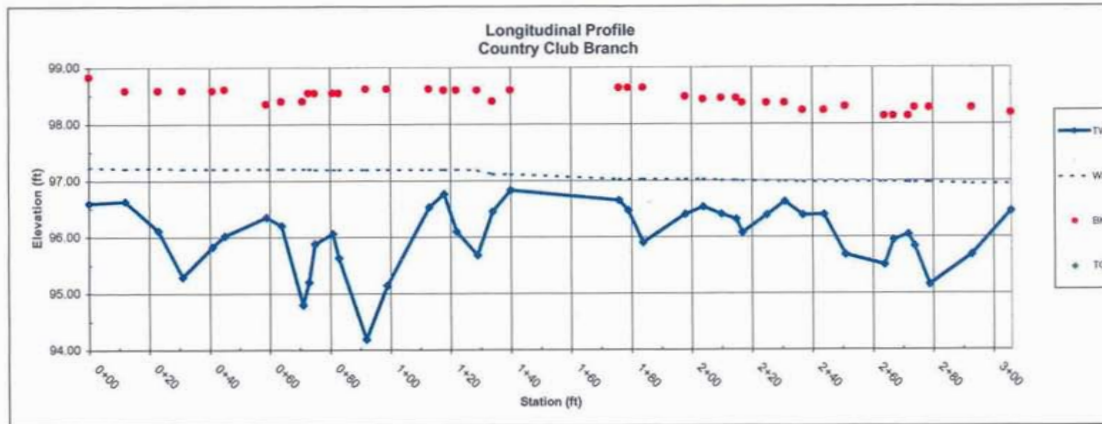
Country Club Branch
Cumberland County

LONGITUDINAL PROFILE
River Basin: Cape Fear
Watershed: Country Club Branch
Stream Reach: Country Club Branch
DA (ac mi): 2.7 sq.mi.
Date: #####

P-P	Pool Length	Max Pool Depth	Pool Slope	Riffle Length	Riffle Slope	
				12.0	0.17	
	18.0	3.30	0.00			
				14.0	0.00	
41.0	9.0	3.60	0.00			
				6.0	0.00	
19.0	16.0	4.43	0.00			
				5.0	0.00	
38.0	12.0	2.62	0.00			
				36.0	0.25	
57.0	19.0	2.74	0.00			
				6.0	0.33	
38.0	10.0	2.30	0.00			
				0.0	0.17	
20.0	20.0	2.62	0.00			
				5.0	0.20	
30.0	10.0	3.13	0.00			
max	57	20	4.43	0.0000	36	0.3333
min	19	9	2.30	0.0000	5	0.1667
avg	38	15	3.13	0.0000	11	0.2375
Max ratio	1.84	0.65	0.14	0.00	1.18	3.07
Min ratio	0.61	0.29	0.07	0.00	0.19	1.54
avg ratio	1.16	0.50	0.10	0.00	0.36	2.19

Average Slope: 0.1084

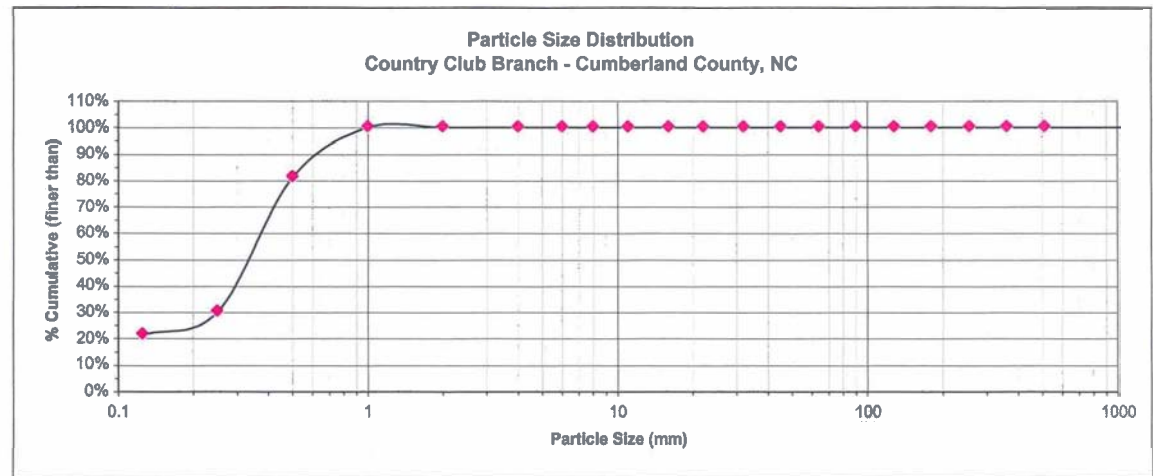
Country Club Branch
Cumberland County

PEBBLE COUNT										
Site: Country Club Branch							3/25/2002			
Party: Ben Goetz, Jan Patterson							Country Club Branch			
Inches	Particle Silt/Clay	Millimeter	S/C	Particle Count				Total No.	Item %	% Cumulative
				Riffle	Pool	Riffle	Pool			
		< 0.062	S	2	0	1	7	10	13%	13%
.04 - .08	Very Fine	.062 - .125	S	2	2	2	1	7	9%	21%
	Fine	.125 - .25	A	1	3	1	2	7	9%	30%
	Medium	.25 - .50	N	11	10	13	7	41	51%	81%
	Coarse	.50 - 1.0	D	4	5	3	3	15	19%	100%
	Very Coarse	1.0 - 2.0	S					0	0%	100%
.08 - .16	Very Fine	2.0 - 4.0						0	0%	100%
.16 - .22	Fine	4.0 - 5.7	G					0	0%	100%
.22 - .31	Fine	5.7 - 8.0	R					0	0%	100%
.31 - .44	Medium	8.0 - 11.3	A					0	0%	100%
.44 - .63	Medium	11.3 - 16.0	V					0	0%	100%
.63 - .89	Coarse	16.0 - 22.6	E					0	0%	100%
.89 - 1.26	Coarse	22.6 - 32.0	L					0	0%	100%

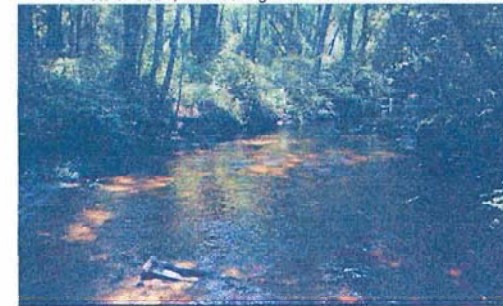
Photo of CS#1, riffle looking in the downstream direction.

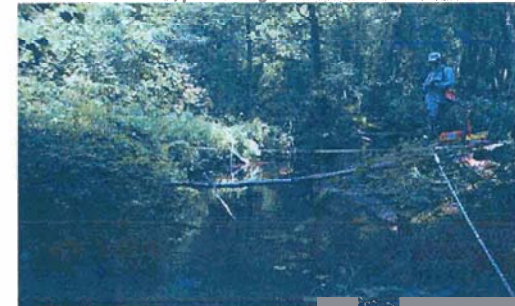
Photo of CS#2, pool looking in the downstream direction.

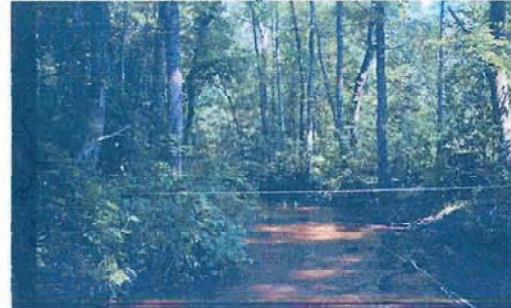
Photo of CS#3, riffle looking in the downstream direction.

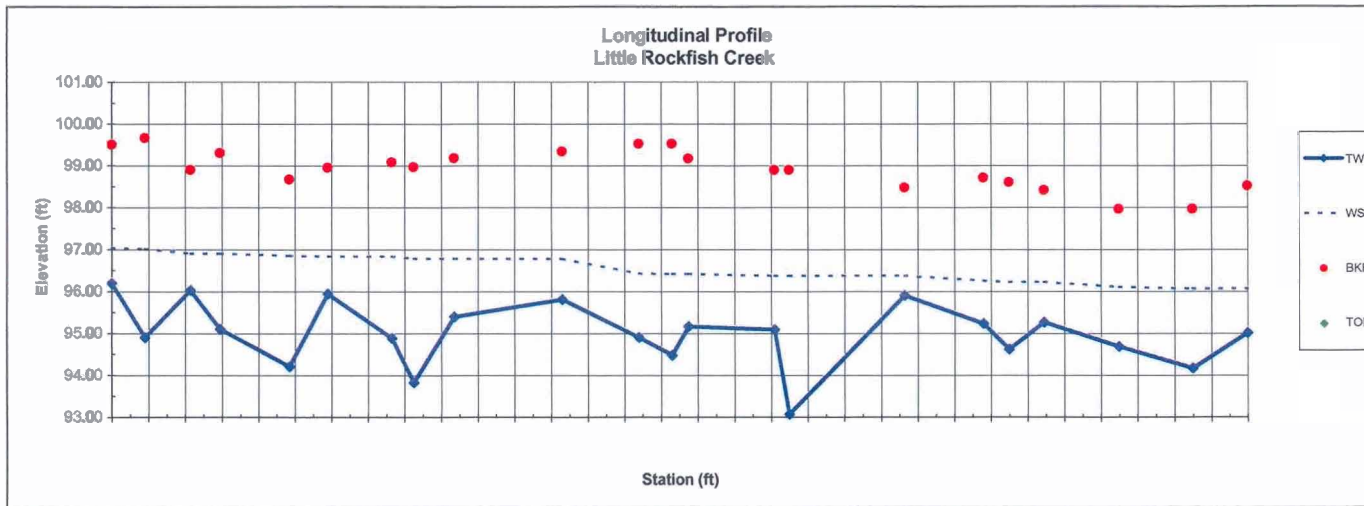
Little Rockfish Creek
Cumberland County

Field Crew: Ben Goetz, Jan Patterson, Jane Almon
River Basin: Cape Fear
Watershed: Little Rockfish Creek
Reach: Gillis Farm
DA: 16.5 sq mi (10,650 ac)
Date: 7/2/2002

Average Water Surface Slope 0.16

P-P	Pool Length	Max Pool Depth	Pool Slope	Riffle Length	Riffle Slope	
	41.0		0.00	18.0	0.11	
		2.88				
				38.0	0.13	
79.0	56.0		0.04			
		3.01				
				12.0	0.42	
68.0	81.0		0.00			
		3.78				
123.0	27.0		0.04	42.0	0.83	
		5.04				
				47.0	0.11	
74.0	71.0		0.00			
		5.83				
				43.0	0.28	
114.0	33.0		0.09			
		3.98				
74.0	70.0		0.06	41.0	0.29	
		3.79				
max	123.0	81.0	5.8	0.0909	47.0000	0.8333
min	68	27	2.88	0.0000	12.0000	0.1064
avg	88.7	54.1	4.0	0.0315	34.4286	0.3101
Max ratio	8.2	4.1	0.3	0.58	300.41	5.33
Min ratio	3.4	1.4	0.1	0.00	76.70	0.68
avg ratio	4.4	2.7	0.2	0.20	220.06	1.98

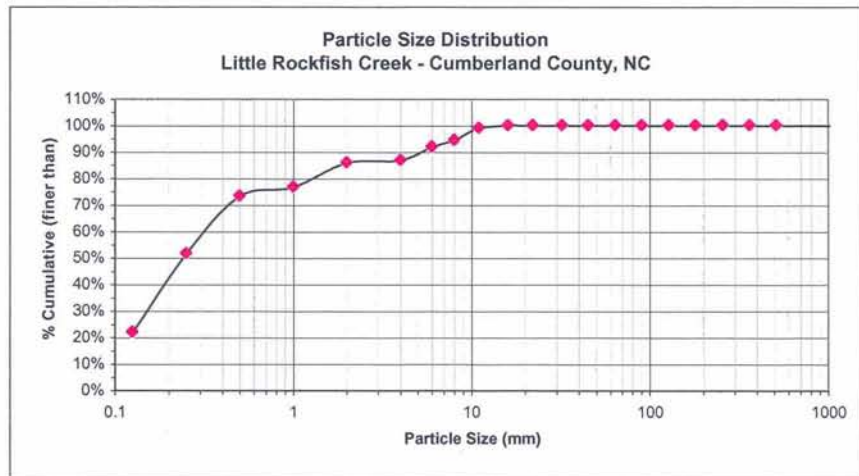
Little Rockfish Creek Cumberland County

PEBBLE COUNT							
Site: Gillis Farm					6/2/2002		
Party: Ben Goetz, Jan Patterson					Little Rockfish Creek		
Particle Count							
Inches	Particle	Millimeter		Riffle	Total No.	Item %	% Cumulative
	Silt/Clay	< 0.062	S/C	12	12	6%	6%
.04 - .08	Very Fine	.062 - .125	S	31	31	16%	22%
	Fine	.125 - .25	A	59	59	30%	52%
	Medium	.25 - .50	N	43	43	22%	73%
	Coarse	.50 - 1.0	D	7	7	4%	77%
	Very Coarse	1.0 - 2.0	S	18	18	9%	86%
.08 - .16	Very Fine	2.0 - 4.0		2	2	1%	87%
.16 - .22	Fine	4.0 - 5.7	G	10	10	5%	92%
.22 - .31	Fine	5.7 - 8.0	R	5	5	3%	94%
.31 - .44	Medium	8.0 - 11.3	A	9	9	5%	99%
.44 - .63	Medium	11.3 - 16.0	V	2	2	1%	100%
.63 - .89	Coarse	16.0 - 22.6	E				100%
.89 - 1.26	Coarse	22.6 - 32.0	L				100%
