Crowns West Restoration Project Mitigation Plan Report

Onslow County, North Carolina

Monitoring Firm: Baker Engineering

Date Submitted: April 2007

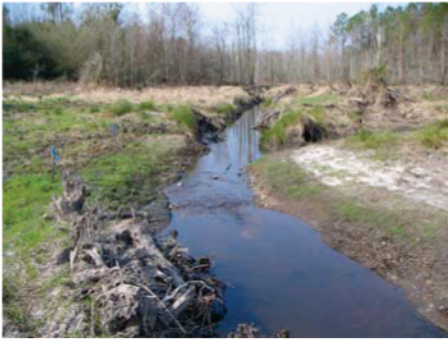
3/21/2007
Photo Point 1 Constructed Riffle 1

Photographs will be taken at each grade control structure along the restored stream. Photographers should make every effort to consistently maintain the same area in each photo over time. Photographs will be used to evaluate channel aggradation or degradation, bank erosion, success of riparian vegetation, and effectiveness of erosion control measures subjectively. Lateral photos should not indicate excessive erosion or continuing degradation of the banks. A series of photos over time should indicate successive maturation of riparian vegetation.

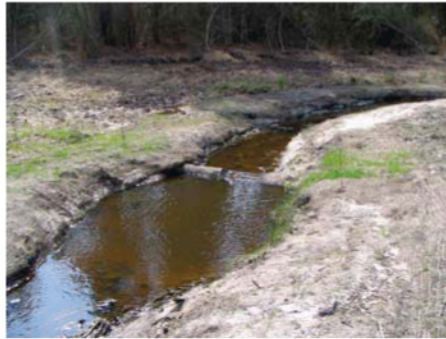
3/21/2007
Photo Point 2 Log Weir 1

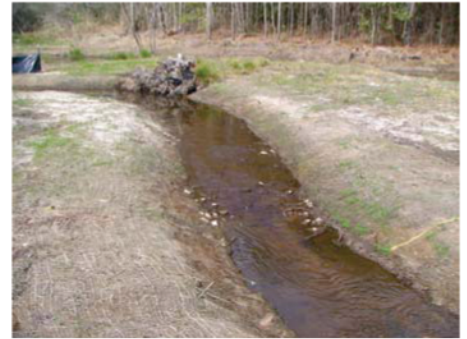
3/21/2007
Photo Point 3 Constructed Riffle 2

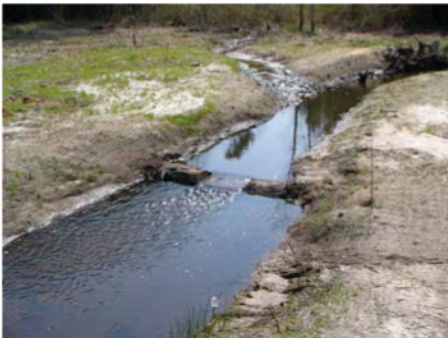
3/21/2007
Photo Point 4 Log Weir 2

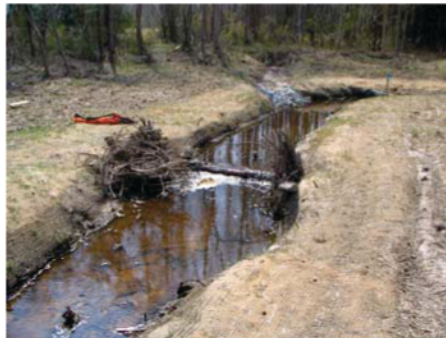
3/21/2007
Photo Point 5 Log Weir 3

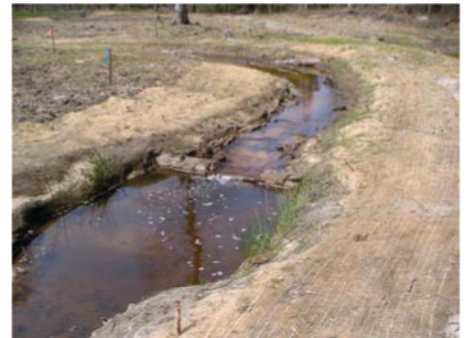
3/21/2007
Photo Point 6 Log Weir 4

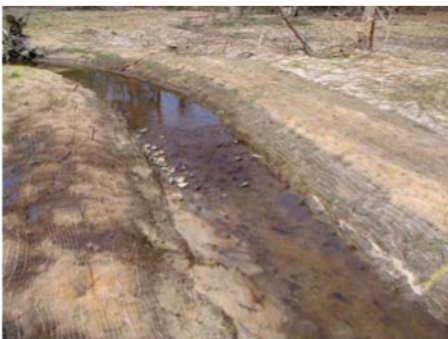
3/21/2007
Photo Point 7 Constructed Riffle 3

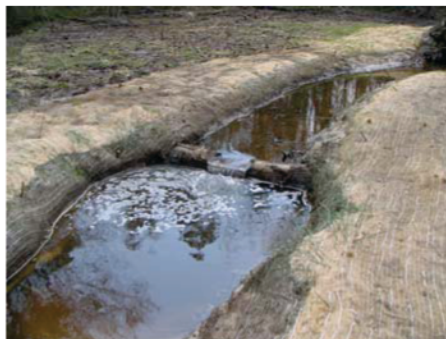
3/21/2007
Photo Point 8 Log Weir 5

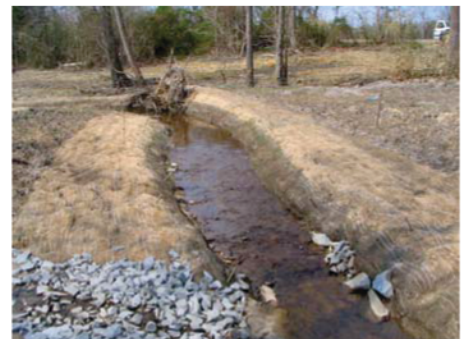
3/21/2007
Photo Point 9 Constructed Riffle 4

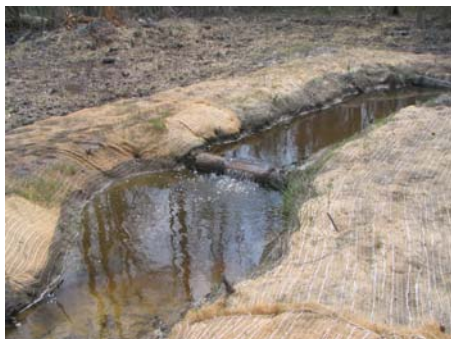
3/21/2007
Photo Point 10 Log Weir 6

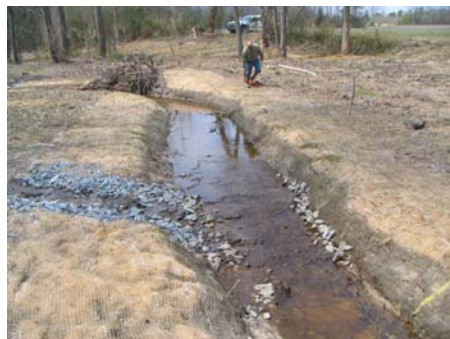
3/21/2007
Photo Point 11 Constructed Riffle 5

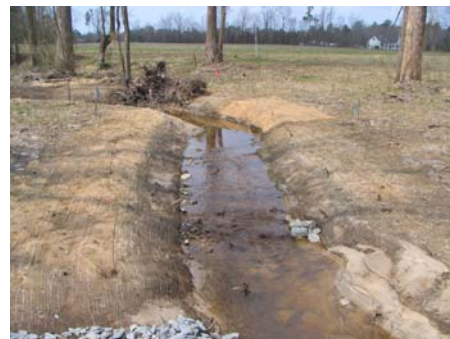
3/21/2007
Photo Point 12 Constructed Riffle 6

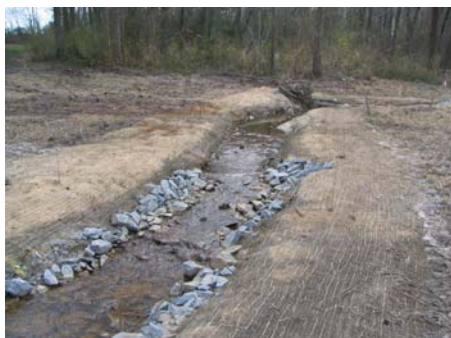
3/21/2007
Photo Point 13 Constructed Riffle 7

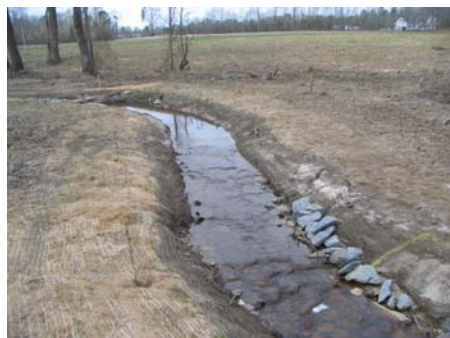
3/21/2007
Photo Point 14 Constructed Riffle 8

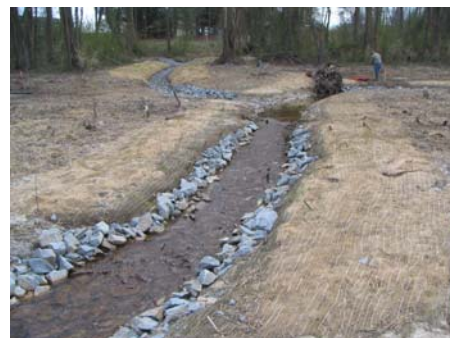
3/21/2007
Photo Point 15 Constructed Riffle 9

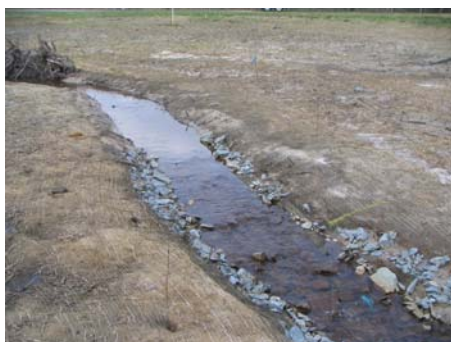
3/21/2007
Photo Point 16 Constructed Riffle 10

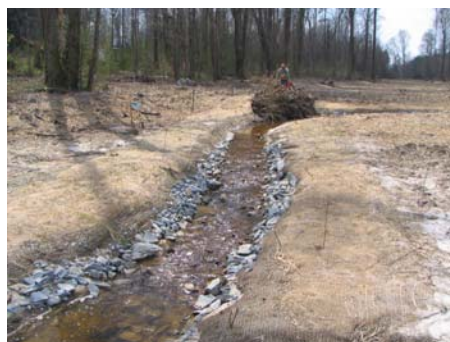
3/21/2007
Photo Point 17 Constructed Riffle 11

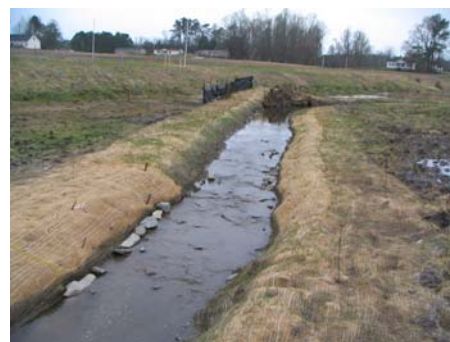
3/21/2007
Photo Point 18 Constructed Riffle 12

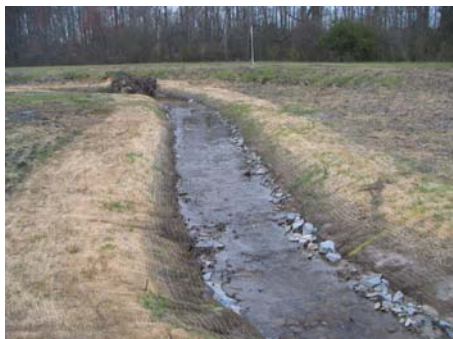
3/21/2007
Photo Point 19 Constructed Riffle 13

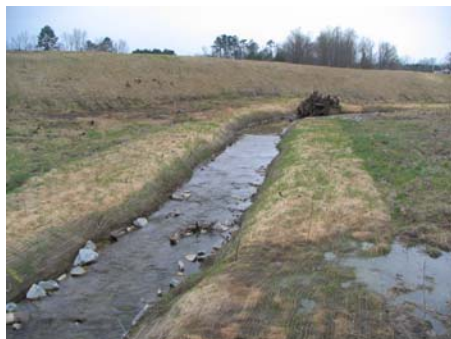
3/21/2007
Photo Point 20 Constructed Riffle 14

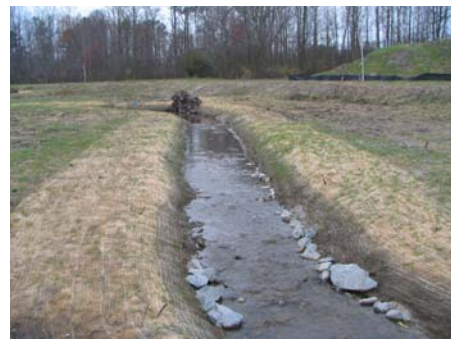
3/21/2007
Photo Point 21 Constructed Riffle 15

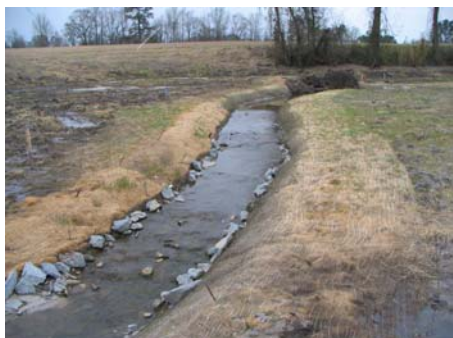
3/21/2007
Photo Point 22 Constructed Riffle 16

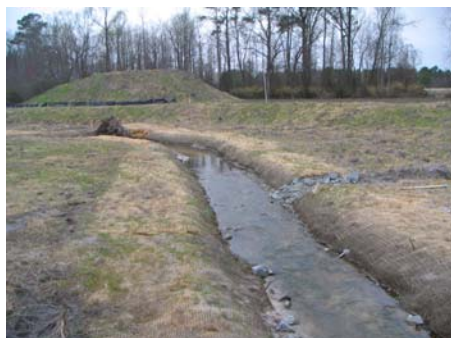
3/21/2007
Photo Point 23 Constructed Riffle 17

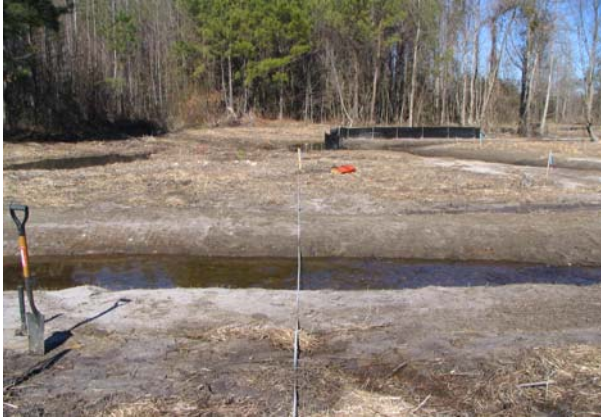
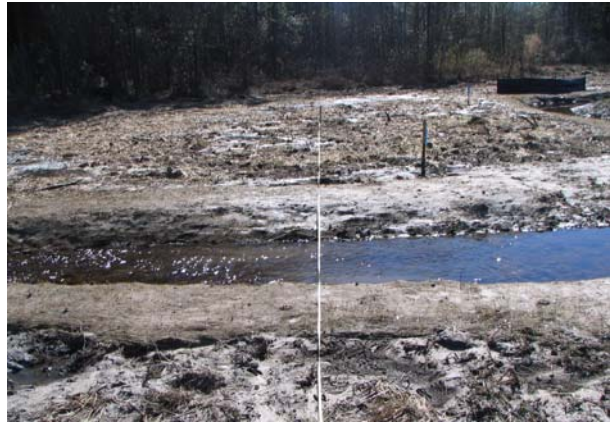
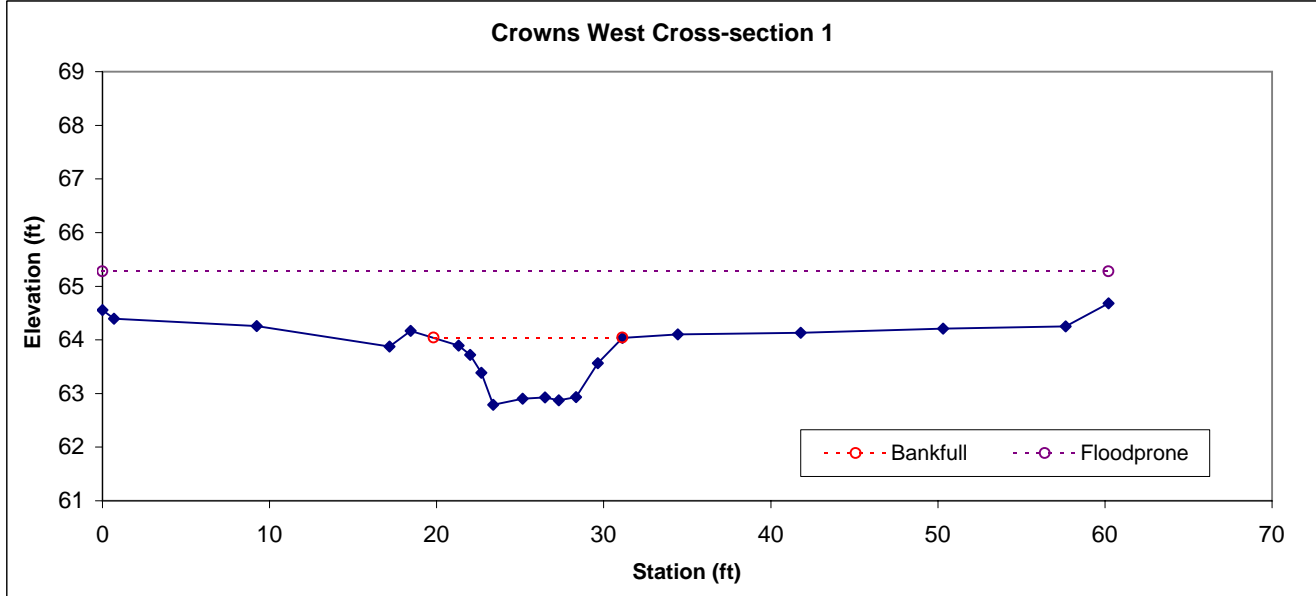
Permanent Cross-section 1
 (As-Built Data - collected Feb. 2007)

Looking at the Left Bank

Looking at the Right Bank

Feature	Stream Type	BKF Area	BKF Width	BKF Depth	Max BKF Depth	W/D	BH Ratio	ER	BKF Elev	TOB Elev	W-fpa
Riffle	C	8.4	11.31	0.74	1.25	15.3	1	5.3	64.04	64.04	60.22

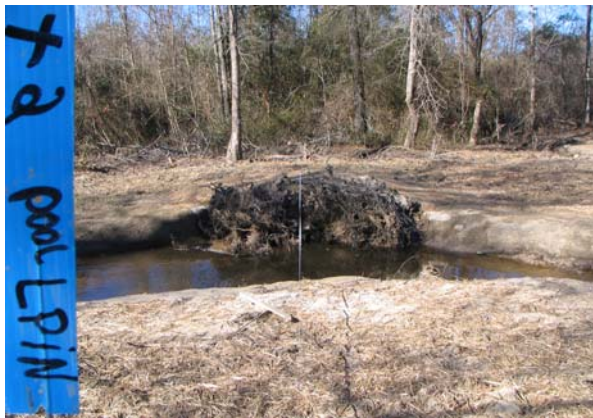
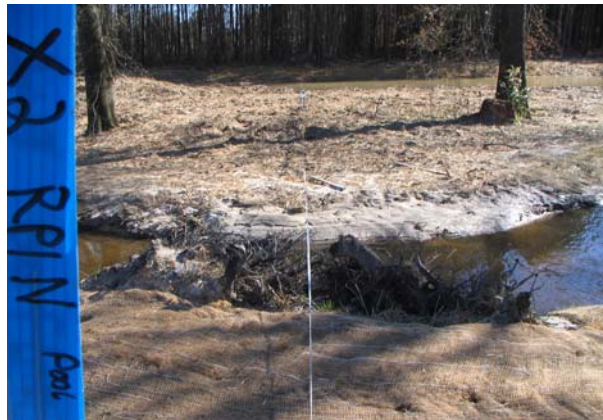
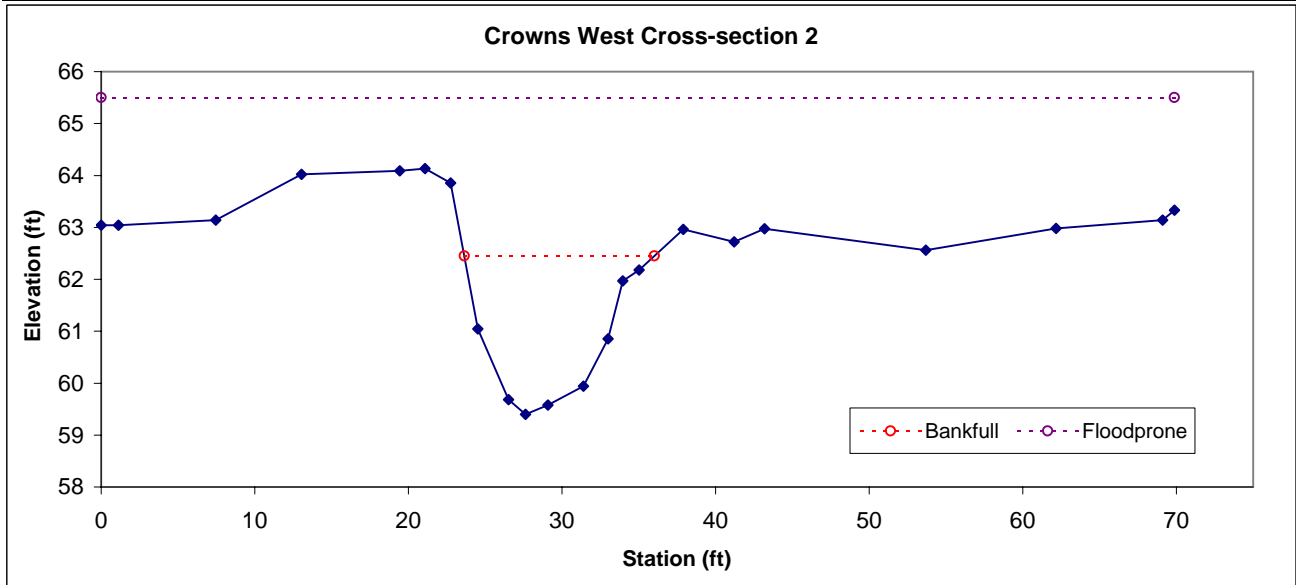
Permanent Cross-section 2
 (As-Built Data - collected Feb. 2007)

Looking at the Left Bank

Looking at the Right Bank

Feature	Stream Type	BKF Area	BKF Width	BKF Depth	Max BKF Depth	W/D	BH Ratio	ER	BKF Elev	TOB Elev	W-fpa
Pool	E	23.3	12.38	1.89	3.05	6.57	1.2	5.6	62.45	62.96	69.87

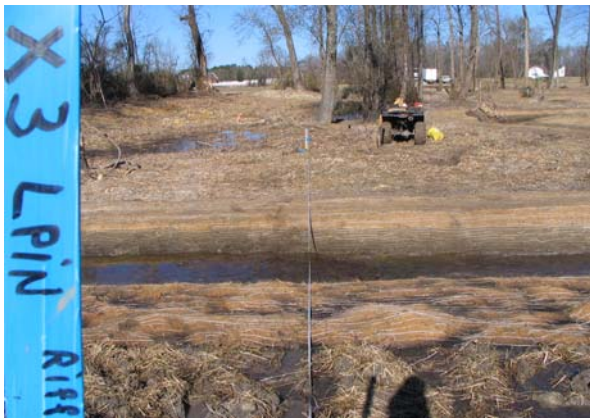
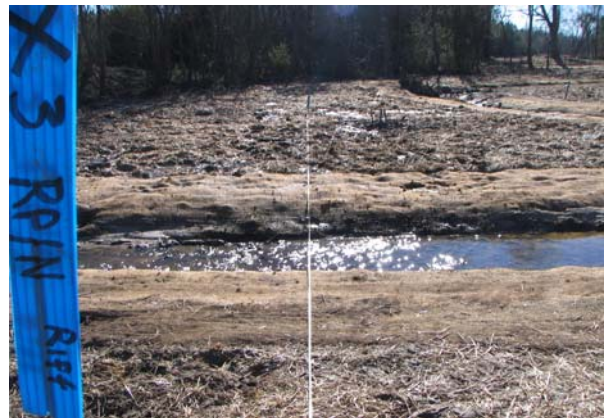
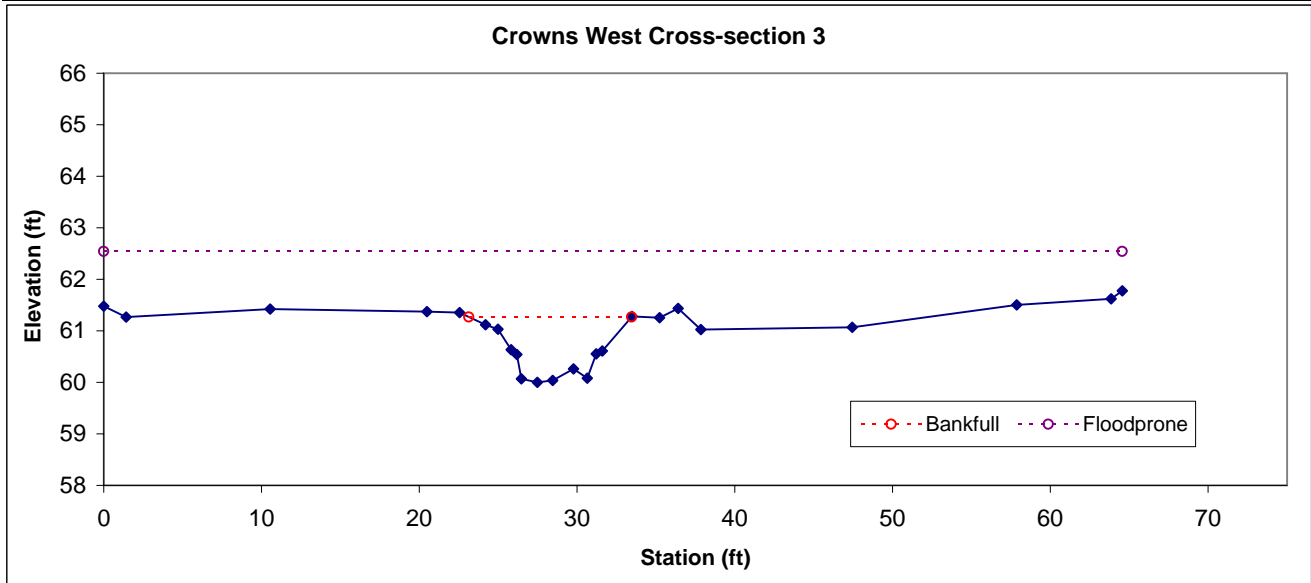
Permanent Cross-section 3
 (As-Built Data - collected Feb. 2007)

Looking at the Left Bank

Looking at the Right Bank

Feature	Stream Type	BKF Area	BKF Width	BKF Depth	Max BKF Depth	W/D	BH Ratio	ER	BKF Elev	TOB Elev	W-fpa
Riffle	C	7.5	10.32	0.72	1.27	14.26	1	6.3	61.27	61.28	64.56

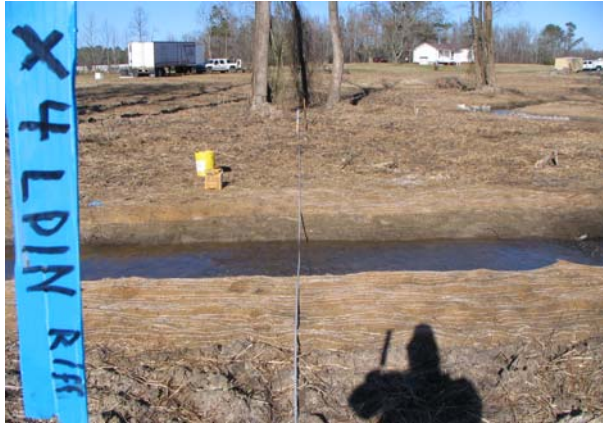
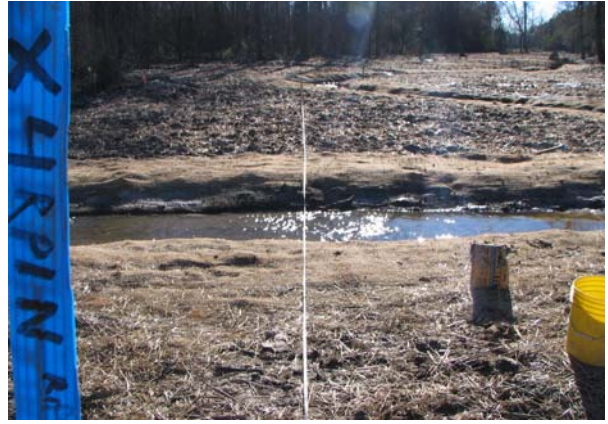
Permanent Cross-section 4
 (As-Built Data - collected Feb 2007)

Looking at the Left Bank

Looking at the Right Bank

Feature	Stream Type	BKF Area	BKF Width	BKF Depth	Max BKF Depth	W/D	BH Ratio	ER	BKF Elev	TOB Elev	W-fpa
Riffle	C	6.3	8.79	0.72	1.2	12.19	1	6.6	58.92	58.92	58.25

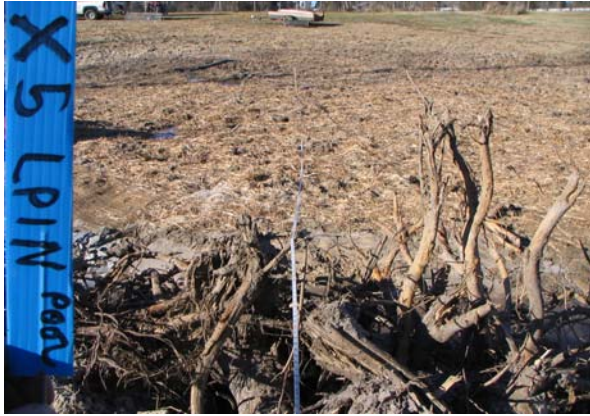
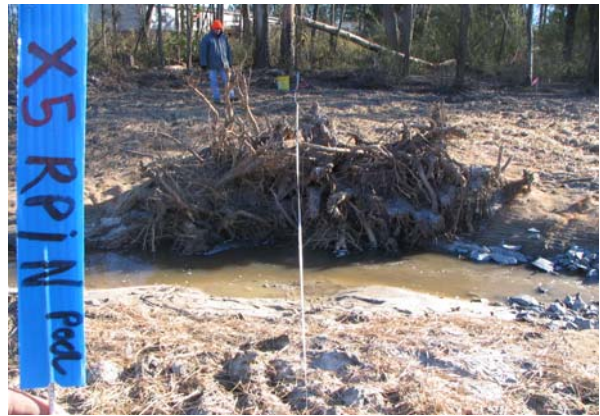
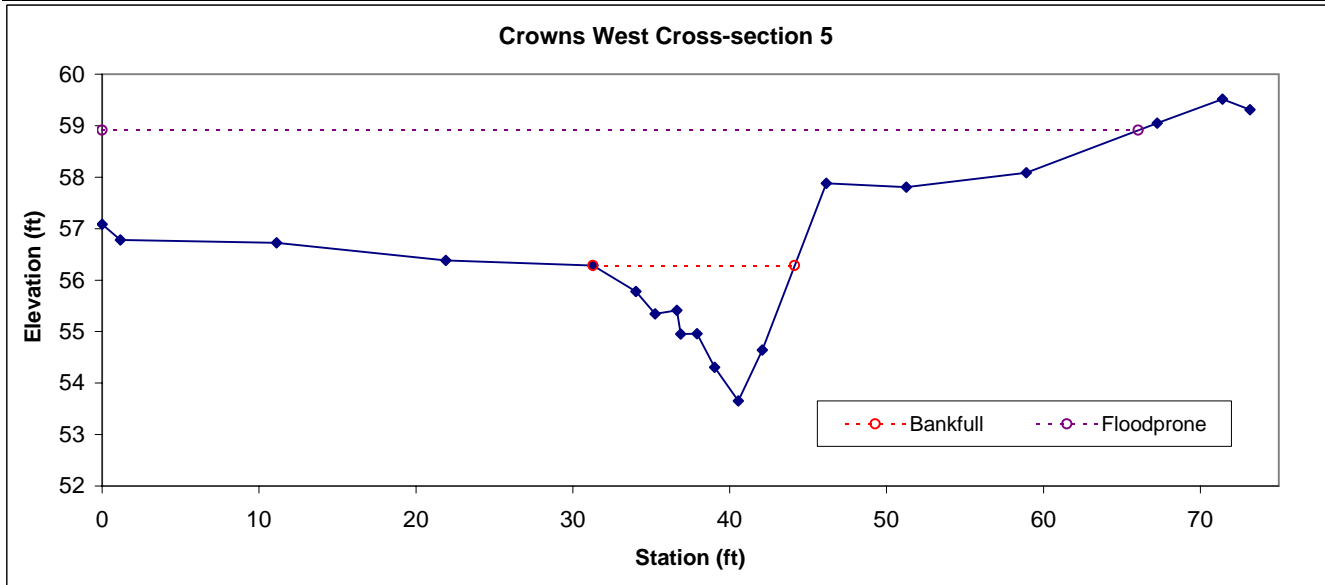
Permanent Cross-section 5
 (As-Built Data - collected Feb. 2007)

Looking at the Left Bank

Looking at the Right Bank

Feature	Stream Type	BKF Area	BKF Width	BKF Depth	Max BKF Depth	W/D	BH Ratio	ER	BKF Elev	TOB Elev	W-fpa
Pool	E	14.7	12.84	1.15	2.63	11.2	1	5.1	56.28	56.28	66.04

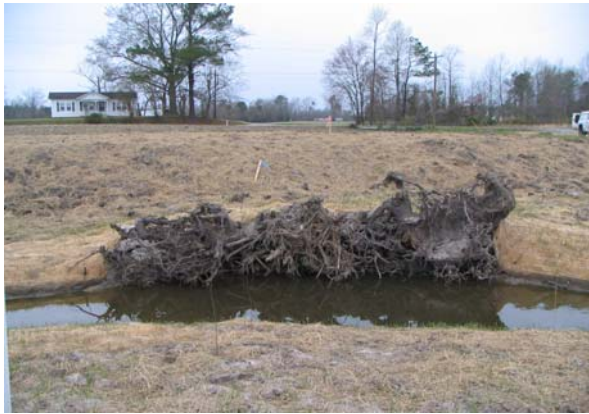
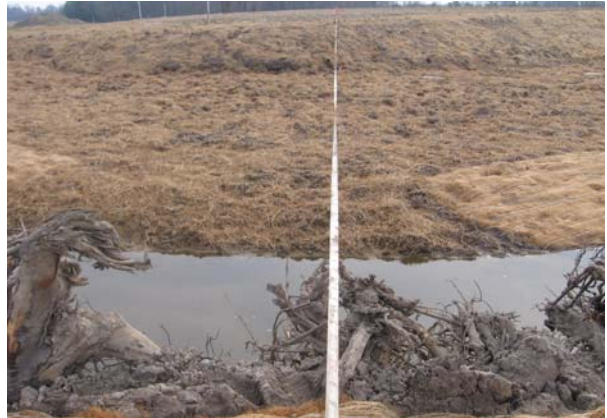
Permanent Cross-section 6
 (As-Built Data - collected March 2007)

Looking at the Left Bank

Looking at the Right Bank

Feature	Stream Type	BKF Area	BKF Width	BKF Depth	Max BKF Depth	W/D	BH Ratio	ER	BKF Elev	TOB Elev	W-fpa
Pool	E	23.8	14	1.7	3.3	8.24	1	5.5	53.05	53.05	76.44

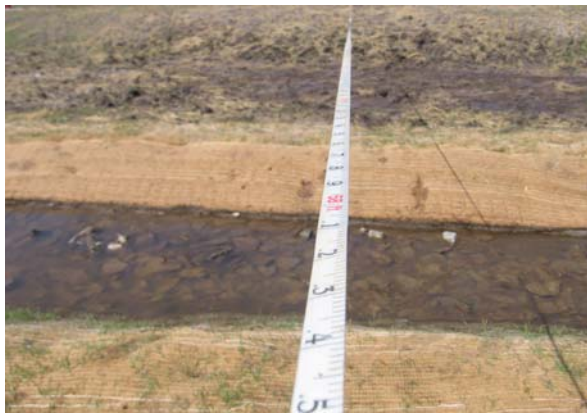
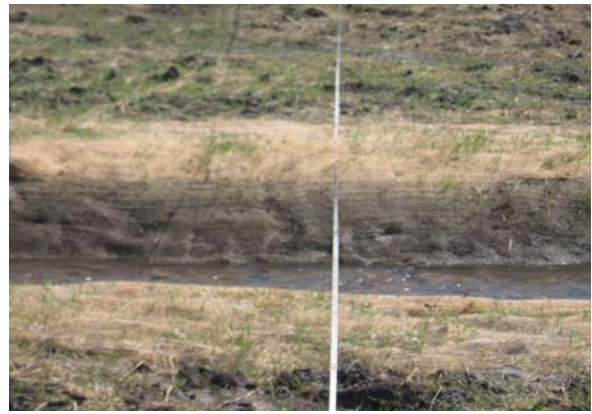
Permanent Cross-section 7
 (As-Built Data - collected March 2007)

Looking at the Left Bank

Looking at the Right Bank

Feature	Stream Type	BKF Area	BKF Width	BKF Depth	Max BKF Depth	W/D	BH Ratio	ER	BKF Elev	TOB Elev	W-fpa
Riffle	E	10	10.6	0.94	1.52	11.25	1	7.1	52.8	52.82	75.71

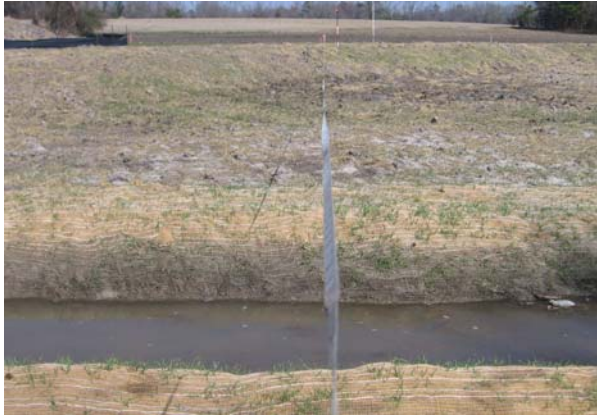
Permanent Cross-section 8
 (As-Built Data - collected March, 2007)

Looking at the Left Bank

There should be little change in the as-built cross-sections. If changes do take place they should be evaluated to determine if they represent a movement toward a more unstable condition (e.g., down-cutting or erosion) or a movement toward increased stability (e.g., settling, vegetative changes, deposition along the banks, or decrease in width/depth ratio).

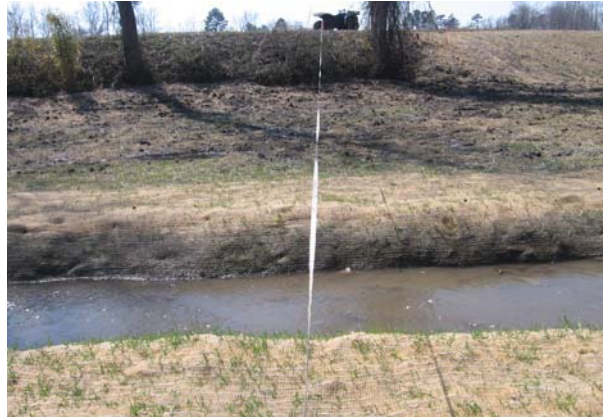
Looking at the Right Bank

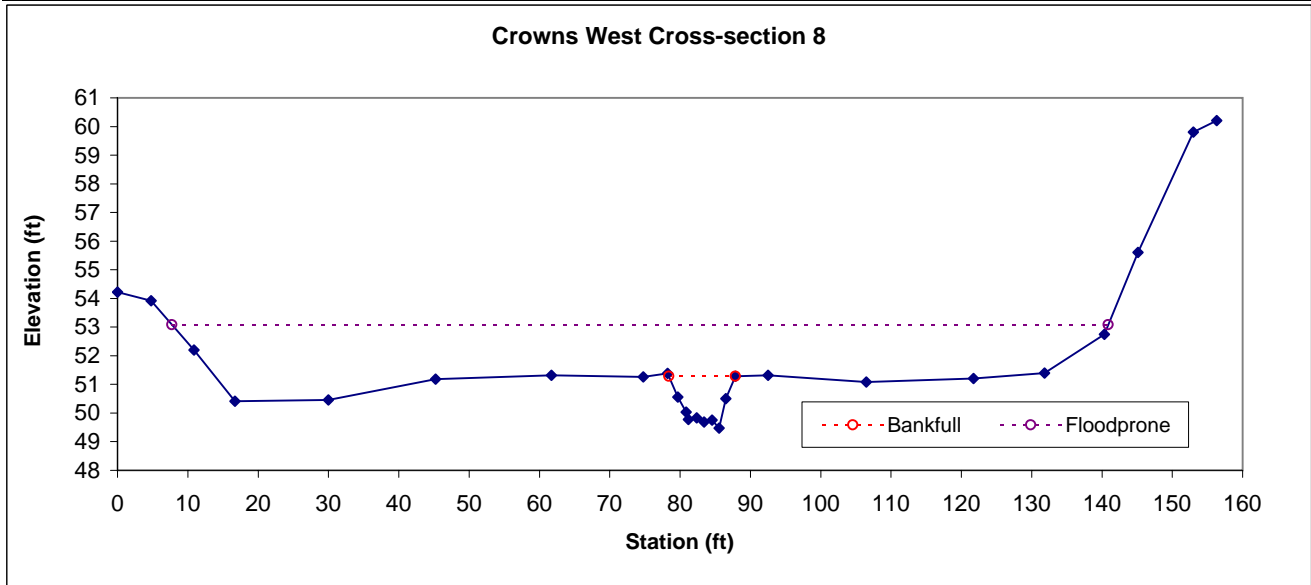
Feature	Stream Type	BKF Area	BKF Width	BKF Depth	Max BKF Depth	W/D	BH Ratio	ER	BKF Elev	TOB Elev	W-fpa
Riffle	E	10.6	9.46	1.12	1.8	8.46	1	14.1	51.28	51.28	133.14

For monitoring stream success criteria, 9 permanent cross-sections, and 1 crest gauge were installed. The permanent cross-sections will be used to monitor channel dimension and bank erosion over time. The crest gauge will be used to document the occurrence of bankfull events. In addition, a complete longitudinal survey was completed for the restored stream channels to provide a base-line for evaluating changes in bed conditions over time. The longitudinal profile included the elevations of all grade control structures. The permanent cross-section and longitudinal data are provided in Appendix B. The location of the permanent cross-sections and the crest gauge are shown on the as-built plan sheets in Appendix C.

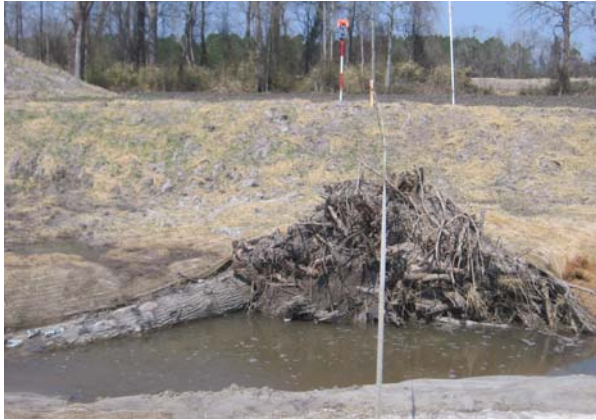
Permanent Cross-section 9
 (As-Built Data - collected March, 2007)

Looking at the Left Bank

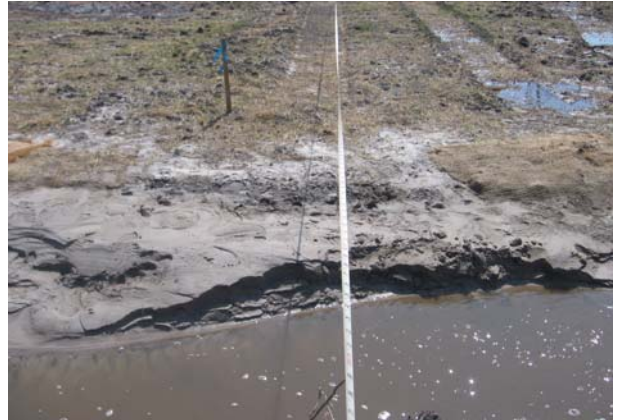
Looking at the Right Bank
