Davis Branch and Unnamed Tributary Restoration Plan

Union County, North Carolina
SCO # D06054-F

Submitted: June 23, 2008

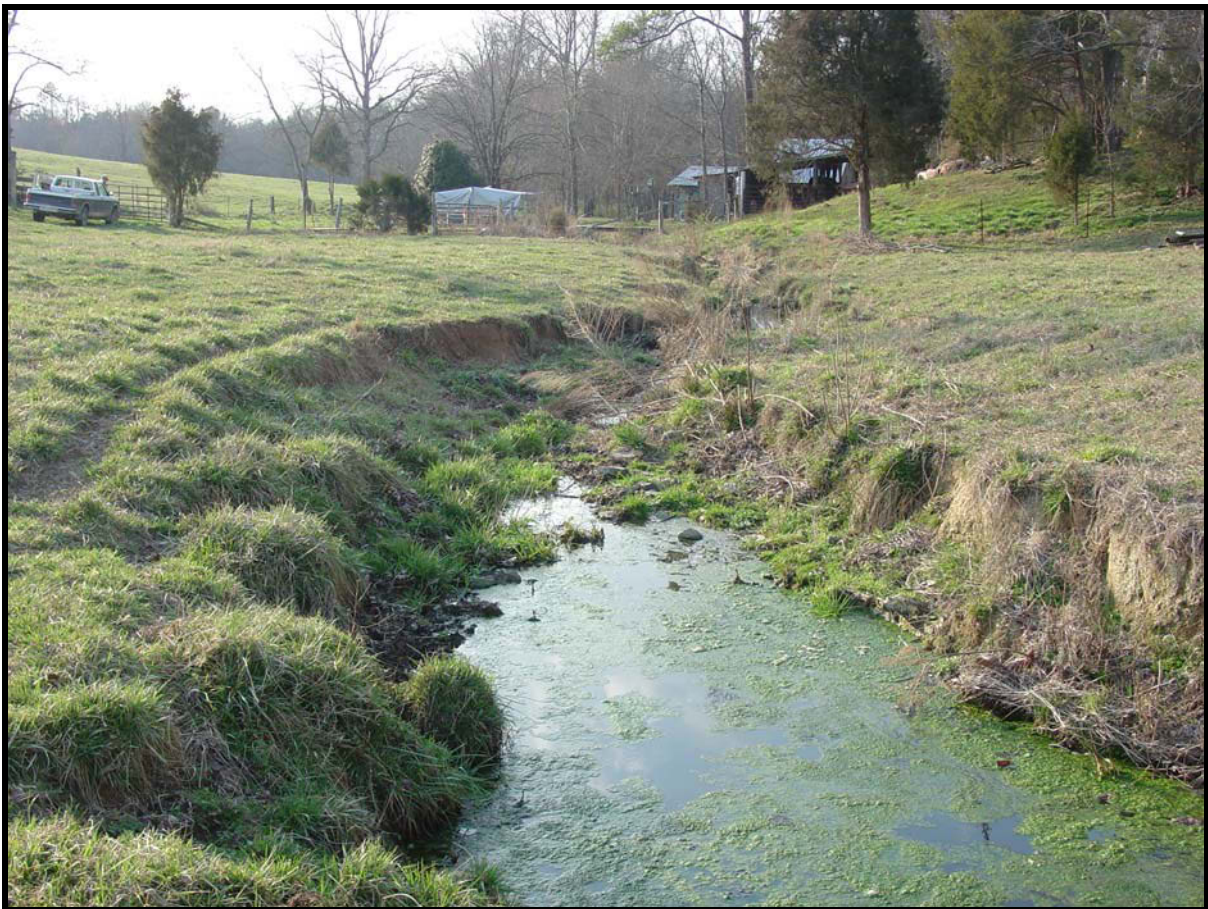
Davis Branch, typical of many of the headwater streams in the Richardson Creek and Lanes Creek catchments, is primarily agricultural land with dug-out impoundments or dammed headwater tributaries used as farm ponds to water livestock. The cited December 2003 basin-wide restoration plan, addressing surface water quality issues in the Richardson and Lanes Creek watersheds, recommends the following actions be taken to improve instream water quality: Reduce nutrients from all sources (agriculture, wastewater infrastructure, and stormwater runoff); widespread implementation of BMPs to control nonpoint sources of pollution, **particularly from agricultural activities**, throughout the watersheds, and no new discharges of oxygen consuming wastes be permitted on Richardson Creek above the Monroe WWTP. The following photograph, taken at the bottom of the Davis Branch mainstem project reach on March 9, 2006, graphically shows nutrient laden agricultural runoff exacerbated by livestock intrusion, and hoof-shear streambank destabilization leading to erosion and offsite discharge of oxygen consuming agricultural runoff and sedimentation.

The preceding photographs shows the impacts of nutrient enriched runoff and sedimentation from agricultural lands, typical in the Rocky River, Richardson Creek and Lanes Creek Watersheds. Restoration and protection of headwater streams and their riparian corridors, such as proposed in this restoration plan for Davis Branch and UT1, throughout Subbasin 03-07-14 will have a cumulative, positive impact on improving instream water quality, riparian and aquatic habitat.

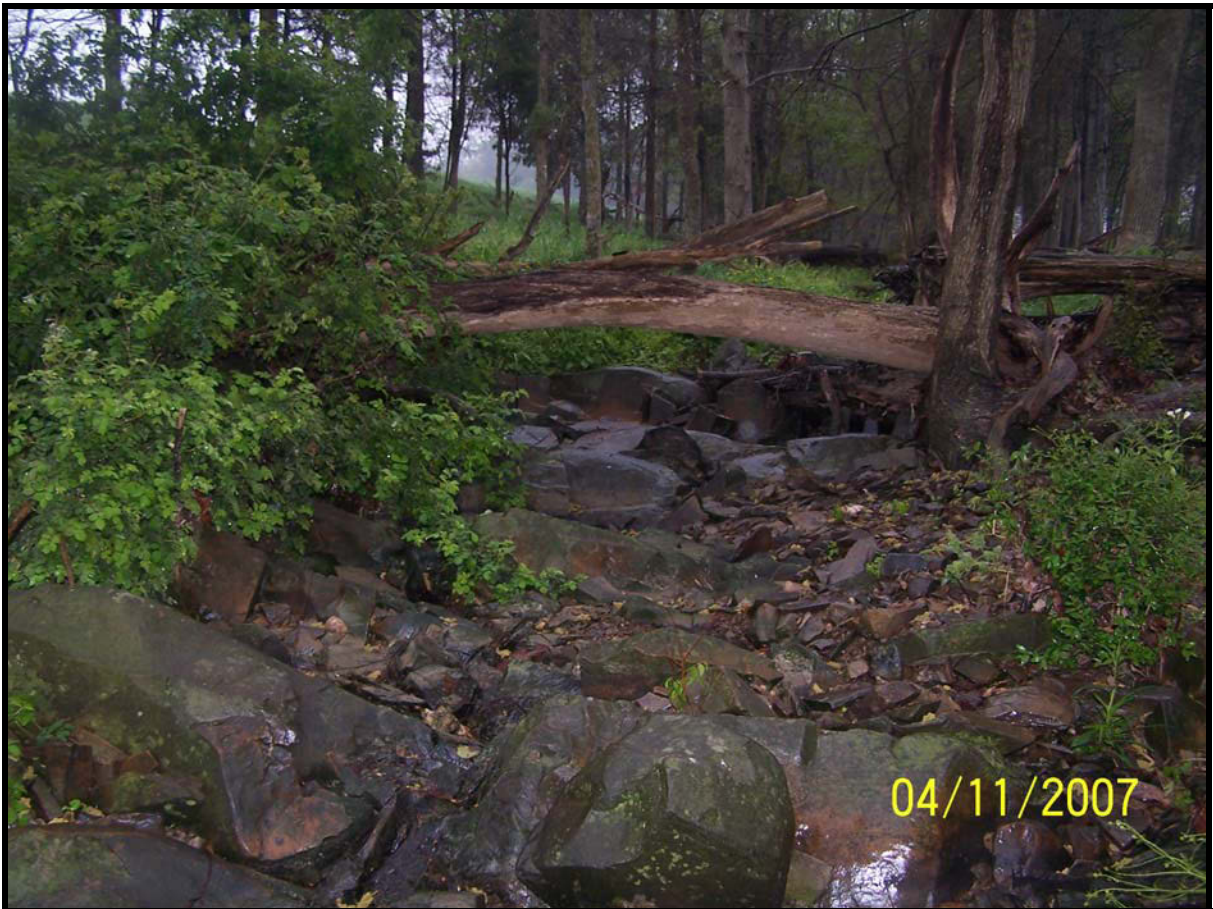
Locally, the site is underlain by the McManus Formation which comprises approximately 11,600 feet, or approximately 70 percent of the Carolina Slate Belt section in Union County, North Carolina. Bedrock is exposed and outcrops in the streambed along the mainstem and the lower segment of UT1 where the channel is incised to bedrock. The Davis Branch reference reach, located on the north side of Olive Branch Road, exhibits strong slate bedrock control. Bedrock exposed in the streambeds is dense, crystalline on a microscopic scale (grains not visible to the naked eye), moderately to steeply dipping fractured, thin to medium bedded slate. (Detailed local structure and stratigraphy from Randazzo, A.F., Petrography and Stratigraphy of the Carolina Slate Belt, Union County, North Carolina, Ph.D. Thesis, University of North Carolina at Chapel Hill, 1968). The structural geologic map on the following page is published in the cited thesis. The following photograph shows typical bedrock streambed conditions on the upper section of the mainstem Enhancement Level I reach.

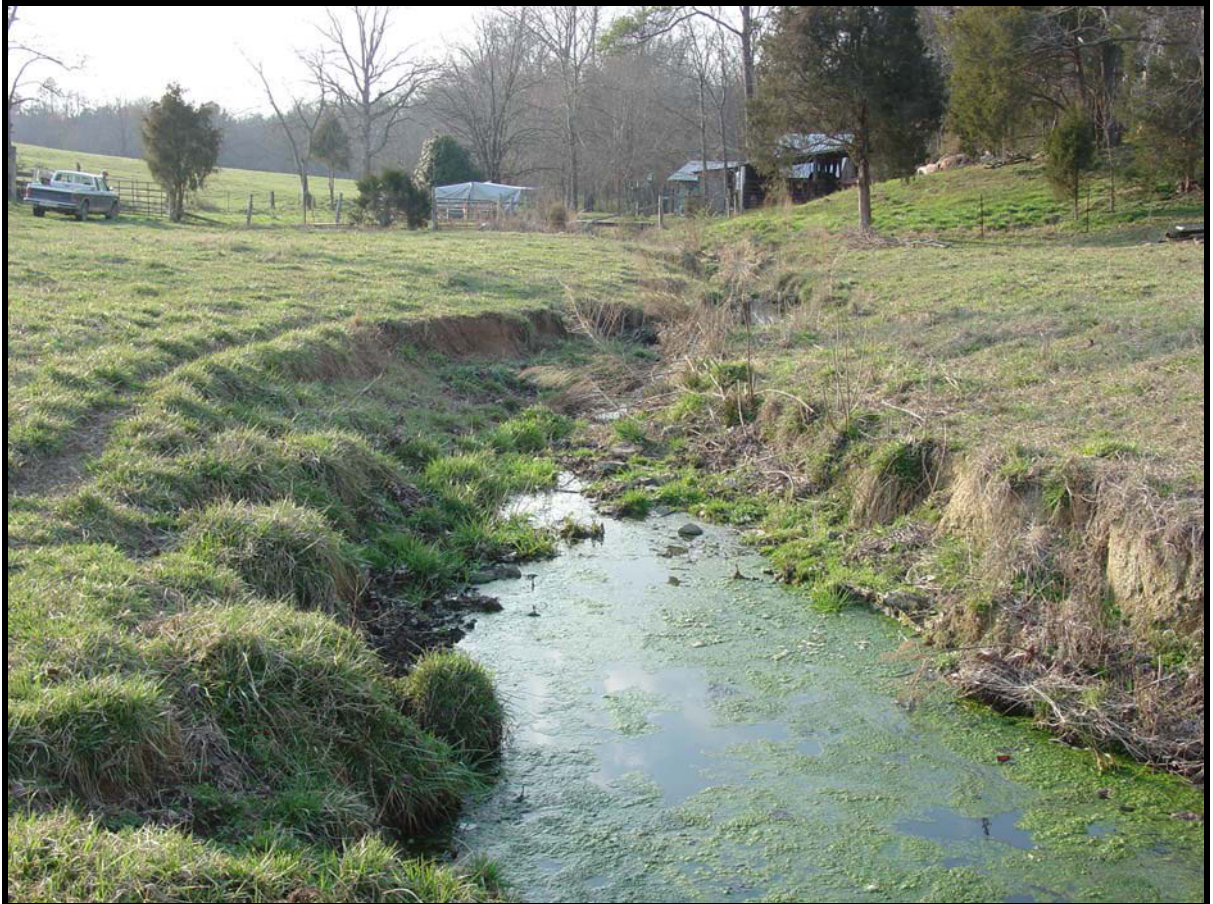
The next photograph, taken at the bottom of the mainstem reach on March 9, 2006, shows the Cid pedon section, with nutrient laden water, as evidenced by prolific algae bloom, attributed to agricultural runoff exacerbated by livestock intrusion, and hoof-shear streambank destabilization leading to erosion.

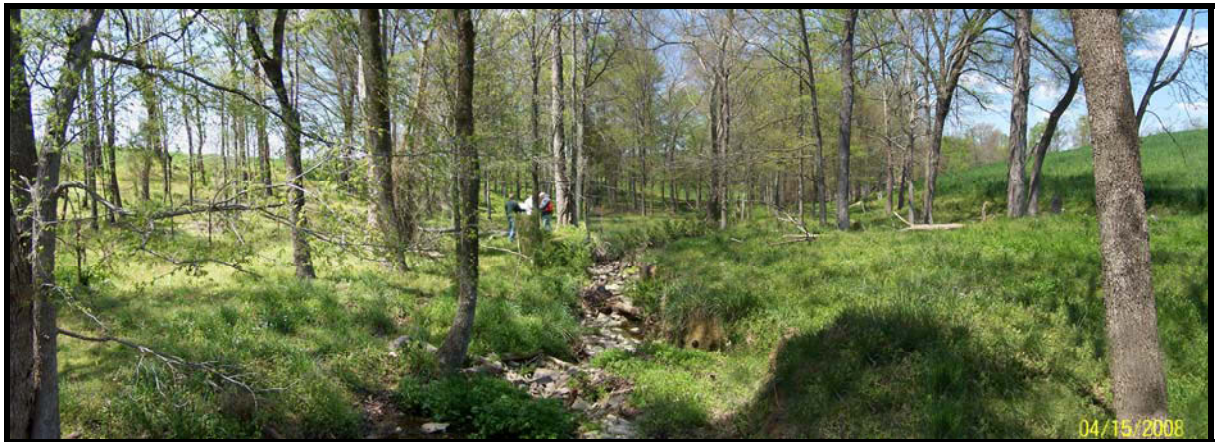
An area of Badin Channery silty clay loam, 2 to 8 percent, eroded (map symbol - BdC2) is present along the lower Enhancement Level 1 mainstem reach on Davis Branch. The soil taxonomy is essentially identical to the BaB map unit described in the preceding paragraph. Some primary differences are the BdC2 map unit is poorly suited to cultivated crops because of slope constraints and the eroded surface layer. The hazard of further erosion is very severe. Weathered, fractured slate bedrock is encountered at a depth of about 29 inches. Hard, fractured slate bedrock is encountered at a depth of about 41 inches. The following photograph, taken on April 15, 2008 looking upstream on Davis Branch mainstem Enhancement Level 1 reach, shows the erodible nature of the Badin, BdC2 soil pedon on site, with streambank sloughing in the foreground and vertical, denuded streambanks upstream attributed to cattle intrusion.

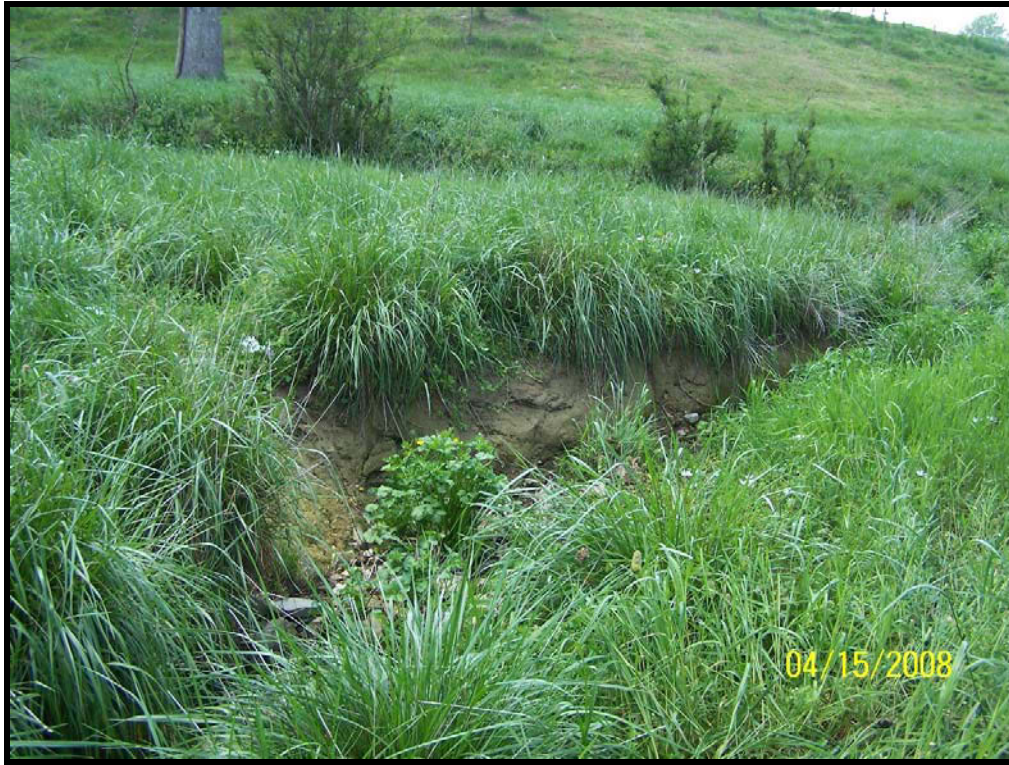
The Goldston soil is well drained to excessively drained and is shallow over bedrock. Typically, the surface layer of the Goldston soil is brown very channery silt loam 5 inches thick. The subsoil is light yellow brown very channery silt loam 11 inches thick. Weathered, fractured slate bedrock is typically encountered at a depth of 16 inches. Hard, fractured slate bedrock is encountered at approximately 27 inches below ground surface. In some places bedrock is exposed at ground surface, resulting in narrow, scattered bands of weathered slate outcrops. In other areas, flagstones are in and on the surface layer. Other than shallower accumulated soil thickness attributed to hill slope landform geomorphologic processes associated with steeper land surface slope, as described above, with the GsB component containing a proportionately higher composition of Goldston soil based on slope position, the GsB pedon is otherwise identical to the GsC pedon. The following photograph shows soil conditions near the mouth of UT-1, partially obscured to vegetation on April 15, 2008, characteristic of the on site GsB soil pedon section.

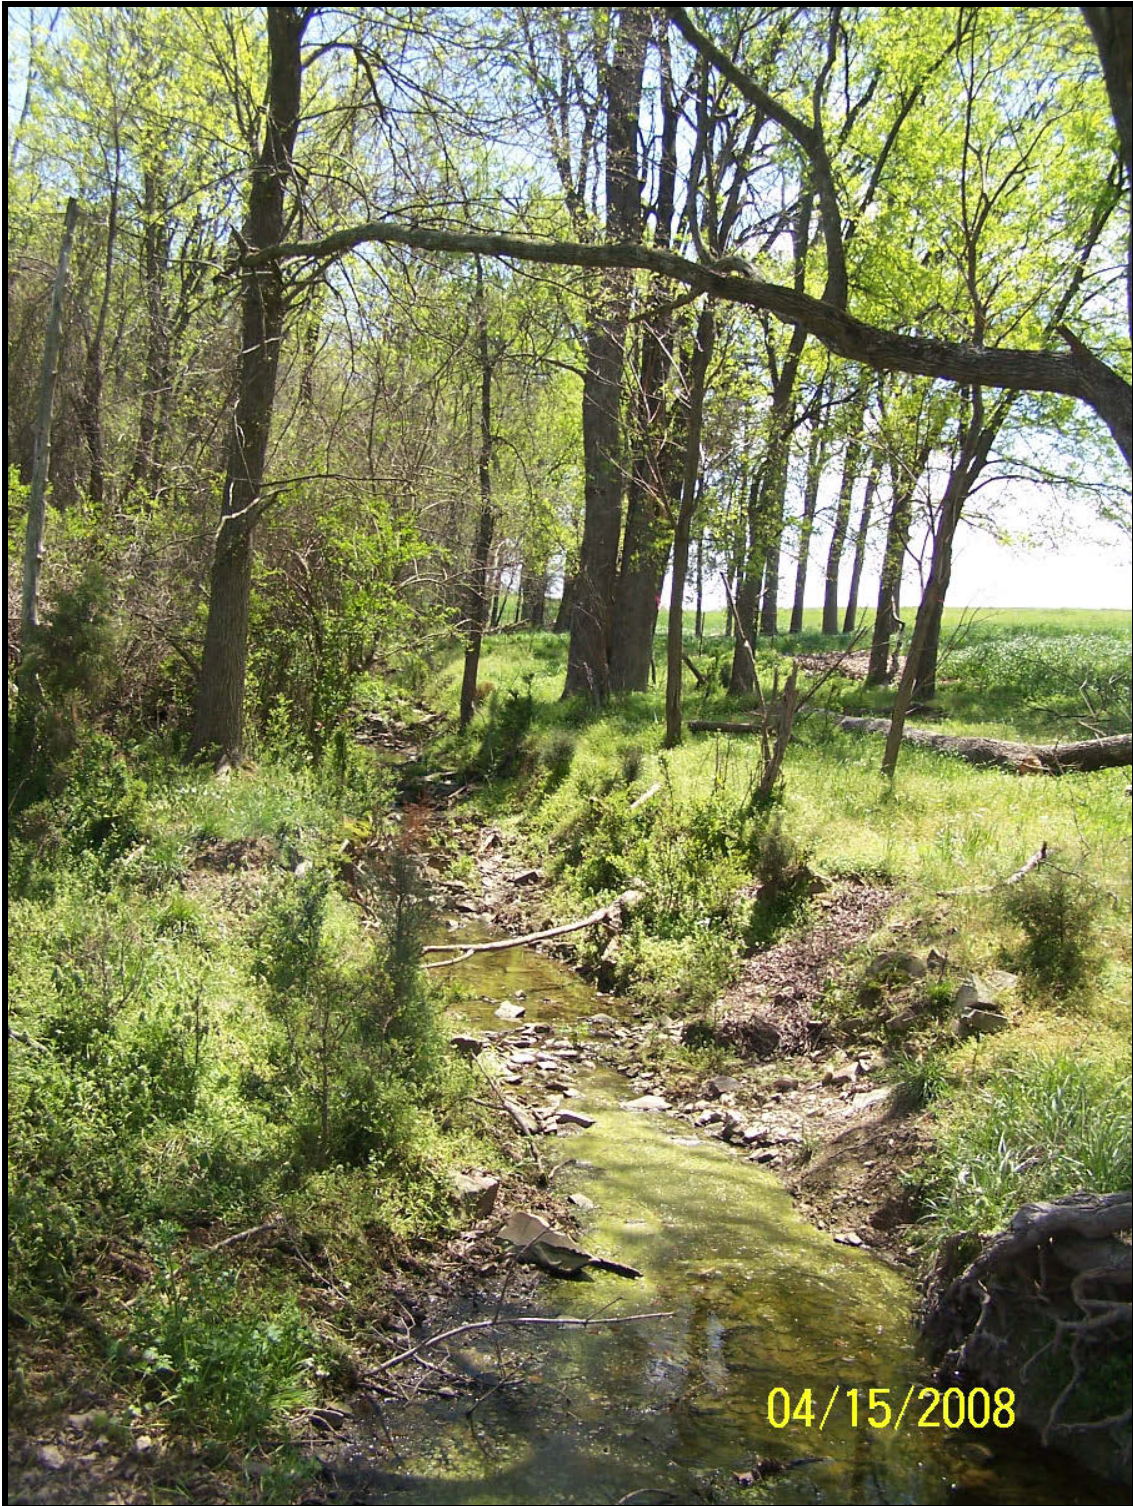
The photograph on the following page, taken on April 15, 2008 near the mouth of UT1 shows channel incision, hoof-shear streambank destabilization, and nutrient loading (algae proliferation) from livestock intrusion and agricultural runoff from adjacent, fertilized pasture and hay land.

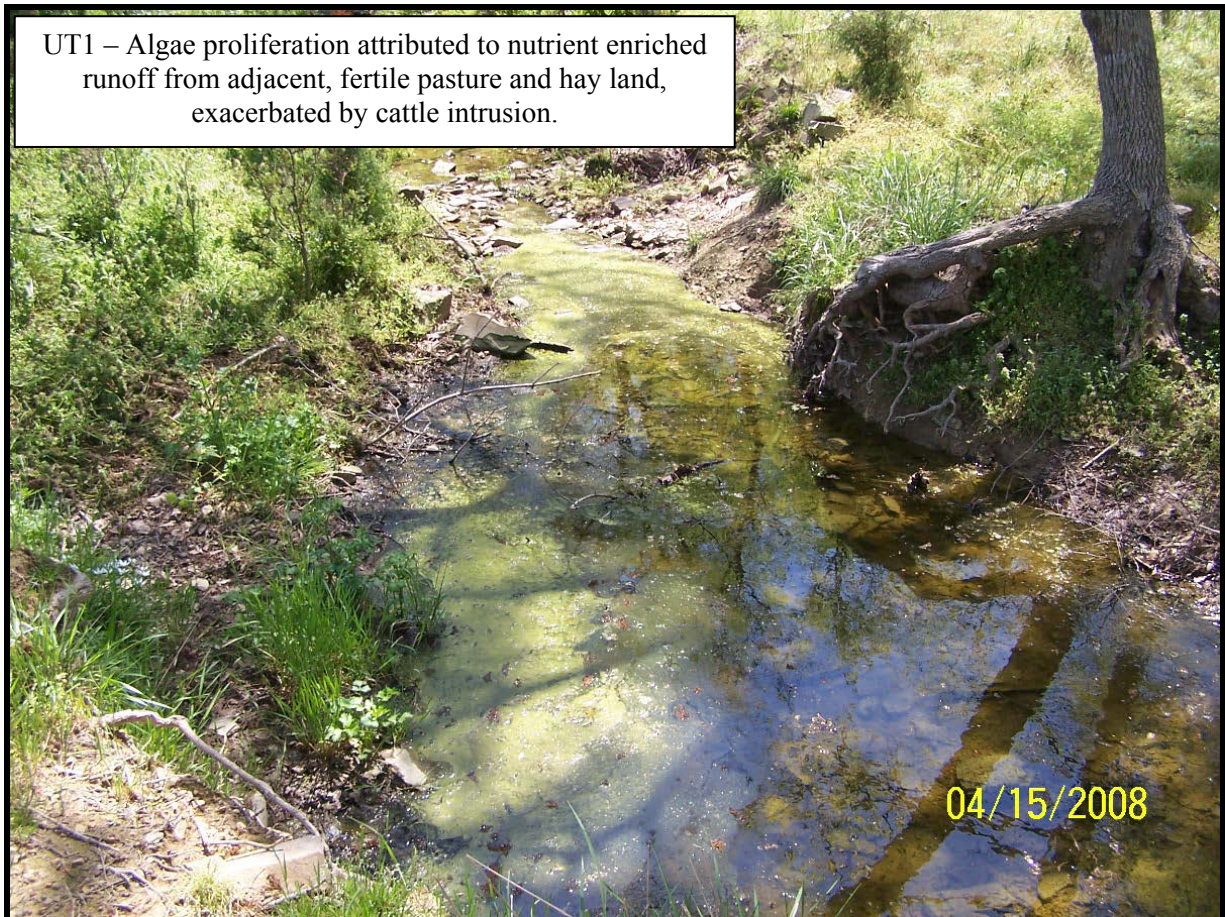
UT1 – Algae proliferation attributed to nutrient enriched runoff from adjacent, fertile pasture and hay land, exacerbated by cattle intrusion.

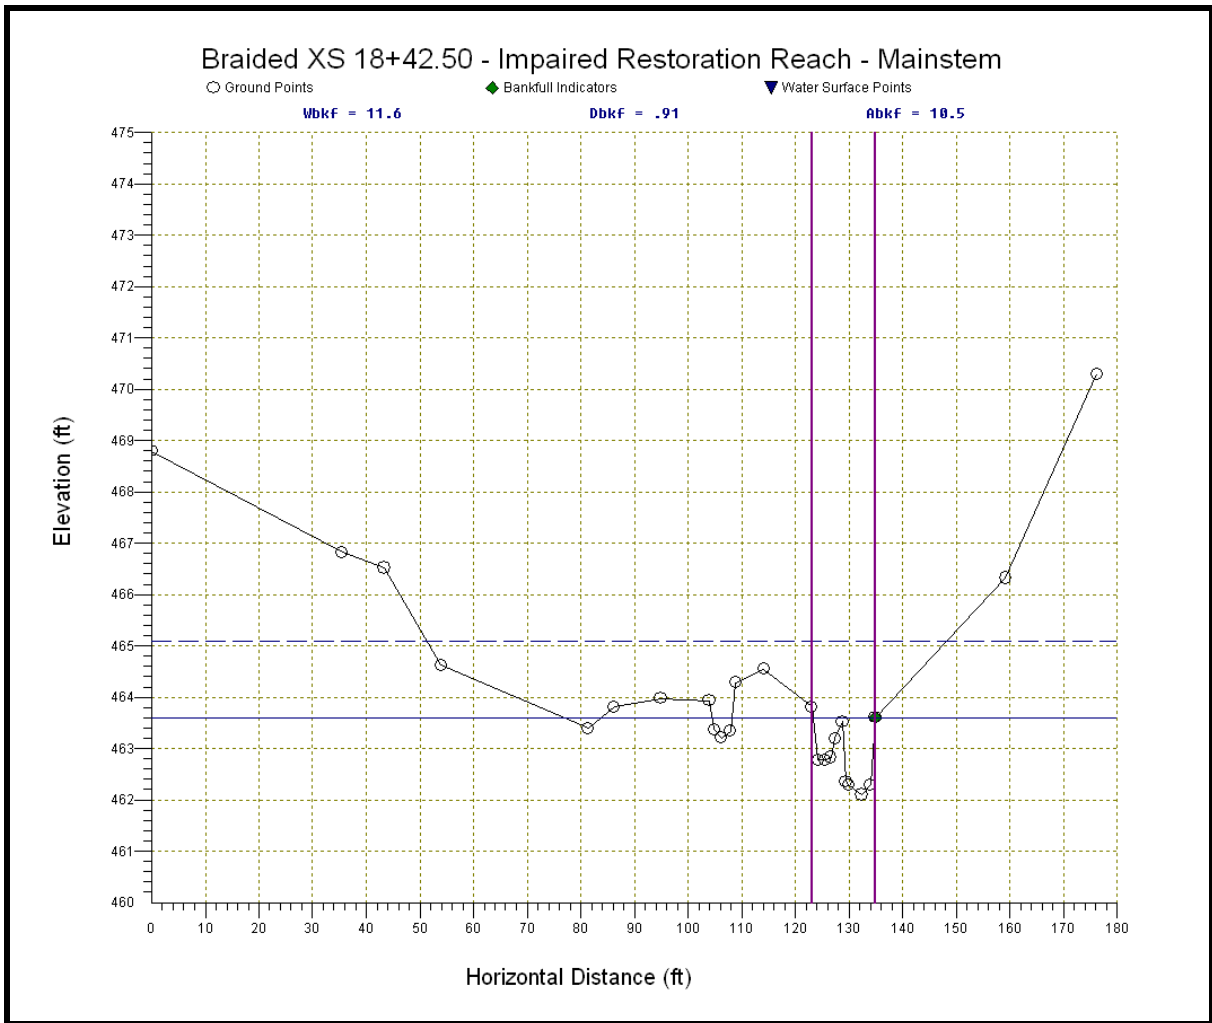
under incised conditions along the reach. In addition to cattle intrusion, channelization (impaired conditions sinuosity = 1.12), and an average channel slope of 1.58 percent has increased hydraulic forces (shear stress) acting on the streambed and banks during verified bankfull flows ($Q_{bkf} = 24.8 \text{ feet}^3/\text{sec}$ with a mean velocity of 5.26 feet/sec under impaired conditions). The following impaired conditions cross-section 18+42.50 graphically shows the braided, multi-thread channel characteristic of stream segments throughout the reach.

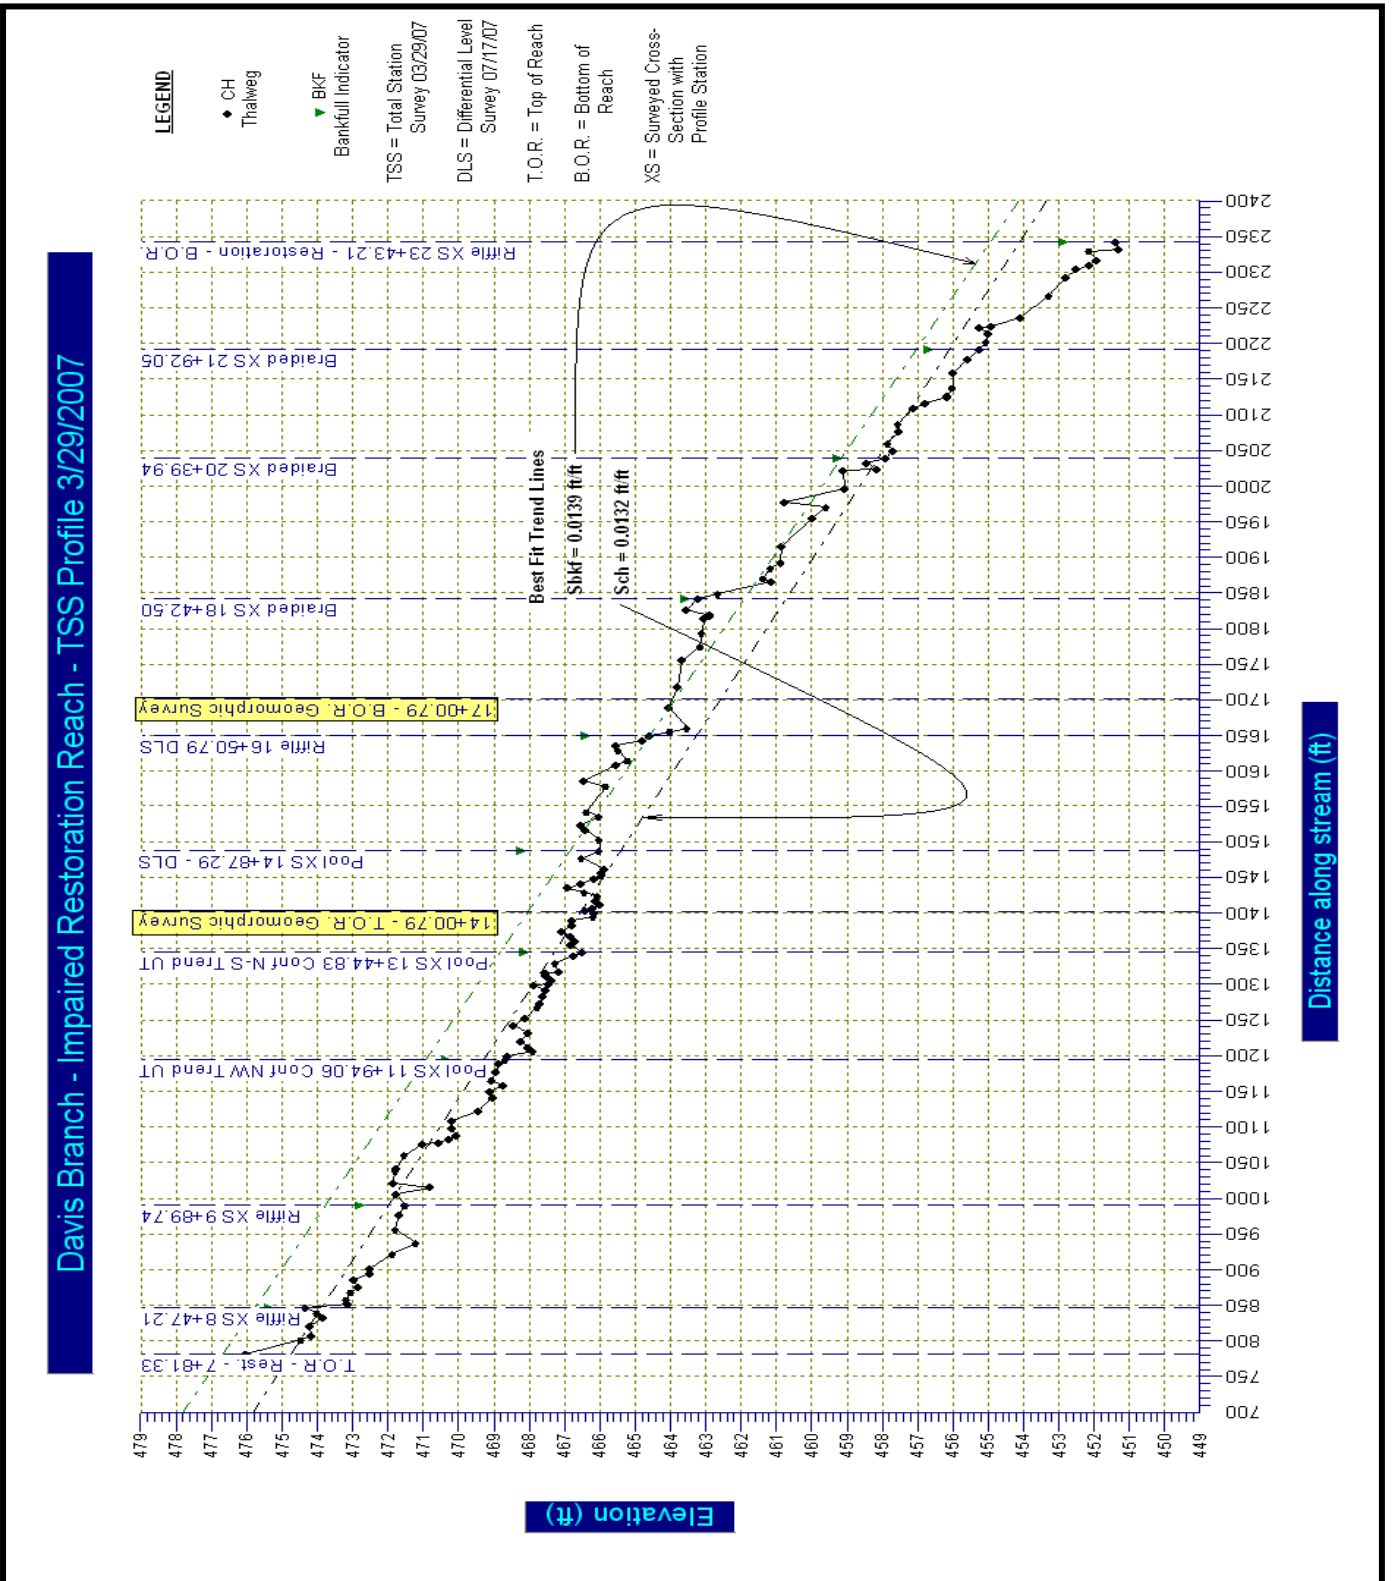
Davis Branch - Restoration Reach
 Impaired Conditions
 Rosgen Stream Classification

Table 4a provides baseline morphologic and hydraulic summaries for reference, existing and proposed channel dimension, pattern, profile and substrate, along with additional reach parameters for upper Davis Branch. The following screenshot from RiverMorph v. 4.1.1, shows impaired project reach Rosgen stream channel classification, dominant substrate materials readily available to the stream, and morphologic and hydraulic impaired conditions on the Davis Branch mainstem restoration reach. The impaired mainstem restoration reach longitudinal profile is presented following the Rosgen Classification screen capture. Supporting impaired conditions documentation is included with the information in **Appendix 3**.

The screenshot displays the RIVERmorph 4.1.1 Professional software interface. The title bar reads "RIVERmorph 4.1.1 Professional - Davis Branch Stream Restoration - Iter 2 - 4.1". The interface is divided into several sections:

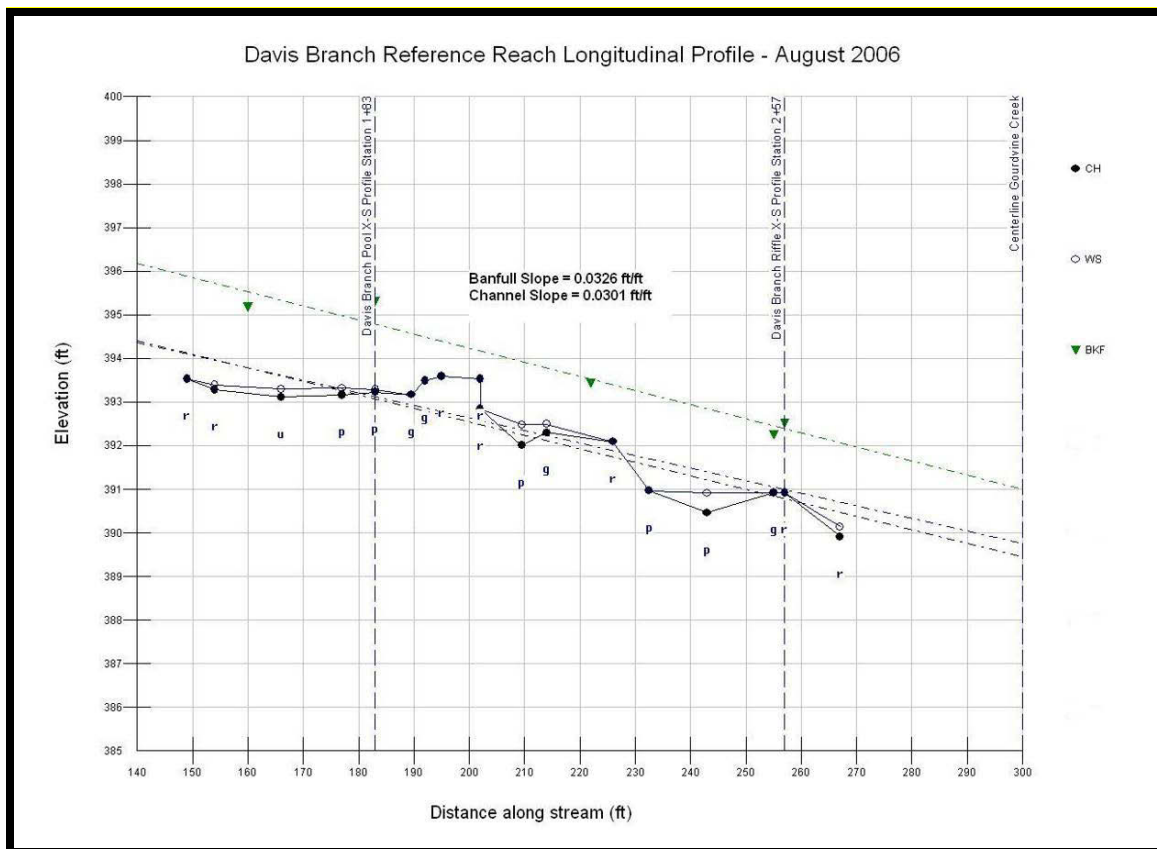
For Davis Branch, bankfull discharge was determined through a quantitative assessment and analysis of reference reach boundary conditions and comparison of predicted bankfull discharge through a stable riffle cross-section located on Davis Branch 43 feet upstream from its confluence with Gourdvine Creek. The reference reach is a Rosgen Valley Type VIII, E3/1b stream type (i.e., E channel morphology, large cobble substrate with strong bedrock control, profile gradient greater than 2 percent). The reference reach is located within a healthy, deciduous hardwood forested riparian corridor. A comprehensive Rosgen Level III watershed assessment and analysis of the reference reach conditions was conducted during August 8 and 9, 2006. The longitudinal profile that follows, analyzed using RiverMorph[®] version 4.0.1, shows the best fit trend lines of the streambed, water surface and bankfull indicators:

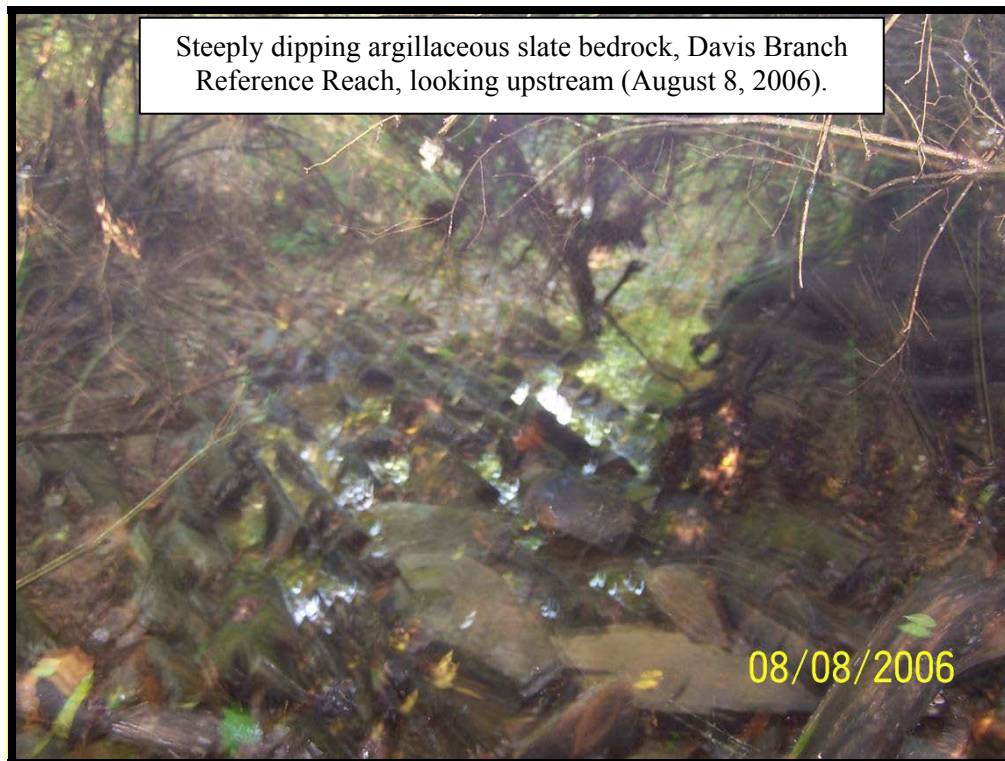
Calculated bankfull discharge for the surveyed reference reach riffle cross-section, was computed using hydraulic radius, wetted perimeter, channel slope and a relative roughness (u/u^*) method based on the average protrusion height of the steeply dipping bedrock bedding planes (Rosgen, 1998). Additionally, a particle distribution was collected from the large angular cobble deposited along the reference reach riffle bed. Based on an average bedrock protrusion height of 0.57 feet (or 174 mm), bankfull discharge is quantified at 77.6 cfs, and closely matches the stratified Rural Piedmont Regional Curve dataset predicted bankfull discharge (80.0) cfs. The D84 particle size from the stable riffle particle distribution is 140.1 mm and is consistent with the observed bed thickness, axial splitting planes and joint sets in the folded and deformed slate bedrock, as shown on the photographs that follow:

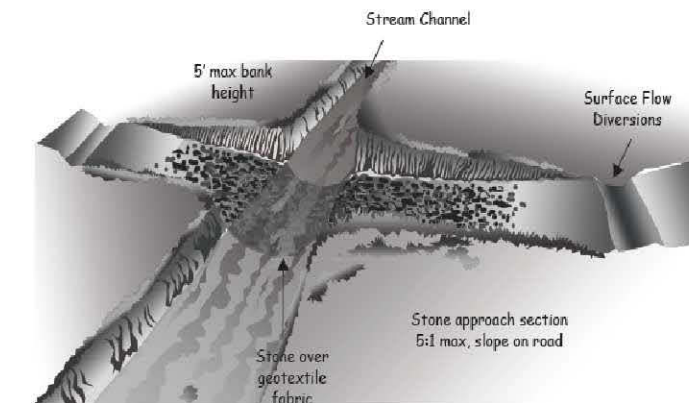
TEMPORARY STREAM CROSSING

- Construction Specifications**
1. Keep clearing and excavation of the stream banks and bed and approach sections to a minimum.
 2. Divert all surface water from the construction site onto undisturbed areas adjoining the stream.

3. Keep stream crossings at right angles to the stream flow.
 4. Align road approaches with the center line of the crossing for a minimum distance of 30 feet. Raise bridge abutments and culvert fills a minimum of 1 foot above the adjoining approach sections to prevent erosion from surface runoff and to allow flood flows to pass around the structure.

8. Any in-stream sediment control measures must be removed upon stabilization of the area.
- Maintenance**
- Inspect temporary stream crossings after runoff-producing rains to check for blockage in channel, erosion of abutments, channel scour, riprap displacement, or piping. Make all repairs immediately to prevent further damage to the installation.

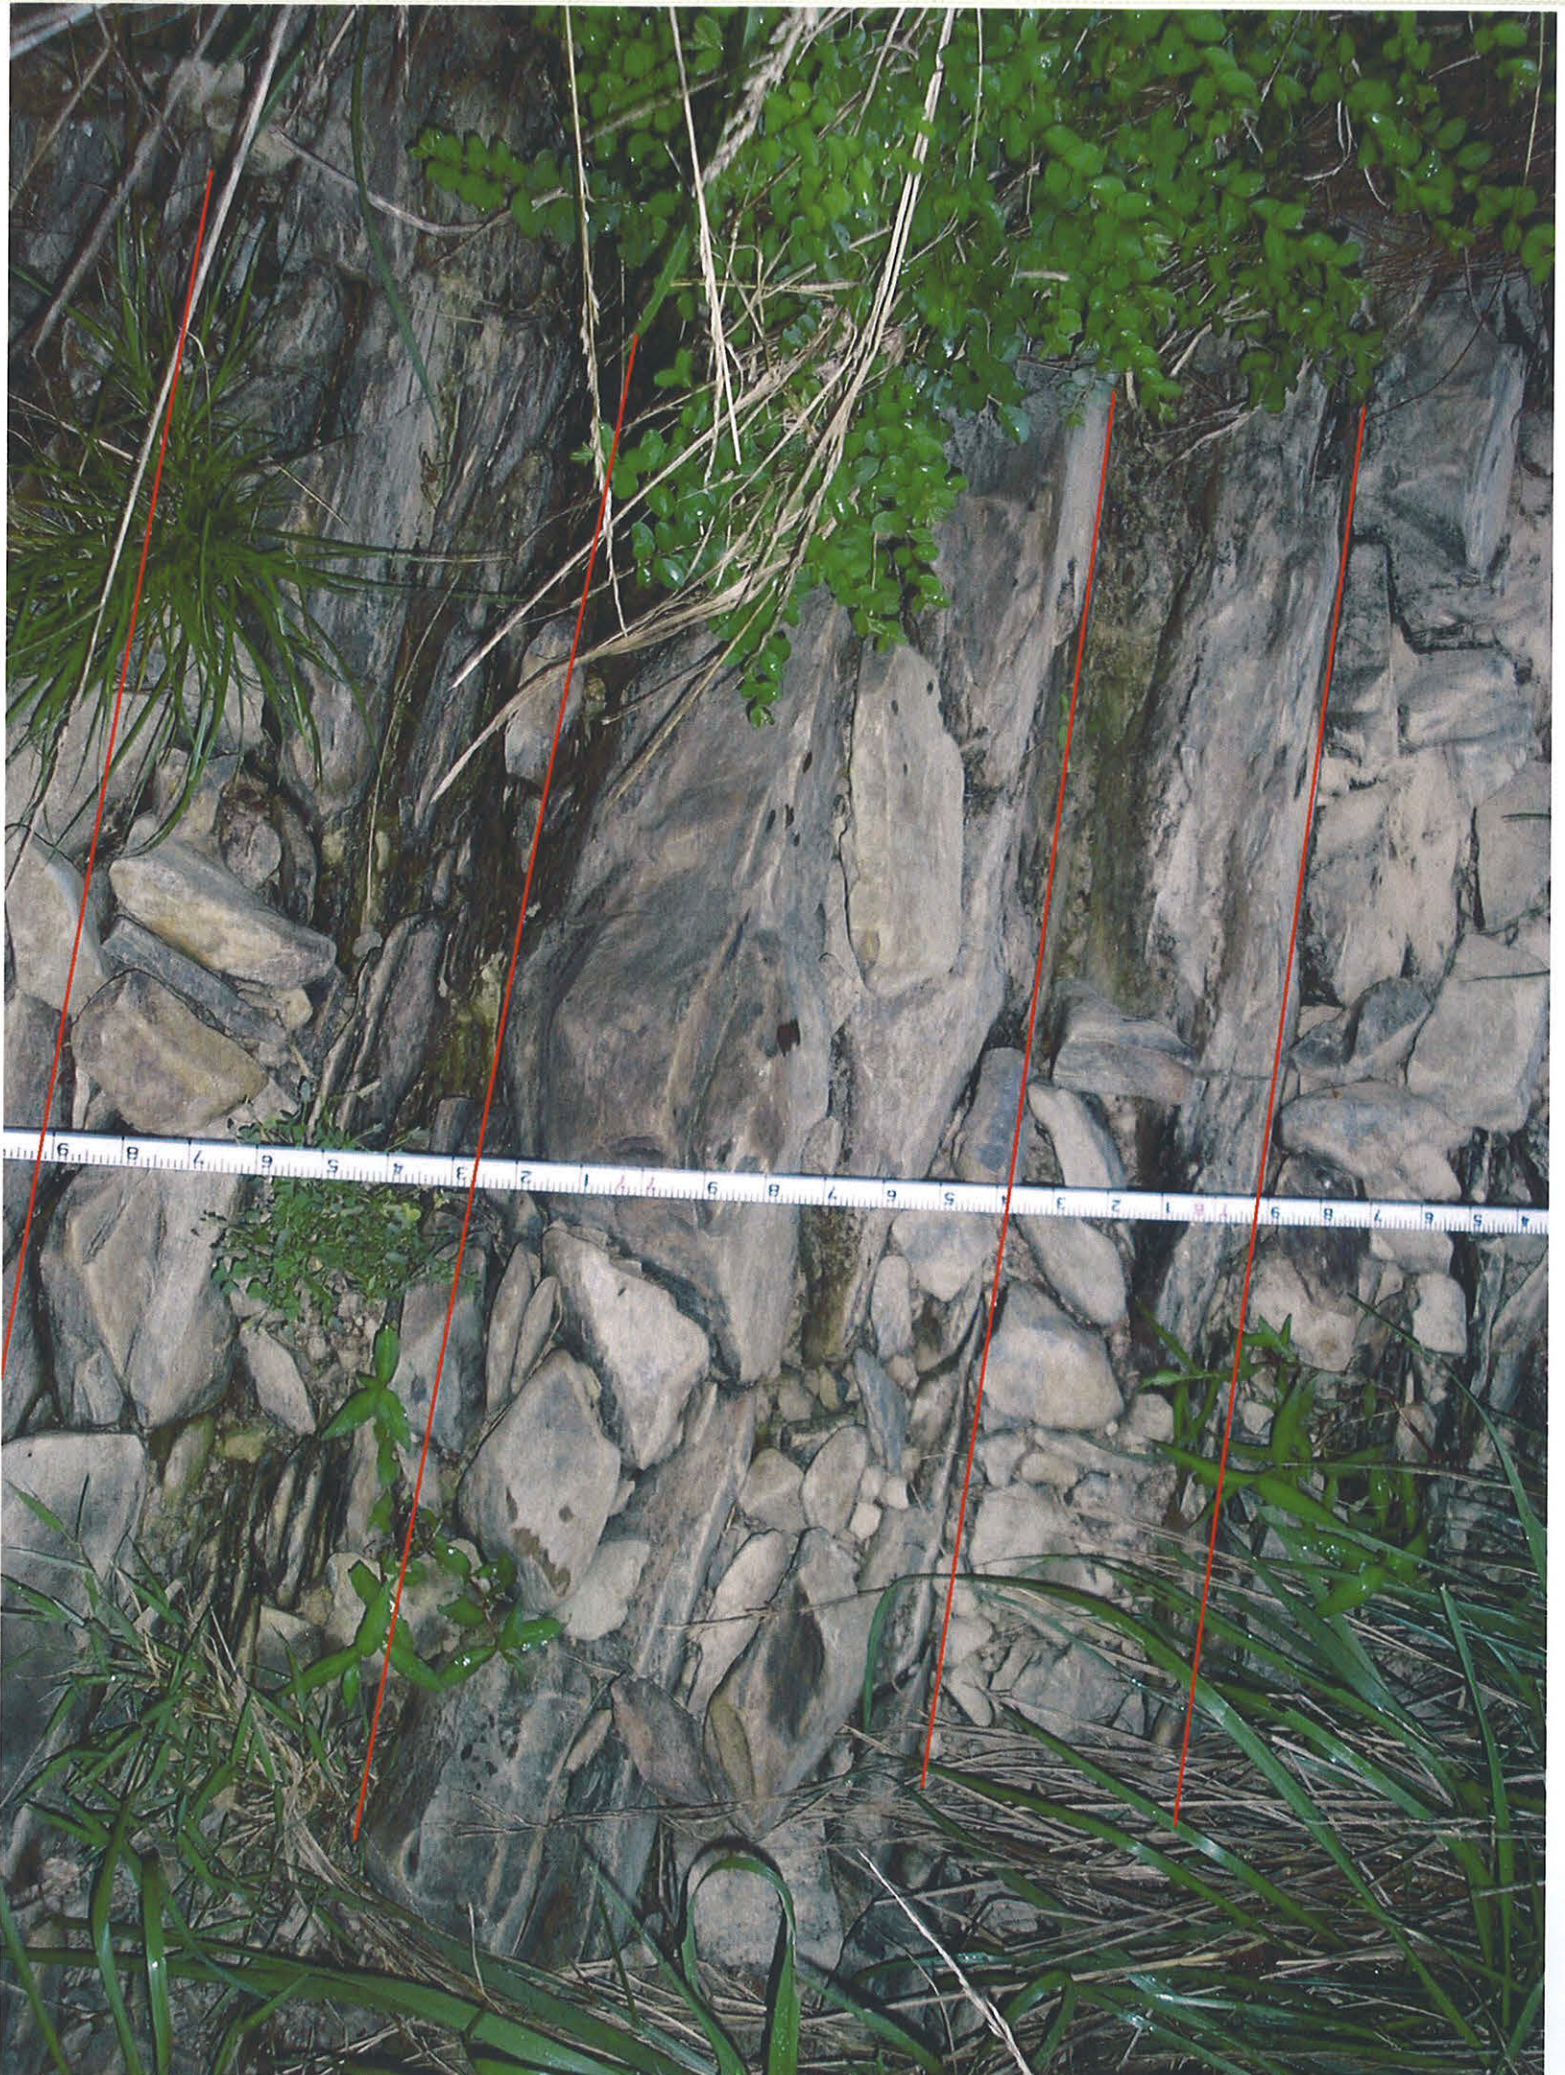
Riffle XS 0+76 Bedrock Protrusion Heights

Lower Davis Branch - Enhancement I Reach

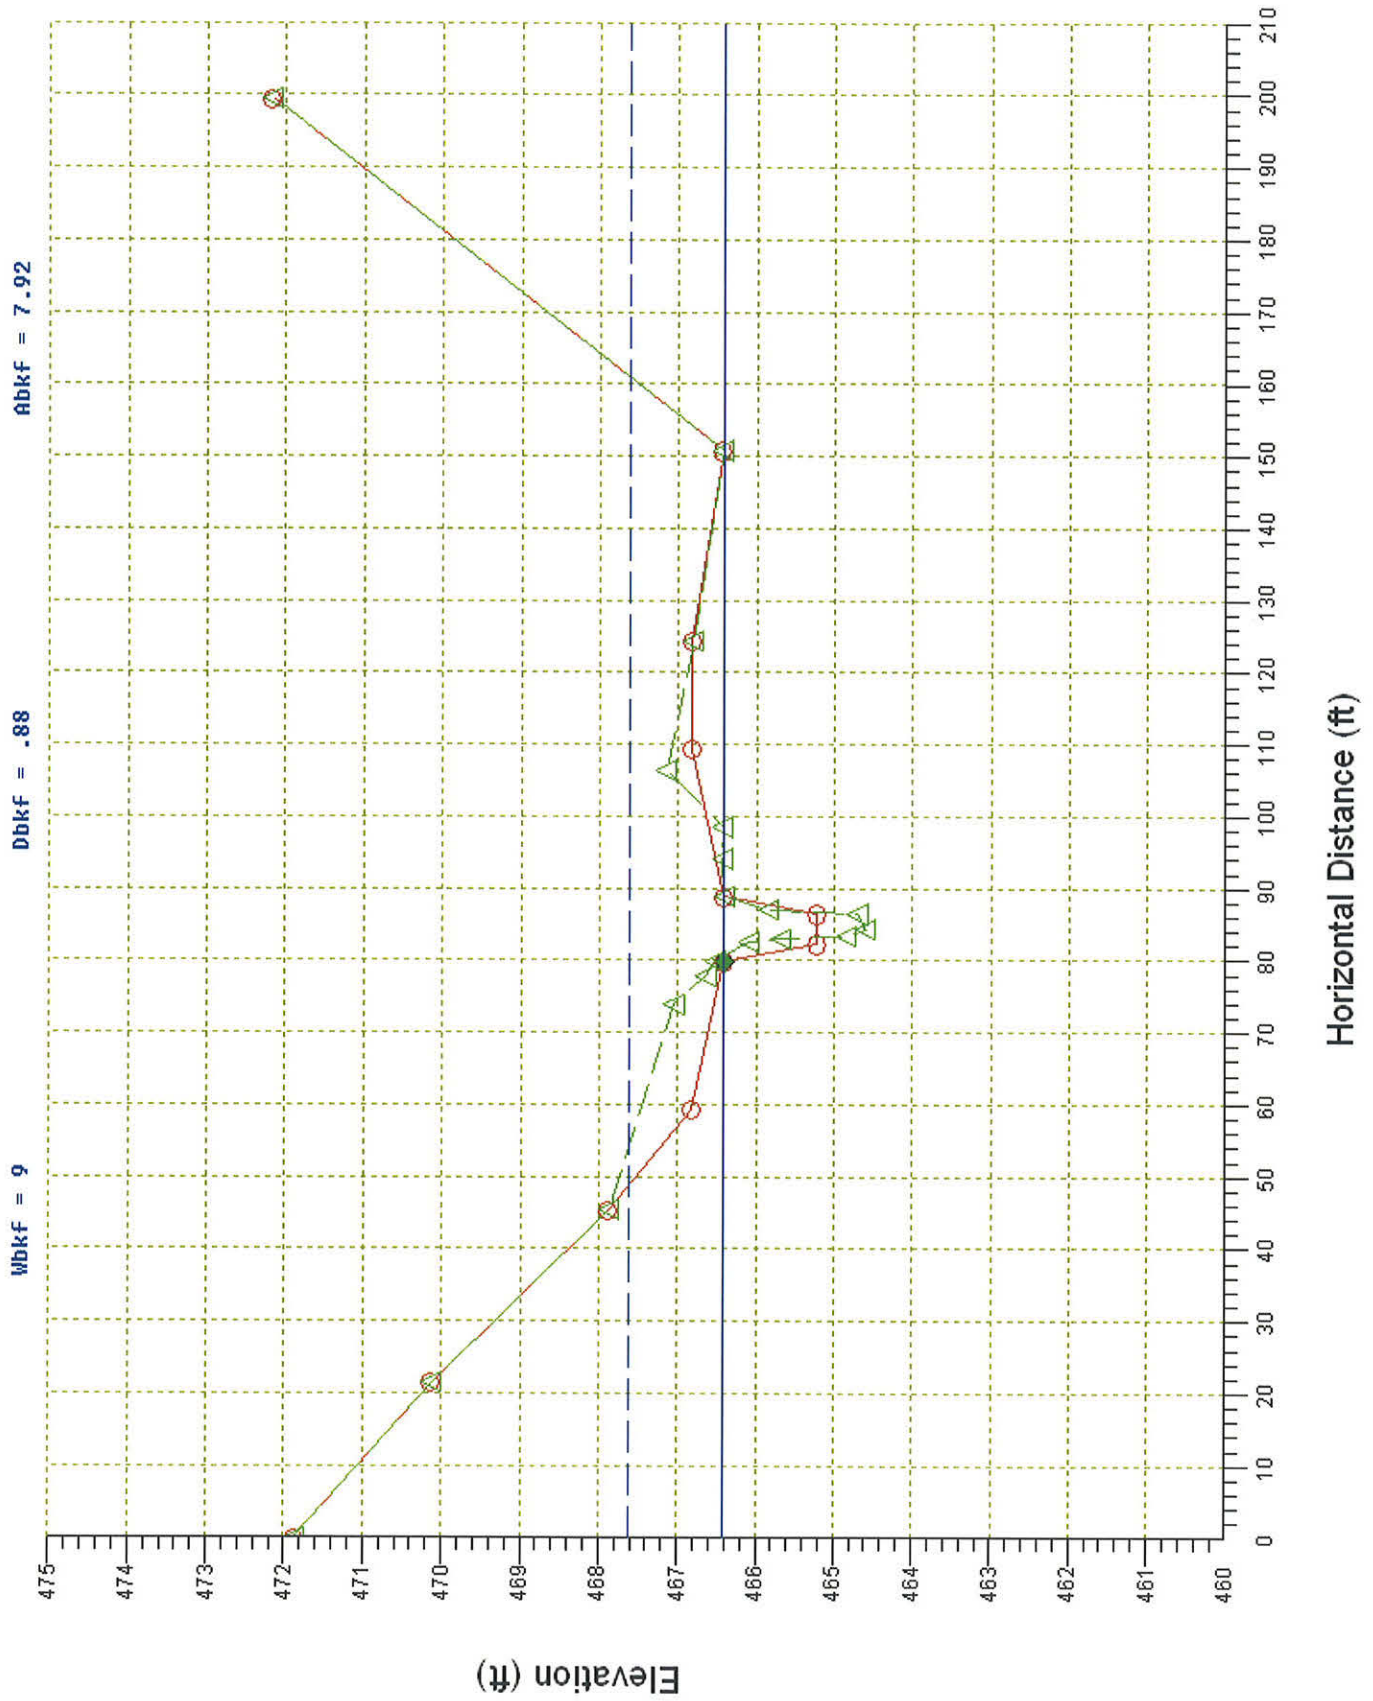
Design Riffle XS 16+50.79 DLS & TSS

- Design Riffle XS 16+50.79 DLS
- ◆ Bankfull Indicators
- ▼ Water Surface Points
- △ Riffle 16+50.79 DLS

Design Riffle XS 16+50.79 DLS & TSS.txt
RIVERMORPH CROSS SECTION SUMMARY

River Name: Davis Branch
 Reach Name: Restoration Reach - Impaired
 Cross Section Name: Design Riffle XS 16+50.79 DLS
 Survey Date: 05/01/2008
