Davis Branch and Unnamed Tributary Restoration Plan

Union County, North Carolina
SCO # D06054-F

Submitted: June 23, 2008

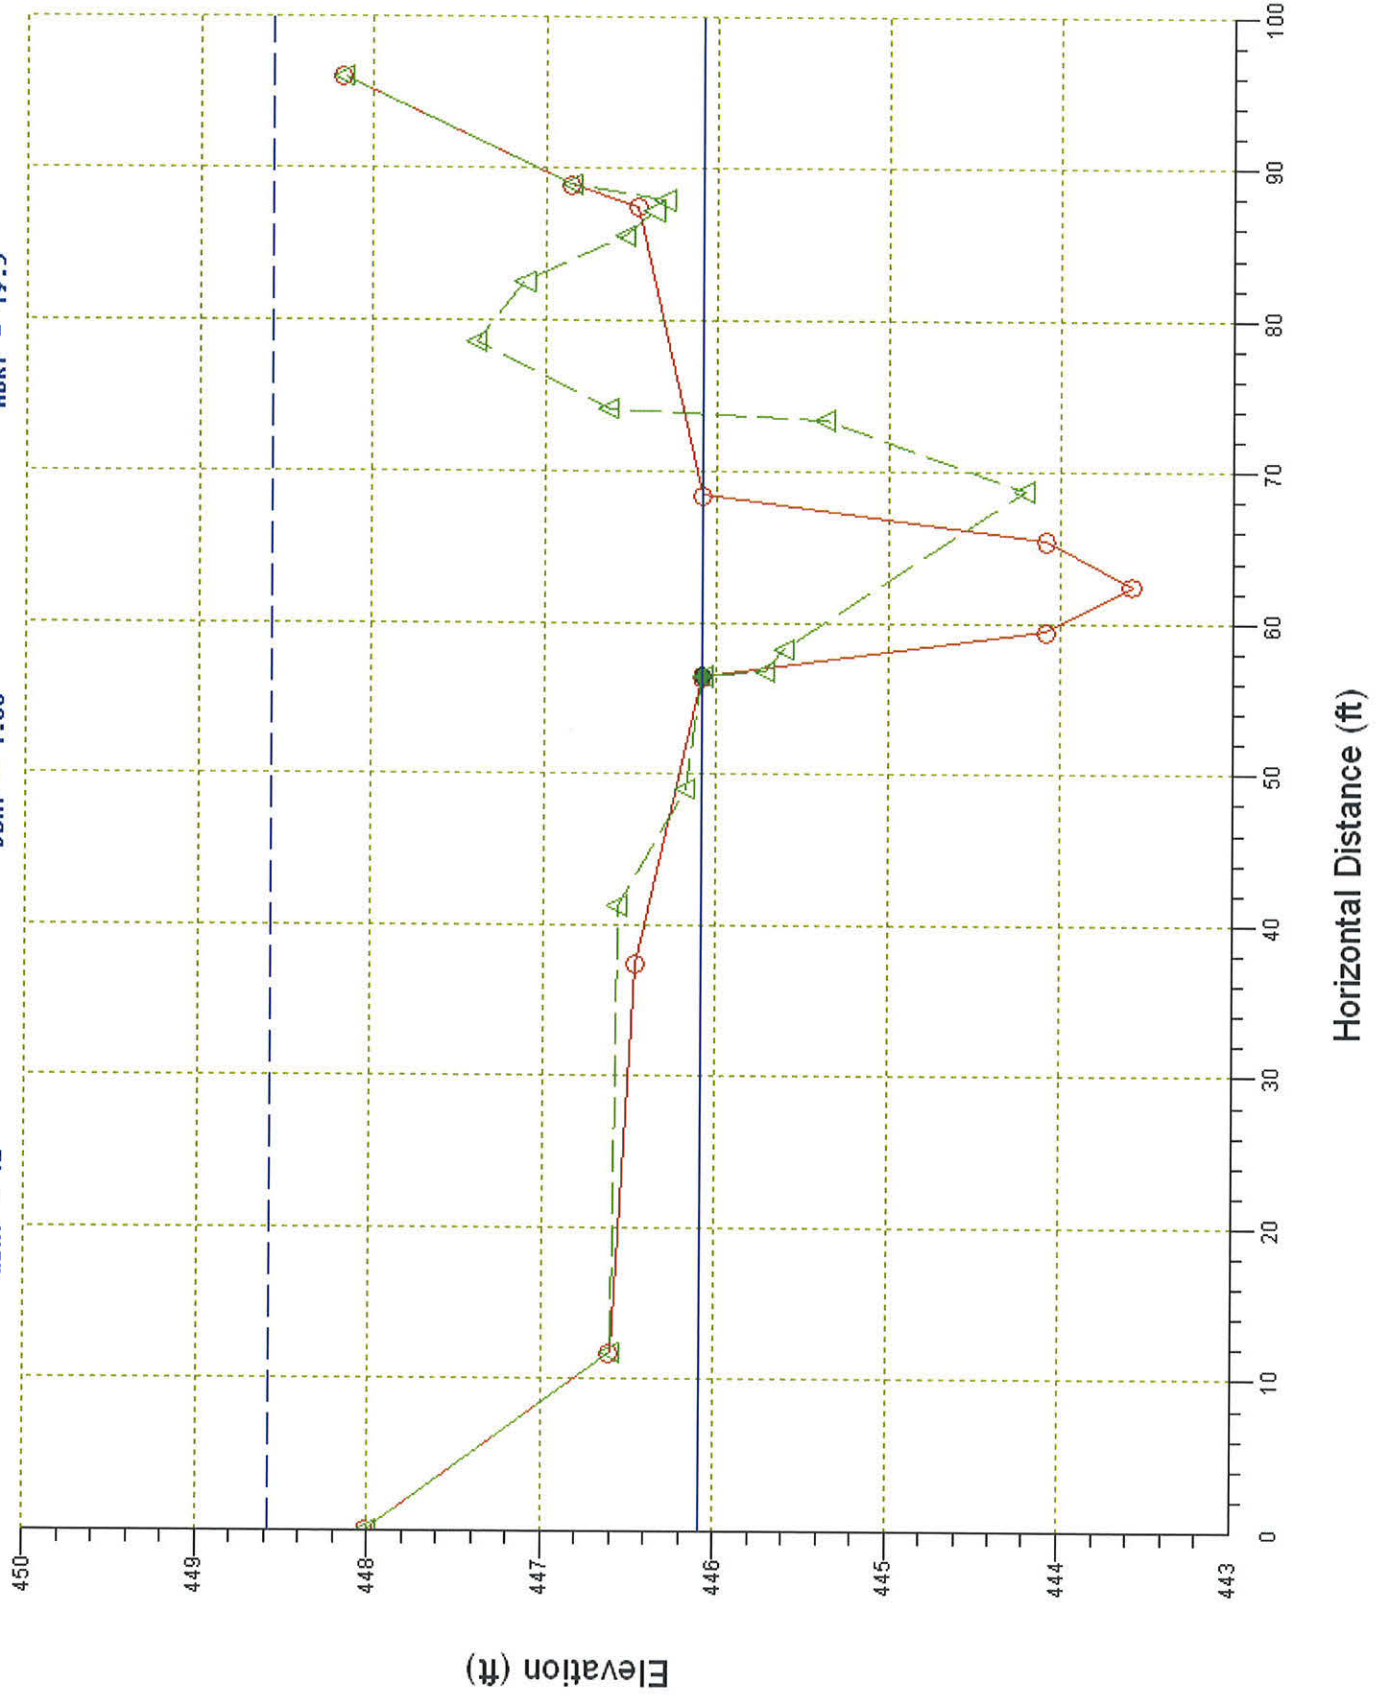
- Design Pool XS 26+16.08 **wbkf = 12**
- ◆ Bankfull Indicators **Dbkf = 1.63**
- △ Pool XS 26+16.08 **Abkf = 19.5**
- ▼ Water Surface Points

Design Pool XS 26+16.08.txt
RIVERMORPH CROSS SECTION SUMMARY

River Name: Davis Branch
 Reach Name: Enhance 1 Reach - Impaired
 Cross Section Name: Design Pool XS 26+16.08
 Survey Date: 02/11/2008
