DEVIL'S RACETRACK STREAM AND WETLAND MITIGATION SITE
Johnston County, NC
DENR Contract 003989
NCEP Project Number 95021

Baseline Monitoring Document and As-Built Baseline Report
FINAL

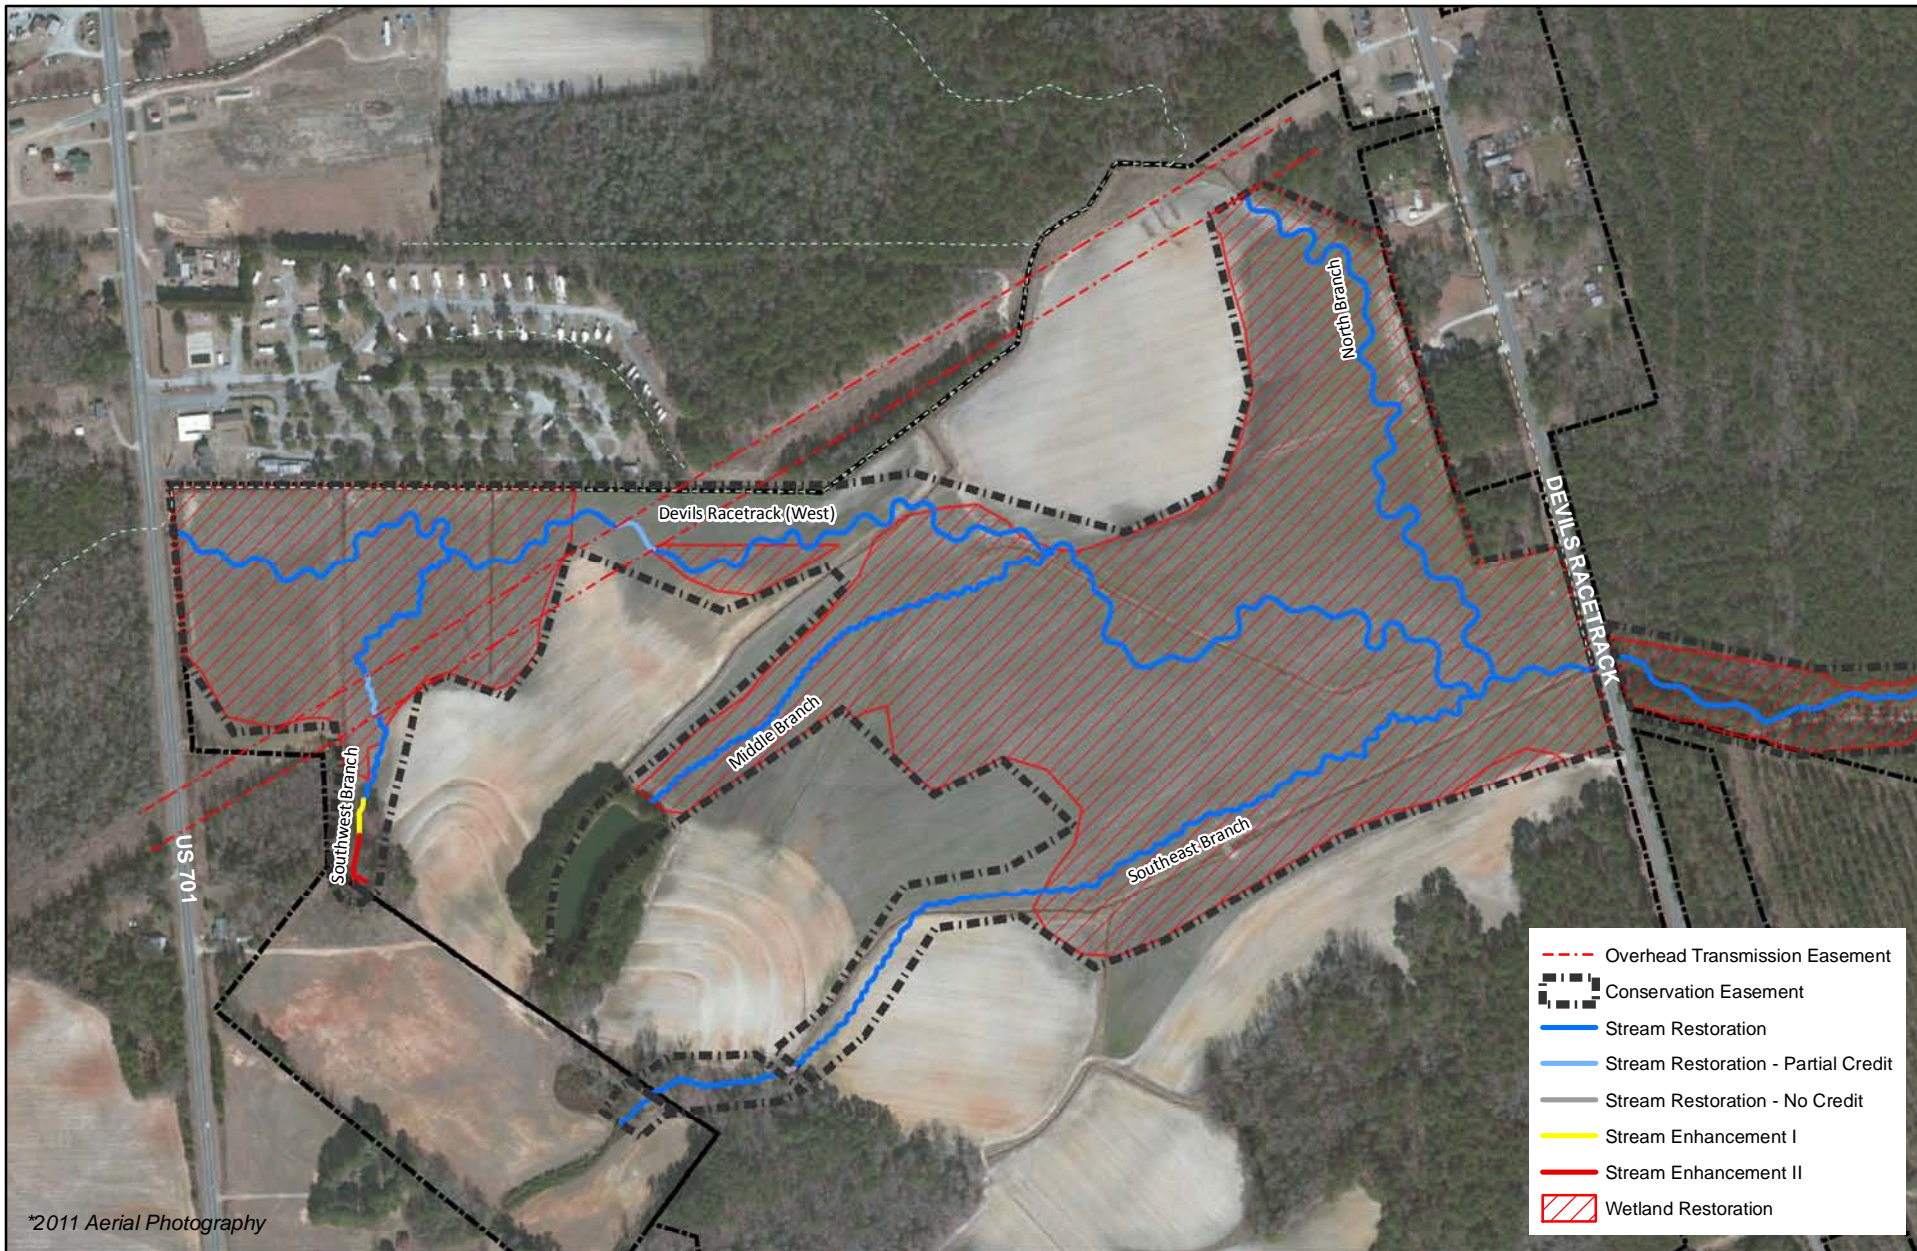
Figure 2a. Project Component/Asset Map
 Devils Racetrack Mitigation Site
 EEP Project No.95021
 Monitoring Year 0
 Johnston County, NC

The project will provide 18,687 stream mitigation units (SMUs) and 62.1 wetland restoration units (WMUs). Please refer to Figures 2a and 2b for the project component/asset map for the stream restoration feature exhibits and Table 1 for the project component and mitigation credit information for the Devil's Racetrack Mitigation Site.

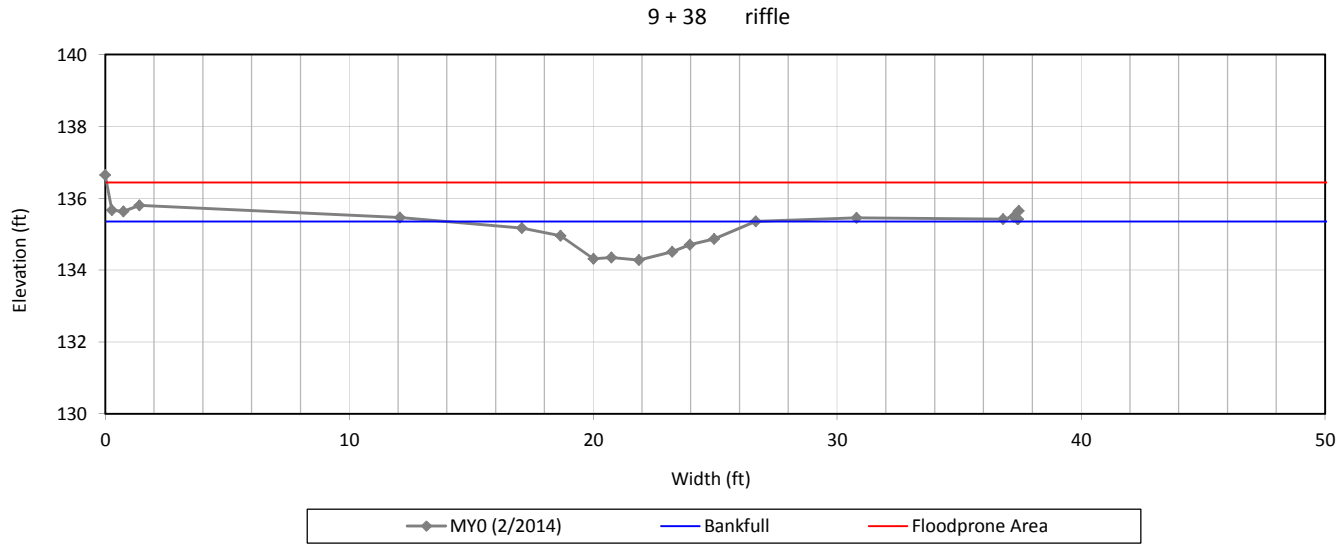
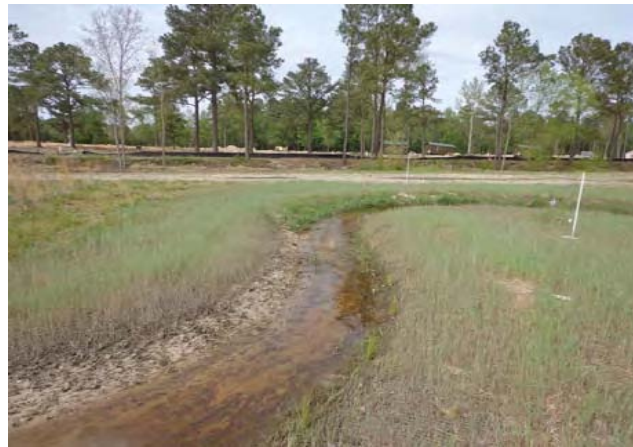
Cross Section 1-DRC West

6.2	x-section area (ft.sq.)
9.6	width (ft)
0.6	mean depth (ft)
1.1	max depth (ft)
9.9	wetted perimeter (ft)
0.6	hyd radi (ft)
14.8	width-depth ratio
200.0	W flood prone area (ft)
0.0	entrenchment ratio
1.0	low bank height ratio

Survey Date: 2/2014
 Field Crew: Turner Surveying

View Downstream

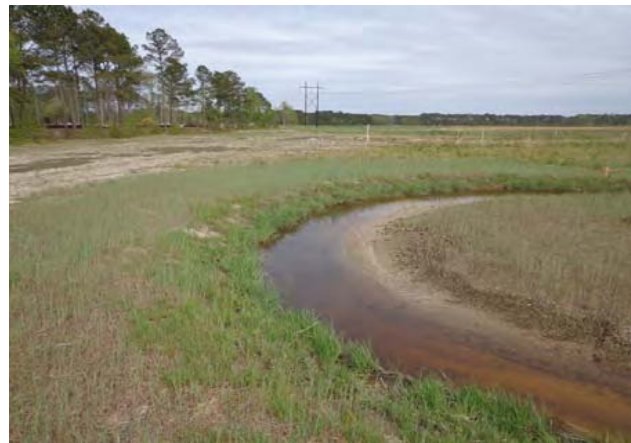
Cross Section 2-DRC West

7.8	x-section area (ft.sq.)
10.7	width (ft)
0.7	mean depth (ft)
1.7	max depth (ft)
11.3	wetted parimeter (ft)
0.7	hyd radi (ft)
14.6	width-depth ratio

Survey Date: 2/2014
 Field Crew: Turner Surveying

View Downstream

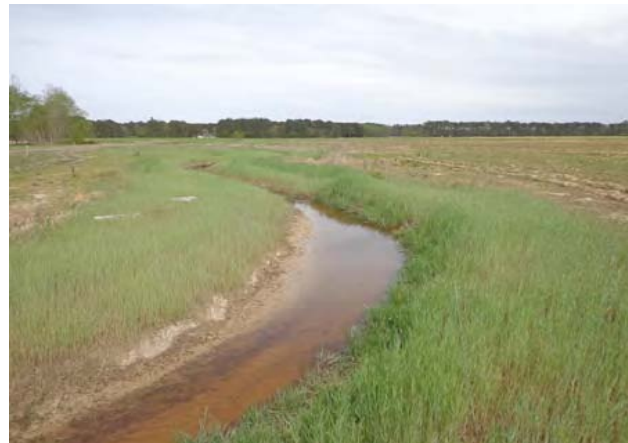
Cross Section 4-DRC West

- 10.7 x-section area (ft.sq.)
- 11.1 width (ft)
- 1.0 mean depth (ft)
- 1.7 max depth (ft)
- 11.8 wetted parimeter (ft)
- 0.9 hyd radi (ft)
- 11.4 width-depth ratio

Survey Date: 2/2014
 Field Crew: Turner Surveying

View Downstream

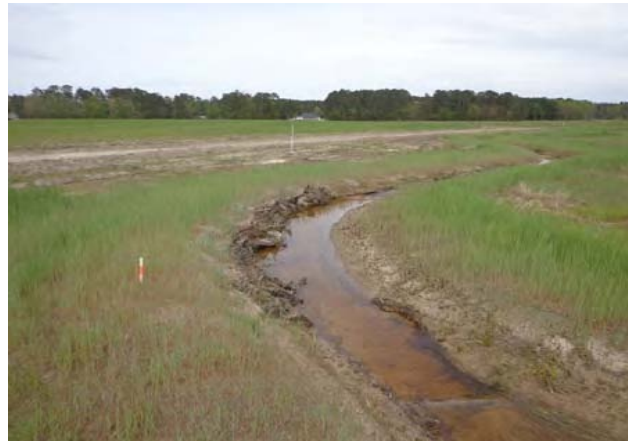
Cross Section 5-DRC West

7.5	x-section area (ft.sq.)
8.9	width (ft)
0.8	mean depth (ft)
1.5	max depth (ft)
9.4	wetted parimeter (ft)
0.8	hyd radi (ft)
10.7	width-depth ratio

Survey Date: 2/2014
 Field Crew: Turner Surveying

View Downstream

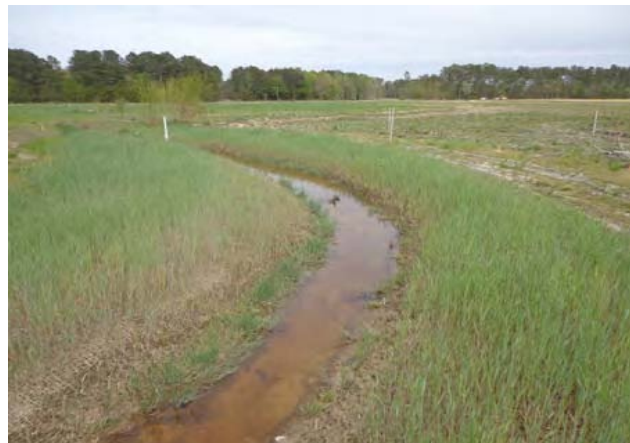
Cross Section 7-DRC West

7.6	x-section area (ft.sq.)
9.5	width (ft)
0.8	mean depth (ft)
1.6	max depth (ft)
10.1	wetted parimeter (ft)
0.8	hyd radi (ft)
11.7	width-depth ratio

Survey Date: 2/2014
 Field Crew: Turner Surveying

View Downstream

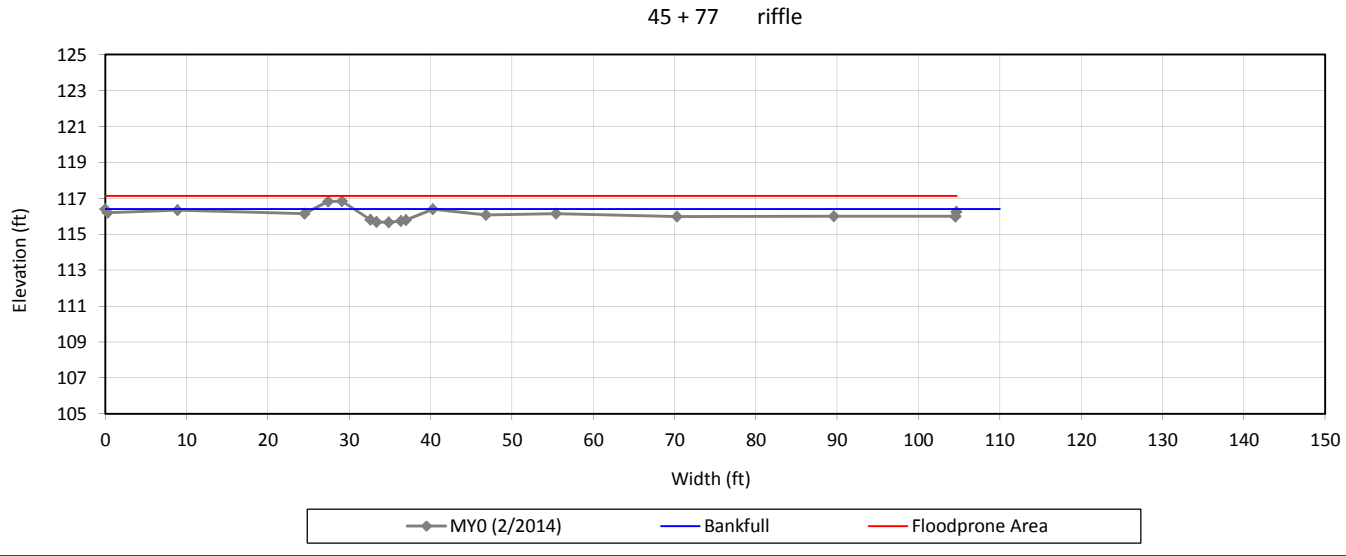
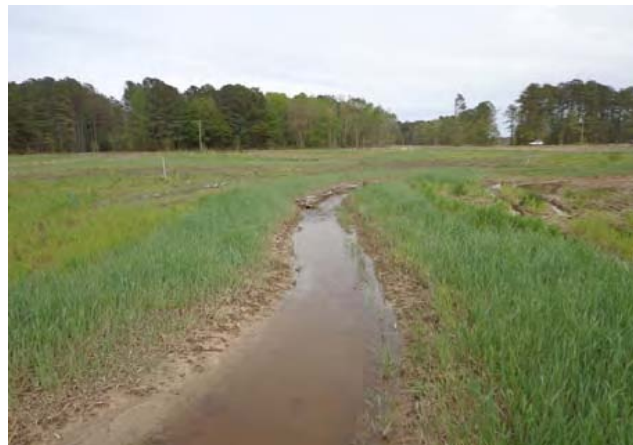
Cross Section 9-DRC West

4.0	x-section area (ft.sq.)
7.7	width (ft)
0.5	mean depth (ft)
0.7	max depth (ft)
7.7	wetted parimeter (ft)
0.5	hyd radi (ft)
14.5	width-depth ratio
200.0	W flood prone area (ft)
26.1	entrenchment ratio
1.0	low bank height ratio

Survey Date: 2/2014
 Field Crew: Turner Surveying

View Downstream

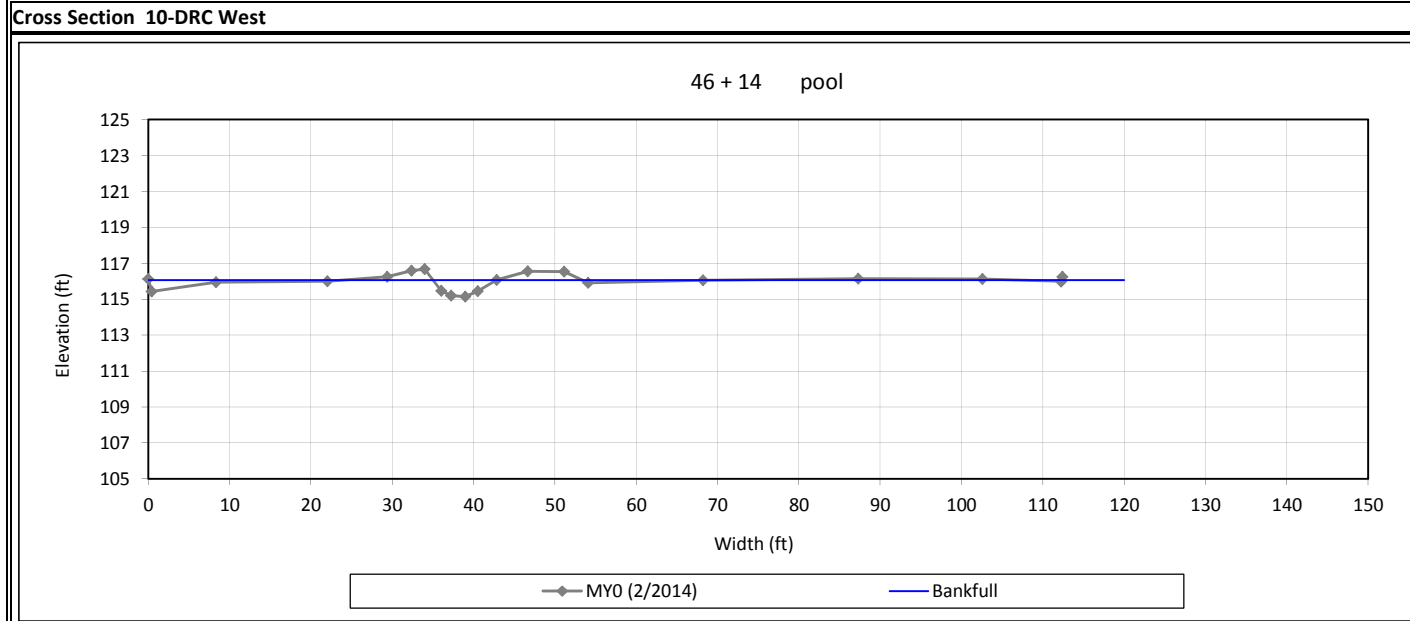
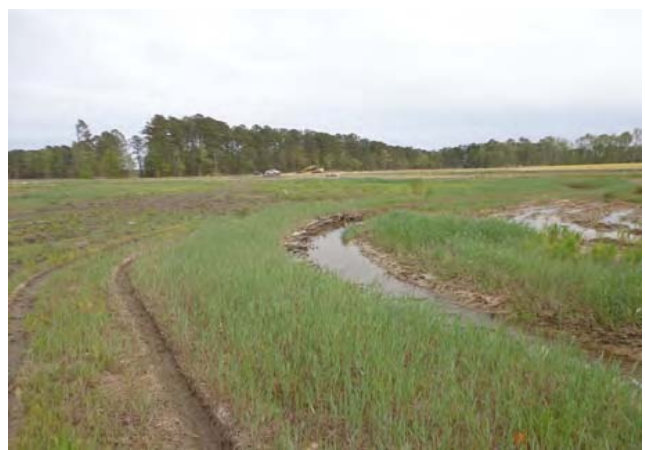
4.4	x-section area (ft.sq.)
6.8	width (ft)
0.6	mean depth (ft)
0.9	max depth (ft)
7.0	wetted parimeter (ft)
0.6	hyd radi (ft)
10.6	width-depth ratio

View Downstream

Survey Date: 2/2014
 Field Crew: Turner Surveying

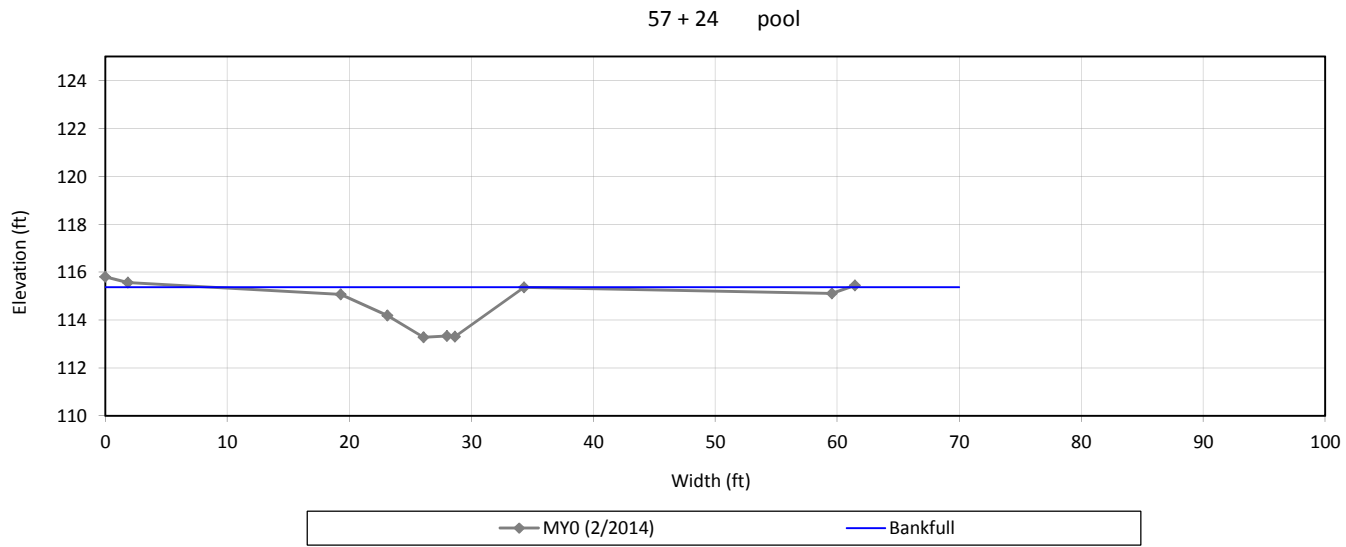
Cross Section 11-DRC East

Cross-Section Plots
 Devil's Racetrack Mitigation Site (Project No. 95021)
 Monitoring Year 0

Bankfull Dimensions

18.8	x-section area (ft.sq.)
15.0	width (ft)
1.2	mean depth (ft)
2.1	max depth (ft)
15.6	wetted parimeter (ft)
1.2	hyd radi (ft)
12.0	width-depth ratio

Survey Date: 2/2014
 Field Crew: Turner Surveying

The baseline (MY-0) dimension numbers closely match the design parameters with minor variations in all reaches. These variations are primarily due to constructed riffles or brush shallows in the riffle sections and brush toe in the pool sections. Installation of these structures results in irregularity of the surface which is reflected in the cross sections. Summary data and cross-section plots of each project reach can be found in Appendix 2.

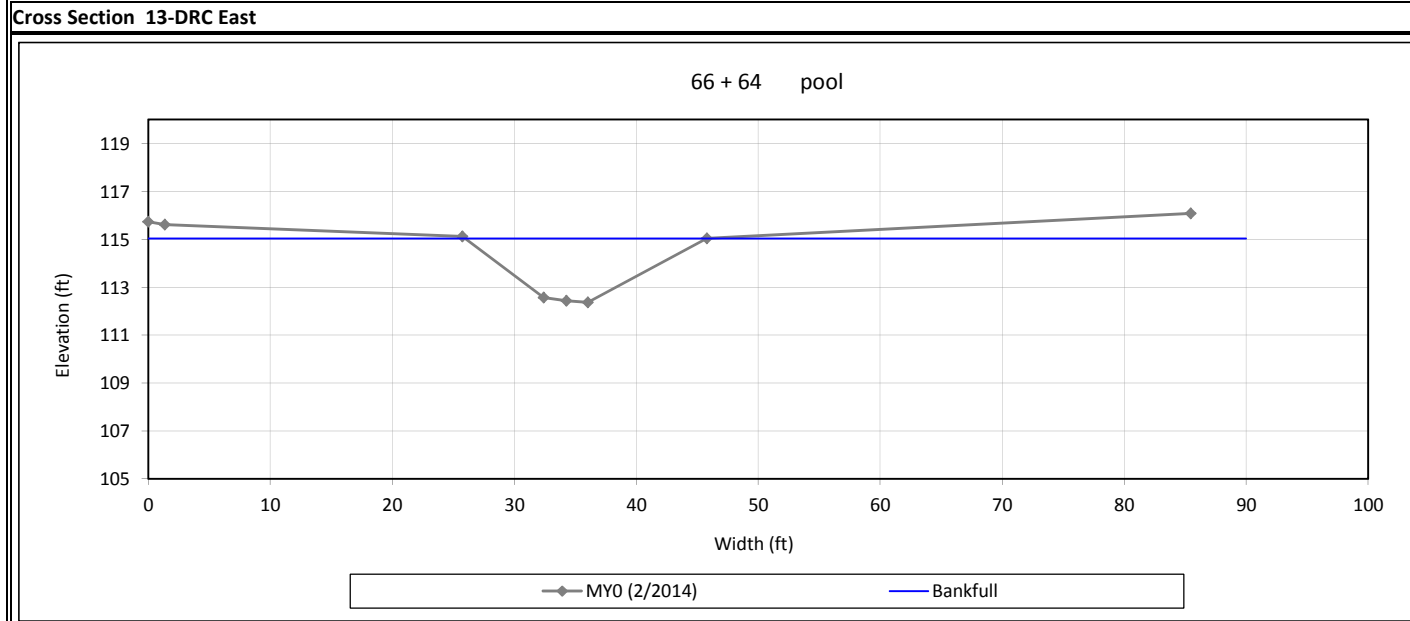
Cross-Section Plots
 Devil's Racetrack Mitigation Site (Project No. 95021)
 Monitoring Year 0

Bankfull Dimensions

30.2	x-section area (ft.sq.)
19.8	width (ft)
1.5	mean depth (ft)
2.7	max depth (ft)
20.6	wetted parimeter (ft)
1.5	hyd radi (ft)
13.0	width-depth ratio

Survey Date: 2/2014
 Field Crew: Turner Surveying

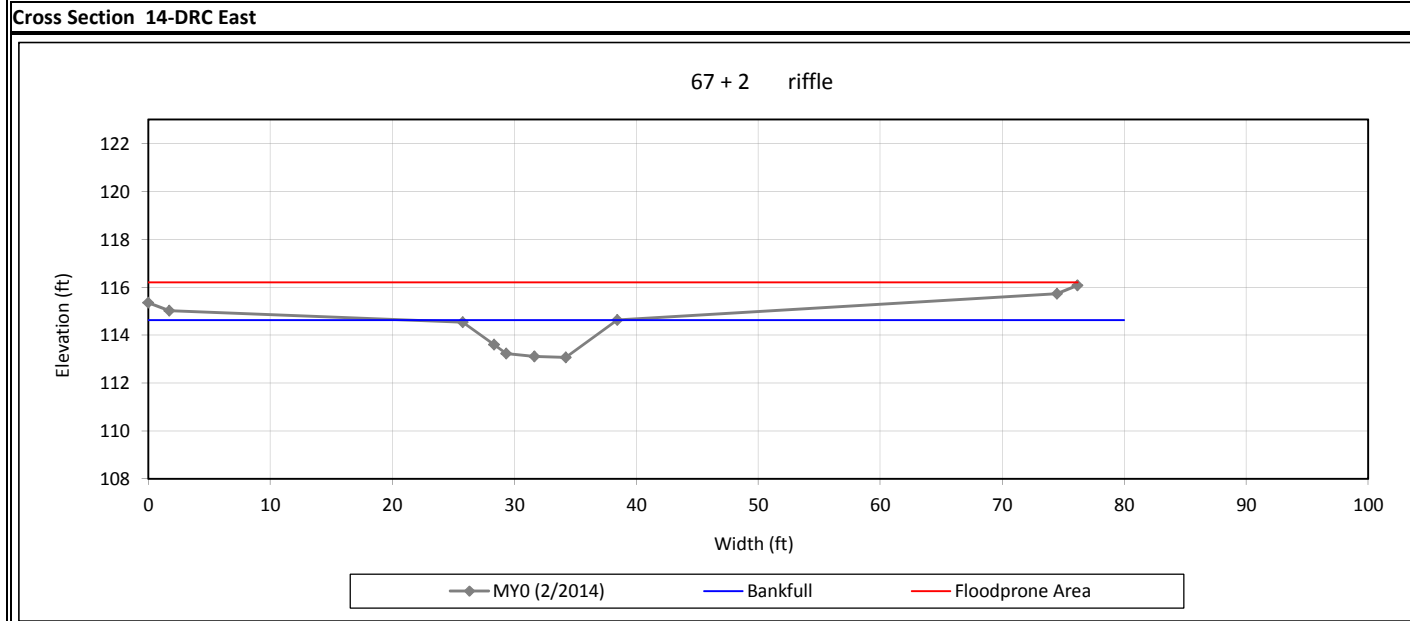
Cross-Section Plots
 Devil's Racetrack Mitigation Site (Project No. 95021)
 Monitoring Year 0

Bankfull Dimensions

13.3	x-section area (ft.sq.)
12.7	width (ft)
1.1	mean depth (ft)
1.6	max depth (ft)
13.2	wetted parimeter (ft)
1.0	hyd radi (ft)
12.1	width-depth ratio
300.0	W flood prone area (ft)
23.7	entrenchment ratio
1.0	low bank height ratio

Survey Date: 2/2014
 Field Crew: Turner Surveying

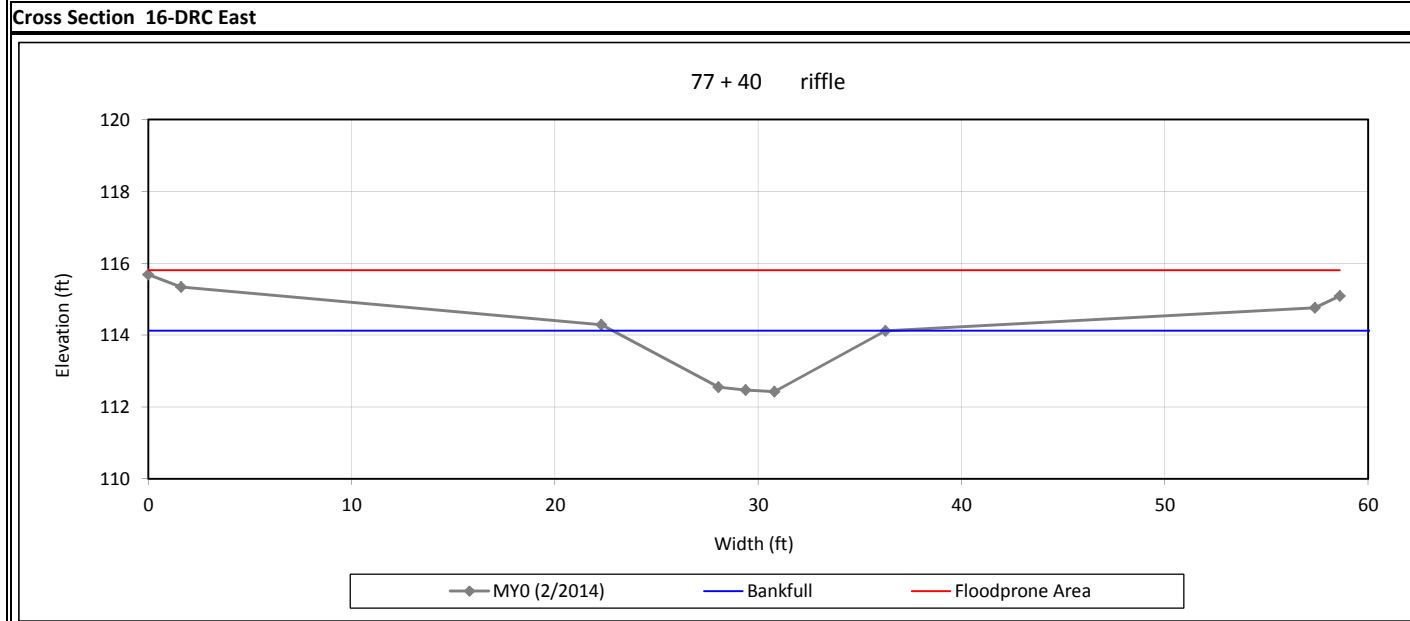
Cross-Section Plots
 Devil's Racetrack Mitigation Site (Project No. 95021)
 Monitoring Year 0

Bankfull Dimensions

- 13.2 x-section area (ft.sq.)
- 13.4 width (ft)
- 1.0 mean depth (ft)
- 1.7 max depth (ft)
- 13.9 wetted parimeter (ft)
- 1.0 hyd radi (ft)
- 13.6 width-depth ratio
- 300.0 W flood prone area (ft)
- 22.3 entrenchment ratio
- 1.0 low bank height ratio

Survey Date: 2/2014
 Field Crew: Turner Surveying

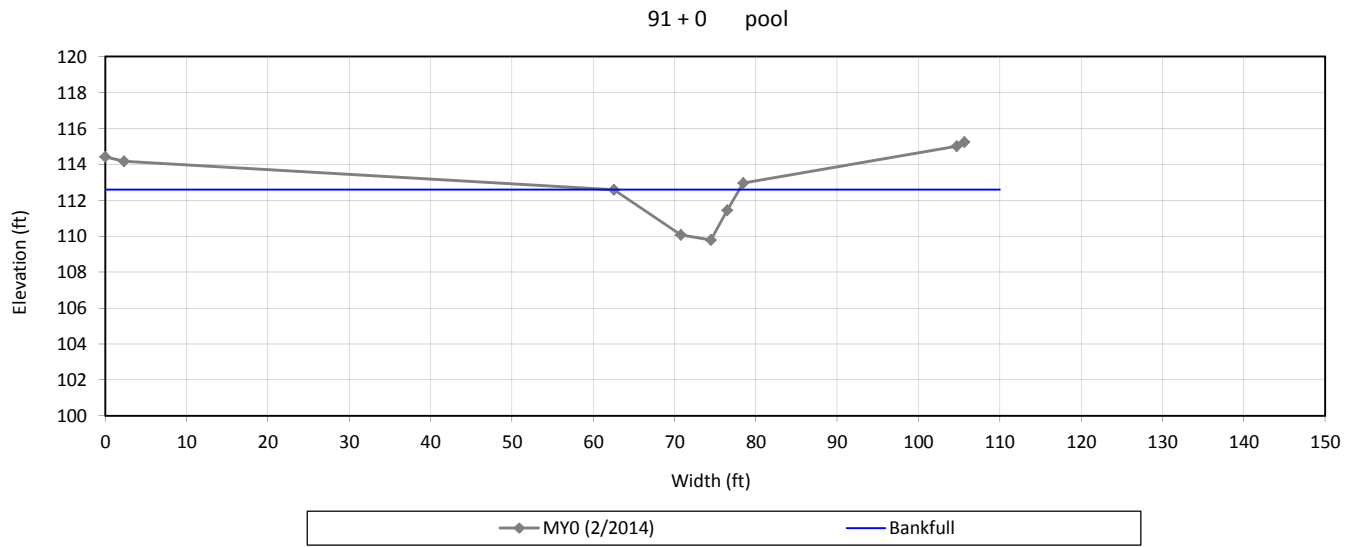
Cross Section 18-DRC East

Cross-Section Plots
 Devil's Racetrack Mitigation Site (Project No. 95021)
 Monitoring Year 0

Bankfull Dimensions

- 25.0 x-section area (ft.sq.)
- 15.5 width (ft)
- 1.6 mean depth (ft)
- 2.8 max depth (ft)
- 16.8 wetted parimeter (ft)
- 1.5 hyd radi (ft)
- 9.5 width-depth ratio

Survey Date: 2/2014
 Field Crew: Turner Surveying

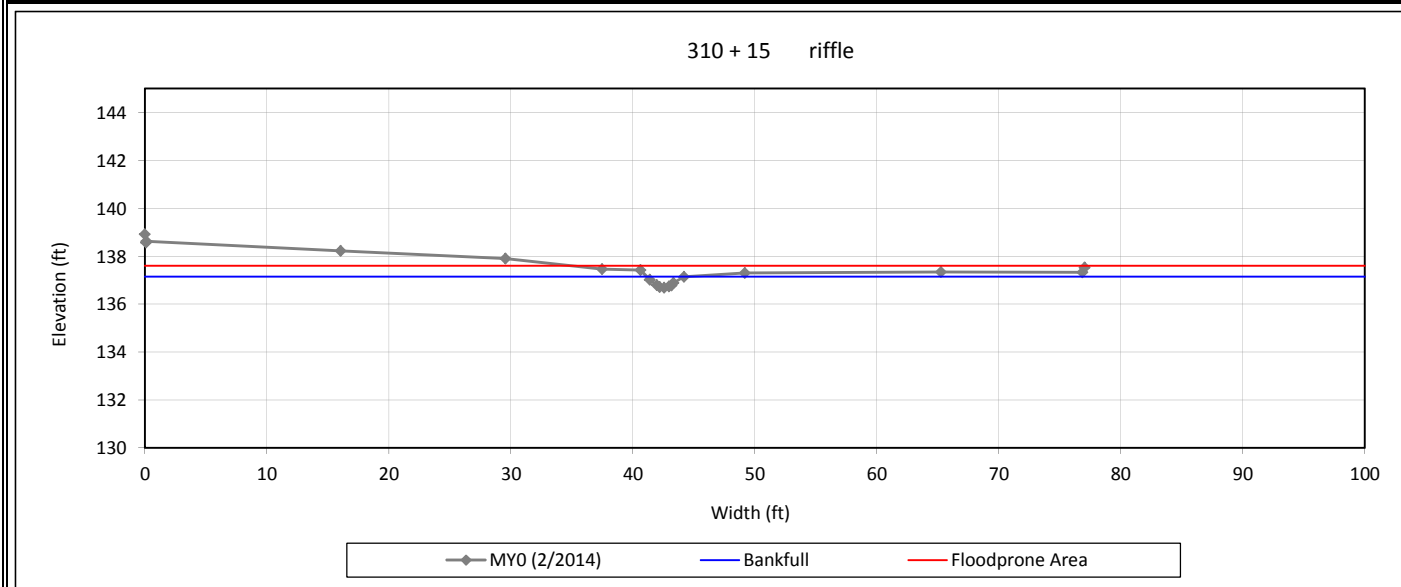
Cross Section 29-Southeast Br

Bankfull Dimensions

- 0.8 x-section area (ft.sq.)
- 3.0 width (ft)
- 0.3 mean depth (ft)
- 0.5 max depth (ft)
- 3.2 wetted perimeter (ft)
- 0.3 hyd radi (ft)
- 11.4 width-depth ratio
- 30.0 W flood prone area (ft)
- 9.9 entrenchment ratio
- 1.0 low bank height ratio

Survey Date: 2/2014
 Field Crew: Turner Surveying

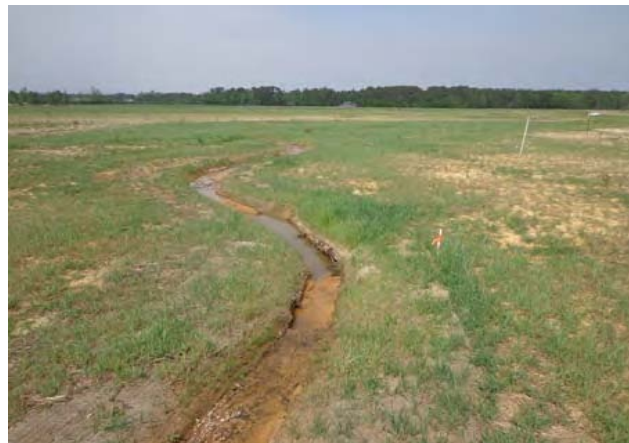
View Downstream

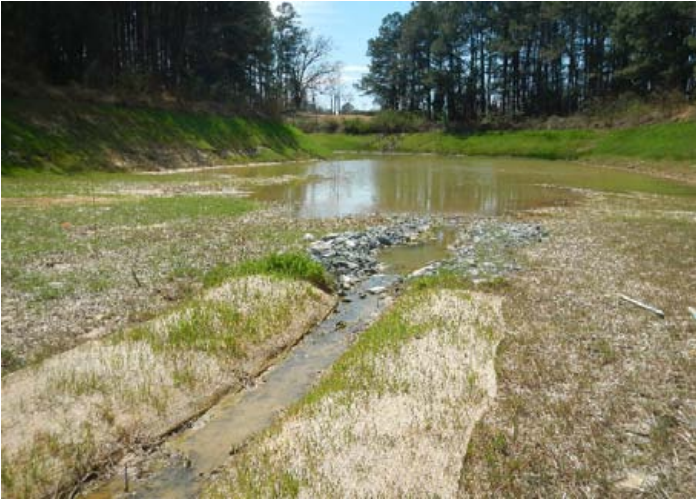
Photo Point 61 – looking upstream (04/01/2014)

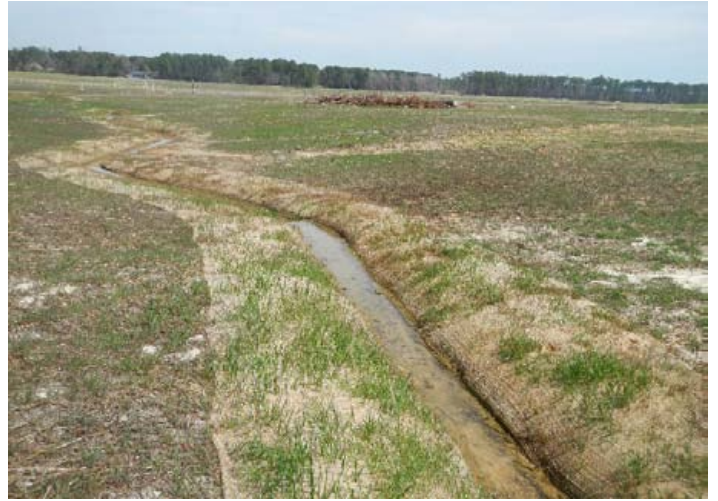
Photo Point 61 – looking downstream (04/01/2014)

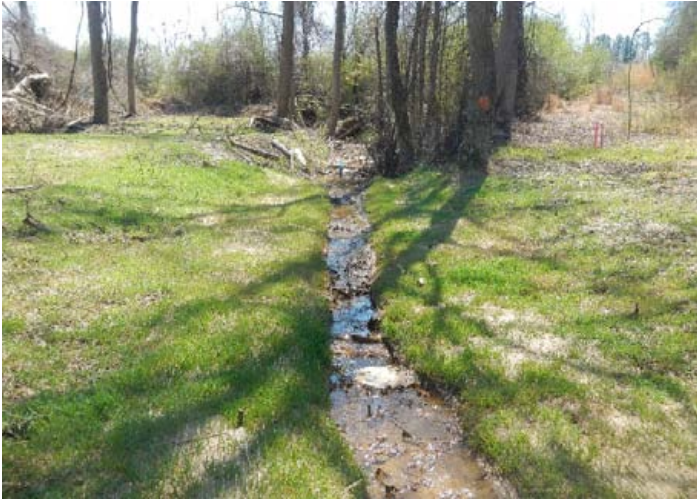
Photo Point 55 – looking upstream (04/01/2014)

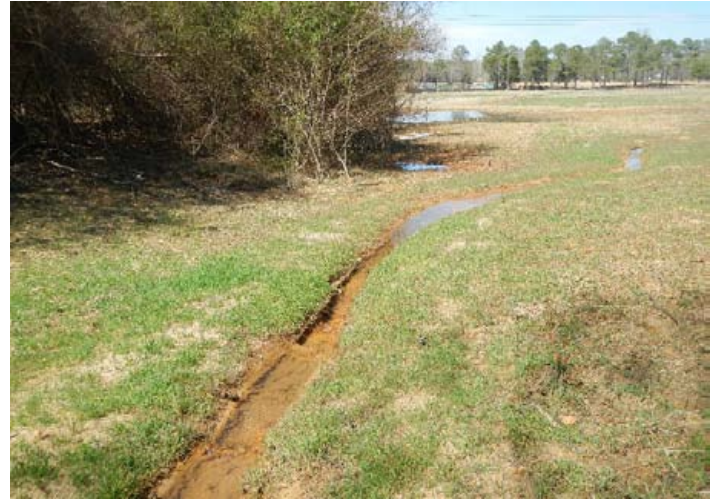
Photo Point 55 – looking downstream (04/01/2014)

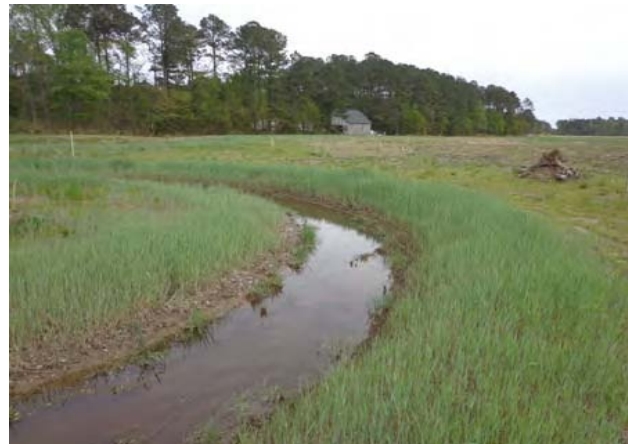
View Downstream

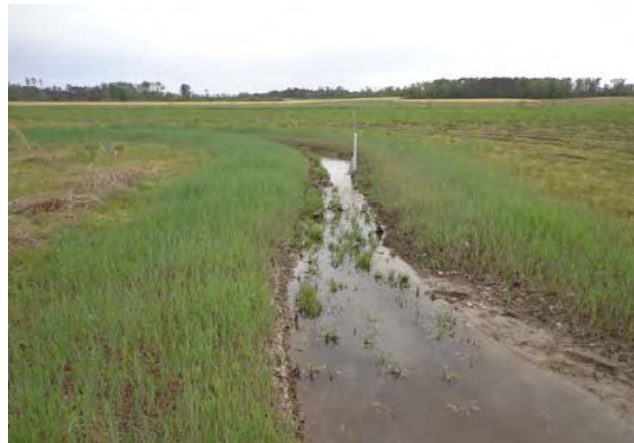
View Downstream

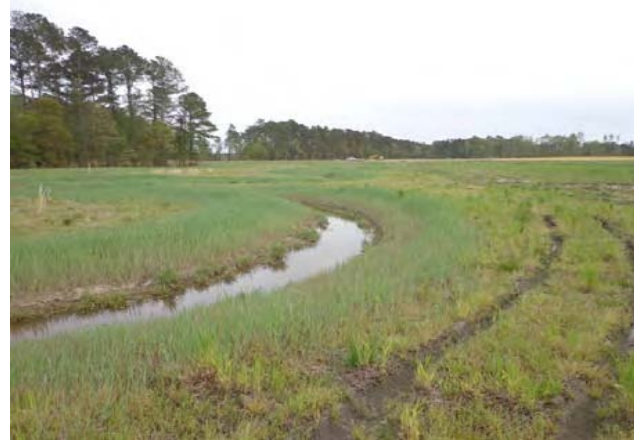
View Downstream
