Dog Bite Site Stream Restoration Plan

Mitchell County, North Carolina

State Contract No. D06056-A

Dog Bite Site
Stream Restoration Plan
Mitchell County, North Carolina

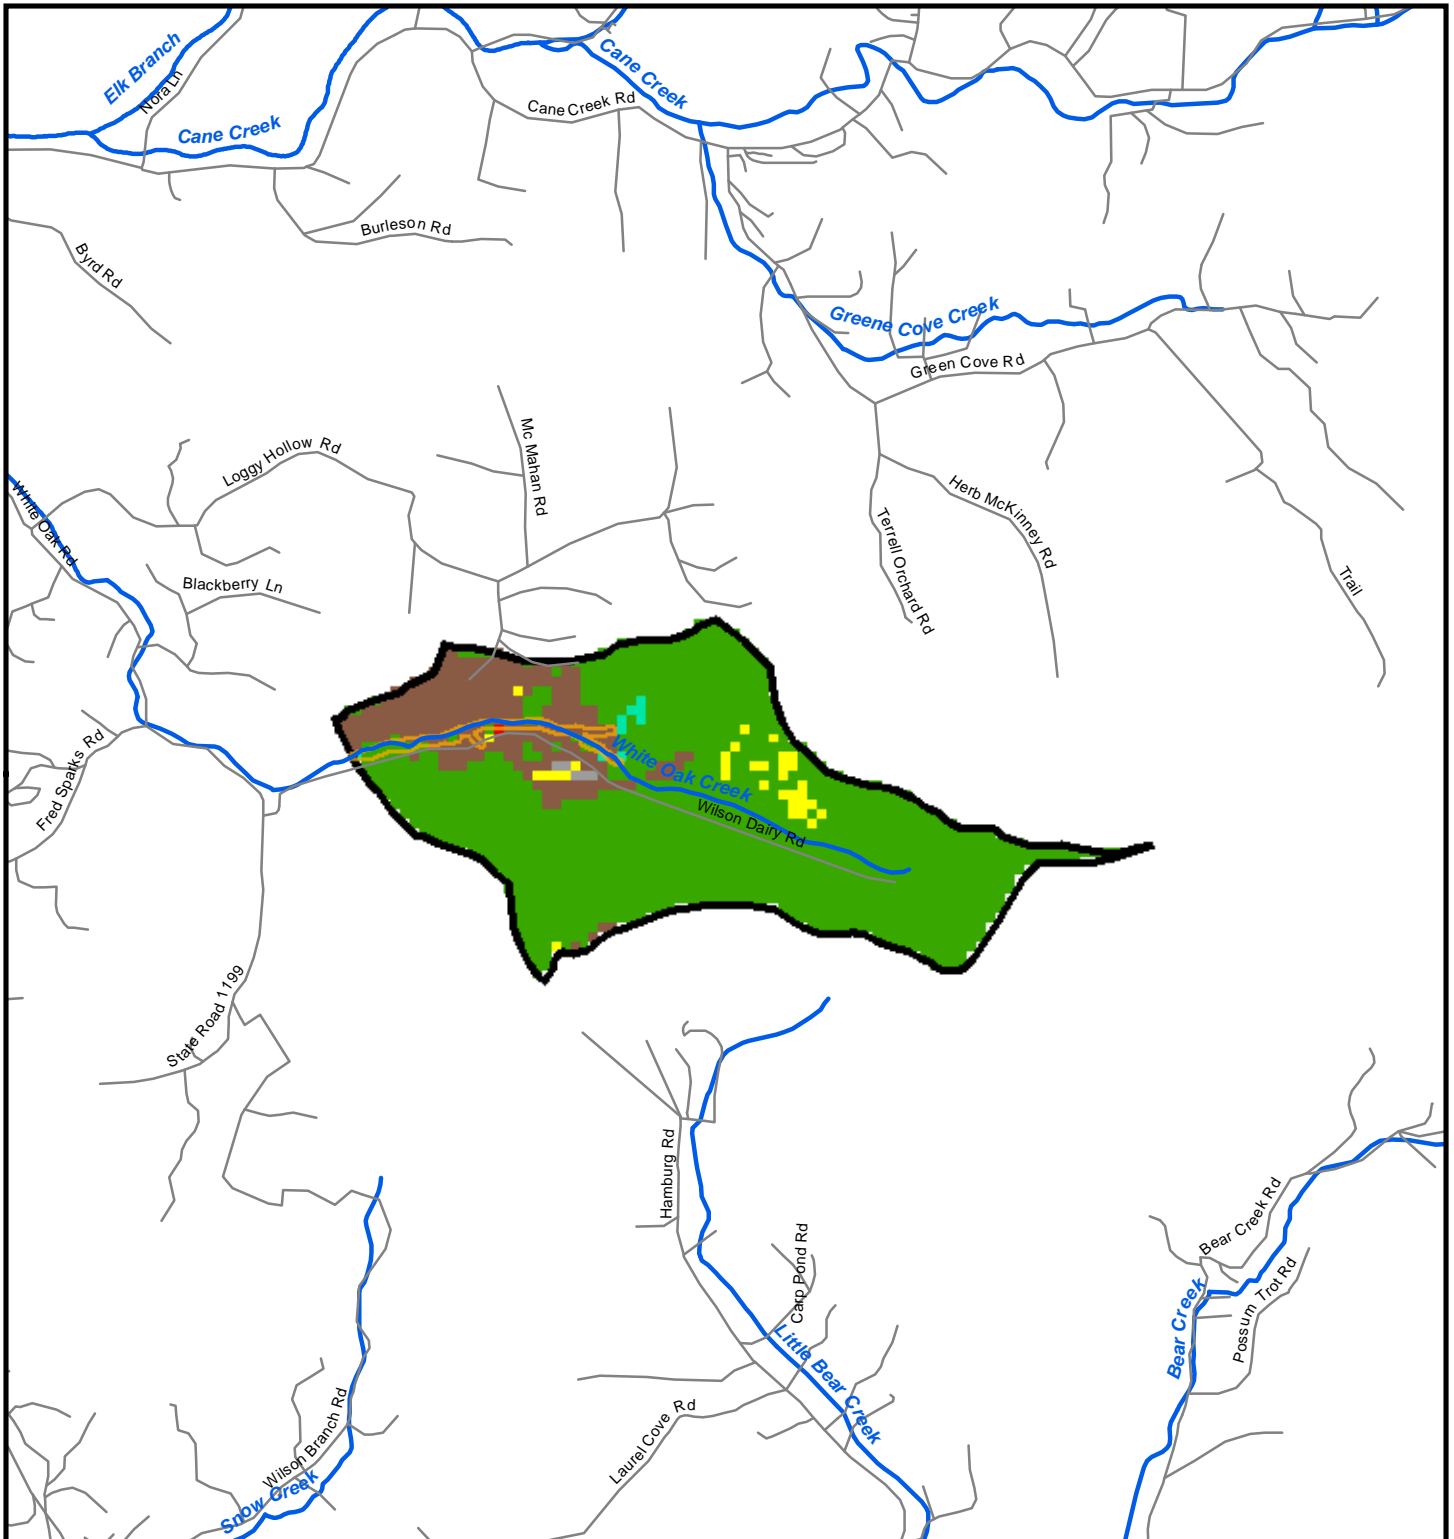
Figure 5. Project Watershed Land Use

Source: NC GAP Land Cover Dataset
Using Anderson 1 Classification Scheme

The DBS site is located solely on one property. In the past the property had been used as a dairy farm. Dairy operations ended in 1996 and since then most of the property has been put into Christmas tree cultivation. Using an Anderson Level I classification, the predominate land uses in the project watershed consist of 2% agriculture, 80% forest, 17% pasture, and less than 1% wetland, open water, and urban or built-up land (See Table 2 and Figure 5) (McKerrow 2003). The surrounding area is rural with low development pressure.

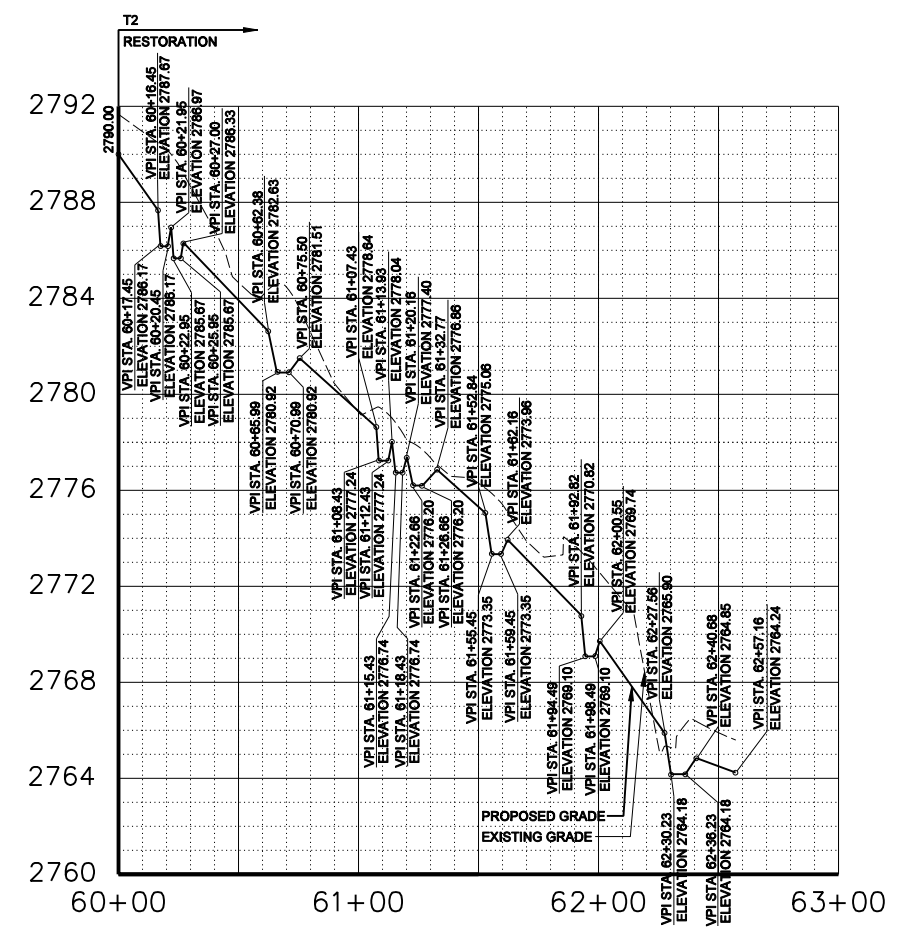
SHEET 5 OF 16

PLAN AND PROFILE

NOTE:
ALL RIFFLES ARE TO BE ENHANCED WITH NATIVE MATERIAL STOCKPILED FROM EXISTING STREAM OR WITH CLASS "B" STONE.

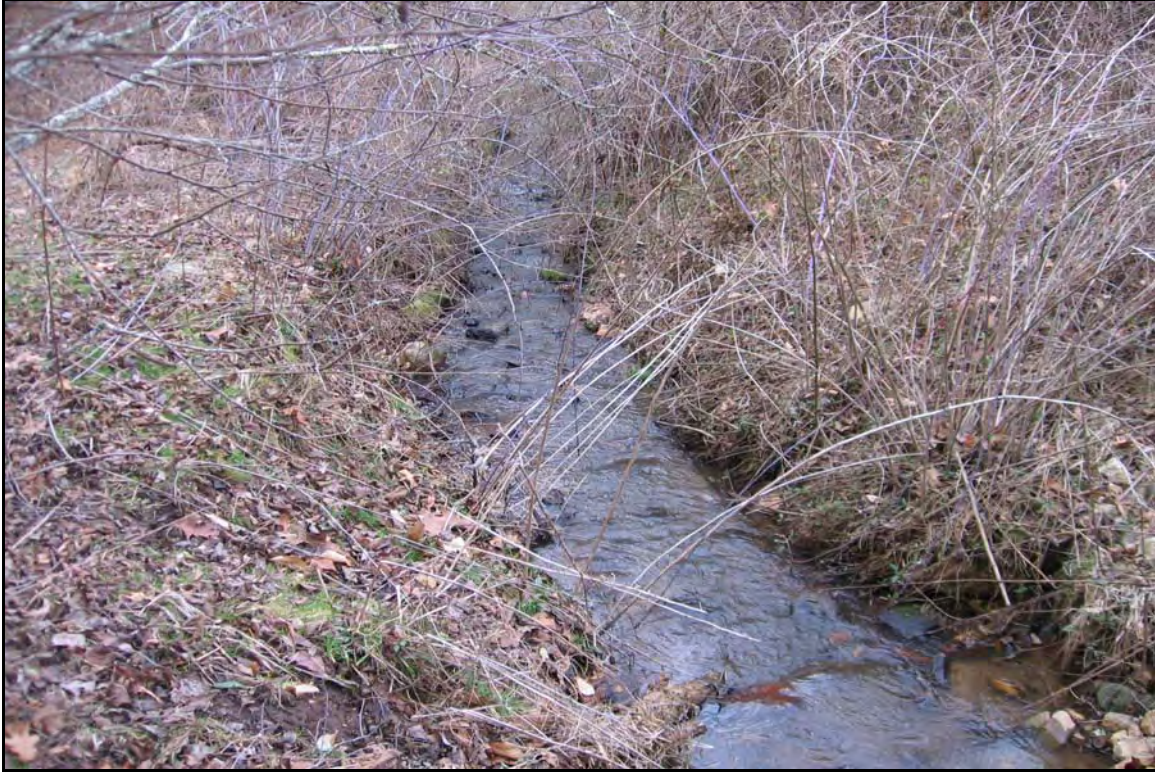
Looking downstream at a long riffle/run sequence that characterizes WOC-1.

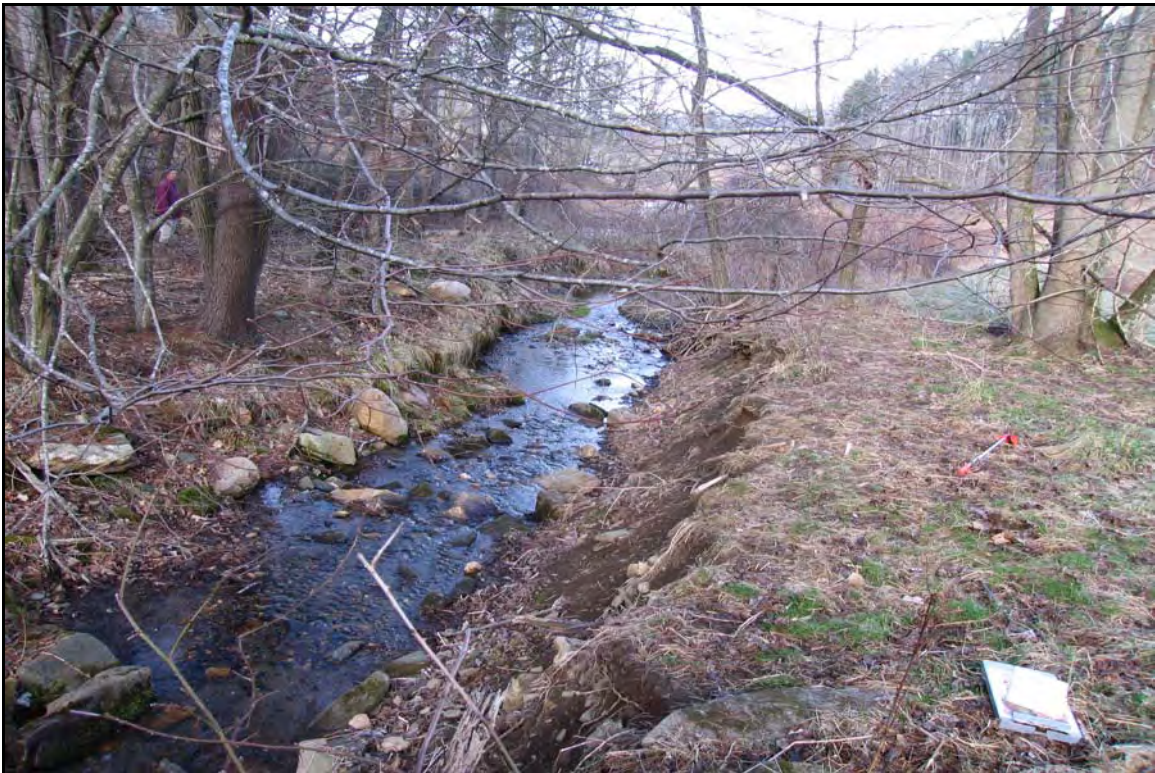
Poor riparian buffer and an eroding bank near the beginning of WOC-2.

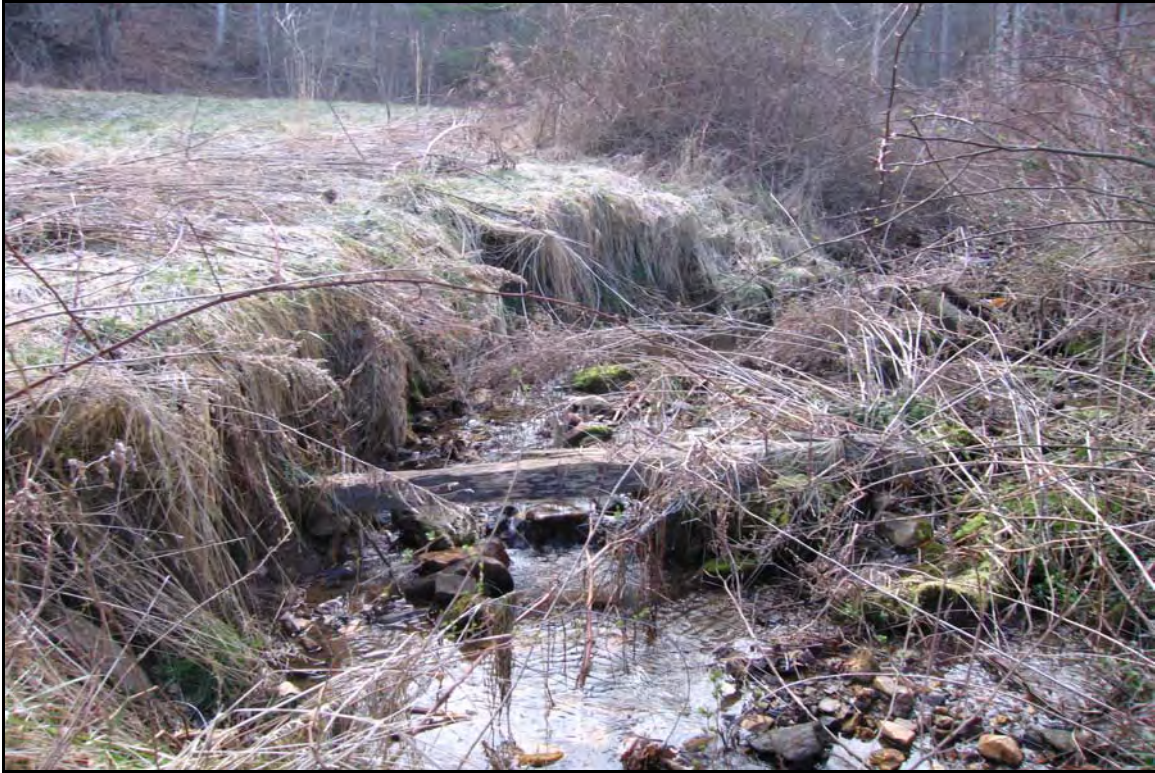
Immediately upstream of the outlet into the irrigation pond on WOC-2.

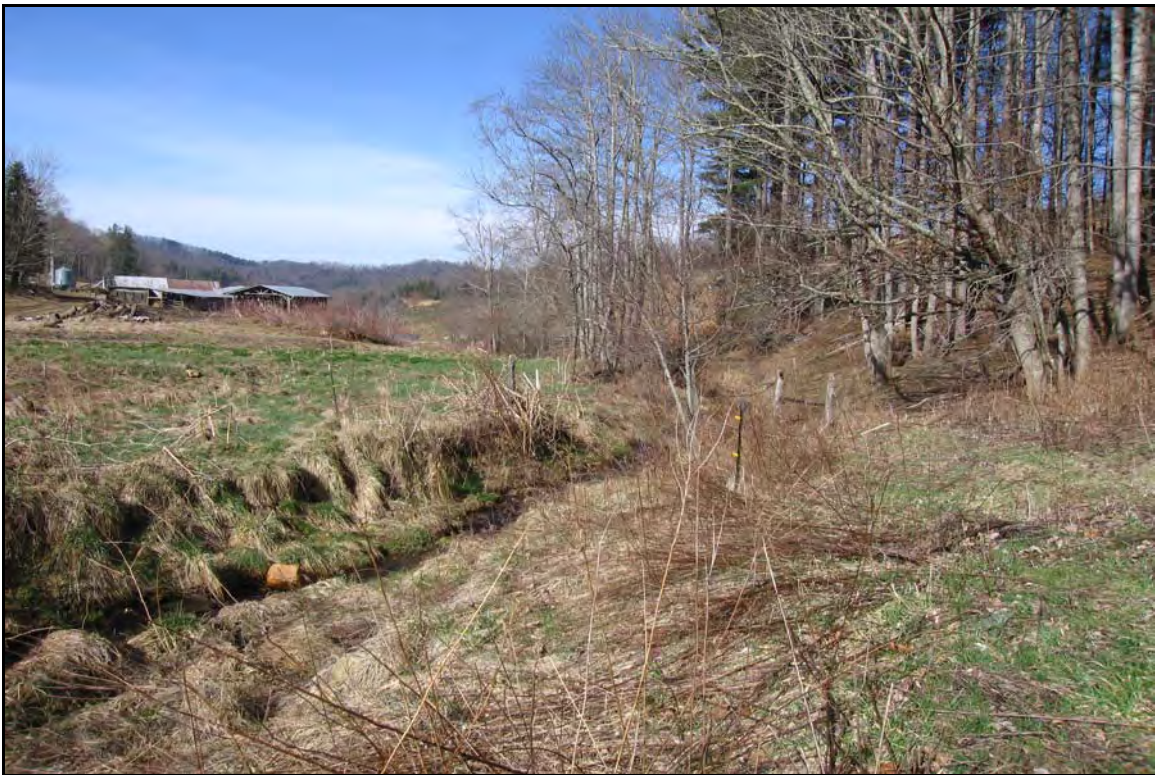
The end of WOC-2. WOC-3 begins under the trees in the background.

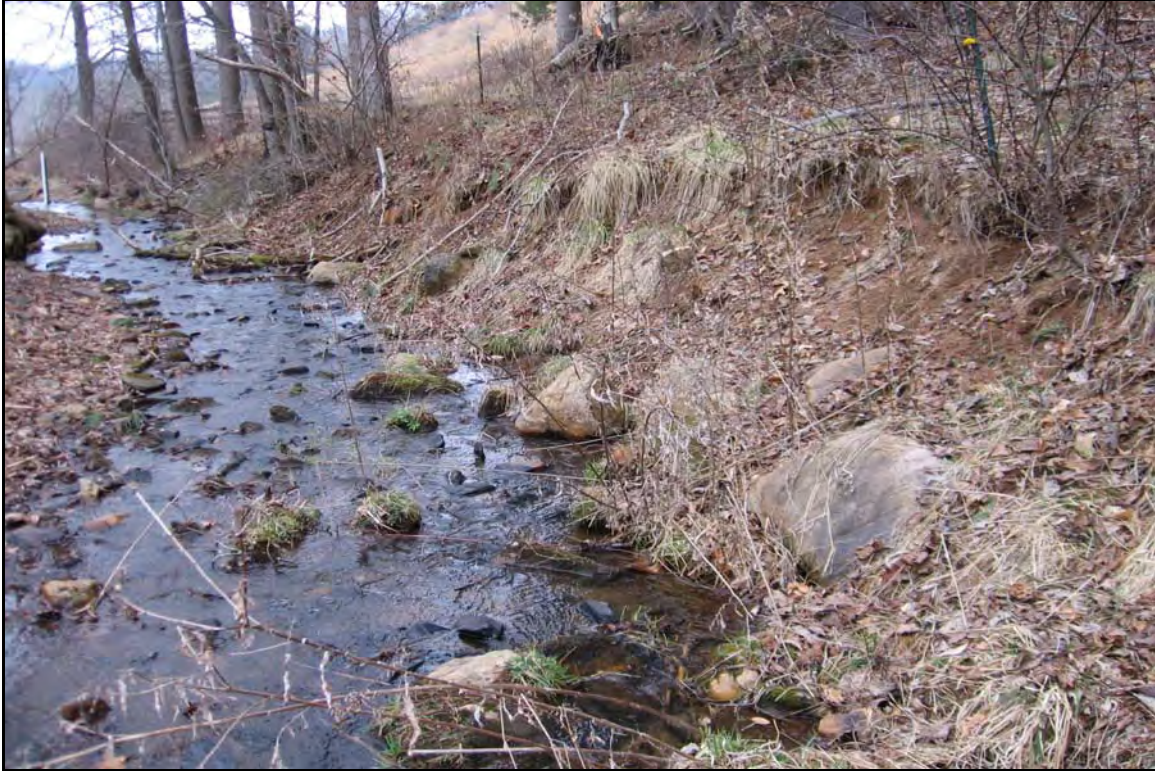
A long riffle/run sequence and eroding bank near the beginning of WOC-3.

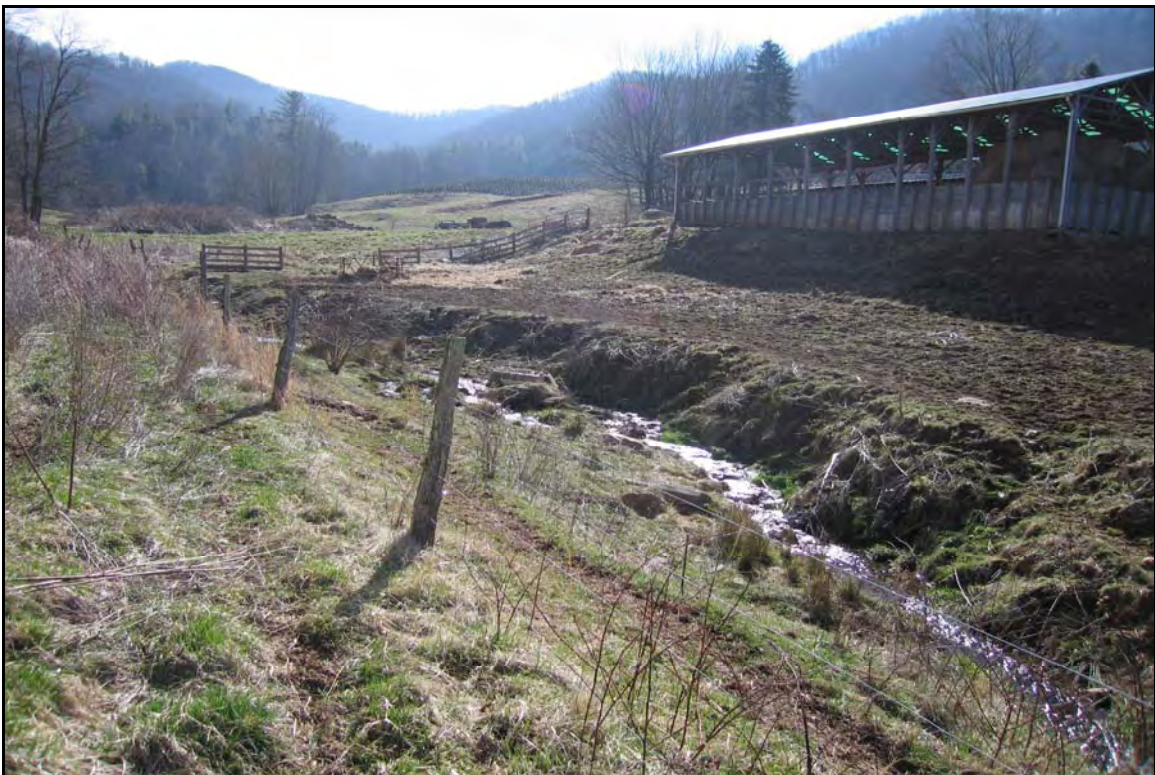
Looking upstream at the beginning of WOC-4 with the livestock barn in the background.

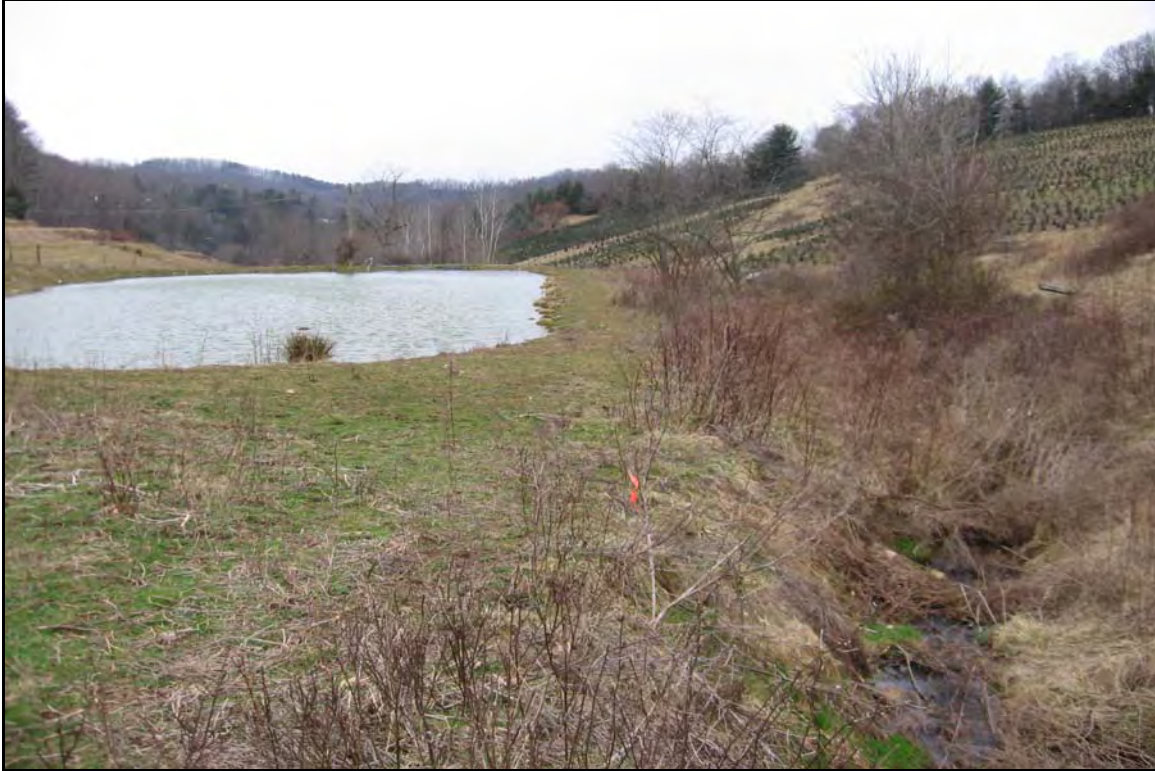
The waste lagoon, which will be removed, with WOC-4 at the base of the berm on the right side of the lagoon.

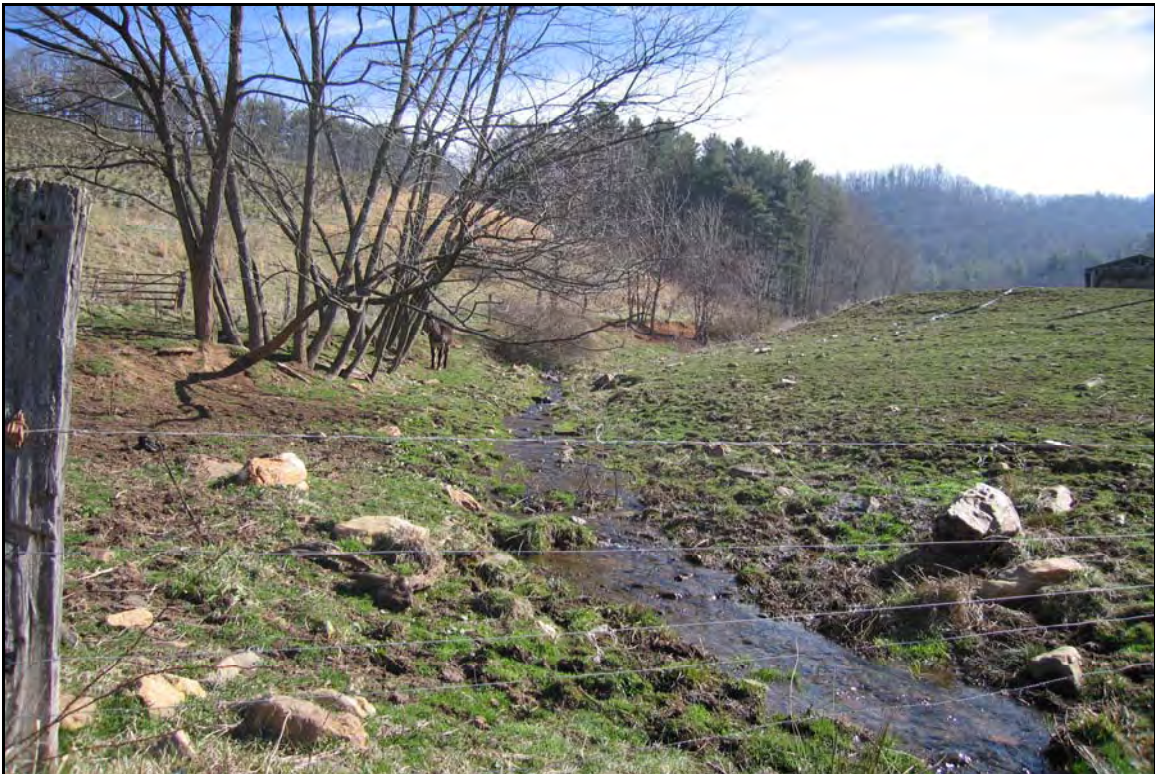
Upstream view of WOC-4 after it passes the waste lagoon; there have been extensive livestock impacts in this location. The lagoon berm is on the right side in this photo.

Portions of WOC-4 have unrestricted livestock access, which has contributed to bank and bed degradation. The reach's instability is also due to the fact that the upper portion of WOC-4 is confined in a narrow portion of the valley and is channelized around a steep pond berm. The stream continues down the valley where there is riparian vegetation, but still a natural stream pattern. While these two factors would normally contribute to stability, the steep grade of the valley and lack of pools continues to cause instability, leading to bank erosion and poor habitat diversity. This reach has a range of bank height ratios between 1.8 and 3.7.

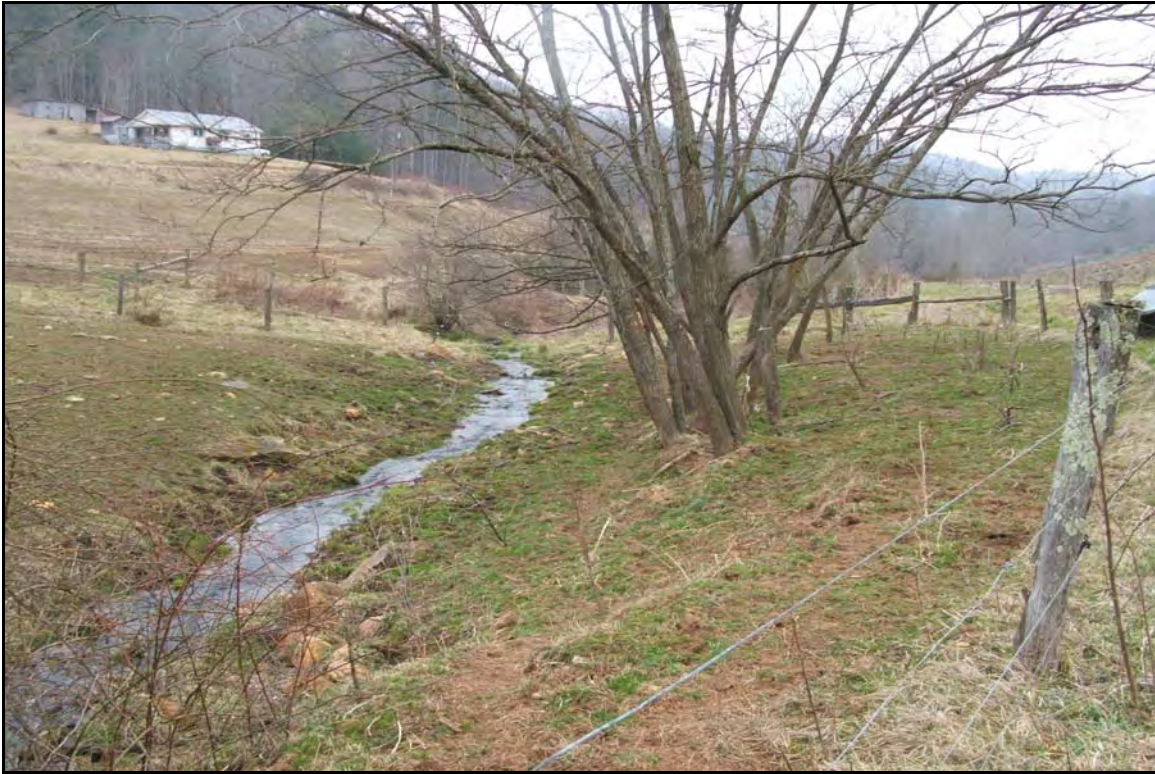
WOC-4 immediately before it becomes further entrenched in the valley.

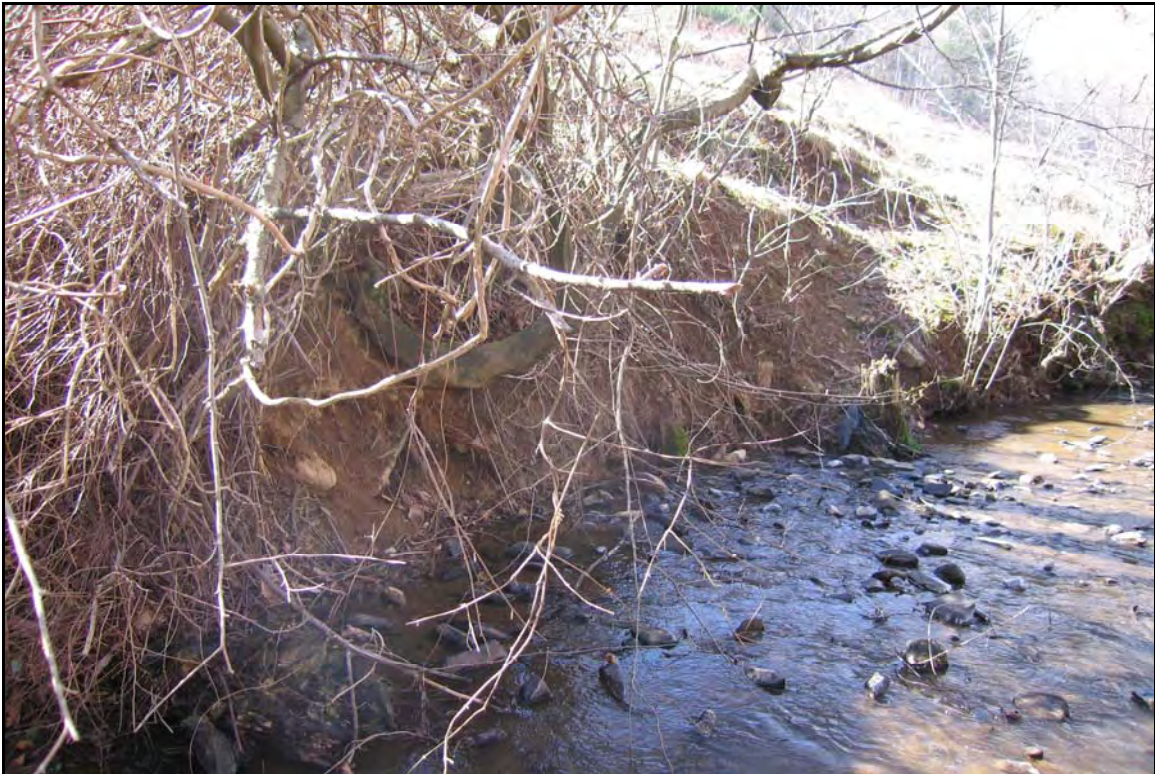
Bank erosion along WOC-4 after the confluence with T2.

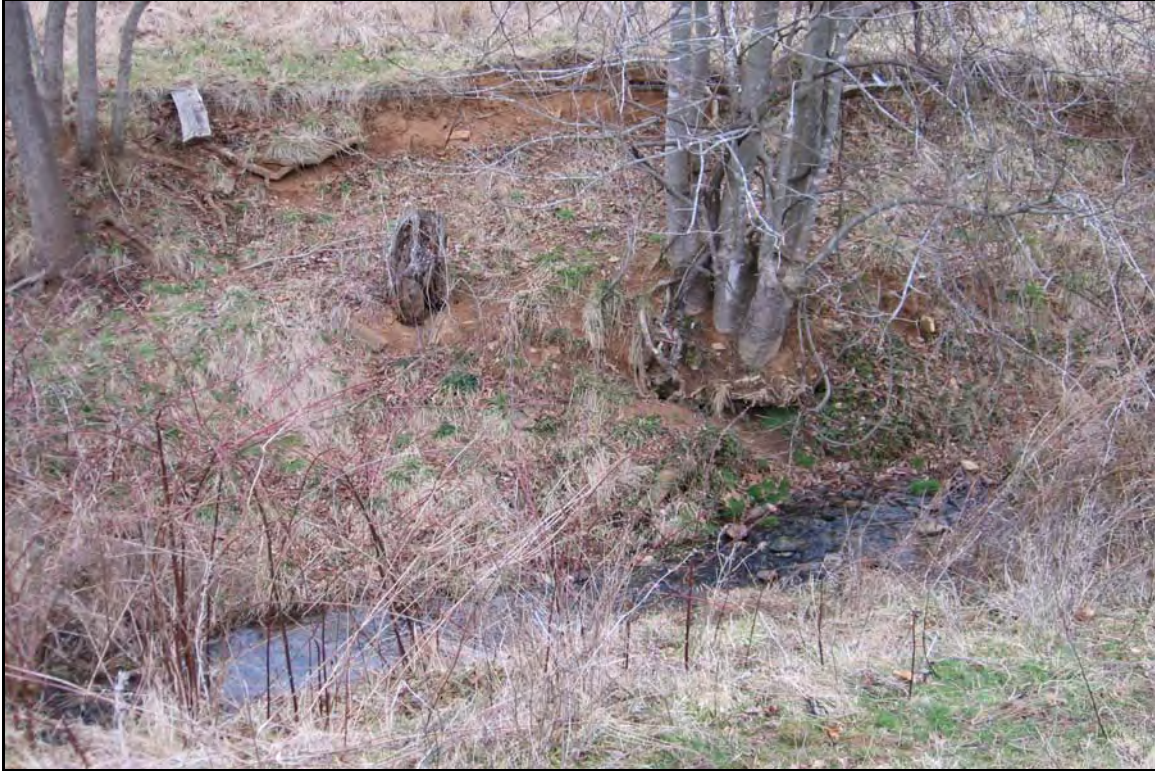
Looking down at WOC-4, which is entrenched within the valley in this section.

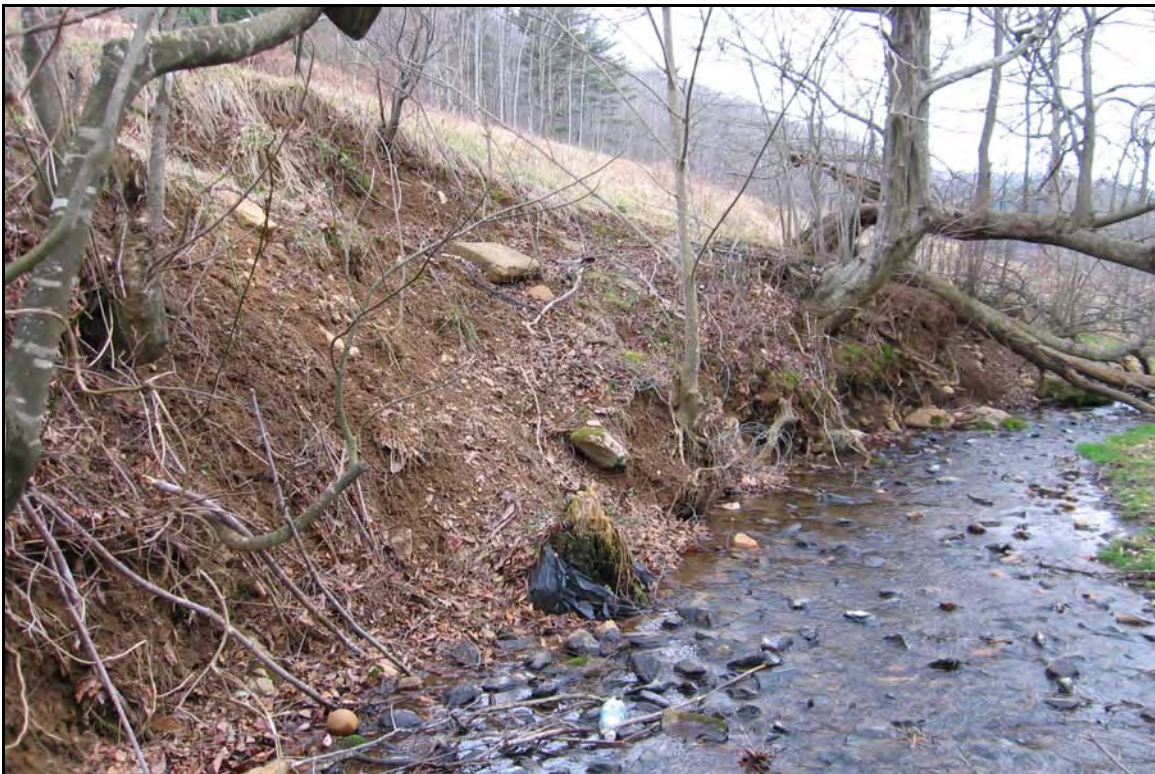
Bank erosion along WOC-4.

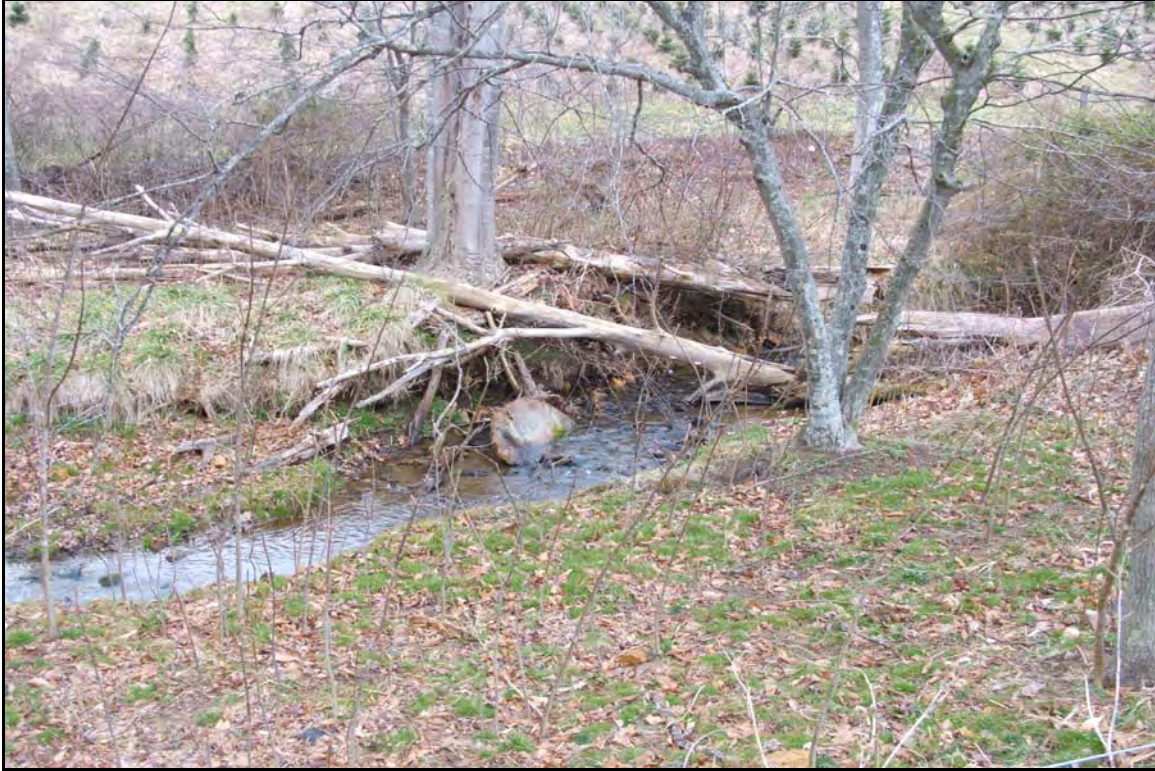
WOC-5 near the end of the project site.

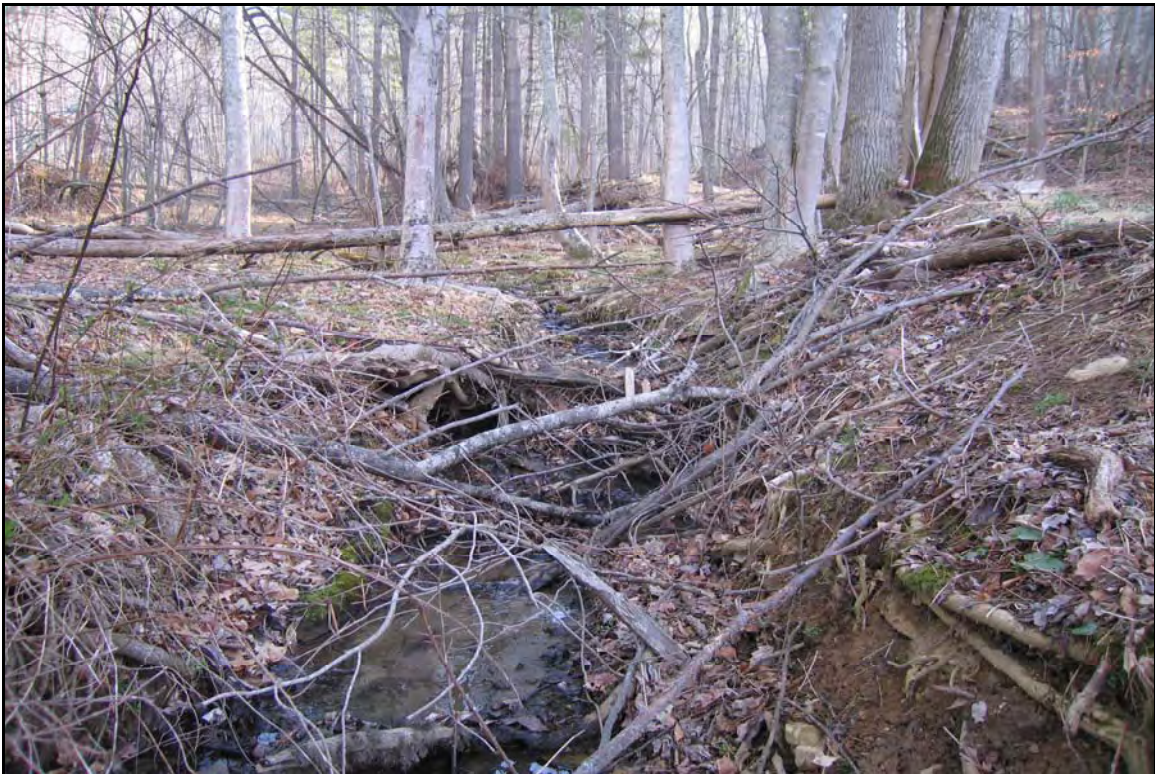
The beginning of T1-1 where a headcut has developed and the stream has become incised.

The two tributaries are both unstable, but they are in different evolutionary stages. T1 and T2 have bank height ratios of 3.6 and 4.2, respectively. T1-1, while in a more forested area, is experiencing incision and widening, as evidenced by the undercut trees on the stream banks. Once T1 leaves the tree line, the channelized stream has filled in and does not have a defined flow path. The instability on T2 has been caused by livestock and the lack of riparian vegetation. T2 has extensive bed and bank degradation due to these two disturbances.

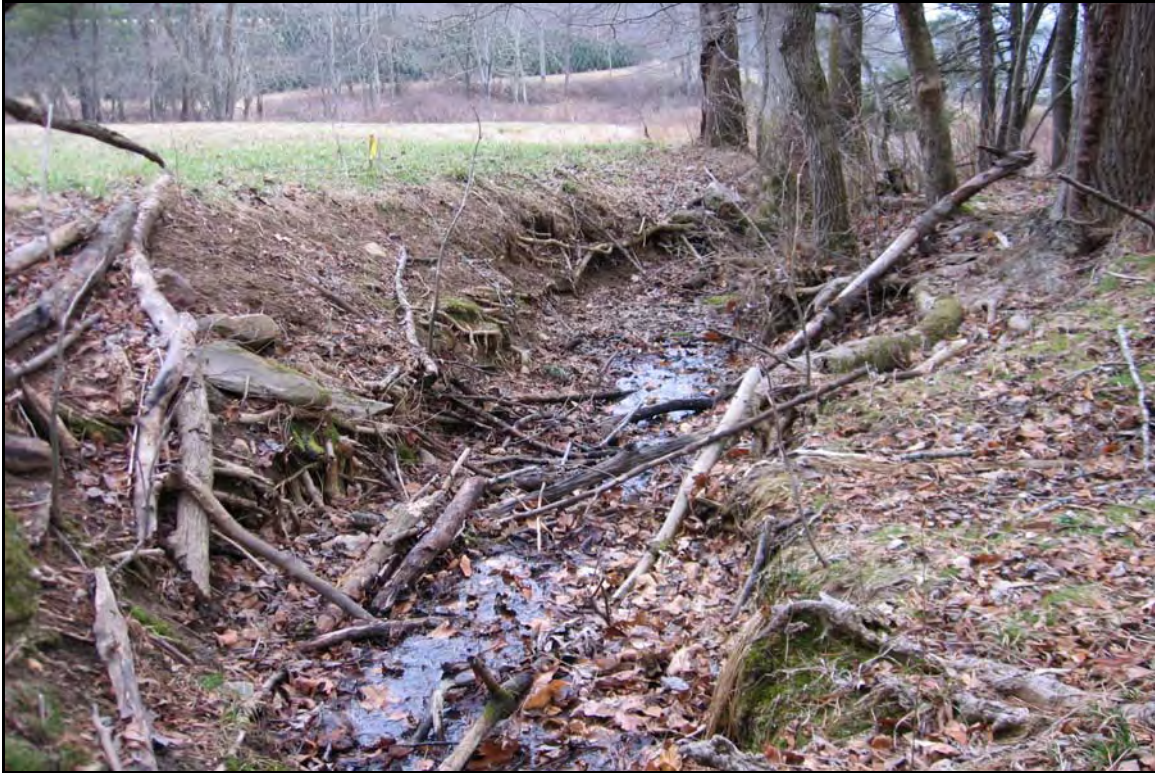
Looking downstream along T1-1 where the stream is incised.

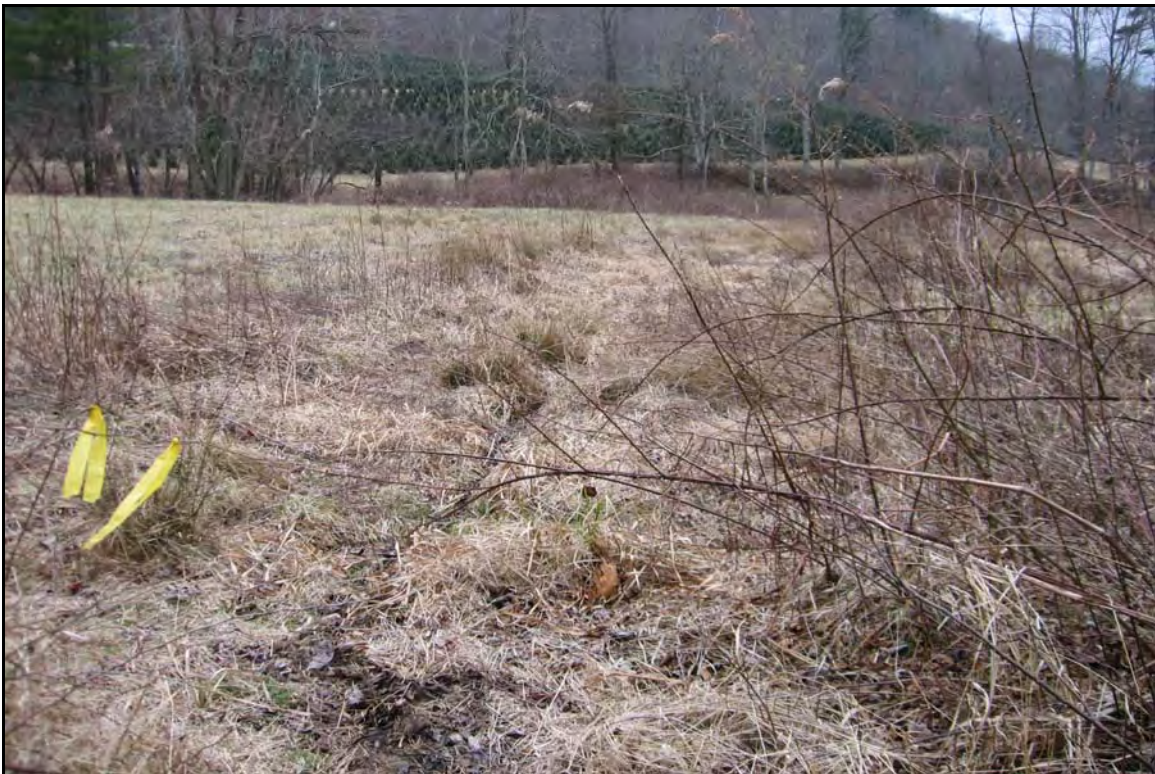
Looking downstream at the beginning of T1-2 where the channel has filled in; the tributary flows diffusely until its confluence with WOC.

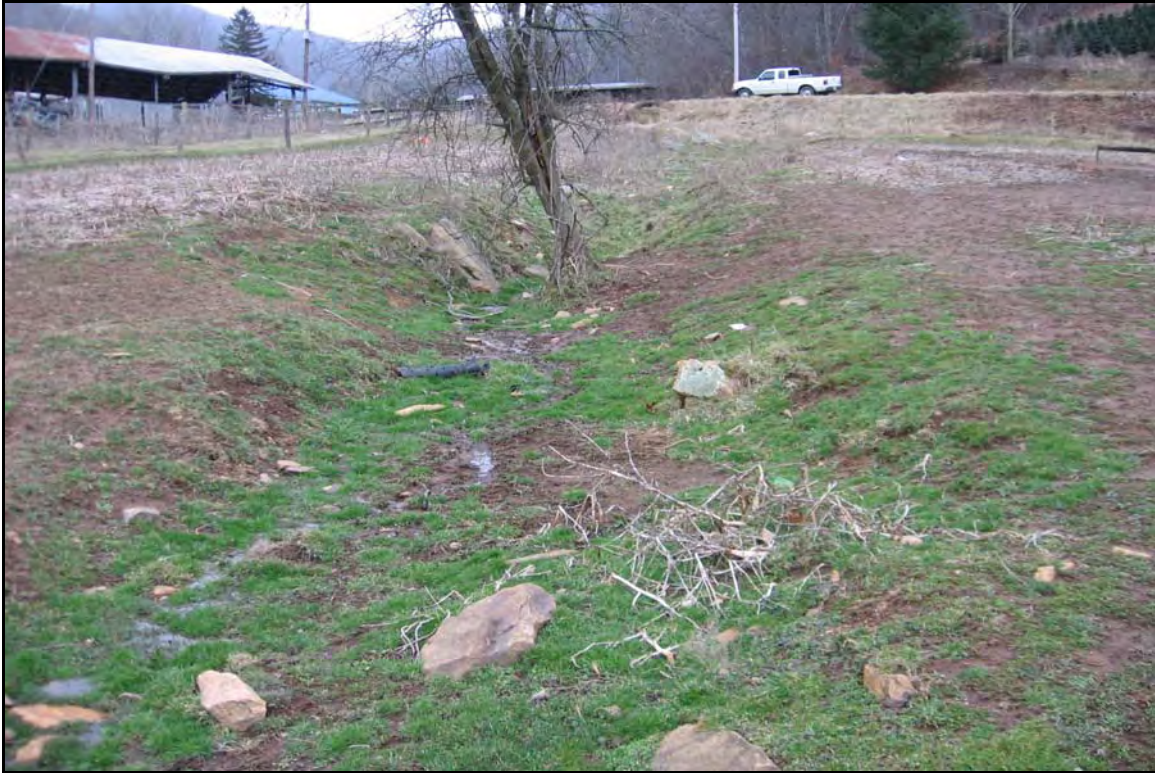
Looking upstream along T2 towards Wilson Dairy Road, where there are heavy cattle impacts.

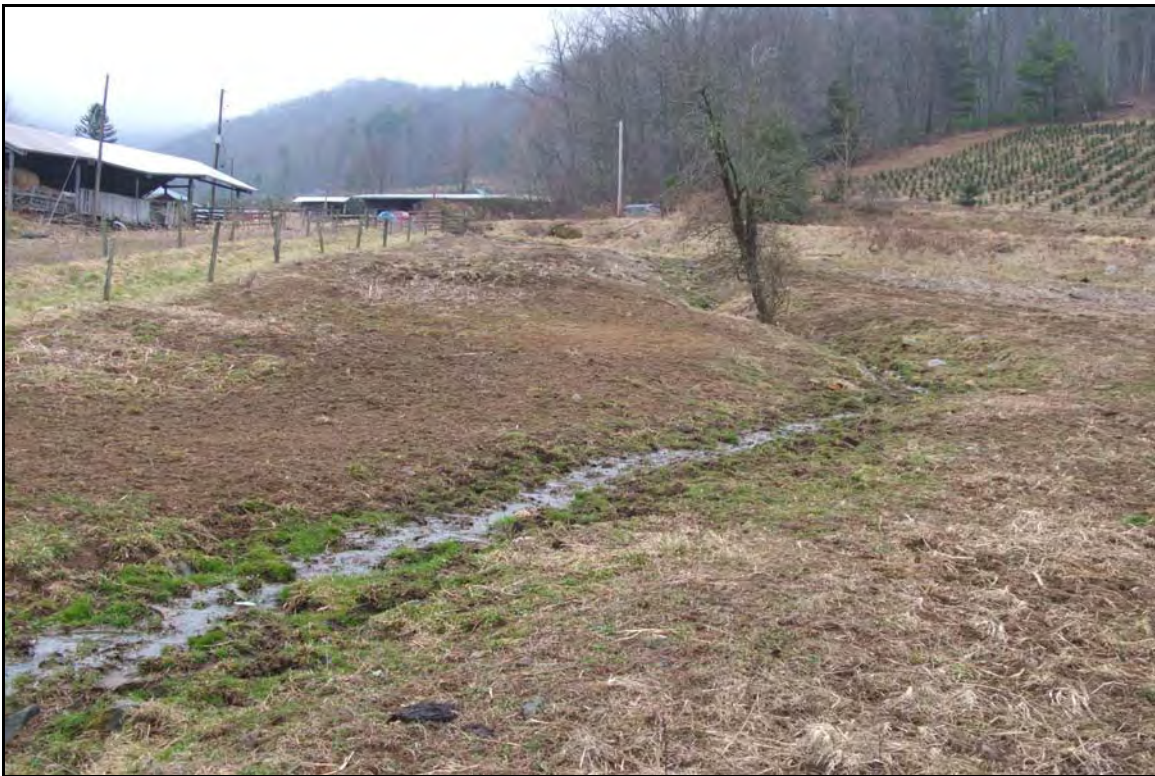
Looking upstream along T2 immediately before the confluence with WOC.

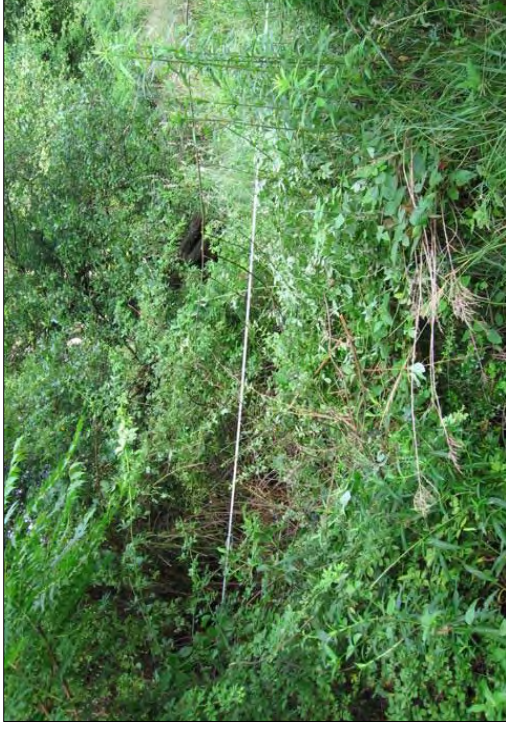
French Broad River Basin, White Oak Creek, Existing Conditions, WOC-1, XS - 1, Riffle

River Basin:	French Broad
Watershed:	White Oak Creek, Existing Conditions, WOC-1
XS ID	XS - 1, Riffle
Drainage Area (sq mi):	0.5
Date:	8/26/2007
Field Crew:	B. Hemel, Z. Mrynceza

Station	Elevation
0.0	2857.39
2.4	2857.41
4.5	2857.46
7.0	2857.52
8.9	2857.82
10.5	2857.97
12.0	2858.13
14.0	2858.17
17.4	2857.15
19.4	2856.85
21.1	2856.03
22.3	2854.52
24.6	2854.47
27.1	2854.68
28.8	2854.75
30.4	2854.89
31.4	2855.19
33.3	2856.85
35.9	2857.14
39.0	2857.56
42.0	2857.82
45.1	2858.19
47.9	2858.30
51.6	2858.59
54.2	2858.71

SUMMARY DATA	
Bankfull Elevation:	2855.2
Bankfull Cross-Sectional Area:	5.0
Bankfull Width:	9.7
Flood Prone Area Elevation:	2855.9
Flood Prone Width:	11
Max Depth at Bankfull:	0.7
Mean Depth at Bankfull:	0.5
W / D Ratio:	18.8
Entrenchment Ratio:	1.1
Bank Height Ratio:	3.3

At the start of WOC-1, the stream is not incising, due to the compact cobble bed, but it is experiencing areas of bank erosion as the stream widens. Erosion has primarily been caused by the lack of floodprone area, a result of berms along both sides of the channel. Riffles and runs are evident features along this reach, but there are no pools. The lack of pools along all of WOC does not allow for adequate energy dissipation from the normal flow, which ultimately causes more bank erosion and unstable flows. The bank height ratios along this reach are between 3.0 and 4.0.

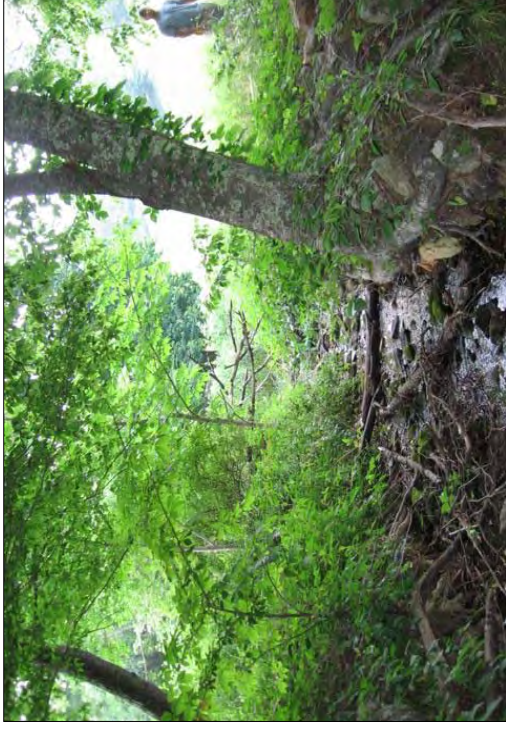
French Broad River Basin, White Oak Creek, Existing Conditions, WOC-1, XS - 2, Riffle

River Basin:	French Broad
Watershed:	White Oak Creek, Existing Conditions, WOC-1
XS ID	XS - 2, Riffle
Drainage Area (sq mi):	0.5
Date:	8/26/2007
Field Crew:	B. Hemel, Z. Mrynceza

Station	Elevation
0.0	2849.03
1.5	2849.03
3.6	2848.99
4.6	2848.95
5.6	2848.81
6.5	2848.57
7.6	2848.45
8.5	2848.63
9.6	2848.56
10.5	2848.50
11.5	2848.35
12.7	2848.16
28.7	2844.52
29.6	2844.53
30.6	2844.58
31.7	2844.52
32.6	2844.64
33.3	2845.14
35.5	2847.44
36.5	2847.68
37.5	2847.76
43.4	2847.99
45.0	2848.22
47.5	2848.20
49.4	2848.29
51.5	2848.33
53.4	2848.31
55.5	2848.45

SUMMARY DATA	
Bankfull Elevation:	2845.2
Bankfull Cross-Sectional Area:	4.9
Bankfull Width:	8.8
Flood Prone Area Elevation:	2845.9
Flood Prone Width:	10
Max Depth at Bankfull:	0.7
Mean Depth at Bankfull:	0.6
W / D Ratio:	15.8
Entrenchment Ratio:	1.2
Bank Height Ratio:	4.2

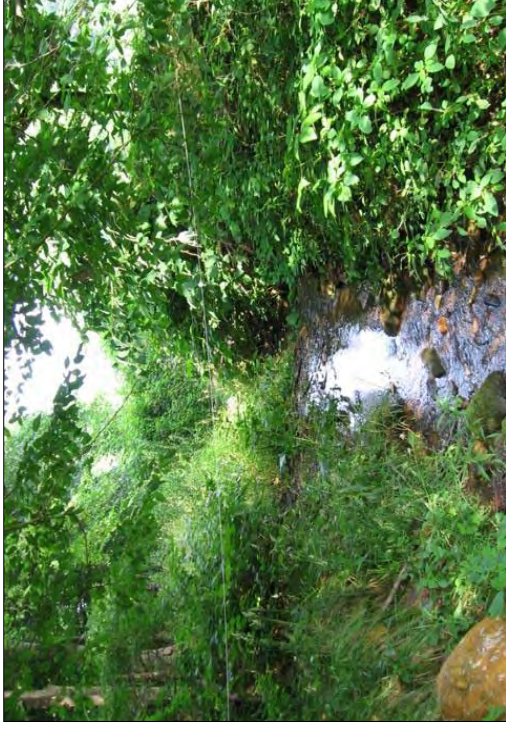
French Broad River Basin, White Oak Creek, Existing Conditions, WOC-2, XS - 3, Riffle

River Basin:	French Broad
Watershed:	White Oak Creek, Existing Conditions, WOC-2
XS ID	XS - 3, Riffle
Drainage Area (sq mi):	0.5
Date:	8/26/2007
Field Crew:	B. Hemel, Z. Mrynceza

Station	Elevation
0.0	2842.38
2.0	2842.11
3.5	2841.09
5.9	2840.65
7.4	2840.07
9.4	2838.85
11.1	2837.58
13.7	2837.54
16.2	2838.08
17.2	2838.51
18.8	2839.23
22.6	2839.29
26.7	2839.00
29.0	2838.07
30.1	2837.82
32.1	2837.45
33.2	2836.10
33.9	2836.05
34.4	2835.49
36.8	2835.45
38.3	2835.44
39.5	2835.50
40.9	2835.80
42.5	2837.12
43.7	2837.91
44.7	2838.75
45.4	2839.62
48.4	2839.76
52.3	2840.08
55.5	2840.17
57.8	2840.18
61.2	2840.34
64.3	2840.43

SUMMARY DATA	
Bankfull Elevation:	2836.2
Bankfull Cross-Sectional Area:	5.0
Bankfull Width:	8.3
Flood Prone Area Elevation:	2837.0
Flood Prone Width:	10
Max Depth at Bankfull:	0.8
Mean Depth at Bankfull:	0.6
W / D Ratio:	13.8
Entrenchment Ratio:	1.2
Bank Height Ratio:	2.6

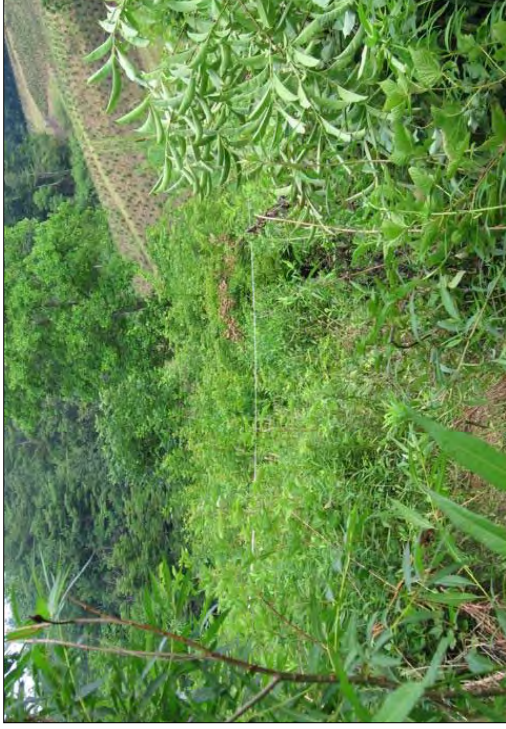
French Broad River Basin, White Oak Creek, Existing Conditions, WOC-2, XS - 4, Riffle

River Basin:	French Broad
Watershed:	White Oak Creek, Existing Conditions, WOC-2
XS ID	XS - 4, Riffle
Drainage Area (sq mi):	0.5
Date:	8/26/2007
Field Crew:	B. Hemel, Z. Mrynceza

Station	Elevation
0.0	2830.35
2.7	2830.32
4.6	2830.85
7.2	2830.78
9.2	2830.82
11.4	2830.72
13.1	2830.63
14.3	2830.12
15.4	2829.87
16.2	2829.76
17.6	2829.50
18.9	2829.05
19.6	2828.05
20.4	2827.31
22.4	2826.95
23.8	2827.45
24.4	2828.32
26.4	2829.32
28.2	2830.04
30.8	2830.51
33.3	2830.98
35.3	2831.18
38.7	2831.17
41.0	2831.37
44.8	2831.45
48.8	2831.75

SUMMARY DATA		
Bankfull Elevation:		2828.3
Bankfull Cross-Sectional Area:		4.6
Bankfull Width:		5.0
Flood Prone Area Elevation:		2829.7
Flood Prone Width:		11
Max Depth at Bankfull:		1.4
Mean Depth at Bankfull:		0.9
W / D Ratio:		5.4
Entrenchment Ratio:		2.1
Bank Height Ratio:		1.6
