Dog Bite Site Stream Restoration Plan

Mitchell County, North Carolina

State Contract No. D06056-A

Dog Bite Site
Stream Restoration Plan
Mitchell County, North Carolina

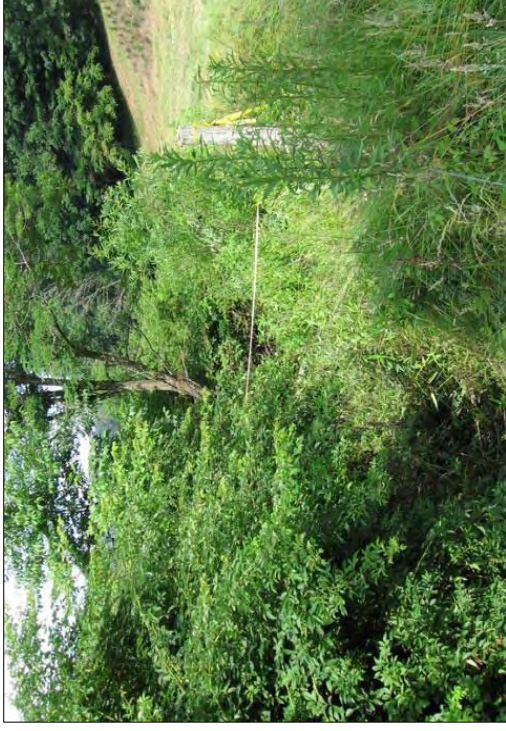
French Broad River Basin, White Oak Creek, Existing Conditions, WOC-2, XS - 5, Riffle

River Basin:	French Broad
Watershed:	White Oak Creek, Existing Conditions, WOC-2
XS ID	XS - 5, Riffle
Drainage Area (sq mi):	0.5
Date:	8/26/2007
Field Crew:	B. Hemel, Z. Mrynceza

Station	Elevation
0.0	2827.08
3.9	2827.22
7.6	2826.76
9.2	2826.11
11.0	2824.79
12.7	2823.88
13.7	2823.22
14.3	2822.92
15.1	2821.32
15.9	2820.24
16.8	2818.93
18.1	2818.44
19.1	2817.82
20.5	2817.81
21.4	2817.67
22.6	2817.60
23.6	2817.71
24.3	2819.24
25.1	2820.15
26.5	2820.61
28.2	2820.80
29.9	2821.08
32.4	2821.10
36.4	2820.99
40.2	2821.38
43.2	2821.15
45.3	2821.40

SUMMARY DATA	
Bankfull Elevation:	2818.9
Bankfull Cross-Sectional Area:	6.7
Bankfull Width:	7.3
Flood Prone Area Elevation:	2820.2
Flood Prone Width:	9
Max Depth at Bankfull:	1.3
Mean Depth at Bankfull:	0.9
W / D Ratio:	8.0
Entrenchment Ratio:	1.3
Bank Height Ratio:	2.0

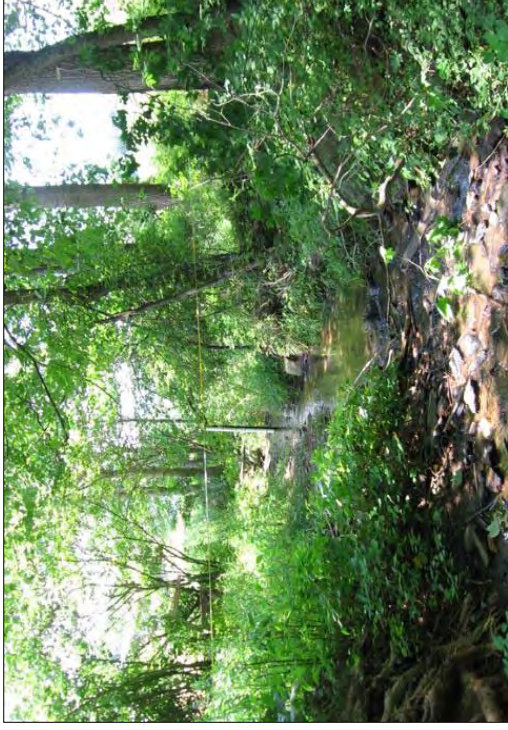
French Broad River Basin, White Oak Creek, Existing Conditions, WOC-3, XS - 6, Pool

River Basin:	French Broad
Watershed:	White Oak Creek, Existing Conditions, WOC-3
XS ID	XS - 6, Pool
Drainage Area (sq mi):	0.5
Date:	8/26/2007
Field Crew:	B. Hemel, Z. Mrynceza

Station	Elevation
0.0	2798.81
3.4	2798.77
6.9	2798.72
8.9	2797.97
10.6	2797.09
13.6	2796.56
17.8	2796.34
19.9	2796.09
20.6	2795.41
23.1	2795.56
24.6	2795.41
26.4	2795.23
27.4	2795.30
28.7	2795.24
29.7	2795.55
32.1	2795.89
34.2	2796.33
35.6	2796.95
36.6	2798.14
37.8	2798.82
38.7	2799.95
40.7	2800.99
43.9	2801.02
48.6	2802.29

SUMMARY DATA	
Bankfull Elevation:	2796.5
Bankfull Cross-Sectional Area:	14.2
Bankfull Width:	19.8
Flood Prone Area Elevation:	2797.8
Flood Prone Width:	26
Max Depth at Bankfull:	1.3
Mean Depth at Bankfull:	0.7
W / D Ratio:	27.6
Entrenchment Ratio:	1.3
Bank Height Ratio:	2.7

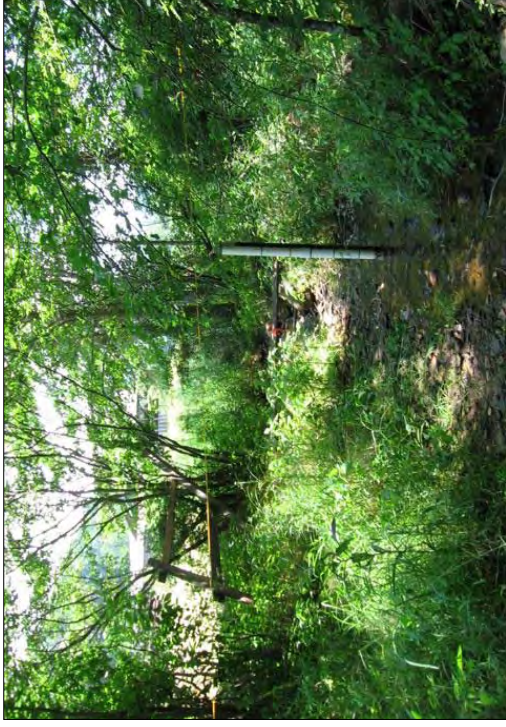
French Broad River Basin, White Oak Creek, Existing Conditions, WOC-3, XS - 7, Riffle

River Basin:	French Broad
Watershed:	White Oak Creek, Existing Conditions, WOC-3
XS ID	XS - 7, Riffle
Drainage Area (sq mi):	0.5
Date:	8/26/2007
Field Crew:	B. Hemel, Z. Mrynceza

Station	Elevation
0.0	2798.90
2.3	2798.55
4.4	2798.33
7.2	2798.21
9.2	2797.52
11.3	2796.84
13.9	2796.26
15.8	2796.08
18.1	2795.90
20.1	2795.98
22.0	2795.67
23.3	2795.56
24.5	2795.34
25.9	2795.33
27.4	2795.24
29.0	2795.21
30.1	2795.33
31.3	2795.42
32.5	2795.77
34.1	2795.90
36.1	2796.57
38.2	2797.43
40.0	2798.15
42.1	2799.23
44.0	2799.61
46.6	2799.92
50.7	2800.19

SUMMARY DATA	
Bankfull Elevation:	2796.0
Bankfull Cross-Sectional Area:	7.1
Bankfull Width:	14.2
Flood Prone Area Elevation:	2796.8
Flood Prone Width:	25
Max Depth at Bankfull:	0.8
W / D Ratio:	0.5
Entrenchment Ratio:	1.8
Bank Height Ratio:	3.8

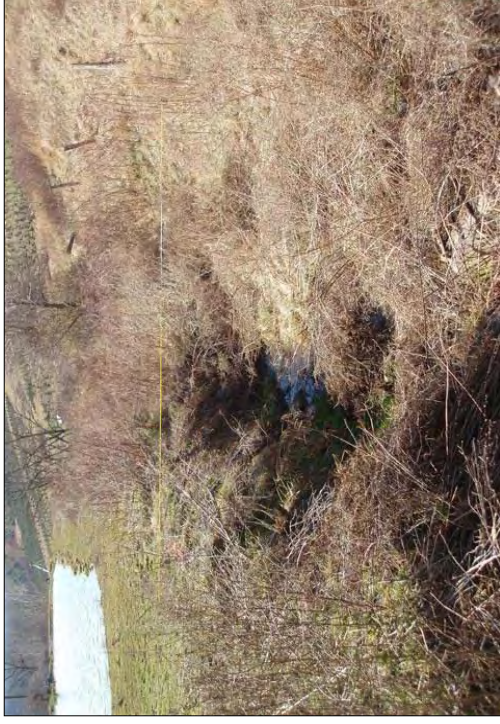
French Broad River Basin, White Oak Creek, Existing Conditions, WOC-4, XS - 8, Riffle

River Basin:	French Broad
Watershed:	White Oak Creek, Existing Conditions, WOC-4
XS ID	XS - 8, Riffle
Drainage Area (sq mi):	0.5
Date:	2/18/2008
Field Crew:	B. Hemel, Z. Mryncza, B. Roberts, A. Spiller

Station	Elevation
0.0	2786.56
4.6	2786.19
9.4	2785.94
10.7	2785.60
12.6	2785.04
13.2	2784.37
14.0	2783.63
14.7	2782.63
15.2	2781.34
16.3	2781.03
17.0	2780.83
17.7	2780.83
18.6	2780.75
19.2	2780.92
20.1	2781.12
21.6	2781.35
24.2	2781.87
27.0	2782.01
29.3	2782.50
31.4	2783.18
33.3	2783.61
34.9	2784.52
36.2	2784.85
37.9	2785.55
42.4	2786.07
58.2	2785.78

SUMMARY DATA	
Bankfull Elevation:	2781.9
Bankfull Cross-Sectional Area:	6.5
Bankfull Width:	9.8
Flood Prone Area Elevation:	2783.1
Flood Prone Width:	17
Max Depth at Bankfull:	1.2
Mean Depth at Bankfull:	0.7
W / D Ratio:	14.8
Entrenchment Ratio:	1.7
Bank Height Ratio:	3.7

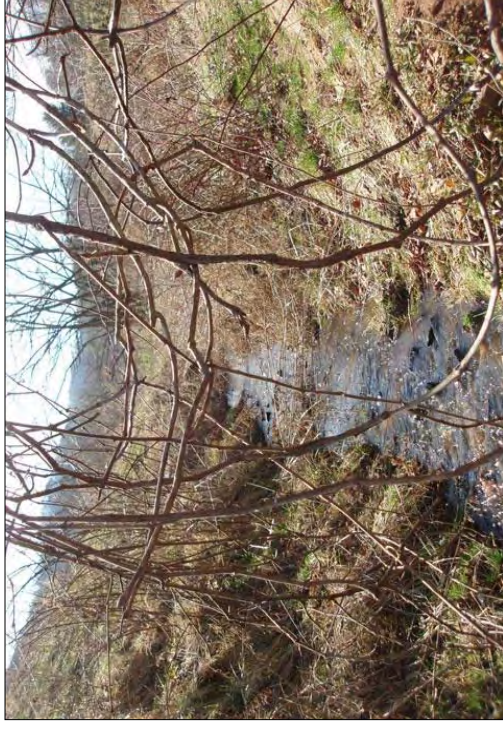
French Broad River Basin, White Oak Creek, Existing Conditions, WOC-4, XS - 9, Riffle

River Basin:	French Broad
Watershed:	White Oak Creek, Existing Conditions, WOC-4
XS ID	XS - 9, Riffle
Drainage Area (sq mi):	0.5
Date:	2/18/2008
Field Crew:	B. Hemel, Z. Mryncza, B. Roberts, A. Spiller

Station	Elevation
0.0	2785.05
3.3	2785.07
7.1	2784.60
9.4	2783.18
12.1	2782.18
14.3	2781.65
16.1	2780.35
18.5	2779.75
20.9	2779.14
22.0	2778.24
23.6	2777.58
24.9	2777.13
27.8	2774.91
29.8	2774.22
30.7	2773.86
31.7	2773.59
32.4	2773.61
33.6	2773.67
34.8	2773.81
36.4	2774.37
37.9	2775.60
39.3	2776.33
43.0	2778.61
46.6	2779.41
47.7	2779.94
48.2	2780.94
49.6	2781.86

SUMMARY DATA	
Bankfull Elevation:	2774.9
Bankfull Cross-Sectional Area:	7.9
Bankfull Width:	9.2
Flood Prone Area Elevation:	2776.2
Flood Prone Width:	13
Max Depth at Bankfull:	1.3
Mean Depth at Bankfull:	0.9
W / D Ratio:	10.7
Entrenchment Ratio:	1.4
Bank Height Ratio:	2.7

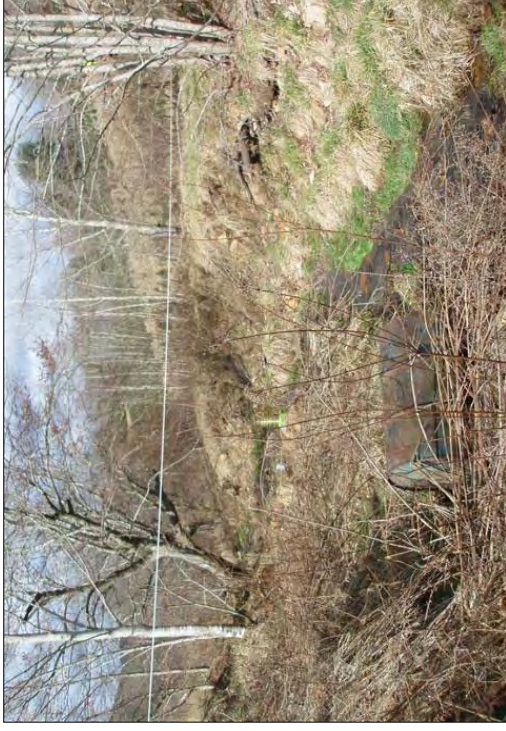
French Broad River Basin, White Oak Creek, Existing Conditions, WOC-4, XS - 10, Riffle

River Basin:	French Broad
Watershed:	White Oak Creek, Existing Conditions, WOC-4
XS ID	XS - 10, Riffle
Drainage Area (sq mi):	0.5
Date:	2/18/2008
Field Crew:	B. Hemel, Z. Mryncza, B. Roberts, A. Spillet

Station	Elevation
0.0	2760.20
3.2	2759.96
7.8	2759.13
11.6	2758.70
14.8	2758.45
19.7	2758.07
22.5	2756.87
25.1	2755.19
27.2	2754.15
30.6	2753.71
33.9	2753.84
35.6	2753.15
36.0	2752.92
36.6	2752.78
37.0	2752.38
37.5	2752.35
40.5	2752.07
41.6	2752.09
41.8	2751.75
43.6	2752.14
44.9	2752.47
47.0	2753.00
48.7	2753.69
50.5	2754.88
51.5	2757.42
53.9	2757.75
58.2	2758.11
64.5	2758.00
69.7	2758.71

SUMMARY DATA	
Bankfull Elevation:	2752.9
Bankfull Cross-Sectional Area:	6.4
Bankfull Width:	10.5
Flood Prone Area Elevation:	2754.1
Flood Prone Width:	21
Max Depth at Bankfull:	1.2
Mean Depth at Bankfull:	0.6
W / D Ratio:	17.2
Entrenchment Ratio:	2.0
Bank Height Ratio:	1.8

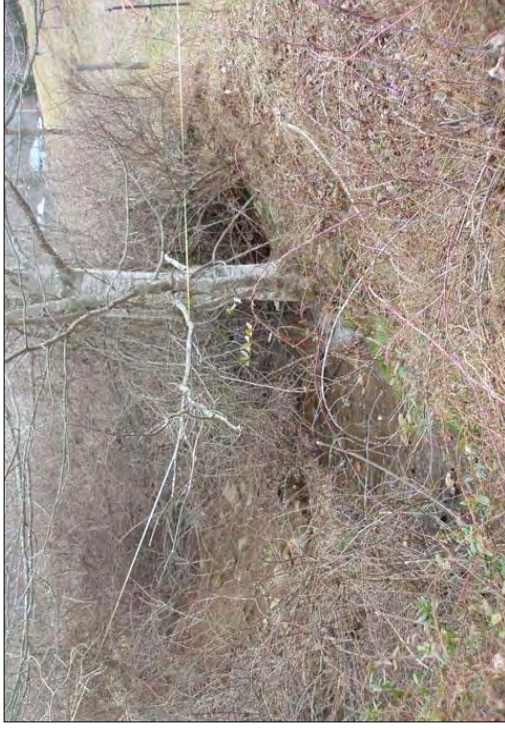
French Broad River Basin, White Oak Creek, Existing Conditions, WOC-4, XS - 11, Riffle

River Basin:	French Broad
Watershed:	White Oak Creek, Existing Conditions, WOC-4
XS ID	XS - 11, Riffle
Drainage Area (sq mi):	0.5
Date:	2/18/2008
Field Crew:	B. Hemel, Z. Mryncza, B. Roberts, A. Spiller

Station	Elevation
0.0	2749.91
6.6	2750.03
9.1	2750.32
11.2	2750.33
12.8	2750.03
14.8	2748.89
16.8	2747.85
18.1	2746.79
18.6	2745.80
18.8	2745.50
20.0	2745.25
20.6	2744.94
21.3	2744.87
23.0	2744.71
24.6	2744.66
27.3	2744.65
29.0	2745.06
30.8	2747.10
32.9	2748.63
35.3	2749.58
41.9	2752.74
43.8	2753.24
46.8	2752.66
55.1	2753.26
58.5	2753.27

SUMMARY DATA		
Bankfull Elevation:		2745.5
Bankfull Cross-Sectional Area:		6.8
Bankfull Width:		10.6
Flood Prone Area Elevation:		2746.4
Flood Prone Width:		12
Max Depth at Bankfull:		0.9
Mean Depth at Bankfull:		0.6
W / D Ratio:		16.5
Entrenchment Ratio:		1.1
Bank Height Ratio:		2.9

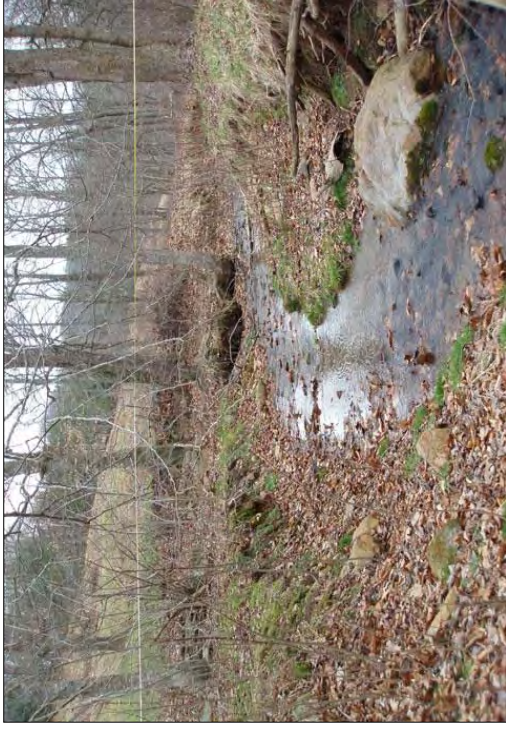
French Broad River Basin, White Oak Creek, Existing Conditions, WOC-5, XS - 12, Riffle

River Basin:	French Broad
Watershed:	White Oak Creek, Existing Conditions, WOC-5
XS ID	XS - 12, Riffle
Drainage Area (sq mi):	0.5
Date:	2/18/2008
Field Crew:	B. Hemel, Z. Mryncza, B. Roberts, A. Spiller

Station	Elevation
0.0	2732.57
2.1	2731.86
4.0	2730.93
6.7	2730.09
9.5	2729.36
13.5	2728.72
17.4	2728.53
19.7	2728.25
21.2	2727.95
22.3	2727.23
23.2	2726.54
24.3	2725.60
25.4	2724.96
26.0	2724.89
27.5	2724.69
28.6	2724.72
30.4	2724.59
31.6	2724.77
32.5	2724.99
34.0	2725.24
36.9	2725.38
39.9	2726.00
40.9	2726.77
41.6	2727.75
44.1	2728.37
47.3	2728.74
50.7	2728.57
55.4	2728.28
76.8	2727.88
78.8	2728.41
80.8	2729.10
82.7	2729.72
84.8	2730.24

SUMMARY DATA	
Bankfull Elevation:	2725.6
Bankfull Cross-Sectional Area:	8.1
Bankfull Width:	13.7
Flood Prone Area Elevation:	2726.6
Flood Prone Width:	18
Max Depth at Bankfull:	1.0
Mean Depth at Bankfull:	0.6
W / D Ratio:	23.2
Entrenchment Ratio:	1.3
Bank Height Ratio:	3.1

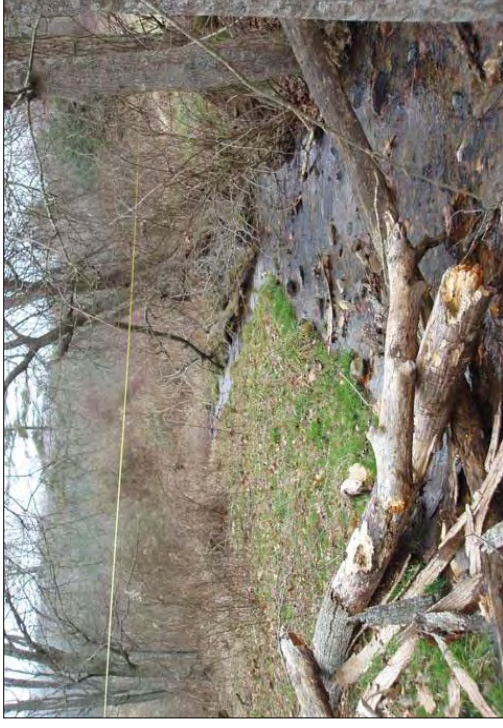
French Broad River Basin, White Oak Creek, Existing Conditions, WOC-5, XS - 13, Riffle

River Basin:	French Broad
Watershed:	White Oak Creek, Existing Conditions, WOC-5
XS ID	XS - 13, Riffle
Drainage Area (sq mi):	0.5
Date:	2/18/2008
Field Crew:	B. Hemel, Z. Mryncza, B. Roberts, A. Spillet

Station	Elevation
0.0	2723.00
3.1	2722.54
6.4	2721.81
10.5	2721.29
15.0	2721.22
19.6	2720.67
24.1	2719.88
31.5	2719.43
34.8	2718.73
38.0	2718.38
39.9	2718.70
41.3	2719.80
43.4	2720.00
46.6	2720.21
53.2	2720.41
58.6	2720.22
63.3	2720.47
70.3	2720.54
73.6	2720.48
80.4	2719.56
82.7	2719.54
86.9	2719.78
89.5	2719.75
94.9	2719.59
97.0	2719.31
98.2	2719.07
99.4	2718.92
101.2	2718.85
106.9	2721.64
108.7	2722.26
110.4	2722.29

SUMMARY DATA	
Bankfull Elevation:	2719.9
Bankfull Cross-Sectional Area:	11.7
Bankfull Width:	27.2
Flood Prone Area Elevation:	2721.4
Flood Prone Width:	97
Max Depth at Bankfull:	1.5
Mean Depth at Bankfull:	0.4
W / D Ratio:	63.2
Entrenchment Ratio:	3.6
Bank Height Ratio:	1.4

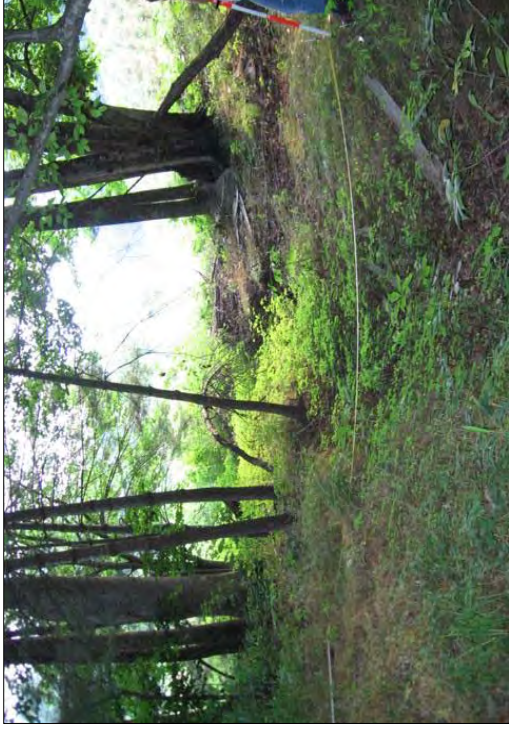
French Broad River Basin, White Oak Creek, Existing Conditions, XS - T1_1, Riffle

River Basin:	French Broad
Watershed:	White Oak Creek, Existing Conditions
XS ID	XS - T1_1, Riffle
Drainage Area (sq mi):	0.5
Date:	8/26/2007
Field Crew:	B. Hemel, Z. Mrynceza

Station	Elevation
0.0	2847.98
2.3	2847.98
5.3	2847.93
8.3	2847.94
11.3	2847.97
14.1	2847.83
16.4	2847.84
19.1	2847.97
20.0	2847.78
21.3	2847.36
21.8	2846.65
22.7	2844.71
24.0	2844.46
24.7	2844.13
25.9	2844.25
27.3	2844.09
28.3	2844.26
28.9	2845.37
29.6	2846.34
31.6	2847.22
33.6	2847.71
39.4	2847.80
42.8	2847.71
46.2	2847.52
47.6	2846.65
49.2	2845.86
51.0	2845.16
52.9	2845.40
54.5	2845.95
57.0	2846.94
58.8	2847.56
59.0	2847.56

SUMMARY DATA	
Bankfull Elevation:	2844.7
Bankfull Cross-Sectional Area:	2.3
Bankfull Width:	5.7
Flood Prone Area Elevation:	2845.3
Flood Prone Width:	8
Max Depth at Bankfull:	0.6
Mean Depth at Bankfull:	0.4
W / D Ratio:	14.1
Entrenchment Ratio:	1.4
Bank Height Ratio:	3.6

The two tributaries are both unstable, but they are in different evolutionary stages. T1 and T2 have bank height ratios of 3.6 and 4.2, respectively. T1-1, while in a more forested area, is experiencing incision and widening, as evidenced by the undercut trees on the stream banks. Once T1 leaves the tree line, the channelized stream has filled in and does not have a defined flow path. The instability on T2 has been caused by livestock and the lack of riparian vegetation. T2 has extensive bed and bank degradation due to these two disturbances.

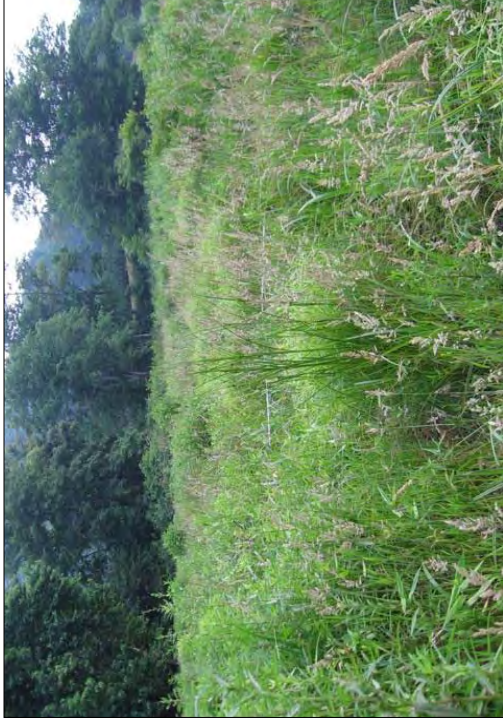
French Broad River Basin, White Oak Creek, Existing Conditions, XS - T1_2, Riffle

River Basin:	French Broad
Watershed:	White Oak Creek, Existing Conditions
XS ID	XS - T1_2, Riffle
Drainage Area (sq mi):	0.5
Date:	8/26/2007
Field Crew:	B. Hemel, Z. Mrynceza

Station	Elevation
0.0	2841.32
2.4	2841.10
5.3	2840.99
8.5	2840.66
11.5	2840.40
14.8	2840.15
17.9	2839.98
20.6	2839.36
23.4	2839.19
25.6	2839.38
27.3	2839.15
28.3	2838.94
28.7	2839.14
32.3	2839.49
35.1	2839.46
38.2	2839.67
41.4	2839.95
44.4	2839.92
46.8	2839.90
49.0	2839.95

SUMMARY DATA	
Bankfull Elevation:	2839.7
Bankfull Cross-Sectional Area:	6.5
Bankfull Width:	19.5
Flood Prone Area Elevation:	2840.5
Flood Prone Width:	38
Max Depth at Bankfull:	0.8
Mean Depth at Bankfull:	0.3
W / D Ratio:	58.5
Entrenchment Ratio:	1.9
Bank Height Ratio:	1.4

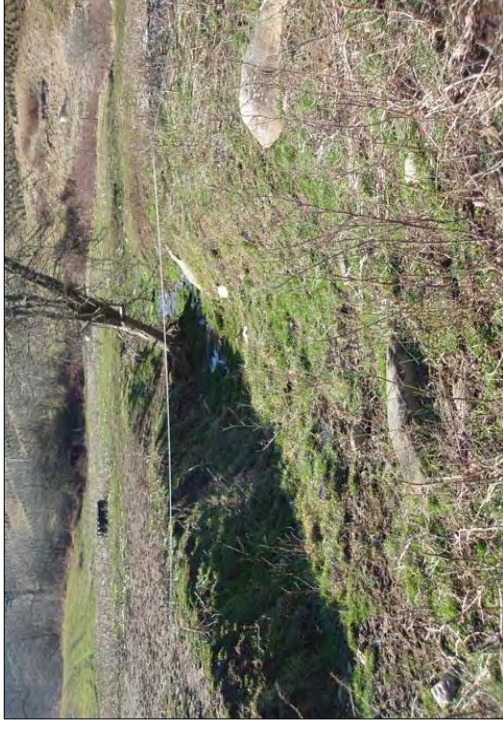
French Broad River Basin, White Oak Creek, Existing Conditions, XS - T2, Riffle

River Basin:	French Broad
Watershed:	White Oak Creek, Existing Conditions
XS ID	XS - T2, Riffle
Drainage Area (sq mi):	0.5
Date:	2/18/2008
Field Crew:	B. Hemel, Z. Mryncza, B. Roberts, A. Spiller

Station	Elevation
0.0	2788.03
17.2	2787.66
19.8	2787.47
22.1	2786.20
23.7	2785.12
24.6	2784.69
26.2	2784.45
27.8	2784.67
29.5	2784.89
32.0	2785.53
34.1	2787.15
39.7	2787.84
48.2	2788.39

SUMMARY DATA	
Bankfull Elevation:	2785.1
Bankfull Cross-Sectional Area:	2.5
Bankfull Width:	6.6
Flood Prone Area Elevation:	2785.7
Flood Prone Width:	10
Max Depth at Bankfull:	0.6
Mean Depth at Bankfull:	0.4
W / D Ratio:	17.4
Entrenchment Ratio:	1.5
Bank Height Ratio:	4.2

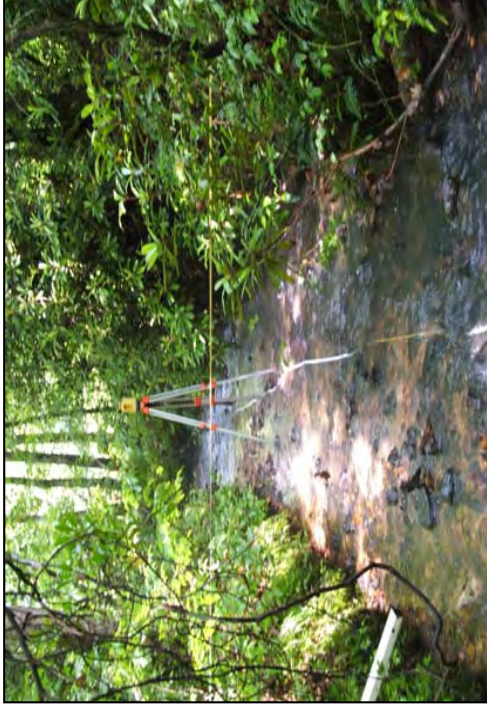
Stream Type: B4c

River Basin:	Yadkin
Watershed:	UT to Fisher River
XS ID	XS#1 Riffle
Drainage Area (sq mi):	0.38
Date:	6/9/2005
Field Crew:	G. Mryncza, A. Spiller

Station	Rod Ht.	Elevation
0.0	2.22	100.00
3.0	2.15	100.07
5.0	2.50	99.72
7.0	2.98	99.24
8.0	3.49	98.73
8.8	4.00	98.22
9.0	4.96	97.26
12.0	5.03	97.19
14.0	5.25	96.97
16.0	5.16	97.06
17.0	5.20	97.02
18.0	5.06	97.16
18.7	4.00	98.22
19.5	2.65	99.57
20.0	1.66	100.56

For this project, the two reference reaches described in Section 5.0 will be used to guide the design of the cross-sections, profile, and planform. However, an ideal reference reach was not found for the DBS. The UT to Fisher River Reference Site has a slope lower than 2%. In the mountain region of North Carolina, stable B3/4 streams with slopes ranging from 3-7% are scarce. KCI has conducted numerous reference reach searches throughout North Carolina and has not been able to find stable B3/4 channels within this slope range.

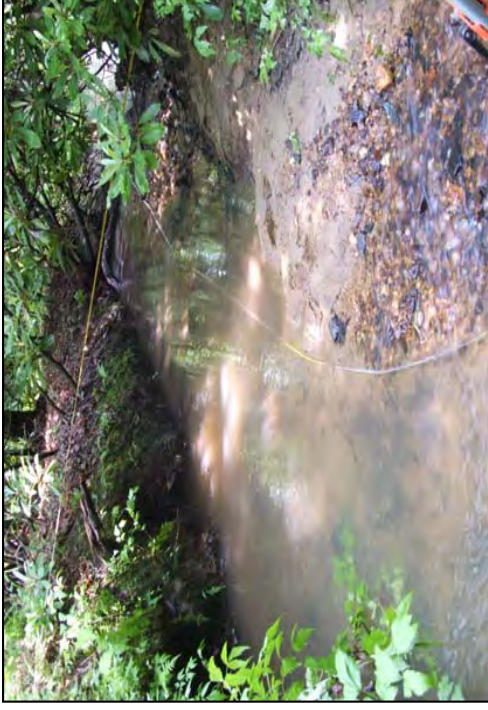
River Basin:	Yadkin
Watershed:	UT to Fisher River
XS ID	XS#3 Pool
Drainage Area (sq mi):	0.38
Date:	6/9/2005
Field Crew:	G. Mryncza, A. Spiller

Stream Type: B4c

Station	Rod Ht.	Elevation
0.0	1.33	100.00
3.0	1.78	99.55
5.0	2.35	98.98
5.5	2.82	98.51
5.7	3.81	97.52
6.0	4.52	96.81
6.5	5.79	95.54
8.0	5.82	95.51
9.0	5.50	95.83
10.0	5.02	96.31
11.5	4.80	96.53
13.0	3.90	97.43
14.0	3.55	97.78
16.0	3.03	98.30
20.0	2.66	98.67

SUMMARY DATA	
Bankfull Elevation:	97.78
Bankfull Cross-Sectional Area:	11.60
Bankfull Width:	8.35
Flood Prone Area Elevation:	100.05
Flood Prone Width:	
Max Depth at Bankfull:	2.27
Mean Depth at Bankfull:	1.39
W / D Ratio:	6.0
Entrenchment Ratio:	
Bank Height Ratio:	0.85
Slope (ft/ft):	0.001
Discharge (cfs)	52

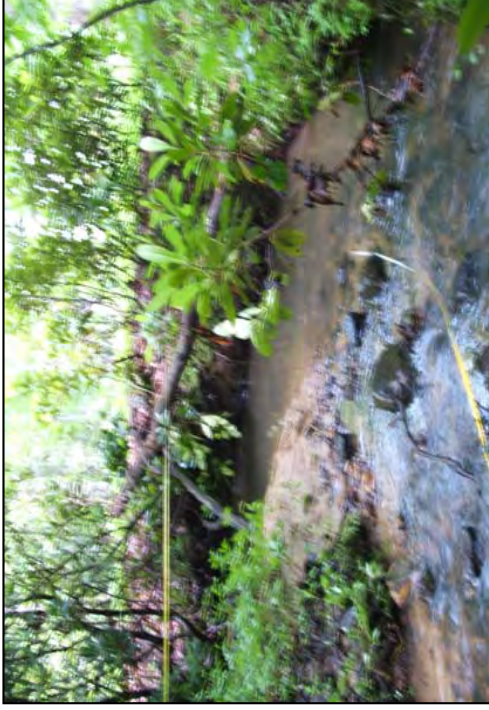
River Basin:	Yadkin
Watershed:	UT to Fisher River
XS ID	XS#2 Pool
Drainage Area (sq mi):	0.38
Date:	6/9/2005
Field Crew:	G. Mryncza, A. Spiller

Stream Type: B4c

Station	Rod Ht.	Elevation
0.0	2.68	100.00
3.0	2.94	99.74
5.0	3.61	99.07
6.0	4.10	98.58
6.8	4.56	98.12
7.0	4.70	97.98
9.0	4.94	97.74
11.0	5.21	97.47
12.0	5.64	97.04
13.0	6.00	96.68
15.0	6.59	96.09
17.0	6.42	96.26
18.0	6.50	96.18
18.2	4.93	97.75
19.0	3.56	99.12
20.0	2.80	99.88

SUMMARY DATA	
Bankfull Elevation:	98.12
Bankfull Cross-Sectional Area:	13.40
Bankfull Width:	11.62
Flood Prone Area Elevation:	100.15
Flood Prone Width:	
Max Depth at Bankfull:	2.03
Mean Depth at Bankfull:	1.15
W / D Ratio:	10.1
Entrenchment Ratio:	
Bank Height Ratio:	0.81
Slope (ft/ft):	0.001
Discharge (cfs)	56

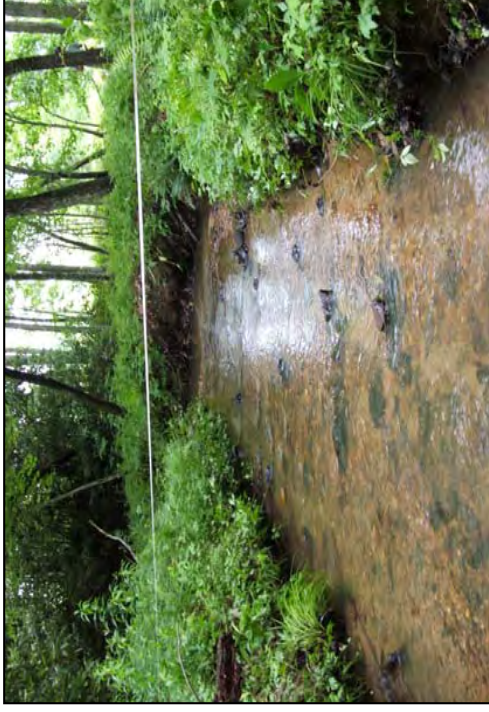
River Basin:	Yadkin
Watershed:	UT to Fisher River
XS ID	XS#4 Riffle
Drainage Area (sq mi):	0.38
Date:	6/9/2005
Field Crew:	G. Mryncza, A. Spiller

Stream Type: B4c

Station	Rod Ht.	Elevation
0.0	4.62	100.00
3.0	5.54	99.08
7.0	6.01	98.61
8.5	6.34	98.28
9.0	7.04	97.58
9.5	7.66	96.96
11.0	7.67	96.95
12.0	7.79	96.83
14.0	7.58	97.04
16.0	7.57	97.05
17.0	7.51	97.11
17.5	6.34	98.28
19.0	5.90	98.72
21.0	5.06	99.56
25.0	4.37	100.25

SUMMARY DATA	
Bankfull Elevation:	98.28
Bankfull Cross-Sectional Area:	10.70
Bankfull Width:	9.00
Flood Prone Area Elevation:	99.73
Flood Prone Width:	20.50
Max Depth at Bankfull:	1.45
Mean Depth at Bankfull:	1.19
W / D Ratio:	7.6
Entrenchment Ratio:	2.30
Bank Height Ratio:	1.00
Slope (ft/ft):	0.013
Discharge (cfs)	46

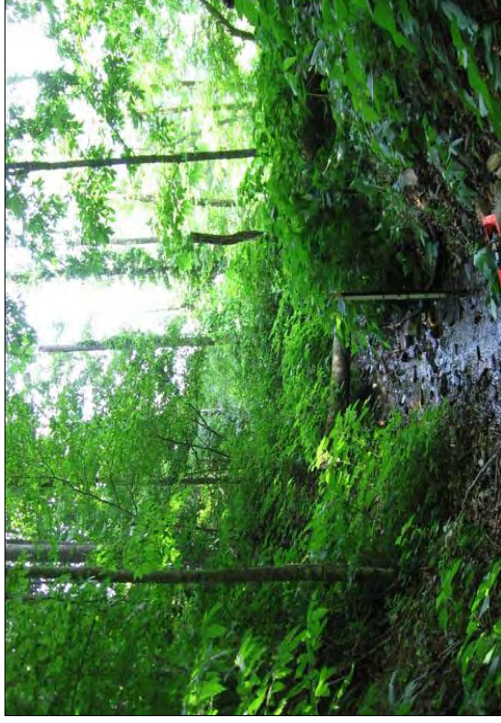
River Basin:	French Broad
Watershed:	White Oak Creek, Existing Conditions
XS ID	XS - R, Riffle
Drainage Area (sq mi):	0.5
Date:	8/26/2007
Field Crew:	B. Hemel, Z. Mrynceza

Station	Elevation
0.0	2881.13
1.8	2880.41
3.3	2879.98
4.6	2879.43
7.1	2878.10
8.1	2877.28
9.9	2875.73
10.9	2874.05
12.2	2872.99
13.3	2872.02
14.1	2871.11
15.6	2869.22
17.4	2868.20
18.2	2867.77
19.7	2867.91
21.6	2867.47
22.8	2867.39
24.1	2867.32
24.9	2867.31
26.0	2868.00
27.1	2869.07
29.0	2869.84
31.7	2870.53
34.3	2870.65
37.9	2870.04
40.9	2869.77
44.4	2870.12
46.7	2870.25

SUMMARY DATA		
Bankfull Elevation:		2868.2
Bankfull Cross-Sectional Area:		5.1
Bankfull Width:		8.8
Flood Prone Area Elevation:		2869.1
Flood Prone Width:		11
Max Depth at Bankfull:		0.9
Mean Depth at Bankfull:		0.6
W / D Ratio:		15.2
Entrenchment Ratio:		1.3
Bank Height Ratio:		1.1

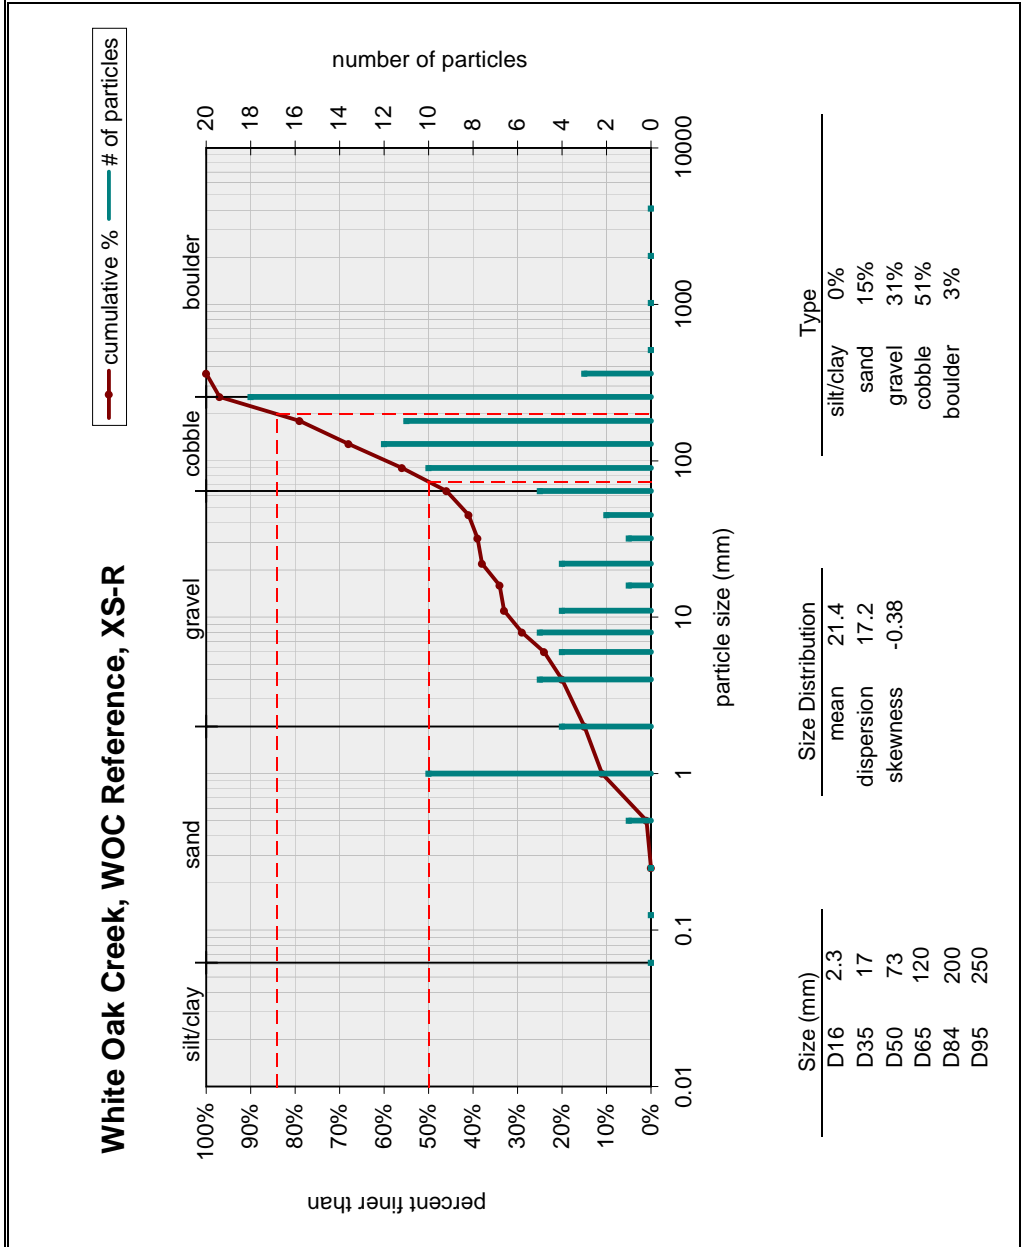
Note: XS-R

Riffle Surface	Material	Size Range (mm)	Count
	silt/clay	0 - 0.062	0
	very fine sand	0.062 - 0.125	0
	fine sand	0.125 - 0.25	0
	medium sand	0.25 - 0.5	1
	coarse sand	0.5 - 1	10
	very coarse sand	1 - 2	4
	very fine gravel	2 - 4	5
	fine gravel	4 - 6	4
	fine gravel	6 - 8	5
	medium gravel	8 - 11	4
	medium gravel	11 - 16	1
	coarse gravel	16 - 22	4
	coarse gravel	22 - 32	1
	very coarse gravel	32 - 45	2
	very coarse gravel	45 - 64	5
	small cobble	64 - 90	10
	medium cobble	90 - 128	12
	large cobble	128 - 180	11
	very large cobble	180 - 256	18
	small boulder	256 - 362	3
	small boulder	362 - 512	0
	medium boulder	512 - 1024	0
	large boulder	1024 - 2048	0
	very large boulder	2048 - 4096	0
	total particle count:		100
	bedrock	-----	
	clay hardpan	-----	
	detritus/wood	-----	
	artificial	-----	
	total count:		100
