**Dog Bite Stream Restoration Site  
Monitoring Report – MY01  
Mitchell County, NC  
Basin 06010108 - Contract # D06056-A**

**December 2010**

## EXECUTIVE SUMMARY

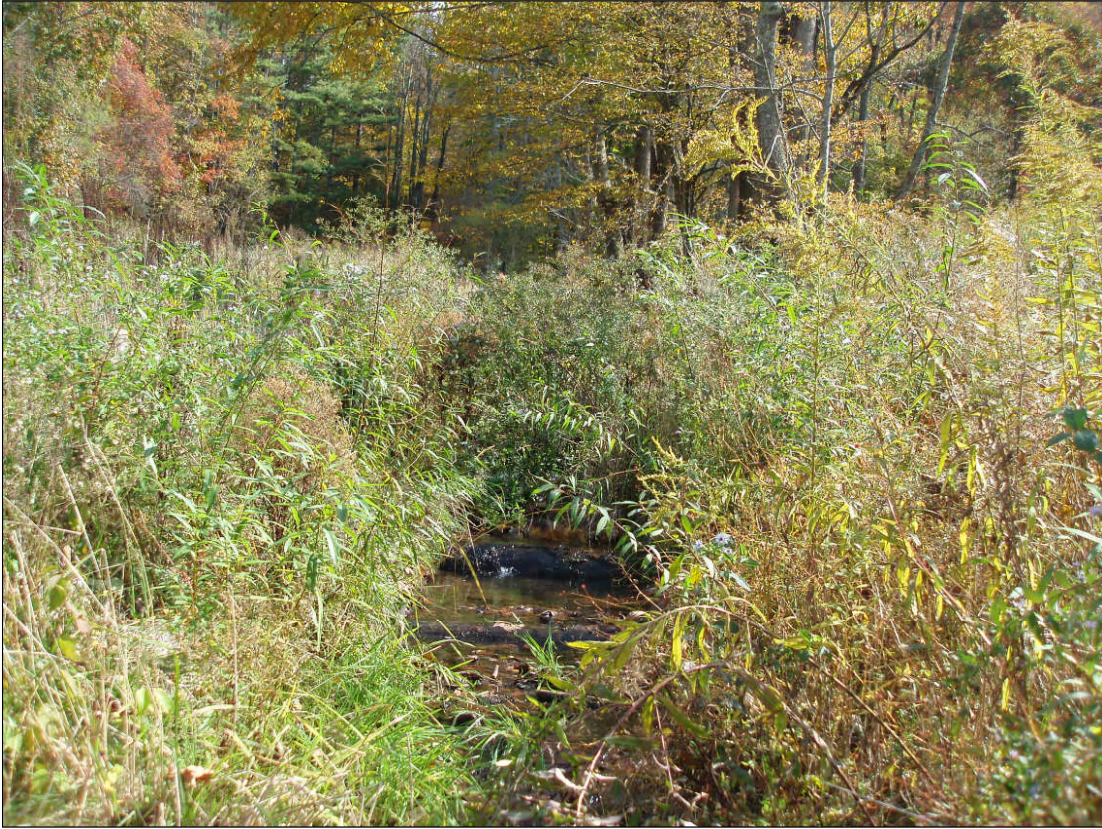
Photo Point 1: View looking upstream, from ford crossing near Station 12+50. 10/19/10 – MY01

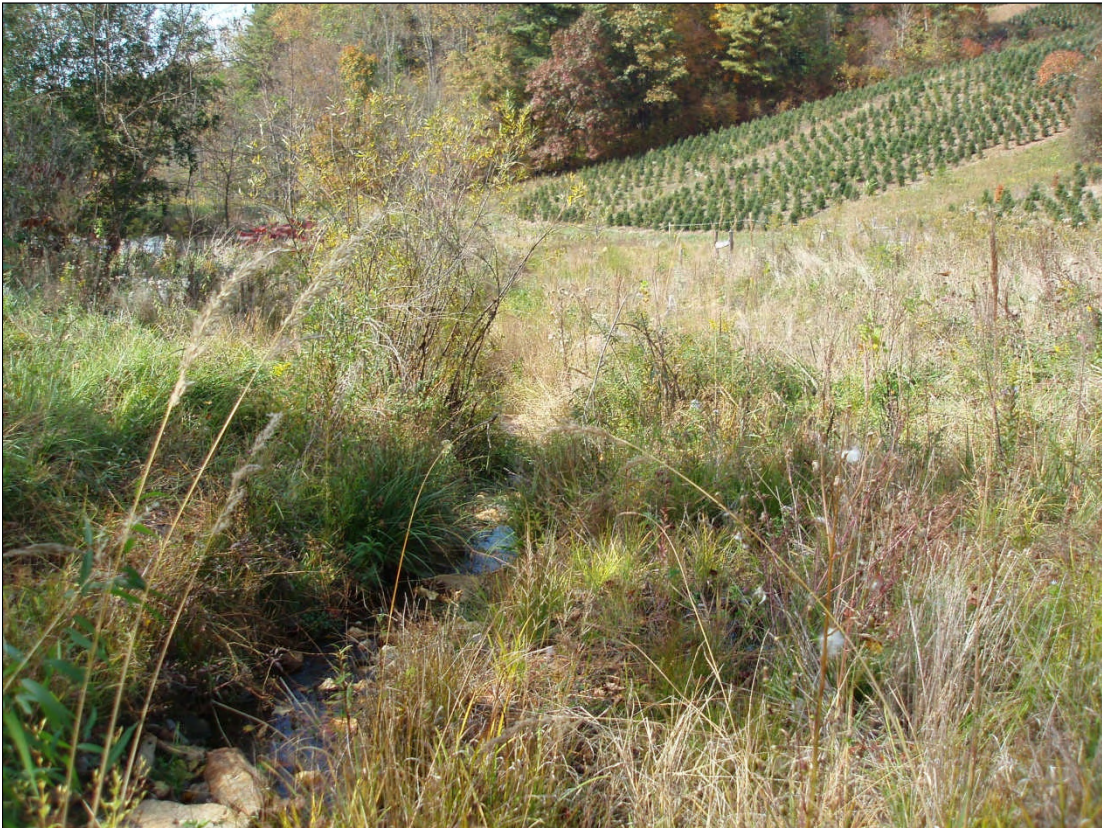
Photo Point 2: View looking downstream, near Station 14+00. 10/19/10 – MY01

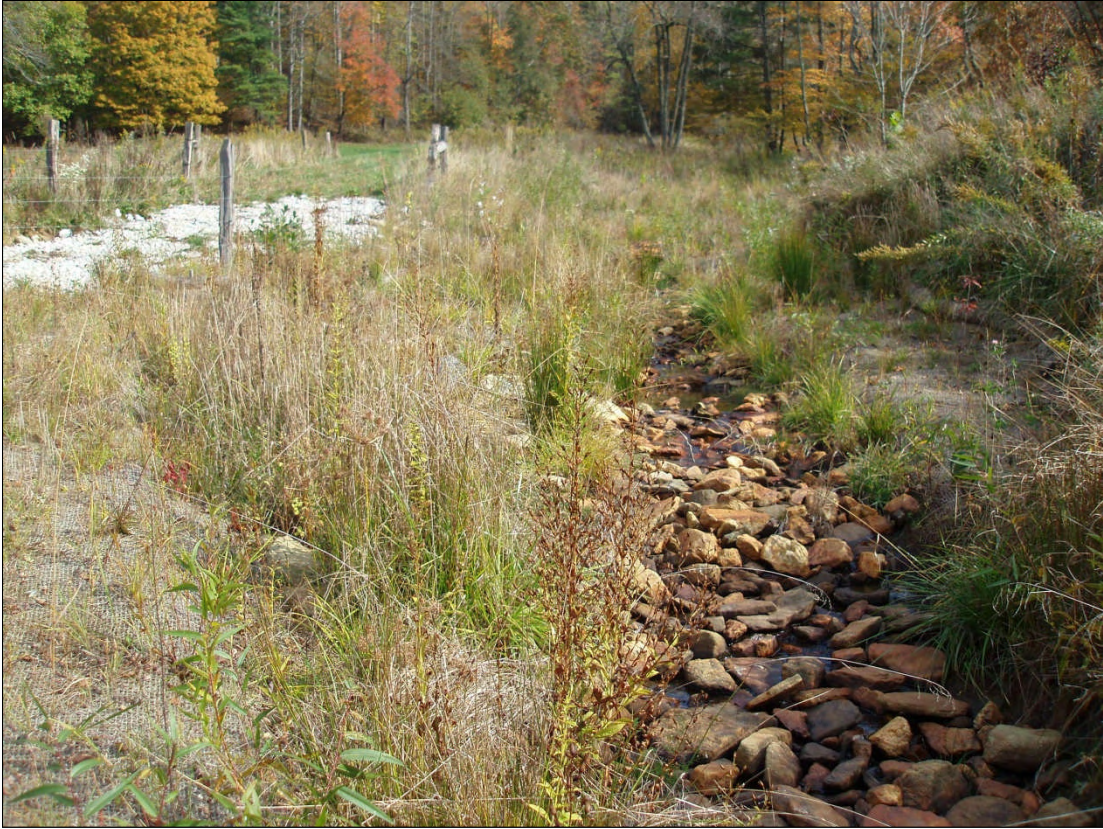
Photo Point 3: View looking upstream at the confluence of WOC and T1. 10/19/10 – MY01

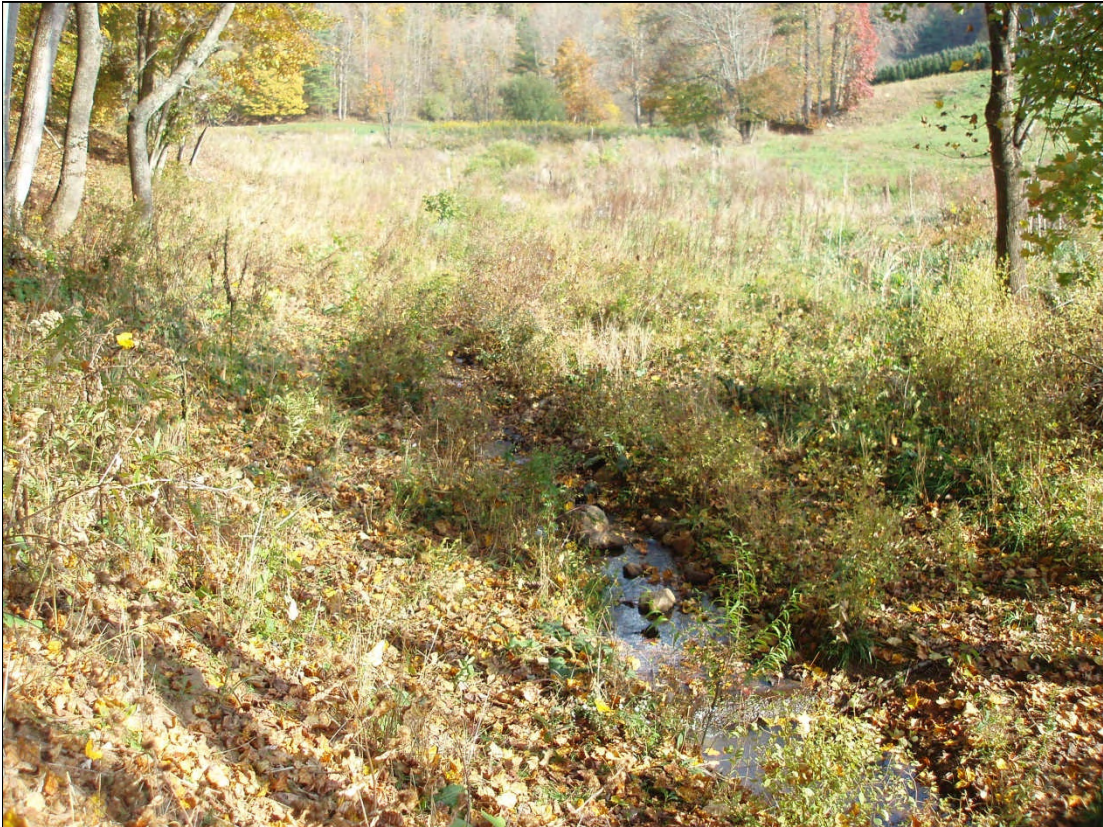
Photo Point 4: View looking upstream taken near Station 20+50. 10/19/10 – MY01

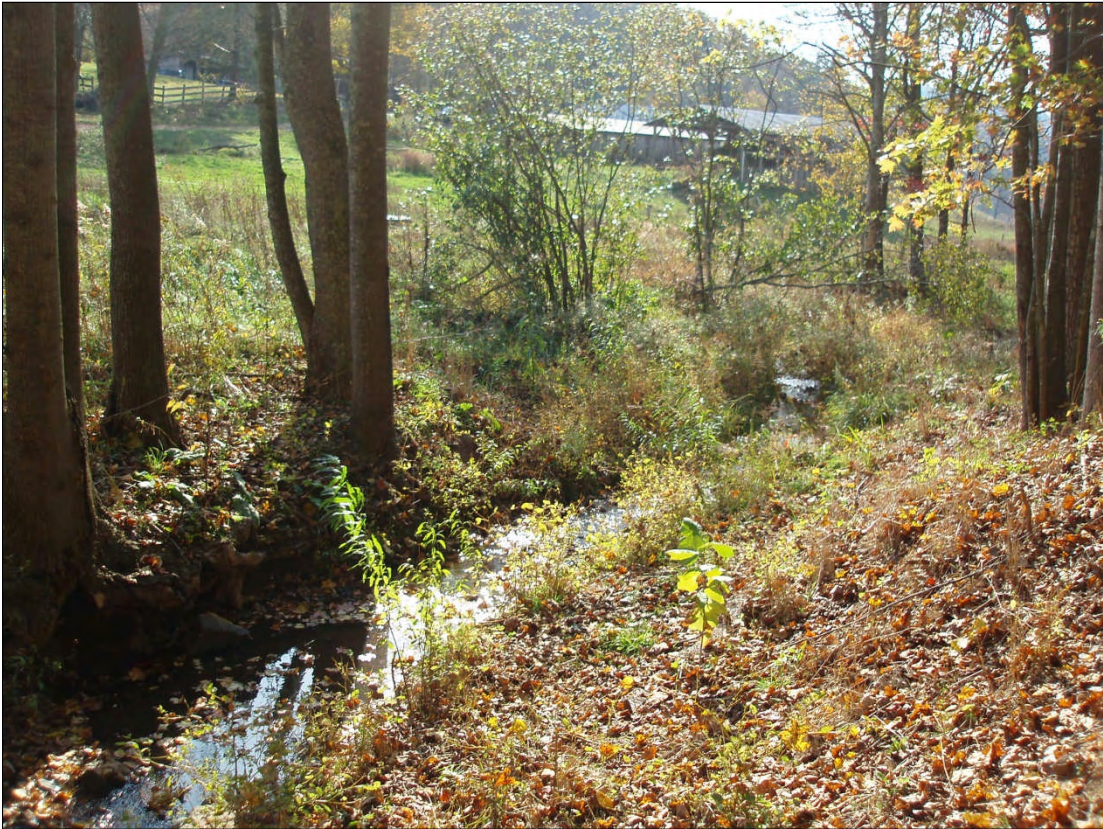
Photo Point 4: View looking downstream near Station 20+50. 10/19/10 – MY01

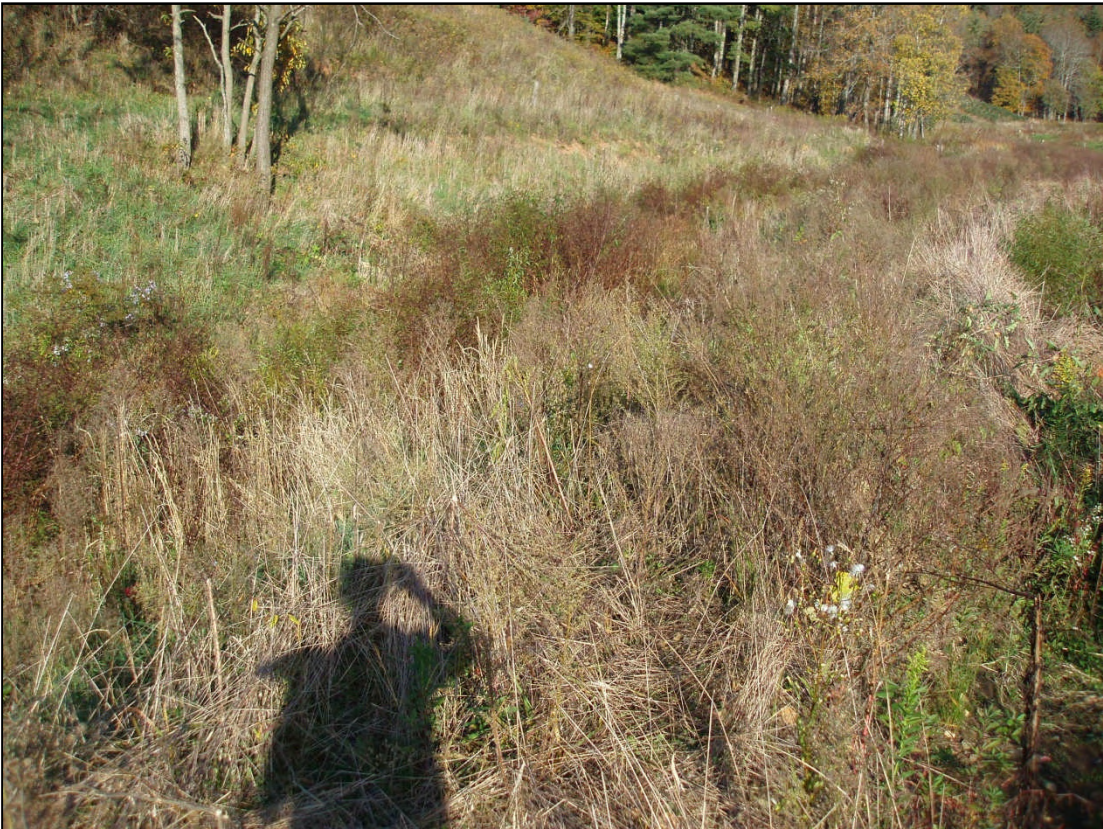
Photo Point 5: View looking upstream at WOC, near Station 26+25. 10/19/10 – MY01

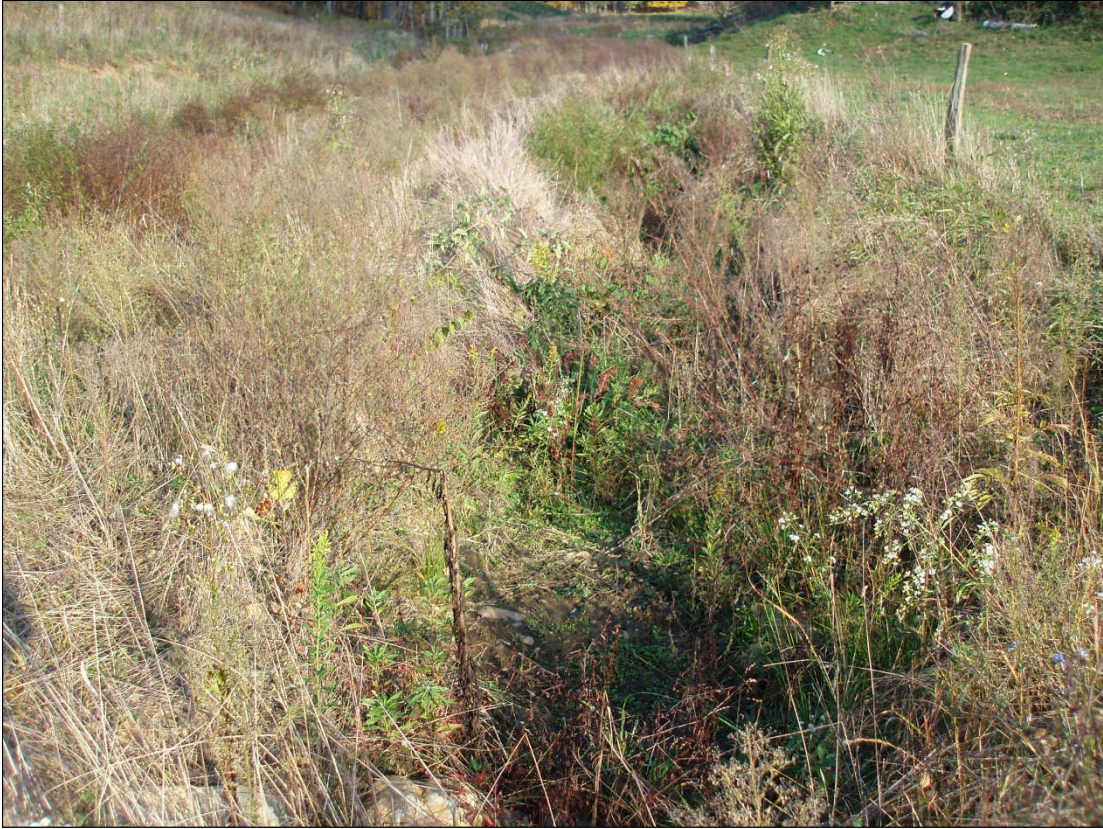
Photo Point 5: View looking at water treatment pool, near Station 26+25. 10/19/10 – MY01

that support a small number of livestock. A water detention structure was built to receive this drainage and hold it before it flows into WOC. WOC-5 (Station 36+35 to 40+82) is the last reach of WOC and was enhanced by grading back the existing eroding banks, narrowing over-widened portions of the channel, building a bankfull bench, and developing distinct riffles and pools with step pool and log vane structures. Throughout most of this reach, one of the two stream banks was left intact where there were mature trees.

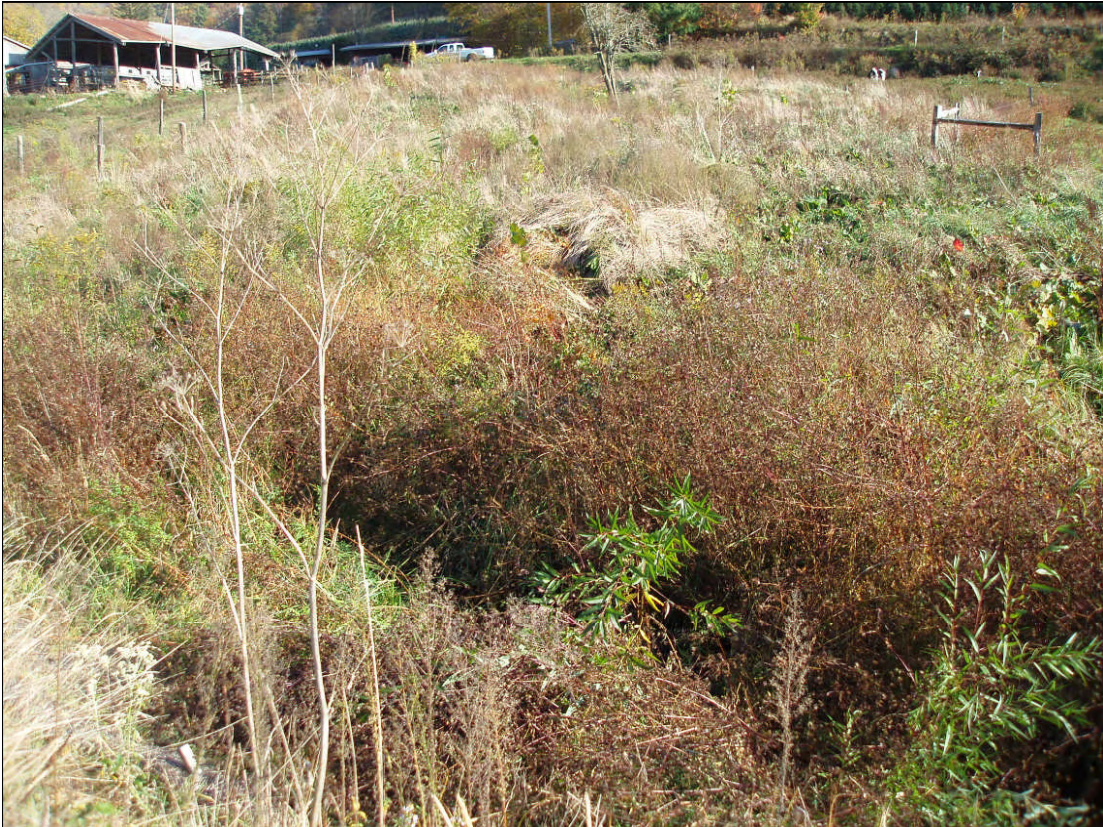
Photo Point 6: View looking upstream at T2, near Station 27+75. 10/19/10 – MY01

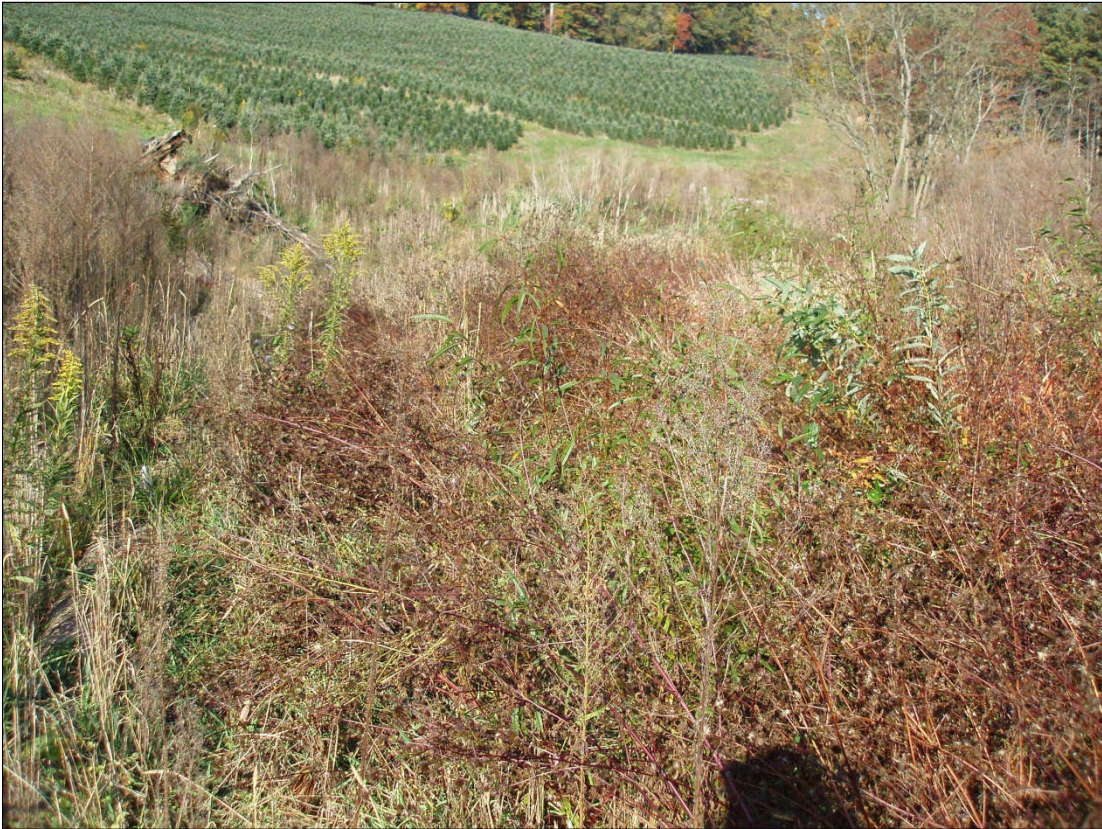
Photo Point 7: View looking upstream near Station 29+25. 10/19/10 – MY01

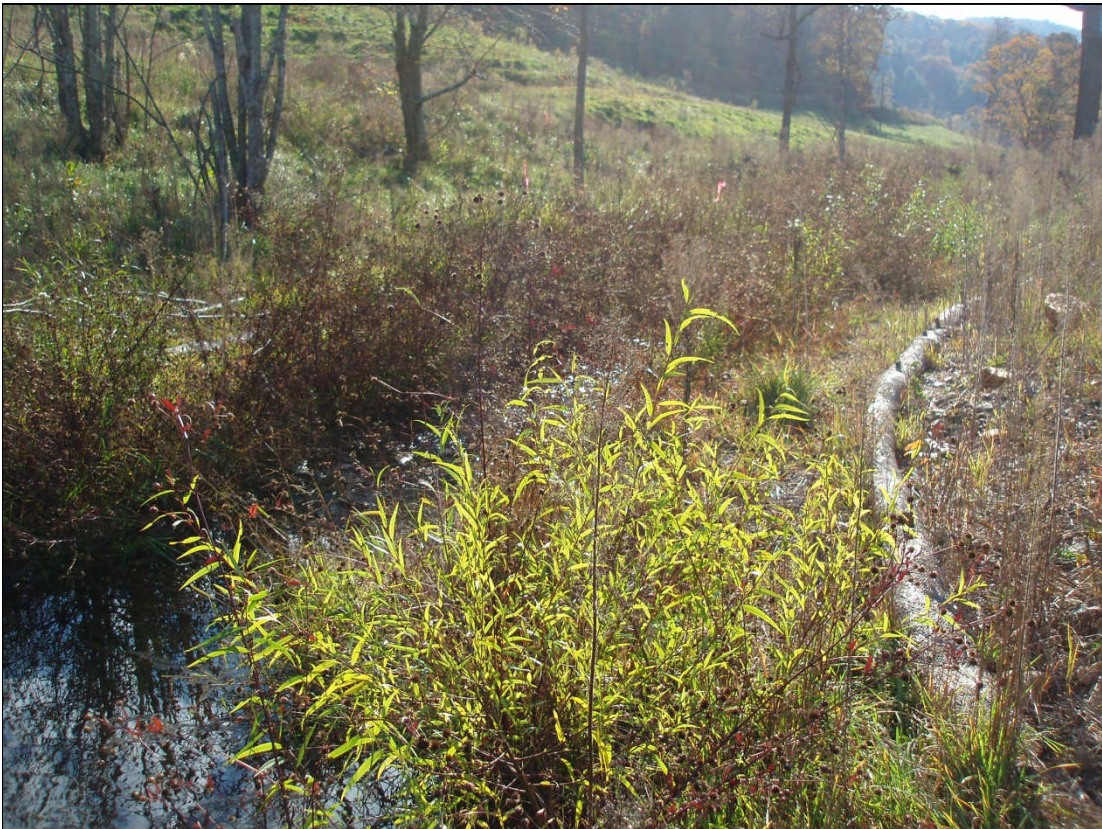
Photo Point 7: View looking downstream near Station 29+25. 10/19/10 – MY01

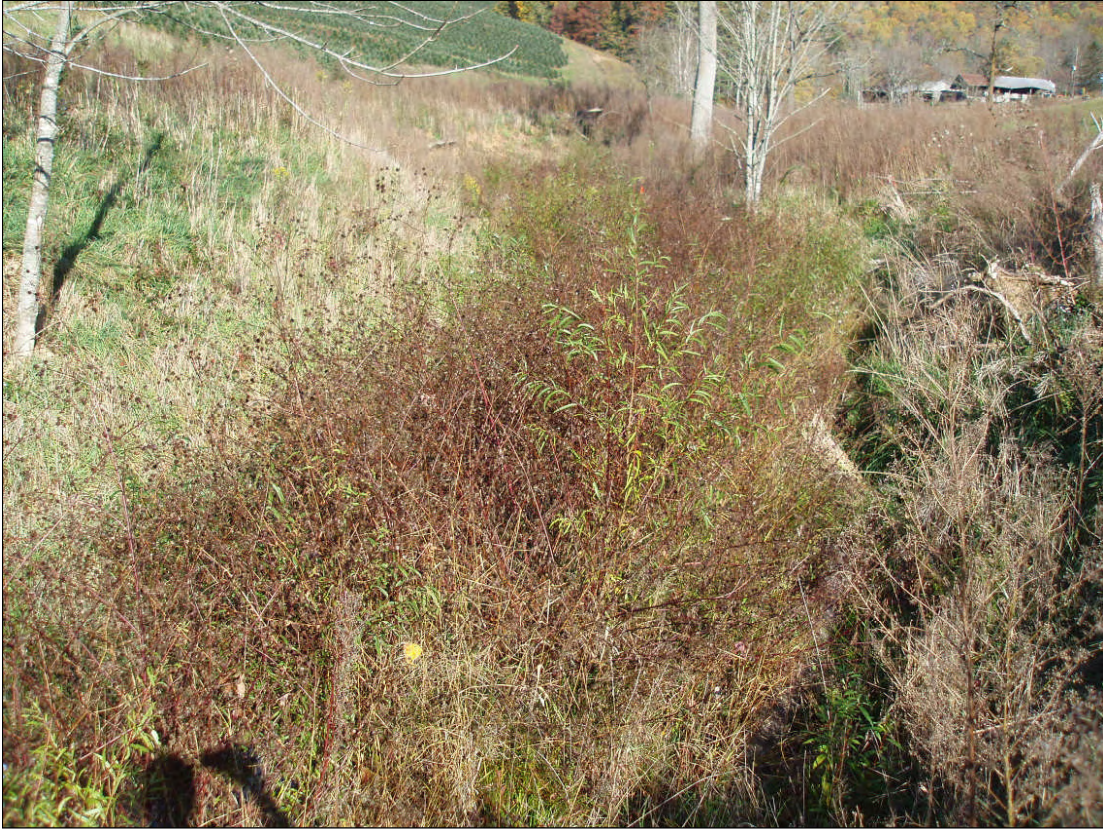
Photo Point 8: View looking upstream near Station 34+00. 10/19/10 – MY01

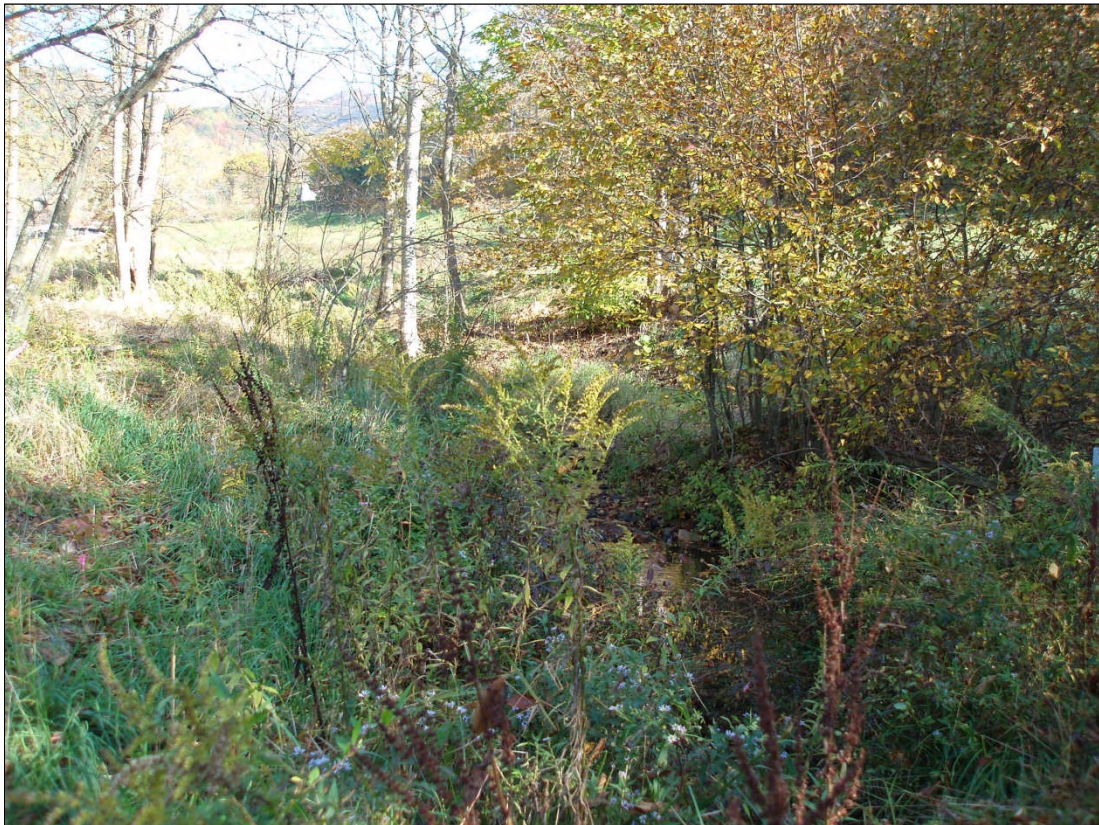
Photo Point 9: View looking upstream near Station 39+25. 10/19/10 – MY01

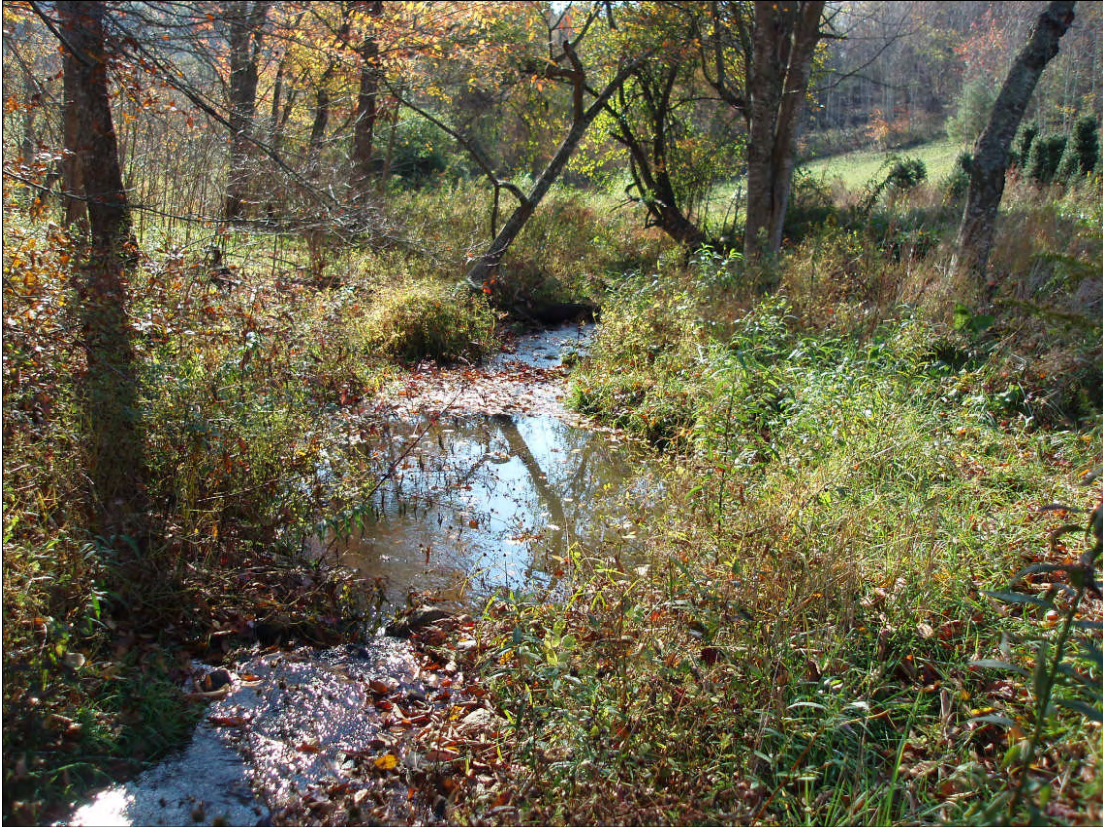
Photo Point 9: View looking downstream near Station 34+00. 10/19/10 – MY01

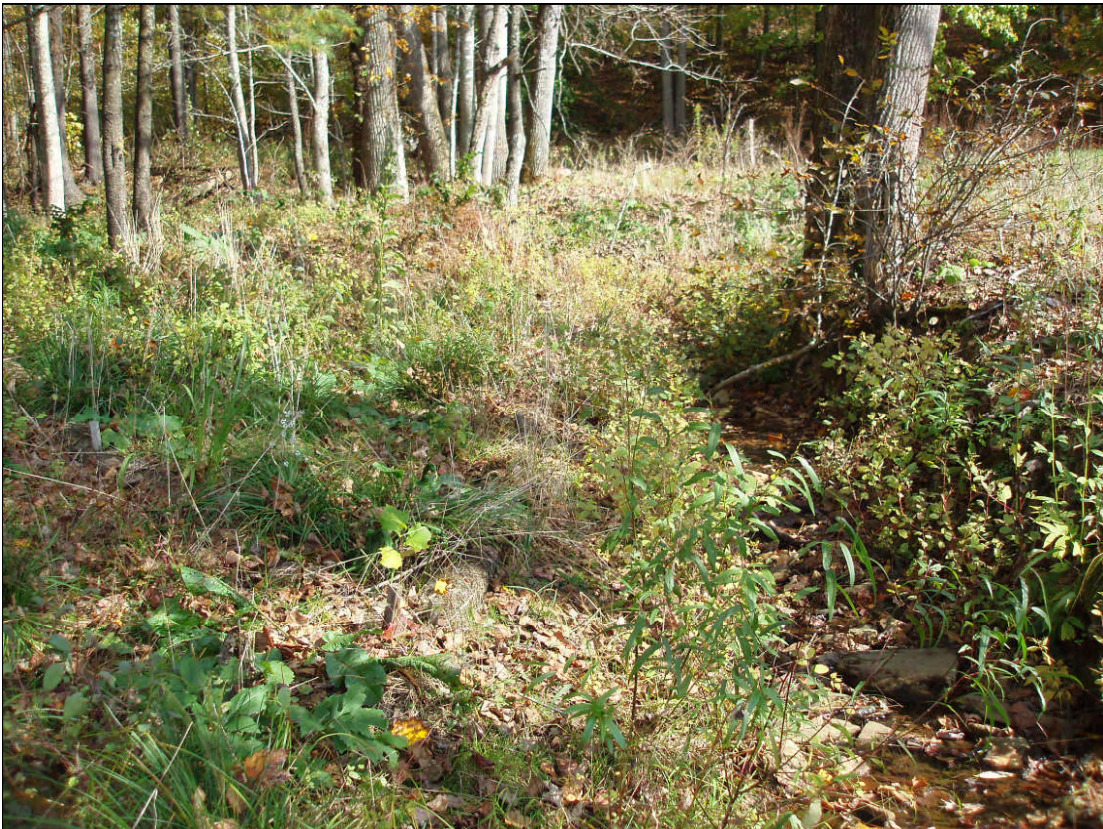
Photo Point 10: View looking upstream on T1 near Station 51+00. 10/19/10 – MY01

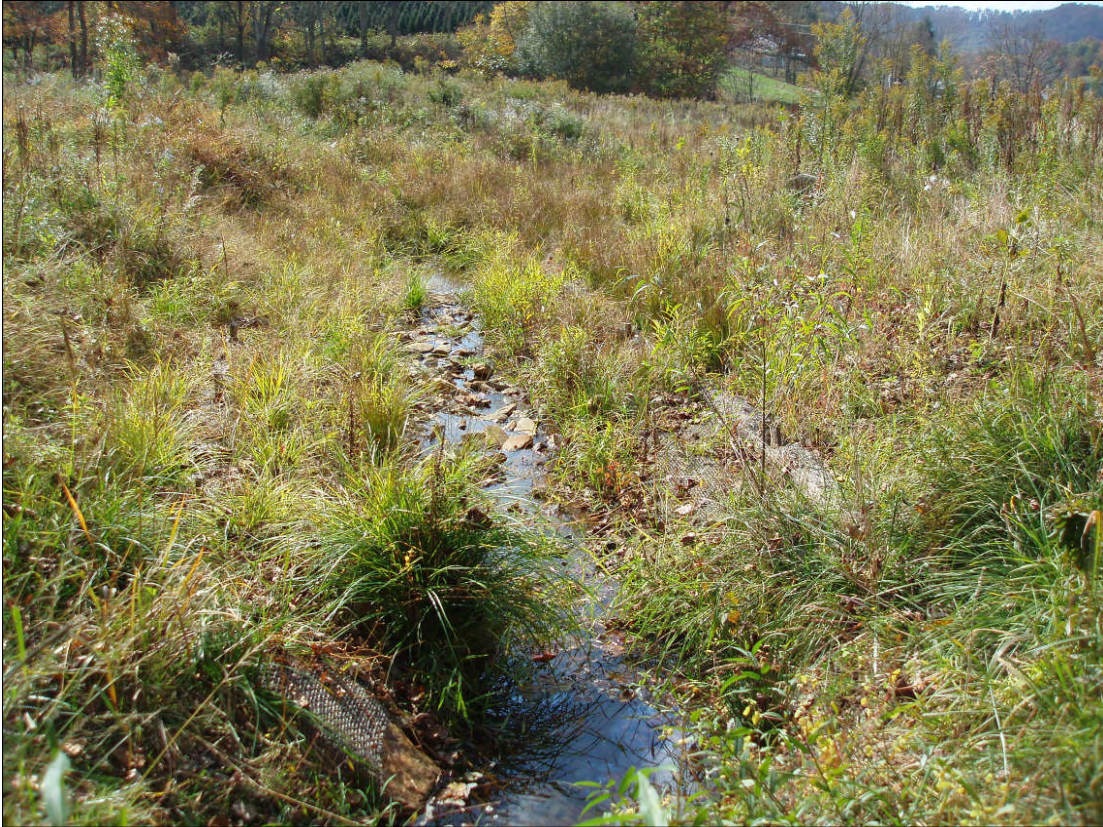
Photo Point 10: View looking downstream on T1 near Station 51+00. 10/19/10 – MY01

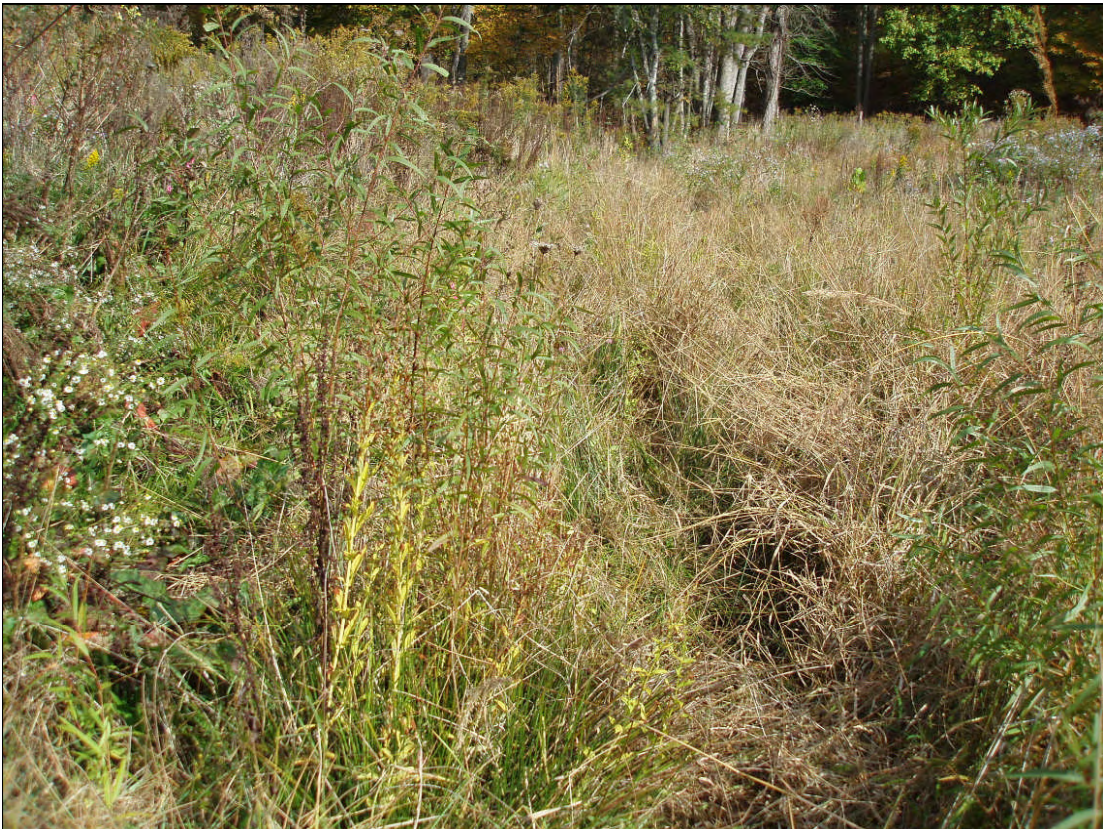
Photo Point 11: View looking upstream on T1 near Station 52+50. 10/19/10 – MY01

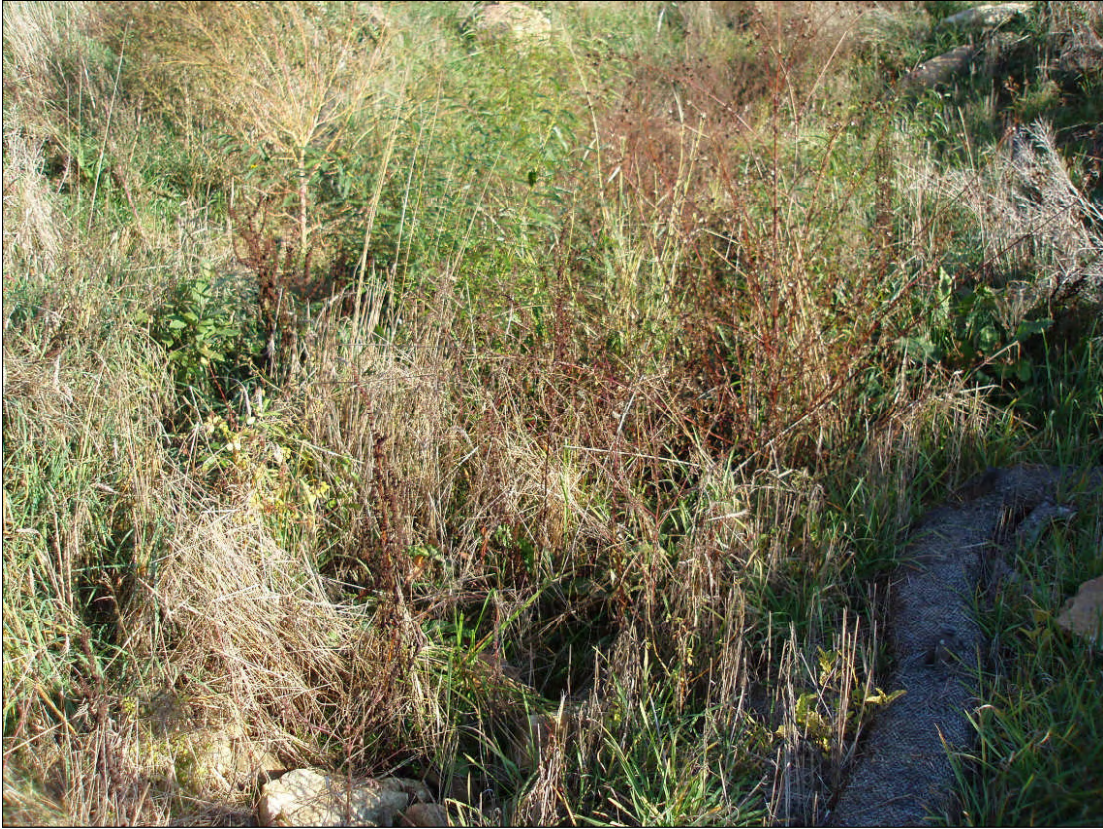
Photo Point 12: View looking upstream on T2 near Station 60+50. 10/19/10 – MY01

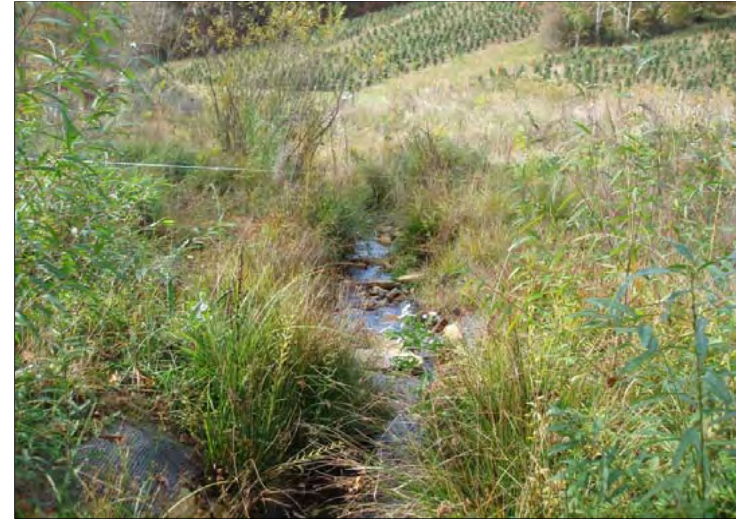
<b>River Basin:</b>	French Broad
<b>Watershed:</b>	Dog Bite
<b>XS ID</b>	XS-1, Riffle, WOC-2
<b>Drainage Area (sq mi):</b>	0.36
<b>Date:</b>	10/19/2010
<b>Field Crew:</b>	A. Spiller, K. Knight-Meng

SUMMARY DATA	
<b>Bankfull Elevation:</b>	2832.1
<b>Bankfull Cross-Sectional Area:</b>	7.1
<b>Bankfull Width:</b>	6.4
<b>Flood Prone Area Elevation:</b>	2833.7
<b>Flood Prone Width:</b>	29
<b>Max Depth at Bankfull:</b>	1.6
<b>Mean Depth at Bankfull:</b>	1.1
<b>W / D Ratio:</b>	5.8
<b>Entrenchment Ratio:</b>	4.5
<b>Bank Height Ratio:</b>	1.0

**Stream Type** C3b

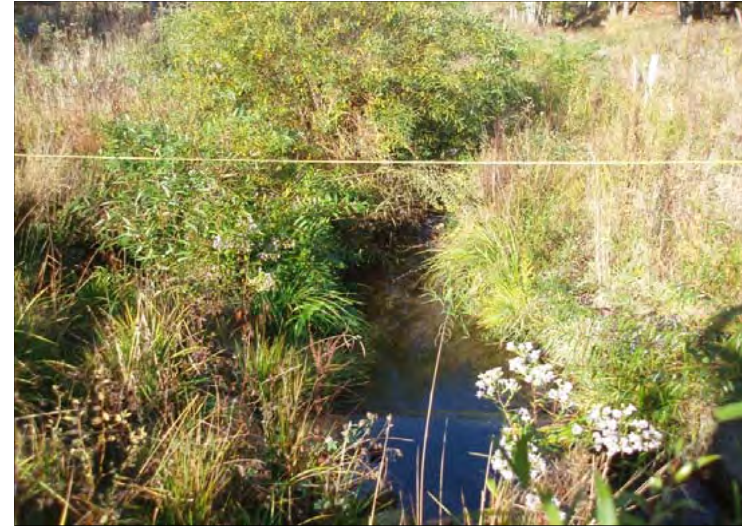
<b>River Basin:</b>	French Broad
<b>Watershed:</b>	Dog Bite
<b>XS ID</b>	XS-2, Pool, WOC-2
<b>Drainage Area (sq mi):</b>	0.36
<b>Date:</b>	10/19/2010
<b>Field Crew:</b>	A. Spiller, K. Knight-Meng

SUMMARY DATA	
<b>Bankfull Elevation:</b>	2810.5
<b>Bankfull Cross-Sectional Area:</b>	11.9
<b>Bankfull Width:</b>	9.6
<b>Flood Prone Area Elevation:</b>	-
<b>Flood Prone Width:</b>	-
<b>Max Depth at Bankfull:</b>	2.0
<b>Mean Depth at Bankfull:</b>	1.2
<b>W / D Ratio:</b>	-
<b>Entrenchment Ratio:</b>	-
<b>Bank Height Ratio:</b>	-

<b>Stream Type</b>	C3b
--------------------	-----

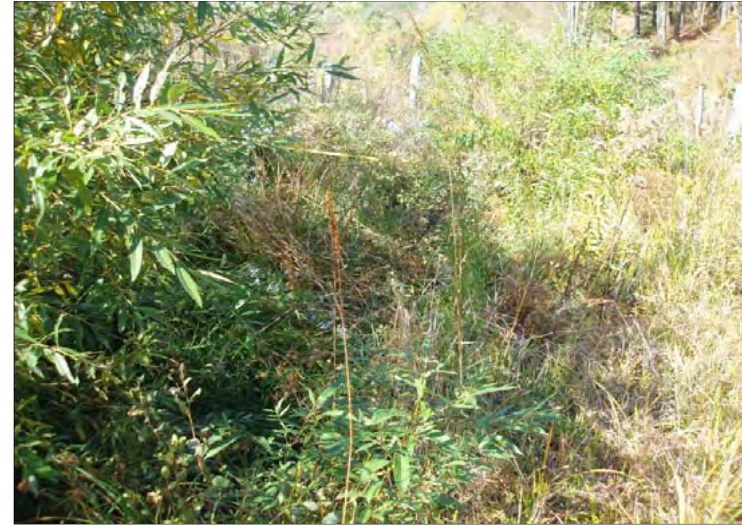
<b>River Basin:</b>	French Broad
<b>Watershed:</b>	Dog Bite
<b>XS ID</b>	XS-3, Riffle, WOC-2
<b>Drainage Area (sq mi):</b>	0.36
<b>Date:</b>	10/19/2010
<b>Field Crew:</b>	A. Spiller, K. Knight-Meng

SUMMARY DATA	
<b>Bankfull Elevation:</b>	2809.0
<b>Bankfull Cross-Sectional Area:</b>	5.4
<b>Bankfull Width:</b>	7.4
<b>Flood Prone Area Elevation:</b>	2810.2
<b>Flood Prone Width:</b>	22
<b>Max Depth at Bankfull:</b>	1.2
<b>Mean Depth at Bankfull:</b>	0.7
<b>W / D Ratio:</b>	10.1
<b>Entrenchment Ratio:</b>	3.0
<b>Bank Height Ratio:</b>	1.0

Stream Type C3b

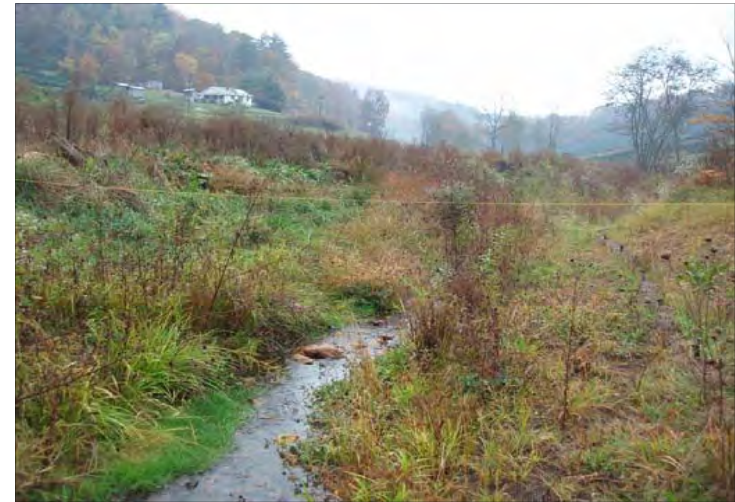
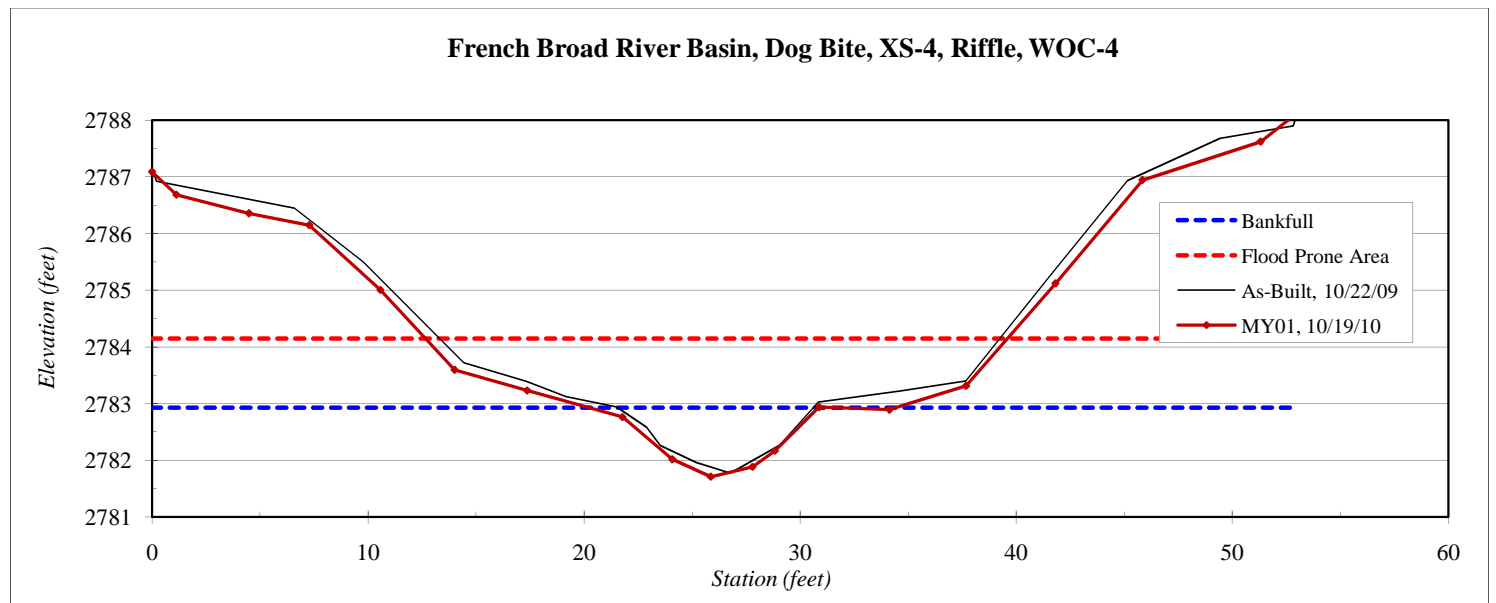
<b>River Basin:</b>	French Broad
<b>Watershed:</b>	Dog Bite
<b>XS ID</b>	XS-4, Riffle, WOC-4
<b>Drainage Area (sq mi):</b>	0.54
<b>Date:</b>	10/19/2010
<b>Field Crew:</b>	A. Spiller, K. Knight-Meng

SUMMARY DATA	
<b>Bankfull Elevation:</b>	2782.9
<b>Bankfull Cross-Sectional Area:</b>	7.2
<b>Bankfull Width:</b>	10.7
<b>Flood Prone Area Elevation:</b>	2784.1
<b>Flood Prone Width:</b>	27
<b>Max Depth at Bankfull:</b>	1.2
<b>Mean Depth at Bankfull:</b>	0.7
<b>W / D Ratio:</b>	15.9
<b>Entrenchment Ratio:</b>	2.5
<b>Bank Height Ratio:</b>	1.0

<b>Stream Type</b>	C3b
--------------------	-----

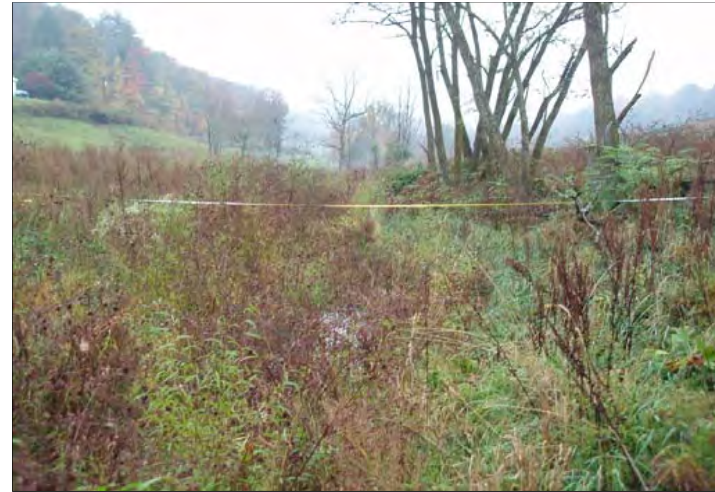
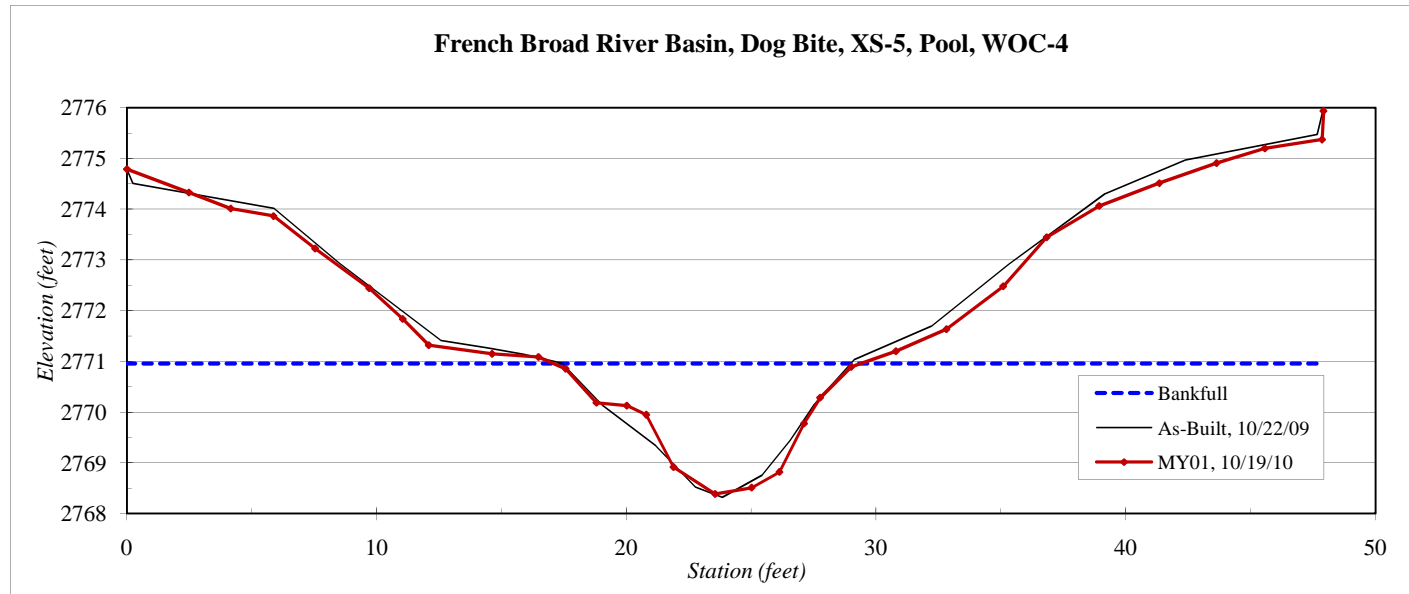
<b>River Basin:</b>	French Broad
<b>Watershed:</b>	Dog Bite
<b>XS ID</b>	XS-5, Pool, WOC-4
<b>Drainage Area (sq mi):</b>	0.54
<b>Date:</b>	10/19/2010
<b>Field Crew:</b>	A. Spiller, K. Knight-Meng

Stream Type C3b

SUMMARY DATA	
<b>Bankfull Elevation:</b>	2771.0
<b>Bankfull Cross-Sectional Area:</b>	16.7
<b>Bankfull Width:</b>	12.3
<b>Flood Prone Area Elevation:</b>	-
<b>Flood Prone Width:</b>	-
<b>Max Depth at Bankfull:</b>	2.6
<b>Mean Depth at Bankfull:</b>	1.4
<b>W / D Ratio:</b>	-
<b>Entrenchment Ratio:</b>	-
<b>Bank Height Ratio:</b>	-

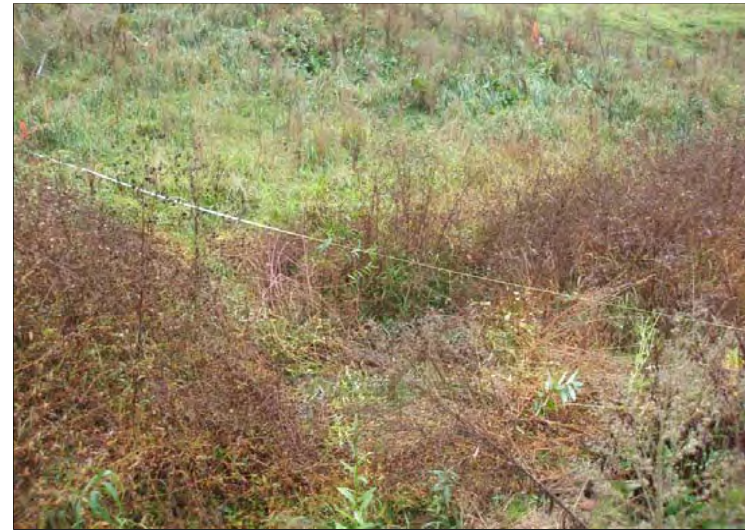
**French Broad River Basin, Dog Bite, XS-6, Riffle, WOC-4**

Station	Elevation
0.0	2758.22
1.4	2757.64
7.6	2756.53
11.8	2755.83
13.1	2755.47
15.4	2755.29
17.7	2755.11
19.7	2754.17
20.8	2753.97
22.5	2753.71
24.7	2754.04
25.6	2754.77
26.6	2755.27
30.0	2755.23
33.5	2755.35
35.0	2755.72
40.9	2759.05
43.5	2759.54
49.8	2760.13
50.8	2760.45

SUMMARY DATA	
<b>Bankfull Elevation:</b>	2755.1
<b>Bankfull Cross-Sectional Area:</b>	7.7
<b>Bankfull Width:</b>	8.5
<b>Flood Prone Area Elevation:</b>	2756.5
<b>Flood Prone Width:</b>	29
<b>Max Depth at Bankfull:</b>	1.4
<b>Mean Depth at Bankfull:</b>	0.9
<b>W / D Ratio:</b>	9.4
<b>Entrenchment Ratio:</b>	3.4
<b>Bank Height Ratio:</b>	1.0

<b>Stream Type</b>	C3b
--------------------	-----

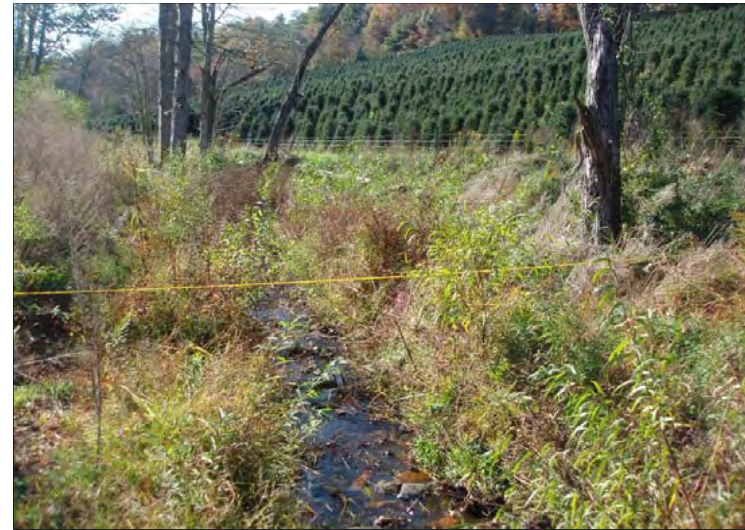
**French Broad River Basin, Dog Bite, XS-7, Riffle, WOC-4**

<b>River Basin:</b>	French Broad
<b>Watershed:</b>	Dog Bite
<b>XS ID</b>	XS-7, Riffle, WOC-4
<b>Drainage Area (sq mi):</b>	0.54
<b>Date:</b>	10/19/2010
<b>Field Crew:</b>	A. Spiller, K. Knight-Meng

Station	Elevation
0.0	2736.53
2.3	2735.95
5.7	2736.08
7.4	2735.12
8.7	2734.72
10.6	2734.80
12.2	2735.00
13.1	2735.08
13.8	2735.79
14.7	2736.07
18.1	2736.05
21.8	2736.32
25.7	2737.20
30.2	2739.36
31.8	2740.27
32.7	2740.67
33.0	2740.96

SUMMARY DATA	
<b>Bankfull Elevation:</b>	2735.8
<b>Bankfull Cross-Sectional Area:</b>	7.0
<b>Bankfull Width:</b>	8.5
<b>Flood Prone Area Elevation:</b>	2736.8
<b>Flood Prone Width:</b>	26
<b>Max Depth at Bankfull:</b>	1.1
<b>Mean Depth at Bankfull:</b>	0.8
<b>W / D Ratio:</b>	10.3
<b>Entrenchment Ratio:</b>	3.1
<b>Bank Height Ratio:</b>	1.0

**Stream Type** C3b

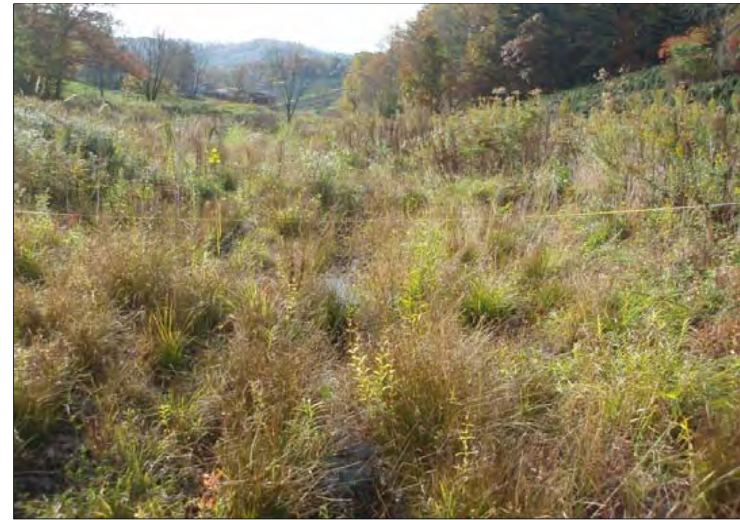
<b>River Basin:</b>	French Broad
<b>Watershed:</b>	Dog Bite
<b>XS ID</b>	XS-8, Riffle, T1-2
<b>Drainage Area (sq mi):</b>	0.08
<b>Date:</b>	10/19/2010
<b>Field Crew:</b>	A. Spiller, K. Knight-Meng

Station	Elevation
0.0	2839.50
0.5	2839.14
8.5	2838.80
15.3	2838.48
19.0	2838.27
20.8	2838.10
22.2	2838.01
23.2	2838.01
23.9	2837.37
24.8	2837.26
25.6	2837.14
26.8	2837.33
27.9	2837.51
28.5	2837.78
29.0	2838.02
30.9	2838.10
32.4	2838.23
34.6	2839.37
37.3	2840.22
40.6	2840.61
45.0	2840.60
46.5	2840.66
46.7	2841.03

SUMMARY DATA	
<b>Bankfull Elevation:</b>	2838.0
<b>Bankfull Cross-Sectional Area:</b>	3.3
<b>Bankfull Width:</b>	5.8
<b>Flood Prone Area Elevation:</b>	2838.9
<b>Flood Prone Width:</b>	27
<b>Max Depth at Bankfull:</b>	0.9
<b>Mean Depth at Bankfull:</b>	0.6
<b>W / D Ratio:</b>	10.2
<b>Entrenchment Ratio:</b>	4.6
<b>Bank Height Ratio:</b>	1.0

<b>Stream Type</b>	C3b
--------------------	-----

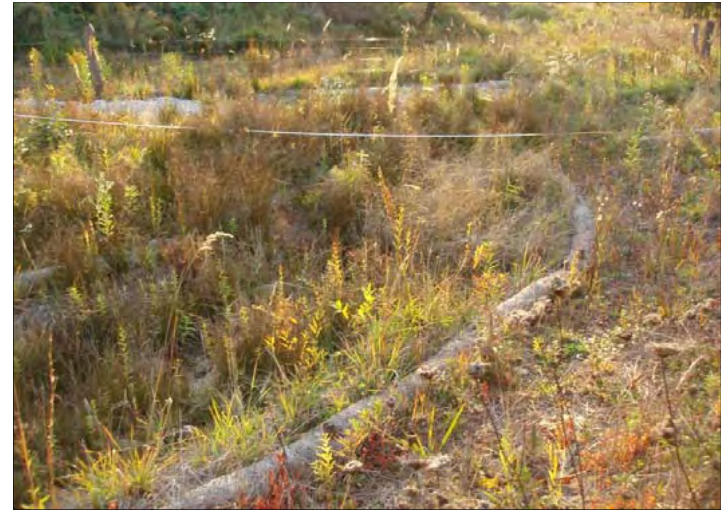
<b>River Basin:</b>	French Broad
<b>Watershed:</b>	Dog Bite
<b>XS ID</b>	XS-9, Pool, T1-2
<b>Drainage Area (sq mi):</b>	0.08
<b>Date:</b>	10/19/2010
<b>Field Crew:</b>	A. Spiller, K. Knight-Meng

Station	Elevation
0.0	2827.22
0.5	2826.72
3.4	2826.25
6.4	2825.69
10.1	2825.09
12.7	2824.69
14.7	2824.49
16.1	2824.43
17.4	2823.86
18.4	2823.49
19.2	2823.57
20.2	2822.81
21.7	2823.01
22.5	2823.80
23.3	2824.42
25.2	2824.45
27.5	2824.62
29.9	2825.73
32.8	2825.90
35.6	2826.16
40.0	2826.20
42.1	2826.56

SUMMARY DATA	
<b>Bankfull Elevation:</b>	2824.4
<b>Bankfull Cross-Sectional Area:</b>	6.2
<b>Bankfull Width:</b>	7.1
<b>Flood Prone Area Elevation:</b>	-
<b>Flood Prone Width:</b>	-
<b>Max Depth at Bankfull:</b>	1.6
<b>Mean Depth at Bankfull:</b>	0.9
<b>W / D Ratio:</b>	-
<b>Entrenchment Ratio:</b>	-
<b>Bank Height Ratio:</b>	-

<b>Stream Type</b>	C3b
--------------------	-----
