**Dog Bite Stream Restoration Site  
Monitoring Report – MY01  
Mitchell County, NC  
Basin 06010108 - Contract # D06056-A**

**December 2010**

## EXECUTIVE SUMMARY

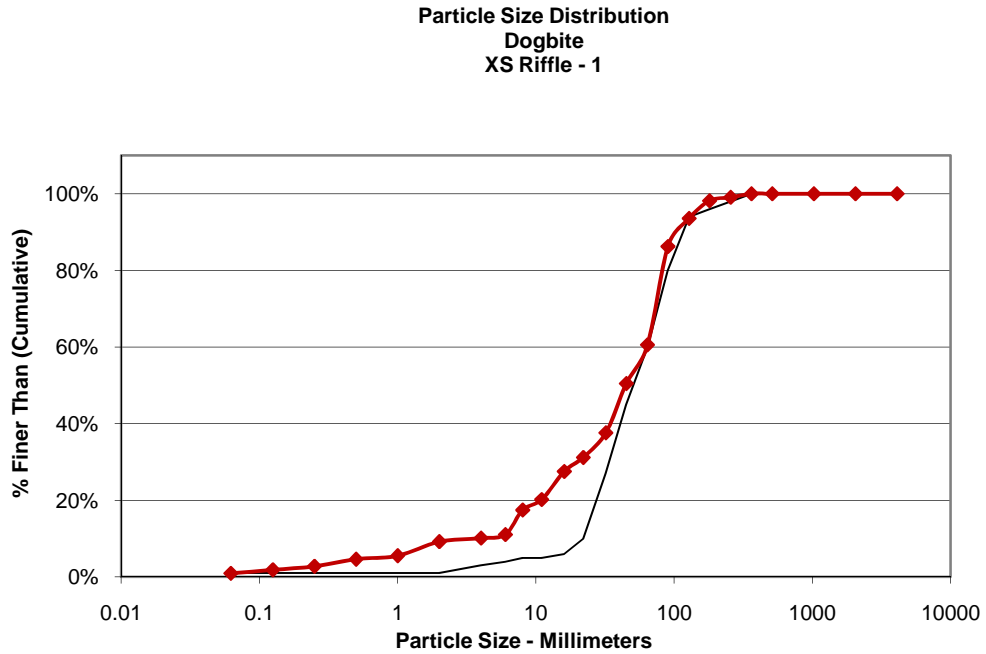
Cross-Section Riffle 1 - MY01			
Particle	Millimeter		Count
Silt/Clay	< 0.062	S/C	1
Very Fine	.062 - .125	S	1
Fine	.125 - .25	A	1
Medium	.25 - .50	N	2
Coarse	.50 - 1	D	1
Very Coarse	1 - 2	S	4
Very Fine	2 - 4		1
Fine	4 - 5.7	G	1
Fine	5.7 - 8	R	7
Medium	8 - 11.3	A	3
Medium	11.3 - 16	V	8
Coarse	16 - 22.6	E	4
Coarse	22.6 - 32	L	7
Very Coarse	32 - 45	S	14
Very Coarse	45 - 64		11
Small	64 - 90	C	28
Small	90 - 128	O	8
Large	128 - 180	B	5
Large	180 - 256	L	1
Small	256 - 362	B	1
Small	362 - 512	L	
Medium	512 - 1024	D	
Lrg- Very Lrg	1024 - 2048	R	
Bedrock	>2048	BDRK	
		<b>Total</b>	109
Note:

Size (mm)	
D16	7.5
D35	27
D50	44
D65	68
D84	87
D95	140

Size Distribution	
mean	25.5
dispersion	3.9
skewness	-0.02

Type	
silt/clay	1%
sand	8%
gravel	51%
cobble	39%
boulder	1%
bedrock	0%
hardpan	0%
wood/det	0%
artificial	0%

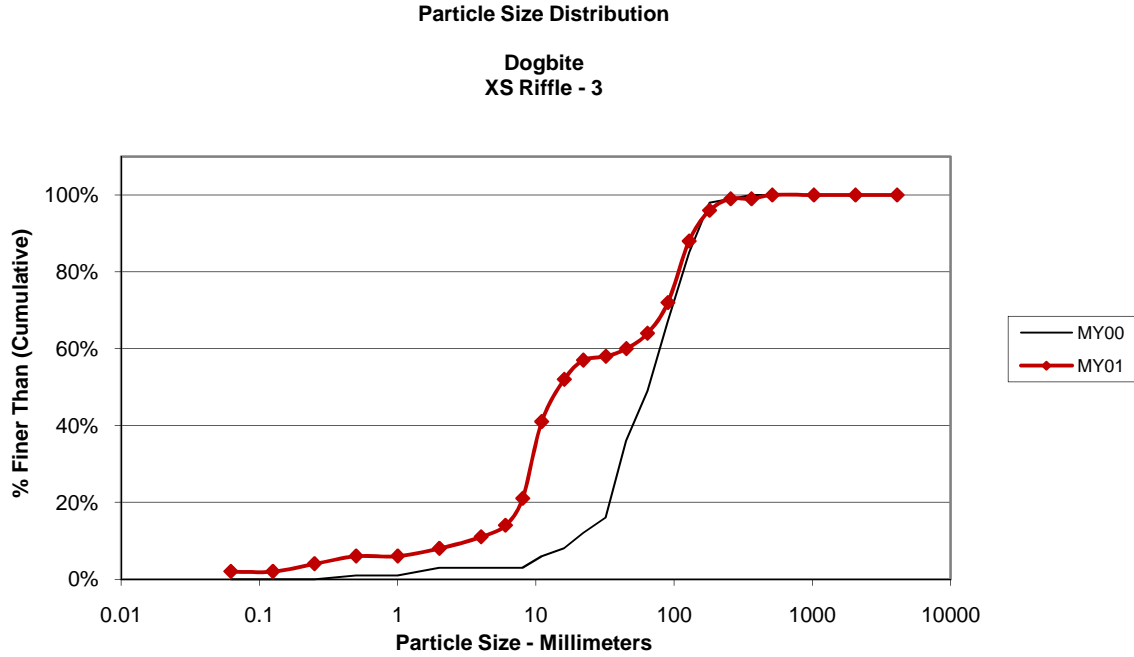
Cross-Section Riffle 3 - MY01			
Particle	Millimeter		Count
Silt/Clay	< 0.062	S/C	2
Very Fine	.062 - .125	S	
Fine	.125 - .25	A	2
Medium	.25 - .50	N	2
Coarse	.50 - 1	D	
Very Coarse	1 - 2	S	2
Very Fine	2 - 4		3
Fine	4 - 5.7	G	3
Fine	5.7 - 8	R	7
Medium	8 - 11.3	A	20
Medium	11.3 - 16	V	11
Coarse	16 - 22.6	E	5
Coarse	22.6 - 32	L	1
Very Coarse	32 - 45	S	2
Very Coarse	45 - 64		4
Small	64 - 90	C	8
Small	90 - 128	O	16
Large	128 - 180	B	8
Large	180 - 256	L	3
Small	256 - 362	B	
Small	362 - 512	L	1
Medium	512 - 1024	D	
Lrg- Very Lrg	1024 - 2048	R	
Bedrock	>2048	BDRK	
		<b>Total</b>	100
Note:

Size (mm)	
D16	6.5
D35	10
D50	15
D65	67
D84	120
D95	170

Size Distribution	
mean	27.9
dispersion	5.2
skewness	0.24

Type	
silt/clay	2%
sand	6%
gravel	56%
cobble	35%
boulder	1%
bedrock	0%
hardpan	0%
wood/det	0%
artificial	0%

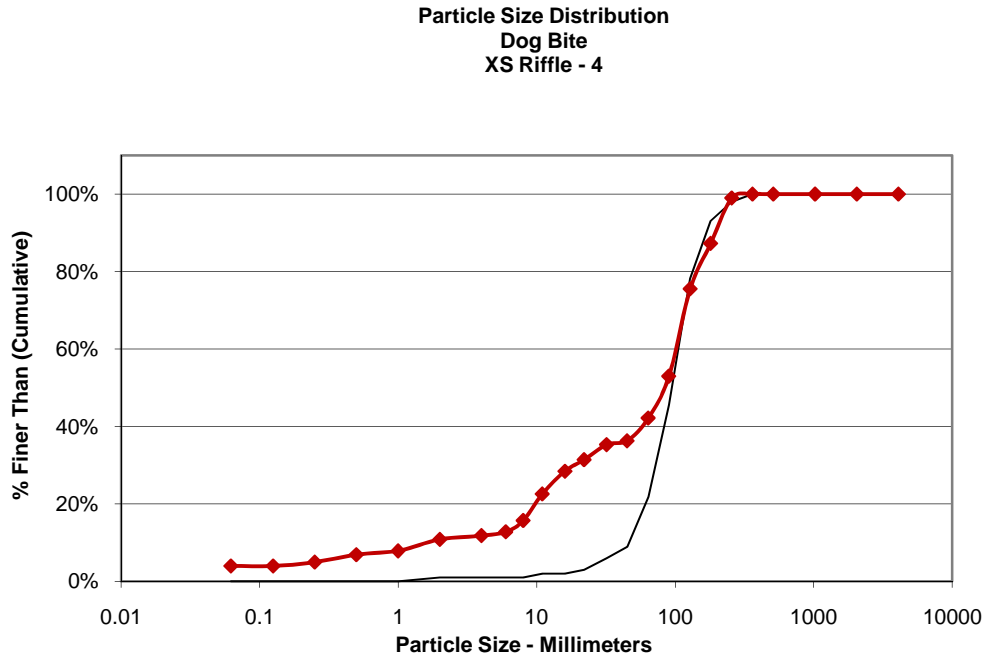
Cross-Section Riffle 4 - MY01			
Particle	Millimeter		Count
Silt/Clay	< 0.062	S/C	4
Very Fine	.062 - .125	S	
Fine	.125 - .25	A	1
Medium	.25 - .50	N	2
Coarse	.50 - 1	D	1
Very Coarse	1 - 2	S	3
Very Fine	2 - 4		1
Fine	4 - 5.7	G	1
Fine	5.7 - 8	R	3
Medium	8 - 11.3	A	7
Medium	11.3 - 16	V	6
Coarse	16 - 22.6	E	3
Coarse	22.6 - 32	L	4
Very Coarse	32 - 45	S	1
Very Coarse	45 - 64		6
Small	64 - 90	C	11
Small	90 - 128	O	23
Large	128 - 180	B	12
Large	180 - 256	L	12
Small	256 - 362	B	1
Small	362 - 512	L	
Medium	512 - 1024	D	
Lrg- Very Lrg	1024 - 2048	R	
Bedrock	>2048	BDRK	
		<b>Total</b>	102
Note:

Size (mm)	
D16	8.1
D35	31
D50	82
D65	110
D84	160
D95	230

Size Distribution	
mean	36.0
dispersion	6.0
skewness	-0.31

Type	
silt/clay	4%
sand	7%
gravel	31%
cobble	57%
boulder	1%
bedrock	0%
hardpan	0%
wood/det	0%
artificial	0%

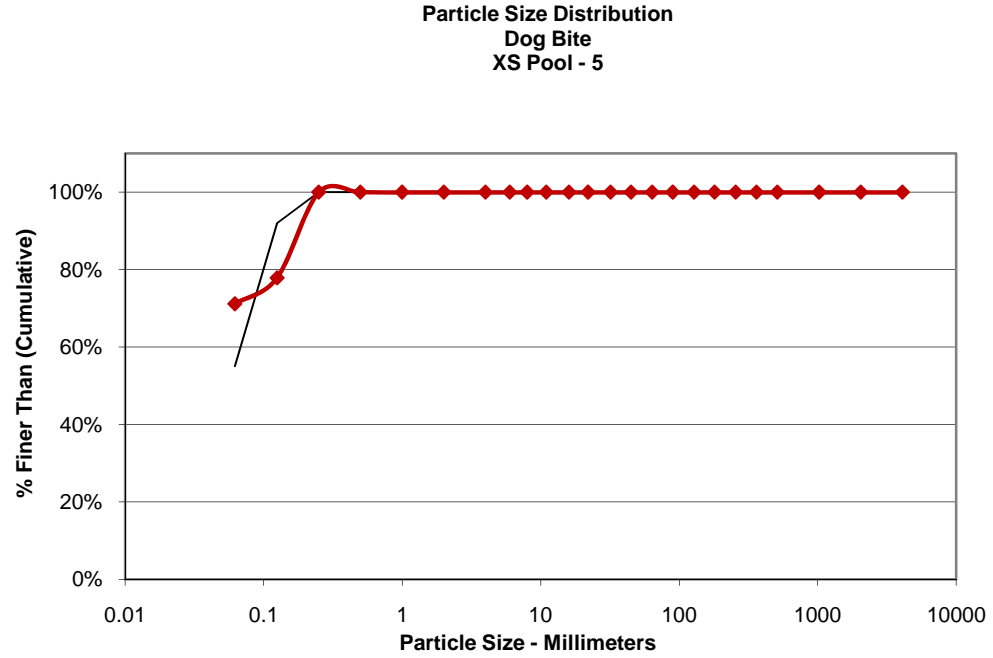
Cross-Section Pool 5 - MY01			
Particle	Millimeter		Count
Silt/Clay	< 0.062	S/C	74
Very Fine	.062 - .125	S	7
Fine	.125 - .25	A	23
Medium	.25 - .50	N	
Coarse	.50 - 1	D	
Very Coarse	1 - 2	S	
Very Fine	2 - 4		
Fine	4 - 5.7	G	
Fine	5.7 - 8	R	
Medium	8 - 11.3	A	
Medium	11.3 - 16	V	
Coarse	16 - 22.6	E	
Coarse	22.6 - 32	L	
Very Coarse	32 - 45	S	
Very Coarse	45 - 64		
Small	64 - 90	C	
Small	90 - 128	O	
Large	128 - 180	B	
Large	180 - 256	L	
Small	256 - 362	B	
Small	362 - 512	L	
Medium	512 - 1024	D	
Lrg- Very Lrg	1024 - 2048	R	
Bedrock	>2048	BDRK	
		<b>Total</b>	104
Note:

Size (mm)	
D16	0.062
D35	0.062
D50	0.062
D65	0.062
D84	0.15
D95	0.21

Size Distribution	
mean	0.1
dispersion	1.7
skewness	0.31

Type	
silt/clay	71%
sand	29%
gravel	0%
cobble	0%
boulder	0%
bedrock	0%
hardpan	0%
wood/det	0%
artificial	0%

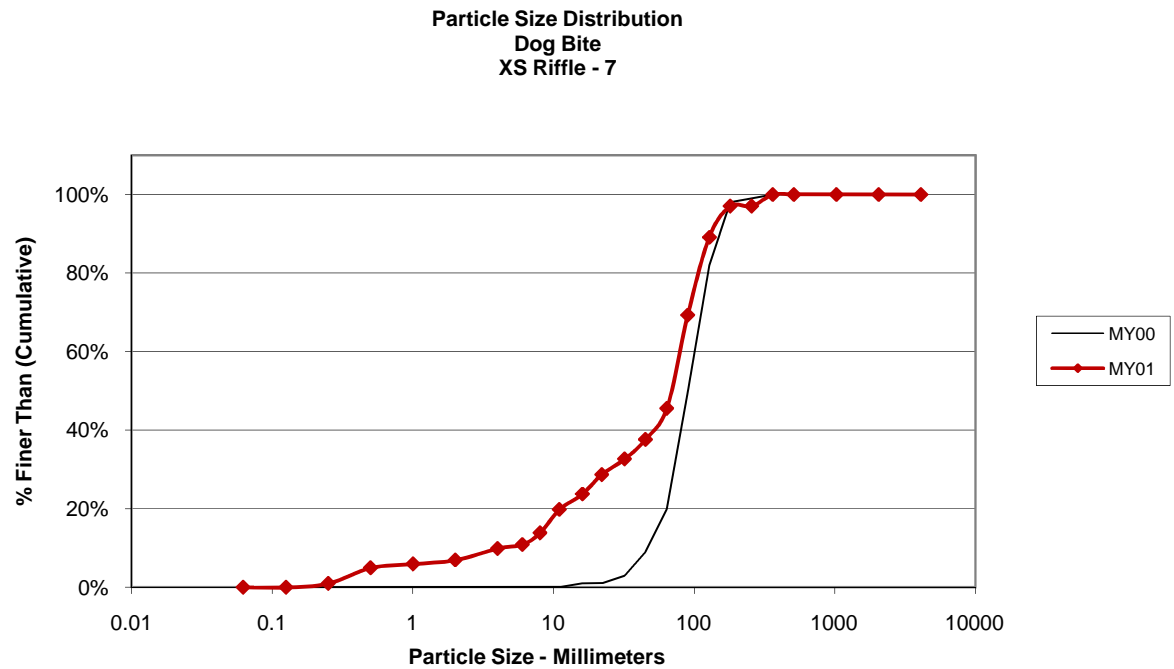
Cross-Section Riffle 7 - MY01			
Particle	Millimeter		Count
Silt/Clay	< 0.062	S/C	
Very Fine	.062 - .125	S	
Fine	.125 - .25	A	1
Medium	.25 - .50	N	4
Coarse	.50 - 1	D	1
Very Coarse	1 - 2	S	1
Very Fine	2 - 4		3
Fine	4 - 5.7	G	1
Fine	5.7 - 8	R	3
Medium	8 - 11.3	A	6
Medium	11.3 - 16	V	4
Coarse	16 - 22.6	E	5
Coarse	22.6 - 32	L	4
Very Coarse	32 - 45	S	5
Very Coarse	45 - 64		8
Small	64 - 90	C	24
Small	90 - 128	O	20
Large	128 - 180	B	8
Large	180 - 256	L	
Small	256 - 362	B	3
Small	362 - 512	L	
Medium	512 - 1024	D	
Lrg- Very Lrg	1024 - 2048	R	
Bedrock	>2048	BDRK	
		<b>Total</b>	101
Note:

Size (mm)	
D16	9
D35	38
D50	68
D65	85
D84	120
D95	160

Size Distribution	
mean	32.9
dispersion	4.7
skewness	-0.30

Type	
silt/clay	0%
sand	7%
gravel	39%
cobble	51%
boulder	3%
bedrock	0%
hardpan	0%
wood/det	0%
artificial	0%

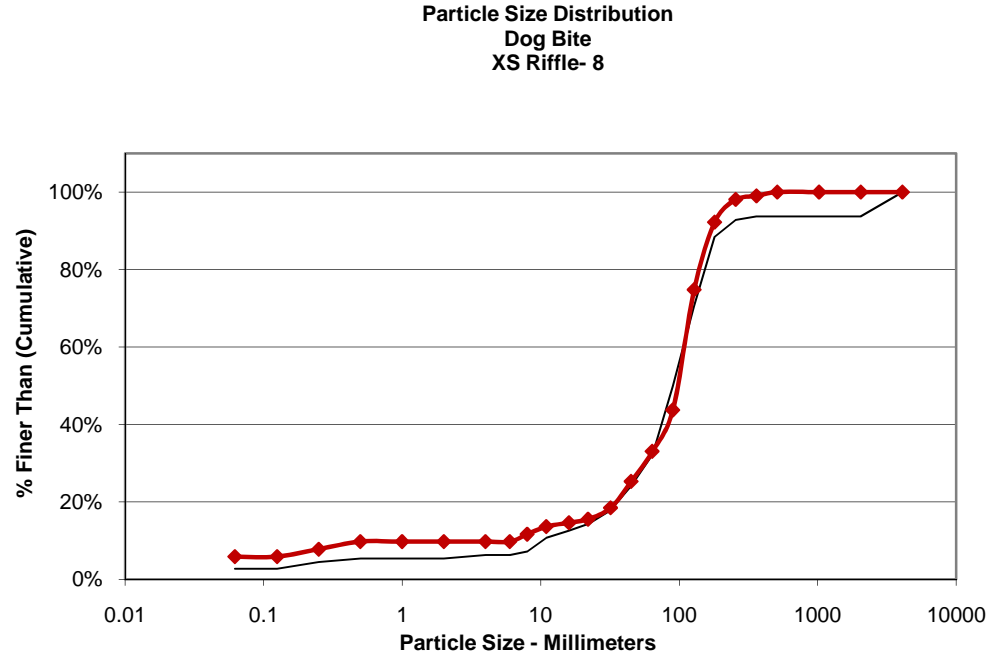
Cross-Section Riffle 8 - MY01			
Particle	Millimeter		Count
Silt/Clay	< 0.062	S/C	6
Very Fine	.062 - .125	S	
Fine	.125 - .25	A	2
Medium	.25 - .50	N	2
Coarse	.50 - 1	D	
Very Coarse	1 - 2	S	
Very Fine	2 - 4		
Fine	4 - 5.7	G	
Fine	5.7 - 8	R	2
Medium	8 - 11.3	A	2
Medium	11.3 - 16	V	1
Coarse	16 - 22.6	E	1
Coarse	22.6 - 32	L	3
Very Coarse	32 - 45	S	7
Very Coarse	45 - 64		8
Small	64 - 90	C	11
Small	90 - 128	O	32
Large	128 - 180	B	18
Large	180 - 256	L	6
Small	256 - 362	B	1
Small	362 - 512	L	1
Medium	512 - 1024	D	
Lrg- Very Lrg	1024 - 2048	R	
Bedrock	>2048	BDRK	
		<b>Total</b>	103
Note:

Size (mm)	
D16	23
D35	68
D50	97
D65	110
D84	150
D95	210

Size Distribution	
mean	58.7
dispersion	2.9
skewness	-0.24

Type	
silt/clay	6%
sand	4%
gravel	23%
cobble	65%
boulder	2%
bedrock	0%
hardpan	0%
wood/det	0%
artificial	0%
