MONITORING YEAR 1 ANNUAL REPORT FINAL

DRY CREEK MITIGATION SITE

Durham County, NC
NCDEQ Contract No. 6827
DMS Project No. 97082
USACE Action ID No. SAW-2016-00880
NCDWR Project No. 2016-0369

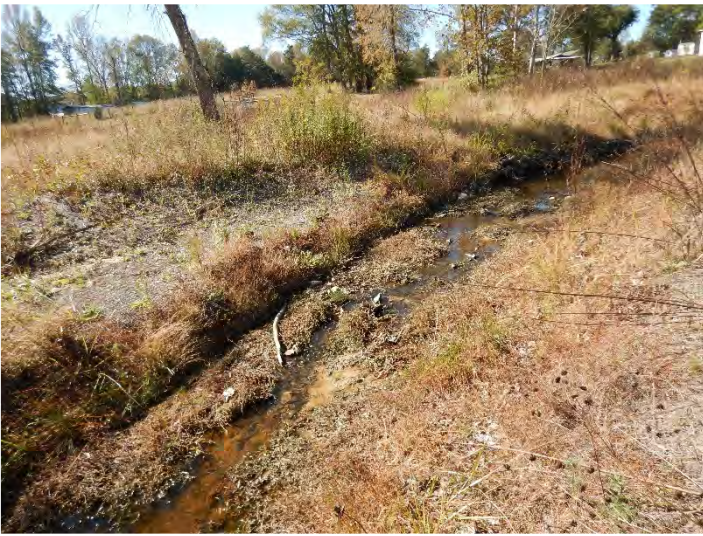
PHOTO POINT 1 Dry Creek R1 – upstream (11/4/2020)

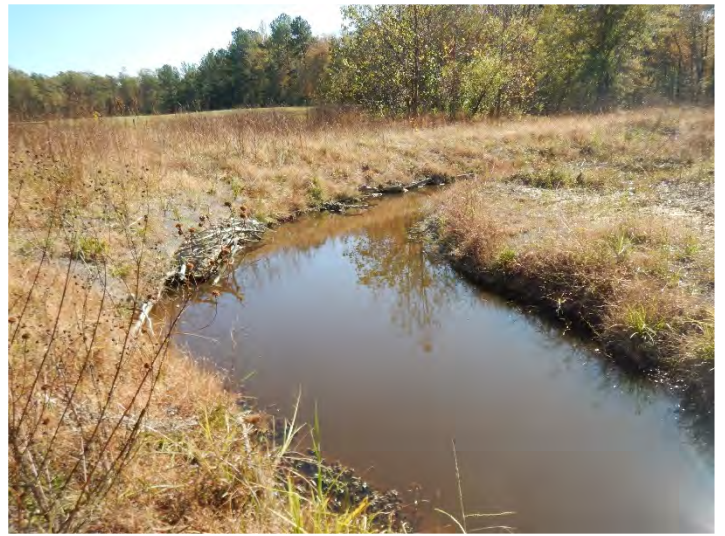
PHOTO POINT 1 Dry Creek R1 – downstream (11/4/2020)

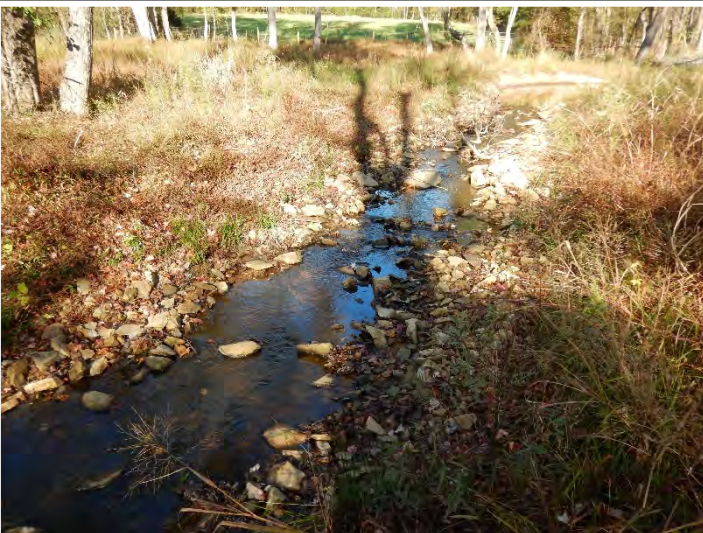
PHOTO POINT 15 Dry Creek R4 – upstream (11/4/2020)

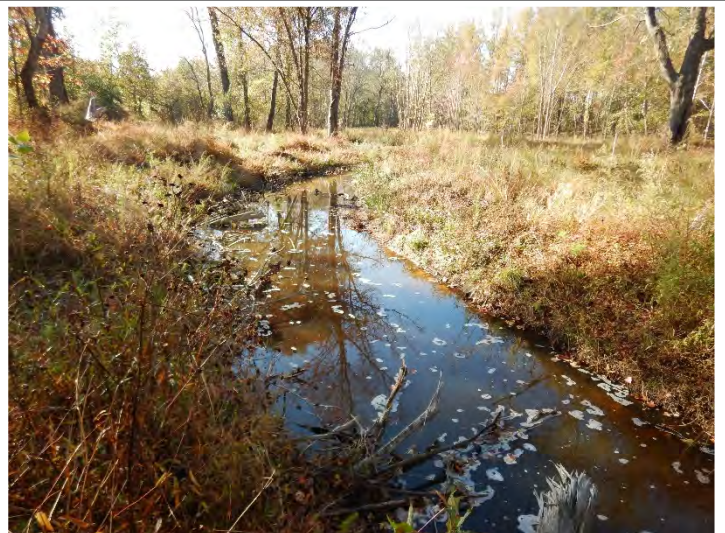
PHOTO POINT 15 Dry Creek R4 – downstream (11/4/2020)

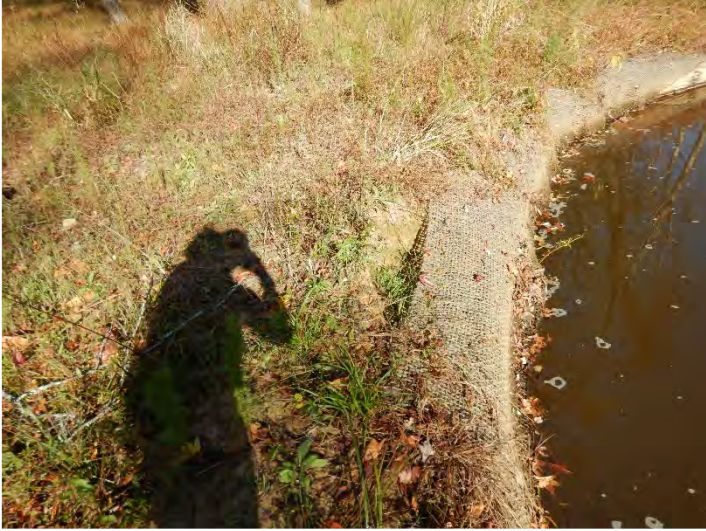
Stream Area of Concern Photographs
Dry Creek Reach 4

Localized Erosion (11/4/2020)

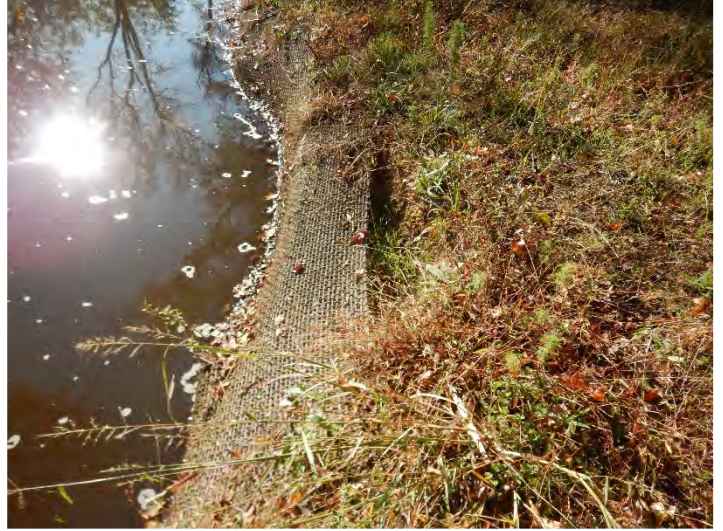
Localized Erosion (11/4/2020)

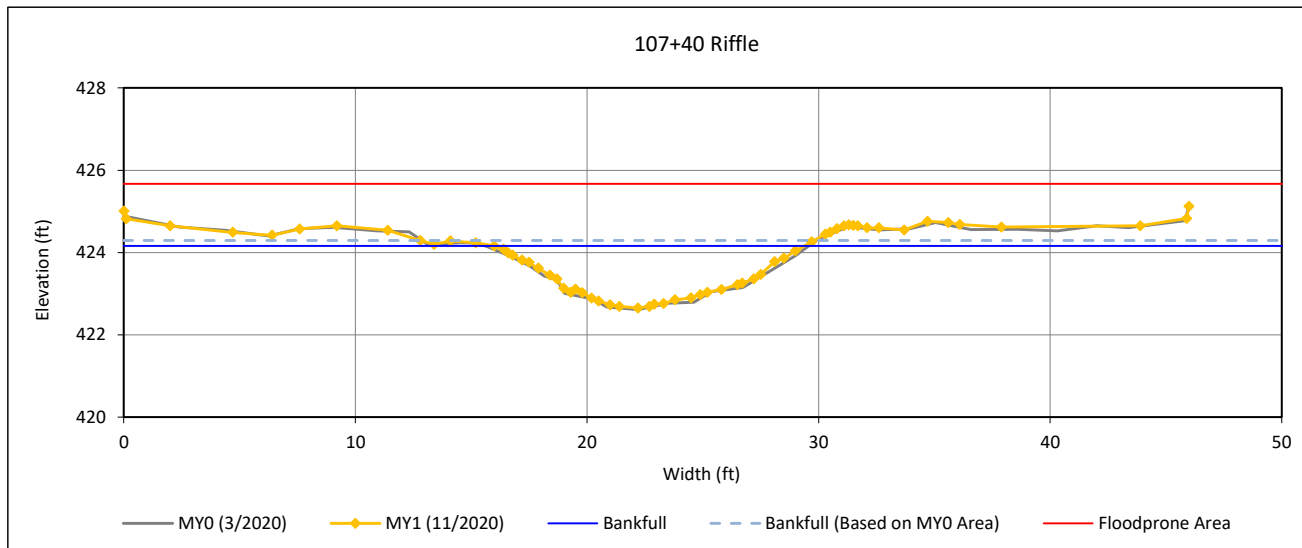
Cross-Section 1 - Dry Creek Reach 1

Bankfull Dimensions

12.3	x-section area (ft.sq.)
13.4	width (ft)
0.9	mean depth (ft)
1.5	max depth (ft)
13.9	wetted perimeter (ft)
0.9	hydraulic radius (ft)
14.6	width-depth ratio
152.0	W flood prone area (ft)
11.4	entrenchment ratio
< 1.0	low bank height ratio

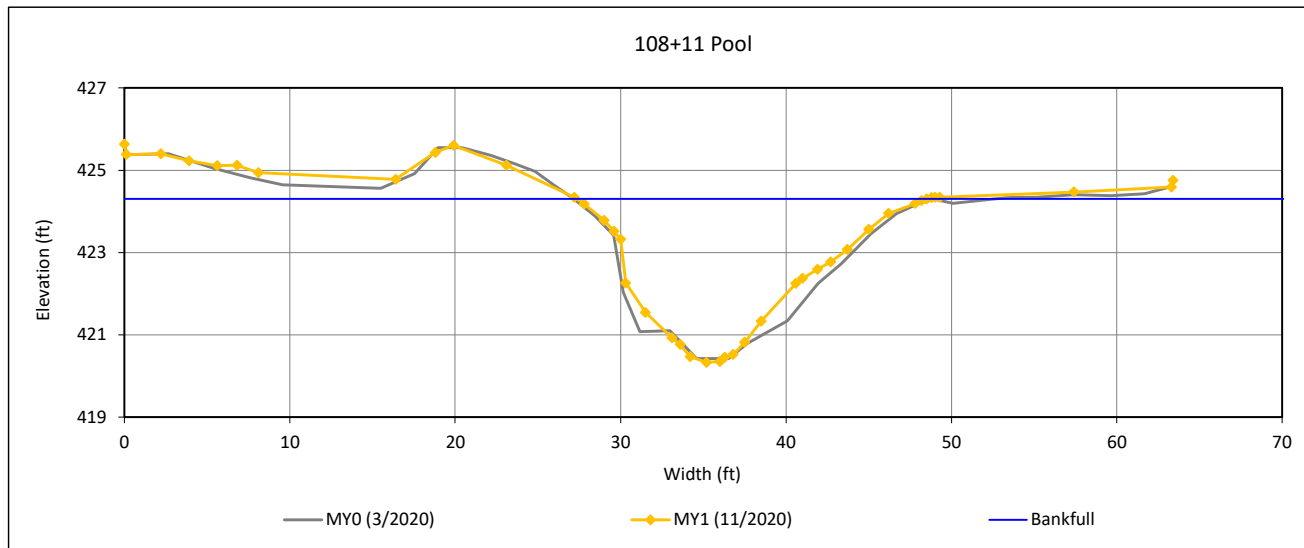
Cross-Section 2 - Dry Creek Reach 1

Bankfull Dimensions

42.0	x-section area (ft.sq.)
21.2	width (ft)
2.0	mean depth (ft)
4.0	max depth (ft)
23.2	wetted perimeter (ft)
1.8	hydraulic radius (ft)
10.7	width-depth ratio

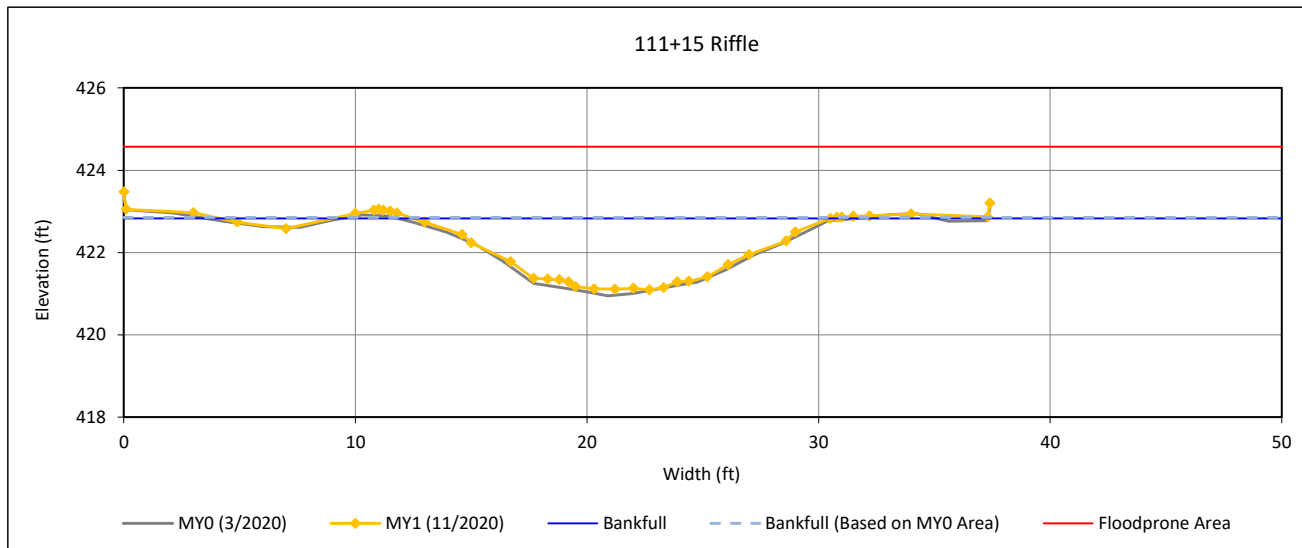
Cross-Section 3 - Dry Creek Reach 1

Bankfull Dimensions

19.0	x-section area (ft.sq.)
18.0	width (ft)
1.1	mean depth (ft)
1.7	max depth (ft)
18.5	wetted perimeter (ft)
1.0	hydraulic radius (ft)
17.1	width-depth ratio
70.0	W flood prone area (ft)
3.9	entrenchment ratio
1.0	low bank height ratio

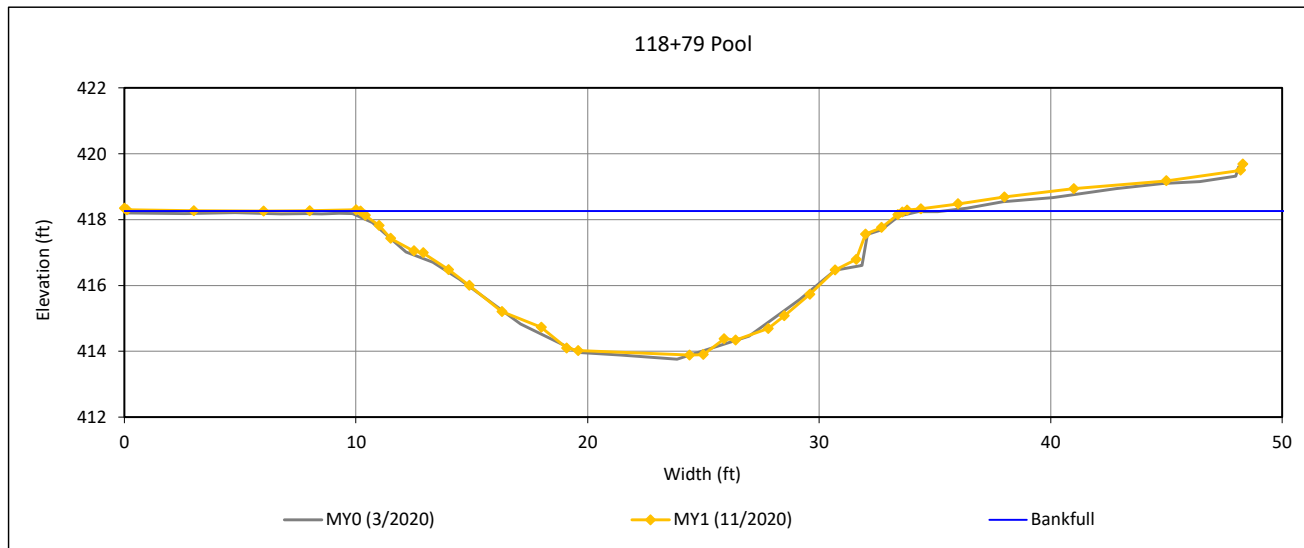
Cross-Section 4 - Dry Creek Reach 2

Bankfull Dimensions

65.8	x-section area (ft.sq.)
23.5	width (ft)
2.8	mean depth (ft)
4.4	max depth (ft)
25.8	wetted perimeter (ft)
2.5	hydraulic radius (ft)
8.4	width-depth ratio

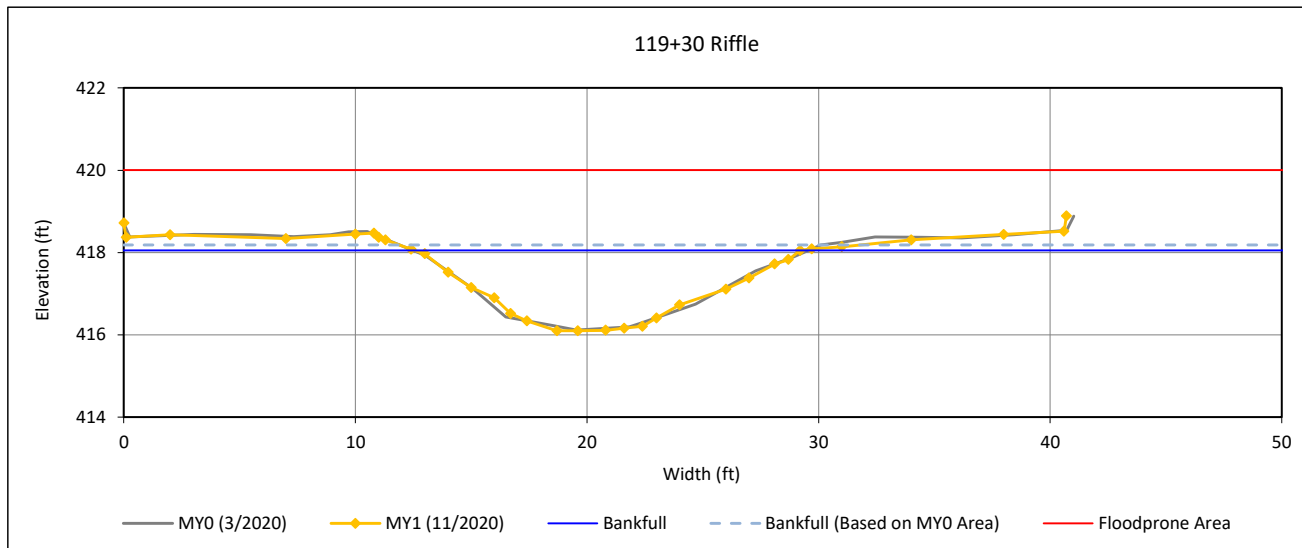
Cross-Section 5 - Dry Creek Reach 2

Bankfull Dimensions

20.0	x-section area (ft.sq.)
16.6	width (ft)
1.2	mean depth (ft)
1.9	max depth (ft)
17.2	wetted perimeter (ft)
1.2	hydraulic radius (ft)
13.8	width-depth ratio
155.0	W flood prone area (ft)
9.3	entrenchment ratio
< 1.0	low bank height ratio

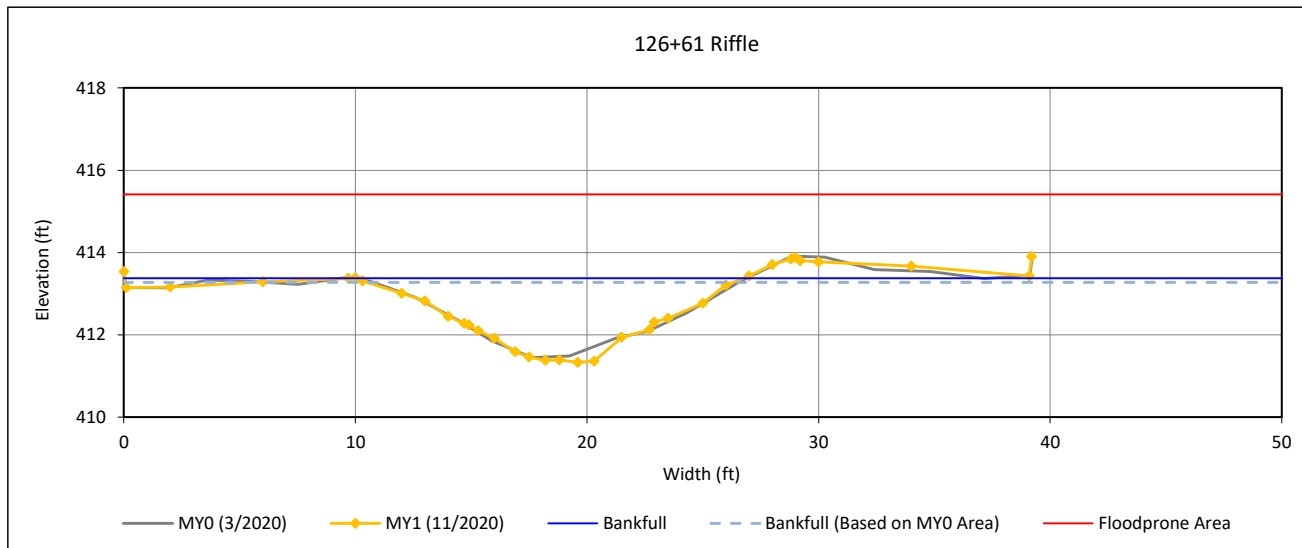
Cross-Section 6 - Dry Creek Reach 2

Bankfull Dimensions

18.2	x-section area (ft.sq.)
16.7	width (ft)
1.1	mean depth (ft)
2.0	max depth (ft)
17.3	wetted perimeter (ft)
1.1	hydraulic radius (ft)
15.3	width-depth ratio
126.0	W flood prone area (ft)
7.6	entrenchment ratio
1.1	low bank height ratio

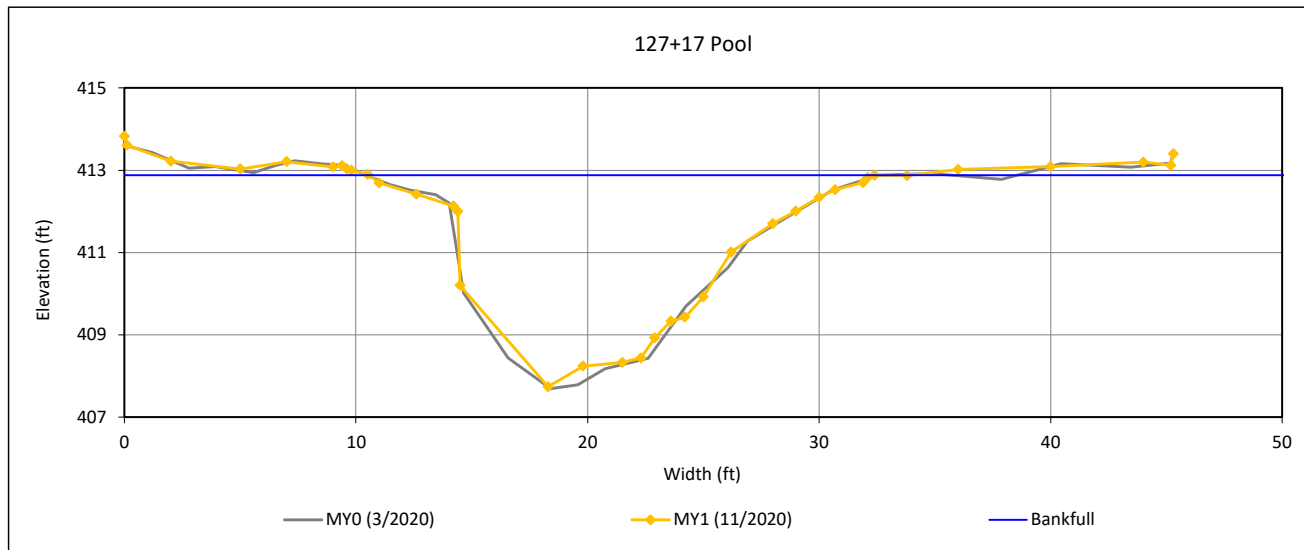
Cross-Section 7 - Dry Creek Reach 2

Bankfull Dimensions

53.3	x-section area (ft.sq.)
21.9	width (ft)
2.4	mean depth (ft)
5.1	max depth (ft)
25.7	wetted perimeter (ft)
2.1	hydraulic radius (ft)
9.0	width-depth ratio

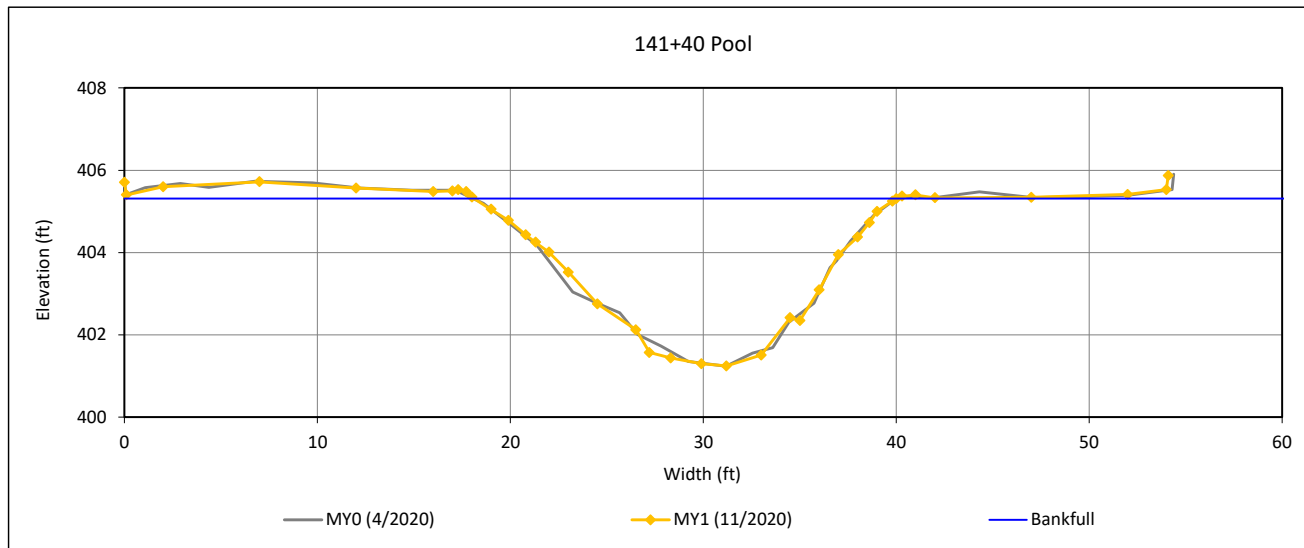
Cross-Section 8 - Dry Creek Reach 3

Bankfull Dimensions

51.0	x-section area (ft.sq.)
21.9	width (ft)
2.3	mean depth (ft)
4.1	max depth (ft)
23.8	wetted perimeter (ft)
2.1	hydraulic radius (ft)
9.4	width-depth ratio

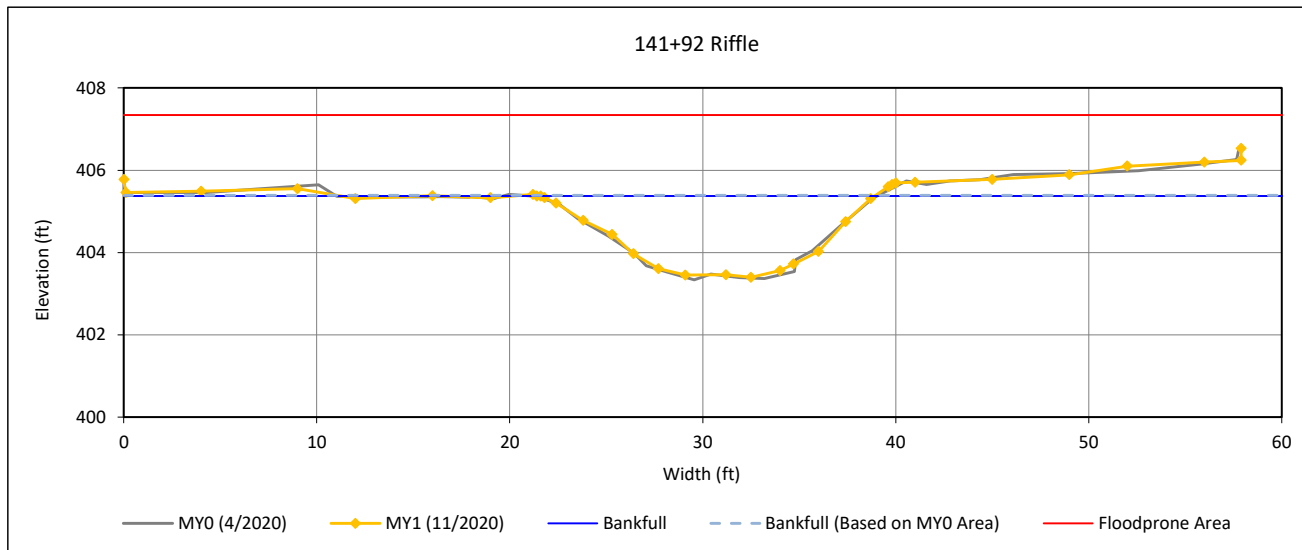
Cross-Section 9 - Dry Creek Reach 3

Bankfull Dimensions

22.0	x-section area (ft.sq.)
17.3	width (ft)
1.3	mean depth (ft)
2.0	max depth (ft)
17.9	wetted perimeter (ft)
1.2	hydraulic radius (ft)
13.6	width-depth ratio
175.0	W flood prone area (ft)
10.1	entrenchment ratio
1.0	low bank height ratio

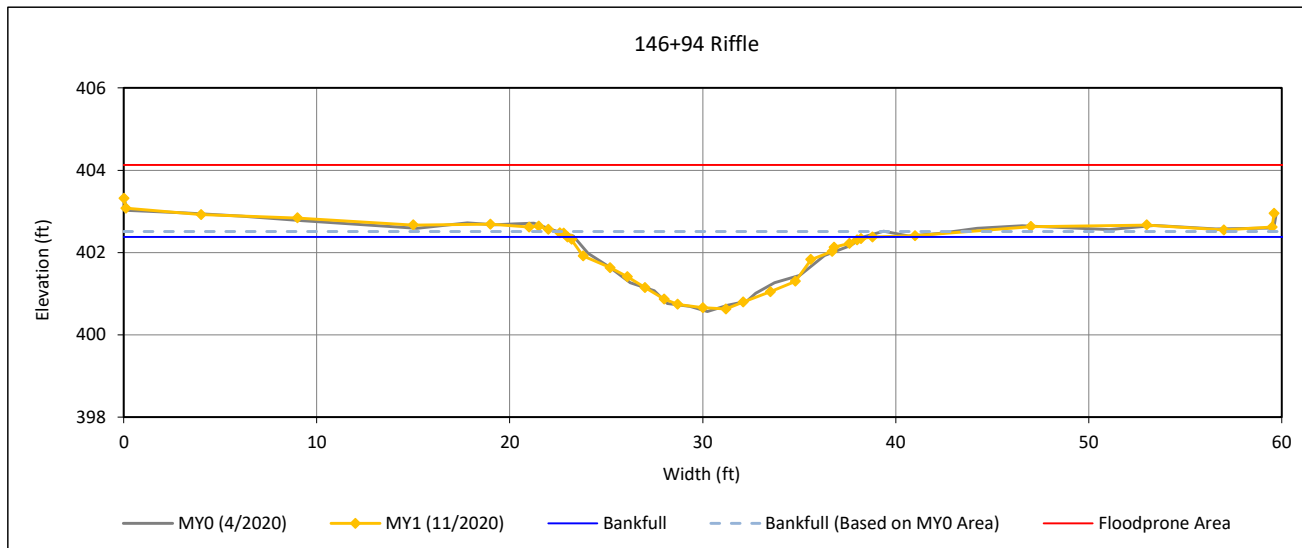
Cross-Section 10 - Dry Creek Reach 3

Bankfull Dimensions

16.0	x-section area (ft.sq.)
15.8	width (ft)
1.0	mean depth (ft)
1.8	max depth (ft)
16.4	wetted perimeter (ft)
1.0	hydraulic radius (ft)
15.6	width-depth ratio
219.0	W flood prone area (ft)
13.9	entrenchment ratio
< 1.0	low bank height ratio

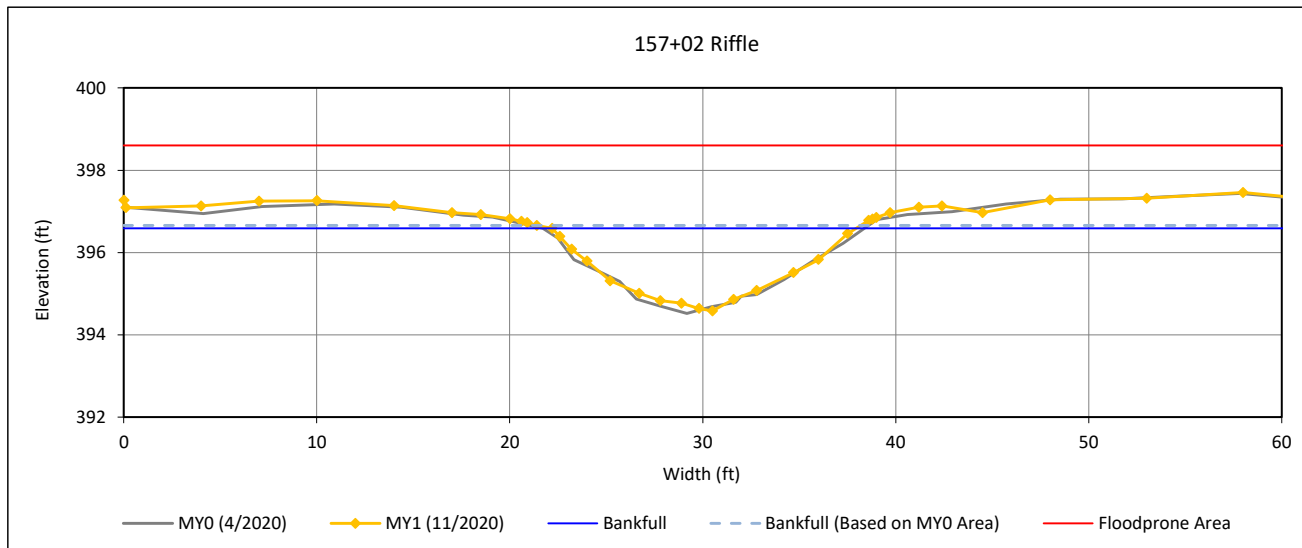
Cross-Section 11 - Dry Creek Reach 4

Bankfull Dimensions

19.4	x-section area (ft.sq.)
15.7	width (ft)
1.2	mean depth (ft)
2.0	max depth (ft)
16.4	wetted perimeter (ft)
1.2	hydraulic radius (ft)
12.8	width-depth ratio
190.0	W flood prone area (ft)
12.1	entrenchment ratio
1.0	low bank height ratio

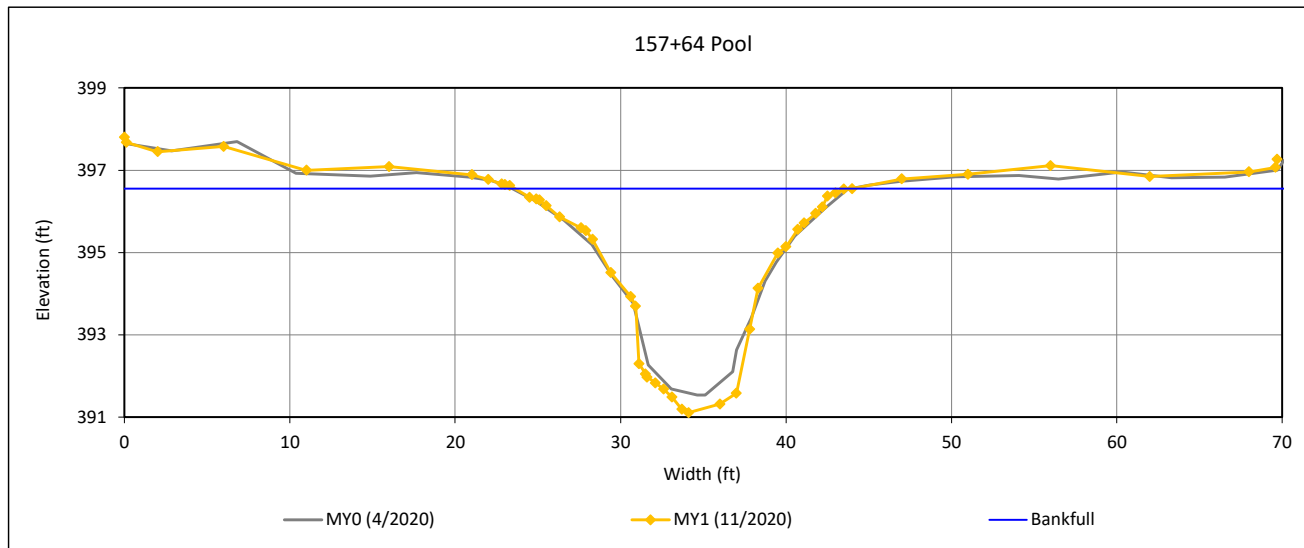
Cross-Section 12 - Dry Creek Reach 4

Bankfull Dimensions

48.7	x-section area (ft.sq.)
20.4	width (ft)
2.4	mean depth (ft)
5.4	max depth (ft)
24.7	wetted perimeter (ft)
2.0	hydraulic radius (ft)
8.5	width-depth ratio

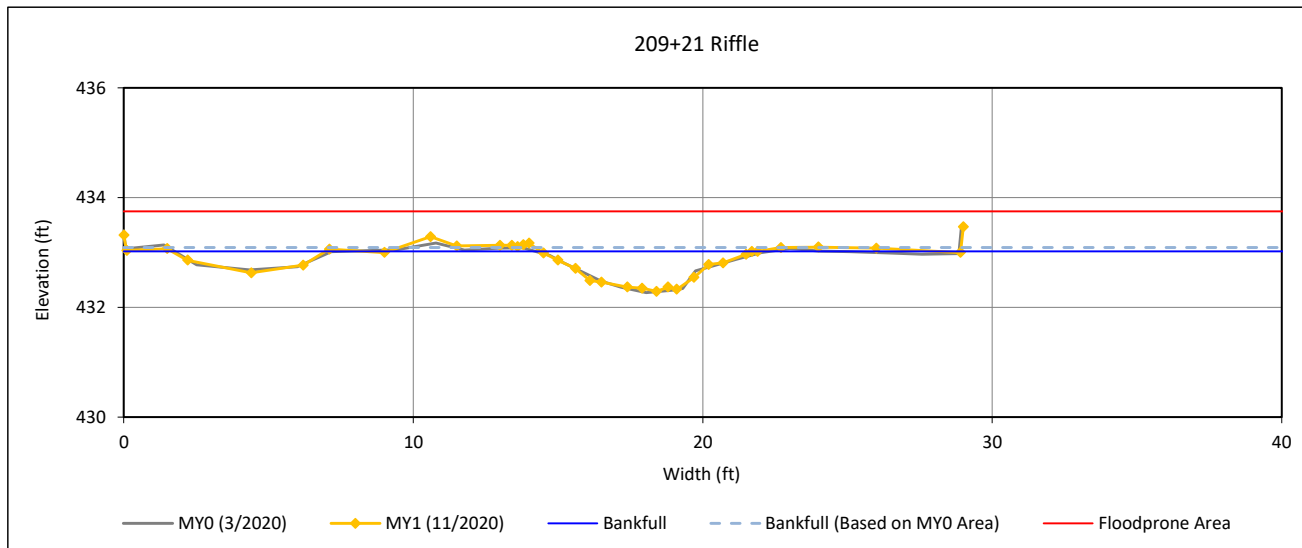
Cross-Section 13 - UT1 Reach 2

Bankfull Dimensions

3.1	x-section area (ft.sq.)
7.3	width (ft)
0.4	mean depth (ft)
0.7	max depth (ft)
7.5	wetted perimeter (ft)
0.4	hydraulic radius (ft)
17.3	width-depth ratio
116.0	W flood prone area (ft)
15.9	entrenchment ratio
< 1.0	low bank height ratio

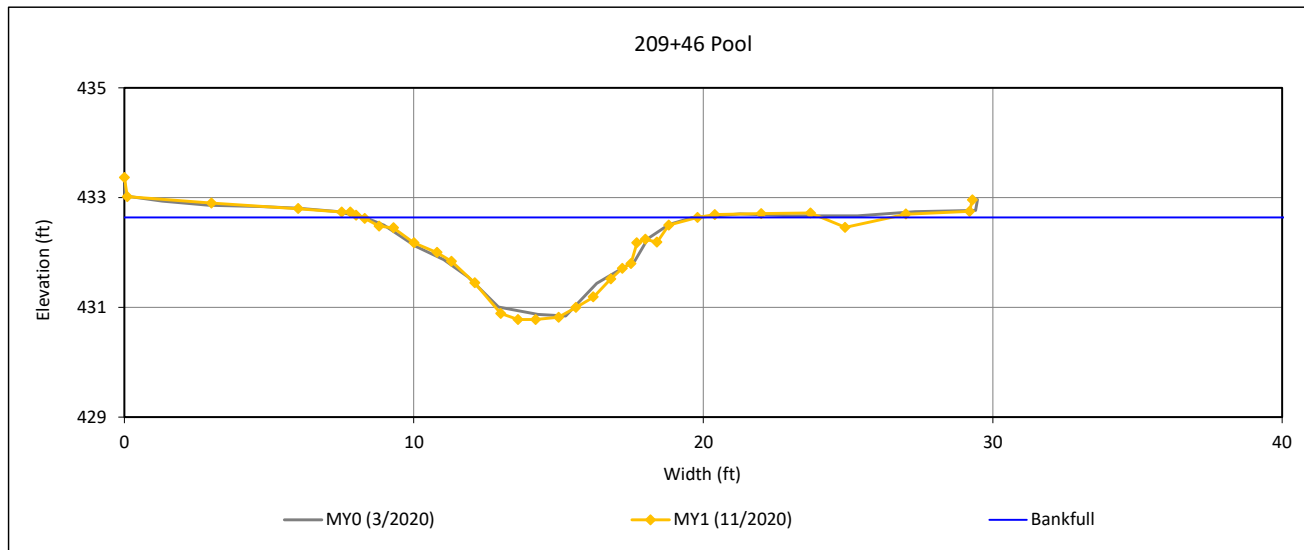
Cross-Section 14 - UT1 Reach 2

Bankfull Dimensions

11.0	x-section area (ft.sq.)
11.6	width (ft)
0.9	mean depth (ft)
1.9	max depth (ft)
12.5	wetted perimeter (ft)
0.9	hydraulic radius (ft)
12.3	width-depth ratio

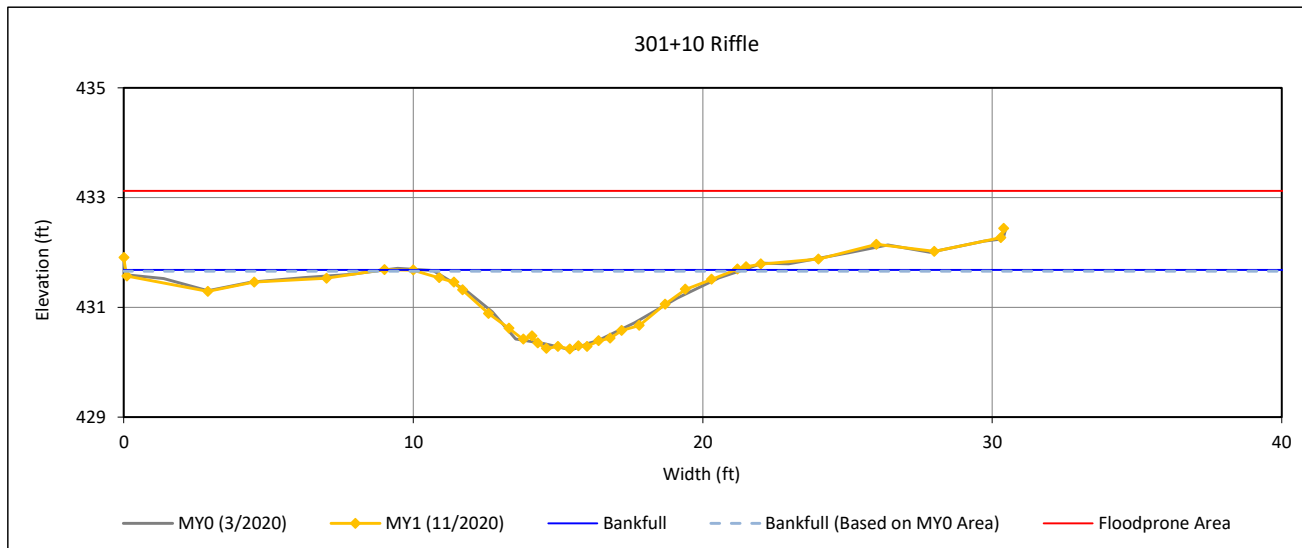
Cross-Section 15 - UT1A

Bankfull Dimensions

8.5	x-section area (ft.sq.)
11.1	width (ft)
0.8	mean depth (ft)
1.4	max depth (ft)
11.6	wetted perimeter (ft)
0.7	hydraulic radius (ft)
14.5	width-depth ratio
78.0	W flood prone area (ft)
7.0	entrenchment ratio
1.0	low bank height ratio

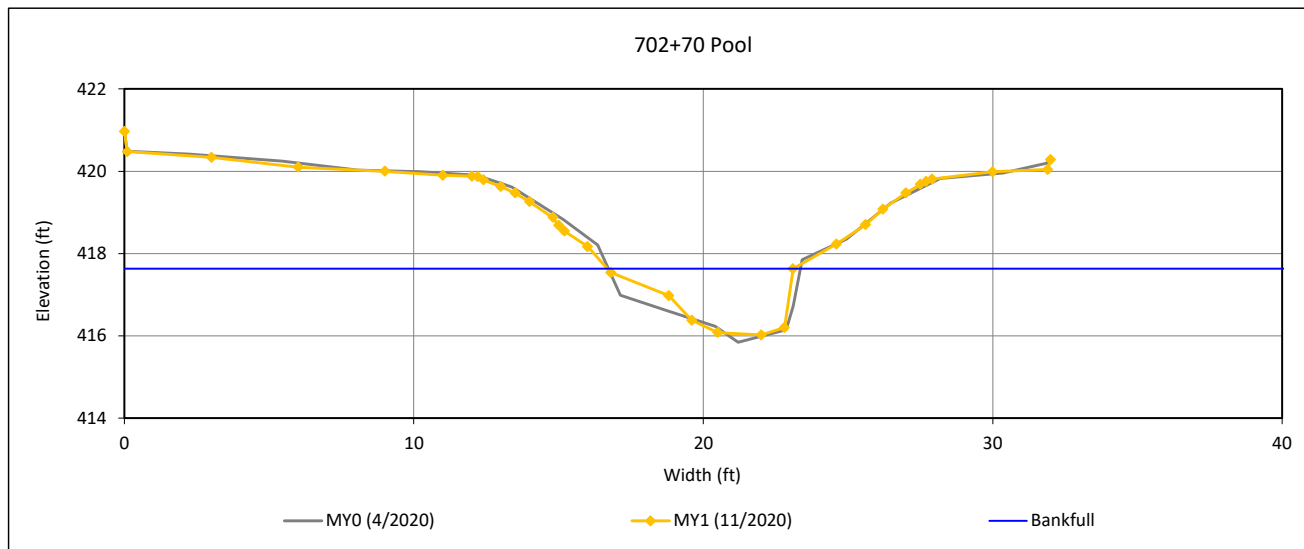
Cross-Section 16 - UT5 Reach 1

Bankfull Dimensions

6.6	x-section area (ft.sq.)
6.4	width (ft)
1.0	mean depth (ft)
1.6	max depth (ft)
8.0	wetted perimeter (ft)
0.8	hydraulic radius (ft)
6.3	width-depth ratio

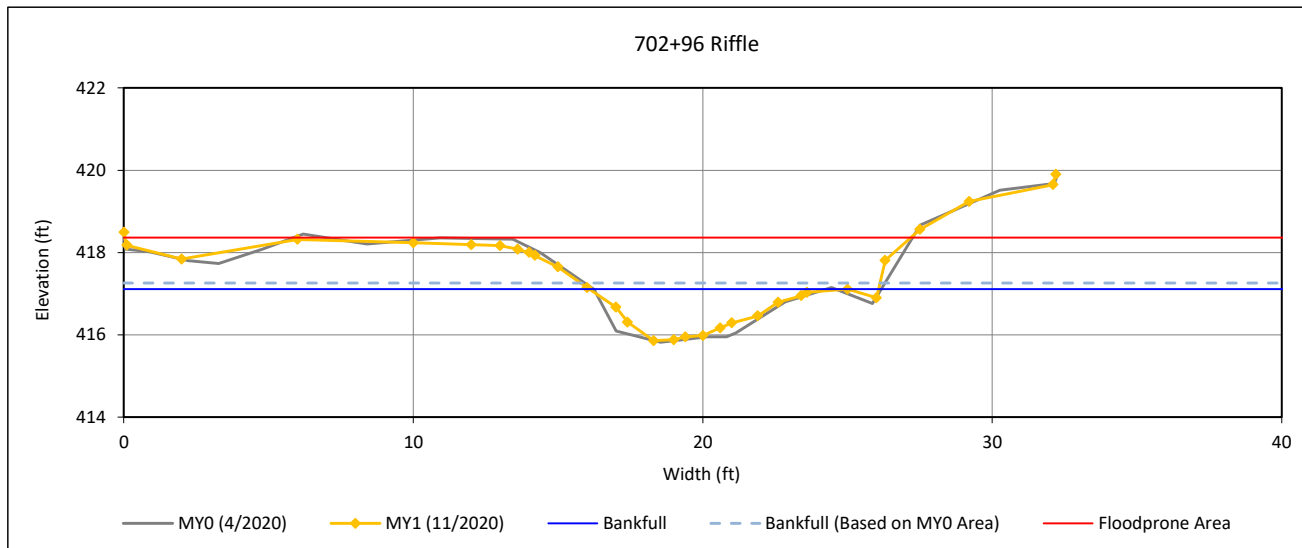
Cross-Section 17 - UT5 Reach 1

Bankfull Dimensions

5.7	x-section area (ft.sq.)
8.9	width (ft)
0.6	mean depth (ft)
1.3	max depth (ft)
9.4	wetted perimeter (ft)
0.6	hydraulic radius (ft)
14.1	width-depth ratio
20.0	W flood prone area (ft)
2.2	entrenchment ratio
< 1.0	low bank height ratio

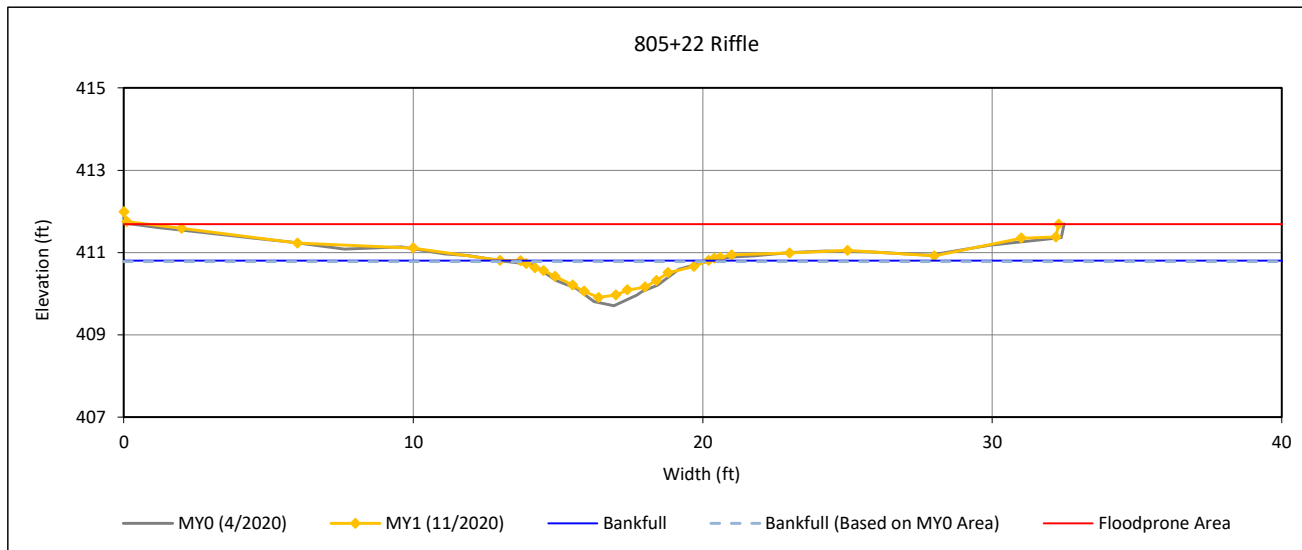
Cross-Section 18 - UT6 Reach 1

Bankfull Dimensions

3.0	x-section area (ft.sq.)
6.5	width (ft)
0.5	mean depth (ft)
0.9	max depth (ft)
6.7	wetted perimeter (ft)
0.4	hydraulic radius (ft)
13.8	width-depth ratio
55.0	W flood prone area (ft)
8.5	entrenchment ratio
1.0	low bank height ratio

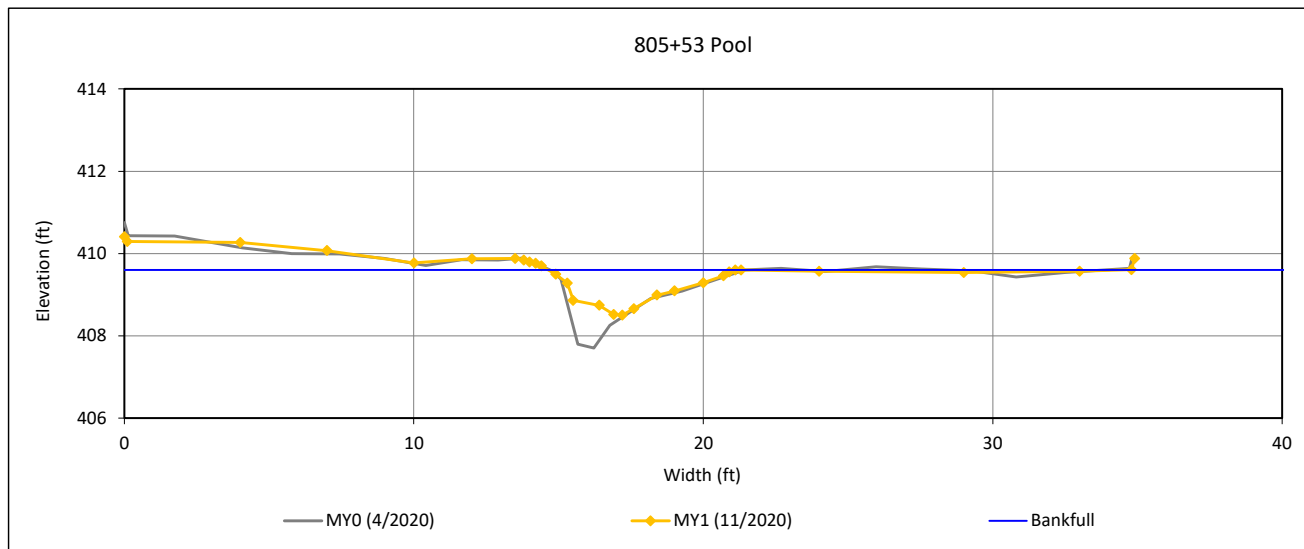
Cross-Section 19 - UT6 Reach 1

Bankfull Dimensions

3.7	x-section area (ft.sq.)
6.5	width (ft)
0.6	mean depth (ft)
1.1	max depth (ft)
7.0	wetted perimeter (ft)
0.5	hydraulic radius (ft)
11.3	width-depth ratio

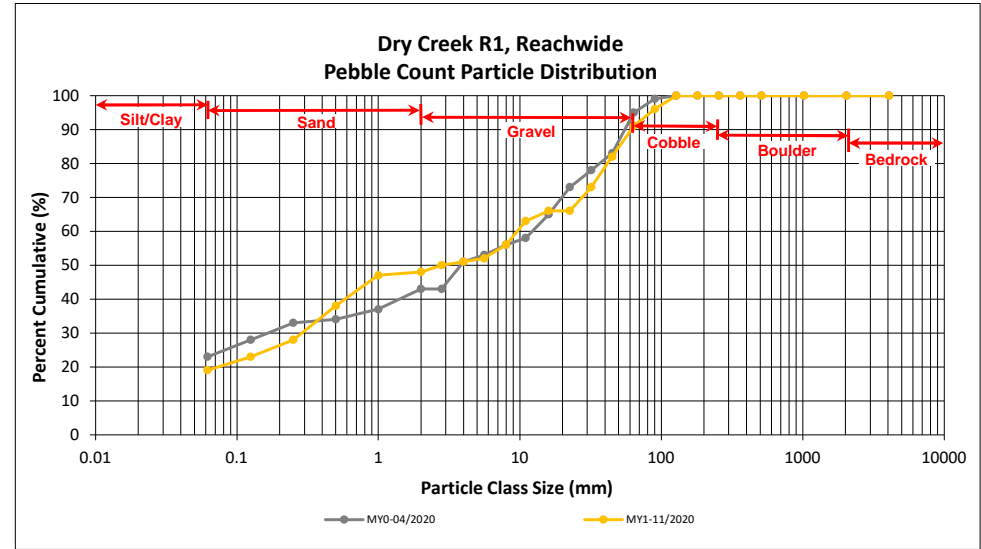
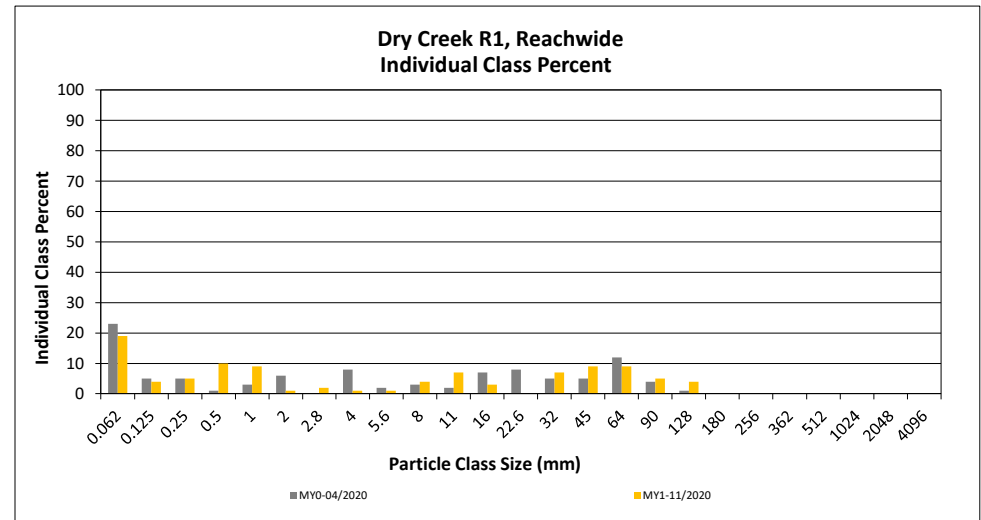
Particle Class		Diameter (mm)		Particle Count			Reach Summary	
		min	max	Riffle	Pool	Total	Class Percentage	Percent Cumulative
SILT/CLAY	Silt/Clay	0.000	0.062	1	18	19	19	19
SAND	Very fine	0.062	0.125		4	4	4	23
	Fine	0.125	0.250		5	5	5	28
	Medium	0.25	0.50	1	9	10	10	38
	Coarse	0.5	1.0	1	8	9	9	47
	Very Coarse	1.0	2.0	1		1	1	48
GRAVEL	Very Fine	2.0	2.8		2	2	2	50
	Very Fine	2.8	4.0		1	1	1	51
	Fine	4.0	5.6	1		1	1	52
	Fine	5.6	8.0	2	2	4	4	56
	Medium	8.0	11.0	2	5	7	7	63
	Medium	11.0	16.0	1	2	3	3	66
	Coarse	16.0	22.6					66
	Coarse	22.6	32	7		7	7	73
	Very Coarse	32	45	6	3	9	9	82
	Very Coarse	45	64	8	1	9	9	91
COBBLE	Small	64	90	5		5	5	96
	Small	90	128	4		4	4	100
	Large	128	180					100
	Large	180	256					100
BOULDER	Small	256	362					100
	Small	362	512					100
	Medium	512	1024					100
	Large/Very Large	1024	2048					100
BEDROCK	Bedrock	2048	>2048					100
Total				40	60	100	100	100

Reachwide Channel materials (mm)	
D ₁₆ =	Silt/Clay
D ₃₅ =	0.41
D ₅₀ =	2.8
D ₈₄ =	48.7
D ₉₅ =	84.1
D ₁₀₀ =	128.0

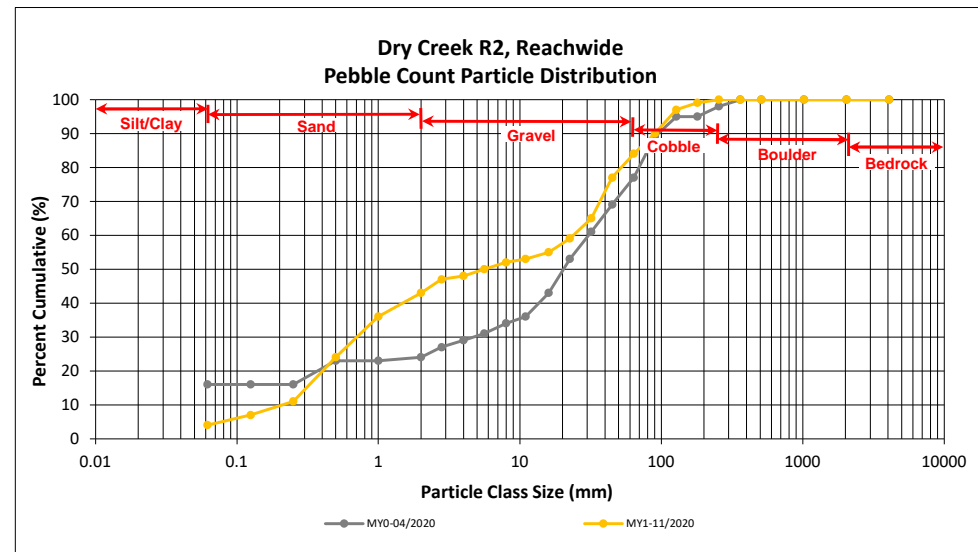
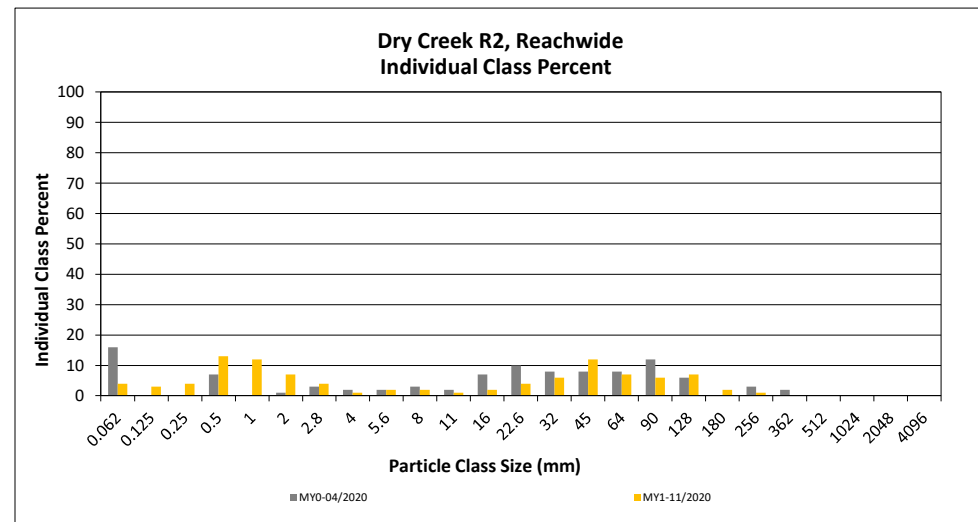
Particle Class		Diameter (mm)		Particle Count			Reach Summary	
		min	max	Riffle	Pool	Total	Class Percentage	Percent Cumulative
SILT/CLAY	Silt/Clay	0.000	0.062	2	19	21	21	21
SAND	Very fine	0.062	0.125					21
	Fine	0.125	0.250		2	2	2	23
	Medium	0.25	0.50	1	7	8	8	31
	Coarse	0.5	1.0		3	3	3	34
	Very Coarse	1.0	2.0	1	4	5	5	39
GRAVEL	Very Fine	2.0	2.8		1	1	1	40
	Very Fine	2.8	4.0	1	3	4	4	44
	Fine	4.0	5.6	3	3	6	6	50
	Fine	5.6	8.0	3	1	4	4	54
	Medium	8.0	11.0	2	2	4	4	58
	Medium	11.0	16.0	6	1	7	7	65
	Coarse	16.0	22.6	10	2	12	12	77
	Coarse	22.6	32	5		5	5	82
	Very Coarse	32	45	8	1	9	9	91
	Very Coarse	45	64	4	1	5	5	96
COBBLE	Small	64	90	4		4	4	100
	Small	90	128					100
	Large	128	180					100
	Large	180	256					100
BOULDER	Small	256	362					100
	Small	362	512					100
	Medium	512	1024					100
	Large/Very Large	1024	2048					100
BEDROCK	Bedrock	2048	>2048					100
Total				50	50	100	100	100

Reachwide Channel materials (mm)	
D ₁₆ =	Silt/Clay
D ₃₅ =	1.15
D ₅₀ =	5.6
D ₈₄ =	34.5
D ₉₅ =	59.6
D ₁₀₀ =	90.0

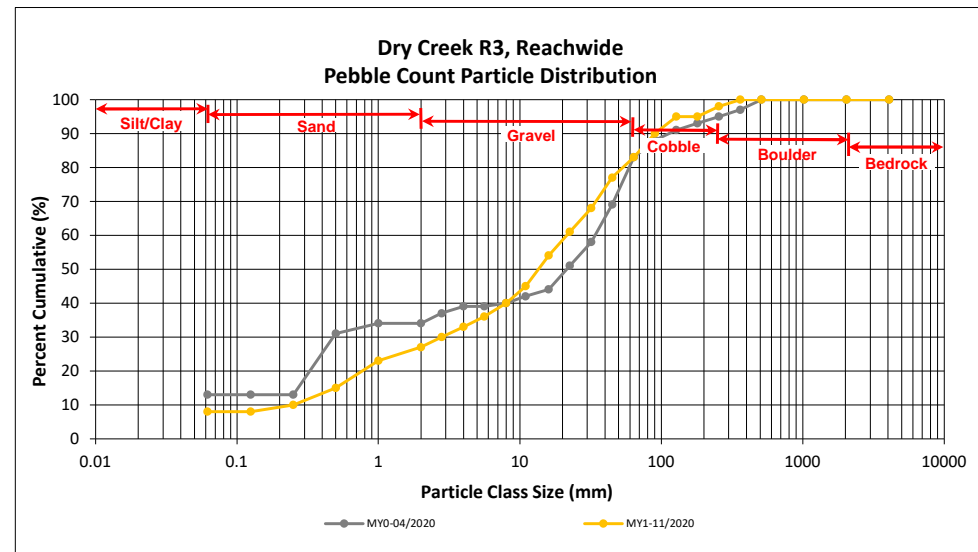
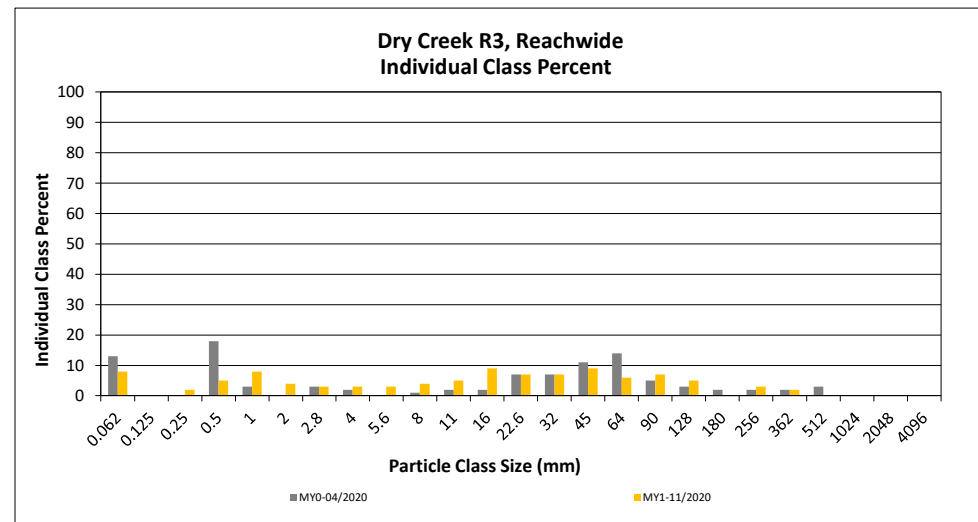
Particle Class		Diameter (mm)		Particle Count			Reach Summary	
		min	max	Riffle	Pool	Total	Class Percentage	Percent Cumulative
SILT/CLAY	Silt/Clay	0.000	0.062		8	8	8	8
SAND	Very fine	0.062	0.125					8
	Fine	0.125	0.250		2	2	2	10
	Medium	0.25	0.50		5	5	5	15
	Coarse	0.5	1.0		8	8	8	23
	Very Coarse	1.0	2.0		4	4	4	27
GRAVEL	Very Fine	2.0	2.8	1	2	3	3	30
	Very Fine	2.8	4.0		3	3	3	33
	Fine	4.0	5.6		3	3	3	36
	Fine	5.6	8.0	2	2	4	4	40
	Medium	8.0	11.0	1	4	5	5	45
	Medium	11.0	16.0	3	6	9	9	54
	Coarse	16.0	22.6	4	3	7	7	61
	Coarse	22.6	32	7		7	7	68
	Very Coarse	32	45	9		9	9	77
	Very Coarse	45	64	6		6	6	83
COBBLE	Small	64	90	7		7	7	90
	Small	90	128	5		5	5	95
	Large	128	180					95
	Large	180	256	3		3	3	98
BOULDER	Small	256	362	2		2	2	100
	Small	362	512					100
	Medium	512	1024					100
	Large/Very Large	1024	2048					100
BEDROCK	Bedrock	2048	>2048					100
Total				50	50	100	100	100

Reachwide Channel materials (mm)	
D ₁₆ =	0.55
D ₃₅ =	5.01
D ₅₀ =	13.5
D ₈₄ =	67.2
D ₉₅ =	128.0
D ₁₀₀ =	362.0

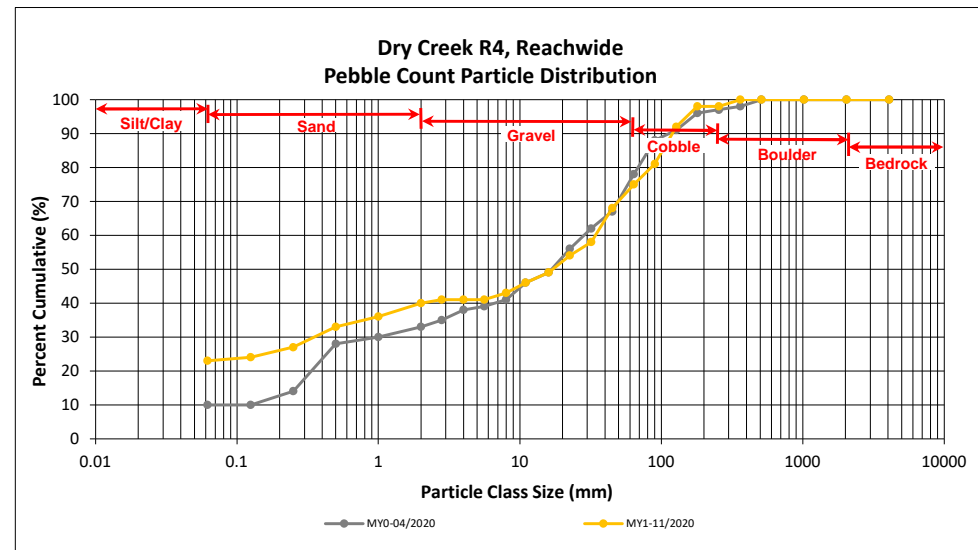
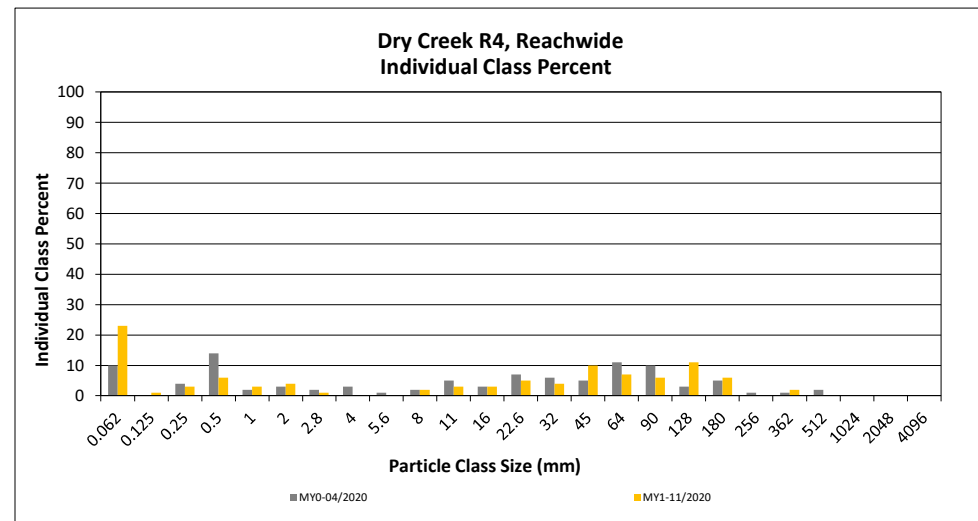
Particle Class		Diameter (mm)		Particle Count			Reach Summary	
		min	max	Riffle	Pool	Total	Class Percentage	Percent Cumulative
SILT/CLAY	Silt/Clay	0.000	0.062		23	23	23	23
SAND	Very fine	0.062	0.125		1	1	1	24
	Fine	0.125	0.250		3	3	3	27
	Medium	0.25	0.50	3	3	6	6	33
	Coarse	0.5	1.0		3	3	3	36
	Very Coarse	1.0	2.0		4	4	4	40
GRAVEL	Very Fine	2.0	2.8		1	1	1	41
	Very Fine	2.8	4.0					41
	Fine	4.0	5.6					41
	Fine	5.6	8.0		2	2	2	43
	Medium	8.0	11.0	1	2	3	3	46
	Medium	11.0	16.0	1	2	3	3	49
	Coarse	16.0	22.6	3	2	5	5	54
	Coarse	22.6	32	3	1	4	4	58
	Very Coarse	32	45	8	2	10	10	68
	Very Coarse	45	64	6	1	7	7	75
COBBLE	Small	64	90	6		6	6	81
	Small	90	128	11		11	11	92
	Large	128	180	6		6	6	98
	Large	180	256					98
BOULDER	Small	256	362	2		2	2	100
	Small	362	512					100
	Medium	512	1024					100
	Large/Very Large	1024	2048					100
BEDROCK	Bedrock	2048	>2048					100
Total				50	50	100	100	100

Reachwide Channel materials (mm)	
D ₁₆ =	Silt/Clay
D ₃₅ =	0.79
D ₅₀ =	17.1
D ₈₄ =	99.1
D ₉₅ =	151.8
D ₁₀₀ =	362.0
