MONITORING YEAR 1 ANNUAL REPORT FINAL

DRY CREEK MITIGATION SITE

Durham County, NC
NCDEQ Contract No. 6827
DMS Project No. 97082
USACE Action ID No. SAW-2016-00880
NCDWR Project No. 2016-0369

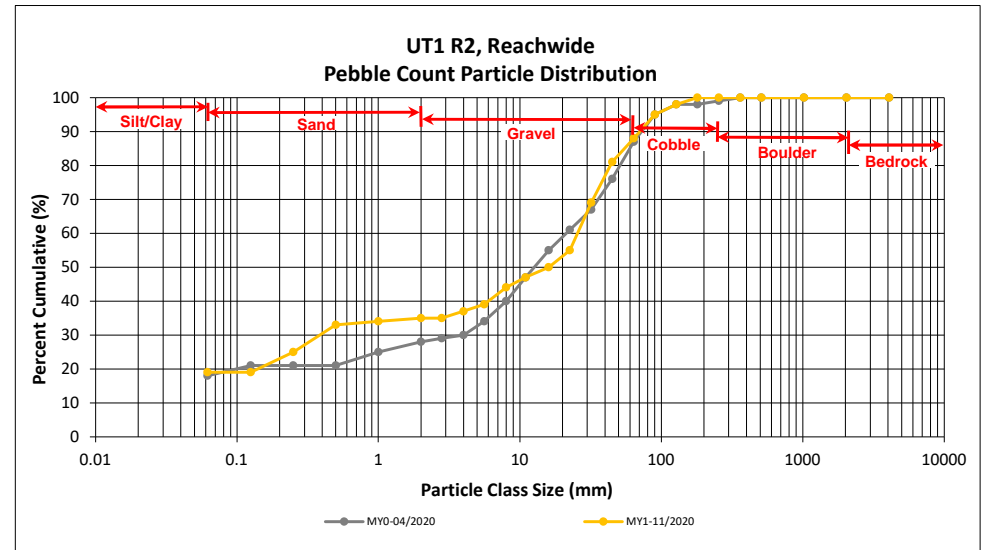
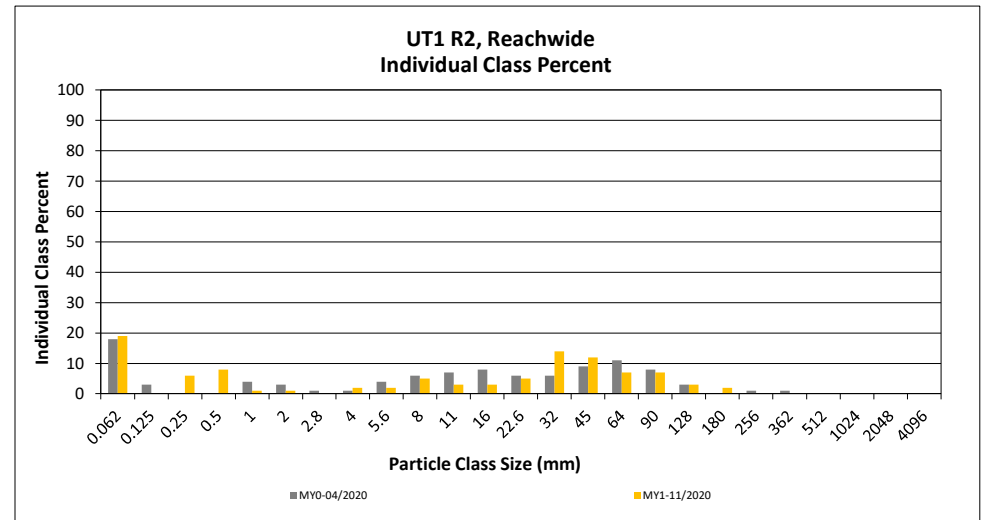
Particle Class		Diameter (mm)		Particle Count			Reach Summary	
		min	max	Riffle	Pool	Total	Class Percentage	Percent Cumulative
SILT/CLAY	Silt/Clay	0.000	0.062			19	19	19
SAND	Very fine	0.062	0.125					19
	Fine	0.125	0.250		6	6	6	25
	Medium	0.25	0.50	1	7	8	8	33
	Coarse	0.5	1.0		1	1	1	34
	Very Coarse	1.0	2.0	1		1	1	35
GRAVEL	Very Fine	2.0	2.8					35
	Very Fine	2.8	4.0	2		2	2	37
	Fine	4.0	5.6	1	1	2	2	39
	Fine	5.6	8.0	1	4	5	5	44
	Medium	8.0	11.0	2	1	3	3	47
	Medium	11.0	16.0	1	2	3	3	50
	Coarse	16.0	22.6	3	2	5	5	55
	Coarse	22.6	32	9	5	14	14	69
	Very Coarse	32	45	11	1	12	12	81
	Very Coarse	45	64	6	1	7	7	88
COBBLE	Small	64	90	7		7	7	95
	Small	90	128	3		3	3	98
	Large	128	180	2		2	2	100
	Large	180	256					100
BOULDER	Small	256	362					100
	Small	362	512					100
	Medium	512	1024					100
	Large/Very Large	1024	2048					100
BEDROCK	Bedrock	2048	>2048					100
Total				50	50	100	100	100

Reachwide Channel materials (mm)	
D ₁₆ =	Silt/Clay
D ₃₅ =	2.00
D ₅₀ =	16.0
D ₈₄ =	52.3
D ₉₅ =	90.0
D ₁₀₀ =	180.0

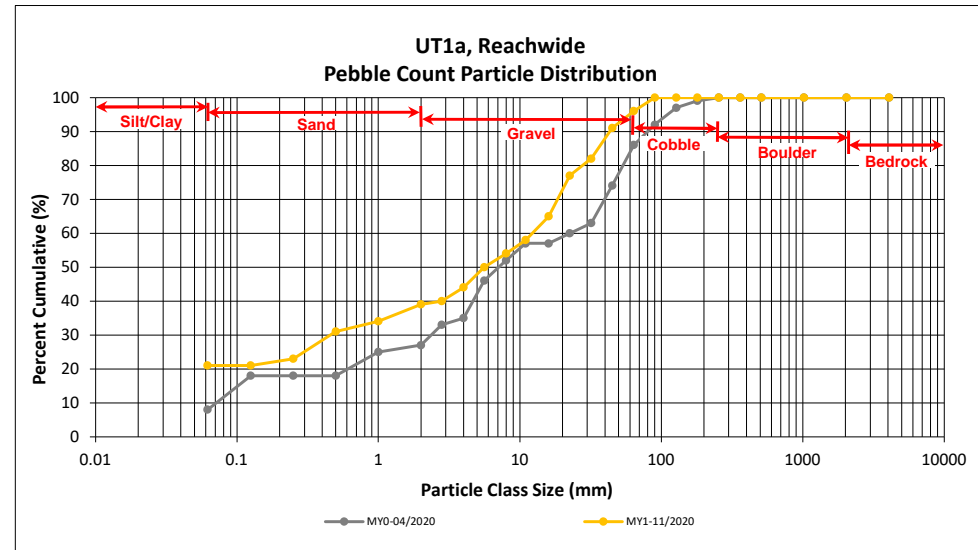
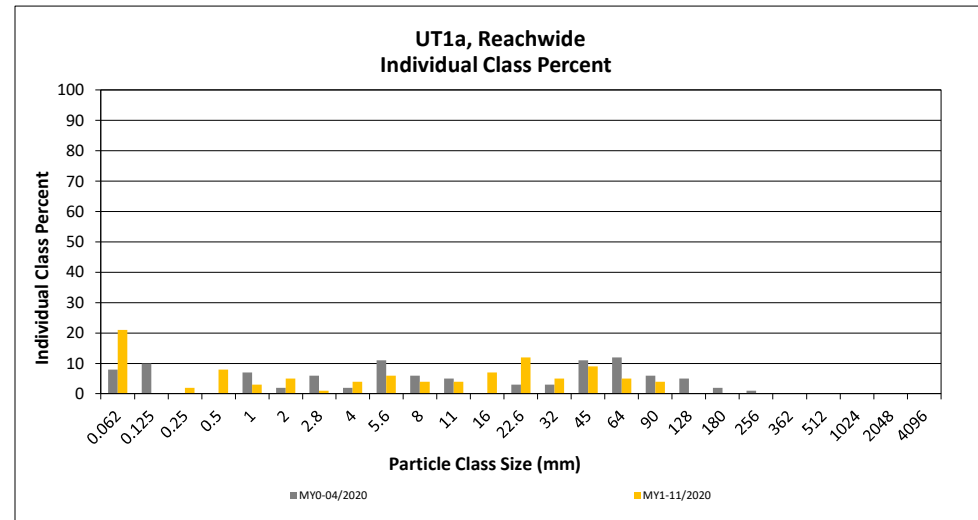
Particle Class		Diameter (mm)		Particle Count			Reach Summary	
		min	max	Riffle	Pool	Total	Class Percentage	Percent Cumulative
SILT/CLAY	Silt/Clay	0.000	0.062	2	19	21	21	21
SAND	Very fine	0.062	0.125					21
	Fine	0.125	0.250		2	2	2	23
	Medium	0.25	0.50	1	7	8	8	31
	Coarse	0.5	1.0		3	3	3	34
	Very Coarse	1.0	2.0	1	4	5	5	39
GRAVEL	Very Fine	2.0	2.8		1	1	1	40
	Very Fine	2.8	4.0	1	3	4	4	44
	Fine	4.0	5.6	3	3	6	6	50
	Fine	5.6	8.0	3	1	4	4	54
	Medium	8.0	11.0	2	2	4	4	58
	Medium	11.0	16.0	6	1	7	7	65
	Coarse	16.0	22.6	10	2	12	12	77
	Coarse	22.6	32	5		5	5	82
	Very Coarse	32	45	8	1	9	9	91
	Very Coarse	45	64	4	1	5	5	96
COBBLE	Small	64	90	4		4	4	100
	Small	90	128					100
	Large	128	180					100
	Large	180	256					100
BOULDER	Small	256	362					100
	Small	362	512					100
	Medium	512	1024					100
	Large/Very Large	1024	2048					100
BEDROCK	Bedrock	2048	>2048					100
Total				50	50	100	100	100

Reachwide Channel materials (mm)	
D ₁₆ =	Silt/Clay
D ₃₅ =	1.15
D ₅₀ =	5.6
D ₈₄ =	34.5
D ₉₅ =	59.6
D ₁₀₀ =	90.0

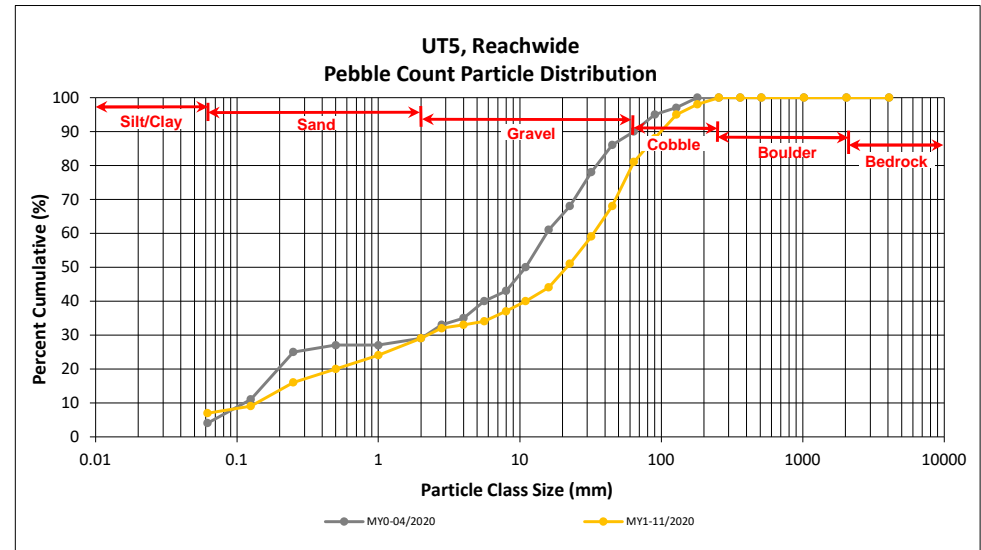
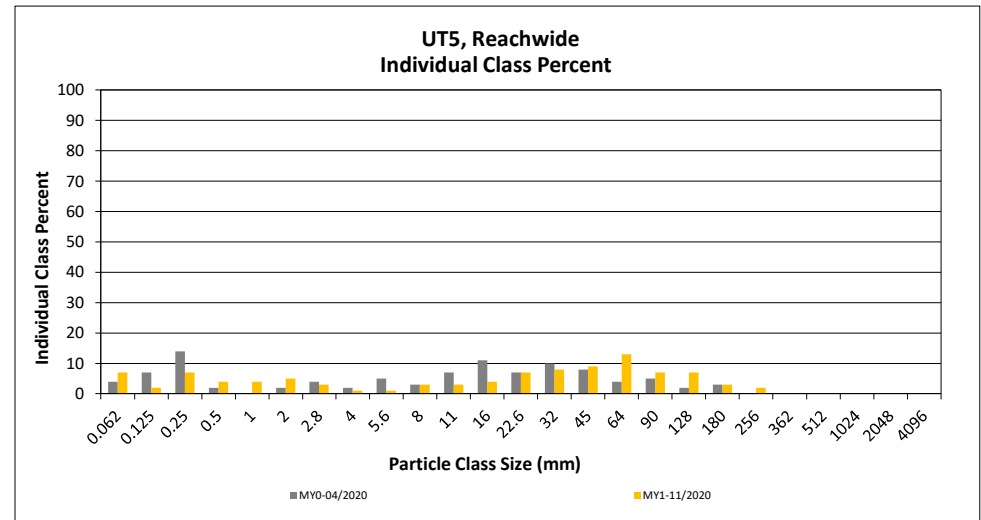
Particle Class		Diameter (mm)		Particle Count			Reach Summary	
		min	max	Riffle	Pool	Total	Class Percentage	Percent Cumulative
SILT/CLAY	Silt/Clay	0.000	0.062		7	7	7	7
SAND	Very fine	0.062	0.125		2	2	2	9
	Fine	0.125	0.250		7	7	7	16
	Medium	0.25	0.50		4	4	4	20
	Coarse	0.5	1.0		4	4	4	24
	Very Coarse	1.0	2.0		5	5	5	29
GRAVEL	Very Fine	2.0	2.8		3	3	3	32
	Very Fine	2.8	4.0	1		1	1	33
	Fine	4.0	5.6		1	1	1	34
	Fine	5.6	8.0	1	2	3	3	37
	Medium	8.0	11.0	2	1	3	3	40
	Medium	11.0	16.0	2	2	4	4	44
	Coarse	16.0	22.6	6	1	7	7	51
	Coarse	22.6	32	3	5	8	8	59
	Very Coarse	32	45	7	2	9	9	68
	Very Coarse	45	64	11	2	13	13	81
COBBLE	Small	64	90	7		7	7	88
	Small	90	128	6	1	7	7	95
	Large	128	180	2	1	3	3	98
	Large	180	256	2		2	2	100
BOULDER	Small	256	362					100
	Small	362	512					100
	Medium	512	1024					100
	Large/Very Large	1024	2048					100
BEDROCK	Bedrock	2048	>2048					100
Total				50	50	100	100	100

Reachwide Channel materials (mm)	
D ₁₆ =	0.25
D ₃₅ =	6.31
D ₅₀ =	21.5
D ₈₄ =	74.1
D ₉₅ =	128.0
D ₁₀₀ =	256.0

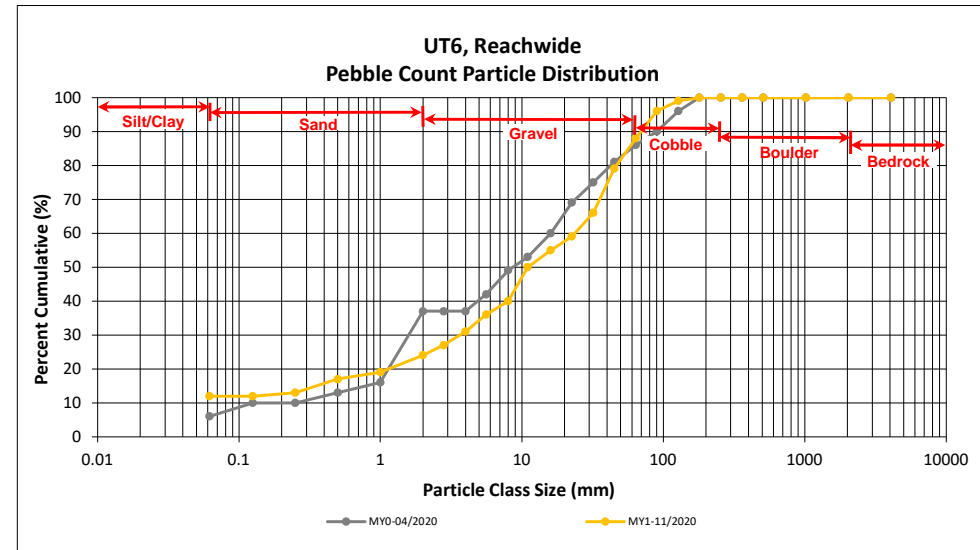
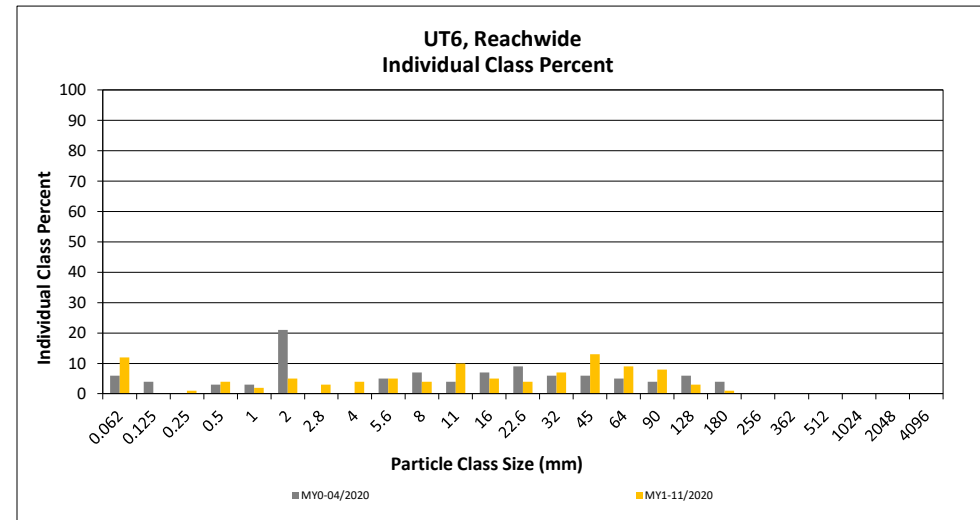
Particle Class		Diameter (mm)		Particle Count			Reach Summary	
		min	max	Riffle	Pool	Total	Class Percentage	Percent Cumulative
SILT/CLAY	Silt/Clay	0.000	0.062	2	10	12	12	12
SAND	Very fine	0.062	0.125					12
	Fine	0.125	0.250		1	1	1	13
	Medium	0.25	0.50	2	2	4	4	17
	Coarse	0.5	1.0		2	2	2	19
	Very Coarse	1.0	2.0		5	5	5	24
GRAVEL	Very Fine	2.0	2.8		3	3	3	27
	Very Fine	2.8	4.0		4	4	4	31
	Fine	4.0	5.6	2	3	5	5	36
	Fine	5.6	8.0	2	2	4	4	40
	Medium	8.0	11.0	7	3	10	10	50
	Medium	11.0	16.0	2	3	5	5	55
	Coarse	16.0	22.6	1	3	4	4	59
	Coarse	22.6	32	5	2	7	7	66
	Very Coarse	32	45	10	3	13	13	79
	Very Coarse	45	64	7	2	9	9	88
	COBBLE	Small	64	90	7	1	8	8
Small		90	128	2	1	3	3	99
Large		128	180	1		1	1	100
Large		180	256					100
BOULDER	Small	256	362					100
	Small	362	512					100
	Medium	512	1024					100
	Large/Very Large	1024	2048					100
BEDROCK	Bedrock	2048	>2048					100
Total				50	50	100	100	100

Reachwide Channel materials (mm)	
D ₁₆ =	0.42
D ₃₅ =	5.24
D ₅₀ =	11.0
D ₈₄ =	54.7
D ₉₅ =	86.2
D ₁₀₀ =	180.0

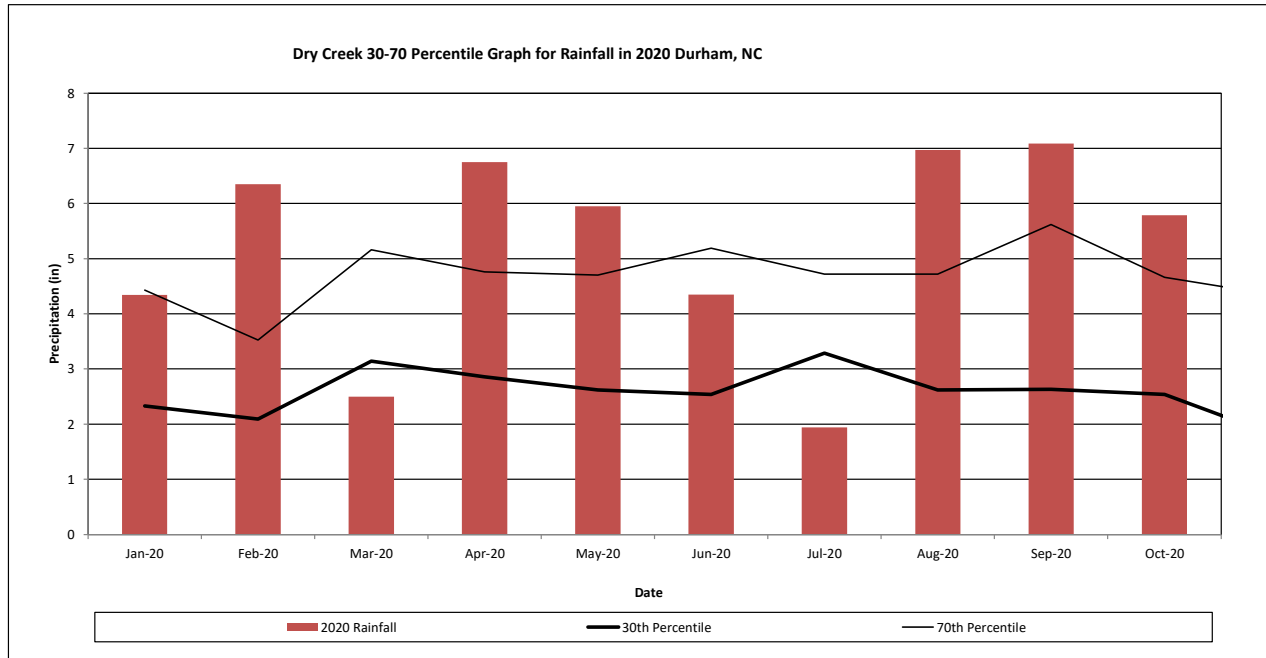
Monthly Rainfall Data

¹ 2020 monthly rainfall from USDA Station Durham 10.7 NNE.

² 30th and 70th percentile rainfall data collected from weather station Roxboro 7 ESE, NC (USDA, 2020).

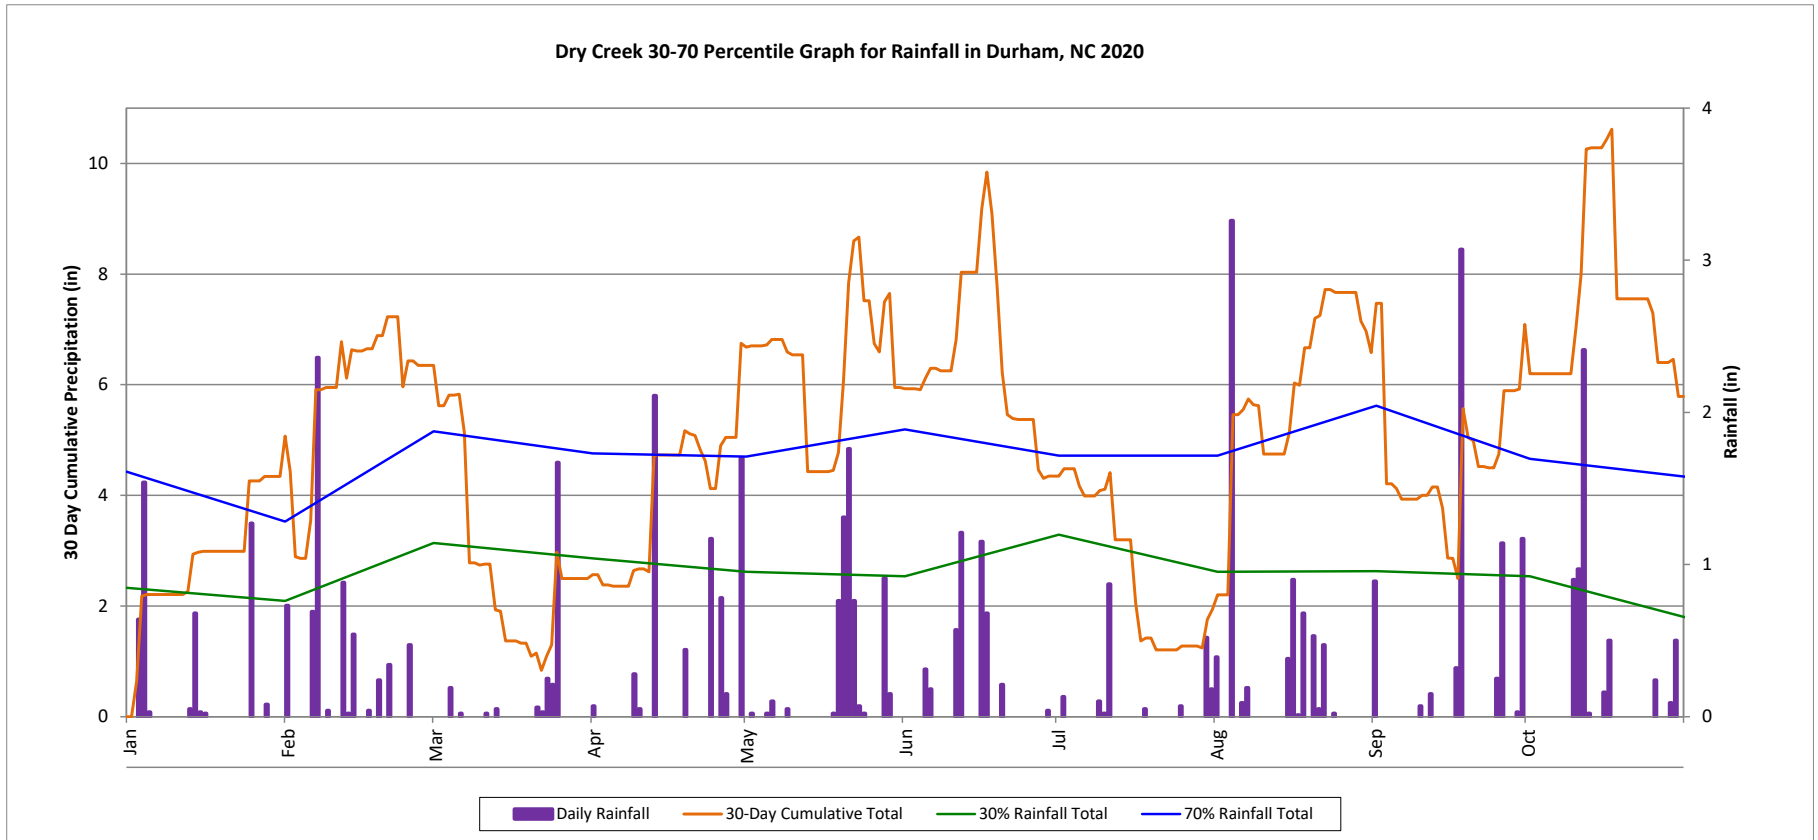
30-Day Cumulative Total Rainfall Data

¹ 2020 monthly rainfall from USDA Station Durham 10.7 NNE.

² 30th and 70th percentile rainfall data collected from weather station Roxboro 7 ESE, NC (USDA, 2020).
