**BISHOP PROPERTY RESTORATION PLAN
ANSON COUNTY, NORTH CAROLINA**

**North Carolina Ecosystem Enhancement Program
Raleigh, North Carolina**

**EcoScience Corporation
1101 Haynes Street, Suite 101
Raleigh, North Carolina 27604**

September 2004

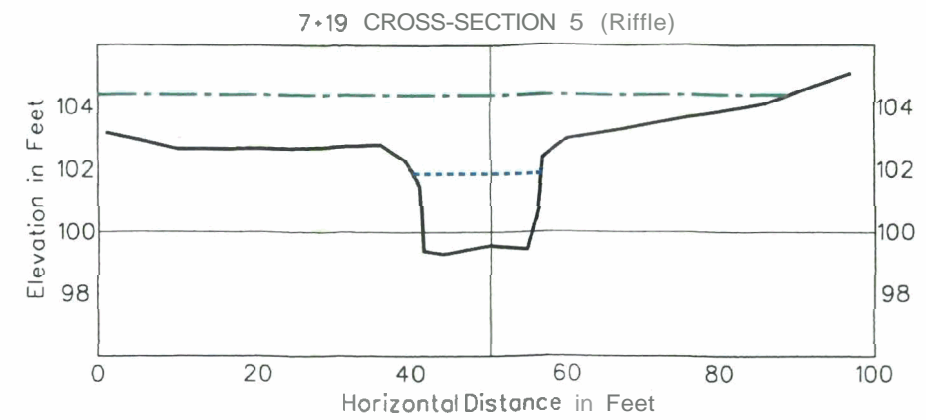
Bankfull Cross-sectional Area: 36.0 ft.sq.
Bankfull Width: 16.5'
Bank full Maximum Depth: 2.6'
Bank full Average Depth: 2.2'
Width of Flood Prone Area: 110±'

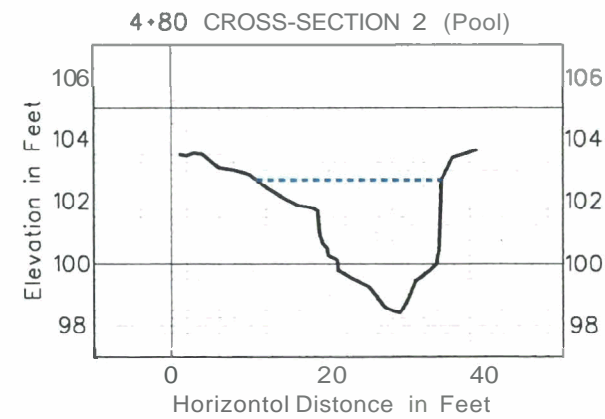
Bankfull Cross-sectional Area: 55.8 ft.sq.
Bankfull Width: 23.6'
Bankfull Maximum Depth: 4.3'
Bankfull Average Depth: 2.4'

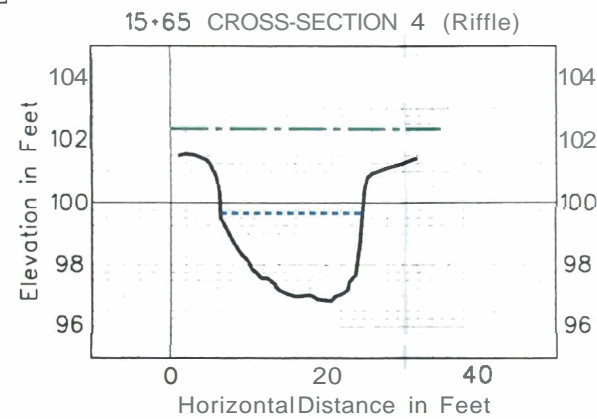
Bankfull Cross-sectional Area: 38.7 ft.sq.
Bankfull Width: 18.3'
Bankfull Maximum Depth: 2.7'
Bankfull Average Depth: 2.1'
Width of Flood Prone Area: 100±'

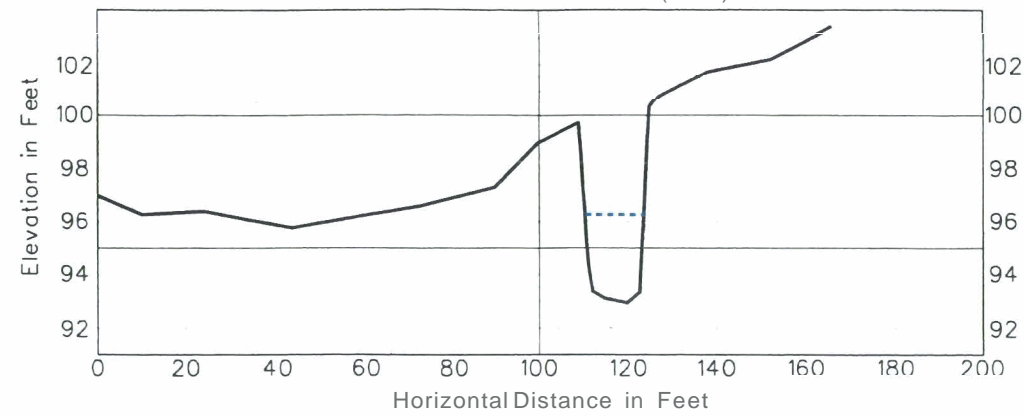
26+38 CROSS-SECTION 7 (Pool)

Bankfull Cross-sectional Area: 38.4 ft.sq.
Bankfull Width: 13.4'
Bankfull Maximum Depth: 3.3'
Bankfull Average Depth: 2.9'

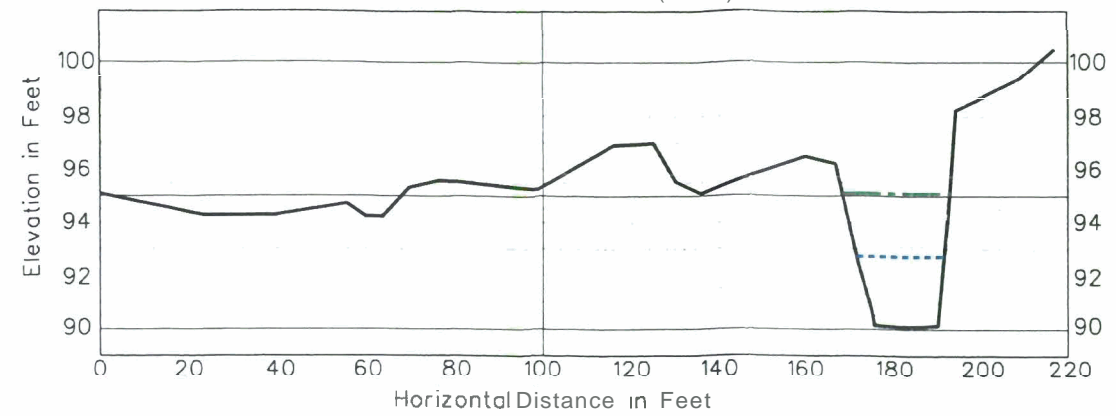
36+23 CROSS-SECTION 9 (Riffle)

Bankfull Cross-sectional Area: 42.0ft.sq.
Bankfull Width: 19.5'
Bankfull Maximum Depth: 2.5'
Bankfull Average Depth: 2.2'
Width of Flood Prone Area: 24.3±'

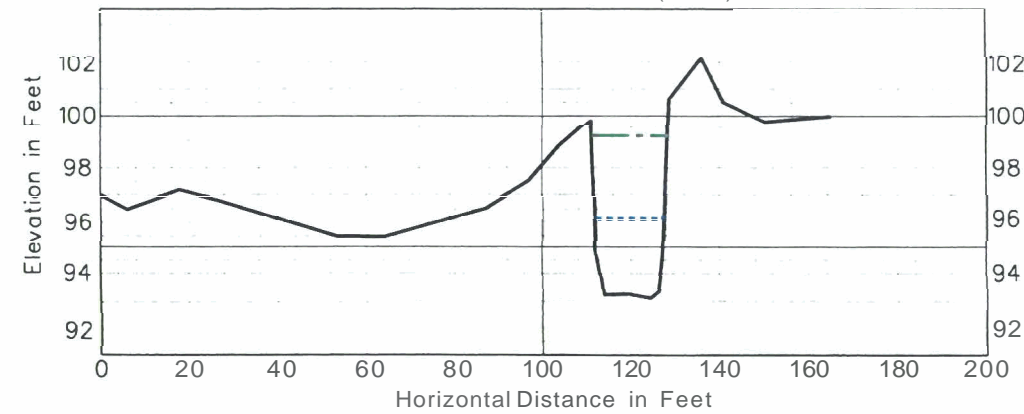
26+86 CROSS-SECTION 8 (Riffle)

Bankfull Cross-sectional Area: 42.0 ft.sq.
Bankfull Width: 16.0'
Bankfull Maximum Depth: 3.0'
Bankfull Average Depth: 2.6'
Width of Flood Prone Area: 17.2±'

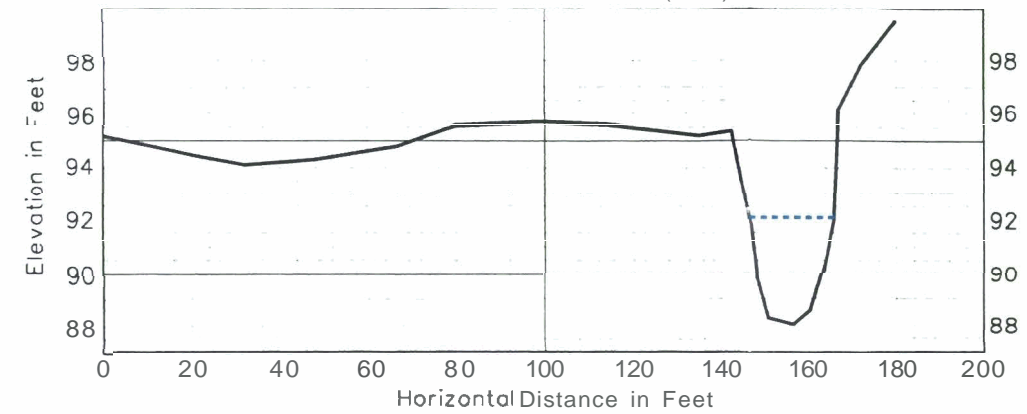
37+51 CROSS-SECTION 10 (Pool)

Bankfull cross-sectional Area: 57.8 ft.sq.
Bankfull Width: 19.4'
Bankfull Maximum Depth: 4.1'
Bankfull Average Depth: 3.0'

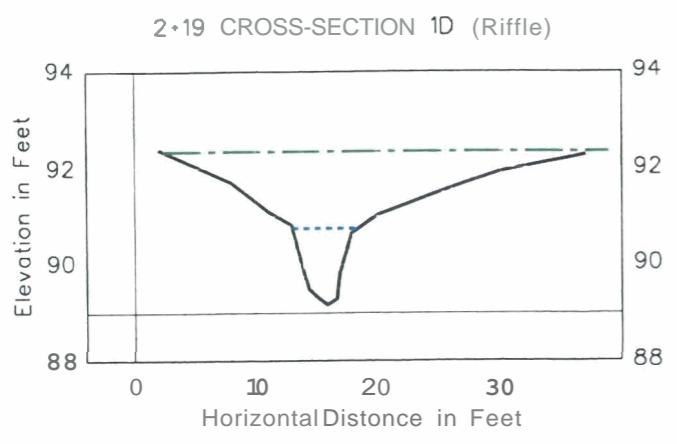
Bankfull Cross-sectional Area: 5.1 ft.sq.
Bankfull Width: 5.5'
Bankfull Maximum Depth: 1.6'
Bankfull Average Depth: 0.9'
Width of Flood Prone Area: 38±'

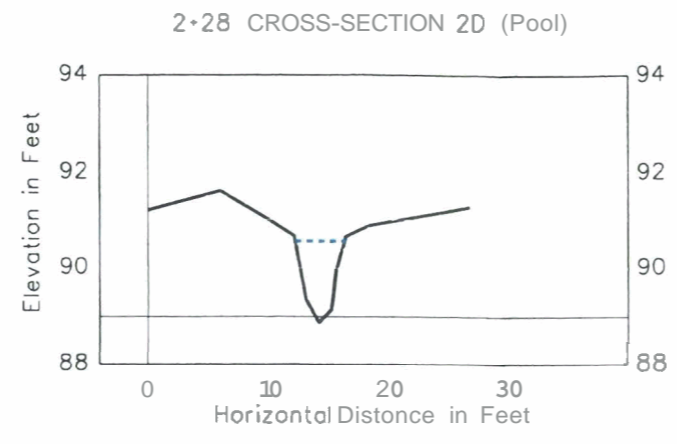
Bankfull Cross-sectional Area: 4.3 ft.sq.
Bankfull Width: 4.1'
Bankfull Maximum Depth: 1.7'
Bankfull Average Depth: 1.1'

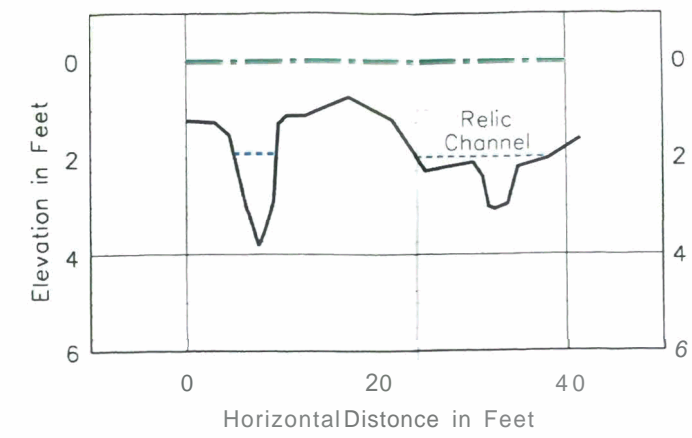
CROSS-SECTION UDT2 (Riffle)

Bankfull Cross-sectional Area: 5.1 ft.sq.
 Bankfull Width: 4.4'
 Bankfull Maximum Depth: 1.9'
 Bankfull Average Depth: 1.2'
 Width of Flood Prone Area: 40'

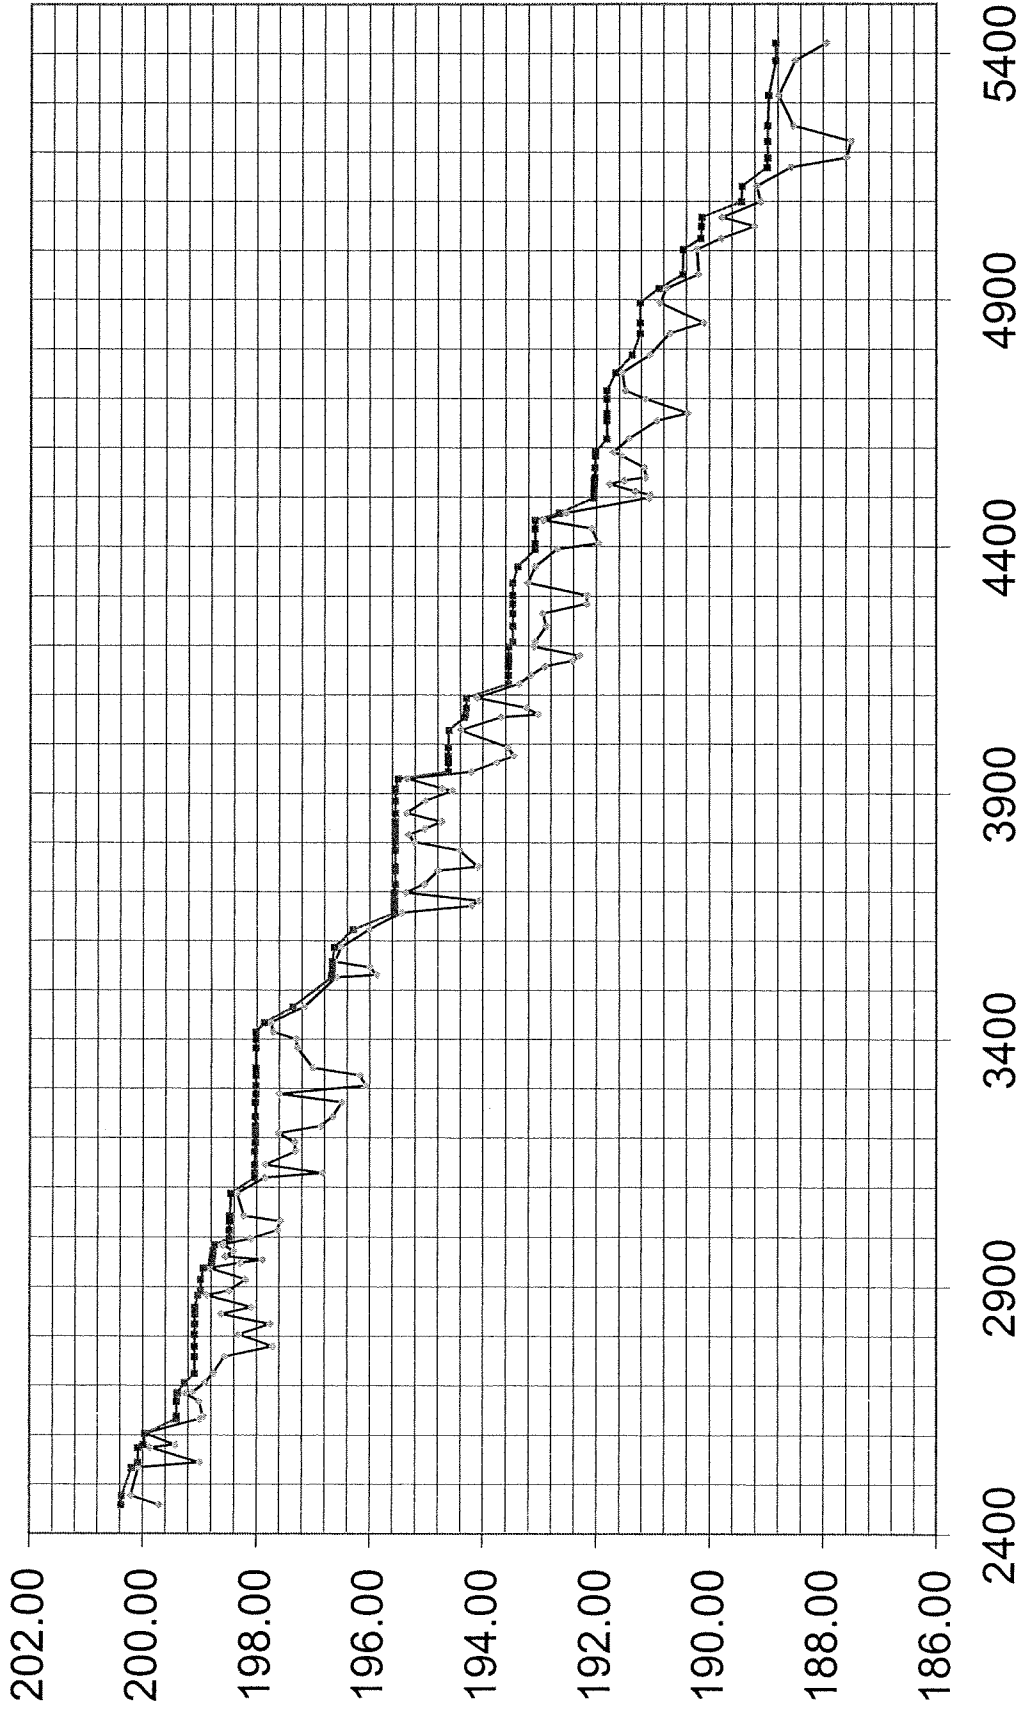
Profile: Camp Branch Reach 3

3828		195.02	195.55	4526		191.77	192.03
3842		194.73	195.55	4534	P38	191.51	192.03
3860		195.35	195.55	4540		191.12	192.02
3885		195.02	195.55	4560		191.15	192.02
3905		194.54	195.55	4584		191.55	192.01
3910		194.71	195.55	4591.5	TR39	191.70	192.01
3929.5	TR33	195.34	195.50	4618	BR39	191.42	191.81
3944	BR33	194.20	194.61	4655		190.92	191.81
3963		193.76	194.61	4670	P39	190.37	191.81
3976	P33	193.45	194.61	4699		191.13	191.81
3994		193.56	194.61	4716	TR40	191.49	191.81
4028.5	TR34	194.39	194.60	4752		191.54	191.66
4055	BR34	193.67	194.32	4788		191.05	191.36
4060		193.03	194.30	4832	BR40	190.69	191.22
4074	P34	193.23	194.29	4853	P40	190.10	191.22
4094	TR35	194.10	194.29	4894	TR41	190.86	191.22
4123	BR35	193.36	193.55	4923		190.75	190.88
4140		193.16	193.55	4952		190.19	190.46
4158		192.91	193.55	5003		190.22	190.45
4169		192.41	193.54	5025	BR41	189.79	190.15
4180	P35	192.29	193.54	5050	P41	189.20	190.14
4198	TR36	193.10	193.54	5068	TR42	189.77	190.13

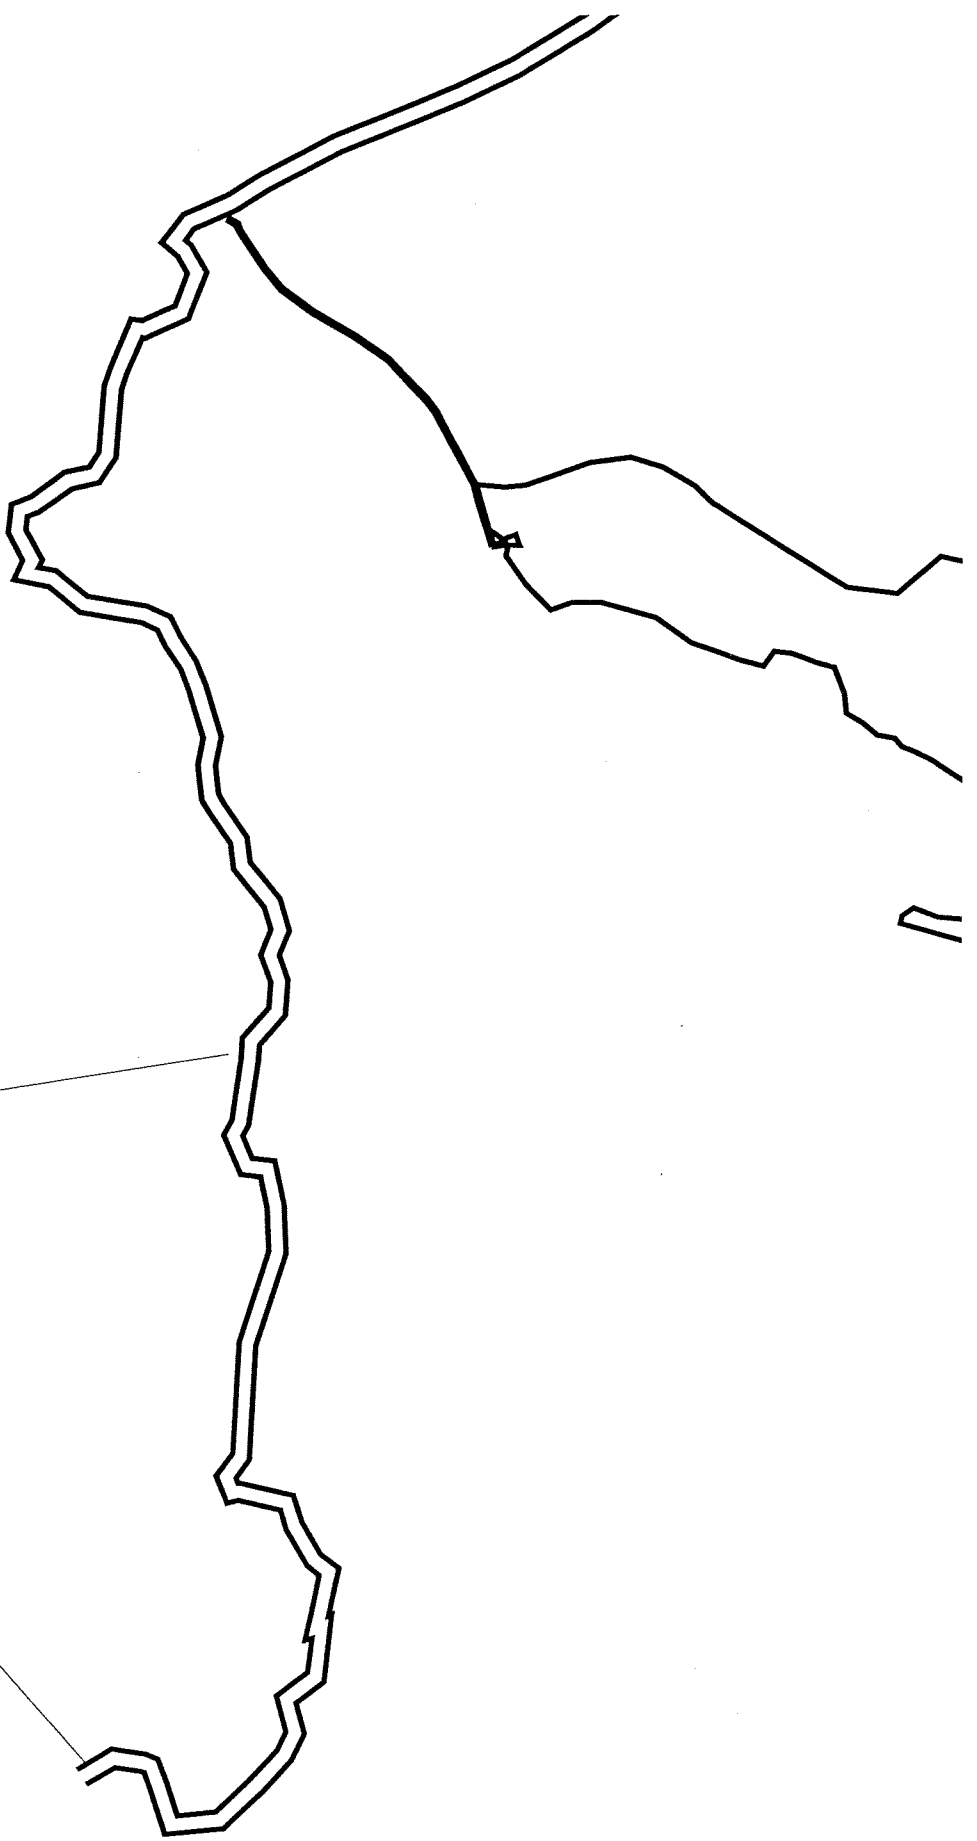
Camp Branch Referecne Reach Pattern

Camp Branch	pool to pool spacing	meander length	beltwidth	radius of curv	bkf width	pool to pool/bkf width	meander/ width	bkf beltwidth/ bkf width	rad/bkf width
Ref Reach	Median	74	133	43	41	19.6	3.8	6.8	2.2
	Range low	45	66	30	17		2.3	3.4	1.5
	Range high	145	240	97	200		7.4	12.2	4.9

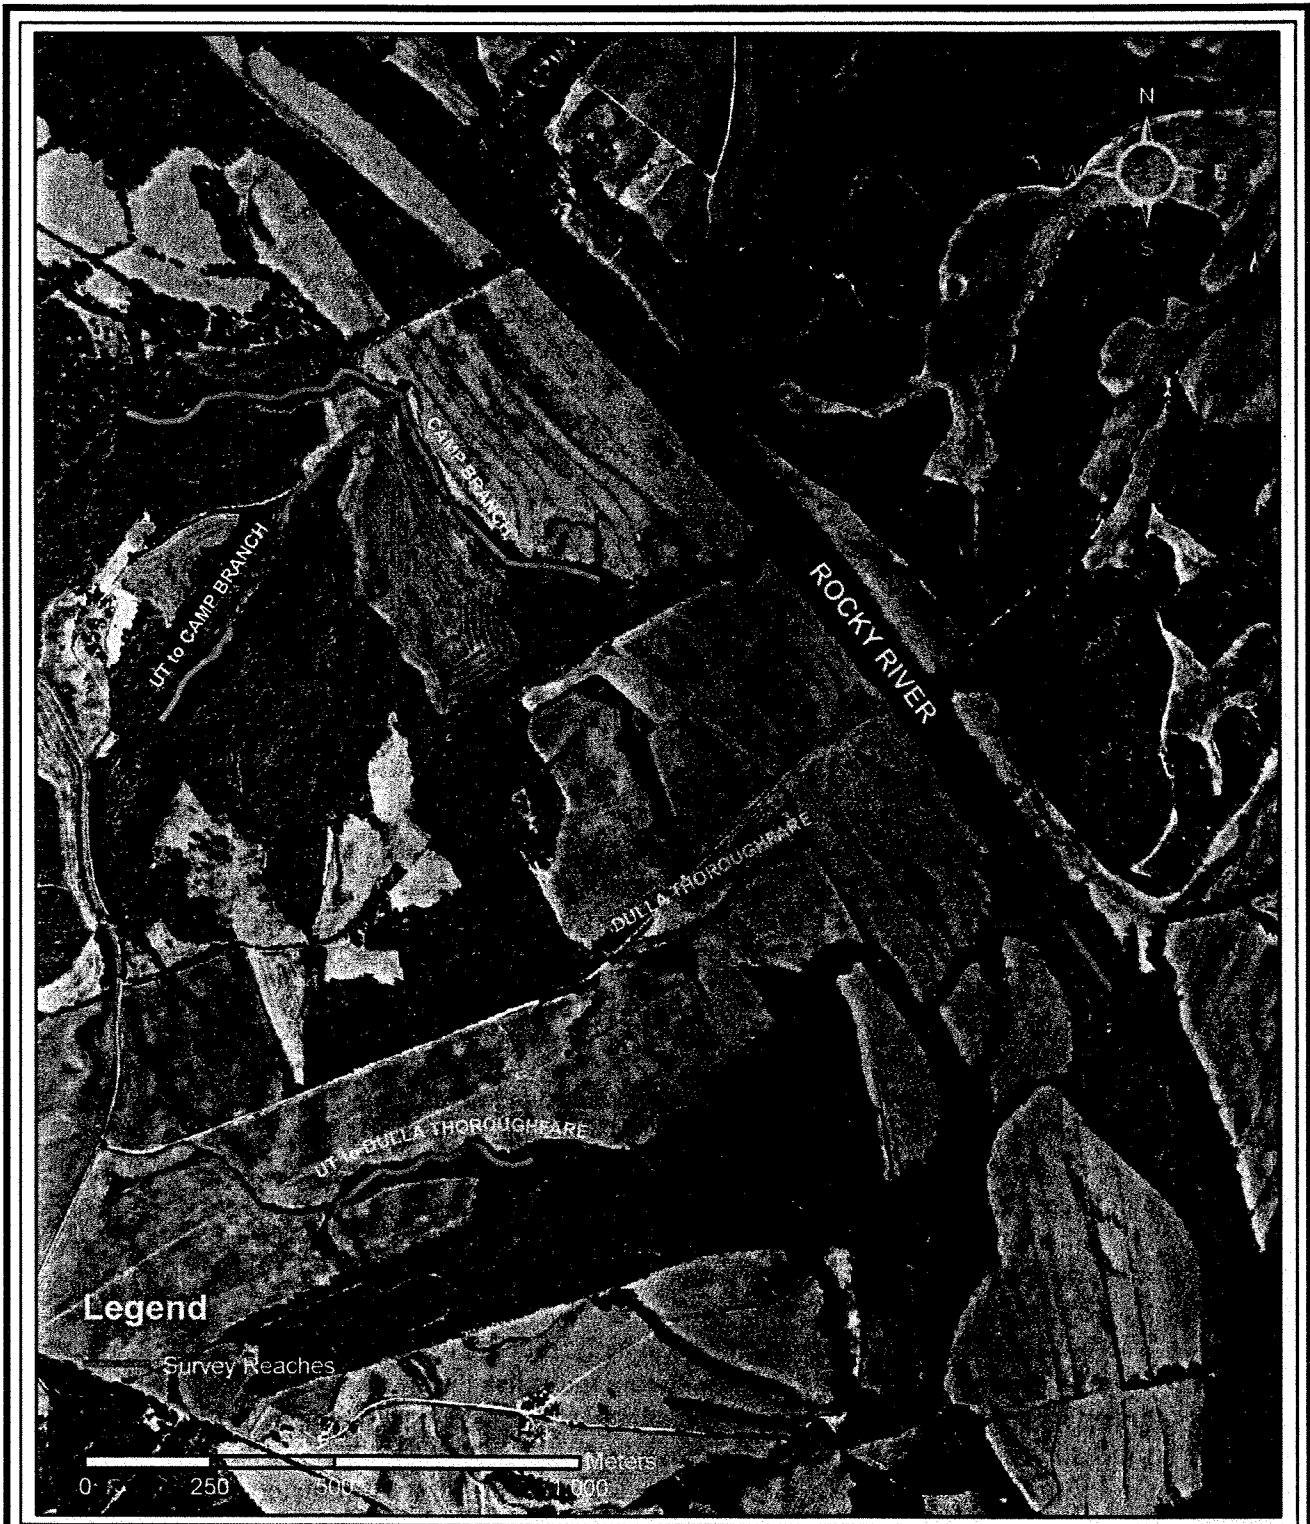
Freshwater Mussel Survey
Locations

Bishop Property Mitigation Site

Visual surveys were conducted using batiscope and tactile methods in each stream except the mainstem Rocky River, which required SCUBA surveys. Searches for relic shells were also conducted concurrently with in-stream surveys. No freshwater mussels were found during the 12 person hours spent surveying the Bishop property. The specific results of each survey reach (Figure 1) are detailed below.
