East Buffalo Creek Mitigation Plan

Graham County, North Carolina

EEP No. 000615

Report Prepared and Submitted by Michael Baker Engineering, Inc.

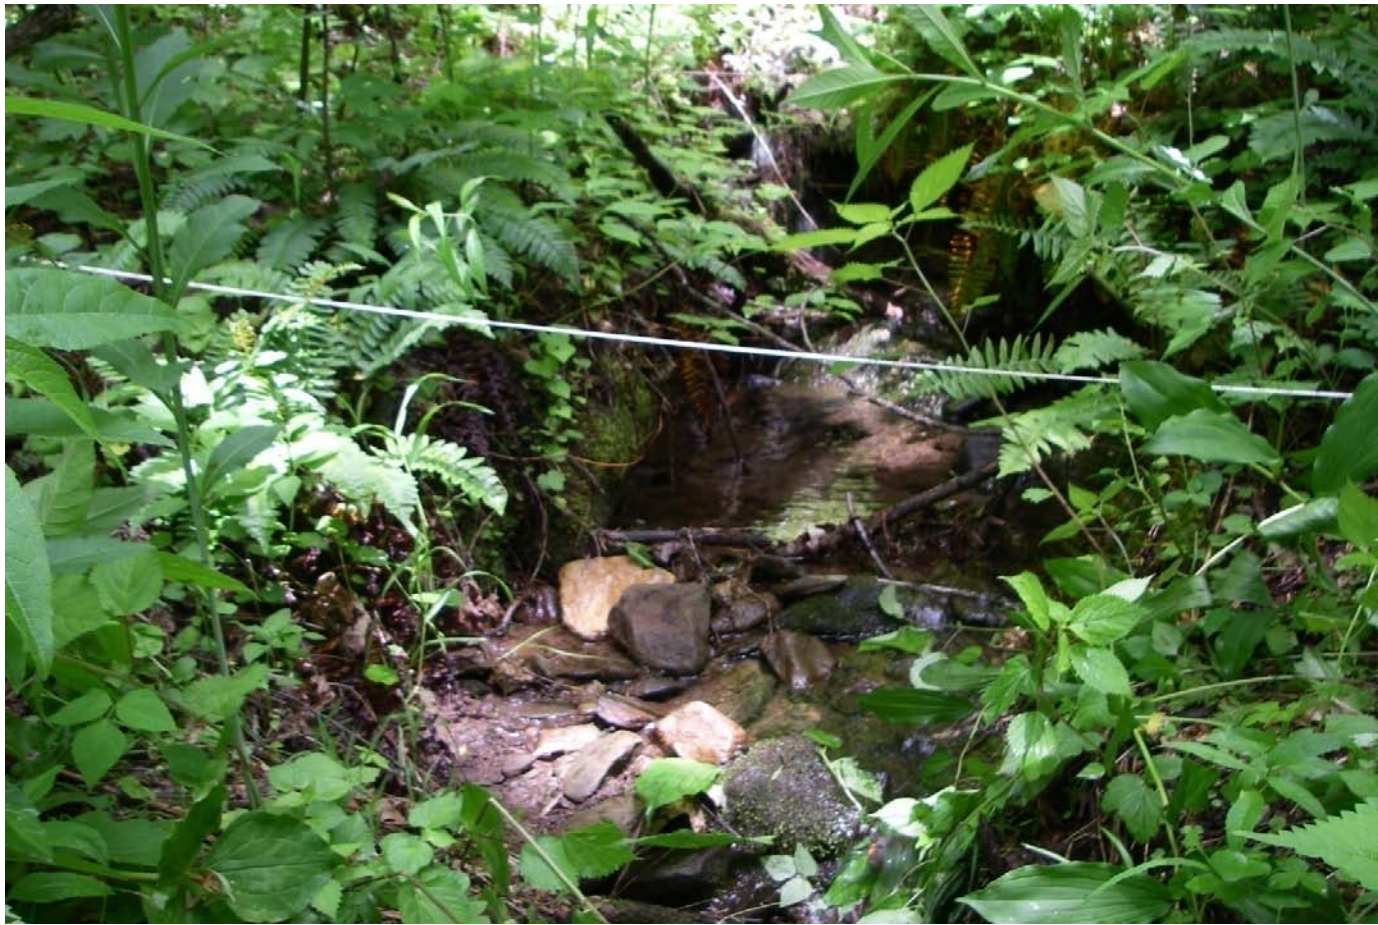
Feature	Stream Type	BKF Area	BKF Width	BKF Depth	Max BKF Depth	W/D	BH Ratio	ER	BKF Elev	TOB Elev
Riffle	A4a+	3.8	5.16	0.74	1.47	7	1	3.1	94.15	94.15

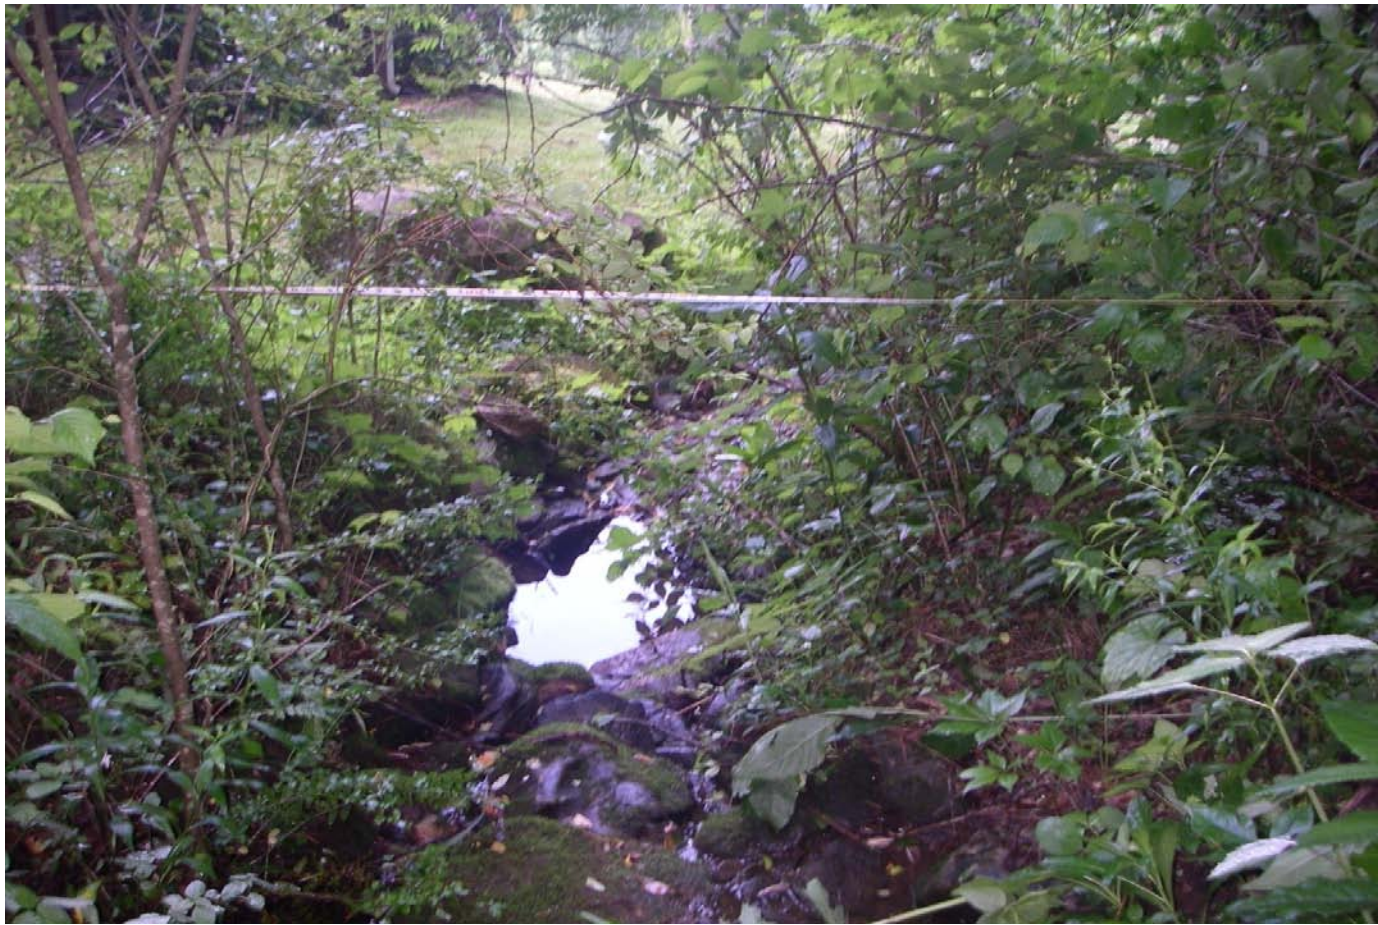
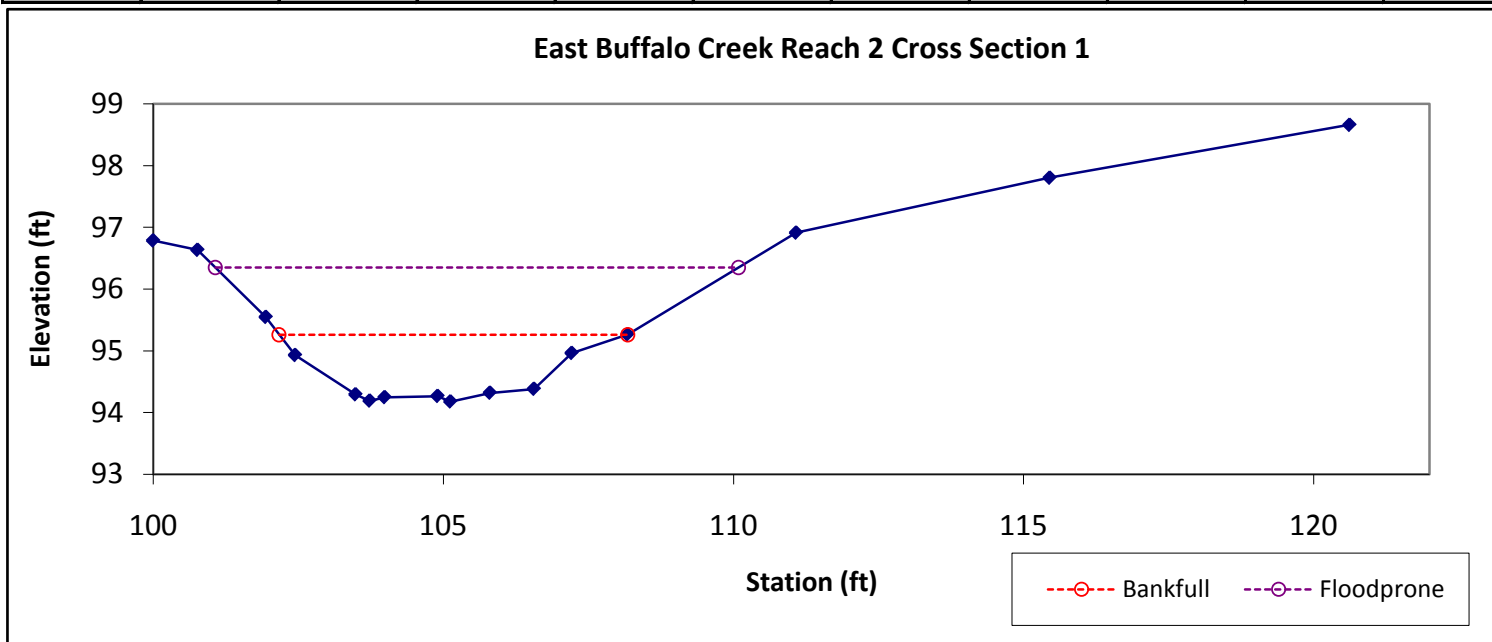
Feature	Stream Type	BKF Area	BKF Width	BKF Depth	Max BKF Depth	W/D	BH Ratio	ER	BKF Elev	TOB Elev
Riffle	A4a+	4.3	6	0.72	1.09	8.37	2.3	1.5	95.26	96.64

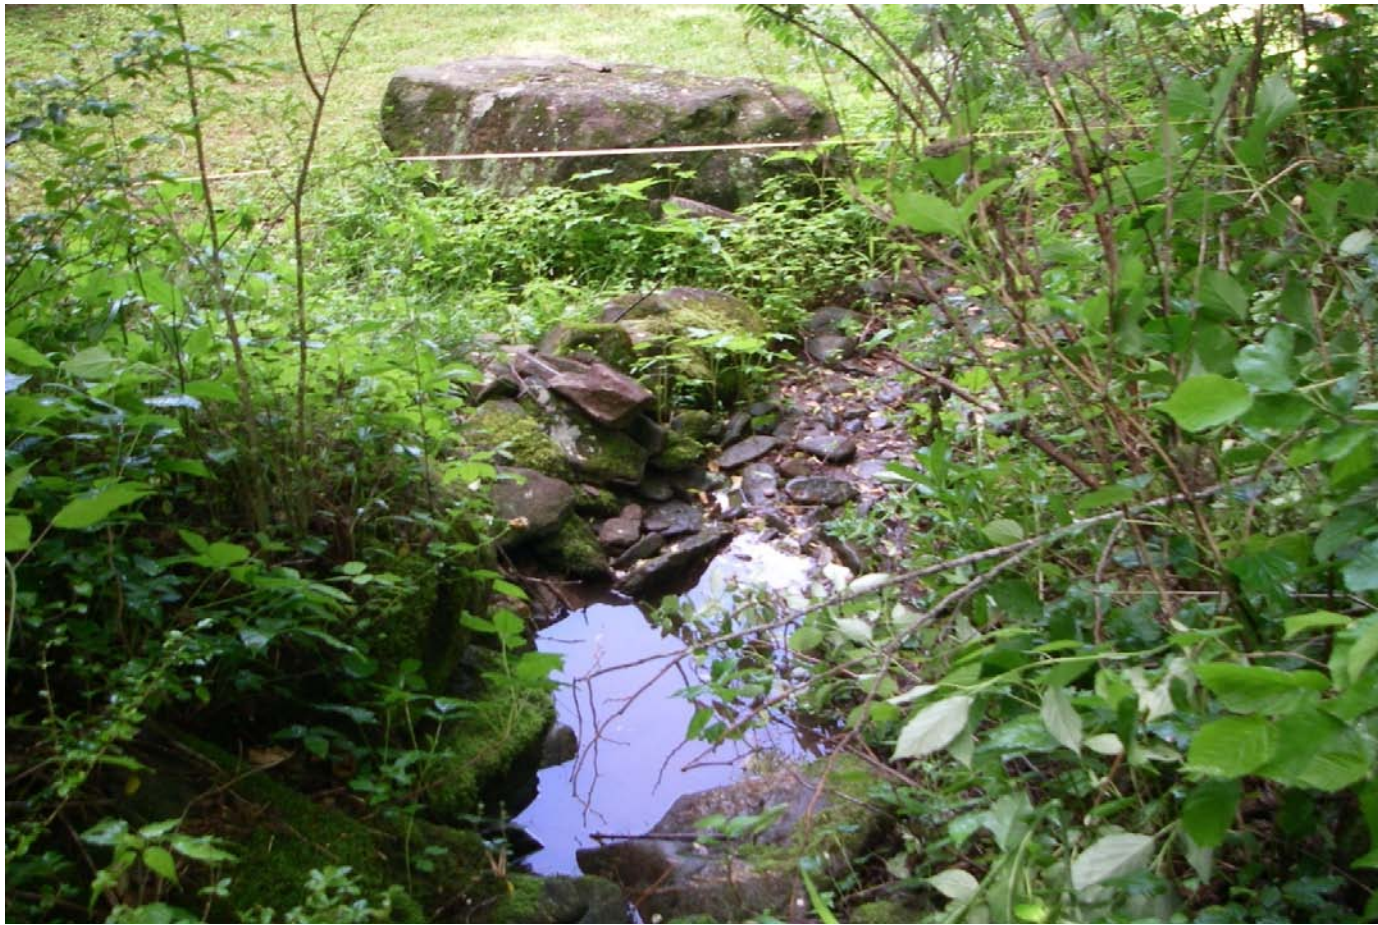
Feature	Stream Type	BKF Area	BKF Width	BKF Depth	Max BKF Depth	W/D	BH Ratio	ER	BKF Elev	TOB Elev
Pool	A4a+	5.6	4.68	1.19	1.77	3.94	1.8	2.4	93.47	94.9

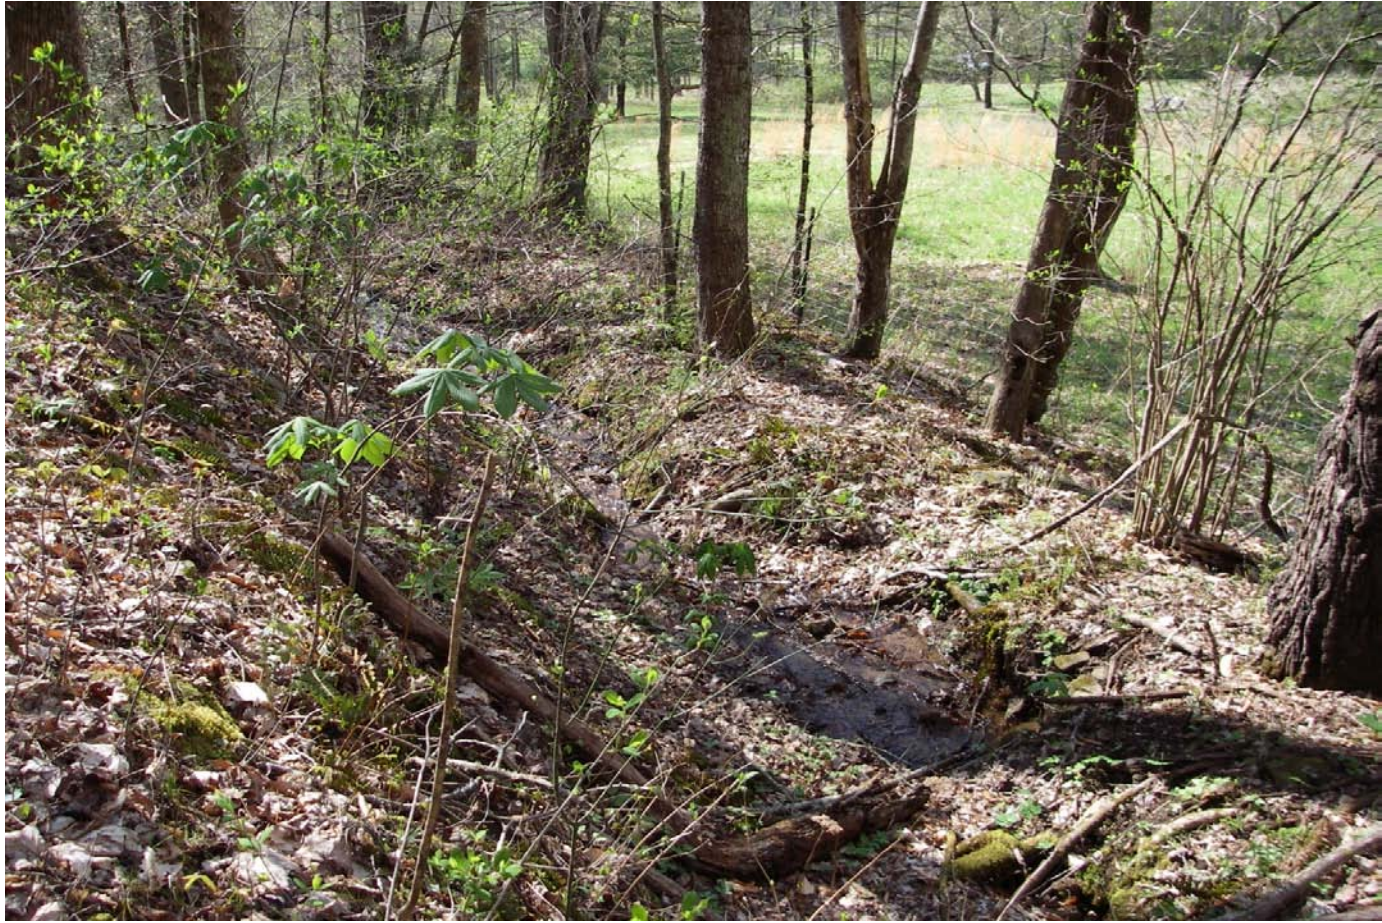
Feature	Stream Type	BKF Area	BKF Width	BKF Depth	Max BKF Depth	W/D	BH Ratio	ER	BKF Elev	TOB Elev
Riffle	A3a+	3.4	4.91	0.69	1.06	7.12	1.2	1.3	2377.1	2377.26

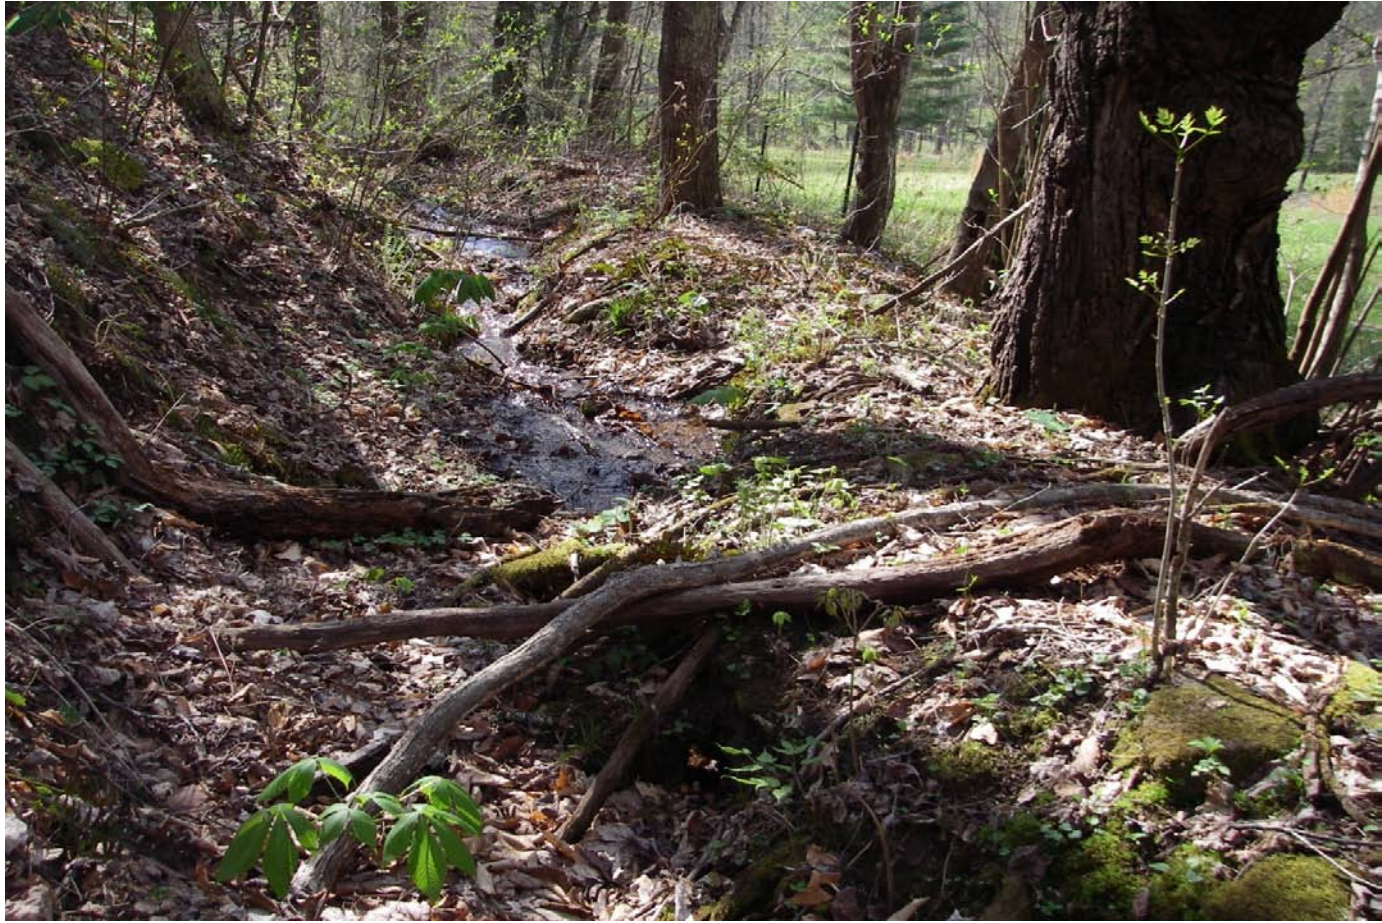
Feature	Stream Type	BKF Area	BKF Width	BKF Depth	Max BKF Depth	W/D	BH Ratio	ER	BKF Elev	TOB Elev
Riffle	A3a+	3	4.64	0.65	0.8	7.11	1.6	1.3	2379.1	2379.54

Note: Photo looking upstream

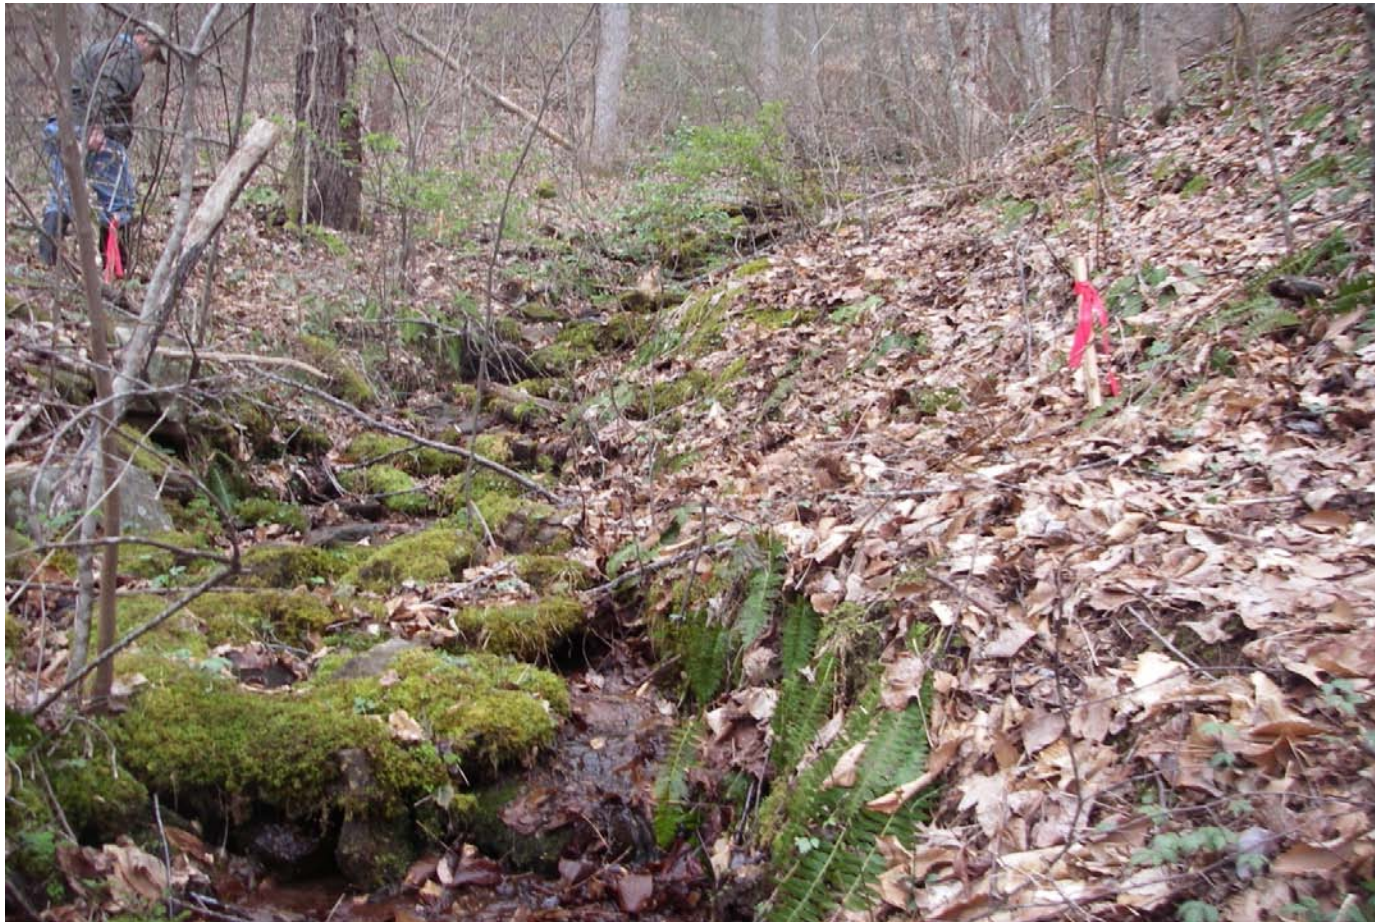
Feature	Stream Type	BKF Area	BKF Width	BKF Depth	Max BKF Depth	W/D	BH Ratio	ER	BKF Elev	TOB Elev
Step (Riffle)	A3a+	3	5.64	0.53	0.83	10.65	1	2.5	2381.28	2381.28

Note: Photo looking upstream

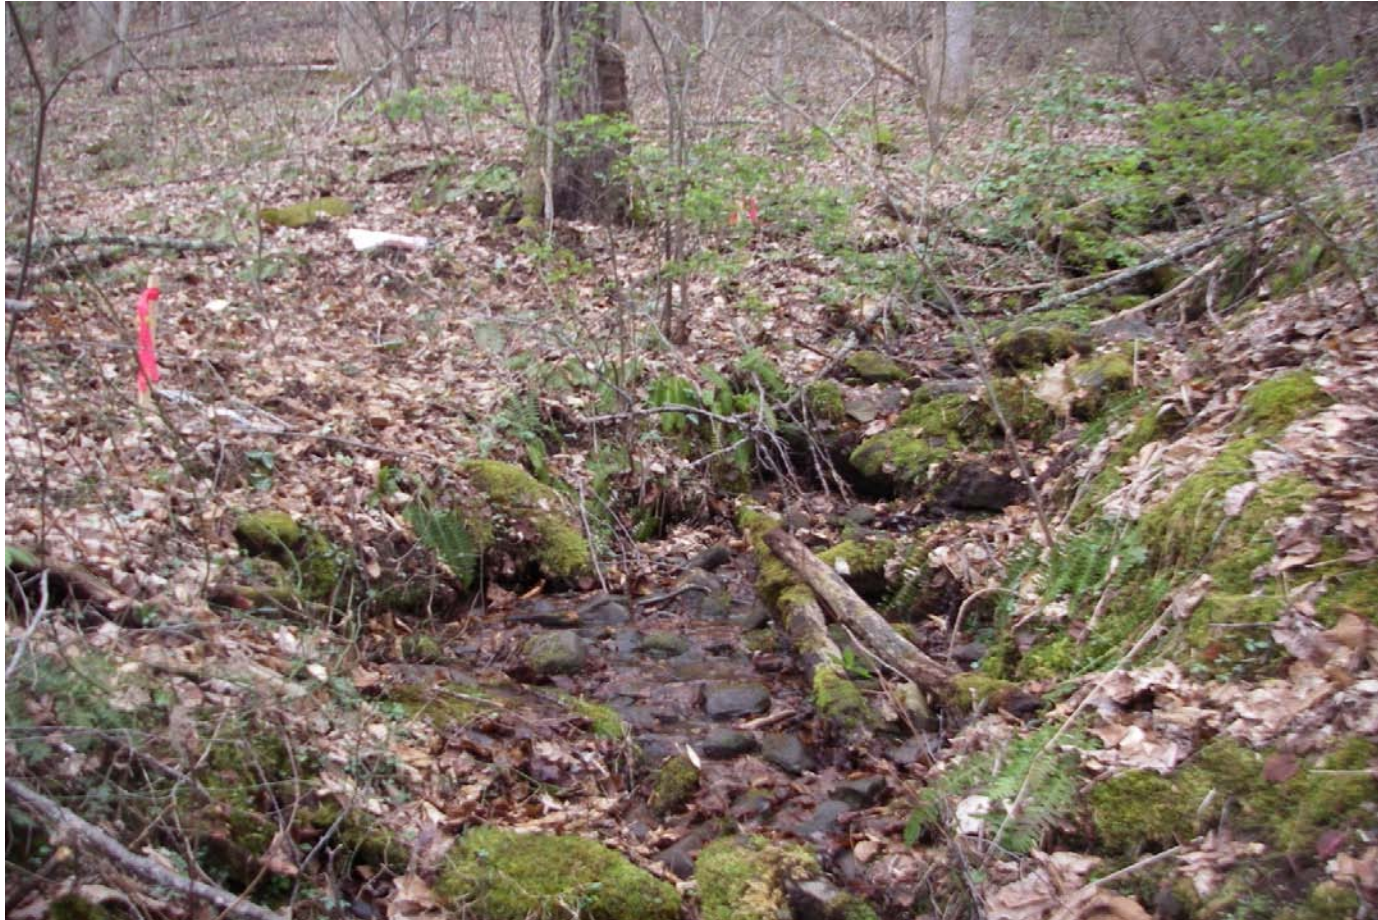
Feature	Stream Type	BKF Area	BKF Width	BKF Depth	Max BKF Depth	W/D	BH Ratio	ER	BKF Elev	TOB Elev
Pool	A3a+	8.5	7.25	1.17	1.41	6.22	1.5	1.8	2384.06	2384.82

Note: Photo looking upstream

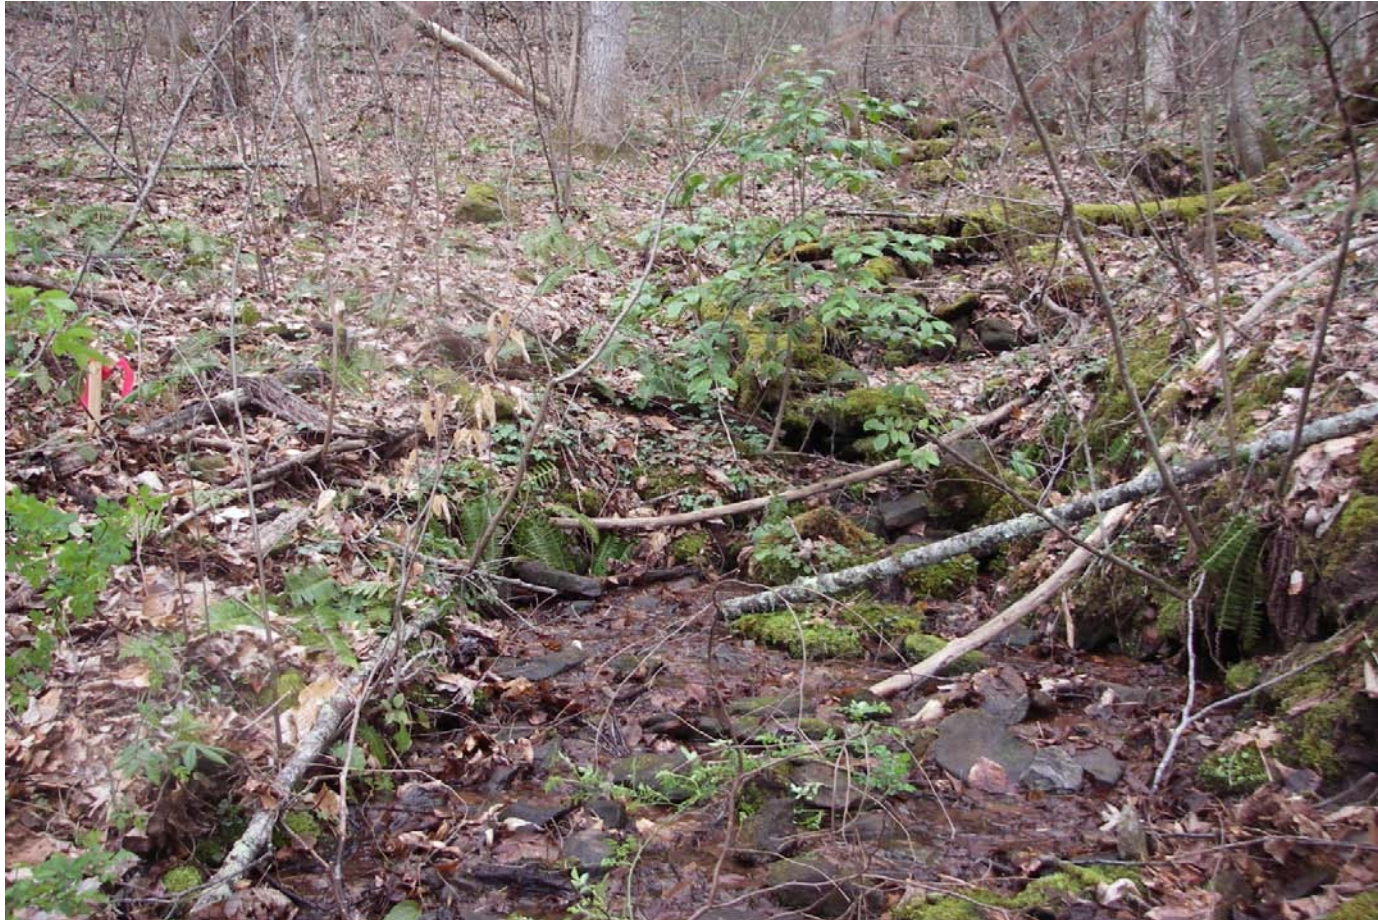
Feature	Stream Type	BKF Area	BKF Width	BKF Depth	Max BKF Depth	W/D	BH Ratio	ER	BKF Elev	TOB Elev
Pool	A3a+	6.2	6.85	0.91	1.08	7.53	1.7	1.5	2387.59	2388.3

Note: Photo looking upstream

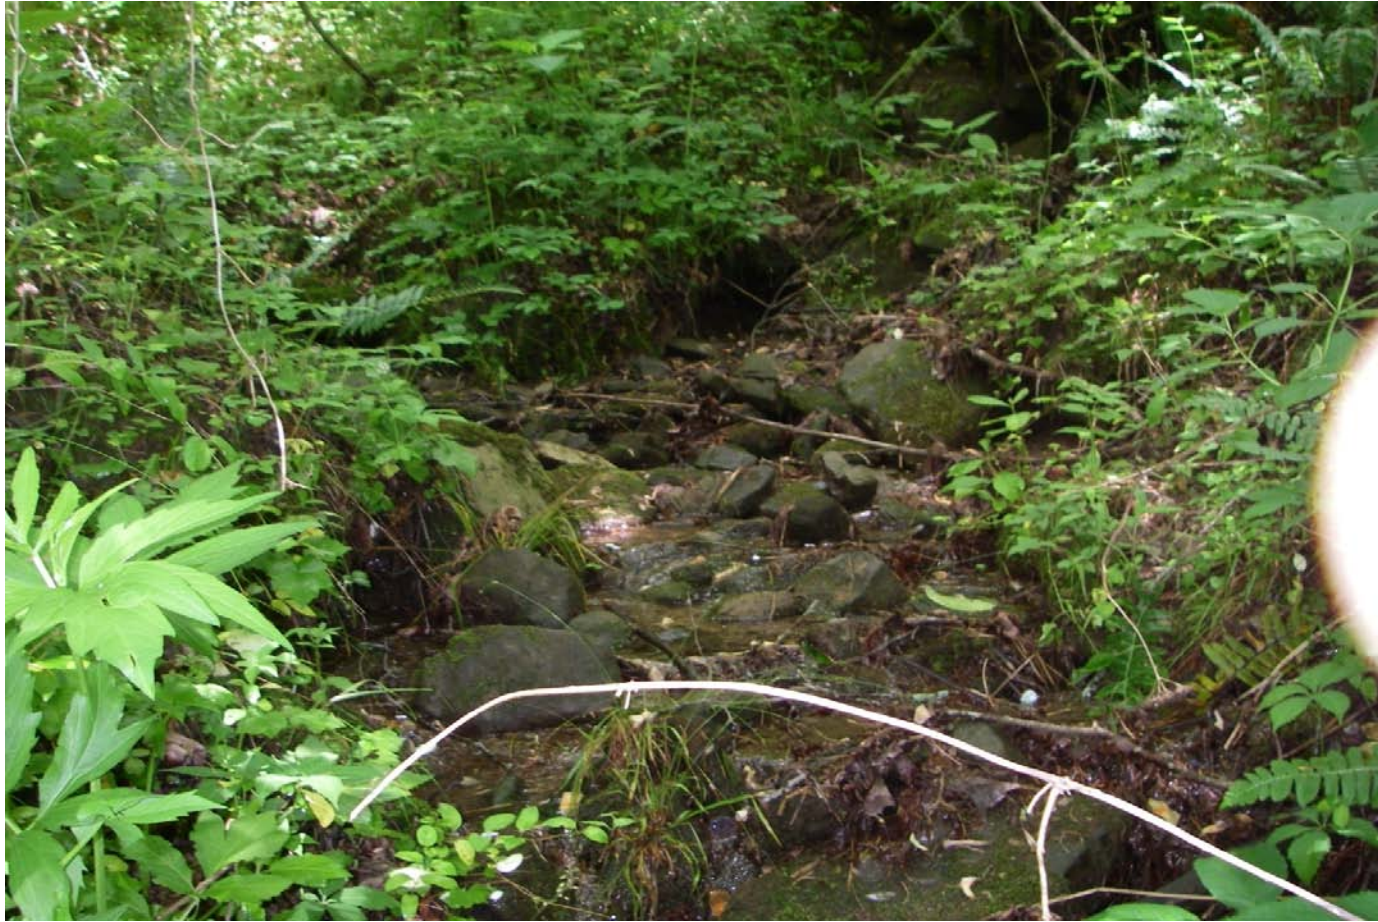
Feature	Stream Type	BKF Area	BKF Width	BKF Depth	Max BKF Depth	W/D	BH Ratio	ER	BKF Elev	TOB Elev
Riffle	A4a+	2.7	5.58	0.48	0.75	11.7	3.3	1.2	91.15	92.9

Note: Photo looking upstream

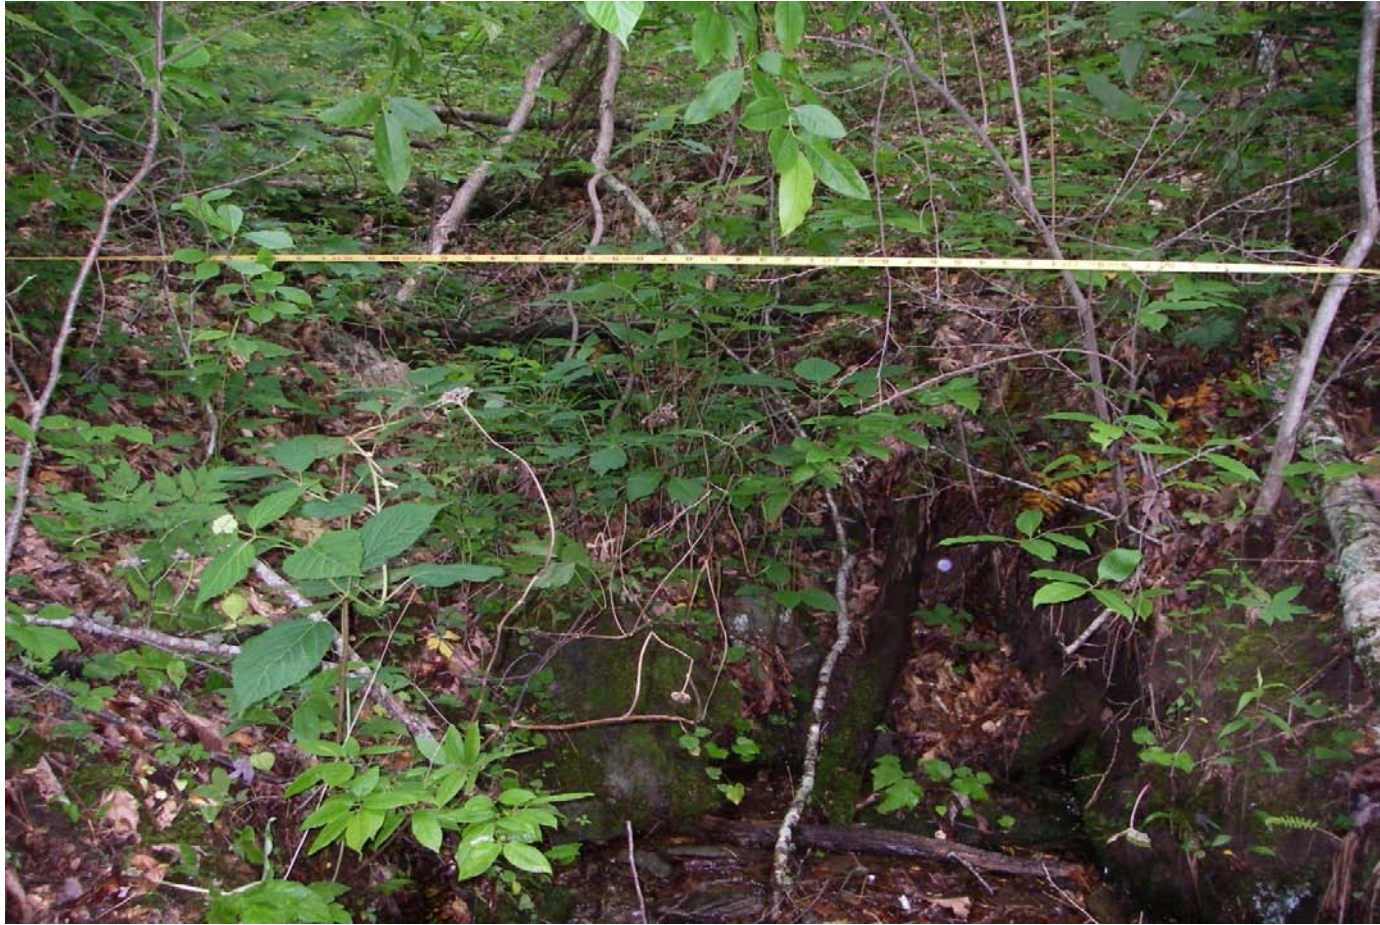
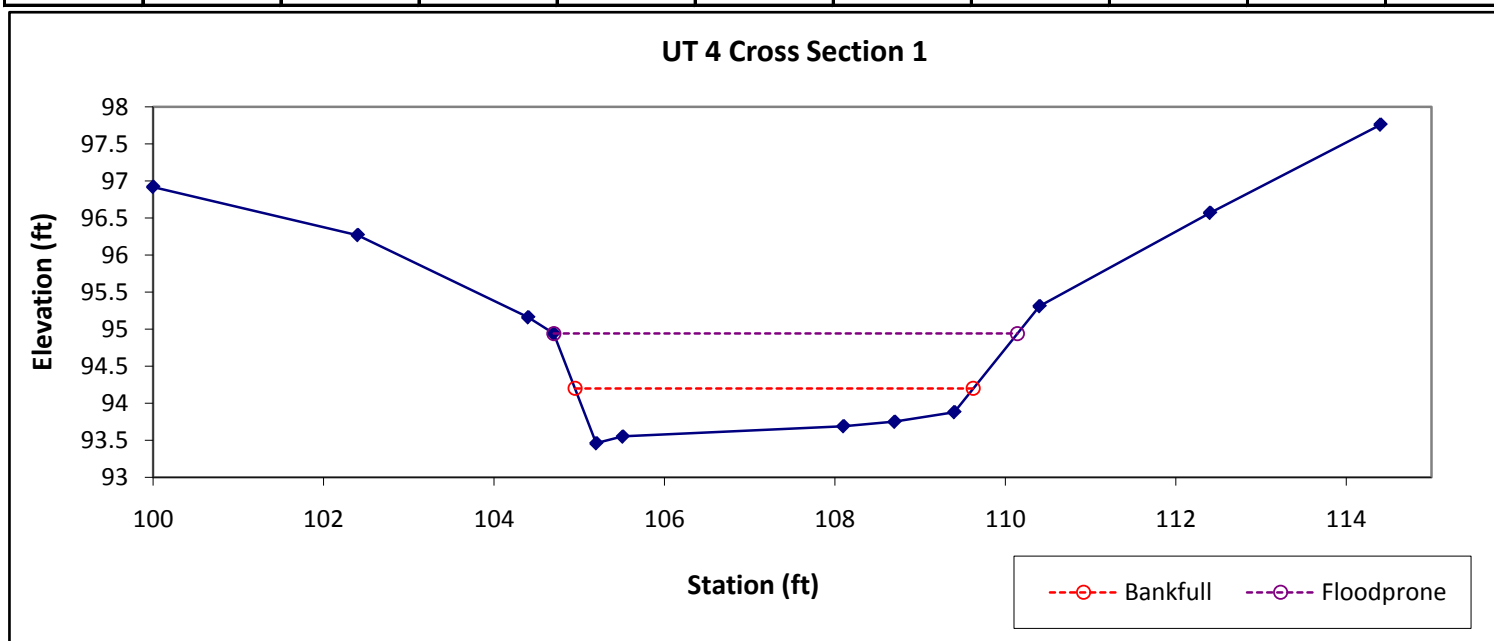
Feature	Stream Type	BKF Area	BKF Width	BKF Depth	Max BKF Depth	W/D	BH Ratio	ER	BKF Elev	TOB Elev
Riffle	A4a+	2.4	4.67	0.51	0.74	9.09	2	1.2	94.2	94.94

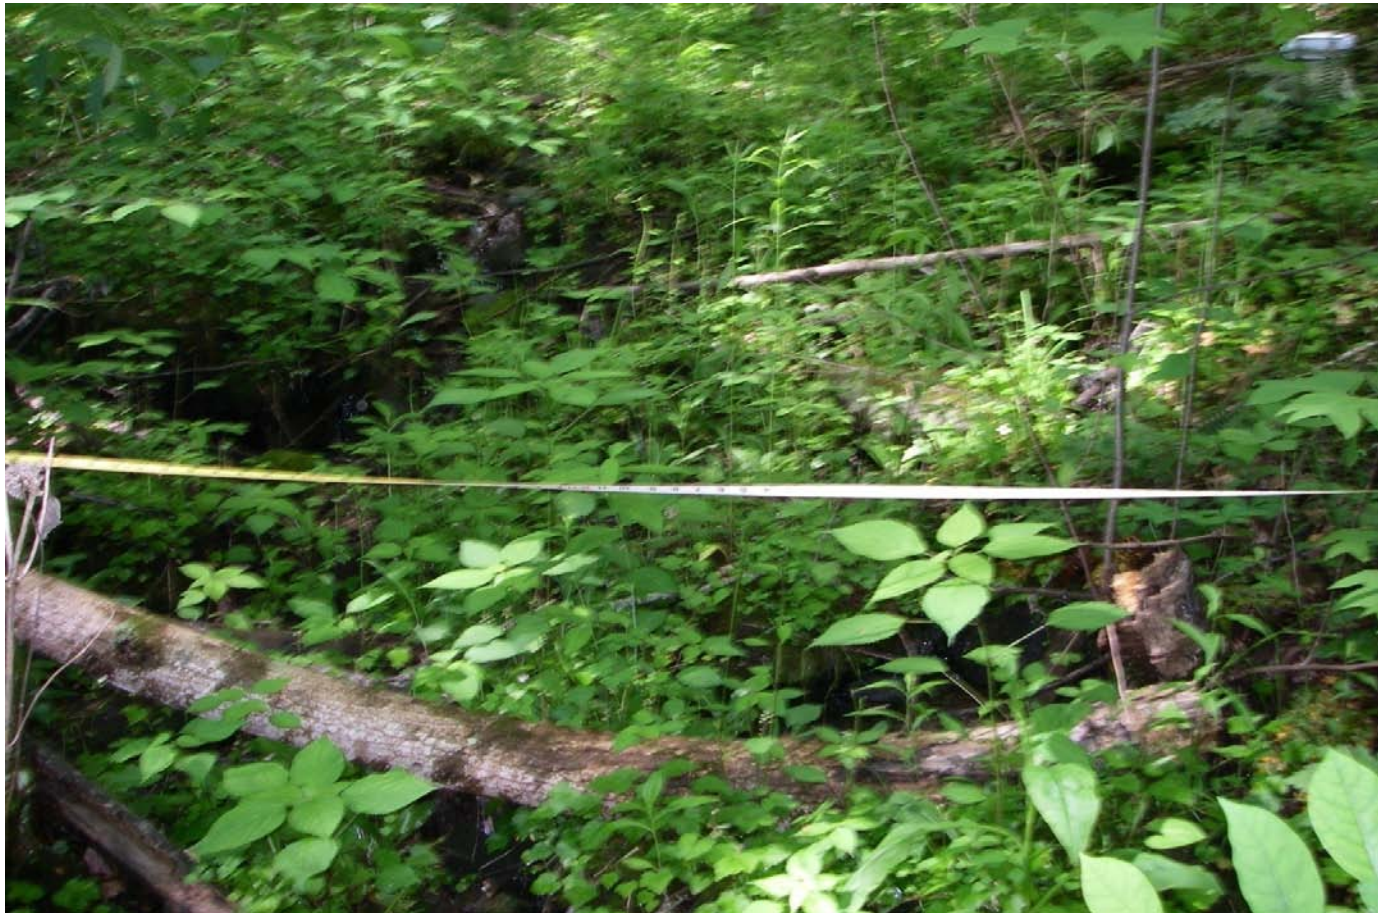
Note: Photo looking upstream

Feature	Stream Type	BKF Area	BKF Width	BKF Depth	Max BKF Depth	W/D	BH Ratio	ER	BKF Elev	TOB Elev
Riffle	A4a+	4	6.06	0.66	1.16	9.13	2.3	1.6	93.54	95.01

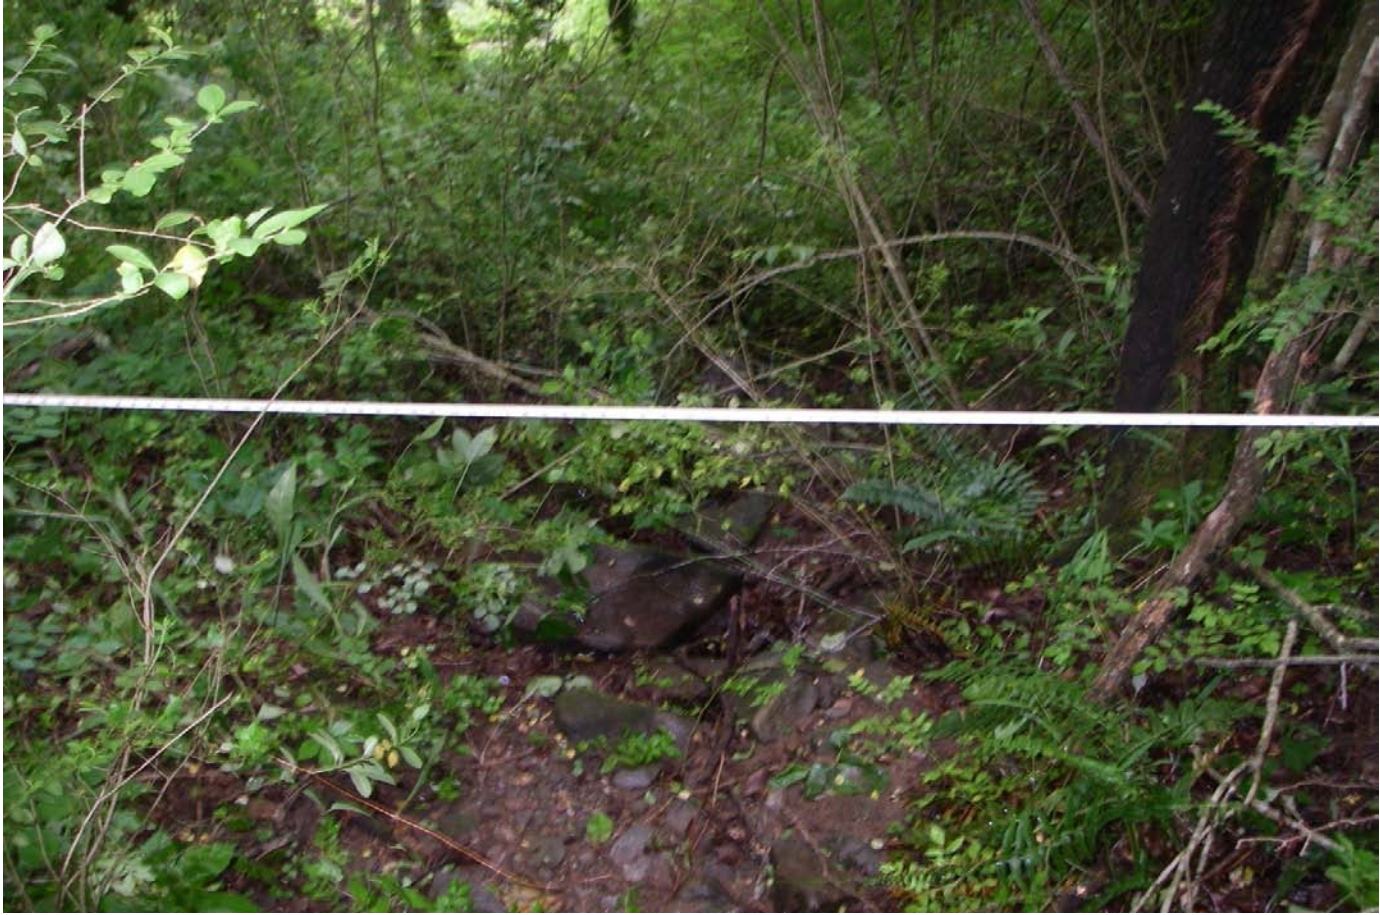
Feature	Stream Type	BKF Area	BKF Width	BKF Depth	Max BKF Depth	W/D	BH Ratio	ER	BKF Elev	TOB Elev
Riffle	A4a+	2.5	7.32	0.35	0.7	21.07	1	1.5	100.86	100.86

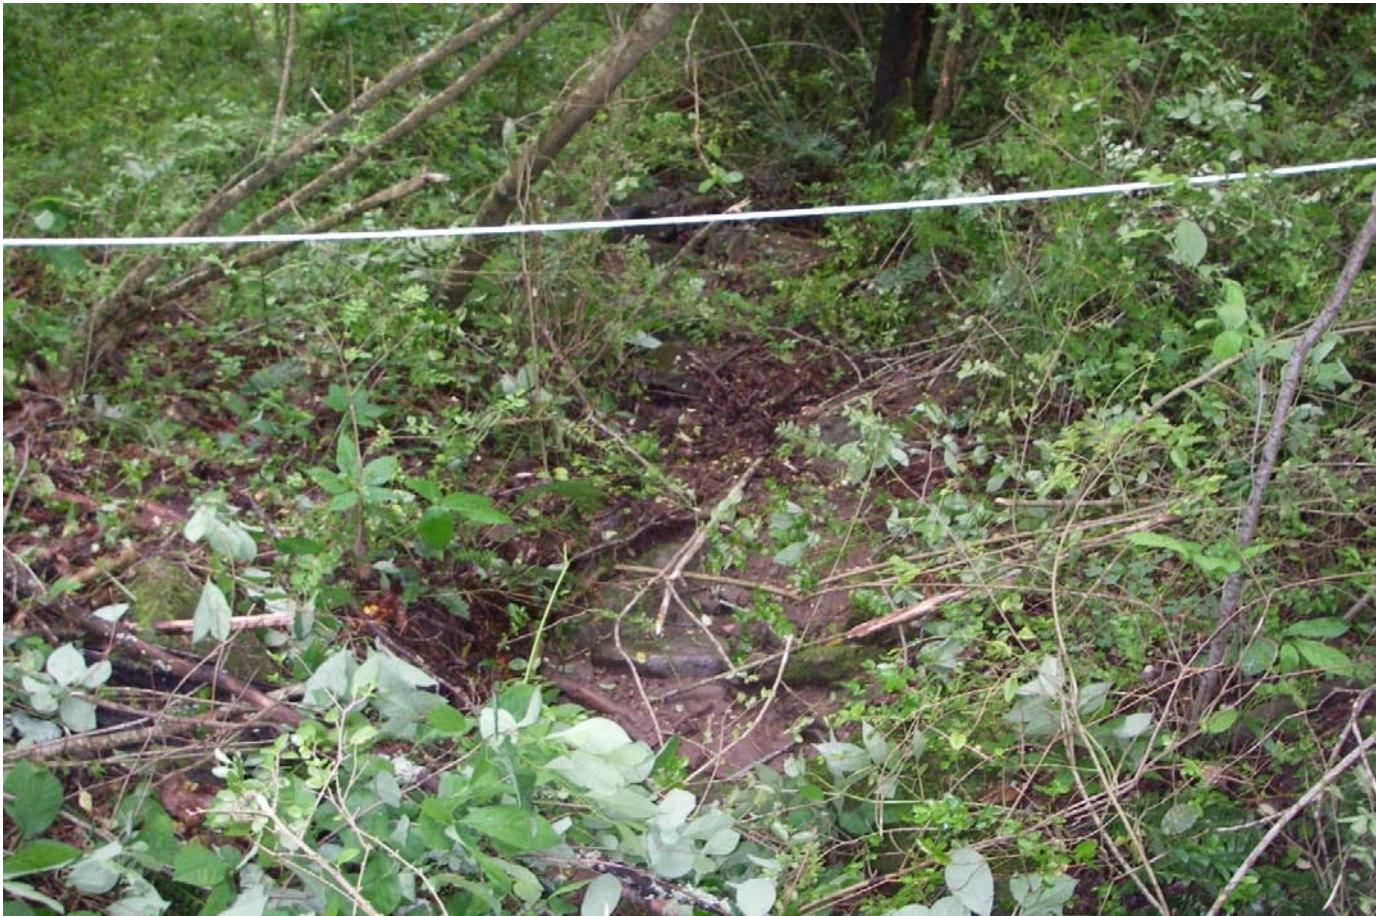
Feature	Stream Type	BKF Area	BKF Width	BKF Depth	Max BKF Depth	W/D	BH Ratio	ER	BKF Elev	TOB Elev
Pool	A4a+	3.8	4.81	0.8	1.26	6.03	1	3.6	102.19	102.15

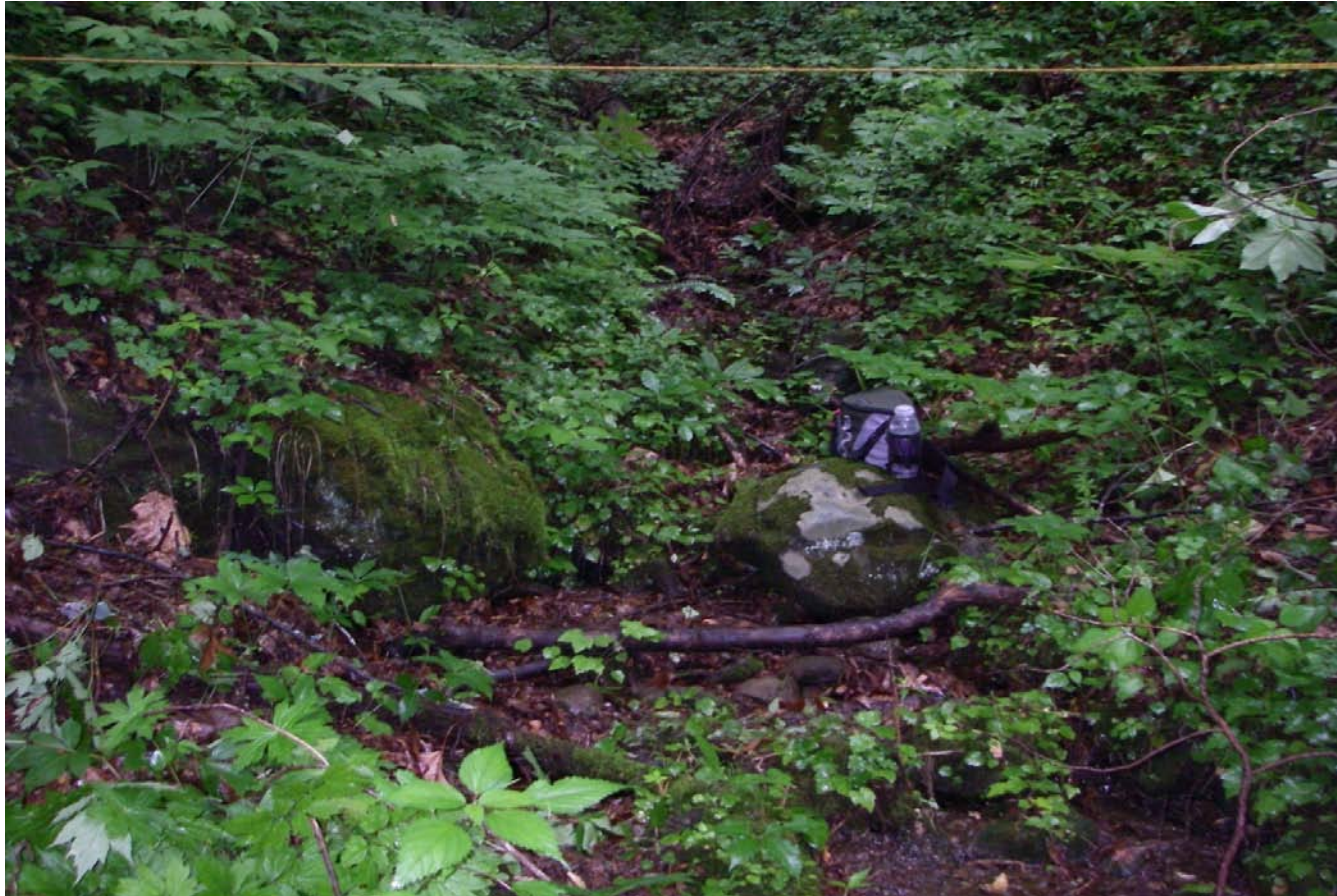
Note: Photo looking upstream

Feature	Stream Type	BKF Area	BKF Width	BKF Depth	Max BKF Depth	W/D	BH Ratio	ER	BKF Elev	TOB Elev
Riffle	A4a+	2.8	5.44	0.51	0.66	10.69	1	1.8	94.2	94.2

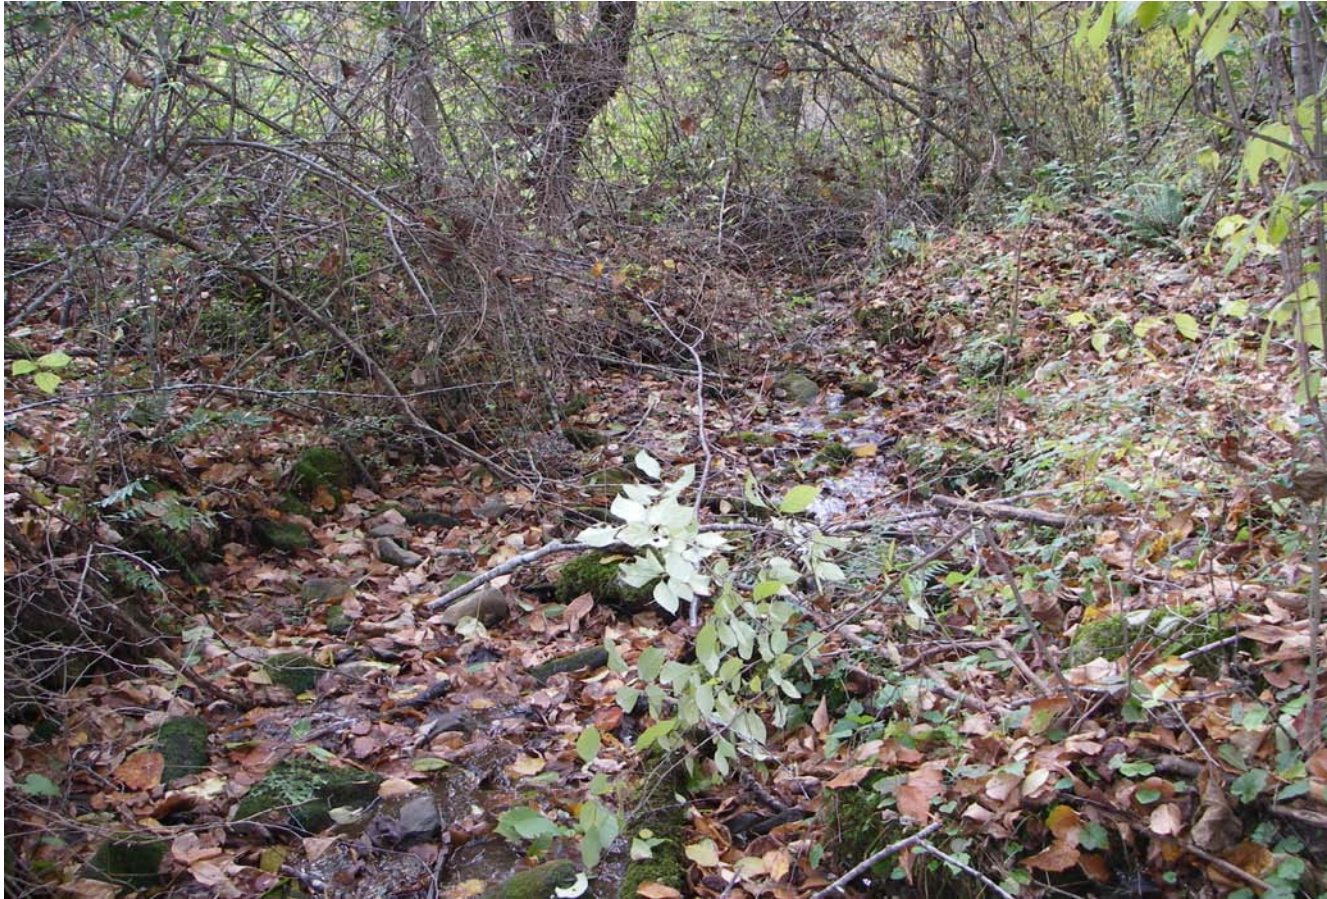
Feature	Stream Type	BKF Area	BKF Width	BKF Depth	Max BKF Depth	W/D	BH Ratio	ER	BKF Elev	TOB Elev
Riffle	A4a+	7.2	7.38	0.98	1.09	7.57	1.2	1.6	99.31	99.55

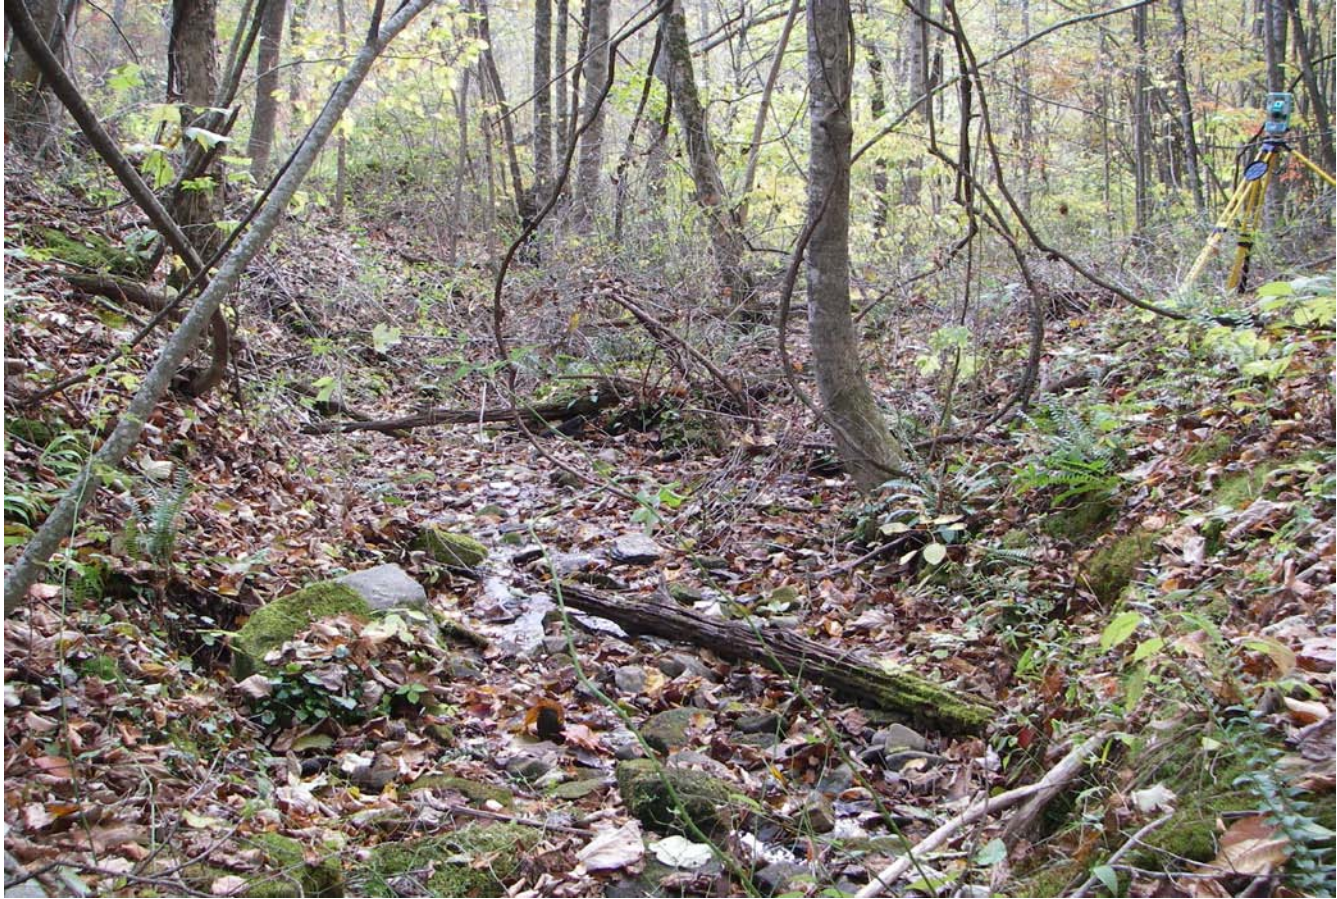
Feature	Stream Type	BKF Area	BKF Width	BKF Depth	Max BKF Depth	W/D	BH Ratio	ER	BKF Elev	TOB Elev
Riffle	A4a+	7	8.04	0.87	1.36	9.22	1	2	88.07	88.14
