East Buffalo Creek Mitigation Plan

Graham County, North Carolina

EEP No. 000615

Report Prepared and Submitted by Michael Baker Engineering, Inc.

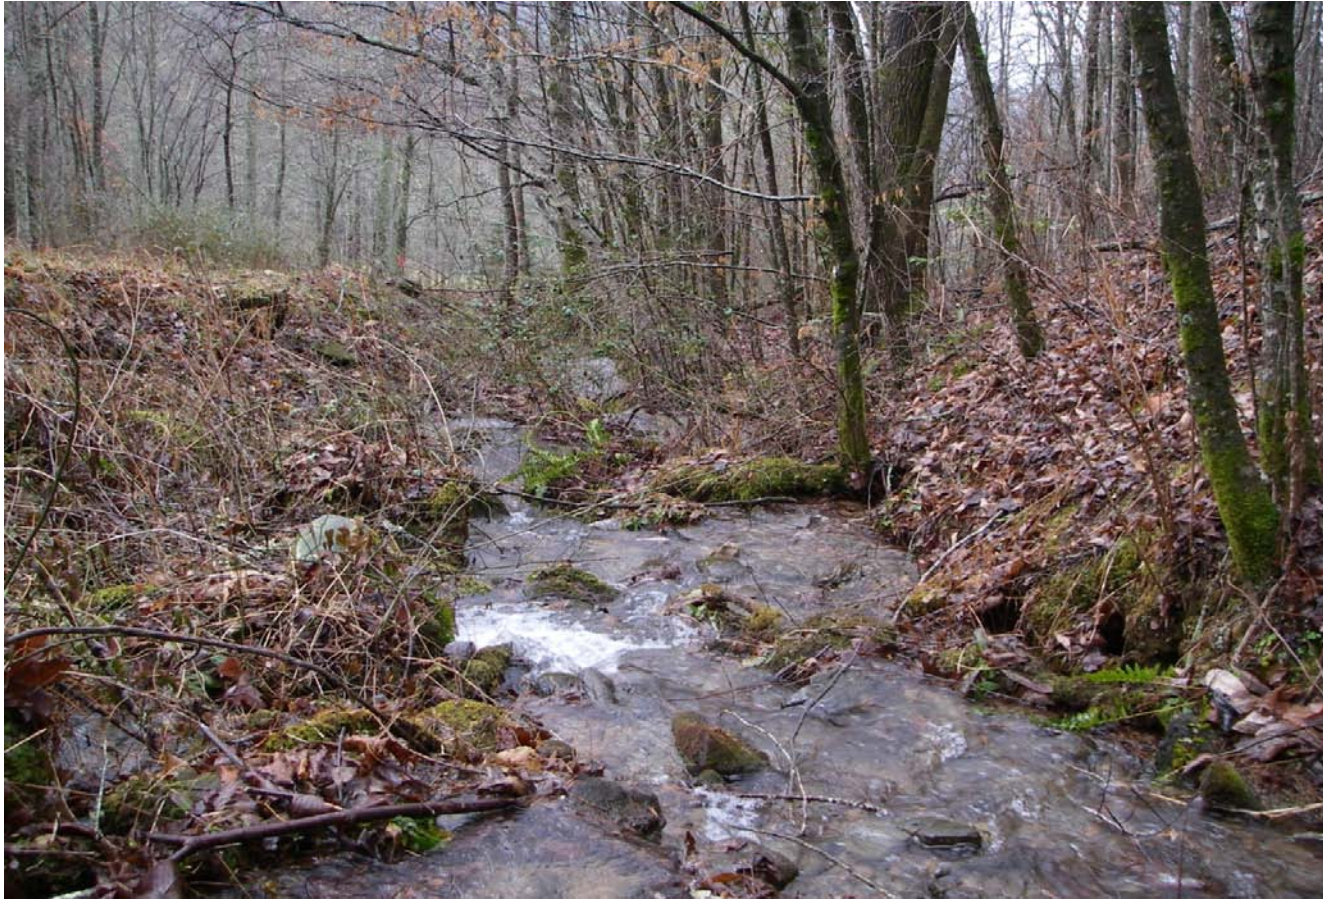
Feature	Stream Type	BKF Area	BKF Width	BKF Depth	Max BKF Depth	W/D	BH Ratio	ER	BKF Elev	TOB Elev
Riffle	F4b	6.6	11.37	0.58	0.88	19.7	5.7	1.1	2320.7	2324.84

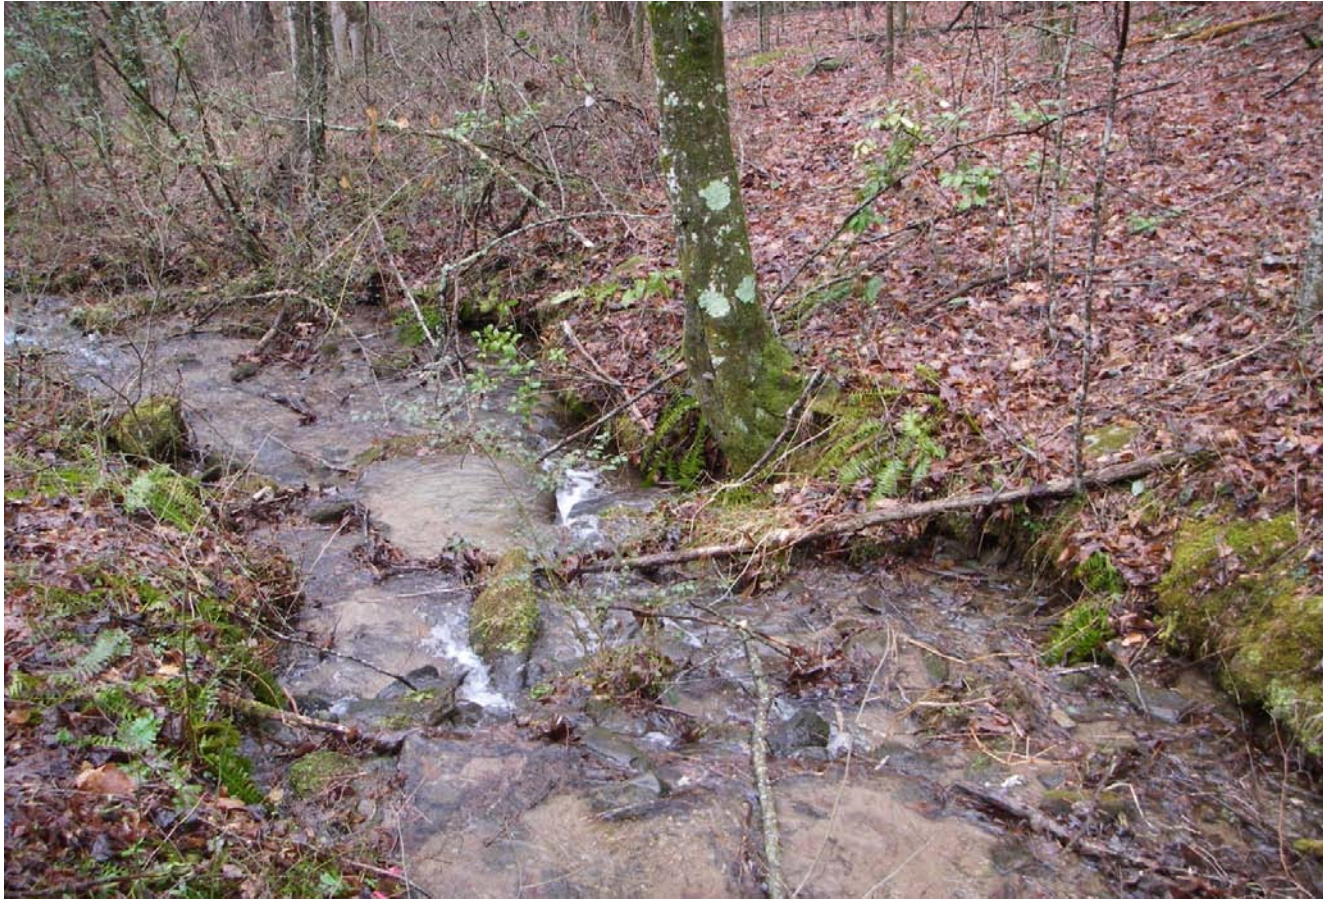
Feature	Stream Type	BKF Area	BKF Width	BKF Depth	Max BKF Depth	W/D	BH Ratio	ER	BKF Elev	TOB Elev
Riffle	F4b	6.3	9.18	0.69	1.06	13.28	2.2	1.2	2306.7	2308.02

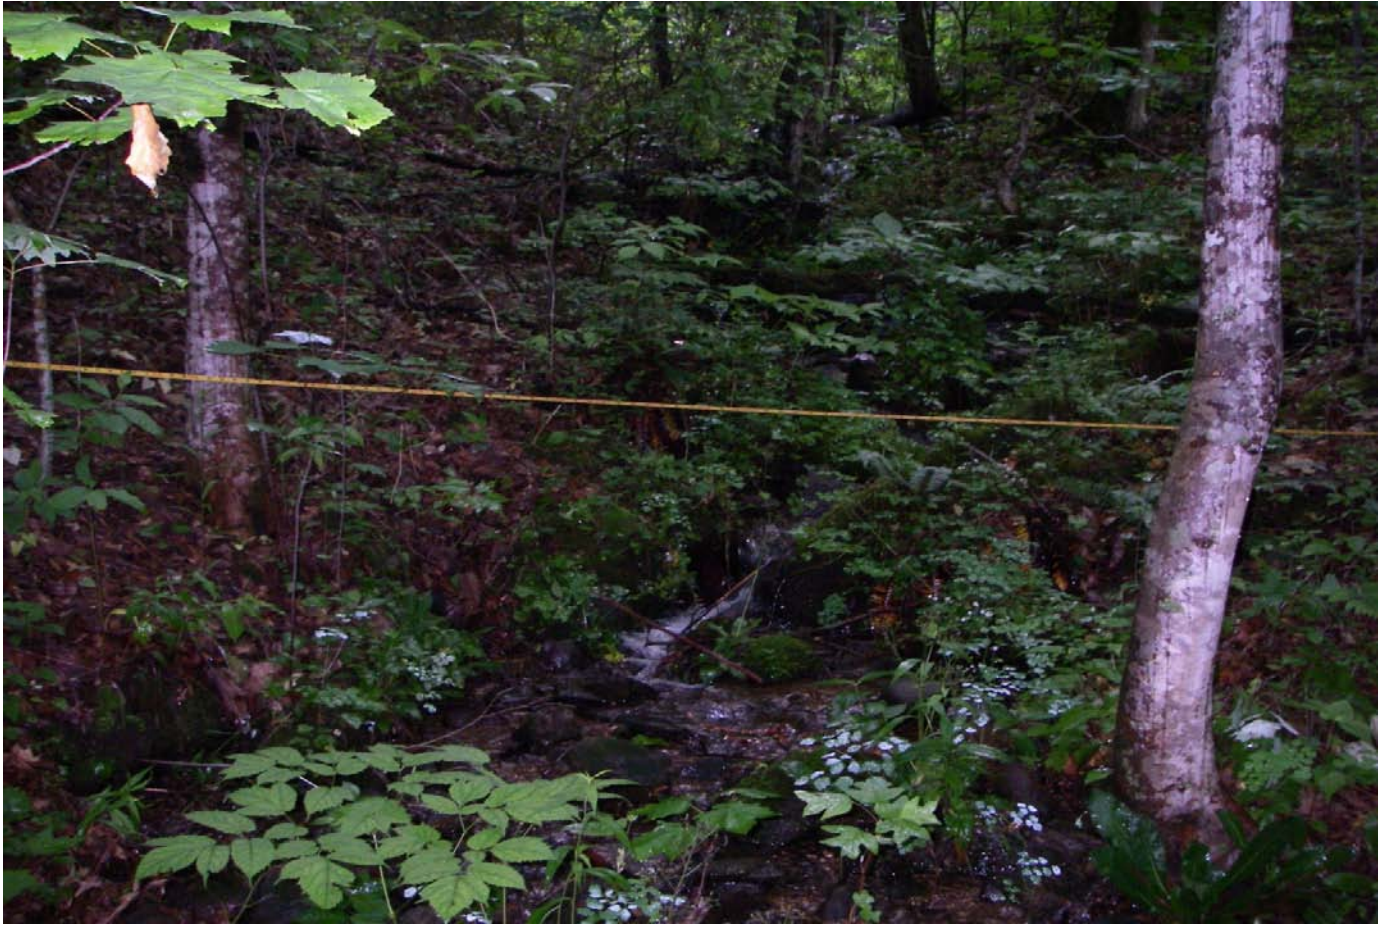
Note: Photo looking upstream

Feature	Stream Type	BKF Area	BKF Width	BKF Depth	Max BKF Depth	W/D	BH Ratio	ER	BKF Elev	TOB Elev
Riffle	B4a	3.2	7.09	0.45	0.69	15.64	1	2.3	96.95	96.98

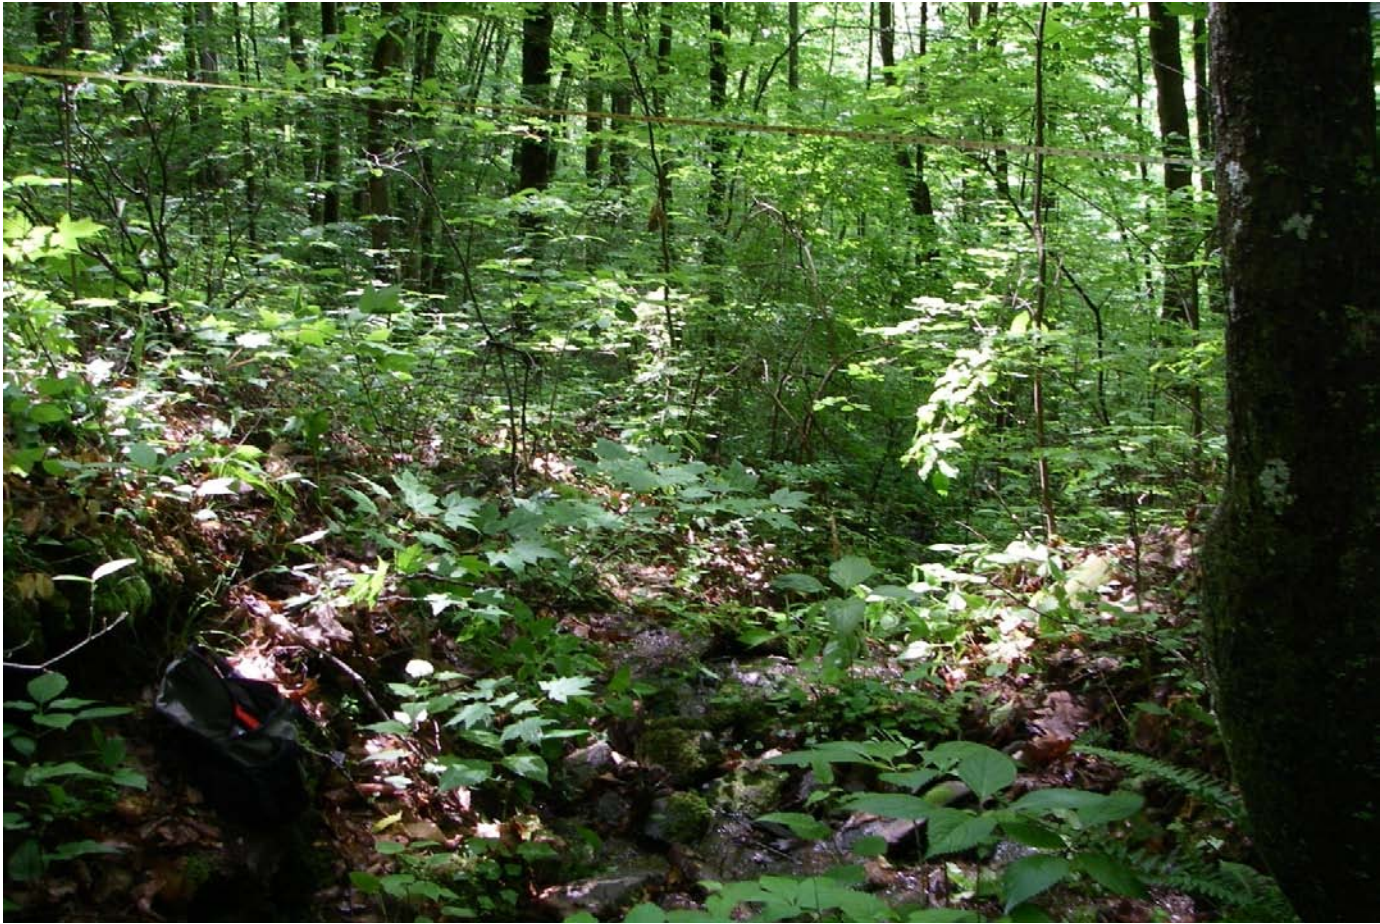
Feature	Stream Type	BKF Area	BKF Width	BKF Depth	Max BKF Depth	W/D	BH Ratio	ER	BKF Elev	TOB Elev
Riffle	A4a+	5.1	5.96	0.86	0.97	6.96	1.7	1.4	95.59	96.27

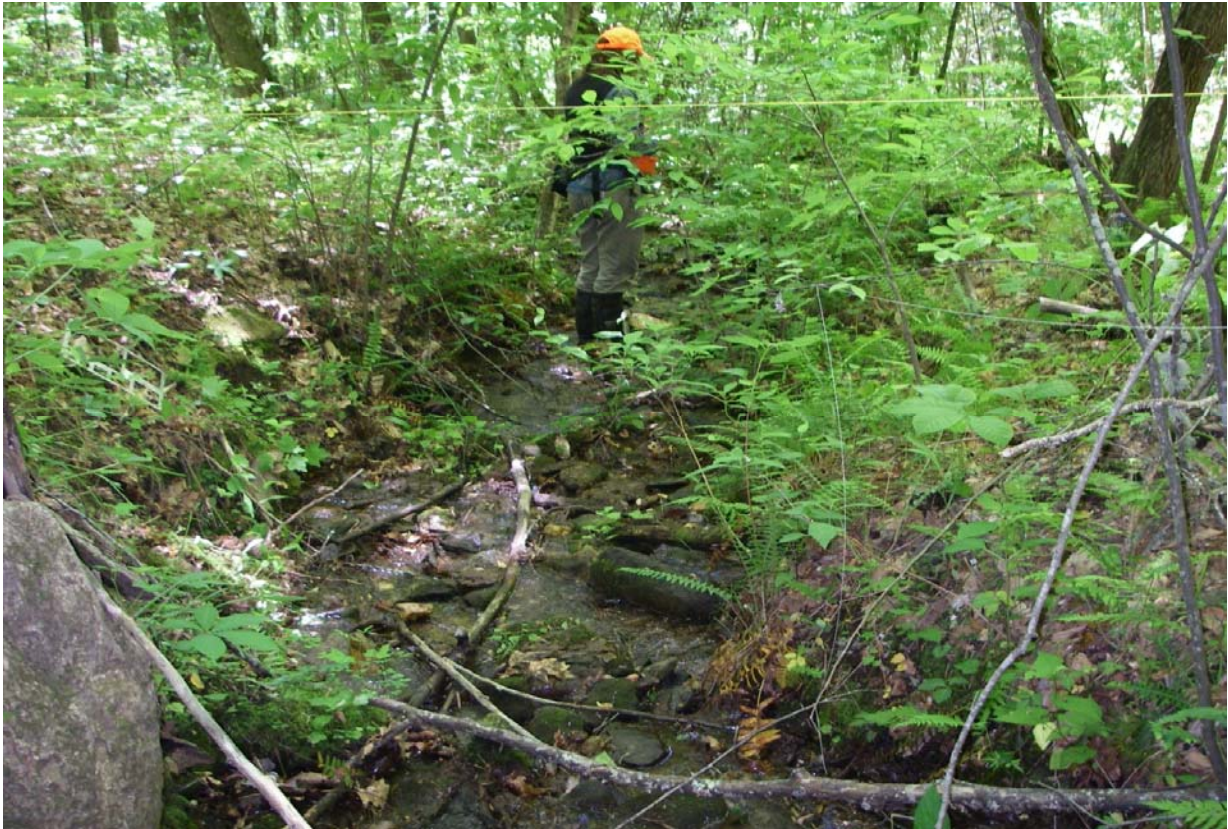
Feature	Stream Type	BKF Area	BKF Width	BKF Depth	Max BKF Depth	W/D	BH Ratio	ER	BKF Elev	TOB Elev
Riffle	F4b	1	3.87	0.27	0.4	14.37	3.7	1.1	89.9	91

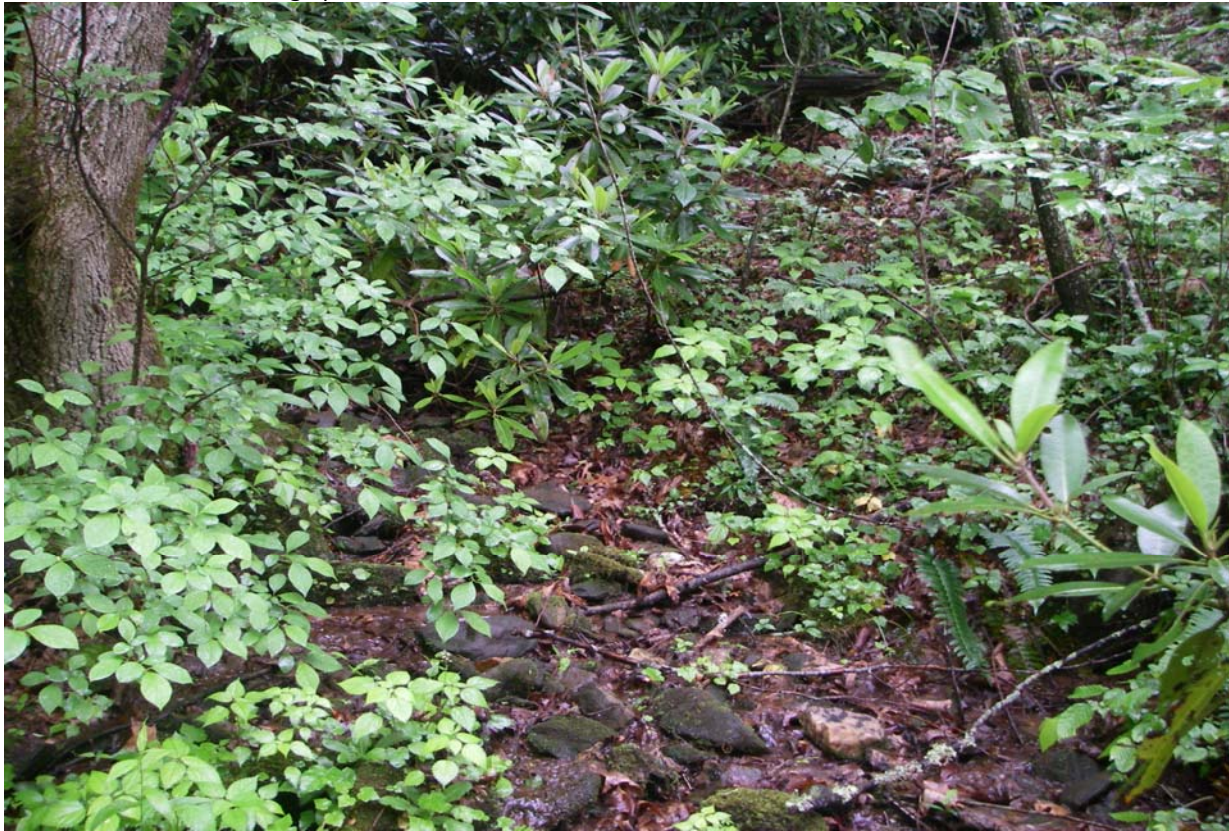
Note: Photo looking upstream

Feature	Stream Type	BKF Area	BKF Width	BKF Depth	Max BKF Depth	W/D	BH Ratio	ER	BKF Elev	TOB Elev
Riffle	A4a+	3.9	6.53	0.59	0.87	11.06	2.4	1.5	95.57	96.82

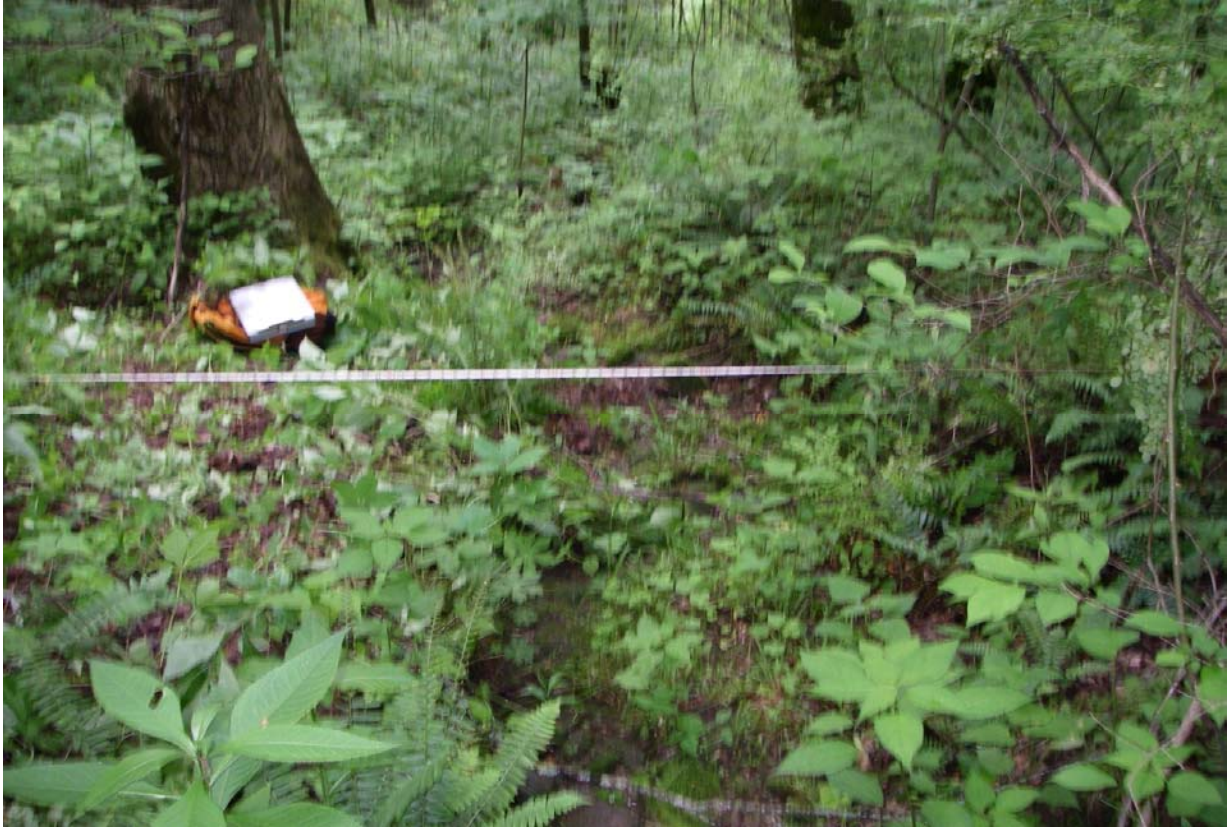
Note: Photo looking upstream

Feature	Stream Type	BKF Area	BKF Width	BKF Depth	Max BKF Depth	W/D	BH Ratio	ER	BKF Elev	TOB Elev
Riffle	B4a	0.5	3.12	0.17	0.56	17.87	2.2	1.5	96.86	97.55

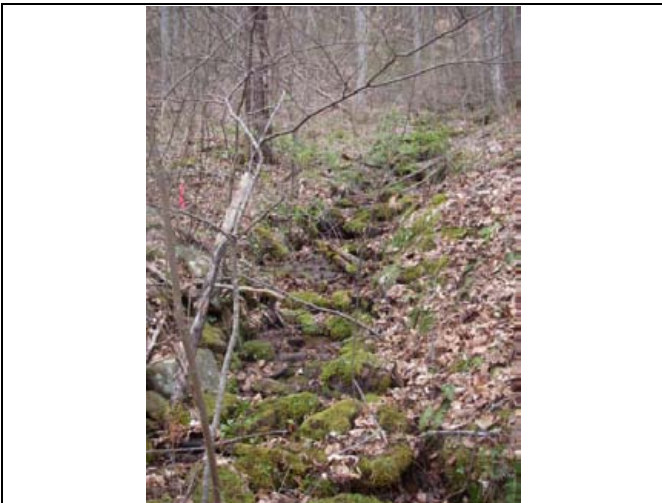
UT2 – Reference reach section located upstream from the perched channel transition.

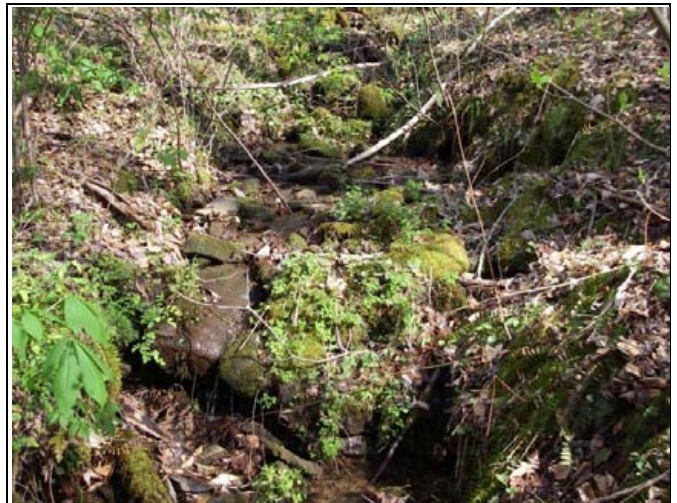
UT2 – Stable step-pool sequence within the reference reach section.

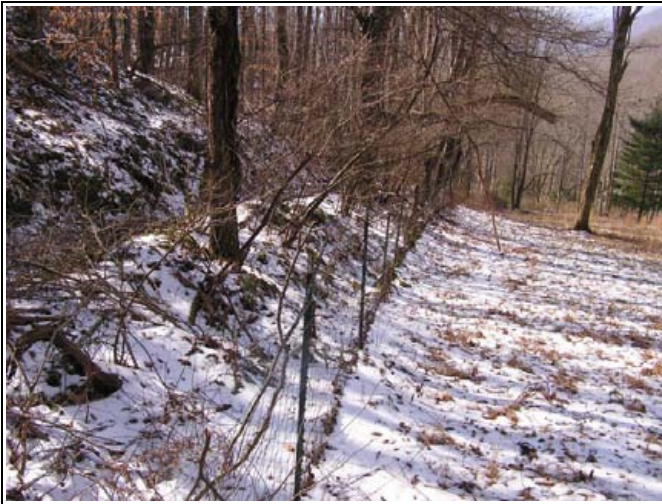
UT2 - Channel perched along the hillside with a berm along the right bank.

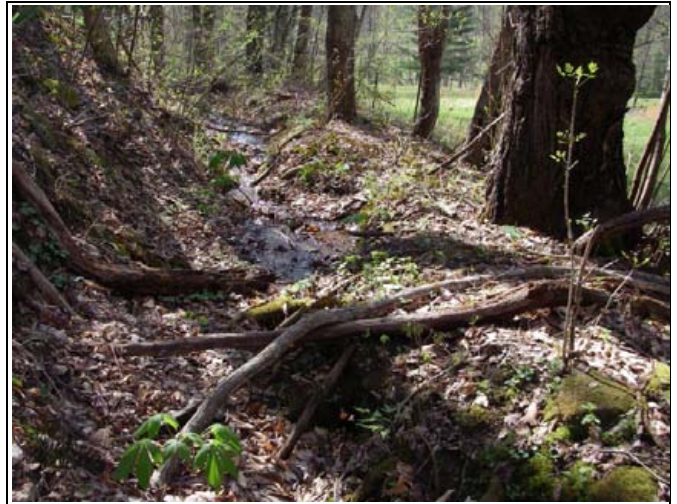
UT2 – Upstream limits of proposed offline channel alignment (by breaching the right bank).

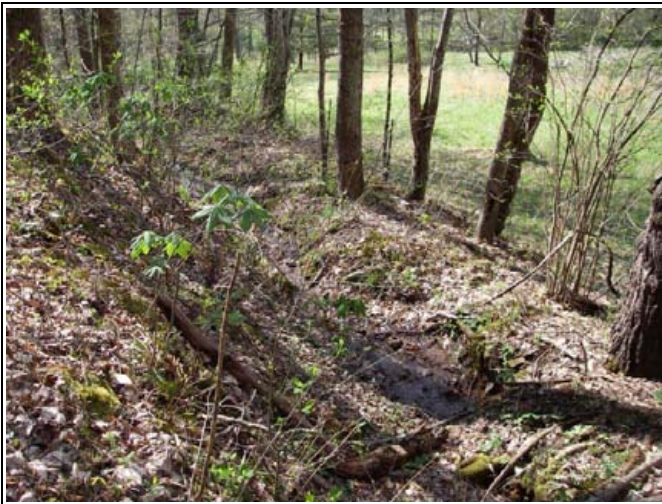
UT2 – Berm along right bank proposed for breaching to re-align channel down valley.

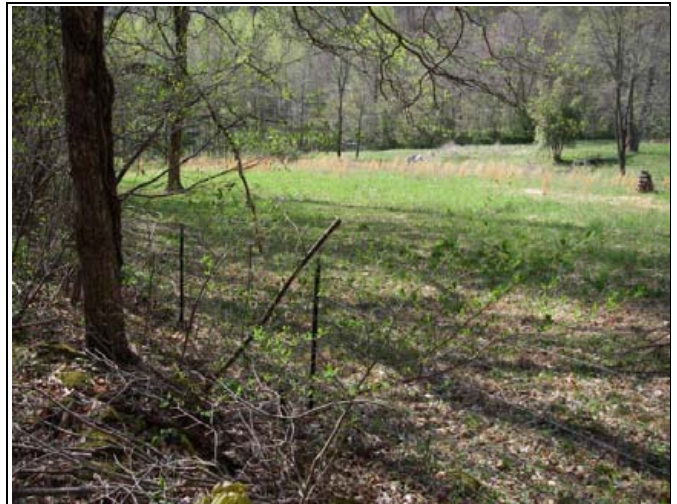
UT2 – Looking down valley where the restored channel will be relocated to the natural low point.

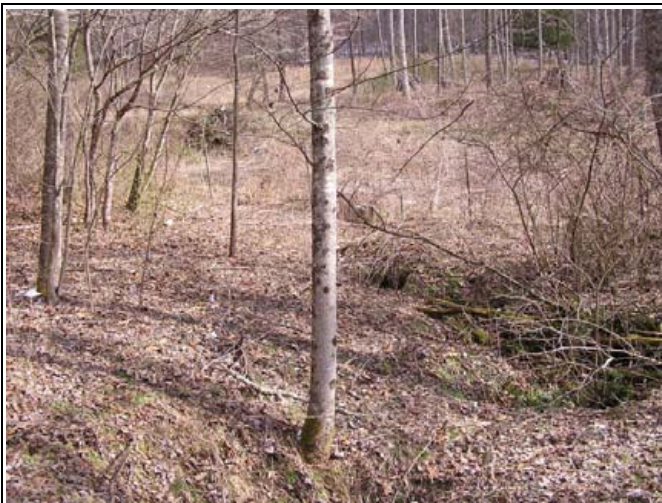
UT2 – Looking up valley where the restored channel will be relocated. Note the seeps on the right where the proposed channel will be routed.

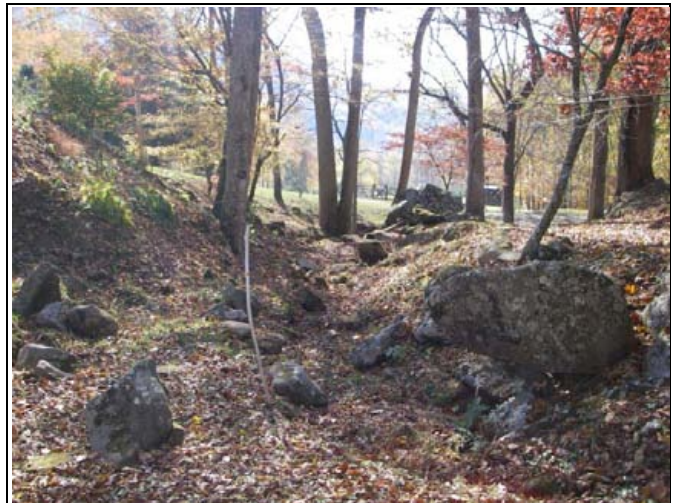
UT2 – ‘Relic’ channel within which UT2 drained before channelization and where flow from the proposed alignment will be re-routed (looking down valley).

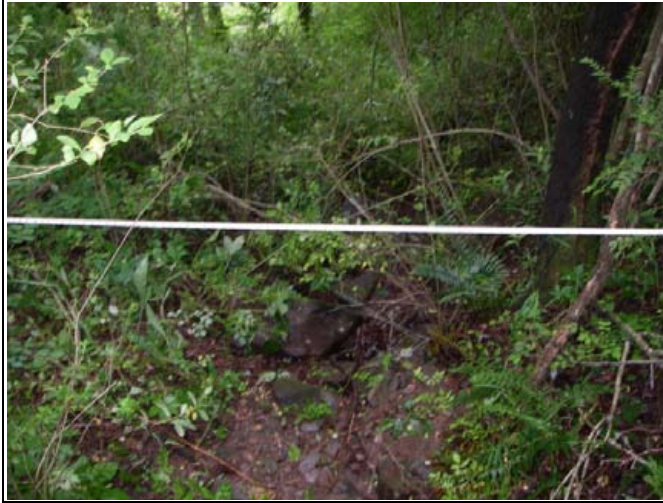
UT5 Reach 2 (enhancement) – Invasive vegetation choking out native species within the downstream reach limits.

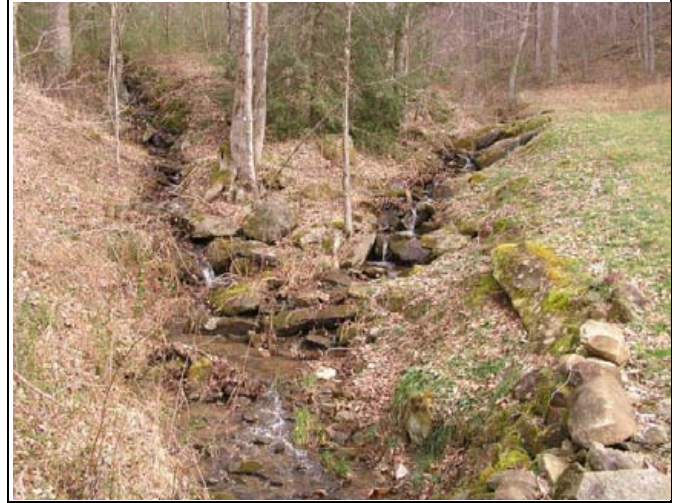
UT5 Reach 2 (enhancement) – Confluence of UT5 Reach 2 and East Buffalo looking upstream.

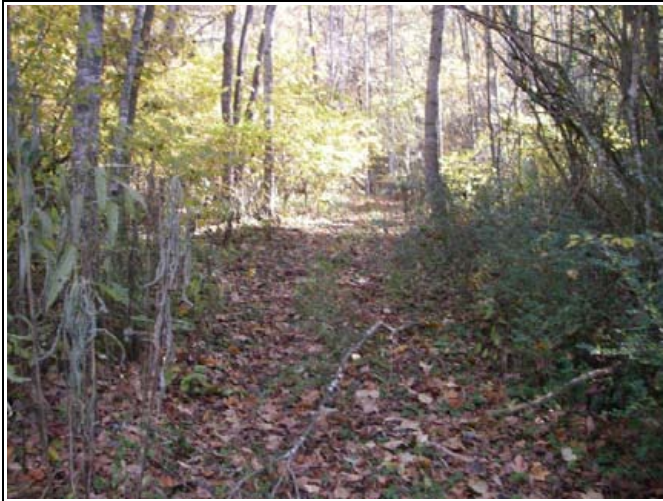
UT5 Reach 2 (enhancement) – Old forest road intersecting channel mid-reach where flow is routed through a culvert beneath the road

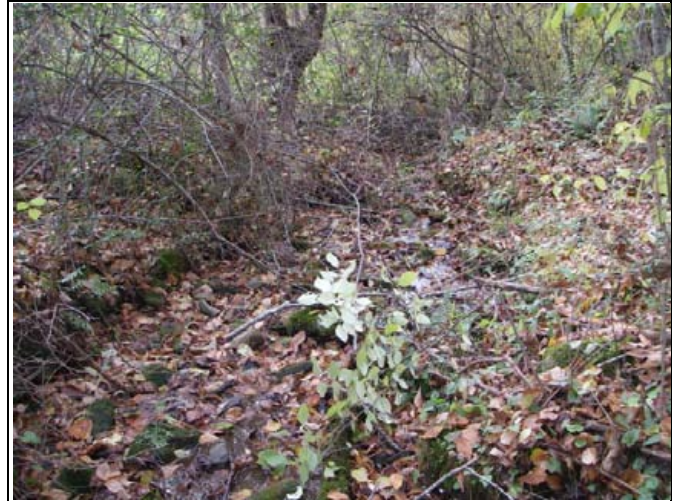
UT6 Reach 2 (enhancement) – Upstream subreach with invasive species situating the left floodplain in proximity to the clearing along the gravel road nearby.

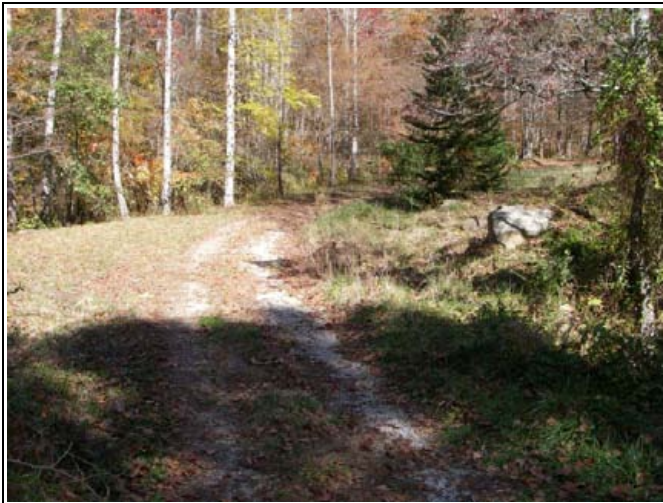
UT6 Reach 2 (enhancement) – Downstream subreach looking up valley at the gravel road realignment origin.

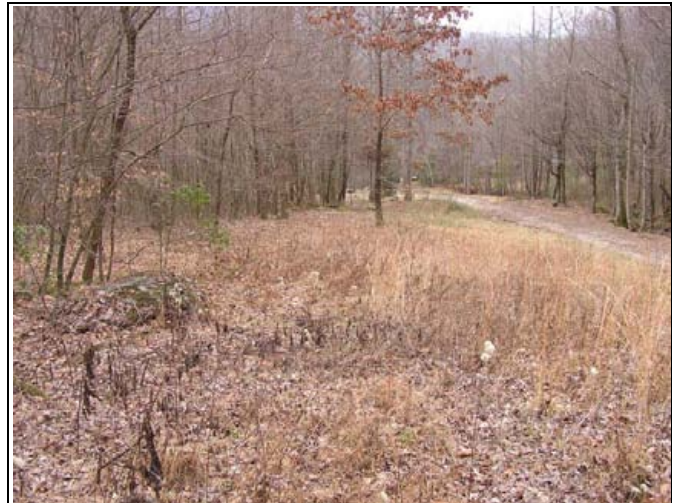
UT6 Reaches 2 & 3 (enhancement) – Looking down valley along proposed corridor for the relocated road.

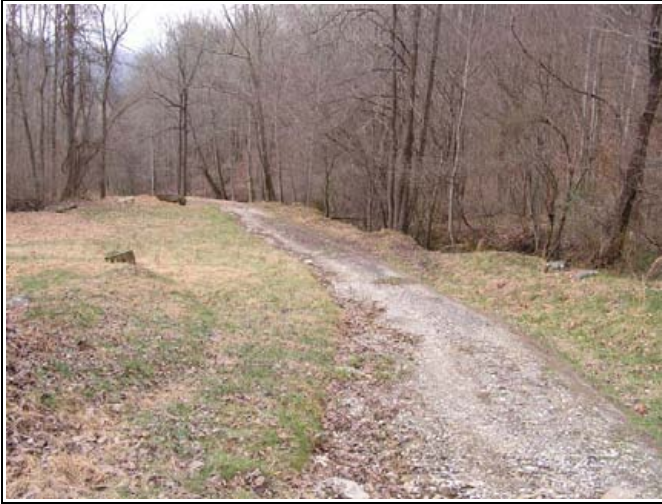
UT6 Reach 2 (enhancement) – Proposed tie-in location for the relocated road up valley (looking down valley).

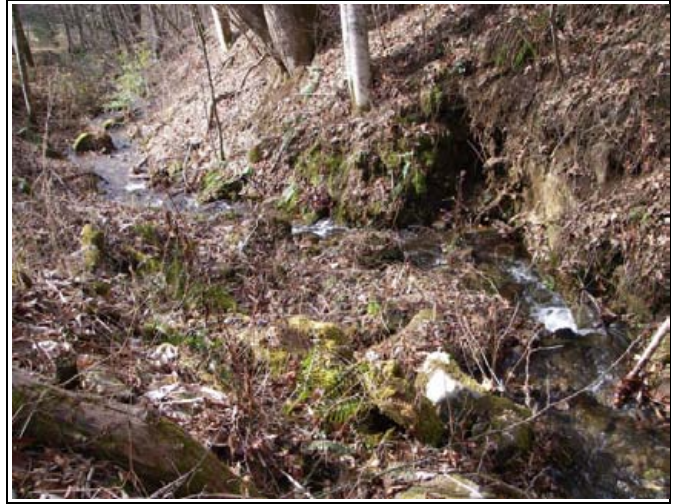
UT6 Reach 3 (enhancement) – Hillside erosion and bank slumping in sharp meander bend where channel is proposed for relocation away from valley wall.

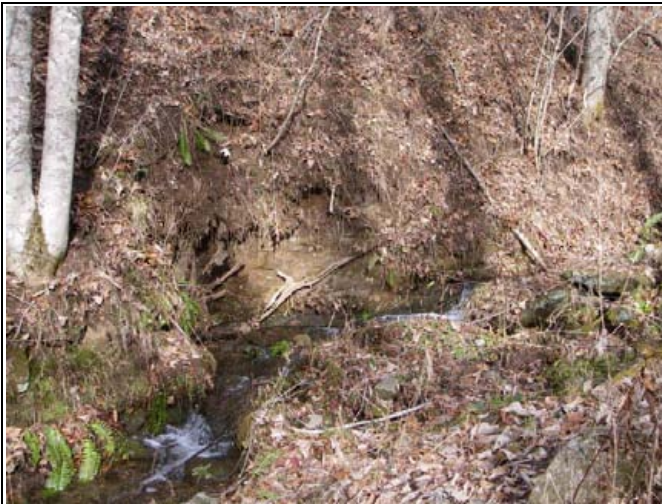
UT6 Reach 3 (enhancement) – Overwidened channel at eroded meander bend where the channel will be relocated.

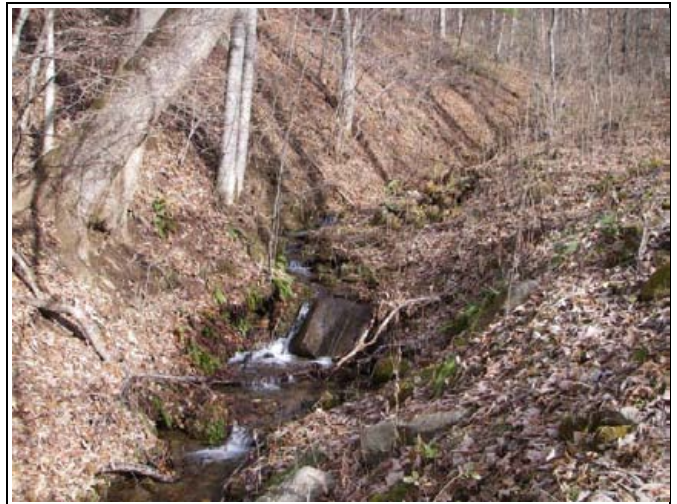
UT6 Reach 3 (enhancement) – Looking upstream at where channel will be relocated. Overwidened channel has eroded around existing grade control (boulder).

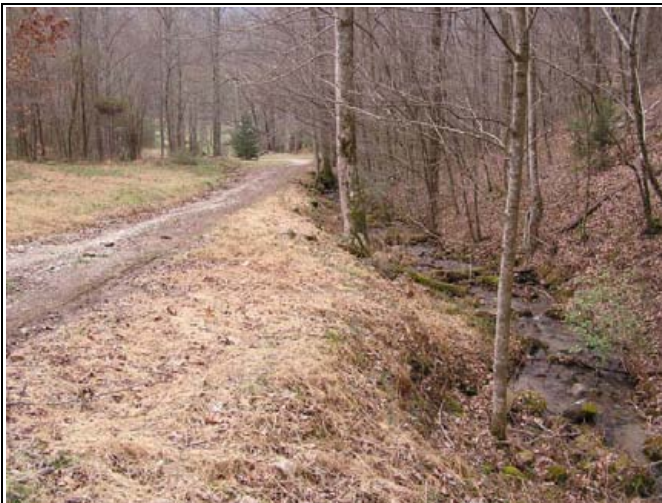
UT6 Reach 3 (enhancement) – Overwidened, entrenched channel with no buffer pinched between valley wall and eroding road embankment.

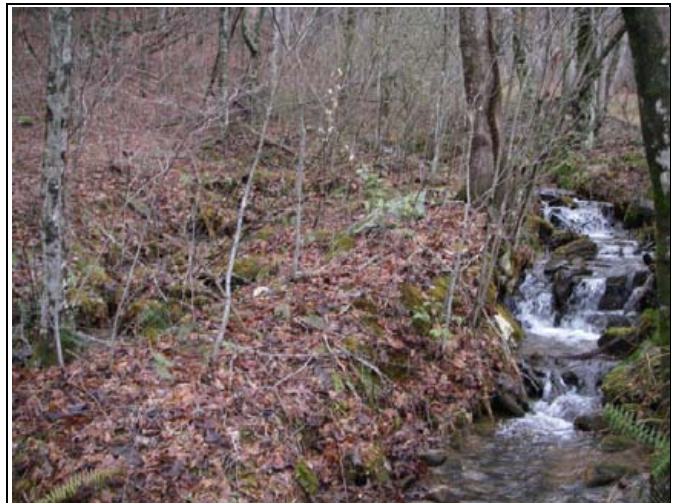
UT6 Reach 3 (enhancement) – Stable step-pool profile and diverse bedform features within downstream reach limits.
