STREAM RESTORATION PLAN

East Tarboro Canal
Edgecombe County, North Carolina

January 2005

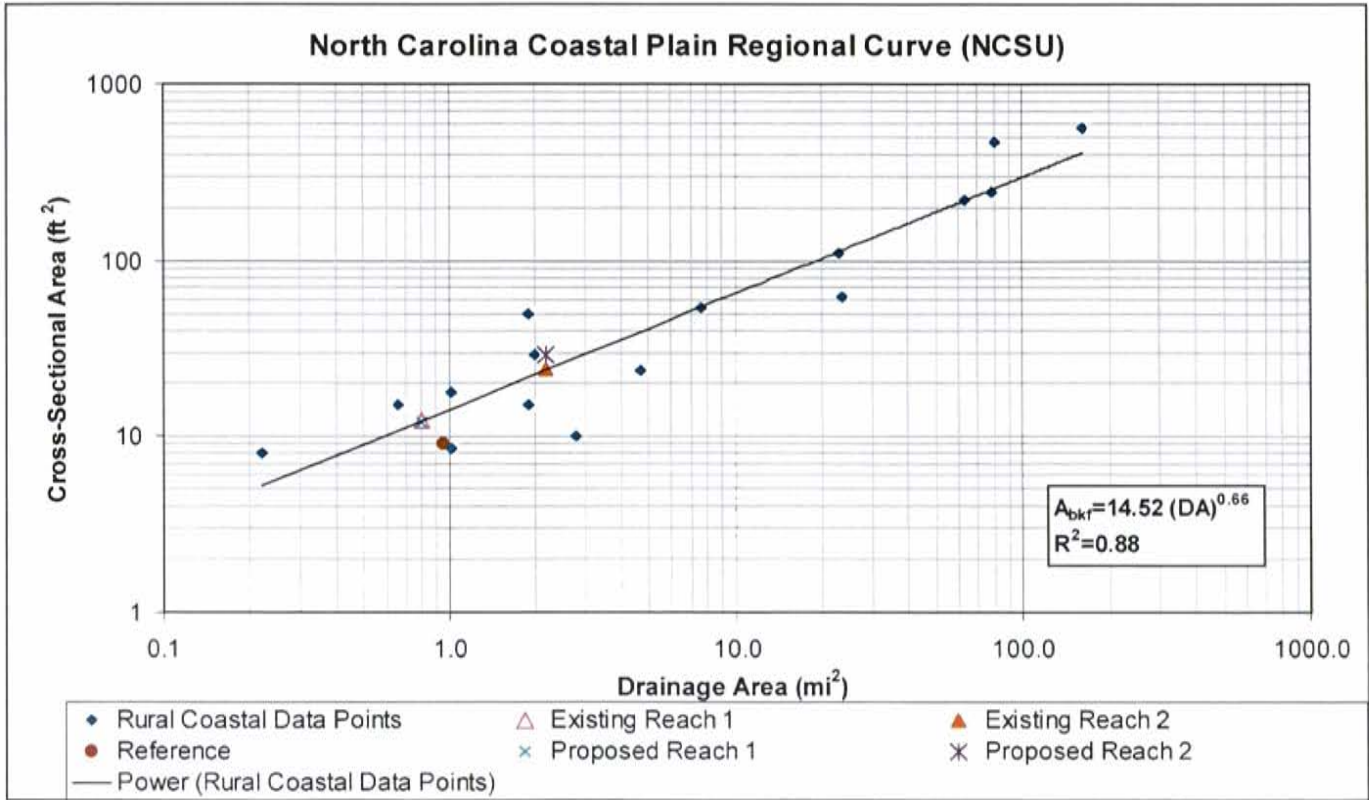
FIGURE 2
NORTH CAROLINA COASTAL
PLAIN BANKFULL
CROSS-SECTIONAL AREA
REGIONAL CURVE
East Tarboro Canal
Tarboro, North Carolina

Data obtained from field surveys described in Section 2.2.2 were used to compute the morphological characteristics shown on the graph. The cross-sectional area for both reaches of East Tarboro Canal plot just above the trend line on the NC Coastal Plain Regional Curve (Figure 2).

In ungauged areas like the East Tarboro Canal, Dave Rosgen recommends verifying bankfull with the development of regional curves. The regional curves normally plot bankfull discharge (Q_{bkf}), cross-sectional area, width, and depth as a function of drainage area. The cross-sectional areas of both reaches of the East Tarboro Canal, the reference reach, and the proposed design area are plotted on the North Carolina Coastal Plain Regional Curve developed by the North Carolina State University (NCSU) Water Quality Group, 2003 (Figure 2).

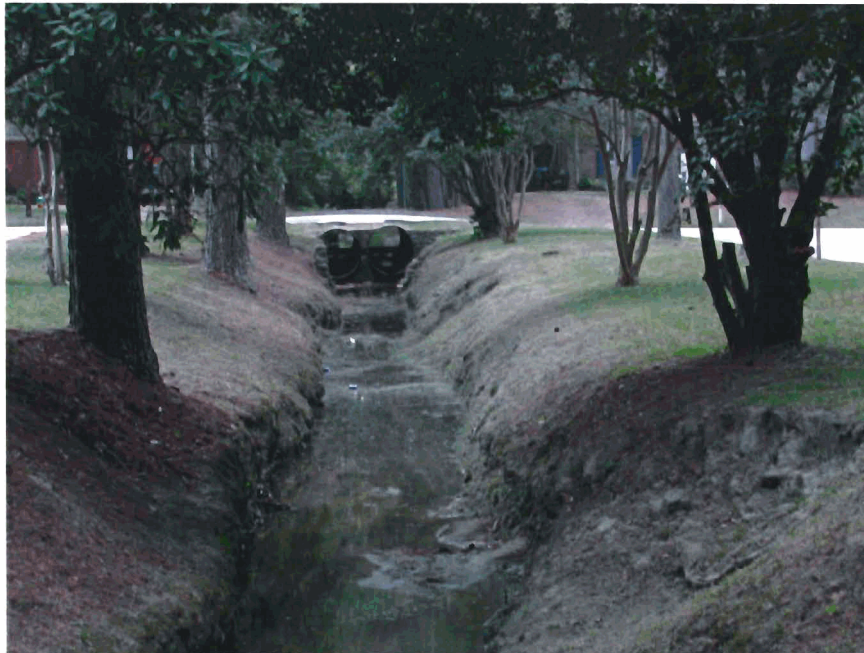
2. Looking upstream at Forest Acres Drive culvert

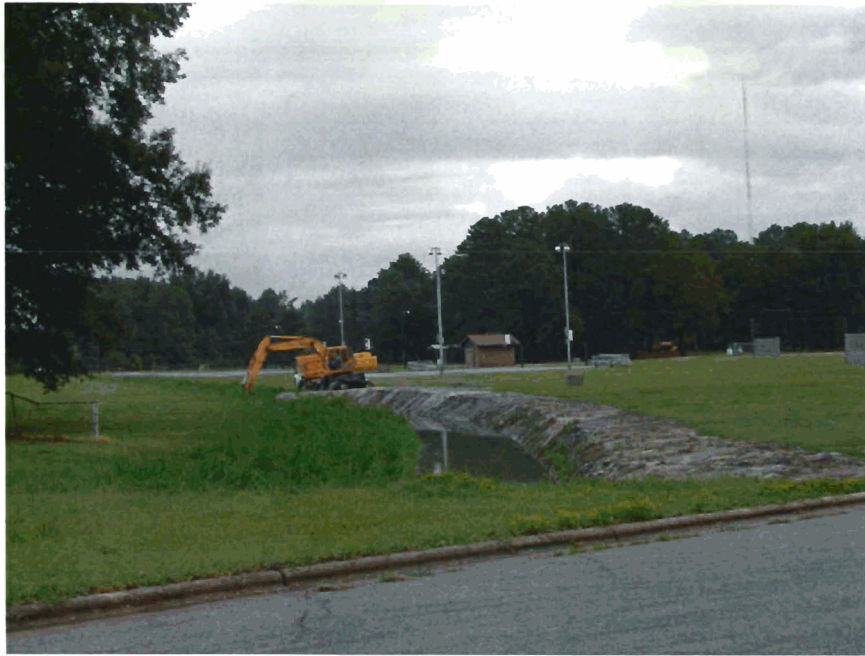
7. Looking upstream from Wilson Street during Town “maintenance” of canal

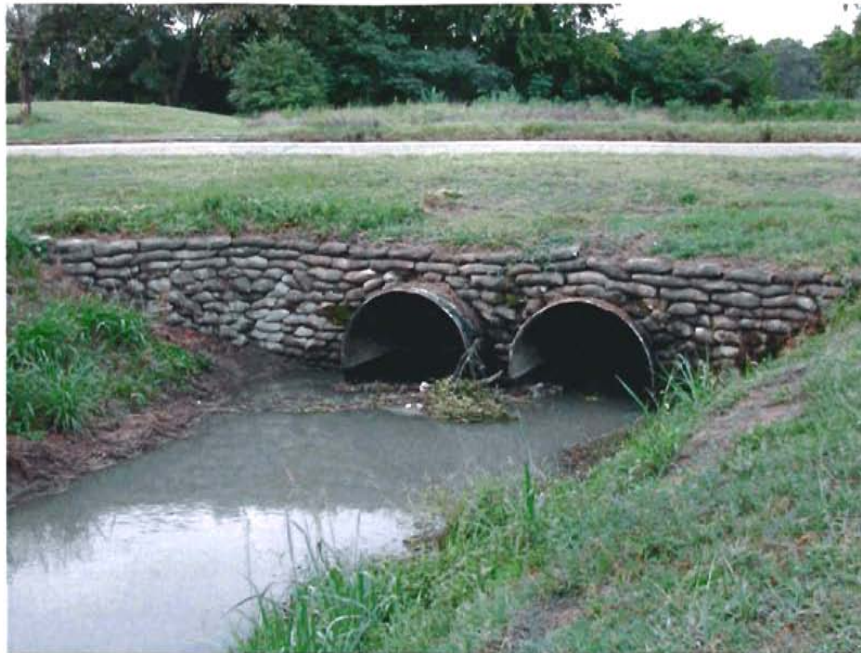
9. Looking downstream at Wilson Street culvert
