Elk Branch Restoration Plan-Final

Mitchell County, North Carolina

EEP Project Number D06125-B

Elk Branch Restoration Plan

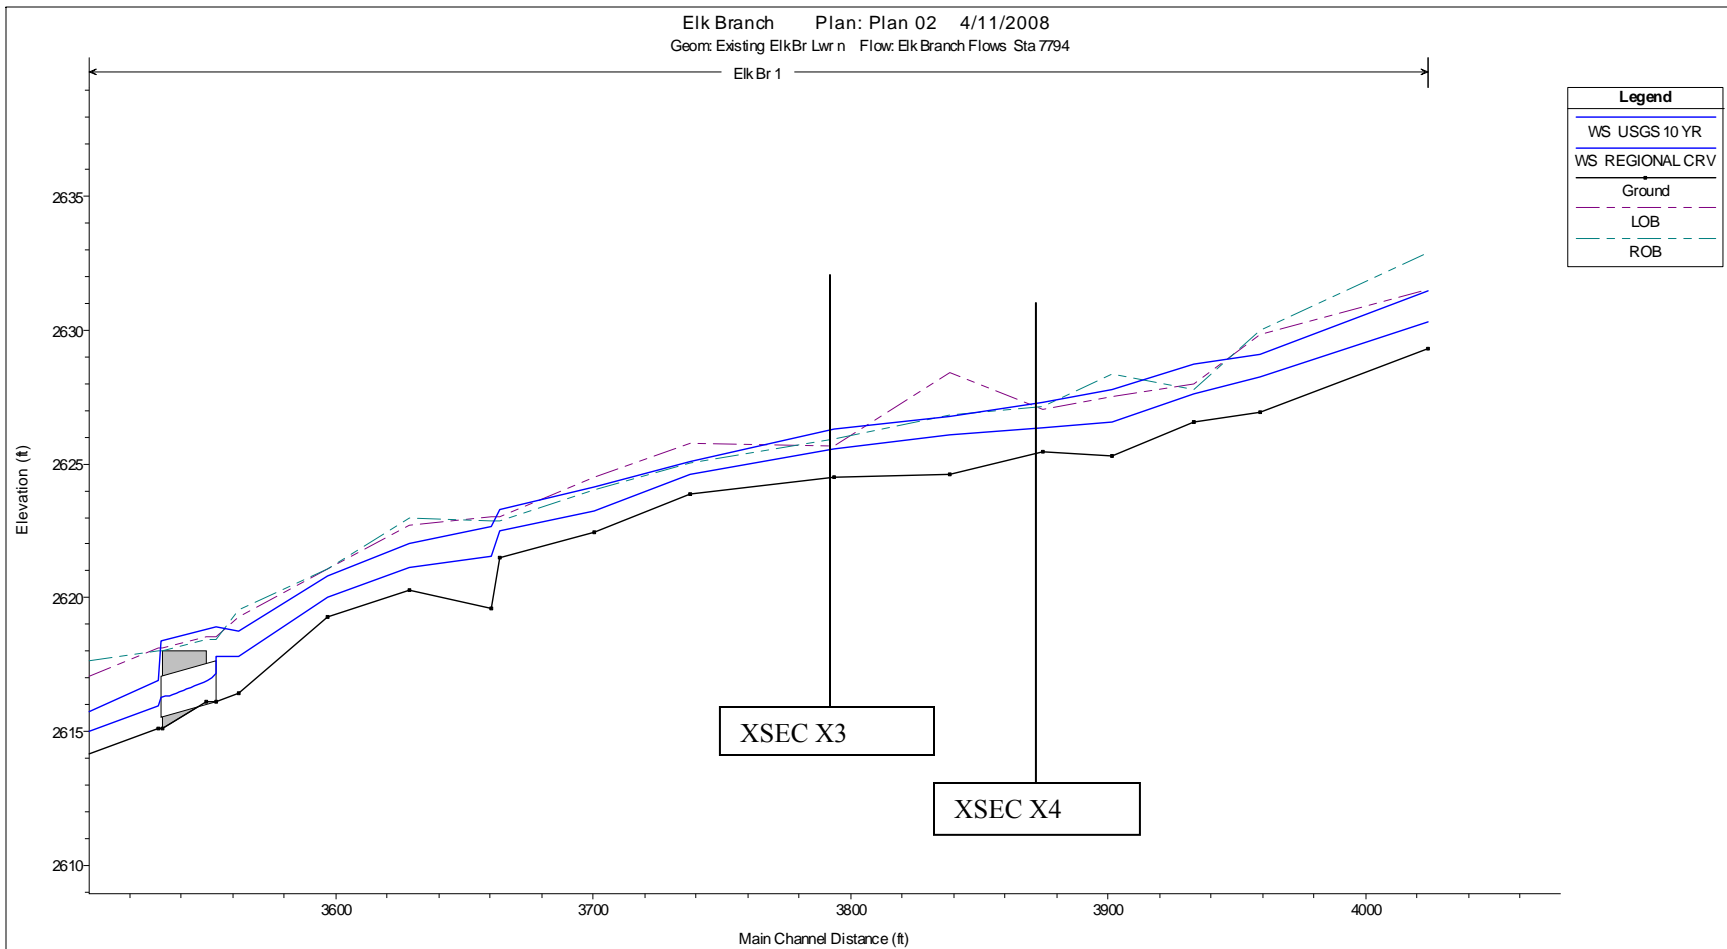
Figure 3.2. HEC-RAS Water Surfaces for Regional Curve (WS REGIONAL CRV) and USGS 10-Year (WS USGS 10 YR) Flows in Reach 1 with Locations of Detailed-survey Cross-sections (X3 and X4) Described in Table 3.1

Modeling of the USGS 2, 5, and 10-year flows indicated that the majority of Reach 1 did not have a good connection with the floodplain (Pope et al., 2001). The channel invert or thalweg (“Ground”), regional curve and 10-year water surface elevations, and left and right top of bank (“LOB”, “ROB”) are shown in Figures 3.2 and 3.3. For the majority of the reach, there is no overbank flow at the regional curve bankfull flow or even at the 2-year flow. Significant portions of the reach hold flows higher than USGS 10-year within the channel.

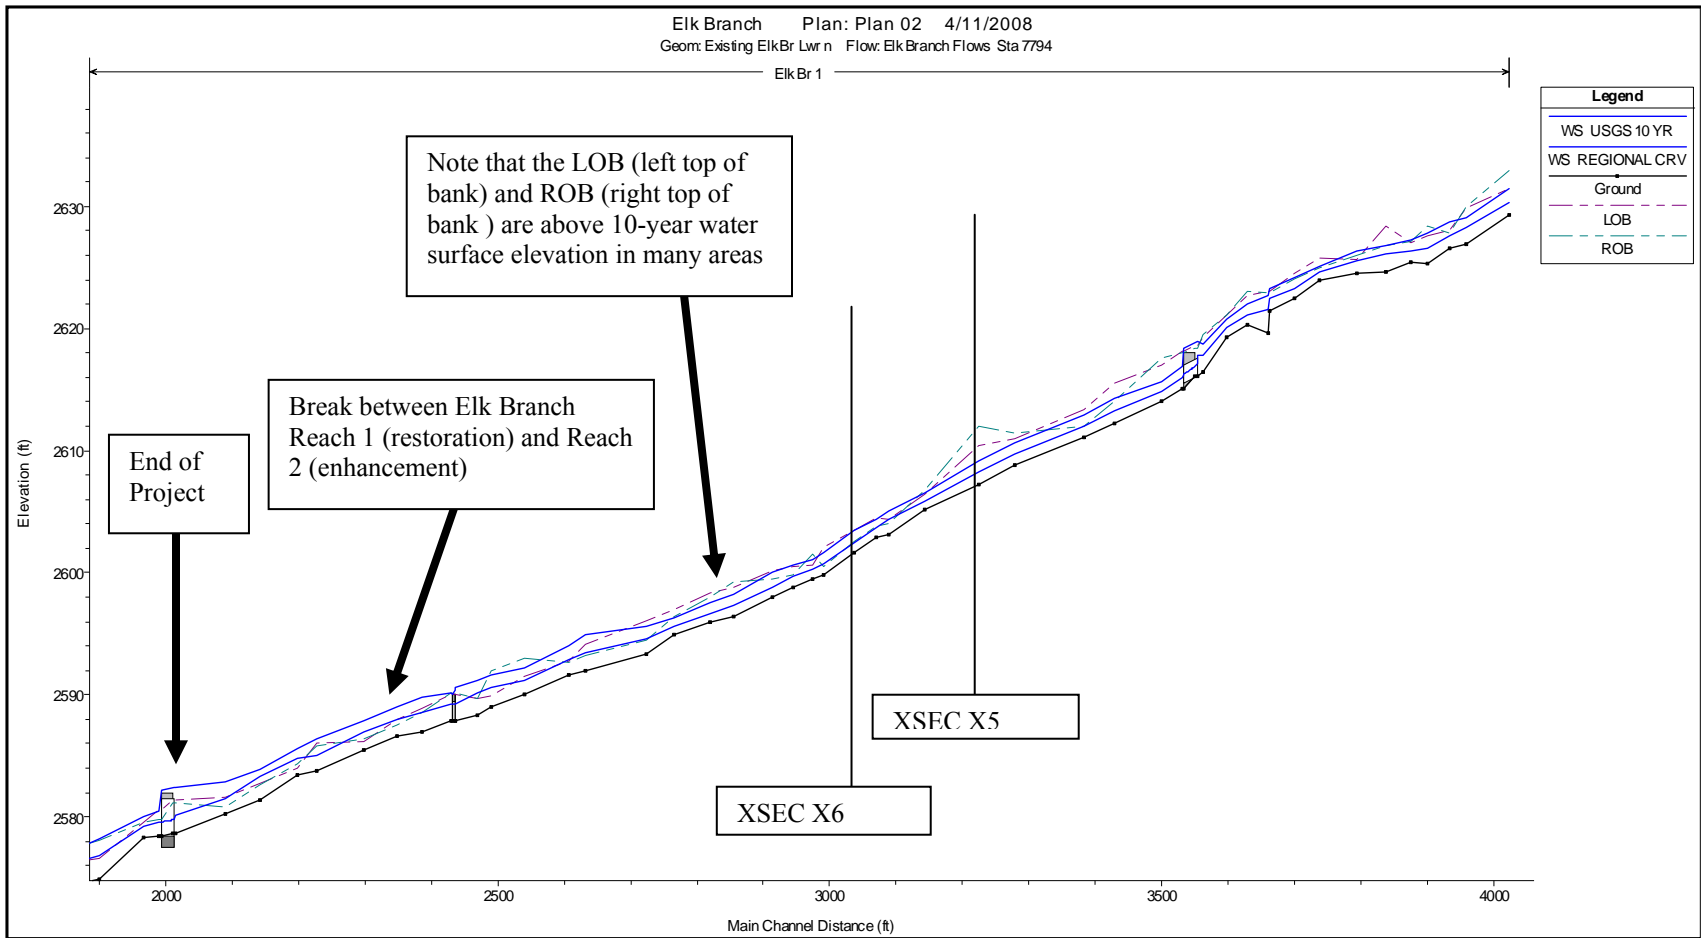
Figure 3.3 HEC-RAS Bankfull and 10-Year Water Surface Profiles, Entire Mainstem Project Reach

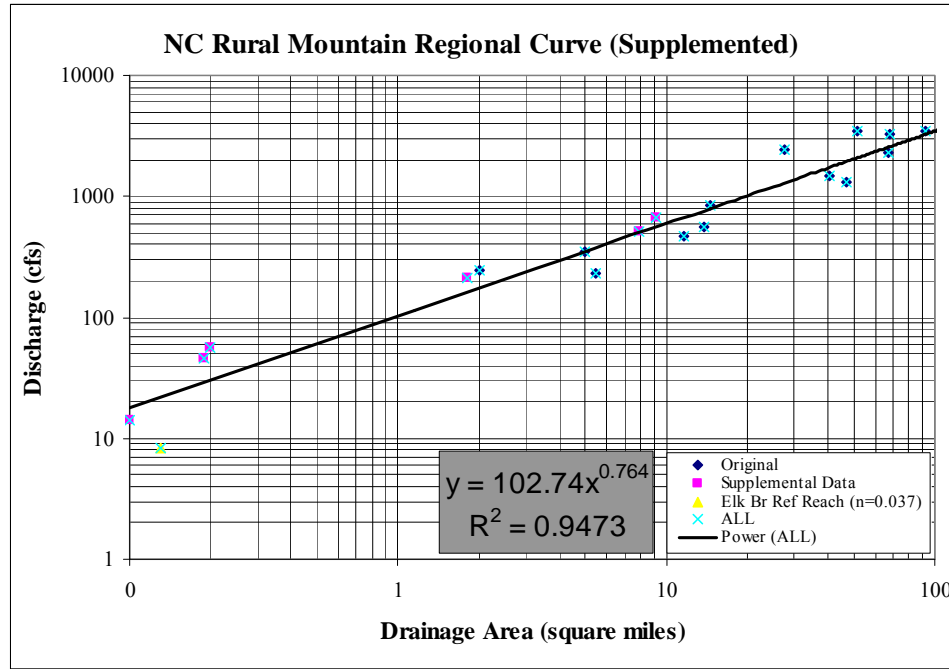
Figure 3.4 Supplemented NC Mountain Regional Curve for Discharge

In-house and publicly available reference stream data was obtained for streams characterized by comparable drainage area size, physiographic and geomorphologic similarity, and relative geographical proximity to the Elk Branch project. The resulting data were used to enhance and extend the published Mountain Regional Curves by including more data on the lower end of the curve (smaller drainage areas). The resulting “mini” curve for discharge, and the new power function fit to those sites which were hand selected for their similarity to the project site, are depicted in Figure 3.4.

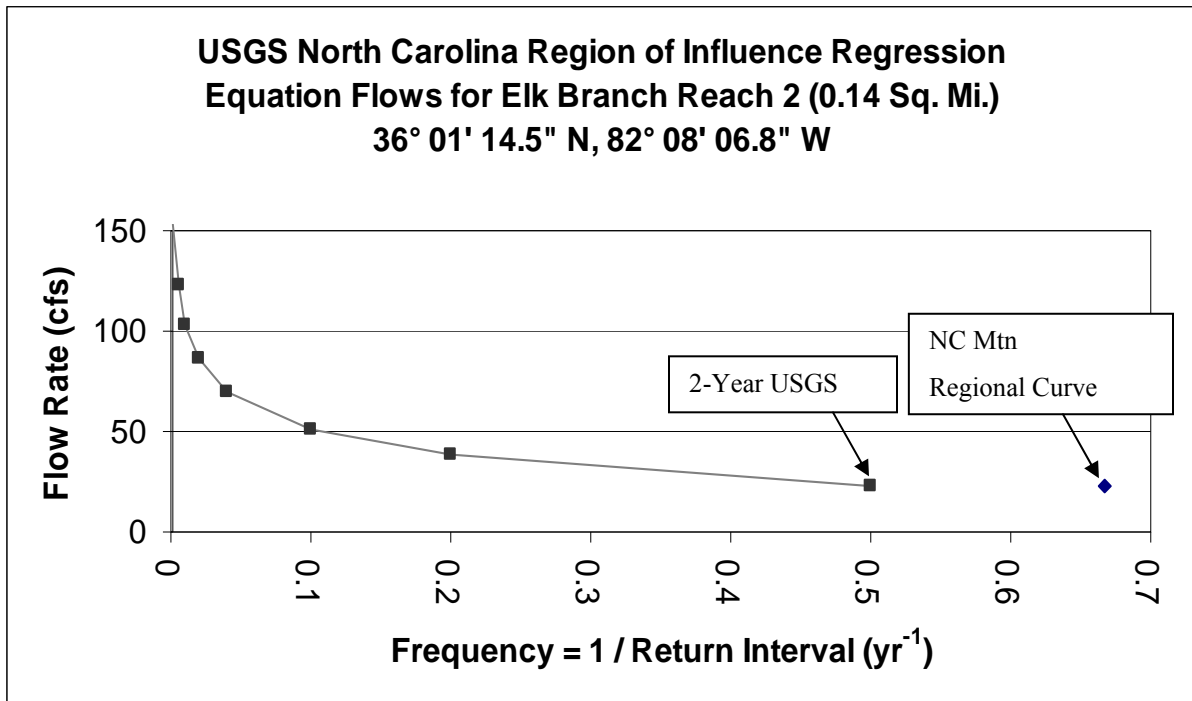
Figure 3.5 USGS Regional Regression Equation Flood Events

North Carolina USGS Regionalized Regression Equations (Pope et al. 2001) incorporate latitude, longitude, and drainage area information when used to calculate flood estimates based on data from USGS gauges. These regression equations were used to calculate the estimates for the 2-, 5-, 10-, and 25-year floods. An example for Elk Branch Reach 2 (drainage area = 0.14 square miles) is plotted in Figure 3.5 below, with the supplemented regional curve flow for this project at the far right (assumed return interval of 1.5 or 0.66 frequency for plotting purposes). These regression equation flows were used as comparative estimates of different flow frequencies.

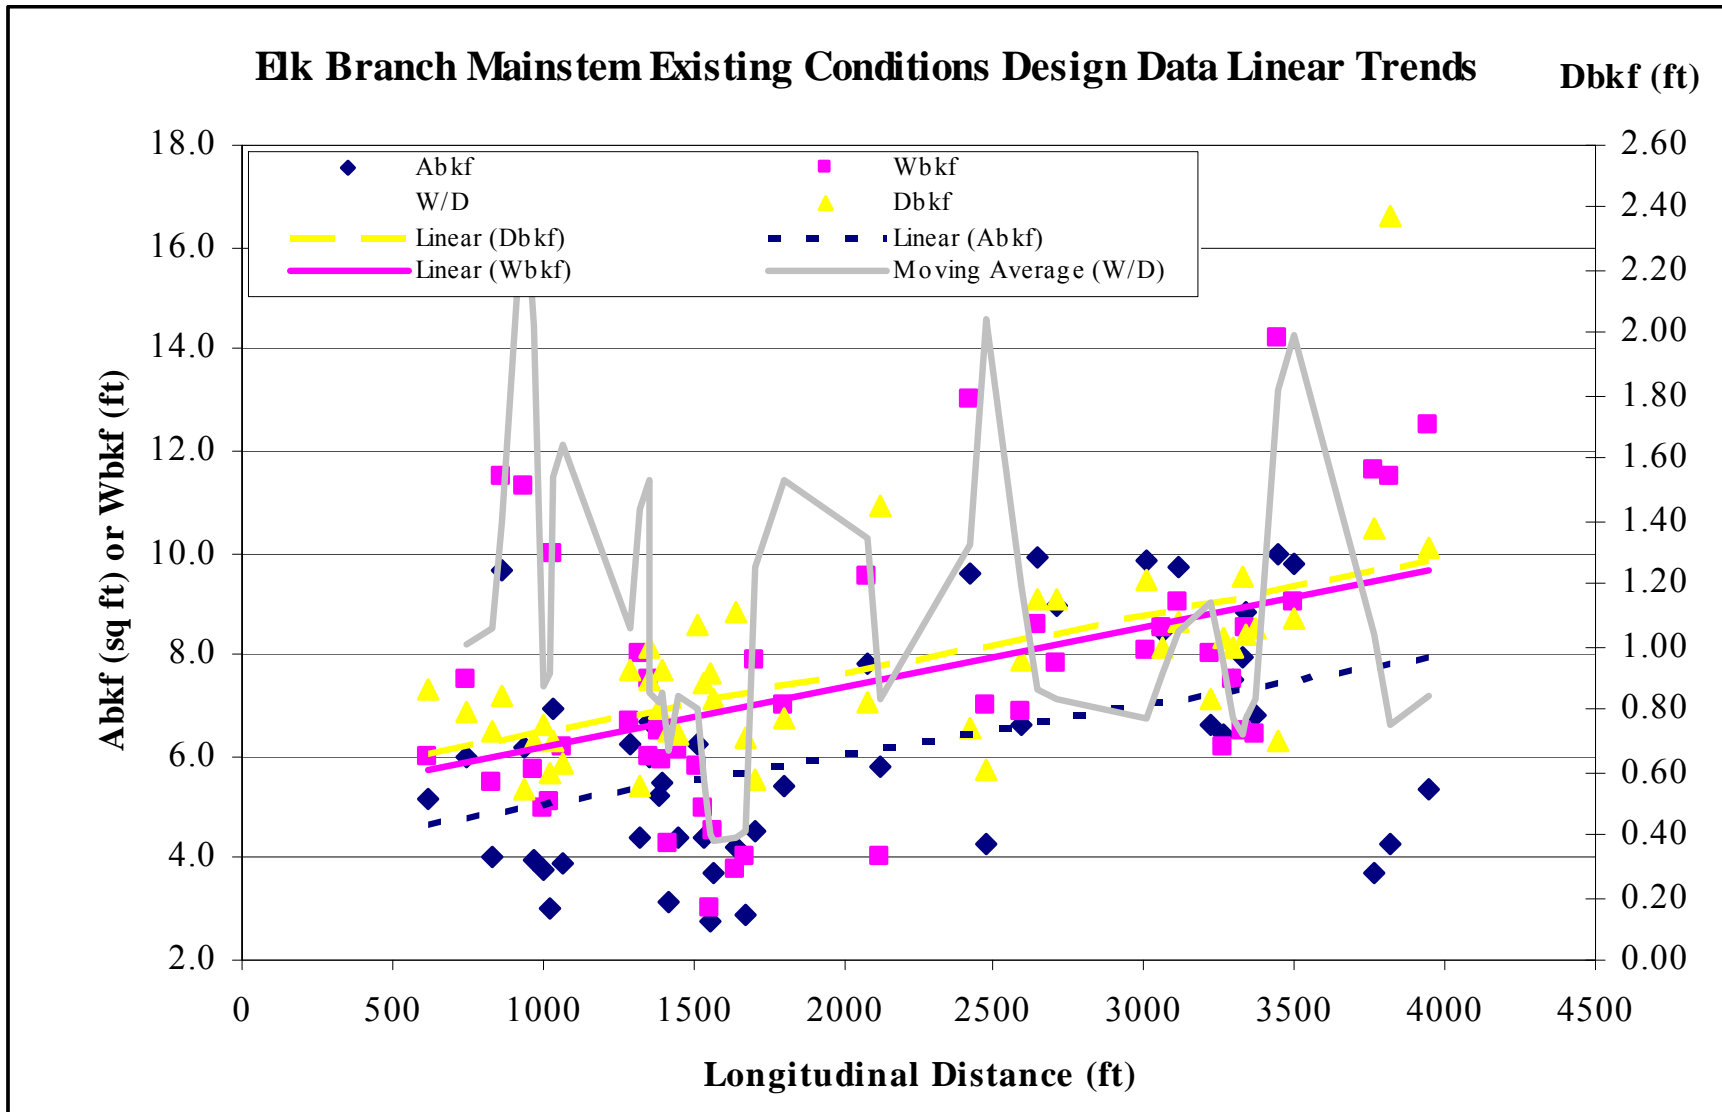
Figure 6.1 Elk Branch Existing Condition Data Trends (In figure, “bkf” is a misnomer, dimensions are from top of bank measurements)

A table of results has been provided (Table 6.1) to show some of the data and some tables produced to assess the impact of slope on channel dimensions. Statistical assessment on a reach or sub-reach scale in the form of averages and standard deviation values may be more easily taken in by the reader in Figure 6.1. The moving average of the W/D ratio for these cross-sections has been plotted. The analysis did provide some information about changes in dimensions potentially related to downstream distance and changes potentially related to slope.

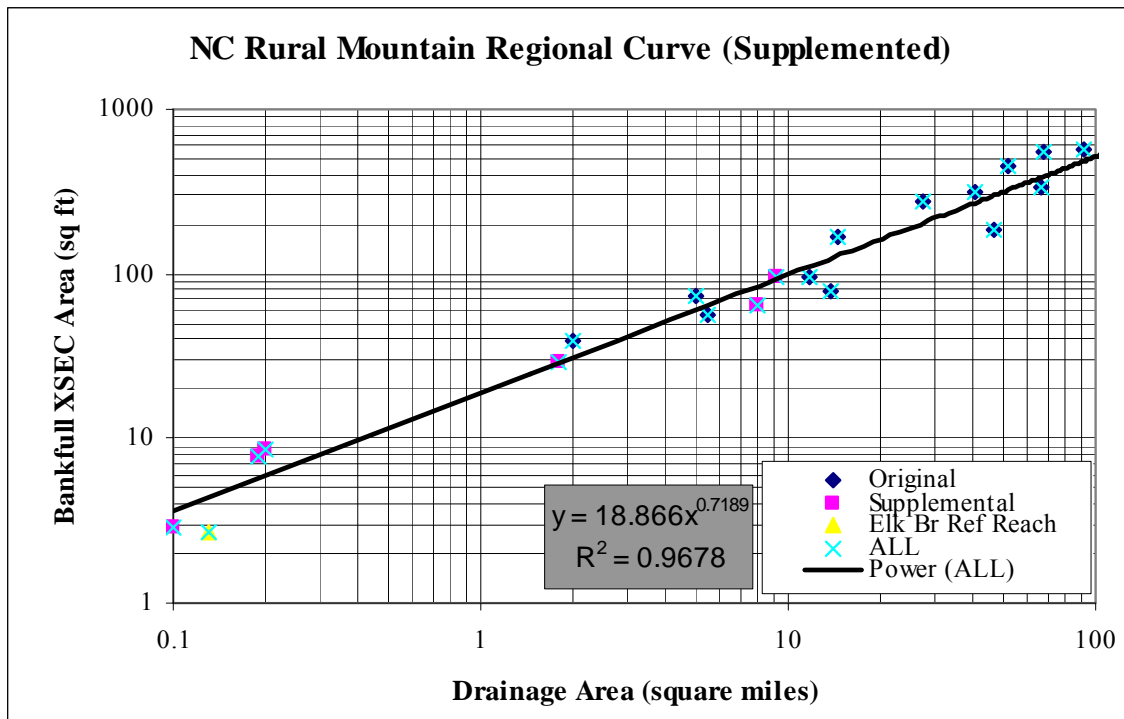
Figure 6.2 Elk Branch Supplemented Regional Curve for Bankfull Cross-sectional Area

Regional curve, reference reach database, and on-site reference data was used to create “mini” (also referred to as “supplemented”) curves for the Elk Branch project (See Figures 6.2, 6.3, and 6.4). Some of the data points from the Mountain Regional Curve with large drainage areas were eliminated from the data set. The remaining points are from similar valley types and have a cap on the drainage area size to view a subset of streams with smaller drainage areas. New R^2 values for the “mini” curve were as good as, or better than, the published Regional Curve.

The on-site reference data from a subreach of Reach 2 of Elk Branch plotted below all of the best fit curves. This is attributed in part to the fact that the data was taken from a nearly perfect rectangular cross-section with a low W/D ratio. Channels of this shape are called efficient because of their ability to carry a larger discharge within a smaller channel because of the minimization of roughness in the form of wetted perimeter (shape roughness). Since constructed channels will be built with a higher W/D ratio, these channels will have a cross-sectional area slightly larger than the reference reach in order to carry the design discharge at the bankfull elevation.

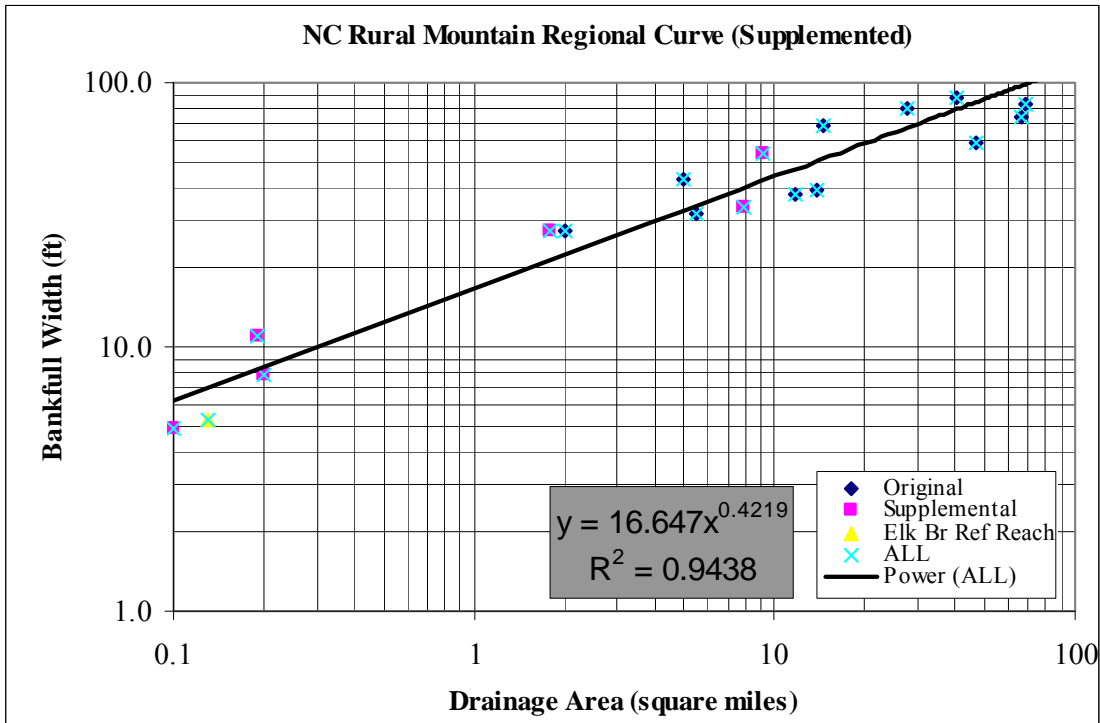
Figure 6.3 Elk Branch Supplemented Regional Curve for Bankfull Width

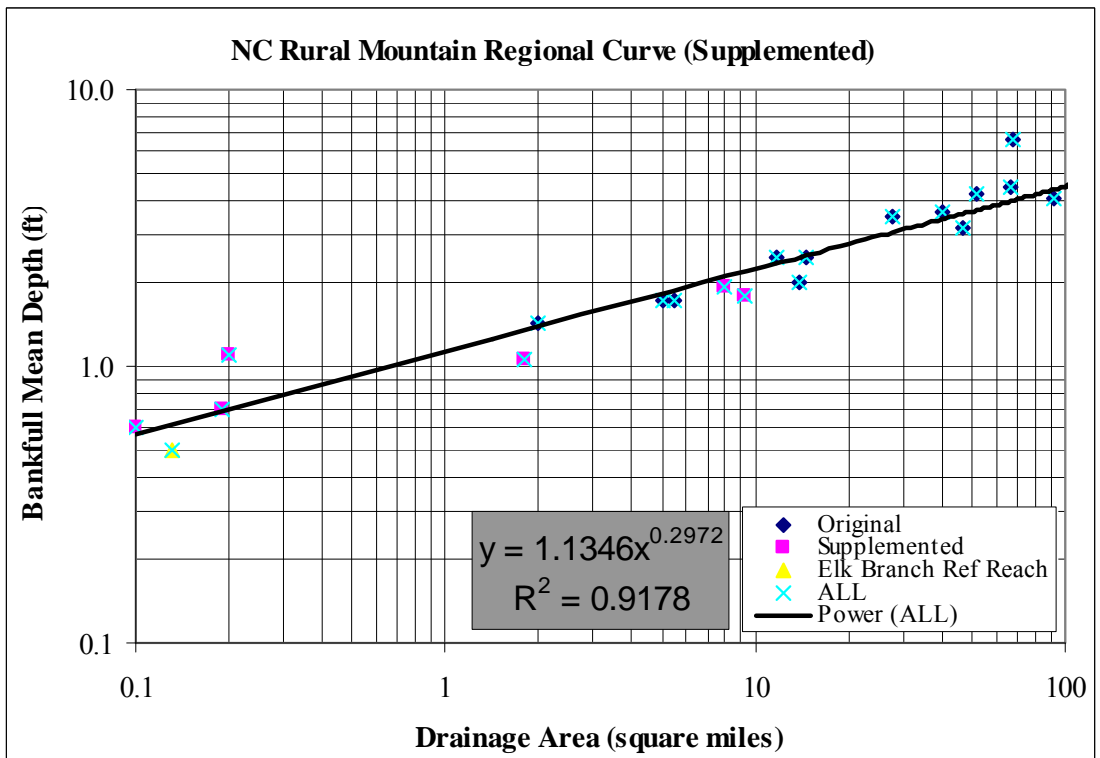
Figure 6.4 Elk Branch Supplemented Regional Curve for Bankfull Depth

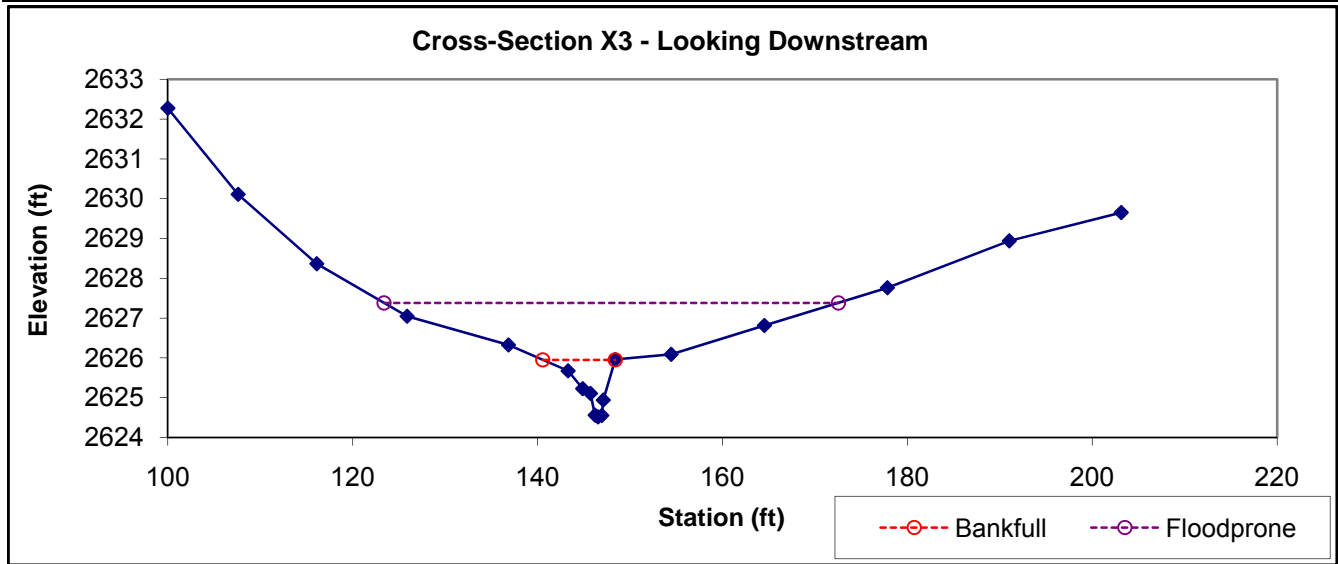
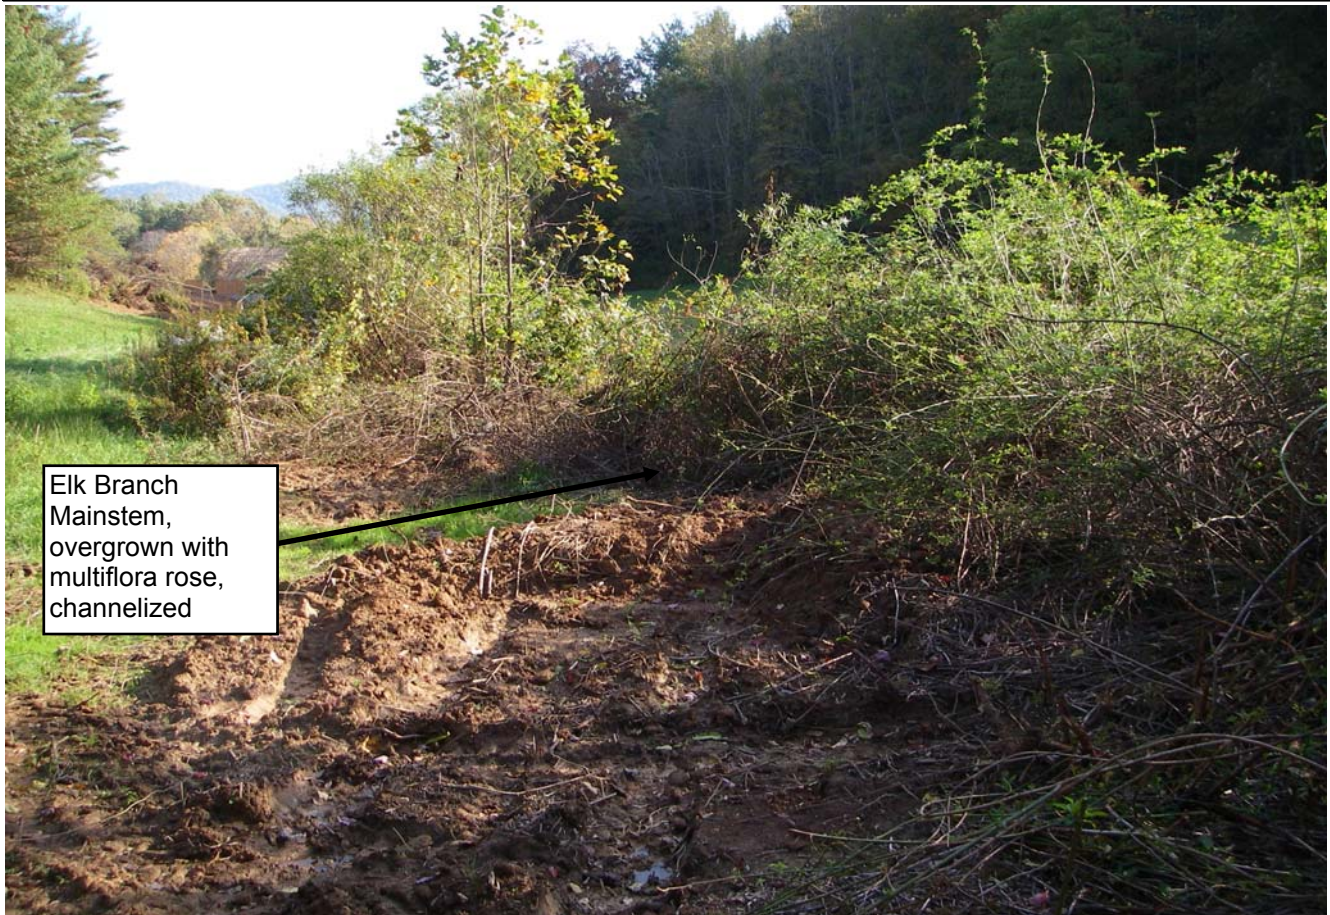
Cross-section Data: Elk Branch Mainstem (Reach 1)

Feature	Stream Type	BKF Area	BKF Width	BKF Depth	Max BKF Depth	W/D	BH Ratio	ER	BKF Elev	TOB Elev
Run	Cb	4.3	7.83	0.54	1.43	14.41	1.1	6.3	2625.95	2626.09

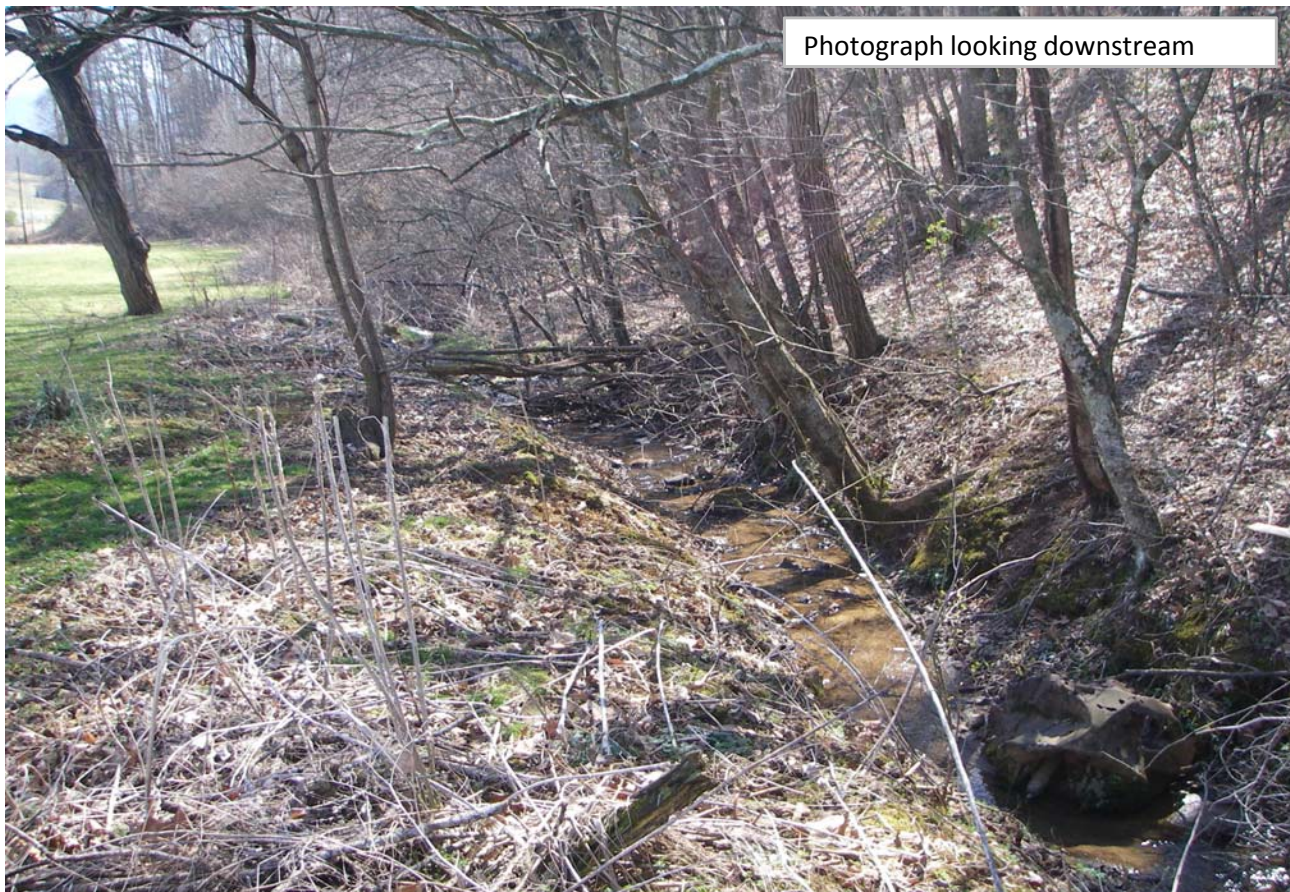
Cross-section Data: Elk Branch Mainstem (Reach 1)

Feature	Stream Type	BKF Area	BKF Width	BKF Depth	Max BKF Depth	W/D	BH Ratio	ER	BKF Elev	TOB Elev
Run	G*	3.0	4.72	0.64	0.99	7.3	3.1	1.6	2608.19	2610.29

* This stream is a G that is closer to moderately entrenched than typical G-type streams, for purposes of classification, ER can vary by +/- 0.2 units, the W/D ratio is too low to be a B-type stream

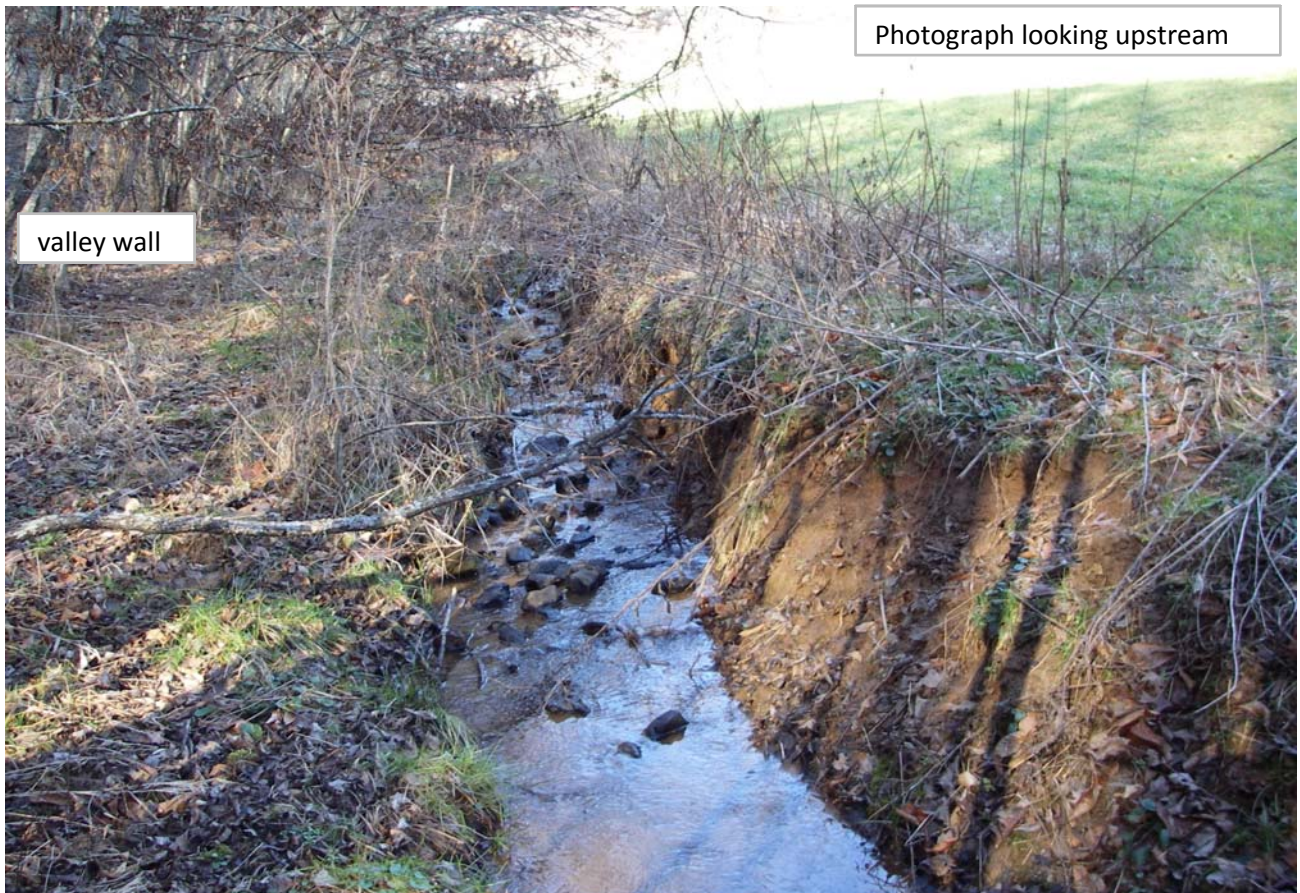
Cross-section Data: Elk Branch Mainstem (Reach 1)

Feature	Stream Type	BKF Area	BKF Width	BKF Depth	Max BKF Depth	W/D	BH Ratio	ER	BKF Elev	TOB Elev
Riffle	Eb*	3.2	5.33	0.6	0.85	8.9	1.1	4	2602.48	2602.52

* In this reach, the channel is either entrenched as shown in XS# 55 or it is eroding as shown in this photograph. In all cases, the channel is near the right valley wall, and confined by the left bank

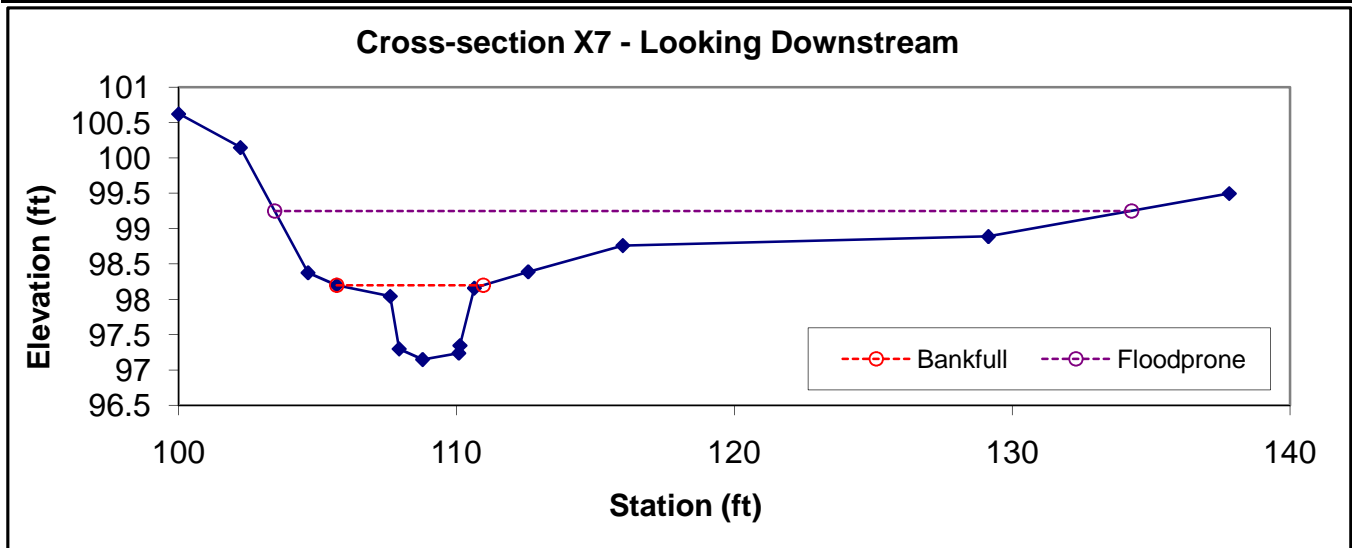
Cross-section Data: Elk Branch Mainstem (Reach 2)

Feature	Stream Type	BKF Area	BKF Width	BKF Depth	Max BKF Depth	W/D	BH Ratio	ER	BKF Elev	TOB Elev
Riffle	Eb	2.7	5.3	0.52	1.05	10.2	0.9	5.8	98.2	98.04

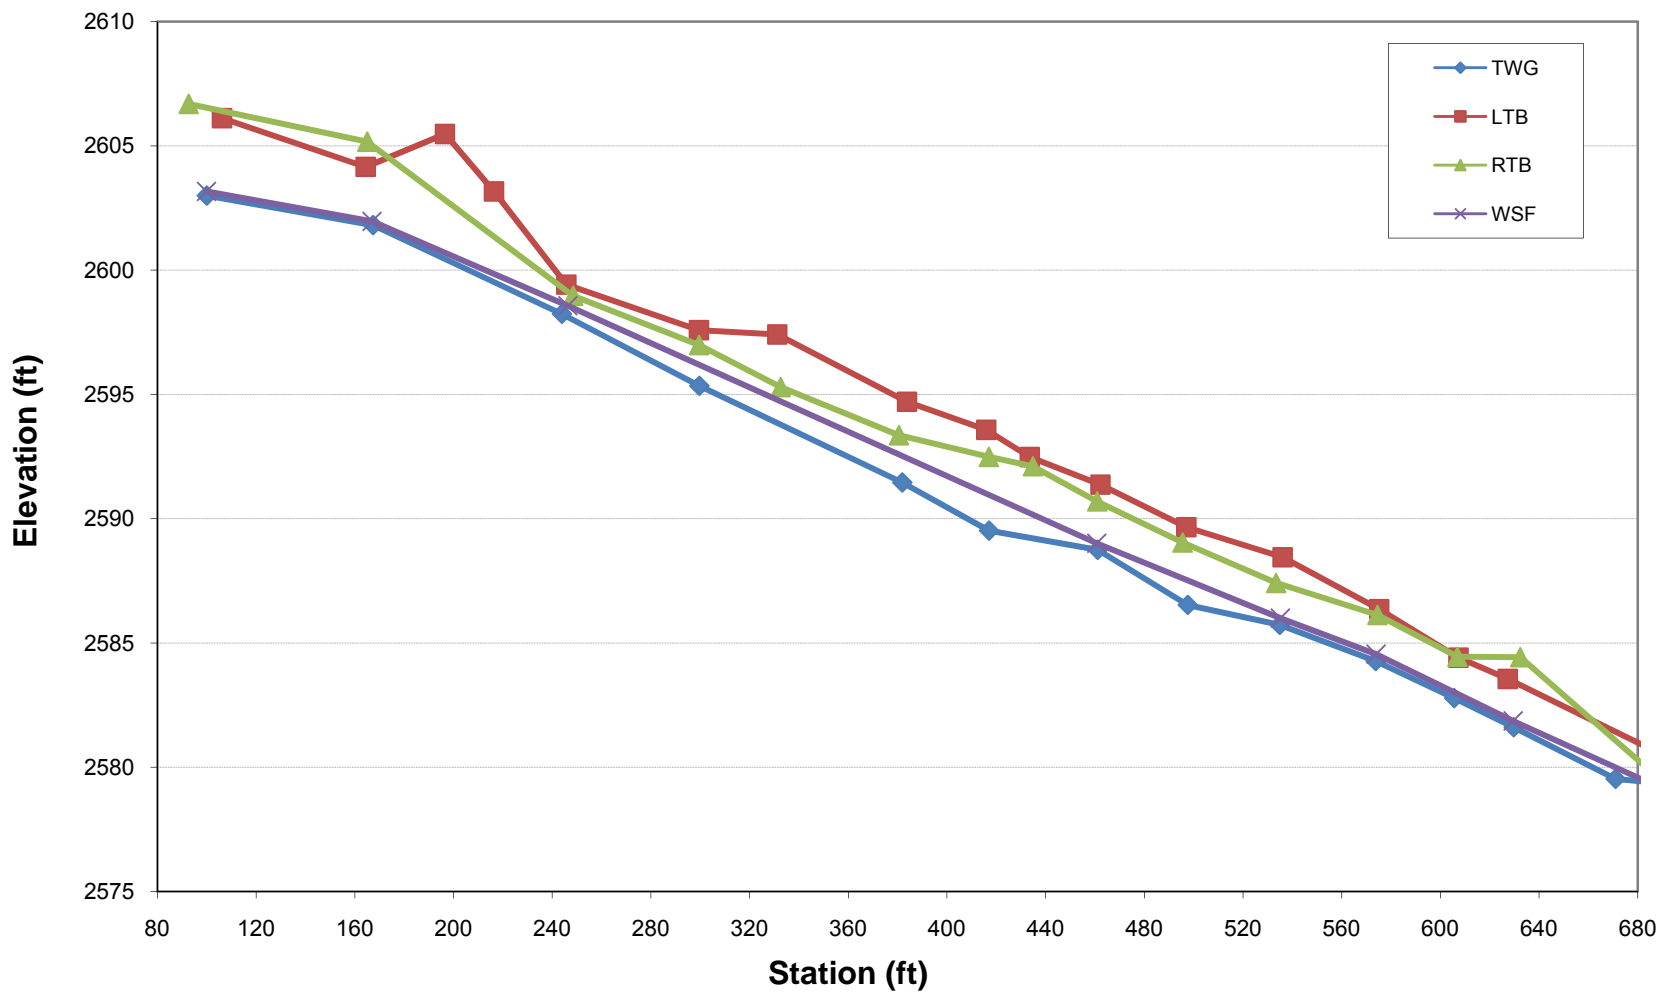
Elk Branch UT 1 Longitudinal Profile

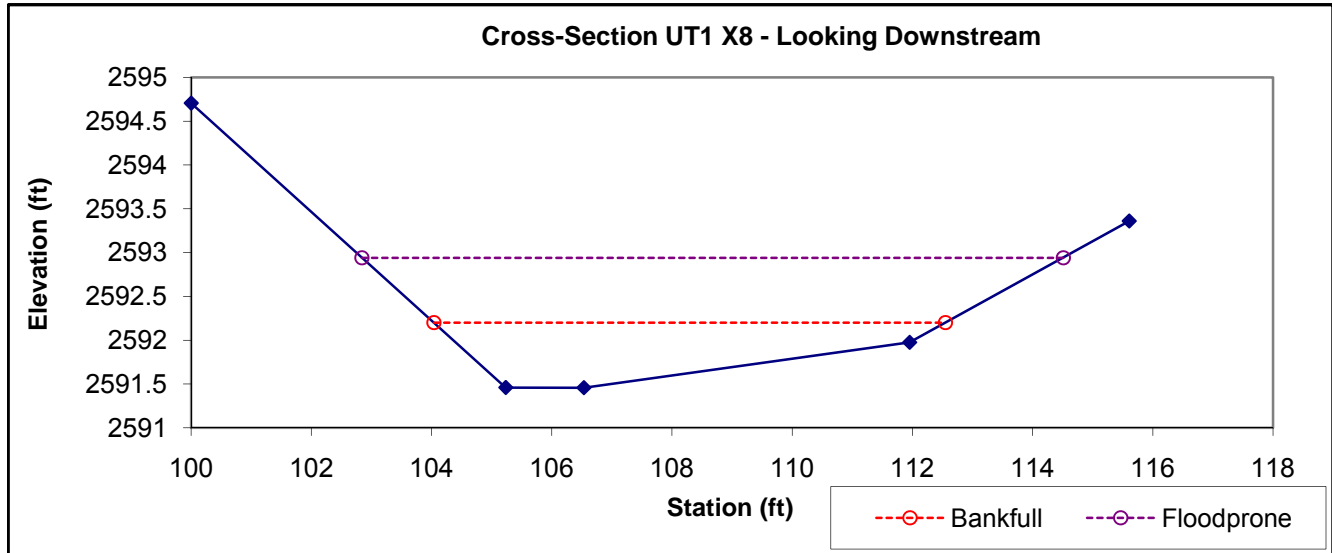
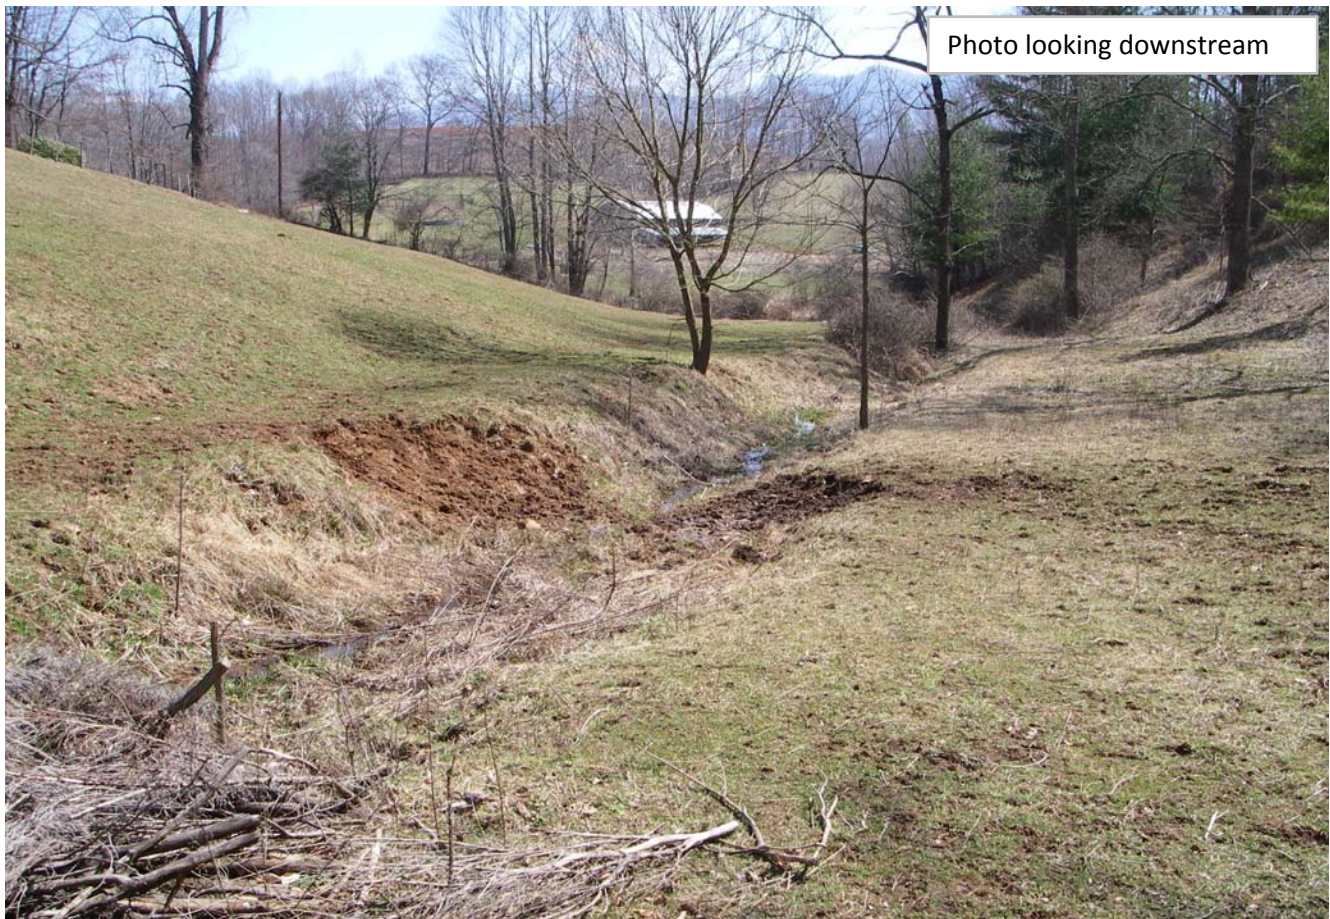
Cross-section Data: UT1 to Elk Branch

Feature	Stream Type	BKF Area	BKF Width	BKF Depth	Max BKF Depth	W/D	BH Ratio	ER	BKF Elev	TOB Elev
Run	Fb	4.1	8.51	0.48	0.74	17.67	2.6	1.4	2592.2	2593.36

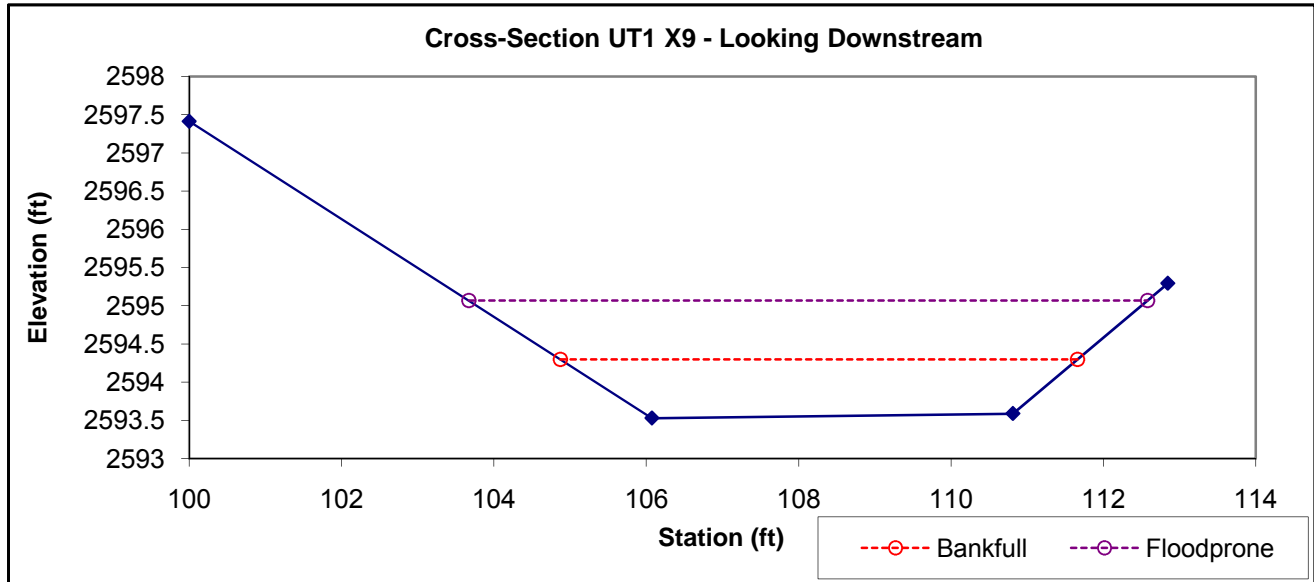
Cross-section Data: UT1 to Elk Branch

Feature	Stream Type	BKF Area	BKF Width	BKF Depth	Max BKF Depth	W/D	BH Ratio	ER	BKF Elev	TOB Elev
Run	Fb	4.3	6.79	0.63	0.77	10.8	2.3	1.3	2594.3	2595.29

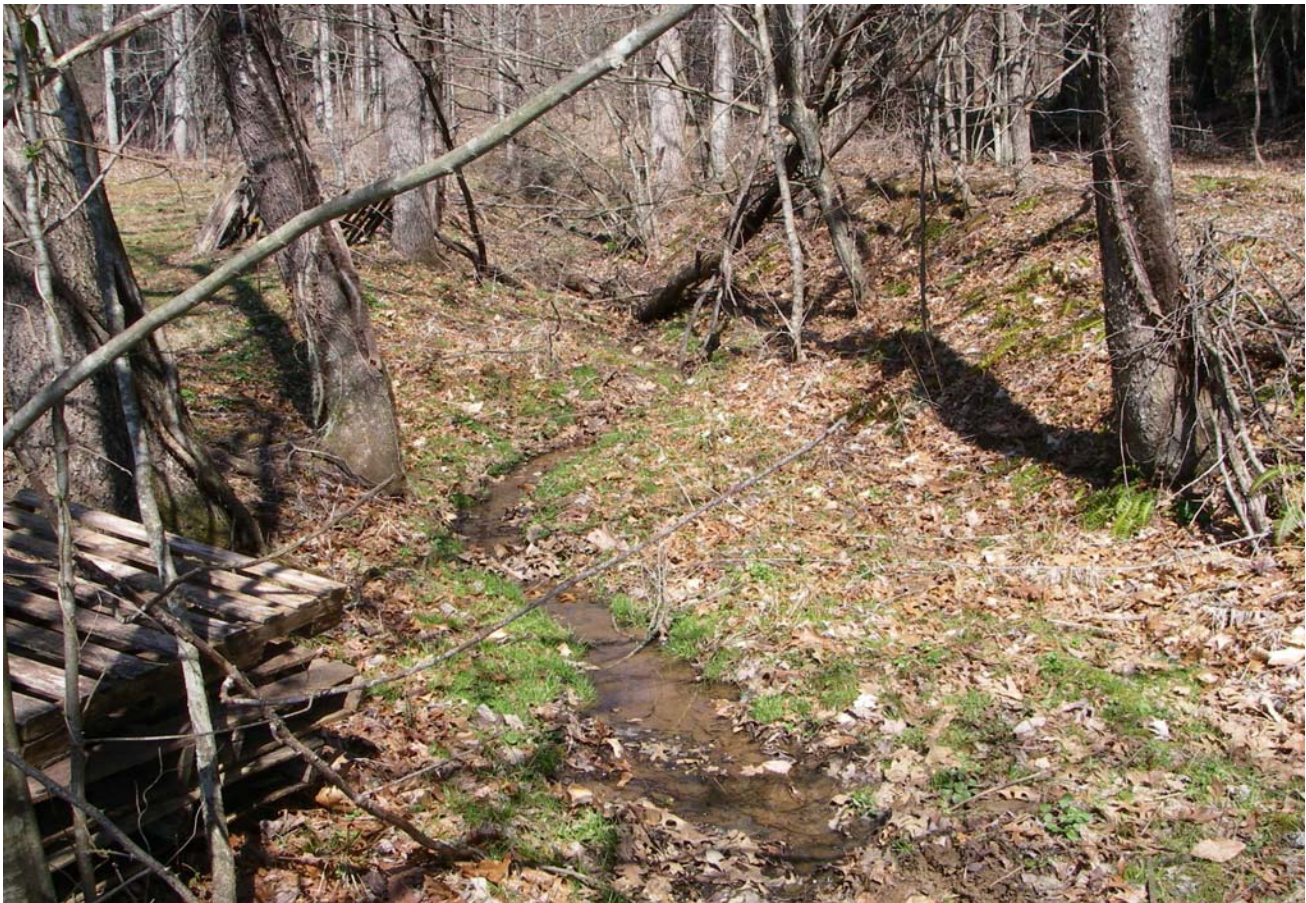
Cross-section Data: UT2 to Elk Branch

Feature	Stream Type	BKF Area	BKF Width	BKF Depth	Max BKF Depth	W/D	BH Ratio	ER	BKF Elev	TOB Elev
Riffle	B	3.0	8.94	0.34	0.66	26.6	2.0	1.3	2642.12	2642.79

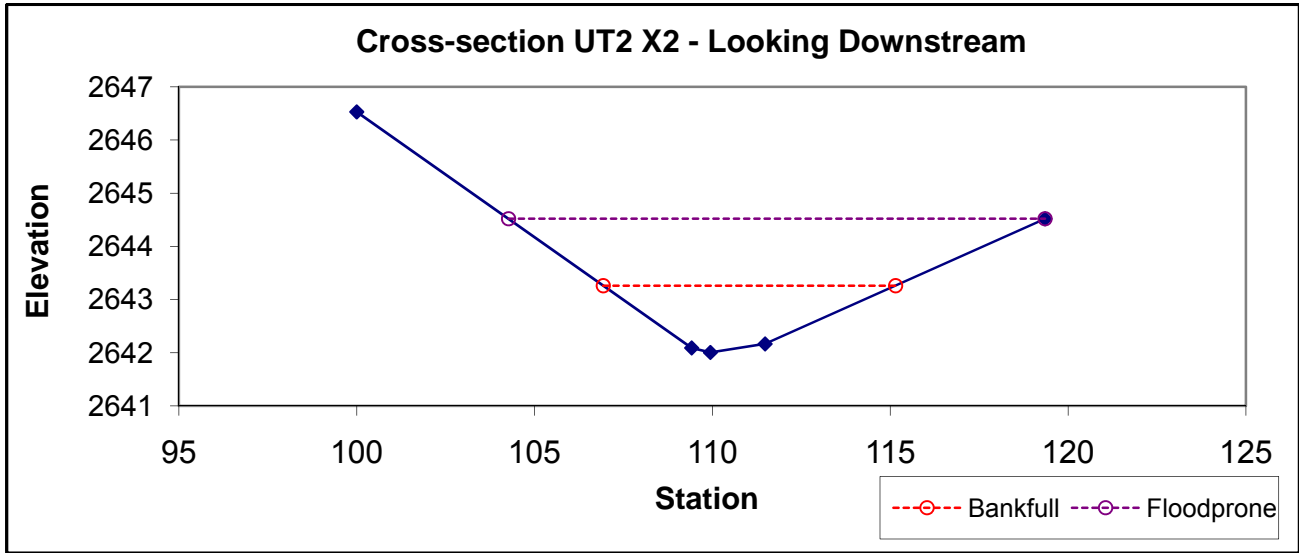
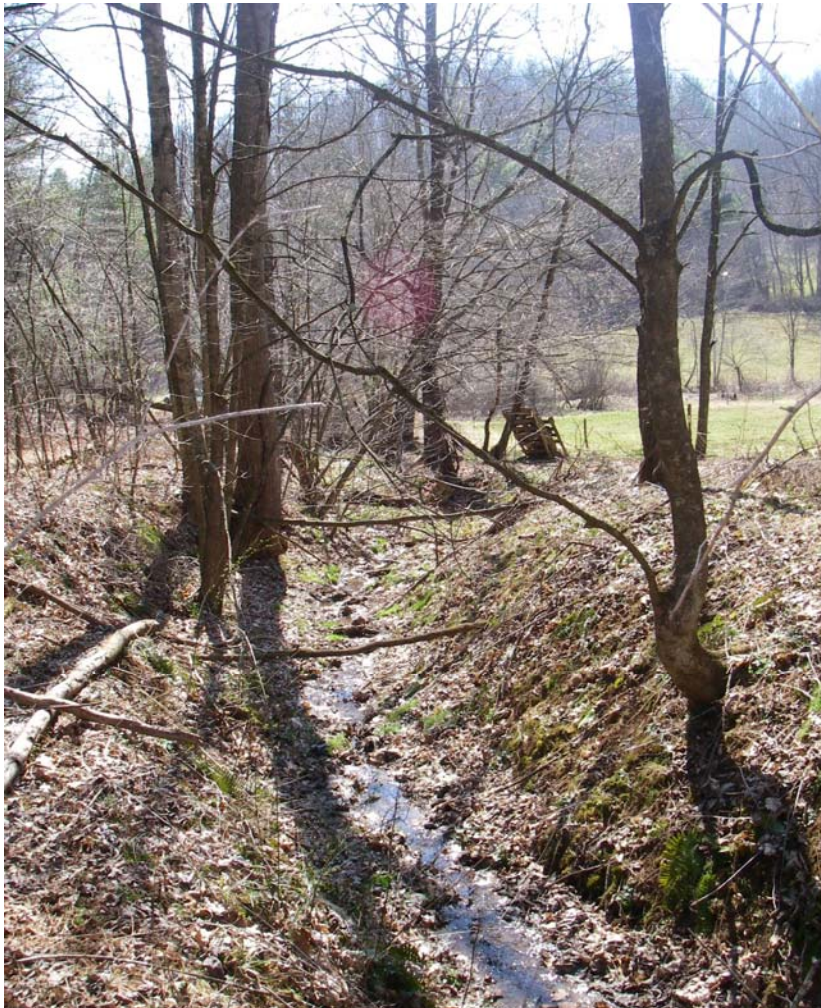
Cross-section Data: UT2 to Elk Branch

Feature	Stream Type	BKF Area	BKF Width	BKF Depth	Max BKF Depth	W/D	BH Ratio	ER	BKF Elev	TOB Elev
Riffle	B	5.9	8.22	0.72	1.26	11.4	2.0	1.8	2643.26	2644.52

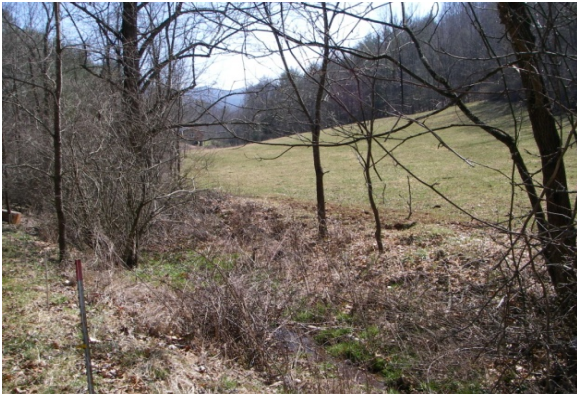
Upstream end of Elk Branch Reach 1
Banks and adjacent area impacted by cattle
