Elk Branch Restoration Plan-Final

Mitchell County, North Carolina

EEP Project Number D06125-B

Elk Branch Restoration Plan

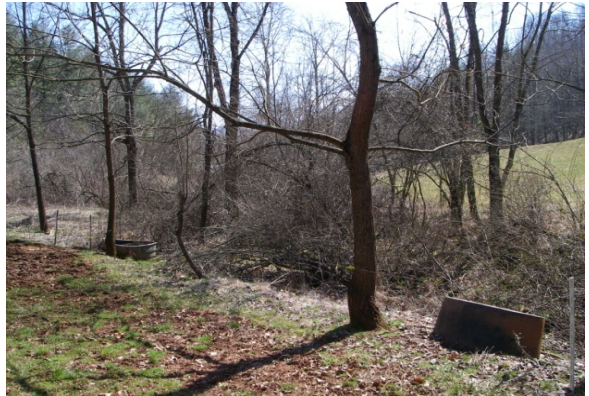
Upstream end of Elk Branch Reach 1
Fencing and water relocation to be performed

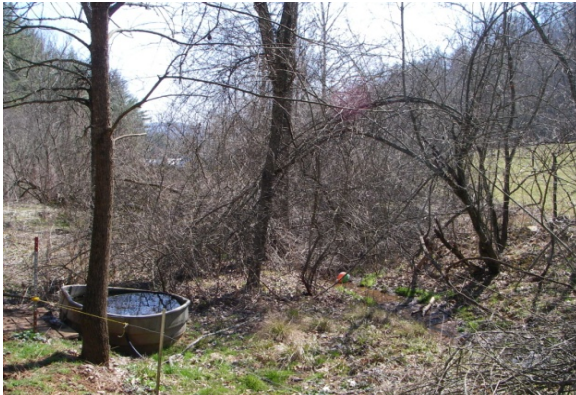
Upstream end of Elk Branch Reach 1
Fencing and water relocation to be performed

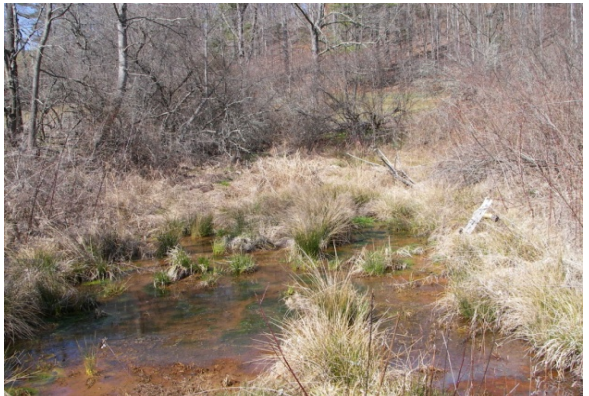
View of creek looking upstream from dredged
area on upper part of Reach 1 of Elk Branch

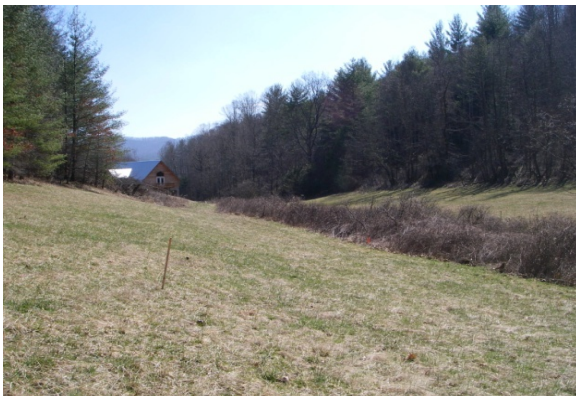
Elk Branch Reach 1 channelized section
through pasture

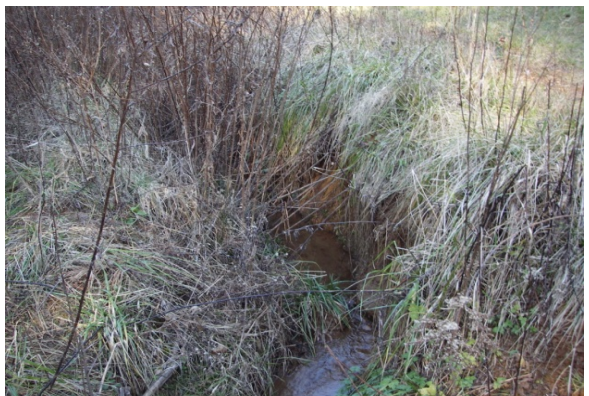
Elk Branch Reach 1 section through field with
bank erosion, head cutting, and lack of
deep-rooted vegetation

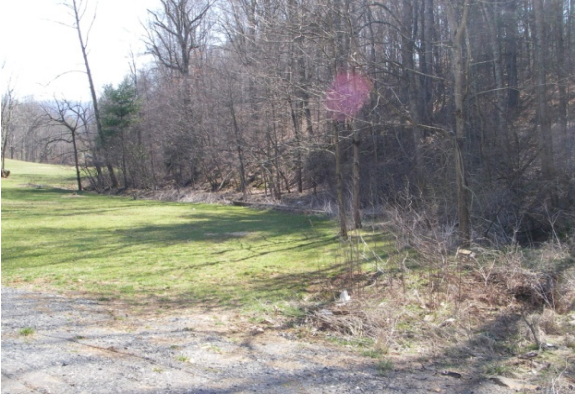
Elk Branch Reach 1 downstream of 15" culvert stream against valley wall

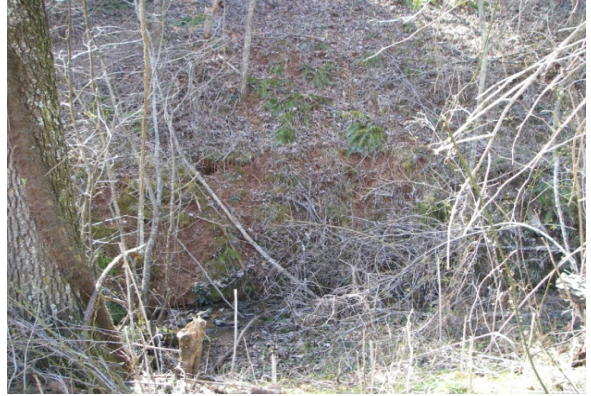
Elk Branch Reach 1 close-up of stream against valley wall and resulting erosion of banks

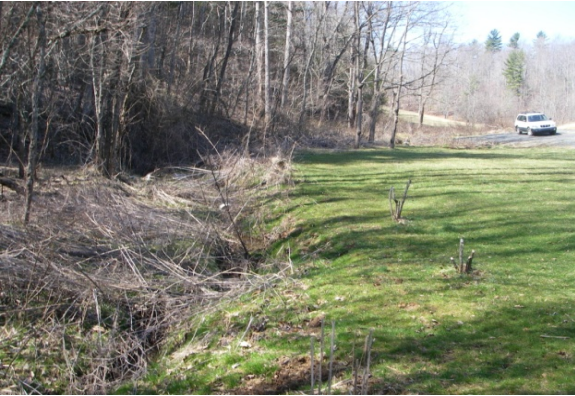
Previously channelized and lacking bank vegetation, Reach 1 of Elk Branch

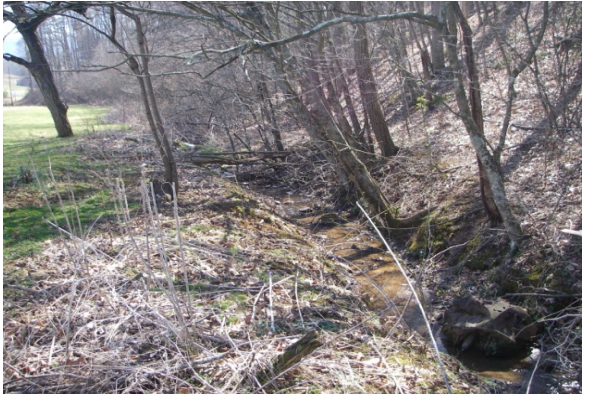
Channelized area against valley wall with leaning and fallen trees in Reach 1 of Elk Branch

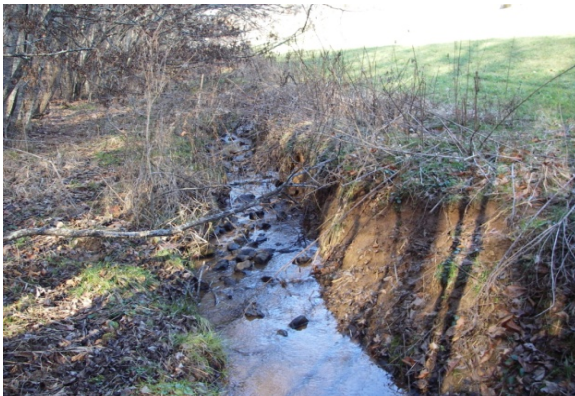
Bank erosion in Reach 1 of Elk Branch

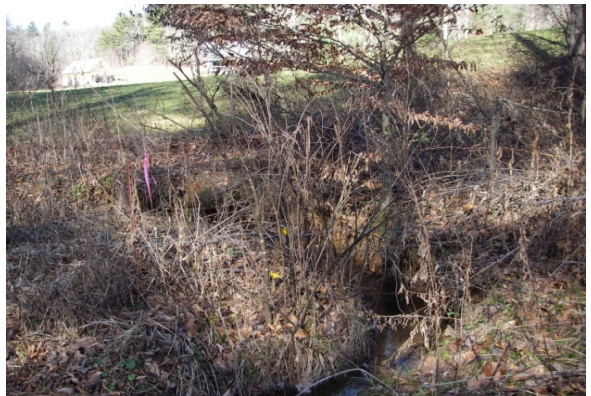
Eroding bend in Reach 1 of Elk Branch

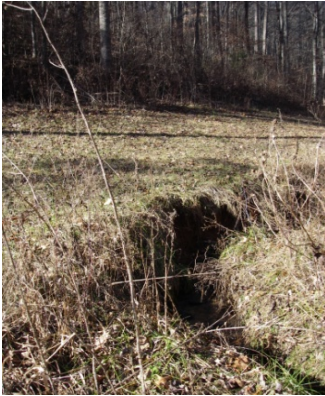
Elk Branch eroding into valley wall at upper part of Reach 2

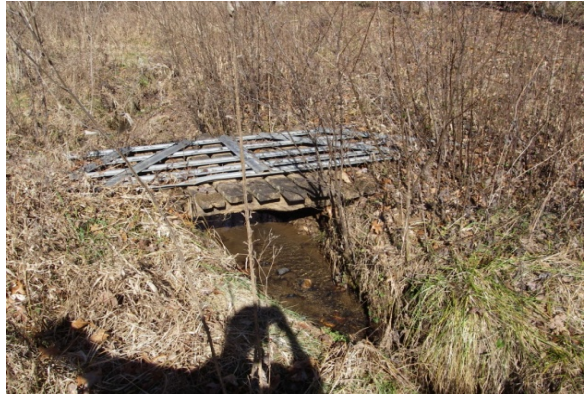
Footbridge between Reach 1 and Reach 2 of Elk Branch (location of easement break)

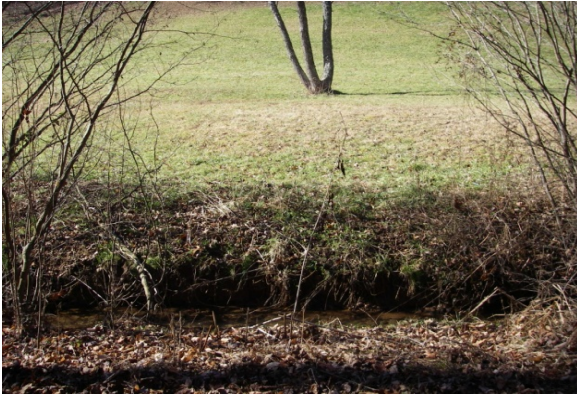
Eroding toe in Elk Branch Reach 2

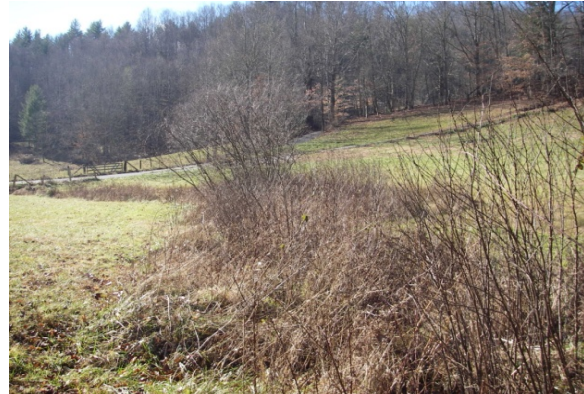
Elk Branch Reach 2 (lower half of reach)

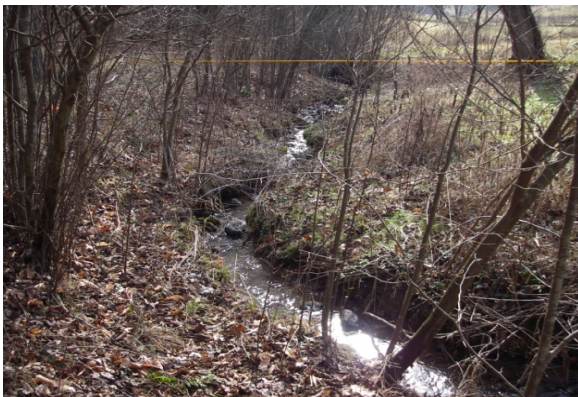
Elk Branch Reach 2, slightly incised and very narrow resulting in toe erosion

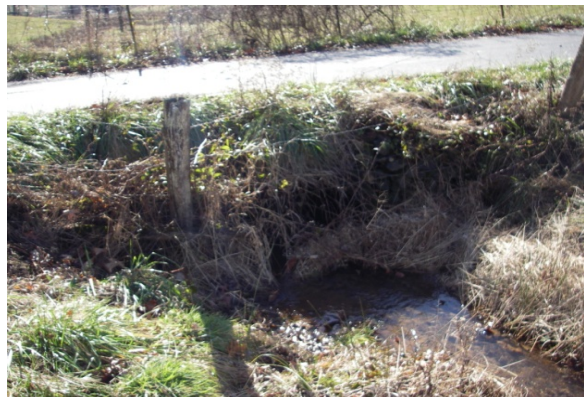
Downstream end of project on Elk Branch Reach 2

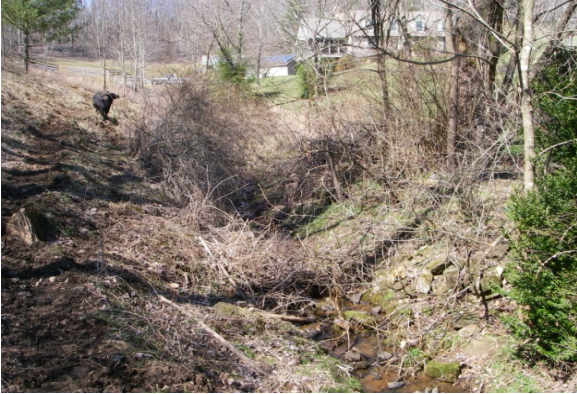
Livestock trails and access to creek on upper part of UT1

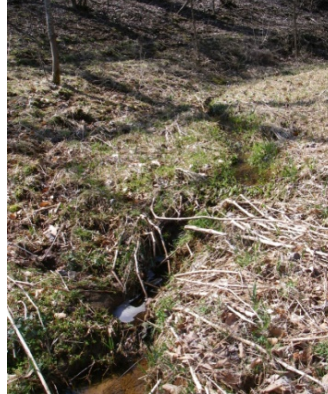
Head-cutting on UT1 in an area of poorly defined channel due to livestock access and overwidening

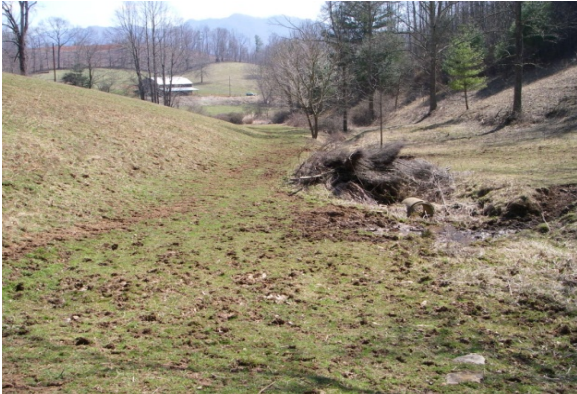
Looking down-valley at lower part of UT 1, livestock crossing and trails

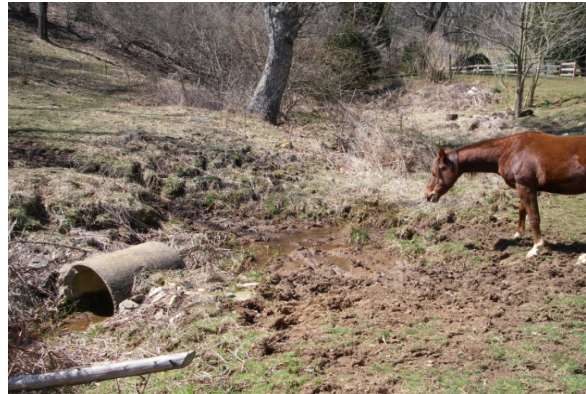
Location of proposed easement break, area to be repaired and culvert correctly installed for x-ing

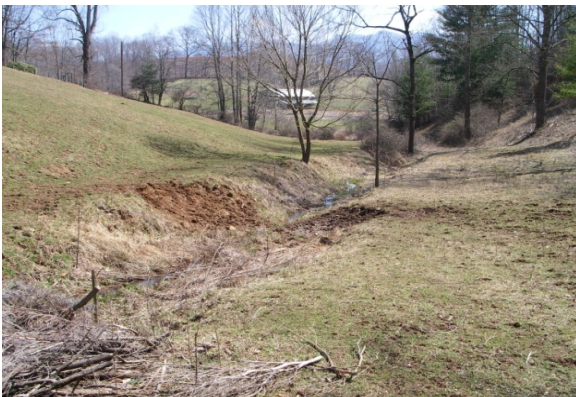
G and F-type stream below the proposed easement break on UT1

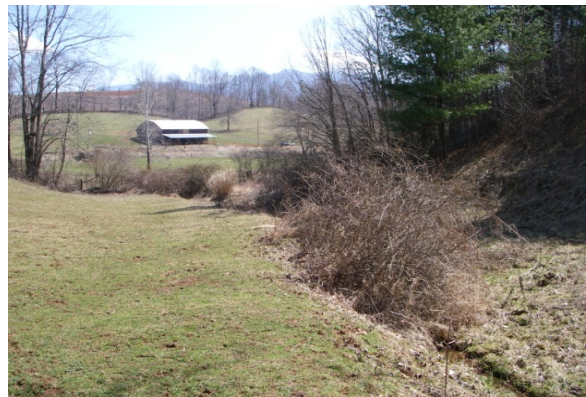
Multi-flora rose and lack of deep-rooting vegetation on UT1

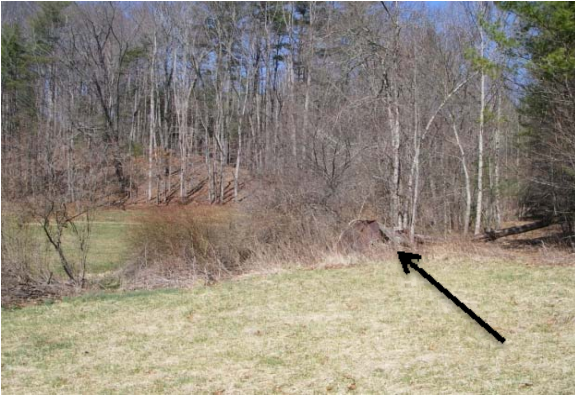
Existing location of UT2 (buried), upper half

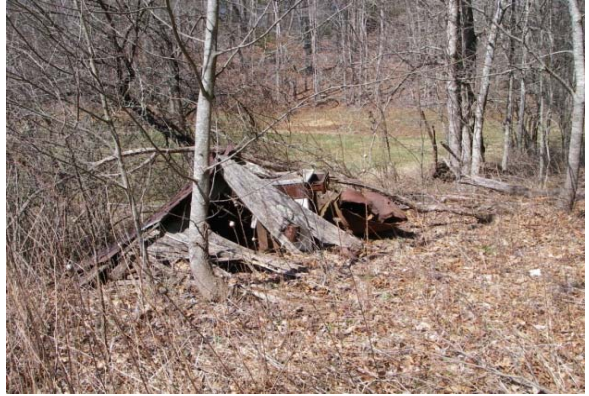
Close-up of UT2 at location of arrow in adjacent photograph (creek buried)

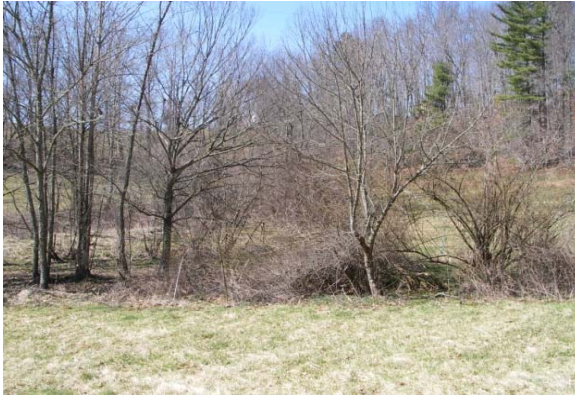
UT2 (buried), lower half

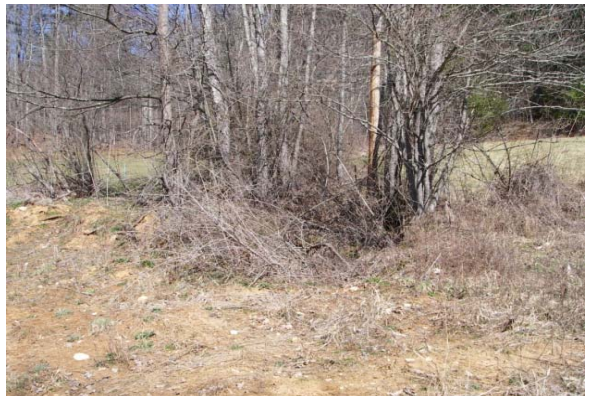
Looking "upstream" from bottom end of UT2

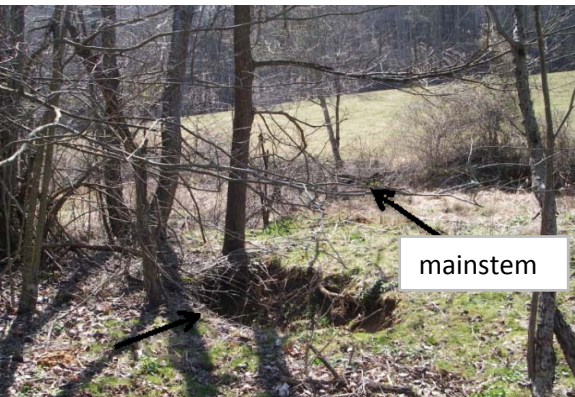
Looking "downstream" towards bottom end of UT2
Sinkhole caused from burial of stream

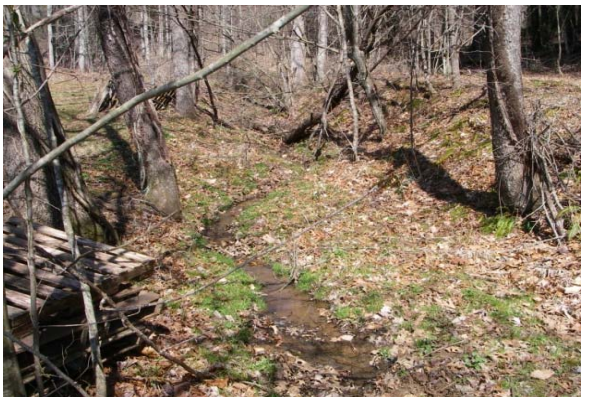
Immediately upstream of project on UT2, serves as adequate template for buried portion

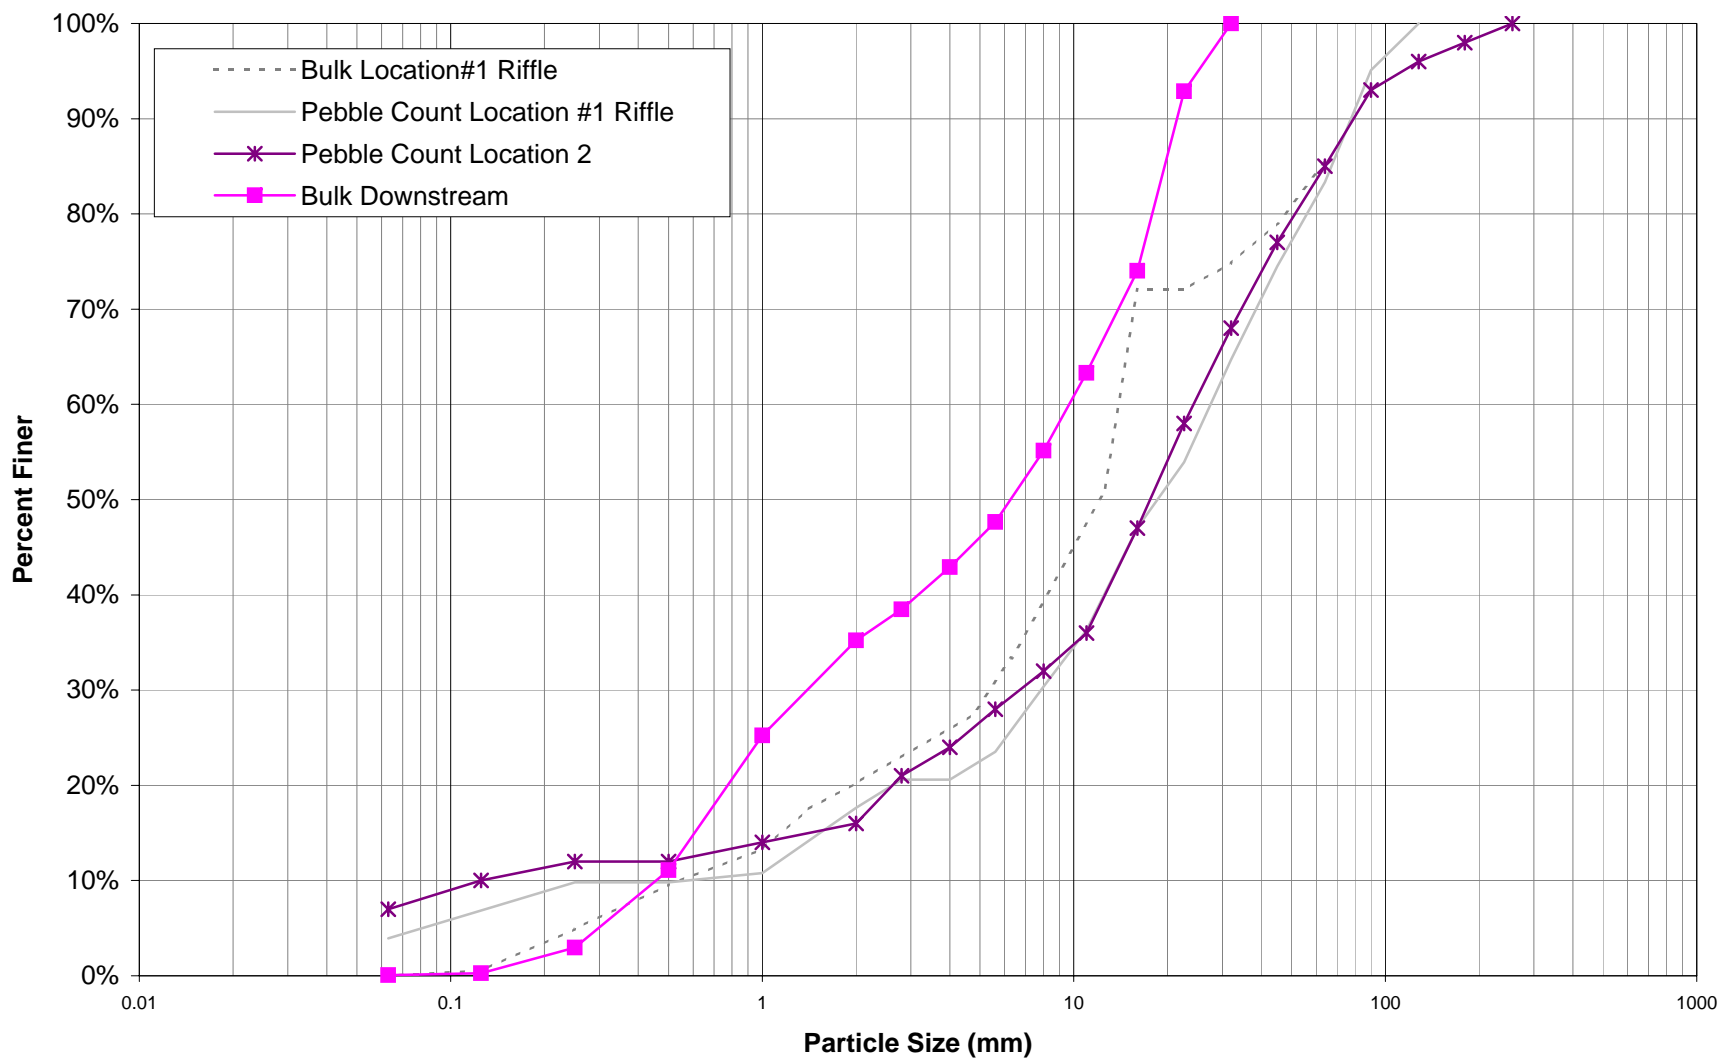
Elk Branch Particle Size Distribution of Bed Material Samples

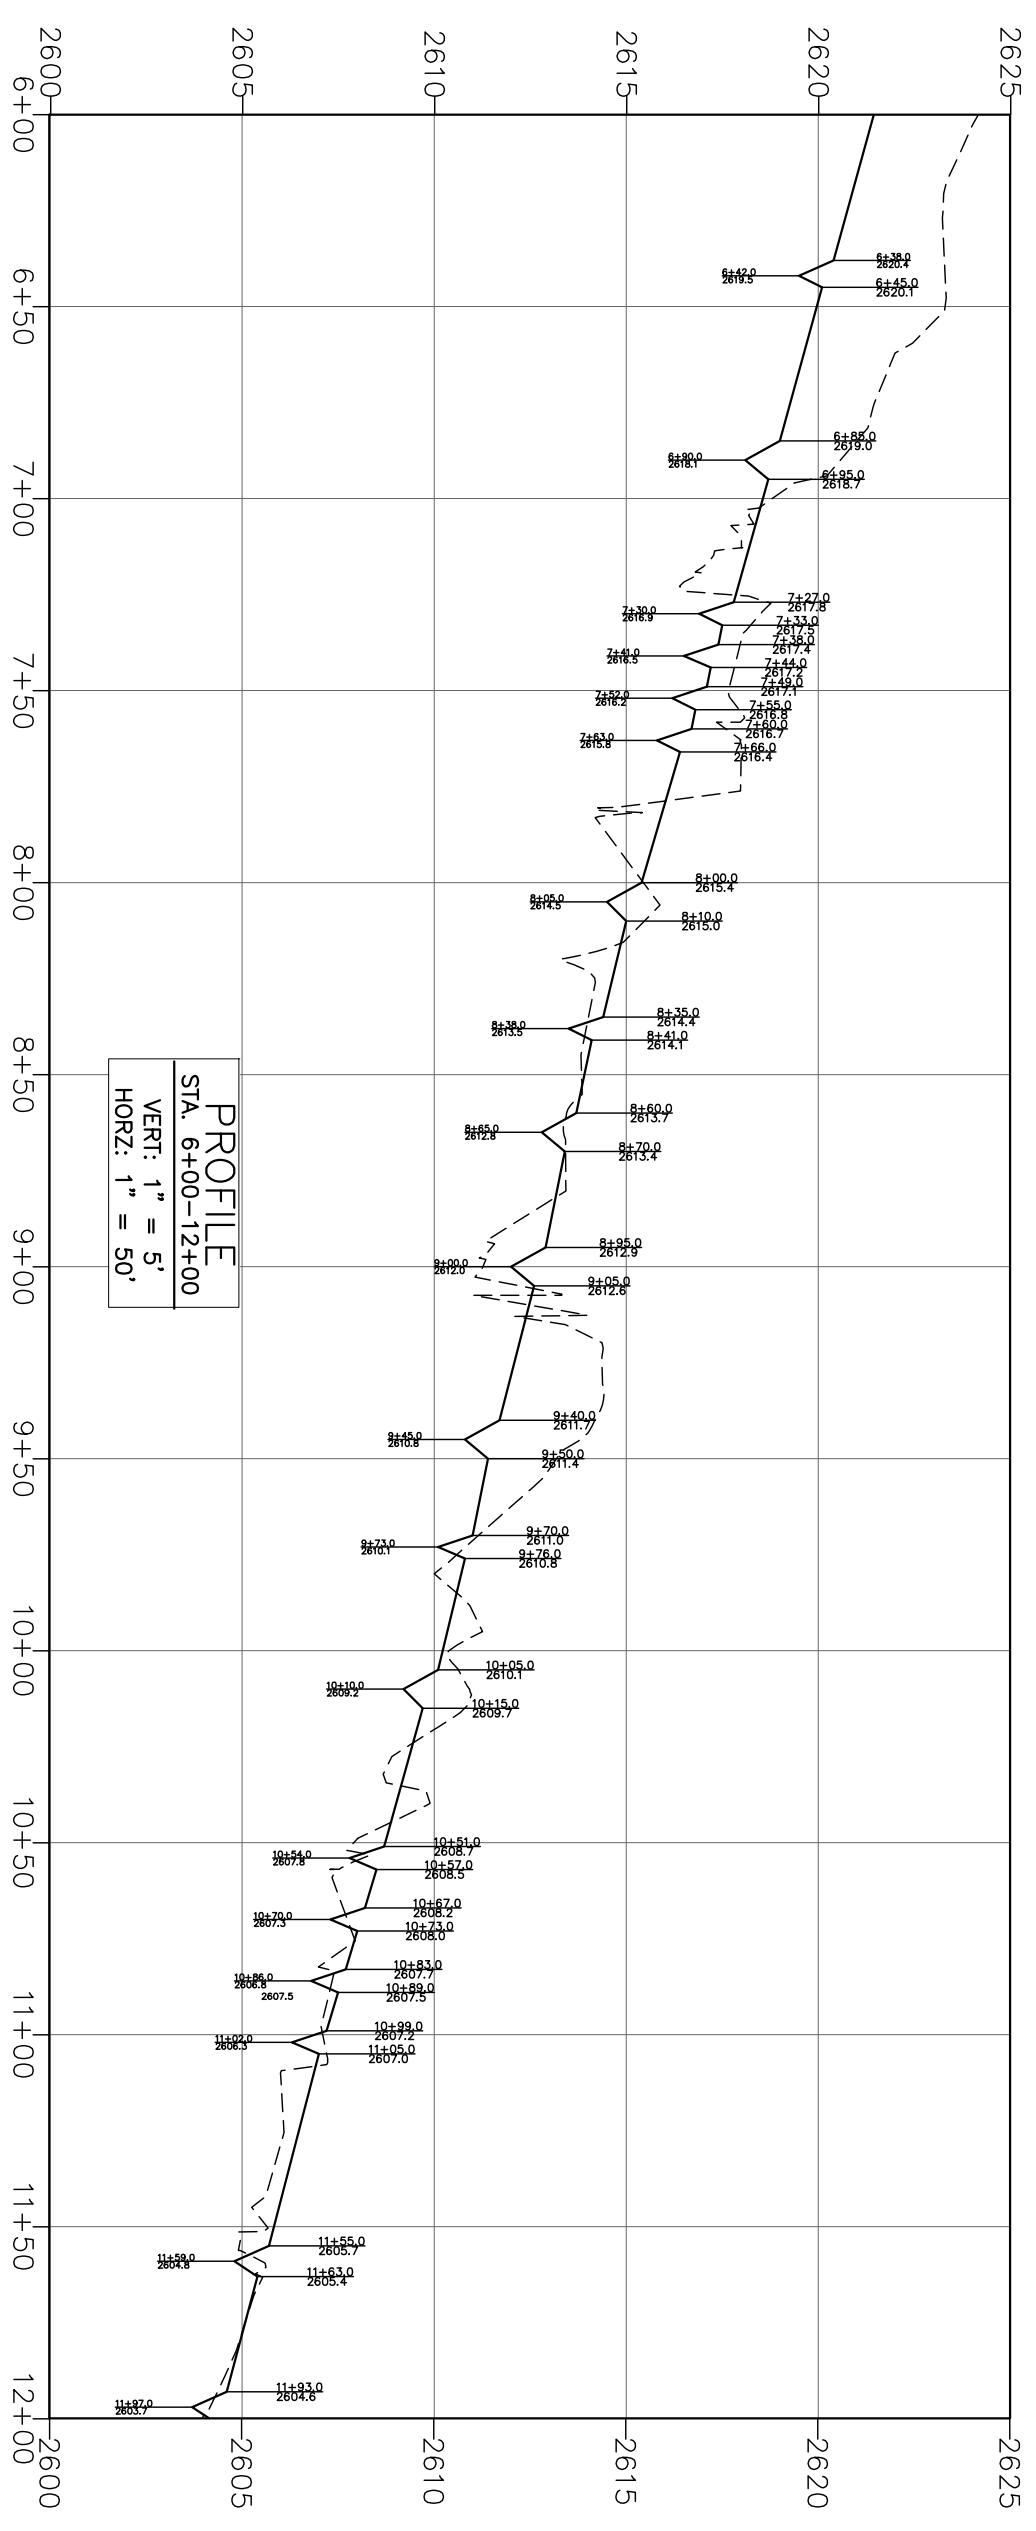
PLAN
 STA. 6+00-12+00
 SCALE: 1" = 50'

PROFILE
 STA. 6+00-12+00
 VERT: 1" = 5'
 HORZ: 1" = 50'

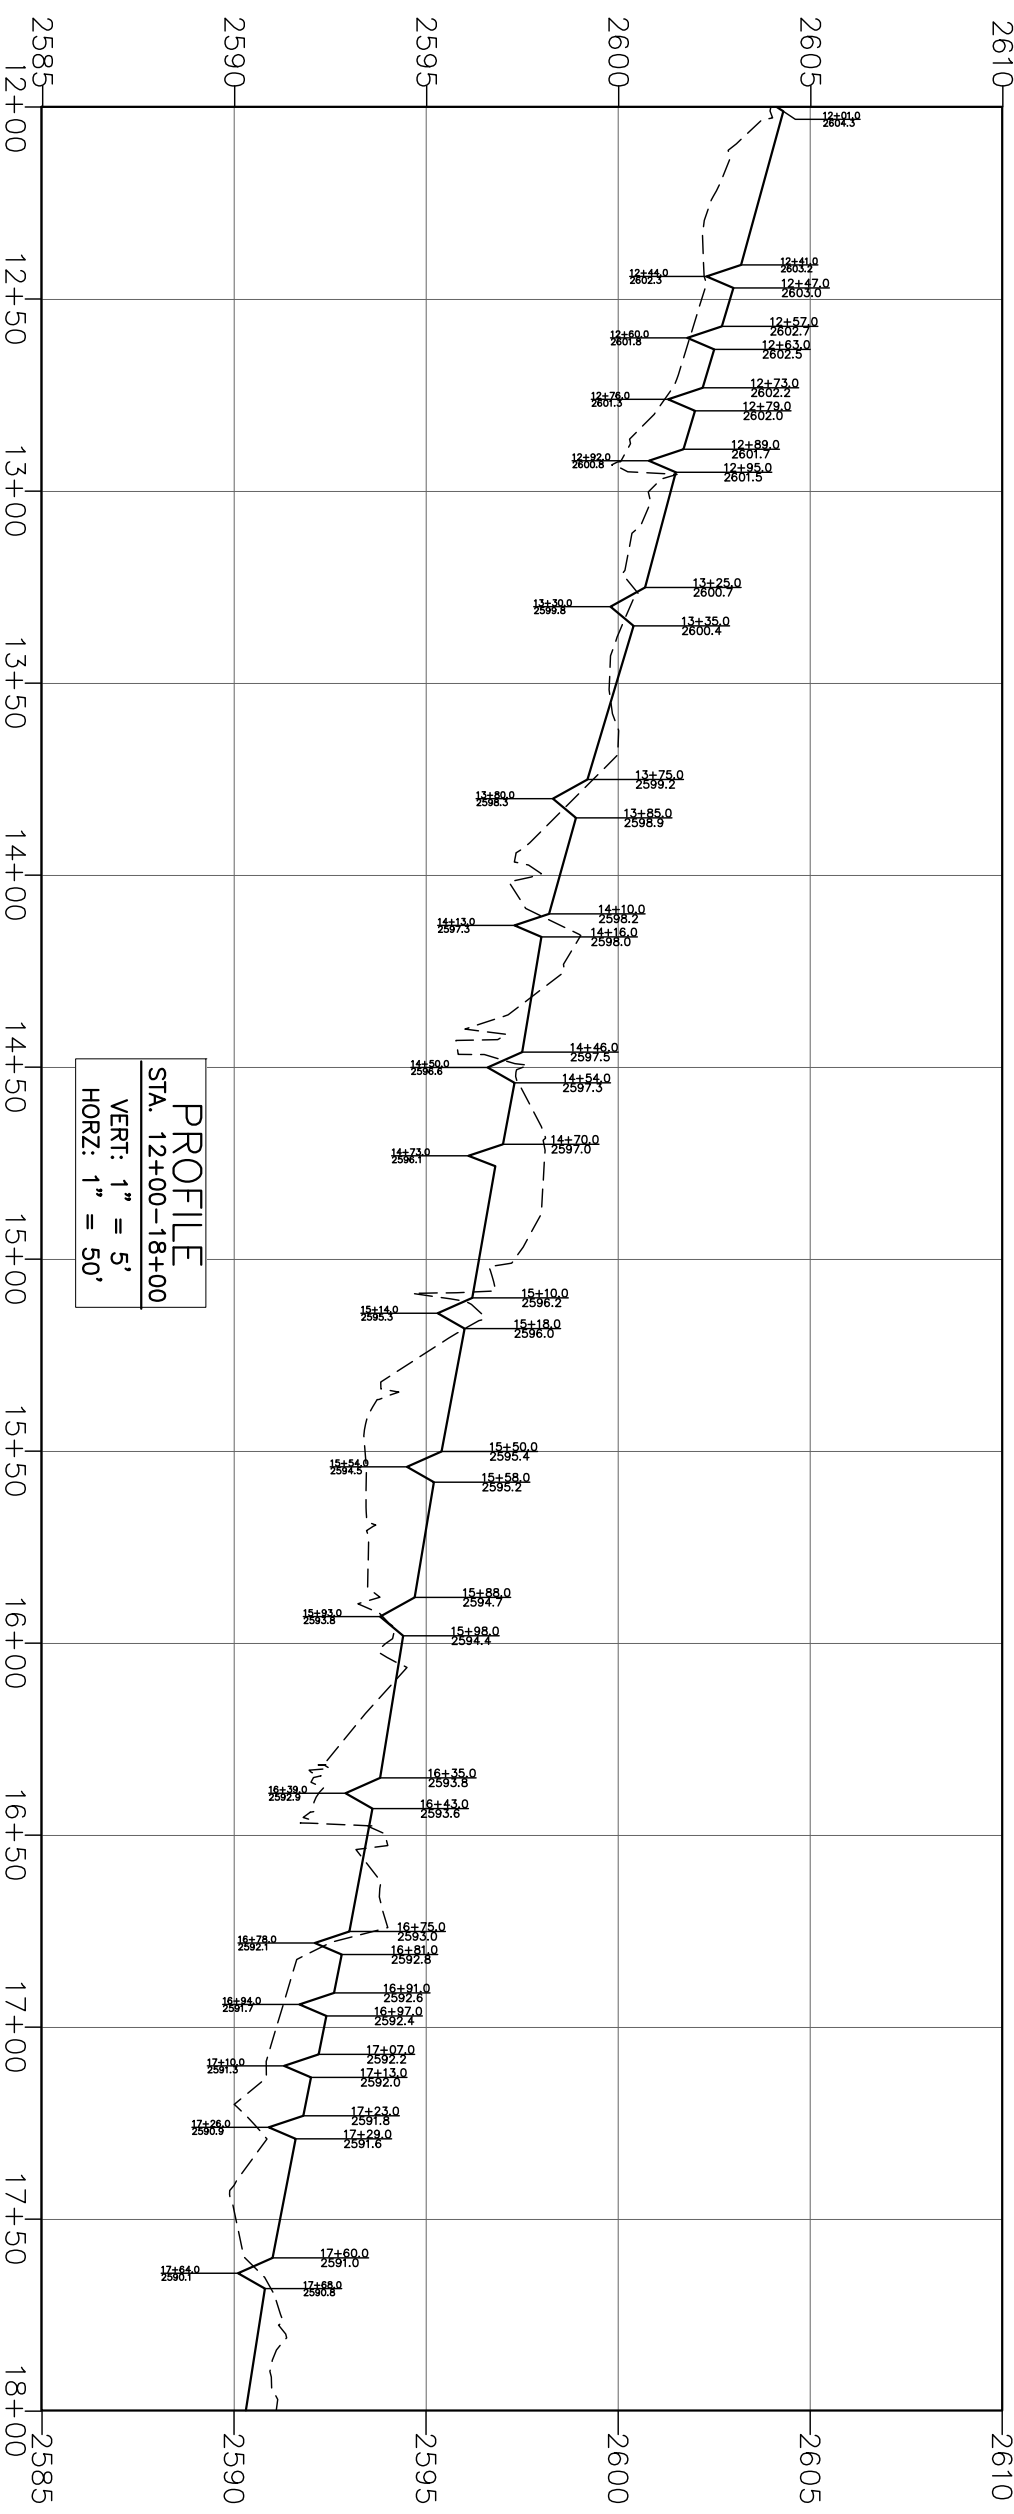
PLAN
STA. 12+00-18+00
SCALE: 1" = 50'

PROFILE
STA. 12+00-18+00
VERT: 1" = 5'
HORZ: 1" = 50'
