Elk Branch Restoration Project

Year 1 Monitoring Report

Mitchell County, North Carolina

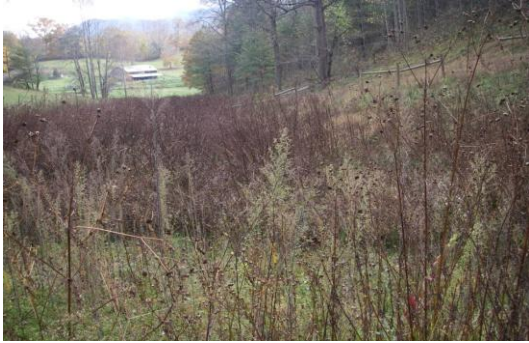
Photo 1: Veg Plot 1

1. Vegetation plots marked by t-posts at corners; herbaceous plot marked by stake within larger plot.
2. Planted vegetation flagged and tagged for future identification.

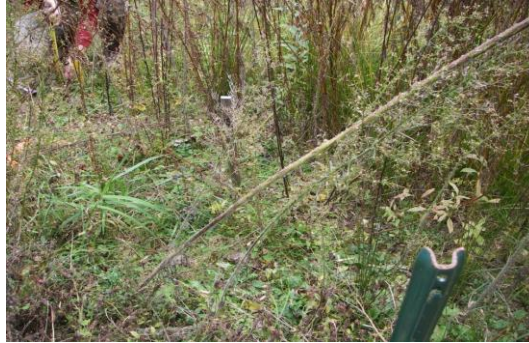
Photo 2: Veg Plot 1: Herbaceous Plot

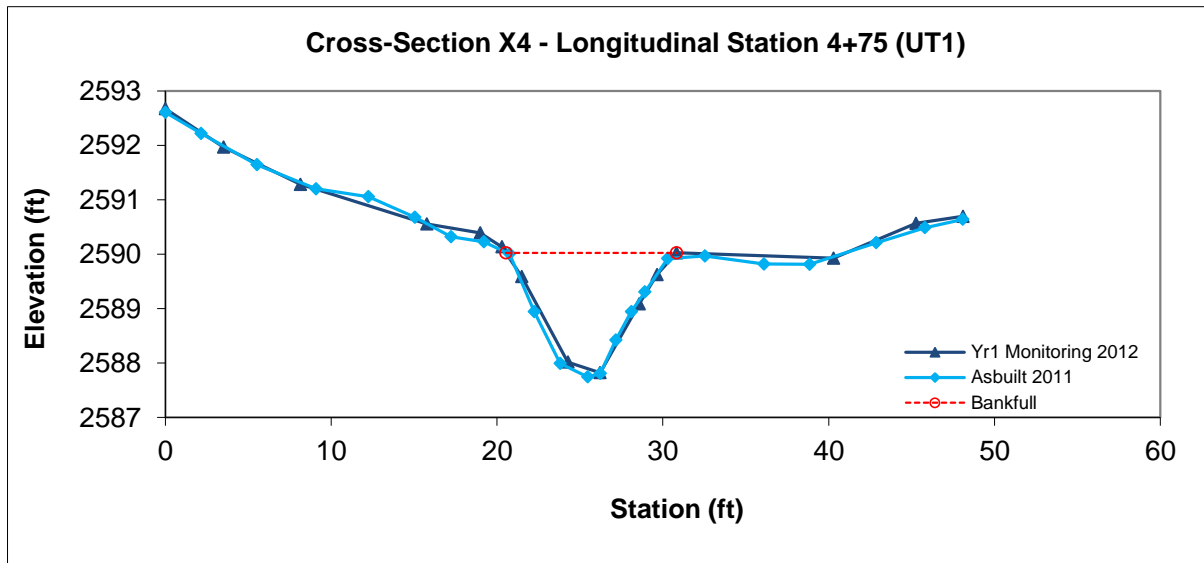
Feature	Stream Type	BKF Area	BKF Width	BKF Depth	Max BKF Depth	W/D	BH Ratio	ER	BKF Elev	TOB Elev
Pool	-	12.4	10.3	1.2	2.2	8.58	1	4.5	2590.02	2590.02
