Ellerbe Creek Stream Restoration

MITIGATION PLAN

Hillandale Golf Course, Durham, North Carolina

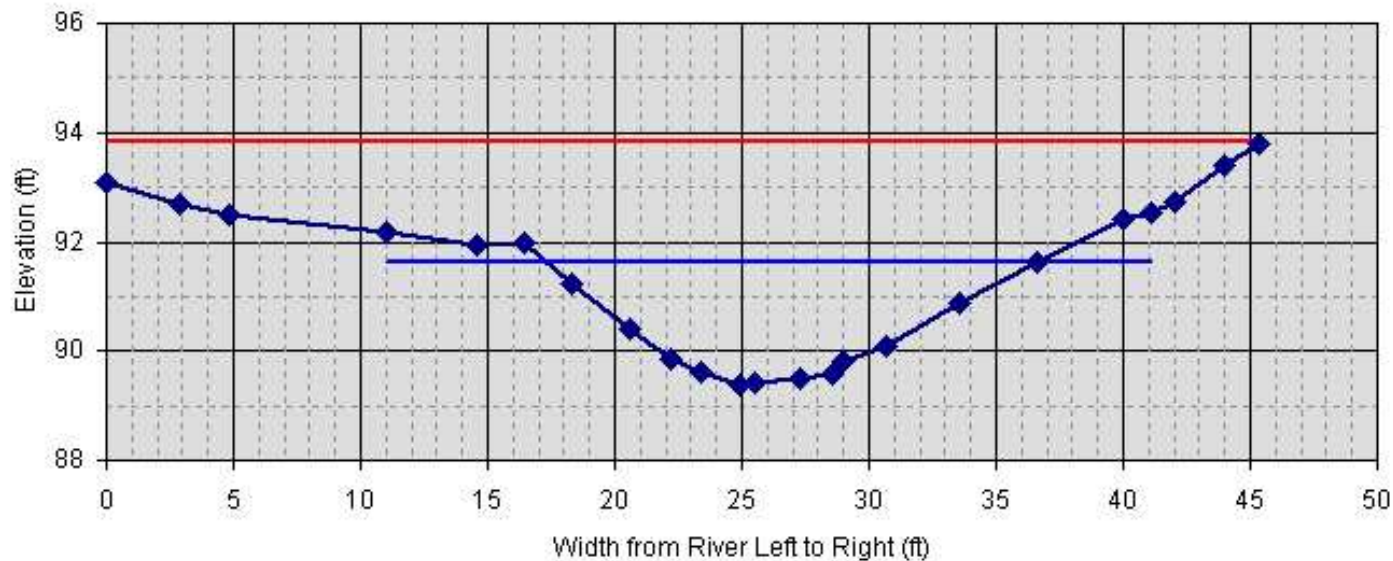
Hillsborough 1 (HB-XS1) Riffle Ellerbe Creek

section: Hillsborough 1 (HB-XS1)

Riffle

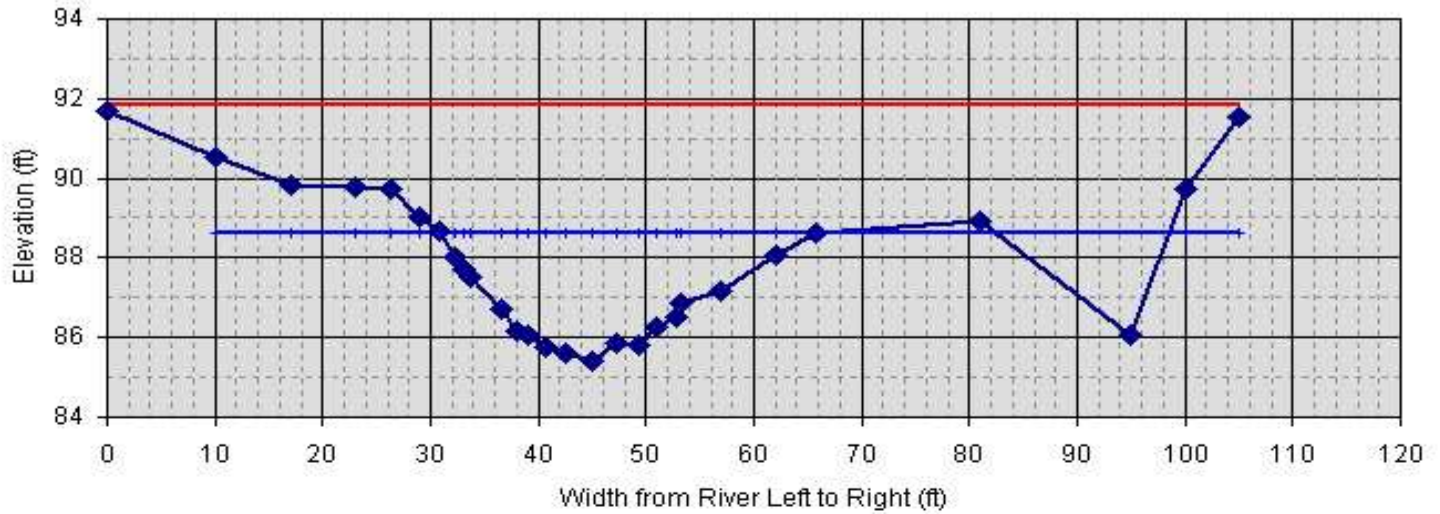
Hillandale 4 (HD-XS4) Riffle Ellerbe Creek

section: Hillandale 4 (HD-XS4)

Riffle
