**Farrar Dairy Stream and Wetland Restoration Site
Monitoring Report – MY03
Harnett County, NC**

December 2011

**Project Manager: Tim Morris
Email: tim.morris@kci.com
KCI Project No: 12065438**

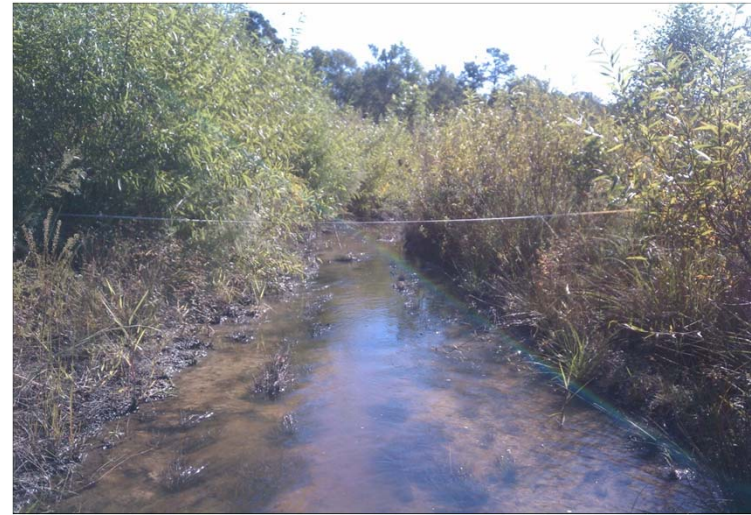
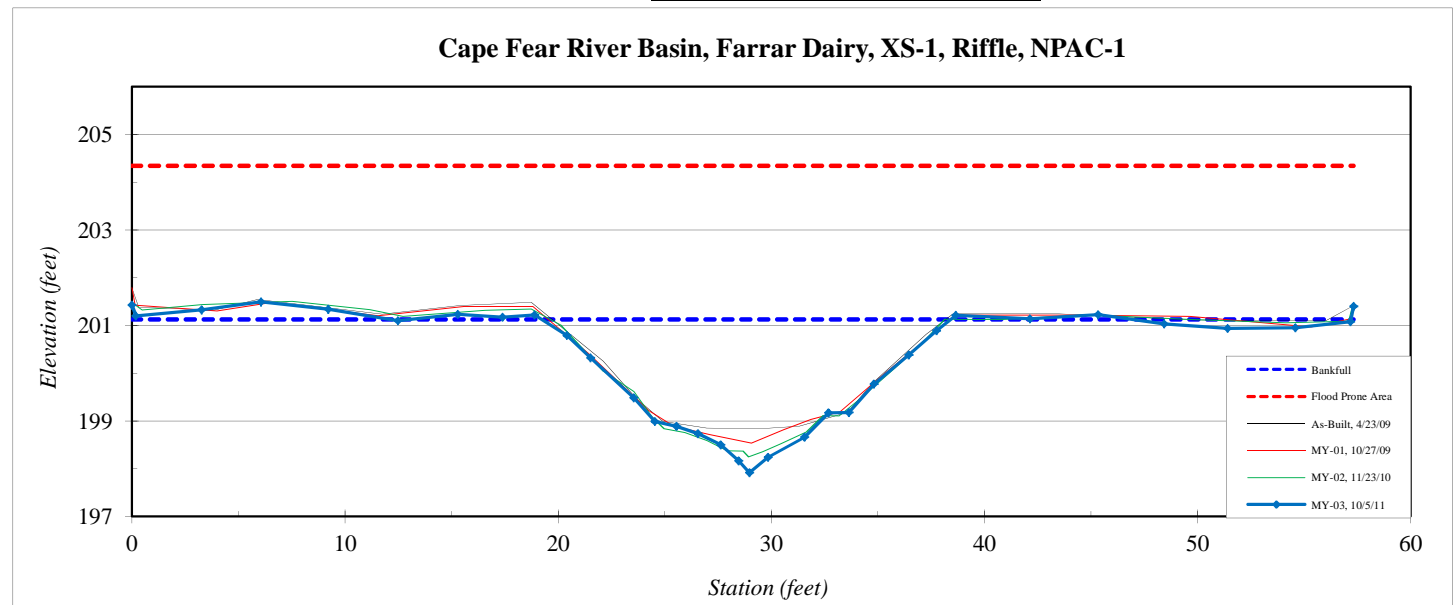
River Basin:	Cape Fear
Watershed:	Farrar Dairy
XS ID	XS-1, Riffle, NPAC-1
Drainage Area (sq mi):	3.92
Date:	10/5/2011
Field Crew:	A. French, M. Koss

SUMMARY DATA	
Bankfull Elevation:	201.1
Bankfull Cross-Sectional Area:	32.4
Bankfull Width:	19.2
Flood Prone Area Elevation:	204.3
Flood Prone Width:	>60
Max Depth at Bankfull:	3.2
Mean Depth at Bankfull:	1.7
W / D Ratio:	11.4
Entrenchment Ratio:	>3.0
Bank Height Ratio:	1.0

Stream Type C5

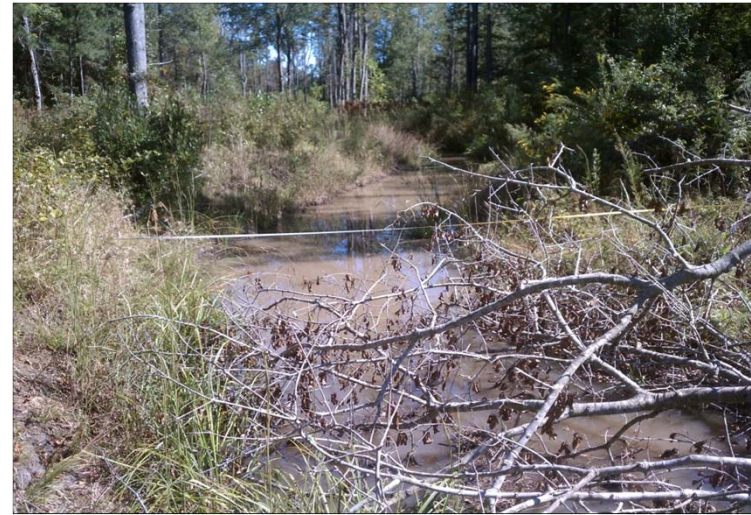
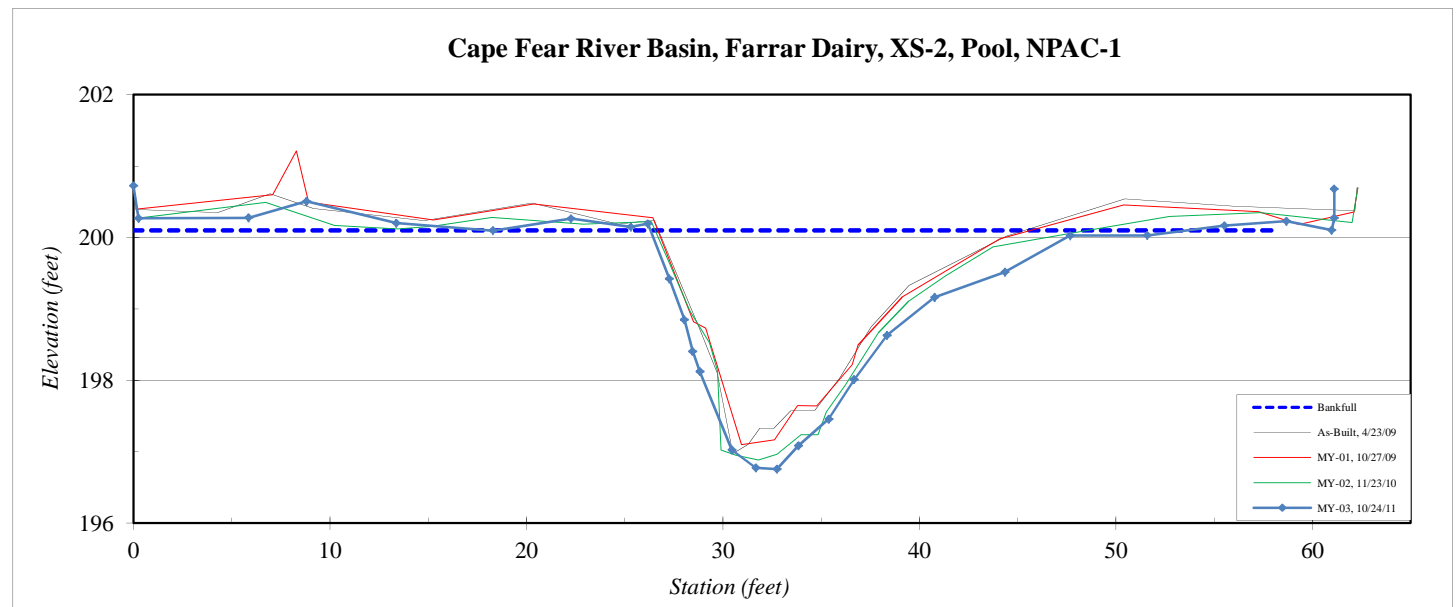
River Basin:	Cape Fear
Watershed:	Farrar Dairy
XS ID	XS-2, Pool, NPAC-1
Drainage Area (sq mi):	3.92
Date:	10/24/2011
Field Crew:	A. French, A. Helms

SUMMARY DATA	
Bankfull Elevation:	200.1
Bankfull Cross-Sectional Area:	31.1
Bankfull Width:	22.3
Flood Prone Area Elevation:	-
Flood Prone Width:	-
Max Depth at Bankfull:	3.3
Mean Depth at Bankfull:	1.4
W / D Ratio:	-
Entrenchment Ratio:	-
Bank Height Ratio:	-

Stream Type	C5
--------------------	----

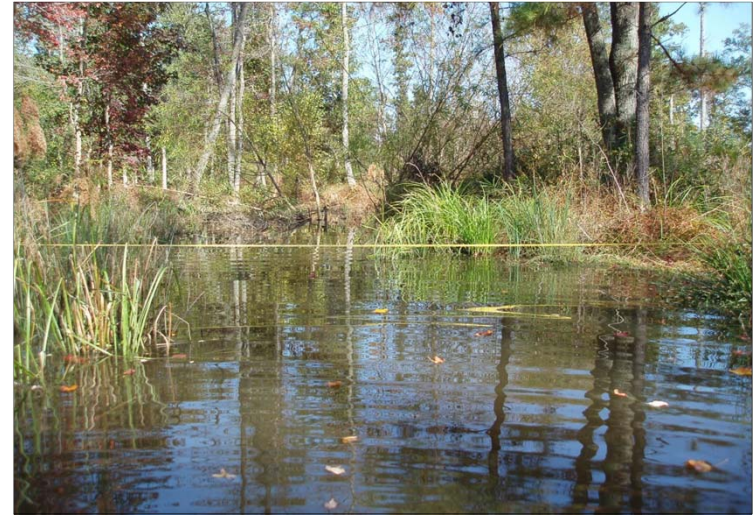
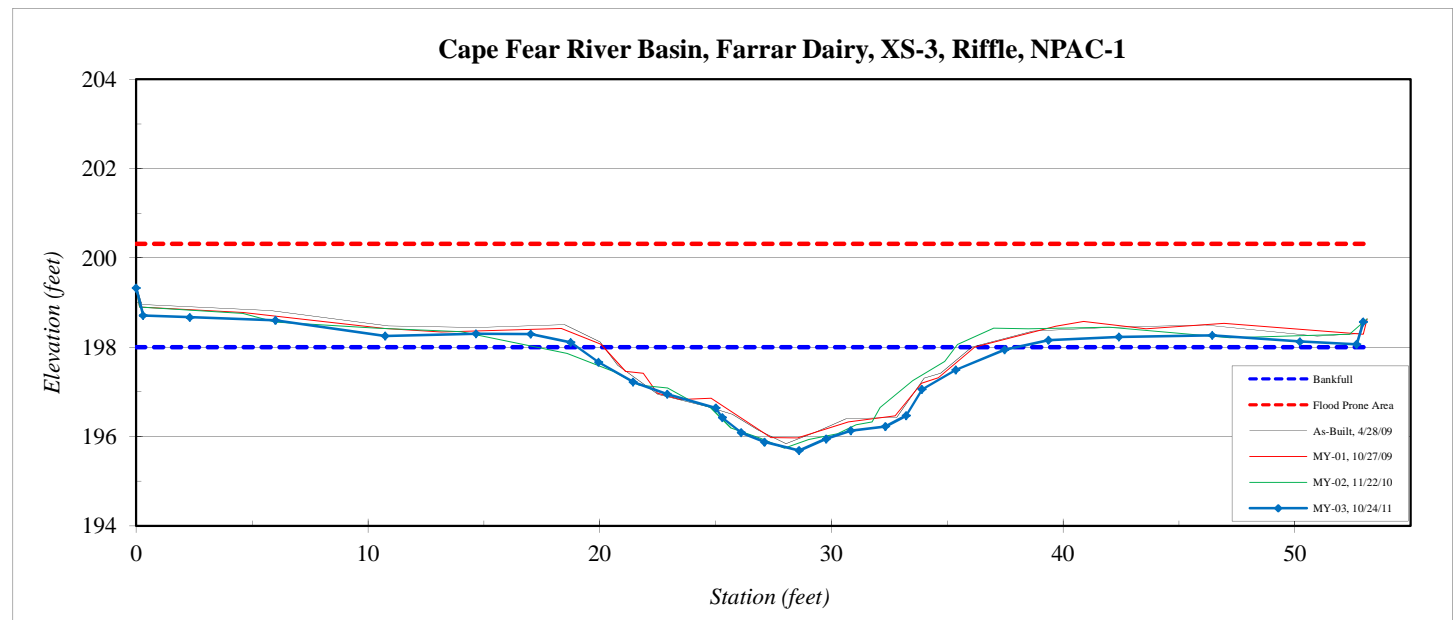
River Basin:	Cape Fear
Watershed:	Farrar Dairy
XS ID	XS-3, Riffle, NPAC-1
Drainage Area (sq mi):	3.92
Date:	10/24/2011
Field Crew:	A. French, A. Helms

SUMMARY DATA	
Bankfull Elevation:	198.0
Bankfull Cross-Sectional Area:	23.4
Bankfull Width:	18.9
Flood Prone Area Elevation:	200.3
Flood Prone Width:	>60
Max Depth at Bankfull:	2.3
Mean Depth at Bankfull:	1.2
W / D Ratio:	15.3
Entrenchment Ratio:	>3.0
Bank Height Ratio:	1.0

Stream Type	C5
--------------------	----

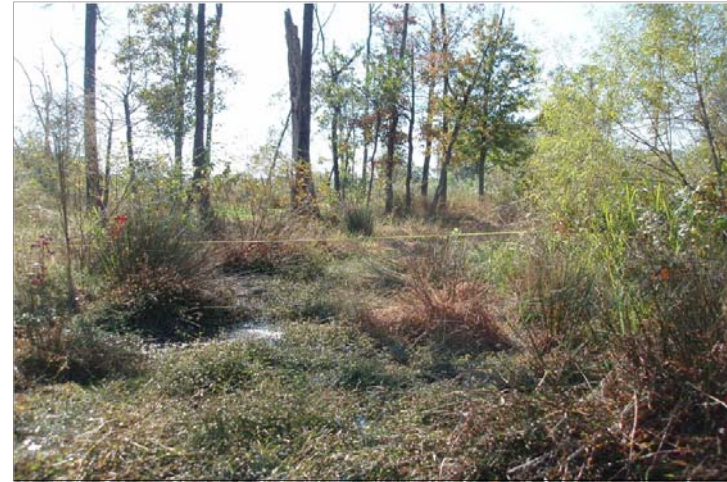
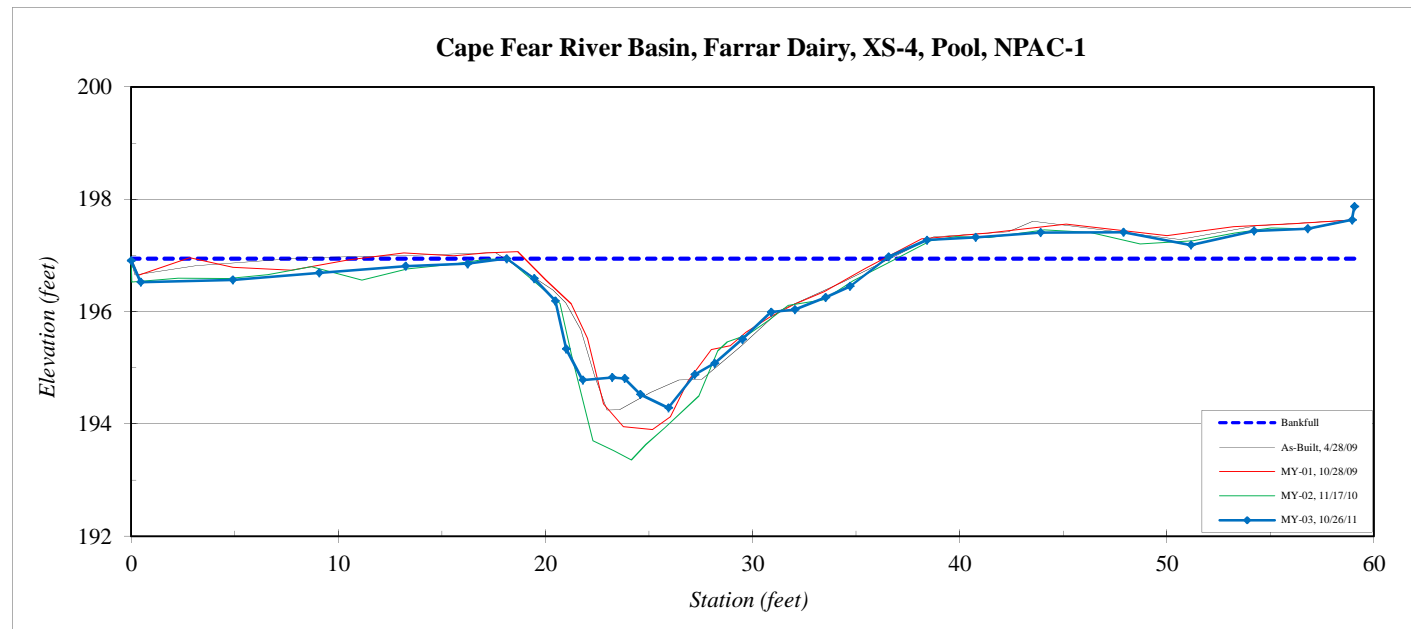
River Basin:	Cape Fear
Watershed:	Farrar Dairy
XS ID	XS-4, Pool, NPAC-1
Drainage Area (sq mi):	4.10
Date:	10/26/2011
Field Crew:	A. French, A. Helms

Stream Type C5

SUMMARY DATA	
Bankfull Elevation:	196.9
Bankfull Cross-Sectional Area:	24.5
Bankfull Width:	18.3
Flood Prone Area Elevation:	-
Flood Prone Width:	-
Max Depth at Bankfull:	2.7
Mean Depth at Bankfull:	1.3
W / D Ratio:	-
Entrenchment Ratio:	-
Bank Height Ratio:	-

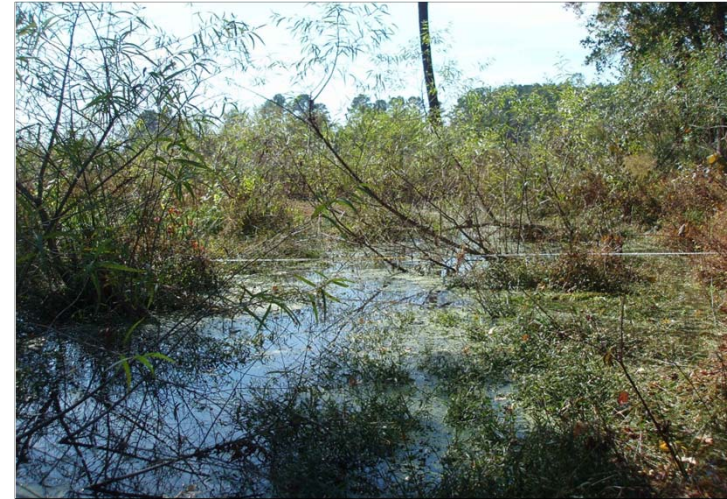
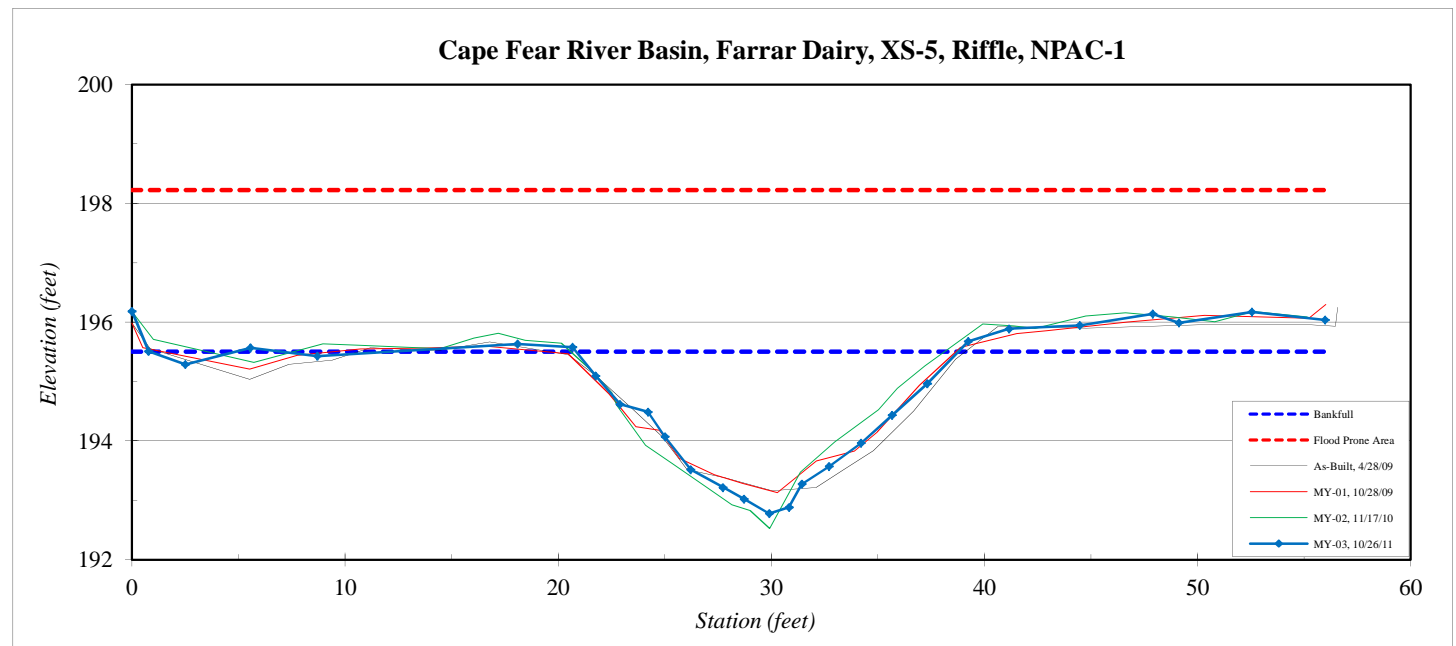
River Basin:	Cape Fear
Watershed:	Farrar Dairy
XS ID	XS-5, Riffle, NPAC-1
Drainage Area (sq mi):	4.10
Date:	10/26/2011
Field Crew:	A. French, A. Helms

SUMMARY DATA	
Bankfull Elevation:	195.5
Bankfull Cross-Sectional Area:	26.7
Bankfull Width:	17.9
Flood Prone Area Elevation:	198.2
Flood Prone Width:	>60
Max Depth at Bankfull:	2.7
Mean Depth at Bankfull:	1.5
W / D Ratio:	12.0
Entrenchment Ratio:	>3.0
Bank Height Ratio:	1.0

Stream Type	C5
--------------------	----

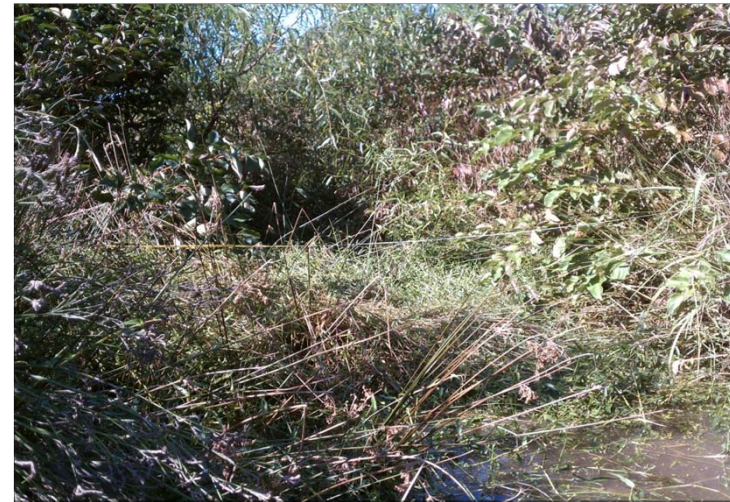
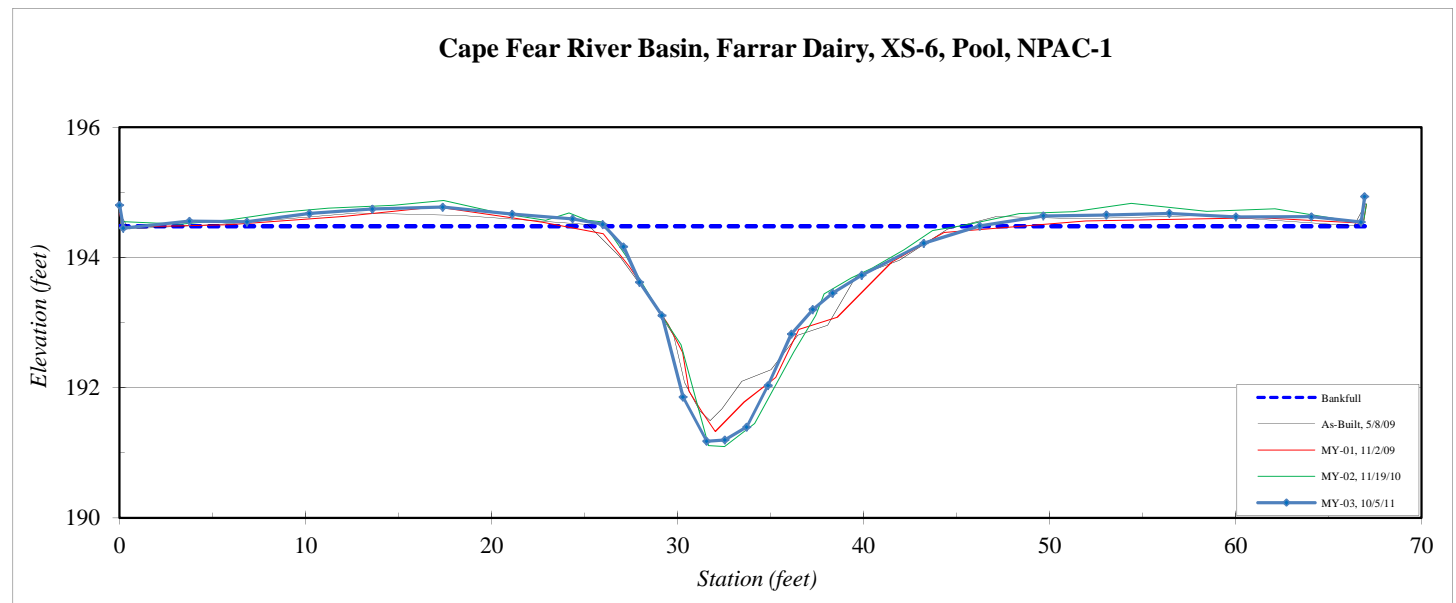
River Basin:	Cape Fear
Watershed:	Farrar Dairy
XS ID	XS-6, Pool, NPAC-1
Drainage Area (sq mi):	4.1
Date:	10/5/2011
Field Crew:	A. French, M. Koss

SUMMARY DATA	
Bankfull Elevation:	194.5
Bankfull Cross-Sectional Area:	27.2
Bankfull Width:	21.1
Flood Prone Area Elevation:	-
Flood Prone Width:	-
Max Depth at Bankfull:	3.3
Mean Depth at Bankfull:	1.3
W / D Ratio:	-
Entrenchment Ratio:	-
Bank Height Ratio:	-

Stream Type C5

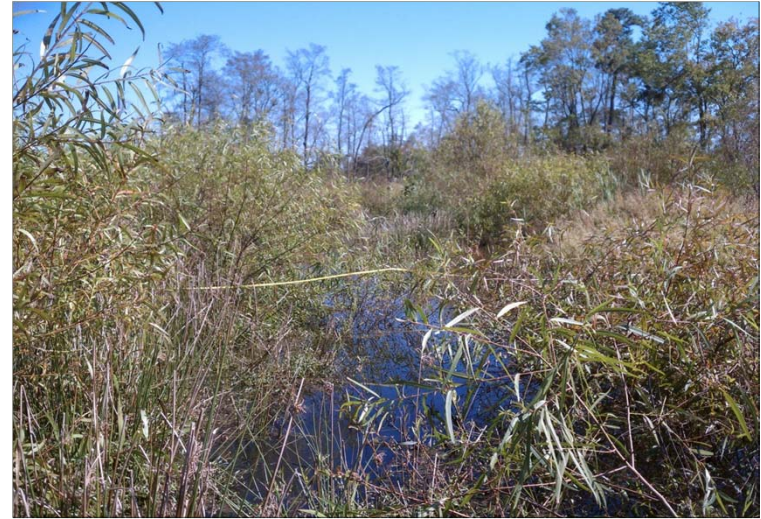
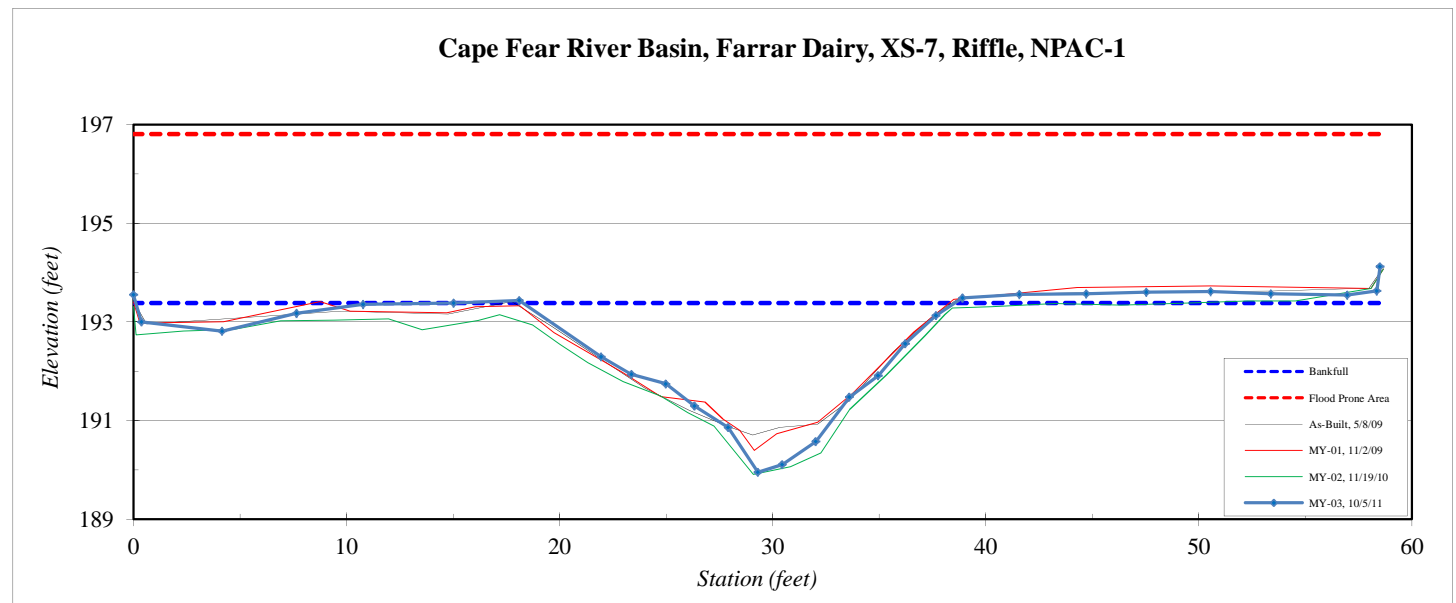
River Basin:	Cape Fear
Watershed:	Farrar Dairy
XS ID	XS-7, Riffle, NPAC-1
Drainage Area (sq mi):	4.1
Date:	10/5/2011
Field Crew:	A. French, M. Koss

SUMMARY DATA	
Bankfull Elevation:	193.4
Bankfull Cross-Sectional Area:	33.5
Bankfull Width:	20.3
Flood Prone Area Elevation:	196.8
Flood Prone Width:	>60
Max Depth at Bankfull:	3.4
Mean Depth at Bankfull:	1.7
W / D Ratio:	12.3
Entrenchment Ratio:	>3.0
Bank Height Ratio:	1.0

Stream Type	C5
--------------------	----

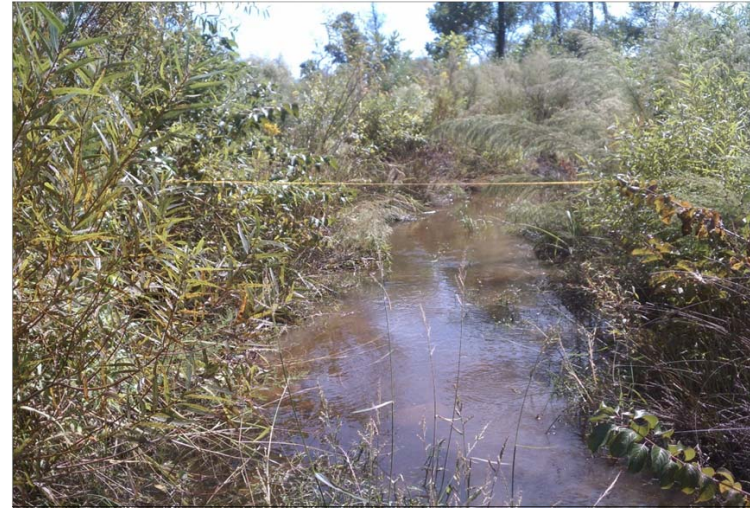
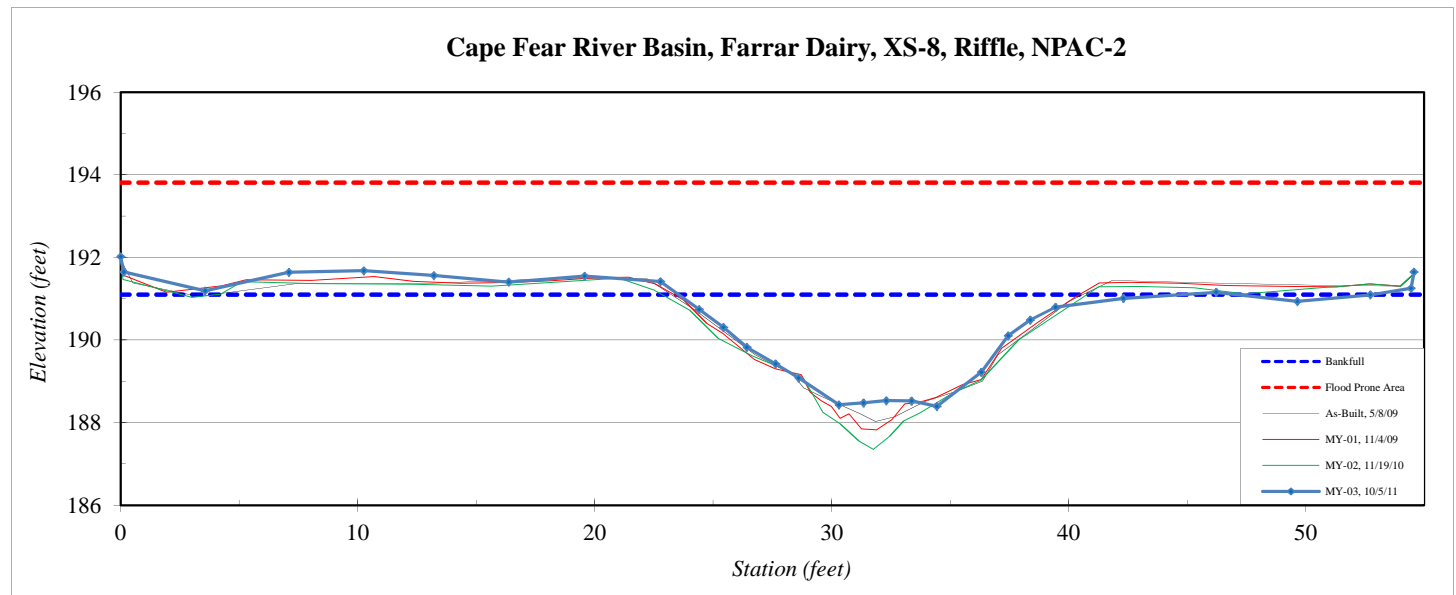
River Basin:	Cape Fear
Watershed:	Farrar Dairy
XS ID	XS-8, Riffle, NPAC-2
Drainage Area (sq mi):	4.1
Date:	10/5/2011
Field Crew:	A. French, M. Koss

SUMMARY DATA	
Bankfull Elevation:	191.1
Bankfull Cross-Sectional Area:	28.0
Bankfull Width:	21.2
Flood Prone Area Elevation:	193.8
Flood Prone Width:	>60
Max Depth at Bankfull:	2.7
Mean Depth at Bankfull:	1.3
W / D Ratio:	16.1
Entrenchment Ratio:	>3.0
Bank Height Ratio:	1.0

Stream Type	C5
--------------------	----

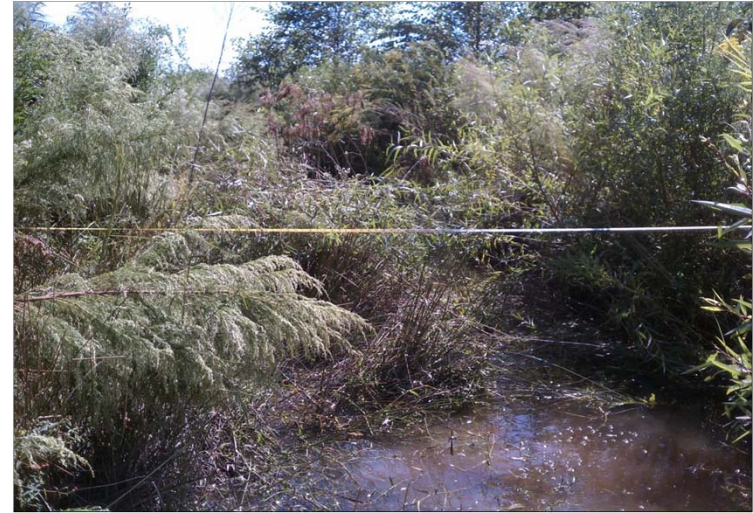
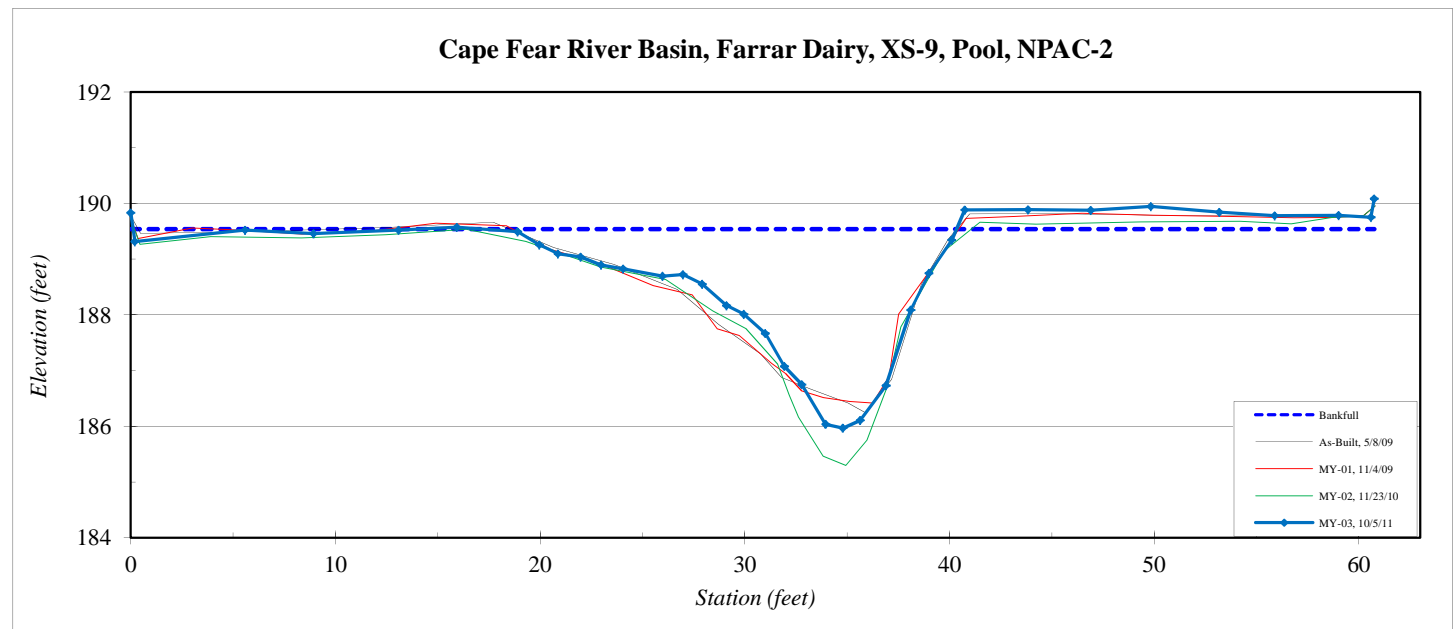
River Basin:	Cape Fear
Watershed:	Farrar Dairy
XS ID	XS-9, Pool, NPAC-2
Drainage Area (sq mi):	4.65
Date:	10/5/2011
Field Crew:	A. French, M. Koss

SUMMARY DATA	
Bankfull Elevation:	189.5
Bankfull Cross-Sectional Area:	31.9
Bankfull Width:	23.3
Flood Prone Area Elevation:	-
Flood Prone Width:	-
Max Depth at Bankfull:	3.6
Mean Depth at Bankfull:	1.4
W / D Ratio:	-
Entrenchment Ratio:	-
Bank Height Ratio:	-

Stream Type	C5
--------------------	----

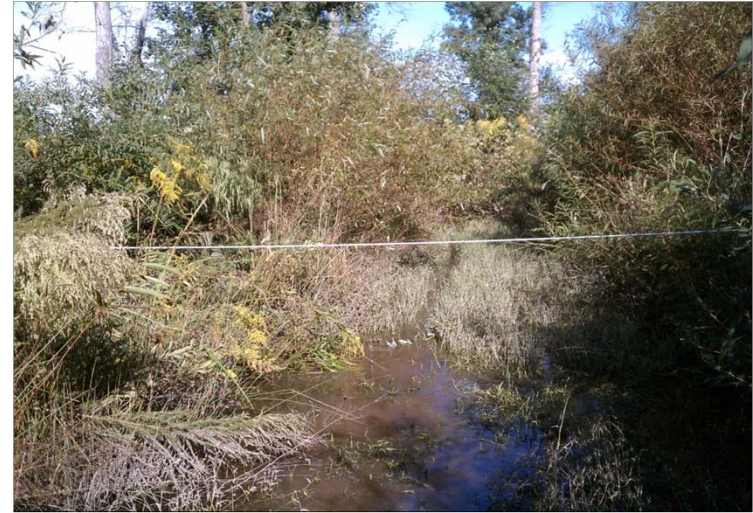
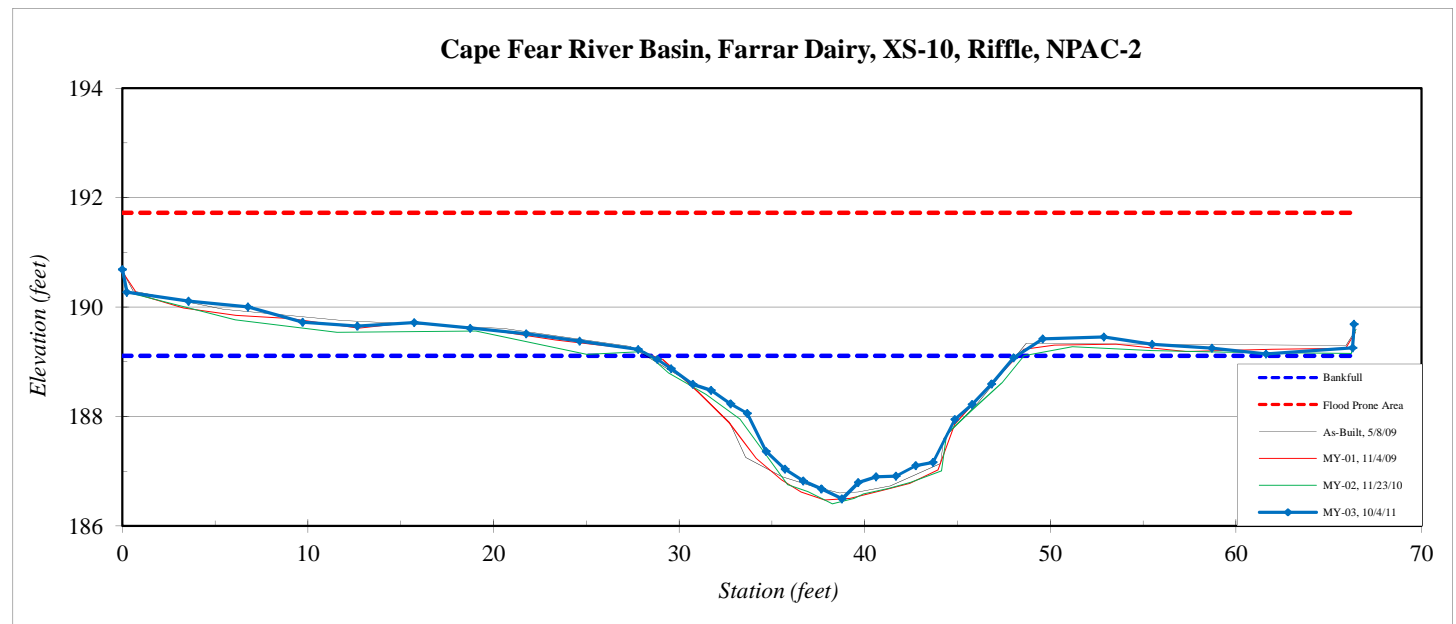
River Basin:	Cape Fear
Watershed:	Farrar Dairy
XS ID	XS-10, Riffle, NPAC-2
Drainage Area (sq mi):	4.65
Date:	10/4/2011
Field Crew:	A. French, M. Koss

SUMMARY DATA	
Bankfull Elevation:	189.1
Bankfull Cross-Sectional Area:	28.0
Bankfull Width:	19.7
Flood Prone Area Elevation:	191.7
Flood Prone Width:	>60
Max Depth at Bankfull:	2.6
Mean Depth at Bankfull:	1.4
W / D Ratio:	13.9
Entrenchment Ratio:	>3.0
Bank Height Ratio:	1.0

Stream Type	C5
--------------------	----

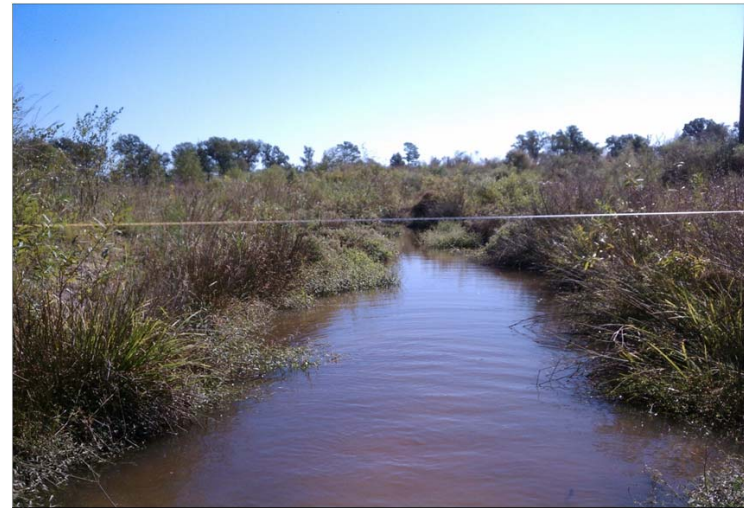
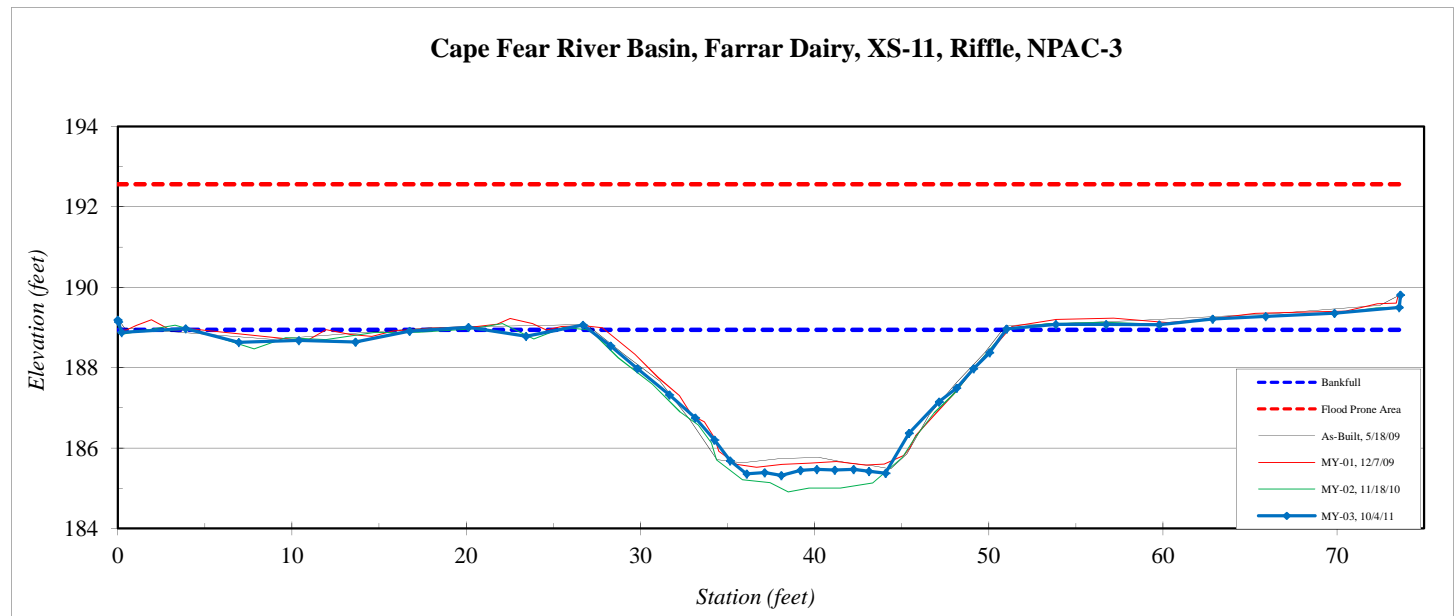
River Basin:	Cape Fear
Watershed:	Farrar Dairy
XS ID	XS-11, Riffle, NPAC-3
Drainage Area (sq mi):	4.82
Date:	10/4/2011
Field Crew:	A. French, M. Koss

SUMMARY DATA	
Bankfull Elevation:	188.9
Bankfull Cross-Sectional Area:	54.9
Bankfull Width:	23.9
Flood Prone Area Elevation:	192.6
Flood Prone Width:	>60
Max Depth at Bankfull:	3.6
Mean Depth at Bankfull:	2.3
W / D Ratio:	10.4
Entrenchment Ratio:	>3.0
Bank Height Ratio:	1.0

Stream Type	C5
--------------------	----

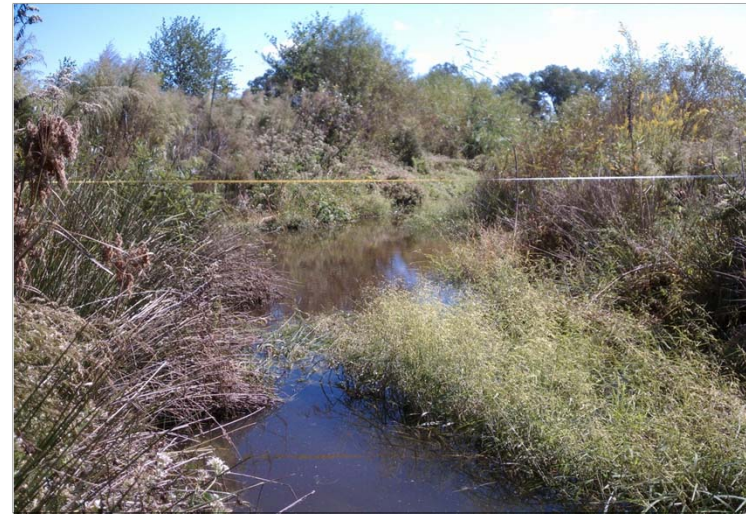
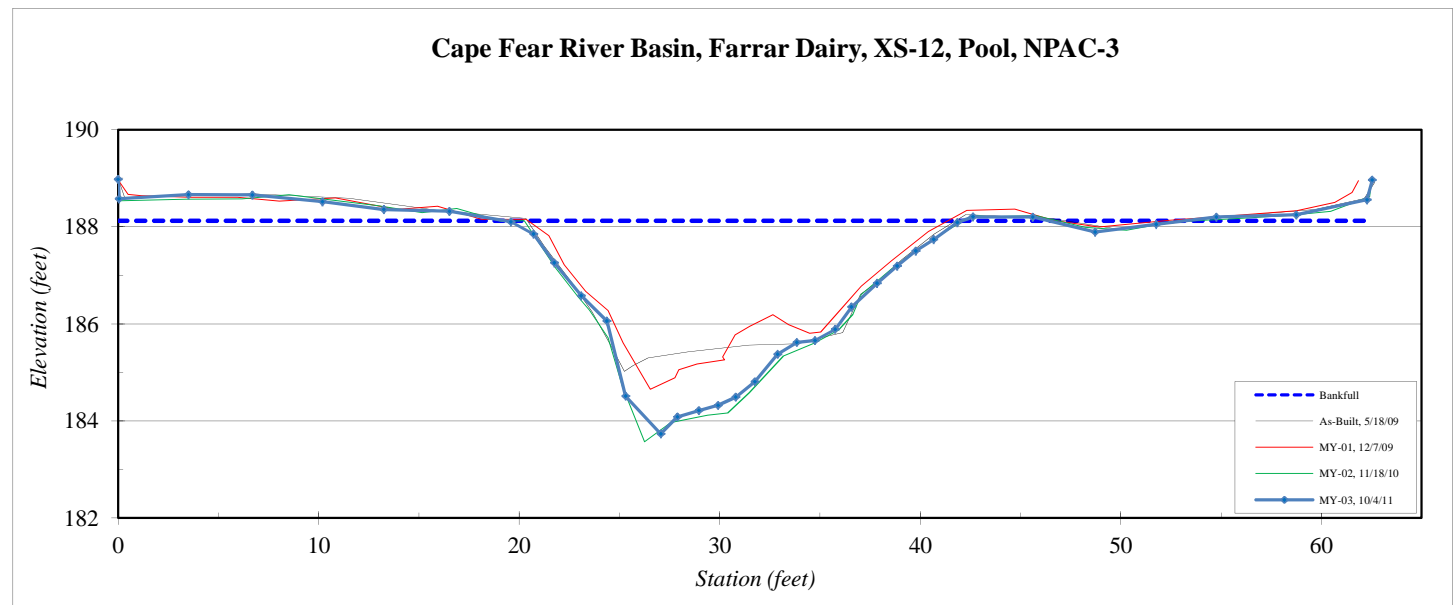
River Basin:	Cape Fear
Watershed:	Farrar Dairy
XS ID	XS-12, Pool, NPAC-3
Drainage Area (sq mi):	4.82
Date:	10/4/2011
Field Crew:	A. French, M. Koss

SUMMARY DATA	
Bankfull Elevation:	188.1
Bankfull Cross-Sectional Area:	49.0
Bankfull Width:	22.7
Flood Prone Area Elevation:	-
Flood Prone Width:	-
Max Depth at Bankfull:	4.4
Mean Depth at Bankfull:	2.2
W / D Ratio:	-
Entrenchment Ratio:	-
Bank Height Ratio:	-

Stream Type	C5
--------------------	----

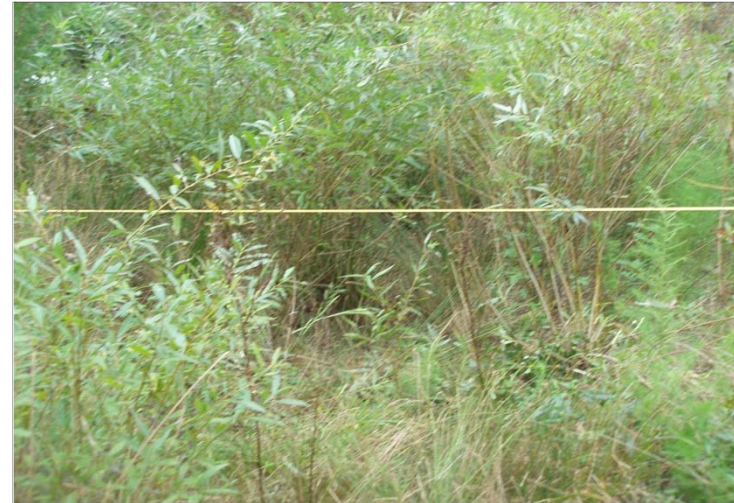
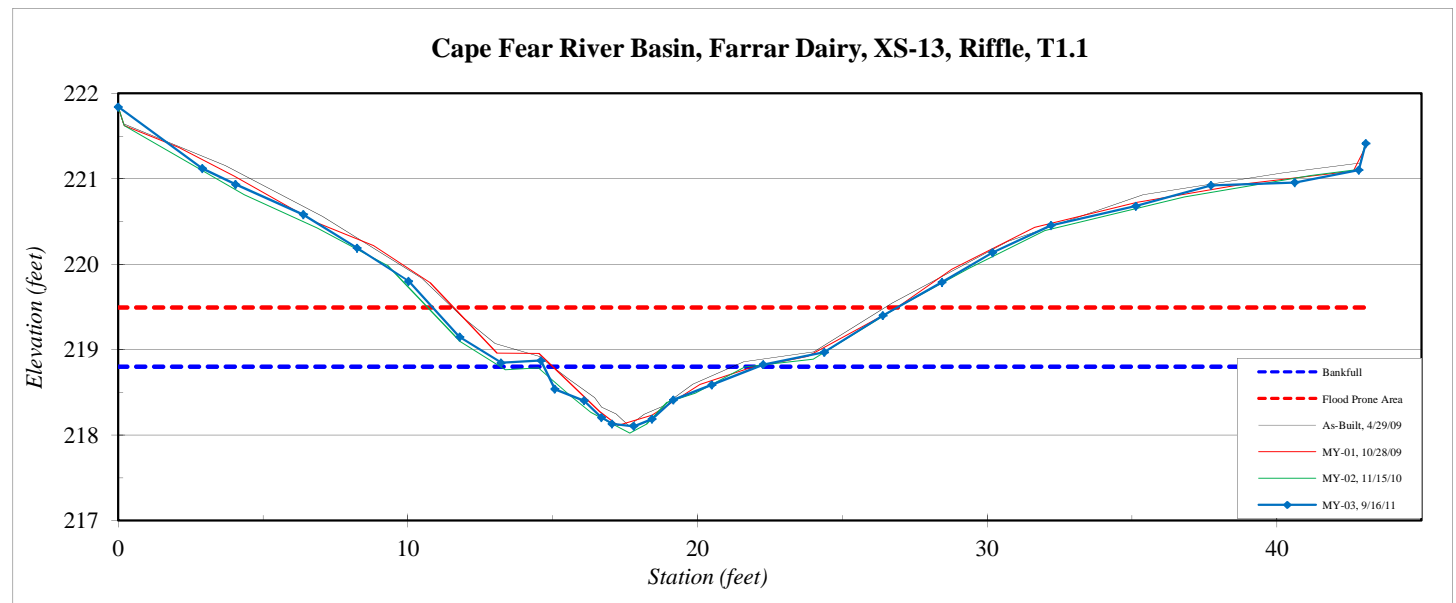
River Basin:	Cape Fear
Watershed:	Farrar Dairy
XS ID	XS-13, Riffle, T1.1
Drainage Area (sq mi):	0.02
Date:	9/16/2011
Field Crew:	A. French, J. Anders

SUMMARY DATA	
Bankfull Elevation:	218.8
Bankfull Cross-Sectional Area:	2.8
Bankfull Width:	7.4
Flood Prone Area Elevation:	219.5
Flood Prone Width:	16
Max Depth at Bankfull:	0.7
Mean Depth at Bankfull:	0.4
W / D Ratio:	19.6
Entrenchment Ratio:	2.2
Bank Height Ratio:	1.0

Stream Type	C5
--------------------	----

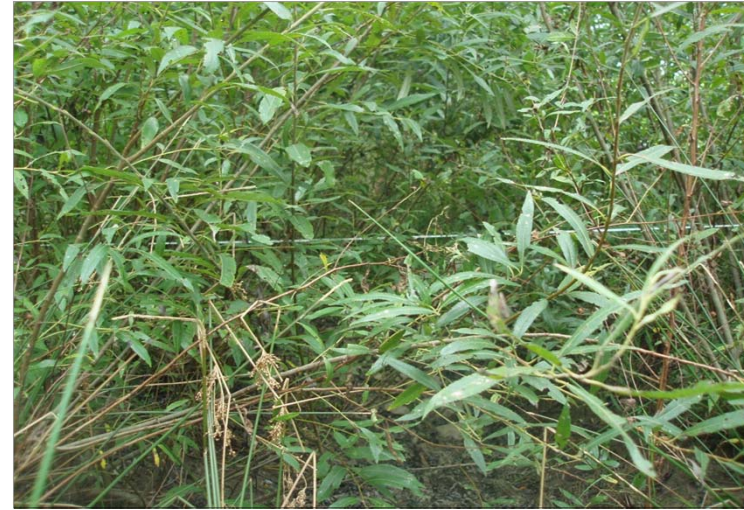
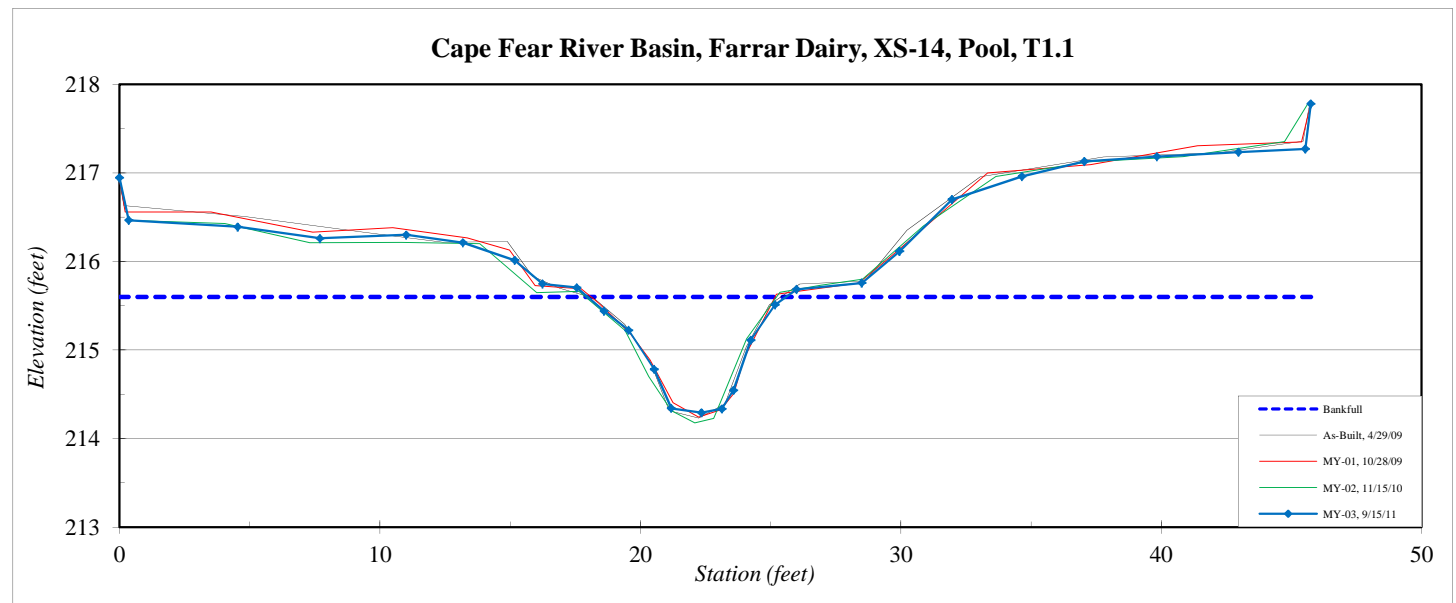
River Basin:	Cape Fear
Watershed:	Farrar Dairy
XS ID	XS-14, Pool, T1.1
Drainage Area (sq mi):	0.02
Date:	9/16/2011
Field Crew:	A. French, J. Anders

SUMMARY DATA	
Bankfull Elevation:	215.6
Bankfull Cross-Sectional Area:	5.4
Bankfull Width:	7.6
Flood Prone Area Elevation:	-
Flood Prone Width:	-
Max Depth at Bankfull:	1.3
Mean Depth at Bankfull:	0.7
W / D Ratio:	-
Entrenchment Ratio:	-
Bank Height Ratio:	-

Stream Type C5

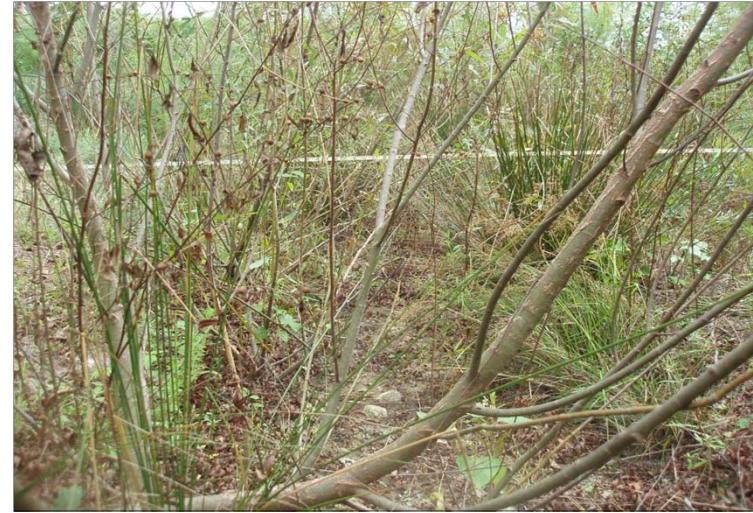
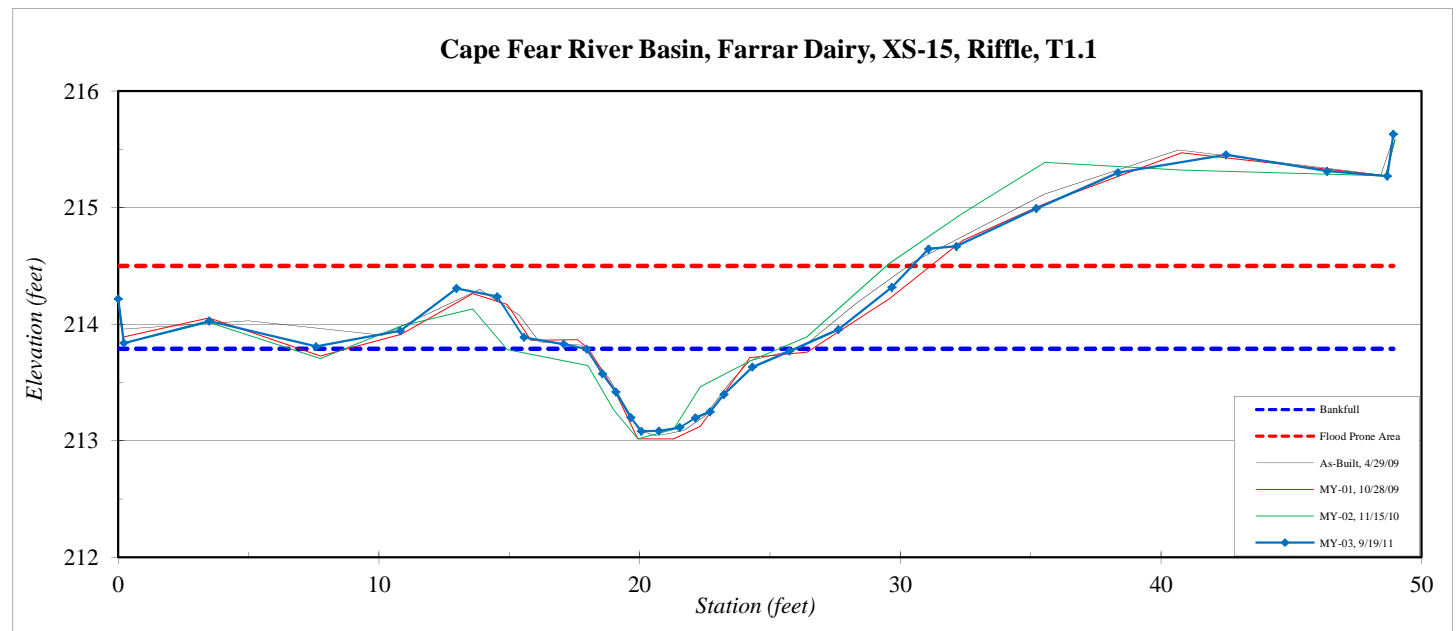
River Basin:	Cape Fear
Watershed:	Farrar Dairy
XS ID	XS-15, Riffle, T1.1
Drainage Area (sq mi):	0.02
Date:	9/19/2011
Field Crew:	A. French, J. Anders

SUMMARY DATA	
Bankfull Elevation:	213.8
Bankfull Cross-Sectional Area:	1.9
Bankfull Width:	6.1
Flood Prone Area Elevation:	214.5
Flood Prone Width:	30
Max Depth at Bankfull:	0.7
Mean Depth at Bankfull:	0.3
W / D Ratio:	19.6
Entrenchment Ratio:	5.0
Bank Height Ratio:	1.0

Stream Type	C5
--------------------	----

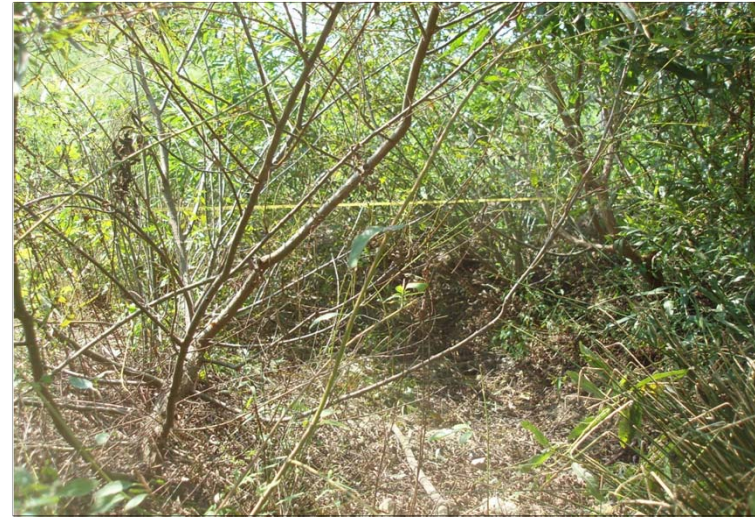
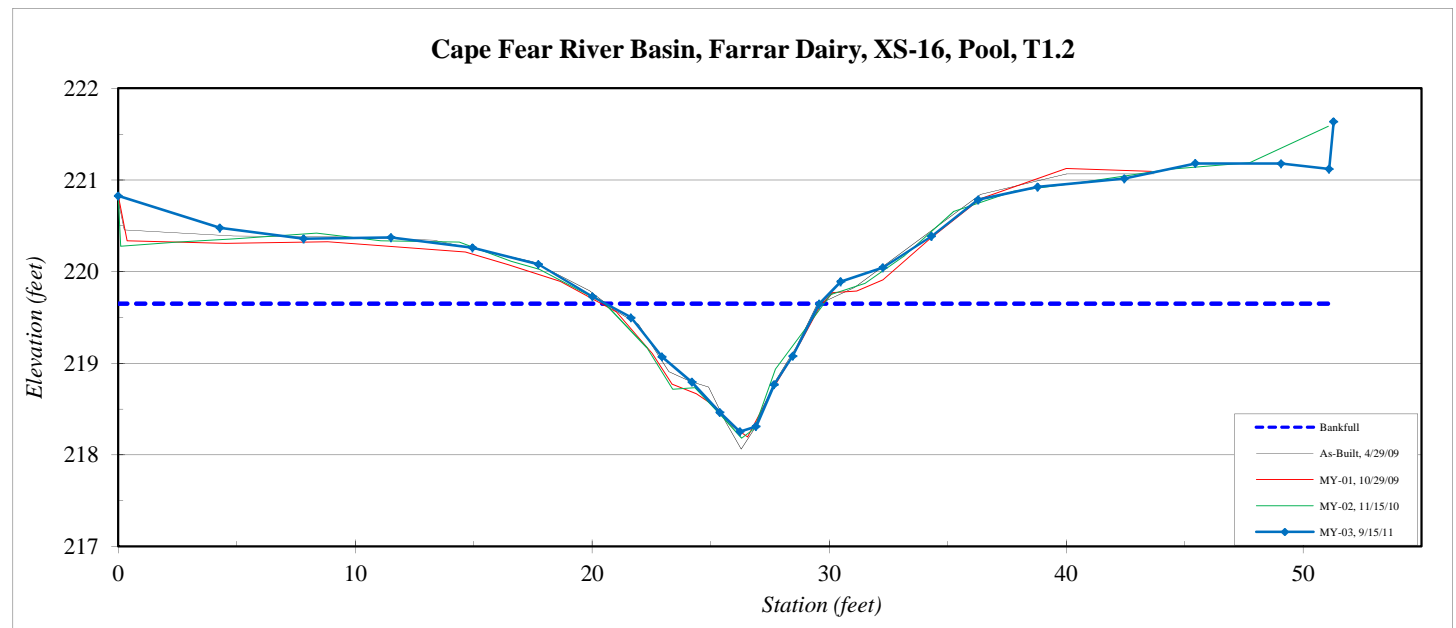
Station	Elevation
0.0	220.83
4.3	220.48
7.8	220.36
11.5	220.37
15.0	220.26
17.7	220.08
20.0	219.73
21.6	219.50
22.9	219.07
24.2	218.79
25.4	218.46
26.2	218.25
26.9	218.31
27.7	218.77
28.5	219.08
29.6	219.65
30.5	219.89
32.3	220.04
34.3	220.39
36.3	220.78
38.8	220.92
42.5	221.01
45.4	221.18
49.1	221.18
51.1	221.12
51.3	221.63

SUMMARY DATA	
Bankfull Elevation:	219.7
Bankfull Cross-Sectional Area:	6.4
Bankfull Width:	9.0
Flood Prone Area Elevation:	-
Flood Prone Width:	-
Max Depth at Bankfull:	1.4
Mean Depth at Bankfull:	0.7
W / D Ratio:	-
Entrenchment Ratio:	-
Bank Height Ratio:	-

Stream Type	C5
--------------------	----
