**Farrar Dairy Stream and Wetland Restoration Site
Monitoring Report – MY03
Harnett County, NC**

December 2011

**Project Manager: Tim Morris
Email: tim.morris@kci.com
KCI Project No: 12065438**

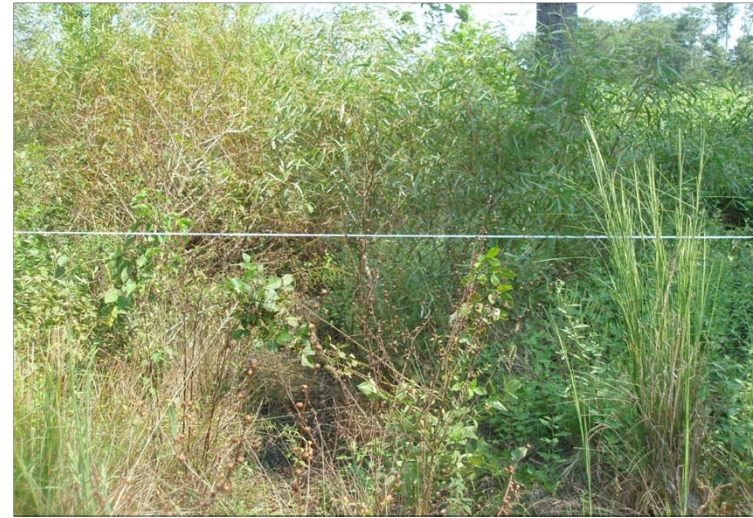
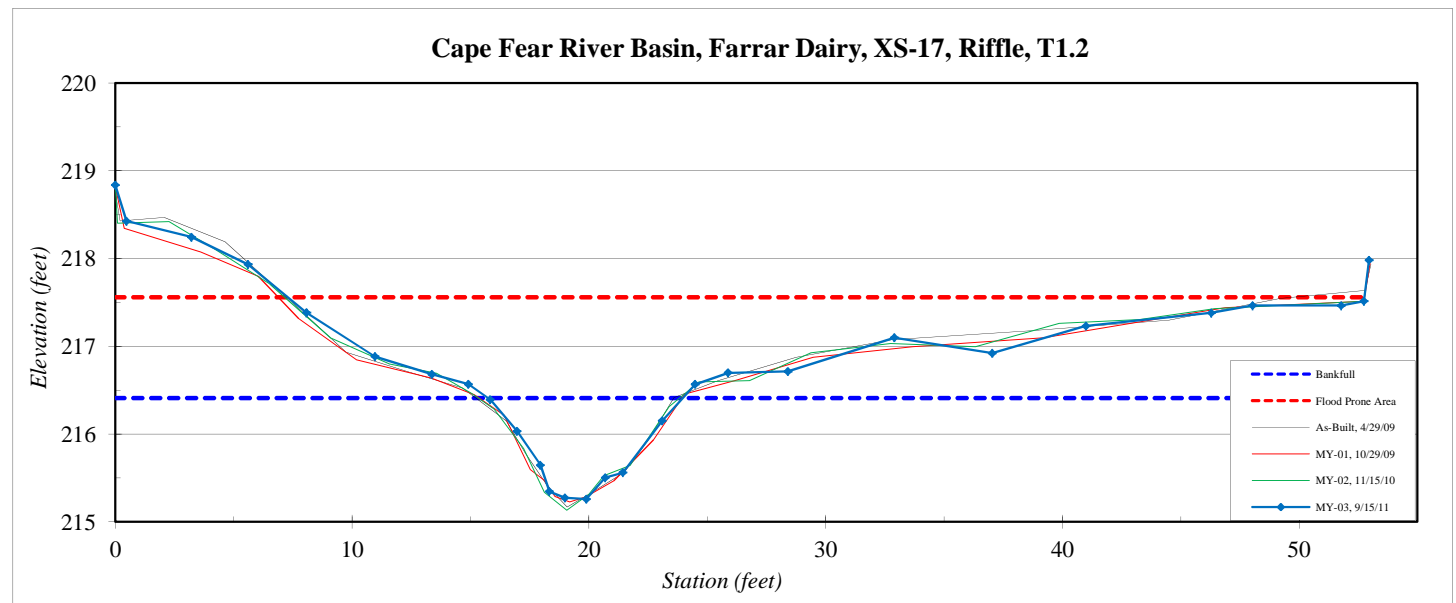
River Basin:	Cape Fear
Watershed:	Farrar Dairy
XS ID	XS-17, Riffle, T1.2
Drainage Area (sq mi):	0.10
Date:	9/15/2011
Field Crew:	A. French, J. Anders

Station	Elevation
0.0	218.84
0.5	218.43
3.2	218.25
5.6	217.93
8.1	217.38
11.0	216.88
13.4	216.68
14.9	216.57
15.8	216.39
17.0	216.03
18.0	215.65
18.3	215.35
19.0	215.28
19.9	215.26
20.7	215.51
21.4	215.56
23.1	216.15
24.5	216.57
25.9	216.70
28.4	216.72
32.9	217.10
37.0	216.92
41.0	217.23
46.3	217.38
48.0	217.47
51.8	217.47
52.7	217.51
53.0	217.98

SUMMARY DATA	
Bankfull Elevation:	216.4
Bankfull Cross-Sectional Area:	5.4
Bankfull Width:	8.2
Flood Prone Area Elevation:	217.6
Flood Prone Width:	46
Max Depth at Bankfull:	1.1
Mean Depth at Bankfull:	0.7
W / D Ratio:	12.5
Entrenchment Ratio:	5.6
Bank Height Ratio:	1.0

Stream Type	C5
--------------------	----

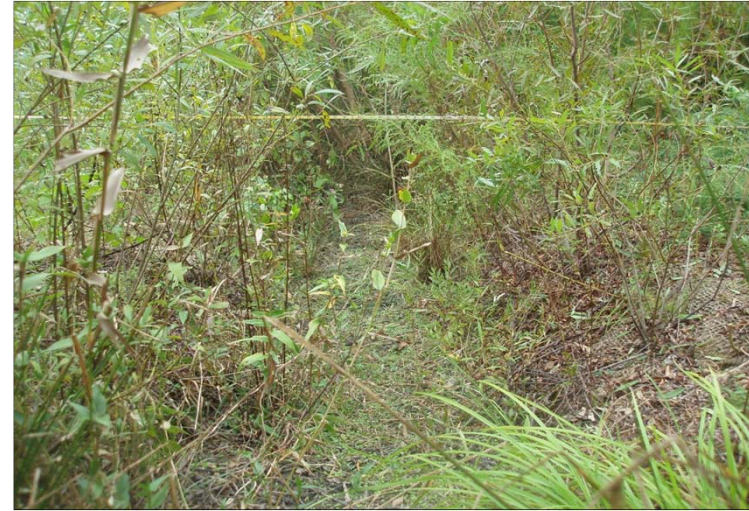
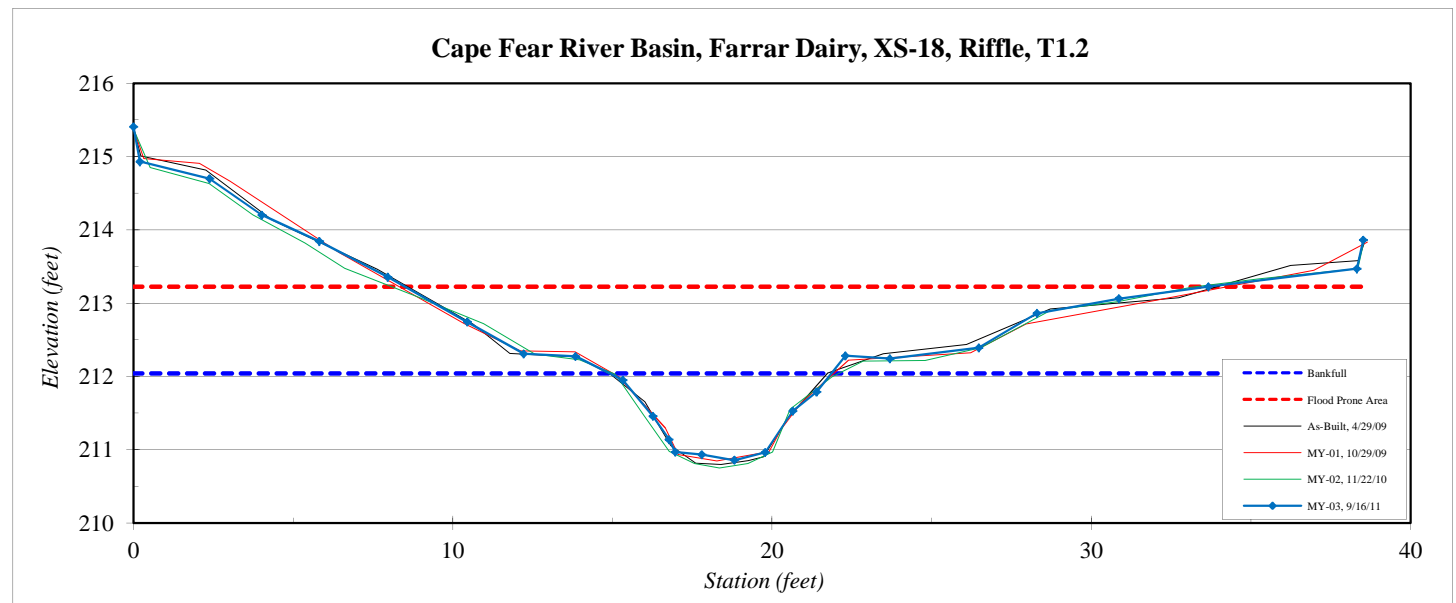
River Basin:	Cape Fear
Watershed:	Farrar Dairy
XS ID	XS-18, Riffle, T1.2
Drainage Area (sq mi):	0.10
Date:	9/16/2011
Field Crew:	A. French, J. Anders

Station	Elevation
0.0	215.41
0.2	214.93
2.4	214.70
4.0	214.20
5.8	213.84
8.0	213.36
10.5	212.74
12.2	212.31
13.8	212.27
15.3	211.95
16.3	211.46
16.8	211.14
17.0	210.97
17.8	210.93
18.8	210.86
19.8	210.96
20.6	211.53
21.4	211.79
22.3	212.28
23.7	212.24
26.5	212.39
28.3	212.86
30.9	213.06
33.7	213.22
38.3	213.47
38.5	213.86

SUMMARY DATA	
Bankfull Elevation:	212.0
Bankfull Cross-Sectional Area:	5.1
Bankfull Width:	6.9
Flood Prone Area Elevation:	213.2
Flood Prone Width:	26
Max Depth at Bankfull:	1.2
Mean Depth at Bankfull:	0.7
W / D Ratio:	9.3
Entrenchment Ratio:	3.8
Bank Height Ratio:	1.0

Stream Type	E5
--------------------	----

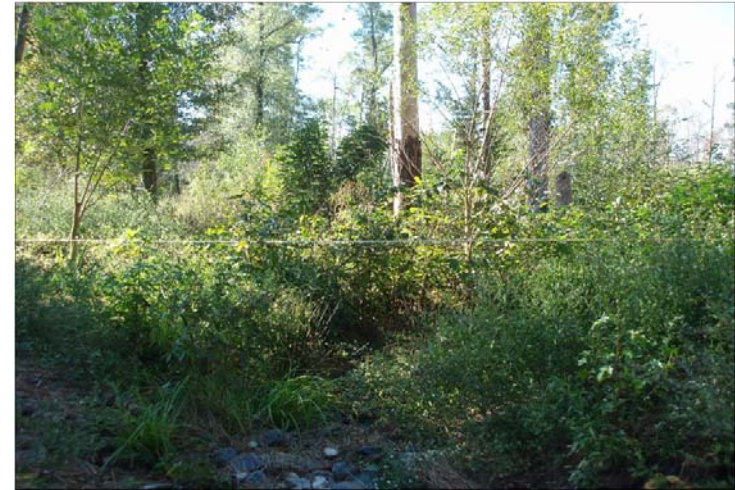
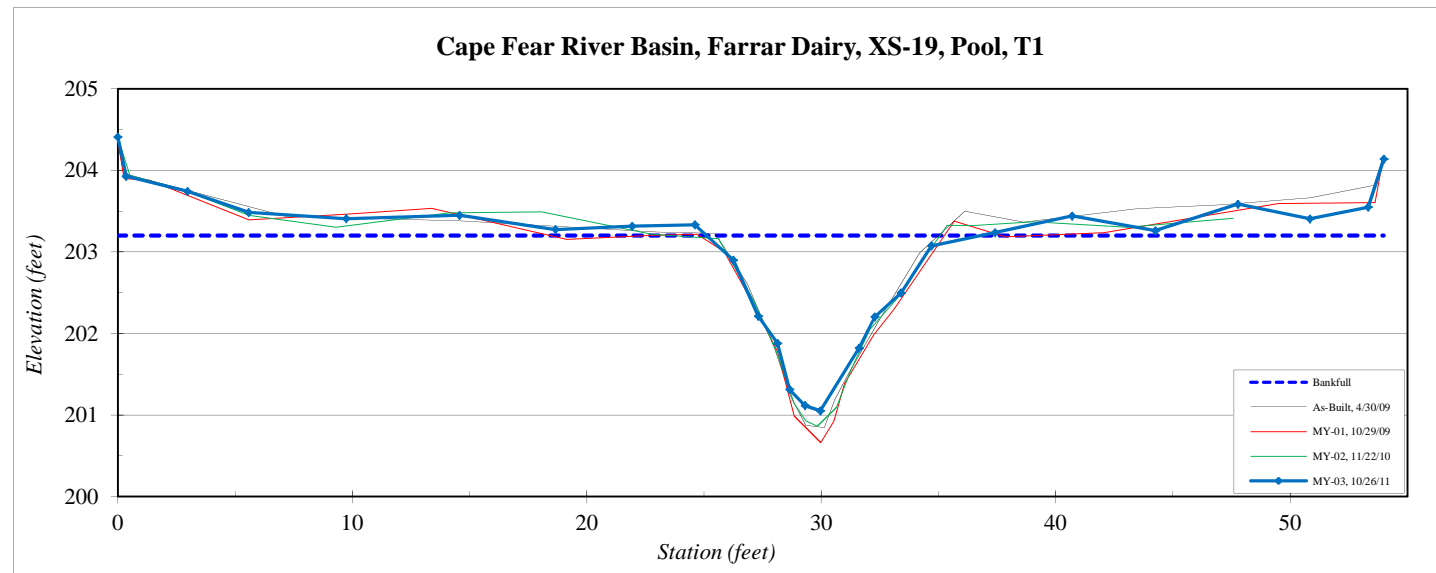
River Basin:	Cape Fear
Watershed:	Farrar Dairy
XS ID	XS-19, Pool, T1
Drainage Area (sq mi):	0.18
Date:	10/26/2011
Field Crew:	A. French, A. Helms

Stream Type	E5
--------------------	----

Station	Elevation
0.0	204.41
0.4	203.93
3.0	203.74
5.6	203.49
9.7	203.41
14.6	203.45
18.7	203.27
21.9	203.32
24.6	203.33
26.3	202.90
27.3	202.21
28.1	201.88
28.7	201.31
29.3	201.12
30.0	201.05
31.6	201.82
32.3	202.20
33.4	202.50
34.7	203.07
37.4	203.24
40.7	203.44
44.3	203.26
47.8	203.59
50.8	203.41
53.3	203.55
54.0	204.14

SUMMARY DATA	
Bankfull Elevation:	203.2
Bankfull Cross-Sectional Area:	10.6
Bankfull Width:	11.7
Flood Prone Area Elevation:	-
Flood Prone Width:	-
Max Depth at Bankfull:	2.1
Mean Depth at Bankfull:	0.9
W / D Ratio:	-
Entrenchment Ratio:	-
Bank Height Ratio:	-

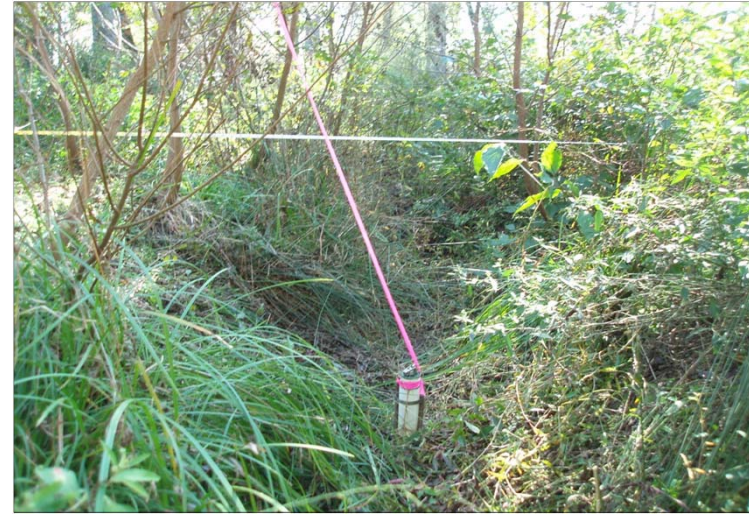
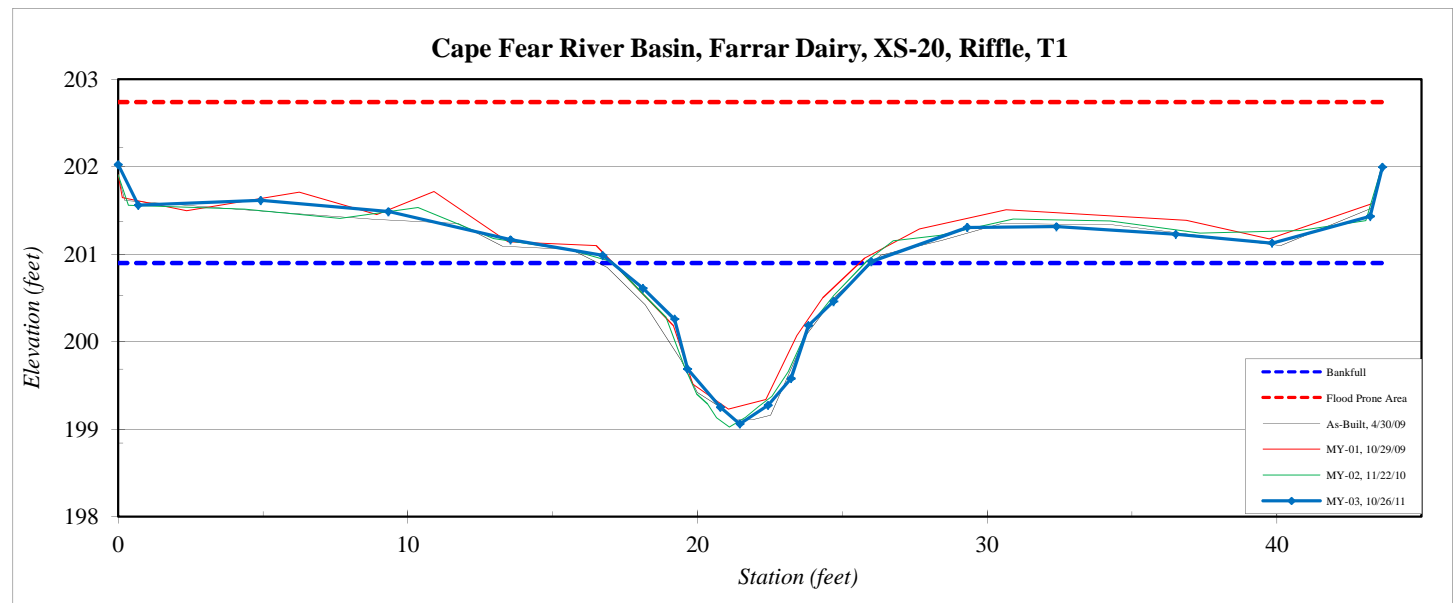
River Basin:	Cape Fear
Watershed:	Farrar Dairy
XS ID	XS-20, Riffle, T1
Drainage Area (sq mi):	0.18
Date:	10/26/2011
Field Crew:	A. French, A. Helms

Station	Elevation
0.0	202.02
0.7	201.56
4.9	201.61
9.3	201.49
13.5	201.17
16.7	200.99
18.1	200.61
19.2	200.26
19.7	199.69
20.8	199.25
21.5	199.06
22.4	199.27
23.2	199.58
23.8	200.19
24.7	200.46
26.0	200.92
29.3	201.31
32.4	201.32
36.5	201.23
39.8	201.13
43.2	201.43
43.6	201.99

SUMMARY DATA	
Bankfull Elevation:	200.9
Bankfull Cross-Sectional Area:	8.1
Bankfull Width:	8.9
Flood Prone Area Elevation:	202.7
Flood Prone Width:	>60
Max Depth at Bankfull:	1.8
Mean Depth at Bankfull:	0.9
W / D Ratio:	9.8
Entrenchment Ratio:	>3.0
Bank Height Ratio:	1.0

Stream Type	E5
--------------------	----

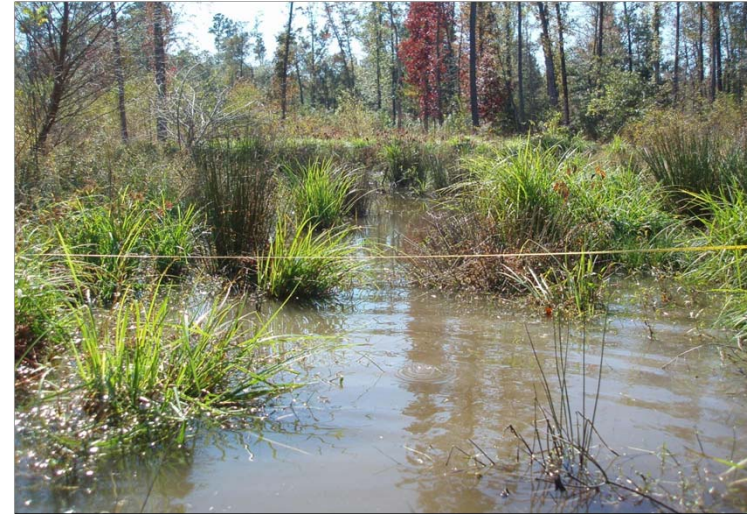
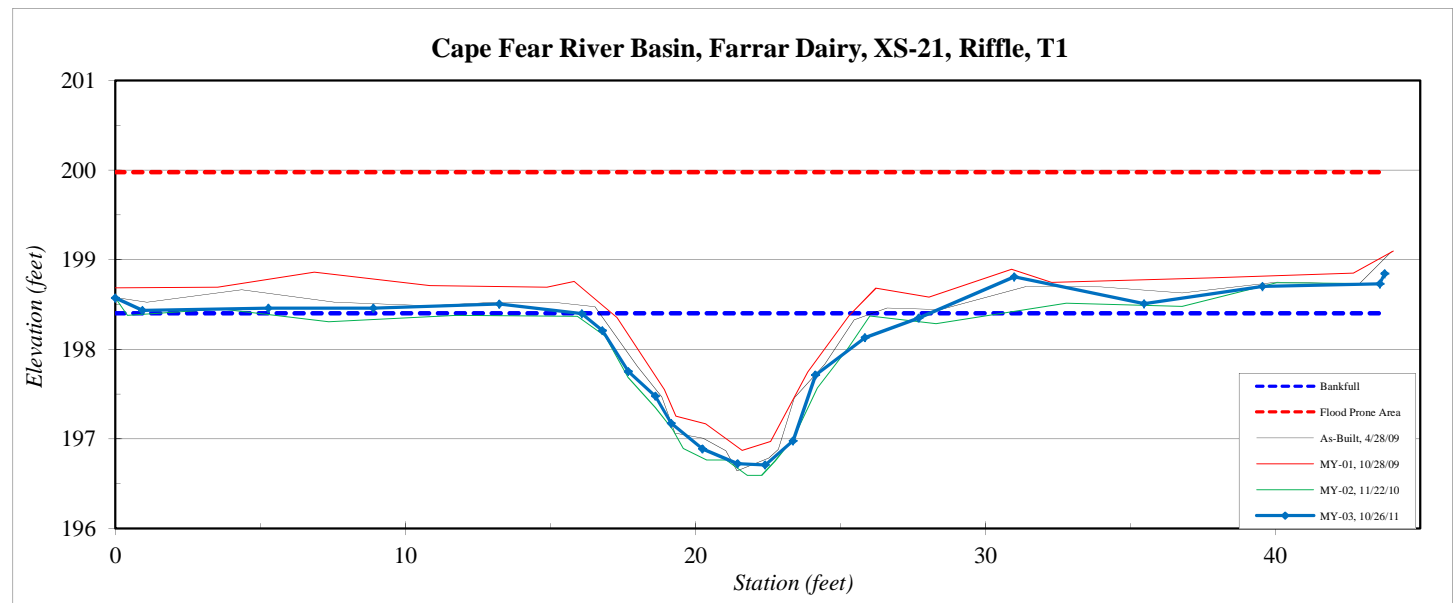
River Basin:	Cape Fear
Watershed:	Farrar Dairy
XS ID	XS-21, Riffle, T1
Drainage Area (sq mi):	0.18
Date:	10/26/2011
Field Crew:	A. French, A. Helms

Station	Elevation
0.0	198.77
0.9	198.64
5.3	198.66
8.9	198.66
13.2	198.70
16.1	198.60
16.8	198.41
17.7	197.95
18.6	197.68
19.2	197.37
20.2	197.09
21.5	196.82
22.4	196.91
23.4	197.08
24.1	197.81
25.9	198.13
27.7	198.35
31.0	198.81
35.5	198.51
39.6	198.70
43.6	198.73
43.8	198.84

SUMMARY DATA	
Bankfull Elevation:	198.4
Bankfull Cross-Sectional Area:	8.8
Bankfull Width:	11.3
Flood Prone Area Elevation:	200.0
Flood Prone Width:	>60
Max Depth at Bankfull:	1.6
Mean Depth at Bankfull:	0.8
W / D Ratio:	14.5
Entrenchment Ratio:	>3.0
Bank Height Ratio:	1.0

Stream Type	E5
--------------------	----

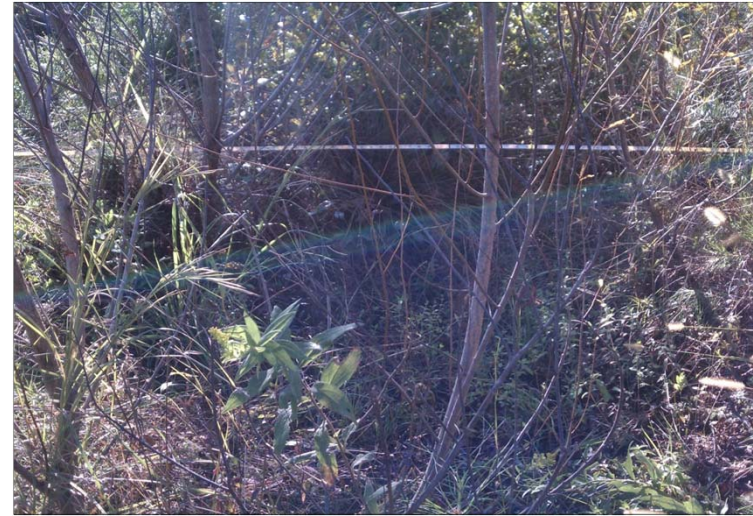
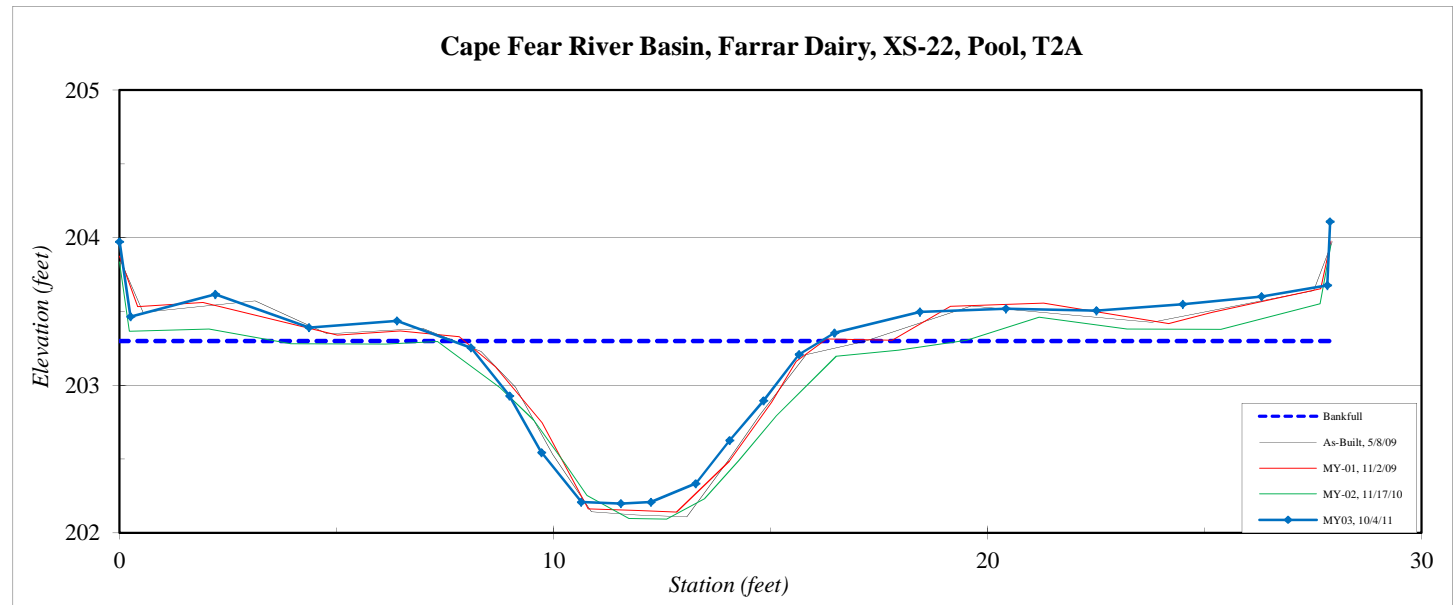
River Basin:	Cape Fear
Watershed:	Farrar Dairy
XS ID	XS-22, Pool, T2A
Drainage Area (sq mi):	0.04
Date:	10/4/2011
Field Crew:	A. French, M. Koss

Station	Elevation
0.0	203.97
0.3	203.46
2.2	203.62
4.4	203.39
6.4	203.44
8.1	203.25
9.0	202.93
9.7	202.54
10.6	202.21
11.6	202.20
12.2	202.21
13.3	202.33
14.1	202.63
14.8	202.89
15.7	203.21
16.5	203.36
18.4	203.50
20.4	203.52
22.5	203.51
24.5	203.55
26.3	203.60
27.8	203.68
27.9	204.11

SUMMARY DATA	
Bankfull Elevation:	203.3
Bankfull Cross-Sectional Area:	5.6
Bankfull Width:	8.5
Flood Prone Area Elevation:	-
Flood Prone Width:	-
Max Depth at Bankfull:	1.1
Mean Depth at Bankfull:	0.7
W / D Ratio:	-
Entrenchment Ratio:	-
Bank Height Ratio:	-

Stream Type	C5
--------------------	----

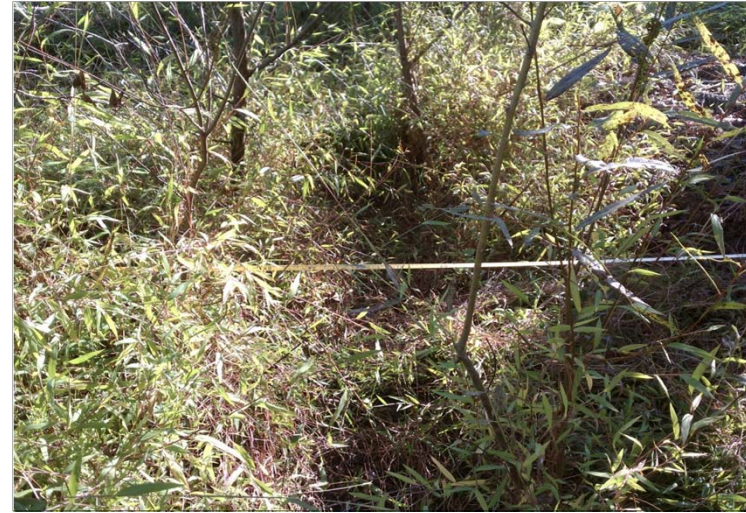
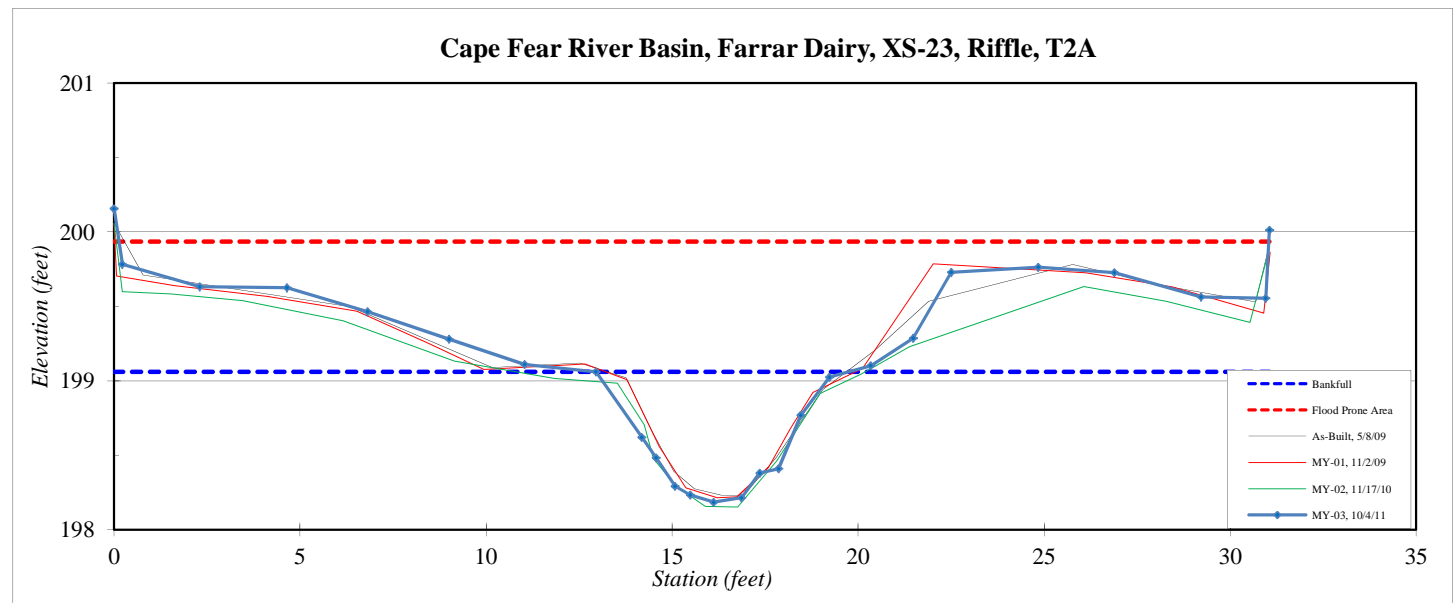
River Basin:	Cape Fear
Watershed:	Farrar Dairy
XS ID	XS-23, Riffle, T2A
Drainage Area (sq mi):	0.04
Date:	10/4/2011
Field Crew:	A. French, M. Koss

Station	Elevation
0.0	200.16
0.2	199.78
2.3	199.63
4.7	199.63
6.8	199.47
9.0	199.28
11.0	199.11
13.0	199.06
14.2	198.62
14.6	198.48
15.1	198.29
15.5	198.23
16.1	198.19
16.9	198.22
17.4	198.38
17.9	198.41
18.5	198.77
19.2	199.03
20.3	199.10
21.5	199.29
22.5	199.73
24.8	199.76
26.9	199.73
29.2	199.56
31.0	199.55
31.1	200.01

SUMMARY DATA	
Bankfull Elevation:	199.1
Bankfull Cross-Sectional Area:	3.4
Bankfull Width:	6.8
Flood Prone Area Elevation:	199.9
Flood Prone Width:	30
Max Depth at Bankfull:	0.9
Mean Depth at Bankfull:	0.5
W / D Ratio:	13.6
Entrenchment Ratio:	4.4
Bank Height Ratio:	1.0

Stream Type C5

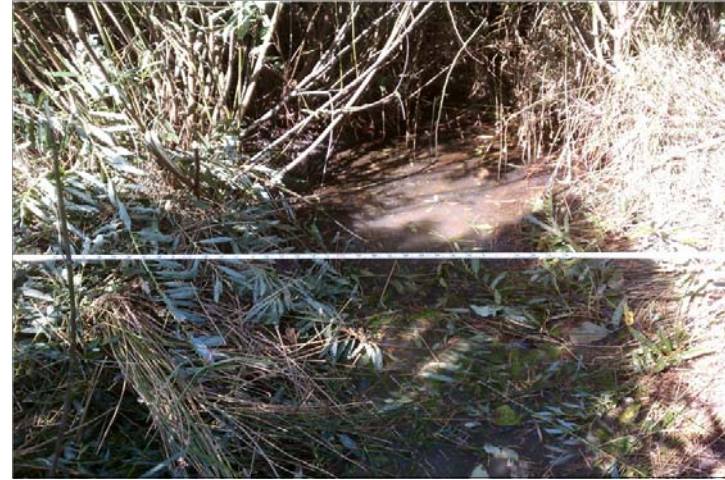
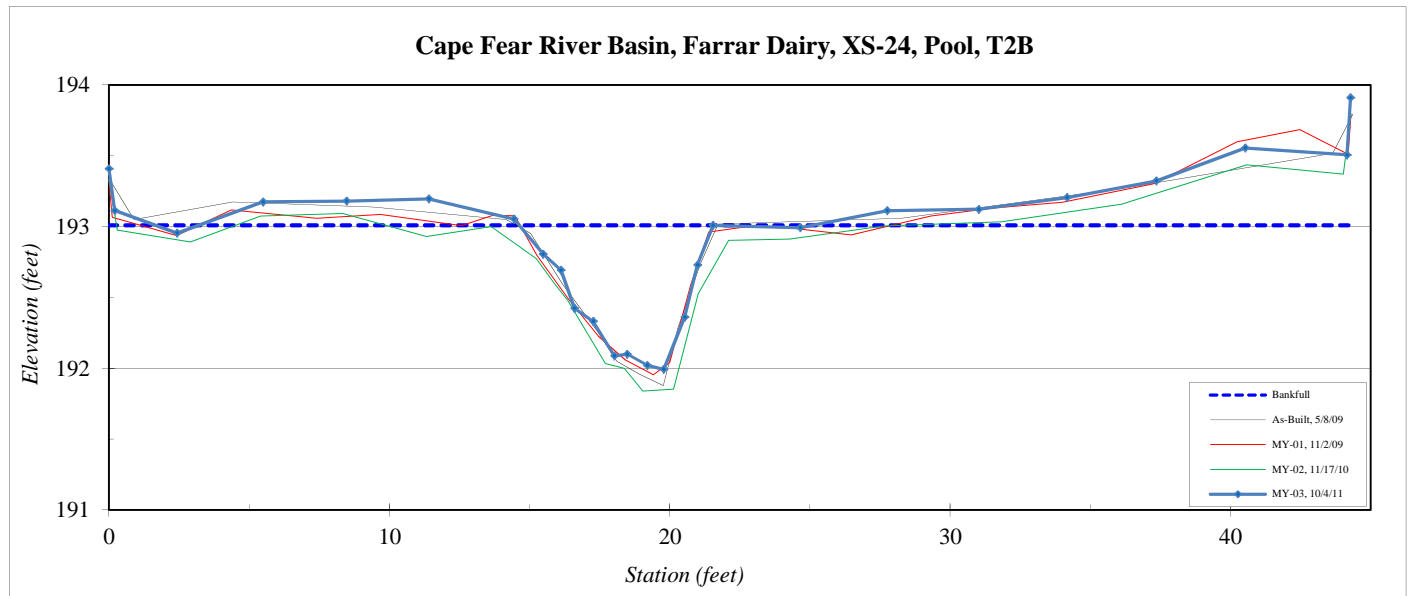
River Basin:	Cape Fear
Watershed:	Farrar Dairy
XS ID	XS-24, Pool, T2B
Drainage Area (sq mi):	0.04
Date:	10/4/2011
Field Crew:	A. French, M. Koss

Station	Elevation
0.0	193.41
0.2	193.11
2.4	192.95
5.5	193.17
8.5	193.18
11.4	193.20
14.4	193.05
15.5	192.81
16.1	192.69
16.6	192.42
17.3	192.33
18.0	192.09
18.5	192.10
19.2	192.02
19.8	191.99
20.5	192.36
21.0	192.73
21.5	193.01
24.7	192.99
27.8	193.11
31.0	193.12
34.2	193.21
37.4	193.32
40.5	193.55
44.2	193.51
44.3	193.91

SUMMARY DATA	
Bankfull Elevation:	193.0
Bankfull Cross-Sectional Area:	4.1
Bankfull Width:	6.9
Flood Prone Area Elevation:	-
Flood Prone Width:	-
Max Depth at Bankfull:	1.0
Mean Depth at Bankfull:	0.6
W / D Ratio:	-
Entrenchment Ratio:	-
Bank Height Ratio:	-

Stream Type	C5
--------------------	----

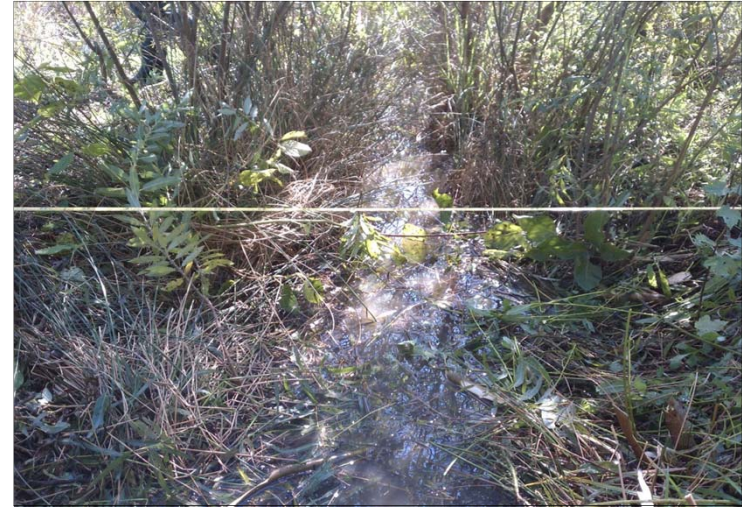
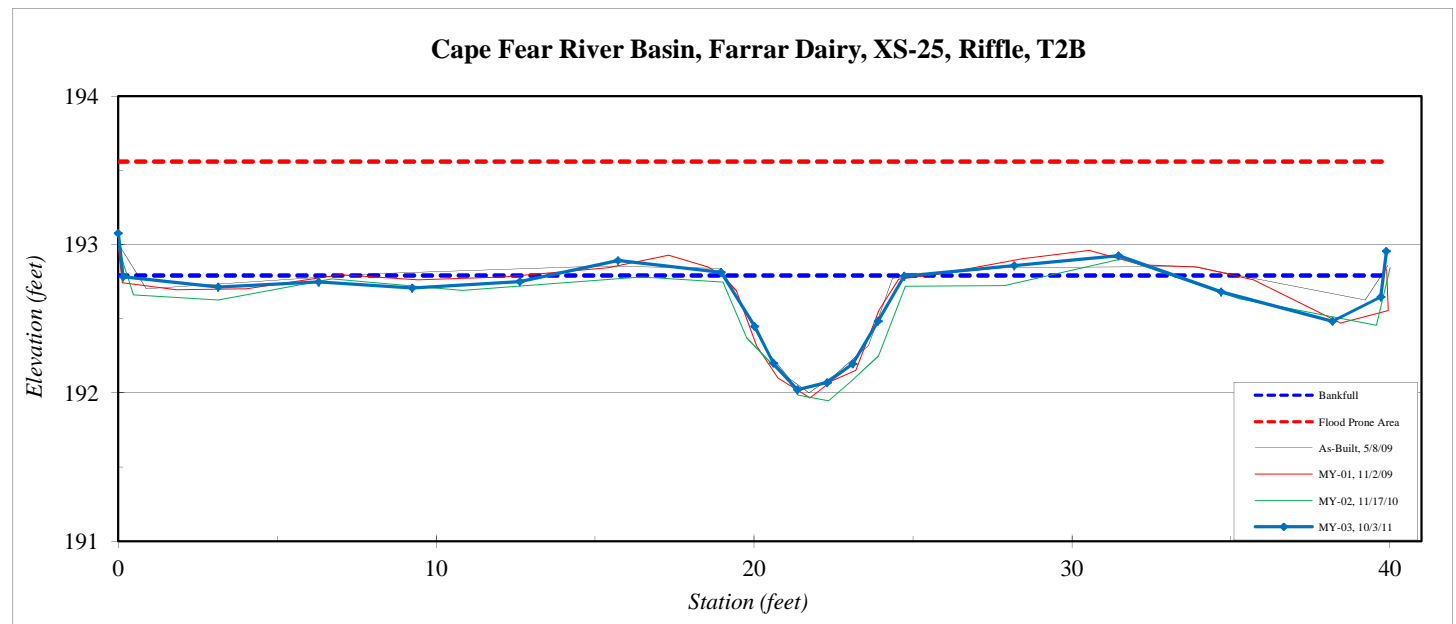
River Basin:	Cape Fear
Watershed:	Farrar Dairy
XS ID	XS-25, Riffle, T2B
Drainage Area (sq mi):	0.04
Date:	10/3/2011
Field Crew:	A. French, M. Koss

Station	Elevation
0.0	193.08
0.2	192.78
3.2	192.71
6.3	192.75
9.3	192.71
12.6	192.75
15.7	192.89
19.0	192.81
20.0	192.45
20.6	192.20
21.4	192.02
22.3	192.07
23.1	192.20
23.9	192.48
24.7	192.79
28.2	192.86
31.5	192.93
34.7	192.68
38.2	192.48
39.7	192.65
39.9	192.96

SUMMARY DATA	
Bankfull Elevation:	192.8
Bankfull Cross-Sectional Area:	2.7
Bankfull Width:	5.9
Flood Prone Area Elevation:	193.6
Flood Prone Width:	>40
Max Depth at Bankfull:	0.8
Mean Depth at Bankfull:	0.5
W / D Ratio:	12.9
Entrenchment Ratio:	6.8
Bank Height Ratio:	1.0

Stream Type C5

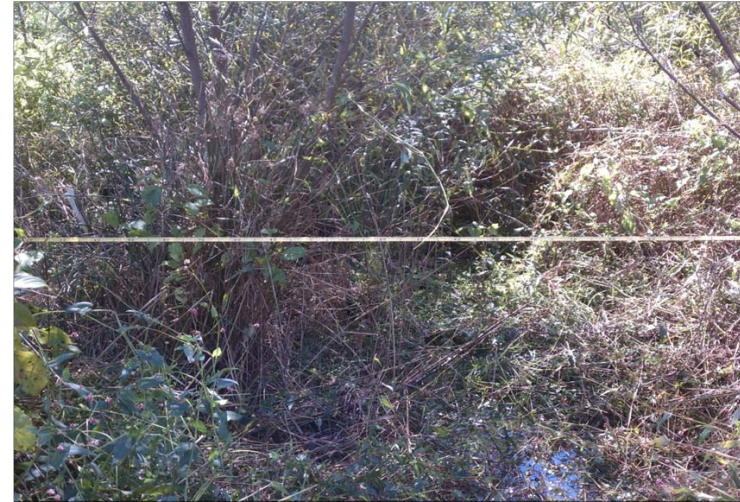
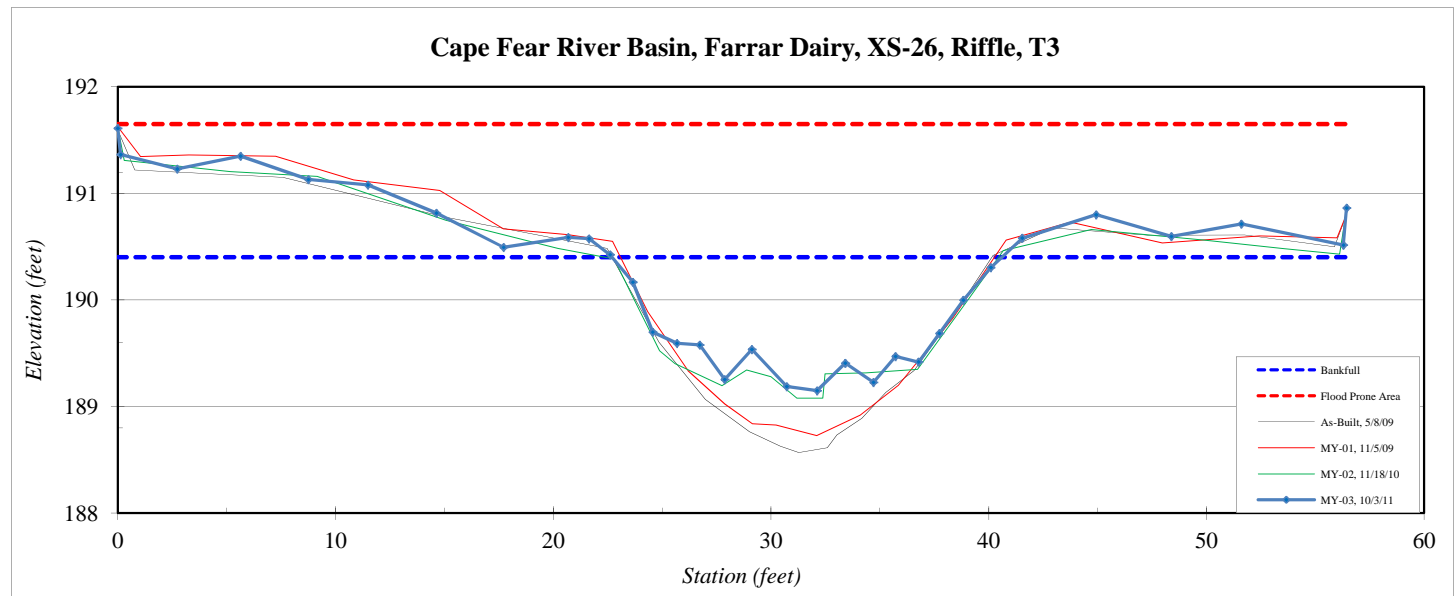
River Basin:	Cape Fear
Watershed:	Farrar Dairy
XS ID	XS-26, Riffle, T3
Drainage Area (sq mi):	0.39
Date:	10/3/2011
Field Crew:	A. French, M. Koss

Station	Elevation
0.0	191.61
0.1	191.37
2.7	191.23
5.6	191.35
8.8	191.13
11.5	191.08
14.6	190.82
17.7	190.49
20.7	190.59
21.6	190.58
22.6	190.42
23.7	190.17
24.6	189.70
25.7	189.59
26.7	189.58
27.9	189.26
29.1	189.54
30.7	189.19
32.1	189.15
33.4	189.41
34.7	189.23
35.7	189.47
36.8	189.42
37.7	189.69
38.8	190.00
40.1	190.31
41.5	190.58
44.9	190.80
48.4	190.60
51.6	190.71
56.3	190.52
56.4	190.87

SUMMARY DATA	
Bankfull Elevation:	190.4
Bankfull Cross-Sectional Area:	14.7
Bankfull Width:	17.9
Flood Prone Area Elevation:	191.7
Flood Prone Width:	>60
Max Depth at Bankfull:	1.3
Mean Depth at Bankfull:	0.8
W / D Ratio:	21.8
Entrenchment Ratio:	>3.0
Bank Height Ratio:	1.0

Stream Type	C5
--------------------	----

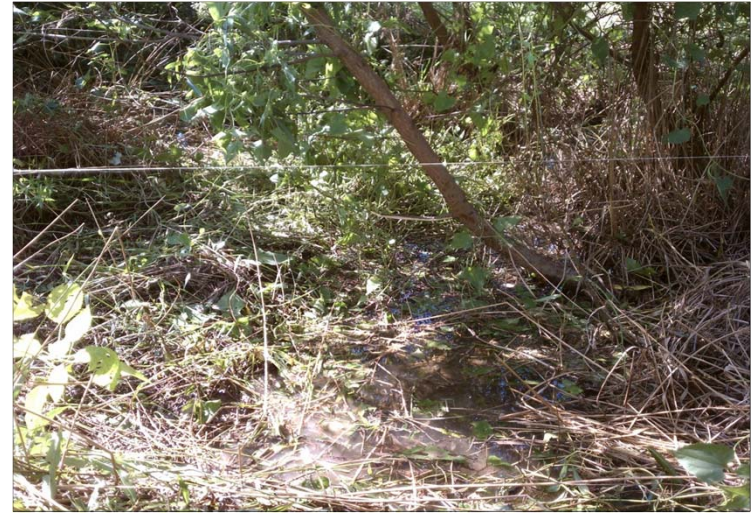
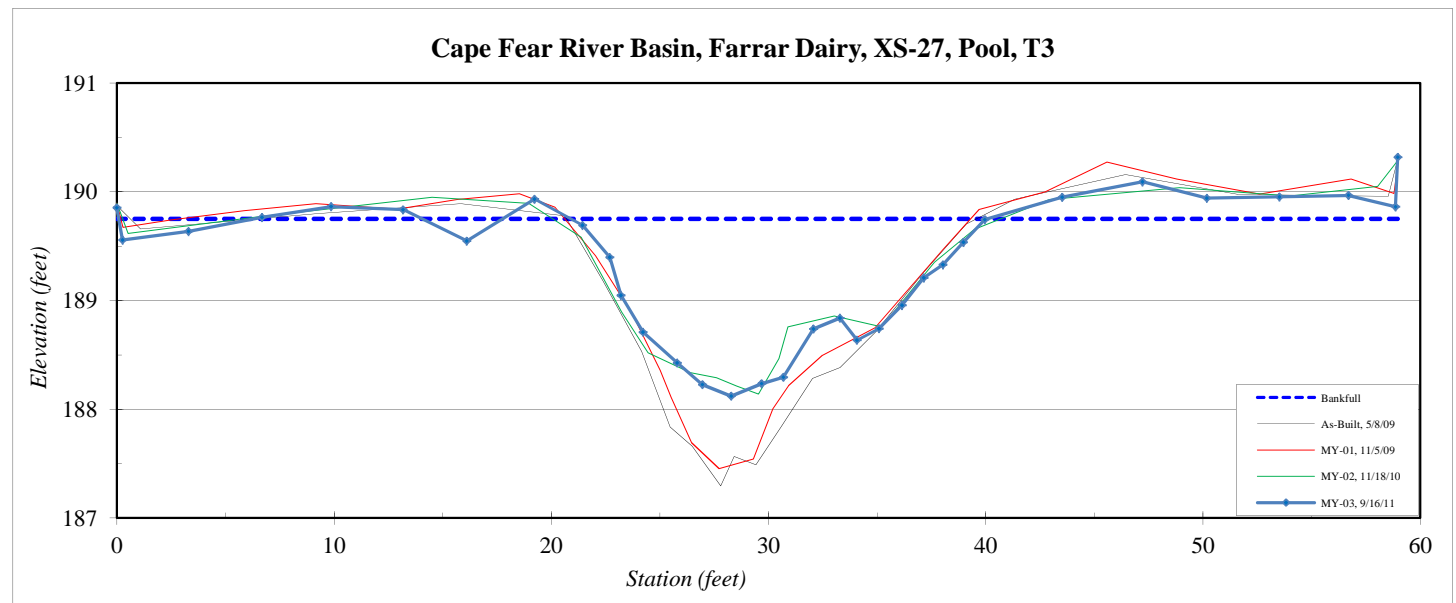
River Basin:	Cape Fear
Watershed:	Farrar Dairy
XS ID	XS-27, Pool, T3
Drainage Area (sq mi):	0.39
Date:	9/16/2011
Field Crew:	A. French, J. Anders

Station	Elevation
0.0	189.85
0.3	189.56
3.3	189.64
6.7	189.77
9.9	189.86
13.2	189.84
16.1	189.55
19.2	189.93
21.4	189.69
22.7	189.40
23.2	189.05
24.2	188.71
25.8	188.43
27.0	188.23
28.3	188.12
29.7	188.24
30.7	188.29
32.1	188.74
33.3	188.84
34.1	188.64
35.1	188.74
36.1	188.96
37.1	189.21
38.0	189.33
39.0	189.54
40.0	189.75
43.5	189.95
47.2	190.09
50.2	189.94
53.5	189.95
56.7	189.97
58.9	189.86
59.0	190.32

SUMMARY DATA	
Bankfull Elevation:	189.8
Bankfull Cross-Sectional Area:	17.9
Bankfull Width:	19.1
Flood Prone Area Elevation:	-
Flood Prone Width:	-
Max Depth at Bankfull:	1.6
Mean Depth at Bankfull:	0.9
W / D Ratio:	-
Entrenchment Ratio:	-
Bank Height Ratio:	-

Stream Type C5

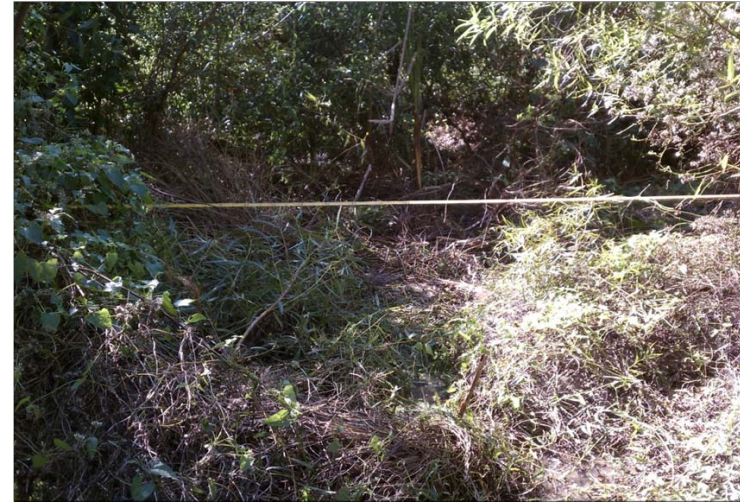
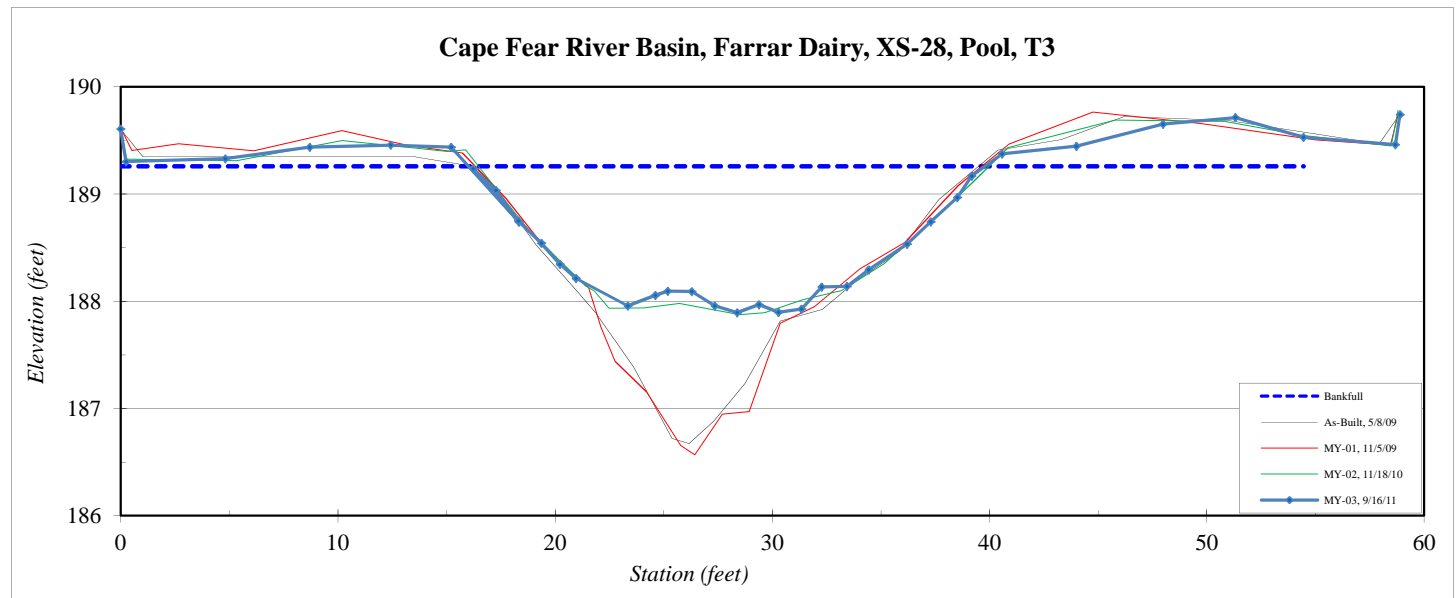
River Basin:	Cape Fear
Watershed:	Farrar Dairy
XS ID	XS-28, Pool, T3
Drainage Area (sq mi):	0.39
Date:	9/16/2011
Field Crew:	A. French, J. Anders

Station	Elevation
0.0	189.61
0.2	189.30
4.8	189.33
8.7	189.44
12.4	189.46
15.2	189.44
18.3	188.74
16.2	189.24
17.3	189.04
18.3	188.75
19.4	188.54
20.2	188.35
21.0	188.21
23.3	187.96
24.6	188.06
25.2	188.09
26.3	188.09
27.4	187.96
28.4	187.90
29.4	187.97
30.3	187.90
31.3	187.93
32.3	188.13
33.4	188.14
34.4	188.29
36.2	188.53
37.3	188.74
38.5	188.97
39.2	189.17
40.6	189.38
44.0	189.45
48.0	189.65
51.3	189.71
54.5	189.53

SUMMARY DATA	
Bankfull Elevation:	189.3
Bankfull Cross-Sectional Area:	21.9
Bankfull Width:	23.8
Flood Prone Area Elevation:	-
Flood Prone Width:	-
Max Depth at Bankfull:	1.4
Mean Depth at Bankfull:	0.9
W / D Ratio:	-
Entrenchment Ratio:	-
Bank Height Ratio:	-

Stream Type C5

*Other shots not included due to space

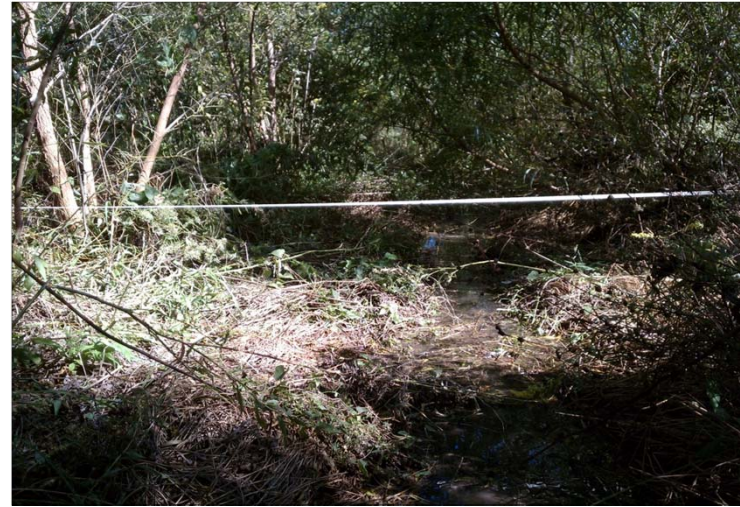
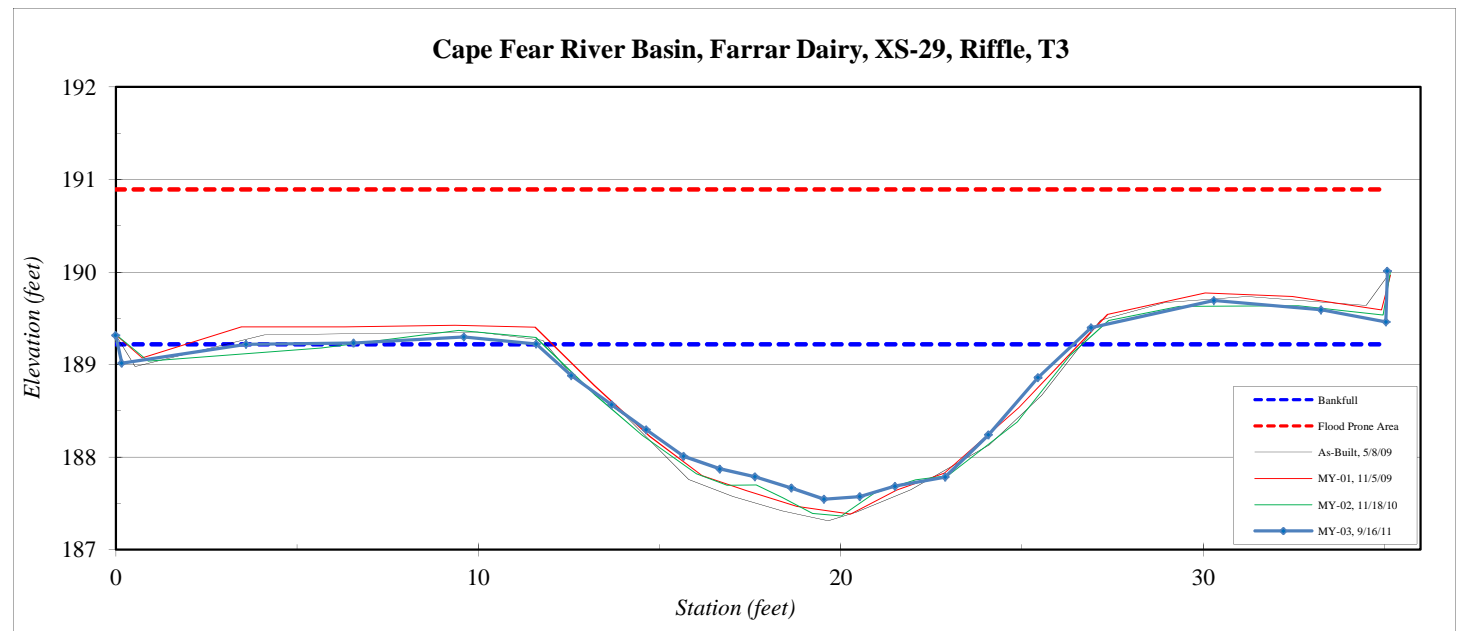
River Basin:	Cape Fear
Watershed:	Farrar Dairy
XS ID	XS-29, Riffle, T3
Drainage Area (sq mi):	0.39
Date:	9/16/2011
Field Crew:	A. French, J. Anders

Station	Elevation
0.0	189.32
0.2	189.02
3.6	189.22
6.6	189.23
9.6	189.30
11.6	189.22
12.6	188.88
13.7	188.57
14.6	188.30
15.7	188.01
16.7	187.87
17.6	187.79
18.6	187.67
19.5	187.55
20.5	187.57
21.5	187.69
22.9	187.78
24.1	188.24
25.4	188.86
26.9	189.40
30.3	189.69
33.3	189.59
35.0	189.46
35.1	190.01

SUMMARY DATA	
Bankfull Elevation:	189.2
Bankfull Cross-Sectional Area:	15.9
Bankfull Width:	14.8
Flood Prone Area Elevation:	190.9
Flood Prone Width:	>60
Max Depth at Bankfull:	1.7
Mean Depth at Bankfull:	1.1
W / D Ratio:	13.8
Entrenchment Ratio:	>3.0
Bank Height Ratio:	1.0

Stream Type C5

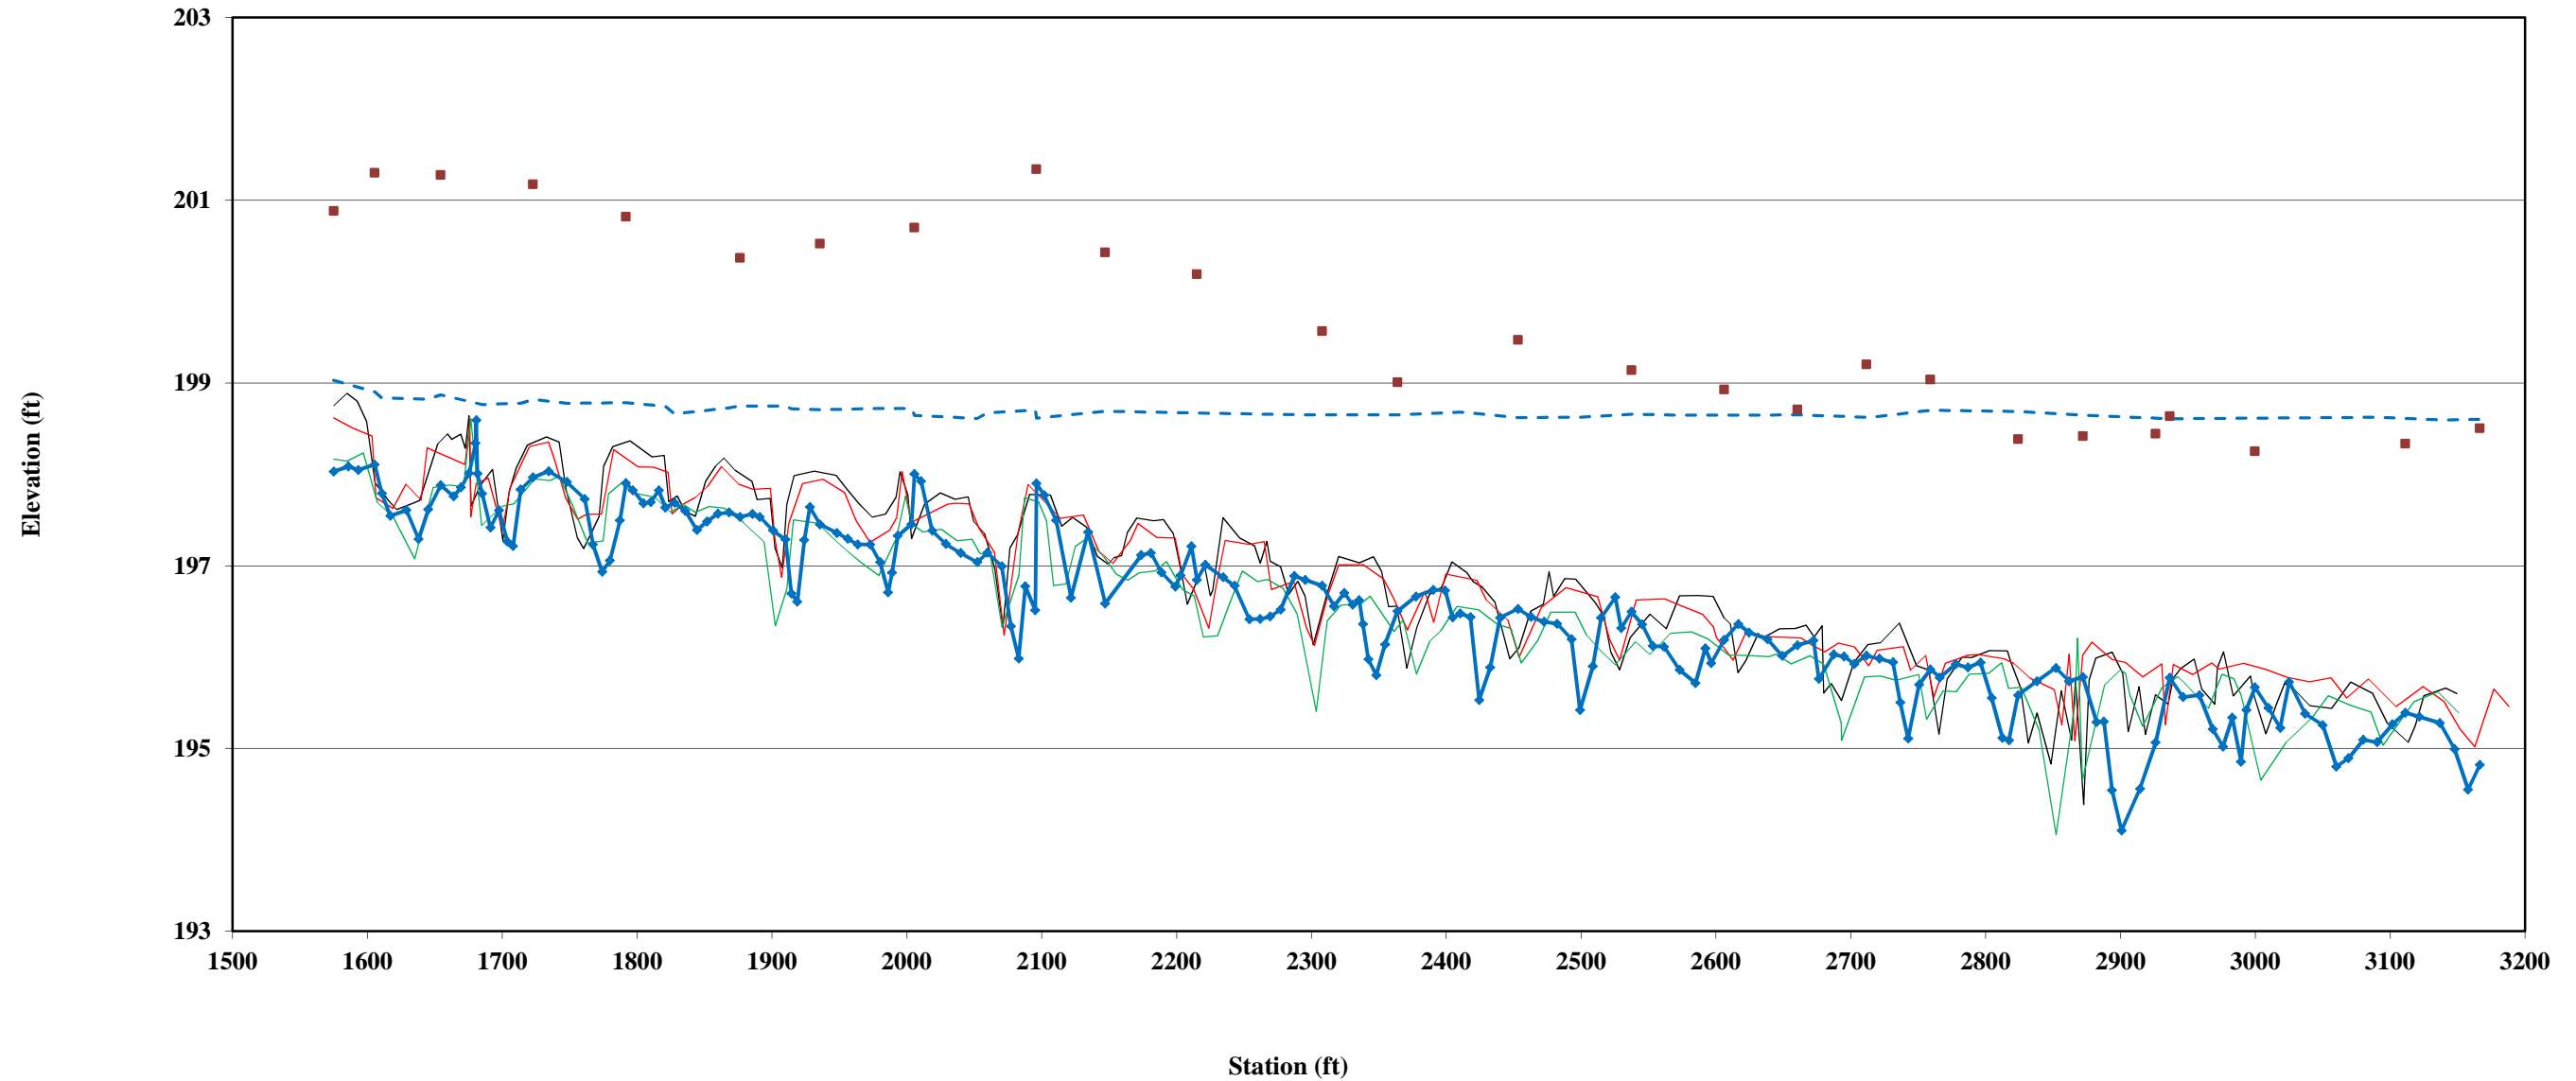
Farrar Dairy Longitudinal Profile
NPAC-1 MY-03
Stations 15+75 - 31+75

The stream assessment found the project streams to be stable. T1.1 and T1 had experienced isolated bed degradation during the first year of monitoring, but no further migration has been shown since. The additional log sills installed in 2010 in T1 are intact and holding grade. During the third-year site assessment a few of these structures were found to be piping. This is not seen as problematic due to the low flow during the assessment and the short duration that the structures, have been in place. With additional vegetation growing around the channel and the accumulation of fine materials in the pore space of the structures the piping should eventually stop. On NPAC, there are isolated areas of bank erosion, which are depicted in the CCPV. All of these stream features will continue to be monitored to make sure that any observed changes are within the range of variability found in stable stream systems.
