**Farrar Dairy Stream and Wetland Restoration Site
Monitoring Report – MY03
Harnett County, NC**

December 2011

**Project Manager: Tim Morris
Email: tim.morris@kci.com
KCI Project No: 12065438**

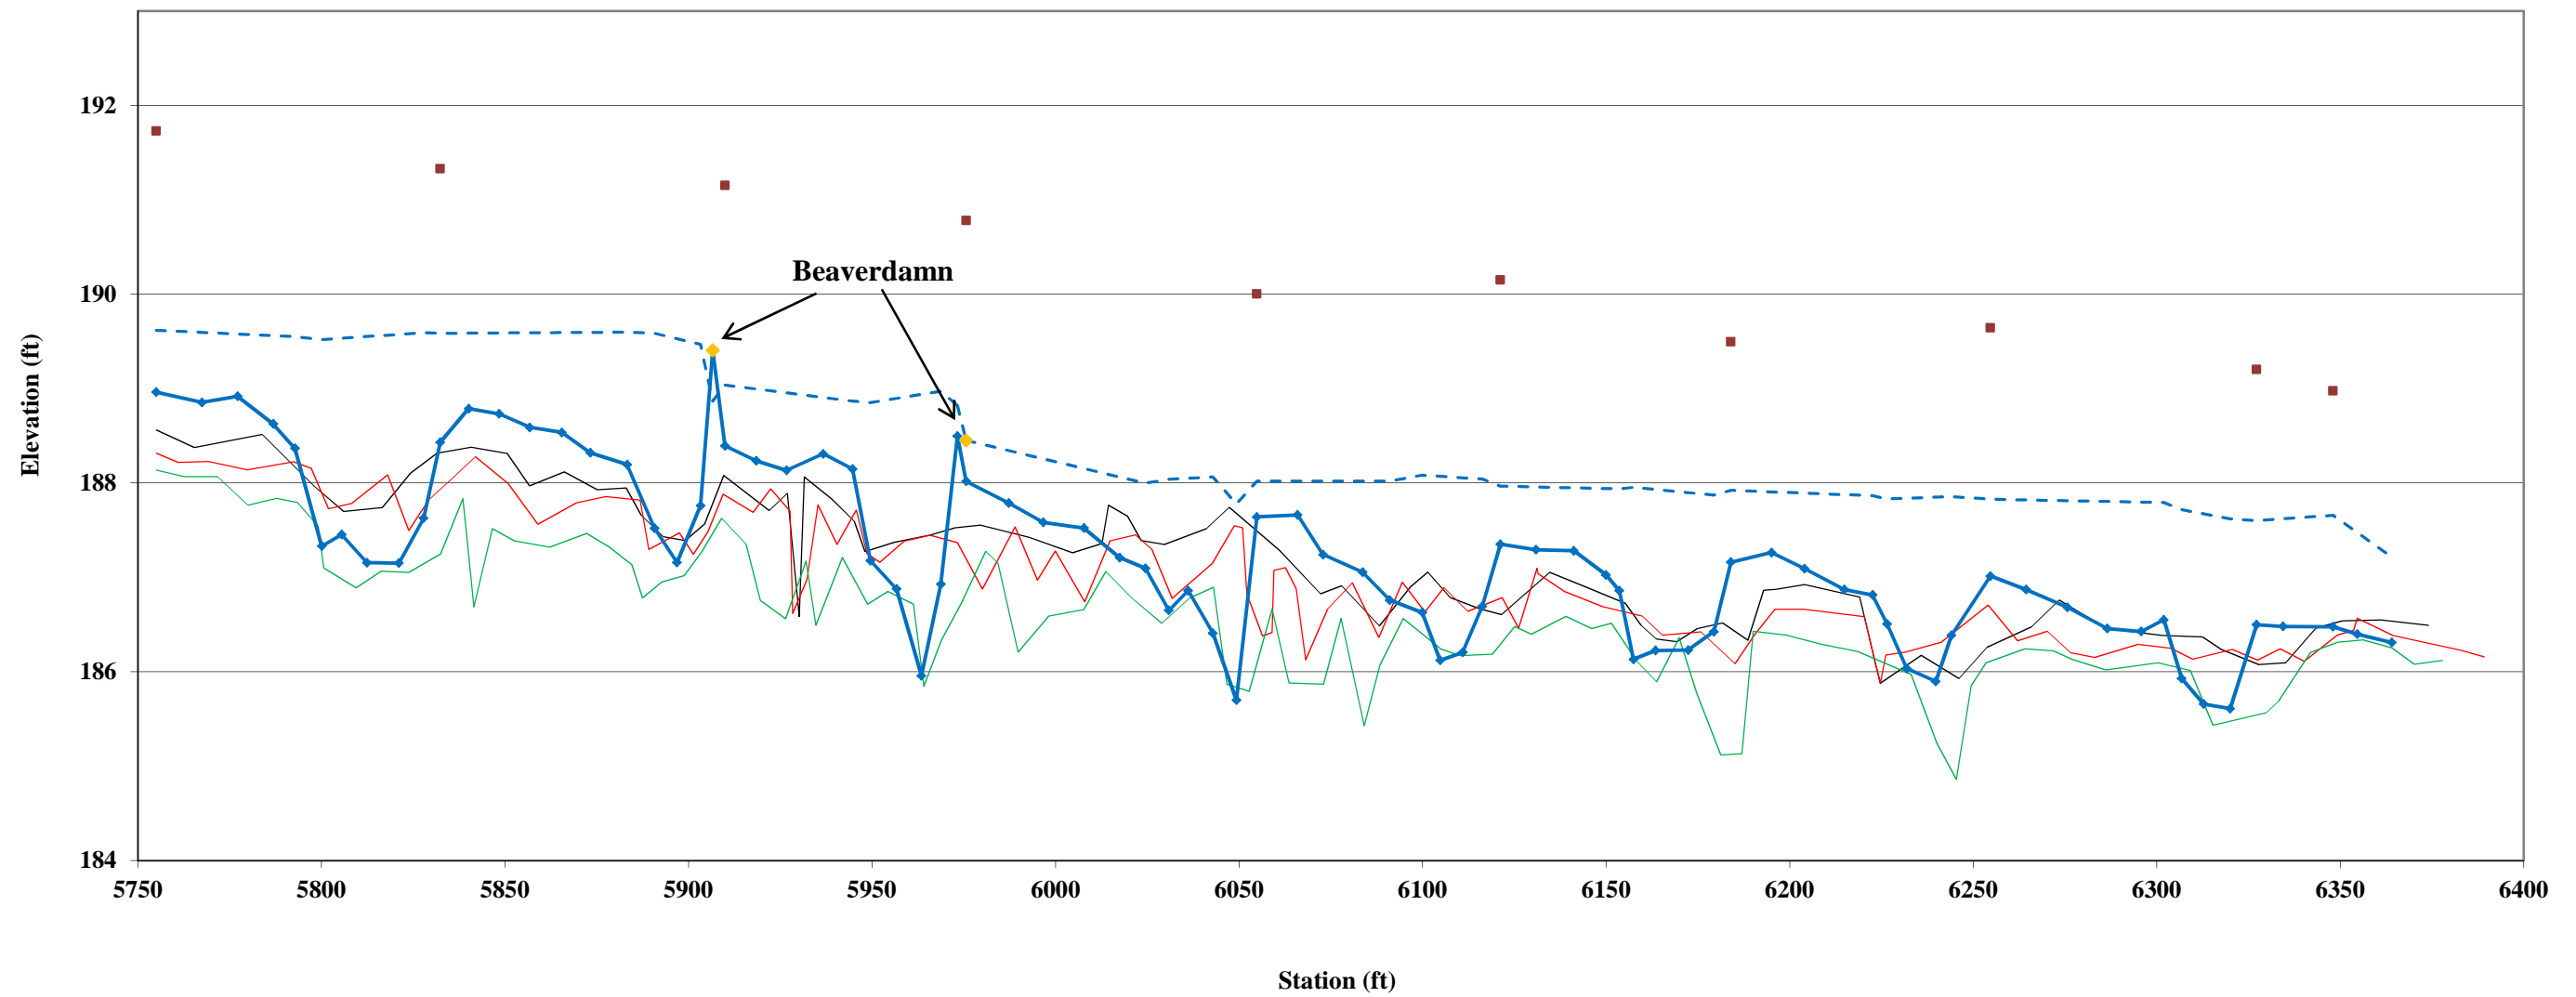
Farrar Dairy Longitudinal Profile
NPAC-2 MY-03
Stations 57+55 - 63+77

Stream and vegetation maintenance actions were completed in 2011. The stream maintenance addressed areas of bed degradation and bank erosion as discussed in the Monitoring Year 2 report. Constructed riffles were installed at Stations 57+58, 58+47, 59+13, 59+84, and 60+50 and bank grading and matting installation occurred at Stations 55+30, 56+80, 60+60, and 61+60. These maintenance areas have exhibited stability throughout the growing season. The bank repairs have not shown any signs of erosion, and the constructed riffles are functioning, with native material washing into the riffle and a stable riffle slope.

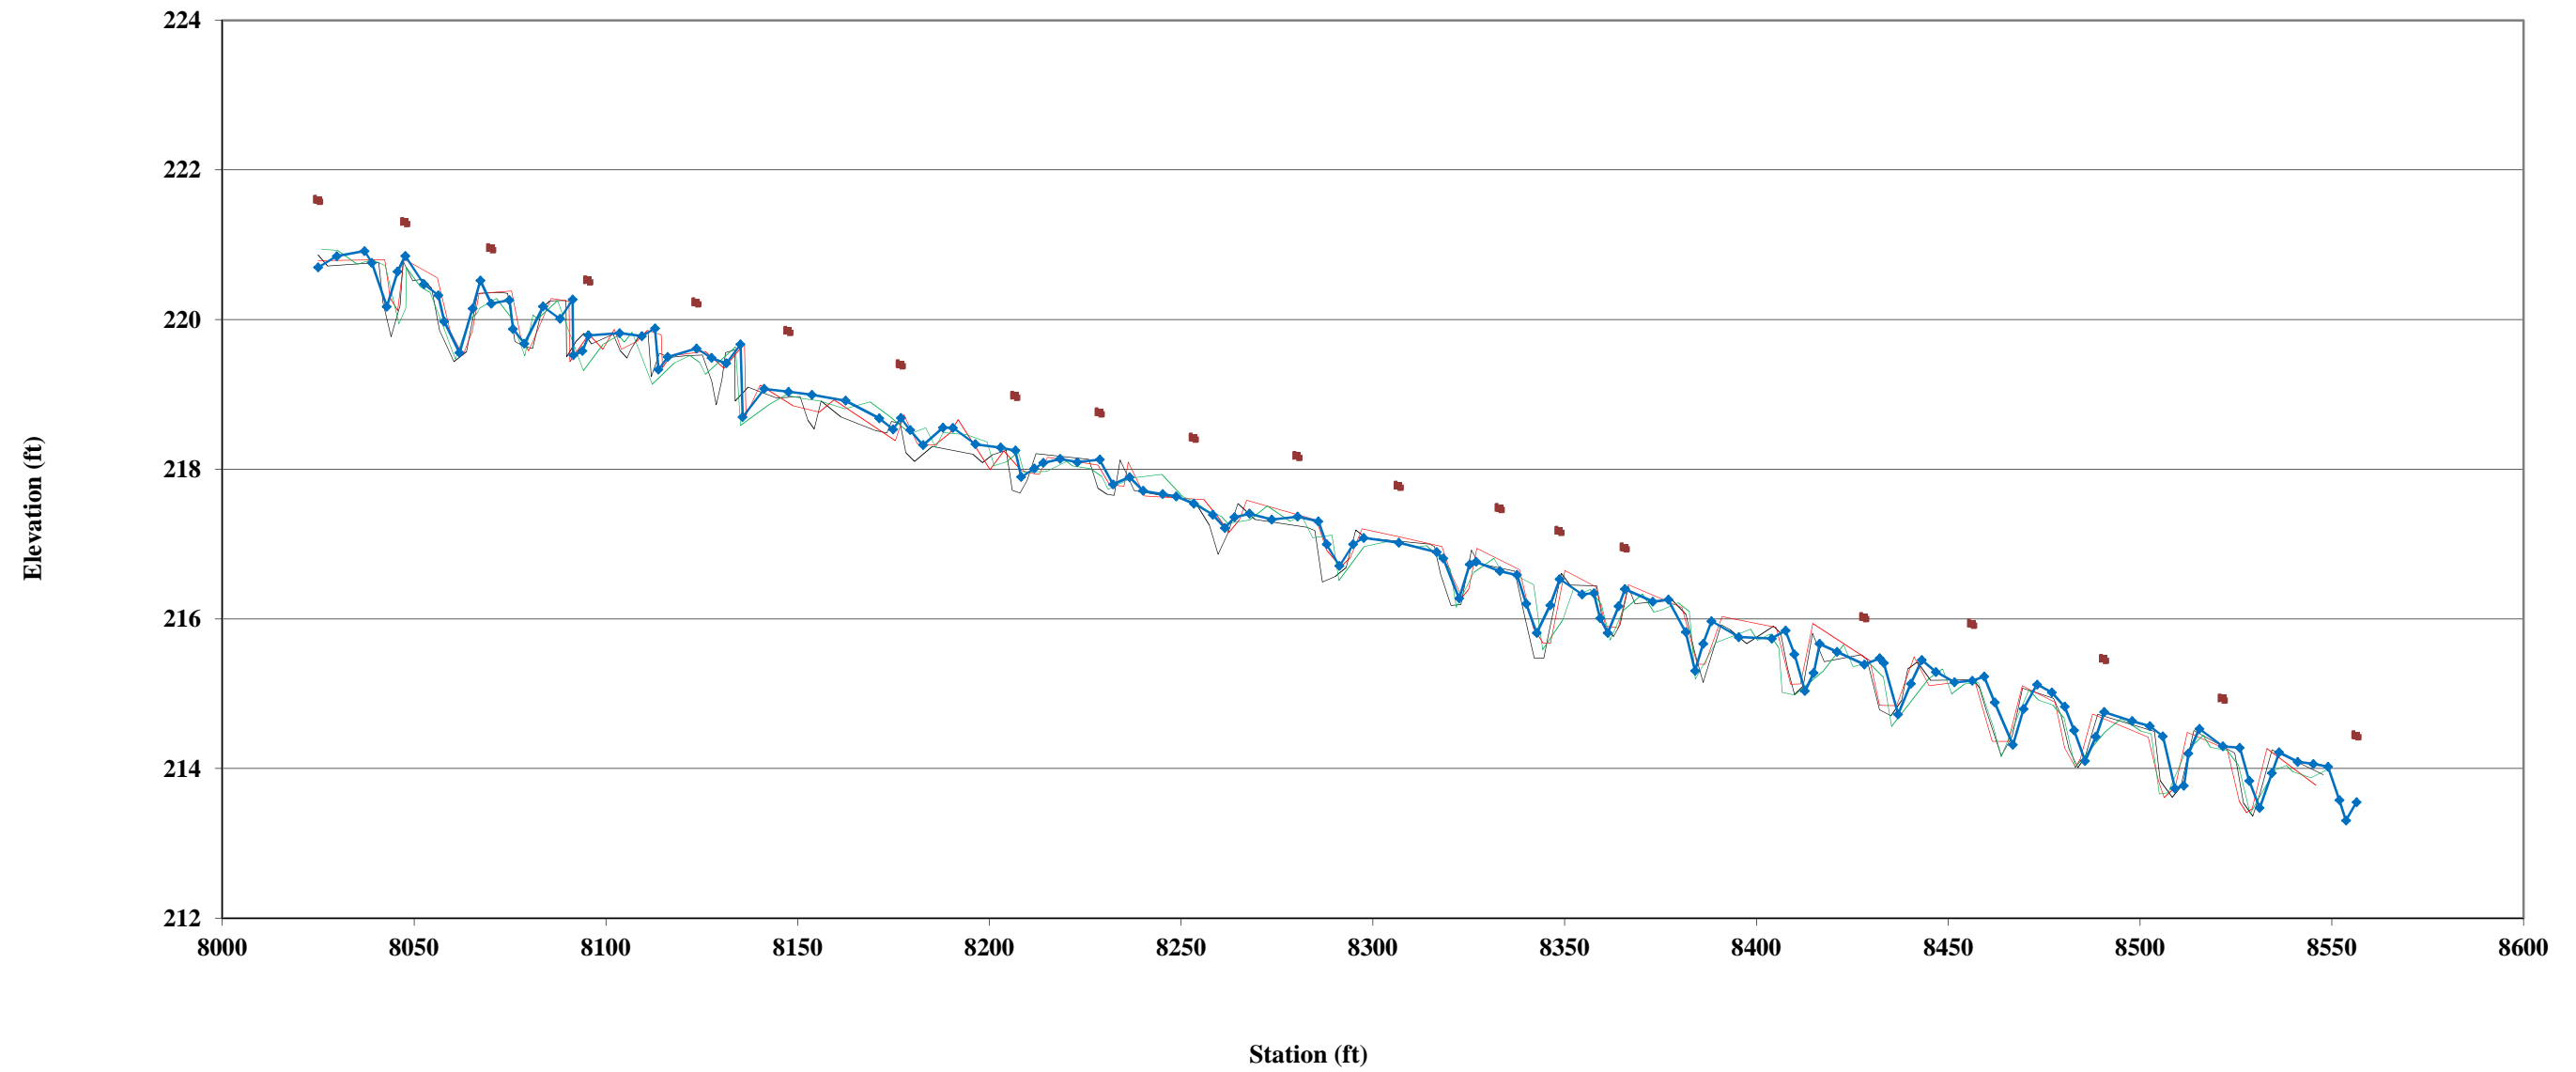
**Farrar Dairy Longitudinal Profile
Tributary 1.1 MY-03
Stations 80+25 - 85+75**

As-Built, 4/29/09 MY-01, 10/27/09 MY-02, 11/15/10 MY-03, 9/19/11 Bankfull

*No WS due to no flow in channel during survey.

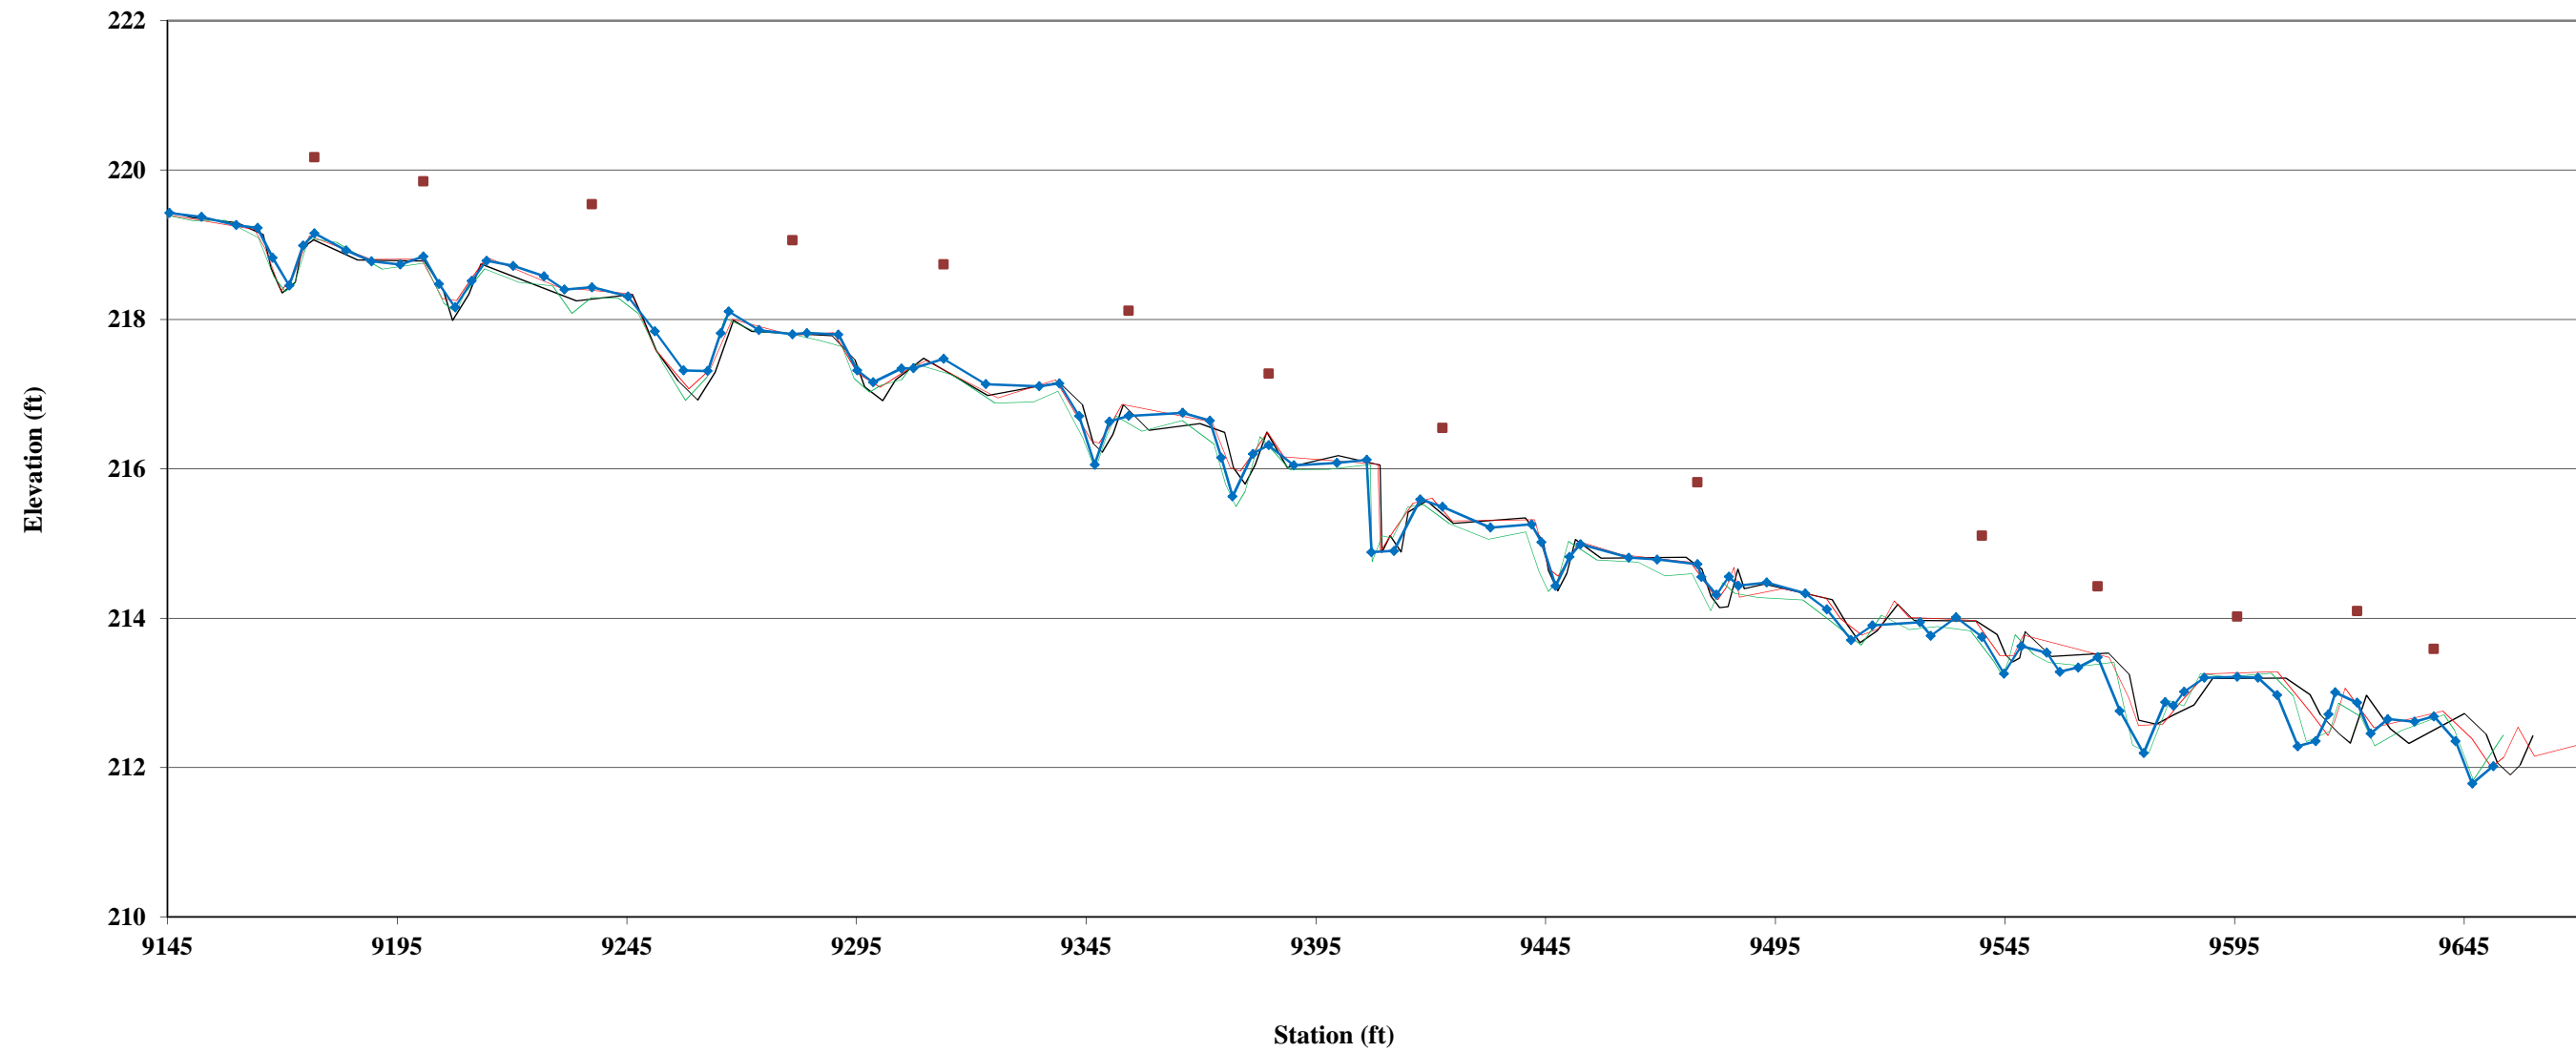
Farrar Dairy Longitudinal Profile
Tributary 1.2 MY-03
Stations 91+45 - 96+70

As-Built, 4/29/09 MY-01, 10/29/09 MY-02, 11/16/10 MY-03, 9/16/11 Bankfull

*No WS due to no flow in channel during survey.

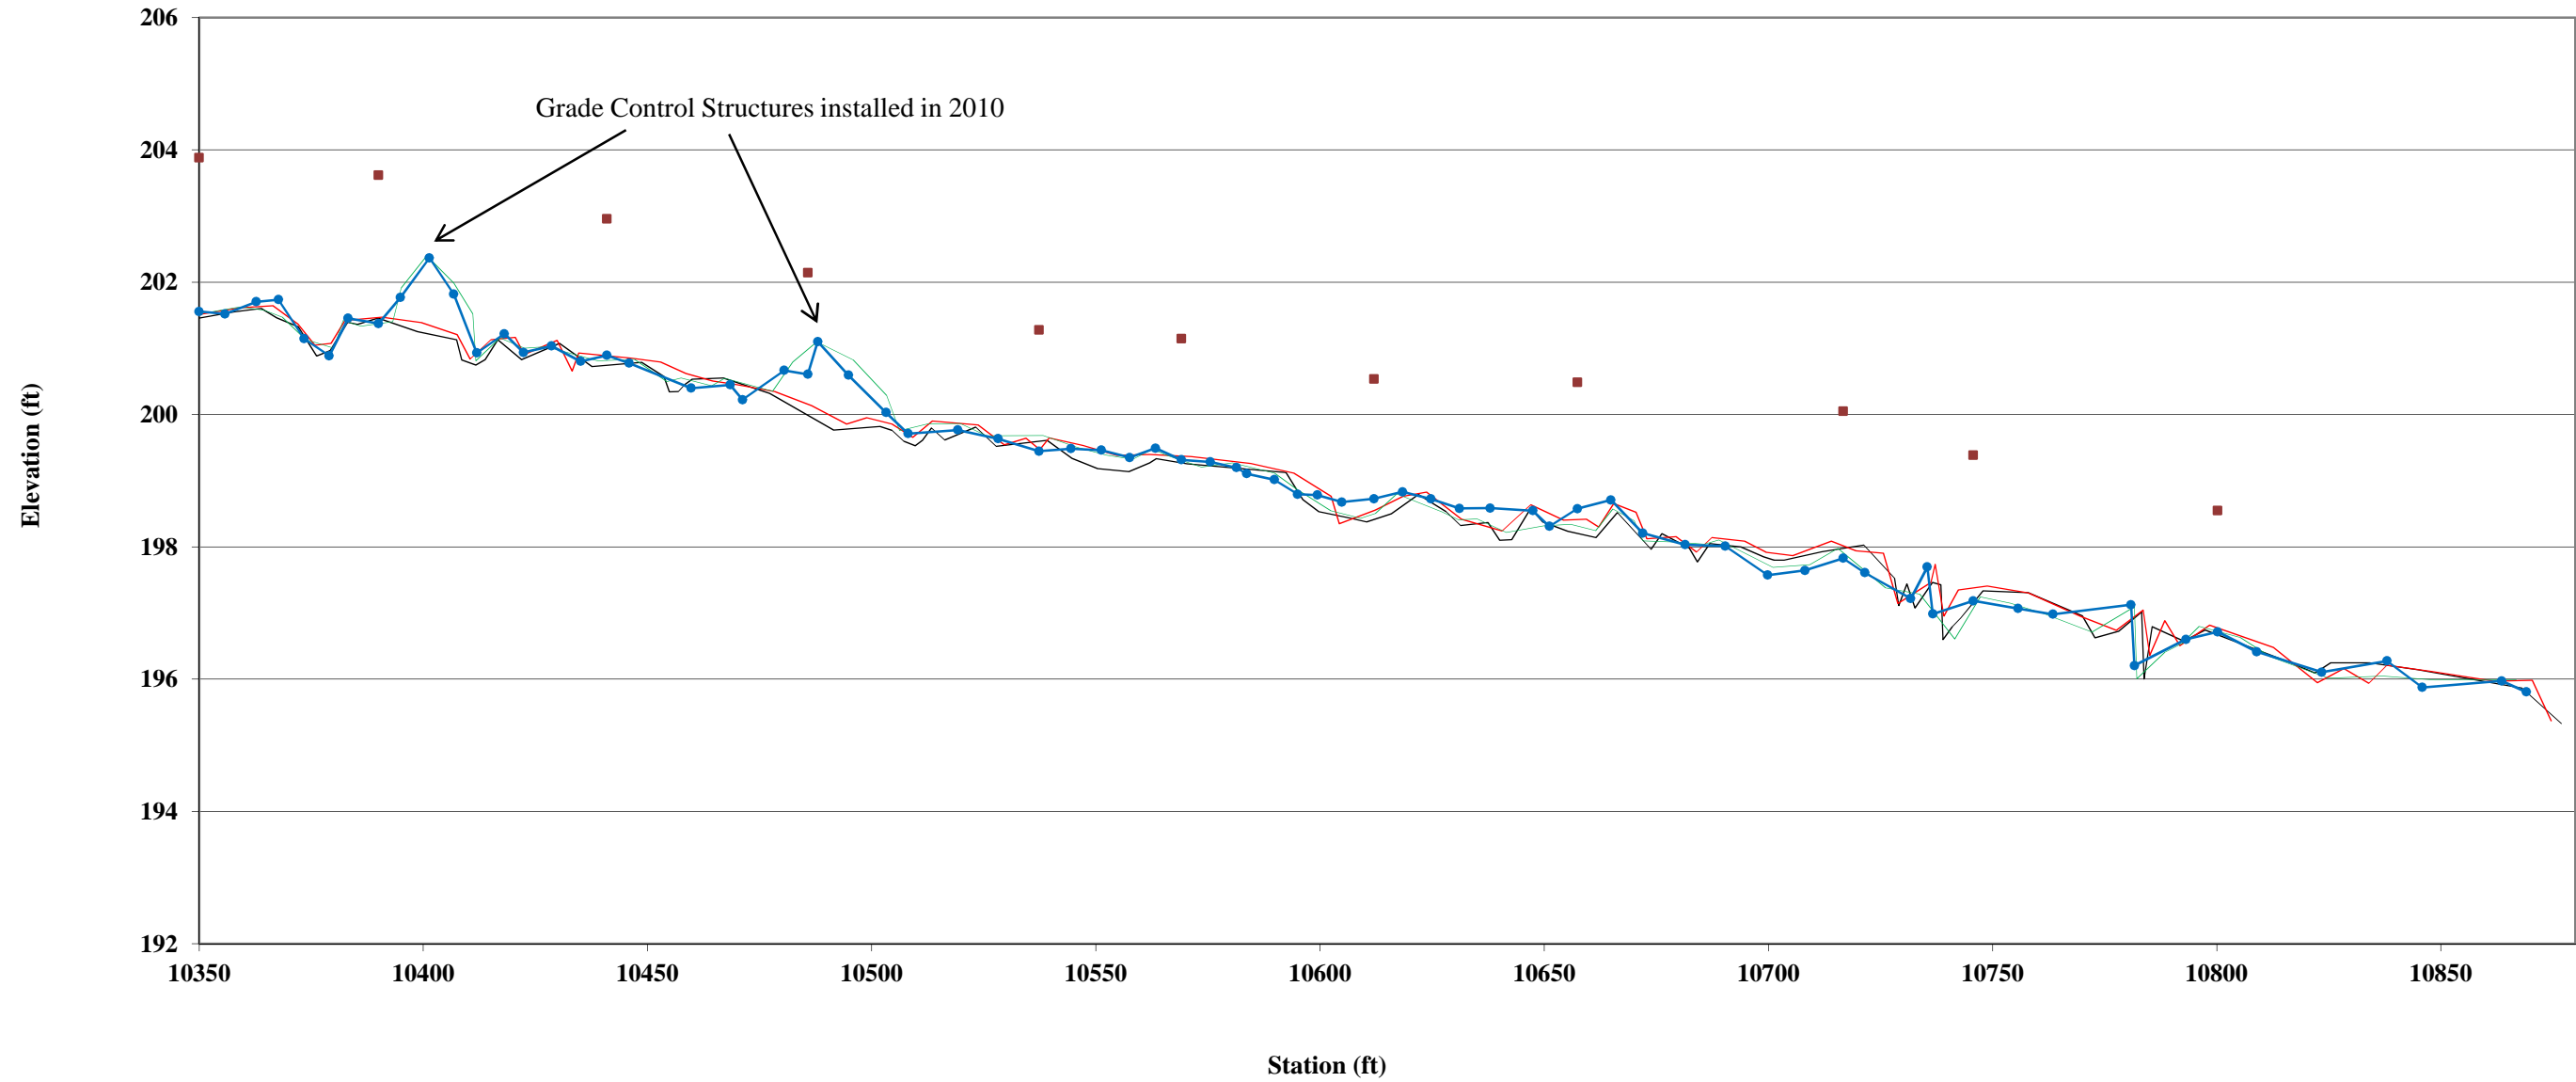
**Farrar Dairy Longitudinal Profile
Tributary 1 MY-03
Stations 103+50 - 108+77**

— As-Built, 4/30/09 — MY-01, 10/29/09 — MY-02, 11/22/10 —●— MY-03, 10/26/11 ■ Bankfull

*No WS due to no flow in channel during survey.

The stream assessment found the project streams to be stable. T1.1 and T1 had experienced isolated bed degradation during the first year of monitoring, but no further migration has been shown since. The additional log sills installed in 2010 in T1 are intact and holding grade. During the third-year site assessment a few of these structures were found to be piping. This is not seen as problematic due to the low flow during the assessment and the short duration that the structures, have been in place. With additional vegetation growing around the channel and the accumulation of fine materials in the pore space of the structures the piping should eventually stop. On NPAC, there are isolated areas of bank erosion, which are depicted in the CCPV. All of these stream features will continue to be monitored to make sure that any observed changes are within the range of variability found in stable stream systems.

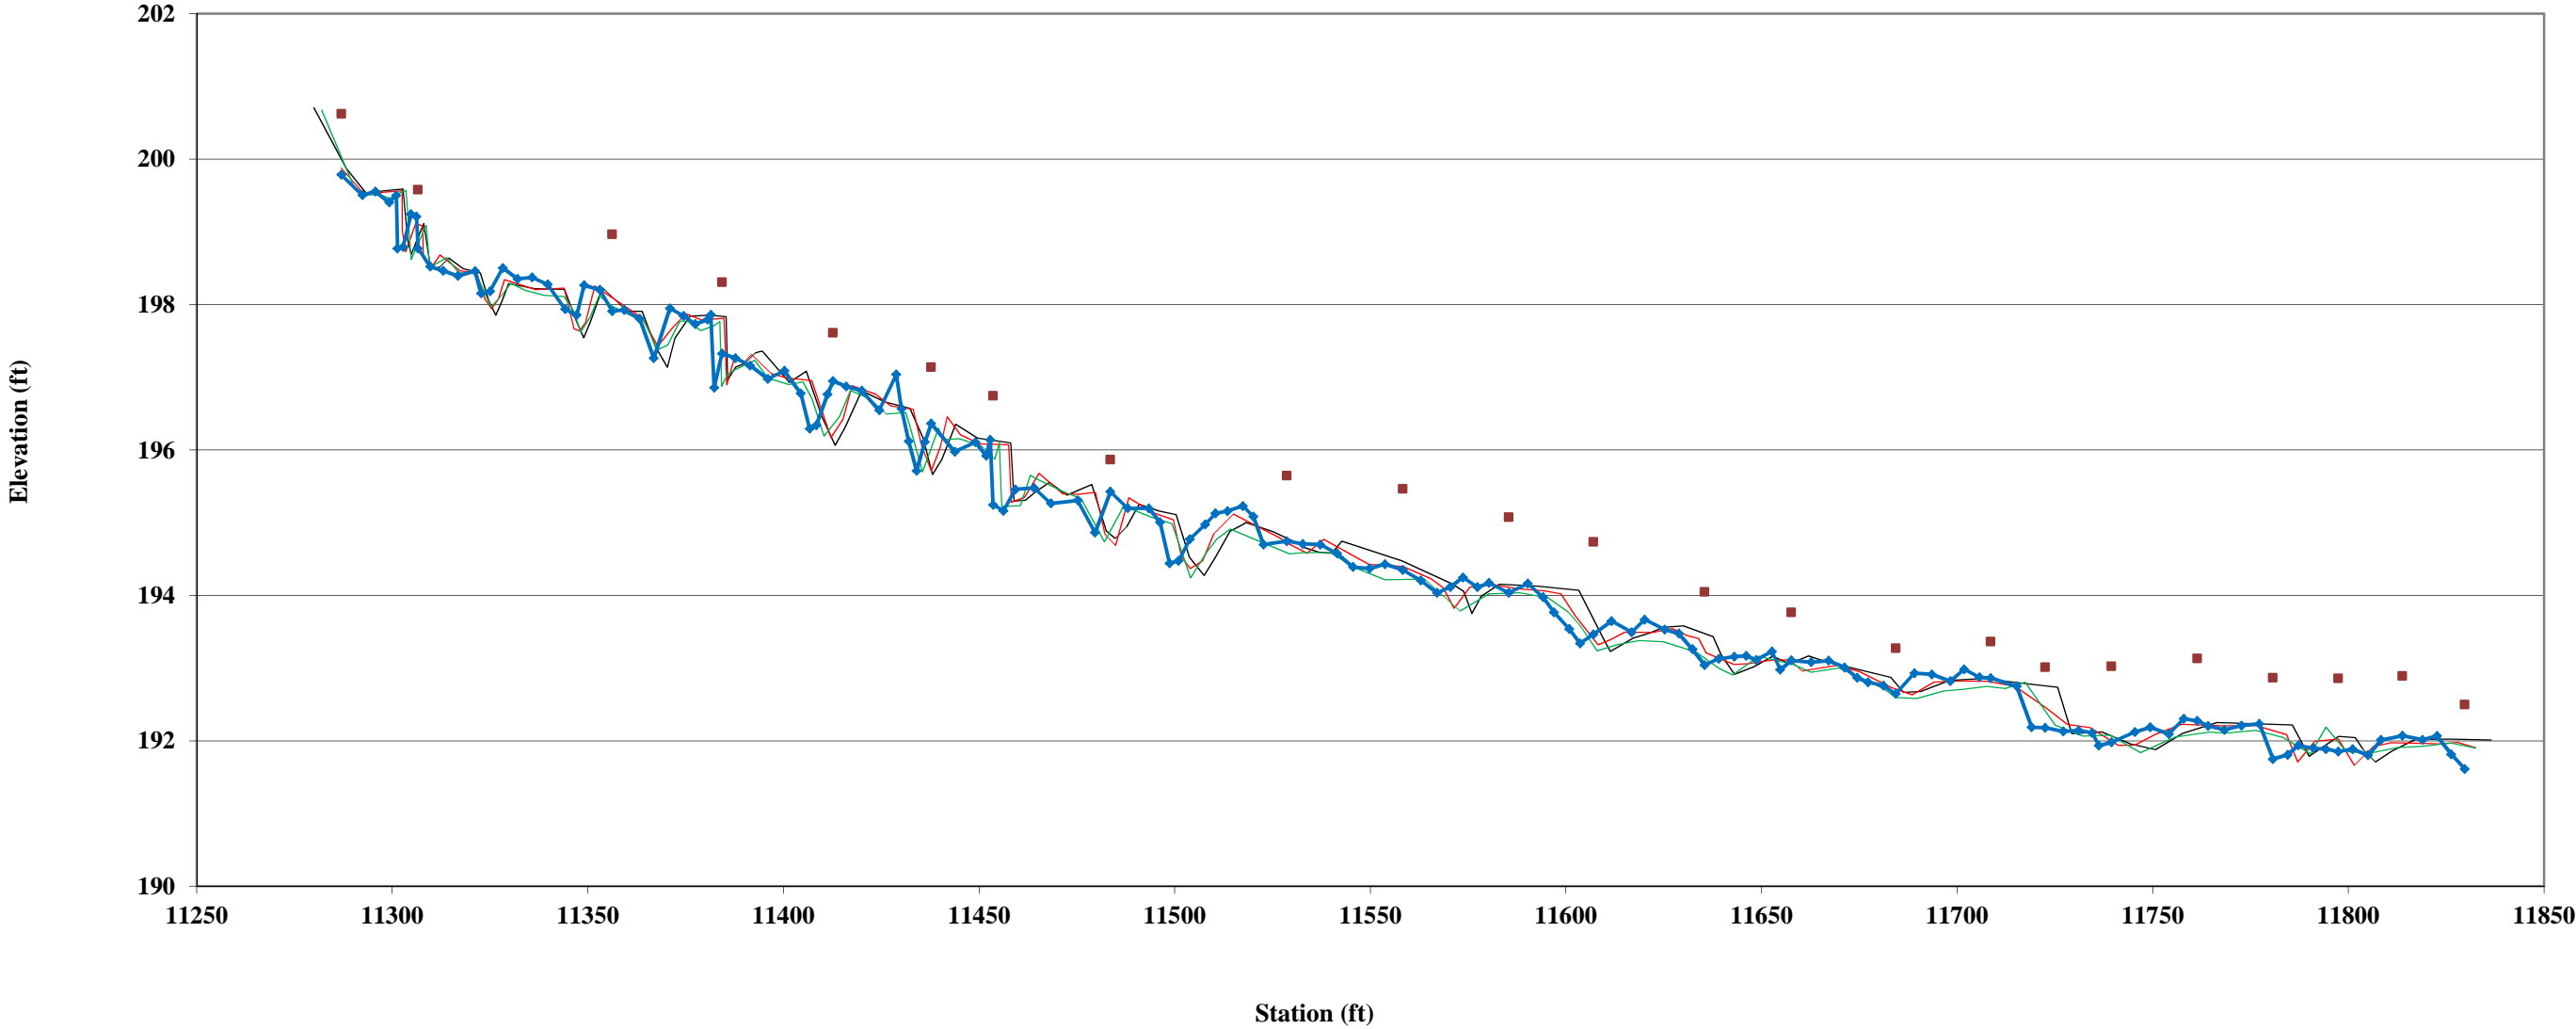
Farrar Dairy Longitudinal Profile
Tributary 2 MY-03
Stations 112+80 - 118+37

As-Built, 5/8/09 MY-01, 11/2/09 MY-02, 11/17/10 MY-03, 10/4/11 Bankfull

*No WS due to no flow in channel during survey.

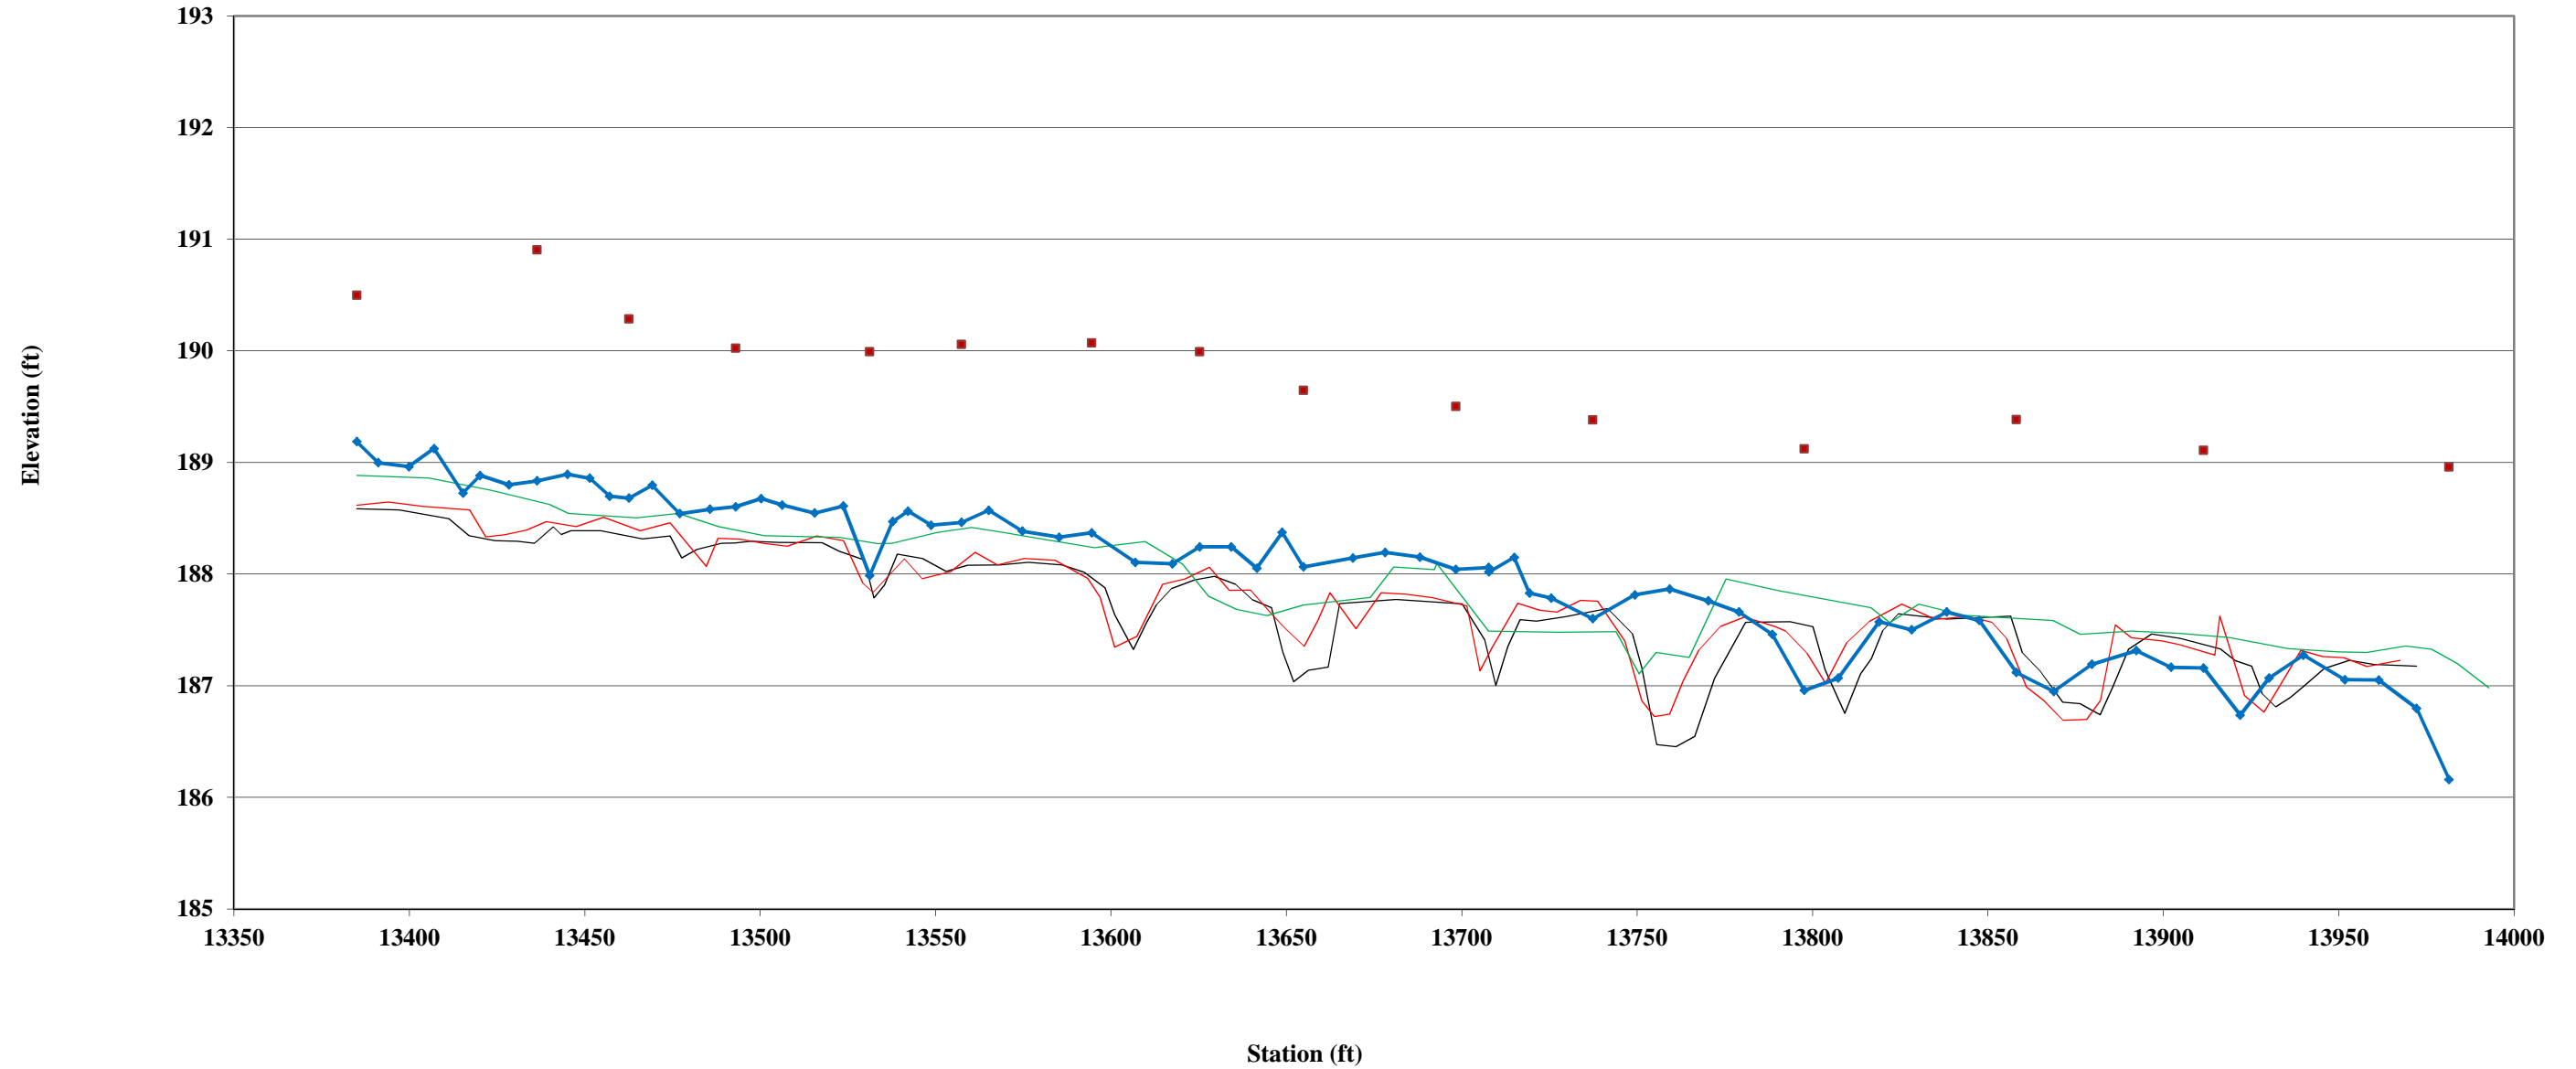
**Farrar Dairy Longitudinal Profile
Tributary 3 MY-03
Stations 133+85 - 139+73**

— As-Built, 5/8/09
— MY-01, 11/5/09
— MY-02, 11/18/10
—●— MY-03, 10/5/11
■ Bankfull

*No WS due to no flow in channel during survey.

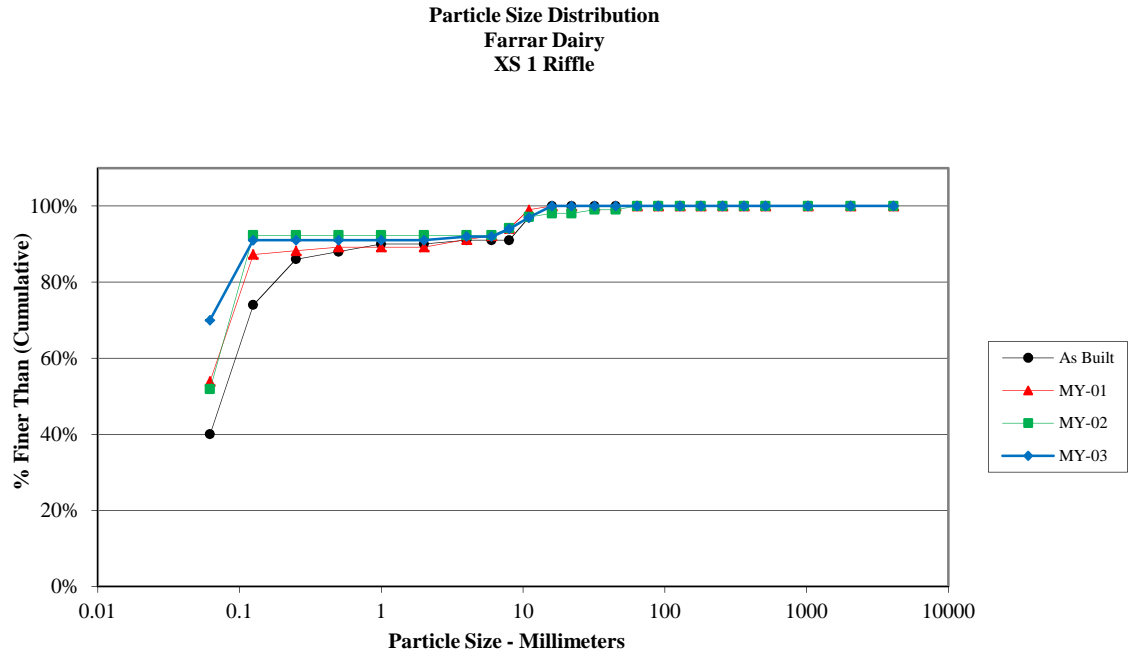
Cross-Section 1 Riffle - MY-03			
Particle	Millimeter		Count
Silt/Clay	< 0.062	S/C	70
Very Fine	.062 - .125	S	21
Fine	.125 - .25	A	
Medium	.25 - .50	N	
Coarse	.50 - 1	D	
Very Coarse	1 - 2	S	
Very Fine	2 - 4		1
Fine	4 - 5.7	G	
Fine	5.7 - 8	R	2
Medium	8 - 11.3	A	3
Medium	11.3 - 16	V	3
Coarse	16 - 22.6	E	
Coarse	22.6 - 32	L	
Very Coarse	32 - 45	S	
Very Coarse	45 - 64		
Small	64 - 90	C	
Small	90 - 128	O	
Large	128 - 180	B	
Large	180 - 256	L	
Small	256 - 362	B	
Small	362 - 512	L	
Medium	512 - 1024	D	
Lrg- Very Lrg	1024 - 2048	R	
Bedrock	>2048	BDRK	
		Total	100
Note:

Size (mm)	
D16	0.062
D35	0.062
D50	0.062
D65	0.062
D84	0.099
D95	8.9

Size Distribution	
mean	0.1
dispersion	1.3
skewness	0.23

Type	
silt/clay	70%
sand	21%
gravel	9%
cobble	0%
boulder	0%
bedrock	0%
hardpan	0%
wood/det	0%
artificial	0%

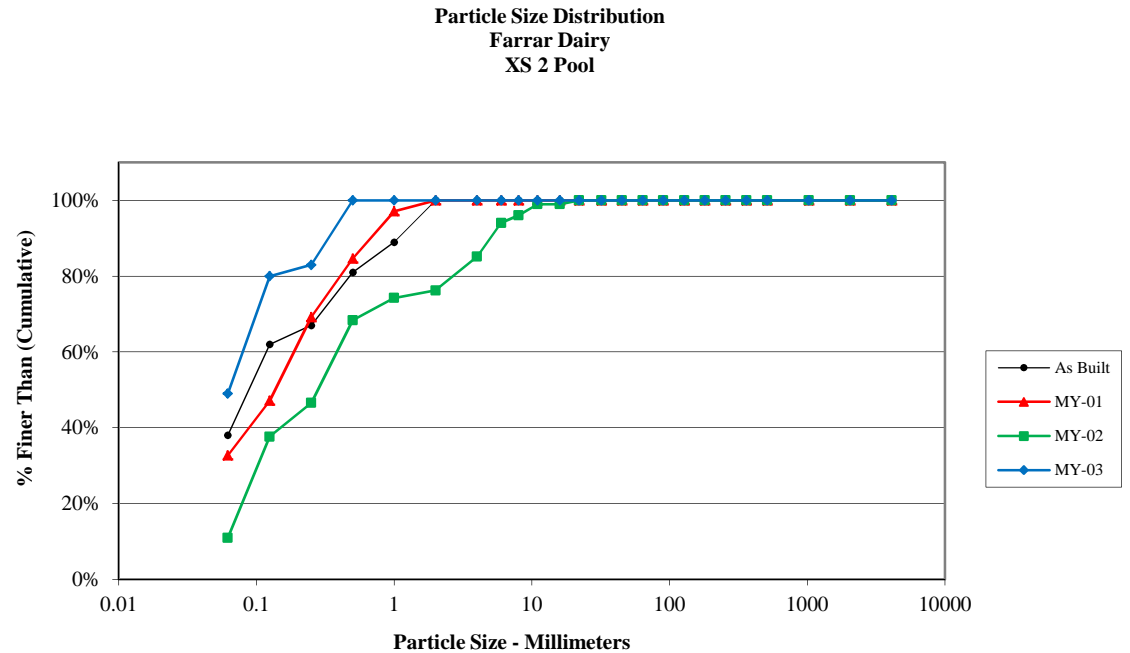
Cross-Section 2 Pool - MY-03			
Particle	Millimeter		Count
Silt/Clay	< 0.062	S/C	49
Very Fine	.062 - .125	S	31
Fine	.125 - .25	A	3
Medium	.25 - .50	N	17
Coarse	.50 - 1	D	
Very Coarse	1 - 2	S	
Very Fine	2 - 4		
Fine	4 - 5.7	G	
Fine	5.7 - 8	R	
Medium	8 - 11.3	A	
Medium	11.3 - 16	V	
Coarse	16 - 22.6	E	
Coarse	22.6 - 32	L	
Very Coarse	32 - 45	S	
Very Coarse	45 - 64		
Small	64 - 90	C	
Small	90 - 128	O	
Large	128 - 180	B	
Large	180 - 256	L	
Small	256 - 362	B	
Small	362 - 512	L	
Medium	512 - 1024	D	
Lrg- Very Lrg	1024 - 2048	R	
Bedrock	>2048	BDRK	
	Total		100
Note:

Size (mm)	
D16	0.062
D35	0.062
D50	0.063
D65	0.089
D84	0.26
D95	0.41

Size Distribution	
mean	0.1
dispersion	2.6
skewness	0.39

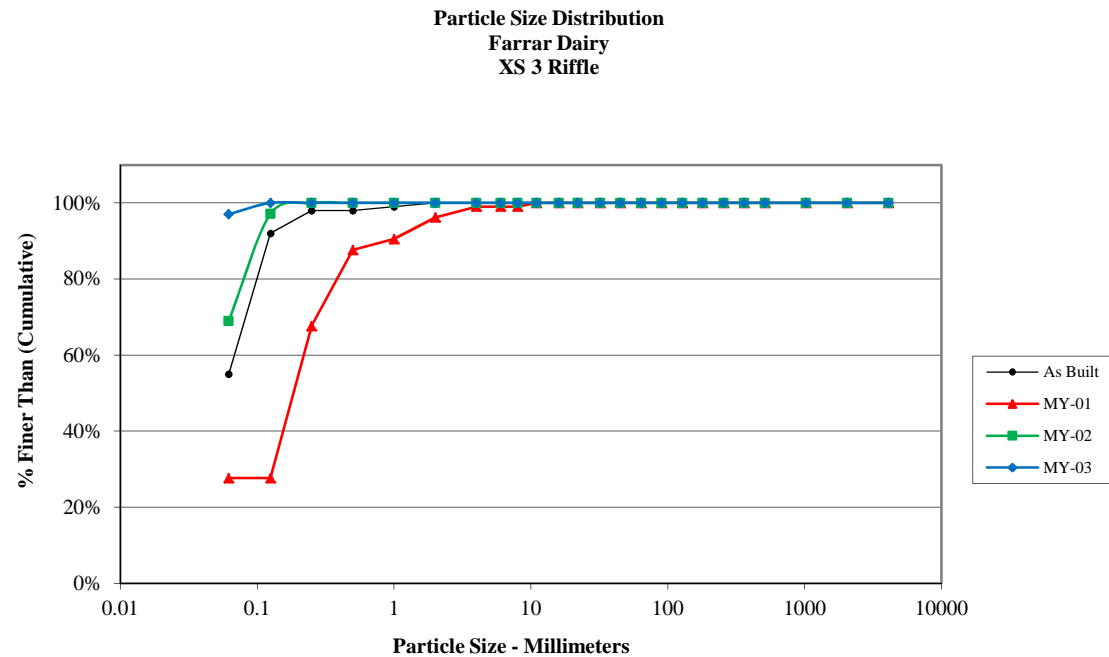
Cross-Section 3 Riffle - MY-03			
Particle	Millimeter		Count
Silt/Clay	< 0.062	S/C	97
Very Fine	.062 - .125	S	3
Fine	.125 - .25	A	
Medium	.25 - .50	N	
Coarse	.50 - 1	D	
Very Coarse	1 - 2	S	
Very Fine	2 - 4		
Fine	4 - 5.7	G	
Fine	5.7 - 8	R	
Medium	8 - 11.3	A	
Medium	11.3 - 16	V	
Coarse	16 - 22.6	E	
Coarse	22.6 - 32	L	
Very Coarse	32 - 45	S	
Very Coarse	45 - 64		
Small	64 - 90	C	
Small	90 - 128	O	
Large	128 - 180	B	
Large	180 - 256	L	
Small	256 - 362	B	
Small	362 - 512	L	
Medium	512 - 1024	D	
Lrg- Very Lrg	1024 - 2048	R	
Bedrock	>2048	BDRK	
		Total	100
Note:

Size (mm)	
D16	0.062
D35	0.062
D50	0.062
D65	0.062
D84	0.062
D95	0.062

Size Distribution	
mean	0.1
dispersion	1.0
skewness	-

Type	
silt/clay	97%
sand	3%
gravel	0%
cobble	0%
boulder	0%
bedrock	0%
hardpan	0%
wood/det	0%
artificial	0%

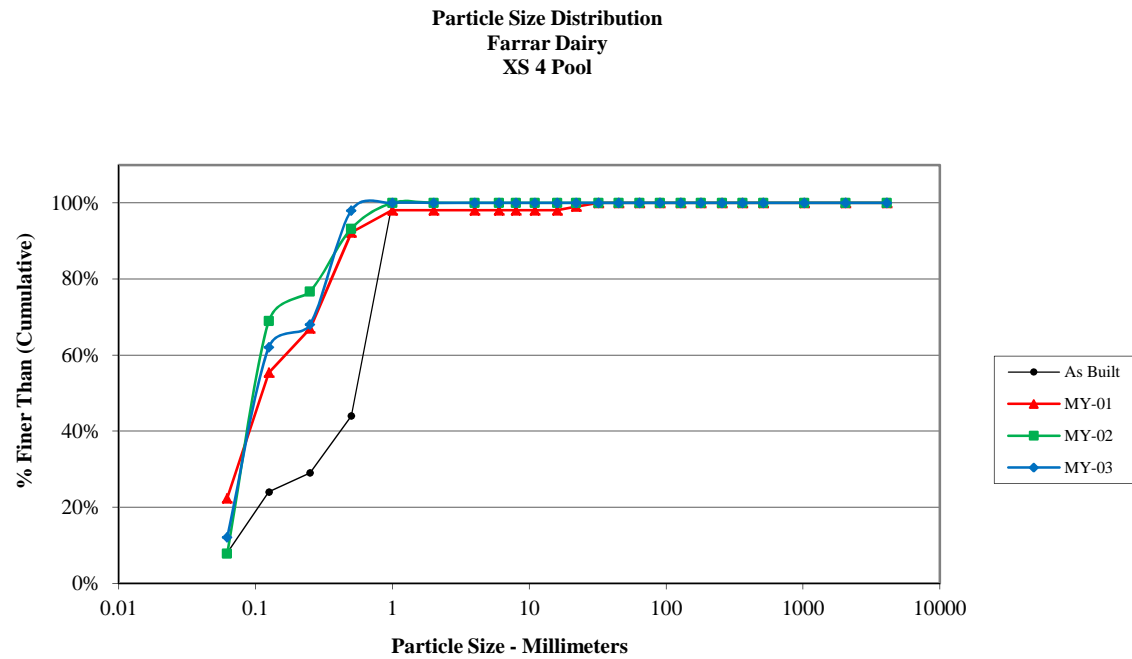
Cross-Section 4 Pool -MY-03			
Particle	Millimeter		Count
Silt/Clay	< 0.062	S/C	12
Very Fine	.062 - .125	S	50
Fine	.125 - .25	A	6
Medium	.25 - .50	N	30
Coarse	.50 - 1	D	2
Very Coarse	1 - 2	S	
Very Fine	2 - 4		
Fine	4 - 5.7	G	
Fine	5.7 - 8	R	
Medium	8 - 11.3	A	
Medium	11.3 - 16	V	
Coarse	16 - 22.6	E	
Coarse	22.6 - 32	L	
Very Coarse	32 - 45	S	
Very Coarse	45 - 64		
Small	64 - 90	C	
Small	90 - 128	O	
Large	128 - 180	B	
Large	180 - 256	L	
Small	256 - 362	B	
Small	362 - 512	L	
Medium	512 - 1024	D	
Lrg- Very Lrg	1024 - 2048	R	
Bedrock	>2048	BDRK	
	Total		100
Note:

Size (mm)	
D16	0.066
D35	0.086
D50	0.11
D65	0.18
D84	0.36
D95	0.47

Size Distribution	
mean	0.2
dispersion	2.5
skewness	0.17

Type	
silt/clay	12%
sand	88%
gravel	0%
cobble	0%
boulder	0%
bedrock	0%
hardpan	0%
wood/det	0%
artificial	0%

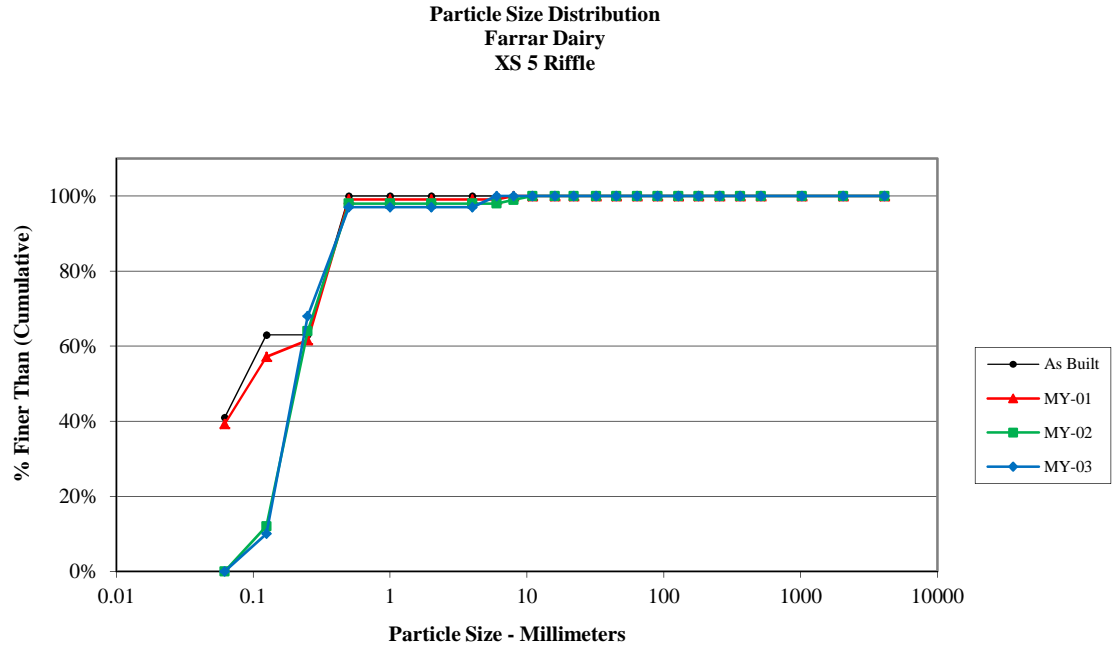
Cross-Section 5 Riffle - MY-03			
Particle	Millimeter		Count
Silt/Clay	< 0.062	S/C	
Very Fine	.062 - .125	S	10
Fine	.125 - .25	A	58
Medium	.25 - .50	N	29
Coarse	.50 - 1	D	
Very Coarse	1 - 2	S	
Very Fine	2 - 4		
Fine	4 - 5.7	G	3
Fine	5.7 - 8	R	
Medium	8 - 11.3	A	
Medium	11.3 - 16	V	
Coarse	16 - 22.6	E	
Coarse	22.6 - 32	L	
Very Coarse	32 - 45	S	
Very Coarse	45 - 64		
Small	64 - 90	C	
Small	90 - 128	O	
Large	128 - 180	B	
Large	180 - 256	L	
Small	256 - 362	B	
Small	362 - 512	L	
Medium	512 - 1024	D	
Lrg- Very Lrg	1024 - 2048	R	
Bedrock	>2048	BDRK	
		Total	100
Note:

Size (mm)	
D16	0.13
D35	0.17
D50	0.20
D65	0.24
D84	0.37
D95	0.48

Size Distribution	
mean	0.2
dispersion	1.7
skewness	0.06

Type	
silt/clay	0%
sand	97%
gravel	3%
cobble	0%
boulder	0%
bedrock	0%
hardpan	0%
wood/det	0%
artificial	0%

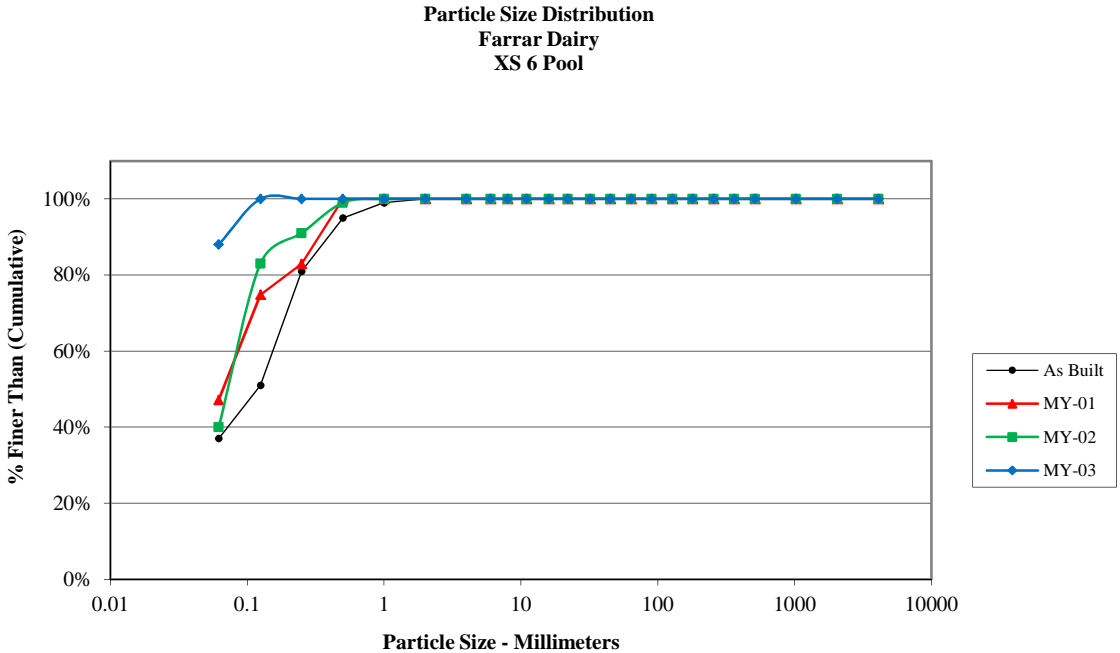
Cross-Section 6 Pool -MY-03			
Particle	Millimeter		Count
Silt/Clay	< 0.062	S/C	88
Very Fine	.062 - .125	S	12
Fine	.125 - .25	A	
Medium	.25 - .50	N	
Coarse	.50 - 1	D	
Very Coarse	1 - 2	S	
Very Fine	2 - 4		
Fine	4 - 5.7	G	
Fine	5.7 - 8	R	
Medium	8 - 11.3	A	
Medium	11.3 - 16	V	
Coarse	16 - 22.6	E	
Coarse	22.6 - 32	L	
Very Coarse	32 - 45	S	
Very Coarse	45 - 64		
Small	64 - 90	C	
Small	90 - 128	O	
Large	128 - 180	B	
Large	180 - 256	L	
Small	256 - 362	B	
Small	362 - 512	L	
Medium	512 - 1024	D	
Lrg- Very Lrg	1024 - 2048	R	
Bedrock	>2048	BDRK	
		Total	100
Note:

Size (mm)	
D16	0.062
D35	0.062
D50	0.062
D65	0.062
D84	0.062
D95	0.093

Size Distribution	
mean	0.1
dispersion	1.0
skewness	-

Type	
silt/clay	88%
sand	12%
gravel	0%
cobble	0%
boulder	0%
bedrock	0%
hardpan	0%
wood/det	0%
artificial	0%
