**Farrar Dairy Stream and Wetland Restoration Site
Monitoring Report – MY03
Harnett County, NC**

December 2011

**Project Manager: Tim Morris
Email: tim.morris@kci.com
KCI Project No: 12065438**

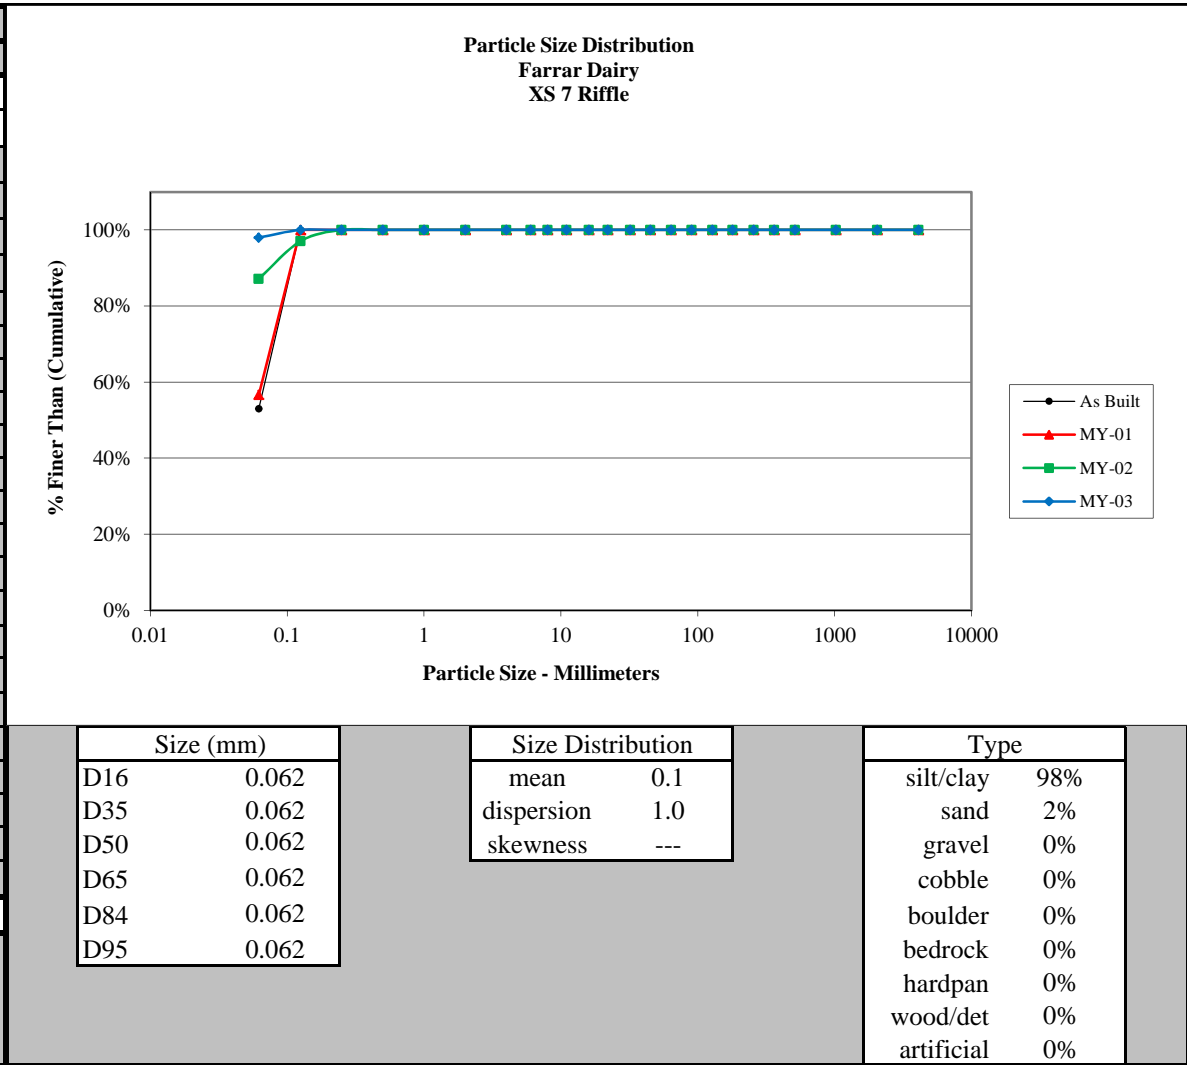
Cross-Section 7 Riffle - MY-03			
Particle	Millimeter		Count
Silt/Clay	< 0.062	S/C	98
Very Fine	.062 - .125	S	2
Fine	.125 - .25	A	
Medium	.25 - .50	N	
Coarse	.50 - 1	D	
Very Coarse	1 - 2	S	
Very Fine	2 - 4		
Fine	4 - 5.7	G	
Fine	5.7 - 8	R	
Medium	8 - 11.3	A	
Medium	11.3 - 16	V	
Coarse	16 - 22.6	E	
Coarse	22.6 - 32	L	
Very Coarse	32 - 45	S	
Very Coarse	45 - 64		
Small	64 - 90	C	
Small	90 - 128	O	
Large	128 - 180	B	
Large	180 - 256	L	
Small	256 - 362	B	
Small	362 - 512	L	
Medium	512 - 1024	D	
Lrg- Very Lrg	1024 - 2048	R	
Bedrock	>2048	BDRK	
		Total	100
Note:

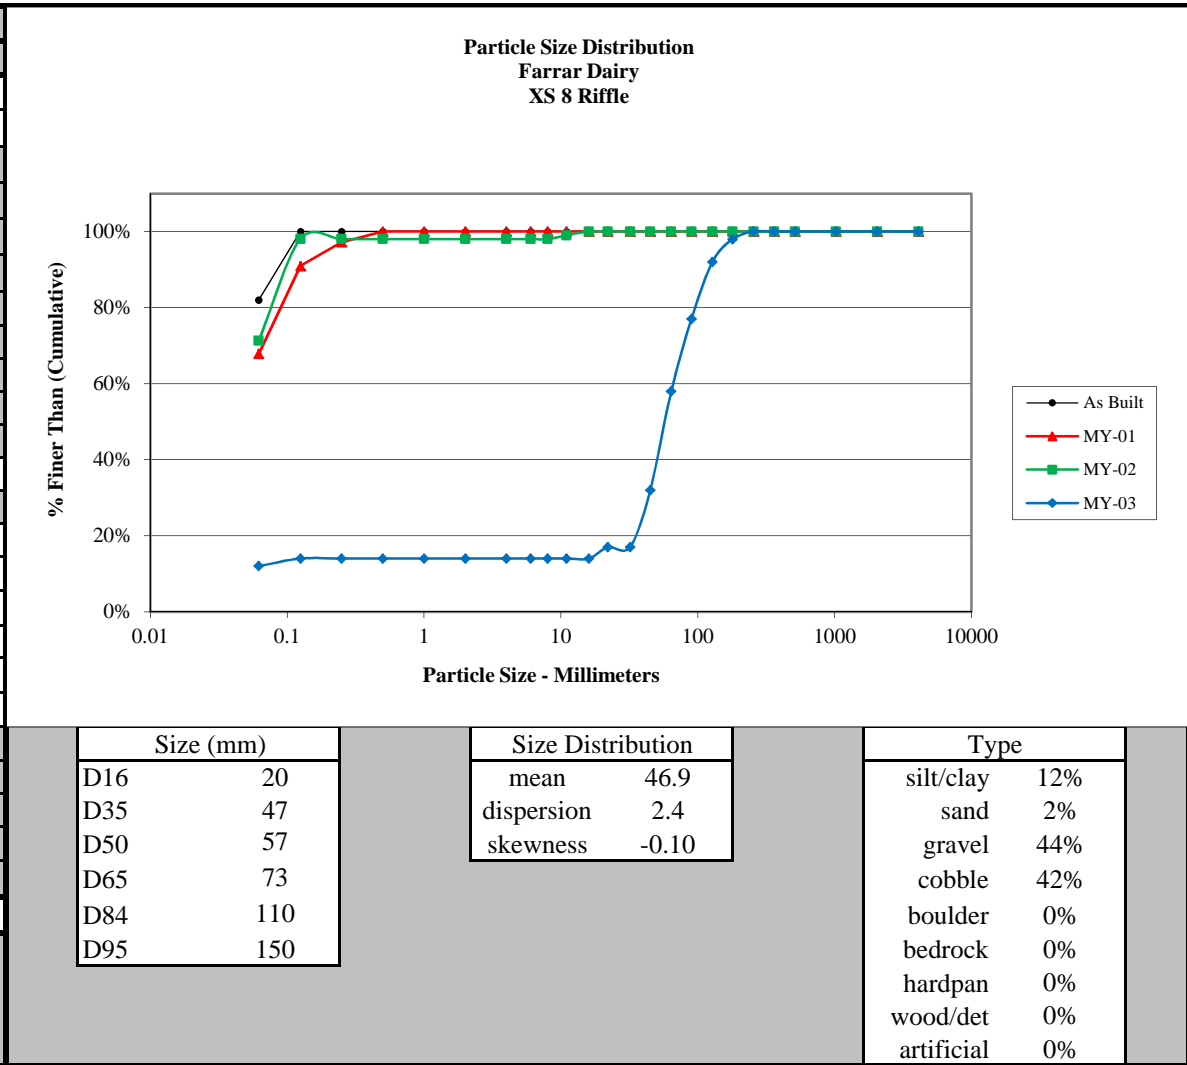
Cross-Section 8 Riffle -MY-03			
Particle	Millimeter		Count
Silt/Clay	< 0.062	S/C	12
Very Fine	.062 - .125	S	2
Fine	.125 - .25	A	
Medium	.25 - .50	N	
Coarse	.50 - 1	D	
Very Coarse	1 - 2	S	
Very Fine	2 - 4		
Fine	4 - 5.7	G	
Fine	5.7 - 8	R	
Medium	8 - 11.3	A	
Medium	11.3 - 16	V	
Coarse	16 - 22.6	E	3
Coarse	22.6 - 32	L	
Very Coarse	32 - 45	S	15
Very Coarse	45 - 64		26
Small	64 - 90	C	19
Small	90 - 128	O	15
Large	128 - 180	B	6
Large	180 - 256	L	2
Small	256 - 362	B	
Small	362 - 512	L	
Medium	512 - 1024	D	
Lrg- Very Lrg	1024 - 2048	R	
Bedrock	>2048	BDRK	
		Total	100
Note:

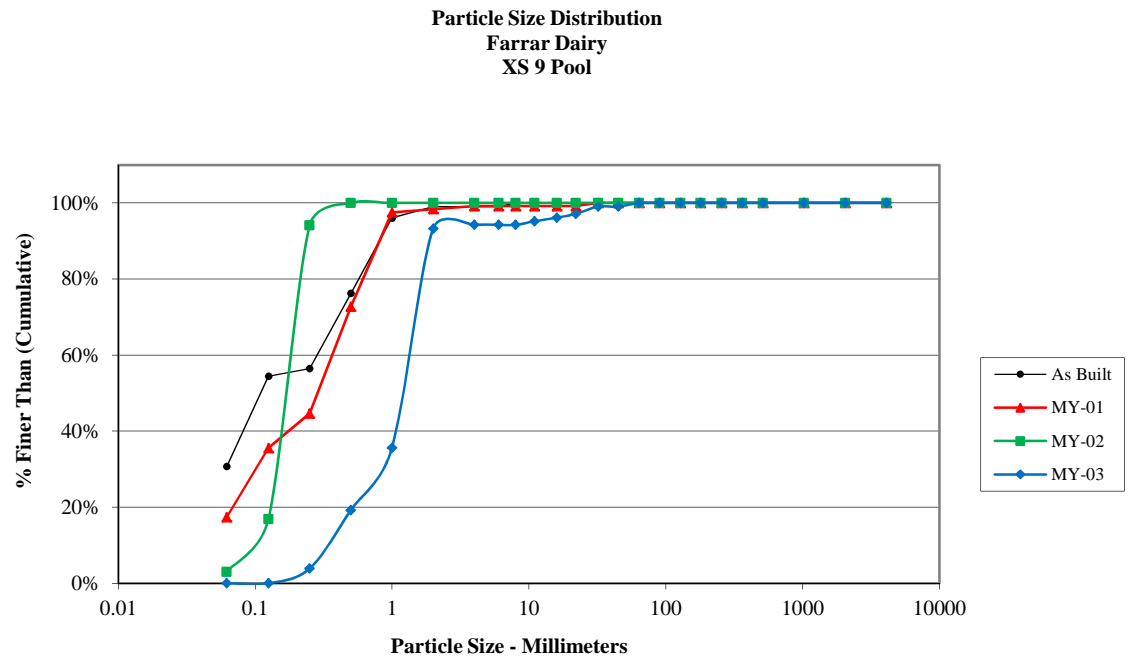
Cross-Section 9 Pool - MY-03			
Particle	Millimeter		Count
Silt/Clay	< 0.062	S/C	
Very Fine	.062 - .125	S	
Fine	.125 - .25	A	4
Medium	.25 - .50	N	16
Coarse	.50 - 1	D	17
Very Coarse	1 - 2	S	60
Very Fine	2 - 4		1
Fine	4 - 5.7	G	
Fine	5.7 - 8	R	
Medium	8 - 11.3	A	1
Medium	11.3 - 16	V	1
Coarse	16 - 22.6	E	1
Coarse	22.6 - 32	L	2
Very Coarse	32 - 45	S	
Very Coarse	45 - 64		1
Small	64 - 90	C	
Small	90 - 128	O	
Large	128 - 180	B	
Large	180 - 256	L	
Small	256 - 362	B	
Small	362 - 512	L	
Medium	512 - 1024	D	
Lrg- Very Lrg	1024 - 2048	R	
Bedrock	>2048	BDRK	
		Total	104
Note:

Size (mm)	
D16	0.43
D35	0.98
D50	1.2
D65	1.4
D84	1.8
D95	10

Size Distribution	
mean	0.9
dispersion	2.1
skewness	-0.17

Type	
silt/clay	0%
sand	93%
gravel	7%
cobble	0%
boulder	0%
bedrock	0%
hardpan	0%
wood/det	0%
artificial	0%

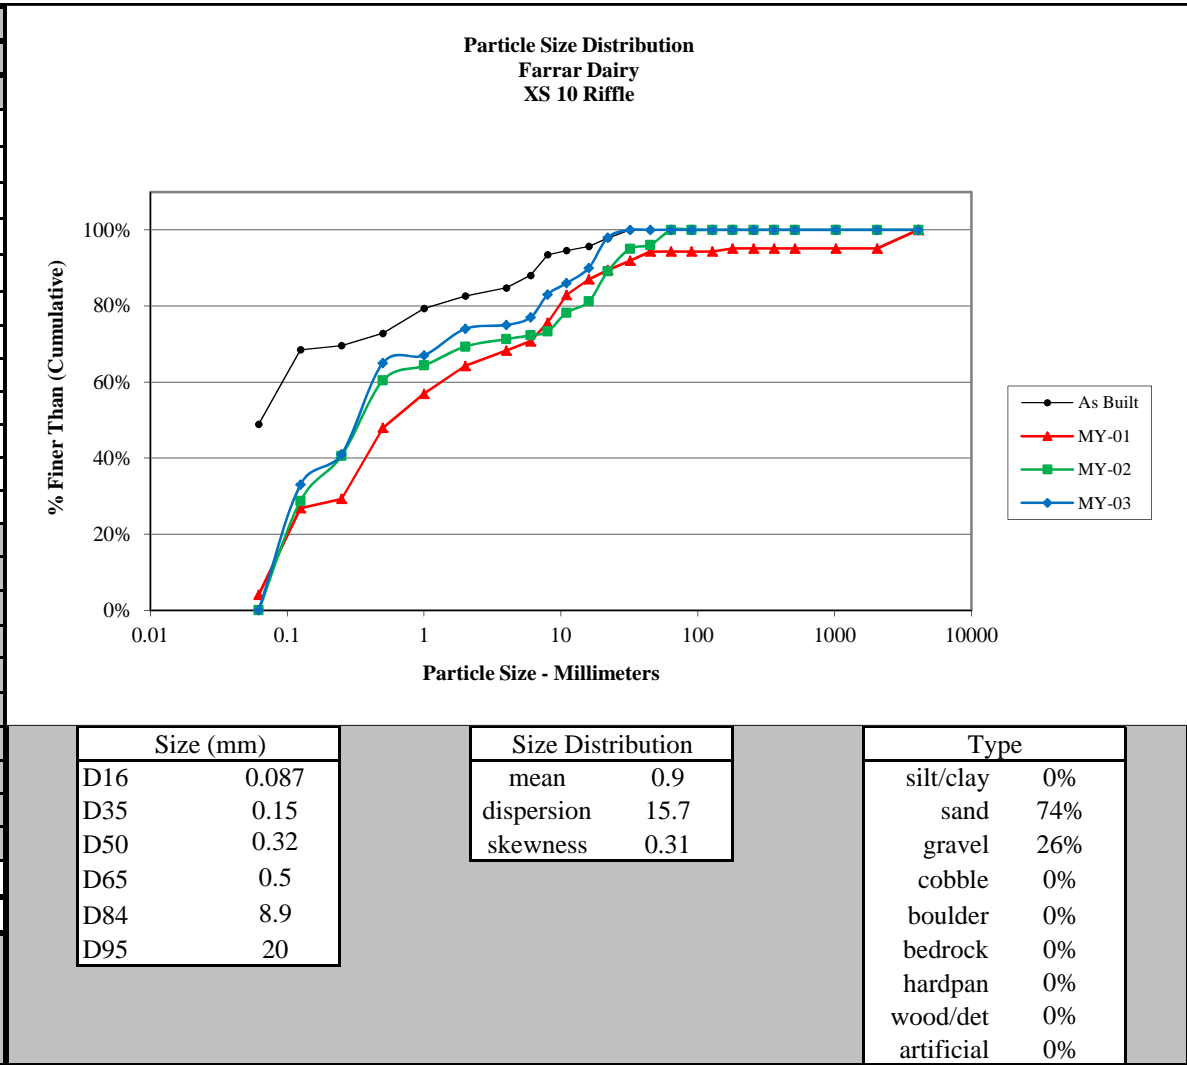
Cross-Section 10 Riffle - MY-03			
Particle	Millimeter		Count
Silt/Clay	< 0.062	S/C	
Very Fine	.062 - .125	S	33
Fine	.125 - .25	A	8
Medium	.25 - .50	N	24
Coarse	.50 - 1	D	2
Very Coarse	1 - 2	S	7
Very Fine	2 - 4		1
Fine	4 - 5.7	G	2
Fine	5.7 - 8	R	6
Medium	8 - 11.3	A	3
Medium	11.3 - 16	V	4
Coarse	16 - 22.6	E	8
Coarse	22.6 - 32	L	2
Very Coarse	32 - 45		
Very Coarse	45 - 64		
Small	64 - 90	C	
Small	90 - 128	O	
Large	128 - 180	B	
Large	180 - 256	L	
Small	256 - 362	B	
Small	362 - 512	L	
Medium	512 - 1024	D	
Lrg- Very Lrg	1024 - 2048	R	
Bedrock	>2048	BDRK	
		Total	100
Note:

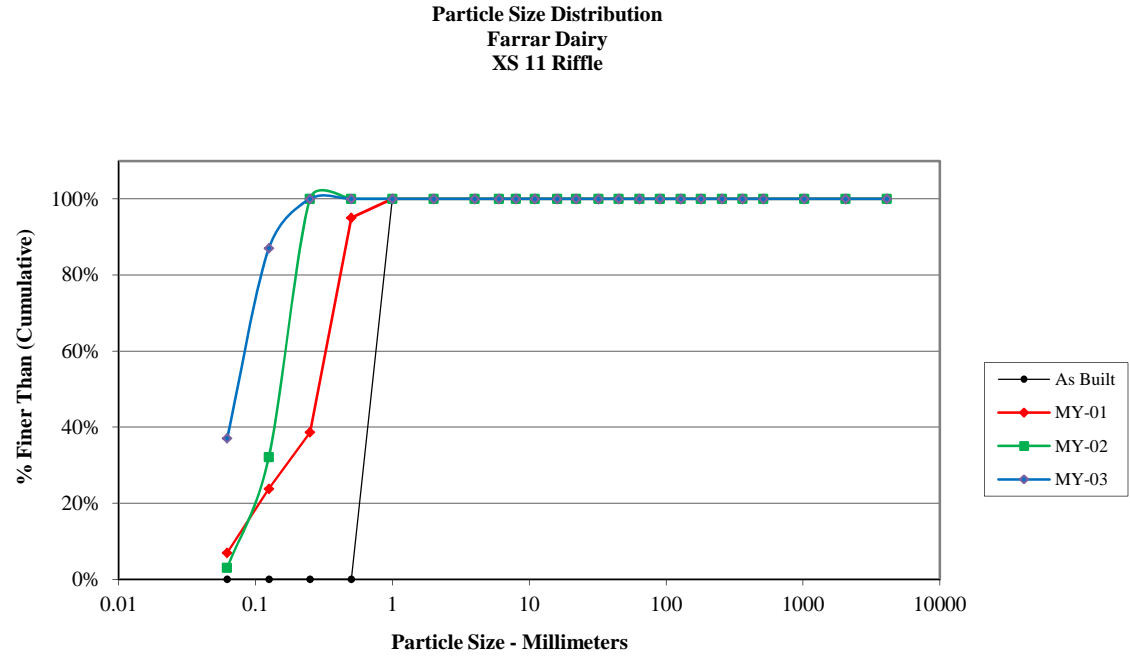
Cross-Section 11 Riffle - MY-03			
Particle	Millimeter		Count
Silt/Clay	< 0.062	S/C	37
Very Fine	.062 - .125	S	50
Fine	.125 - .25	A	13
Medium	.25 - .50	N	
Coarse	.50 - 1	D	
Very Coarse	1 - 2	S	
Very Fine	2 - 4		
Fine	4 - 5.7	G	
Fine	5.7 - 8	R	
Medium	8 - 11.3	A	
Medium	11.3 - 16	V	
Coarse	16 - 22.6	E	
Coarse	22.6 - 32	L	
Very Coarse	32 - 45	S	
Very Coarse	45 - 64		
Small	64 - 90	C	
Small	90 - 128	O	
Large	128 - 180	B	
Large	180 - 256	L	
Small	256 - 362	B	
Small	362 - 512	L	
Medium	512 - 1024	D	
Lrg- Very Lrg	1024 - 2048	R	
Bedrock	>2048	BDRK	
		Total	100
Note:

Size (mm)	
D16	0.062
D35	0.062
D50	0.074
D65	0.092
D84	0.12
D95	0.19

Size Distribution	
mean	0.1
dispersion	1.4
skewness	0.12

Type	
silt/clay	37%
sand	63%
gravel	0%
cobble	0%
boulder	0%
bedrock	0%
hardpan	0%
wood/det	0%
artificial	0%

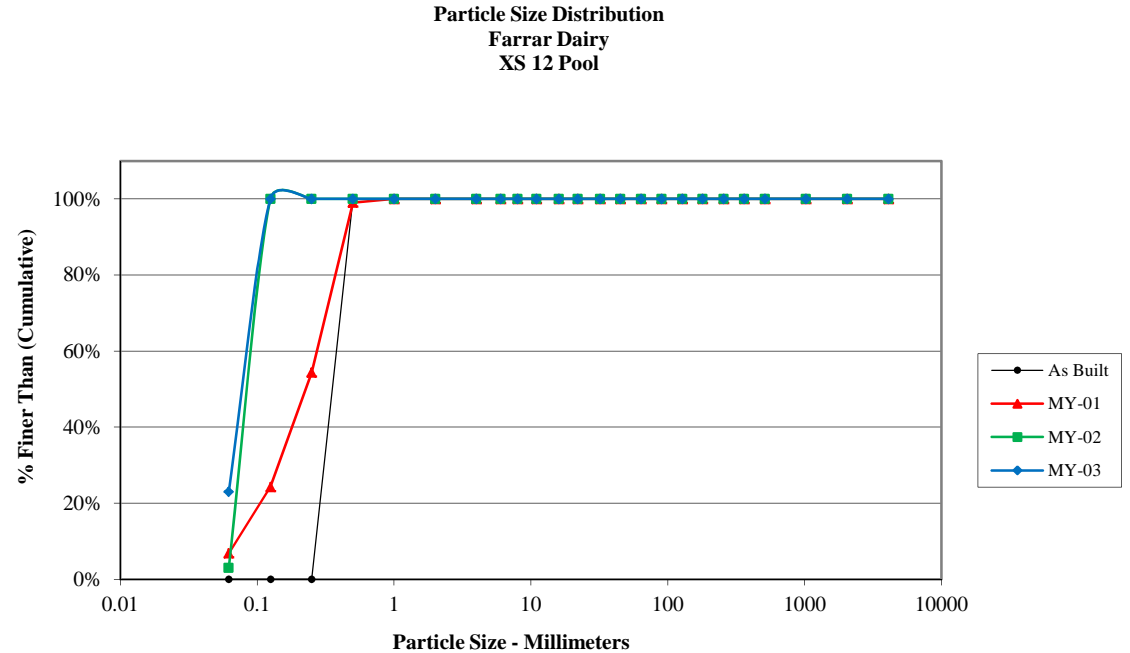
Cross-Section 12 Pool - MY-03			
Particle	Millimeter		Count
Silt/Clay	< 0.062	S/C	23
Very Fine	.062 - .125	S	77
Fine	.125 - .25	A	
Medium	.25 - .50	N	
Coarse	.50 - 1	D	
Very Coarse	1 - 2	S	
Very Fine	2 - 4		
Fine	4 - 5.7	G	
Fine	5.7 - 8	R	
Medium	8 - 11.3	A	
Medium	11.3 - 16	V	
Coarse	16 - 22.6	E	
Coarse	22.6 - 32	L	
Very Coarse	32 - 45	S	
Very Coarse	45 - 64		
Small	64 - 90	C	
Small	90 - 128	O	
Large	128 - 180	B	
Large	180 - 256	L	
Small	256 - 362	B	
Small	362 - 512	L	
Medium	512 - 1024	D	
Lrg- Very Lrg	1024 - 2048	R	
Bedrock	>2048	BDRK	
	Total		100
Note:

Size (mm)	
D16	0.062
D35	0.069
D50	0.079
D65	0.091
D84	0.11
D95	0.12

Size Distribution	
mean	0.1
dispersion	1.3
skewness	0.04

Type	
silt/clay	23%
sand	77%
gravel	0%
cobble	0%
boulder	0%
bedrock	0%
hardpan	0%
wood/det	0%
artificial	0%

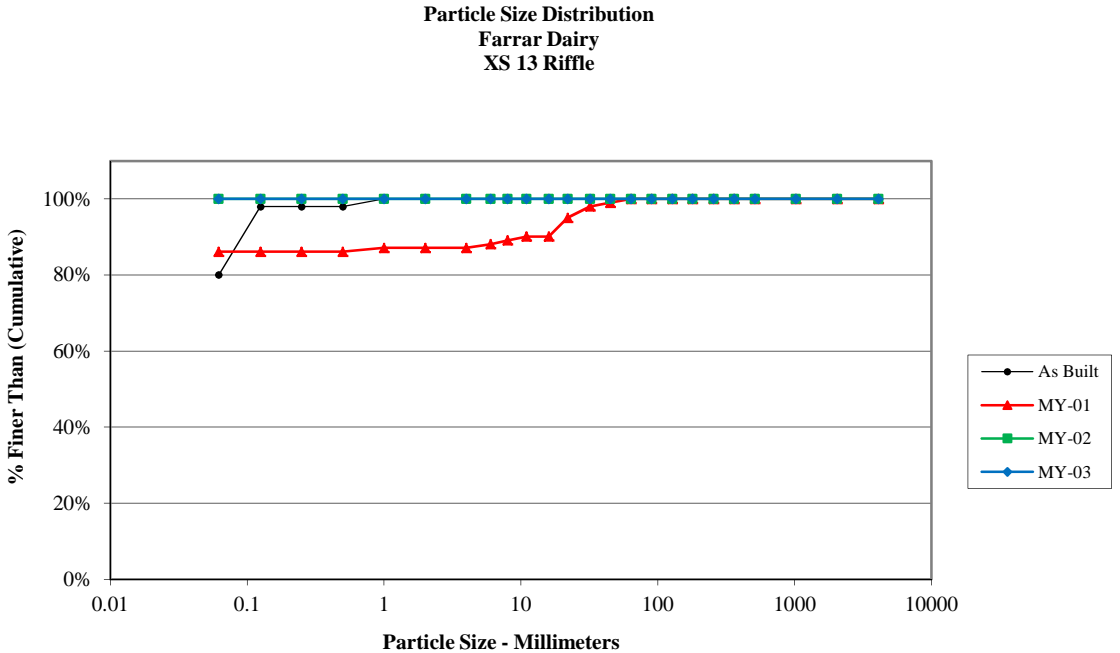
Cross-Section 13 Riffle - MY-03			
Particle	Millimeter		Count
Silt/Clay	< 0.062	S/C	100
Very Fine	.062 - .125	S	
Fine	.125 - .25	A	
Medium	.25 - .50	N	
Coarse	.50 - 1	D	
Very Coarse	1 - 2	S	
Very Fine	2 - 4		
Fine	4 - 5.7	G	
Fine	5.7 - 8	R	
Medium	8 - 11.3	A	
Medium	11.3 - 16	V	
Coarse	16 - 22.6	E	
Coarse	22.6 - 32	L	
Very Coarse	32 - 45	S	
Very Coarse	45 - 64		
Small	64 - 90	C	
Small	90 - 128	O	
Large	128 - 180	B	
Large	180 - 256	L	
Small	256 - 362	B	
Small	362 - 512	L	
Medium	512 - 1024	D	
Lrg- Very Lrg	1024 - 2048	R	
Bedrock	>2048	BDRK	
		Total	100
Note:

Size (mm)	
D16	0.062
D35	0.062
D50	0.062
D65	0.062
D84	0.062
D95	0.062

Size Distribution	
mean	0.1
dispersion	1.0
skewness	---

Type	
silt/clay	100%
sand	0%
gravel	0%
cobble	0%
boulder	0%
bedrock	0%
hardpan	0%
wood/det	0%
artificial	0%

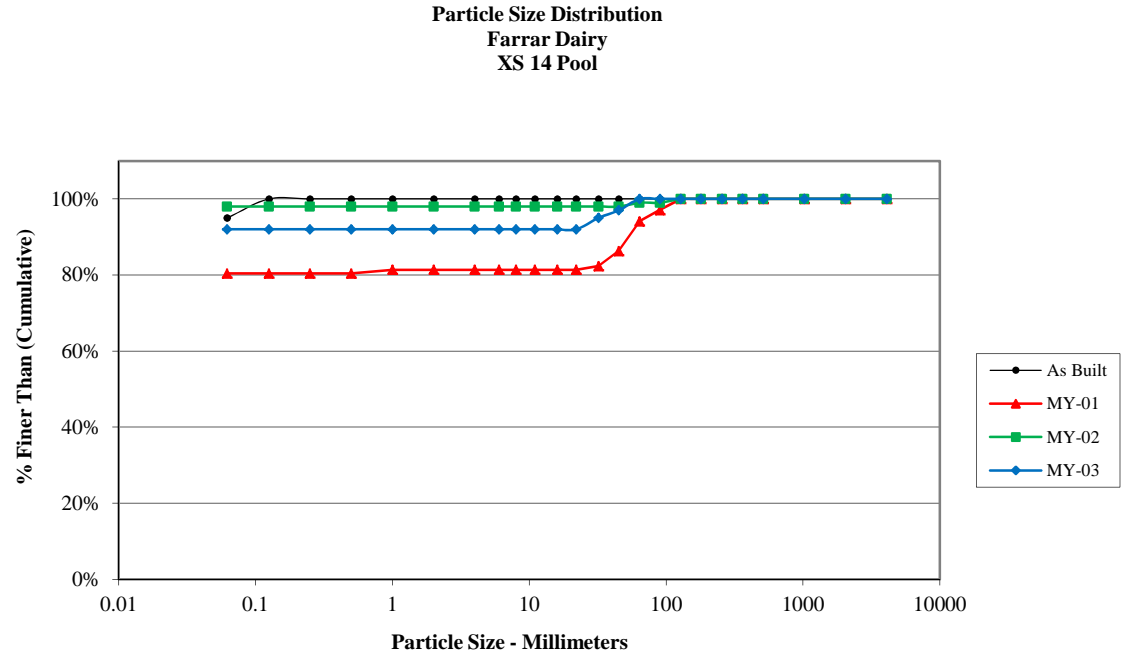
Cross-Section 14 Pool - MY-03			
Particle	Millimeter		Count
Silt/Clay	< 0.062	S/C	92
Very Fine	.062 - .125	S	
Fine	.125 - .25	A	
Medium	.25 - .50	N	
Coarse	.50 - 1	D	
Very Coarse	1 - 2	S	
Very Fine	2 - 4		
Fine	4 - 5.7	G	
Fine	5.7 - 8	R	
Medium	8 - 11.3	A	
Medium	11.3 - 16	V	
Coarse	16 - 22.6	E	
Coarse	22.6 - 32	L	3
Very Coarse	32 - 45	S	2
Very Coarse	45 - 64		3
Small	64 - 90	C	
Small	90 - 128	O	
Large	128 - 180	B	
Large	180 - 256	L	
Small	256 - 362	B	
Small	362 - 512	L	
Medium	512 - 1024	D	
Lrg- Very Lrg	1024 - 2048	R	
Bedrock	>2048	BDRK	
		Total	100
Note:

Size (mm)	
D16	0.062
D35	0.062
D50	0.062
D65	0.062
D84	0.062
D95	32

Size Distribution	
mean	0.1
dispersion	1.0
skewness	---

Type	
silt/clay	92%
sand	0%
gravel	8%
cobble	0%
boulder	0%
bedrock	0%
hardpan	0%
wood/det	0%
artificial	0%

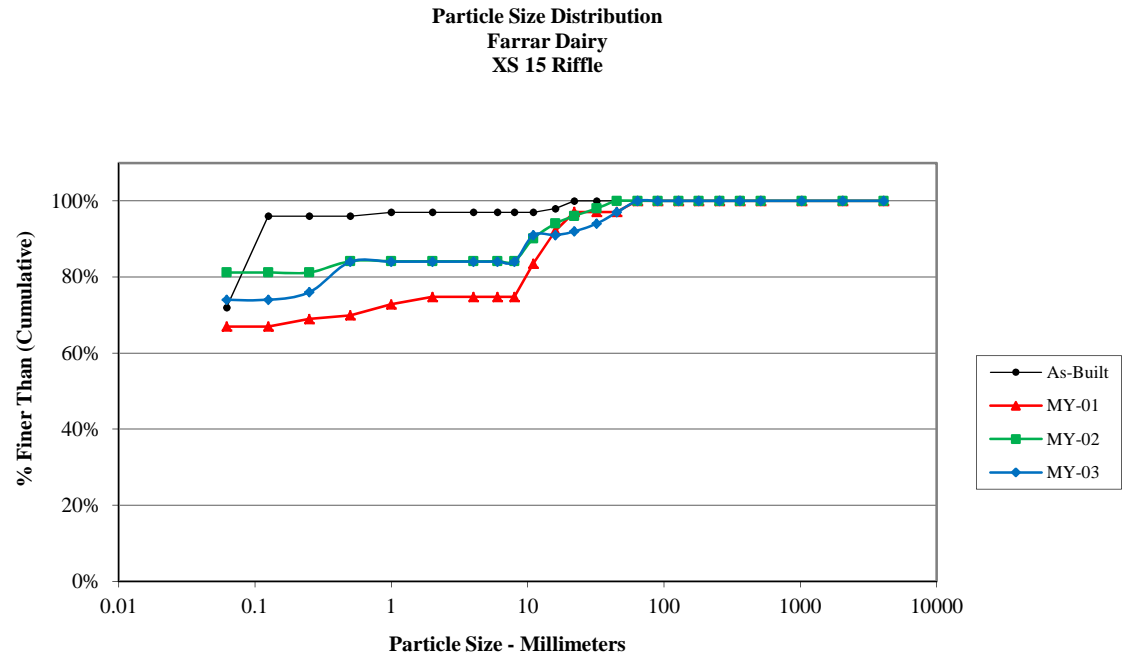
Cross-Section 15 Riffle - MY-03			
Particle	Millimeter		Count
Silt/Clay	< 0.062	S/C	74
Very Fine	.062 - .125	S	
Fine	.125 - .25	A	2
Medium	.25 - .50	N	8
Coarse	.50 - 1	D	
Very Coarse	1 - 2	S	
Very Fine	2 - 4		
Fine	4 - 5.7	G	
Fine	5.7 - 8	R	
Medium	8 - 11.3	A	7
Medium	11.3 - 16	V	
Coarse	16 - 22.6	E	1
Coarse	22.6 - 32	L	2
Very Coarse	32 - 45	S	3
Very Coarse	45 - 64		3
Small	64 - 90	C	
Small	90 - 128	O	
Large	128 - 180	B	
Large	180 - 256	L	
Small	256 - 362	B	
Small	362 - 512	L	
Medium	512 - 1024	D	
Lrg- Very Lrg	1024 - 2048	R	
Bedrock	>2048	BDRK	
		Total	100
Note:

Size (mm)	
D16	0.062
D35	0.062
D50	0.062
D65	0.062
D84	0.5
D95	36

Size Distribution	
mean	0.2
dispersion	4.5
skewness	0.48

Type	
silt/clay	74%
sand	10%
gravel	16%
cobble	0%
boulder	0%
bedrock	0%
hardpan	0%
wood/det	0%
artificial	0%

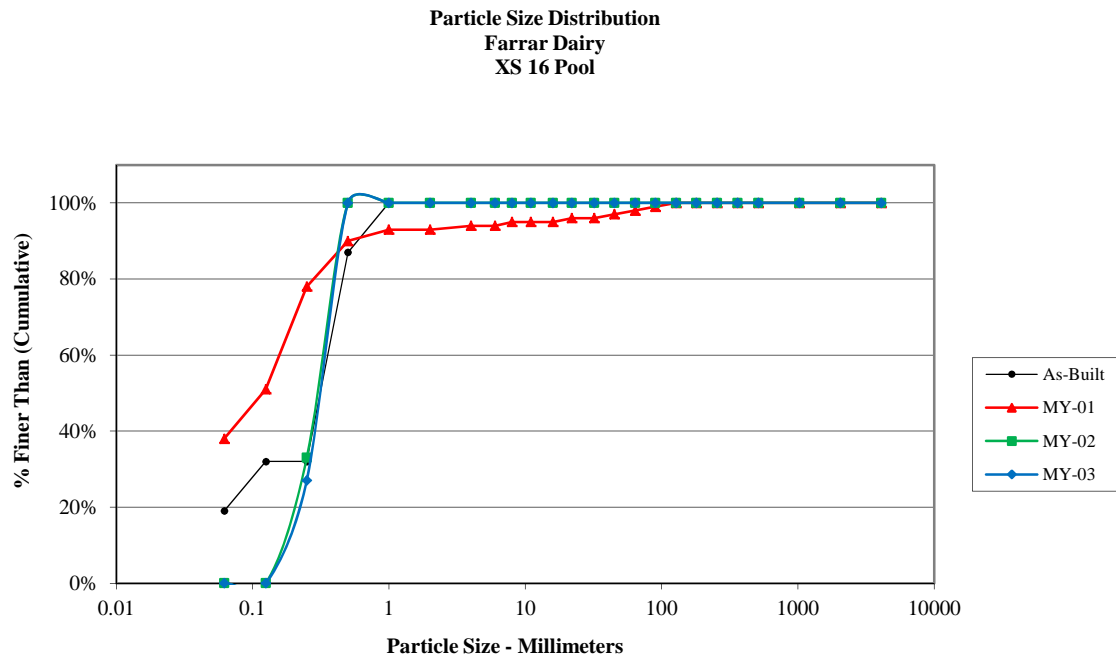
Cross-Section 16 Pool -MY-03			
Particle	Millimeter		Count
Silt/Clay	< 0.062	S/C	
Very Fine	.062 - .125	S	
Fine	.125 - .25	A	27
Medium	.25 - .50	N	73
Coarse	.50 - 1	D	
Very Coarse	1 - 2	S	
Very Fine	2 - 4		
Fine	4 - 5.7	G	
Fine	5.7 - 8	R	
Medium	8 - 11.3	A	
Medium	11.3 - 16	V	
Coarse	16 - 22.6	E	
Coarse	22.6 - 32	L	
Very Coarse	32 - 45	S	
Very Coarse	45 - 64		
Small	64 - 90	C	
Small	90 - 128	O	
Large	128 - 180	B	
Large	180 - 256	L	
Small	256 - 362	B	
Small	362 - 512	L	
Medium	512 - 1024	D	
Lrg- Very Lrg	1024 - 2048	R	
Bedrock	>2048	BDRK	
	Total		100
Note:

Size (mm)	
D16	0.19
D35	0.27
D50	0.31
D65	0.36
D84	0.43
D95	0.48

Size Distribution	
mean	0.3
dispersion	1.5
skewness	-0.06

Type	
silt/clay	0%
sand	100%
gravel	0%
cobble	0%
boulder	0%
bedrock	0%
hardpan	0%
wood/det	0%
artificial	0%

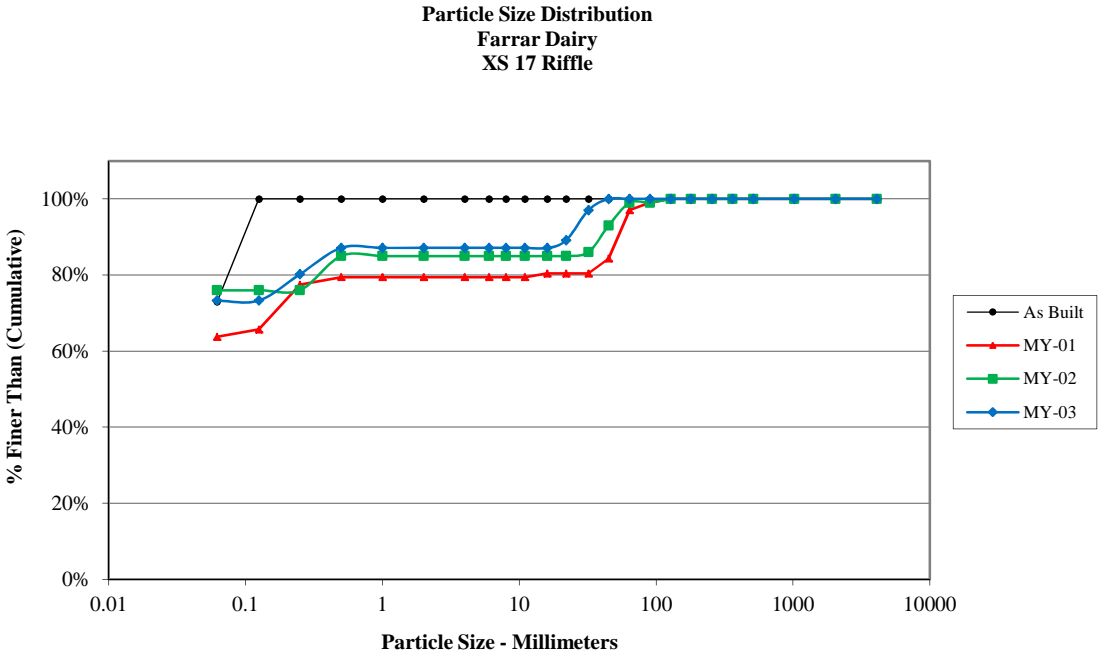
Cross-Section 17 Riffle - MY-03			
Particle	Millimeter		Count
Silt/Clay	< 0.062	S/C	74
Very Fine	.062 - .125	S	
Fine	.125 - .25	A	7
Medium	.25 - .50	N	7
Coarse	.50 - 1	D	
Very Coarse	1 - 2	S	
Very Fine	2 - 4		
Fine	4 - 5.7	G	
Fine	5.7 - 8	R	
Medium	8 - 11.3	A	
Medium	11.3 - 16	V	
Coarse	16 - 22.6	E	2
Coarse	22.6 - 32	L	8
Very Coarse	32 - 45	S	3
Very Coarse	45 - 64		
Small	64 - 90	C	
Small	90 - 128	O	
Large	128 - 180	B	
Large	180 - 256	L	
Small	256 - 362	B	
Small	362 - 512	L	
Medium	512 - 1024	D	
Lrg- Very Lrg	1024 - 2048	R	
Bedrock	>2048	BDRK	
	Total		101
Note:

Size (mm)	
D16	0.062
D35	0.062
D50	0.062
D65	0.062
D84	0.37
D95	29

Size Distribution	
mean	0.2
dispersion	3.5
skewness	0.44

Type	
silt/clay	73%
sand	14%
gravel	13%
cobble	0%
boulder	0%
bedrock	0%
hardpan	0%
wood/det	0%
artificial	0%

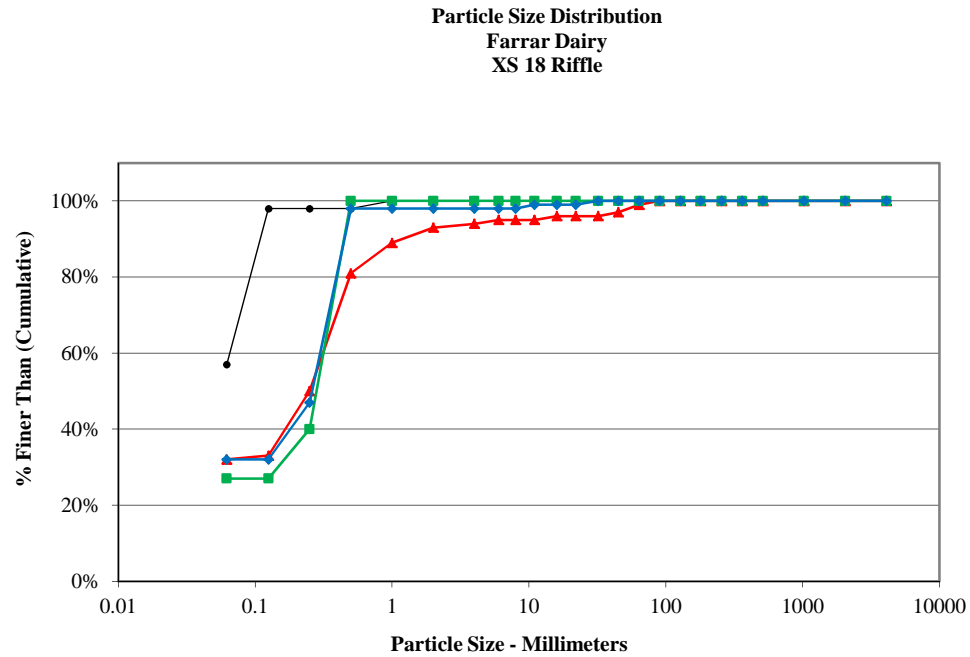
Cross-Section 18 Riffle - MY-03			
Particle	Millimeter		Count
Silt/Clay	< 0.062	S/C	32
Very Fine	.062 - .125	S	
Fine	.125 - .25	A	15
Medium	.25 - .50	N	51
Coarse	.50 - 1	D	
Very Coarse	1 - 2	S	
Very Fine	2 - 4		
Fine	4 - 5.7	G	
Fine	5.7 - 8	R	
Medium	8 - 11.3	A	1
Medium	11.3 - 16	V	
Coarse	16 - 22.6	E	
Coarse	22.6 - 32	L	1
Very Coarse	32 - 45	S	
Very Coarse	45 - 64		
Small	64 - 90	C	
Small	90 - 128	O	
Large	128 - 180	B	
Large	180 - 256	L	
Small	256 - 362	B	
Small	362 - 512	L	
Medium	512 - 1024	D	
Lrg- Very Lrg	1024 - 2048	R	
Bedrock	>2048	BDRK	
	Total		100
Note:

Size (mm)	
D16	0.062
D35	0.14
D50	0.26
D65	0.32
D84	0.41
D95	0.48

Size Distribution	
mean	0.2
dispersion	2.9
skewness	-0.23

Type	
silt/clay	32%
sand	66%
gravel	2%
cobble	0%
boulder	0%
bedrock	0%
hardpan	0%
wood/det	0%
artificial	0%

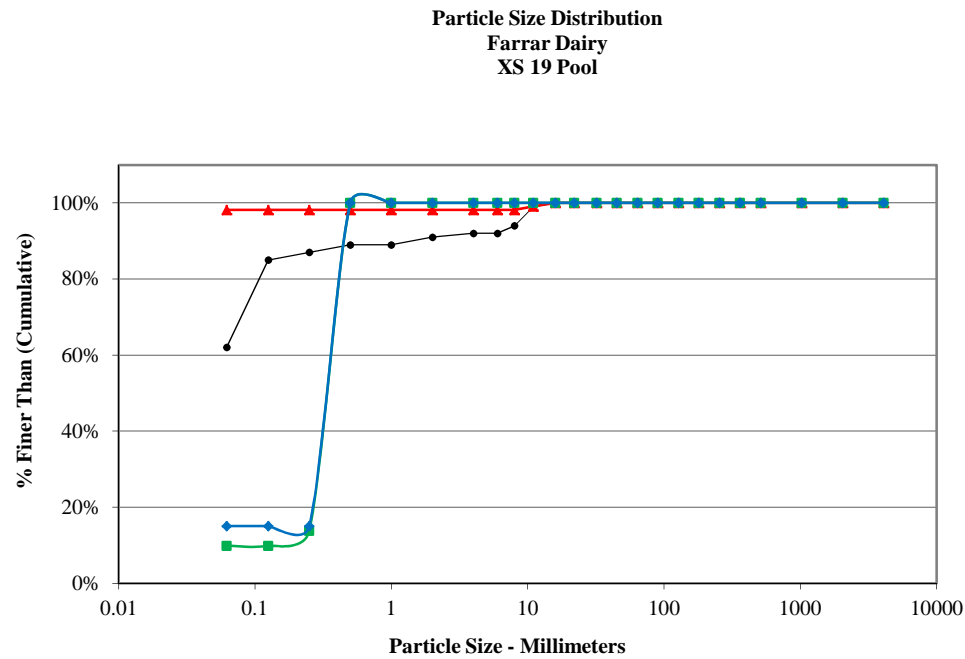
Cross-Section 19 Pool - MY-03			
Particle	Millimeter		Count
Silt/Clay	< 0.062	S/C	15
Very Fine	.062 - .125	S	
Fine	.125 - .25	A	
Medium	.25 - .50	N	85
Coarse	.50 - 1	D	
Very Coarse	1 - 2	S	
Very Fine	2 - 4		
Fine	4 - 5.7	G	
Fine	5.7 - 8	R	
Medium	8 - 11.3	A	
Medium	11.3 - 16	V	
Coarse	16 - 22.6	E	
Coarse	22.6 - 32	L	
Very Coarse	32 - 45	S	
Very Coarse	45 - 64		
Small	64 - 90	C	
Small	90 - 128	O	
Large	128 - 180	B	
Large	180 - 256	L	
Small	256 - 362	B	
Small	362 - 512	L	
Medium	512 - 1024	D	
Lrg- Very Lrg	1024 - 2048	R	
Bedrock	>2048	BDRK	
	Total		100
Note:

Size (mm)	
D16	0.25
D35	0.29
D50	0.33
D65	0.38
D84	0.44
D95	0.48

Size Distribution	
mean	0.3
dispersion	1.3
skewness	0.00

Type	
silt/clay	15%
sand	85%
gravel	0%
cobble	0%
boulder	0%
bedrock	0%
hardpan	0%
wood/det	0%
artificial	0%

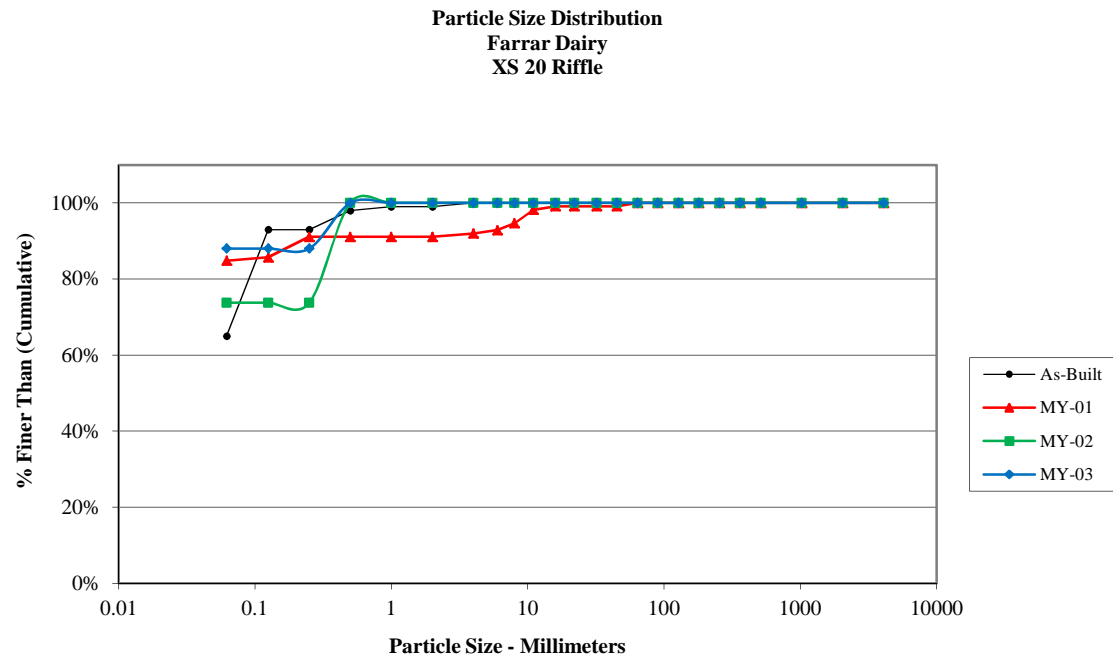
Cross-Section 20 Riffle - MY-03			
Particle	Millimeter		Count
Silt/Clay	< 0.062	S/C	88
Very Fine	.062 - .125	S	
Fine	.125 - .25	A	
Medium	.25 - .50	N	12
Coarse	.50 - 1	D	
Very Coarse	1 - 2	S	
Very Fine	2 - 4		
Fine	4 - 5.7	G	
Fine	5.7 - 8	R	
Medium	8 - 11.3	A	
Medium	11.3 - 16	V	
Coarse	16 - 22.6	E	
Coarse	22.6 - 32	L	
Very Coarse	32 - 45	S	
Very Coarse	45 - 64		
Small	64 - 90	C	
Small	90 - 128	O	
Large	128 - 180	B	
Large	180 - 256	L	
Small	256 - 362	B	
Small	362 - 512	L	
Medium	512 - 1024	D	
Lrg- Very Lrg	1024 - 2048	R	
Bedrock	>2048	BDRK	
	Total		100
Note:

Size (mm)	
D16	0.062
D35	0.062
D50	0.062
D65	0.062
D84	0.062
D95	0.37

Size Distribution	
mean	0.1
dispersion	1.0
skewness	---

Type	
silt/clay	88%
sand	12%
gravel	0%
cobble	0%
boulder	0%
bedrock	0%
hardpan	0%
wood/det	0%
artificial	0%

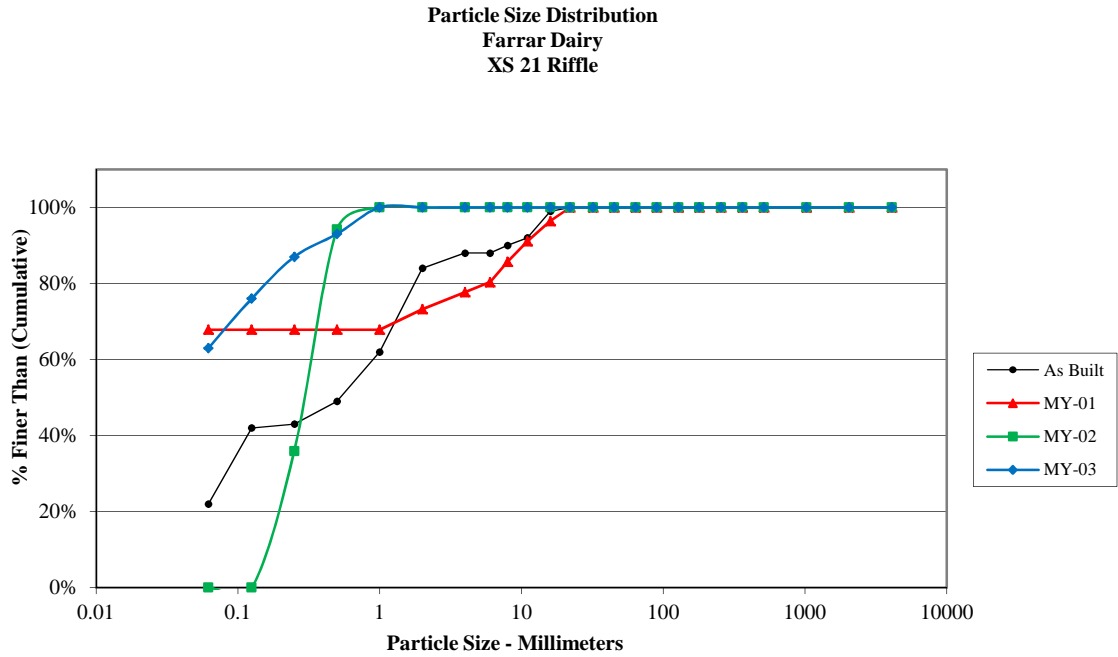
Cross-Section 21 Riffle - MY-03			
Particle	Millimeter		Count
Silt/Clay	< 0.062	S/C	63
Very Fine	.062 - .125	S	13
Fine	.125 - .25	A	11
Medium	.25 - .50	N	6
Coarse	.50 - 1	D	7
Very Coarse	1 - 2	S	
Very Fine	2 - 4		
Fine	4 - 5.7	G	
Fine	5.7 - 8	R	
Medium	8 - 11.3	A	
Medium	11.3 - 16	V	
Coarse	16 - 22.6	E	
Coarse	22.6 - 32	L	
Very Coarse	32 - 45	S	
Very Coarse	45 - 64		
Small	64 - 90	C	
Small	90 - 128	O	
Large	128 - 180	B	
Large	180 - 256	L	
Small	256 - 362	B	
Small	362 - 512	L	
Medium	512 - 1024	D	
Lrg- Very Lrg	1024 - 2048	R	
Bedrock	>2048	BDRK	
		Total	100
Note:

Size (mm)	
D16	0.062
D35	0.062
D50	0.062
D65	0.069
D84	0.21
D95	0.61

Size Distribution	
mean	0.1
dispersion	2.2
skewness	0.36

Type	
silt/clay	63%
sand	37%
gravel	0%
cobble	0%
boulder	0%
bedrock	0%
hardpan	0%
wood/det	0%
artificial	0%

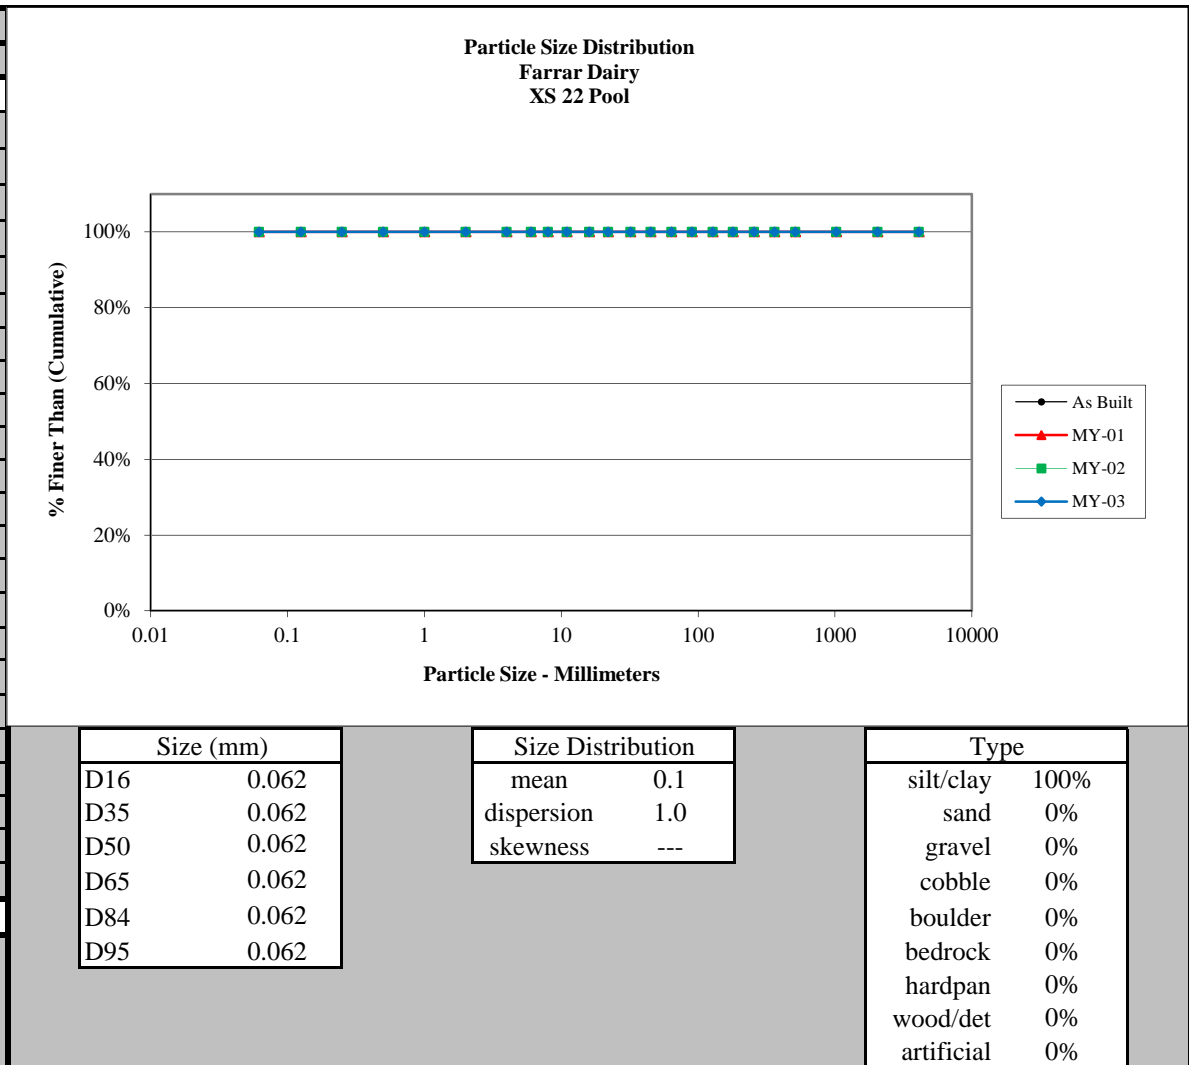
Cross-Section 22 Pool - MY-03			
Particle	Millimeter		Count
Silt/Clay	< 0.062	S/C	100
Very Fine	.062 - .125	S	
Fine	.125 - .25	A	
Medium	.25 - .50	N	
Coarse	.50 - 1	D	
Very Coarse	1 - 2	S	
Very Fine	2 - 4		
Fine	4 - 5.7	G	
Fine	5.7 - 8	R	
Medium	8 - 11.3	A	
Medium	11.3 - 16	V	
Coarse	16 - 22.6	E	
Coarse	22.6 - 32	L	
Very Coarse	32 - 45	S	
Very Coarse	45 - 64		
Small	64 - 90	C	
Small	90 - 128	O	
Large	128 - 180	B	
Large	180 - 256	L	
Small	256 - 362	B	
Small	362 - 512	L	
Medium	512 - 1024	D	
Lrg- Very Lrg	1024 - 2048	R	
Bedrock	>2048	BDRK	
		Total	100
Note:

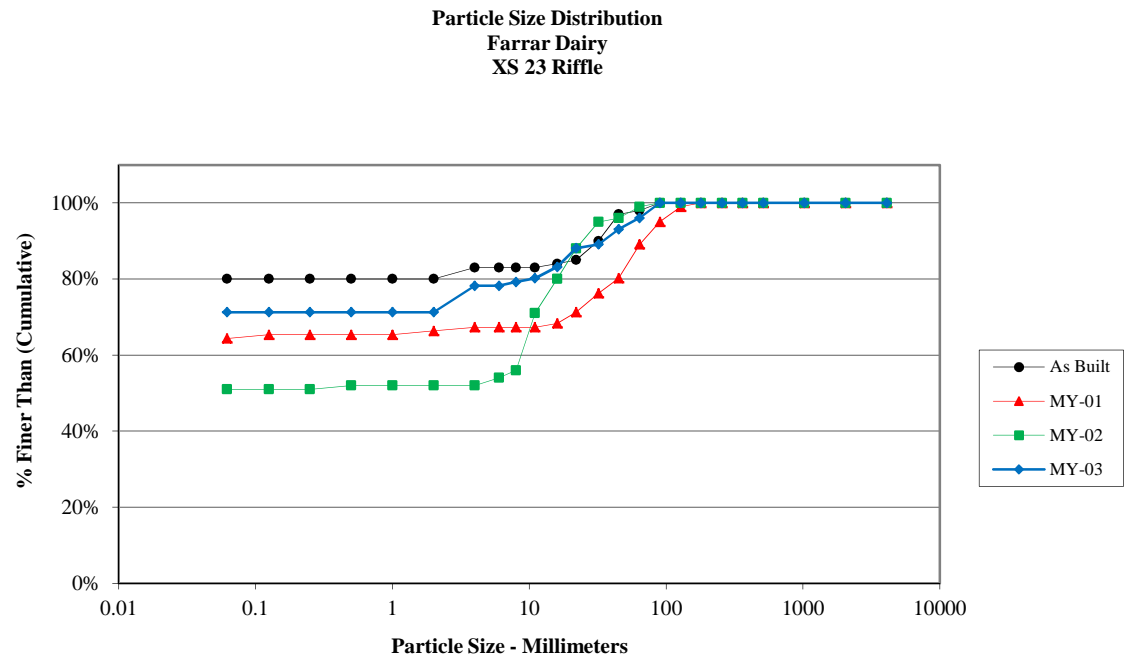
Cross-Section 23 Riffle - MY-03			
Particle	Millimeter		Count
Silt/Clay	< 0.062	S/C	72
Very Fine	.062 - .125	S	
Fine	.125 - .25	A	
Medium	.25 - .50	N	
Coarse	.50 - 1	D	
Very Coarse	1 - 2	S	
Very Fine	2 - 4		7
Fine	4 - 5.7	G	
Fine	5.7 - 8	R	1
Medium	8 - 11.3	A	1
Medium	11.3 - 16	V	3
Coarse	16 - 22.6	E	5
Coarse	22.6 - 32	L	1
Very Coarse	32 - 45	S	4
Very Coarse	45 - 64		3
Small	64 - 90	C	4
Small	90 - 128	O	
Large	128 - 180	B	
Large	180 - 256	L	
Small	256 - 362	B	
Small	362 - 512	L	
Medium	512 - 1024	D	
Lrg- Very Lrg	1024 - 2048	R	
Bedrock	>2048	BDRK	
		Total	101
Note:

Size (mm)	Count
D16	0.062
D35	0.062
D50	0.062
D65	0.062
D84	17
D95	57

Size Distribution	
mean	1.0
dispersion	137.6
skewness	0.78

Type	
silt/clay	71%
sand	0%
gravel	25%
cobble	4%
boulder	0%
bedrock	0%
hardpan	0%
wood/det	0%
artificial	0%

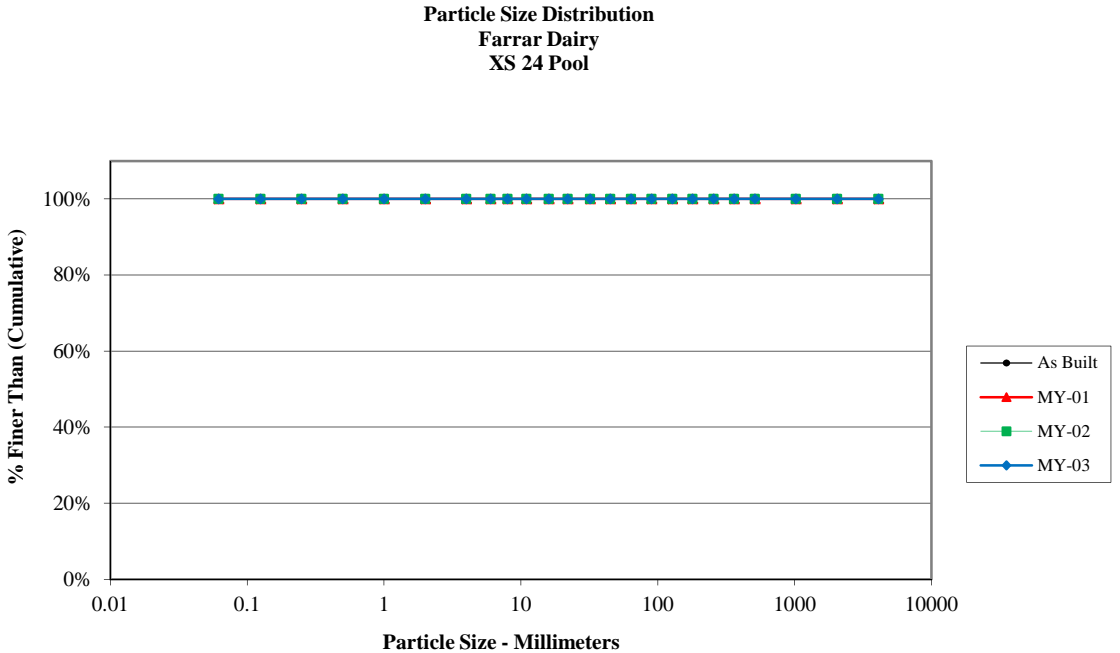
Cross-Section 24 Pool - MY-03			
Particle	Millimeter		Count
Silt/Clay	< 0.062	S/C	100
Very Fine	.062 - .125	S	
Fine	.125 - .25	A	
Medium	.25 - .50	N	
Coarse	.50 - 1	D	
Very Coarse	1 - 2	S	
Very Fine	2 - 4		
Fine	4 - 5.7	G	
Fine	5.7 - 8	R	
Medium	8 - 11.3	A	
Medium	11.3 - 16	V	
Coarse	16 - 22.6	E	
Coarse	22.6 - 32	L	
Very Coarse	32 - 45	S	
Very Coarse	45 - 64		
Small	64 - 90	C	
Small	90 - 128	O	
Large	128 - 180	B	
Large	180 - 256	L	
Small	256 - 362	B	
Small	362 - 512	L	
Medium	512 - 1024	D	
Lrg- Very Lrg	1024 - 2048	R	
Bedrock	>2048	BDRK	
		Total	100
Note:

Size (mm)	
D16	0.062
D35	0.062
D50	0.062
D65	0.062
D84	0.062
D95	0.062

Size Distribution	
mean	0.1
dispersion	1.0
skewness	---

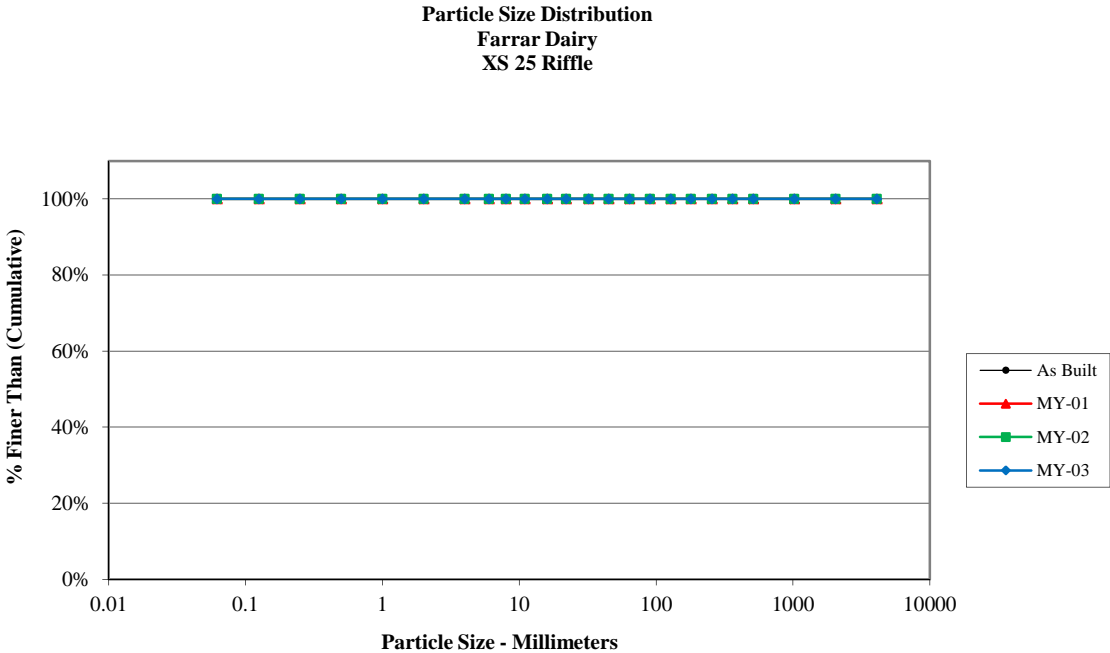
Cross-Section 25 Riffle - MY-03			
Particle	Millimeter		Count
Silt/Clay	< 0.062	S/C	100
Very Fine	.062 - .125	S	
Fine	.125 - .25	A	
Medium	.25 - .50	N	
Coarse	.50 - 1	D	
Very Coarse	1 - 2	S	
Very Fine	2 - 4		
Fine	4 - 5.7	G	
Fine	5.7 - 8	R	
Medium	8 - 11.3	A	
Medium	11.3 - 16	V	
Coarse	16 - 22.6	E	
Coarse	22.6 - 32	L	
Very Coarse	32 - 45	S	
Very Coarse	45 - 64		
Small	64 - 90	C	
Small	90 - 128	O	
Large	128 - 180	B	
Large	180 - 256	L	
Small	256 - 362	B	
Small	362 - 512	L	
Medium	512 - 1024	D	
Lrg- Very Lrg	1024 - 2048	R	
Bedrock	>2048	BDRK	
		Total	100
Note:

Size (mm)	
D16	0.062
D35	0.062
D50	0.062
D65	0.062
D84	0.062
D95	0.062

Size Distribution	
mean	0.1
dispersion	1.0
skewness	---

Type	
silt/clay	100%
sand	0%
gravel	0%
cobble	0%
boulder	0%
bedrock	0%
hardpan	0%
wood/det	0%
artificial	0%

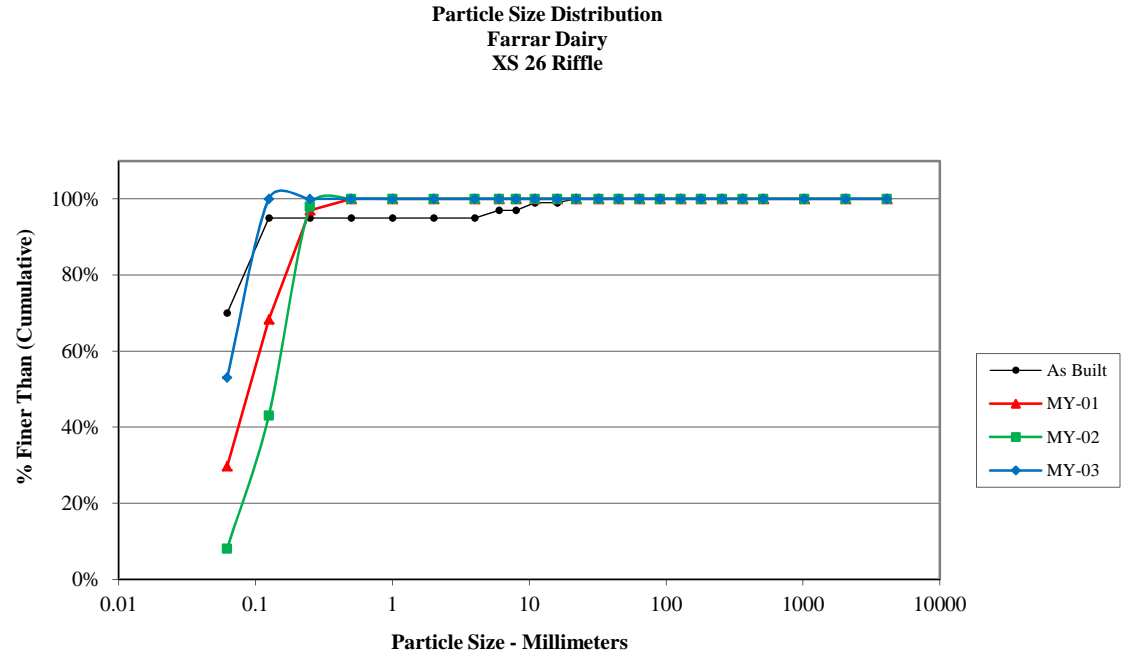
Cross-Section 26 Riffle - MY-03			
Particle	Millimeter		Count
Silt/Clay	< 0.062	S/C	53
Very Fine	.062 - .125	S	47
Fine	.125 - .25	A	
Medium	.25 - .50	N	
Coarse	.50 - 1	D	
Very Coarse	1 - 2	S	
Very Fine	2 - 4		
Fine	4 - 5.7	G	
Fine	5.7 - 8	R	
Medium	8 - 11.3	A	
Medium	11.3 - 16	V	
Coarse	16 - 22.6	E	
Coarse	22.6 - 32	L	
Very Coarse	32 - 45	S	
Very Coarse	45 - 64		
Small	64 - 90	C	
Small	90 - 128	O	
Large	128 - 180	B	
Large	180 - 256	L	
Small	256 - 362	B	
Small	362 - 512	L	
Medium	512 - 1024	D	
Lrg- Very Lrg	1024 - 2048	R	
Bedrock	>2048	BDRK	
	Total		100
Note:

Size (mm)	
D16	0.062
D35	0.062
D50	0.062
D65	0.074
D84	0.098
D95	0.12

Size Distribution	
mean	0.1
dispersion	1.3
skewness	0.22

Type	
silt/clay	53%
sand	47%
gravel	0%
cobble	0%
boulder	0%
bedrock	0%
hardpan	0%
wood/det	0%
artificial	0%

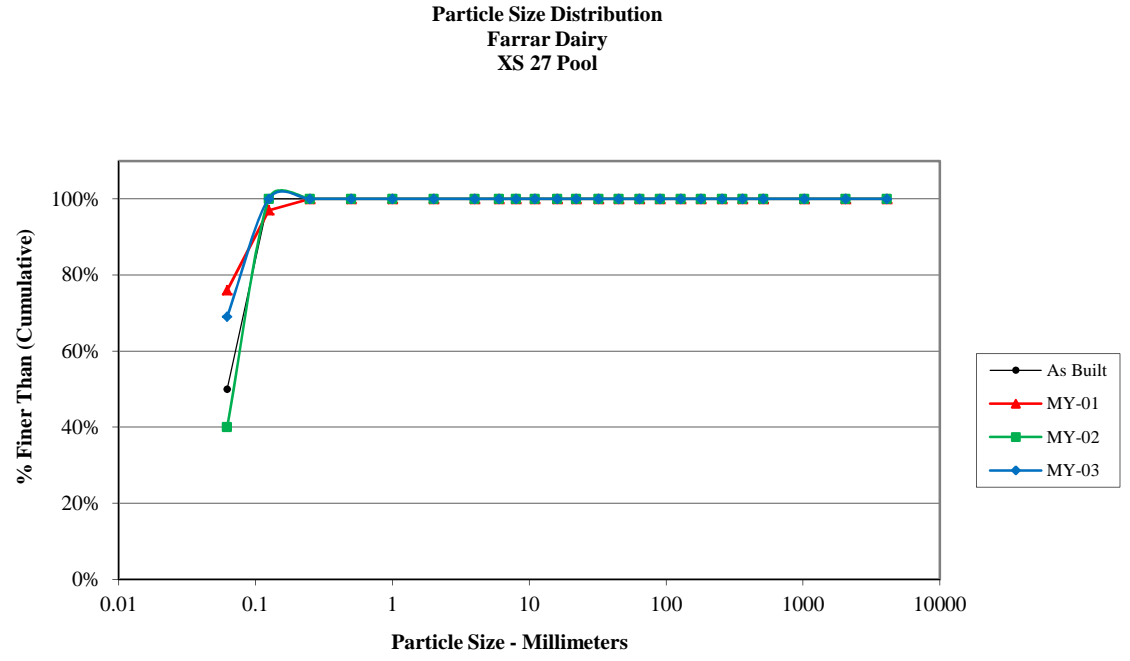
Cross-Section 27 Pool - MY-03			
Particle	Millimeter		Count
Silt/Clay	< 0.062	S/C	69
Very Fine	.062 - .125	S	31
Fine	.125 - .25	A	
Medium	.25 - .50	N	
Coarse	.50 - 1	D	
Very Coarse	1 - 2	S	
Very Fine	2 - 4		
Fine	4 - 5.7	G	
Fine	5.7 - 8	R	
Medium	8 - 11.3	A	
Medium	11.3 - 16	V	
Coarse	16 - 22.6	E	
Coarse	22.6 - 32	L	
Very Coarse	32 - 45	S	
Very Coarse	45 - 64		
Small	64 - 90	C	
Small	90 - 128	O	
Large	128 - 180	B	
Large	180 - 256	L	
Small	256 - 362	B	
Small	362 - 512	L	
Medium	512 - 1024	D	
Lrg- Very Lrg	1024 - 2048	R	
Bedrock	>2048	BDRK	
		Total	100
Note:

Size (mm)	
D16	0.062
D35	0.062
D50	0.062
D65	0.062
D84	0.087
D95	0.11

Size Distribution	
mean	0.1
dispersion	1.2
skewness	0.19

Type	
silt/clay	69%
sand	31%
gravel	0%
cobble	0%
boulder	0%
bedrock	0%
hardpan	0%
wood/det	0%
artificial	0%

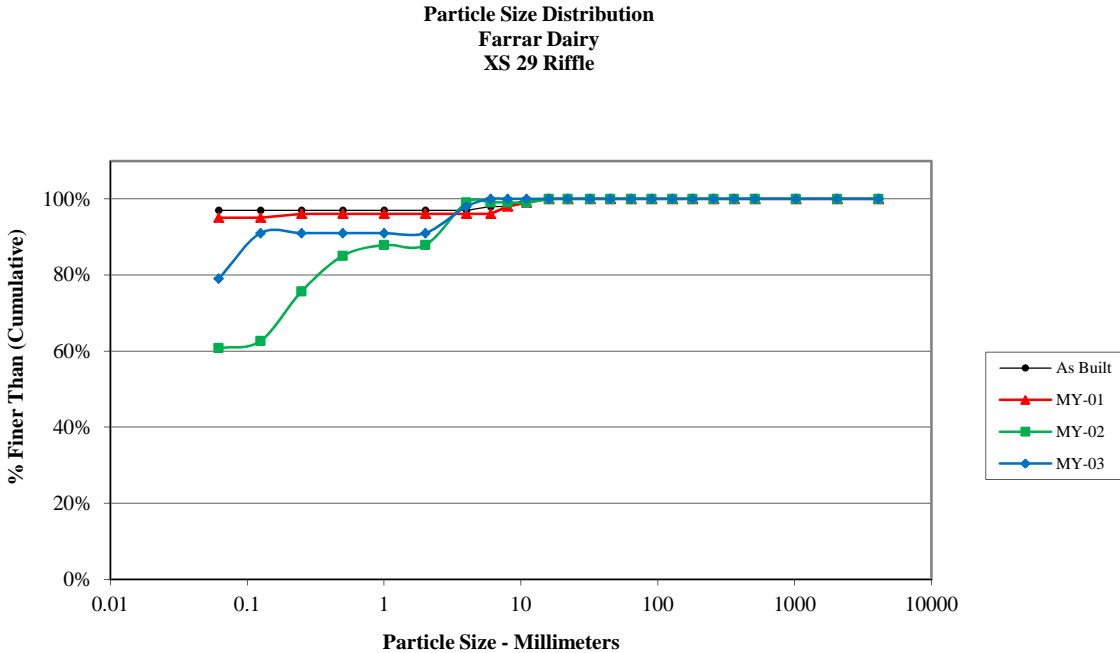
Cross-Section 29 Riffle - MY-03			
Particle	Millimeter		Count
Silt/Clay	< 0.062	S/C	79
Very Fine	.062 - .125	S	12
Fine	.125 - .25	A	
Medium	.25 - .50	N	
Coarse	.50 - 1	D	
Very Coarse	1 - 2	S	
Very Fine	2 - 4		7
Fine	4 - 5.7	G	2
Fine	5.7 - 8	R	
Medium	8 - 11.3	A	
Medium	11.3 - 16	V	
Coarse	16 - 22.6	E	
Coarse	22.6 - 32	L	
Very Coarse	32 - 45	S	
Very Coarse	45 - 64		
Small	64 - 90	C	
Small	90 - 128	O	
Large	128 - 180	B	
Large	180 - 256	L	
Small	256 - 362	B	
Small	362 - 512	L	
Medium	512 - 1024	D	
Lrg- Very Lrg	1024 - 2048	R	
Bedrock	>2048	BDRK	
		Total	100
Note:

Size (mm)	
D16	0.062
D35	0.062
D50	0.062
D65	0.062
D84	0.083
D95	3

Size Distribution	
mean	0.1
dispersion	1.2
skewness	0.18

Type	
silt/clay	79%
sand	12%
gravel	9%
cobble	0%
boulder	0%
bedrock	0%
hardpan	0%
wood/det	0%
artificial	0%
