**Farrar Dairy Stream and Wetland Restoration Site
Monitoring Report – MY03
Harnett County, NC**

December 2011

**Project Manager: Tim Morris
Email: tim.morris@kci.com
KCI Project No: 12065438**

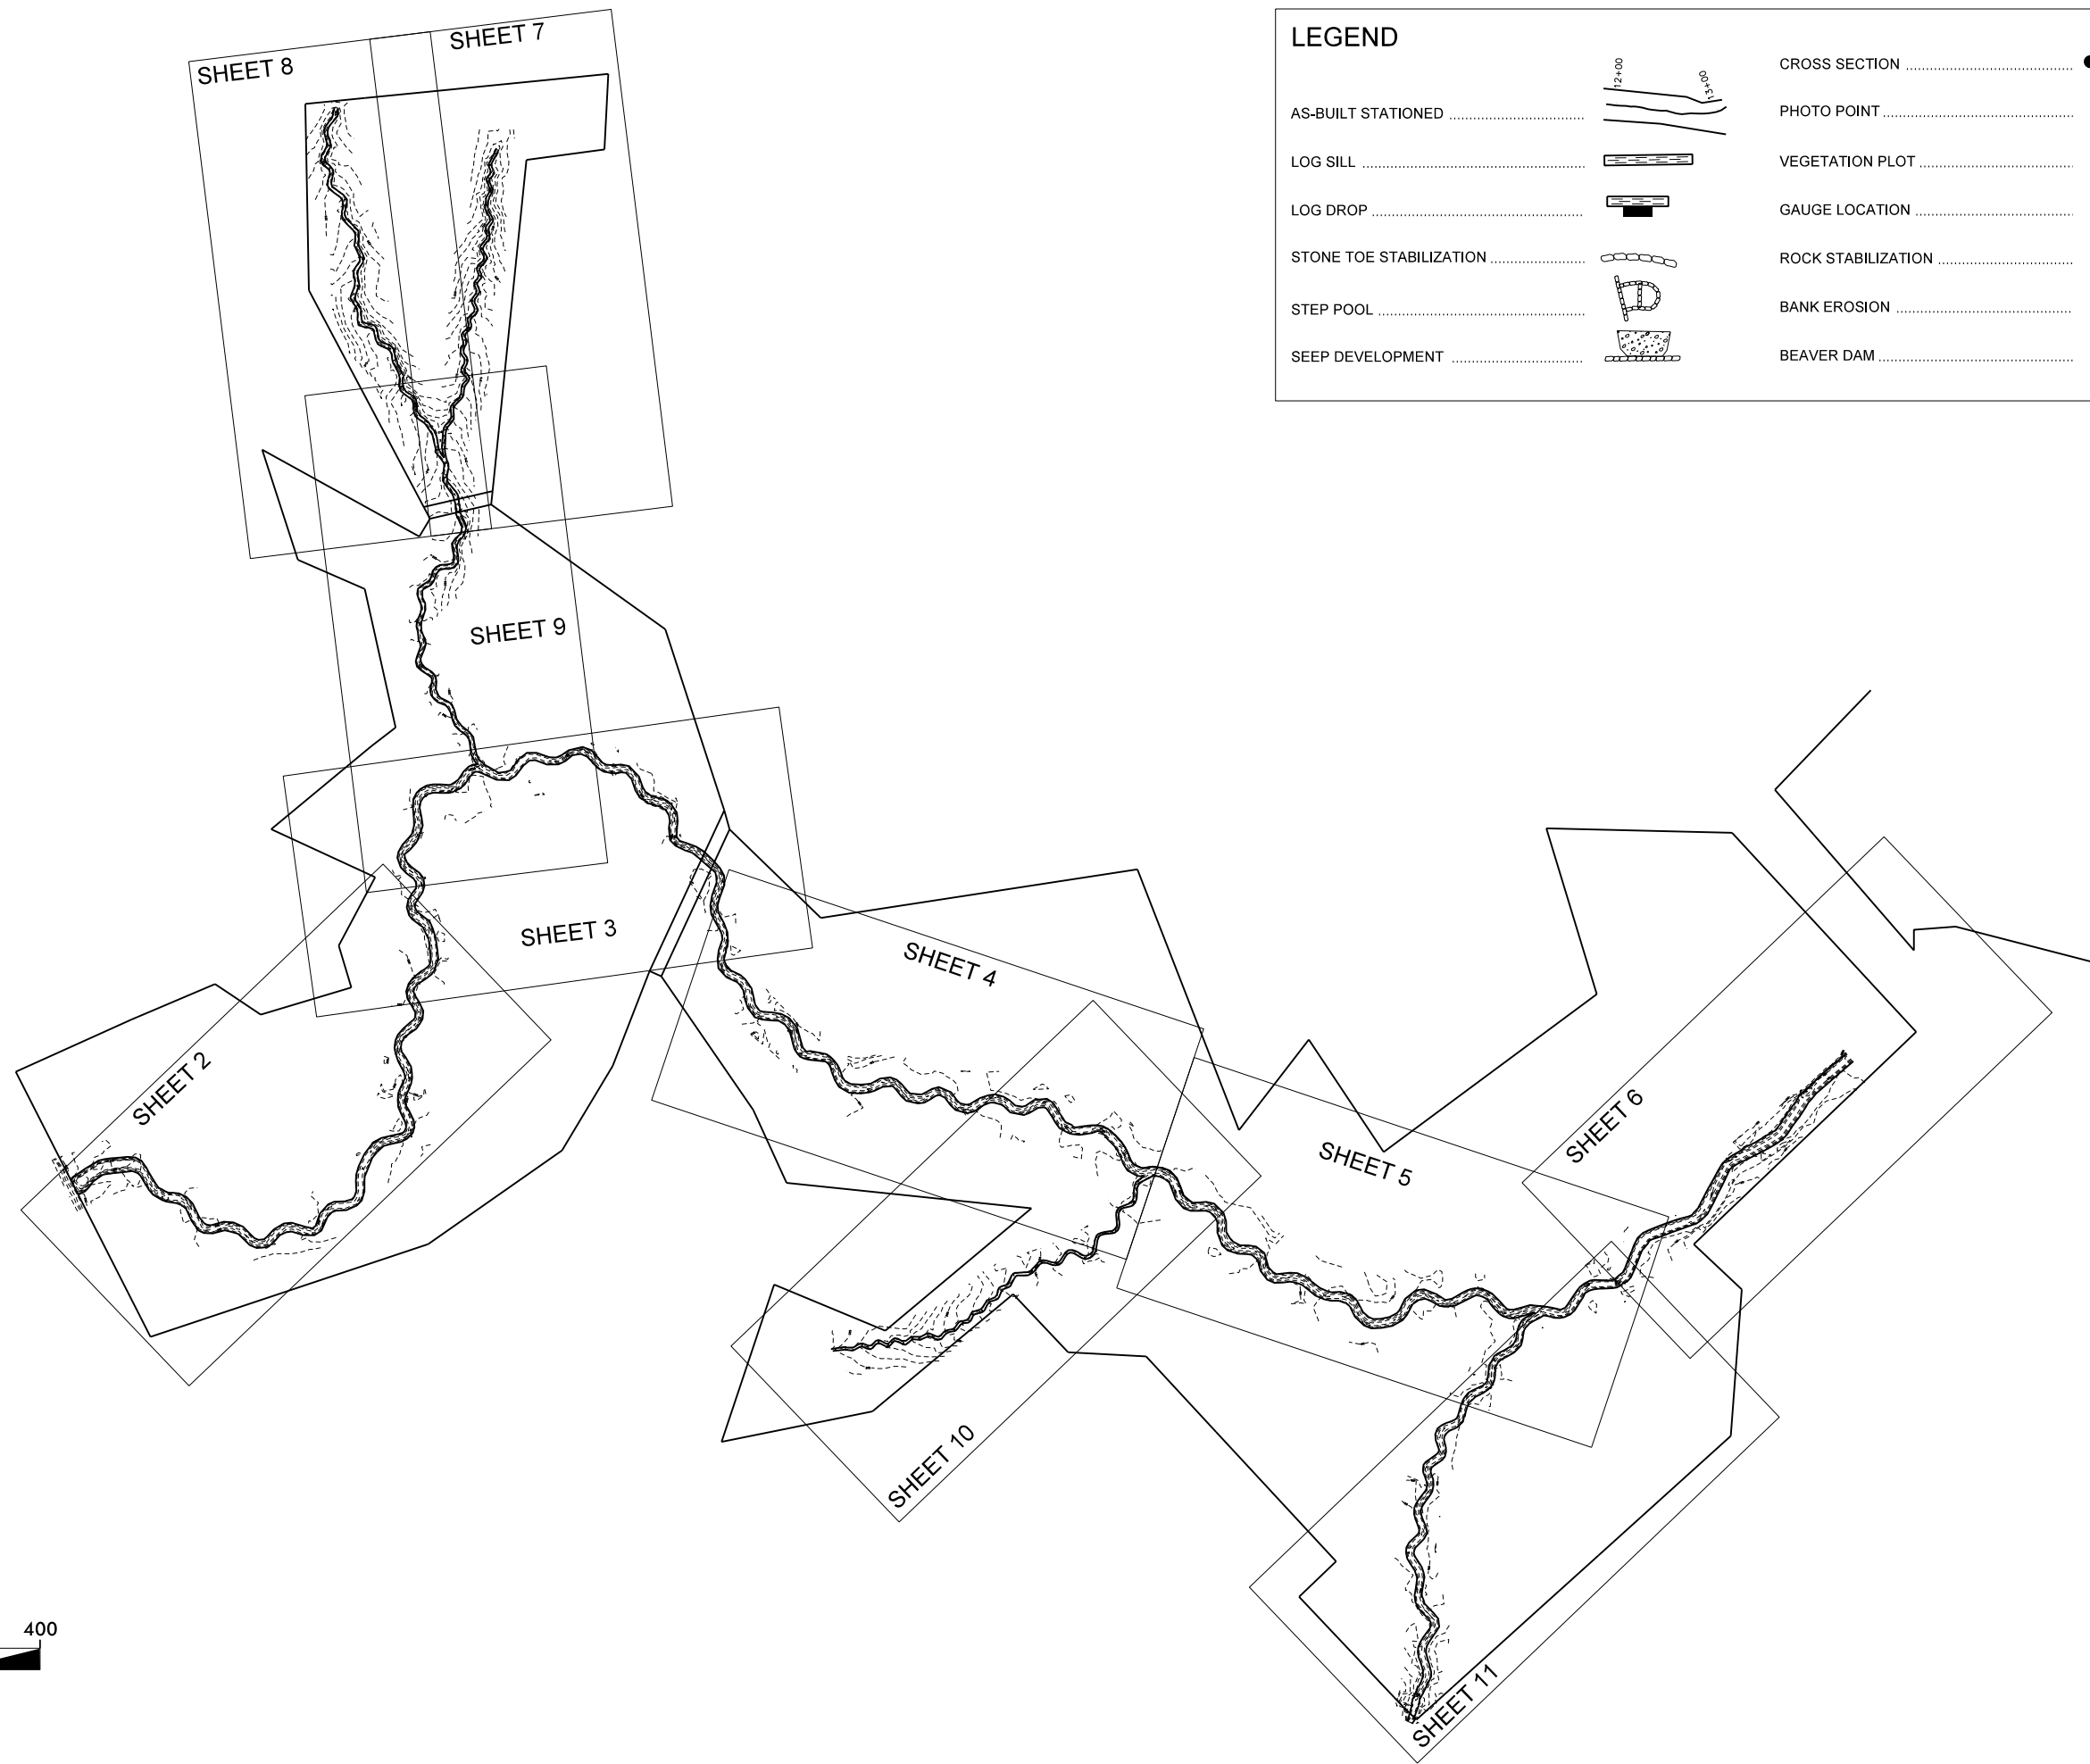
DATE: DEC 2011
SCALE: 1"=400'
CURRENT CONDITION PLAN VIEW
SHEET 1 OF 11

Current Condition Plan View

The vegetative monitoring results are displayed in Appendix A, and the Current Condition Plan View (CCPV). See Section 4.0 for additional maintenance details concerning invasive control and additional planting.

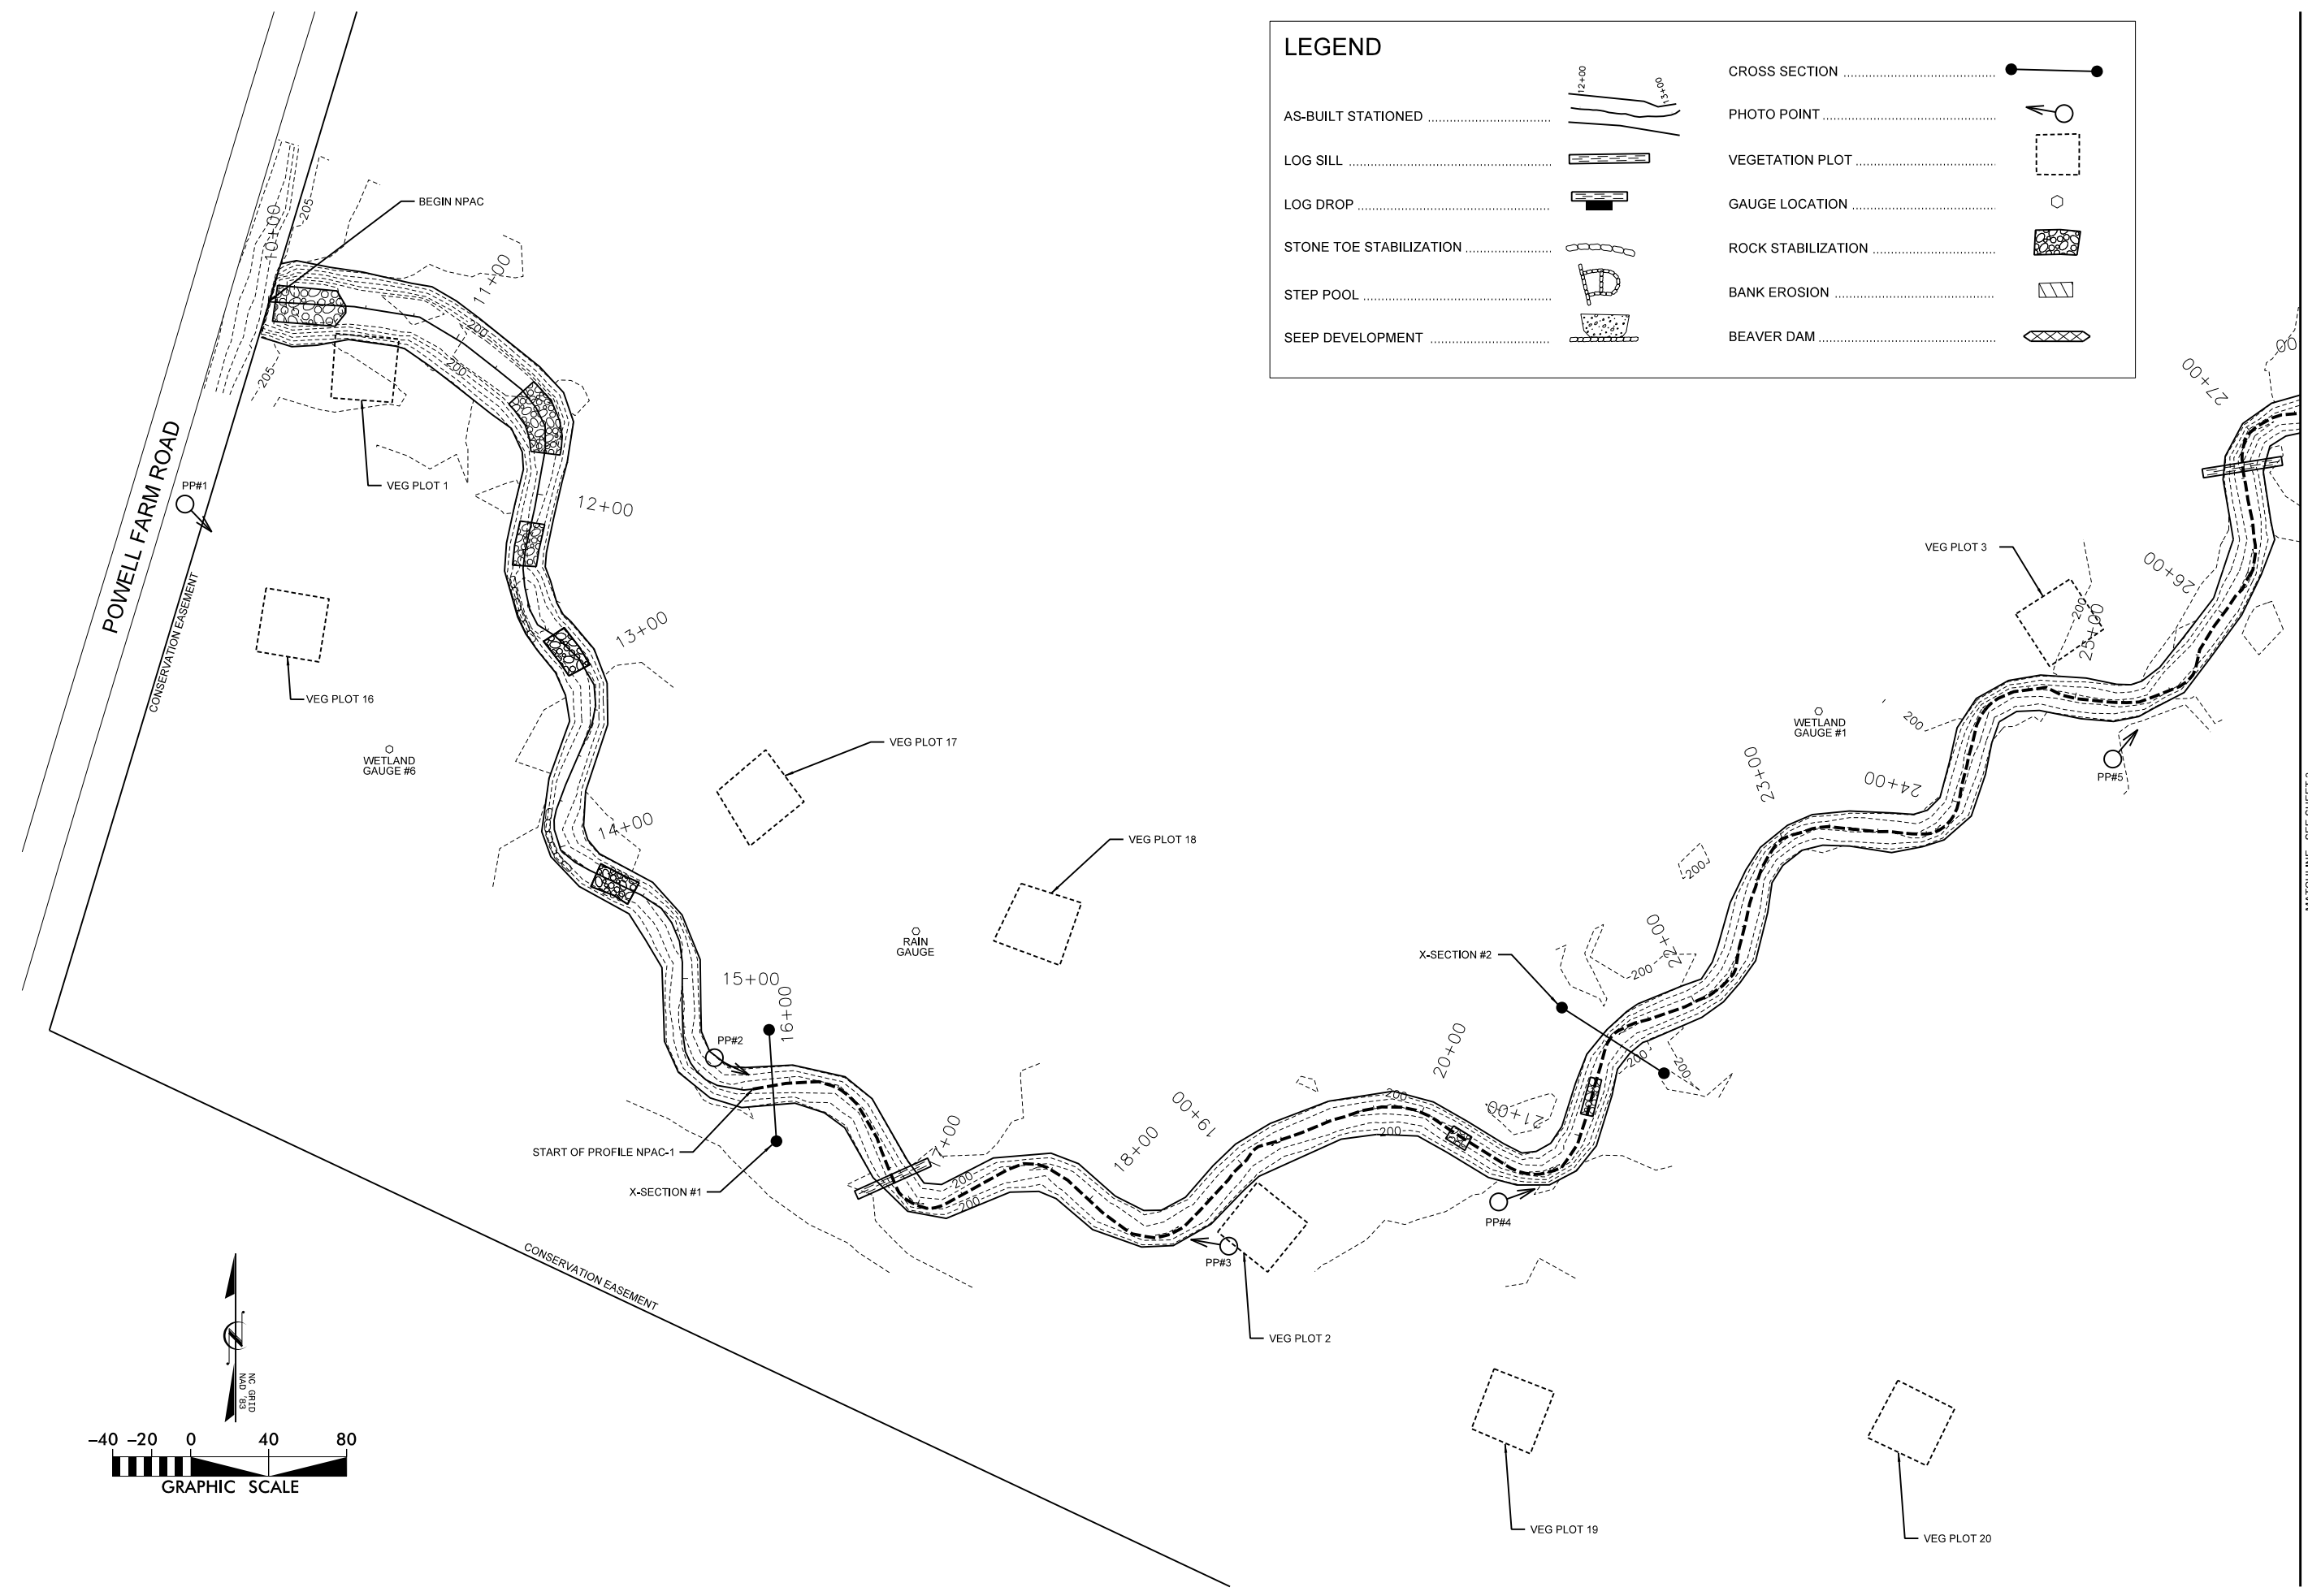
DATE: DEC 2011
 SCALE: 1"=80'
 CURRENT
 CONDITION
 PLAN VIEW
 SHEET 2 OF 11

**FARRAR DAIRY
 STREAM AND WETLAND RESTORATION**
 LILLINGTON, HARNETT COUNTY, NORTH CAROLINA
 NPAC - STATION 10+00 TO STATION 27+17

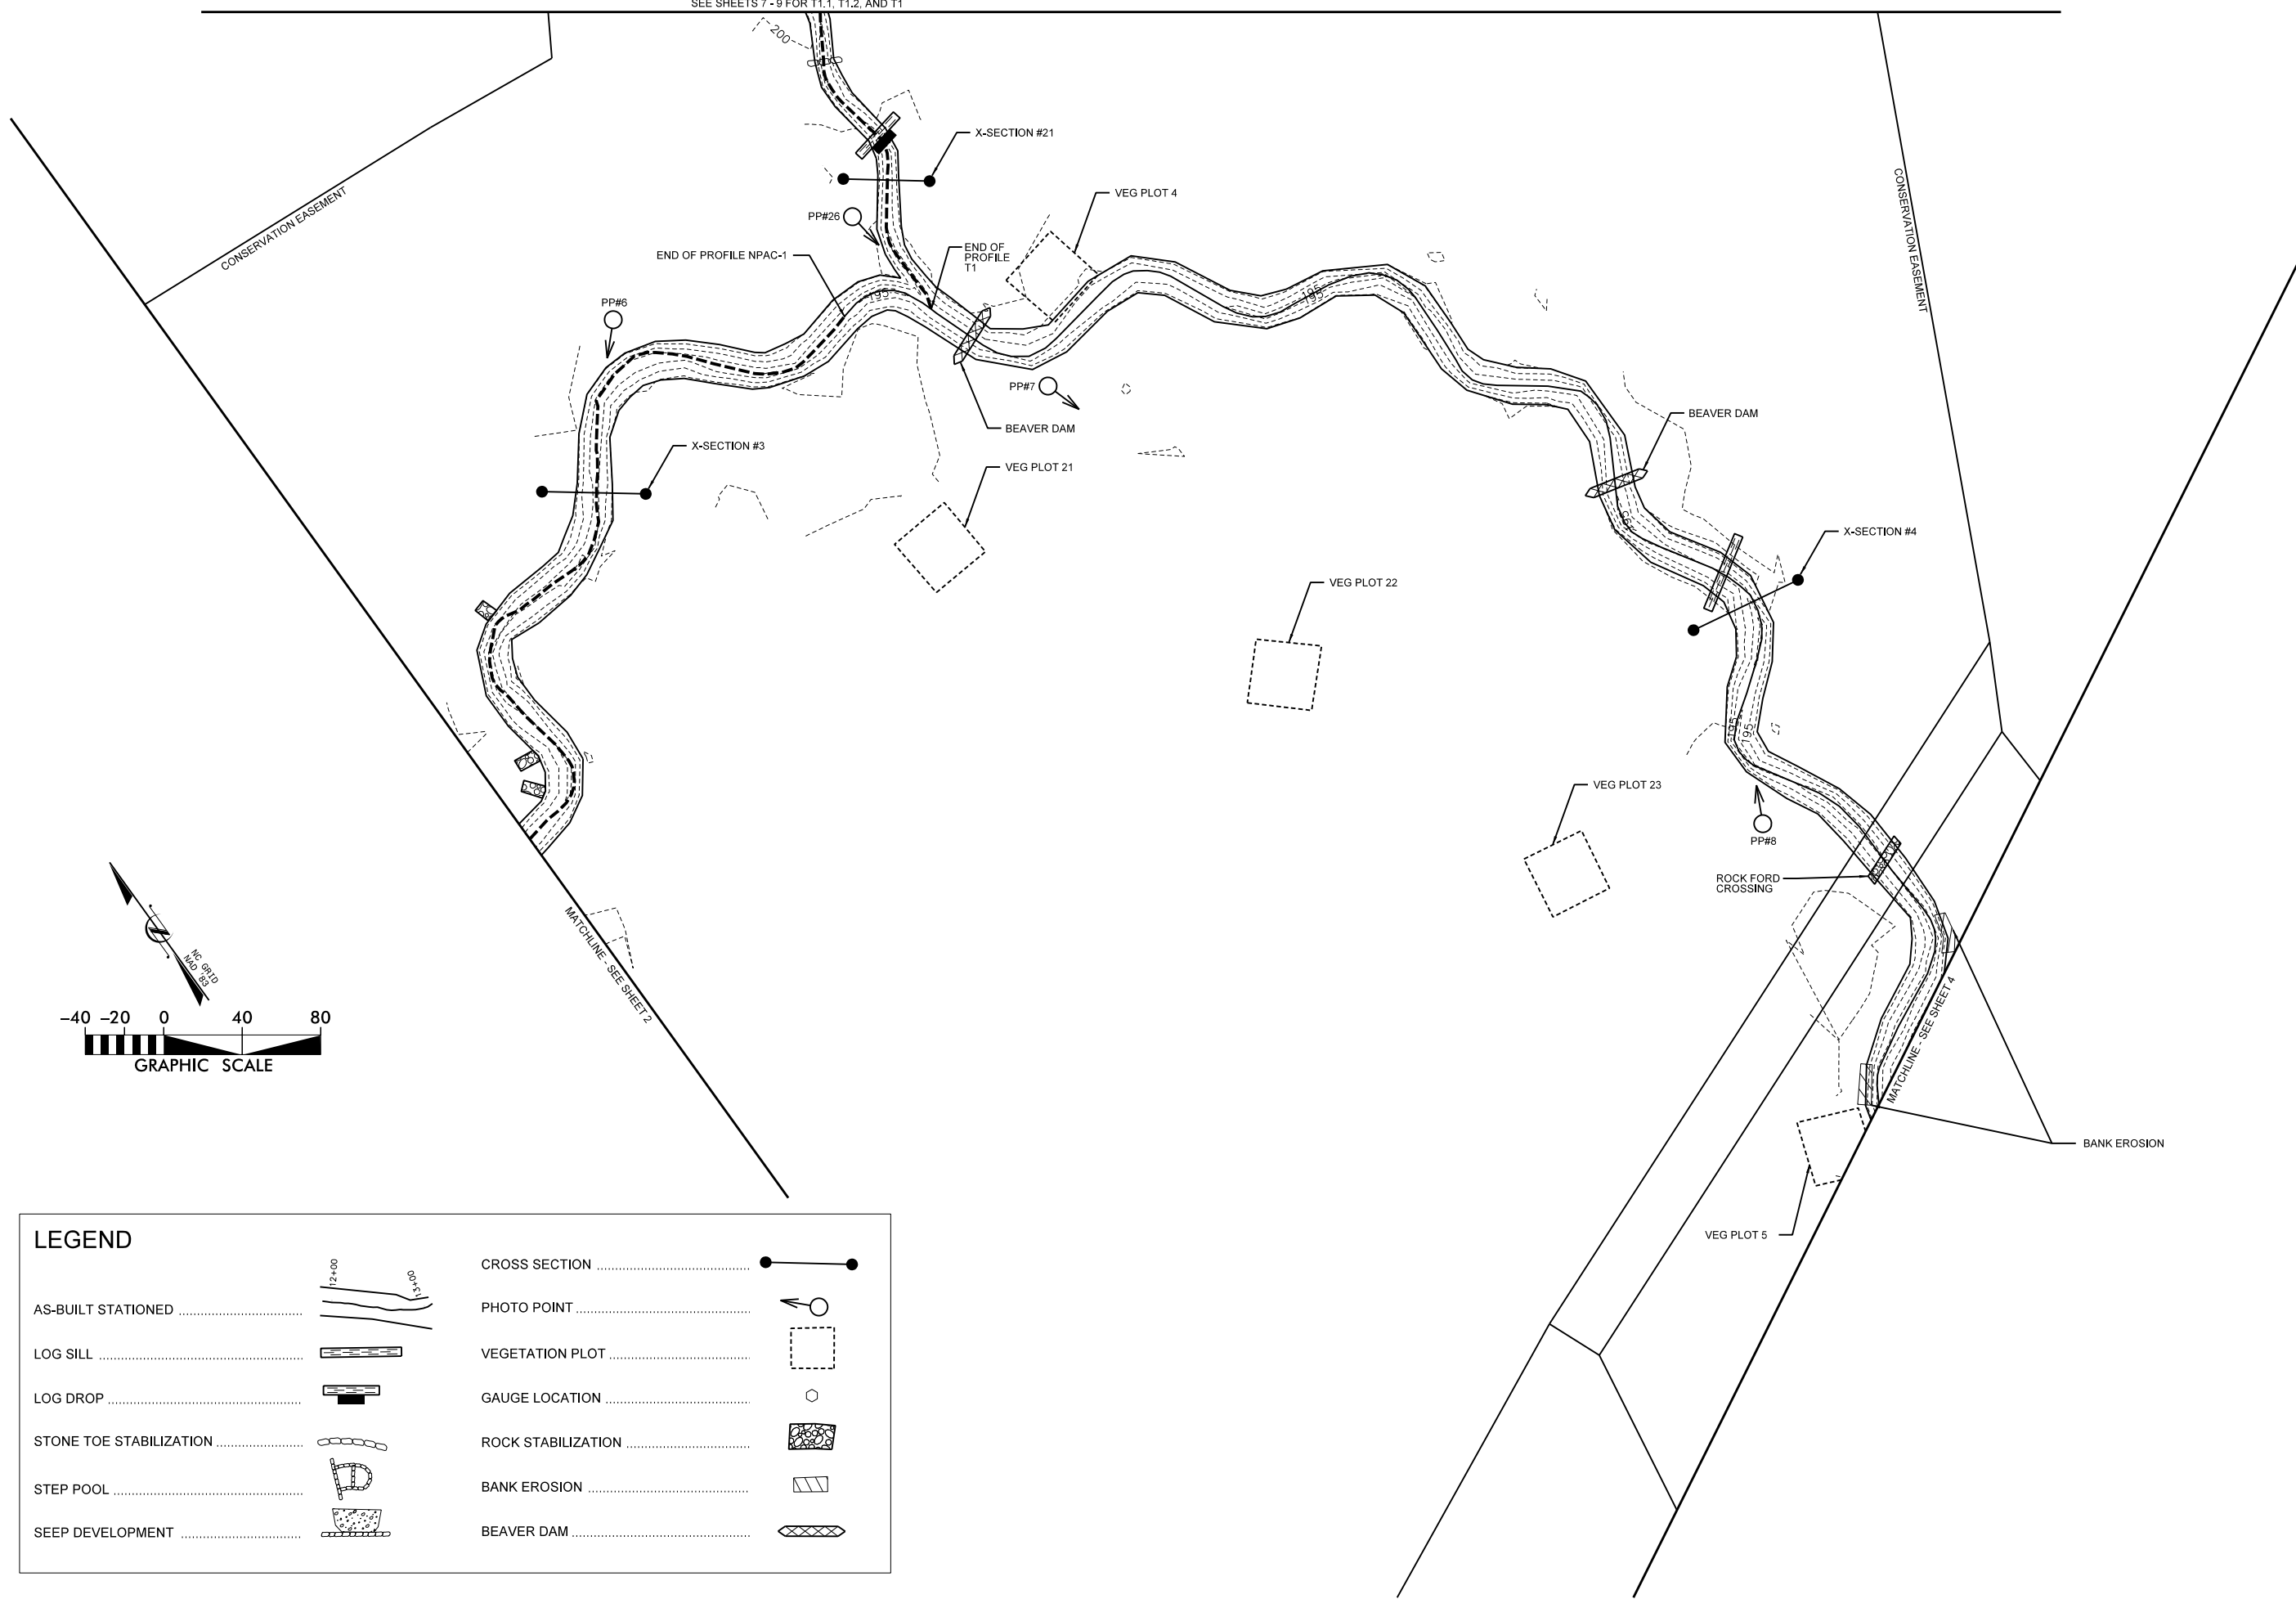
DATE: DEC 2011
SCALE: 1"=80'
CURRENT CONDITION PLAN VIEW
SHEET 3 OF 11

**FARRAR DAIRY
 STREAM AND WETLAND RESTORATION**
 LILLINGTON, HARNETT COUNTY, NORTH CAROLINA
 NPAC - STATION 27+17 TO STATION 40+51

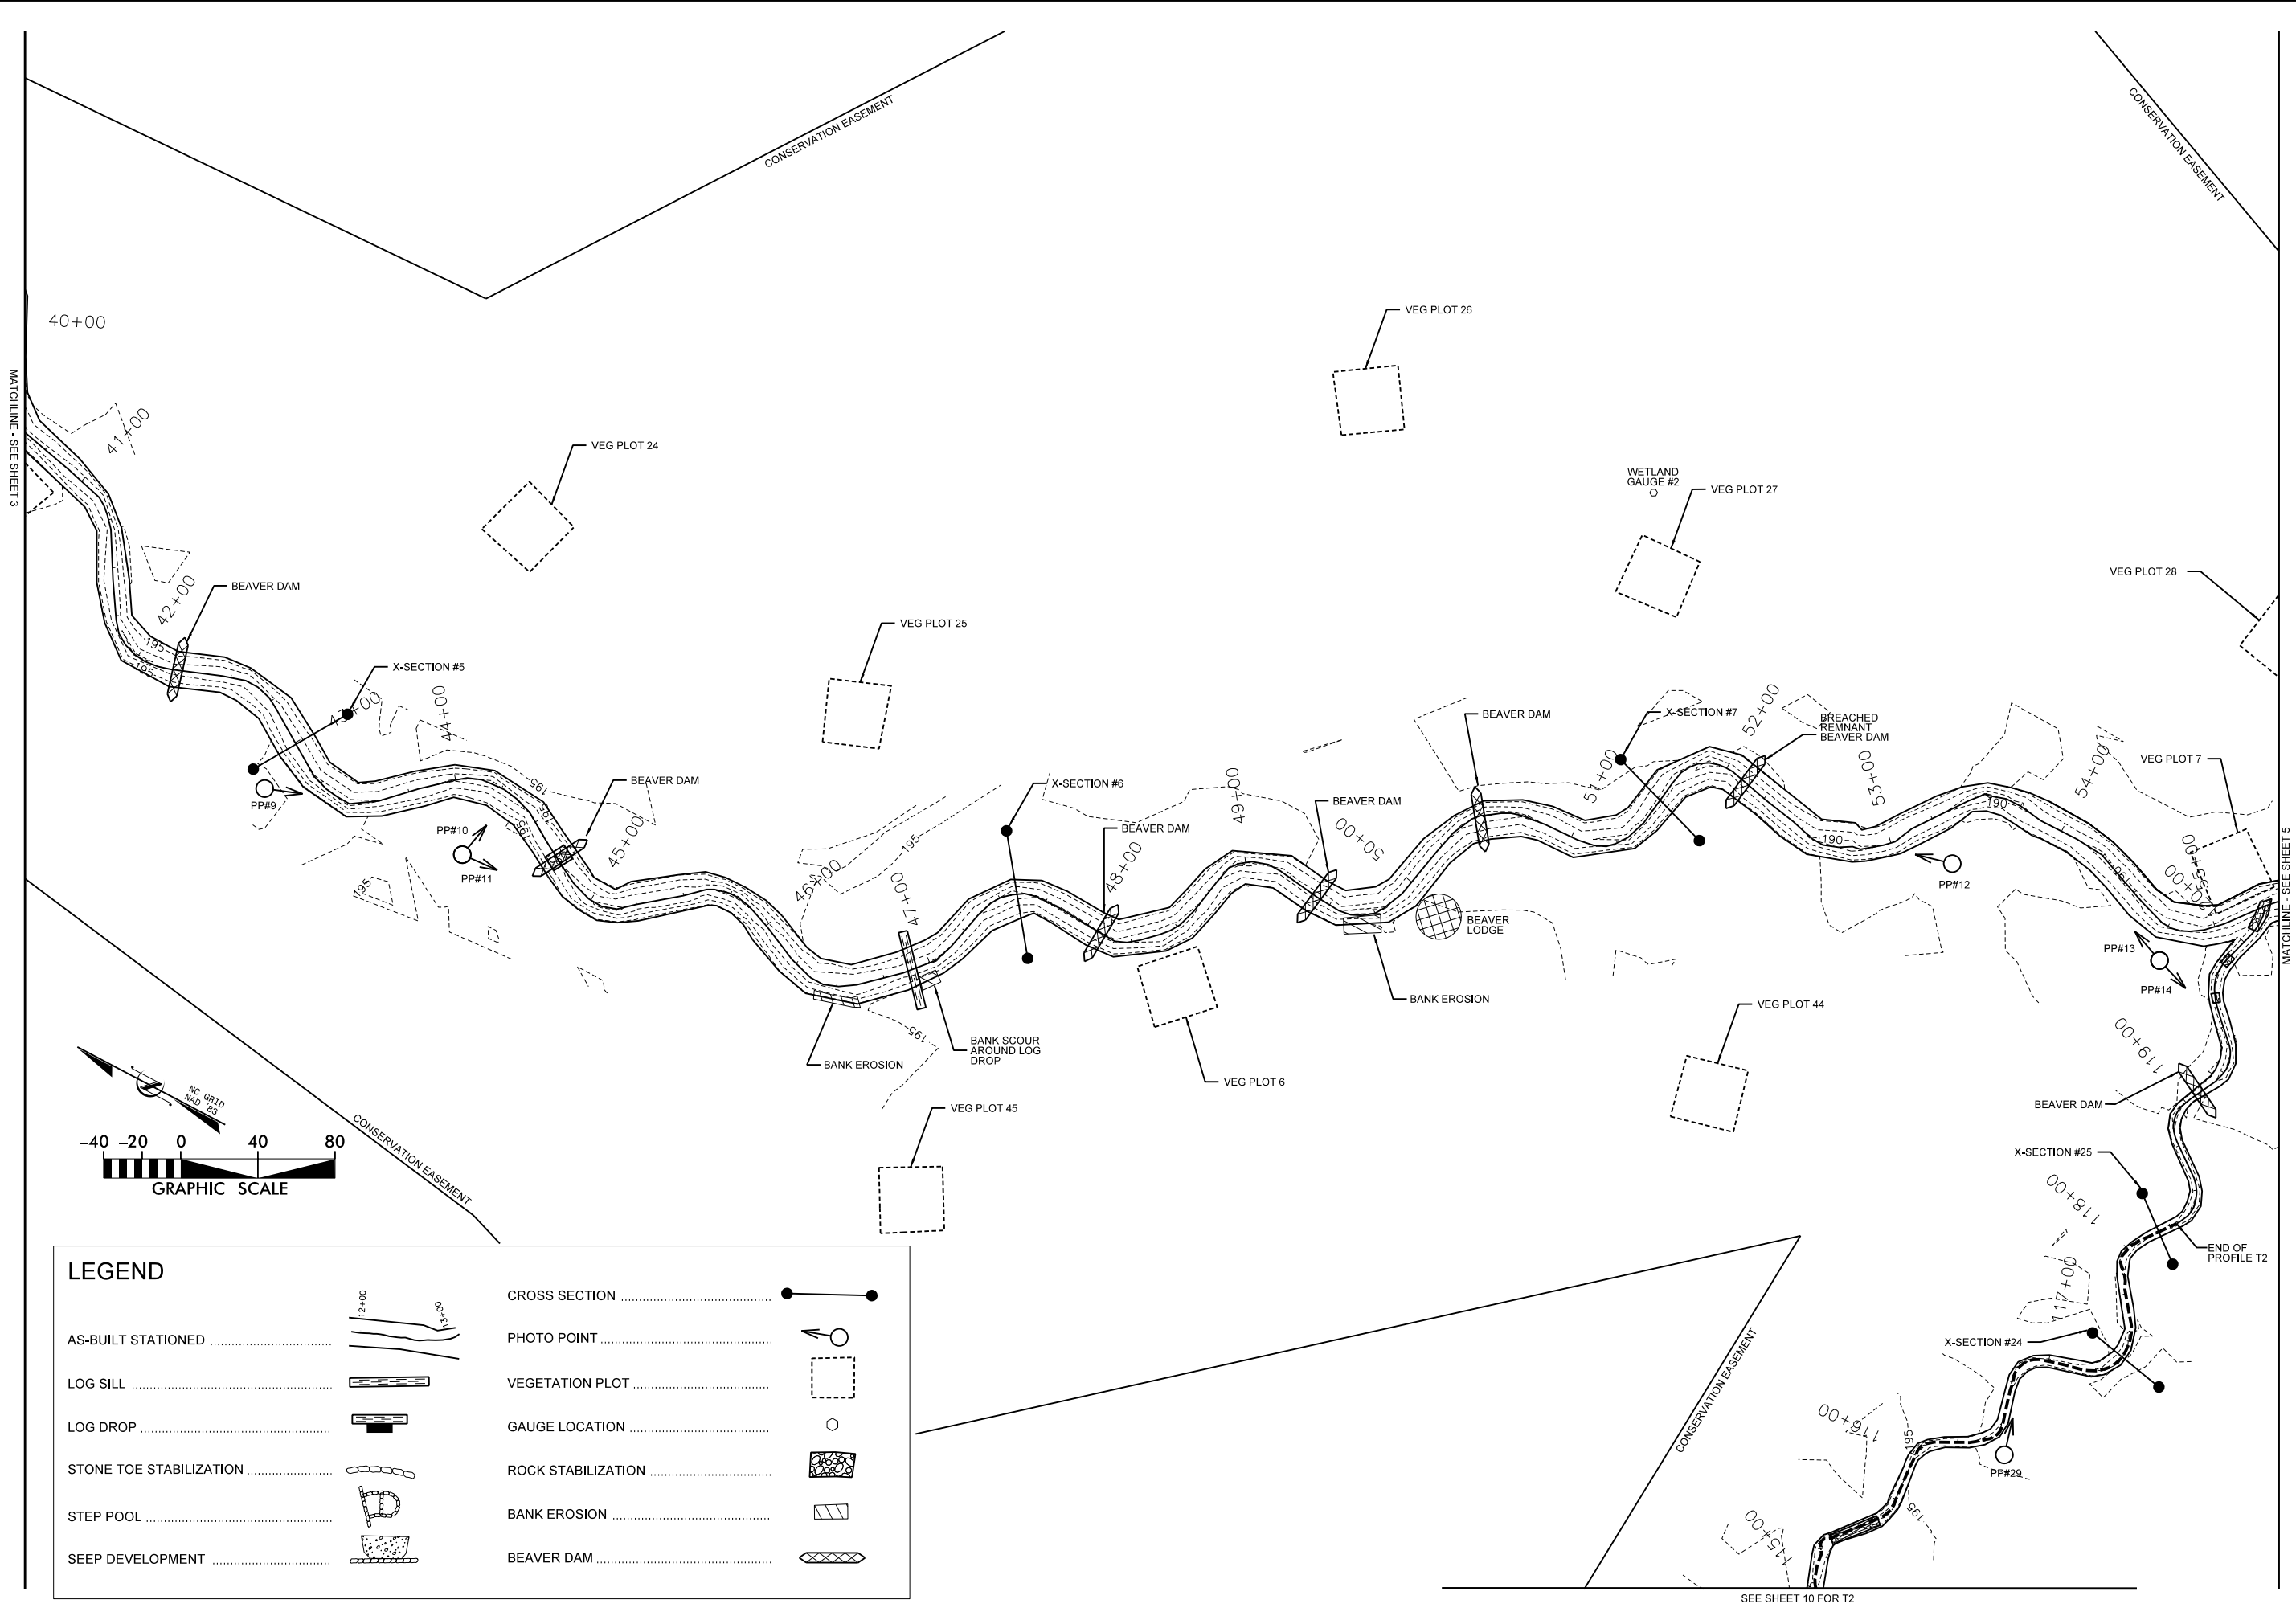
DATE: DEC 2011
 SCALE: 1"=80'
**CURRENT
 CONDITION
 PLAN VIEW**
 SHEET 4 OF 11

**FARRAR DAIRY
 STREAM AND WETLAND RESTORATION**
 LILLINGTON, HARNETT COUNTY, NORTH CAROLINA
 NPAC - STATION 40+51 TO STATION 55+39

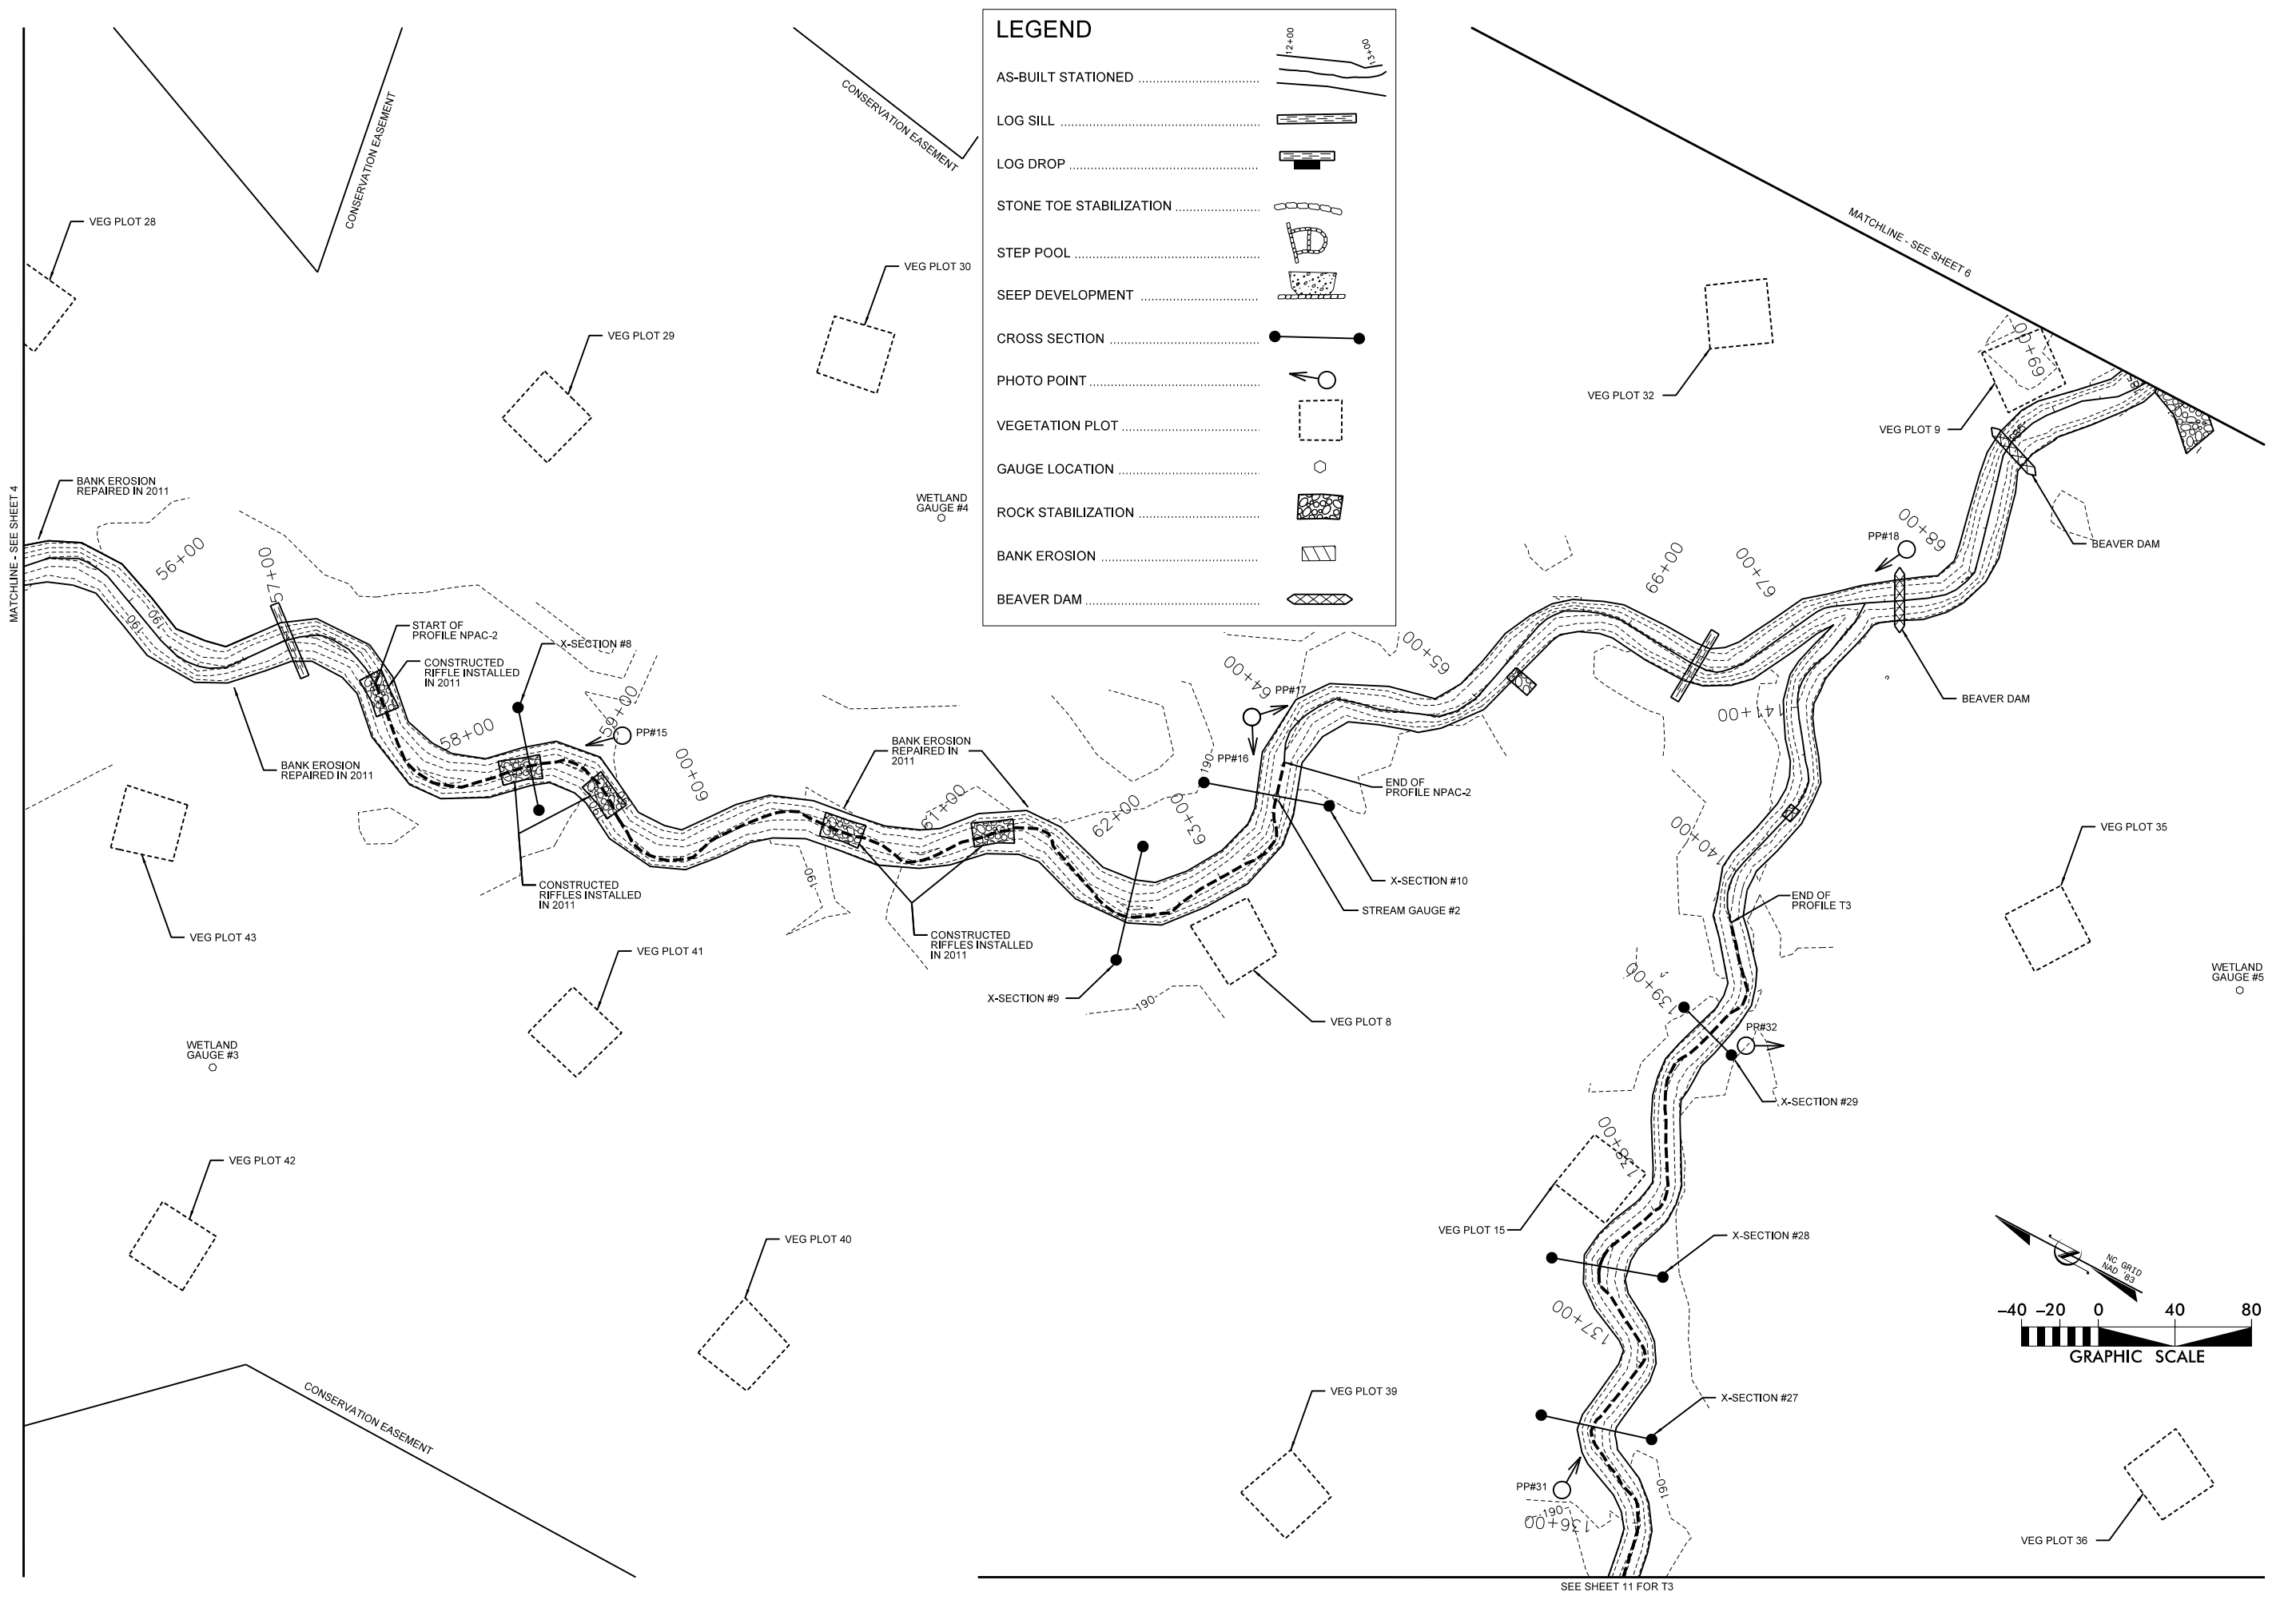
DATE: DEC 2011
 SCALE: 1"=80'
**CURRENT
 CONDITION
 PLAN VIEW**
 SHEET 5 OF 11

**FARRAR DAIRY
 STREAM AND WETLAND RESTORATION**
 LILLINGTON, HARNETT COUNTY, NORTH CAROLINA
 NPAC - STATION 55+39 TO STATION 69+51

Stream and vegetation maintenance actions were completed in 2011. The stream maintenance addressed areas of bed degradation and bank erosion as discussed in the Monitoring Year 2 report. Constructed riffles were installed at Stations 57+58, 58+47, 59+13, 59+84, and 60+50 and bank grading and matting installation occurred at Stations 55+30, 56+80, 60+60, and 61+60. These maintenance areas have exhibited stability throughout the growing season. The bank repairs have not shown any signs of erosion, and the constructed riffles are functioning, with native material washing into the riffle and a stable riffle slope.

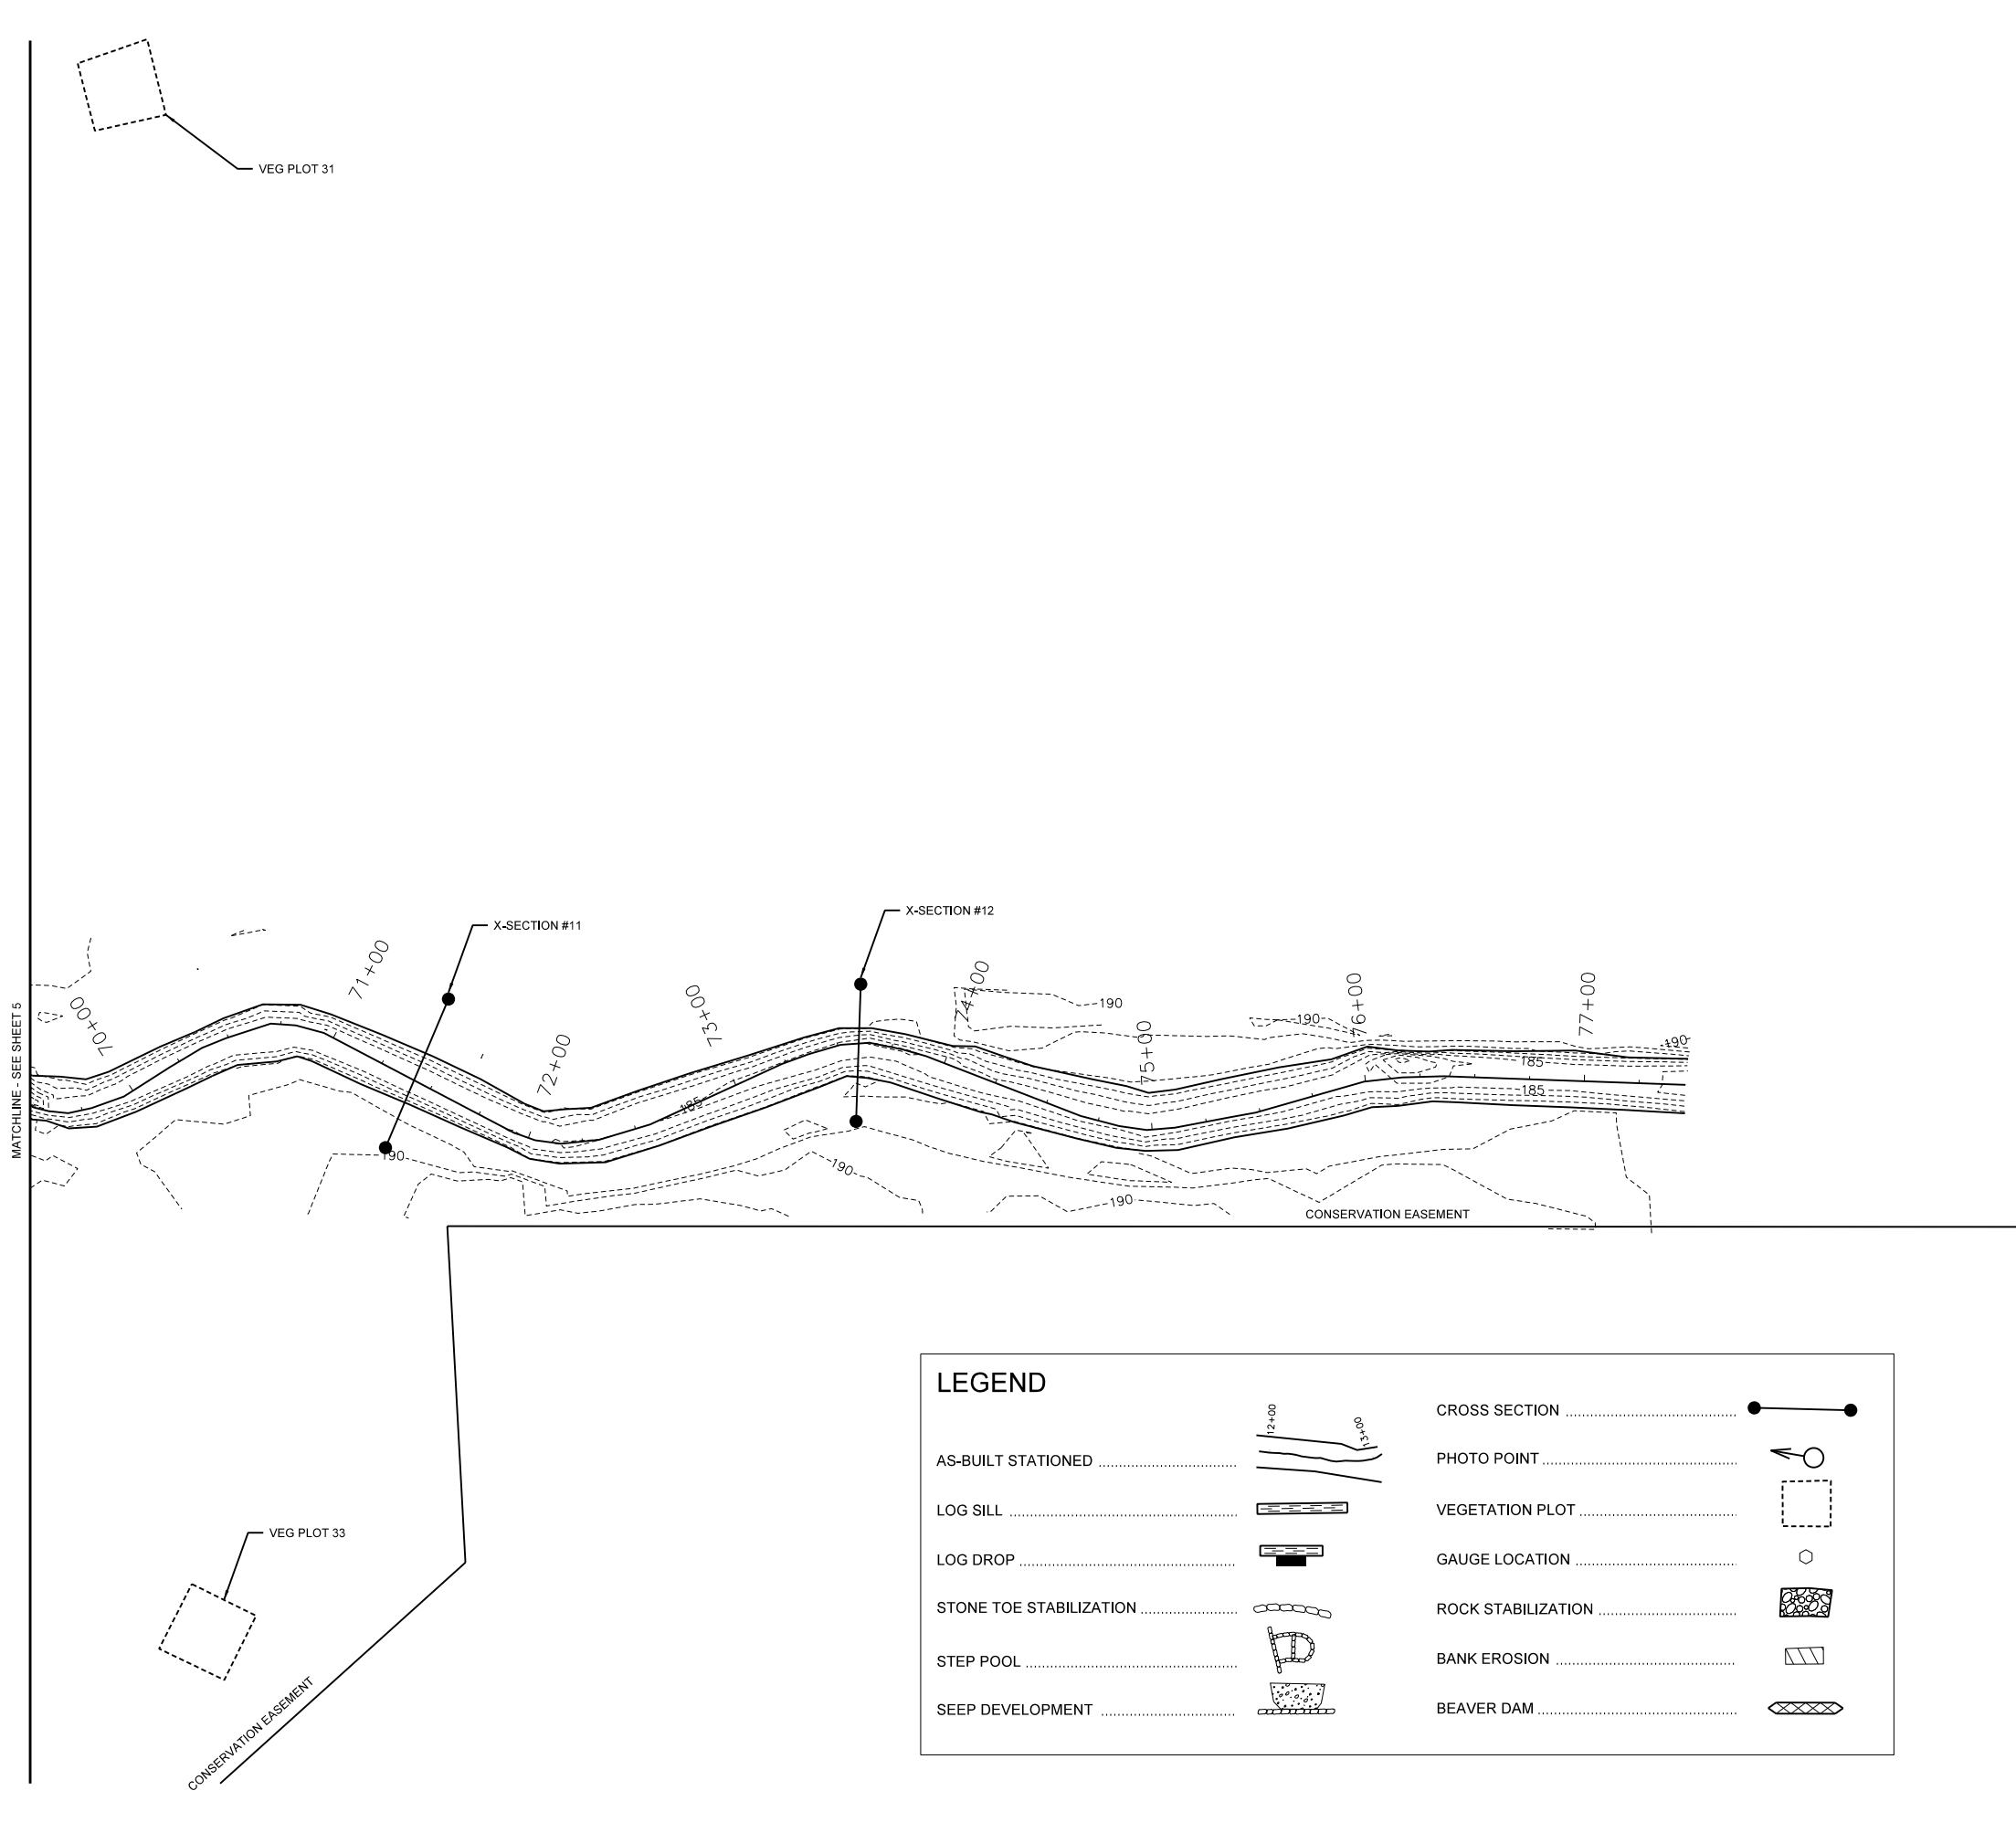
Ecosystem Enhancement PROGRAM																								
FARRAR DAIRY STREAM AND WETLAND RESTORATION LILLINGTON, HARNETT COUNTY, NORTH CAROLINA NPAC - STATION 69+51 TO STATION 77+46	REVISIONS
