**Farrar Dairy Stream and Wetland Restoration Site
Monitoring Report – MY03
Harnett County, NC**

December 2011

**Project Manager: Tim Morris
Email: tim.morris@kci.com
KCI Project No: 12065438**

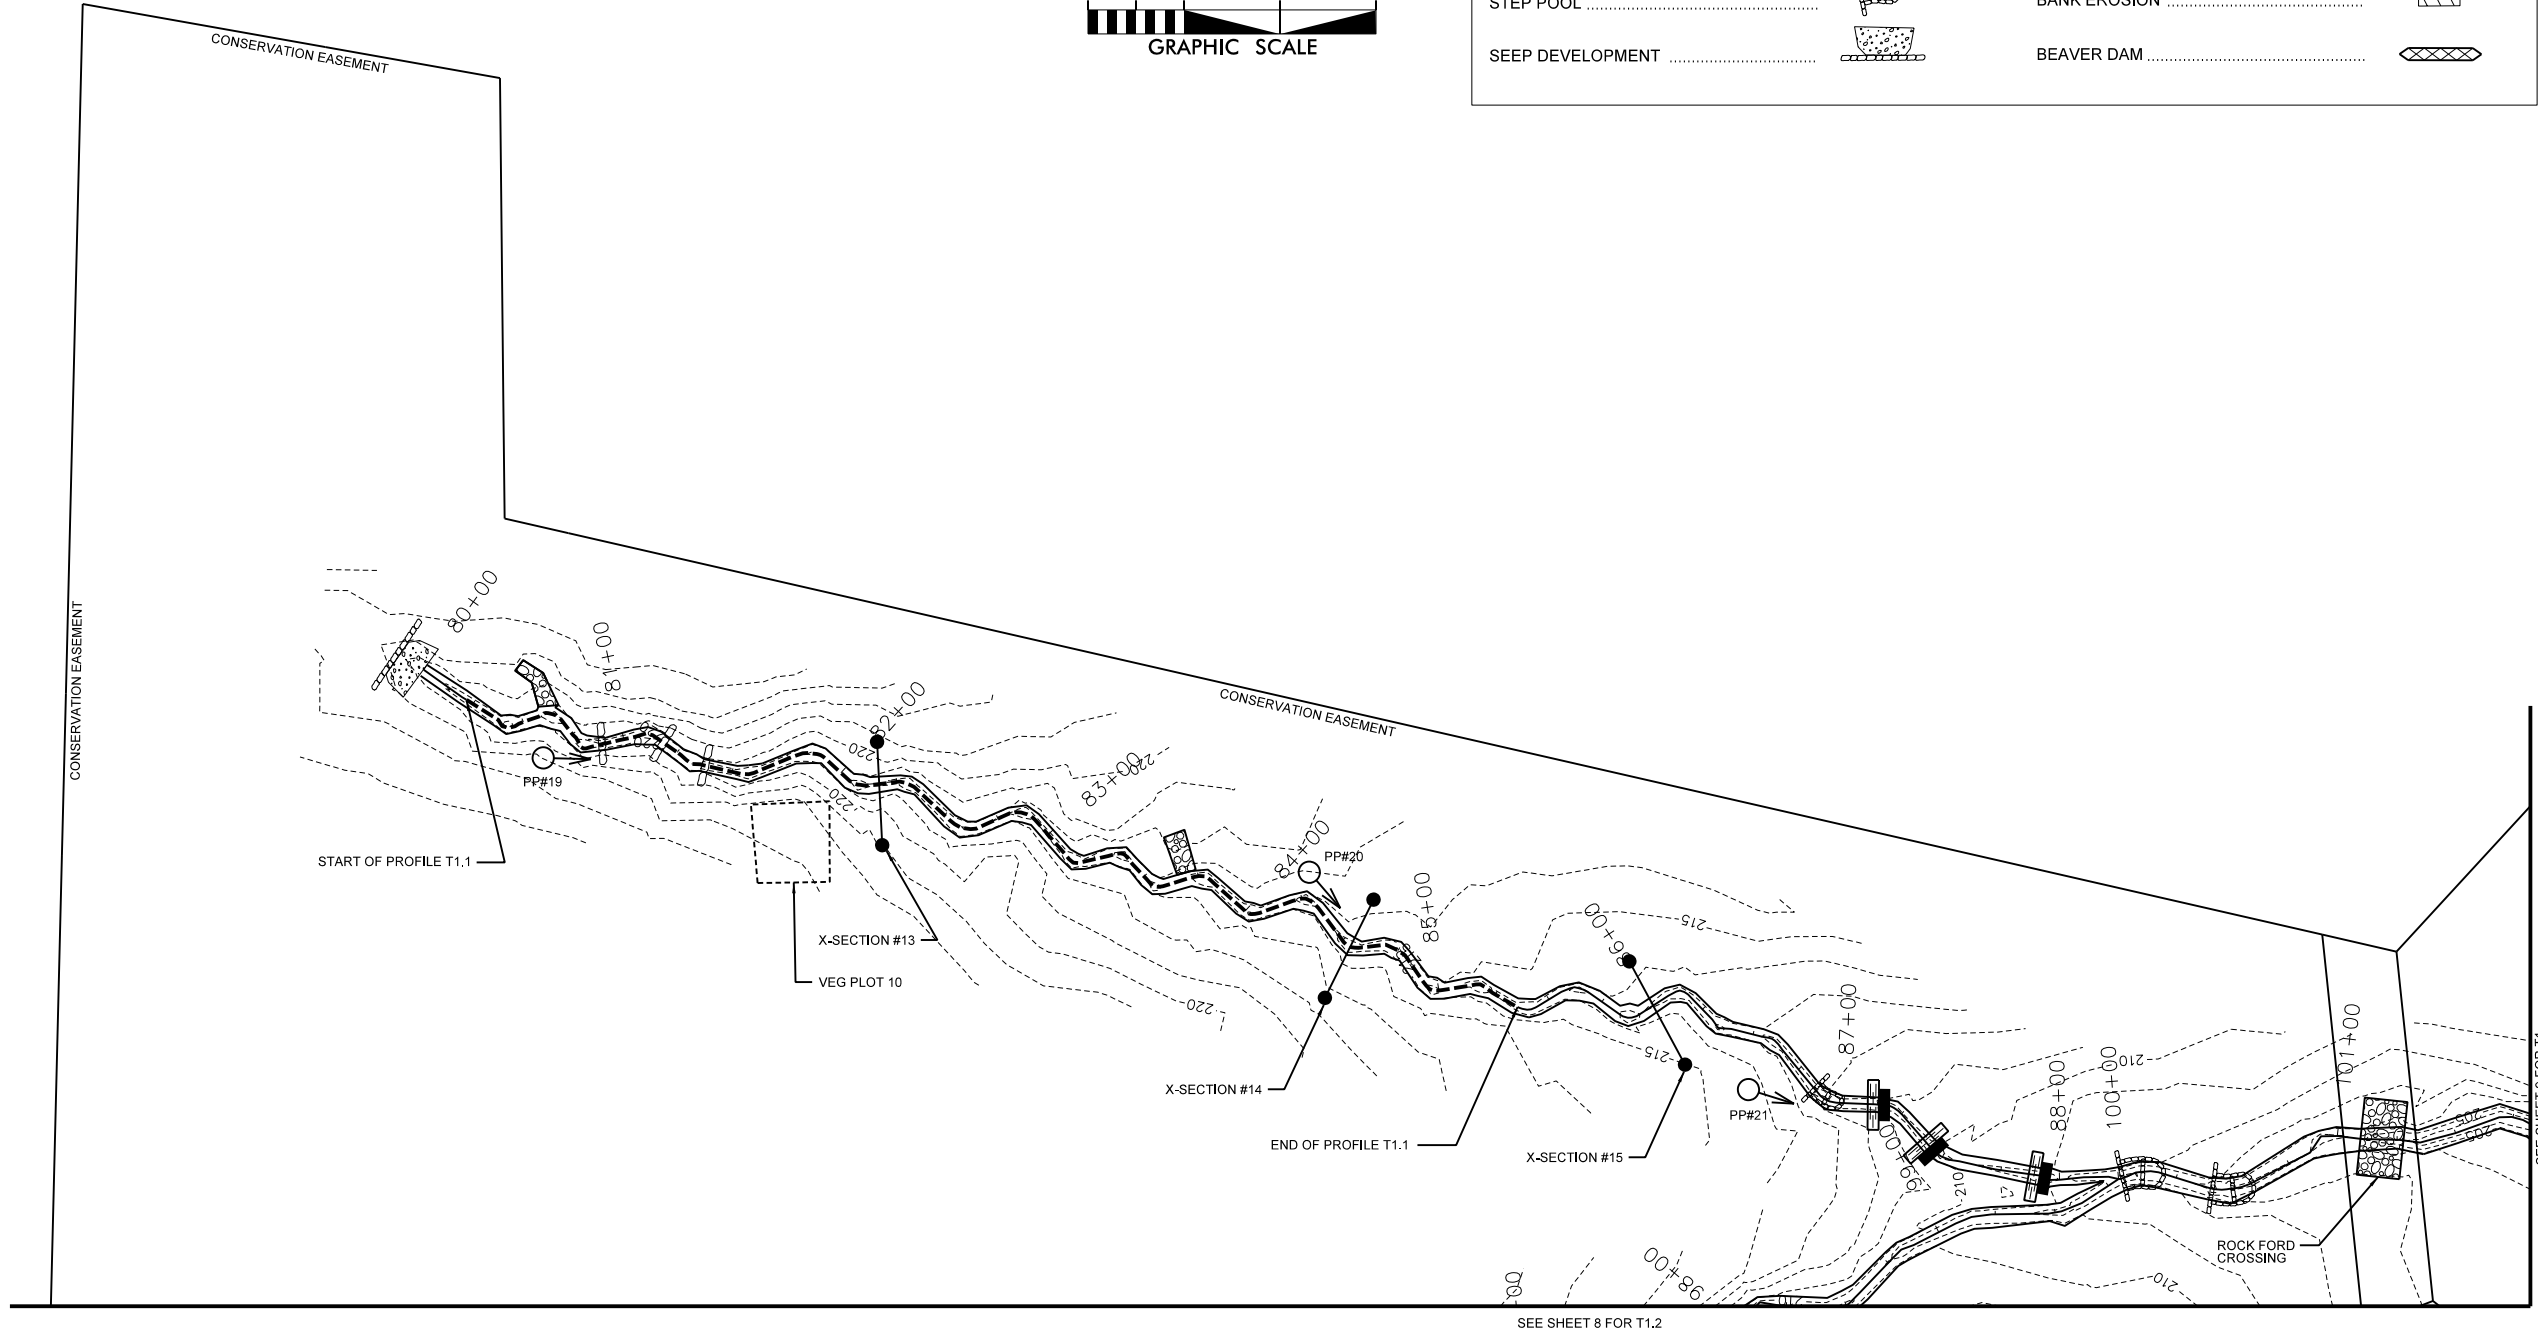
DATE: DEC 2011
 SCALE: 1"=80'
 CURRENT
 CONDITION
 PLAN VIEW
 SHEET 7 OF 11

**FARRAR DAIRY
 STREAM AND WETLAND RESTORATION**
 LILLINGTON, HARNETT COUNTY, NORTH CAROLINA
 T1.1 - STATION 80+00 TO STATION 88+25

The stream assessment found the project streams to be stable. T1.1 and T1 had experienced isolated bed degradation during the first year of monitoring, but no further migration has been shown since. The additional log sills installed in 2010 in T1 are intact and holding grade. During the third-year site assessment a few of these structures were found to be piping. This is not seen as problematic due to the low flow during the assessment and the short duration that the structures, have been in place. With additional vegetation growing around the channel and the accumulation of fine materials in the pore space of the structures the piping should eventually stop. On NPAC, there are isolated areas of bank erosion, which are depicted in the CCPV. All of these stream features will continue to be monitored to make sure that any observed changes are within the range of variability found in stable stream systems.

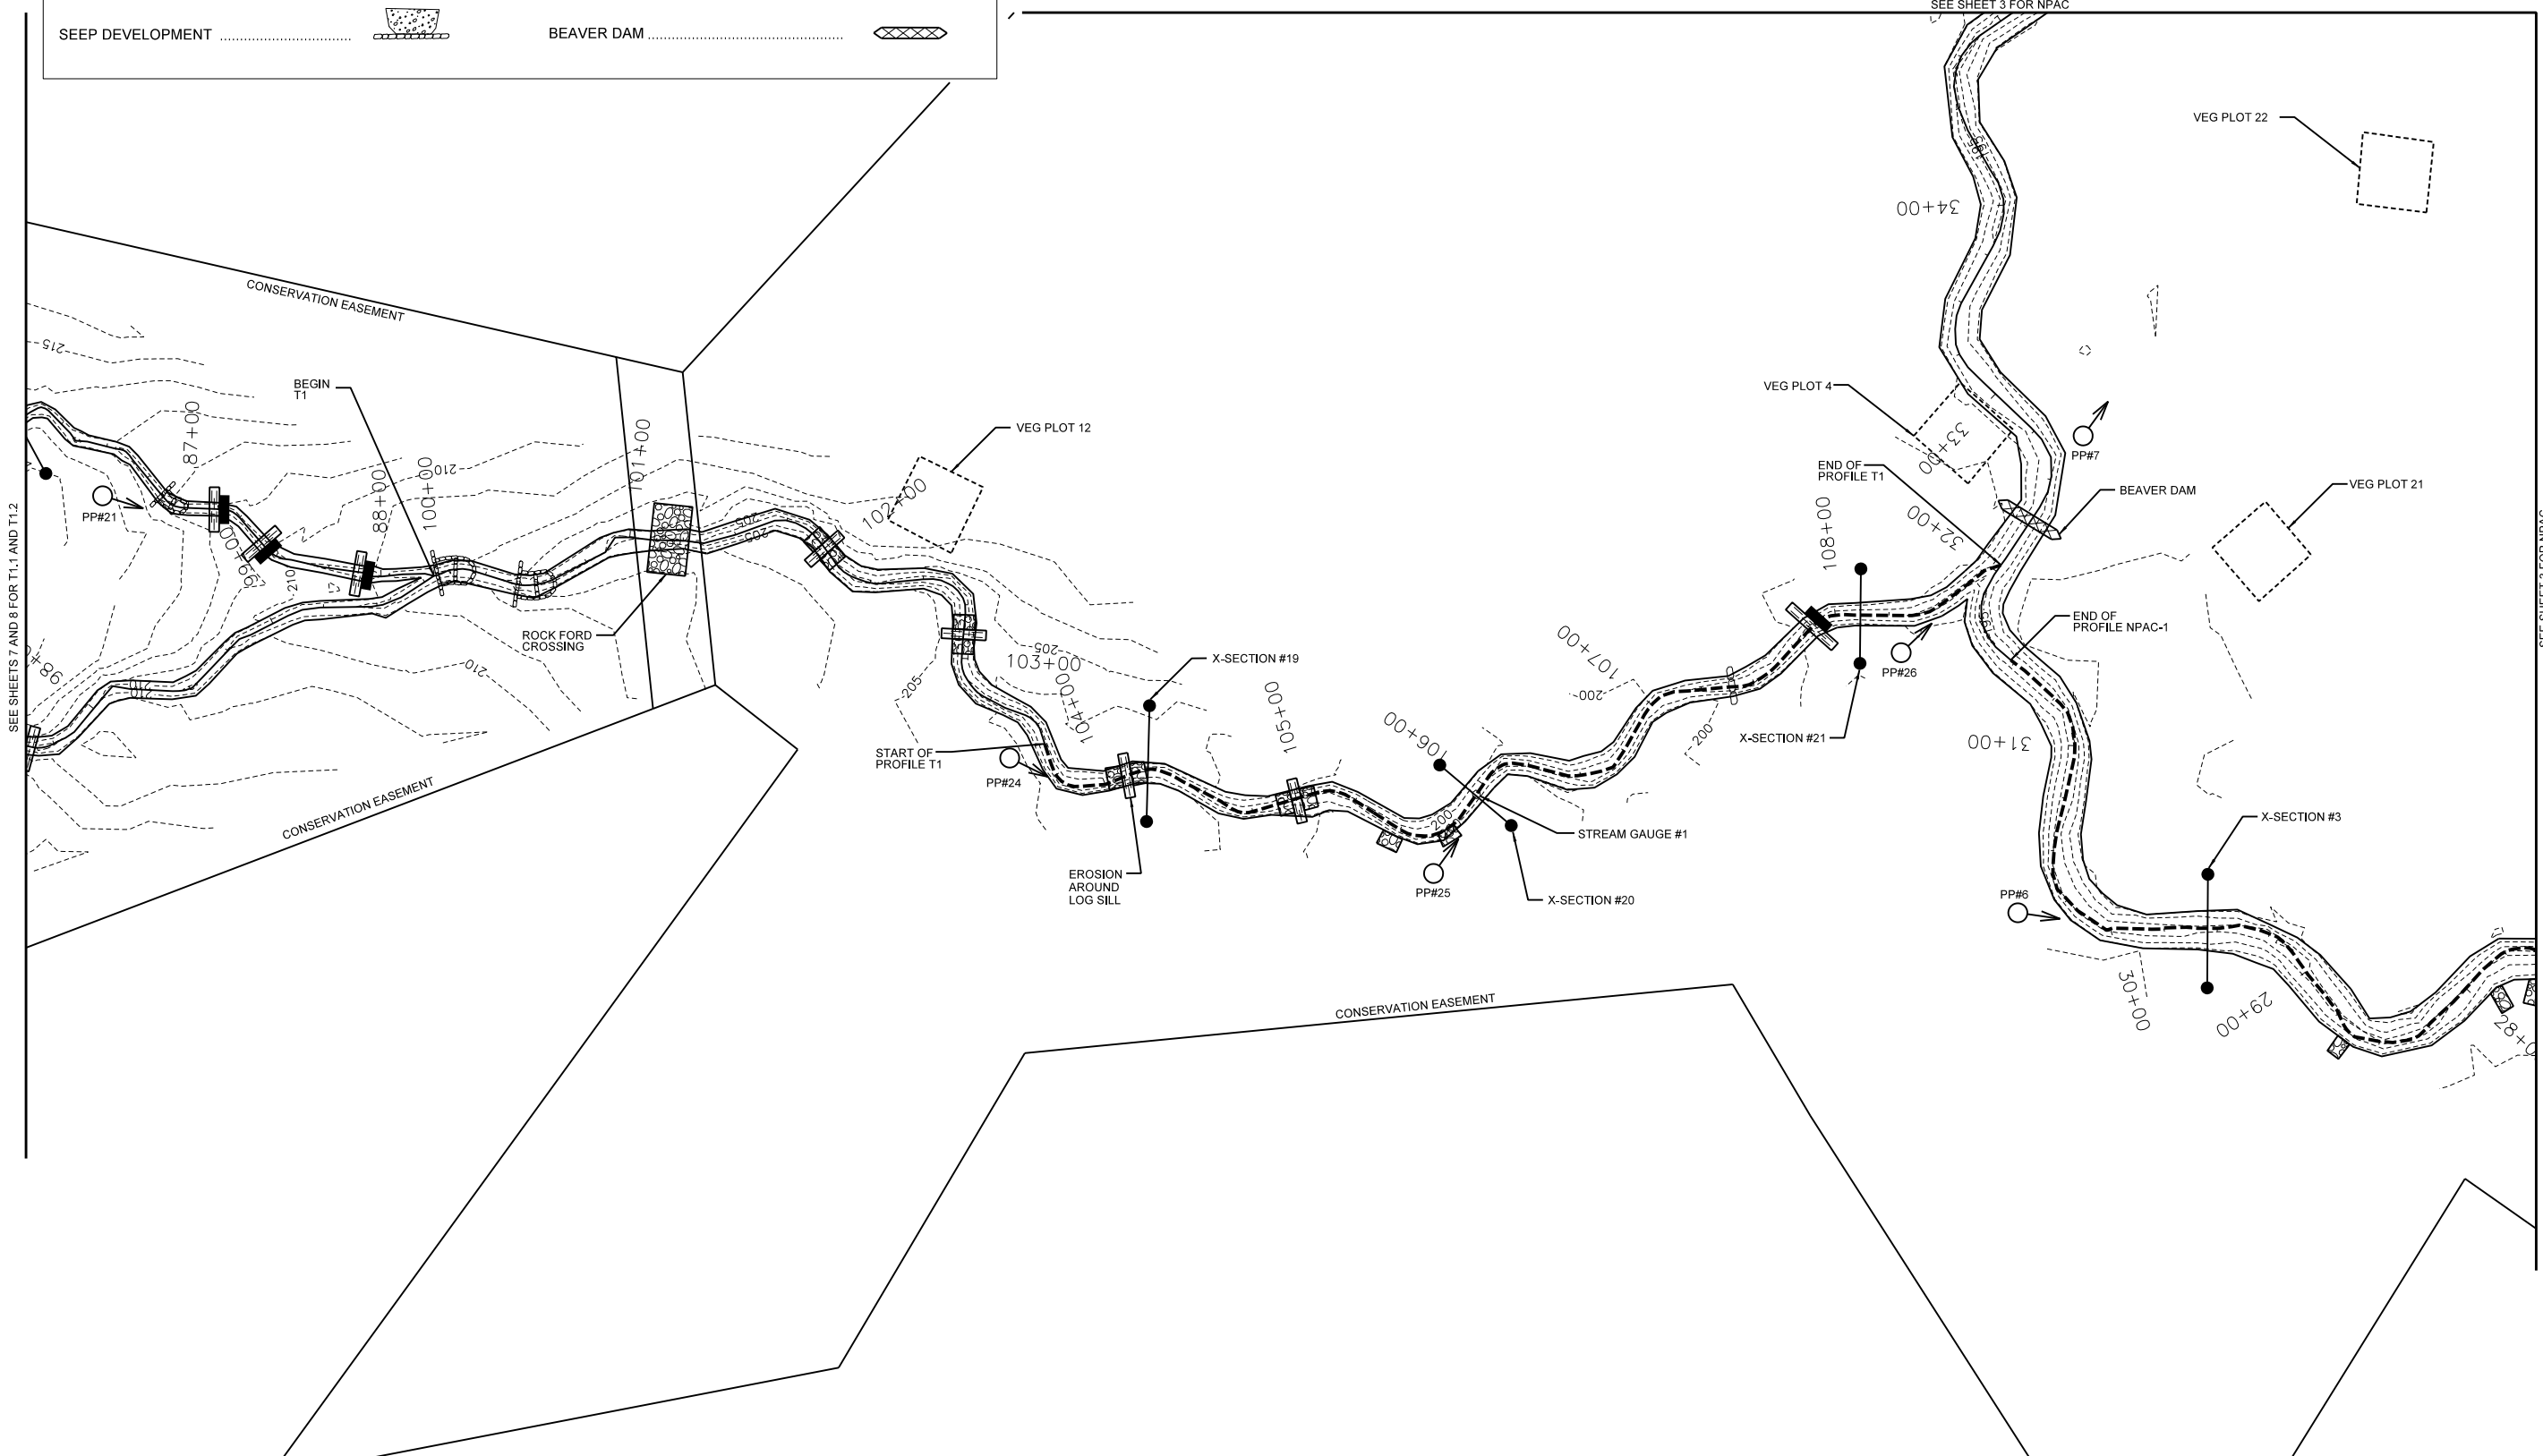
DATE: DEC 2011
 SCALE: 1"=80'
 CURRENT
 CONDITION
 PLAN VIEW
 SHEET 9 OF 11

**FARRAR DAIRY
 STREAM AND WETLAND RESTORATION**
 LILLINGTON, HARNETT COUNTY, NORTH CAROLINA
 T1 - STATION 100+00 TO STATION 108+84
