**Farrar Dairy Stream and Wetland Restoration Site
Monitoring Report – MY04
Harnett County, NC
EEP Project # 92552
EEP Contract # D06002**

January 2013

**Landmark Center II, Suite 220
4601 Six Forks Road
Raleigh, NC 27609
Phone: (919) 278-2512
Fax: (919) 783-9266**

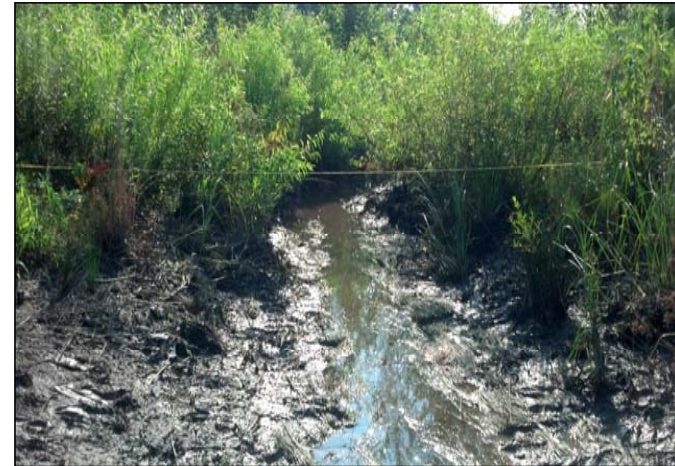
River Basin:	Cape Fear
Watershed:	Farrar Dairy
XS ID	XS-1, Riffle, NPAC-1
Drainage Area (sq mi):	3.92
Date:	7/26/2012
Field Crew:	A. French, M. Koss

Station	Elevation
0.0	201.55
0.2	201.40
4.9	201.69
8.8	201.47
12.7	201.30
16.8	201.33
18.9	201.32
20.3	200.86
21.8	200.24
23.1	199.97
24.0	199.50
24.8	198.99
25.8	198.84
26.8	198.64
27.9	198.49
28.3	198.07
29.2	197.84
30.2	198.25
31.8	198.79
33.6	199.34
35.4	199.93
36.6	200.40
38.2	201.08
41.8	201.18
45.7	201.17
49.7	201.08
54.1	201.01
56.8	201.08
57.2	201.08
57.3	201.40

SUMMARY DATA	
Bankfull Elevation:	201.1
Bankfull Cross-Sectional Area:	31.0
Bankfull Width:	18.5
Flood Prone Area Elevation:	204.3
Flood Prone Width:	>60
Max Depth at Bankfull:	3.2
Mean Depth at Bankfull:	1.7
W / D Ratio:	11.0
Entrenchment Ratio:	>3.0
Bank Height Ratio:	1.0

Stream Type	C5
--------------------	----

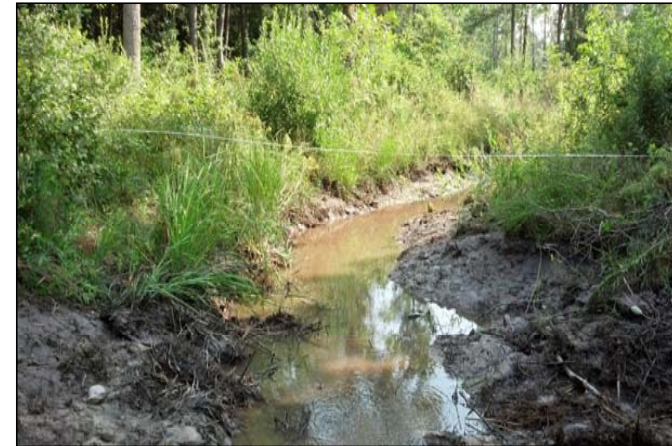
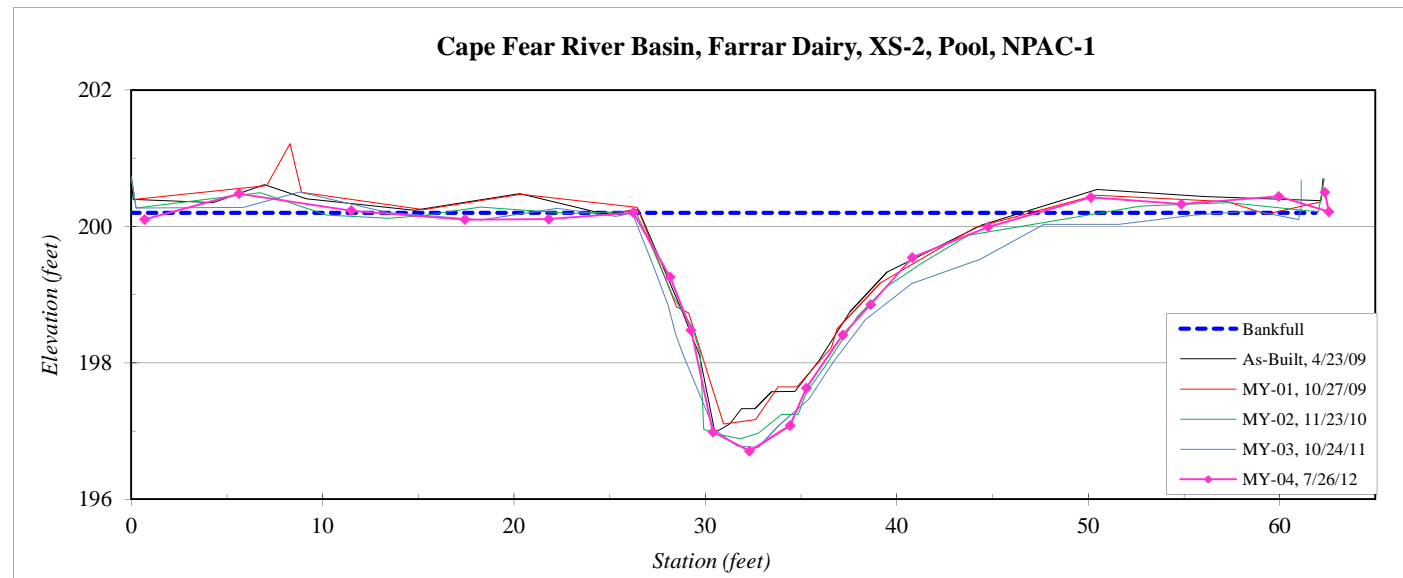
River Basin:	Cape Fear
Watershed:	Farrar Dairy
XS ID	XS-2, Pool, NPAC-1
Drainage Area (sq mi):	3.92
Date:	7/26/2012
Field Crew:	A. French, M. Koss

Station	Elevation
0.0	200.10
4.9	200.48
10.8	200.23
16.7	200.10
21.1	200.11
25.5	200.20
27.5	199.26
28.5	198.48
29.7	196.99
31.6	196.71
33.7	197.08
34.6	197.63
36.5	198.41
37.9	198.86
40.1	199.54
44.1	199.99
49.4	200.42
54.2	200.33
59.2	200.44
61.9	200.21
61.6	200.50

SUMMARY DATA	
Bankfull Elevation:	200.2
Bankfull Cross-Sectional Area:	31.6
Bankfull Width:	21.1
Flood Prone Area Elevation:	-
Flood Prone Width:	-
Max Depth at Bankfull:	3.5
Mean Depth at Bankfull:	1.5
W / D Ratio:	-
Entrenchment Ratio:	-
Bank Height Ratio:	-

Stream Type	C5
--------------------	----

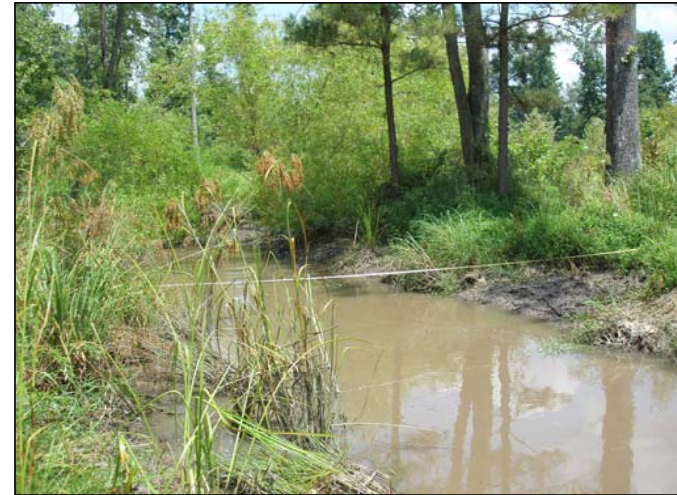
River Basin:	Cape Fear
Watershed:	Farrar Dairy
XS ID	XS-3, Riffle, NPAC-1
Drainage Area (sq mi):	3.92
Date:	7/26/2012
Field Crew:	A. French, M. Koss

Station	Elevation
0.0	198.59
5.3	198.53
9.6	198.43
13.9	198.45
17.2	198.14
18.2	198.04
20.2	197.67
23.0	196.76
24.8	196.16
26.4	195.67
28.0	195.73
29.6	195.83
31.5	196.06
33.6	197.14
35.2	197.69
38.4	198.10
40.7	198.19
44.9	198.37
50.0	198.17
52.3	198.24
52.4	198.58

SUMMARY DATA	
Bankfull Elevation:	198.0
Bankfull Cross-Sectional Area:	24.0
Bankfull Width:	19.2
Flood Prone Area Elevation:	200.3
Flood Prone Width:	>60
Max Depth at Bankfull:	2.3
Mean Depth at Bankfull:	1.2
W / D Ratio:	15.4
Entrenchment Ratio:	>3.0
Bank Height Ratio:	1.0

Stream Type	C5
--------------------	----

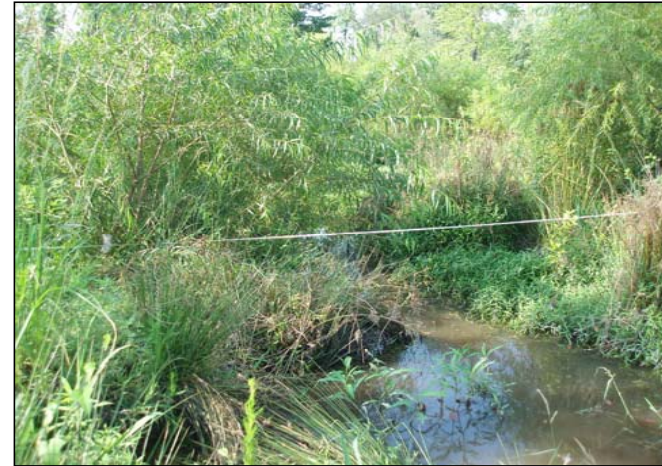
River Basin:	Cape Fear
Watershed:	Farrar Dairy
XS ID	XS-4, Pool, NPAC-1
Drainage Area (sq mi):	4.10
Date:	8/13/2012
Field Crew:	A. French, M. Koss

Station	Elevation
0.0	196.53
4.6	196.60
8.0	196.72
12.7	196.82
16.7	196.89
18.8	196.80
19.8	196.37
20.4	196.01
21.2	195.37
22.2	195.55
23.2	194.38
24.3	194.60
25.6	194.45
27.4	194.59
27.7	194.79
28.6	195.79
29.8	195.96
31.1	196.17
32.5	196.24
34.5	196.71
37.7	197.12
40.6	197.31
44.1	197.39
46.9	197.33
50.9	197.19
54.2	197.40
58.2	197.49
58.7	197.83

SUMMARY DATA	
Bankfull Elevation:	196.9
Bankfull Cross-Sectional Area:	21.3
Bankfull Width:	19.0
Flood Prone Area Elevation:	-
Flood Prone Width:	-
Max Depth at Bankfull:	2.5
Mean Depth at Bankfull:	1.1
W / D Ratio:	-
Entrenchment Ratio:	-
Bank Height Ratio:	-

Stream Type	C5
--------------------	----

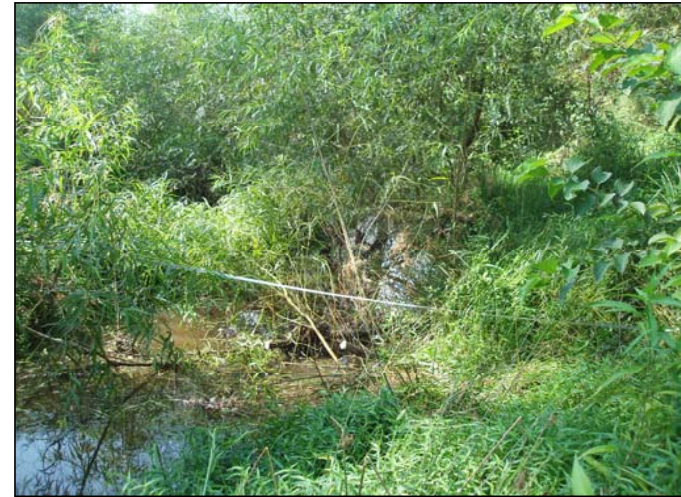
River Basin:	Cape Fear
Watershed:	Farrar Dairy
XS ID	XS-5, Riffle, NPAC-1
Drainage Area (sq mi):	4.10
Date:	8/13/2012
Field Crew:	A. French, M. Koss

Station	Elevation
0.0	196.18
0.8	195.51
5.5	195.12
9.4	195.46
13.5	195.16
17.7	195.11
21.0	195.15
22.5	194.70
23.5	194.46
25.6	193.76
27.4	192.93
28.7	192.92
29.5	192.57
30.4	192.68
32.2	193.39
34.3	194.08
36.8	194.79
39.1	195.15
43.8	195.56
49.7	195.68
54.4	195.58
58.9	195.59
61.4	195.45

SUMMARY DATA	
Bankfull Elevation:	195.5
Bankfull Cross-Sectional Area:	31.5
Bankfull Width:	19.1
Flood Prone Area Elevation:	198.4
Flood Prone Width:	>60
Max Depth at Bankfull:	2.9
Mean Depth at Bankfull:	1.6
W / D Ratio:	11.6
Entrenchment Ratio:	>3.0
Bank Height Ratio:	1.0

Stream Type	C5
--------------------	----

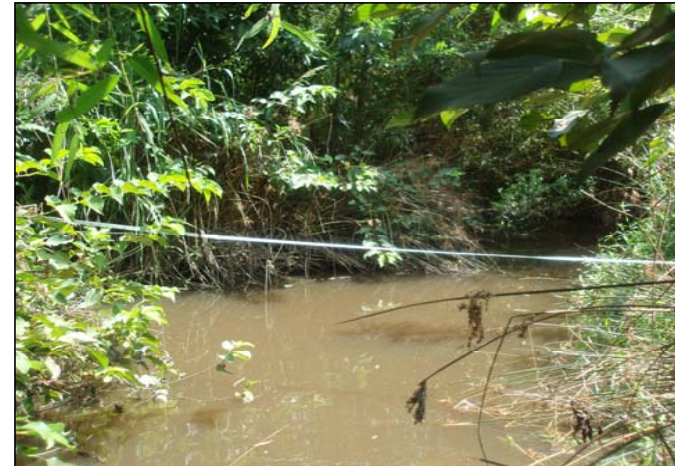
River Basin:	Cape Fear
Watershed:	Farrar Dairy
XS ID	XS-6, Pool, NPAC-1
Drainage Area (sq mi):	4.1
Date:	8/13/2012
Field Crew:	A. French, M. Koss

Station	Elevation
0.0	194.82
0.6	194.49
4.8	194.62
9.0	194.63
13.6	194.85
17.6	194.59
20.9	194.64
25.3	194.48
26.7	194.23
28.2	193.49
30.1	192.71
31.5	191.27
33.4	190.96
34.8	191.55
36.4	192.57
37.9	193.31
39.1	193.55
40.1	193.88
44.0	194.36
48.2	194.60
52.5	194.63
58.2	194.67
62.9	194.60
66.5	194.52

SUMMARY DATA	
Bankfull Elevation:	194.5
Bankfull Cross-Sectional Area:	27.8
Bankfull Width:	20.8
Flood Prone Area Elevation:	-
Flood Prone Width:	-
Max Depth at Bankfull:	3.5
Mean Depth at Bankfull:	1.3
W / D Ratio:	-
Entrenchment Ratio:	-
Bank Height Ratio:	-

Stream Type C5

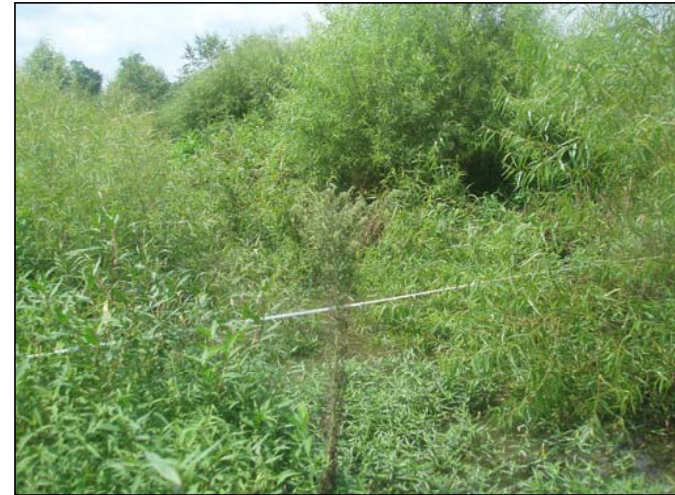
River Basin:	Cape Fear
Watershed:	Farrar Dairy
XS ID	XS-7, Riffle, NPAC-1
Drainage Area (sq mi):	4.1
Date:	8/13/2012
Field Crew:	A. French, M. Koss

Station	Elevation
0.0	193.49
0.4	192.98
3.8	192.89
8.0	193.07
11.5	193.22
15.6	193.30
18.4	193.29
19.6	192.74
21.2	192.41
23.3	191.94
26.1	191.40
27.9	190.56
29.3	190.14
30.1	190.14
31.4	190.47
33.7	191.54
35.0	192.00
36.6	192.67
39.8	193.49
44.1	193.59
48.2	193.62
52.5	193.59
55.7	193.61
57.9	193.69

SUMMARY DATA	
Bankfull Elevation:	193.3
Bankfull Cross-Sectional Area:	32.5
Bankfull Width:	20.6
Flood Prone Area Elevation:	196.4
Flood Prone Width:	>60
Max Depth at Bankfull:	3.2
Mean Depth at Bankfull:	1.6
W / D Ratio:	13.1
Entrenchment Ratio:	>3.0
Bank Height Ratio:	1.0

Stream Type	C5
--------------------	----

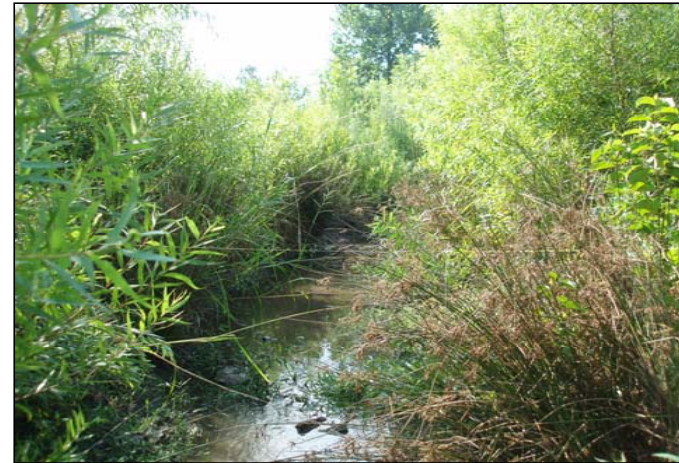
River Basin:	Cape Fear
Watershed:	Farrar Dairy
XS ID	XS-8, Riffle, NPAC-2
Drainage Area (sq mi):	4.1
Date:	7/26/2012
Field Crew:	A. French, M. Koss

Station	Elevation
0.0	191.92
0.3	191.41
5.5	191.37
11.9	191.33
16.7	191.36
21.8	191.45
23.5	190.94
25.1	190.08
26.7	189.67
27.9	189.39
28.6	189.32
29.3	188.55
30.8	188.20
31.4	188.33
33.3	188.48
34.7	188.45
35.9	189.01
38.0	190.07
40.3	190.94
44.9	191.16
49.7	190.93
53.9	191.06

SUMMARY DATA	
Bankfull Elevation:	191.1
Bankfull Cross-Sectional Area:	29.9
Bankfull Width:	20.7
Flood Prone Area Elevation:	194.0
Flood Prone Width:	>60
Max Depth at Bankfull:	2.9
Mean Depth at Bankfull:	1.4
W / D Ratio:	14.3
Entrenchment Ratio:	>3.0
Bank Height Ratio:	1.0

Stream Type	C5
--------------------	----

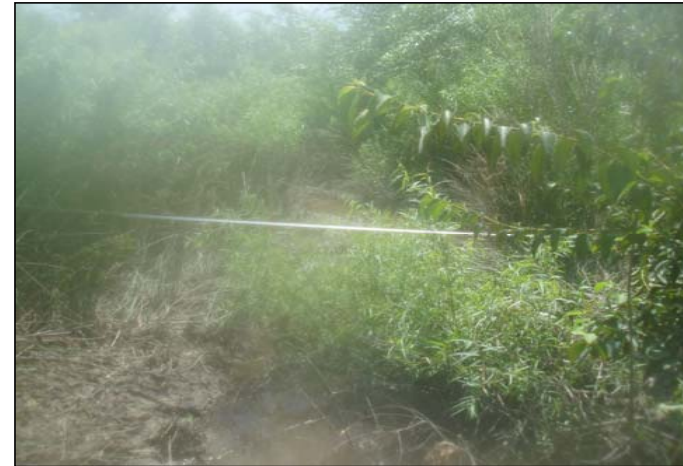
River Basin:	Cape Fear
Watershed:	Farrar Dairy
XS ID	XS-9, Pool, NPAC-2
Drainage Area (sq mi):	4.65
Date:	8/13/2012
Field Crew:	A. French, M. Koss

Station	Elevation
0.0	189.85
0.2	189.42
5.2	189.46
11.3	189.52
15.7	189.72
19.5	189.31
23.1	188.75
27.4	188.66
29.3	188.15
31.1	187.37
32.5	186.61
33.7	186.03
34.7	185.80
35.9	186.16
37.3	186.71
38.6	188.35
39.9	189.19
41.0	189.74
44.7	189.76
48.5	189.75
51.8	189.69
55.7	189.73
60.5	189.70
60.8	190.00

SUMMARY DATA	
Bankfull Elevation:	189.5
Bankfull Cross-Sectional Area:	34.6
Bankfull Width:	23.2
Flood Prone Area Elevation:	-
Flood Prone Width:	-
Max Depth at Bankfull:	3.7
Mean Depth at Bankfull:	1.5
W / D Ratio:	-
Entrenchment Ratio:	-
Bank Height Ratio:	-

Stream Type	C5
--------------------	----

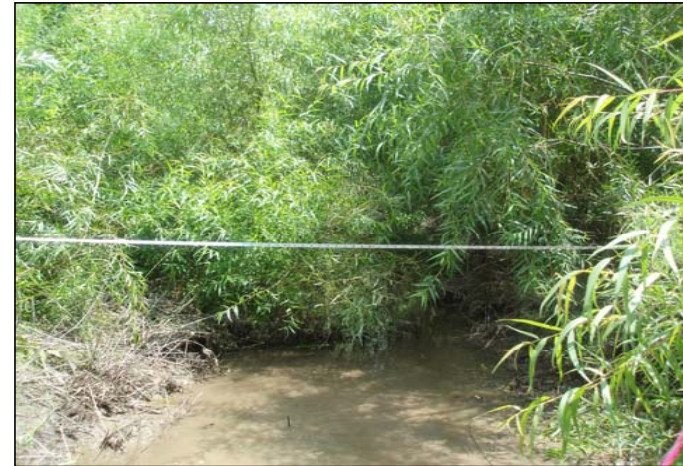
River Basin:	Cape Fear
Watershed:	Farrar Dairy
XS ID	XS-10, Riffle, NPAC-2
Drainage Area (sq mi):	4.65
Date:	8/13/2012
Field Crew:	A. French, M. Koss

Station	Elevation
0	190.65
0.8	190.22
4.8	189.87
9.9	189.79
15.1	189.69
19.6	189.44
24.1	189.37
27.4	189.23
28.8	189.01
30.0	188.67
31.5	188.30
33.1	188.05
34.4	187.56
35.5	186.86
37.3	186.60
38.9	186.43
39.9	186.74
41.3	186.72
42.7	186.96
43.9	187.24
45.2	187.99
46.6	188.62
48.9	189.39
50.5	189.40
54.6	189.34
59.0	189.28
63.5	189.41
66.1	189.28
66.4	189.69

SUMMARY DATA	
Bankfull Elevation:	189.1
Bankfull Cross-Sectional Area:	29.9
Bankfull Width:	19.3
Flood Prone Area Elevation:	191.8
Flood Prone Width:	>60
Max Depth at Bankfull:	2.7
Mean Depth at Bankfull:	1.6
W / D Ratio:	12.4
Entrenchment Ratio:	>3.0
Bank Height Ratio:	1.0

Stream Type	C5
--------------------	----

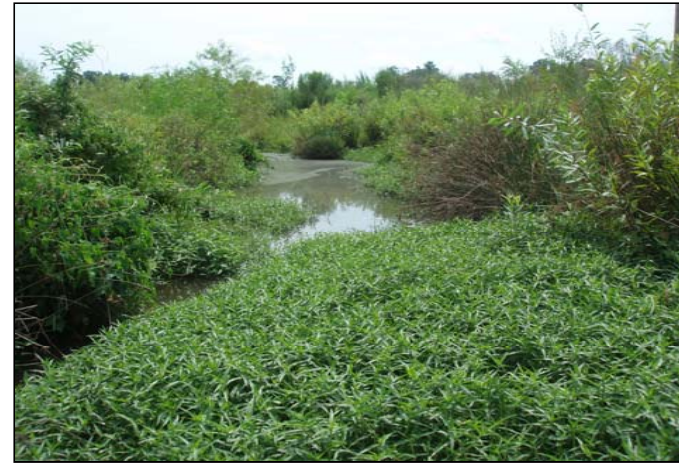
River Basin:	Cape Fear
Watershed:	Farrar Dairy
XS ID	XS-11, Riffle, NPAC-3
Drainage Area (sq mi):	4.82
Date:	8/13/2012
Field Crew:	A. French, M. Koss

Station	Elevation
0.0	189.13
0.4	188.84
5.1	188.86
11.4	188.69
18.9	188.93
26.6	188.97
29.2	188.16
31.4	187.37
33.1	186.65
34.3	185.91
35.5	185.29
37.9	184.77
40.5	185.01
43.3	185.14
45.3	185.84
48.0	187.32
51.0	188.90
56.4	189.14
61.6	189.12
67.4	189.33
73.3	189.54
73.7	189.83

SUMMARY DATA	
Bankfull Elevation:	188.9
Bankfull Cross-Sectional Area:	60.4
Bankfull Width:	24.3
Flood Prone Area Elevation:	193.1
Flood Prone Width:	>60
Max Depth at Bankfull:	4.2
Mean Depth at Bankfull:	2.5
W / D Ratio:	9.8
Entrenchment Ratio:	>3.0
Bank Height Ratio:	1.0

Stream Type	C5
--------------------	----

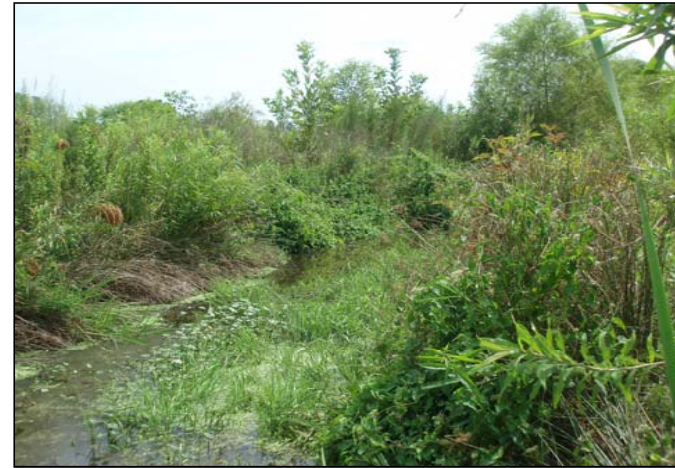
River Basin:	Cape Fear
Watershed:	Farrar Dairy
XS ID	XS-12, Pool, NPAC-3
Drainage Area (sq mi):	4.82
Date:	8/13/2012
Field Crew:	A. French, M. Koss

Station	Elevation
0.0	188.99
0.2	188.59
5.4	188.69
12.8	188.53
19.6	188.10
21.4	187.42
23.2	186.51
24.5	186.10
25.6	184.40
27.8	183.48
30.5	184.51
32.7	185.23
35.0	185.68
36.6	186.44
39.0	187.16
42.2	188.15
47.0	188.12
51.2	188.00
56.4	188.22
59.4	188.26
62.2	188.54

SUMMARY DATA	
Bankfull Elevation:	188.1
Bankfull Cross-Sectional Area:	49.9
Bankfull Width:	22.9
Flood Prone Area Elevation:	-
Flood Prone Width:	-
Max Depth at Bankfull:	4.6
Mean Depth at Bankfull:	2.2
W / D Ratio:	-
Entrenchment Ratio:	-
Bank Height Ratio:	-

Stream Type	C5
--------------------	----

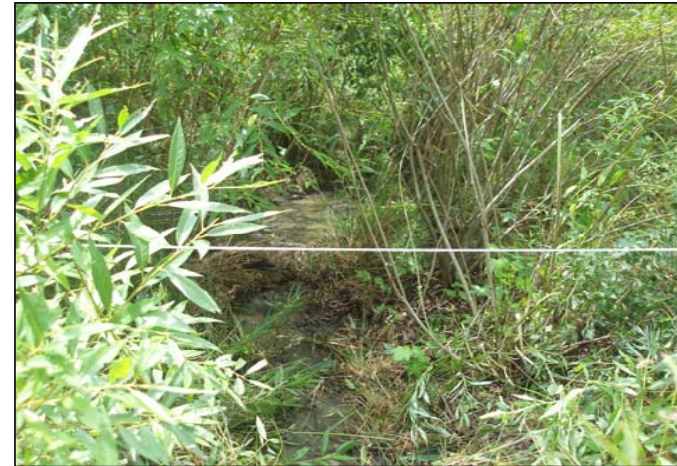
River Basin:	Cape Fear
Watershed:	Farrar Dairy
XS ID	XS-13, Riffle, T1.1
Drainage Area (sq mi):	0.02
Date:	7/26/2012
Field Crew:	A. French, M. Koss

Station	Elevation
0.0	222.09
0.4	221.59
3.6	221.26
6.6	220.65
9.4	220.18
11.8	219.24
13.5	218.90
14.8	218.95
16.2	218.42
17.2	218.14
18.4	218.26
19.7	218.60
21.6	218.81
23.8	218.98
26.3	219.48
29.7	220.11
33.3	220.64
37.4	220.91
42.6	221.11
43.1	221.51

SUMMARY DATA	
Bankfull Elevation:	218.9
Bankfull Cross-Sectional Area:	2.7
Bankfull Width:	7.7
Flood Prone Area Elevation:	219.6
Flood Prone Width:	16.4
Max Depth at Bankfull:	0.8
Mean Depth at Bankfull:	0.4
W / D Ratio:	22.0
Entrenchment Ratio:	2.1
Bank Height Ratio:	1.0

Stream Type	C5
--------------------	----

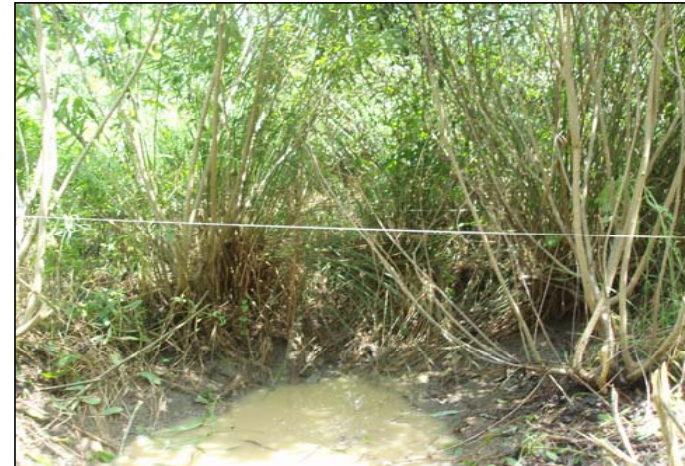
River Basin:	Cape Fear
Watershed:	Farrar Dairy
XS ID	XS-14, Pool, T1.1
Drainage Area (sq mi):	0.02
Date:	7/26/2012
Field Crew:	A. French, M. Koss

Station	Elevation
0.0	216.96
0.5	216.54
3.8	216.47
7.5	216.24
10.5	216.29
14.2	216.27
16.1	215.76
18.6	215.53
20.0	215.13
20.8	214.58
22.2	214.13
23.6	214.55
24.5	215.13
25.8	215.80
28.3	215.77
30.5	216.37
33.2	216.93
37.3	217.08
41.3	217.21
45.3	217.39
45.8	217.87

SUMMARY DATA	
Bankfull Elevation:	215.6
Bankfull Cross-Sectional Area:	5.4
Bankfull Width:	7.6
Flood Prone Area Elevation:	-
Flood Prone Width:	-
Max Depth at Bankfull:	1.5
Mean Depth at Bankfull:	0.7
W / D Ratio:	-
Entrenchment Ratio:	-
Bank Height Ratio:	-

Stream Type	C5
--------------------	----

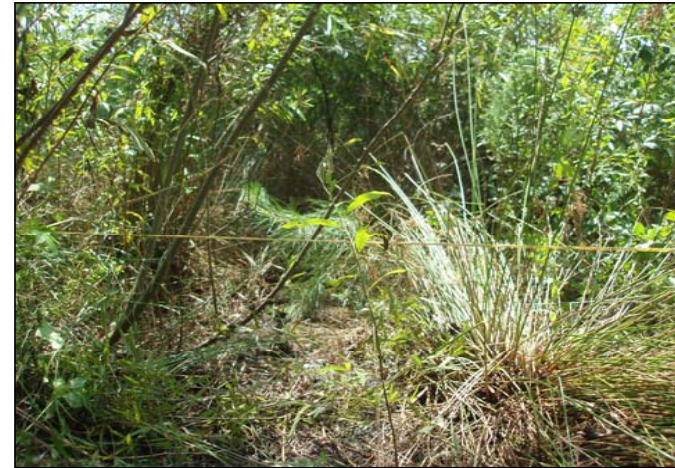
River Basin:	Cape Fear
Watershed:	Farrar Dairy
XS ID	XS-15, Riffle, T1.1
Drainage Area (sq mi):	0.02
Date:	7/26/2012
Field Crew:	A. French, M. Koss

Station	Elevation
0.0	214.30
0.2	213.88
3.5	214.20
6.8	213.95
9.3	213.82
12.2	214.09
14.6	214.31
16.5	213.87
18.1	213.82
19.2	213.46
20.2	213.10
21.4	213.13
22.4	213.16
23.7	213.61
24.7	213.77
26.4	213.87
29.2	214.32
31.6	214.81
34.1	215.01
37.2	215.22
41.2	215.57
45.8	215.36
48.7	215.33
48.9	215.72

SUMMARY DATA	
Bankfull Elevation:	213.8
Bankfull Cross-Sectional Area:	2.8
Bankfull Width:	6.5
Flood Prone Area Elevation:	214.5
Flood Prone Width:	30.0
Max Depth at Bankfull:	0.7
Mean Depth at Bankfull:	0.4
W / D Ratio:	15.1
Entrenchment Ratio:	4.6
Bank Height Ratio:	1.0

Stream Type	C5
--------------------	----

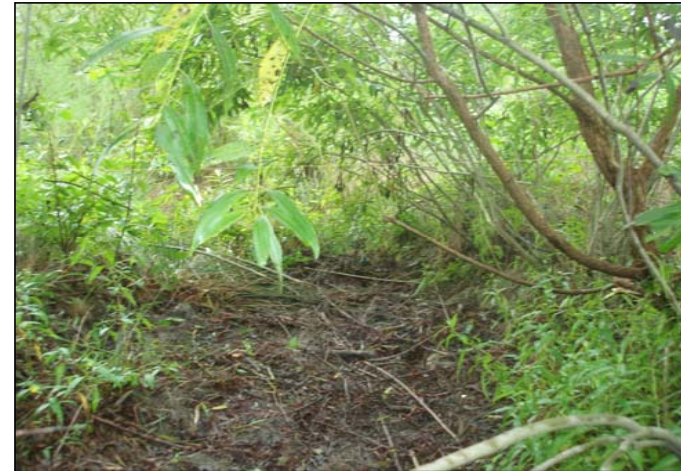
River Basin:	Cape Fear
Watershed:	Farrar Dairy
XS ID	XS-16, Pool, T1.2
Drainage Area (sq mi):	0.10
Date:	7/26/2012
Field Crew:	A. French, M. Koss

Station	Elevation
0.0	220.81
0.2	220.33
5.5	220.29
9.7	220.39
14.7	220.31
18.1	219.97
20.3	219.69
21.8	219.51
23.0	218.89
24.5	218.55
25.4	218.33
26.9	218.36
27.8	218.73
29.3	219.56
31.0	219.68
33.4	220.12
35.4	220.66
40.3	220.86
45.1	221.17
48.0	221.25
50.5	221.20
51.3	221.63

SUMMARY DATA	
Bankfull Elevation:	219.7
Bankfull Cross-Sectional Area:	6.4
Bankfull Width:	8.8
Flood Prone Area Elevation:	-
Flood Prone Width:	-
Max Depth at Bankfull:	1.3
Mean Depth at Bankfull:	0.7
W / D Ratio:	-
Entrenchment Ratio:	-
Bank Height Ratio:	-

Stream Type C5

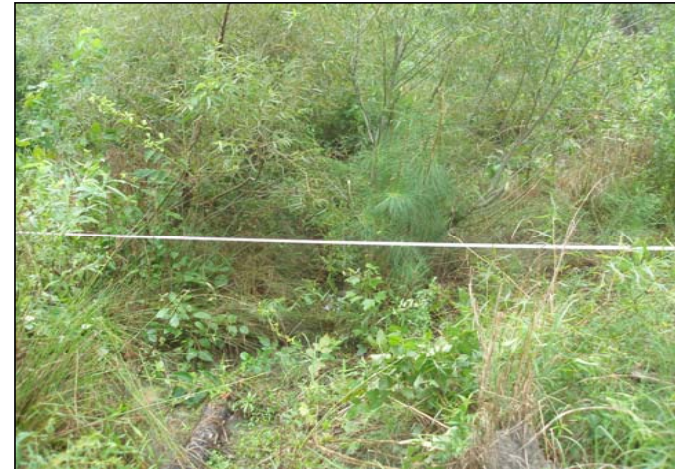
River Basin:	Cape Fear
Watershed:	Farrar Dairy
XS ID	XS-17, Riffle, T1.2
Drainage Area (sq mi):	0.10
Date:	7/26/2012
Field Crew:	A. French, M. Koss

Station	Elevation
0.0	218.78
0.2	218.45
3.7	218.21
5.5	217.86
8.0	217.29
11.0	216.74
13.3	216.53
15.4	216.38
16.8	216.04
17.7	215.57
18.5	215.32
19.5	215.19
20.8	215.47
22.1	215.72
23.5	216.18
24.5	216.50
27.9	216.65
31.4	217.02
34.7	217.06
39.2	217.09
44.4	217.25
49.1	217.41
52.6	217.42
52.9	217.79

SUMMARY DATA	
Bankfull Elevation:	216.4
Bankfull Cross-Sectional Area:	5.7
Bankfull Width:	8.7
Flood Prone Area Elevation:	217.6
Flood Prone Width:	46.0
Max Depth at Bankfull:	1.2
Mean Depth at Bankfull:	0.7
W / D Ratio:	11.6
Entrenchment Ratio:	>3.0
Bank Height Ratio:	1.0

Stream Type	C5
--------------------	----

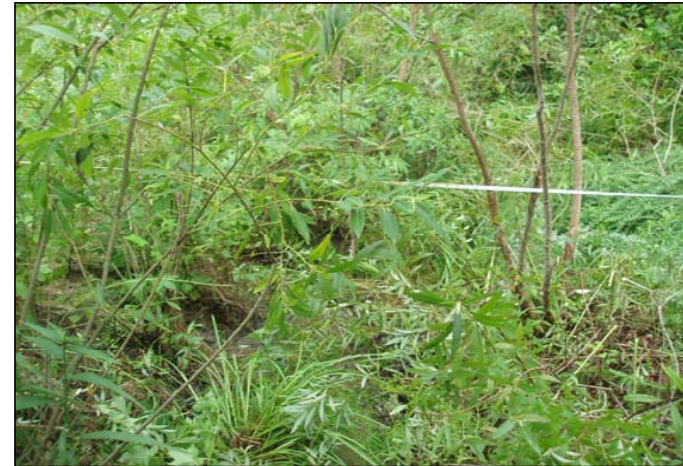
River Basin:	Cape Fear
Watershed:	Farrar Dairy
XS ID	XS-18, Riffle, T1.2
Drainage Area (sq mi):	0.10
Date:	7/26/2012
Field Crew:	A. French, M. Koss

Station	Elevation
0.0	215.52
0.6	215.00
1.7	214.86
4.2	214.14
6.2	213.65
8.5	213.27
11.0	212.70
12.7	212.37
14.7	212.27
16.4	211.63
17.3	211.14
18.7	210.88
20.0	211.20
21.4	211.95
22.7	212.40
26.6	212.55
29.9	213.21
33.5	213.47
38.1	213.65
38.5	214.07

SUMMARY DATA	
Bankfull Elevation:	212.1
Bankfull Cross-Sectional Area:	4.6
Bankfull Width:	6.7
Flood Prone Area Elevation:	213.3
Flood Prone Width:	21.0
Max Depth at Bankfull:	1.2
Mean Depth at Bankfull:	0.7
W / D Ratio:	9.8
Entrenchment Ratio:	3.1
Bank Height Ratio:	1.0

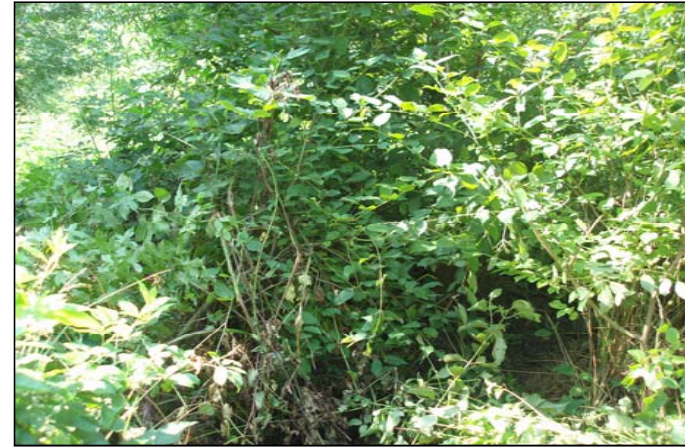
River Basin:	Cape Fear
Watershed:	Farrar Dairy
XS ID	XS-19, Pool, T1
Drainage Area (sq mi):	0.18
Date:	8/13/2012
Field Crew:	A. French, M. Koss

Station	Elevation
0.0	204.10
0.3	203.67
6.2	203.16
13.0	203.54
17.4	203.31
22.8	203.20
25.0	203.18
26.4	202.84
27.5	202.10
28.5	201.42
32.2	201.81
33.3	202.08
34.9	202.70
36.2	203.38
41.8	203.10
49.2	203.25
52.3	203.30
53.7	203.49
53.9	204.06

SUMMARY DATA	
Bankfull Elevation:	203.2
Bankfull Cross-Sectional Area:	10.3
Bankfull Width:	10.6
Flood Prone Area Elevation:	-
Flood Prone Width:	-
Max Depth at Bankfull:	1.8
Mean Depth at Bankfull:	1.0
W / D Ratio:	-
Entrenchment Ratio:	-
Bank Height Ratio:	-

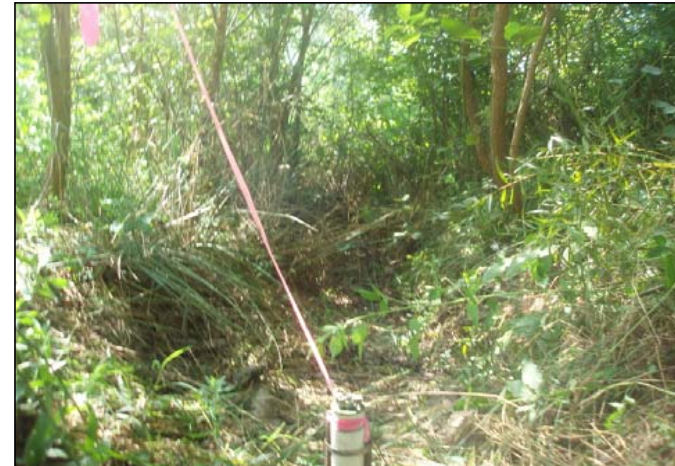
River Basin:	Cape Fear
Watershed:	Farrar Dairy
XS ID	XS-20, Riffle, T1
Drainage Area (sq mi):	0.18
Date:	8/13/2012
Field Crew:	A. French, M. Koss

Station	Elevation
0.0	202.13
0.3	201.73
7.0	201.75
12.5	201.25
16.5	201.03
18.9	200.24
19.9	199.60
21.0	199.03
21.5	199.19
22.2	199.20
23.2	199.48
24.3	200.20
26.3	200.82
30.7	201.15
41.4	201.17
42.9	201.33
43.6	201.99

SUMMARY DATA	
Bankfull Elevation:	201.0
Bankfull Cross-Sectional Area:	10.2
Bankfull Width:	12.1
Flood Prone Area Elevation:	203.0
Flood Prone Width:	>60
Max Depth at Bankfull:	2.0
Mean Depth at Bankfull:	0.8
W / D Ratio:	15.1
Entrenchment Ratio:	>3.0
Bank Height Ratio:	1.0

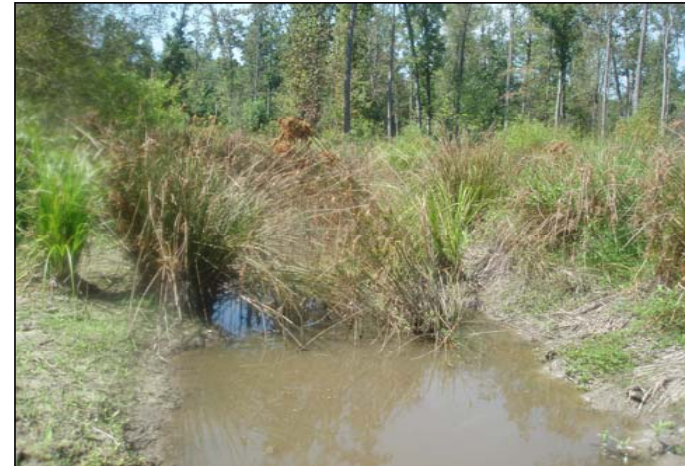
River Basin:	Cape Fear
Watershed:	Farrar Dairy
XS ID	XS-21, Riffle, T1
Drainage Area (sq mi):	0.18
Date:	8/13/2012
Field Crew:	A. French, M. Koss

Station	Elevation
0.0	198.73
5.2	198.85
9.8	198.74
12.3	198.95
14.0	198.76
15.8	198.46
17.5	198.22
18.7	197.51
20.3	196.99
21.4	196.82
22.8	196.95
23.9	197.49
25.3	198.16
27.1	198.40
31.1	198.81
35.4	198.84
38.9	198.84
42.7	198.69
43.8	199.05
44.1	199.10

SUMMARY DATA	
Bankfull Elevation:	198.6
Bankfull Cross-Sectional Area:	11.1
Bankfull Width:	14.1
Flood Prone Area Elevation:	200.4
Flood Prone Width:	>60
Max Depth at Bankfull:	1.8
Mean Depth at Bankfull:	0.8
W / D Ratio:	17.9
Entrenchment Ratio:	>3.0
Bank Height Ratio:	1.0

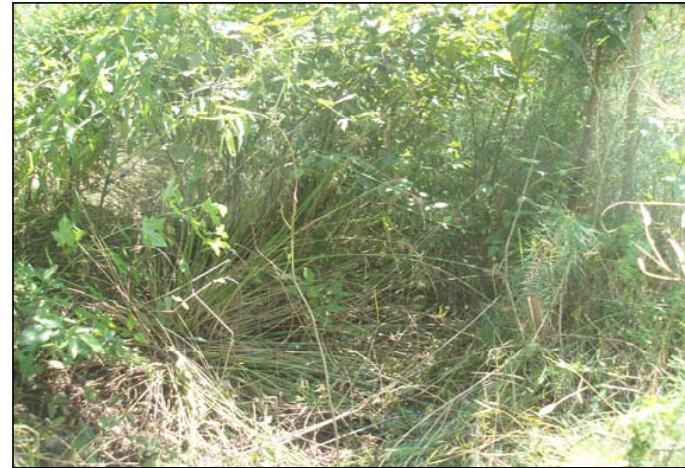
River Basin:	Cape Fear
Watershed:	Farrar Dairy
XS ID	XS-22, Pool, T2A
Drainage Area (sq mi):	0.04
Date:	8/13/2012
Field Crew:	A. French, M. Koss

Station	Elevation
0.0	203.98
0.3	203.52
3.3	203.52
6.4	203.34
8.1	203.30
9.3	202.79
10.8	202.19
12.0	202.08
13.5	202.34
15.0	202.90
16.7	203.38
20.3	203.44
23.4	203.44
26.3	203.53
27.8	203.59
28.0	204.03

SUMMARY DATA	
Bankfull Elevation:	203.3
Bankfull Cross-Sectional Area:	5.8
Bankfull Width:	8.4
Flood Prone Area Elevation:	-
Flood Prone Width:	-
Max Depth at Bankfull:	1.2
Mean Depth at Bankfull:	0.7
W / D Ratio:	-
Entrenchment Ratio:	-
Bank Height Ratio:	-

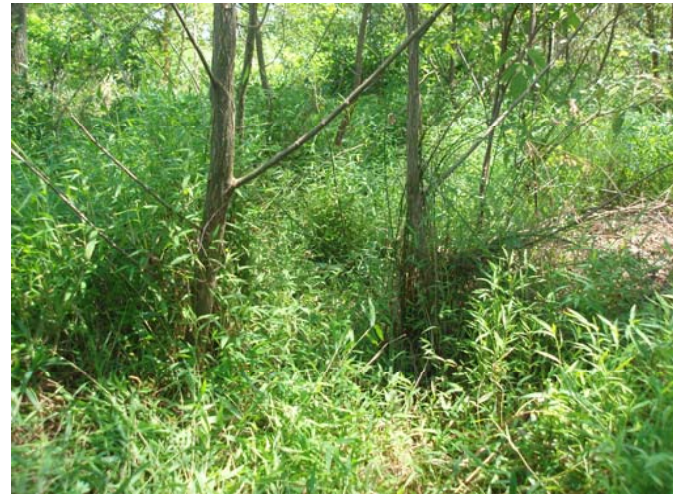
River Basin:	Cape Fear
Watershed:	Farrar Dairy
XS ID	XS-23, Riffle, T2A
Drainage Area (sq mi):	0.04
Date:	8/13/2012
Field Crew:	A. French, M. Koss

Station	Elevation
0.0	199.63
2.8	199.55
7.0	199.30
11.2	198.93
13.2	198.90
14.3	198.39
15.3	198.13
16.7	198.29
18.2	198.90
20.2	199.01
22.4	199.64
26.7	199.61
30.1	199.26
31.1	200.01

SUMMARY DATA	
Bankfull Elevation:	198.9
Bankfull Cross-Sectional Area:	2.5
Bankfull Width:	6.8
Flood Prone Area Elevation:	199.7
Flood Prone Width:	>30
Max Depth at Bankfull:	0.8
Mean Depth at Bankfull:	0.4
W / D Ratio:	18.5
Entrenchment Ratio:	>3.0
Bank Height Ratio:	1.0

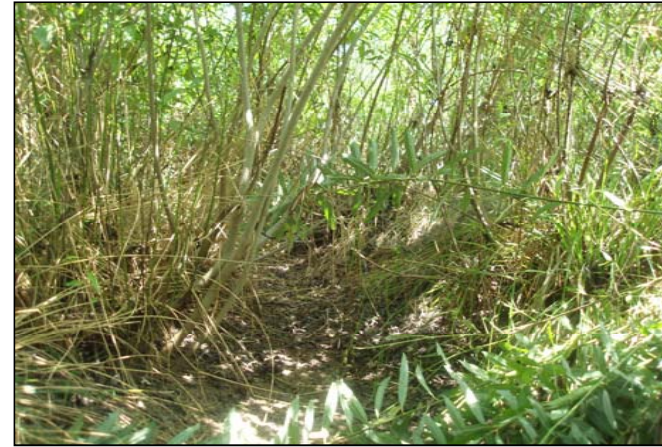
River Basin:	Cape Fear
Watershed:	Farrar Dairy
XS ID	XS-24, Pool, T2B
Drainage Area (sq mi):	0.04
Date:	8/13/2012
Field Crew:	A. French, M. Koss

Station	Elevation
0.0	193.38
0.3	193.10
3.0	193.00
7.3	193.33
11.0	193.15
15.1	192.78
16.5	192.31
17.8	192.04
19.1	192.03
20.1	192.07
21.1	192.65
22.0	192.98
25.6	193.07
30.9	193.09
37.0	193.26
42.1	193.55
44.2	193.35
44.4	193.77

SUMMARY DATA	
Bankfull Elevation:	193.0
Bankfull Cross-Sectional Area:	4.7
Bankfull Width:	9.0
Flood Prone Area Elevation:	-
Flood Prone Width:	-
Max Depth at Bankfull:	0.9
Mean Depth at Bankfull:	0.5
W / D Ratio:	-
Entrenchment Ratio:	-
Bank Height Ratio:	-

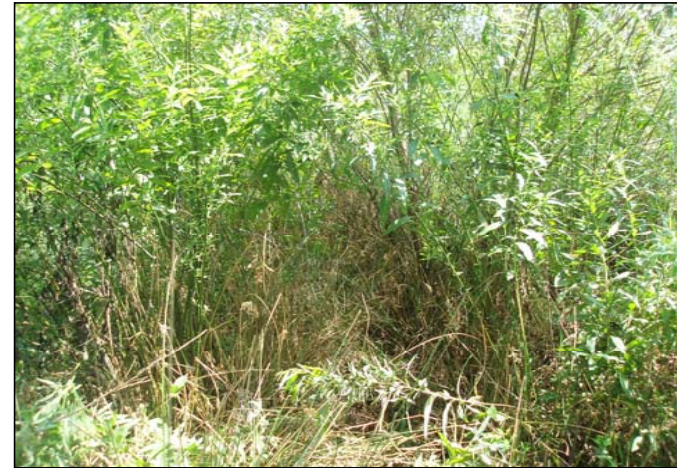
River Basin:	Cape Fear
Watershed:	Farrar Dairy
XS ID	XS-25, Riffle, T2B
Drainage Area (sq mi):	0.04
Date:	8/13/2012
Field Crew:	A. French, M. Koss

Station	Elevation
0.0	192.92
0.2	192.64
4.4	192.57
8.3	192.51
14.0	192.55
17.3	192.59
19.4	192.39
20.6	192.03
21.8	191.76
22.9	191.92
24.2	192.28
25.4	192.56
29.4	192.86
33.7	192.80
37.3	192.25
39.8	192.42
39.9	192.75

SUMMARY DATA	
Bankfull Elevation:	192.8
Bankfull Cross-Sectional Area:	3.2
Bankfull Width:	8.4
Flood Prone Area Elevation:	193.8
Flood Prone Width:	>60
Max Depth at Bankfull:	1.0
Mean Depth at Bankfull:	0.4
W / D Ratio:	22.1
Entrenchment Ratio:	>3.0
Bank Height Ratio:	1.0

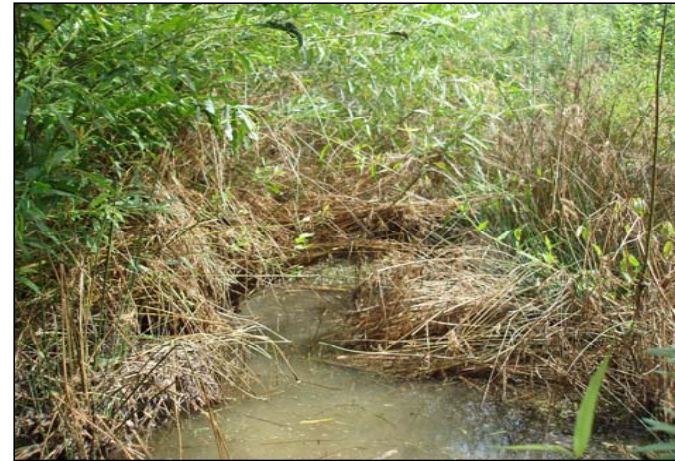
River Basin:	Cape Fear
Watershed:	Farrar Dairy
XS ID	XS-26, Riffle, T3
Drainage Area (sq mi):	0.39
Date:	8/13/2012
Field Crew:	A. French, M. Koss

Station	Elevation
0.0	191.64
0.3	191.35
5.3	191.29
11.2	191.06
17.6	190.63
22.0	190.63
23.6	190.08
24.9	189.63
26.6	189.48
28.5	189.50
30.0	189.13
31.6	188.88
33.5	189.22
35.4	189.37
37.9	189.59
39.1	189.99
40.3	190.37
41.9	190.59
47.3	190.56
51.9	190.50
56.2	190.20
56.4	190.79

SUMMARY DATA	
Bankfull Elevation:	190.4
Bankfull Cross-Sectional Area:	15.8
Bankfull Width:	17.9
Flood Prone Area Elevation:	191.9
Flood Prone Width:	>60
Max Depth at Bankfull:	1.5
Mean Depth at Bankfull:	0.9
W / D Ratio:	20.3
Entrenchment Ratio:	>3.0
Bank Height Ratio:	1.1

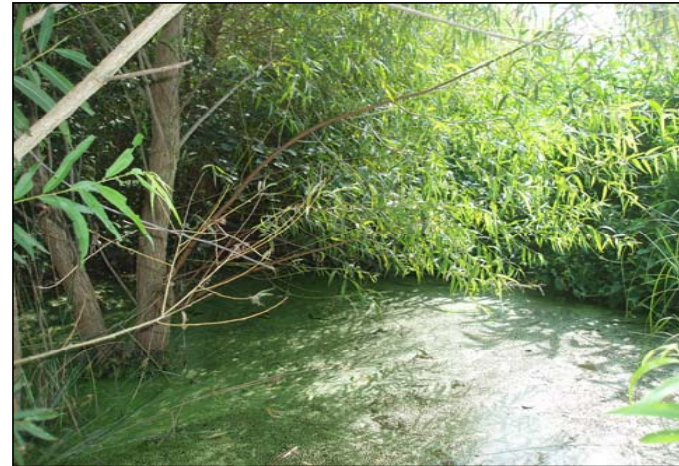
River Basin:	Cape Fear
Watershed:	Farrar Dairy
XS ID	XS-27, Pool, T3
Drainage Area (sq mi):	0.39
Date:	8/13/2012
Field Crew:	A. French, M. Koss

Station	Elevation
0.0	189.92
0.3	189.67
3.6	189.43
7.3	189.75
11.6	189.78
17.7	189.85
20.7	189.80
21.9	189.33
23.0	188.98
24.2	188.50
26.3	188.30
27.9	187.76
29.5	187.70
31.4	188.36
33.4	188.79
36.5	189.03
38.7	189.48
42.4	189.93
47.0	190.05
51.6	189.90
55.4	189.99
58.5	189.90
59.0	190.32

SUMMARY DATA	
Bankfull Elevation:	189.8
Bankfull Cross-Sectional Area:	20.5
Bankfull Width:	20.1
Flood Prone Area Elevation:	-
Flood Prone Width:	-
Max Depth at Bankfull:	2.0
Mean Depth at Bankfull:	1.0
W / D Ratio:	-
Entrenchment Ratio:	-
Bank Height Ratio:	-

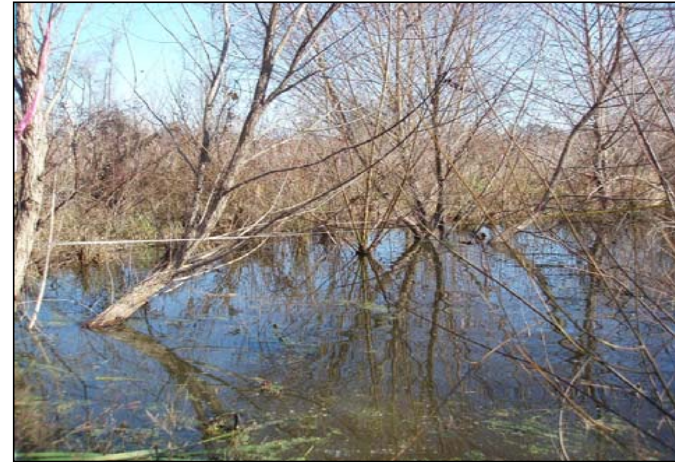
River Basin:	Cape Fear
Watershed:	Farrar Dairy
XS ID	XS-28, Pool, T3
Drainage Area (sq mi):	0.39
Date:	11/26/2012
Field Crew:	A. Helms, M. Koss

Station	Elevation
0.0	189.56
0.3	189.22
6.0	189.20
10.8	189.33
15.8	189.27
18.7	188.65
20.4	188.17
23.0	187.80
24.4	187.93
26.2	187.87
27.9	187.73
29.0	187.58
30.1	187.56
31.5	187.80
33.0	188.06
36.1	188.54
38.1	188.89
39.8	189.28
42.0	189.35
46.4	189.71
50.6	189.58
54.2	189.46
58.3	189.31
58.7	189.70

SUMMARY DATA	
Bankfull Elevation:	189.3
Bankfull Cross-Sectional Area:	24.7
Bankfull Width:	23.8
Flood Prone Area Elevation:	-
Flood Prone Width:	-
Max Depth at Bankfull:	1.7
Mean Depth at Bankfull:	1.0
W / D Ratio:	22.9
Entrenchment Ratio:	-
Bank Height Ratio:	-

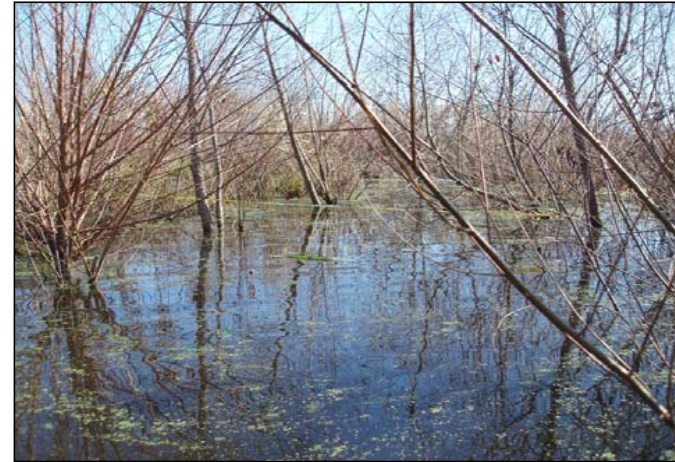
River Basin:	Cape Fear
Watershed:	Farrar Dairy
XS ID	XS-29, Riffle, T3
Drainage Area (sq mi):	0.39
Date:	11/26/2012
Field Crew:	A. Helms, M. Koss

Station	Elevation
0.0	189.34
0.4	188.91
3.9	189.16
7.8	189.39
11.2	189.28
12.9	188.79
14.3	188.42
15.6	188.00
16.9	187.76
18.1	187.56
19.4	187.34
20.5	187.32
21.9	187.62
23.3	187.81
25.0	188.41
27.0	189.26
28.3	189.53
32.1	189.74
35.0	189.44
35.1	189.99

SUMMARY DATA	
Bankfull Elevation:	189.2
Bankfull Cross-Sectional Area:	17.6
Bankfull Width:	15.5
Flood Prone Area Elevation:	191.1
Flood Prone Width:	>35
Max Depth at Bankfull:	1.9
Mean Depth at Bankfull:	1.1
W / D Ratio:	13.7
Entrenchment Ratio:	2.3
Bank Height Ratio:	1.0

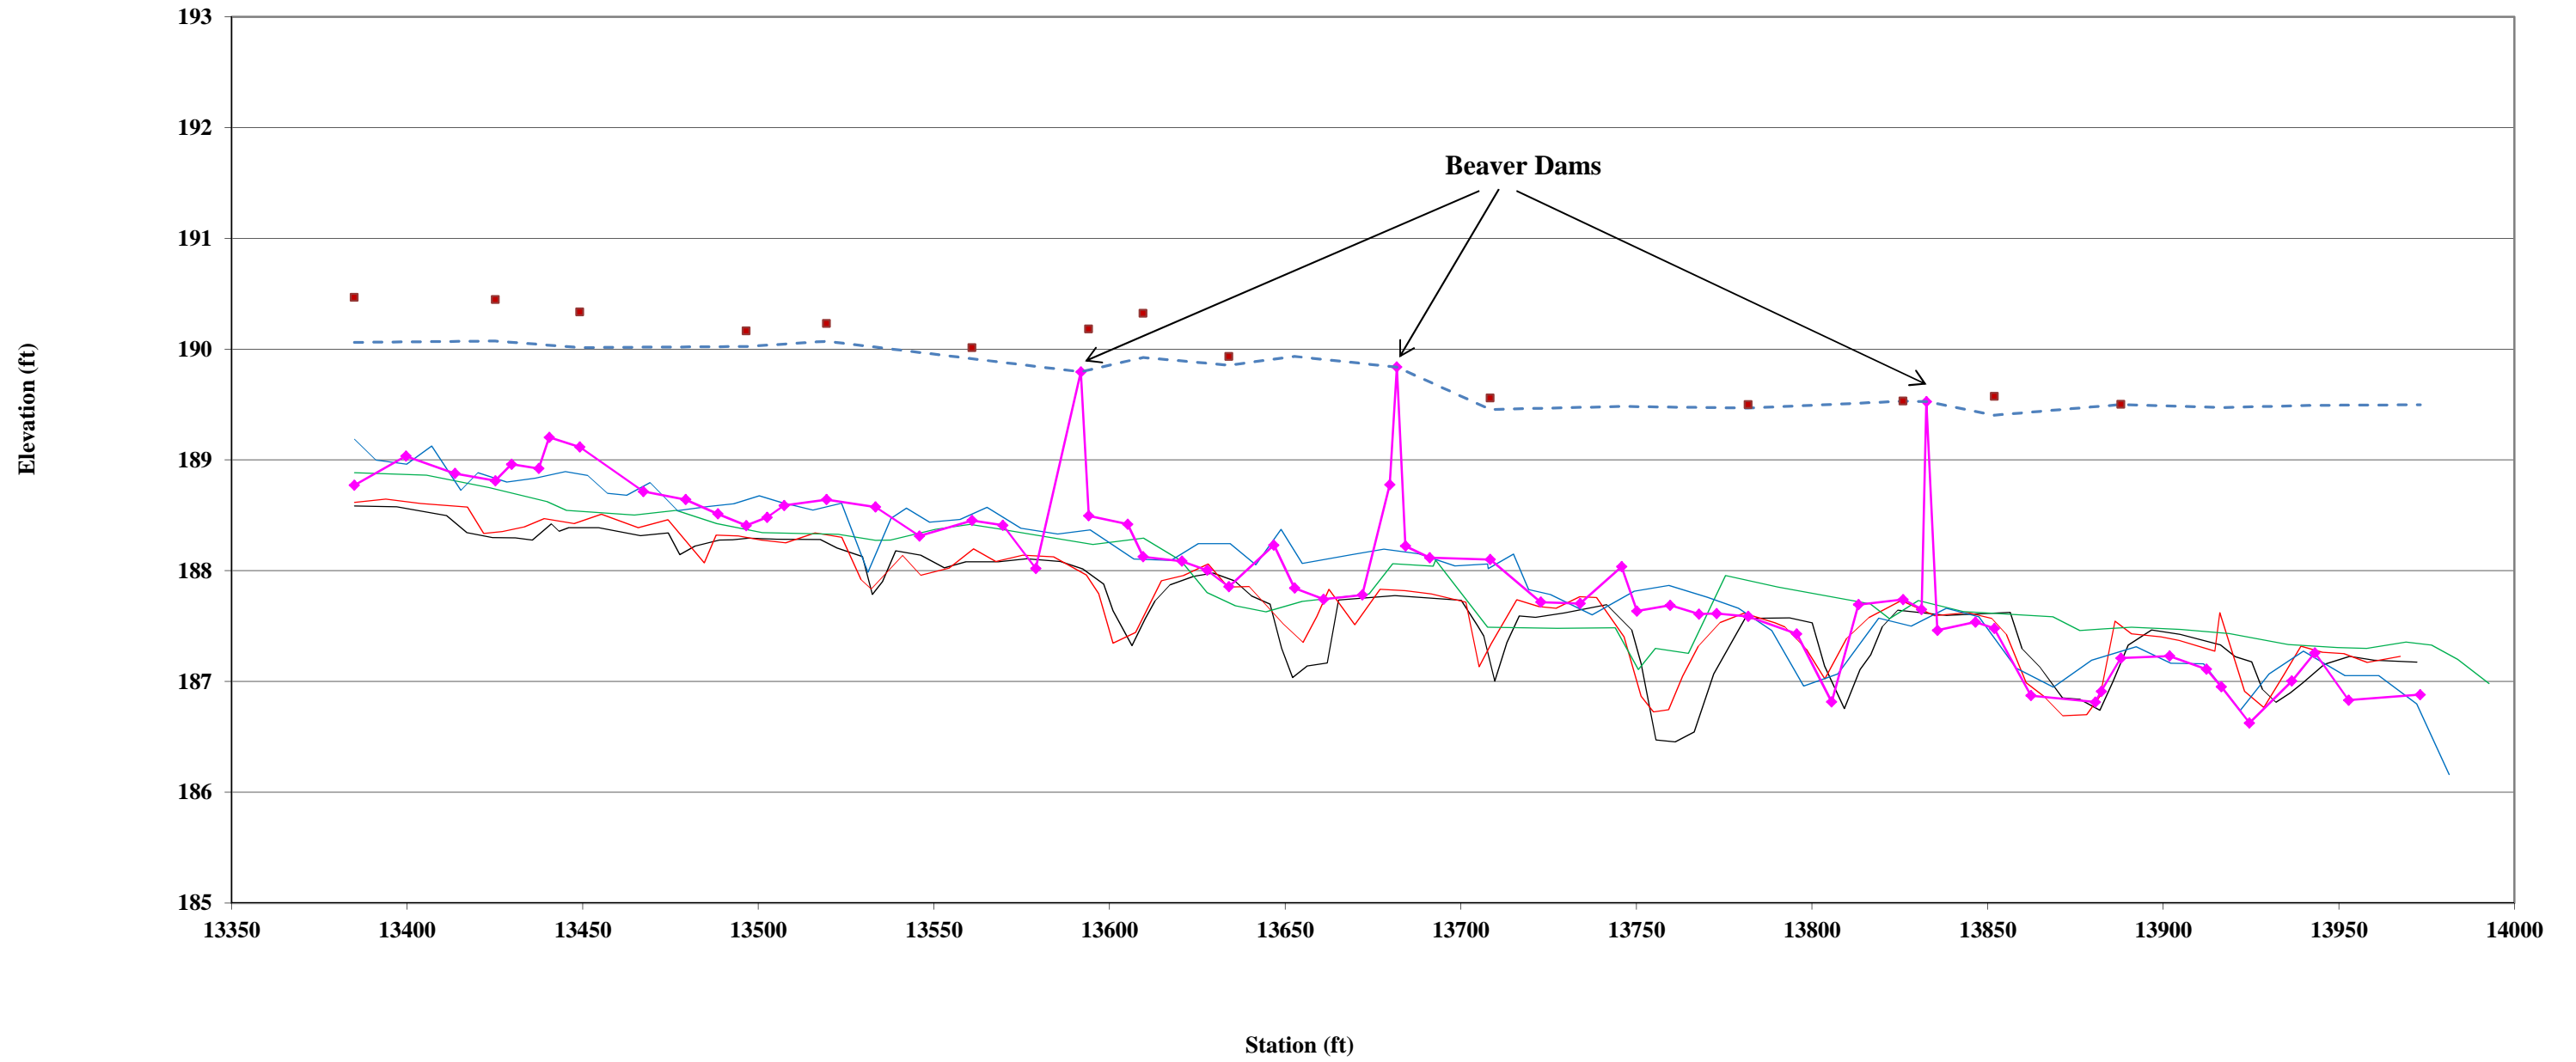
**Farrar Dairy Longitudinal Profile
Tributary 3 MY-04
Stations 133+85 - 139+73**

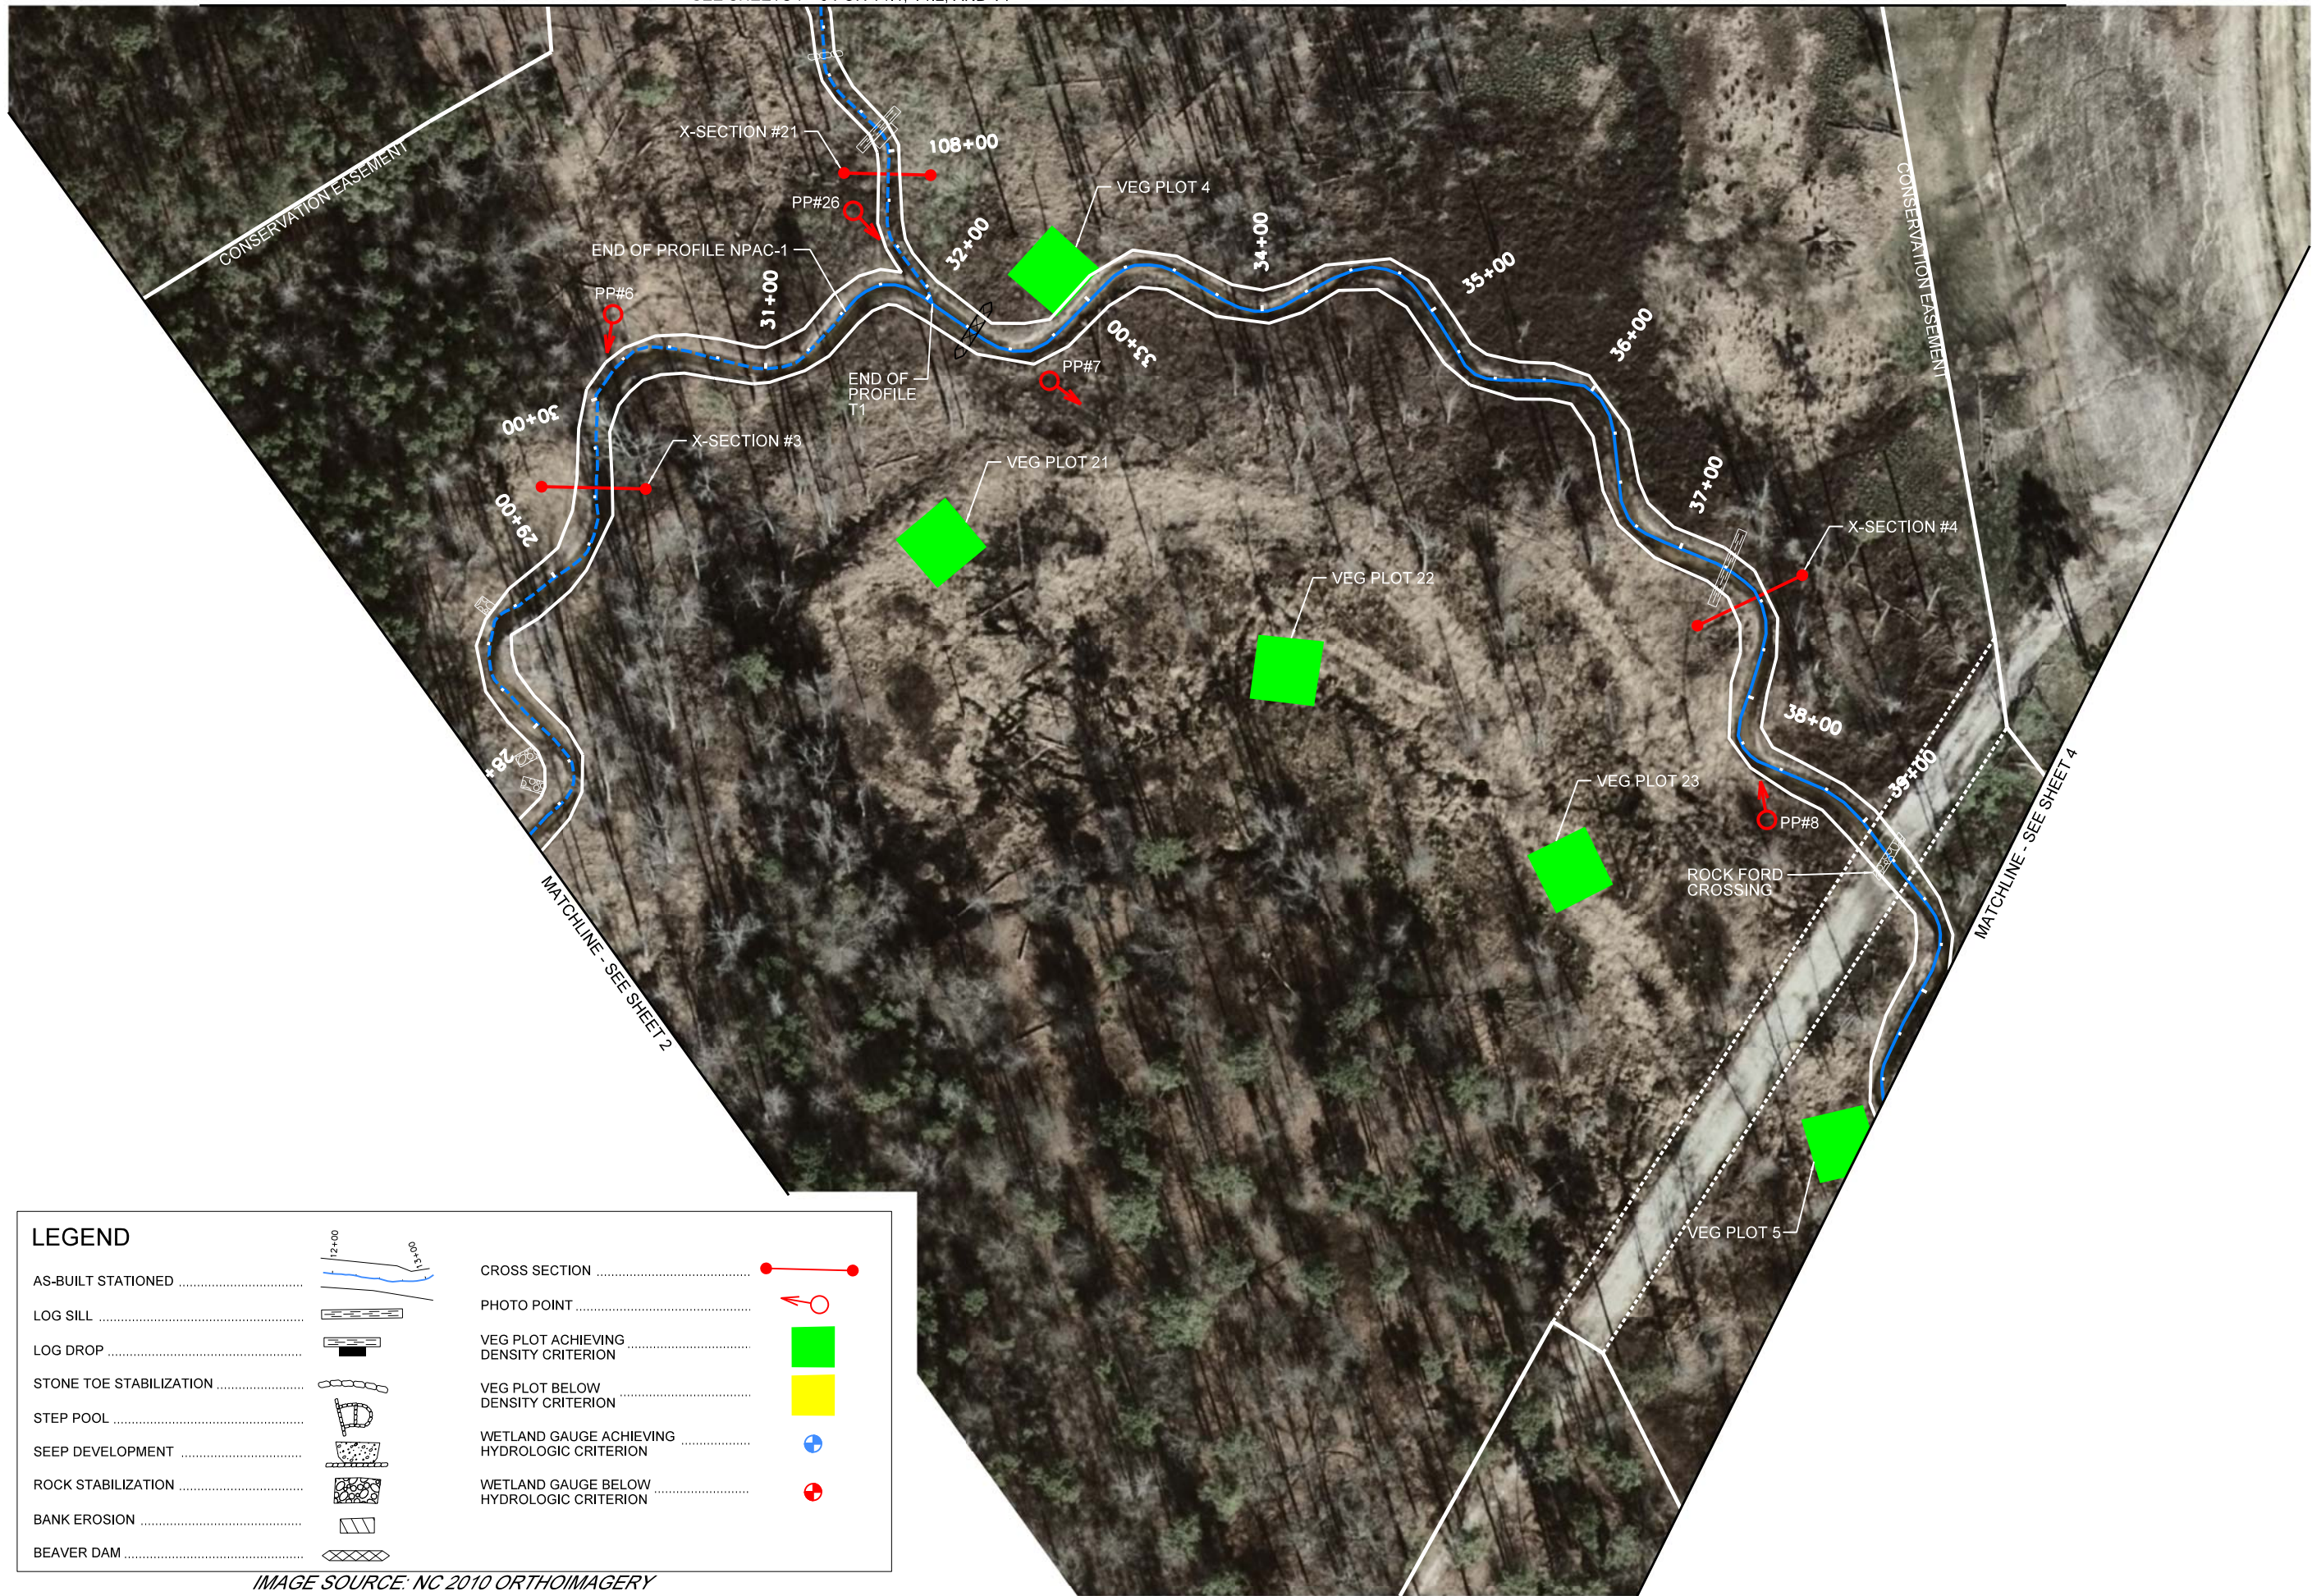
**FARRAR DAIRY
 STREAM AND WETLAND RESTORATION**
 LILLINGTON, HARNETT COUNTY, NORTH CAROLINA
 NPAC - STATION 27+17 TO STATION 40+51

DATE: DEC 2012
SCALE: 1"=80'
CURRENT CONDITION PLAN VIEW
SHEET 3 OF 11
