**Farrar Dairy Stream and Wetland Restoration Site
Monitoring Report – MY04
Harnett County, NC
EEP Project # 92552
EEP Contract # D06002**

January 2013

**Landmark Center II, Suite 220
4601 Six Forks Road
Raleigh, NC 27609
Phone: (919) 278-2512
Fax: (919) 783-9266**

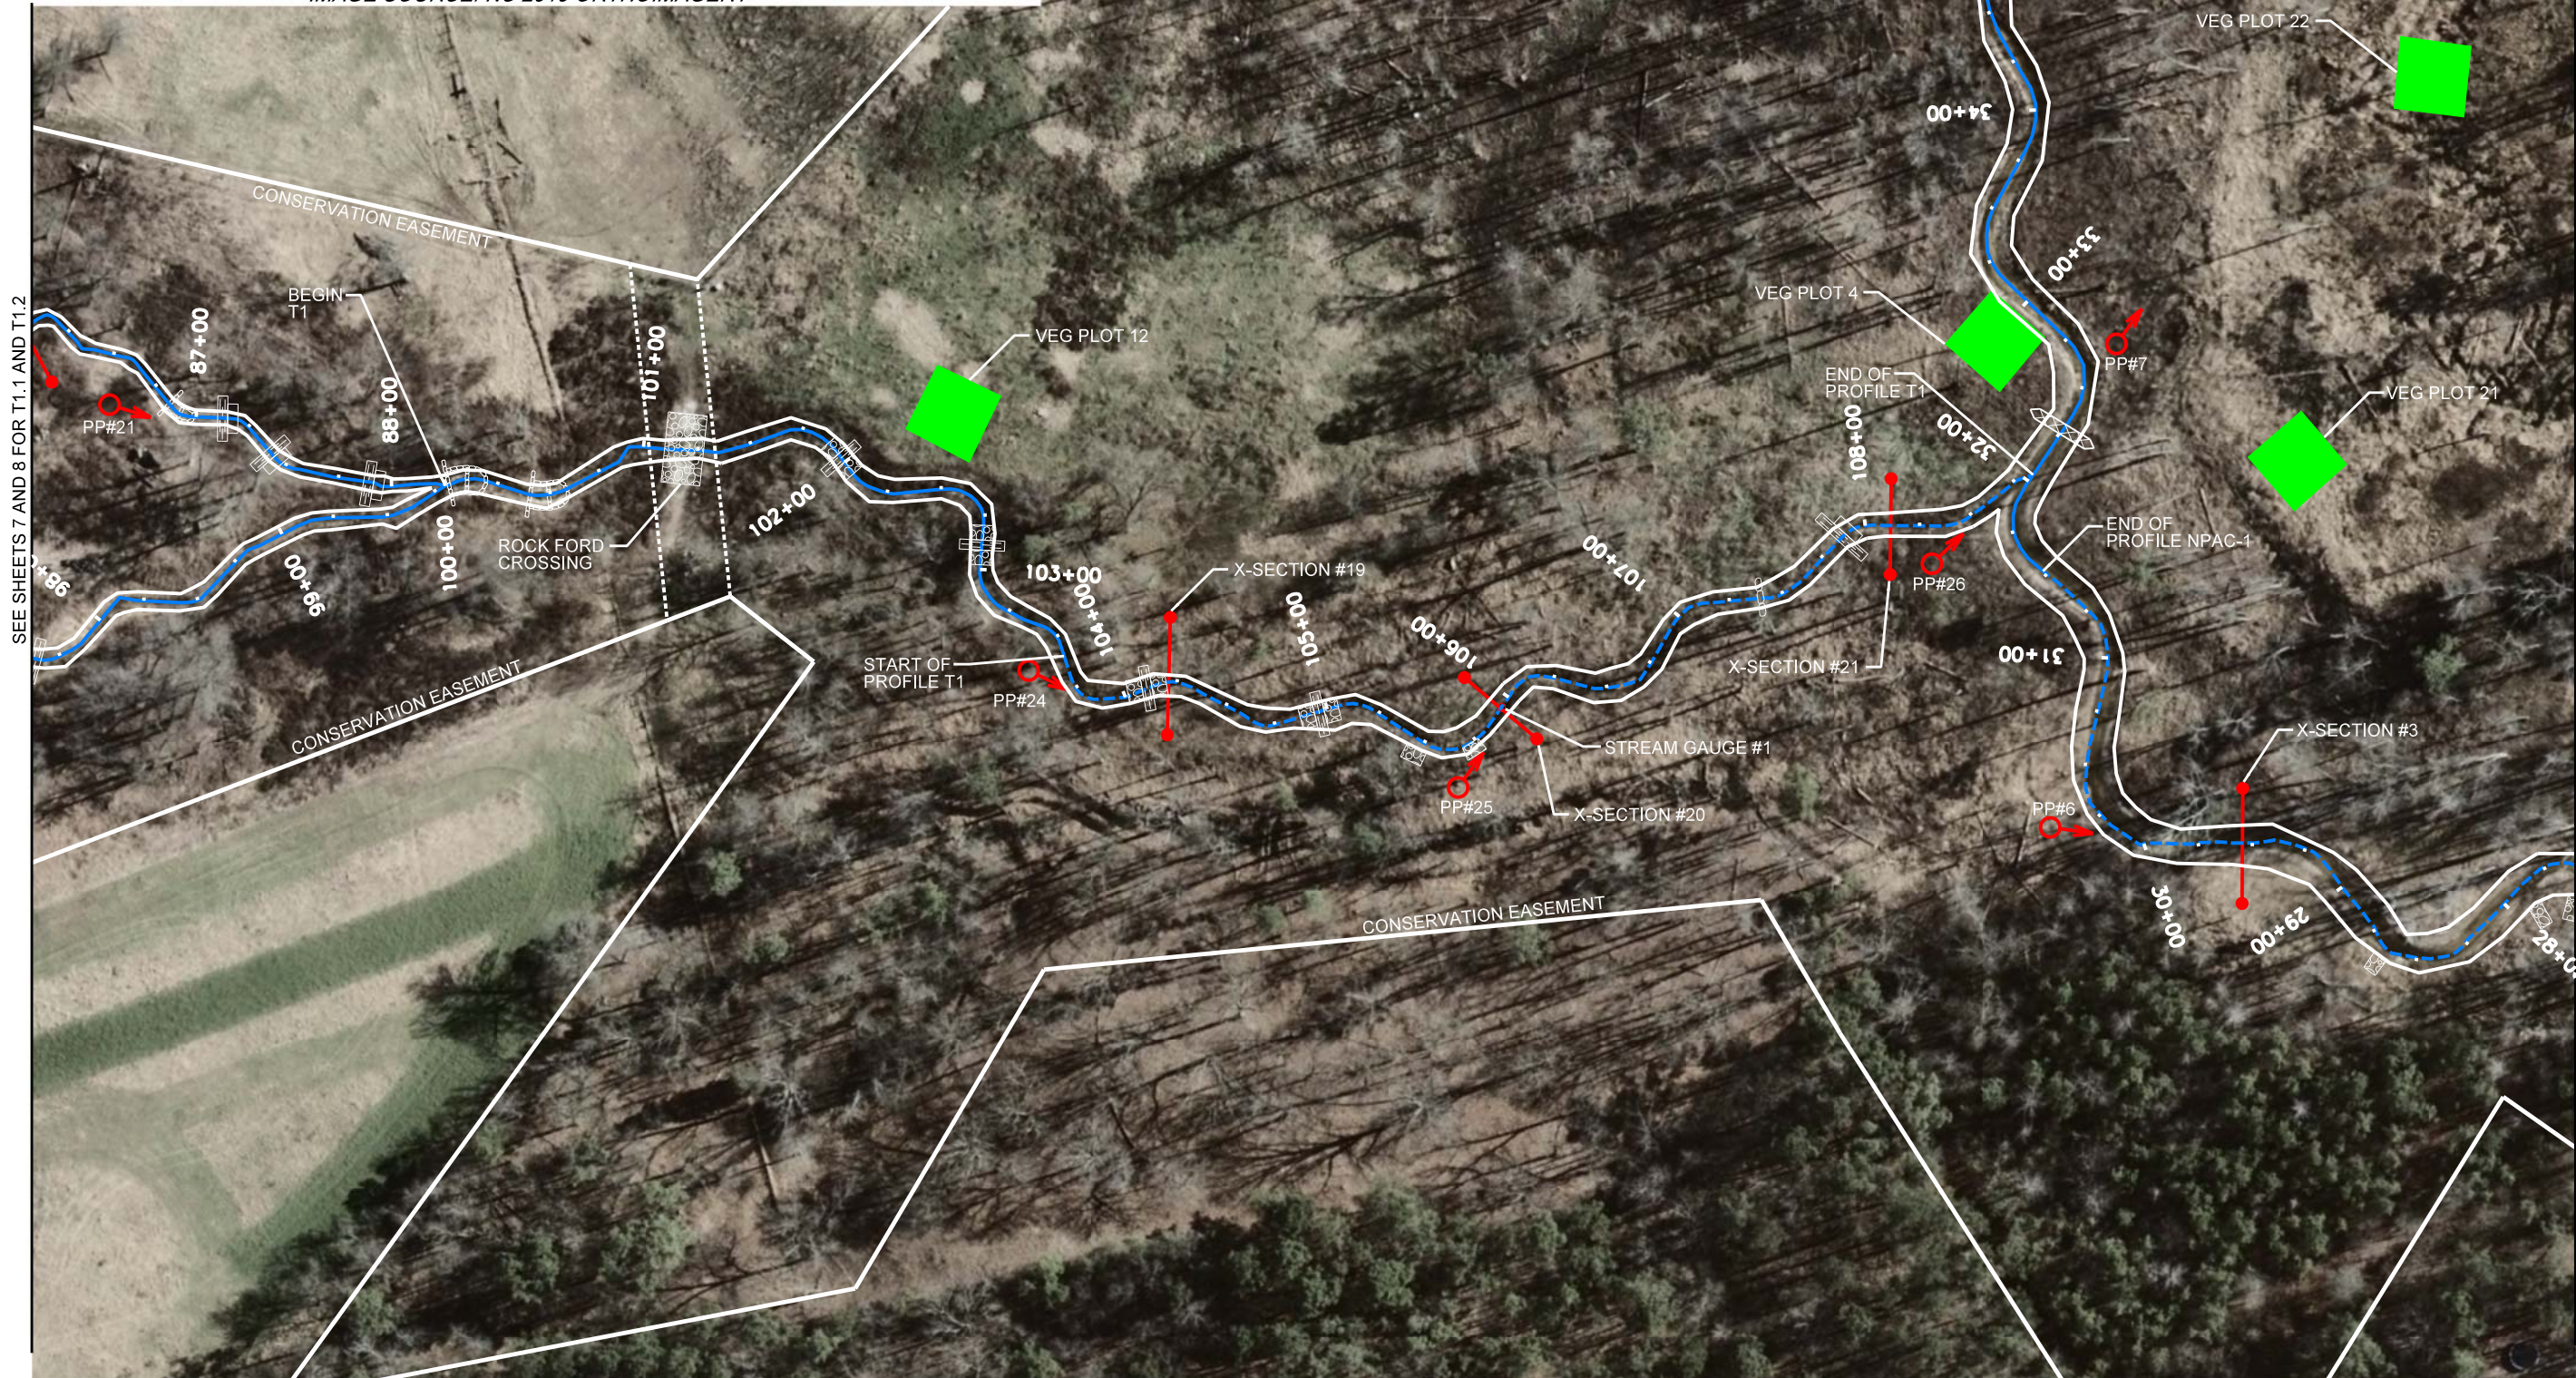
**FARRAR DAIRY
 STREAM AND WETLAND RESTORATION**
 LILLINGTON, HARNETT COUNTY, NORTH CAROLINA
 T1 - STATION 100+00 TO STATION 108+84

DATE: DEC 2012
 SCALE: 1"=80'
 CURRENT CONDITION PLAN VIEW
 SHEET 9 OF 11
