**Stream and Wetland Mitigation  
Plan Report for Five-Mile Branch**

Iredell County, North Carolina

December 2009

Prepared by:  
ARCADIS G&M of North Carolina, Inc.  
801 Corporate Center Drive  
Suite 300  
Raleigh  
North Carolina 27607  
Tel 919.854.1282  
Fax 919.854.5448

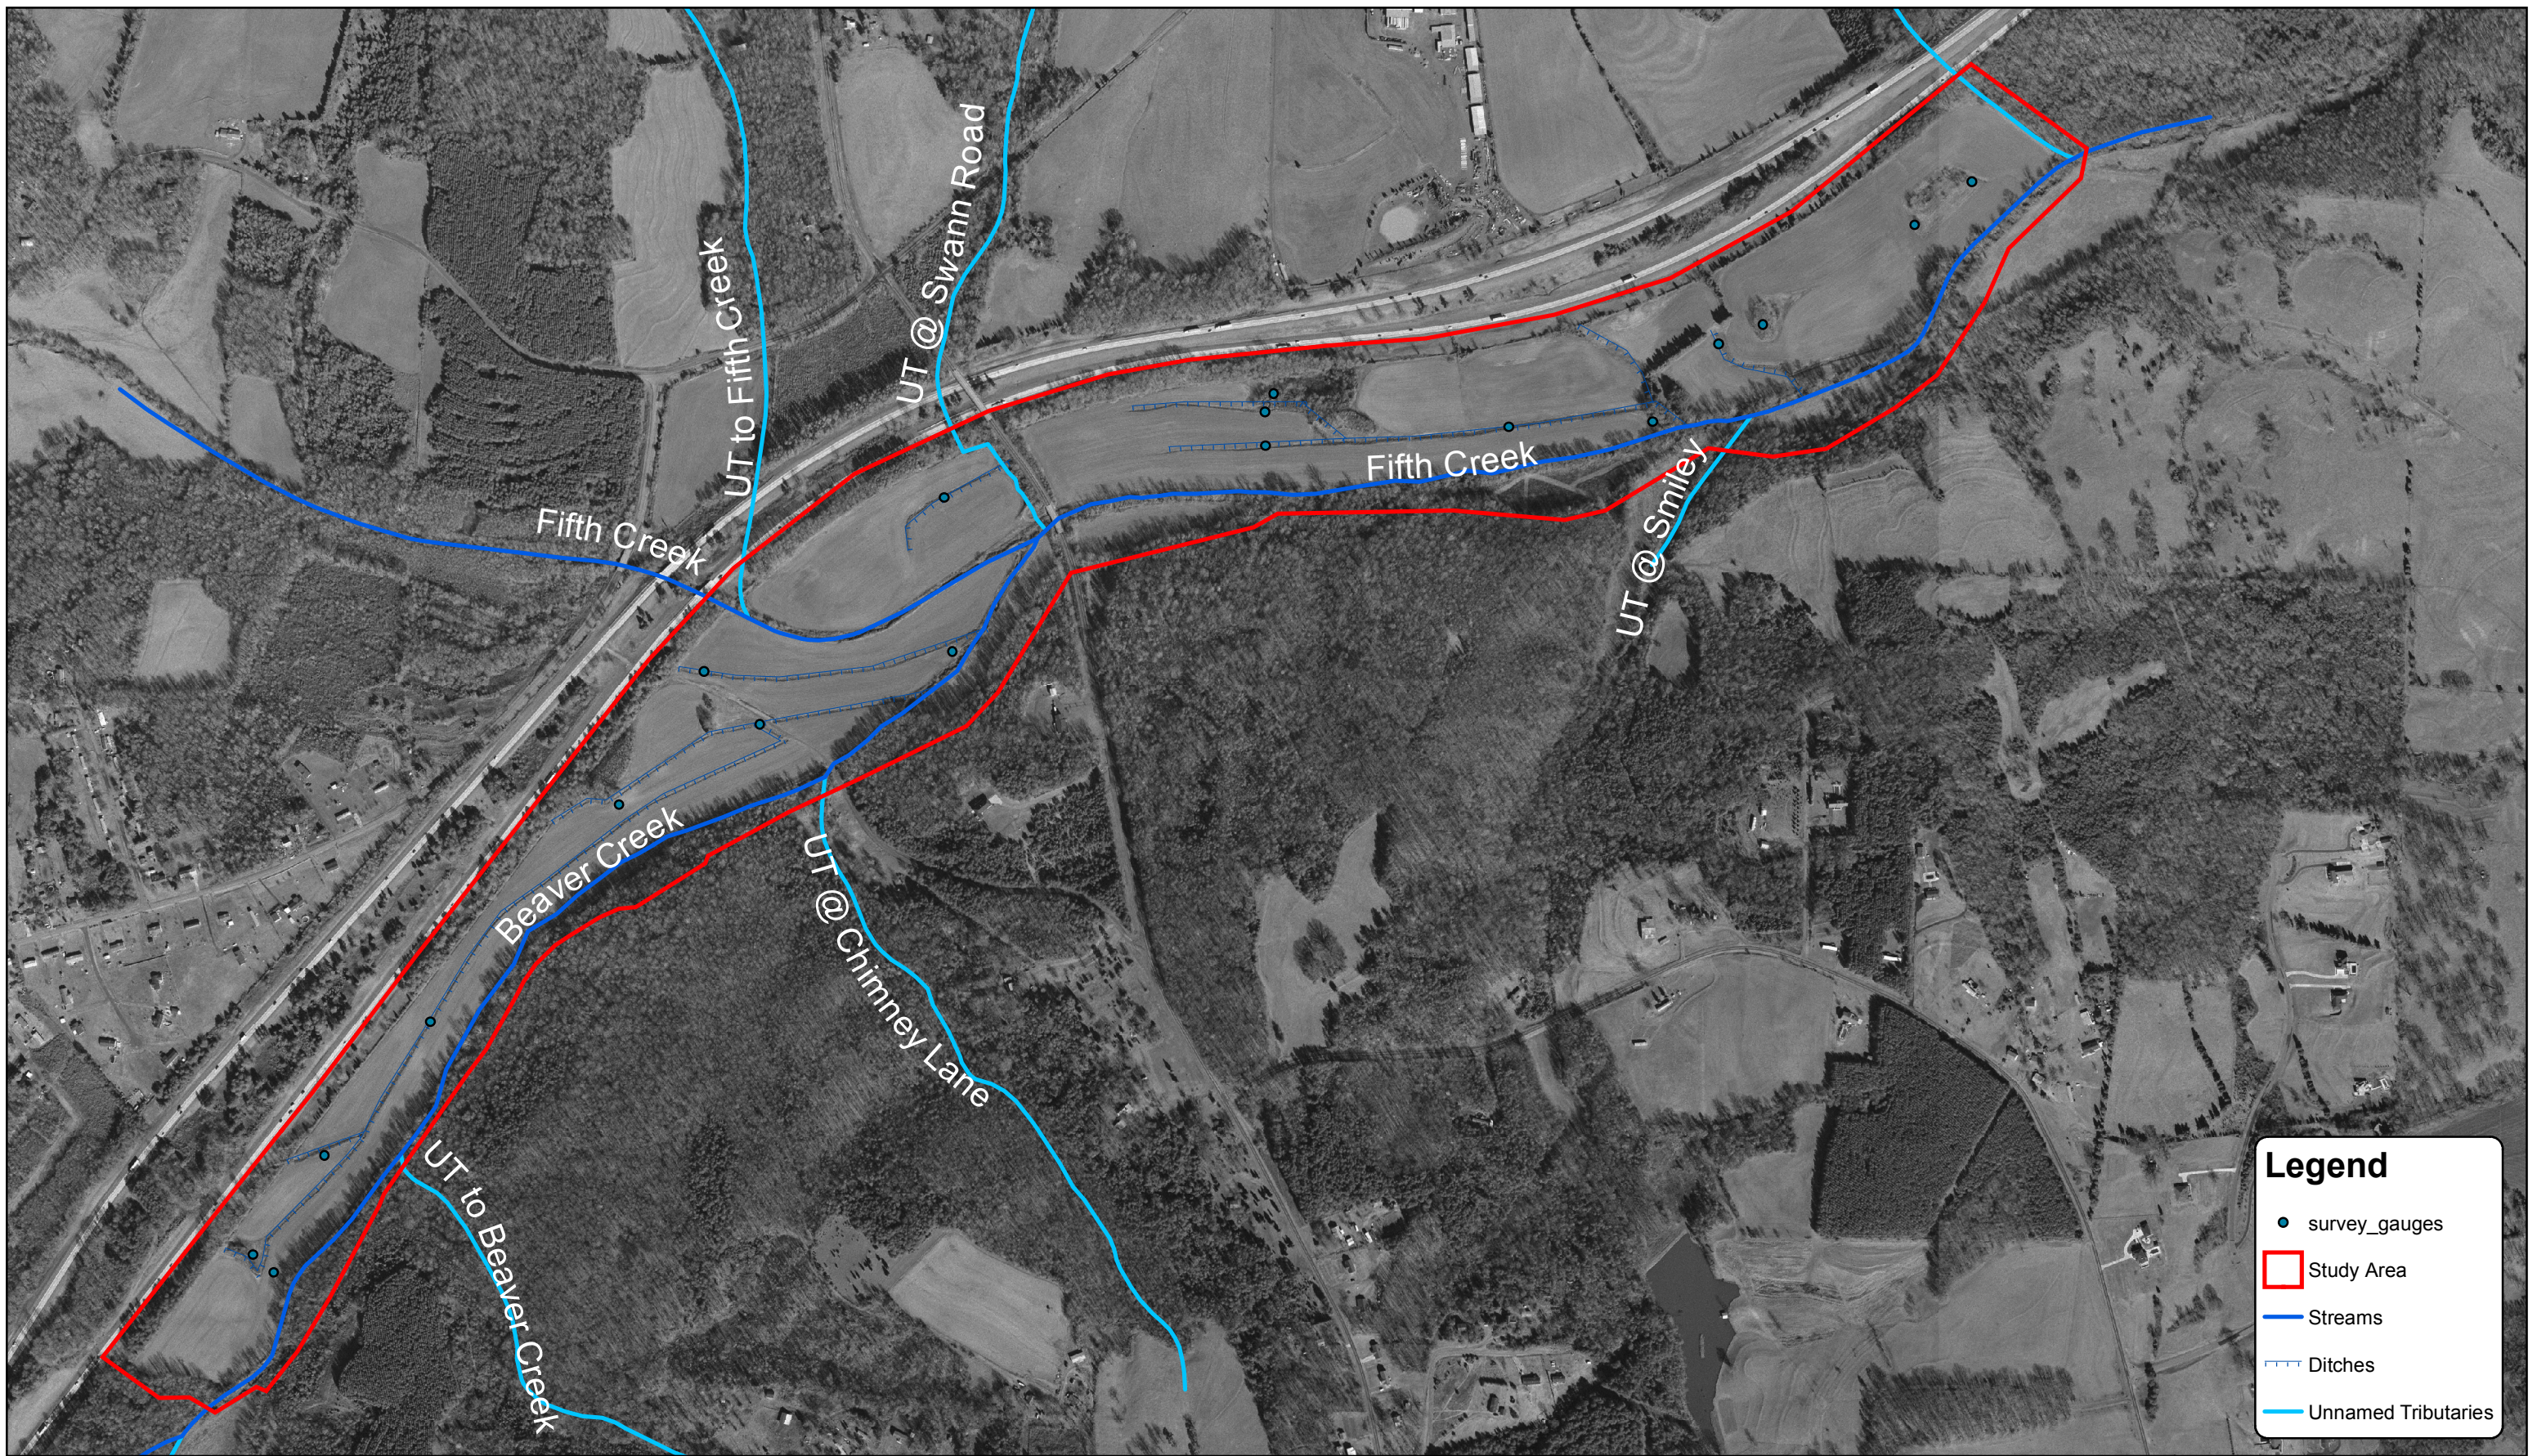
**Figure No.**  
**4**

**Hydrologic Features and Gauge Locations**  
**Five Mile Branch**  
**Stream and Wetland Restoration Site**  
**Iredell County, North Carolina**

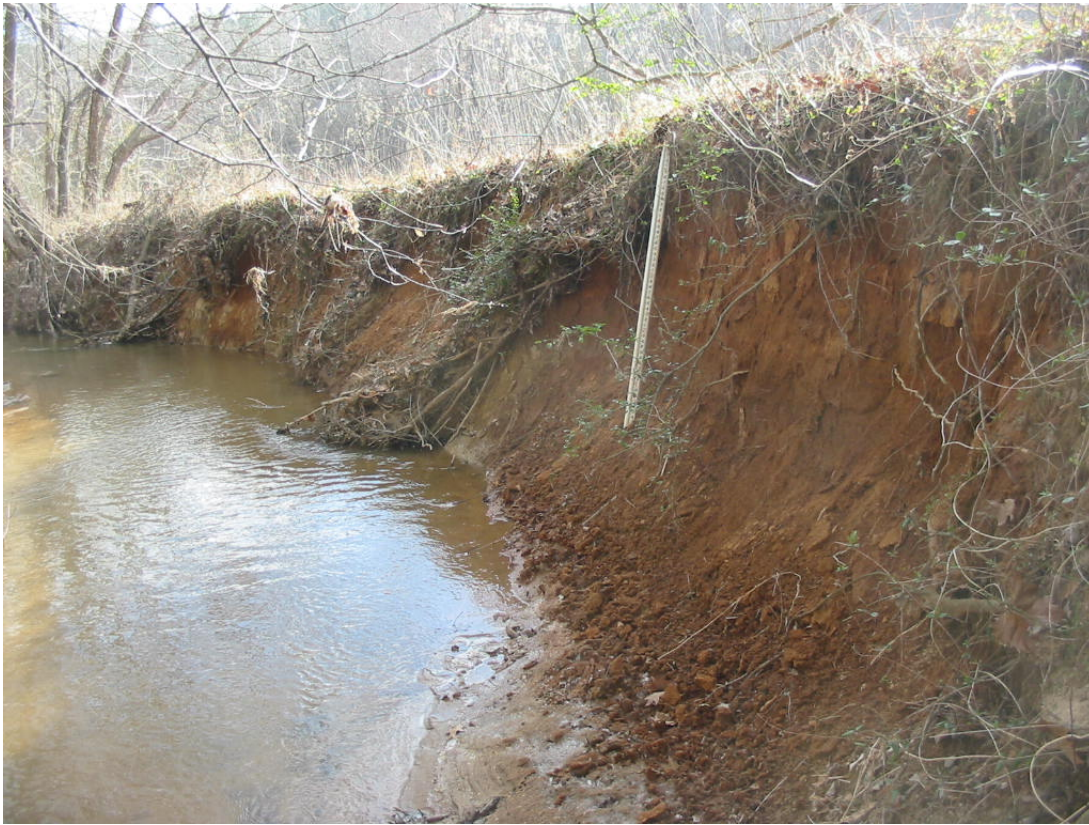
Photo 1: Typical eroding bank on Beaver Creek

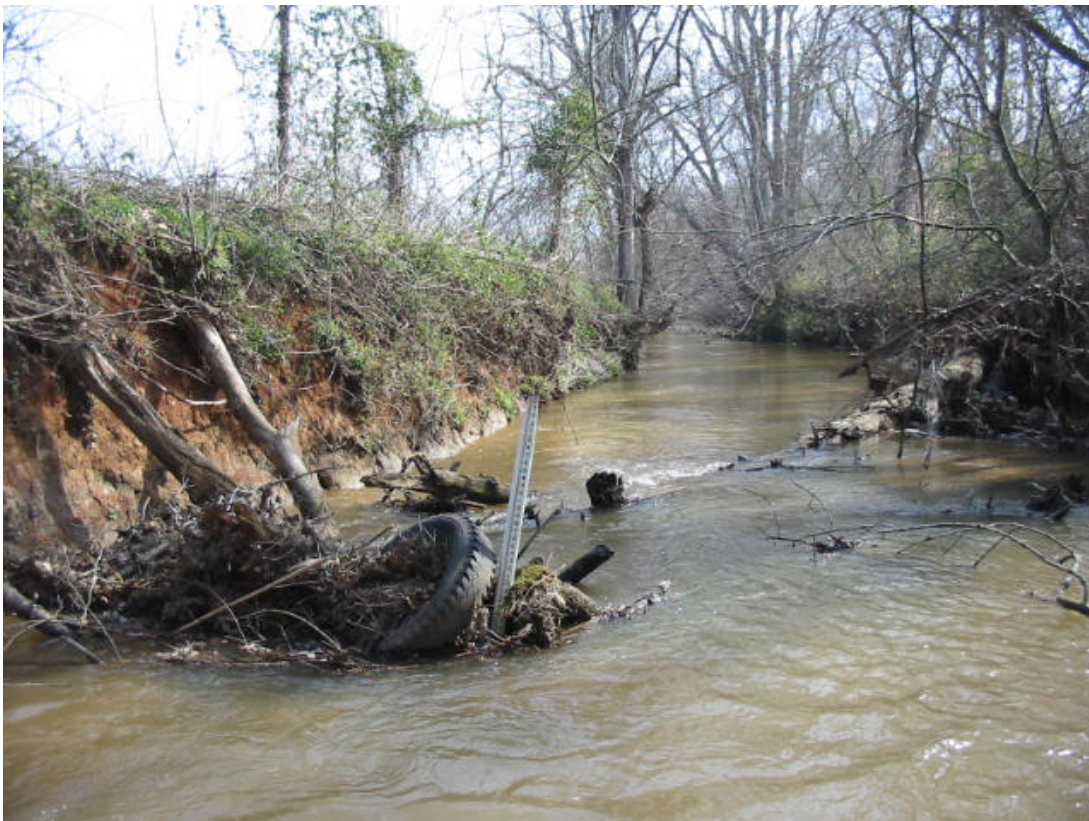
Photo 2: Typical debris jam on Beaver Creek

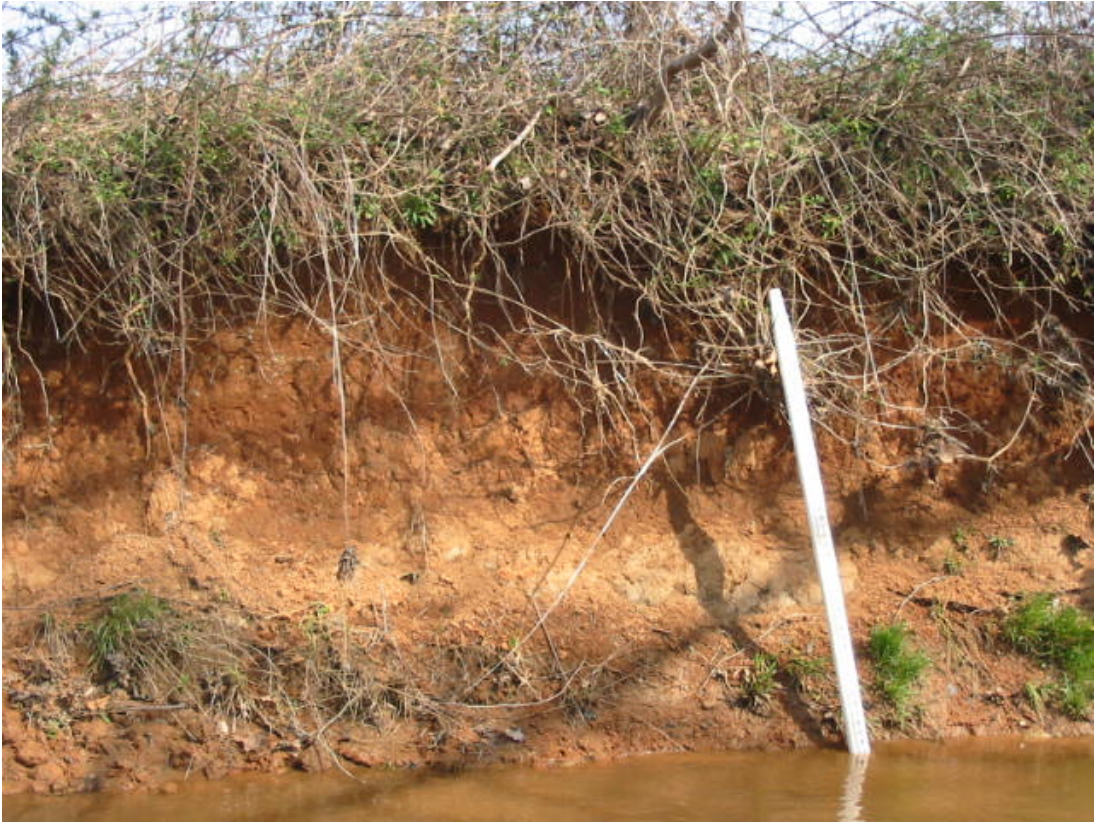
Photo 3: Eroding bank on Beaver Creek

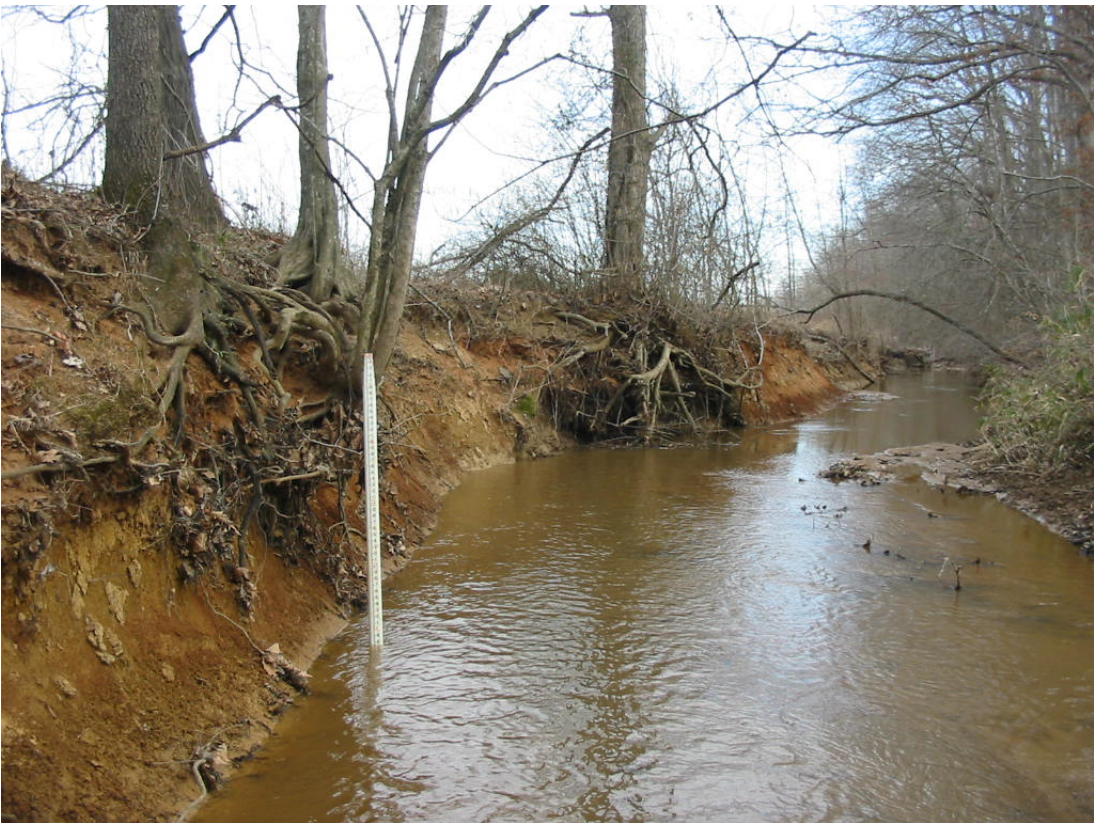
Photo 4: Eroding bank On Beaver Creek

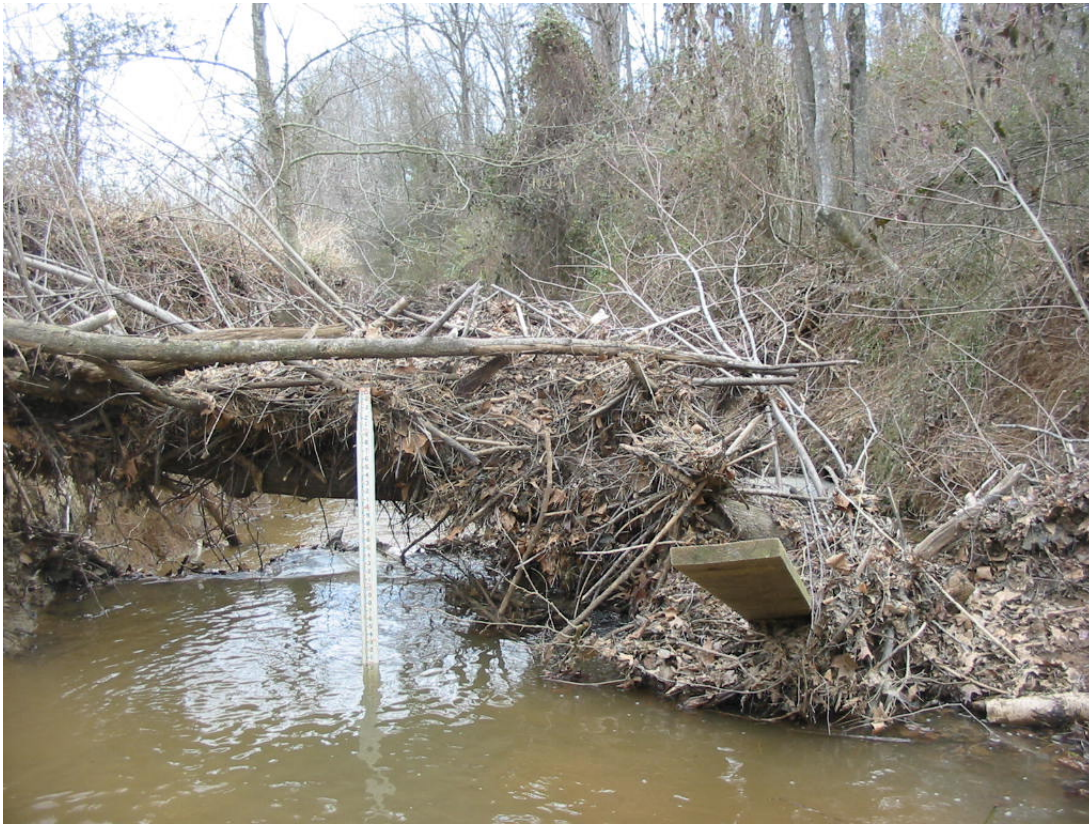
Photo 5: Log jam on Beaver Creek

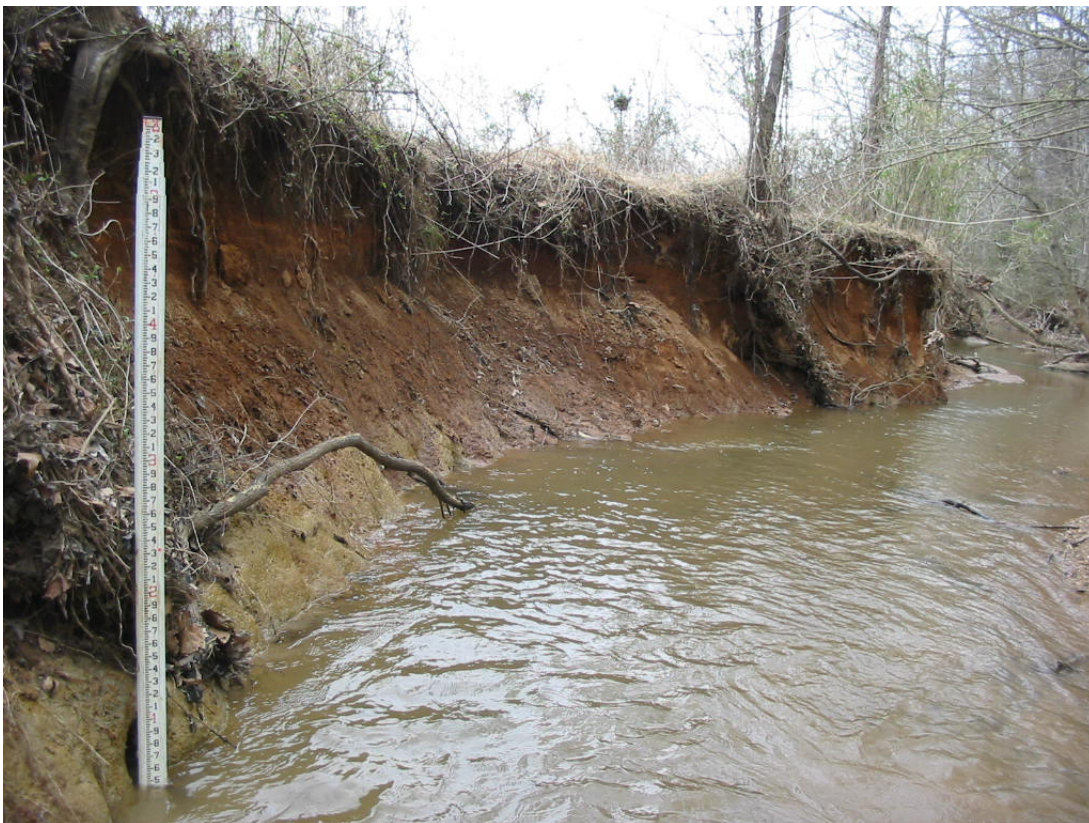
Photo 6: Eroding bank On Beaver Creek.

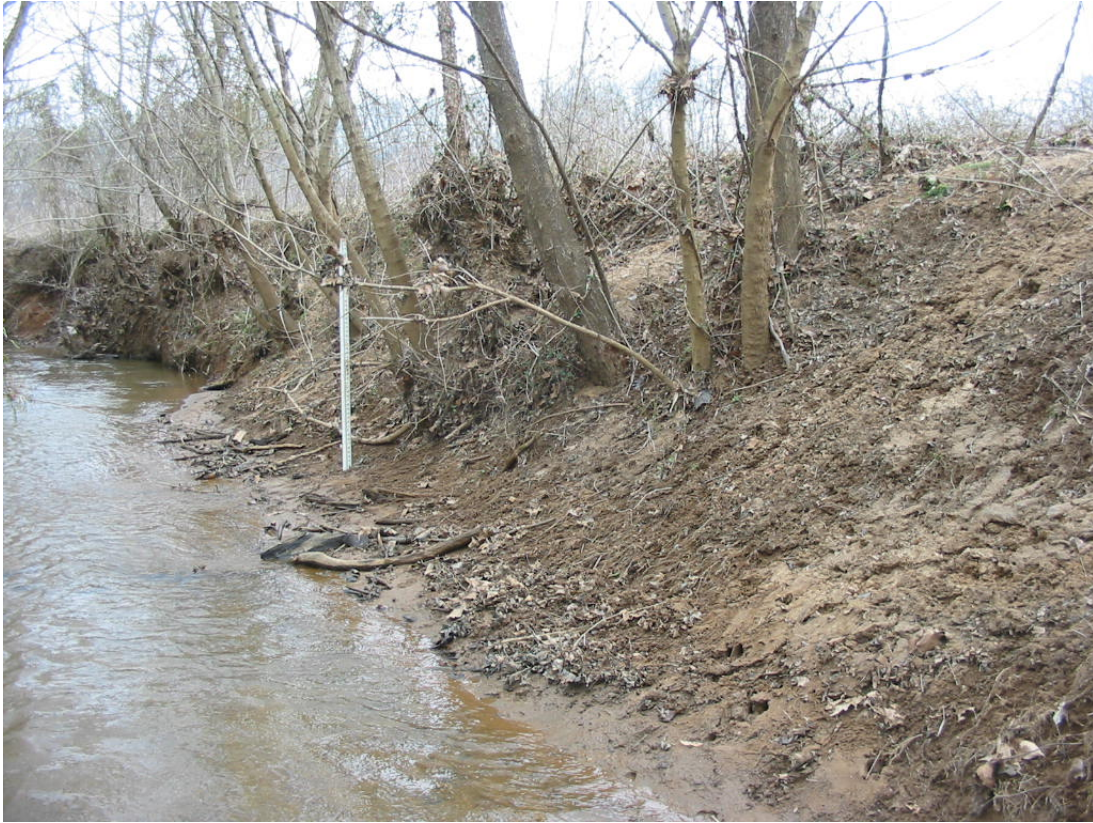
Photo 7: Stable bank on Fifth Creek

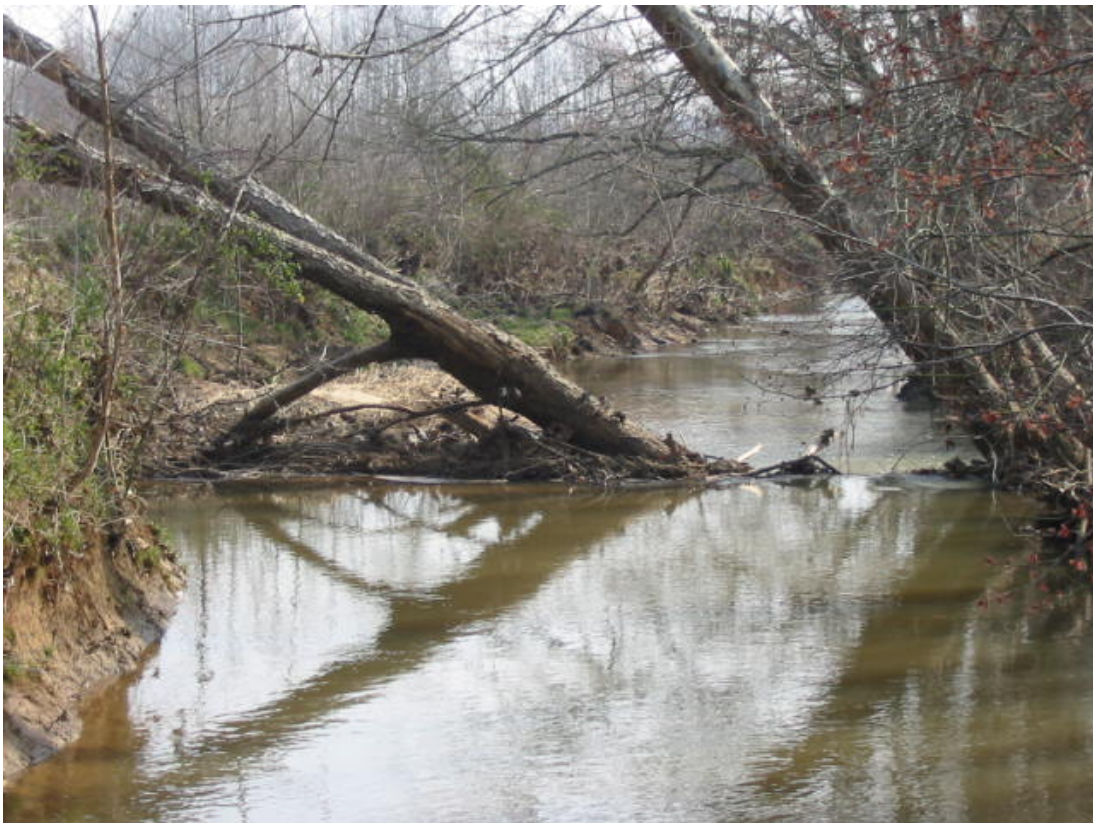
Photo 8: Log jam on Fifth Creek

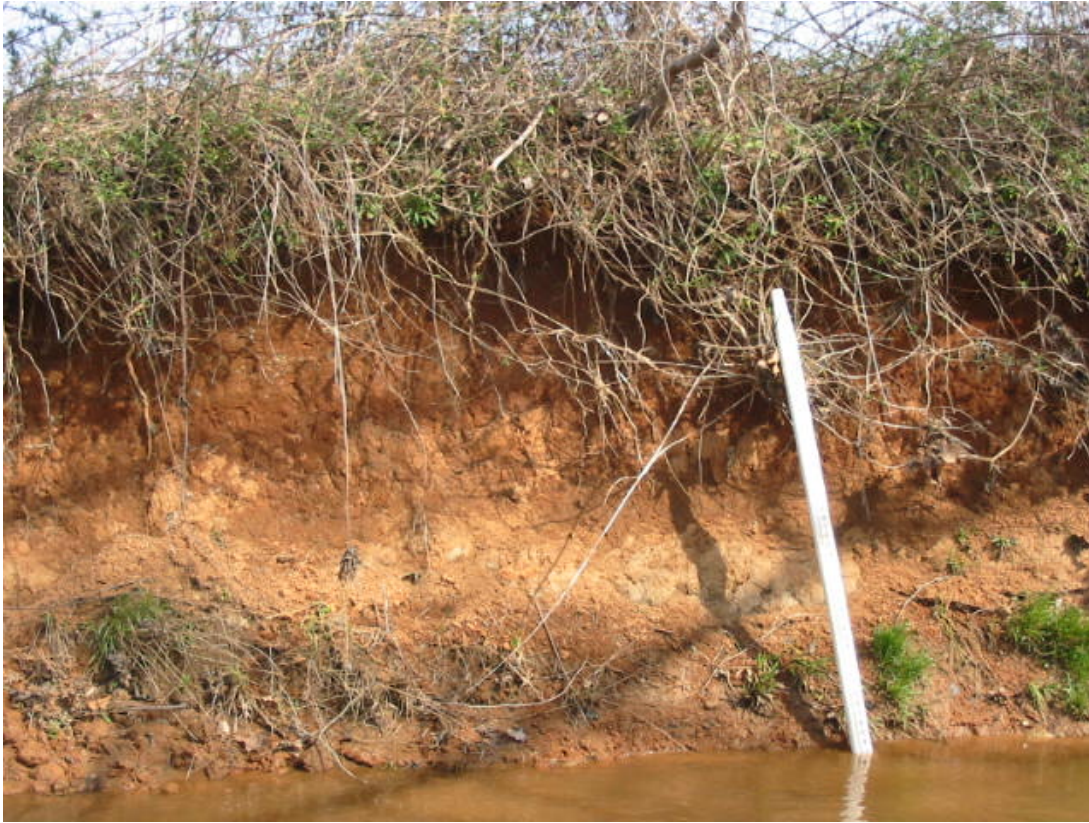
Photo 9: Eroding bank on Fifth Creek

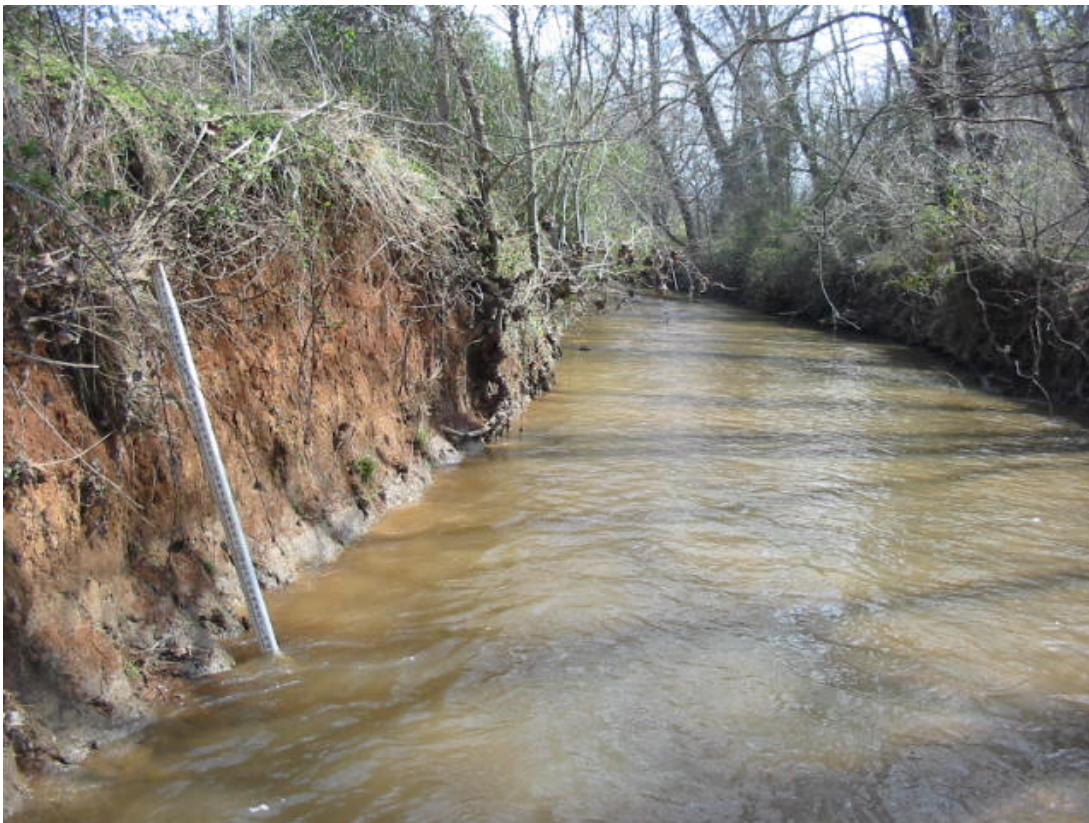
Photo 10: Typical eroding bank on Fifth Creek and moderate right bank

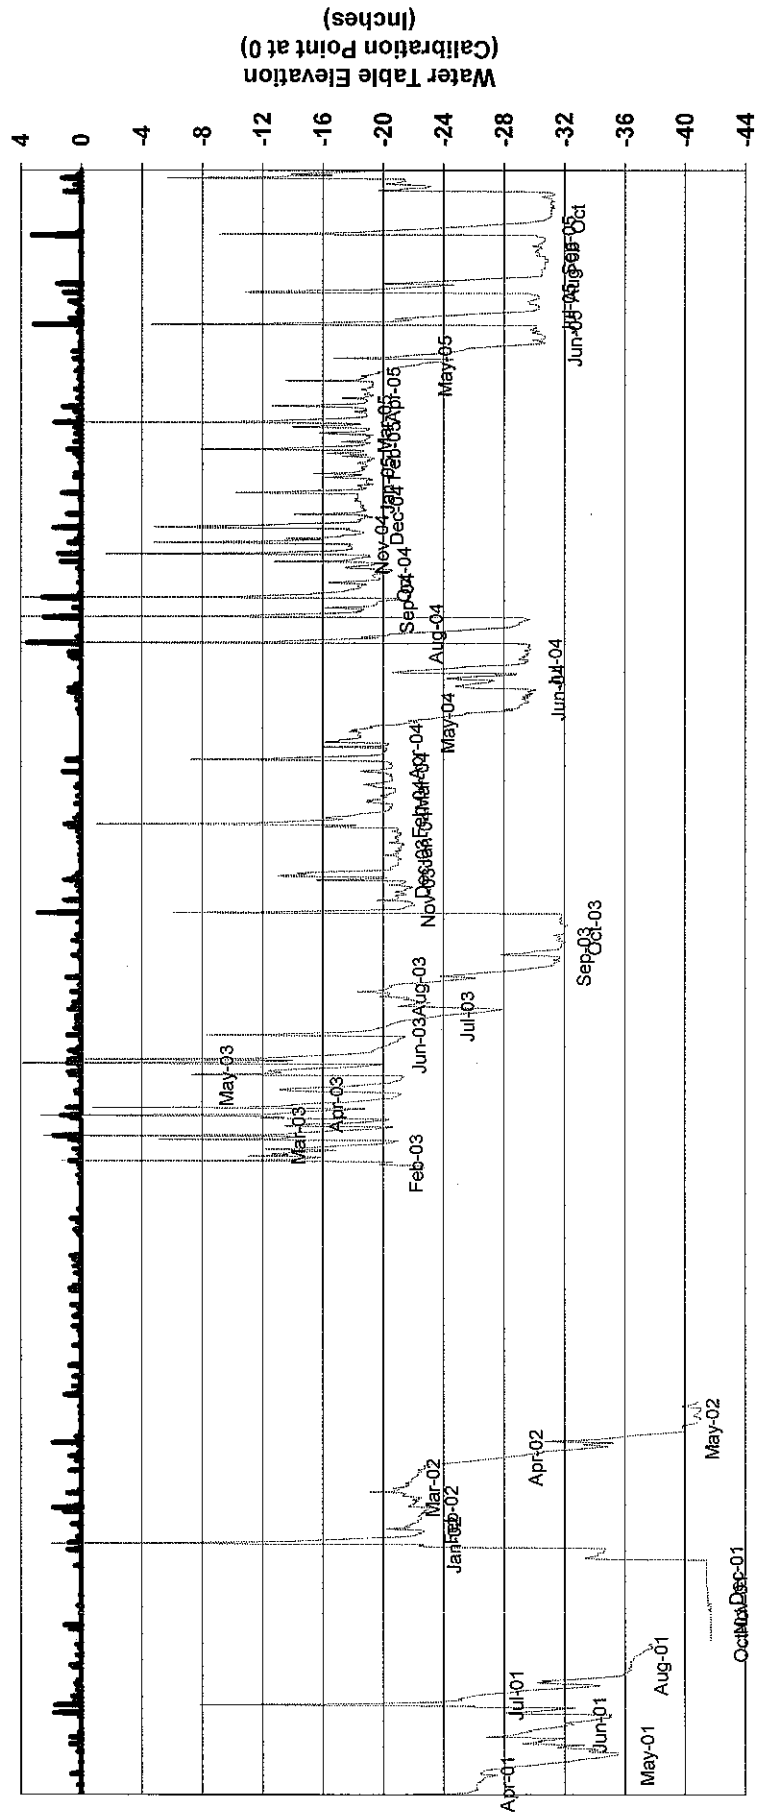
**Gauge Location No. 7  
Monitoring Period  
Apr. 3, 2001 to December 13, 2005**
