# *Mitigation Plan*

## **Third Fork Creek, Forest Hills Park Durham, North Carolina**

**December 2005**

**KCI Associates of North Carolina, P.A.  
Landmark Center II, Suite 220  
4601 Six Forks Road  
Raleigh, North Carolina 27609**

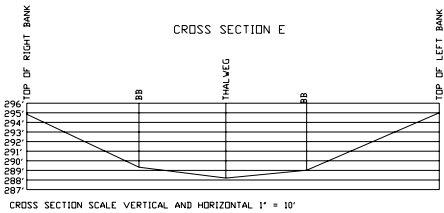
CROSS SECTION SCALE VERTICAL AND HORIZONTAL 1" = 10'
