MONITORING YEAR 7 ANNUAL REPORT

FOUST CREEK MITIGATION SITE

Alamance County, NC

DMS Project Number 95715

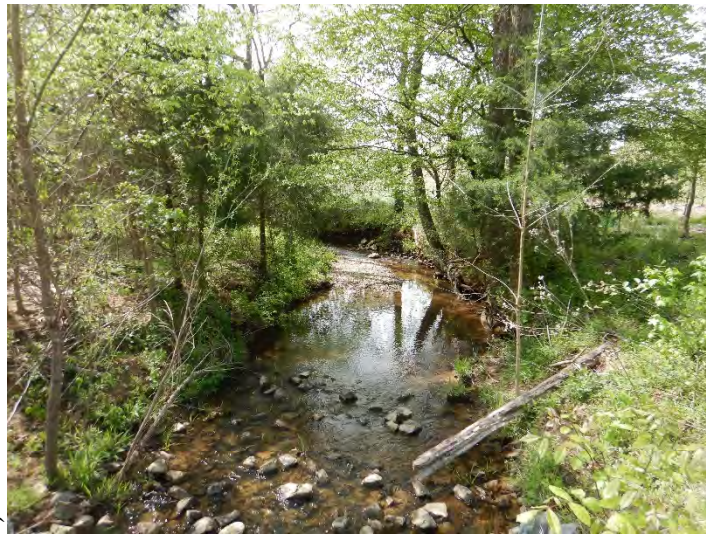
PHOTO POINT 1 Foust Creek R1 – looking downstream (4/20/2021)

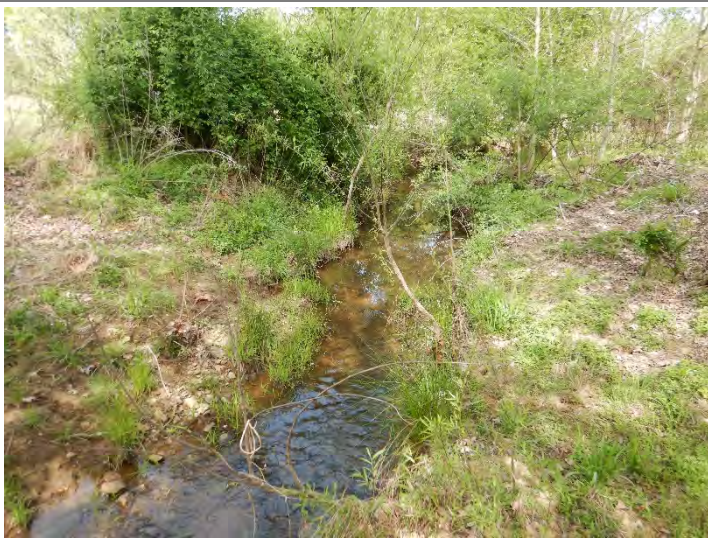
PHOTO POINT 2 Foust Creek R1 – looking upstream (4/20/2021)

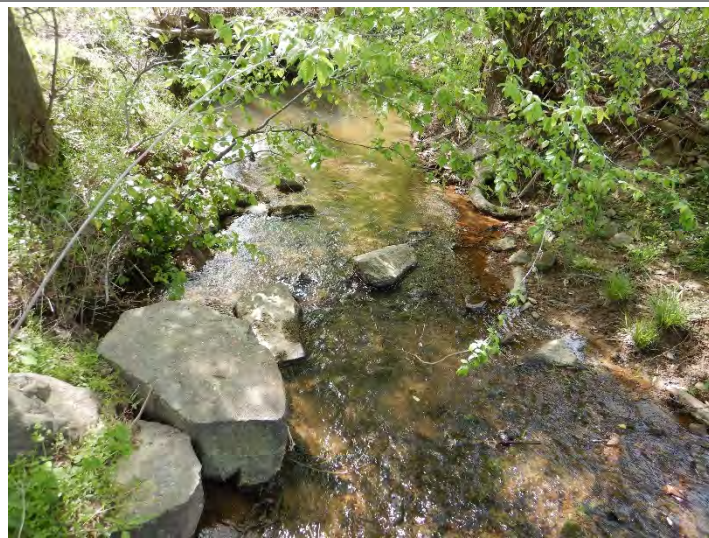
PHOTO POINT 2 Foust Creek R1 – looking downstream (4/20/2021)

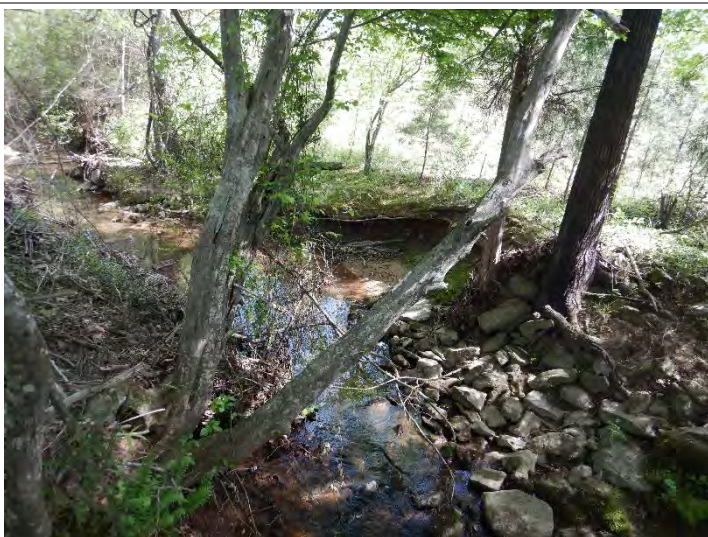
PHOTO POINT 3 Foust Creek R1 – looking upstream (4/20/2021)

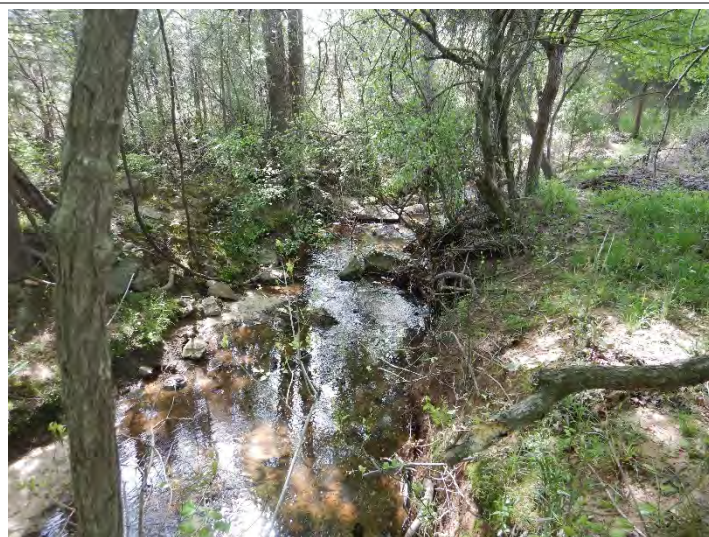
PHOTO POINT 3 Foust Creek R1 – looking downstream (4/20/2021)

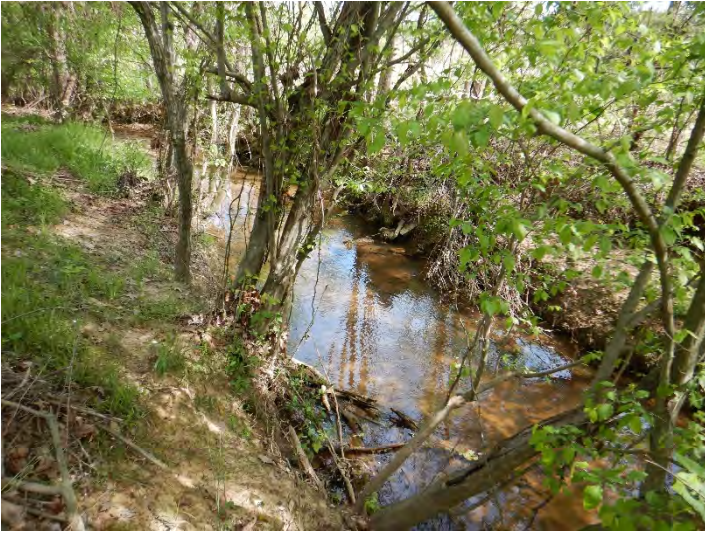
PHOTO POINT 4 Foust Creek R1 – looking upstream (4/20/2021)

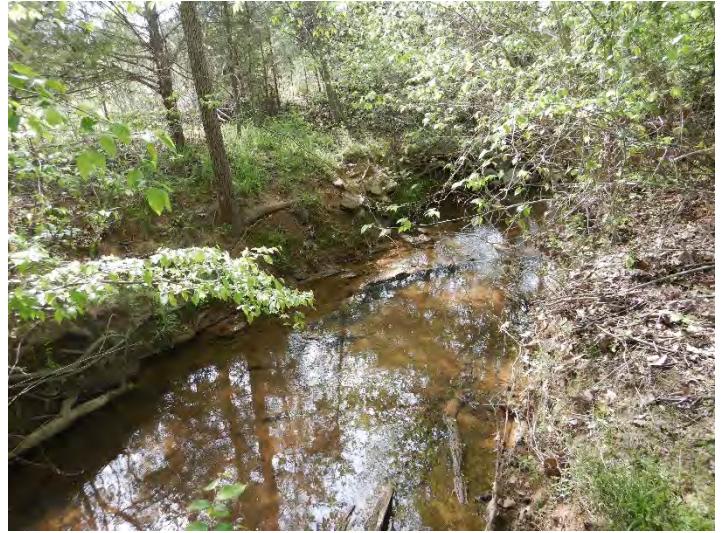
PHOTO POINT 4 Foust Creek R1 – looking downstream (4/20/2021)

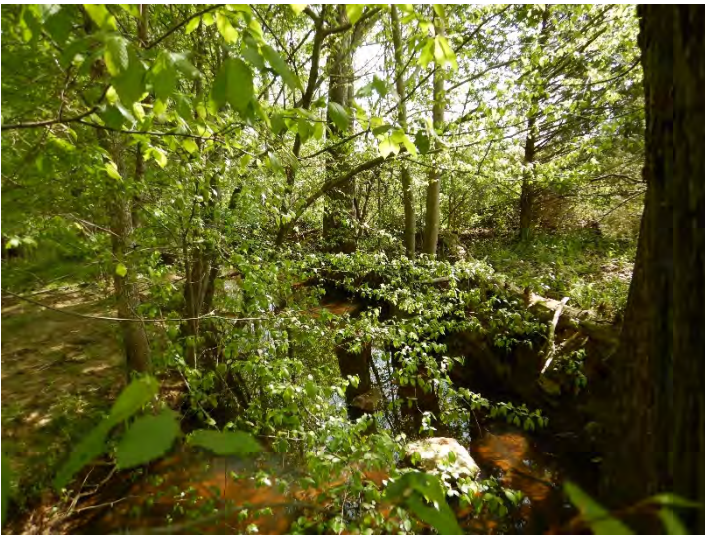
PHOTO POINT 5 Foust Creek R1 – looking upstream (4/20/2021)

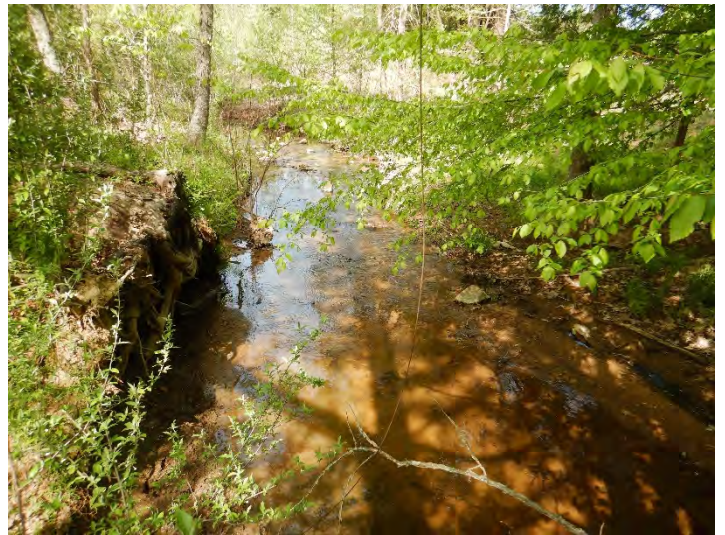
PHOTO POINT 5 Foust Creek R1 – looking downstream (4/20/2021)

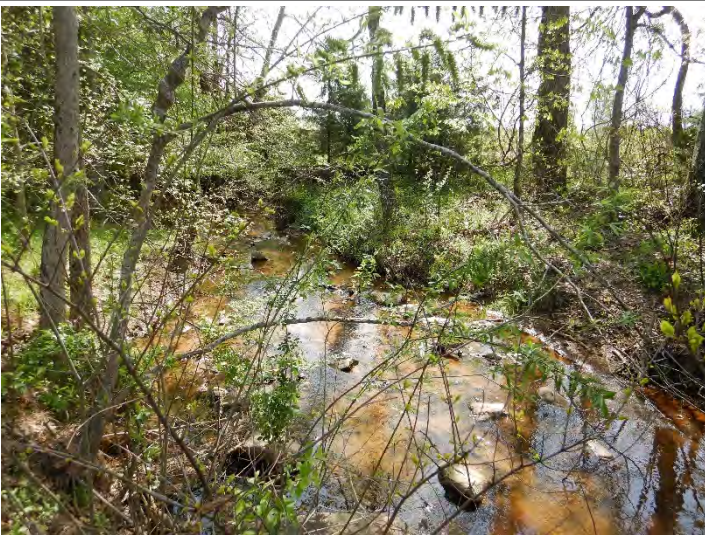
PHOTO POINT 6 Foust Creek R2 – looking upstream (4/20/2021)

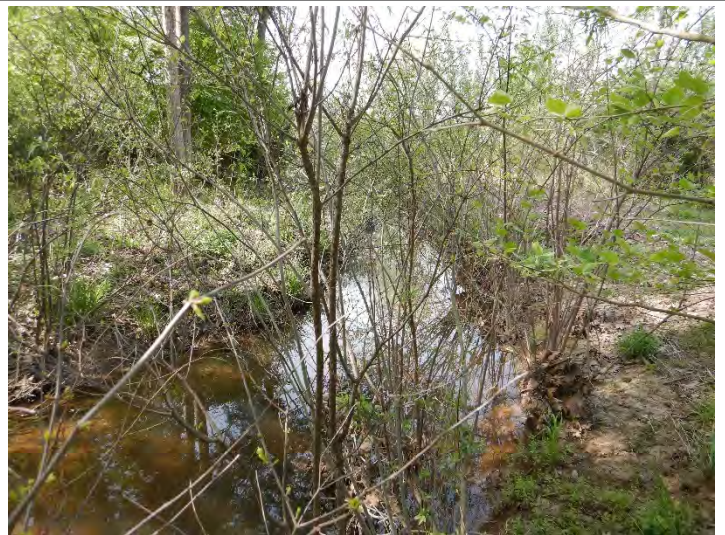
PHOTO POINT 6 Foust Creek R2 – looking downstream (4/20/2021)

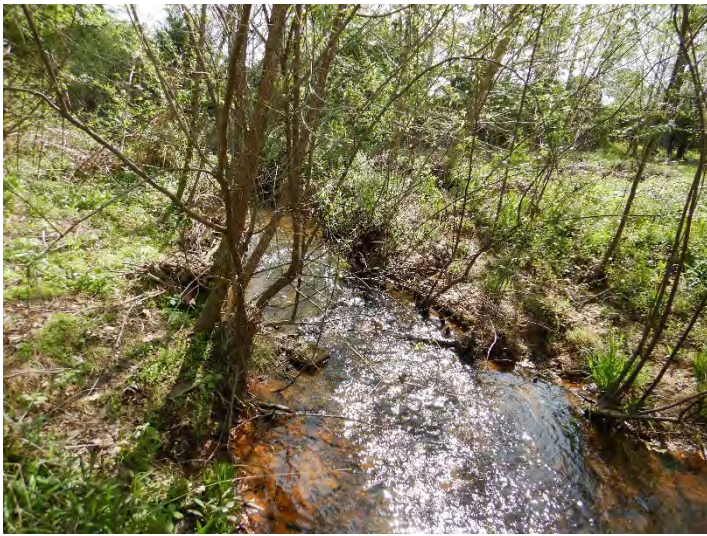
PHOTO POINT 7 Foust Creek R2 – looking upstream (4/20/2021)

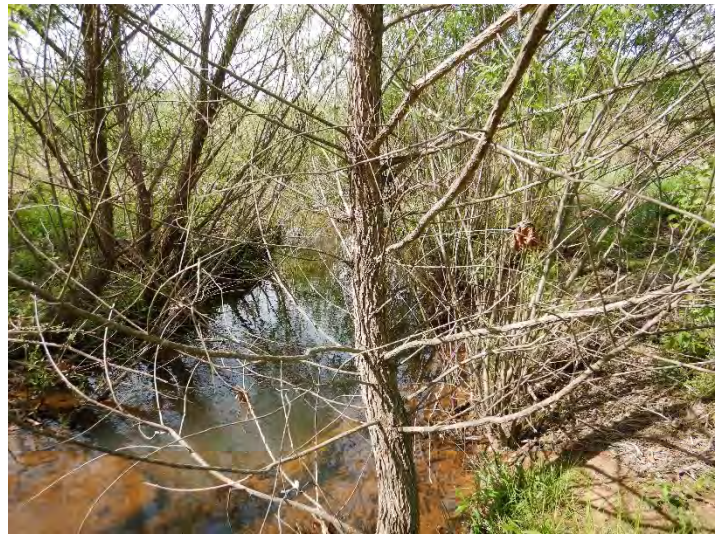
PHOTO POINT 7 Foust Creek R2 – looking downstream (4/20/2021)

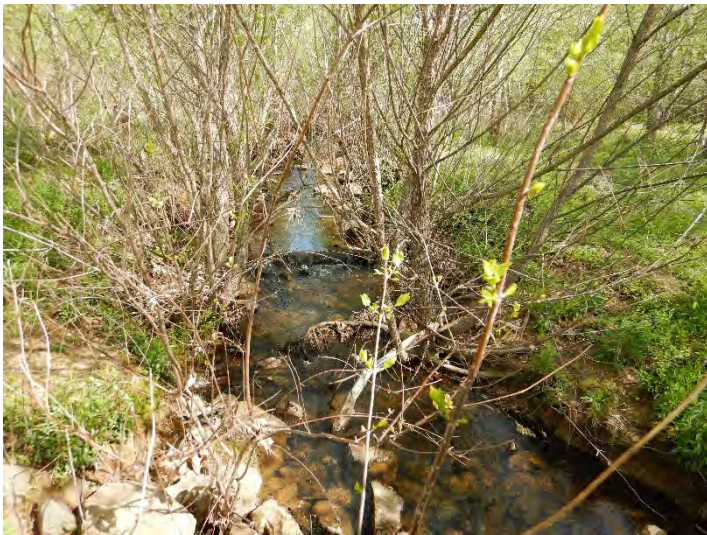
PHOTO POINT 8 Foust Creek R2 – looking upstream (4/20/2021)

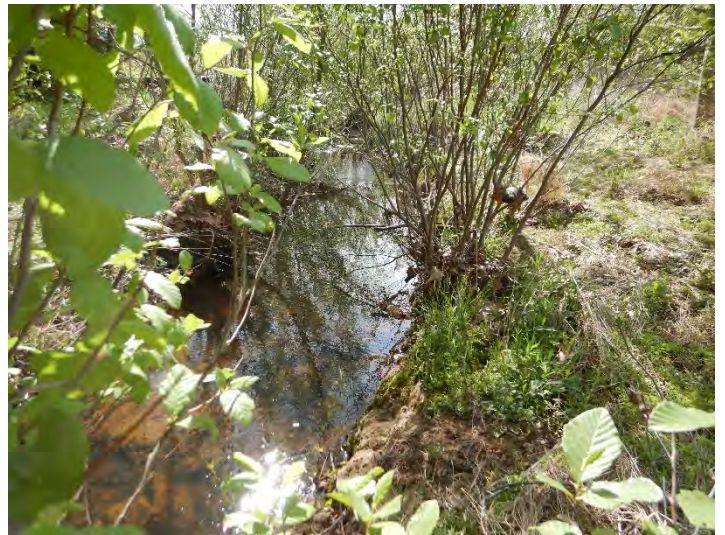
PHOTO POINT 8 Foust Creek R2 – looking downstream (4/20/2021)

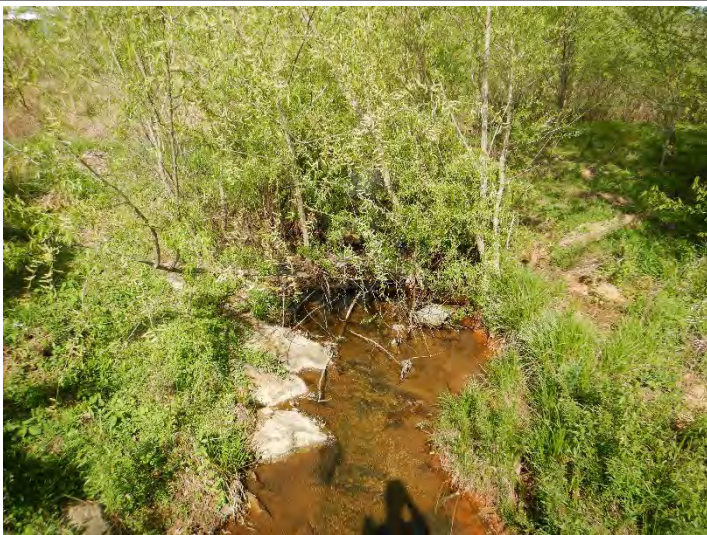
PHOTO POINT 9 Foust Creek R2 – looking upstream (4/20/2021)

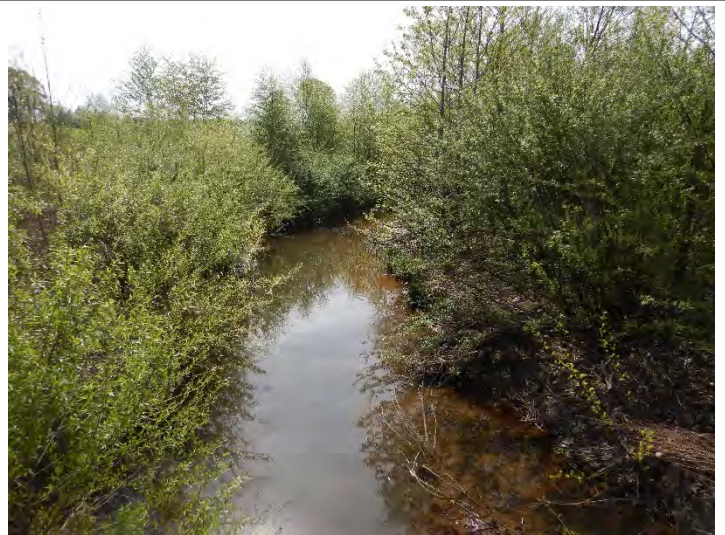
PHOTO POINT 9 Foust Creek R2 – looking downstream (4/20/2021)

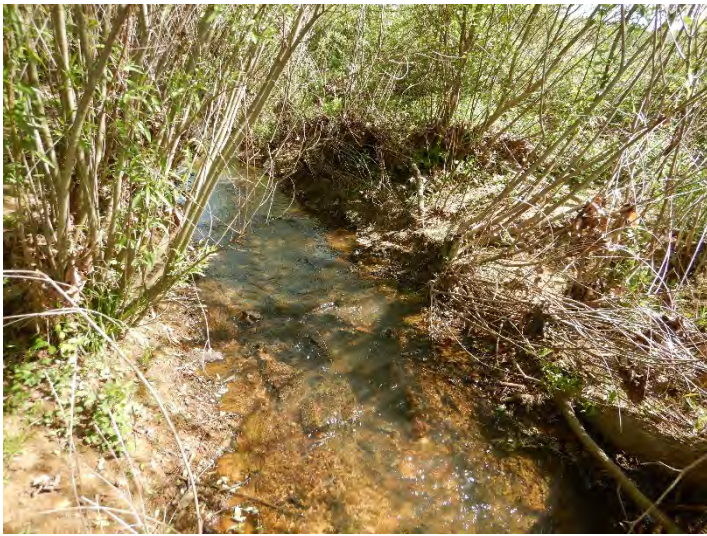
PHOTO POINT 10 Foust Creek R2 – looking upstream (4/20/2021)

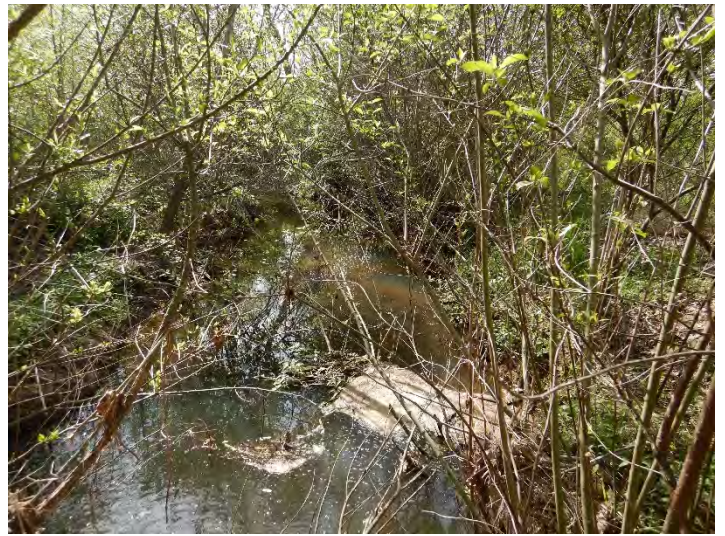
PHOTO POINT 10 Foust Creek R2 – looking downstream (4/20/2021)

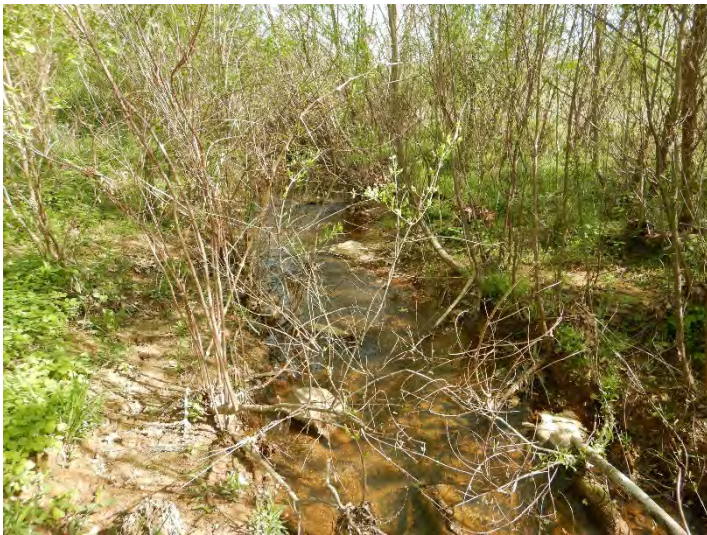
PHOTO POINT 11 Foust Creek R2 – looking upstream (4/20/2021)

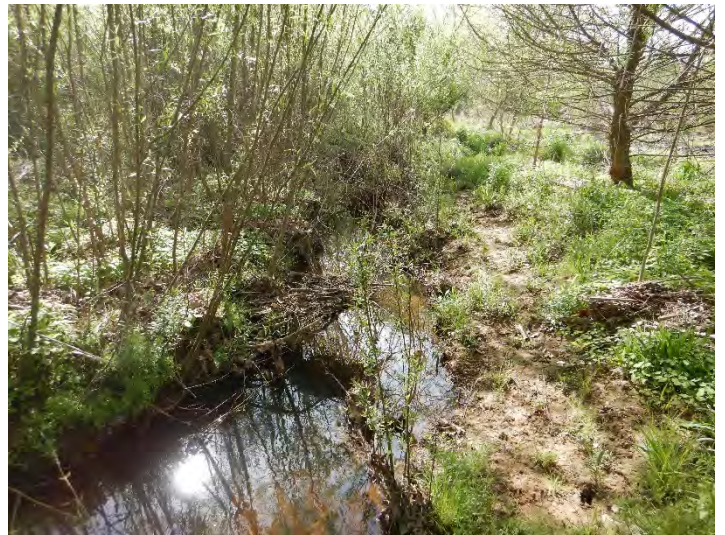
PHOTO POINT 11 Foust Creek R2 – looking downstream (4/20/2021)

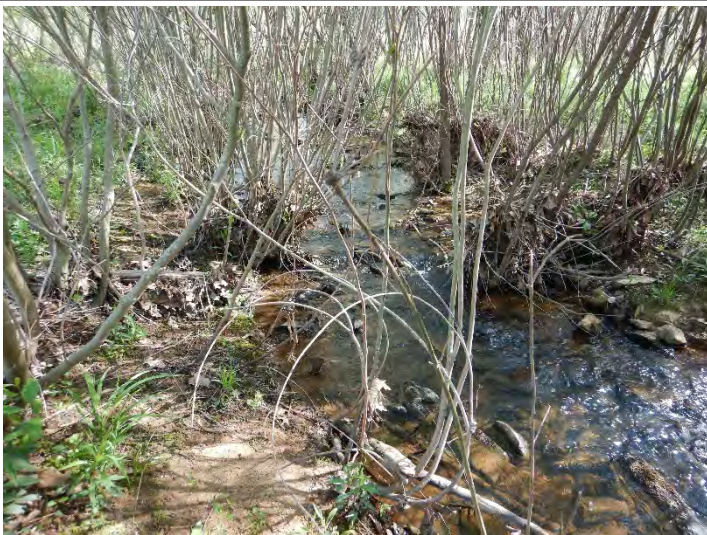
PHOTO POINT 12 Foust Creek R2 – looking upstream (4/20/2021)

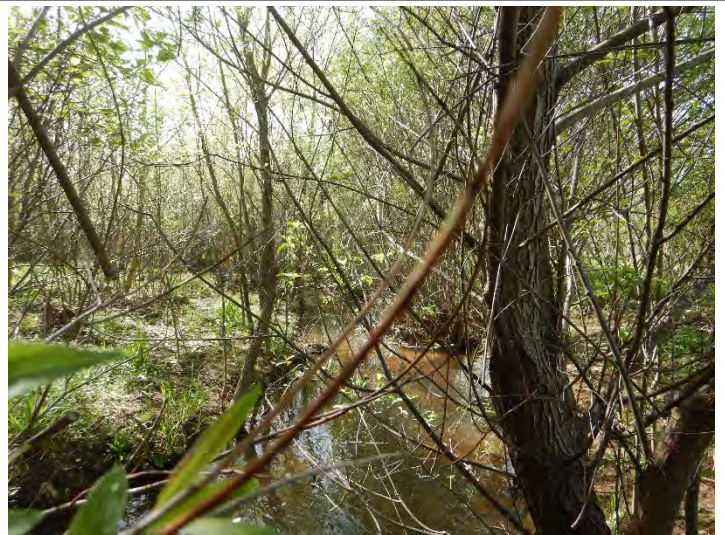
PHOTO POINT 12 Foust Creek R2 – looking downstream (4/20/2021)

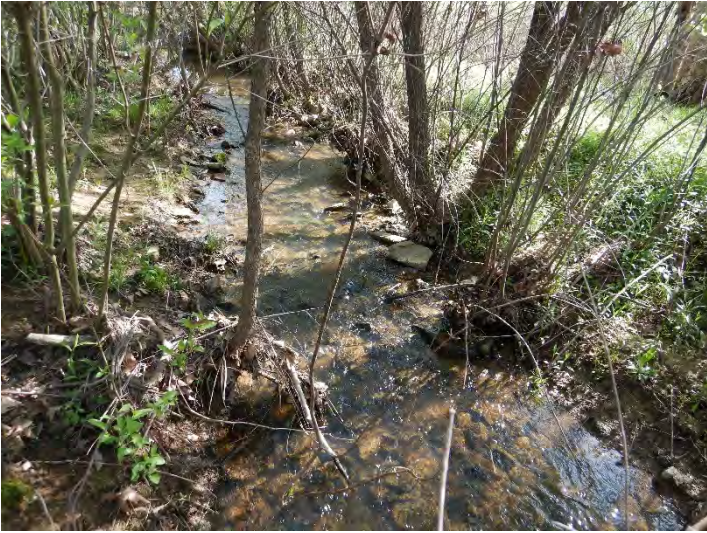
PHOTO POINT 13 Foust Creek R2 – looking upstream (4/20/2021)

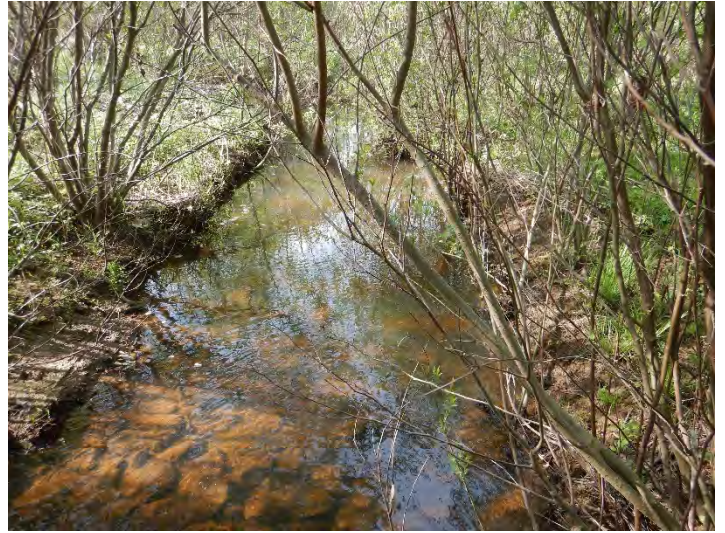
PHOTO POINT 13 Foust Creek R2 – looking downstream (4/20/2021)

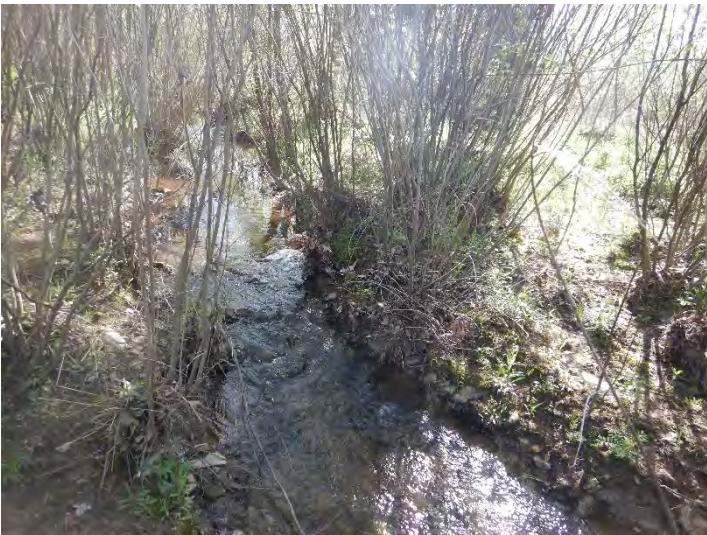
PHOTO POINT 14 Foust Creek R2 – looking upstream (4/20/2021)

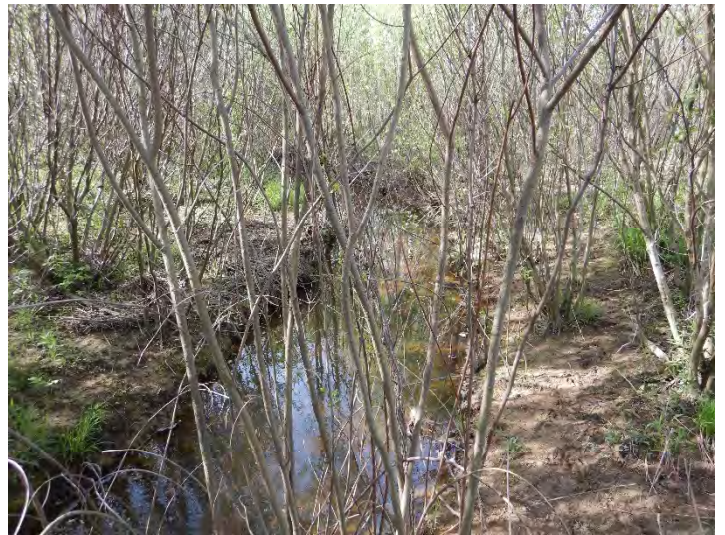
PHOTO POINT 14 Foust Creek R2 – looking downstream (4/20/2021)

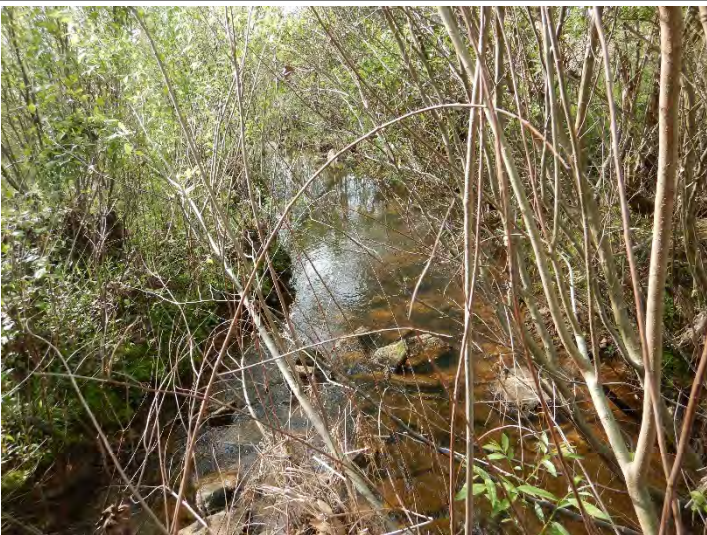
PHOTO POINT 15 Foust Creek R2 – looking upstream (4/20/2021)

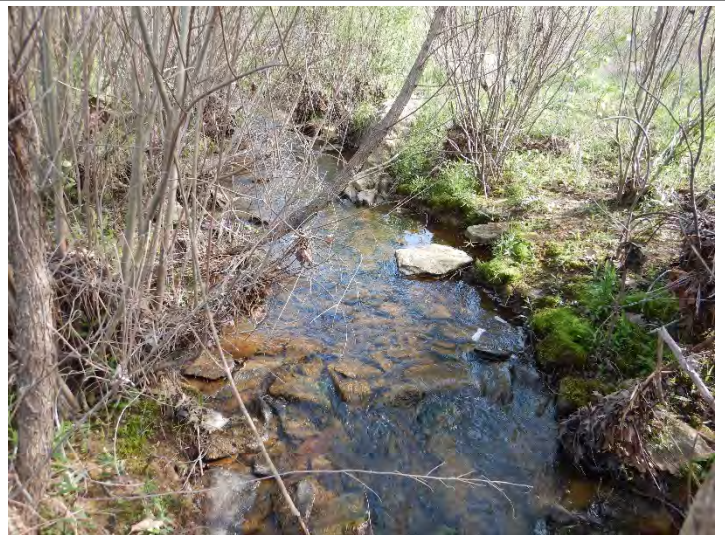
PHOTO POINT 15 Foust Creek R2 – looking downstream (4/20/2021)

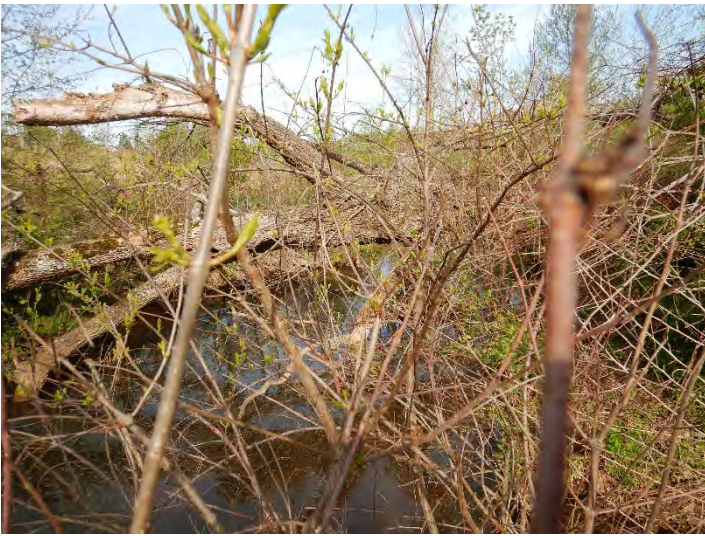
PHOTO POINT 16 Foust Creek R2 – looking upstream (4/20/2021)

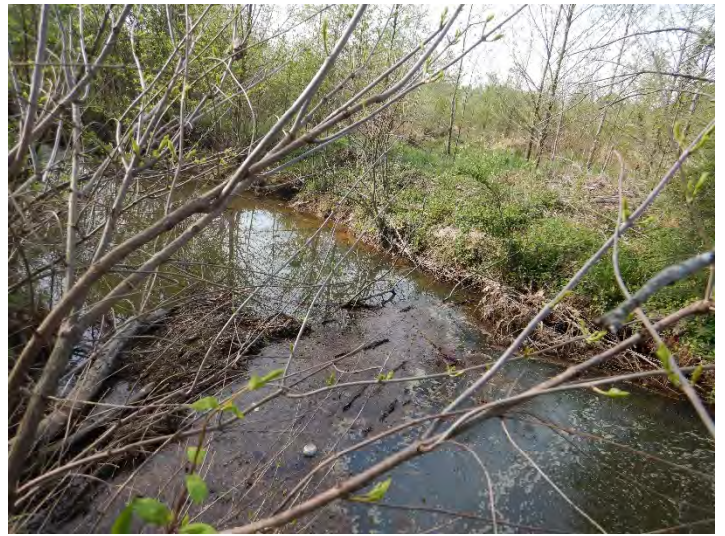
PHOTO POINT 16 Foust Creek R2 – looking downstream (4/20/2021)

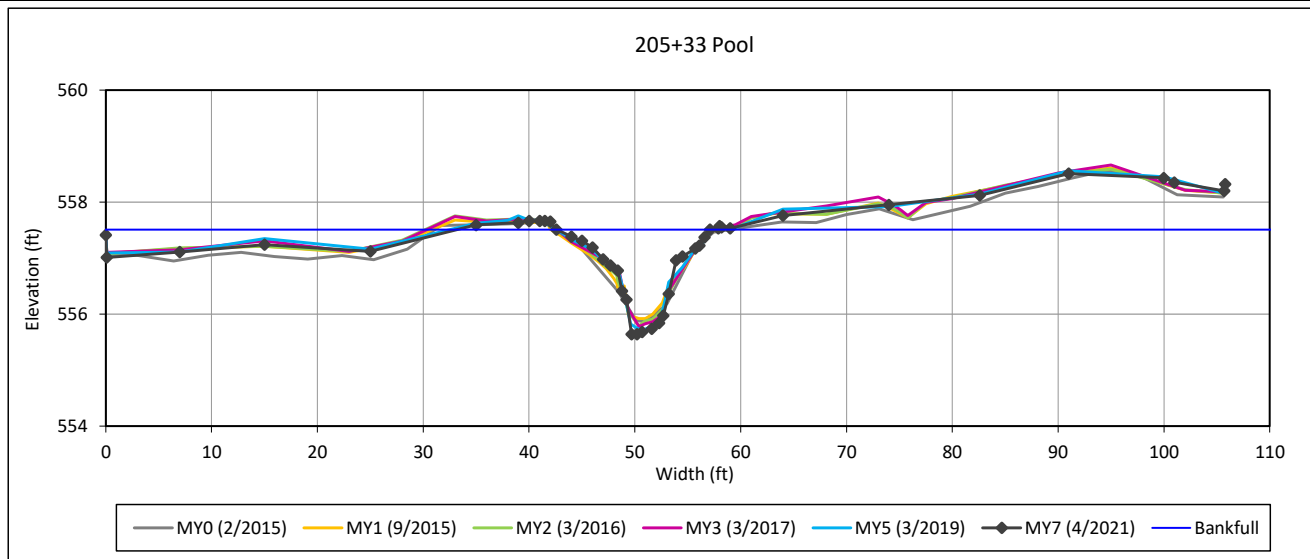
Cross Section 12-UT1

Bankfull Dimensions

11.1	x-section area (ft.sq.)
14.5	width (ft)
0.8	mean depth (ft)
1.9	max depth (ft)
15.5	wetted perimeter (ft)
0.7	hyd radi (ft)
18.9	width-depth ratio

Survey Date: 4/2021
Field Crew: Wildlands Engineering

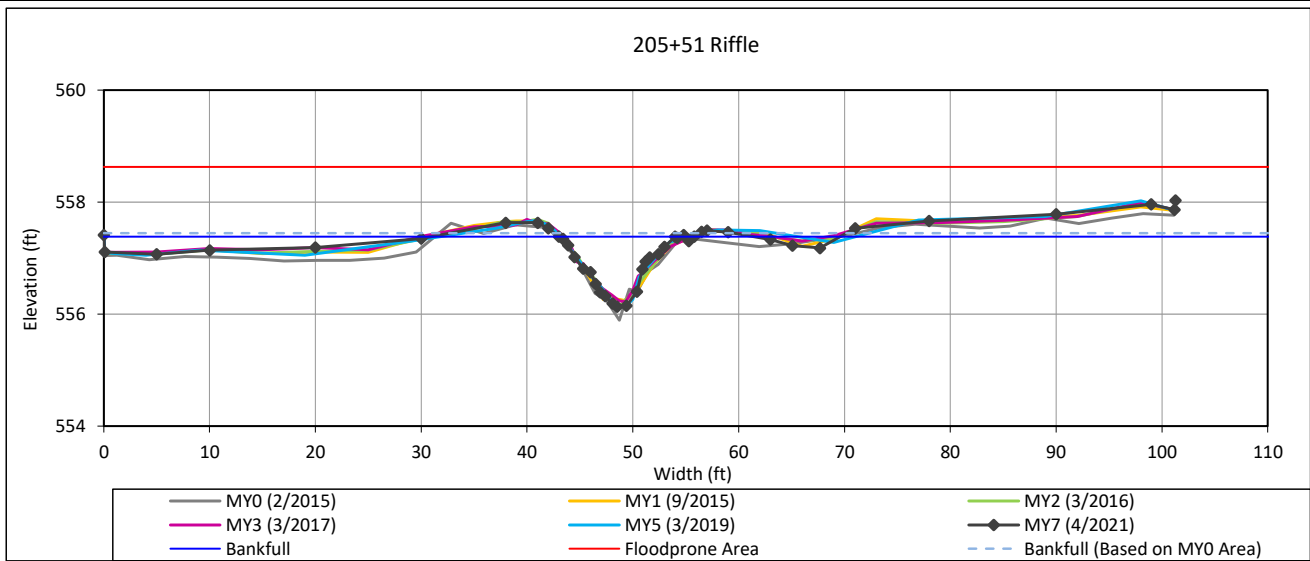
Cross Section 13-UT1

Bankfull Dimensions

7.0	x-section area (ft.sq.)
11.4	width (ft)
0.6	mean depth (ft)
1.3	max depth (ft)
11.9	wetted perimeter (ft)
0.6	hyd radi (ft)
18.8	width-depth ratio
150.0	W flood prone area (ft)
13.1	entrenchment ratio
< 1.0	low bank height ratio

Survey Date: 4/2021
Field Crew: Wildlands Engineering

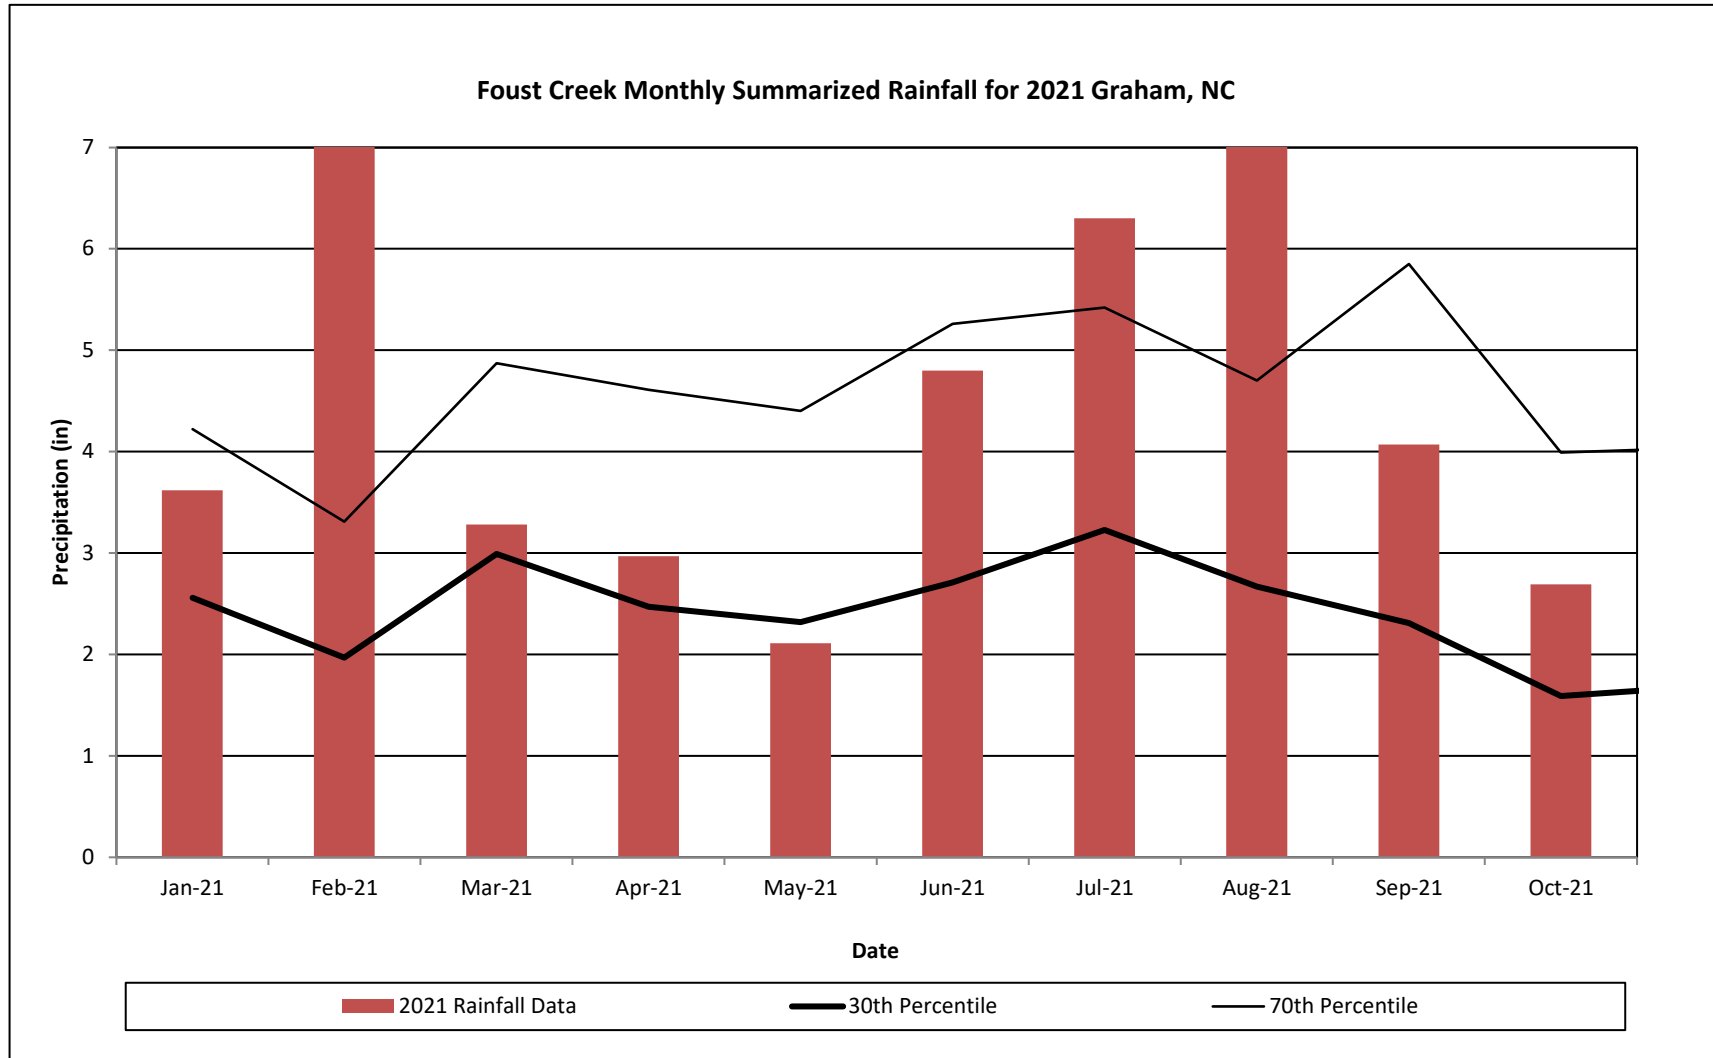
¹ 2021 monthly rainfall collected from weather station 3135555, Graham 2 ENE, NC

² 30th and 70th percentile rainfall data collected from weather station 3135555, Graham 2 ENE, NC.
