FINAL REPORT

Little Sugar Creek at Freedom Park Stream Restoration Plan

Mecklenburg County,
North Carolina

October 2002

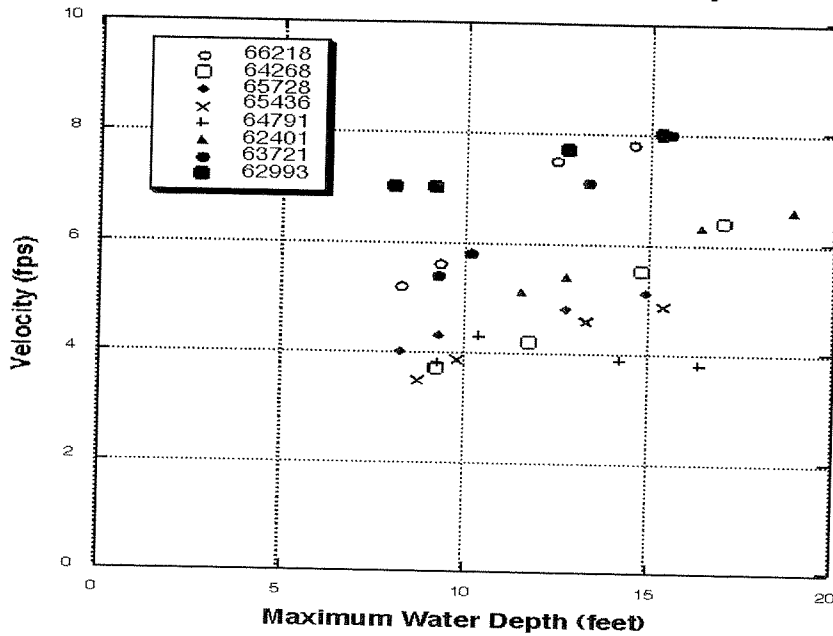
Freedom Park Velocities (1.5, 2, 10, and 100 yr storms)

Velocity Maximum Depth Estimates from HEC-RAS based flow calculations for 1.5, 2, 10 and 100 Year Storms at 8 sections using the proposed general riffle and meander cross sections.

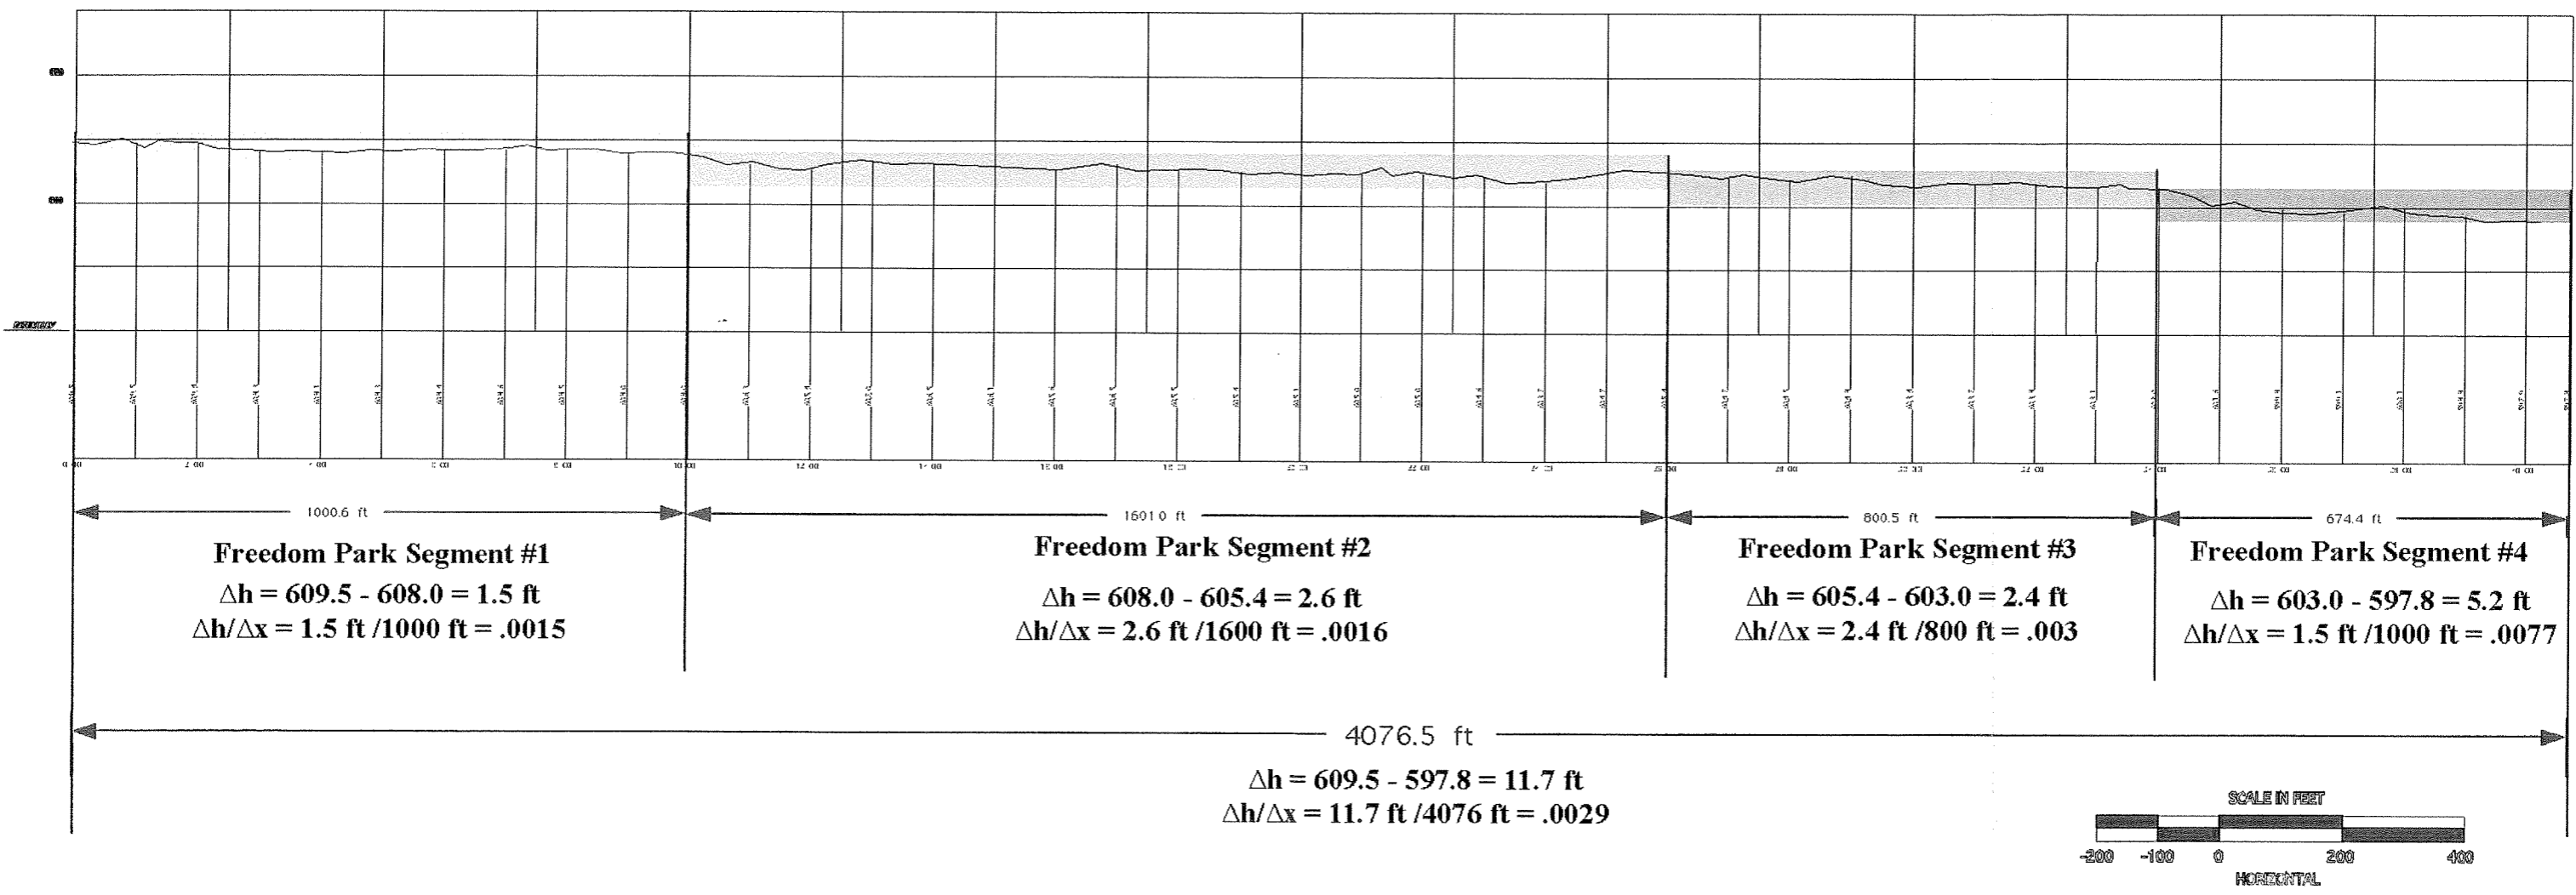
**Approximate Bedrock
Locations**

Date Aug. 2002	Project No. 09177-017-018-05	Drawing No. Fig. 5	Issue A
Scale AS NOTED	File Name XXXXX.DWG

Little Sugar Creek within Freedom Park can be classified as a Rosgen Class C3 to C5 stream. Class C streams are typically slightly entrenched with a moderate to high width to depth ratio (Rosgen, 1996). Little Sugar Creek exhibits an entrenchment ratio of greater than 5 and a high width to depth ratio of 12.5 (Table 1). More specifically, Class C3 to C5 streams exhibit a slope ranging from 0.001 to 0.02 (Rosgen, 1996). Little Sugar Creek at Freedom Park exhibits a slope of 0.0029, which is within this range (Figure 4). Bedrock outcroppings also influence the channel slope and sinuosity by creating nick points (Figure 5).

The stream travels over several zones of bedrock and, in at least six locations within the stream course, large outcrops of the native bedrock material can be seen in the stream channel and along the banks. The channel bottom is comprised primarily of sand and pebbles, with several areas of cobble riffles, a few large boulders, and native rock outcrop zones (Figure 5).

With respect to bed stability, the Little Sugar Creek reach at Freedom Park contains numerous bedrock nick points that have been carefully considered in the preparation of the new channel’s alignment (Figure 5). The new alignment intersects in a sufficient number of the riffle sections to provide distributed grade control along the 4,000+ feet of this restoration. Thus, no artificial grade control is needed in this design.

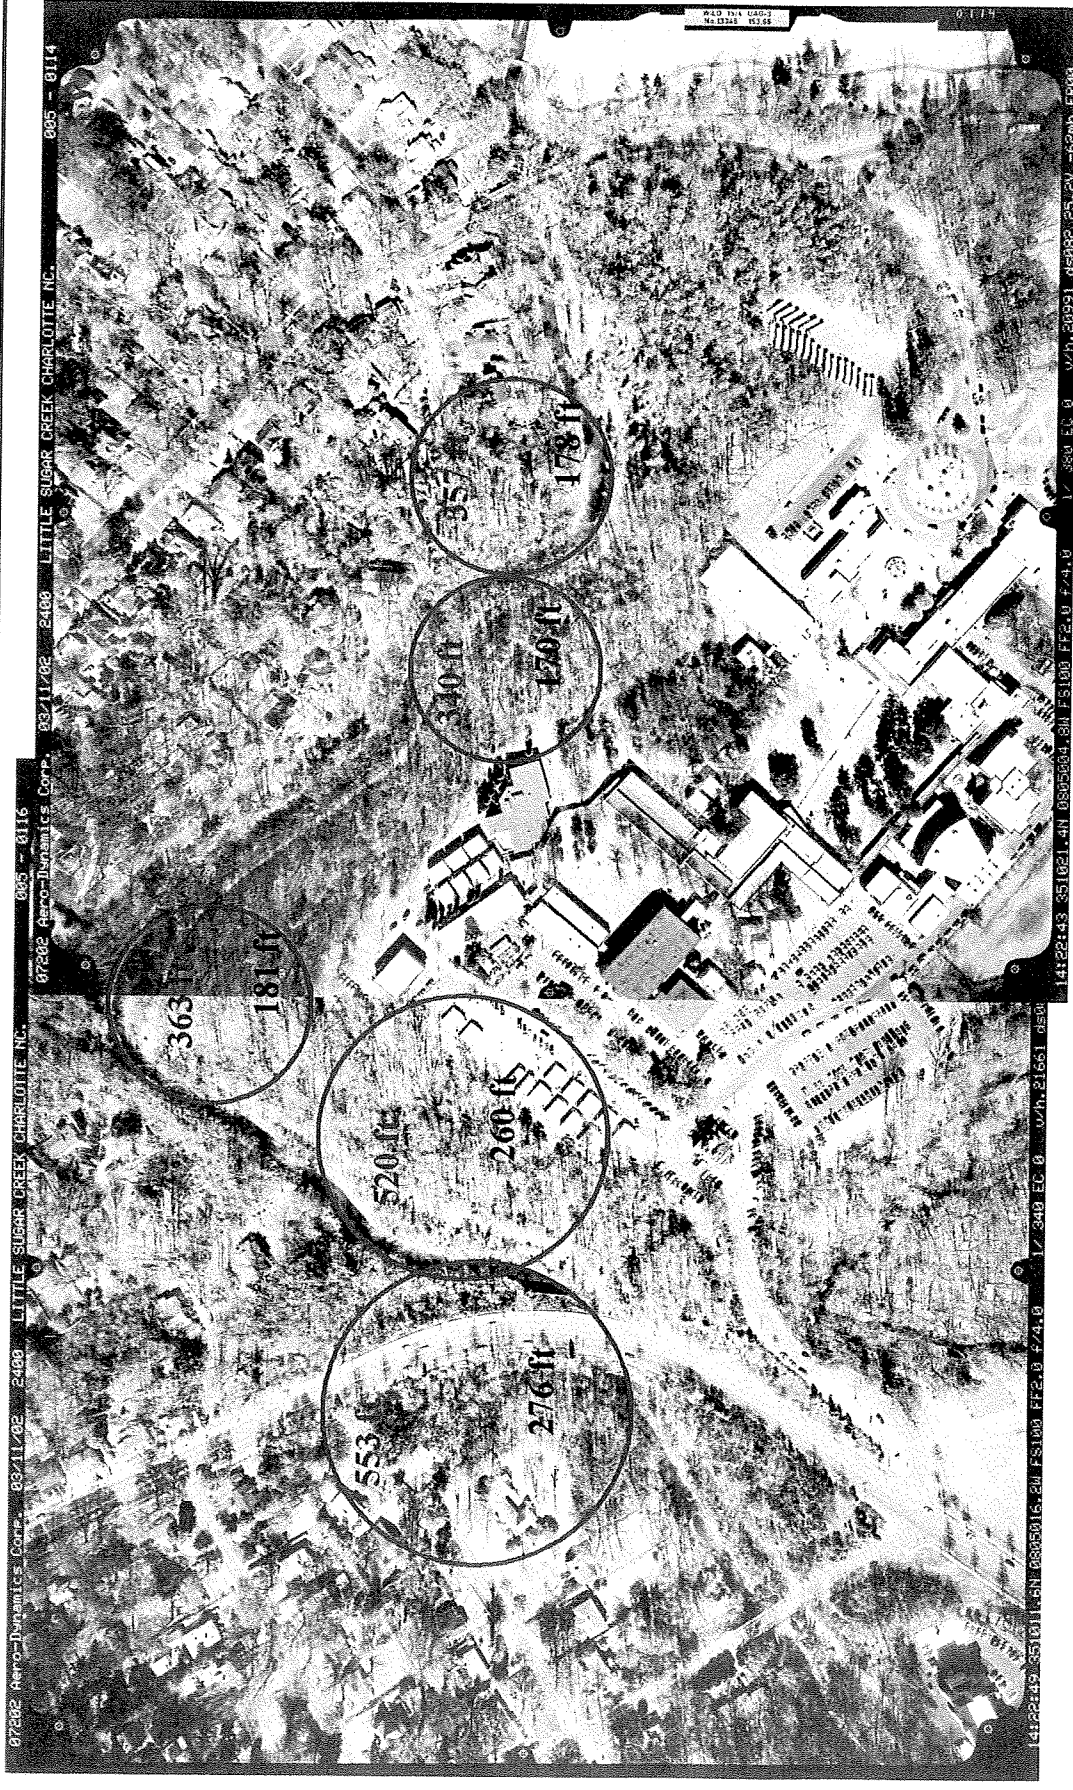
Figure 8a : Diameters and Radii of Stream for Briar Creek Behind Myers Park High School Stream Restoration Plan Little Sugar Creek at Freedom Park

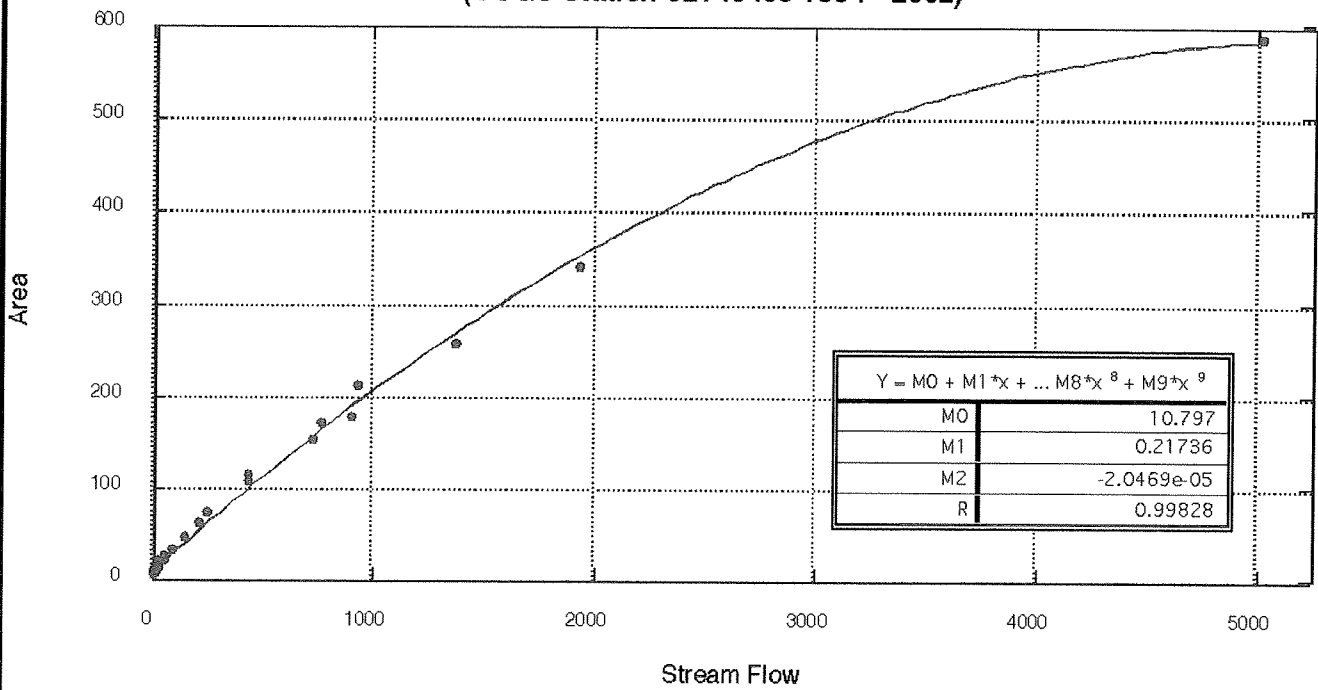
**Area - Discharge Rating Curve for Little Sugar Creek
Near Medical Center
(USGS Station 02146409 1994 - 2002)**

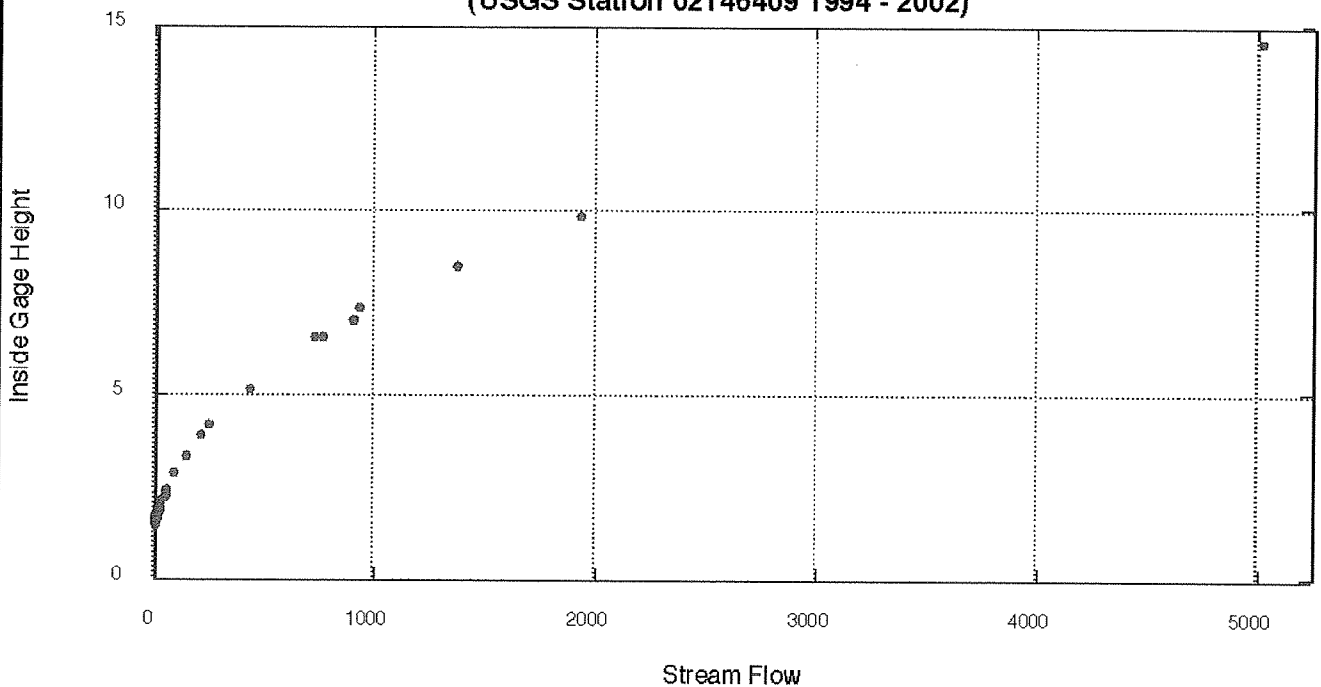
**Inside Gage Height - Discharge Rating Curve for Little Sugar Creek
Near Medical Center
(USGS Station 02146409 1994 - 2002)**

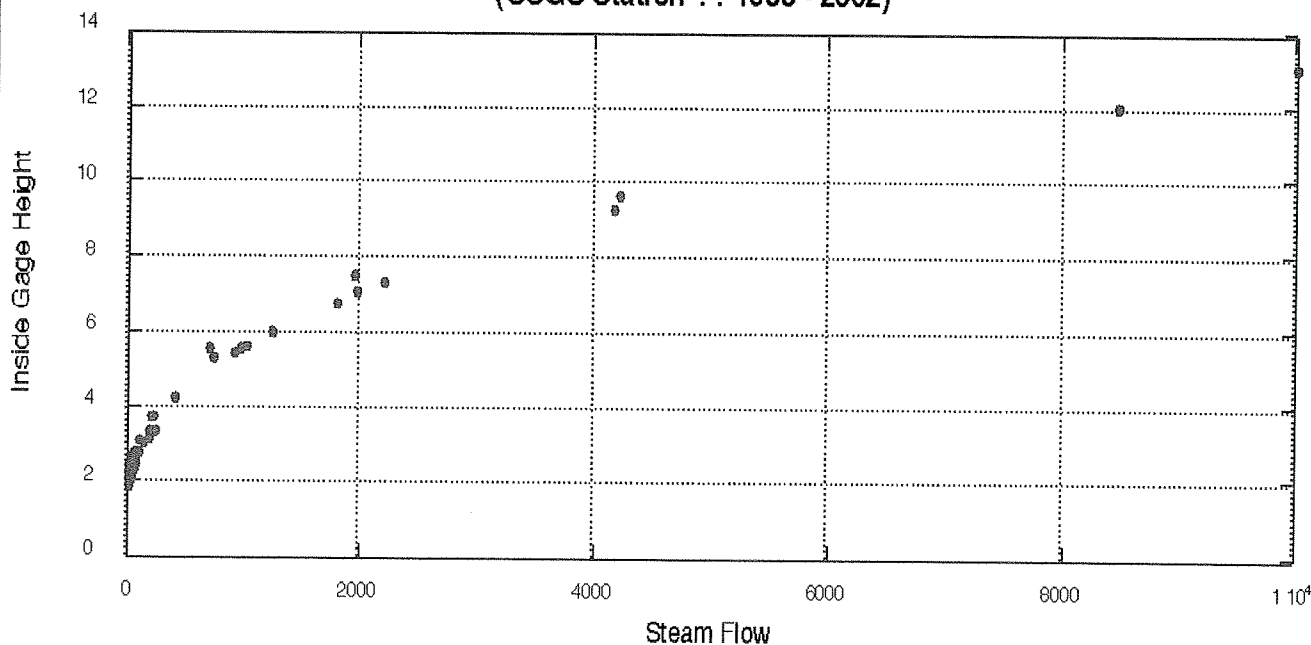
**Inside Gage Height - Discharge Rating Curve for Little Sugar Creek
Near Archdale Drive
(USGS Station ?? 1985 - 2002)**

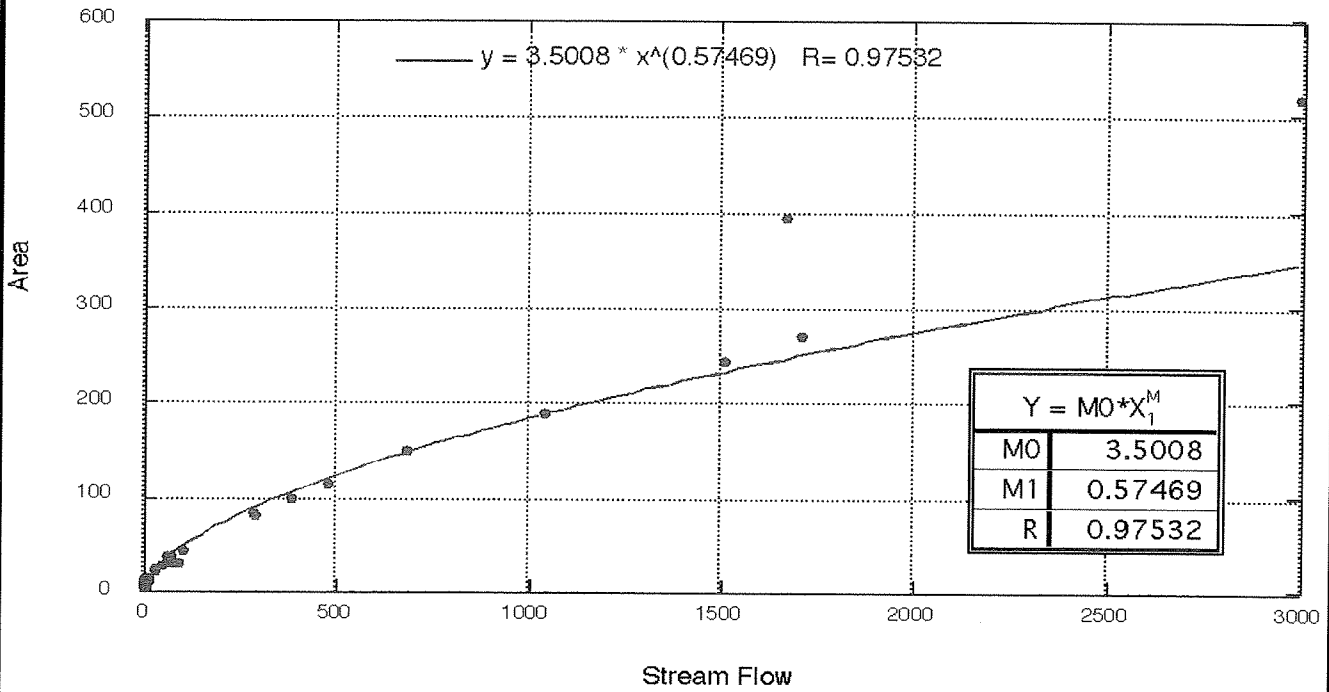
**Area - Discharge Rating Curve for Briar Creek Near Colony Road
(USGS Station 0214645022 1995 - 2002)**

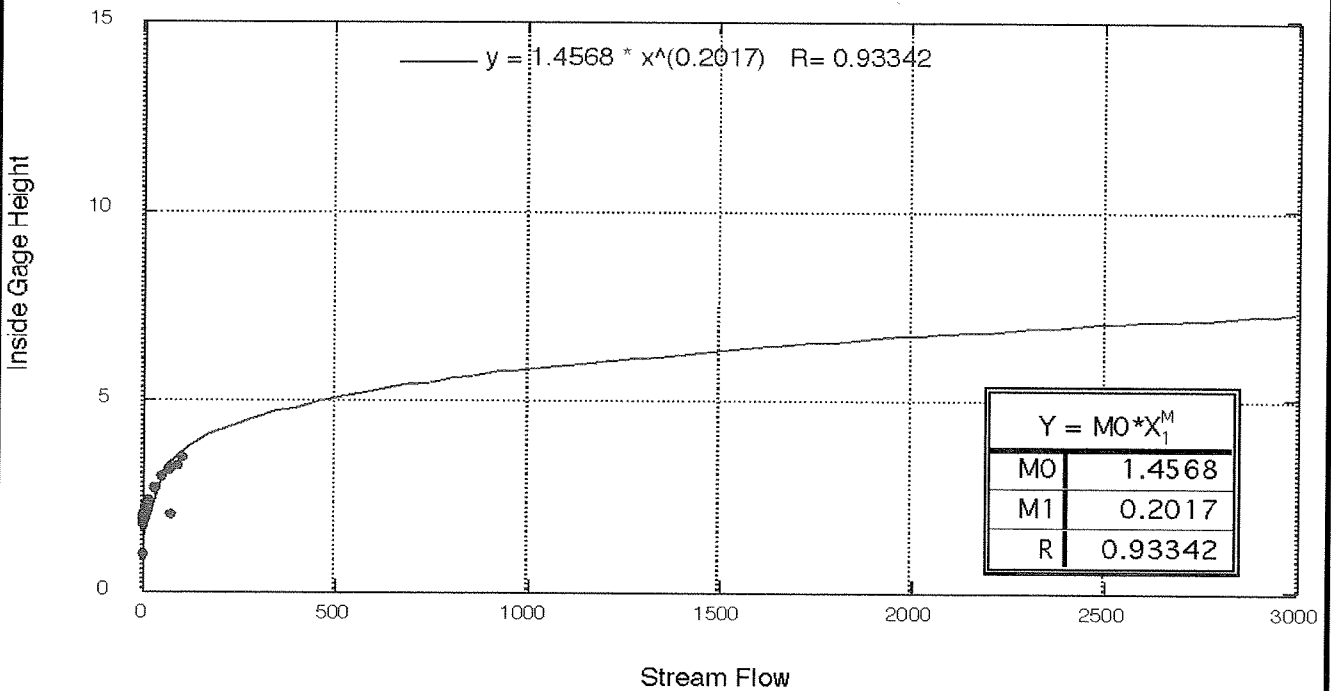
**Inside Gage Height - Discharge Rating Curve for Briar Creek Near Colony Road
(USGS Station 0214645022 1995 - 2002)**

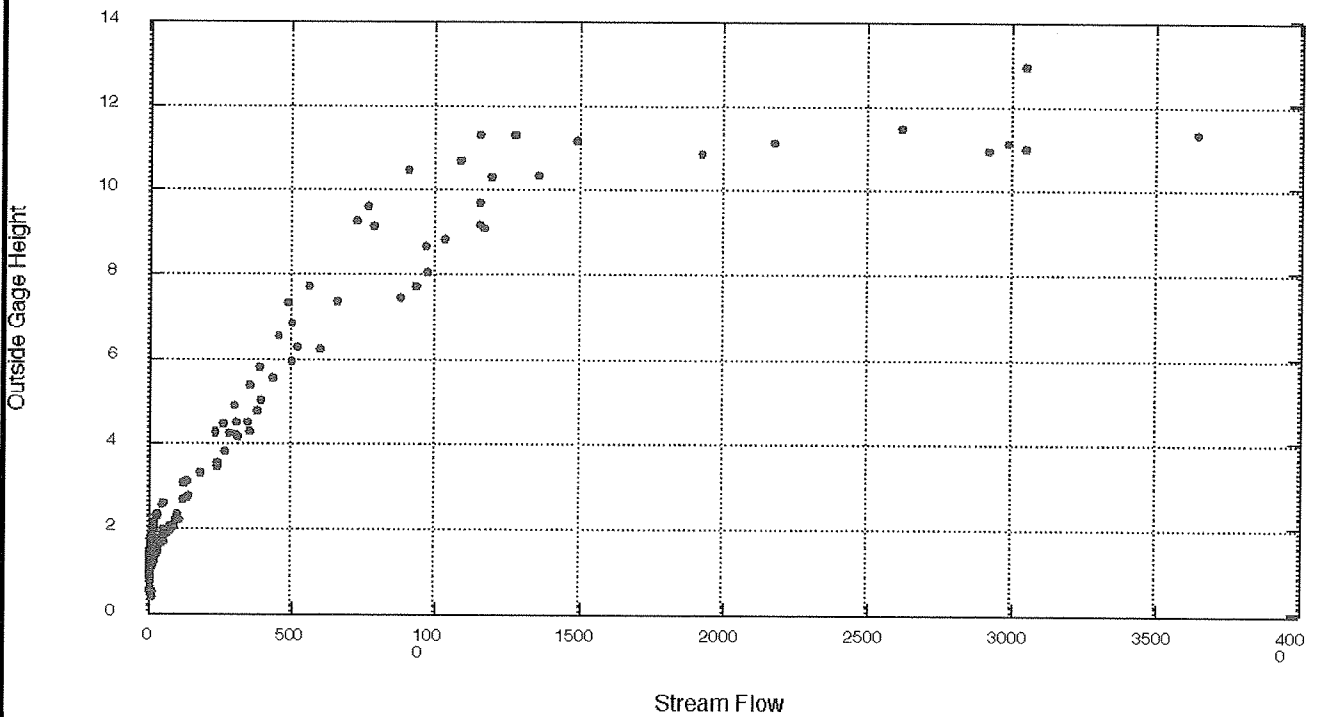
**Outside Gage Height - Discharge Rating Curve for Long Creek
(USGS Station No. 02142900 1965 - 2002)**
