Freedom Park (Little Sugar Creek) Monitoring Report Year 5 of 5 (2009)

Project ID No. 141

Executive Summary

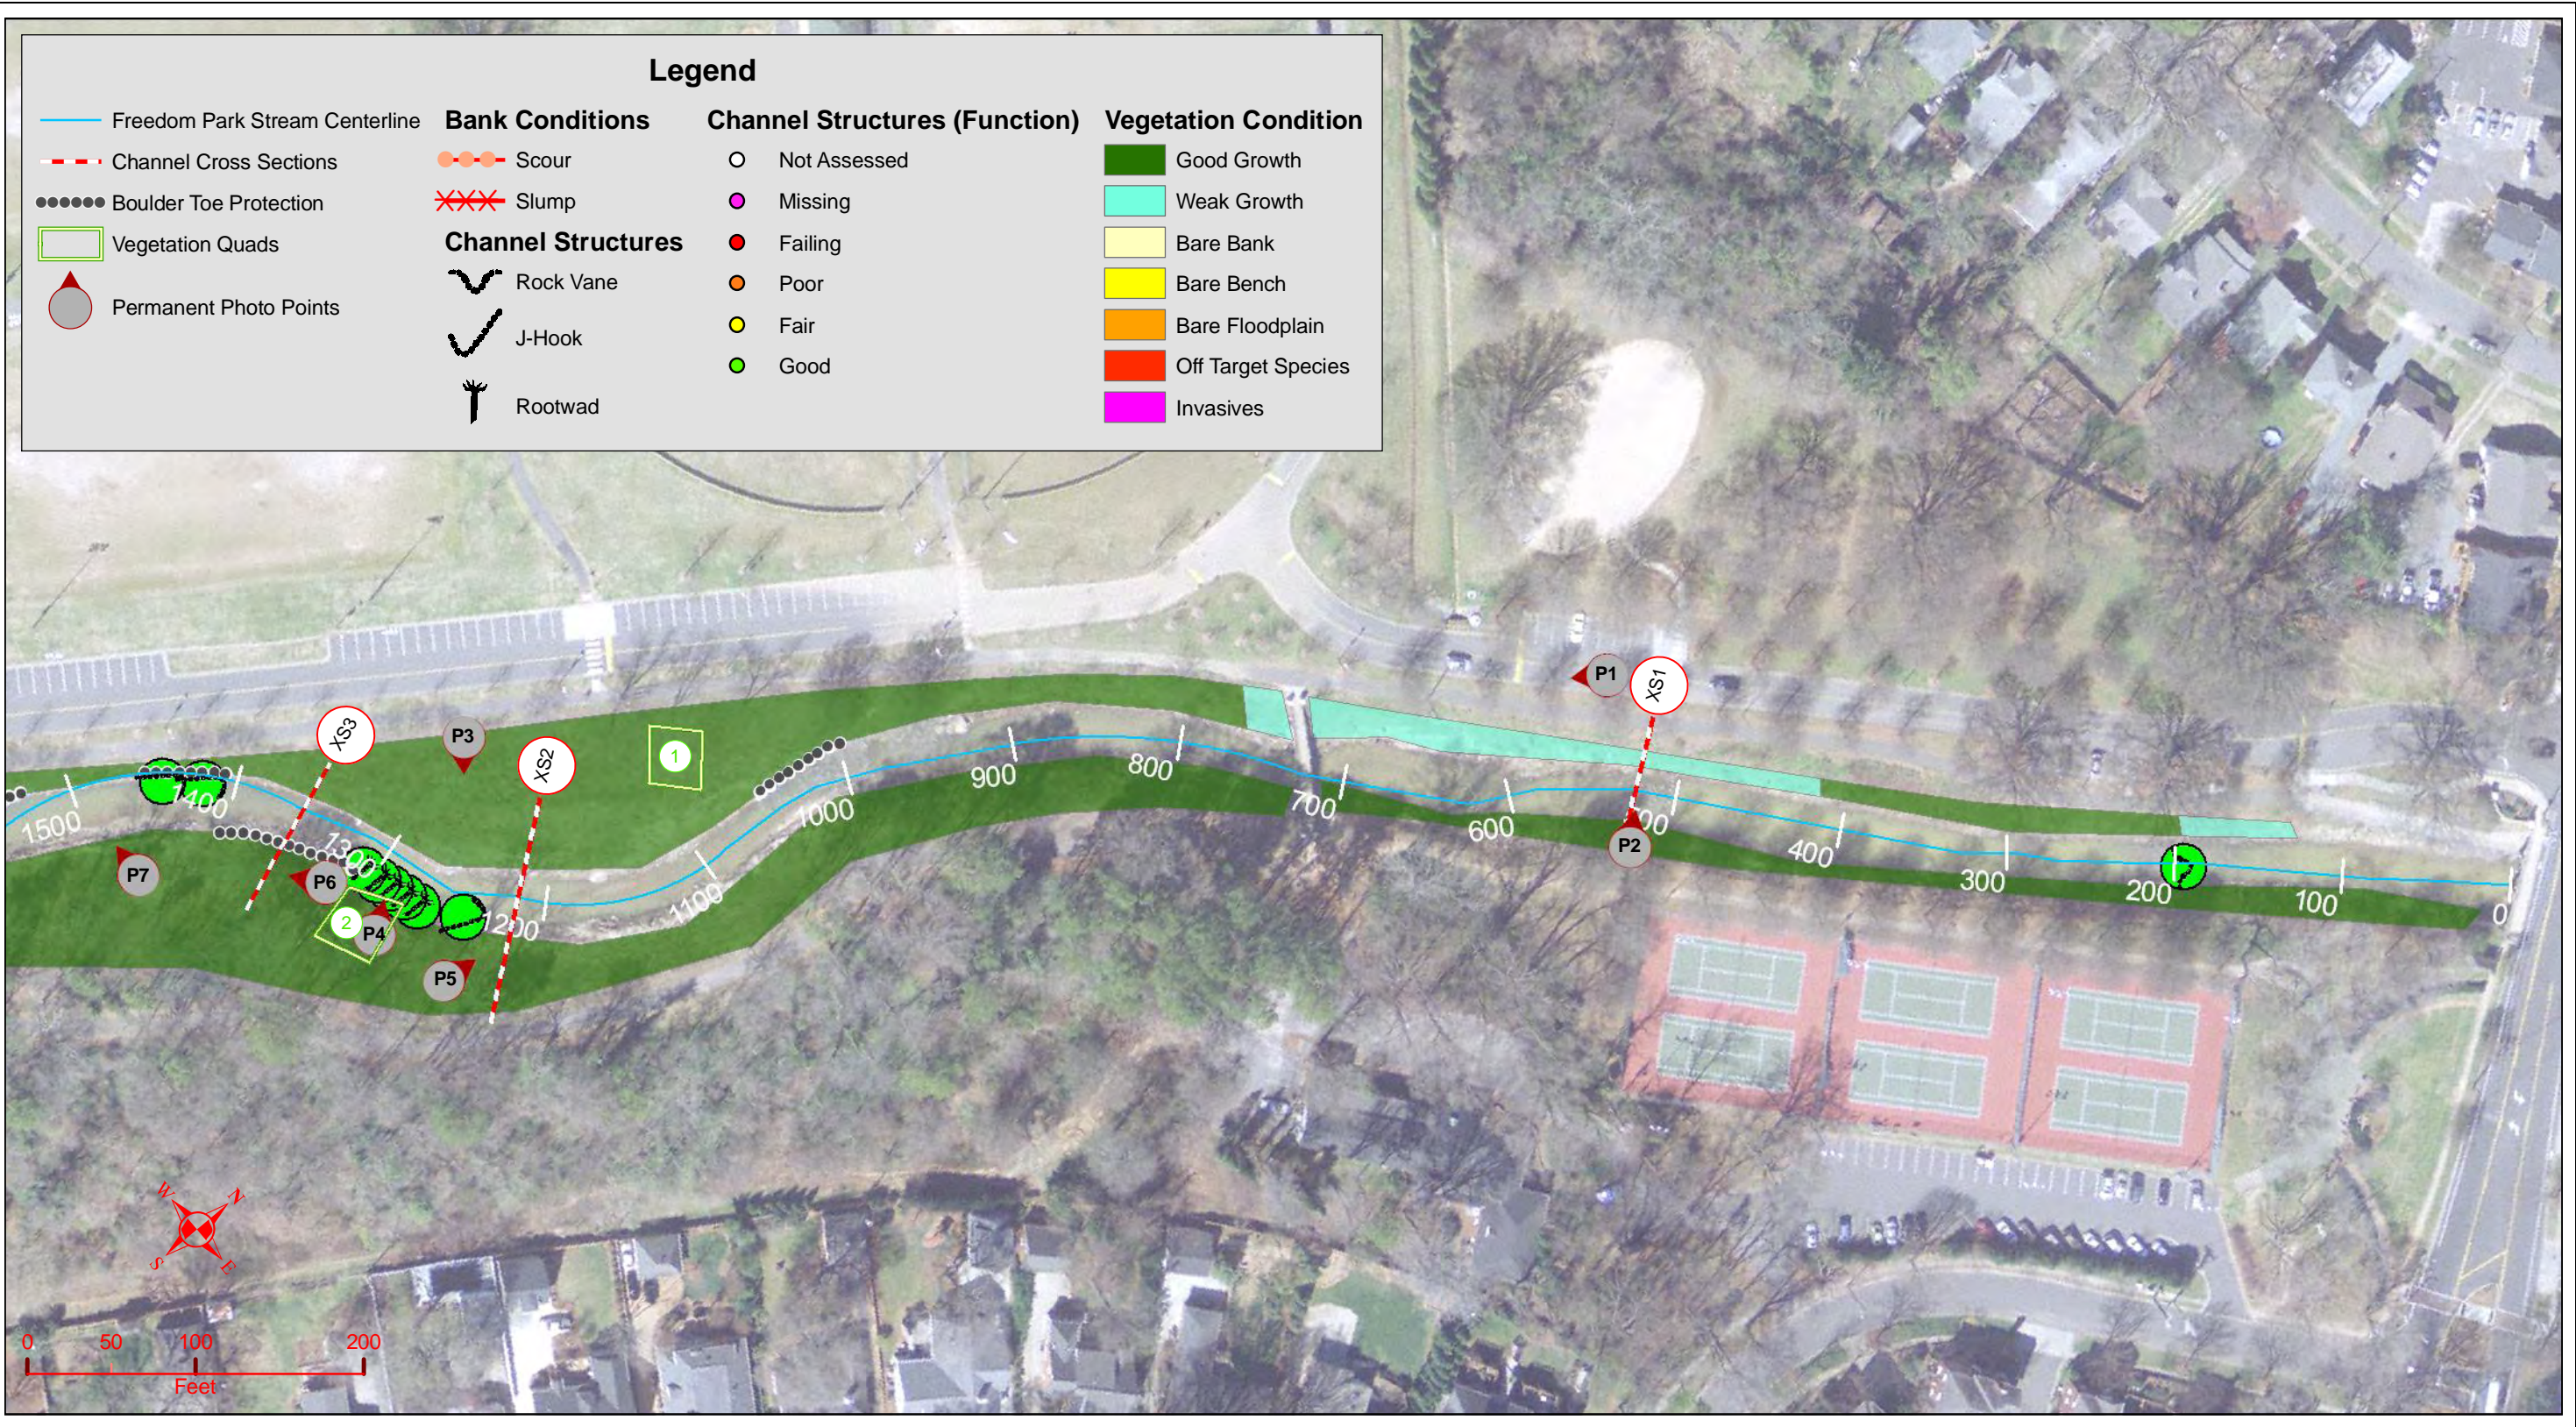
Title		Current Conditions Plan View Upper (2007 Aerial)		
Prepared For:

FIGURE 1	PROJECT SETTING
FIGURE 2	CURRENT CONDITIONS PLAN VIEW UPPER
FIGURE 3	CURRENT CONDITIONS PLAN VIEW MIDDLE
FIGURE 4	CURRENT CONDITIONS PLAN VIEW LOWER

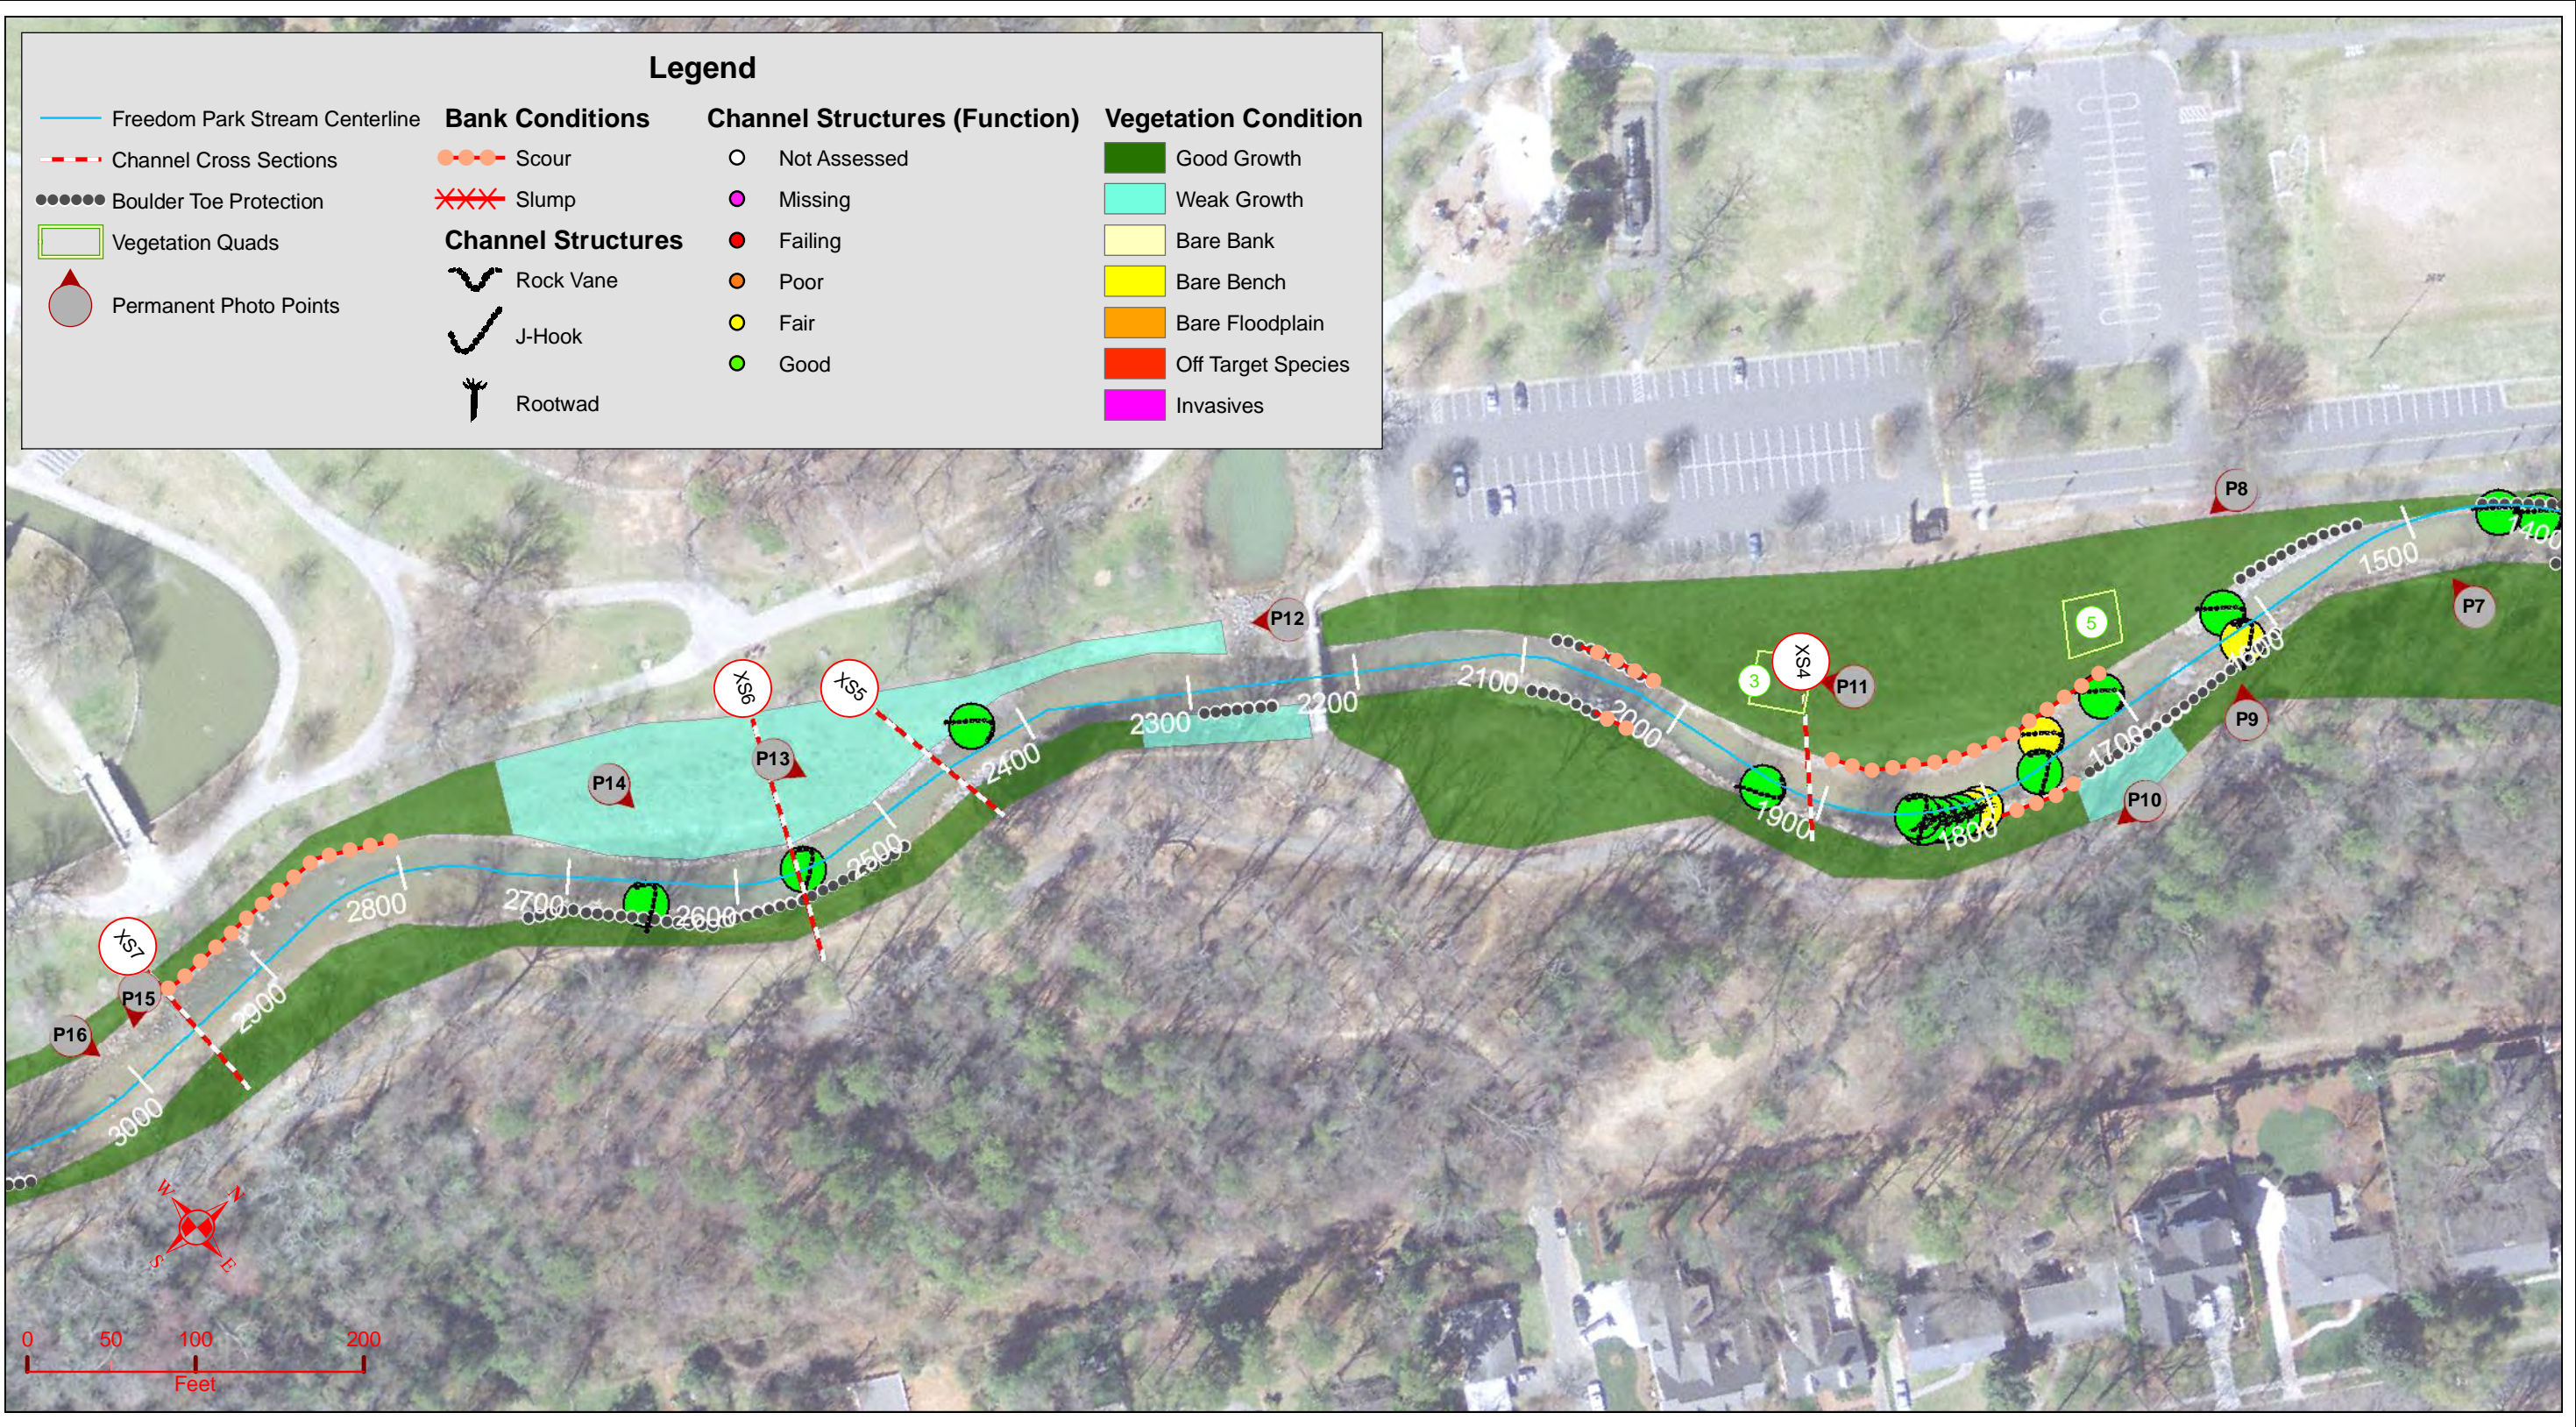
Title		Current Conditions Plan View Middle (2007 Aerial)		
Prepared For:

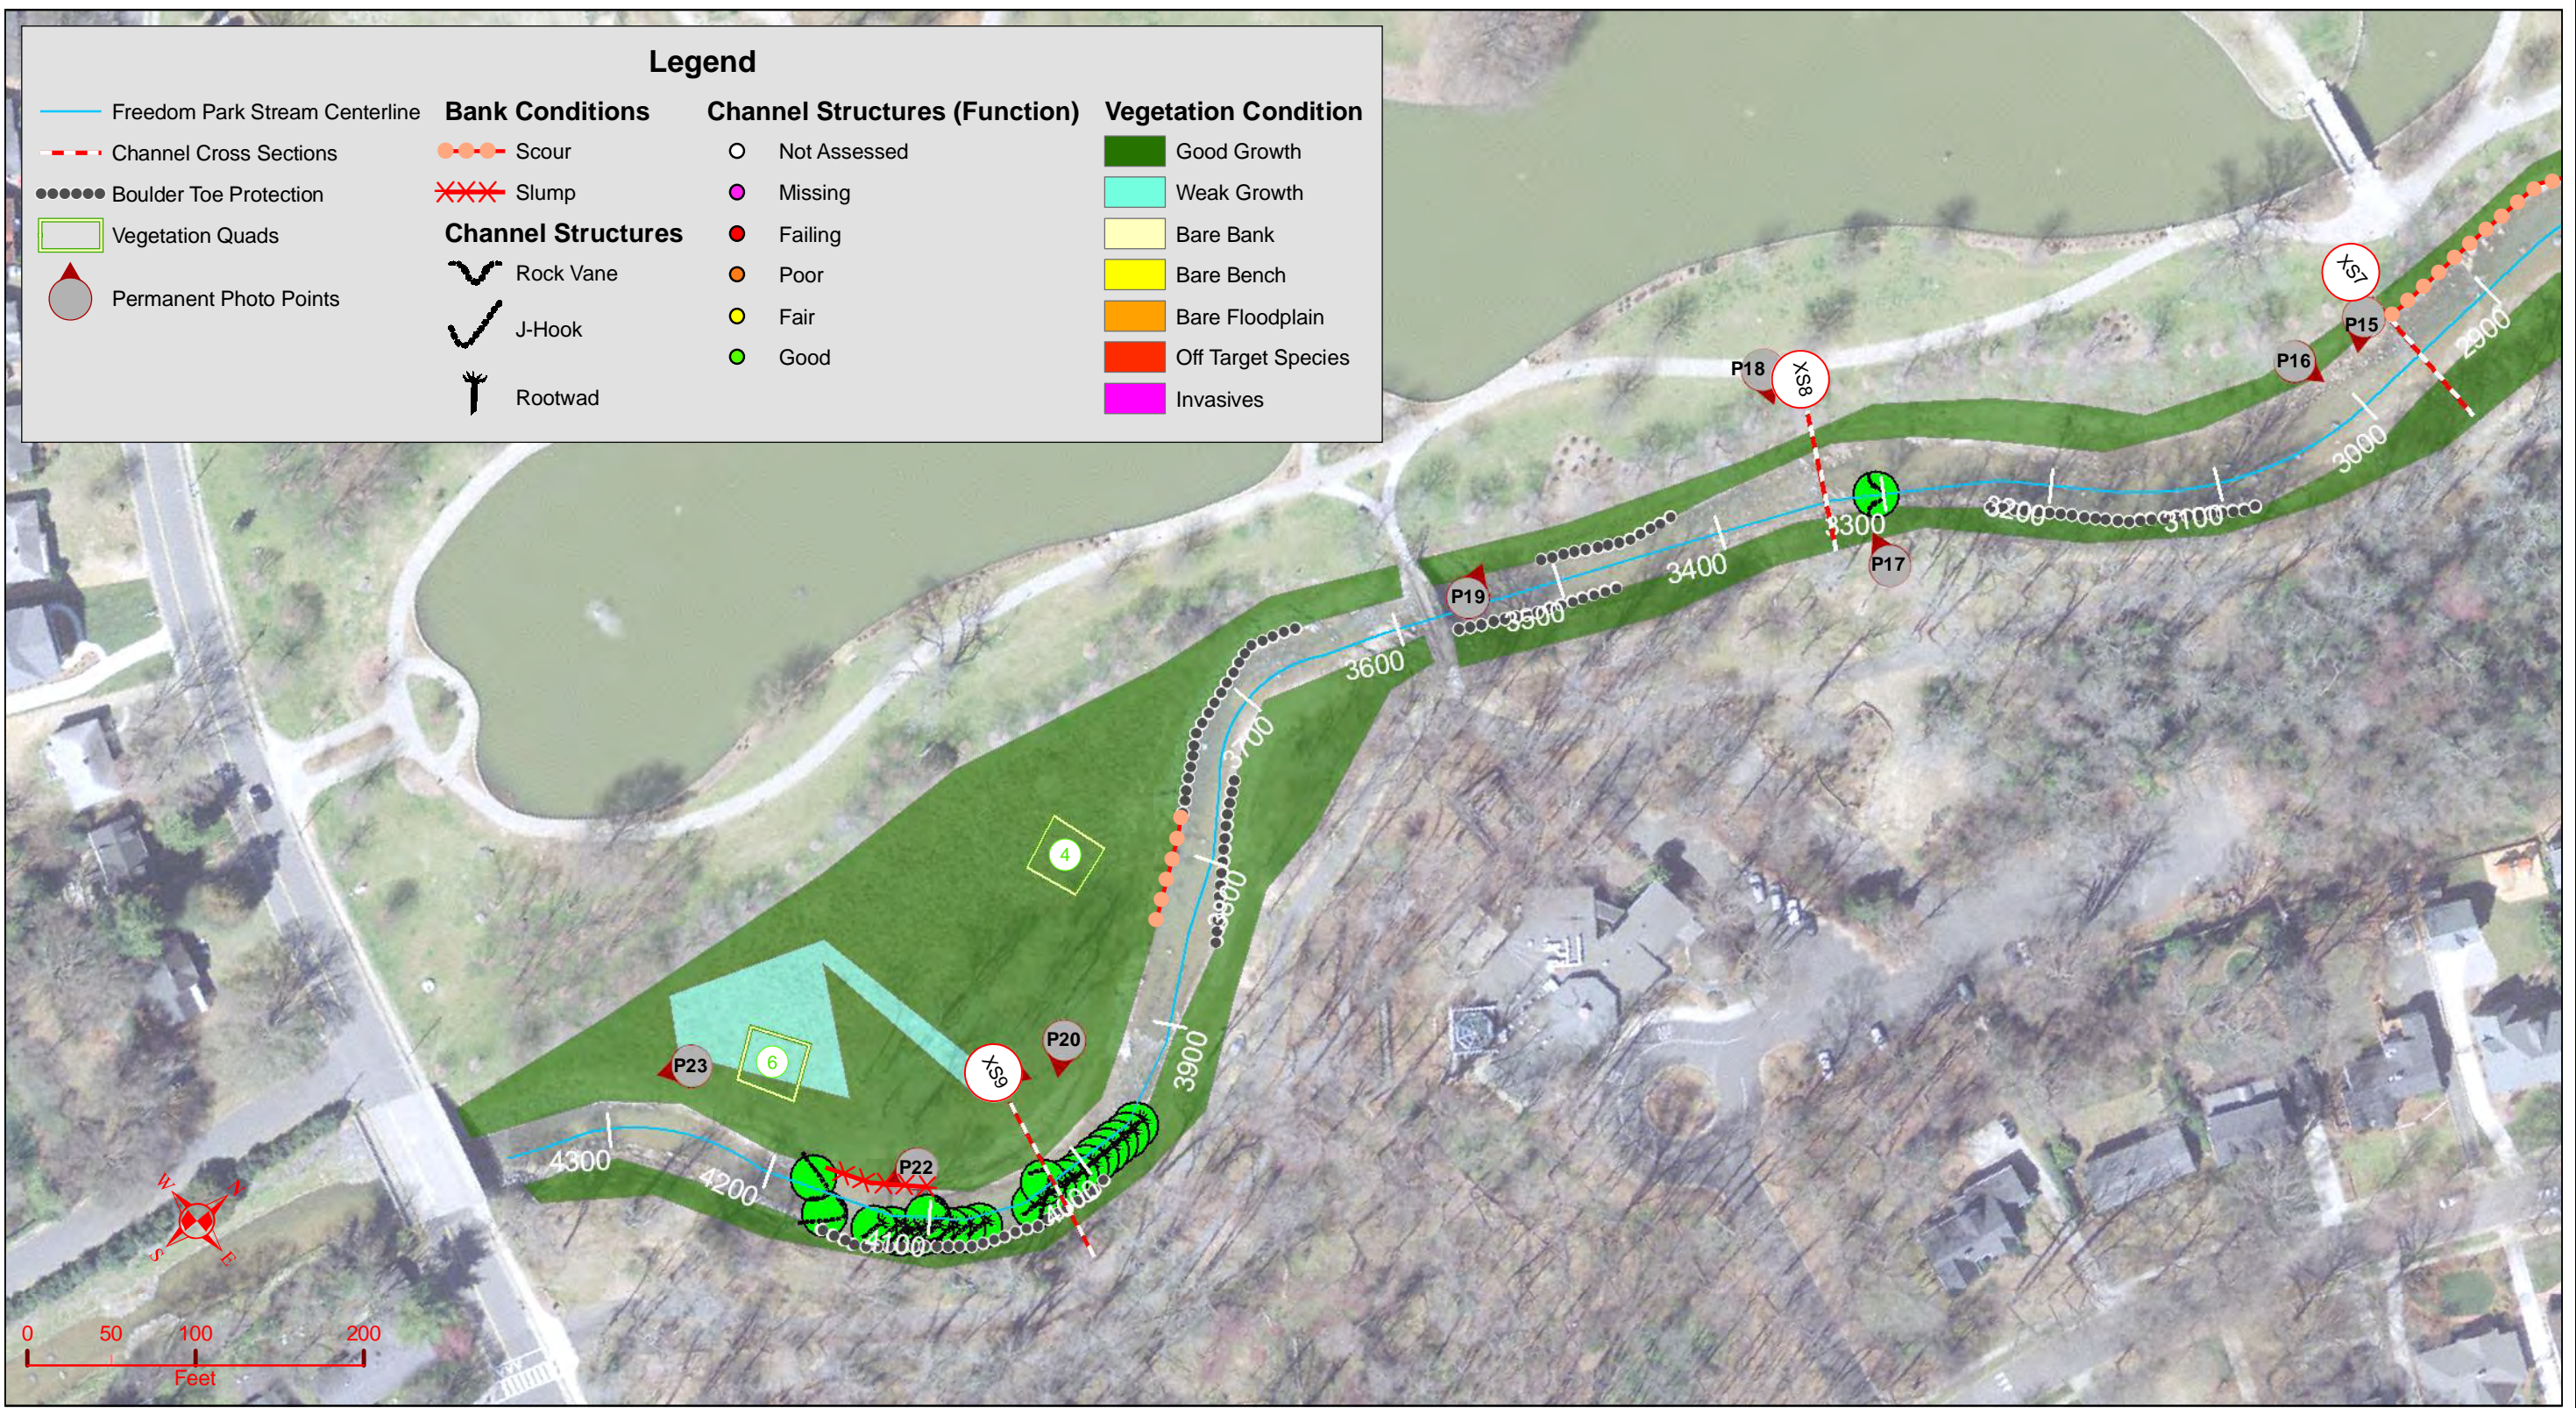
Title	Current Conditions Plan View Lower (2007 Aerial)		
Prepared For:

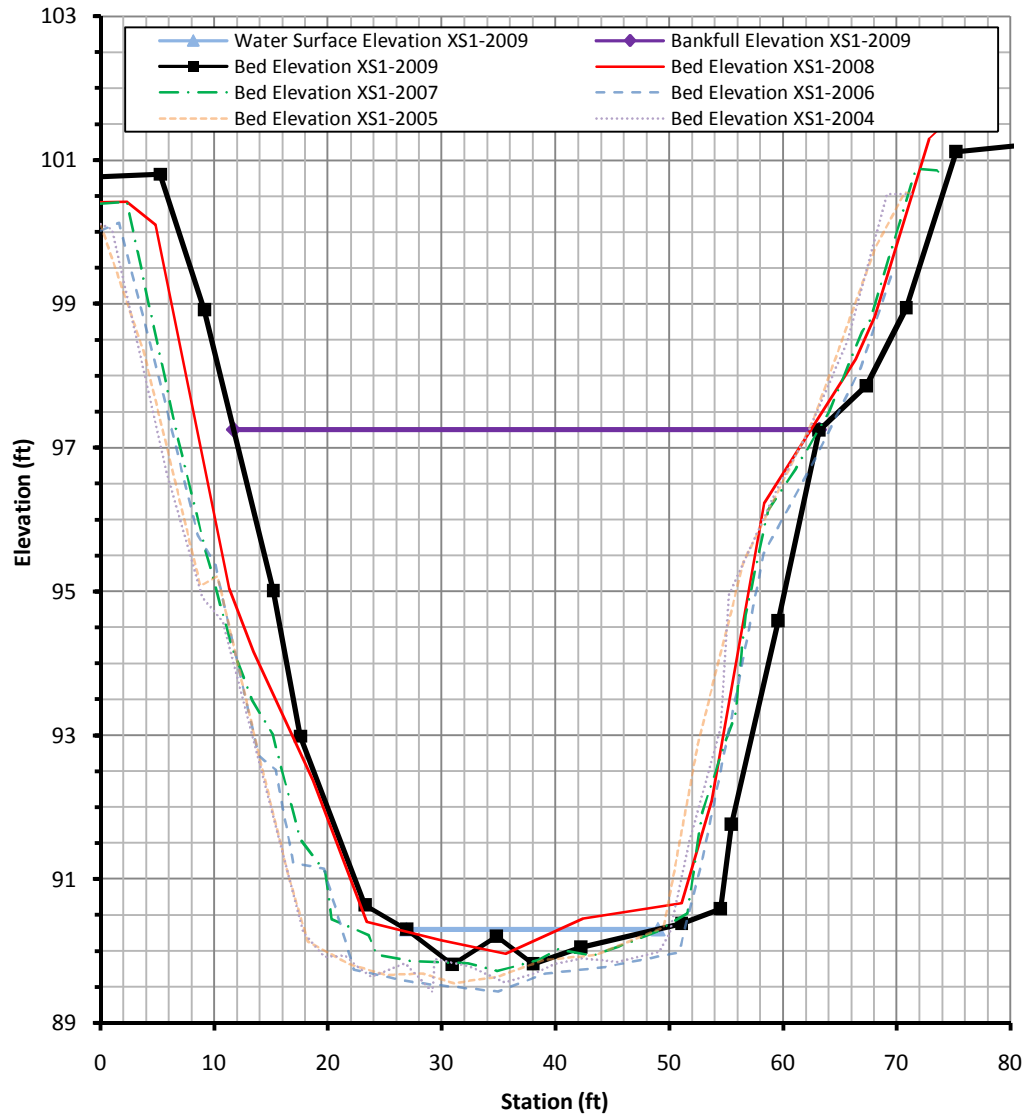
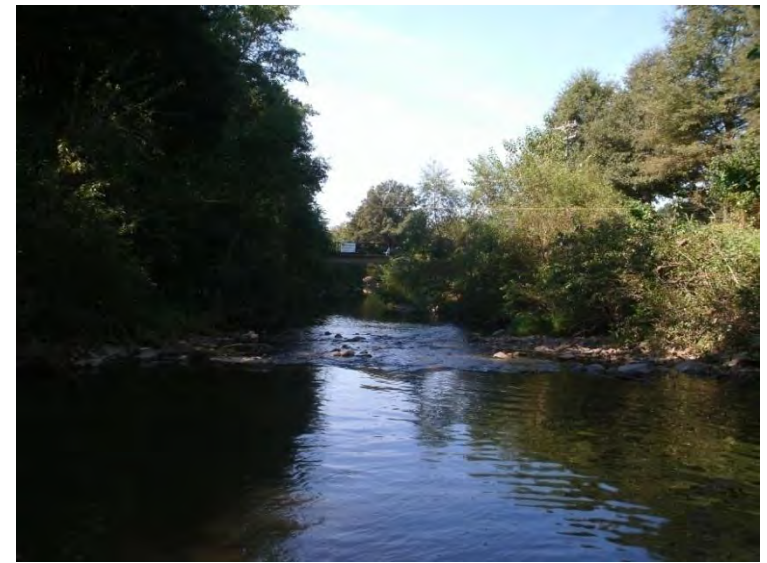
ID	YEAR	PHASE	FACET TYPE	Wbkf	Abkf	Dbkf
XS1		DS	RIFFLE	54.0	33.9	6.3
XS1	2004	AB	RIFFLE	46.3	197.3	4.3
XS1	2005	MY1	RIFFLE	47.6	205.7	4.3
XS1	2006	MY2	RIFFLE	47.6	214.7	4.5
XS1	2007	MY3	RIFFLE	48.9	223.0	4.6
XS1	2008	MY4	RIFFLE	48.6	229.5	4.7
XS1	2009	MY5	RIFFLE	51.5	291.3	5.7

ID	YEAR	PHASE	d50 (mm)	d84 (mm)
XS1	2006	MY2	11.14	66.60
XS1	2007	MY3	18.84	75.96
XS1	2008	MY4	16.00	62.78
XS1	2009	MY5	40.27	62.64

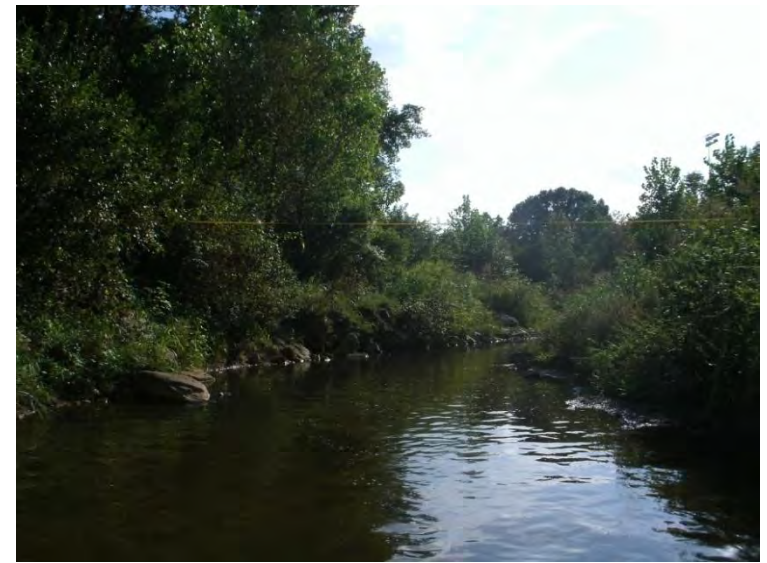
ID	YEAR	PHASE	FACET TYPE	Wbkf	Abkf	Dbkf
XS2		DS	POOL	54.0	339.0	6.3
XS2	2004	AB	POOL	66.5	235.9	3.6
XS2	2005	MY1	POOL	71.4	253.5	3.5
XS2	2006	MY2	POOL	64.8	236.0	3.6
XS2	2007	MY3	POOL	74.6	235.6	3.2
XS2	2008	MY4	POOL	72.9	262.8	3.6
XS2	2009	MY5	POOL	46.4	224.2	4.8

ID	YEAR	PHASE	d50 (mm)	d84 (mm)
XS2	2006	MY2	0.73	25.94
XS2	2007	MY2	0.31	0.85
XS2	2008	MY4	0.48	54.50
XS2	2009	MY5	15.69	54.50

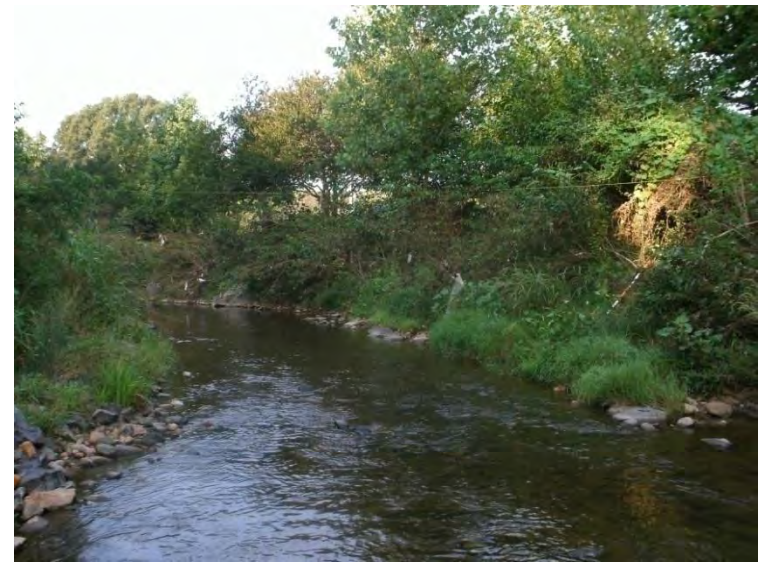
ID	YEAR	PHASE	FACET TYPE	Wbkf	Abkf	Dbkf
XS3		DS	RIFFLE	54.0	339.0	6.3
XS3	2004	AB	RIFFLE	45.3	208.2	4.6
XS3	2005	MY1	RIFFLE	46.1	213.0	4.6
XS3	2006	MY2	RIFFLE	46.3	213.0	4.6
XS3	2007	MY3	RIFFLE	46.9	215.0	4.6
XS3	2008	MY4	RIFFLE	41.36	175.0	4.2
XS3	2009	MY5	RIFFLE	36.3	146.1	4.0

ID	YEAR	PHASE	d50 (mm)	d84 (mm)
XS3	2006	MY2	0.85	33.69
XS3	2007	MY3	1.43	5.38
XS3	2008	MY4	9.65	128.00
XS3	2009	MY5	18.06	64.99

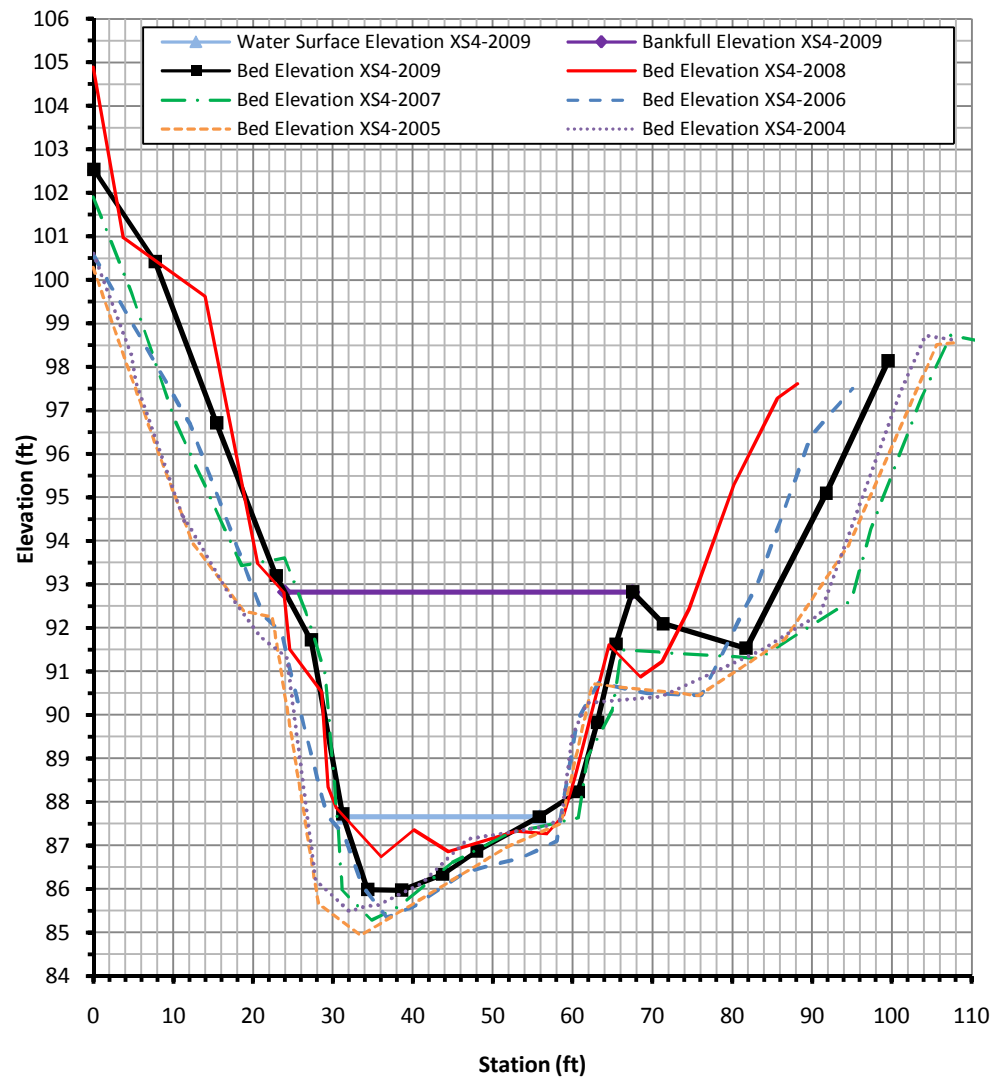
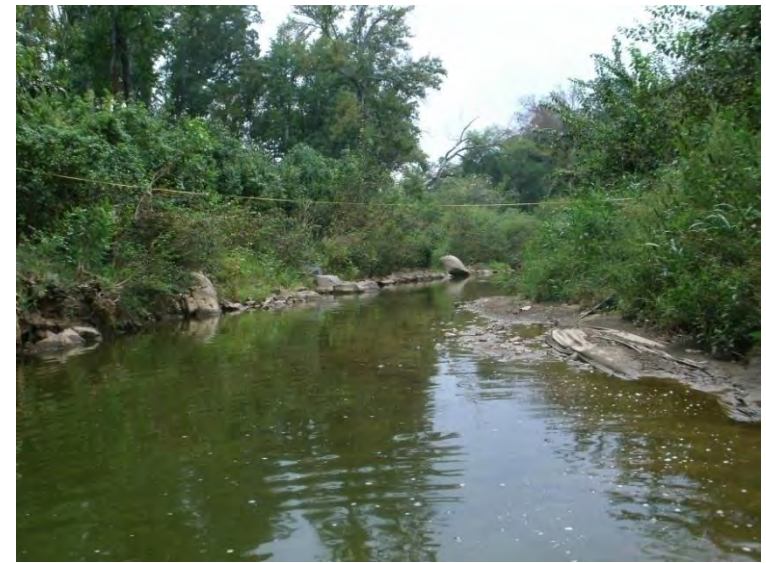
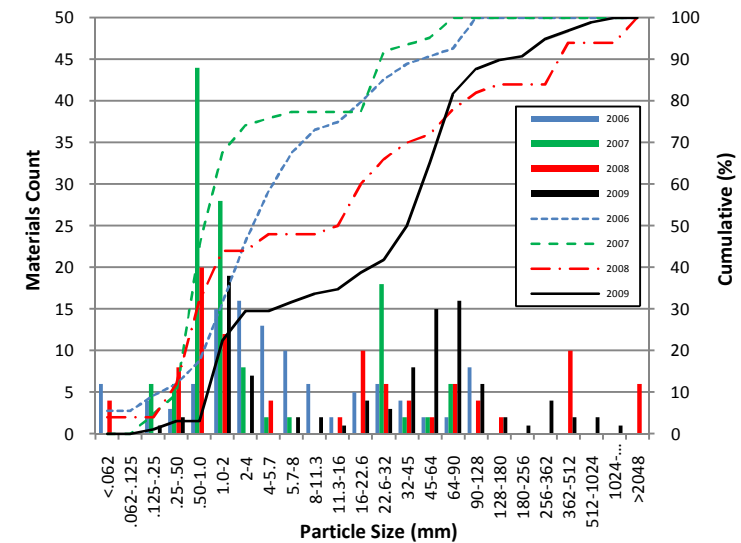
ID	YEAR	PHASE	FACET TYPE	Wbkf	Abkf	Dbkf
XS4		DS	RIFFLE	54.0	339.0	6.3
XS4	2004	AB	RIFFLE	68.7	223.6	3.3
XS4	2005	MY1	RIFFLE	63.7	219.9	3.5
XS4	2006	MY2	RIFFLE	56.4	204.8	3.6
XS4	2007	MY3	RIFFLE	61.2	188.4	3.1
XS4	2008	MY4	RIFFLE	50.5	188.4	3.7
XS4	2009	MY5	RIFFLE	61.5	220.0	3.6

ID	YEAR	PHASE	d50 (mm)	d84 (mm)
XS4	2006	MY2	2.62	21.19
XS4	2007	MY3	0.61	18.99
XS4	2008	MY4	11.30	128.00
XS4	2009	MY5	32.00	74.05

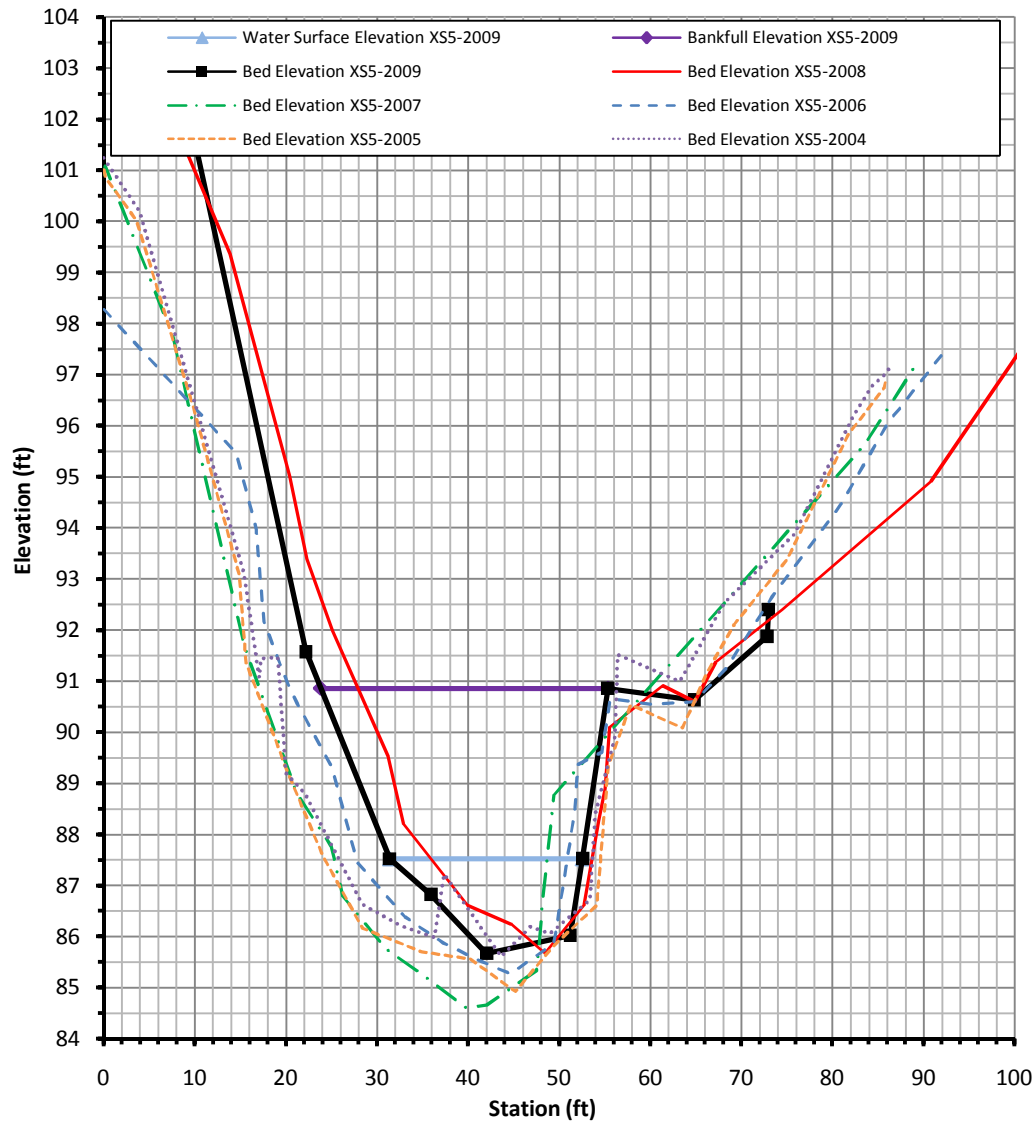
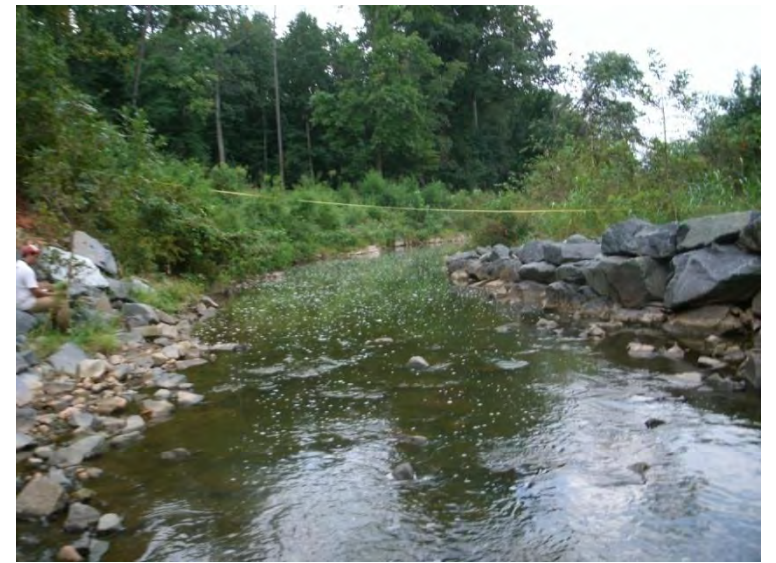
ID	YEAR	PHASE	FACET TYPE	Wbkf	Abkf	Dbkf
XS5		DS	RIFFLE	54.0	339.0	6.3
XS5	2004	AB	RIFFLE	52.3	222.2	4.3
XS5	2005	MY1	RIFFLE	53.9	236.6	4.4
XS5	2006	MY2	RIFFLE	56.0	223.9	4.0
XS5	2007	MY3	RIFFLE	53.0	228.3	4.3
XS5	2008	MY4	RIFFLE	58.7	221.0	3.8
XS5	2009	MY5	RIFFLE	42.5	115.0	2.7

ID	YEAR	PHASE	d50 (mm)	d84 (mm)
XS5	2006	MY2	7.90	107.48
XS5	2007	MY3	41.75	205.33
XS5	2008	MY4	11.30	230.67
XS5	2009	MY5	1.80	135.60

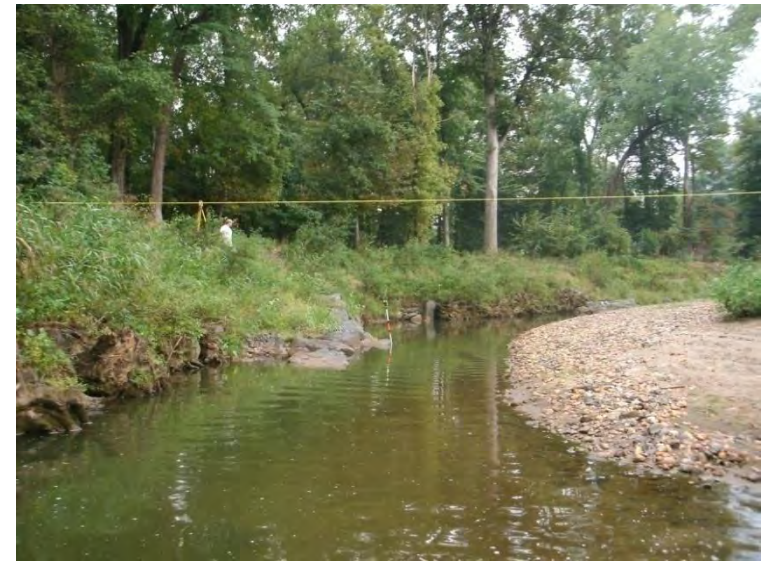
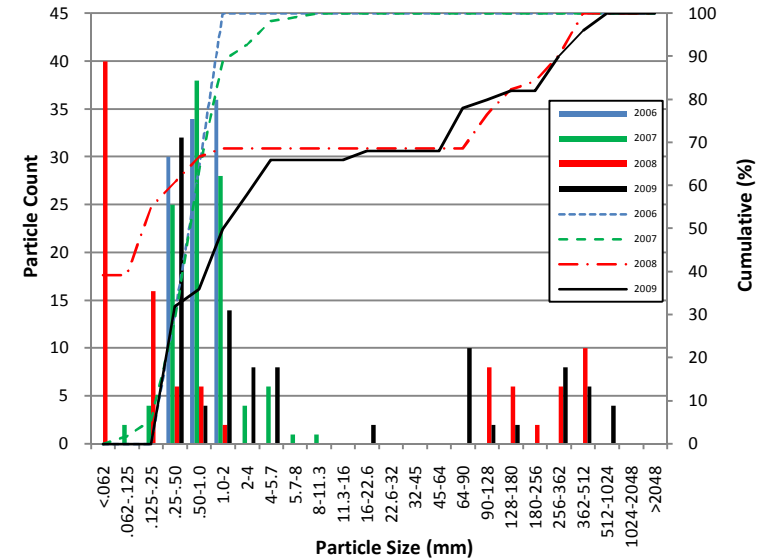
ID	YEAR	PHASE	FACET TYPE	Wbkf	Abkf	Dbkf
XS6		DS	POOL	54.0	339.0	6.3
XS6	2004	AB	POOL	79.5	273.7	3.4
XS6	2005	MY1	POOL	85.2	284.6	3.3
XS6	2006	MY2	POOL	79.5	284.3	3.6
XS6	2007	MY3	POOL	85.1	286.3	3.4
XS6	2008	MY4	POOL	76.9	256.9	3.3
XS6	2009	MY5	POOL	91.7	269.6	2.9

ID	YEAR	PHASE	d50 (mm)	d84 (mm)
XS6	2006	MY2	0.40	0.78
XS6	2007	MY3	0.40	0.90
XS6	2008	MY4	0.11	171.68
XS6	2009	MY5	1.00	199.00

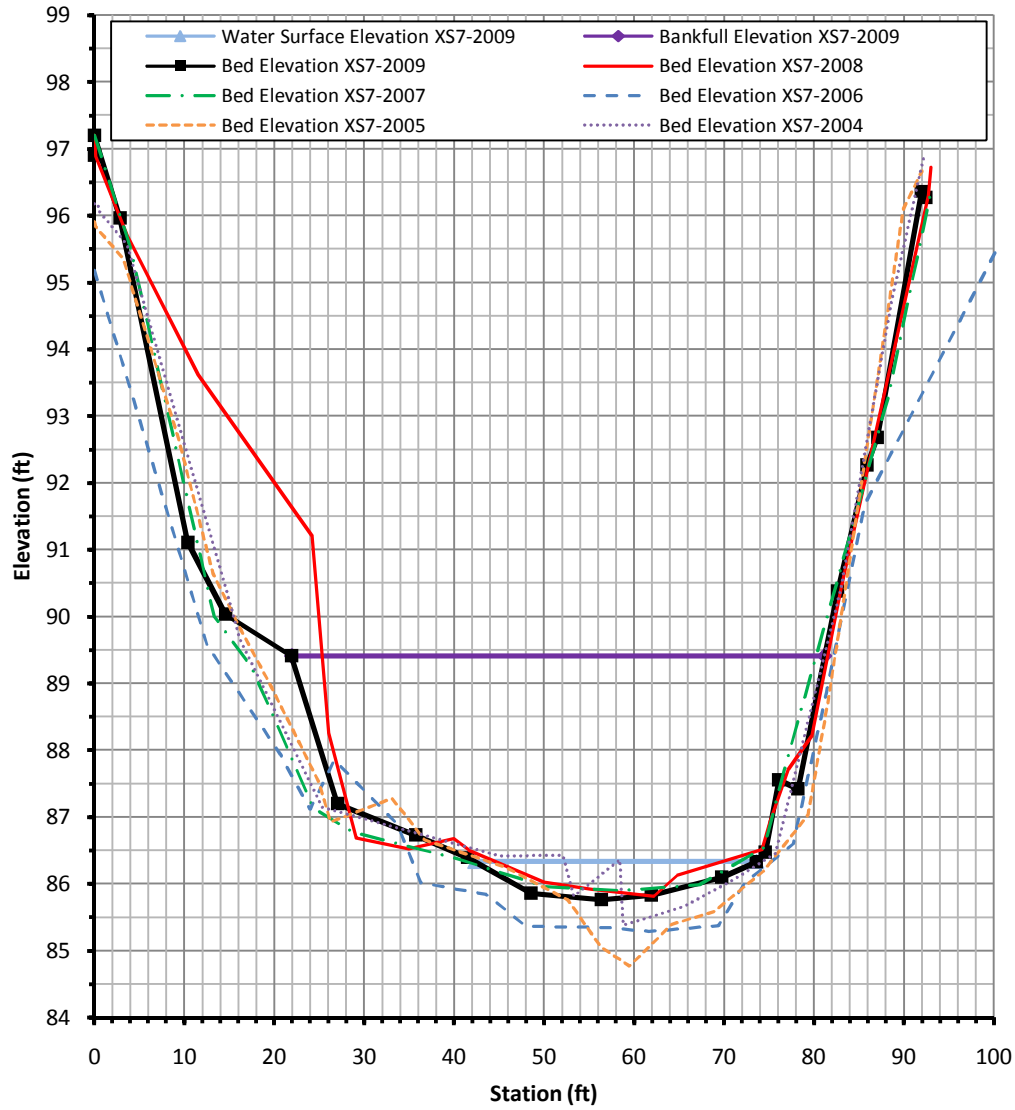
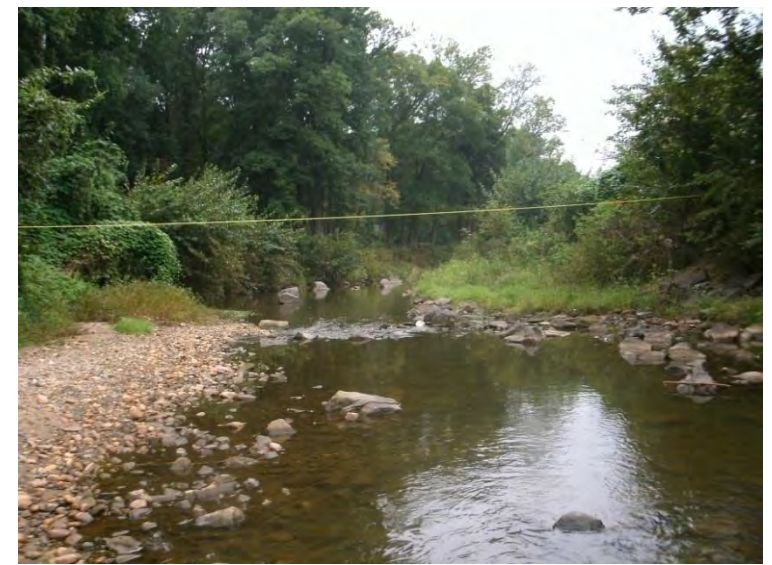
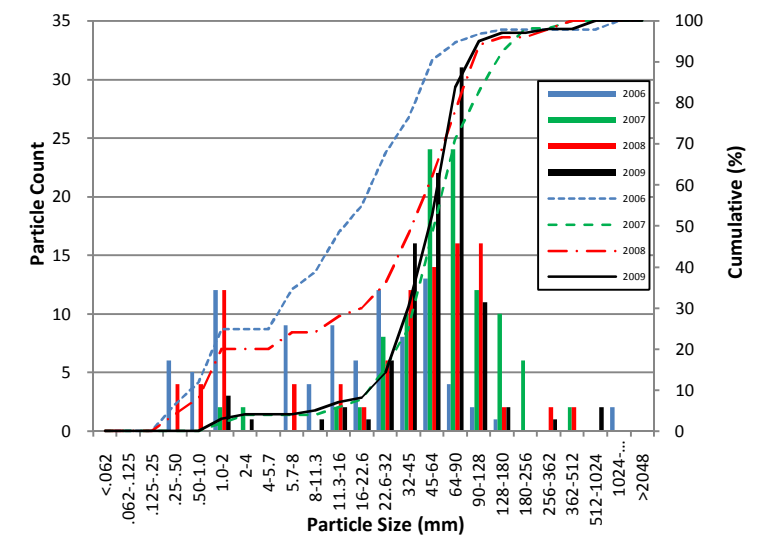
ID	YEAR	PHASE	FACET TYPE	Wbkf	Abkf	Dbkf
XS7		DS	RIFFLE	54.0	339.0	6.3
XS7	2004	AB	RIFFLE	68.4	239.2	3.5
XS7	2005	MY1	RIFFLE	66.5	214.1	3.2
XS7	2006	MY2	RIFFLE	70.0	213.8	3.1
XS7	2007	MY3	RIFFLE	69.3	233.7	3.4
XS7	2008	MY4	RIFFLE	60.2	264.7	4.4
XS7	2009	MY5	RIFFLE	59.3	157.6	2.8

ID	YEAR	PHASE	d50 (mm)	d84 (mm)
XS7	2006	MY2	12.48	39.12
XS7	2007	MY3	46.58	95.17
XS7	2008	MY4	30.66	73.75
XS7	2009	MY5	43.52	45.28

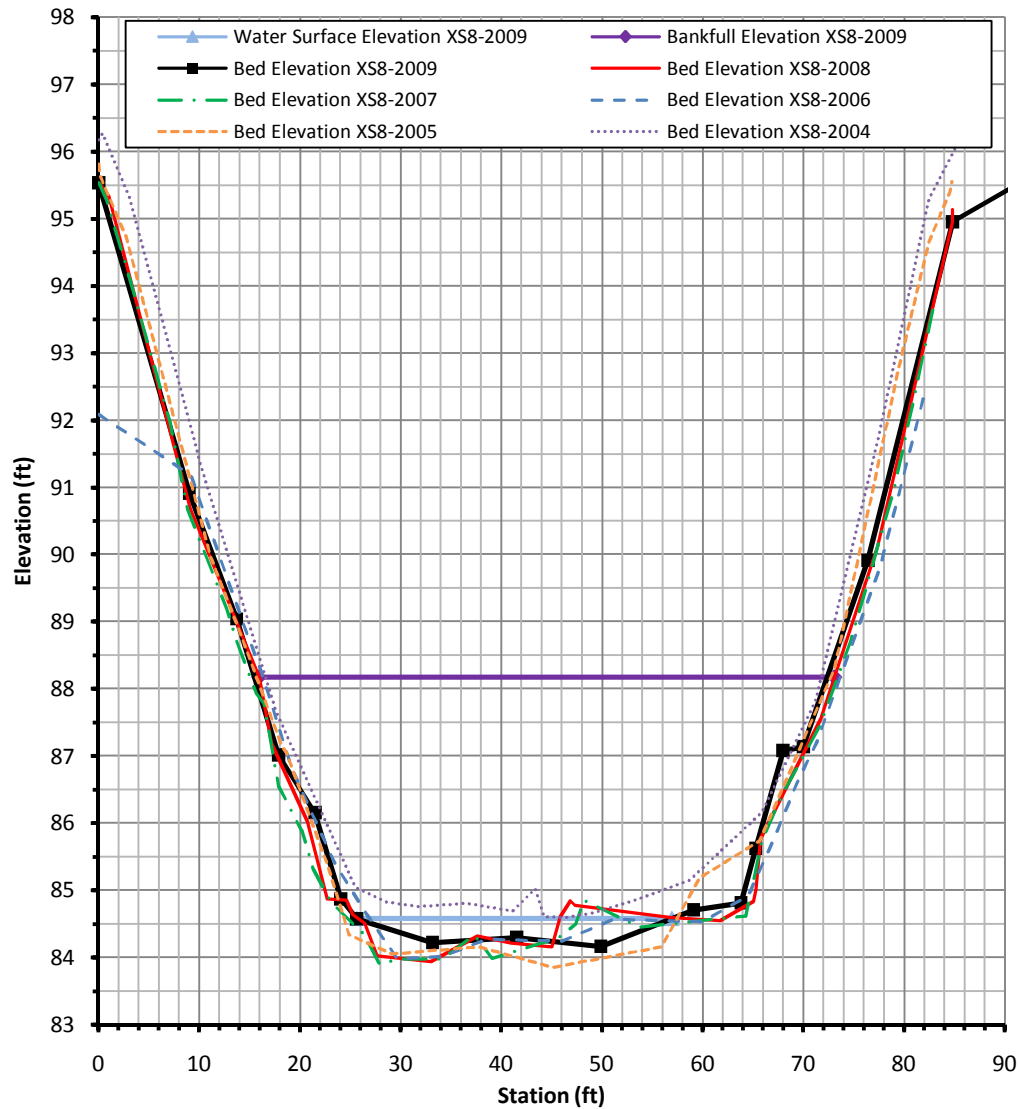
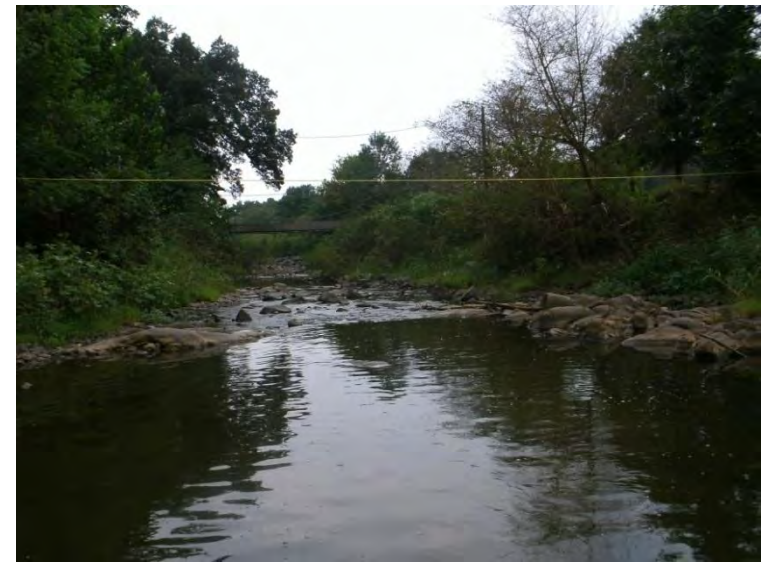
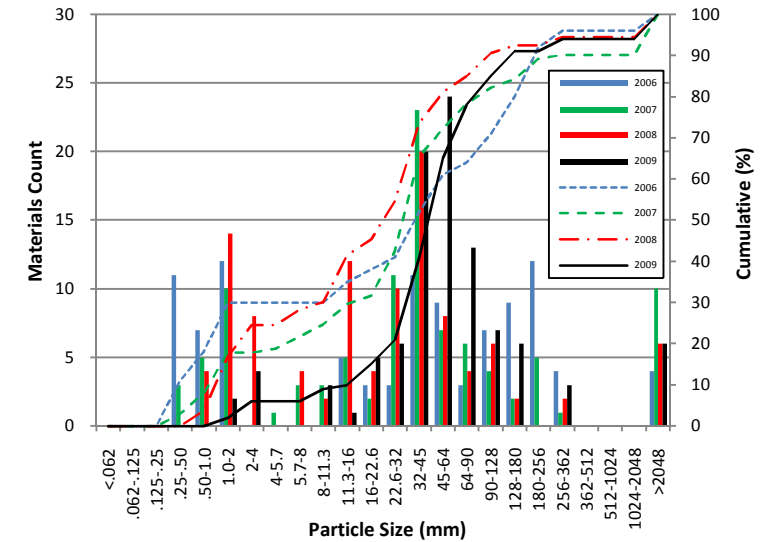
ID	YEAR	PHASE	FACET TYPE	Wbkf	Abkf	Dbkf
XS8		DS	RIFFLE	54.0	339.0	6.3
XS8	2004	AB	RIFFLE	59.5	219.7	3.7
XS8	2005	MY1	RIFFLE	59.7	219.9	3.7
XS8	2006	MY2	RIFFLE	60.8	221.3	3.6
XS8	2007	MY3	RIFFLE	61.0	219.7	3.6
XS8	2008	MY4	RIFFLE	57.1	181.3	3.2
XS8	2009	MY5	RIFFLE	56.9	176.5	3.1

ID	YEAR	PHASE	d50 (mm)	d84 (mm)
XS8	2006	MY2	30.29	145.33
XS8	2007	MY3	25.67	124.96
XS8	2008	MY4	19.30	59.44
XS8	2009	MY5	26.13	86.29
