**Gillespie Golf Course (Mile Run Creek)
Stream Restoration
Greensboro, North Carolina
Annual Monitoring Report
Monitoring Year 2005**

Monitoring Year: 2005
Measurement Year 2
As-Built Date: 2004
NCEEP Project Number 144

**GILLESPIE GOLF COURSE (MILE RUN CREEK) STREAM RESTORATION
2005 MONITORING REPORT**

CONDUCTED FOR THE NORTH CAROLINA DEPARTMENT
OF
ENVIRONMENT AND NATURAL RESOURCES

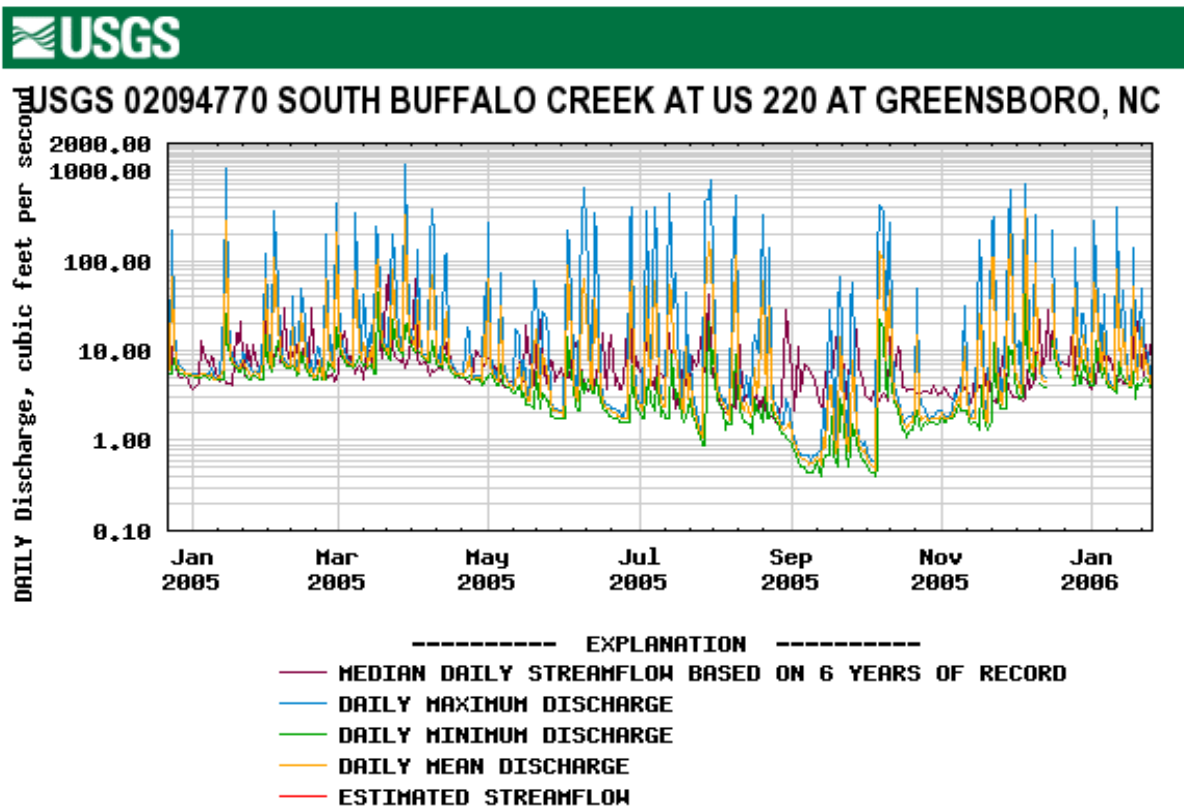
Figure 3. USGS Stream gauge discharge data for South Buffalo Creek at US 220.

No crest gauges are installed at this site to document bankfull events. Therefore, potential occurrence was extrapolated based on USGS stream gauge discharge data for South Buffalo Creek at US 220 (approximately 2 miles southwest of project site) with a drainage area of 15.4 square miles. Bankfull events were determined by comparing the stream discharge [cubic feet per second (cfs)] against the drainage area on the urban piedmont regional curve. According to the urban piedmont regional curve a bankfull event occurs on a stream with a 15.4 mi² drainage area when the discharge is between 1,538 and 1,704 cfs. Based on USGS data no bankfull events occurred in 2005. However, there may have been one bankfull event on December 10, 2004 when the maximum discharge reached 1,700 cfs for one day. Two high flow events were recorded for 2005. On January 14 and March 28 maximum discharge was recorded at 1,040 and 1,140 cfs respectively.
