**Glade Creek  
Stream Restoration  
NCEEP Project Number: 854  
Monitoring Year 1  
2011 Final Report**

**Submitted to  
North Carolina Ecosystem Enhancement Program  
North Carolina Department of Environment and Natural Resources  
January 2012**

# **Glade Creek Stream Restoration 2011 Monitoring Report (MY 1)**

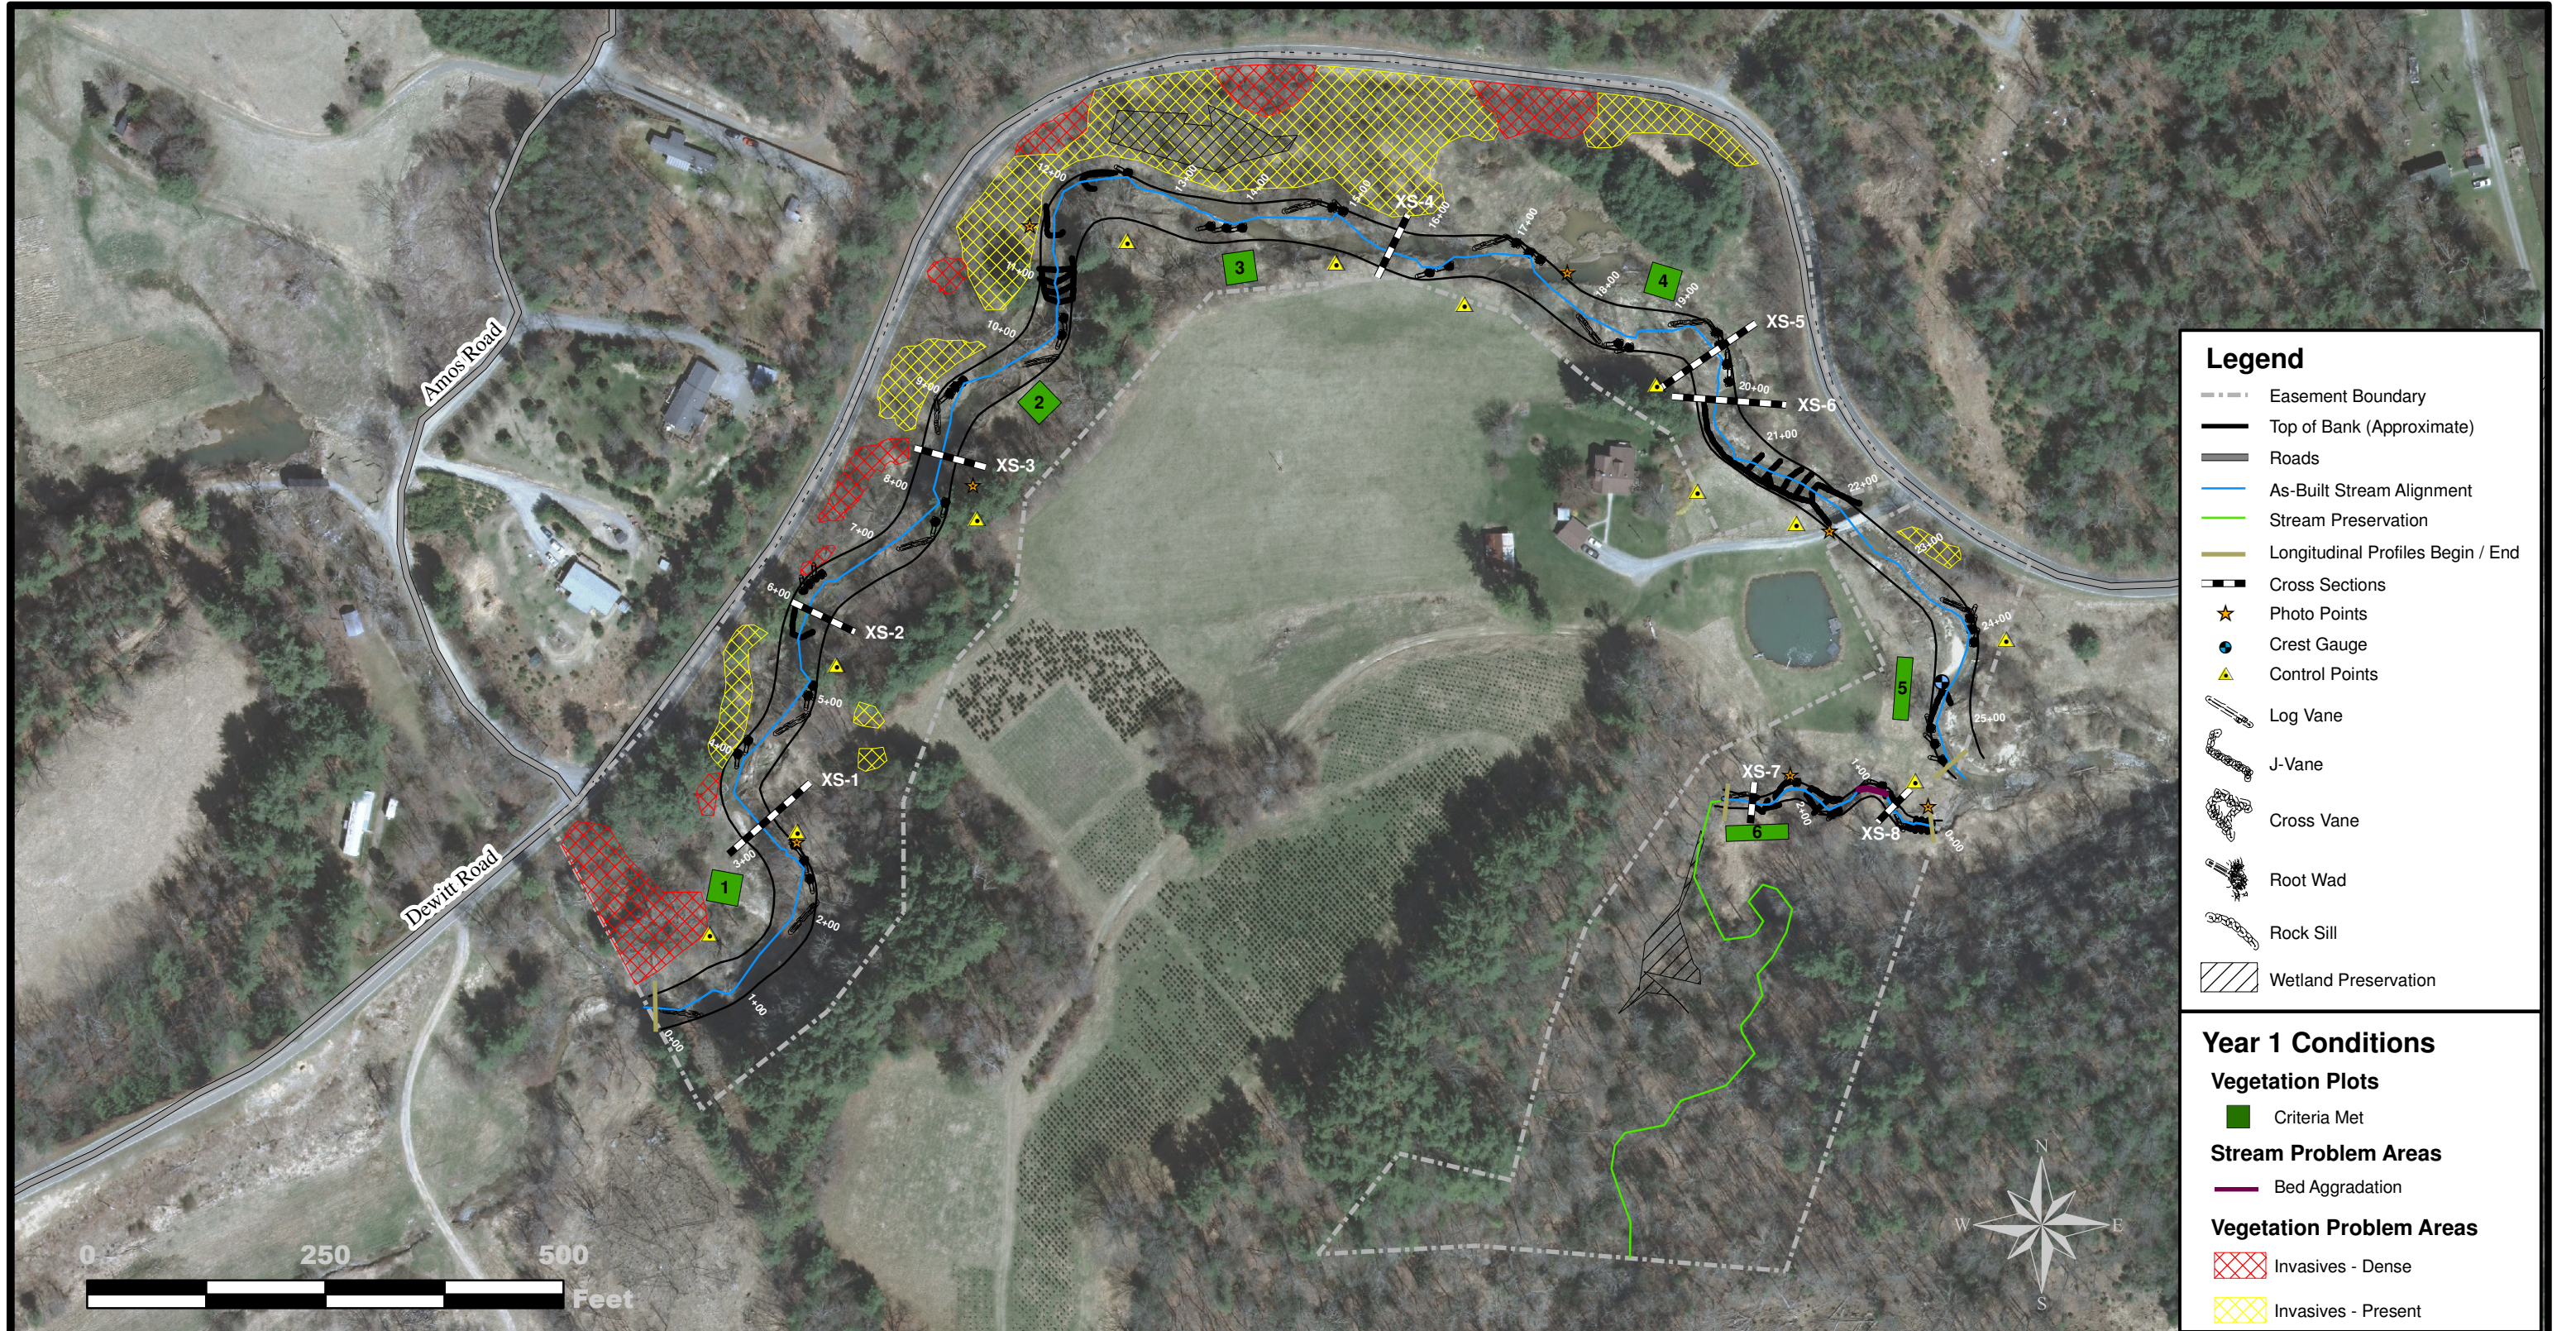
Prepared for	<b>Project:</b> Glade Creek Stream Restoration Year 1 Monitoring Alleghany County, North Carolina	Notes: 1) Base Map Data Provided by NCEEP & Biohabitats 2) 2010 Aerial Photo	Prepared by

- Figure 2. Integrated Current Condition Plan View
- Table 5. Visual Stream Morphology Stability Assessment
- Table 6. Vegetation Condition Assessment
- Photo Station Photos

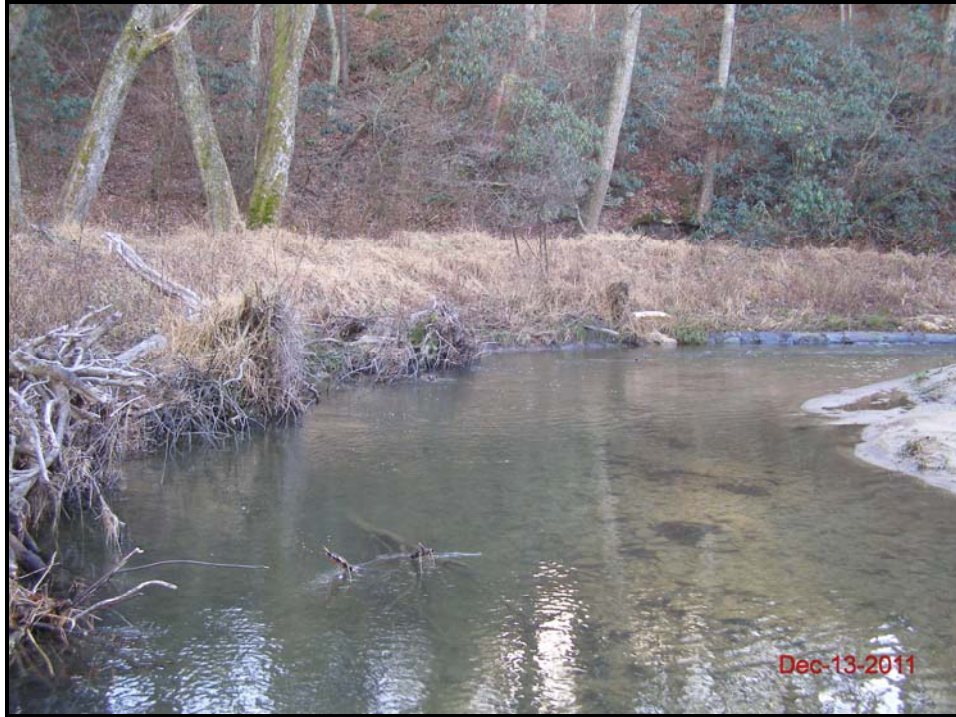
Glade Creek – Permanent Photo Station 1  
Looking Upstream

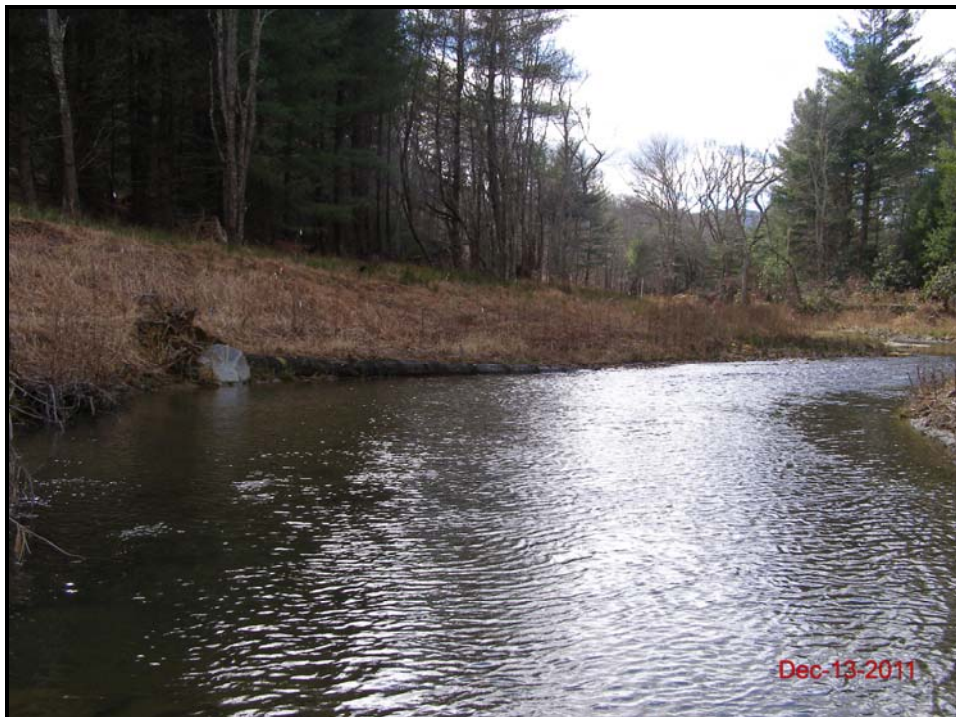
Glade Creek – Permanent Photo Station 2  
Looking Upstream

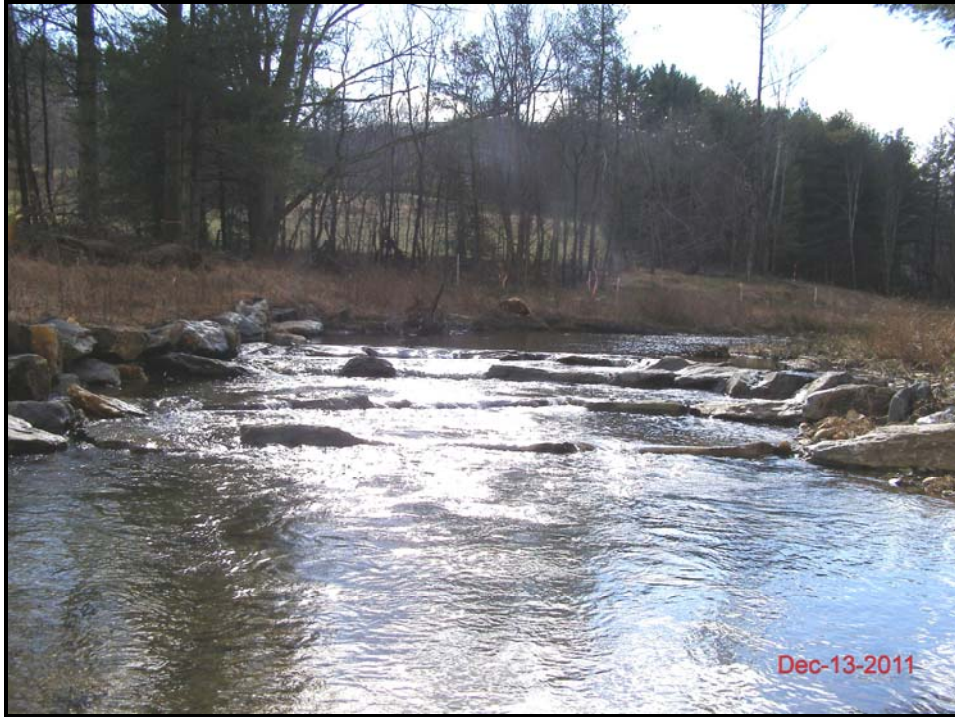
Glade Creek – Permanent Photo Station 3  
Looking Upstream

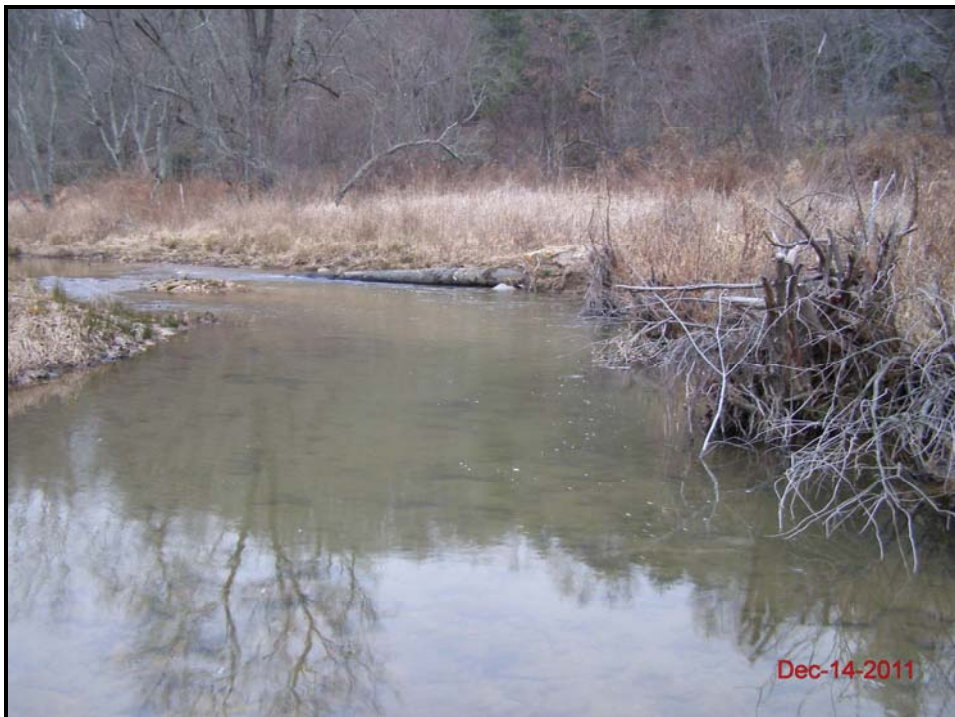
Glade Creek – Permanent Photo Station 4  
Looking Upstream

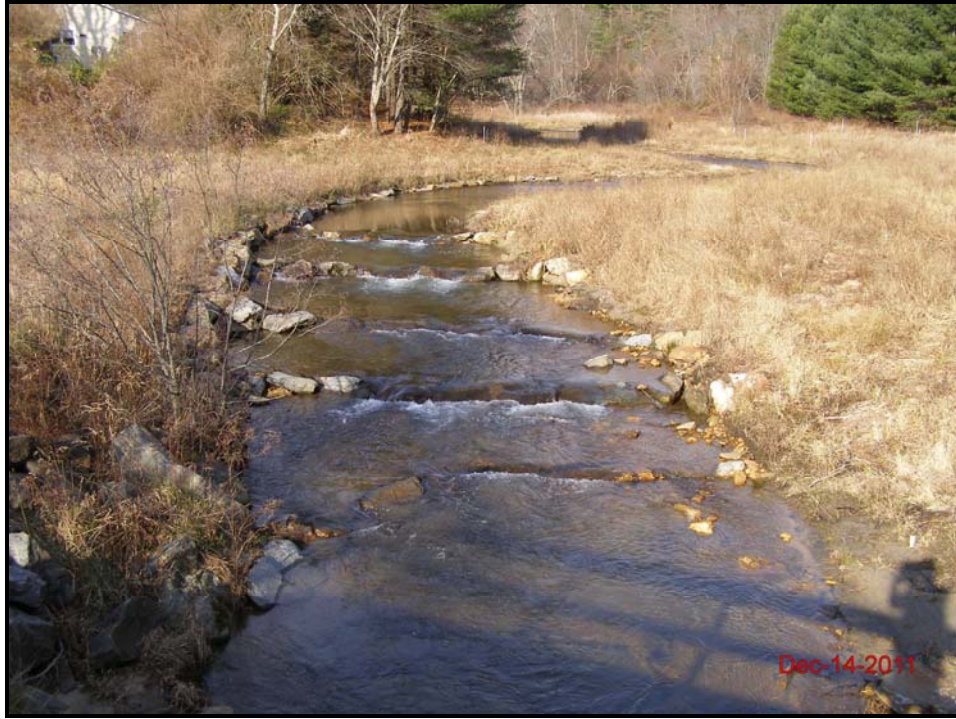
Glade Creek – Permanent Photo Station 5  
Looking Upstream

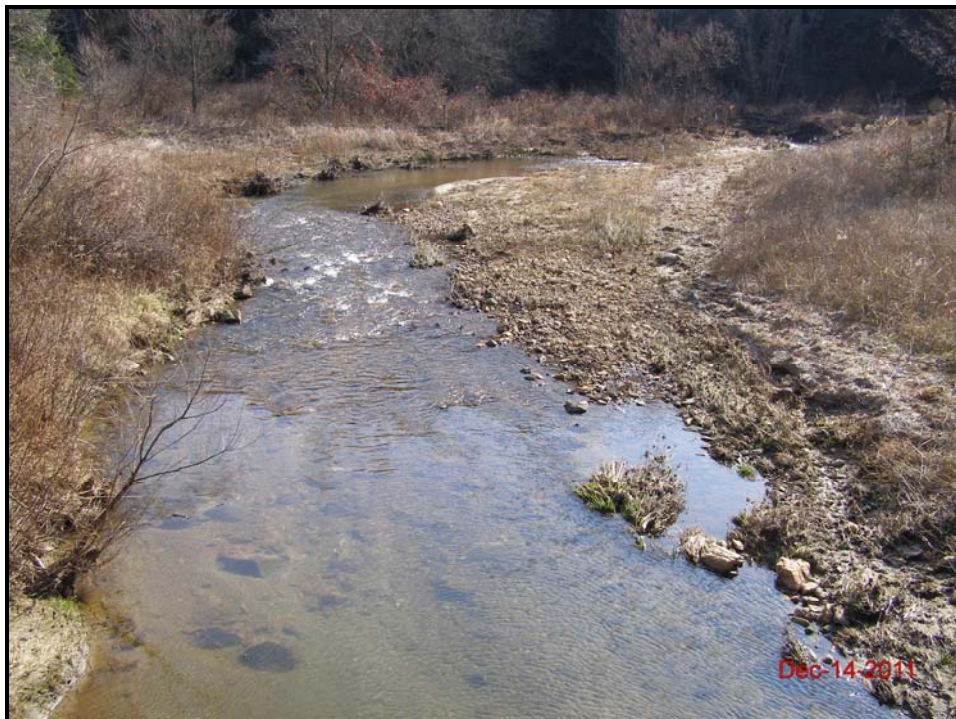
Glade Creek – Permanent Photo Station 5  
Looking Downstream

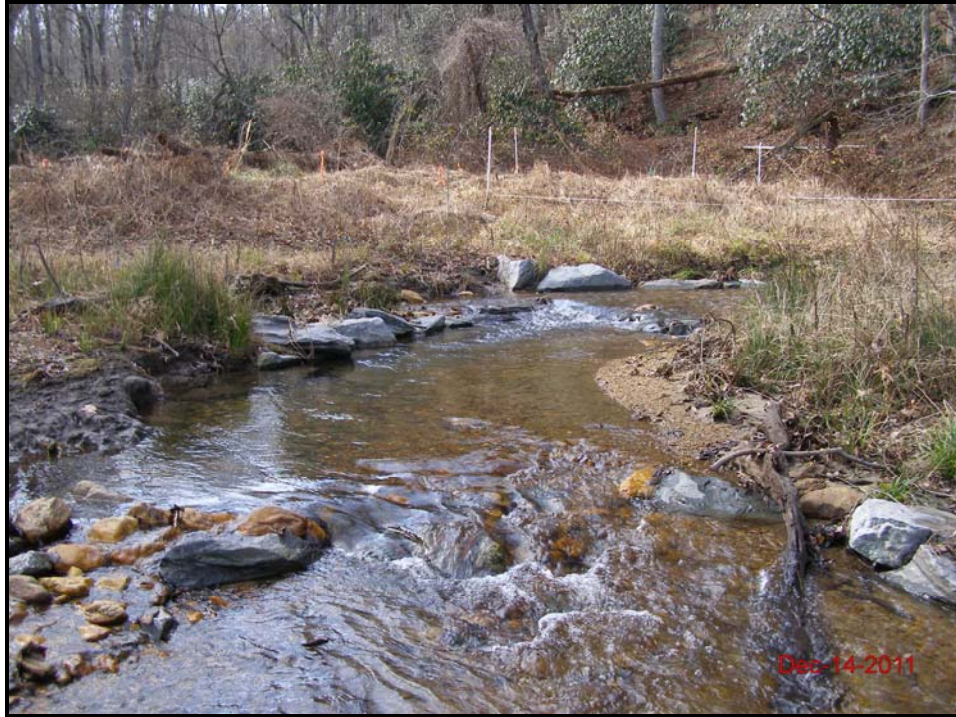
Unnamed Tributary Lower – Permanent Photo Station 6  
Looking Upstream

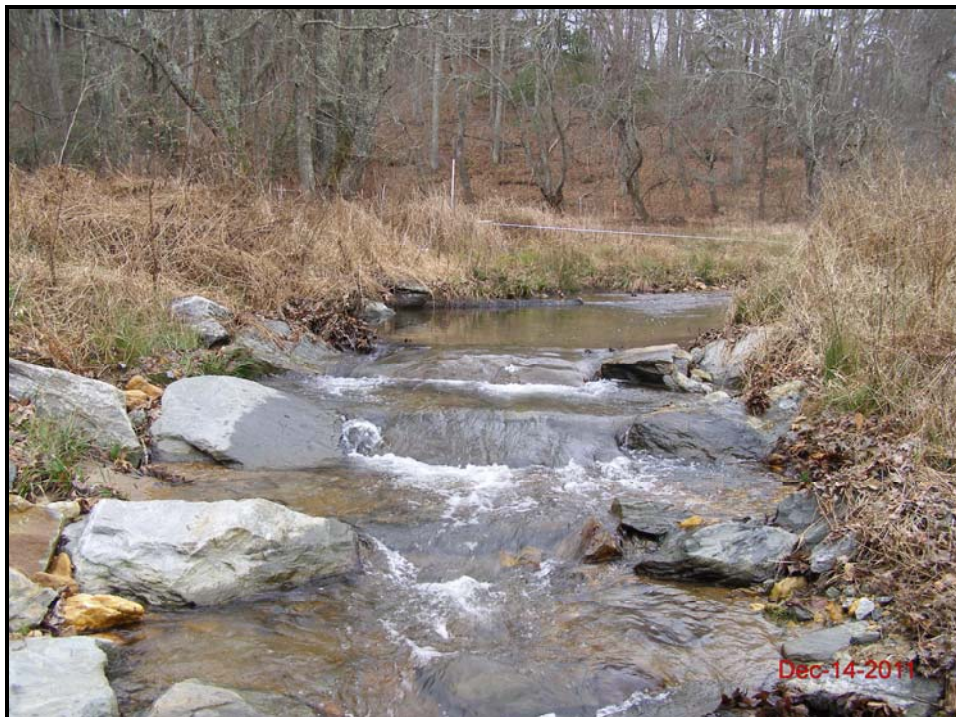
Unnamed Tributary Lower – Permanent Photo Station 7  
Looking Upstream

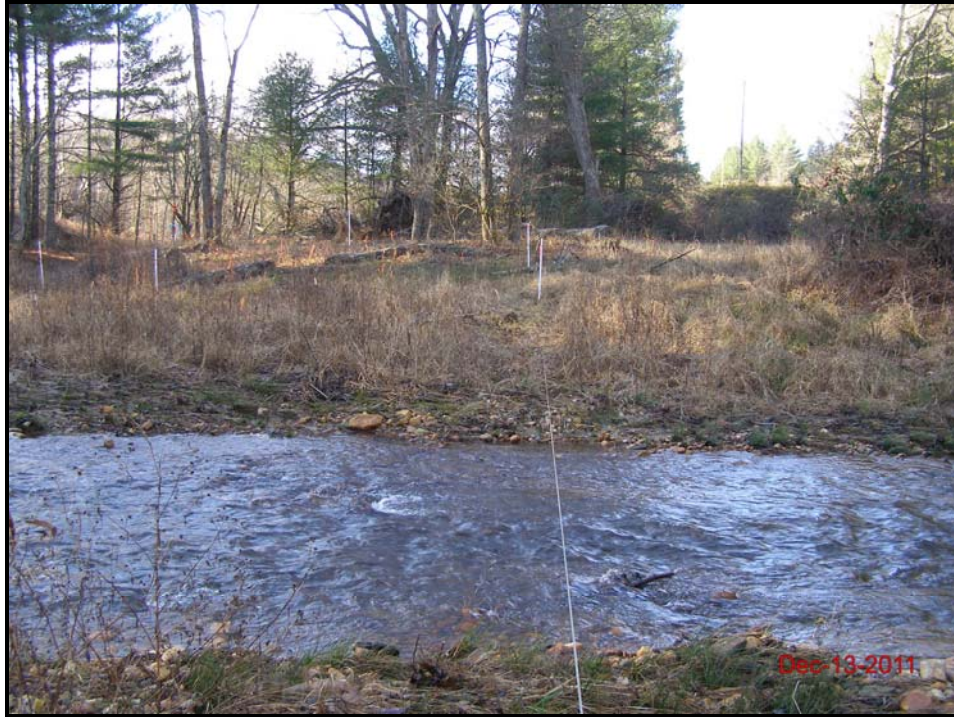
Glade Creek – Cross-Section 1 – Riffle  
(Looking at Left Bank Descending)  
Monitoring Year 1 – December 13, 2011

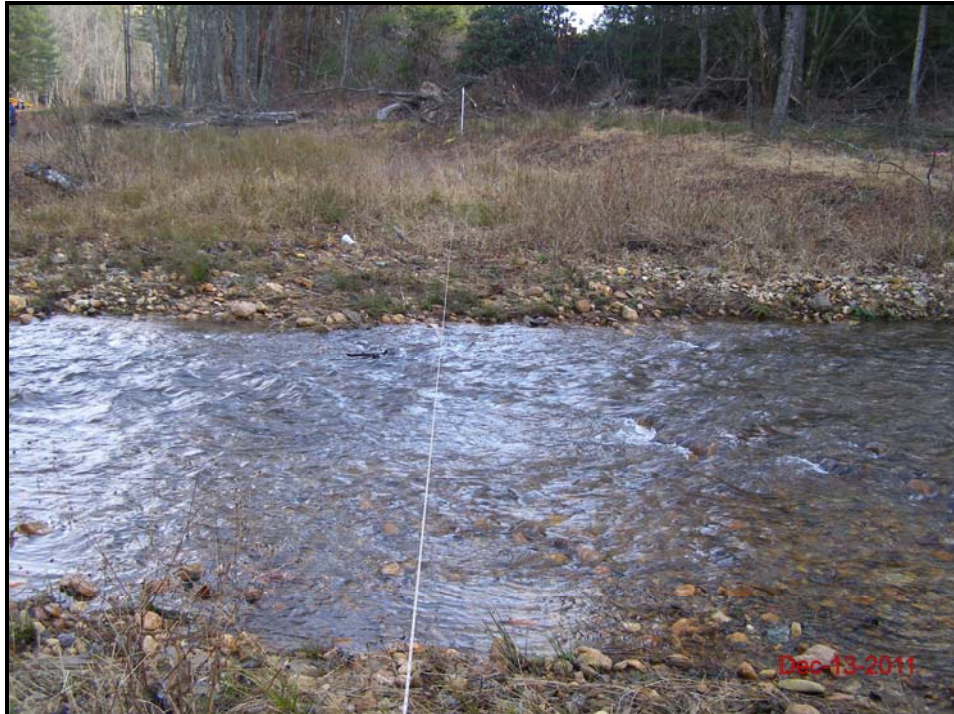
Glade Creek – Cross-Section 1 – Riffle  
(Looking at Right Bank Descending)  
Monitoring Year 1 – December 13, 2011

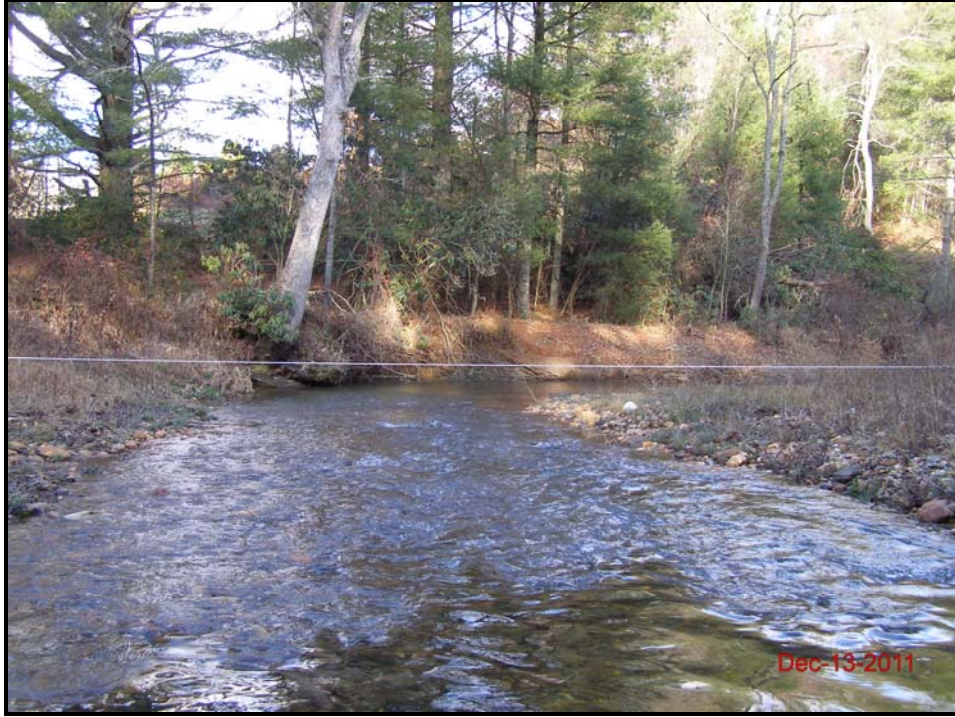
Glade Creek – Cross-Section 1 – Riffle  
(Looking Downstream)  
Monitoring Year 1 – December 13, 2011

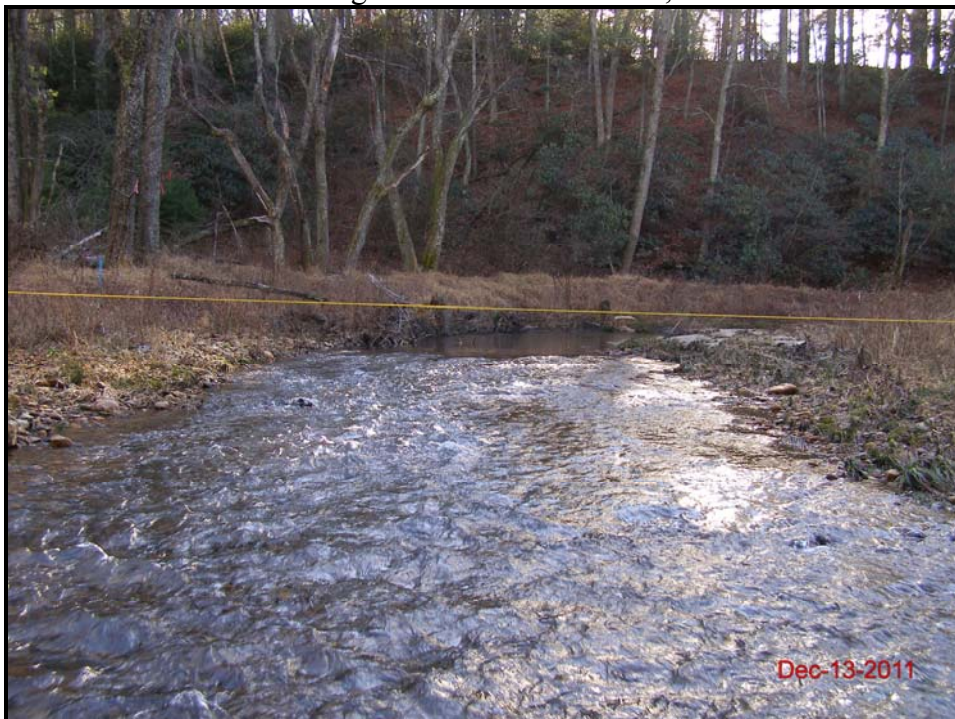
Glade Creek – Cross-Section 1 – Riffle  
(Looking Upstream)  
Monitoring Year 1 – December 13, 2011

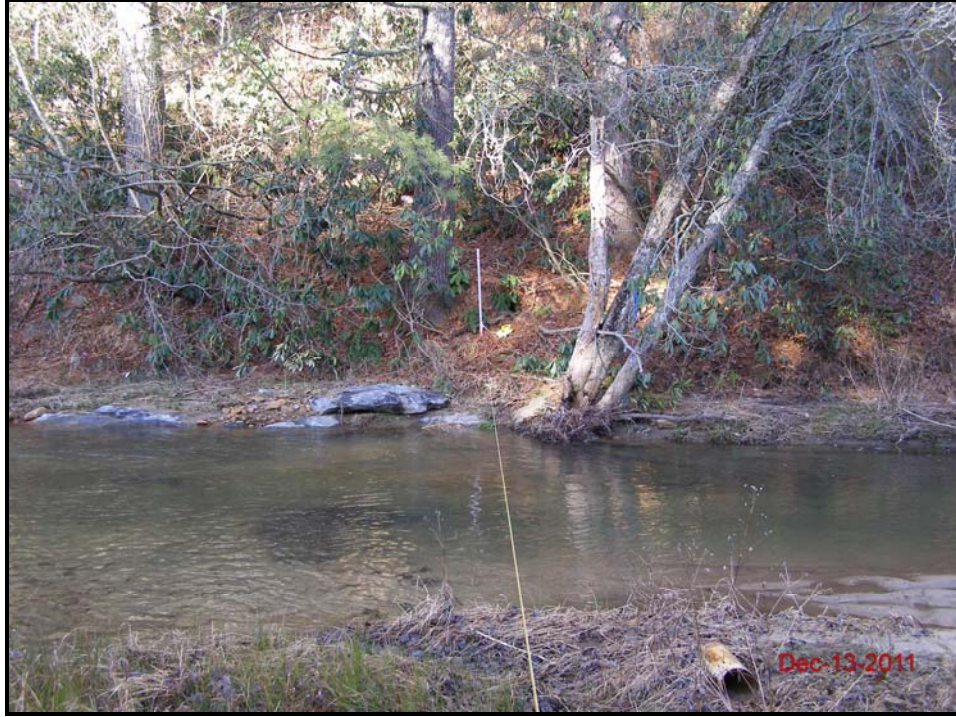
Glade Creek – Cross-Section 2 – Pool  
(Looking at Left Bank Descending)  
Monitoring Year 1 – December 13, 2011

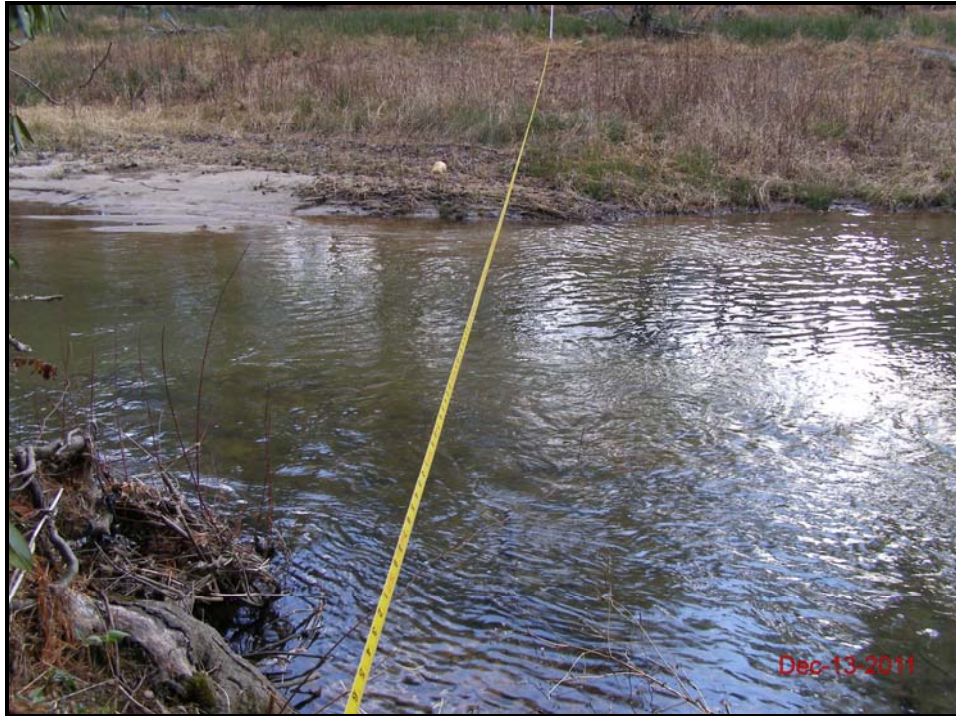
Glade Creek – Cross-Section 2 – Pool  
(Looking at Right Bank Descending)  
Monitoring Year 1 – December 13, 2011

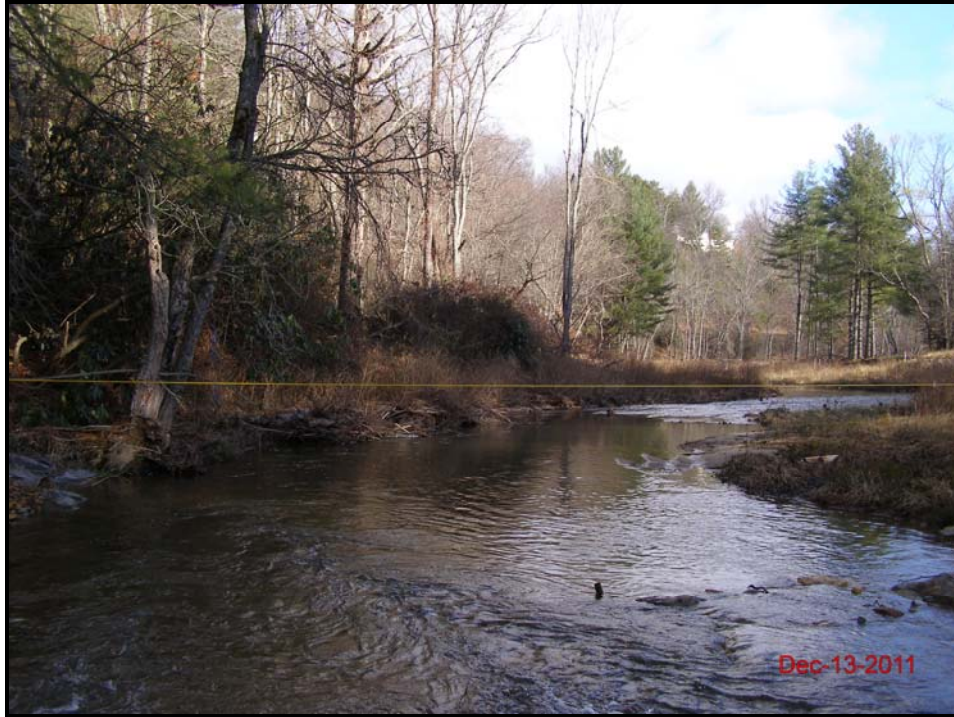
Glade Creek – Cross-Section 2 – Pool  
(Looking Downstream)  
Monitoring Year 1 – December 13, 2011

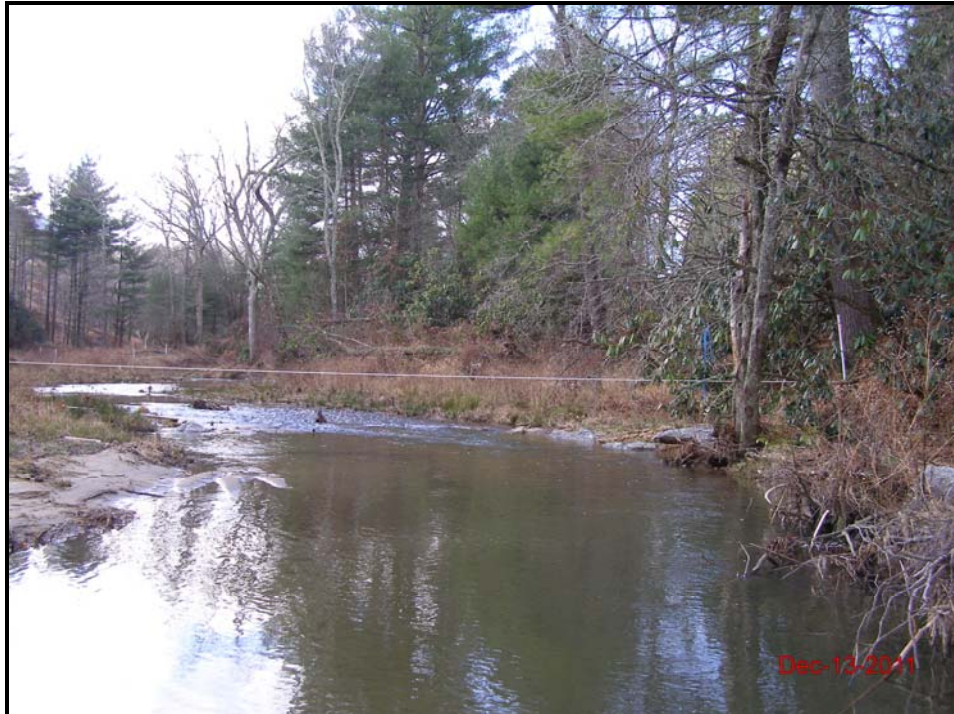
Glade Creek – Cross-Section 2 – Pool  
(Looking Upstream)  
Monitoring Year 1 – December 13, 2011

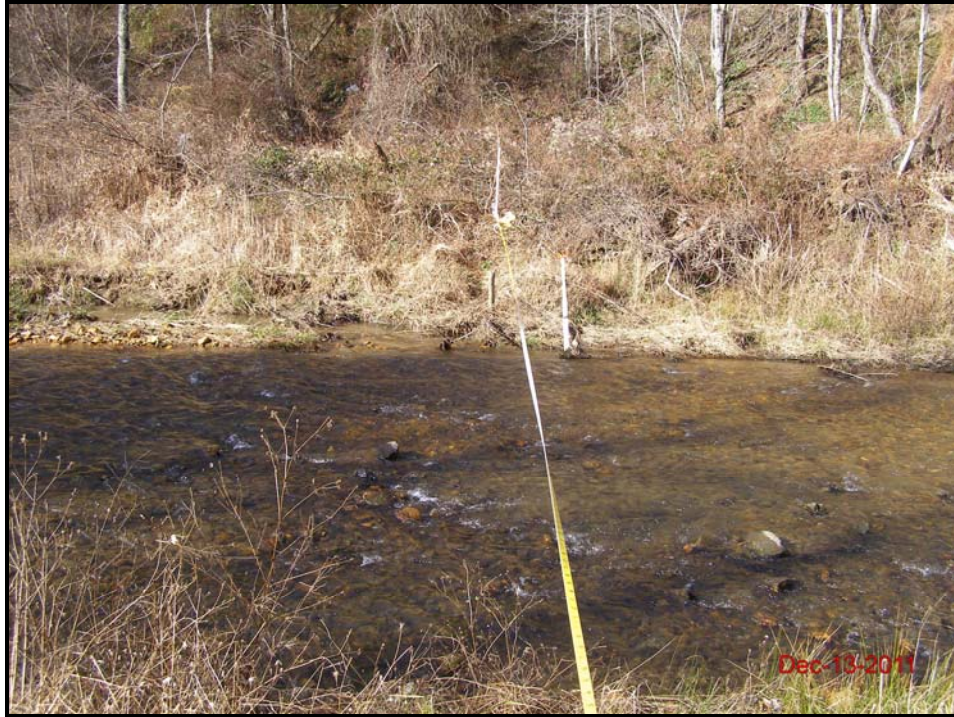
Glade Creek – Cross-Section 3 – Riffle  
(Looking at Left Bank Descending)  
Monitoring Year 1 – December 13, 2011

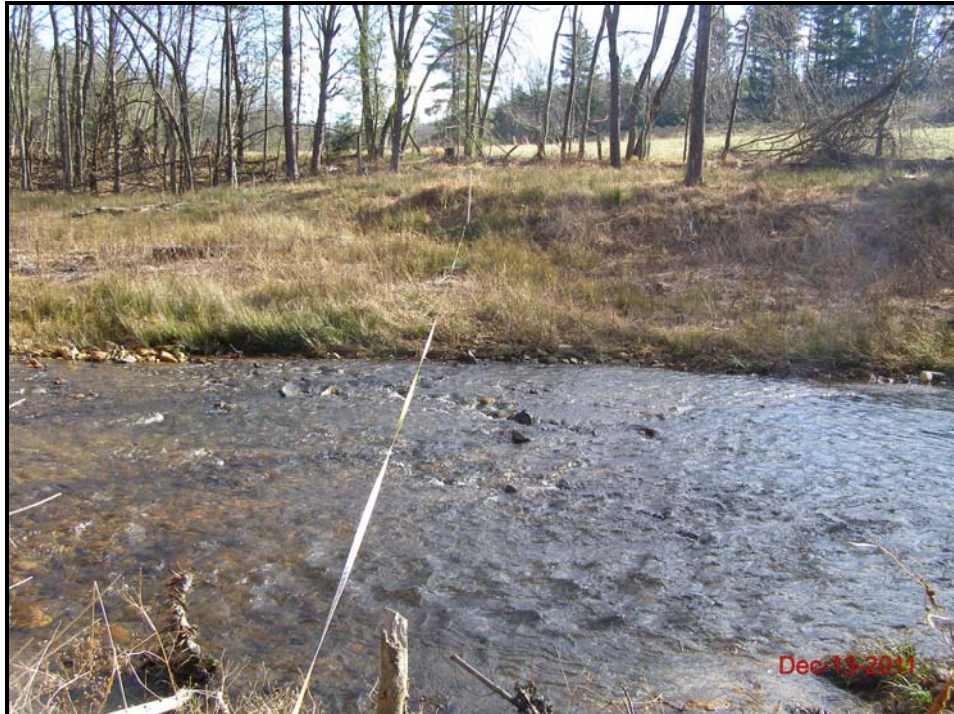
Glade Creek – Cross-Section 3 – Riffle  
(Looking at Right Bank Descending)  
Monitoring Year 1 – December 13, 2011

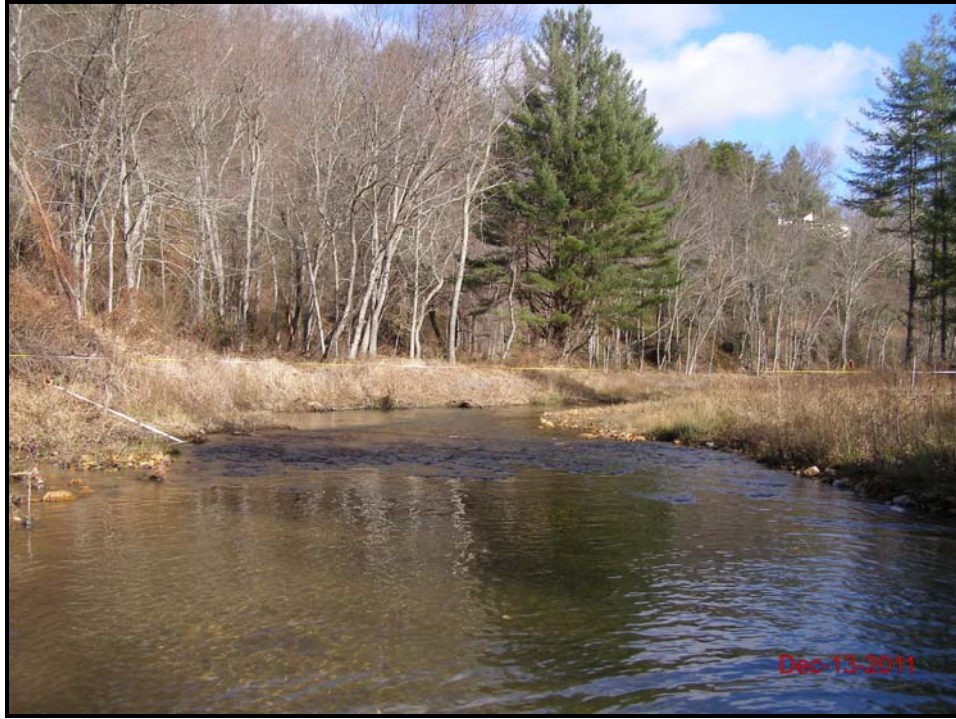
Glade Creek – Cross-Section 3 – Riffle  
(Looking Downstream)  
Monitoring Year 1 – December 13, 2011

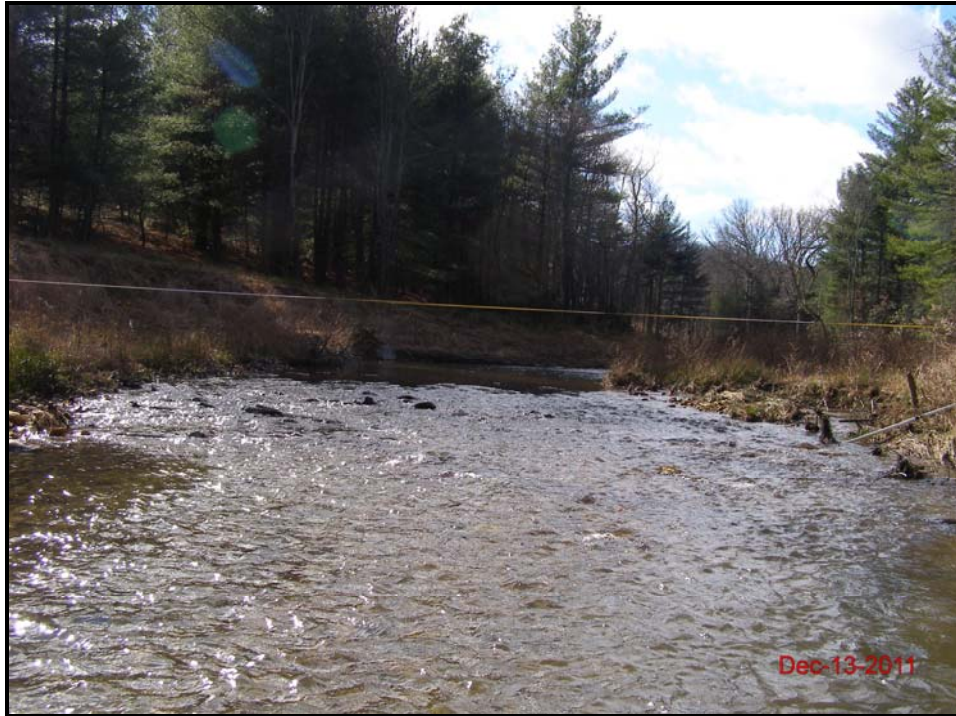
Glade Creek – Cross-Section 3 – Riffle  
(Looking Upstream)  
Monitoring Year 1 – December 13, 2011

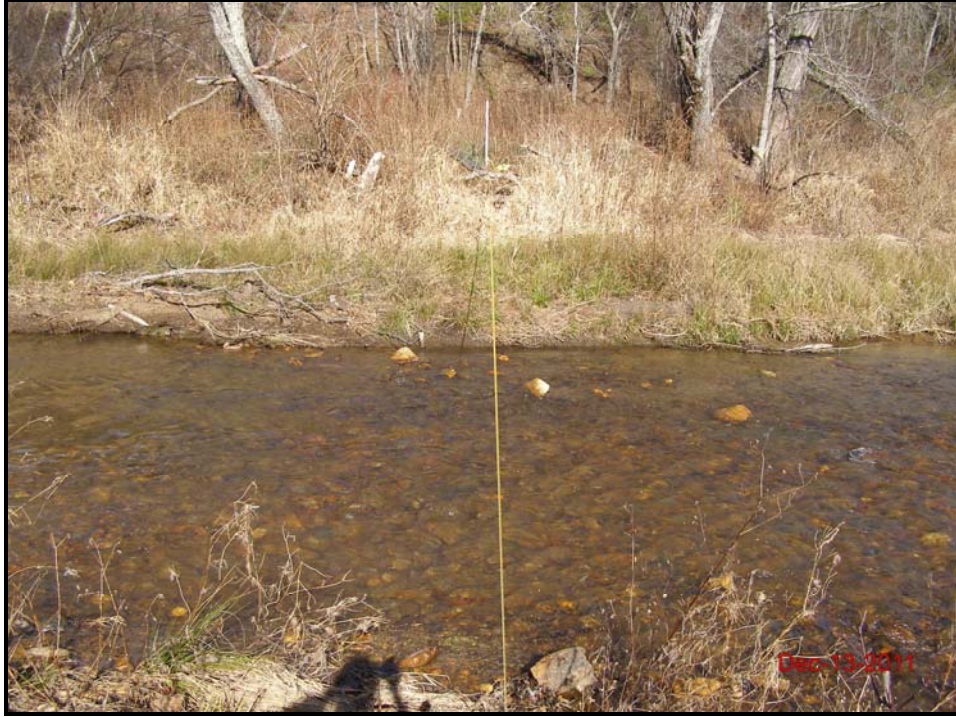
Glade Creek – Cross-Section 4 – Riffle  
(Looking at Left Bank Descending)  
Monitoring Year 1 – December 13, 2011

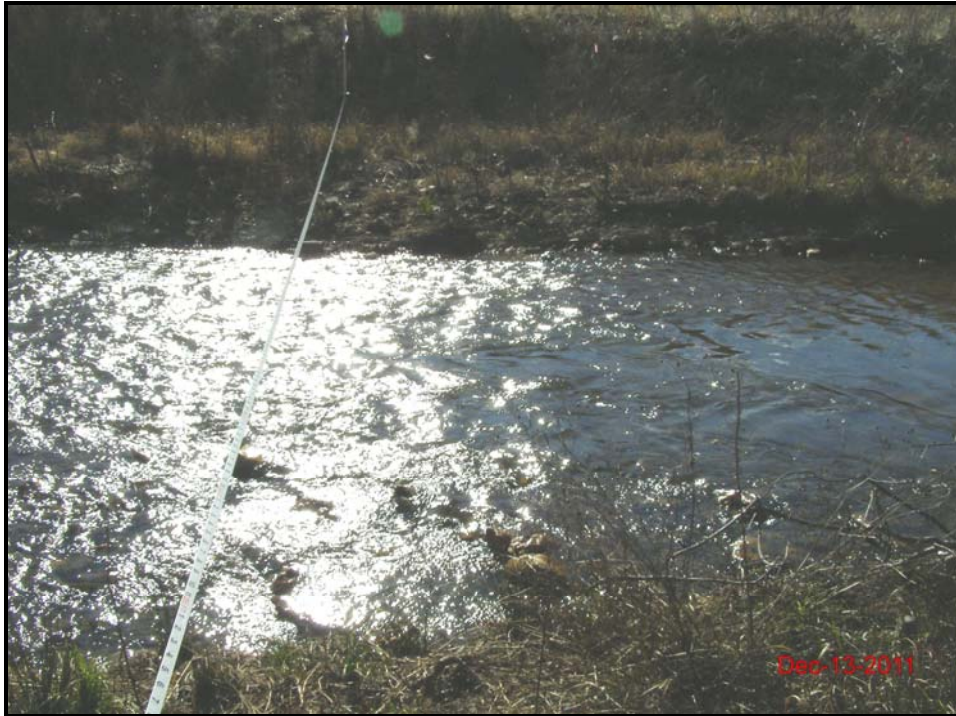
Glade Creek – Cross-Section 4 – Riffle  
(Looking at Right Bank Descending)  
Monitoring Year 1 – December 13, 2011

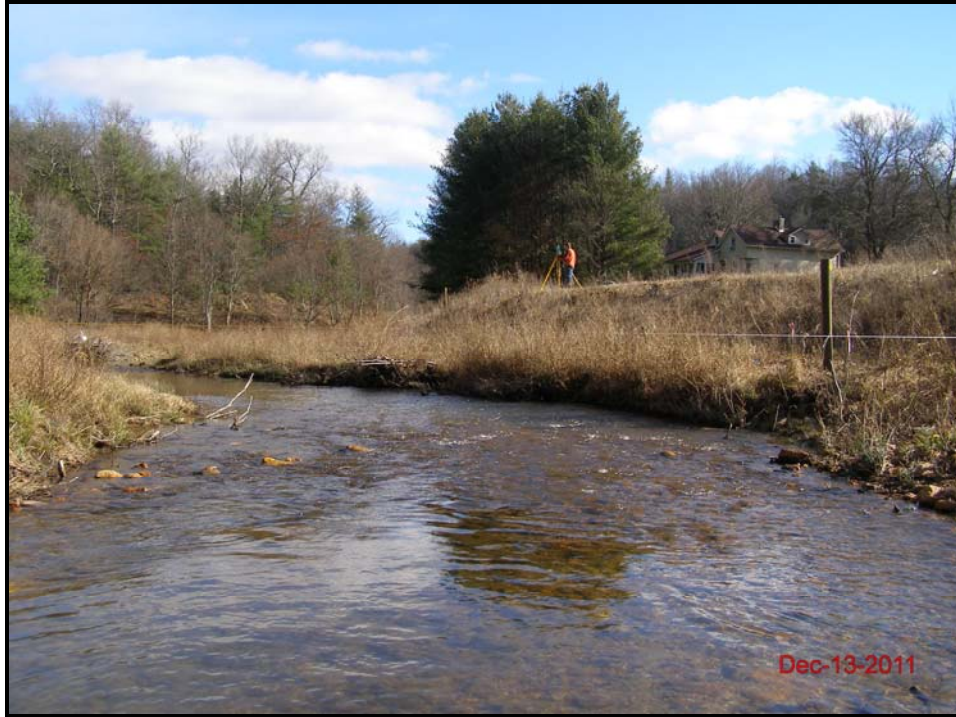
Glade Creek – Cross-Section 4 – Riffle  
(Looking Downstream)  
Monitoring Year 1 – December 13, 2011

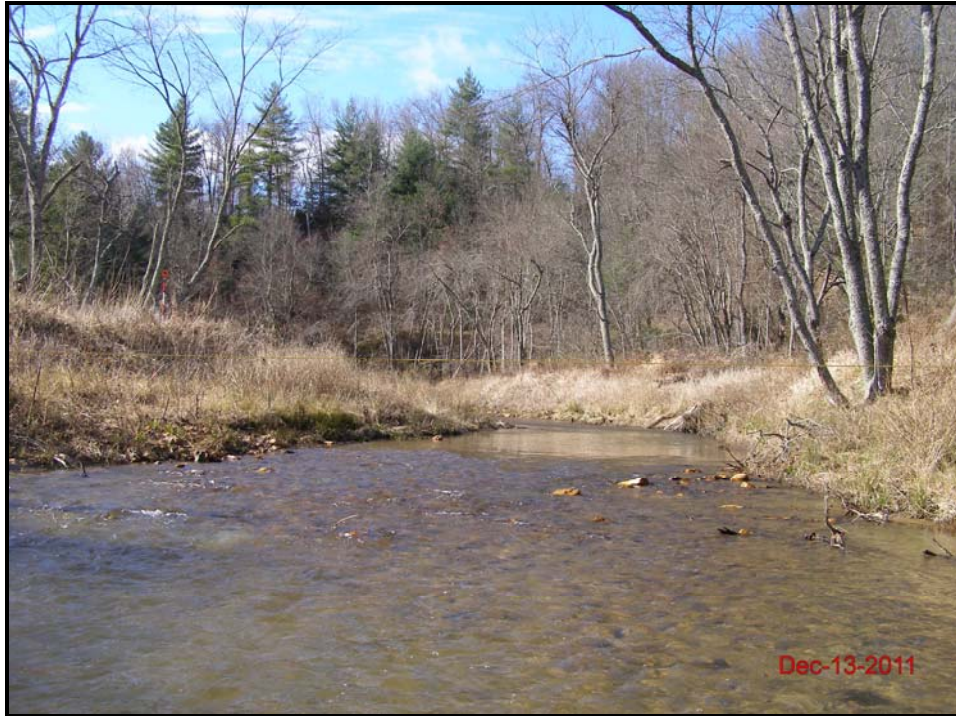
Glade Creek – Cross-Section 4 – Riffle  
(Looking Upstream)  
Monitoring Year 1 – December 13, 2011

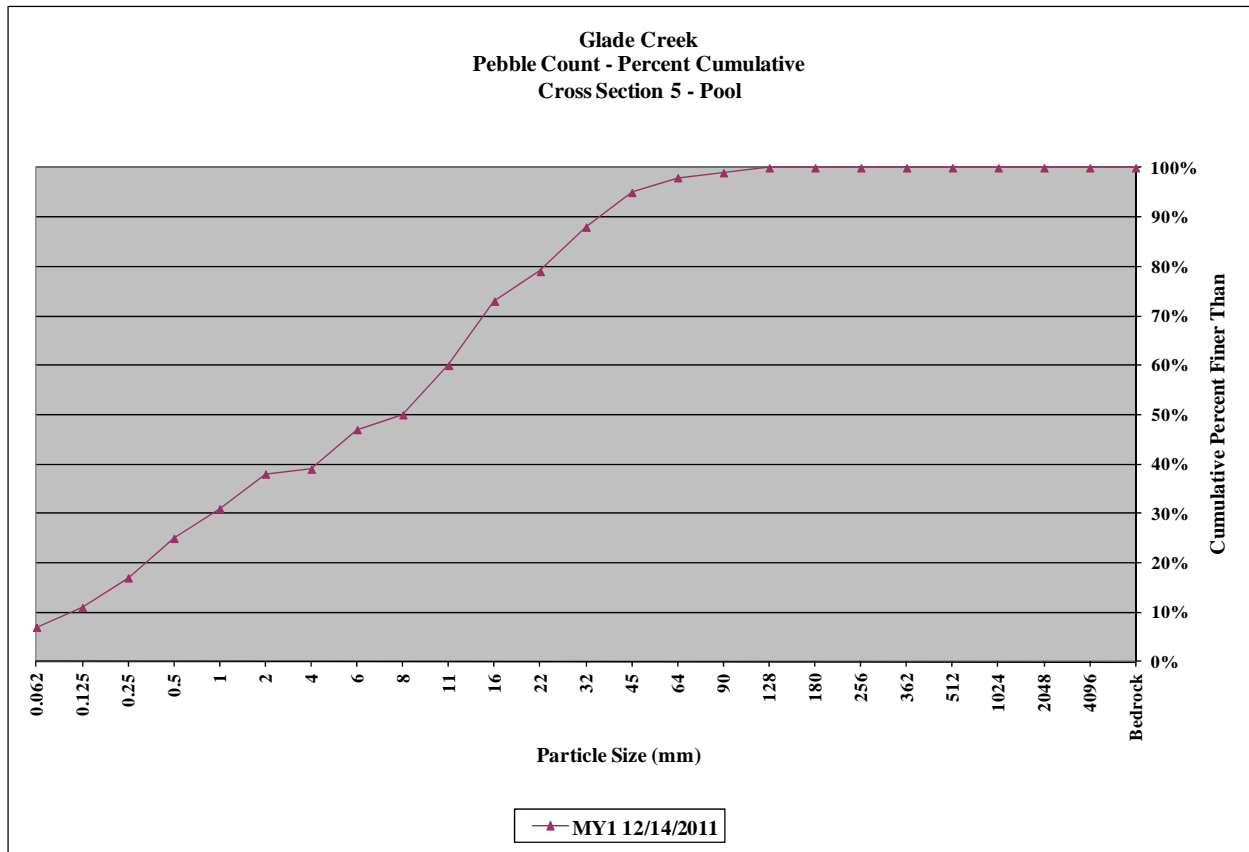
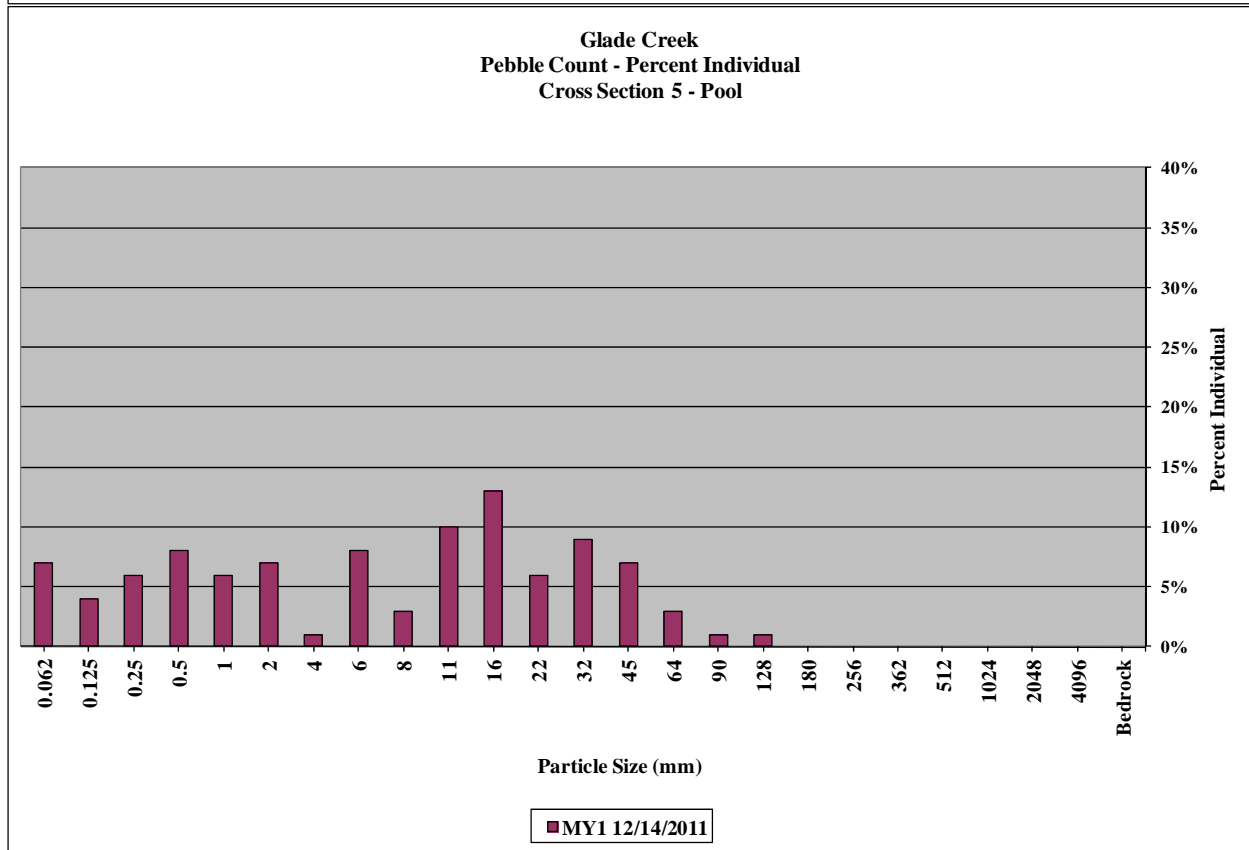
<b>Glade Creek / Project No. 854</b>					
<b>Glade Creek - Cross-Section 5 - Pool</b>					
<b>Pebble Count Summary</b>					
			Monitoring Year 1		
<b>Description</b>	<b>Material</b>	<b>Size (mm)</b>	<b>Total #</b>	<b>Item %</b>	<b>Cum %</b>
<b>Silt/Clay</b>	silt/clay	0.062	7	7%	7%
<b>Sand</b>	very fine sand	0.125	4	4%	11%
	fine sand	0.25	6	6%	17%
	medium sand	0.50	8	8%	25%
	coarse sand	1.00	6	6%	31%
	very coarse sand	2.00	7	7%	38%
<b>Gravel</b>	very fine gravel	4.0	1	1%	39%
	fine gravel	5.7	8	8%	47%
	fine gravel	8.0	3	3%	50%
	medium gravel	11.3	10	10%	60%
	medium gravel	16.0	13	13%	73%
	coarse gravel	22.3	6	6%	79%
	coarse gravel	32	9	9%	88%
	very coarse gravel	45	7	7%	95%
	very coarse gravel	64	3	3%	98%
<b>Cobble</b>	small cobble	90	1	1%	99%
	medium cobble	128	1	1%	100%
	large cobble	180	0	0%	100%
	very large cobble	256	0	0%	100%
<b>Boulder</b>	small boulder	362	0	0%	100%
	small boulder	512	0	0%	100%
	medium boulder	1024	0	0%	100%

<b>Summary Data</b>	
D50	8
D84	27
D95	45
