**Glade Creek  
Stream Restoration  
NCEEP Project Number: 854  
Monitoring Year 1  
2011 Final Report**

**Submitted to  
North Carolina Ecosystem Enhancement Program  
North Carolina Department of Environment and Natural Resources  
January 2012**

# **Glade Creek Stream Restoration 2011 Monitoring Report (MY 1)**

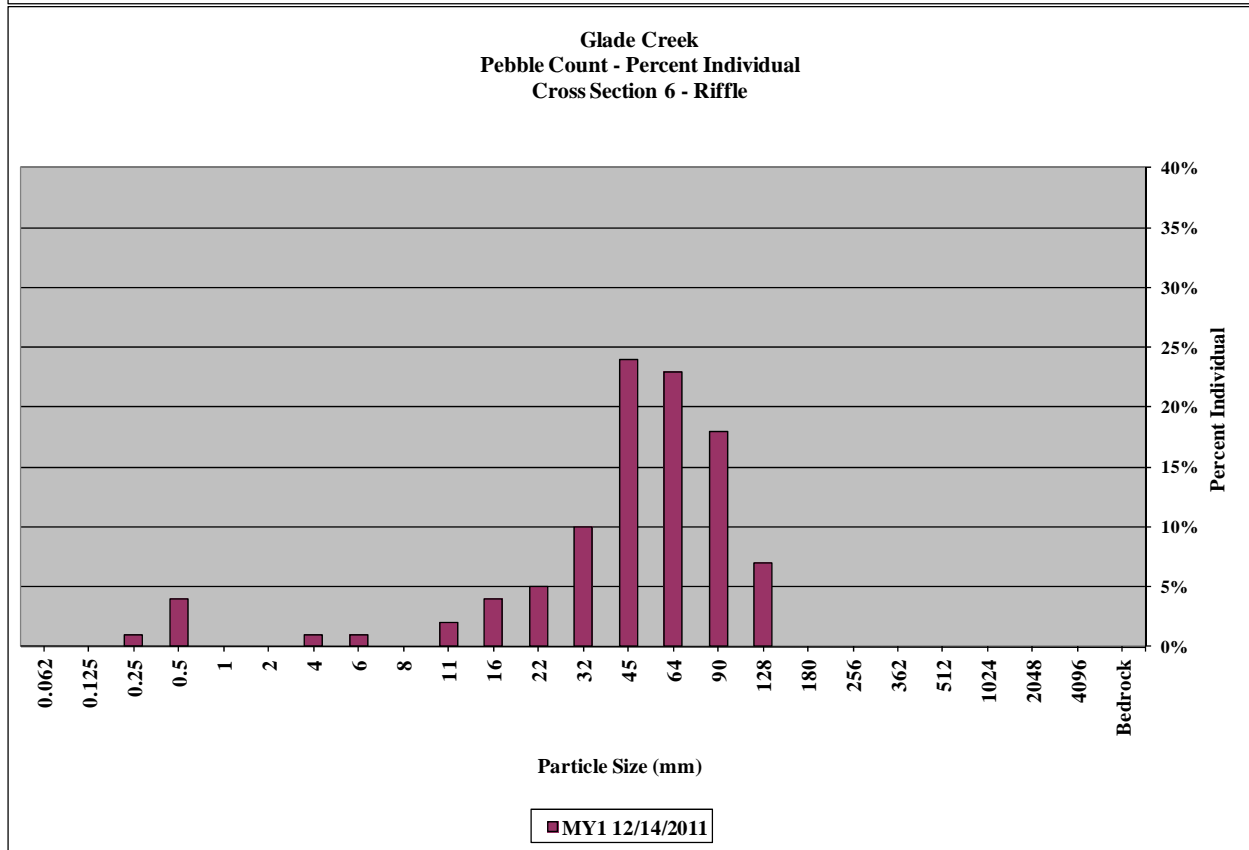
<b>Glade Creek / Project No. 854</b>					
<b>Glade Creek - Cross-Section 6 - Riffle</b>					
<b>Pebble Count Summary</b>					
			Monitoring Year 1		
<b>Description</b>	<b>Material</b>	<b>Size (mm)</b>	<b>Total #</b>	<b>Item %</b>	<b>Cum %</b>
<b>Silt/Clay</b>	silt/clay	0.062	0	0%	0%
<b>Sand</b>	very fine sand	0.125	0	0%	0%
	fine sand	0.25	1	1%	1%
	medium sand	0.50	4	4%	5%
	coarse sand	1.00	0	0%	5%
	very coarse sand	2.00	0	0%	5%
<b>Gravel</b>	very fine gravel	4.0	1	1%	6%
	fine gravel	5.7	1	1%	7%
	fine gravel	8.0	0	0%	7%
	medium gravel	11.3	2	2%	9%
	medium gravel	16.0	4	4%	13%
	coarse gravel	22.3	5	5%	18%
	coarse gravel	32	10	10%	28%
	very coarse gravel	45	24	24%	52%
	very coarse gravel	64	23	23%	75%
<b>Cobble</b>	small cobble	90	18	18%	93%
	medium cobble	128	7	7%	100%
	large cobble	180	0	0%	100%
	very large cobble	256	0	0%	100%
<b>Boulder</b>	small boulder	362	0	0%	100%
	small boulder	512	0	0%	100%
	medium boulder	1024	0	0%	100%

<b>Summary Data</b>	
D50	44
D84	76
D95	100

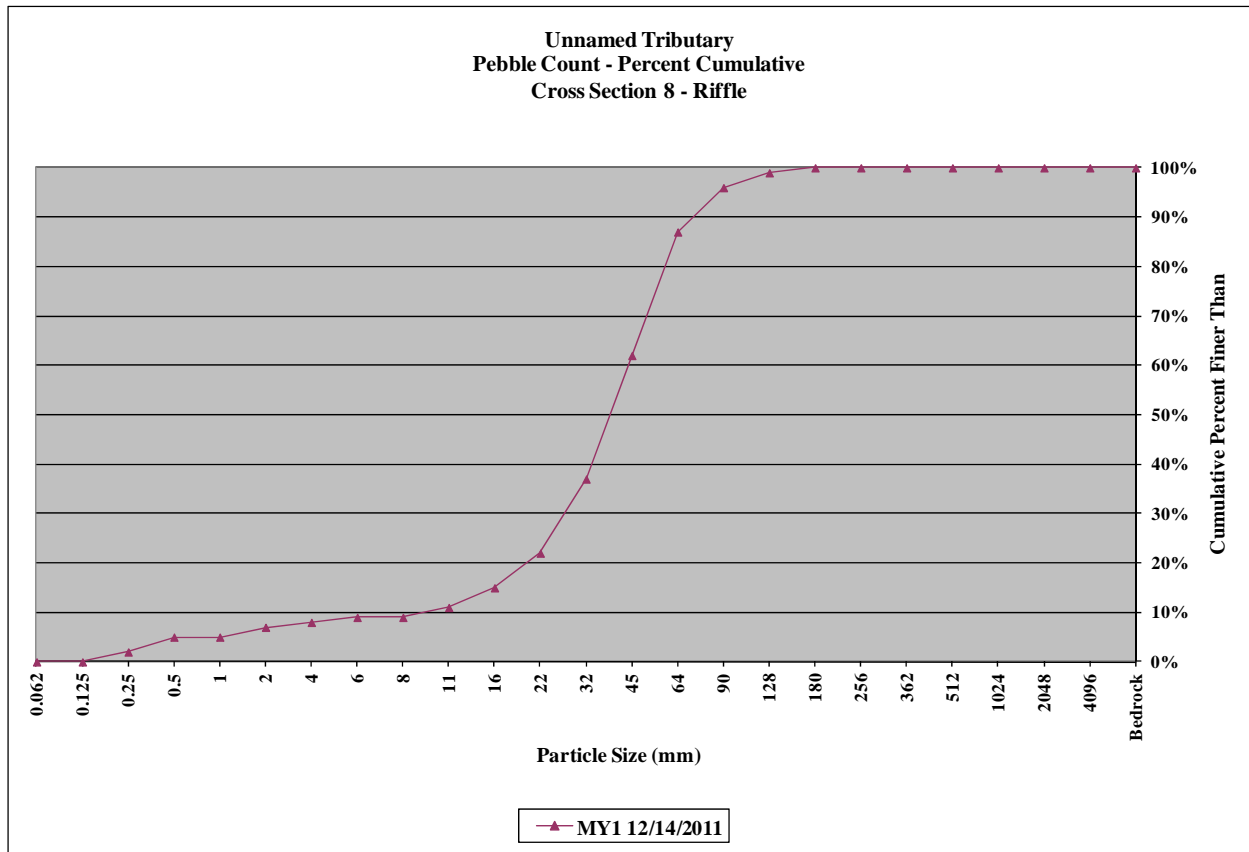
<b>Glade Creek / Project No. 854</b>					
<b>Unnamed Tributary - Cross-Section 8 - Riffle</b>					
<b>Pebble Count Summary</b>					
			Monitoring Year 1		
<b>Description</b>	<b>Material</b>	<b>Size (mm)</b>	<b>Total #</b>	<b>Item %</b>	<b>Cum %</b>
<b>Silt/Clay</b>	silt/clay	0.062	0	0%	0%
<b>Sand</b>	very fine sand	0.125	0	0%	0%
	fine sand	0.25	2	2%	2%
	medium sand	0.50	3	3%	5%
	coarse sand	1.00	0	0%	5%
	very coarse sand	2.00	2	2%	7%
<b>Gravel</b>	very fine gravel	4.0	1	1%	8%
	fine gravel	5.7	1	1%	9%
	fine gravel	8.0	0	0%	9%
	medium gravel	11.3	2	2%	11%
	medium gravel	16.0	4	4%	15%
	coarse gravel	22.3	7	7%	22%
	coarse gravel	32	15	15%	37%
	very coarse gravel	45	25	25%	62%
<b>Cobble</b>	very coarse gravel	64	25	25%	87%
	small cobble	90	9	9%	96%
	medium cobble	128	3	3%	99%
	large cobble	180	1	1%	100%
<b>Boulder</b>	very large cobble	256	0	0%	100%
	small boulder	362	0	0%	100%
	small boulder	512	0	0%	100%
	medium boulder	1024	0	0%	100%

<b>Summary Data</b>	
D50	38
D84	61
D95	87
