**Glade Creek
Stream Restoration
NCEEP Project Number: 854
Monitoring Contract Number: D08033S
Monitoring Year 4
2014 Draft Report**

**Submitted to
North Carolina Ecosystem Enhancement Program
North Carolina Department of Environment and Natural Resources
January 2015**

Glade Creek Stream Restoration 2014 Monitoring Report (MY 4)

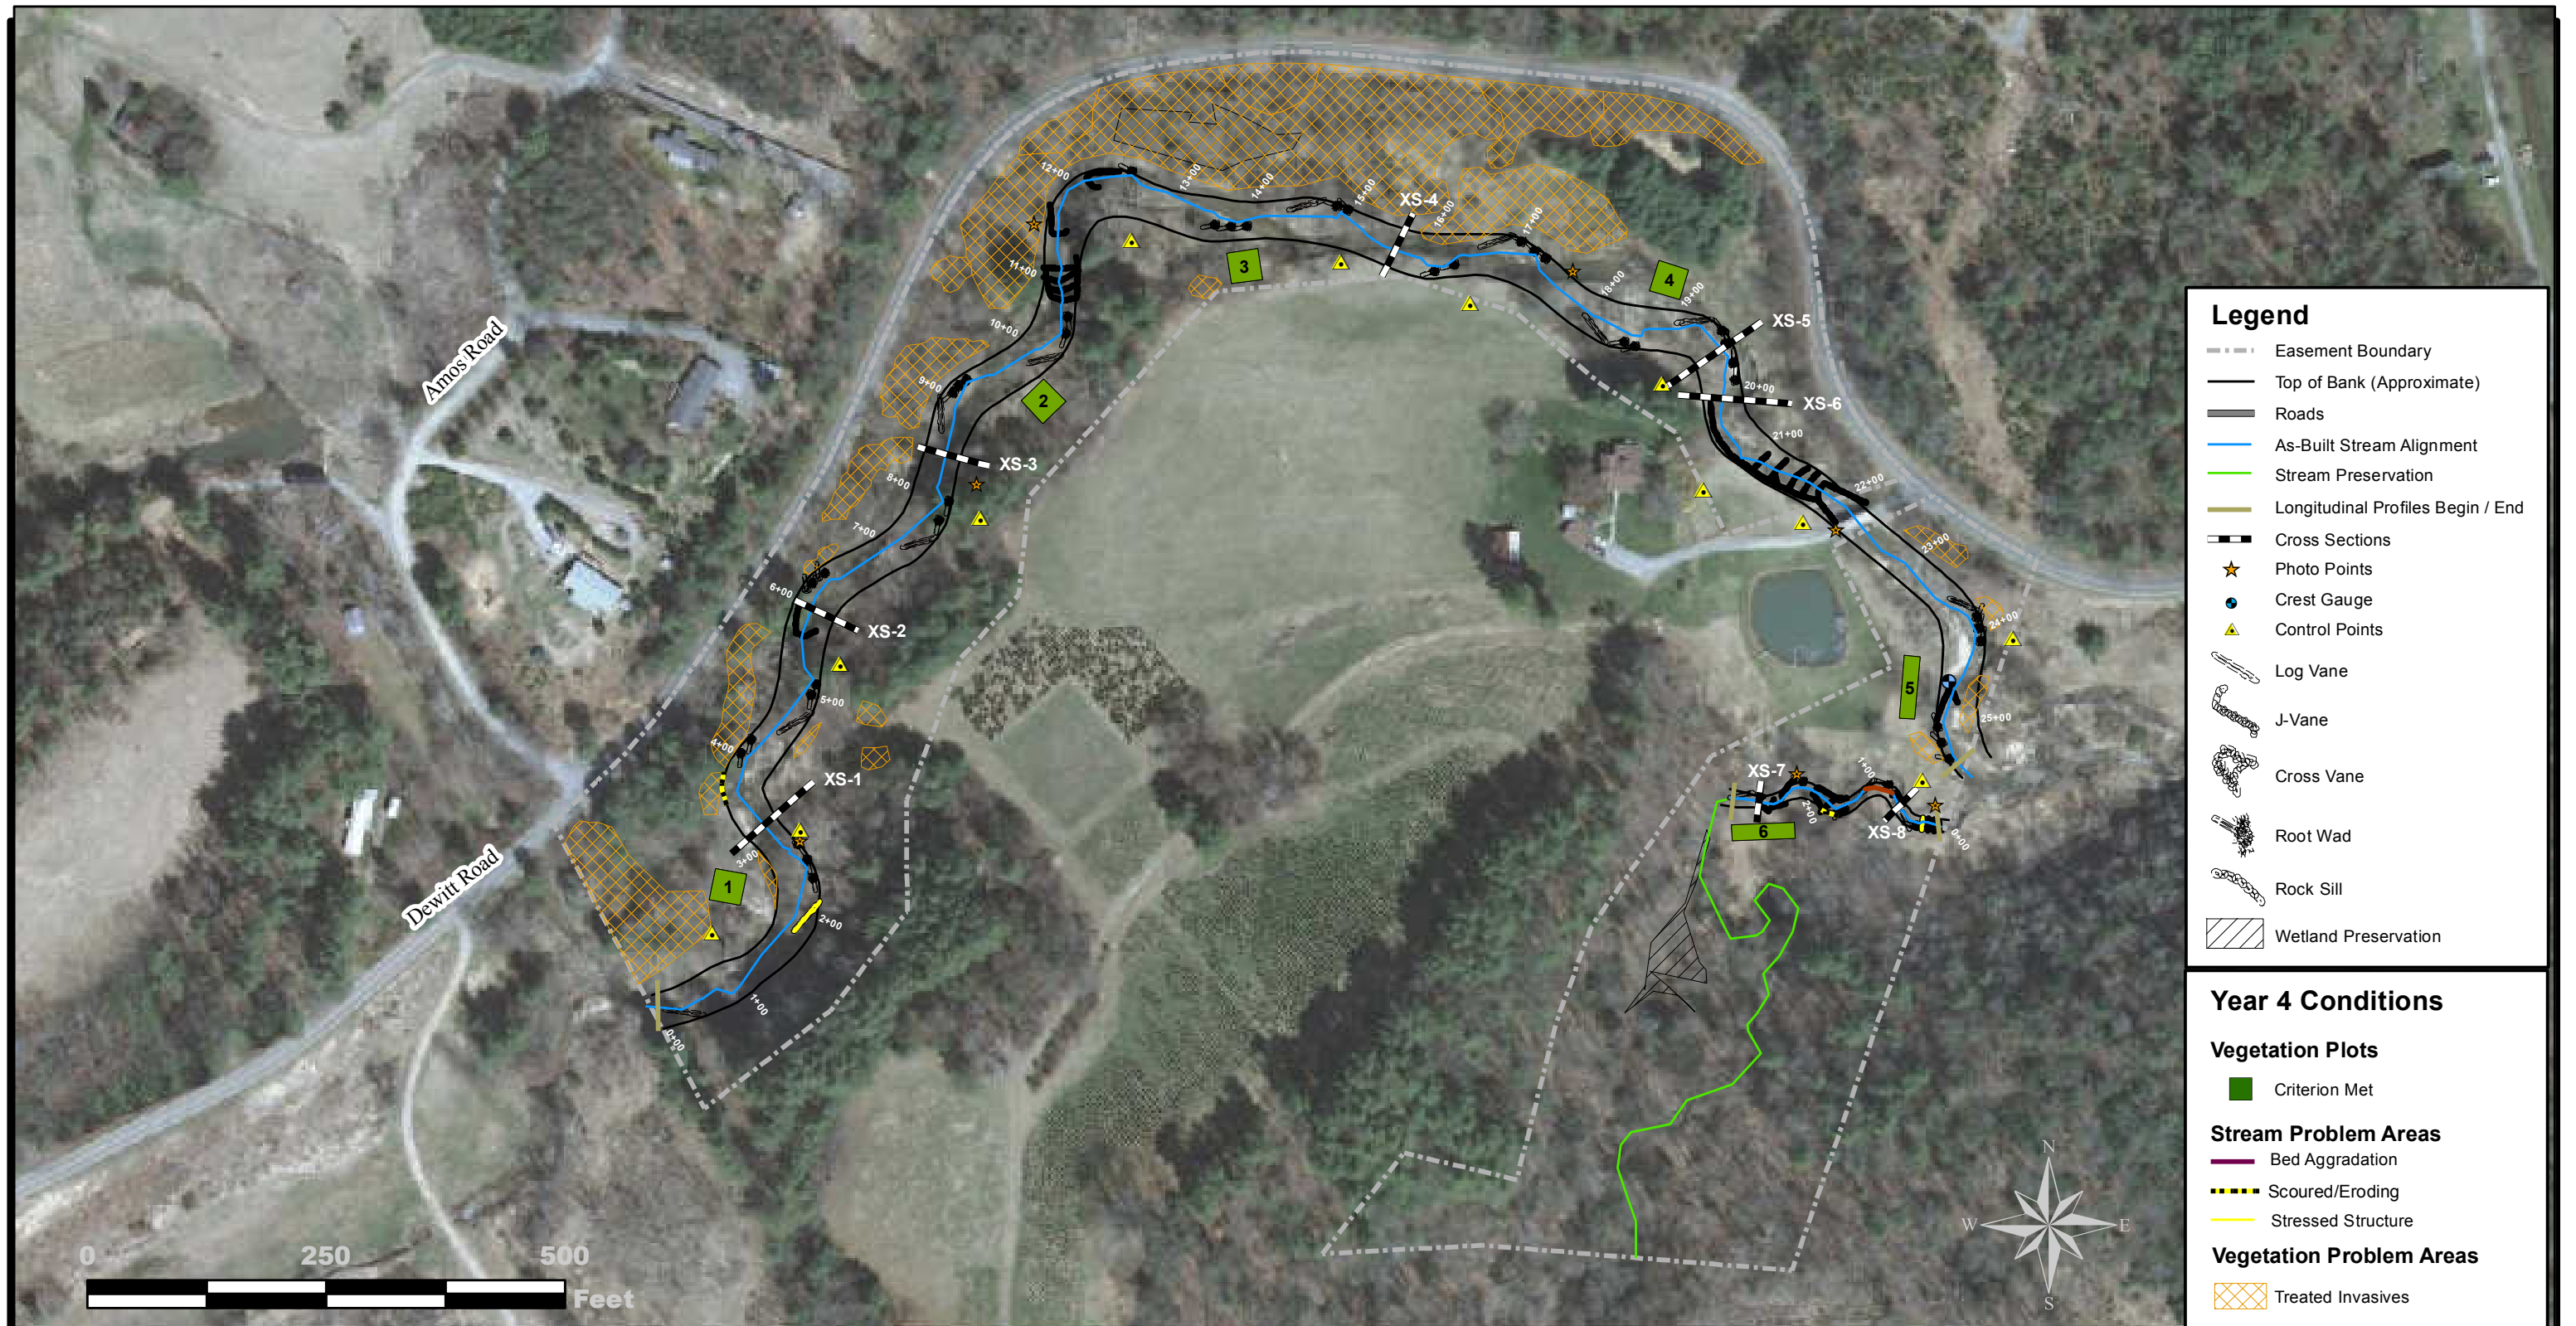
Figure 2. Integrated Current Condition Plan View

Prepared for	Project: Glade Creek Stream Restoration	Notes: 1) Base Map Data Provided by NCEEP & Biohabitats	Prepared by

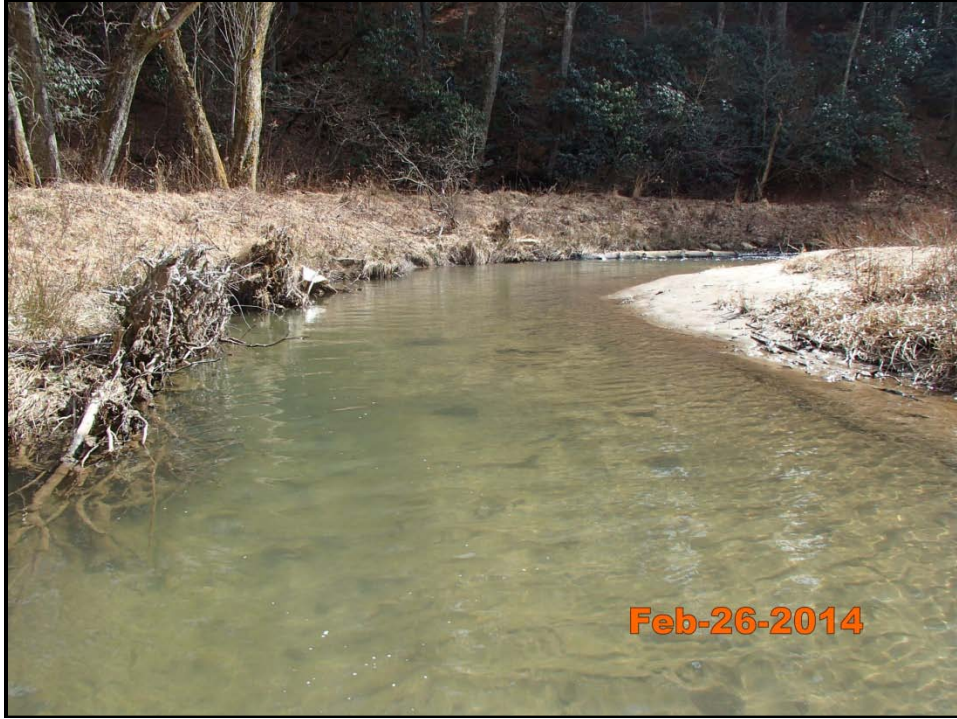
Glade Creek – Permanent Photo Station 1
Upstream

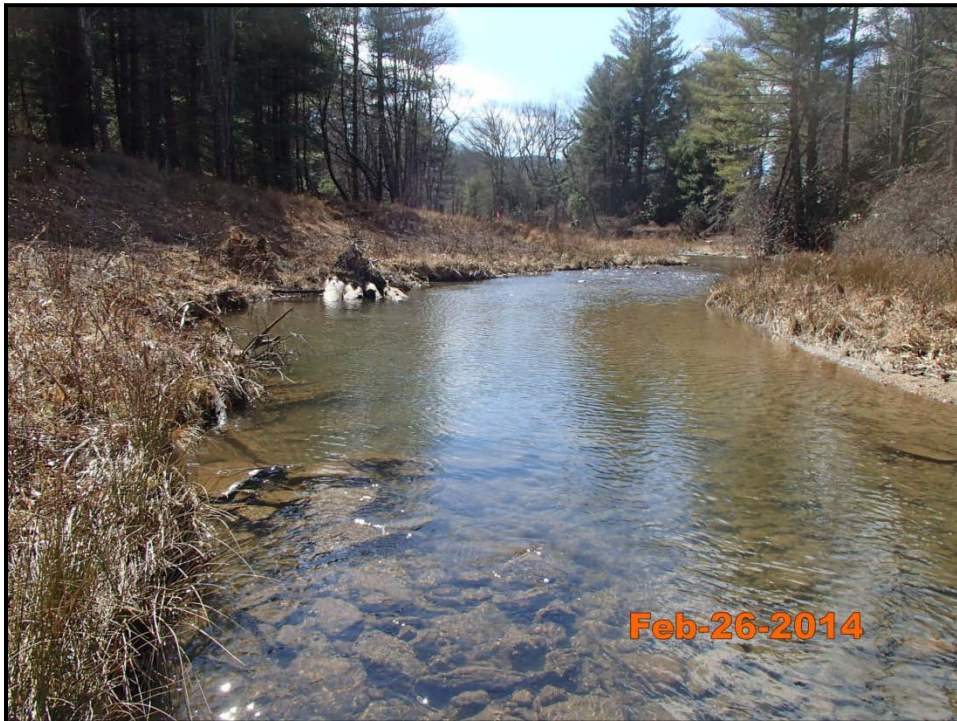
Glade Creek – Permanent Photo Station 2
Upstream

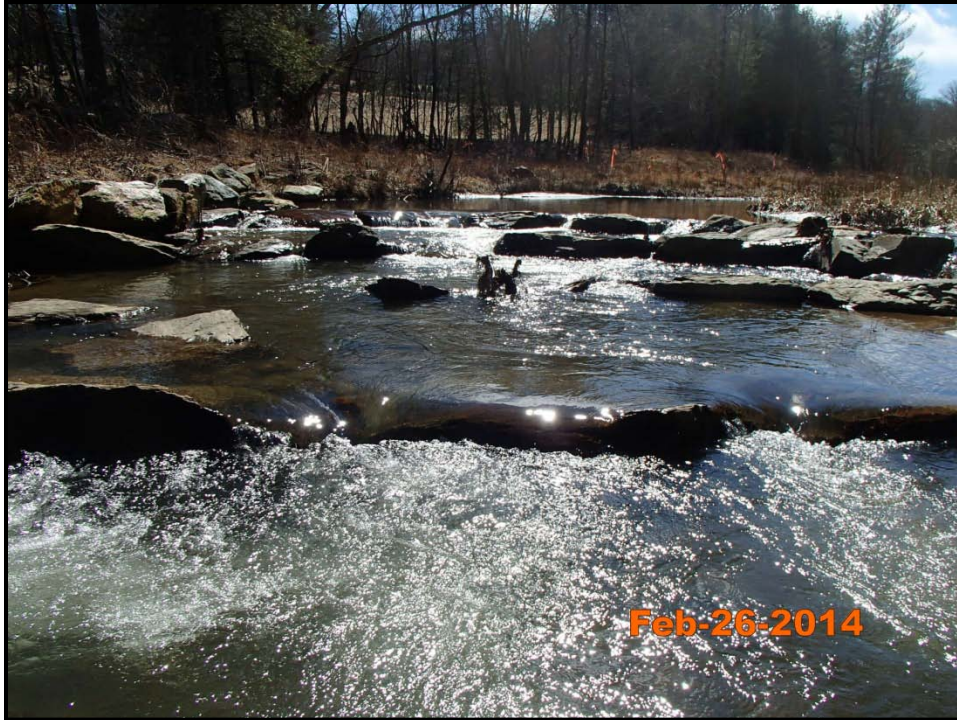
Glade Creek – Permanent Photo Station 3
Upstream

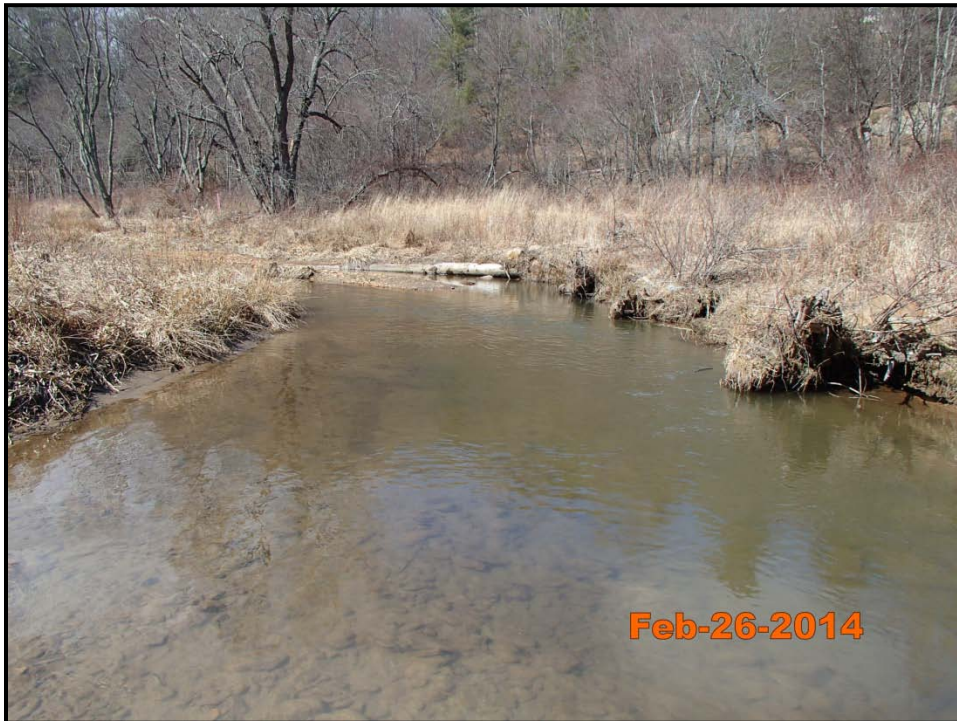
Glade Creek – Permanent Photo Station 4
Upstream

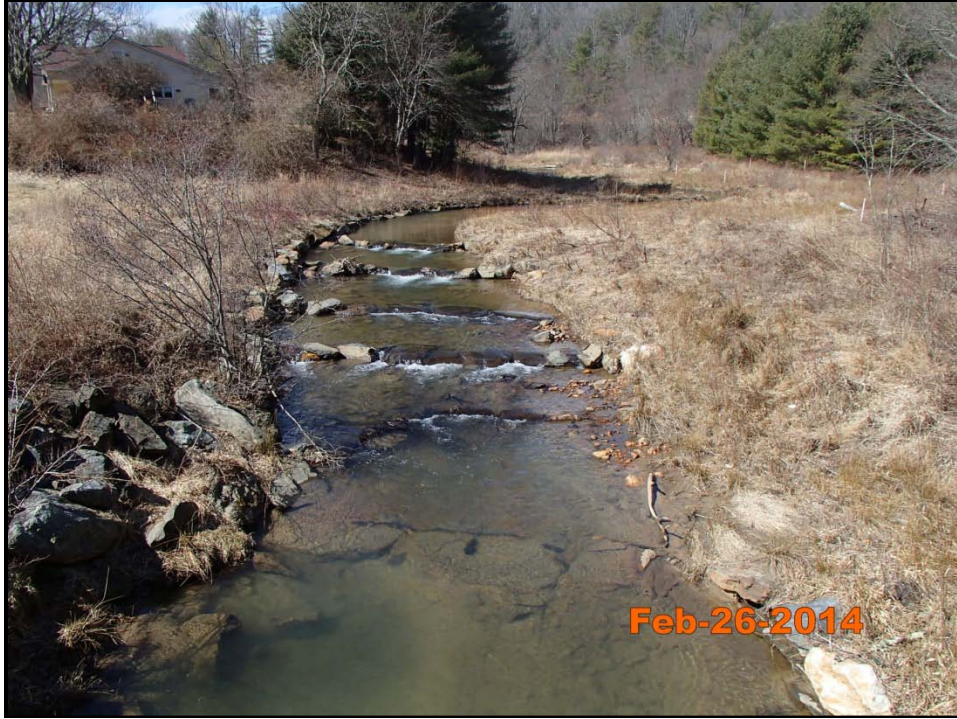
Glade Creek – Permanent Photo Station 5
Upstream

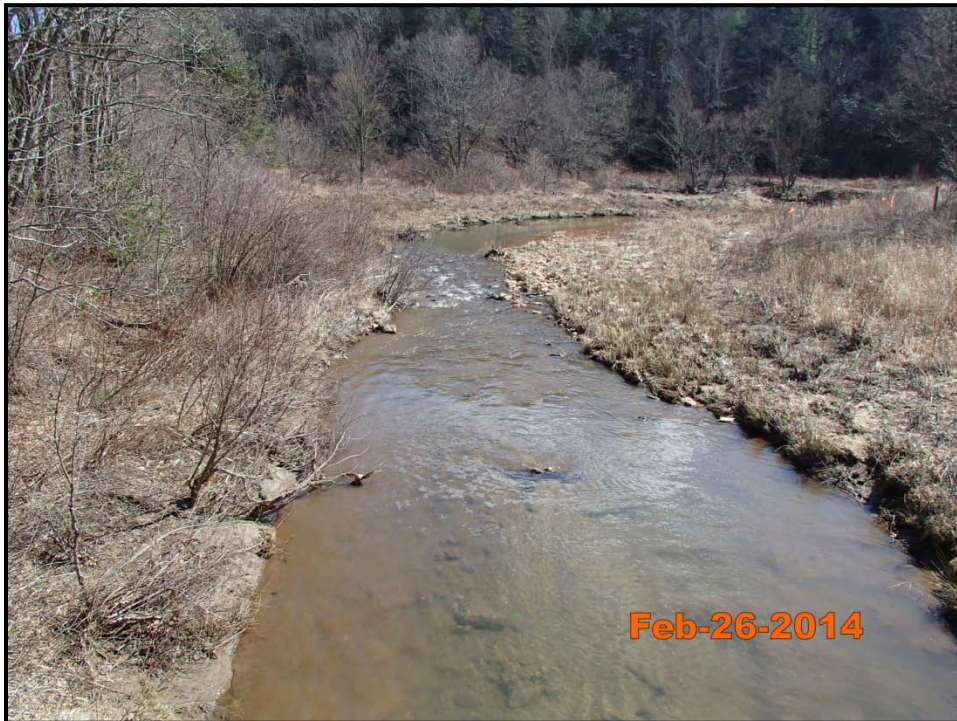
Glade Creek – Permanent Photo Station 5
Downstream

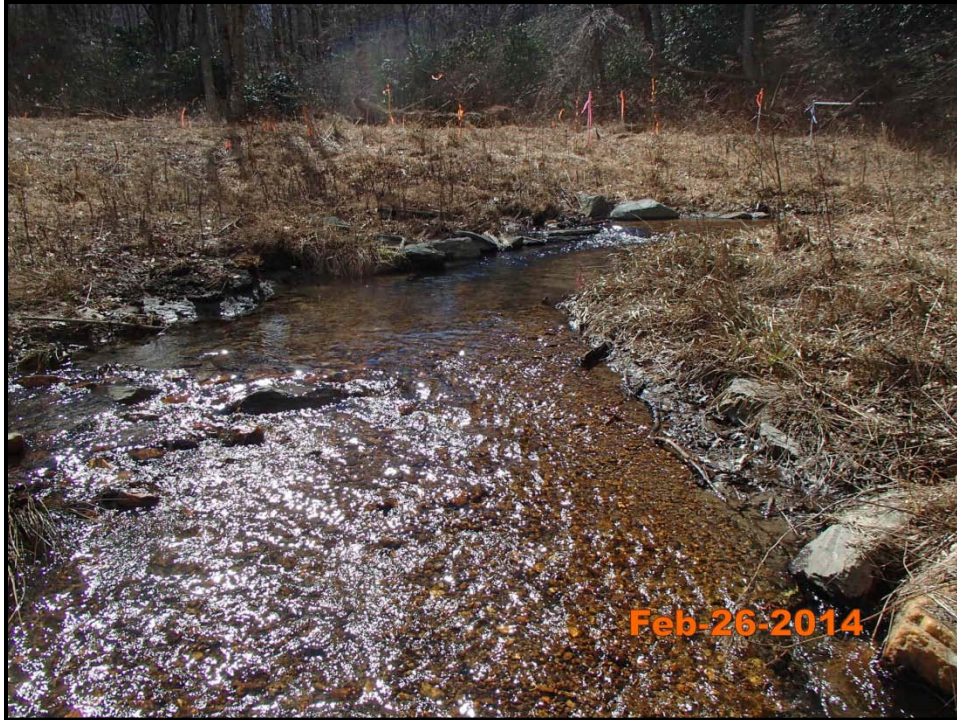
Unnamed Tributary Lower – Permanent Photo Station 6
Upstream

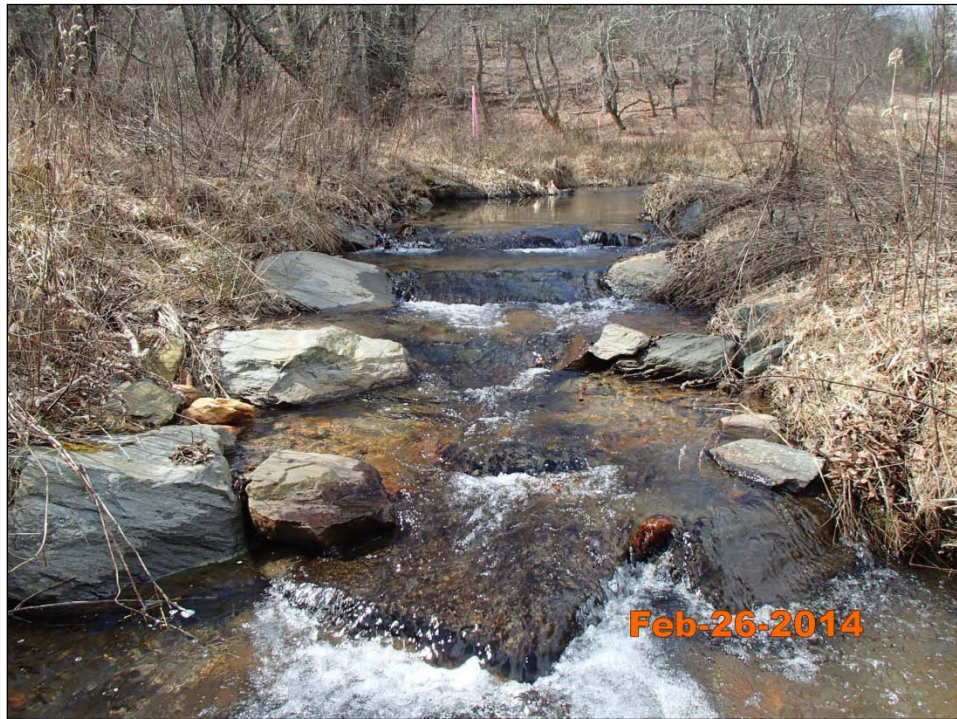
Unnamed Tributary Lower – Permanent Photo Station 7
Upstream

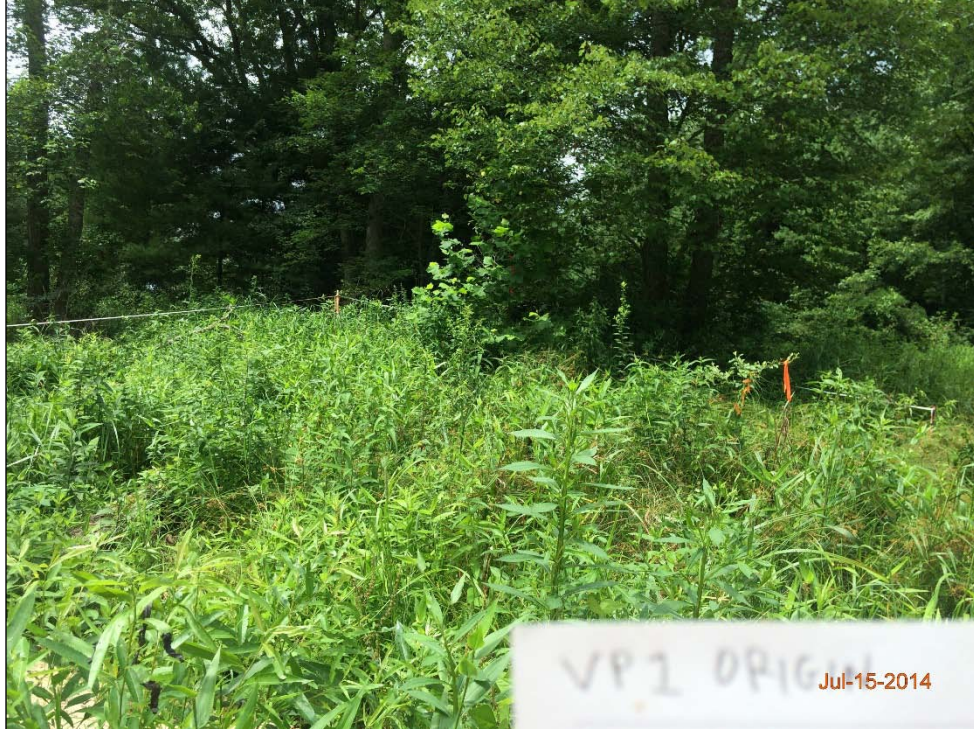
Vegetation Monitoring Plot 1
Monitoring Year 4 – July 15, 2014

The monitoring year four (MY4) vegetation plot data revealed the average planted stem density to be 472 stems/acre; exceeding both the interim 320 stems per acre density as well as the final 260 stems per acre minimum density criterion that must be achieved by the end of MY5. Stem densities were found to have declined by approximately 7% from the previous year due to dead or missing stems. Additionally, 16 isolated patches of high threat invasive plants are distributed throughout the project area and are illustrated on the Current Condition Plan View (Figure 2). Multiflora rose *Rosa multiflora* and oriental bittersweet *Celastrus orbiculatus* are the most dominant species present, while secondary species found included Japanese honeysuckle *Lonicera japonica*, Japanese barberry *Berberis thunbergii*, and Japanese spiraea *Spiraea japonica*. These targeted invasive plants have been treated in the spring, summer, and fall of 2014 with good efficacy. Follow up treatments in spring and summers are also scheduled.

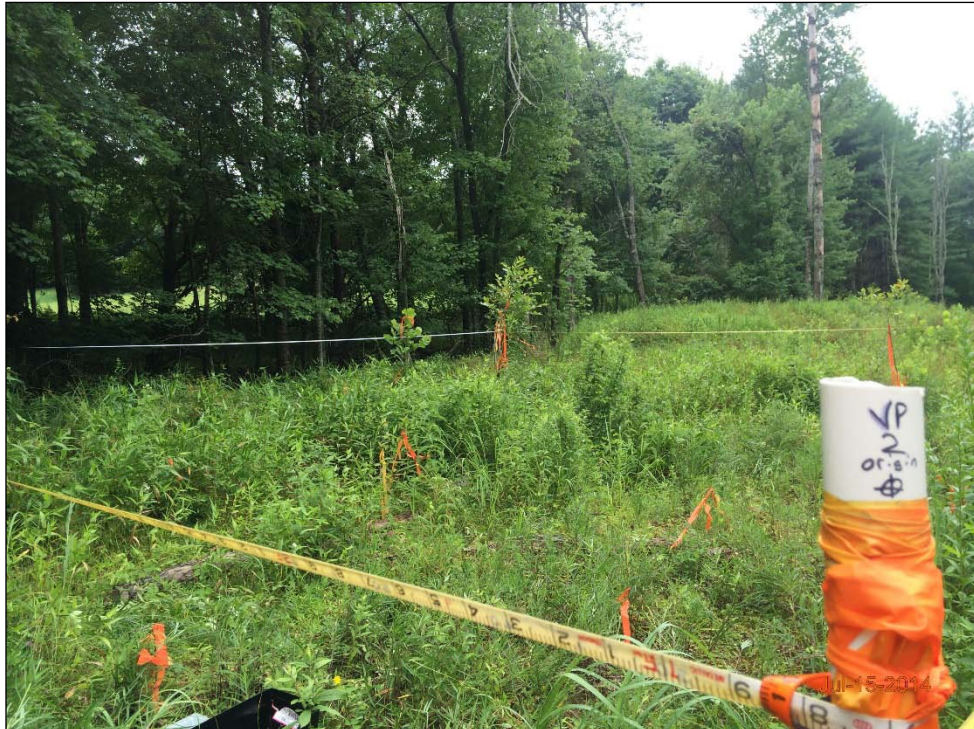
Vegetation Monitoring Plot 2
Monitoring Year 4 – July 15, 2014

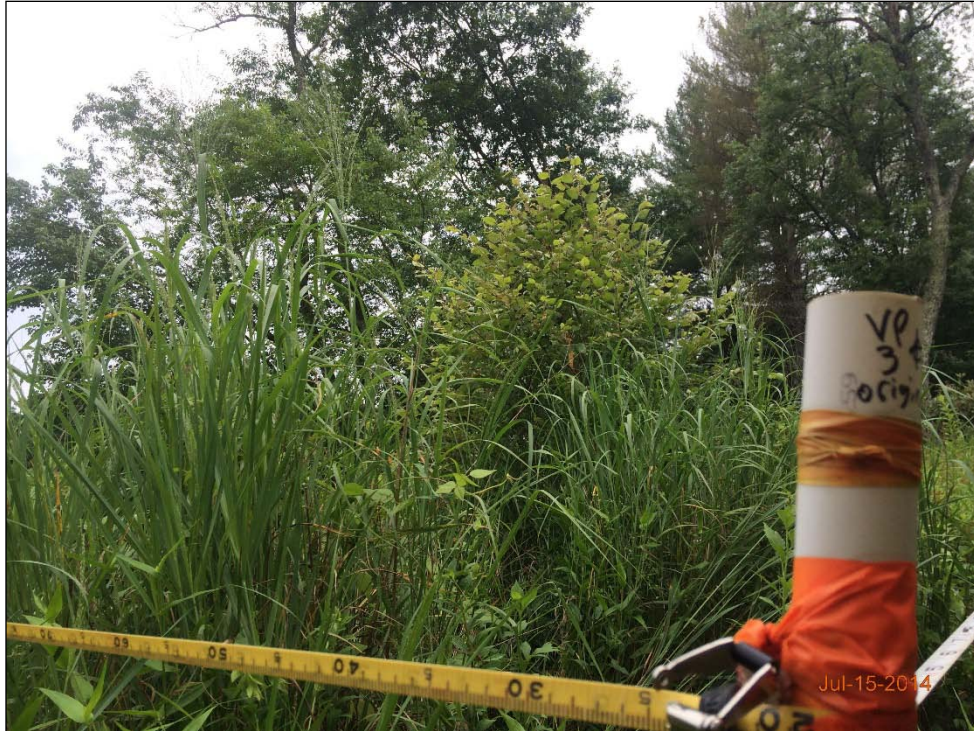
Vegetation Monitoring Plot 3
Monitoring Year 4 – July 15, 2014

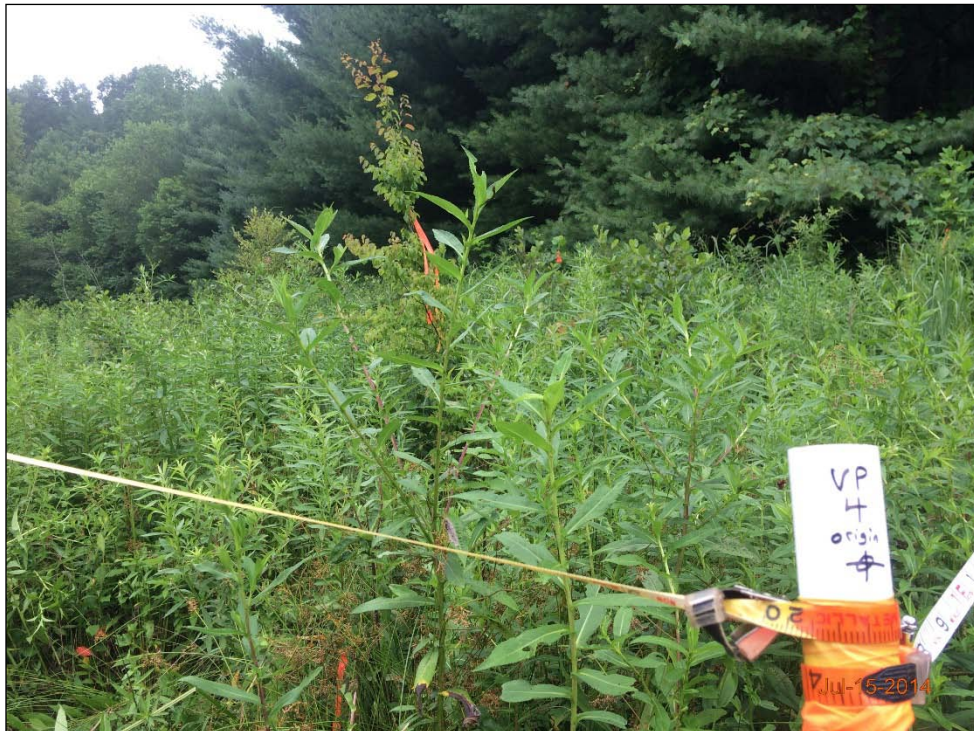
Vegetation Monitoring Plot 4
Monitoring Year 4 – July 15, 2014

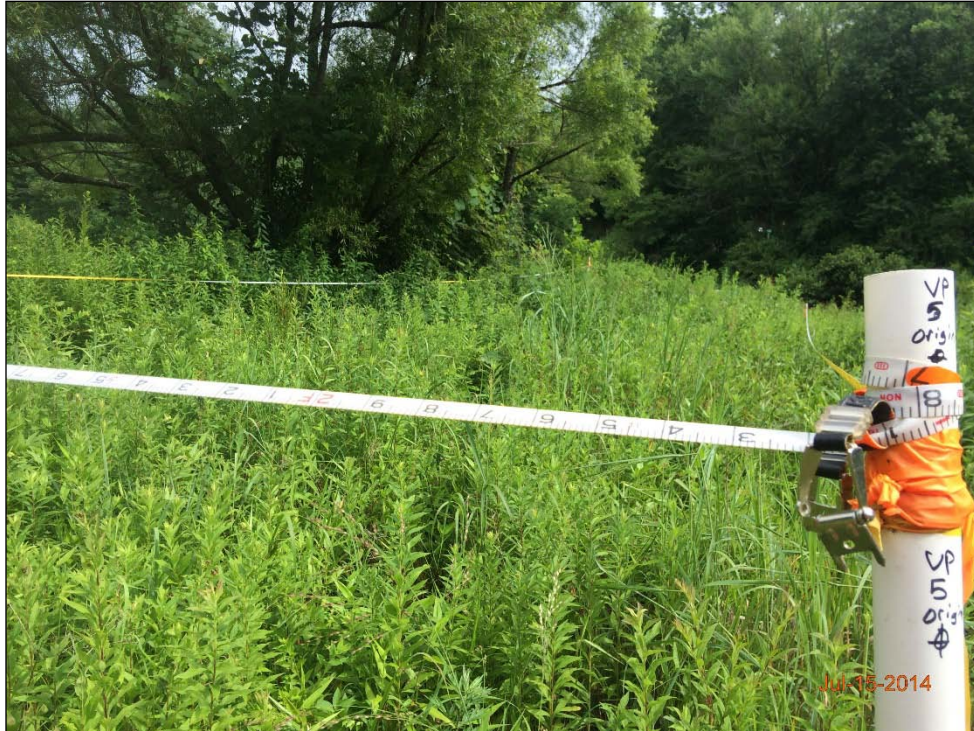
Vegetation Monitoring Plot 5
Monitoring Year 4 – July 15, 2014

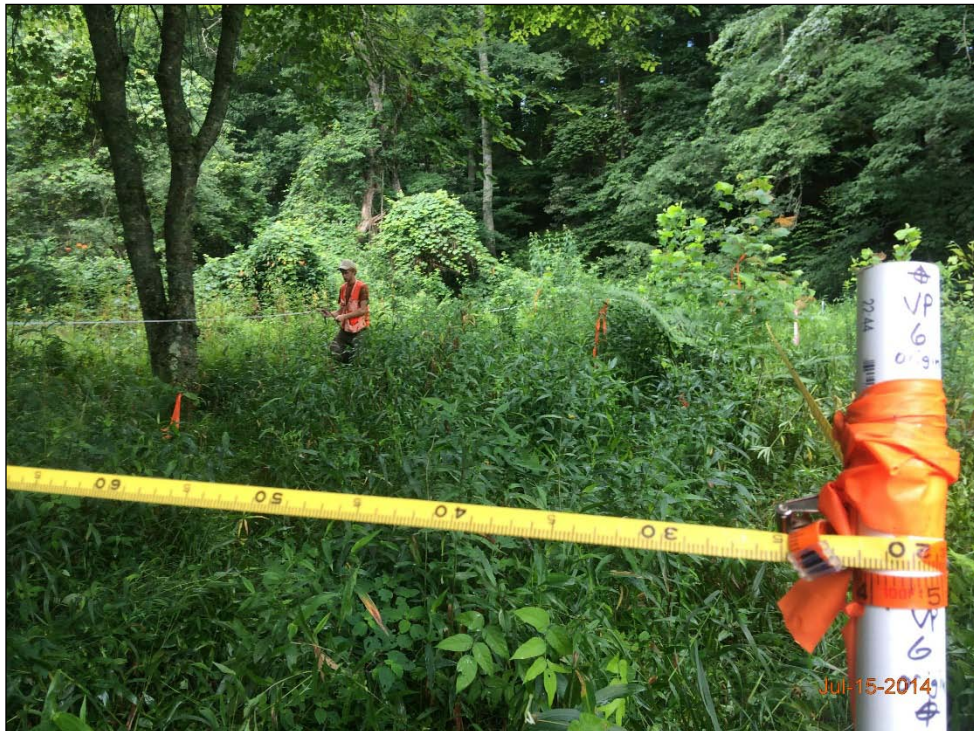
Vegetation Monitoring Plot 6
Monitoring Year 4 – July 15, 2014

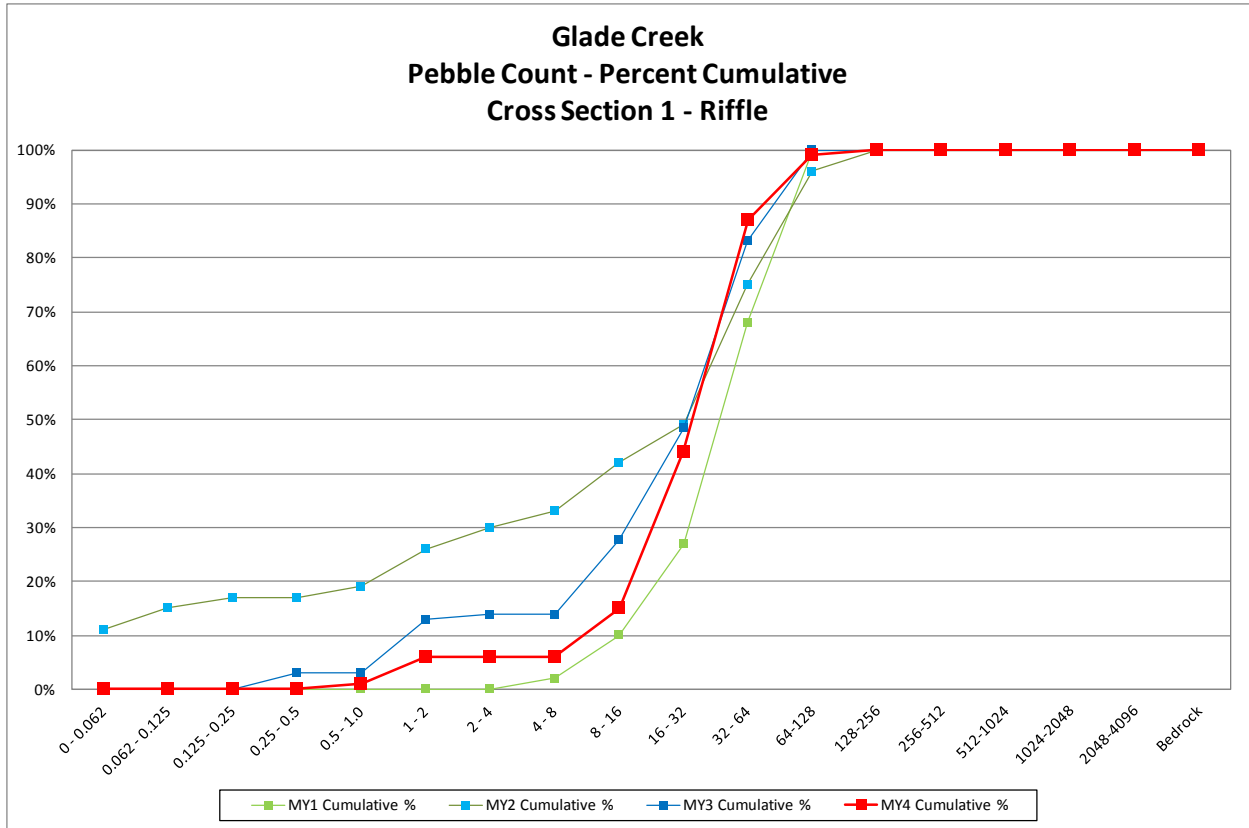
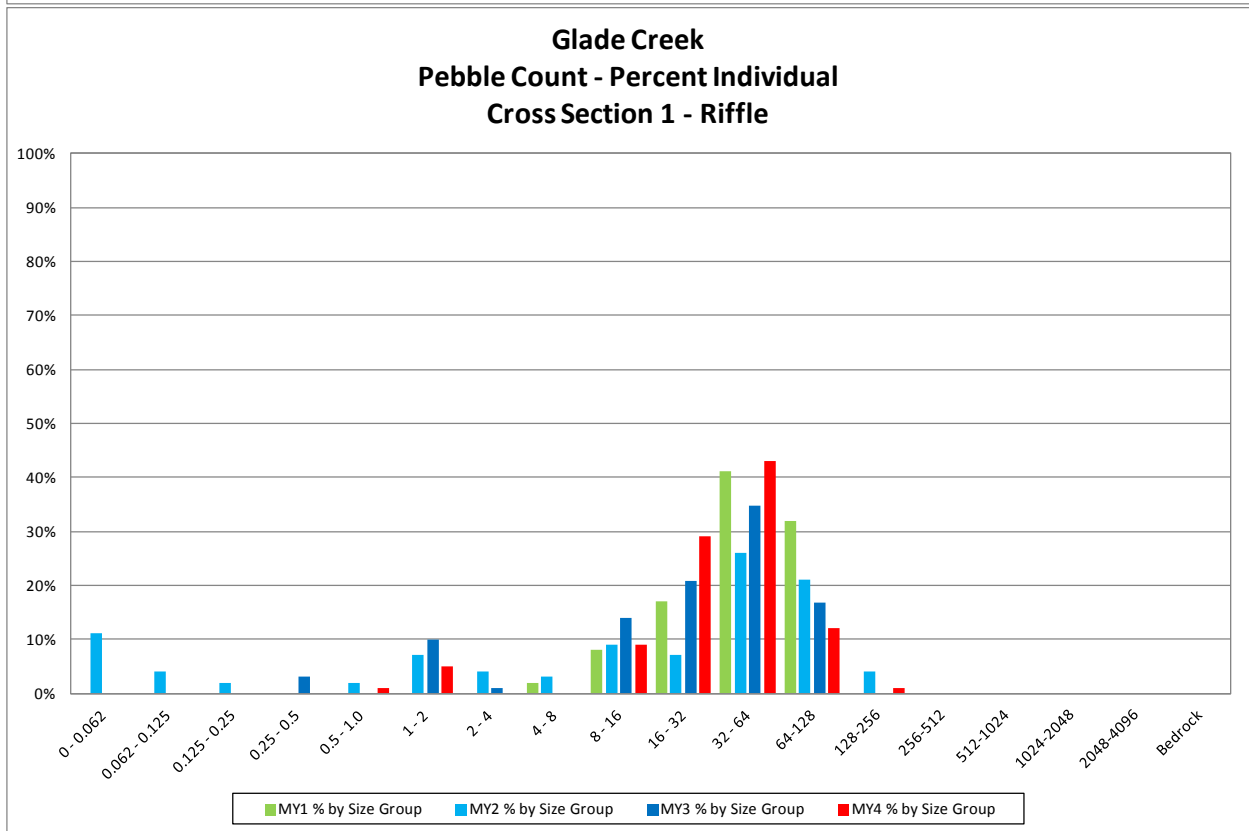
Glade Creek			
Cross Section 1 - Riffle			
Monitoring Year - 2014; MY4			
Bed Surface Material Particle Size Class (mm)	Number	% Individual	% Cumulative
0 - 0.062	0	0.0%	0%
0.062 - 0.125	0	0.0%	0%
0.125 - 0.25	0	0.0%	0%
0.25 - 0.5	0	0.0%	0%
0.5 - 1.0	1	1.0%	1%
1 - 2	5	5.0%	6%
2 - 4	0	0.0%	6%
4 - 8	0	0.0%	6%
8 - 16	9	9.0%	15%
16 - 32	29	29.0%	44%
32 - 64	43	43.0%	87%
64-128	12	12.0%	99%
128-256	1	1.0%	100%
256-512	0	0.0%	100%
512-1024	0	0.0%	100%
1024-2048	0	0.0%	100%
2048-4096	0	0.0%	100%
Bedrock	0	0.0%	100%
Total	100	100%	100%
		Summary Data	
		D50	35
		D84	61
		D95	90

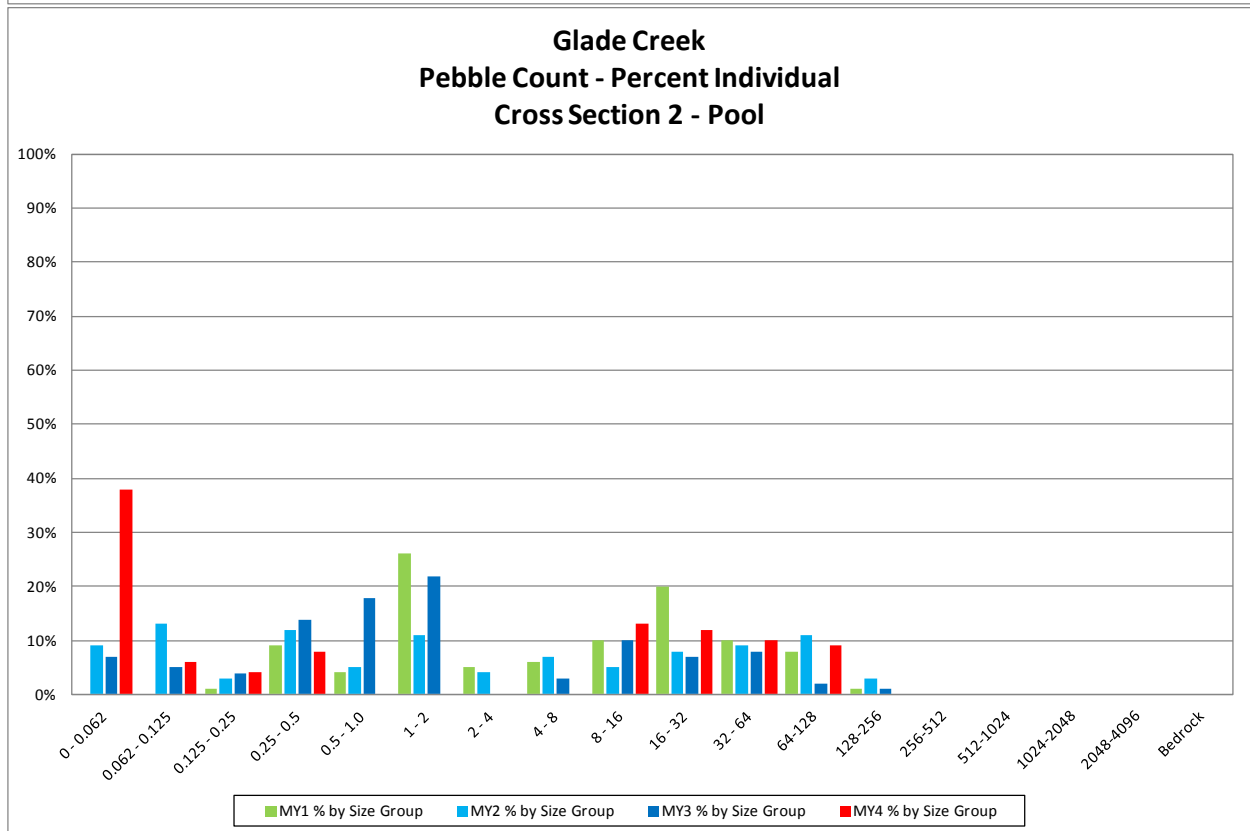
Glade Creek			
Cross Section 2 - Pool			
Monitoring Year - 2014; MY4			
Bed Surface Material Particle Size Class (mm)	Number	% Individual	% Cumulative
0 - 0.062	38	38.0%	38%
0.062 - 0.125	6	6.0%	44%
0.125 - 0.25	4	4.0%	48%
0.25 - 0.5	8	8.0%	56%
0.5 - 1.0	0	0.0%	56%
1 - 2	0	0.0%	56%
2 - 4	0	0.0%	56%
4 - 8	0	0.0%	56%
8 - 16	13	13.0%	69%
16 - 32	12	12.0%	81%
32 - 64	10	10.0%	91%
64-128	9	9.0%	100%
128-256	0	0.0%	100%
256-512	0	0.0%	100%
512-1024	0	0.0%	100%
1024-2048	0	0.0%	100%
2048-4096	0	0.0%	100%
Bedrock	0	0.0%	100%
Total	100	100%	100%
		Summary Data	
		D50	0.3
		D84	37
		D95	80

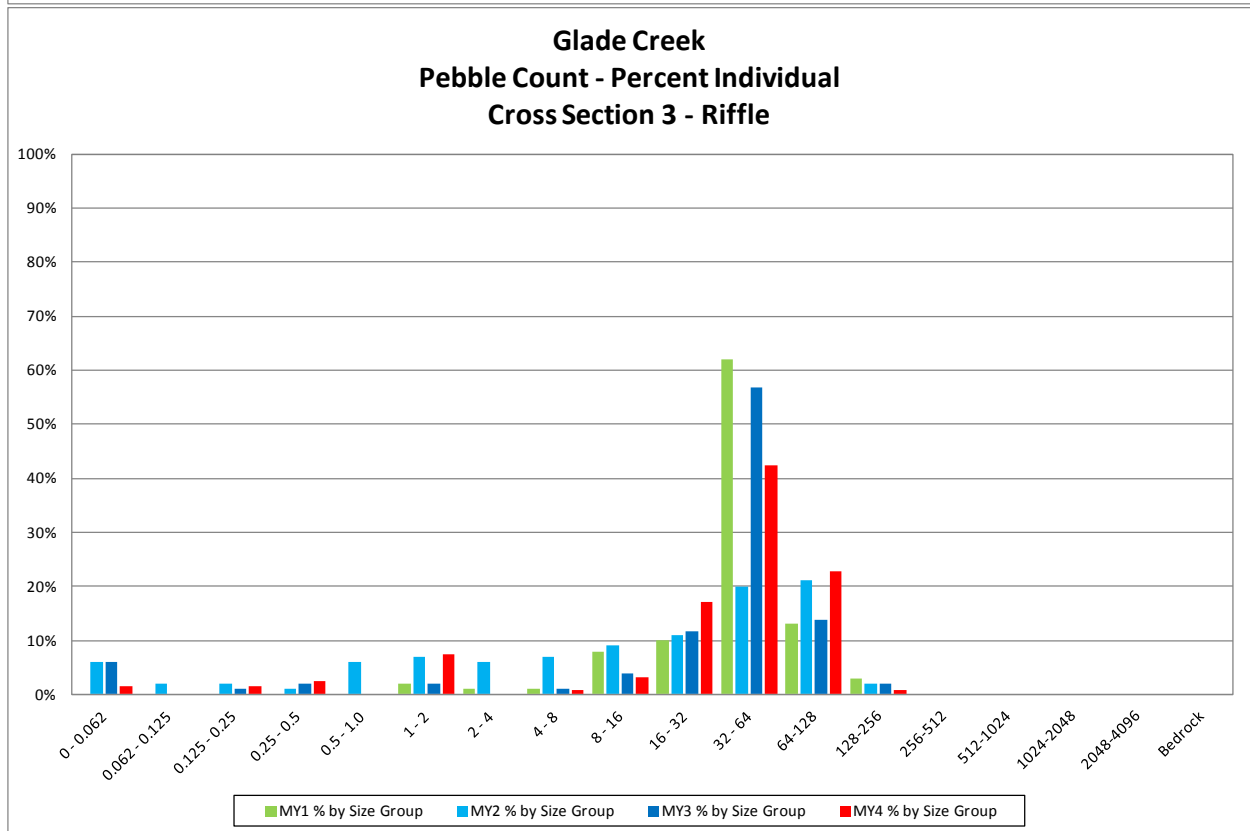
Glade Creek			
Cross Section 3 - Riffle			
Monitoring Year - 2014; MY4			
Bed Surface Material Particle Size Class (mm)	Number	% Individual	% Cumulative
0 - 0.062	2	1.6%	2%
0.062 - 0.125	0	0.0%	2%
0.125 - 0.25	2	1.6%	3%
0.25 - 0.5	3	2.4%	6%
0.5 - 1.0	0	0.0%	6%
1 - 2	9	7.3%	13%
2 - 4	0	0.0%	13%
4 - 8	1	0.8%	14%
8 - 16	4	3.3%	17%
16 - 32	21	17.1%	34%
32 - 64	52	42.3%	76%
64-128	28	22.8%	99%
128-256	1	0.8%	100%
256-512	0	0.0%	100%
512-1024	0	0.0%	100%
1024-2048	0	0.0%	100%
2048-4096	0	0.0%	100%
Bedrock	0	0.0%	100%
Total	123	100%	100%
		Summary Data	
		D50	41
		D84	76
		D95	110

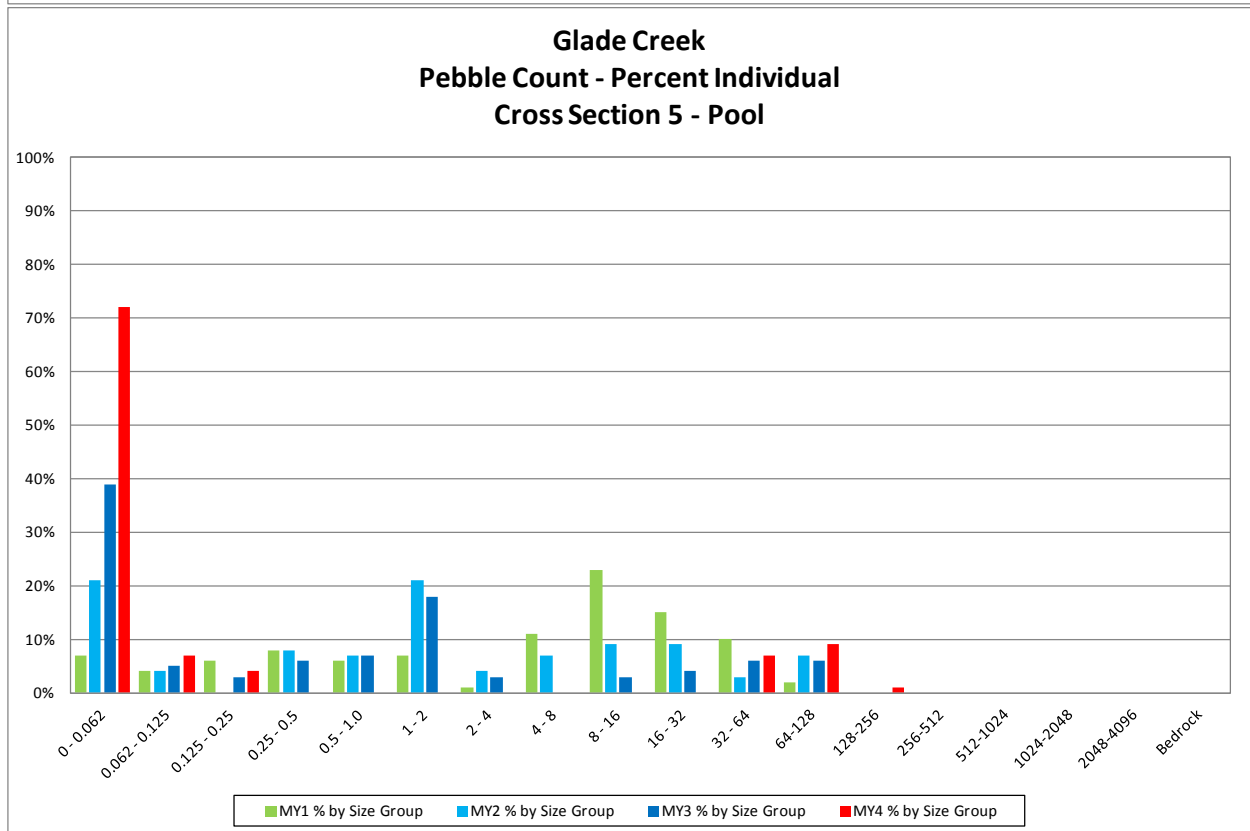
Glade Creek			
Cross Section 5 - Pool			
Monitoring Year - 2014; MY4			
Bed Surface Material Particle Size Class (mm)	Number	% Individual	% Cumulative
0 - 0.062	72	72.0%	72%
0.062 - 0.125	7	7.0%	79%
0.125 - 0.25	4	4.0%	83%
0.25 - 0.5	0	0.0%	83%
0.5 - 1.0	0	0.0%	83%
1 - 2	0	0.0%	83%
2 - 4	0	0.0%	83%
4 - 8	0	0.0%	83%
8 - 16	0	0.0%	83%
16 - 32	0	0.0%	83%
32 - 64	7	7.0%	90%
64-128	9	9.0%	99%
128-256	1	1.0%	100%
256-512	0	0.0%	100%
512-1024	0	0.0%	100%
1024-2048	0	0.0%	100%
2048-4096	0	0.0%	100%
Bedrock	0	0.0%	100%
Total	100	100%	100%
		Summary Data	
		D50	0.062
		D84	36
		D95	85

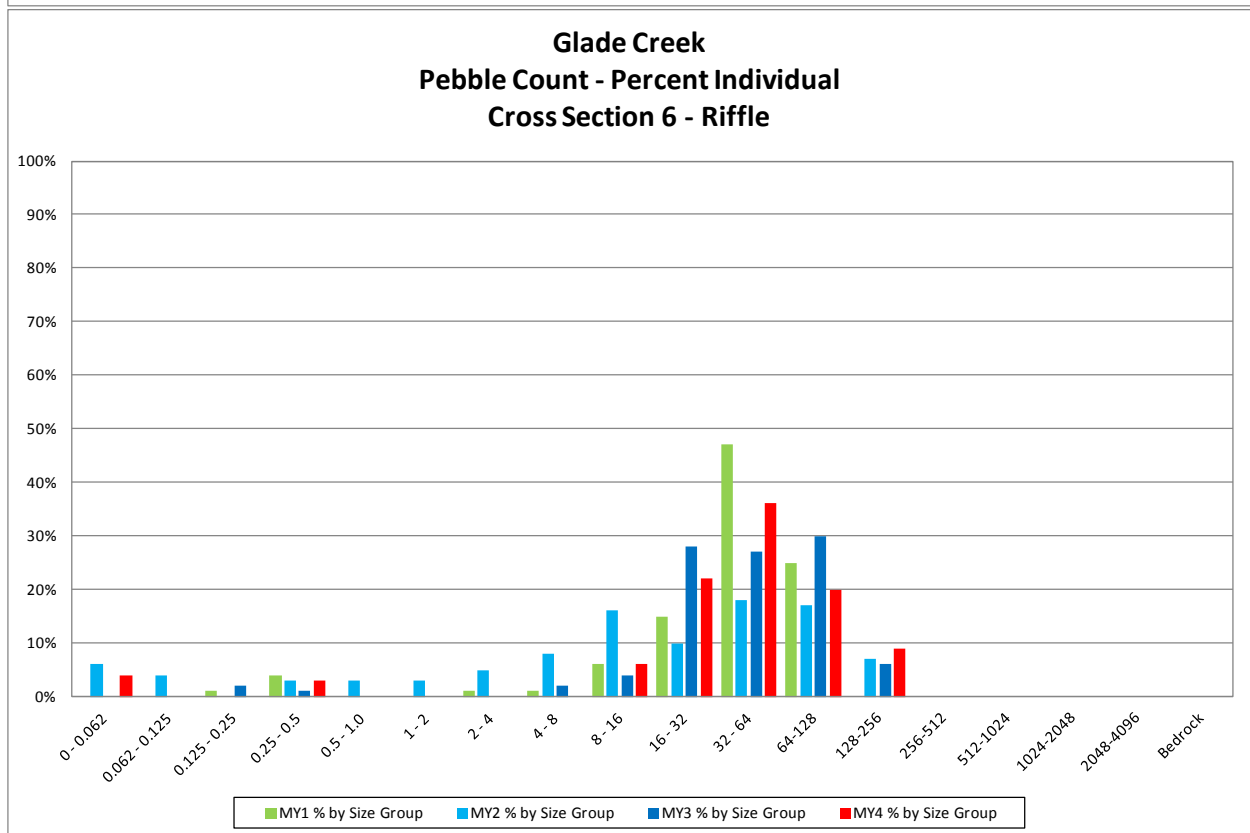
Glade Creek			
Cross Section 6 - Riffle			
Monitoring Year - 2014; MY4			
Bed Surface Material Particle Size Class (mm)	Number	% Individual	% Cumulative
0 - 0.062	4	4.0%	4%
0.062 - 0.125	0	0.0%	4%
0.125 - 0.25	0	0.0%	4%
0.25 - 0.5	3	3.0%	7%
0.5 - 1.0	0	0.0%	7%
1 - 2	0	0.0%	7%
2 - 4	0	0.0%	7%
4 - 8	0	0.0%	7%
8 - 16	6	6.0%	13%
16 - 32	22	22.0%	35%
32 - 64	36	36.0%	71%
64-128	20	20.0%	91%
128-256	9	9.0%	100%
256-512	0	0.0%	100%
512-1024	0	0.0%	100%
1024-2048	0	0.0%	100%
2048-4096	0	0.0%	100%
Bedrock	0	0.0%	100%
Total	100	100%	100%
		Summary Data	
		D50	43
		D84	90
		D95	160

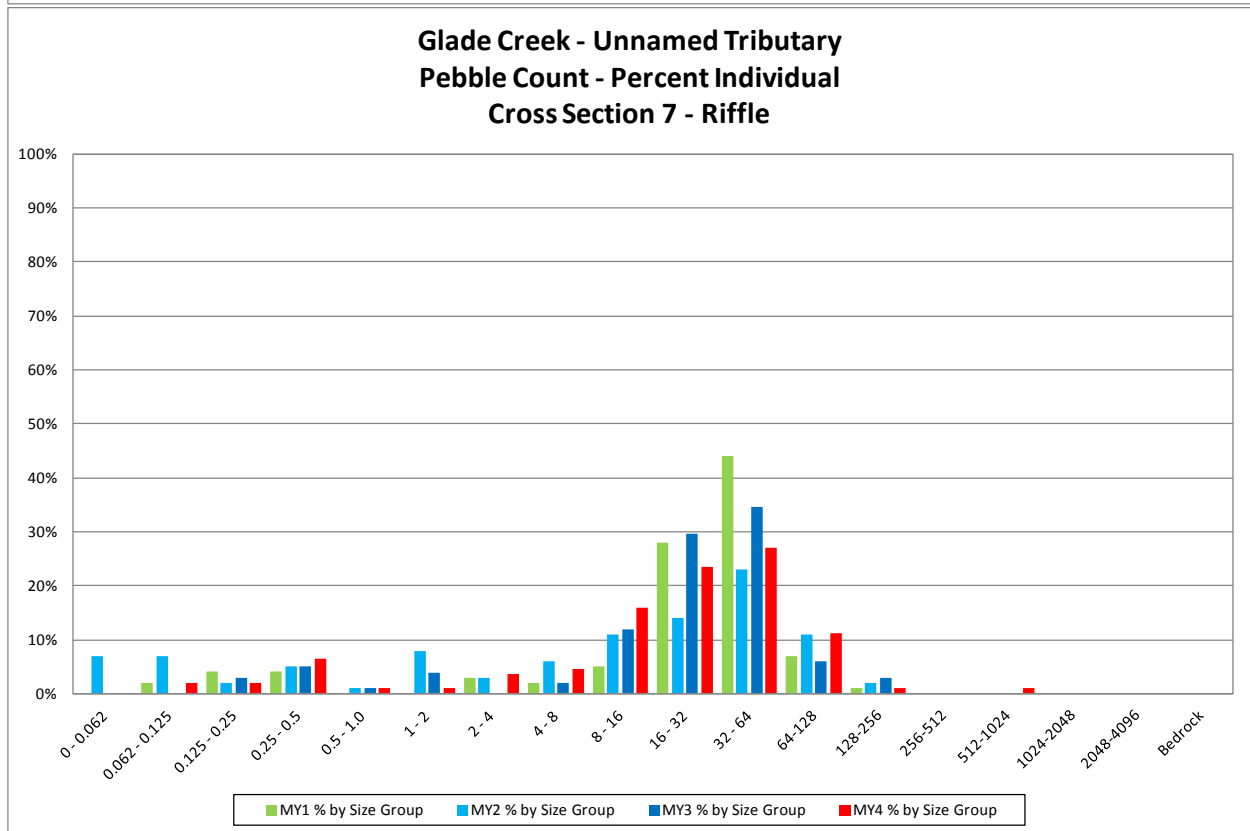
Glade Creek			
Cross Section 7 - Riffle			
Monitoring Year - 2014; MY4			
Bed Surface Material Particle Size Class (mm)	Number	% Individual	% Cumulative
0 - 0.062	0	0.0%	0%
0.062 - 0.125	2	1.9%	2%
0.125 - 0.25	2	1.9%	4%
0.25 - 0.5	7	6.5%	10%
0.5 - 1.0	1	0.9%	11%
1 - 2	1	0.9%	12%
2 - 4	4	3.7%	16%
4 - 8	5	4.7%	21%
8 - 16	17	15.9%	36%
16 - 32	25	23.4%	60%
32 - 64	29	27.1%	87%
64-128	12	11.2%	98%
128-256	1	0.9%	99%
256-512	0	0.0%	99%
512-1024	1	0.9%	100%
1024-2048	0	0.0%	100%
2048-4096	0	0.0%	100%
Bedrock	0	0.0%	100%
Total	107	100%	100%
		Summary Data	
		D50	25
		D84	59
		D95	86
