**Glade Creek
Stream Restoration
NCEEP Project Number: 854
Monitoring Contract Number: D08033S
Monitoring Year 4
2014 Draft Report**

**Submitted to
North Carolina Ecosystem Enhancement Program
North Carolina Department of Environment and Natural Resources
January 2015**

Glade Creek Stream Restoration 2014 Monitoring Report (MY 4)

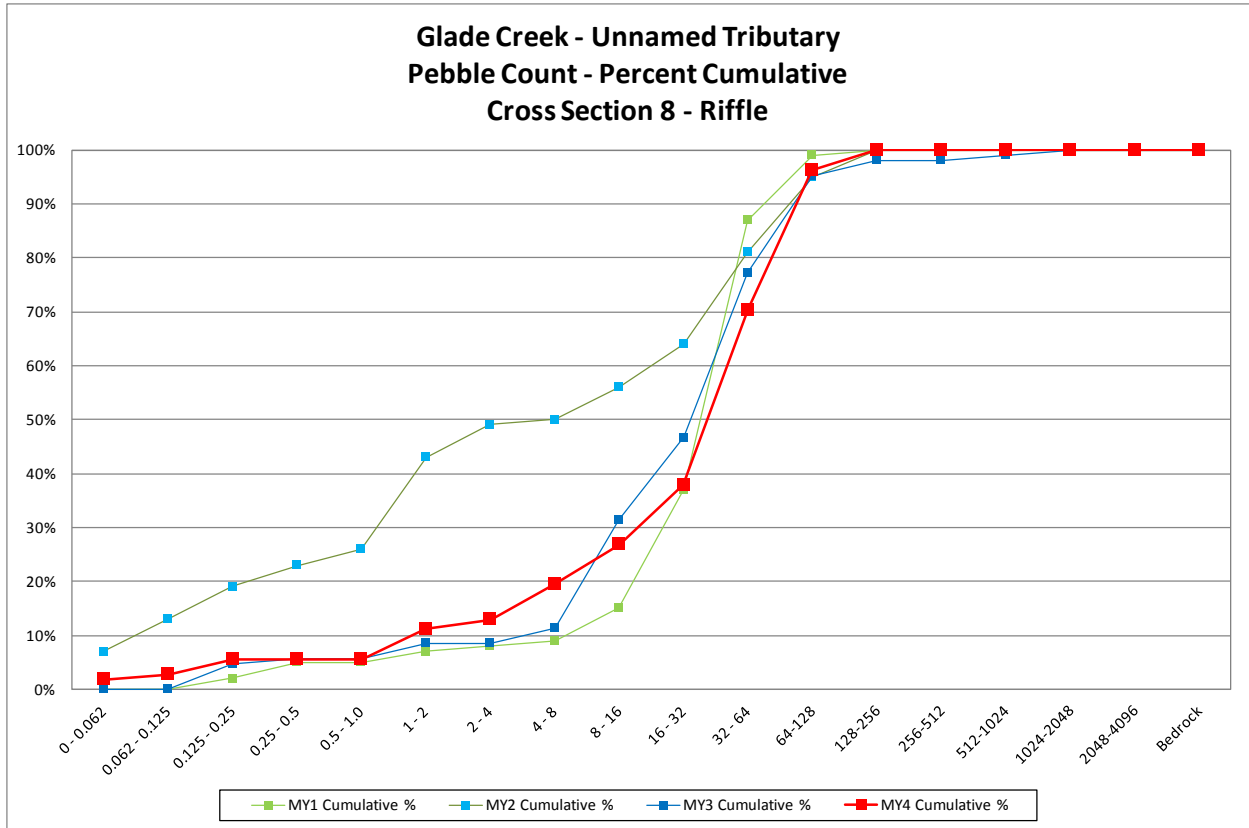
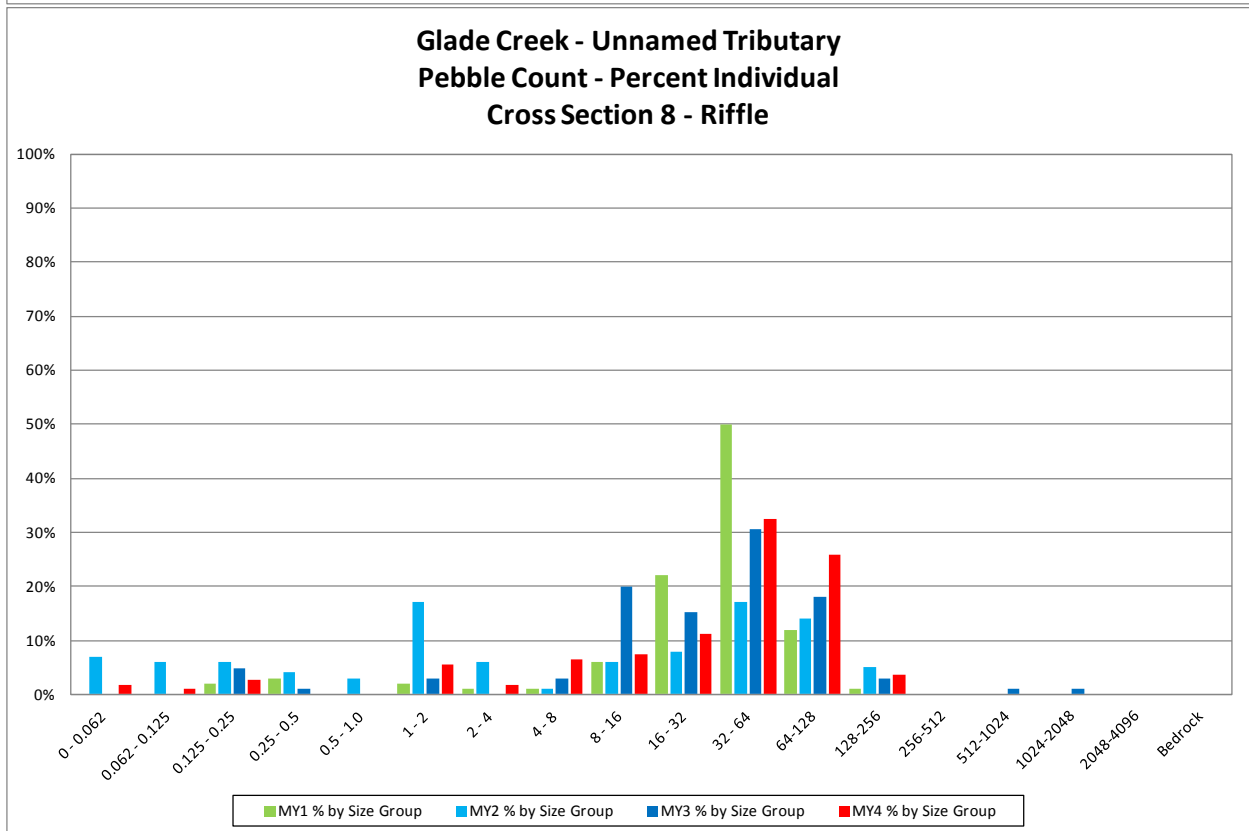
Glade Creek			
Cross Section 8 - Riffle			
Monitoring Year - 2014; MY4			
Bed Surface Material Particle Size Class (mm)	Number	% Individual	% Cumulative
0 - 0.062	2	1.9%	2%
0.062 - 0.125	1	0.9%	3%
0.125 - 0.25	3	2.8%	6%
0.25 - 0.5	0	0.0%	6%
0.5 - 1.0	0	0.0%	6%
1 - 2	6	5.6%	11%
2 - 4	2	1.9%	13%
4 - 8	7	6.5%	19%
8 - 16	8	7.4%	27%
16 - 32	12	11.1%	38%
32 - 64	35	32.4%	70%
64-128	28	25.9%	96%
128-256	4	3.7%	100%
256-512	0	0.0%	100%
512-1024	0	0.0%	100%
1024-2048	0	0.0%	100%
2048-4096	0	0.0%	100%
Bedrock	0	0.0%	100%
Total	108	100%	100%
		Summary Data	
		D50	41
		D84	81
		D95	120
