**FINAL
ANNUAL MONITORING REPORT
GOLDSBORO HOUSING AUTHORITY**

**STREAM RESTORATION
WAYNE COUNTY, NORTH CAROLINA
(EEP Project Number 145)**

Monitoring Year 1 of 5 (2009)

Prepared by:
Axiom Environmental, Inc.
20 Enterprise Street, Suite 7
Raleigh, North Carolina 27607

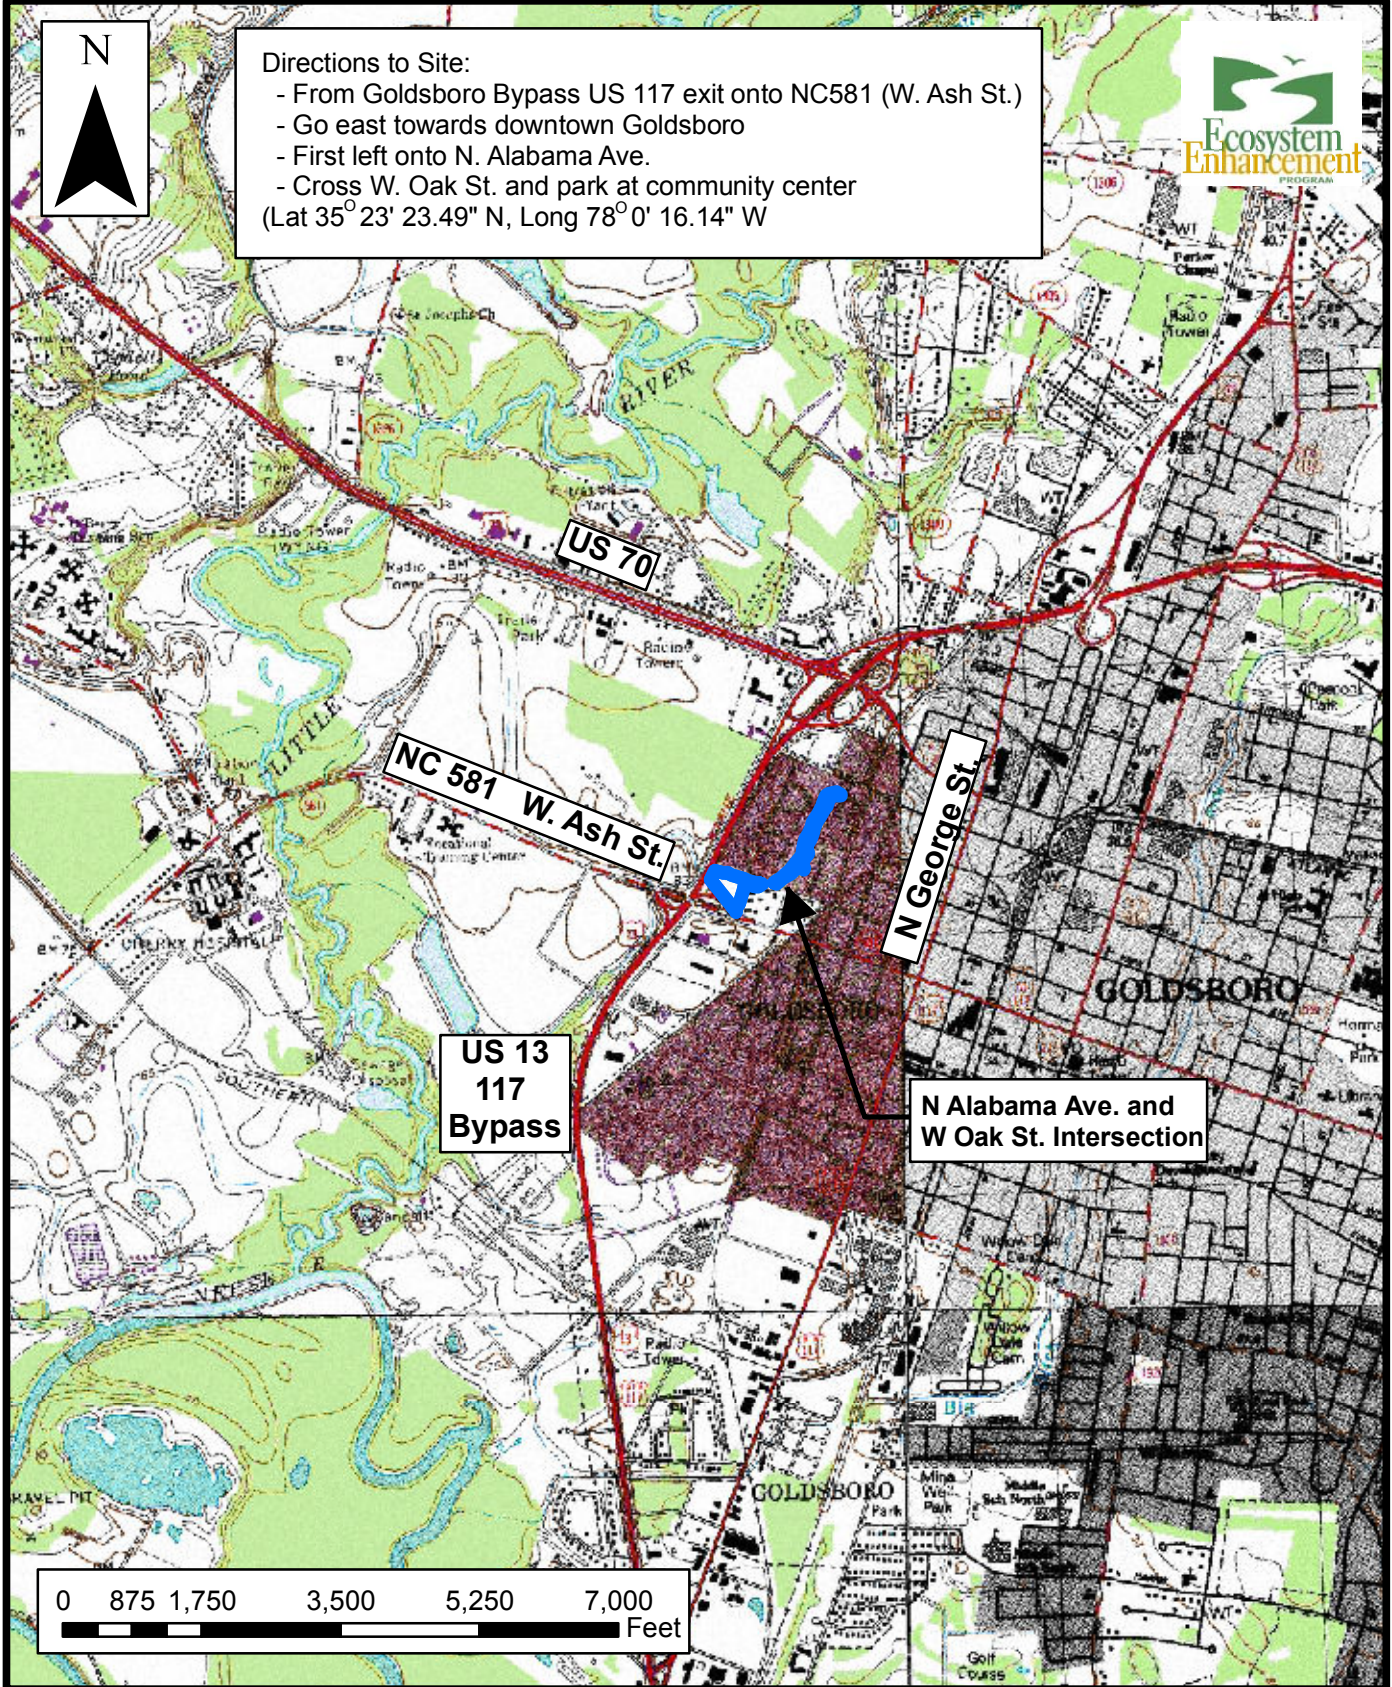
SITE LOCATION
GOLDSBORO HOUSING AUTHORITY - EEP #145
STREAM RESTORATION PROJECT
 Wayne County, North Carolina

Figure 1. Site Location	Appendix A
Figure 2. Monitoring Plan View	Appendix A

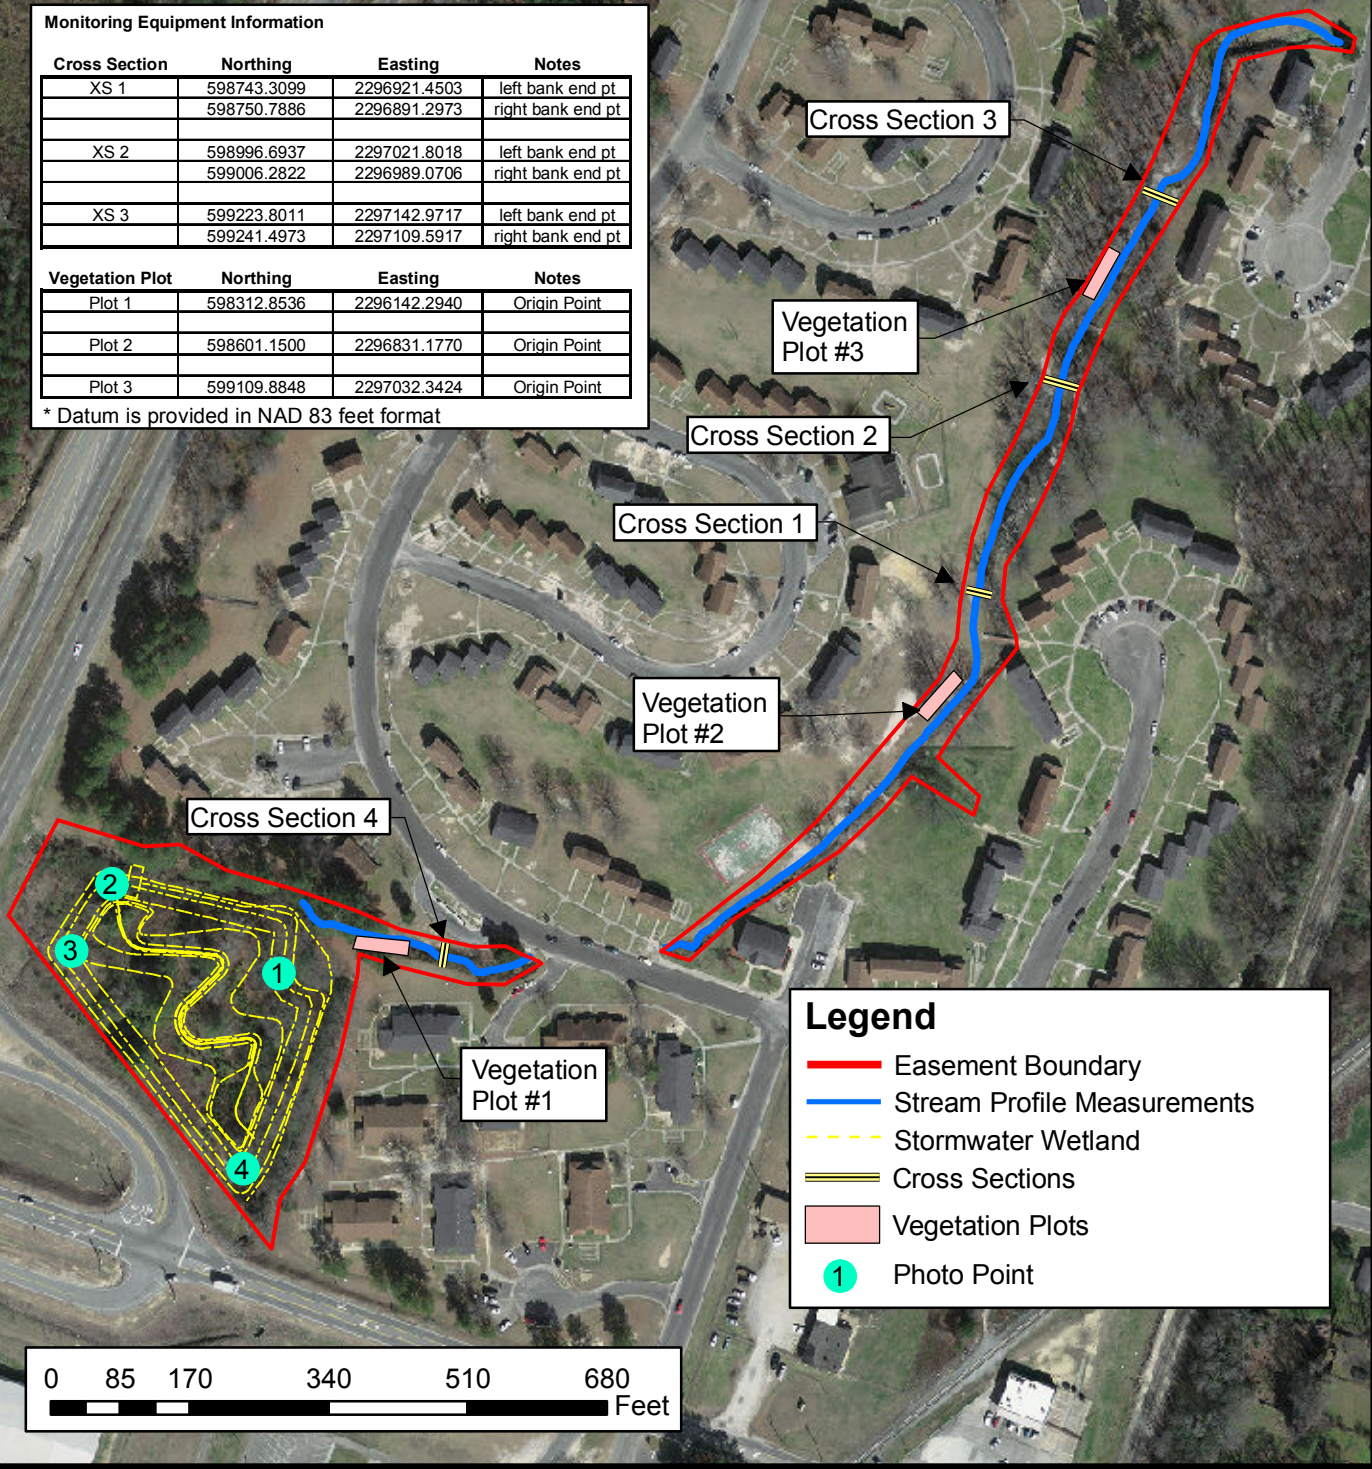
Figure 2. Monitoring Plan

Vegetation Plot	Northing	Easting	Notes
Plot 1	598312.8536	2296142.2940	Origin Point
Plot 2	598601.1500	2296831.1770	Origin Point
Plot 3	599109.8848	2297032.3424	Origin Point

Following Site construction, three plots (20-meters by 5-meters) were established and monumented with metal rebar at all plot corners. Plots were surveyed in September 2009 for the year 1 (2009) monitoring season. Sampling was conducted as outlined in the *CVS-EEP Protocol for Recording Vegetation, Version 4.0* (Lee et al. 2006) (<http://cvs.bio.unc.edu/methods.htm>); results are included in Appendix C. The taxonomic standard for vegetation used for this document was *Flora of the Carolinas, Virginia, Georgia, and Surrounding Areas* (Weakley 2007). The locations of vegetation monitoring plots are depicted on Figure 2 in Appendix A.

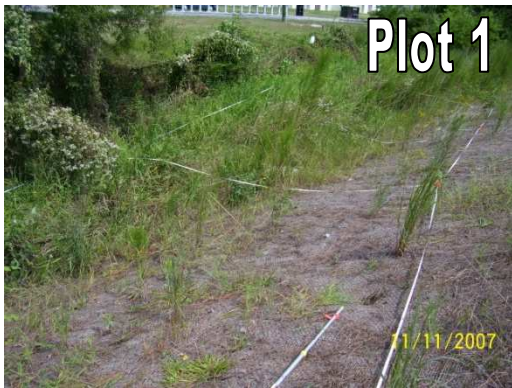
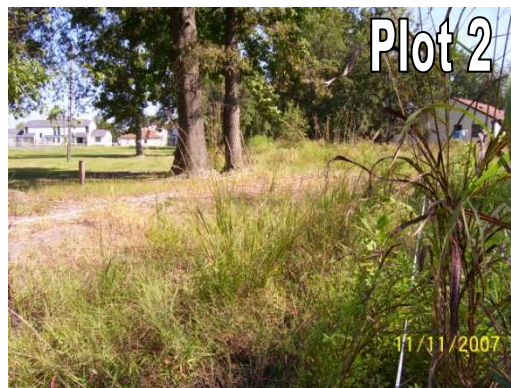
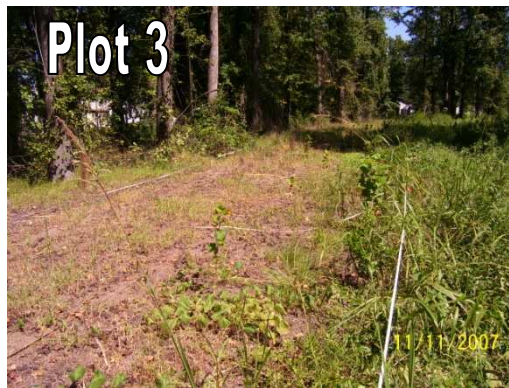
**Goldsboro Housing Authority
 Year 1 (2009) Annual Monitoring
 Vegetation Plot Photos (taken September 2009)**

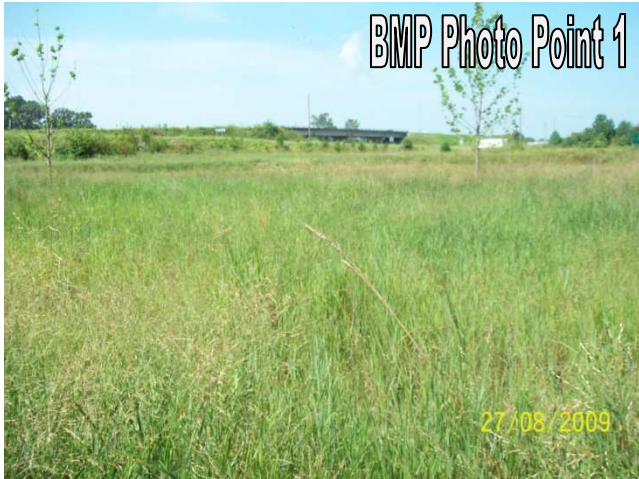
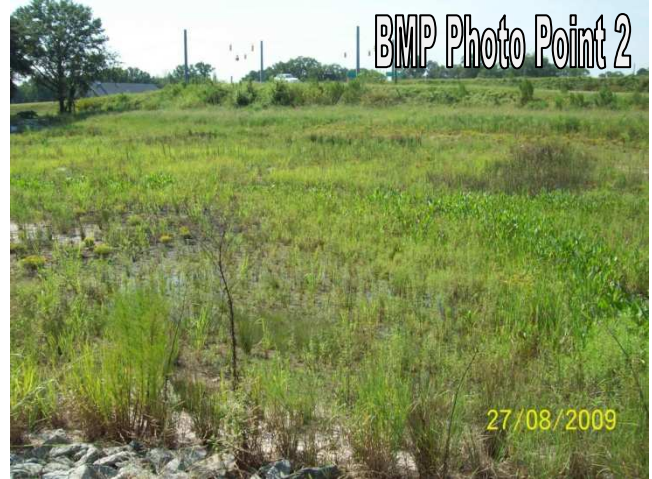
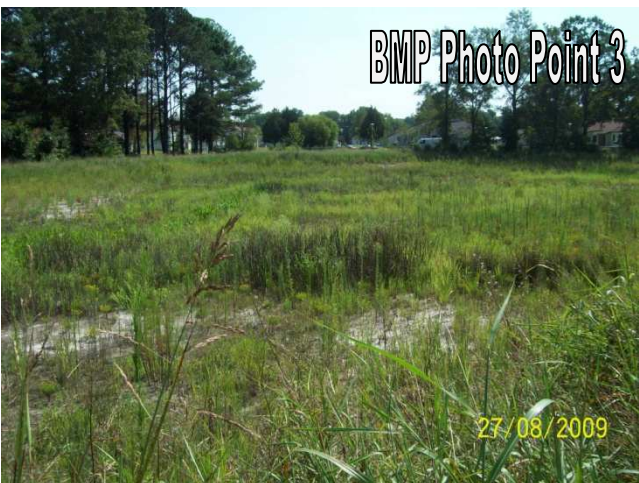
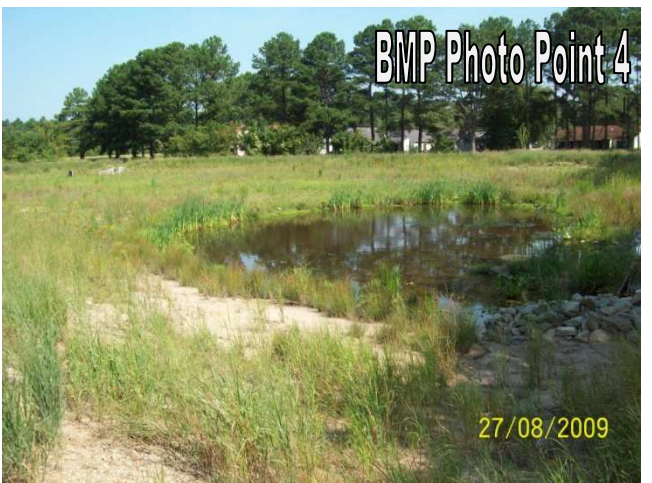
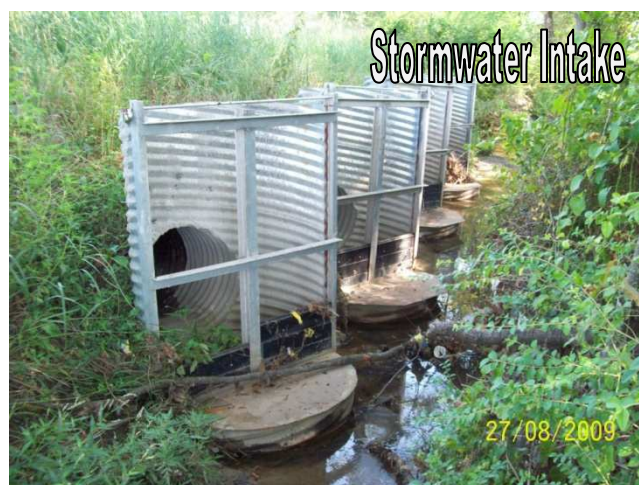
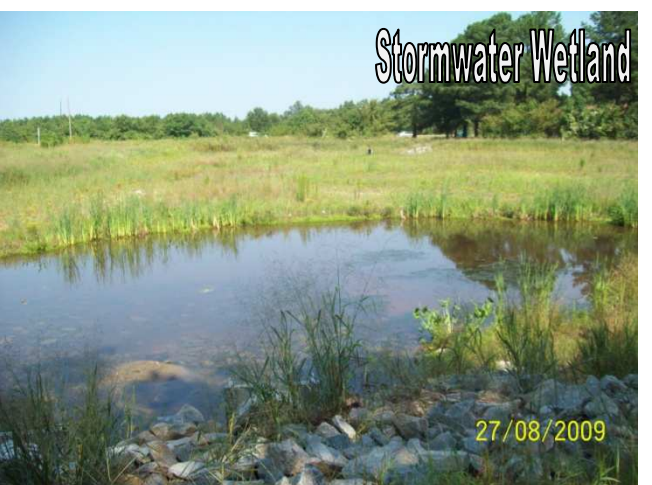
**Goldsboro Housing Authority Stream/BMP Project
(EEP Project Number 145)
Fixed-Station Photographs
taken August 2009**
